SUSITNA-WATANA HYDROELECTRIC PROJECT
 LINEAMENT GROUP 8
 MAP DATA

FIGURE
 A8-2.1

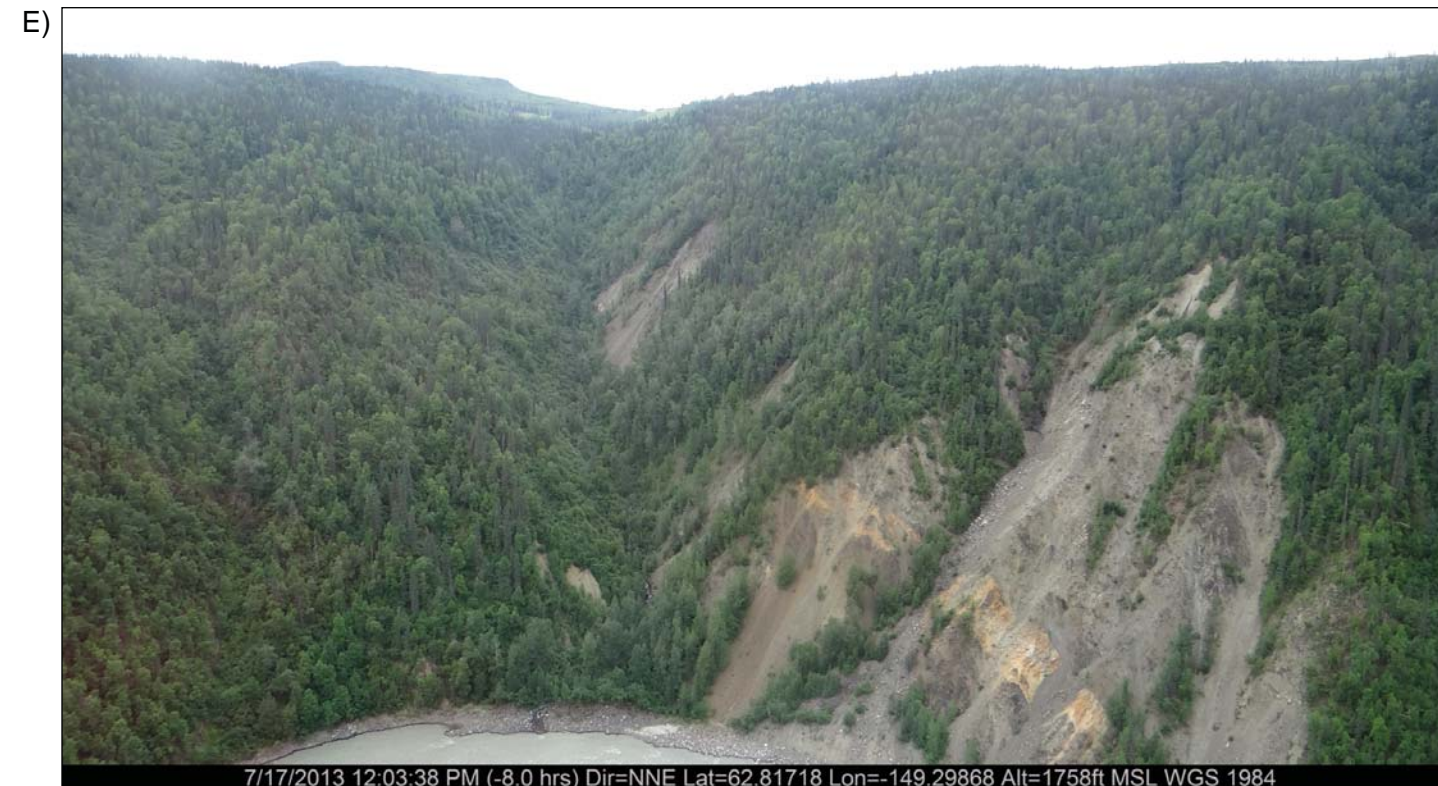
View looking north at north (right) bank of Susitna River showing oxidized mafic dike interpreted by WCC (1982) to not be truncated by the linear drainage.

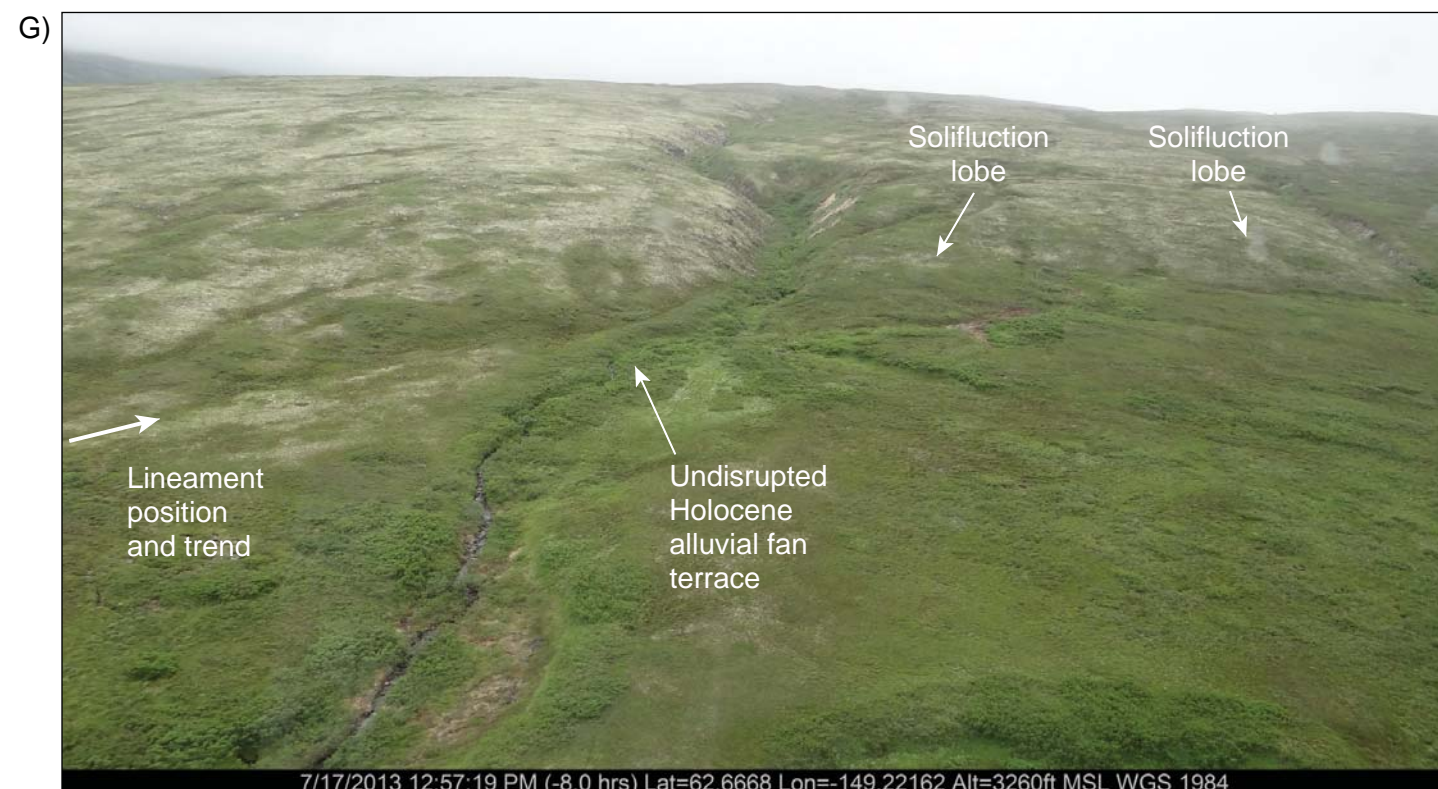
View looking west directly towards 1- to 2-m-high east-facing scarps shown in Photographs F and H. Large arrow points along mapped lineament.

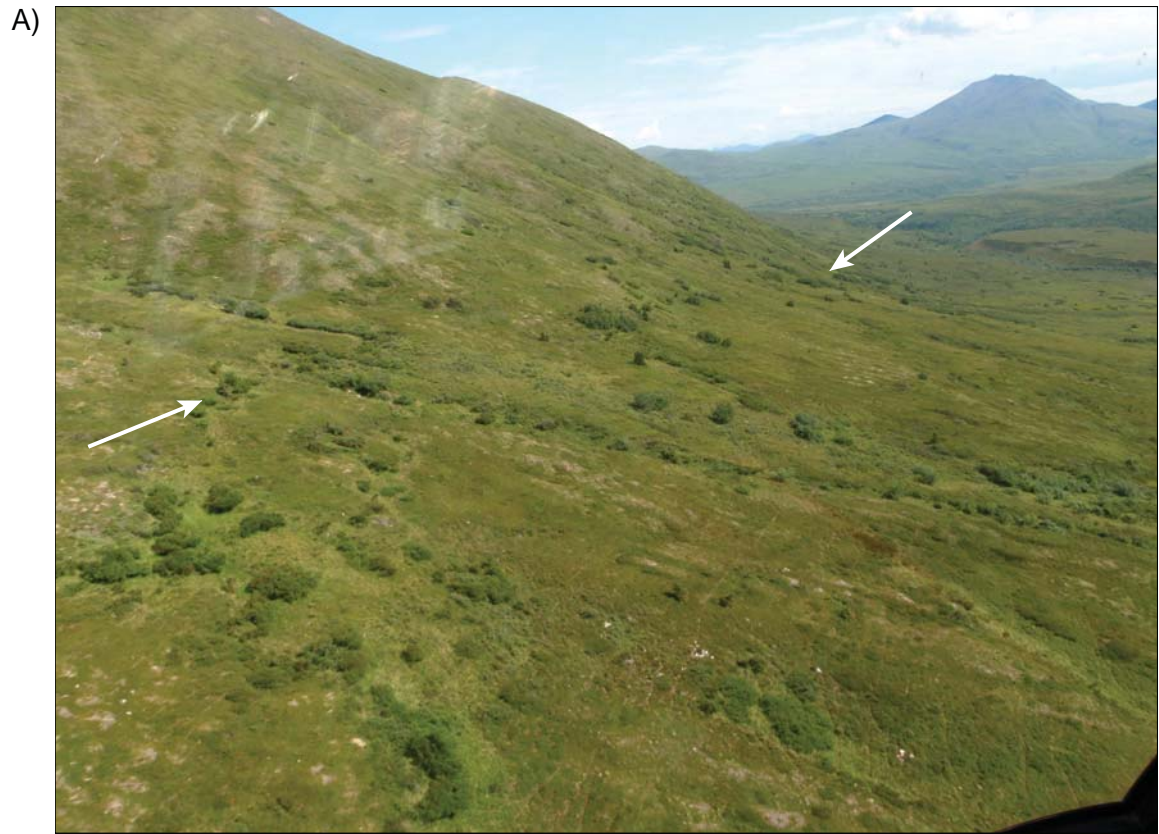
View looking northeasterly along lineaments. Arrows point along trend and position of lineaments.

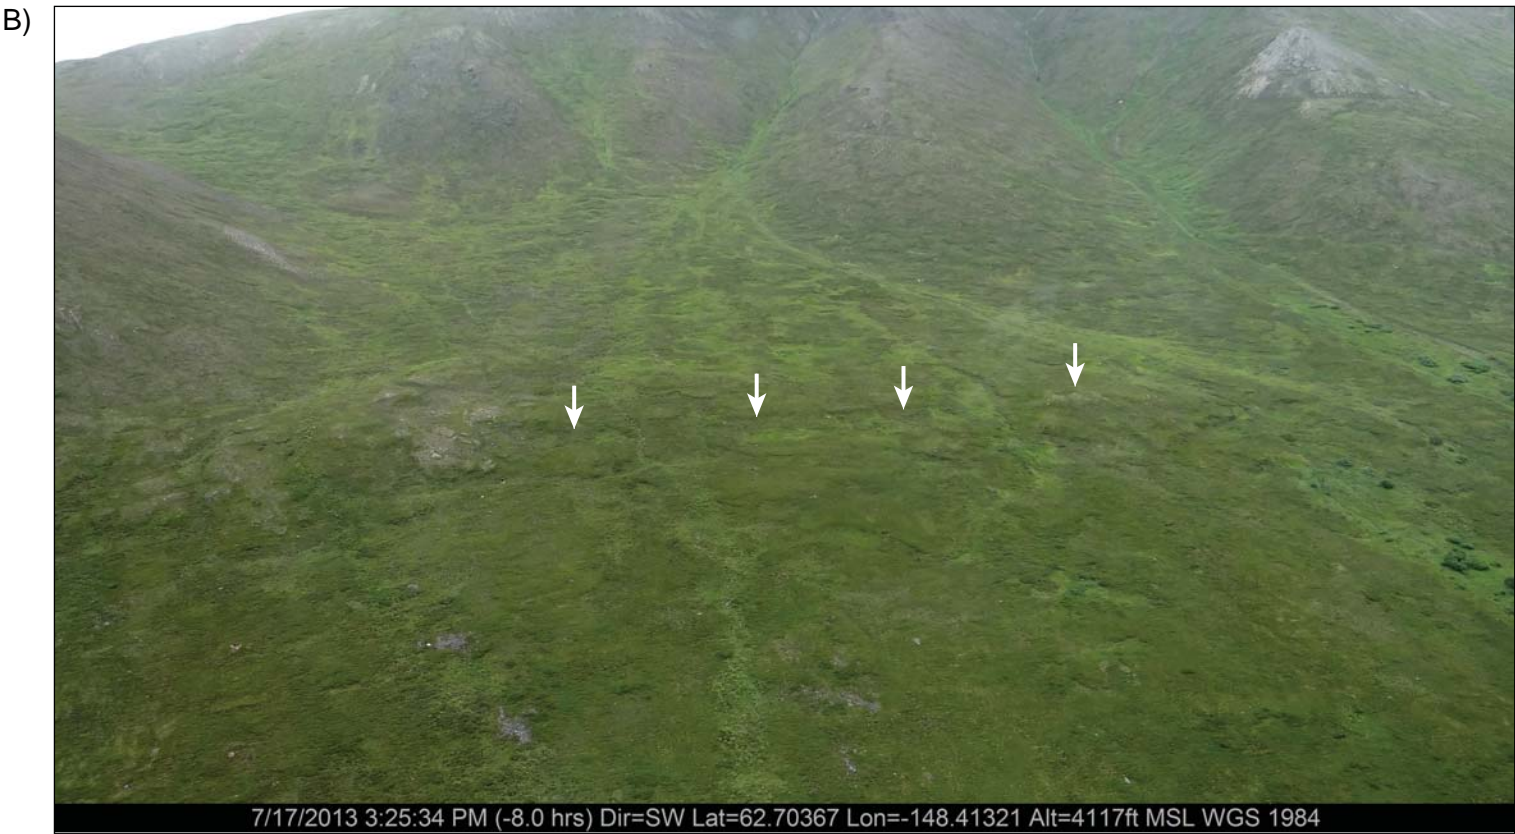
View of lineaments expressed in Quaternary sediment.

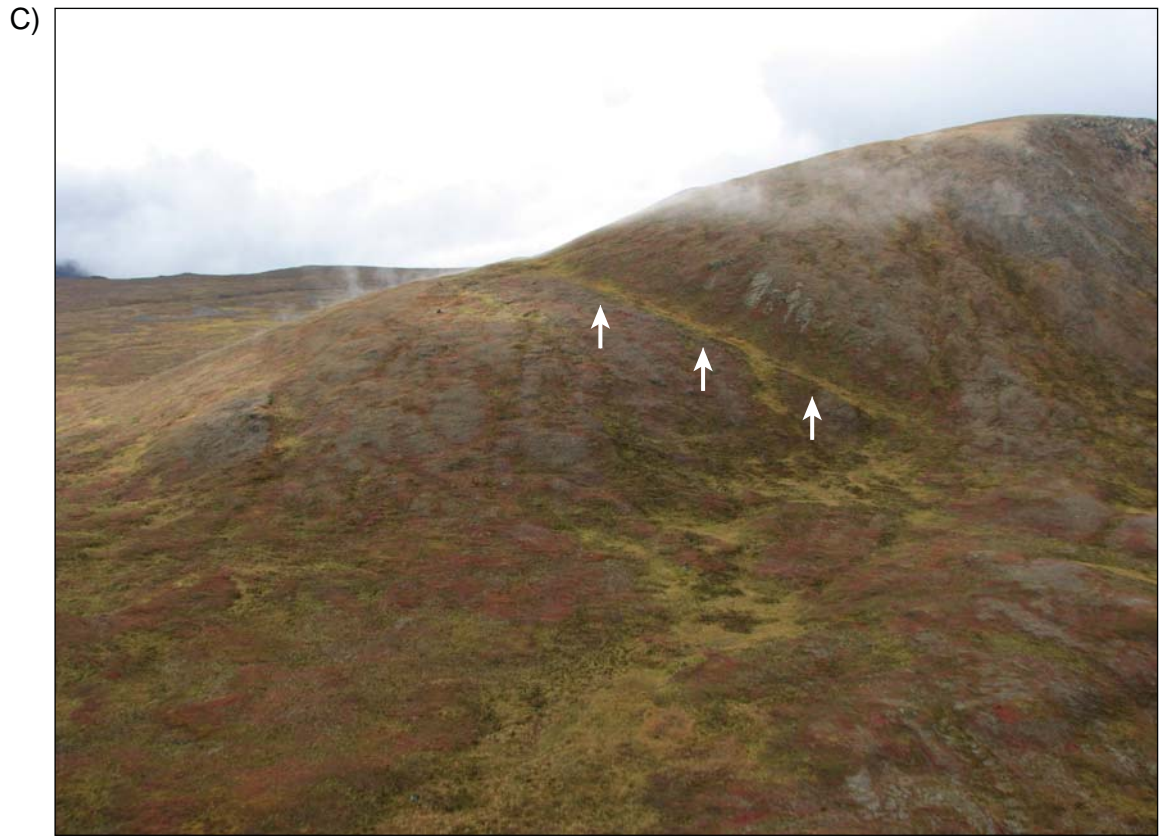
View looking at notch in bedrock with expression of apparent northwesterly dip.

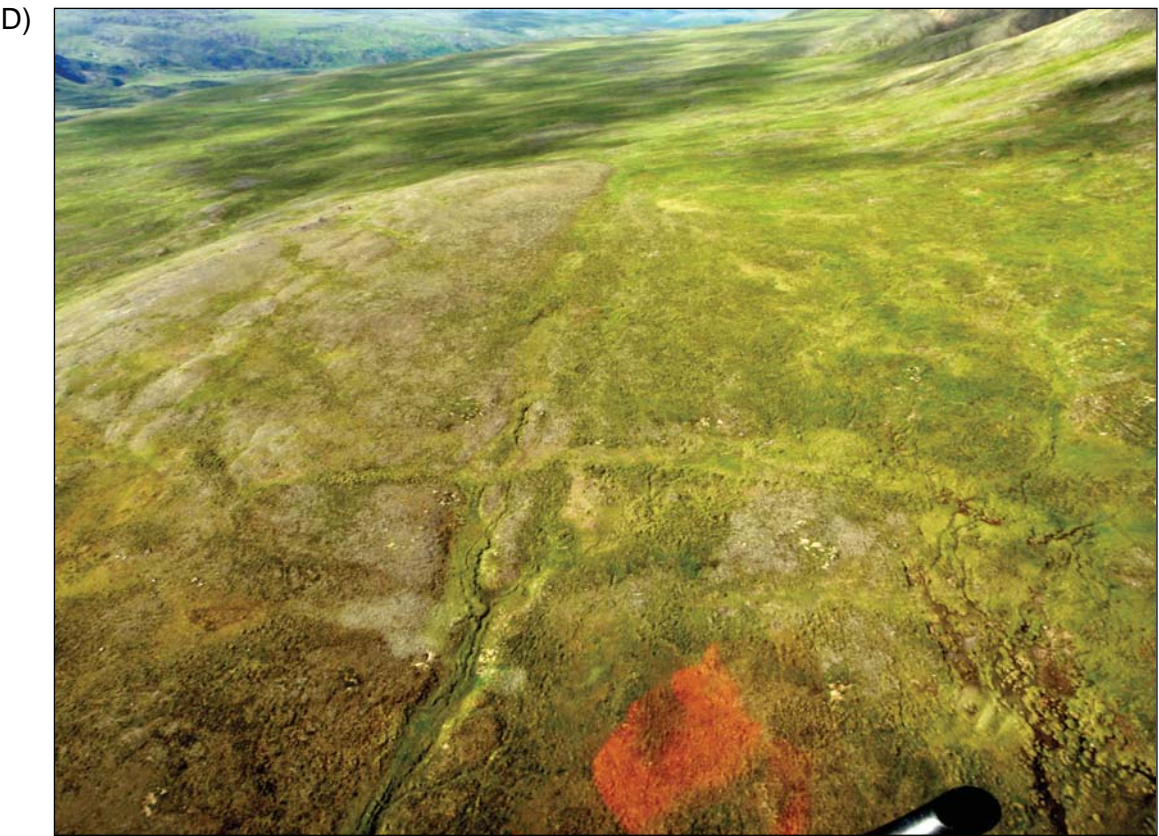
View looking southwesterly along glacially scoured surface.

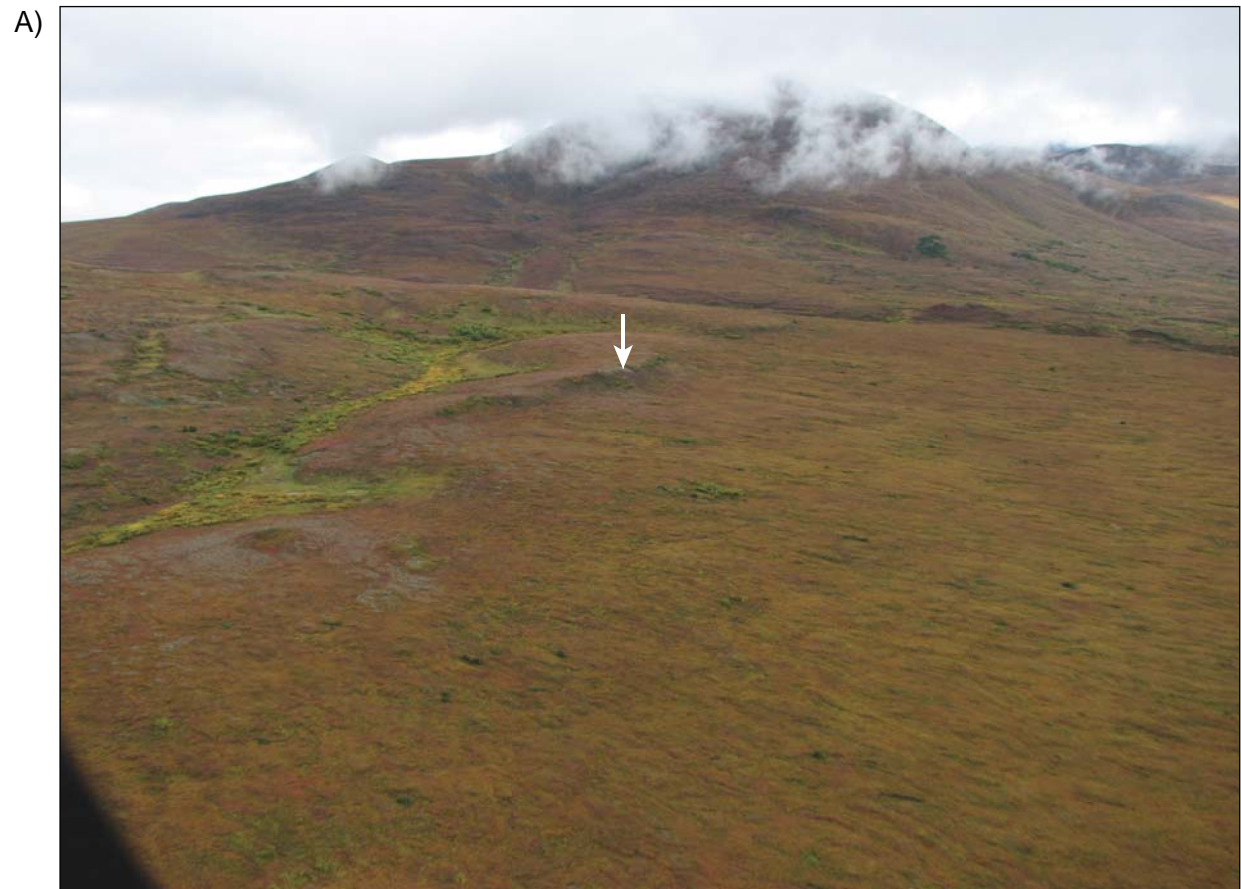
View looking northeast at erosional break-in-slope mapped as an individual lineament. Feature is absent in the background along projection of strike.

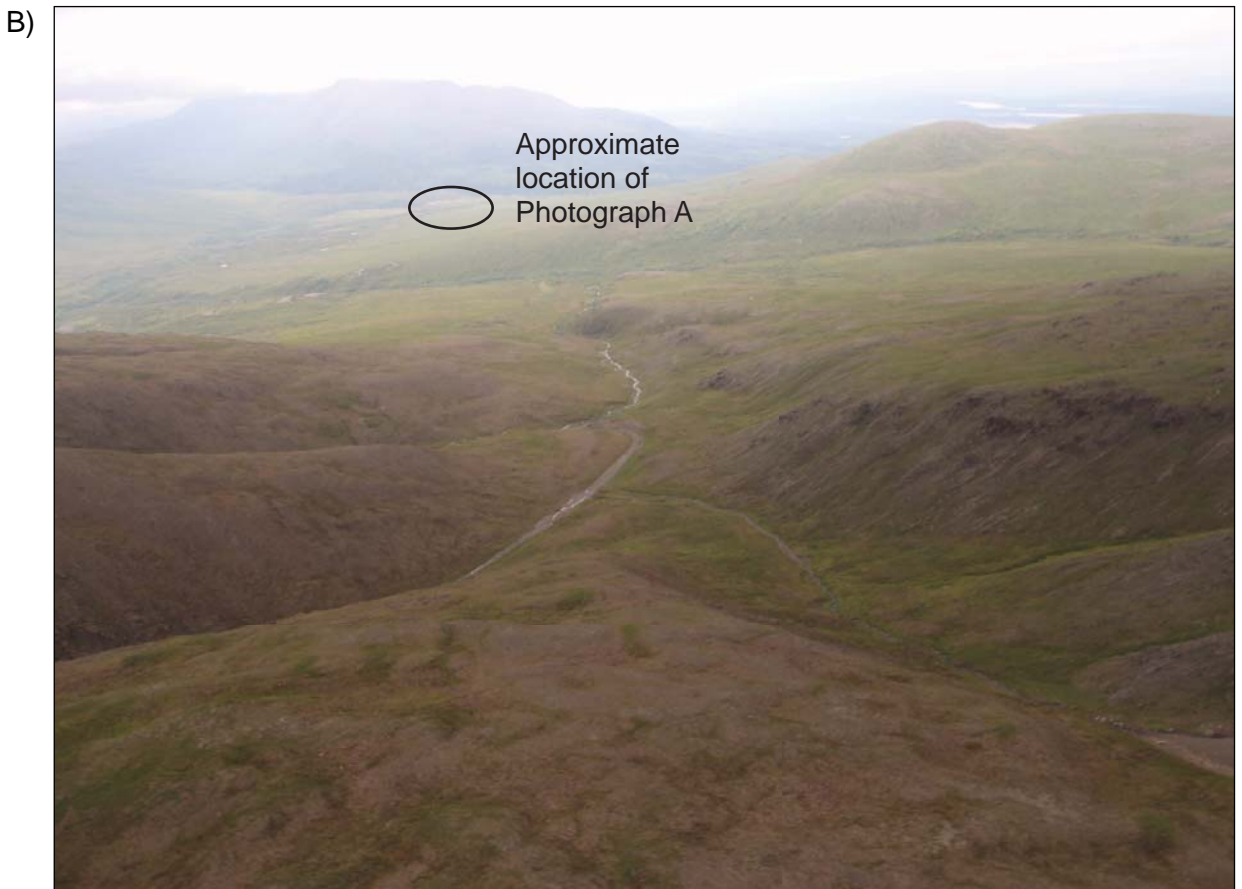
View looking southwest down-valley along lineament geomorphically expressed as linear valley. Very little alluvium has accumulated in the drainage, and glacially sculpted bedrock is shallow.

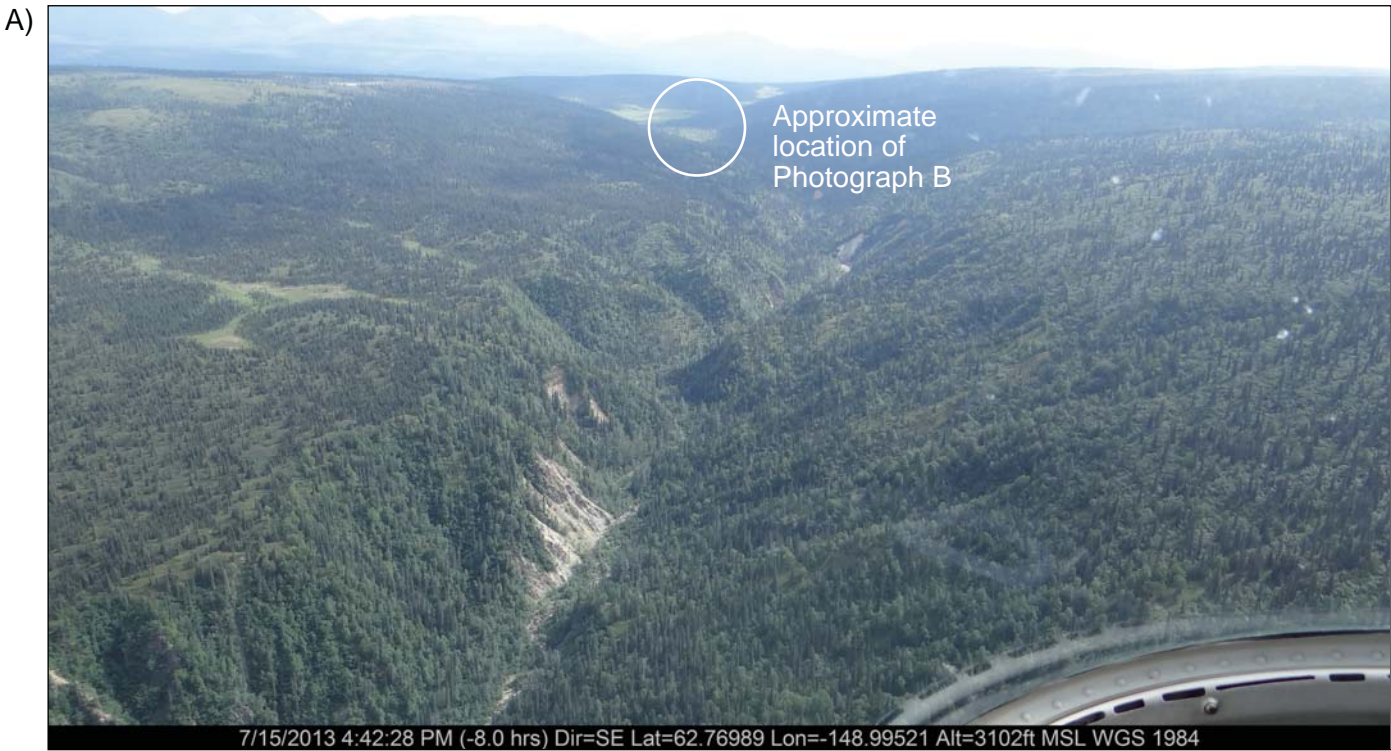
View looking south at linear canyon that is tributary to the Susitna River. Canyon bottom and creek drainage have sinuosity not apparent at smaller scales.

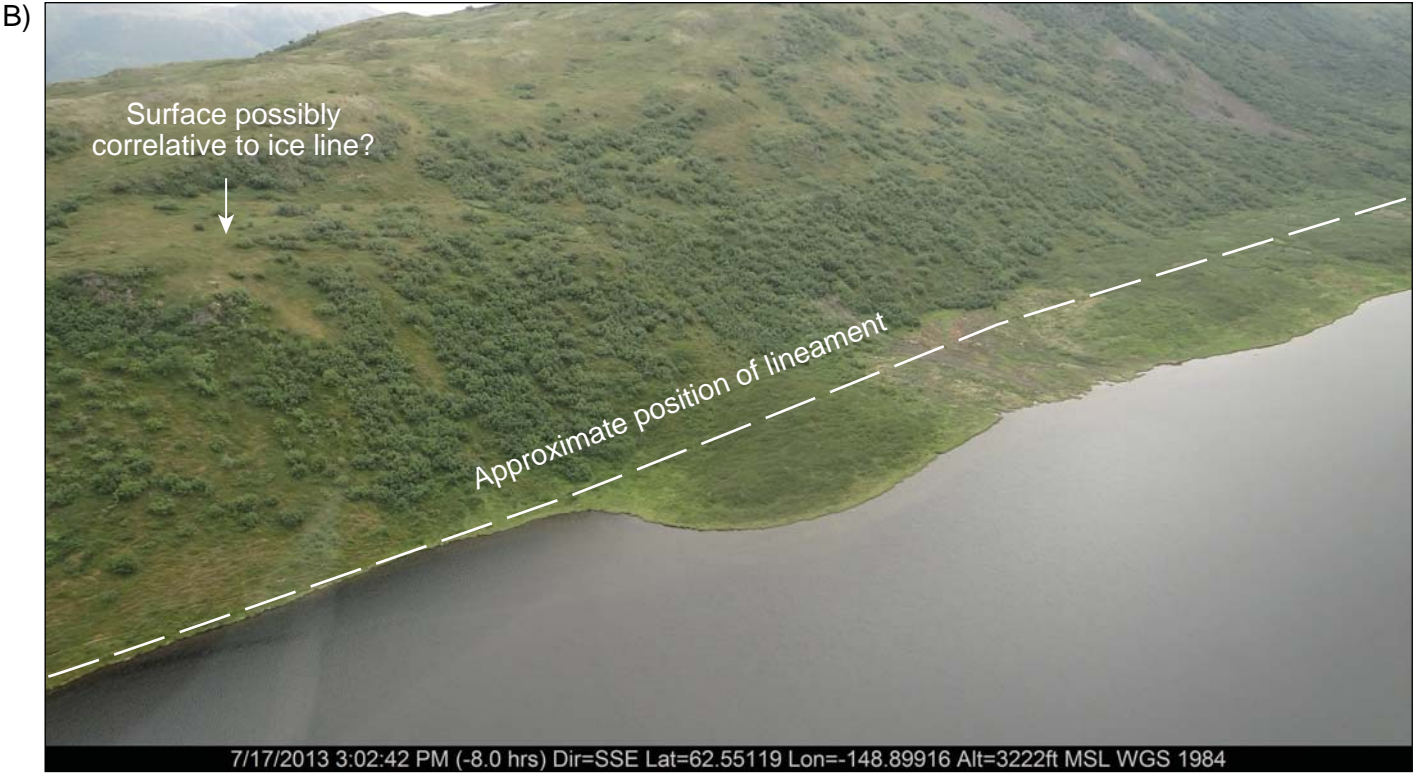
View looking south southwest at lake margin of glacial valley. Lineament was mapped at base of slope, and is not expressed as a scarp-type feature. Apparent colluvium along projection of lineament does not appear offset.

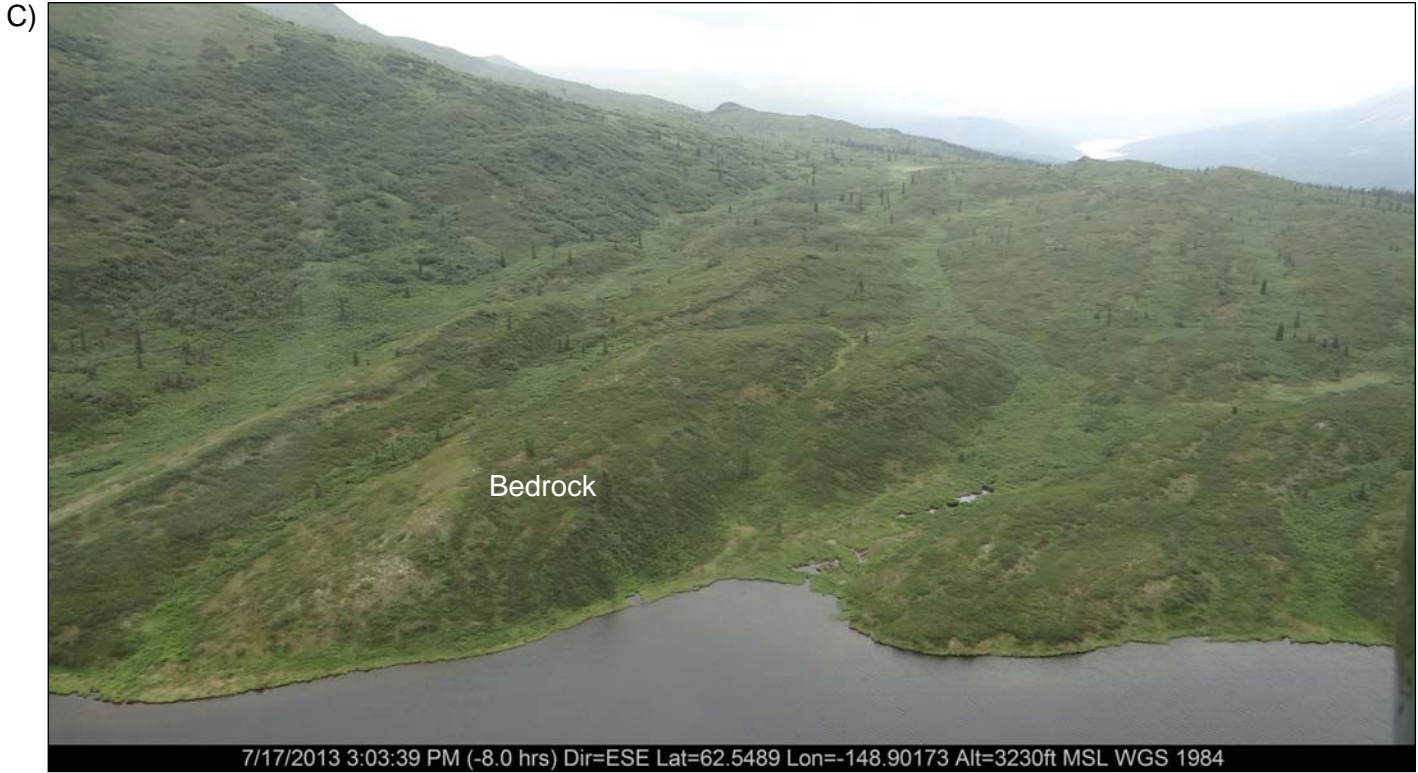
View looking south southeast along glacially-sculpted terrain along which Csejtey (1974) has inferred a fault within the glacial sediment that mantles the bedrock knolls (Figure A17b.1).

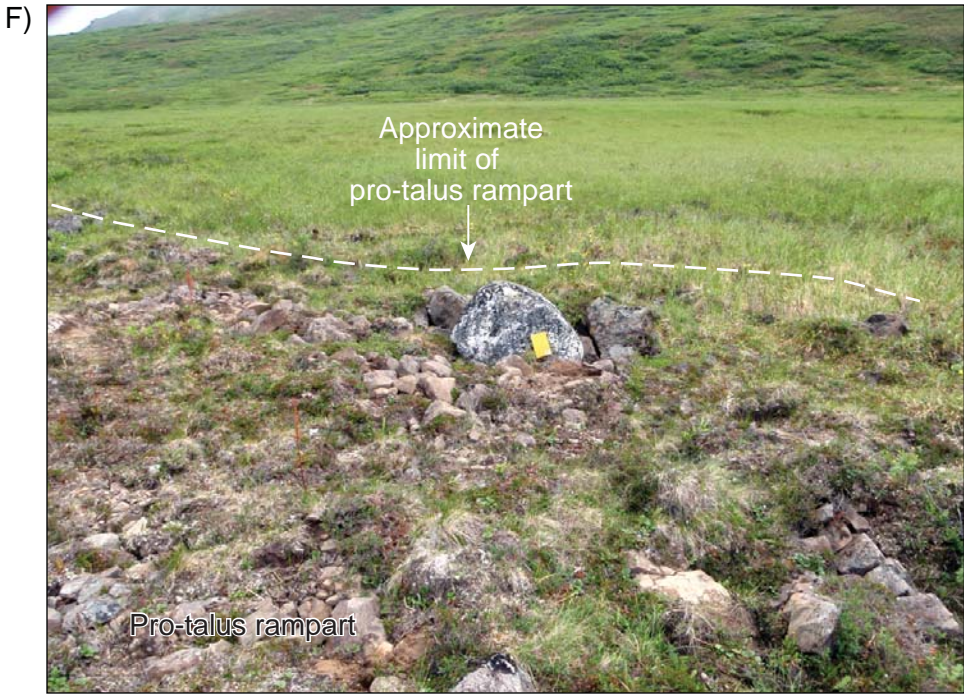
Pro-talus rampart constructed from blocky, frost-shattered volcanic rocks. Photograph is centered on more sub-rounded glacial erratic (granitic) that is not similar to any of the local hillside lithologies. Field notebook is 19 cm tall.

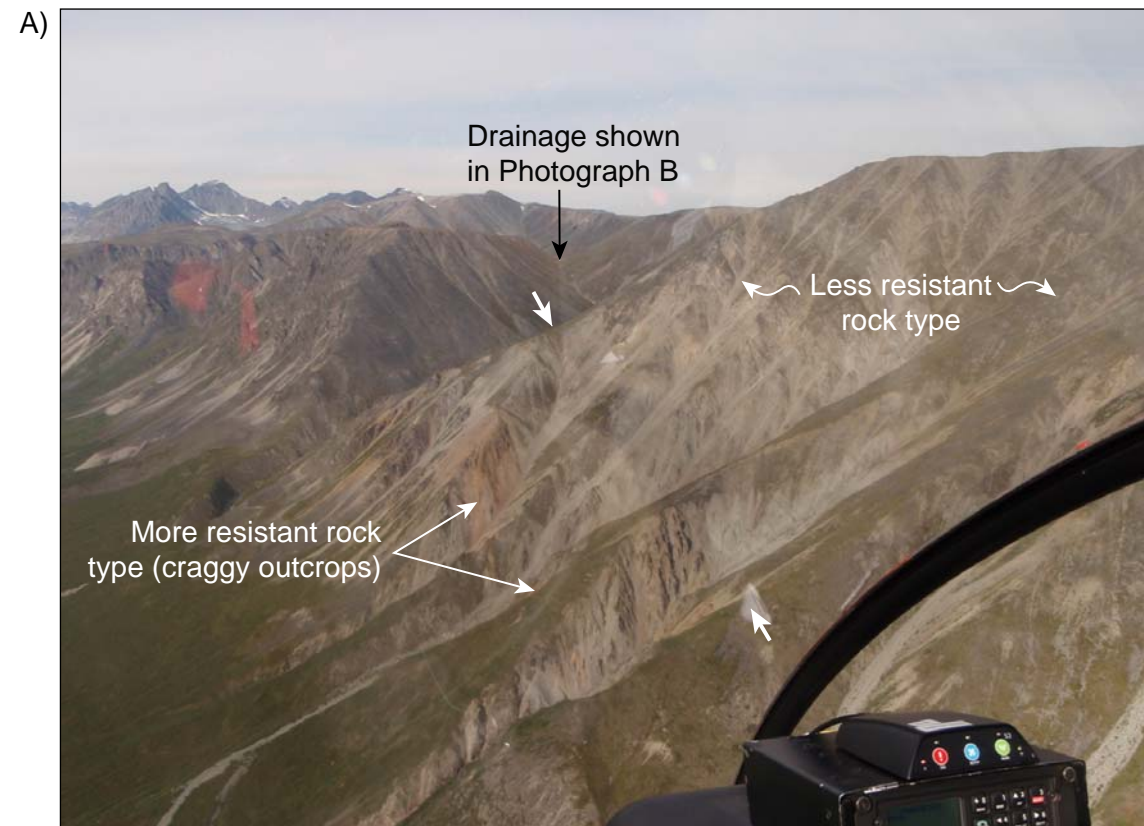
Photograph taken from location A looking southwest along apparent rock type contrast (contact?) and towards mapped lineaments in steep-walled, v-shaped, linear drainage. Arrows point along apparent contact between less-resistant rock on the north and more resistant and craggy outcrops on the south.

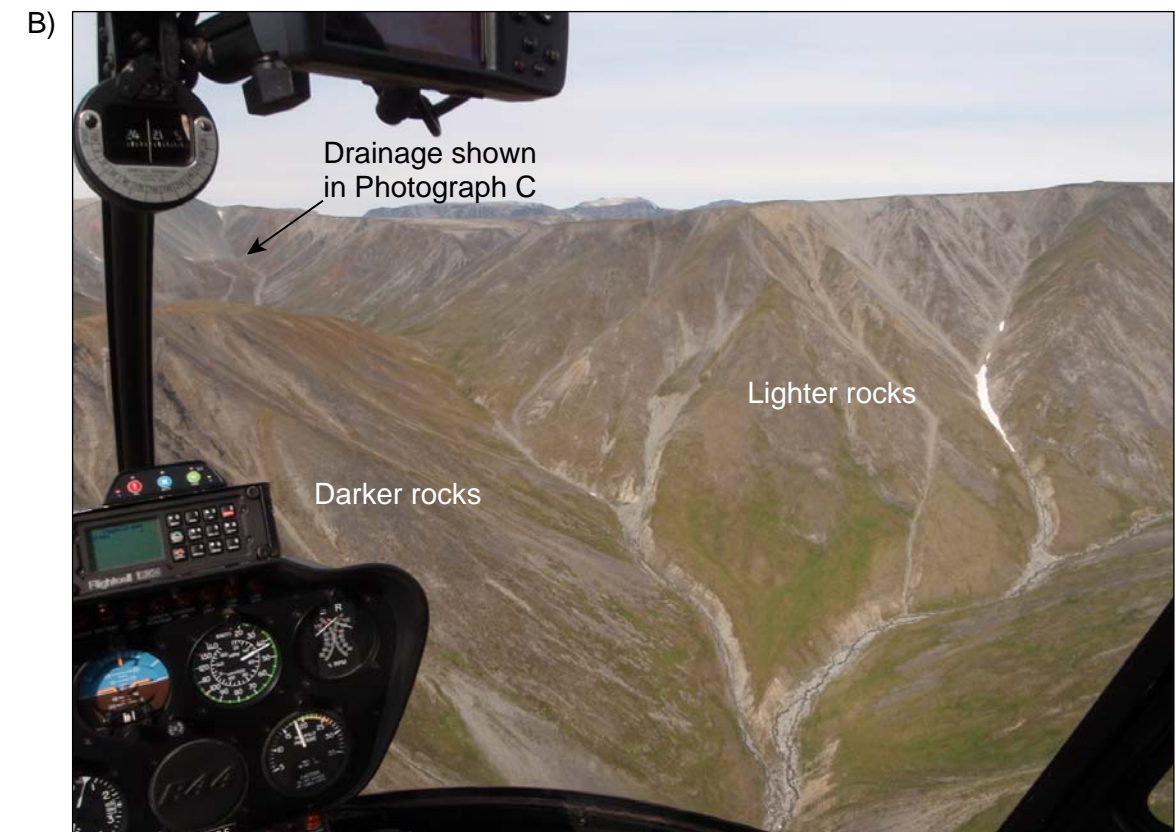
Photograph taken from location B looking west along mapped lineaments and apparent rock contact in steep-walled, v-shaped, linear drainages.

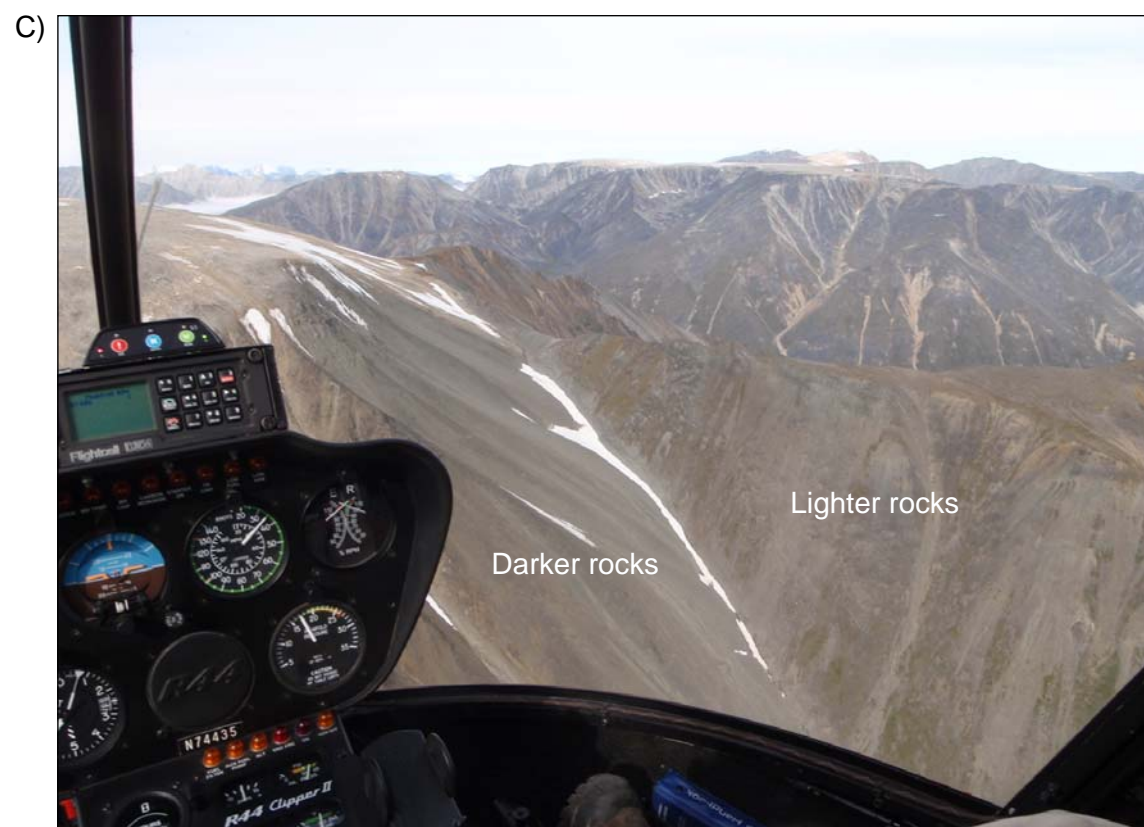
Photograph taken from location C looking west at head of steep-walled, v-shaped, linear drainage where mapped lineaments correspond to apparent rock contact.

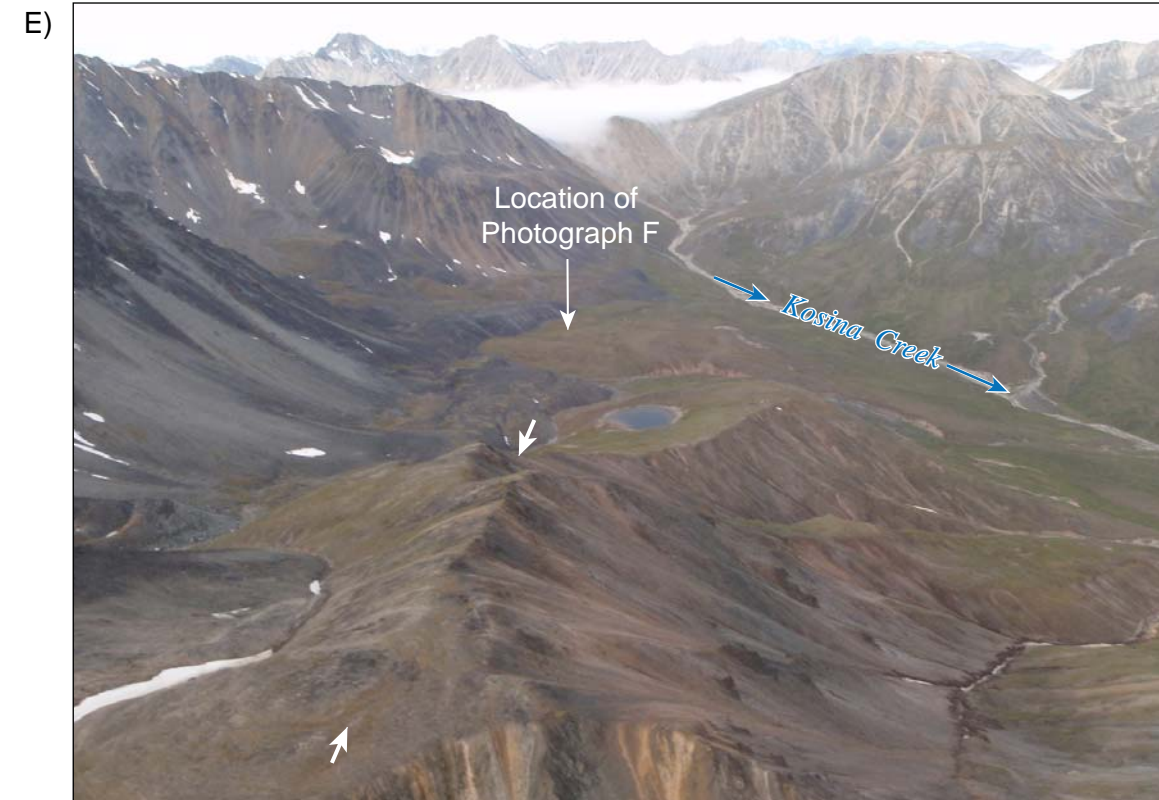
Photograph from location E looking southwest down the ridgeline shown in Photograph D. View is 180 degrees from that in Photograph D. Note presence of rock glacier and glacial deposits in valley bottom. Arrows point along apparent contact.

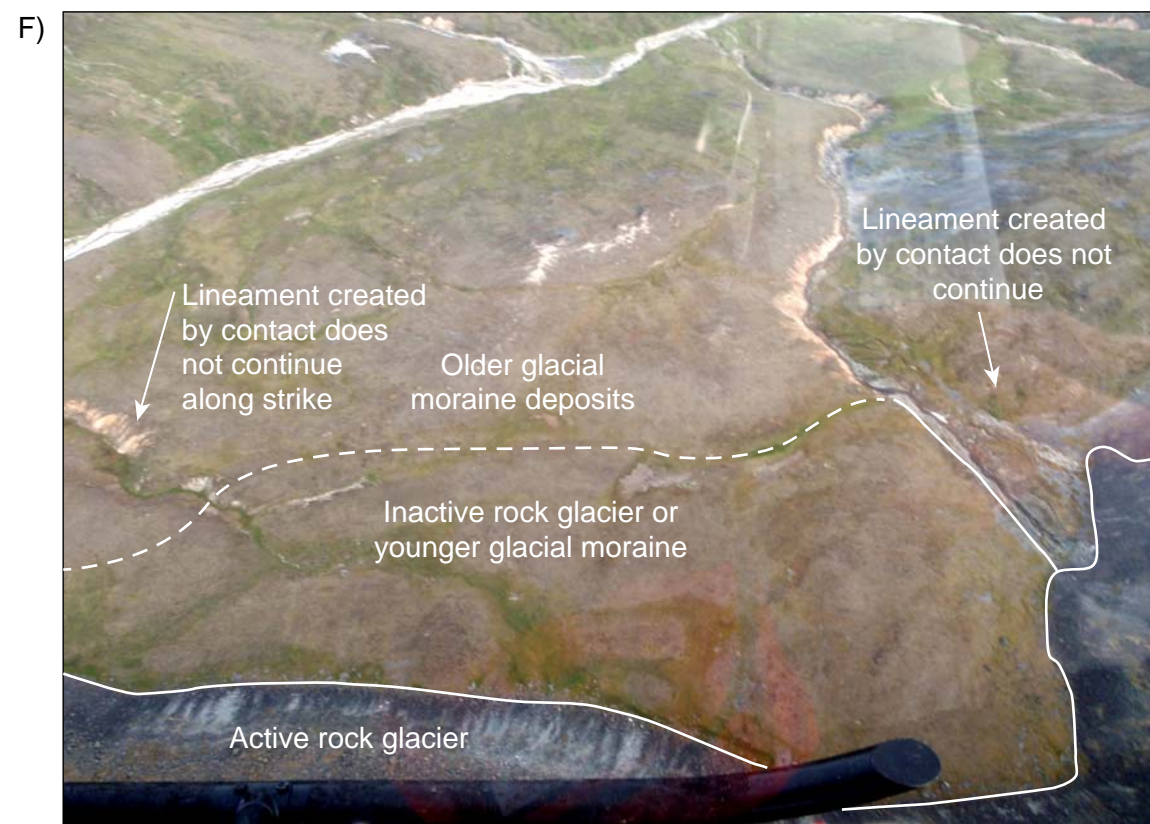
Photograph looking northwest from location F showing apparently undeformed rock glacier and/or glacial deposits along strike of the mapped lineaments and apparent rock contact shown in Photographs A through D.

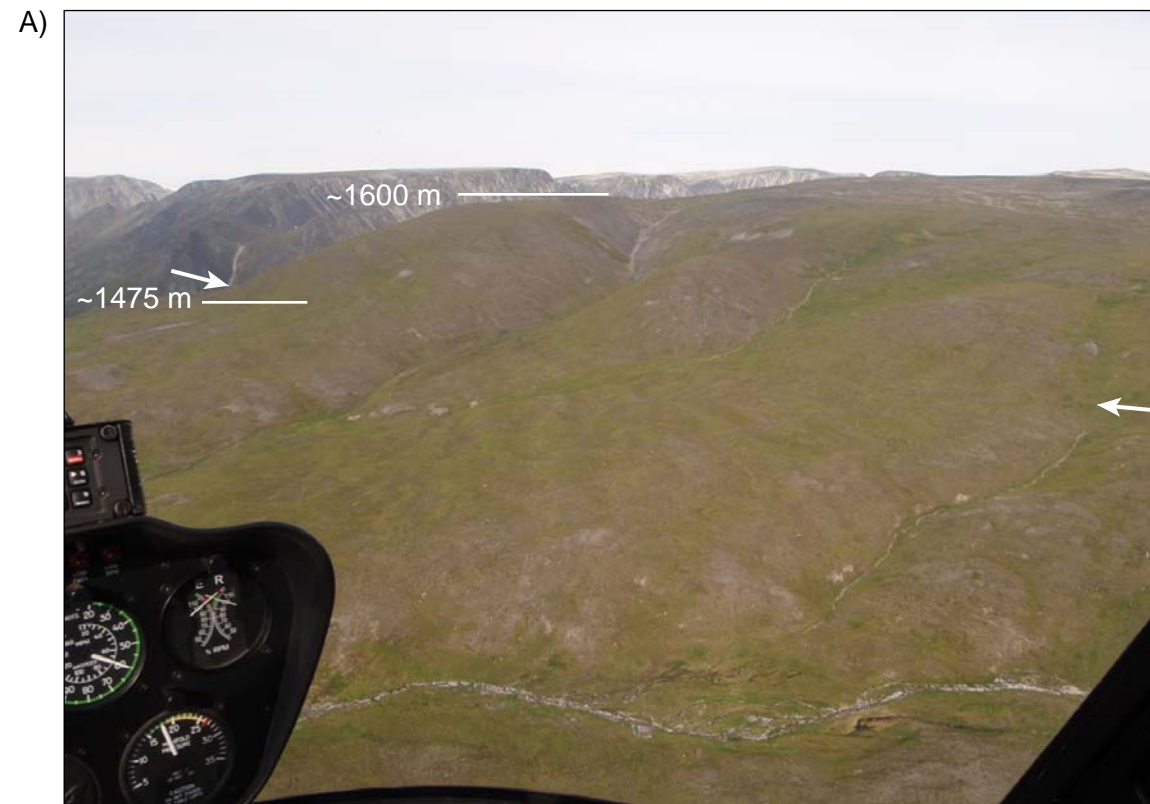
Photograph taken from location A looking west. Arrows point along trend of mapped lineaments along southwest-facing aligned break-in-slope. Note the rounded and subdued nature of break-in-slope. Relief across break-in-slope is ~125 m.

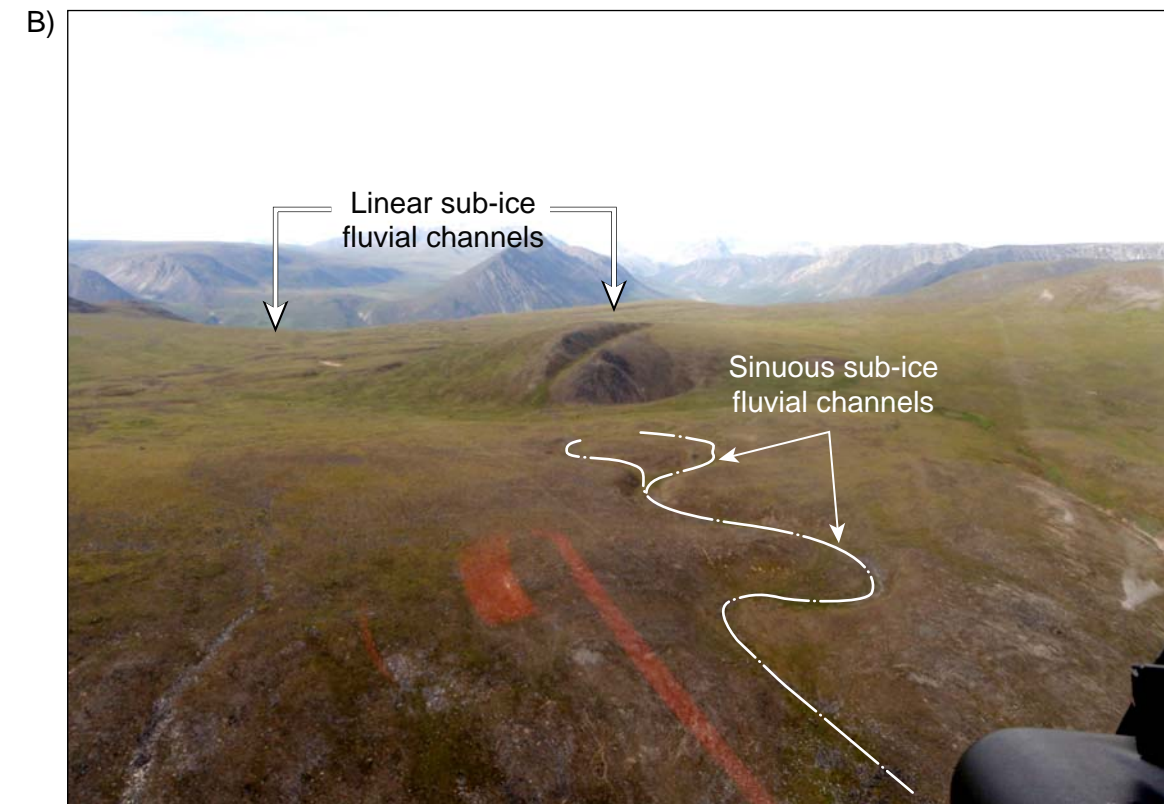
Photograph looking southwest from location B. The sinuous sub-ice channels are not large enough features to be seen on INSAR data.

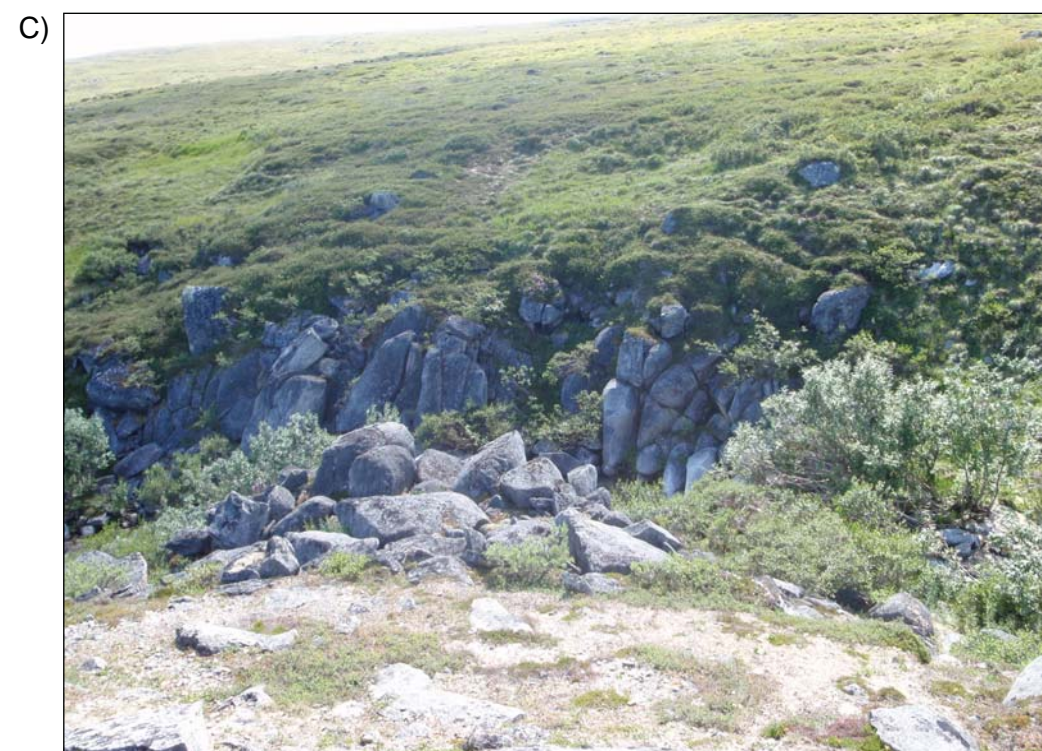
Photograph looking south-southwest from location C at widely spaced, near vertical, well-developed joints in trondhjemite (aka tonalite) bedrock. Joint spacing is 1 to 1.5 meters. Predominant orientations of joints are 042/80SE, 012/85SE, and 082/85SE but other orientations exist. Joint faces have clean surfaces with relief of minerals of 1 to 3 mm. No gouge or mineralization observed on joint surfaces, nor any sense of movement indicators (striae or mullions).

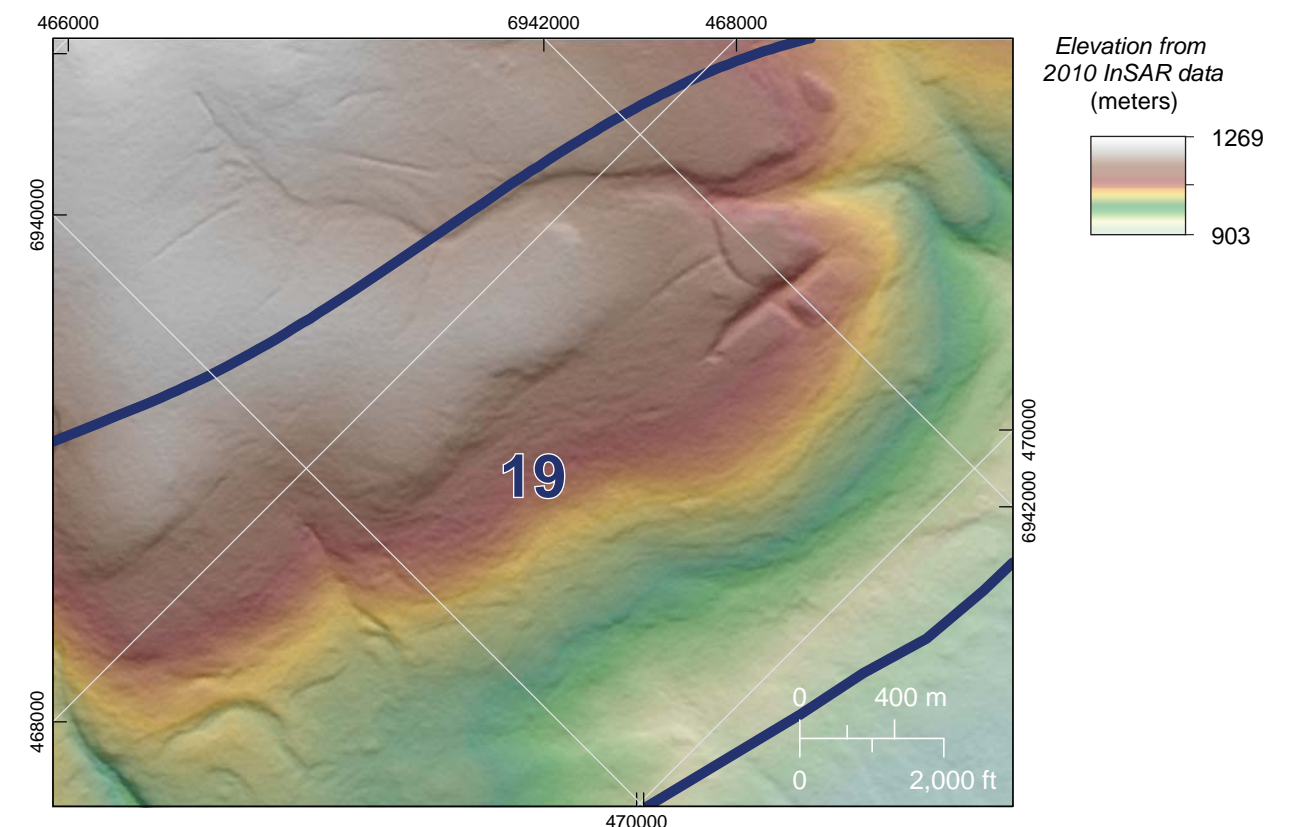
Detailed DEM showing orthogonal joint sets at northeast end of group 19.

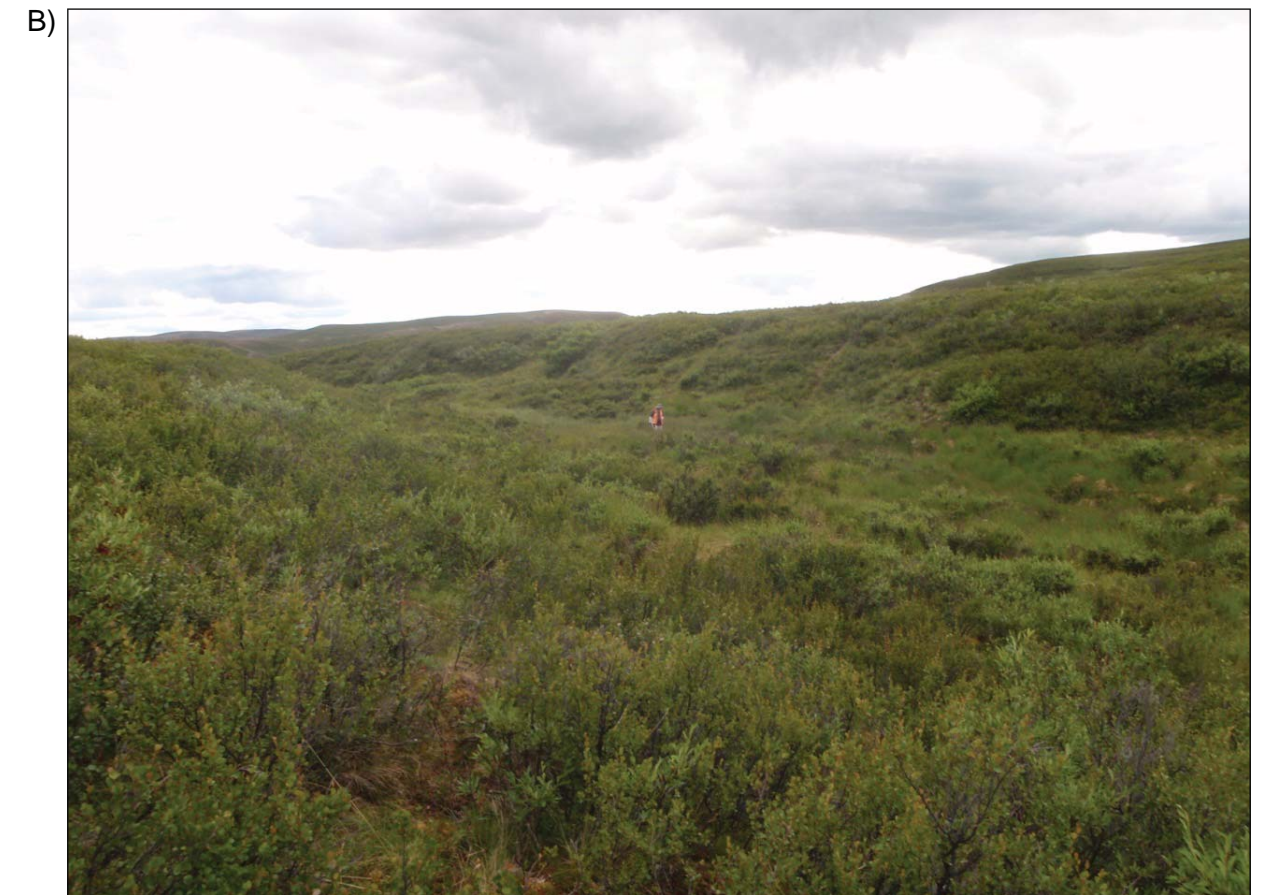
Photograph looking west-southwest from location B. Geologist standing in 3- to 6-m deep- and ~30-m-wide swale. Swale only exists in saddle; it does not continue down either side of saddle.
