SUSITNA-WATANA HYDROELECTRIC PROJECT
 LINEAMENT GROUP 8
 MAP DATA

FIGURE
 A8-2.1

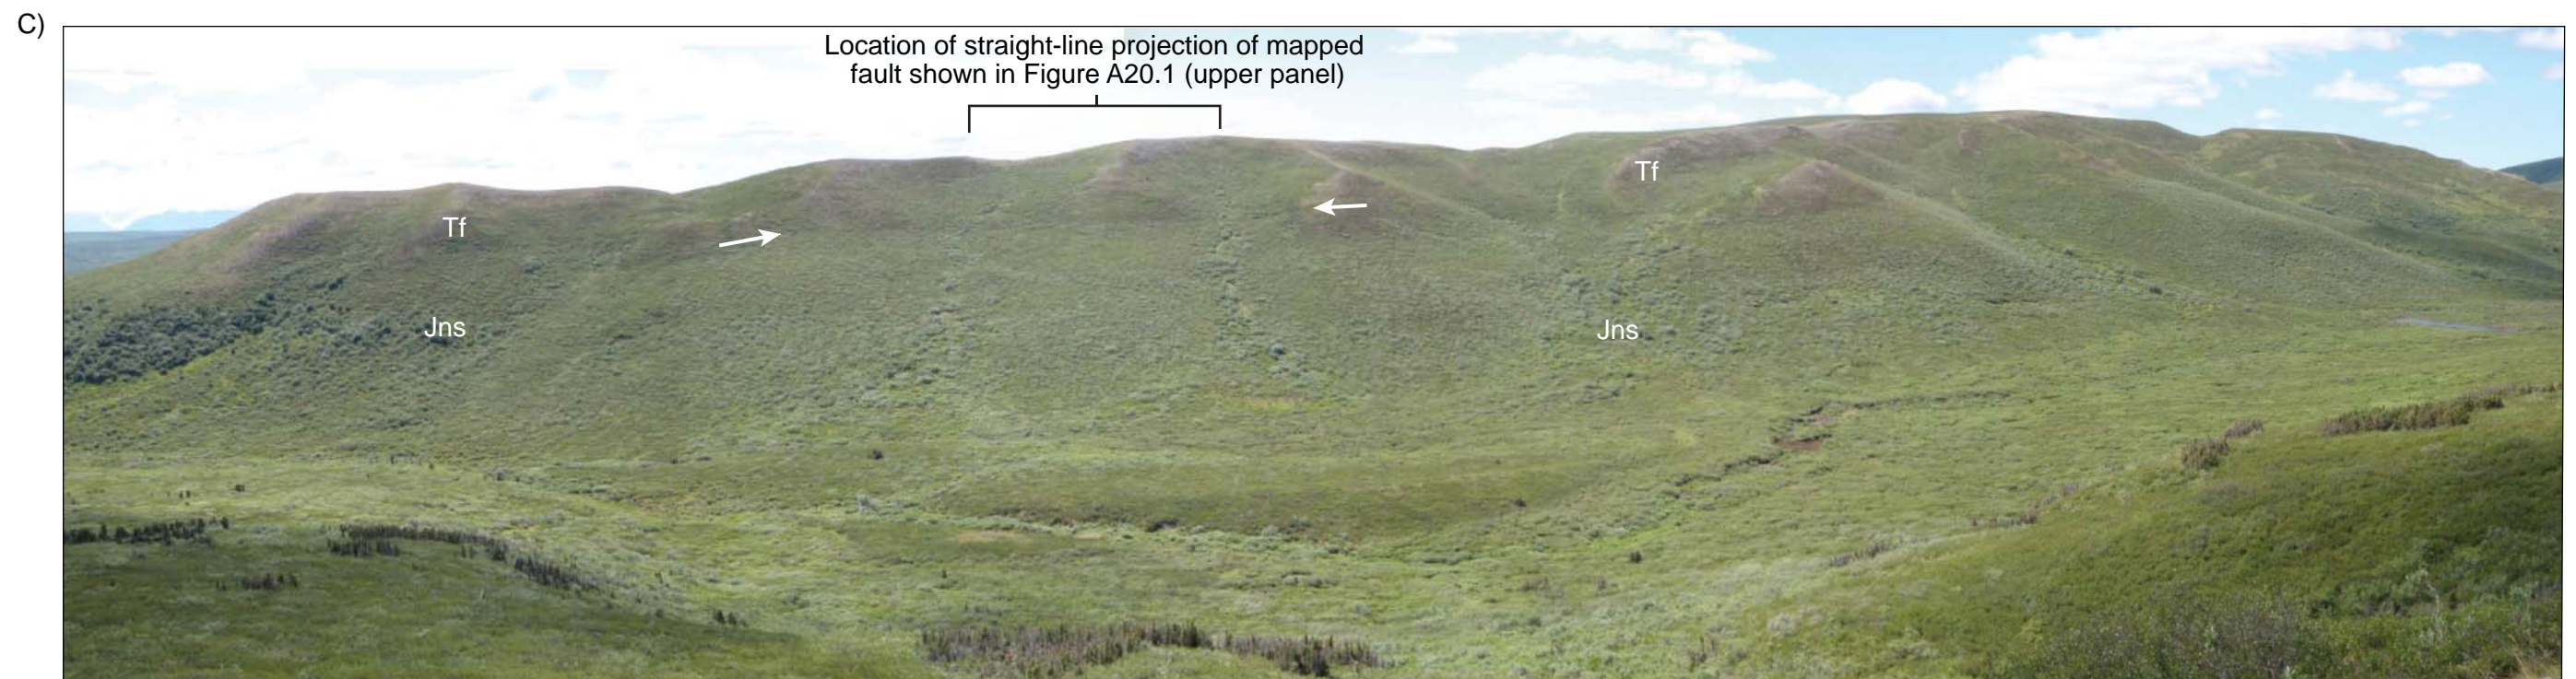
Photograph looking southwest from location C. Basal contact shown by arrows. Note that base of contact is not apparently deformed along projection of fault and that no expression of faulting in valley bottom is apparent.

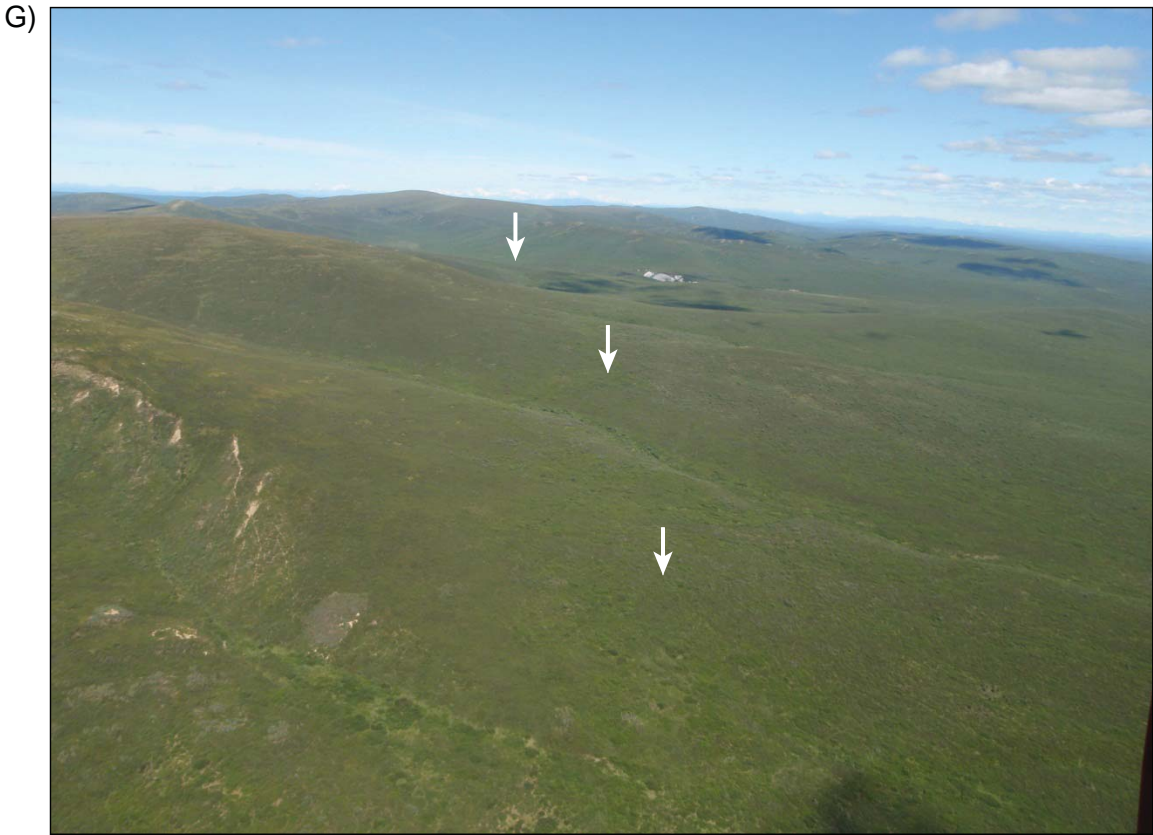
Photograph looking north from location G along mapped fault of Grantz (1960). Arrows point to approximate location of mapped fault. Note absence of apparent geomorphic expression fault.

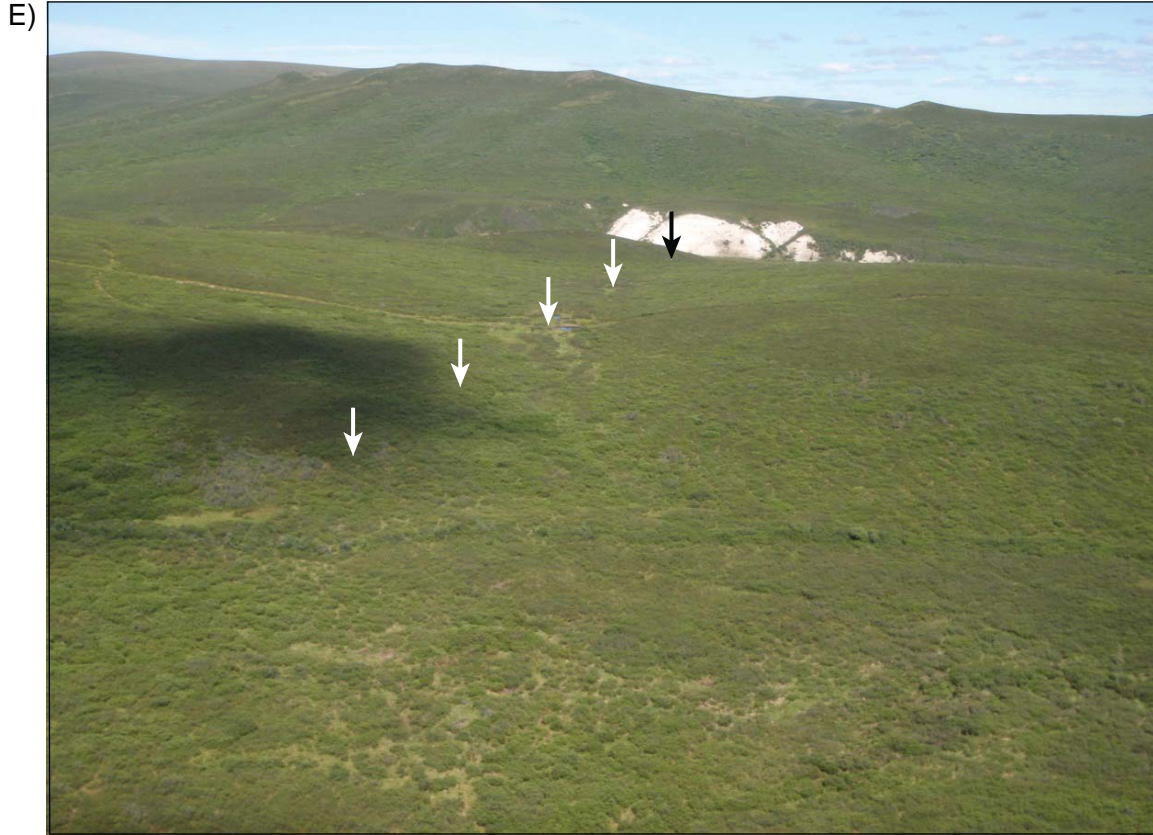
Arrows show location of FCL mapped lineament (shallow U-shaped swale). Note no apparent deformation of white-bedded sediments (glacial lake sediments) along projection of lineament.

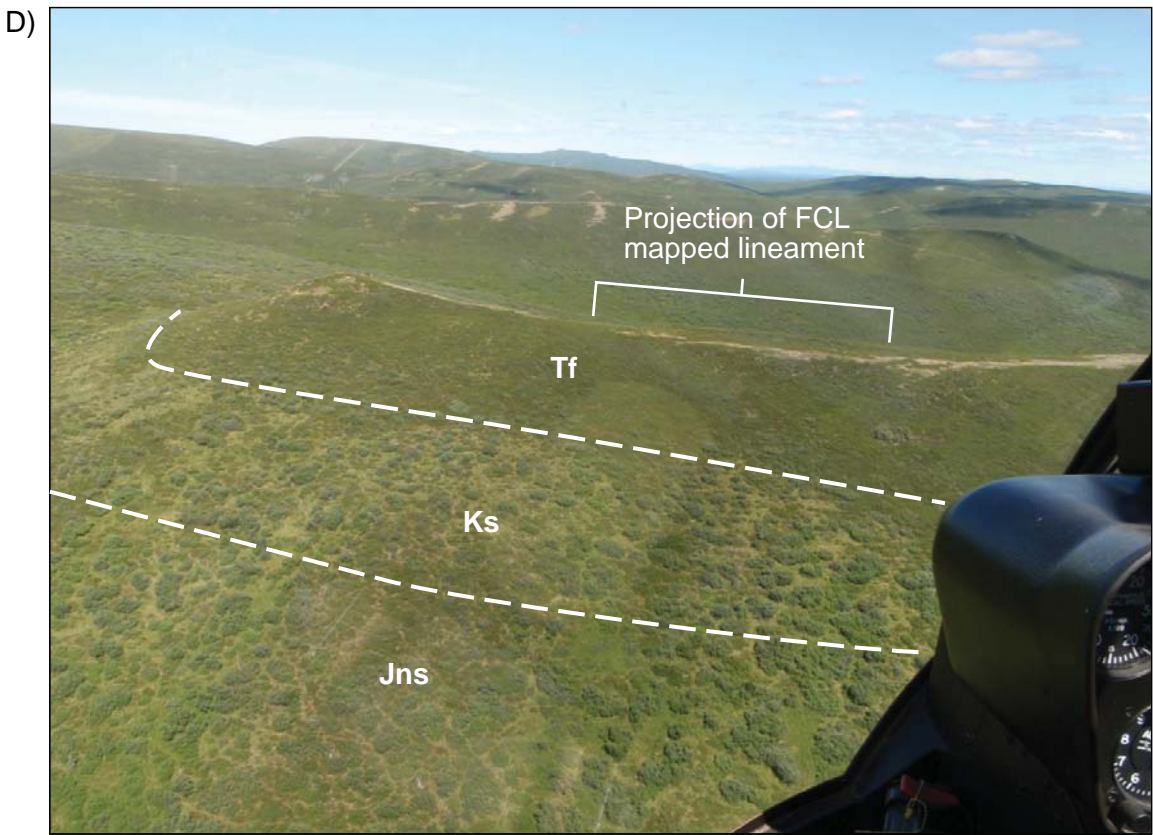
Photograph looking northeast from location D. Note absence of deformation in ridge line of Tf.

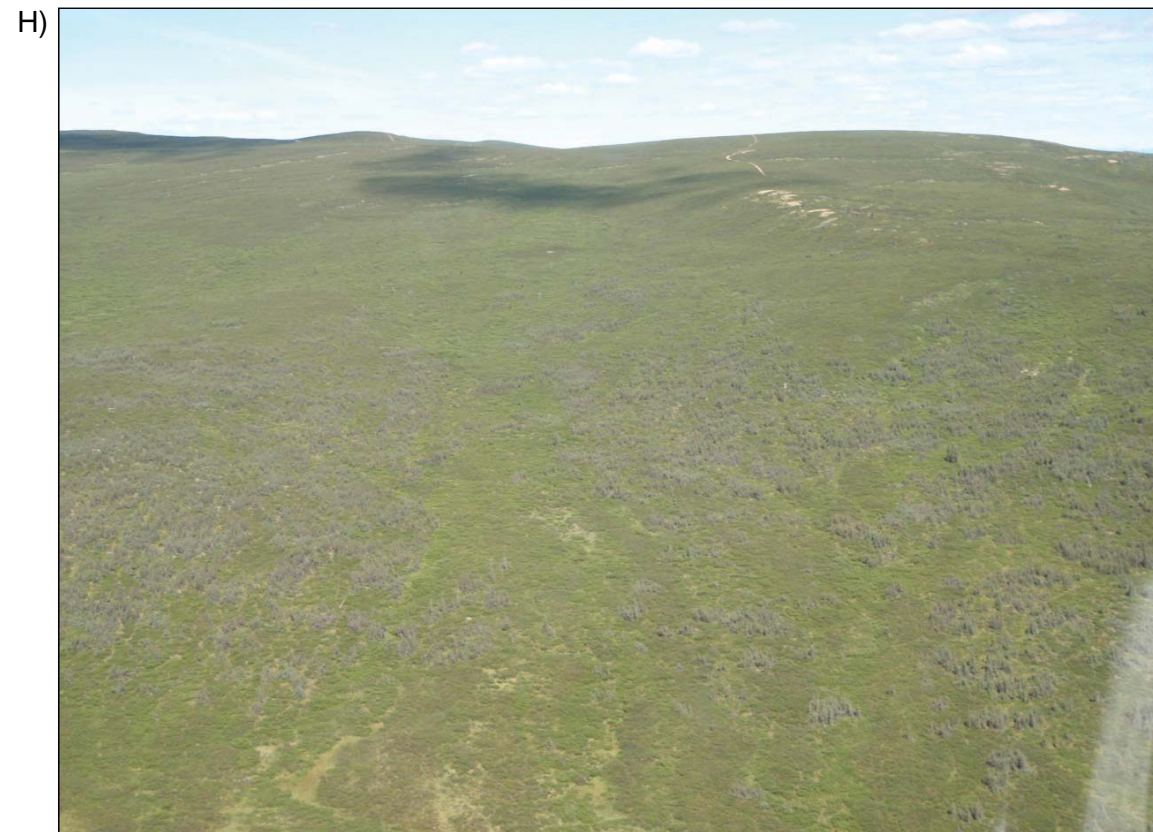
Photograph looking north-northeast from location H along queried mapped fault of Grantz (1960) that lies outside of lineament group. Note absence of fault expression.

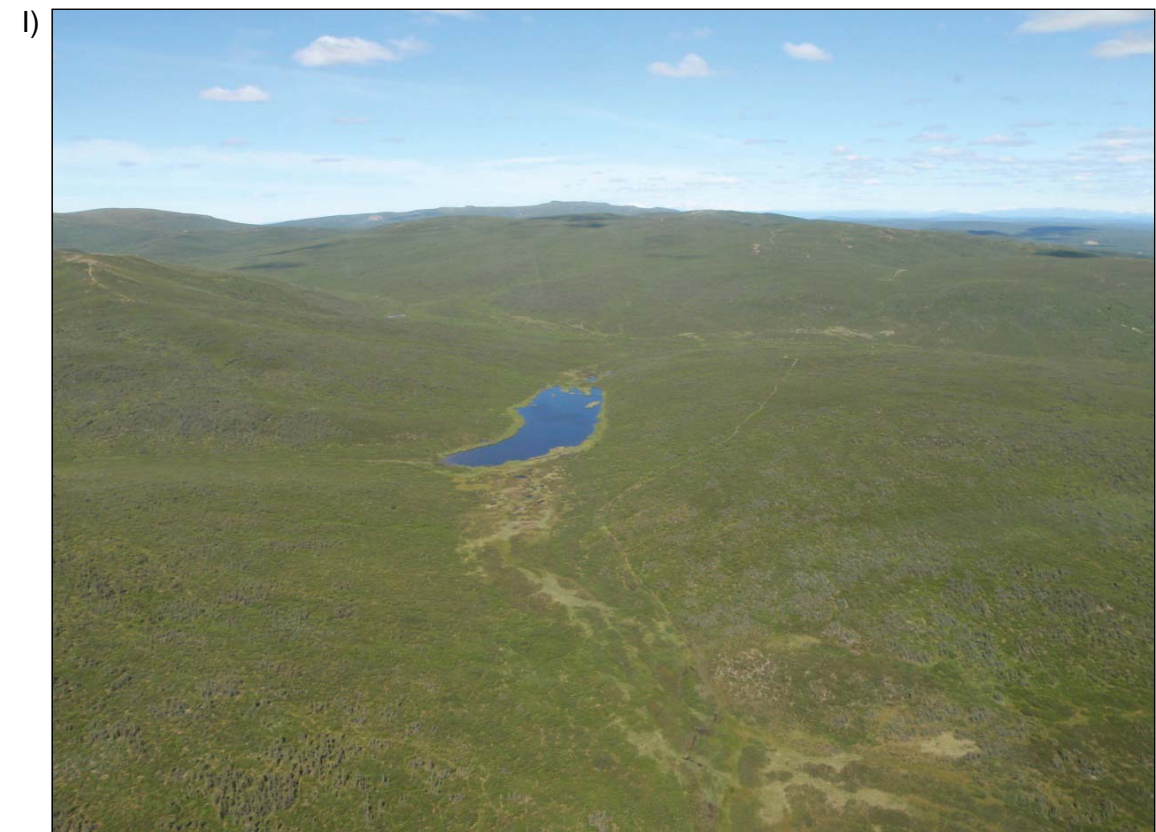
Photograph looking north-northeast from location I along queried mapped fault of Grantz (1960) that lies outside of lineament group. Note absence of fault expression.

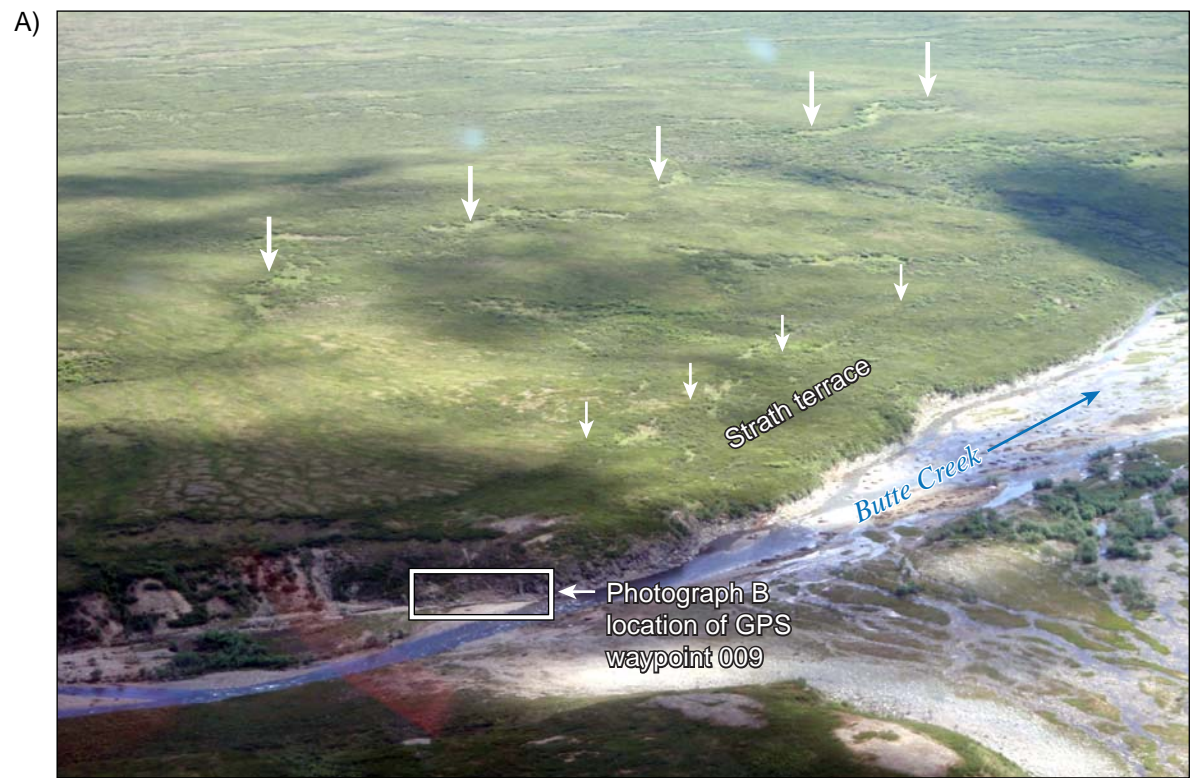
Photograph looking east from location A. Large arrows point to downhill facing slope break visible in INSAR and mapped by Fugro (2013). Field reconnaissance revealed smaller lineament (not visible in INSAR data) lies along the small arrows and projects toward the vertically-dipping bedrock exposed in the creek bank shown in Photograph B.

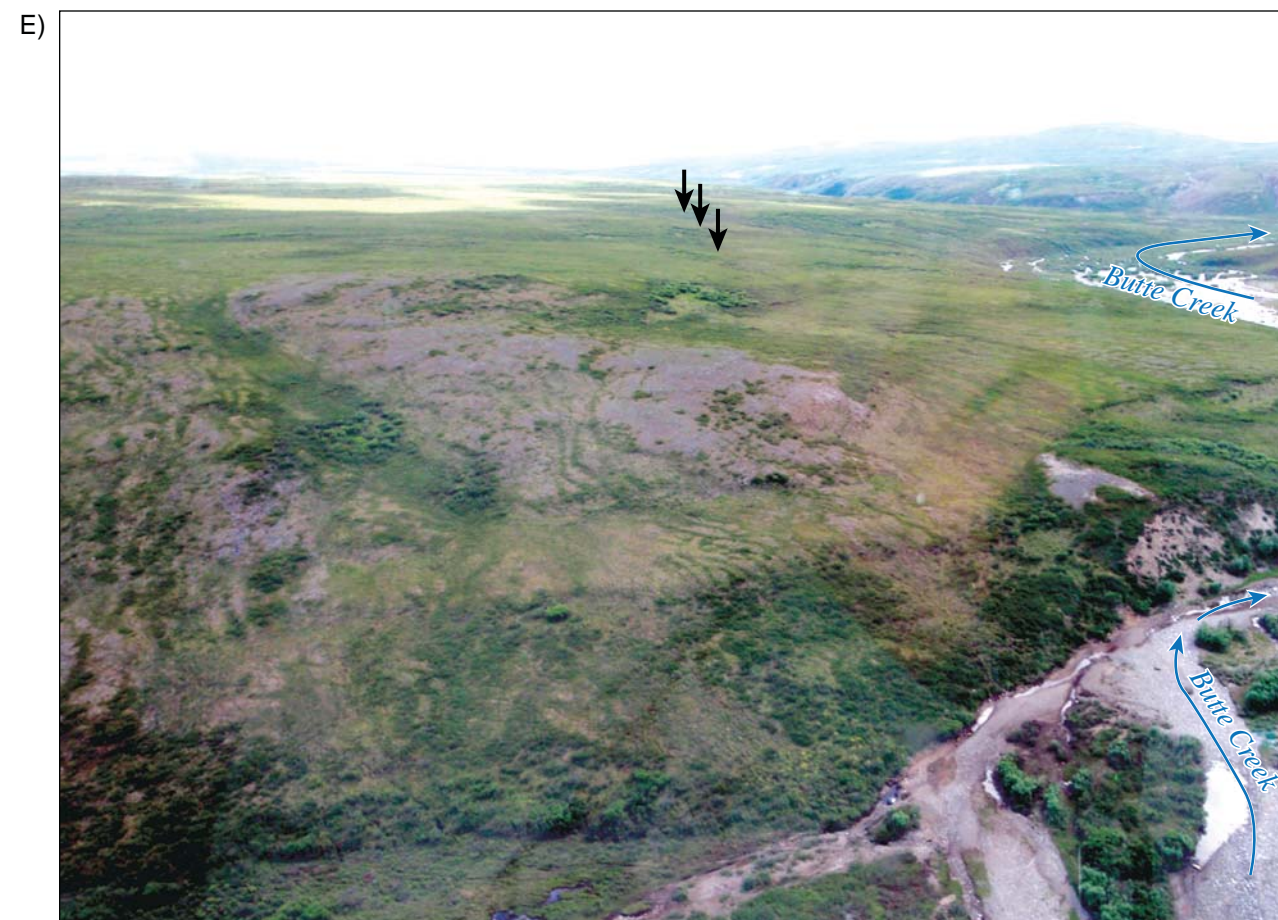
Photograph taken from location E looking east-southeast along trend of FCL mapped lineament (shown by arrows). Note absence of any apparent deformation in surficial deposits or in terrace riser on left bank of Butte Creek.

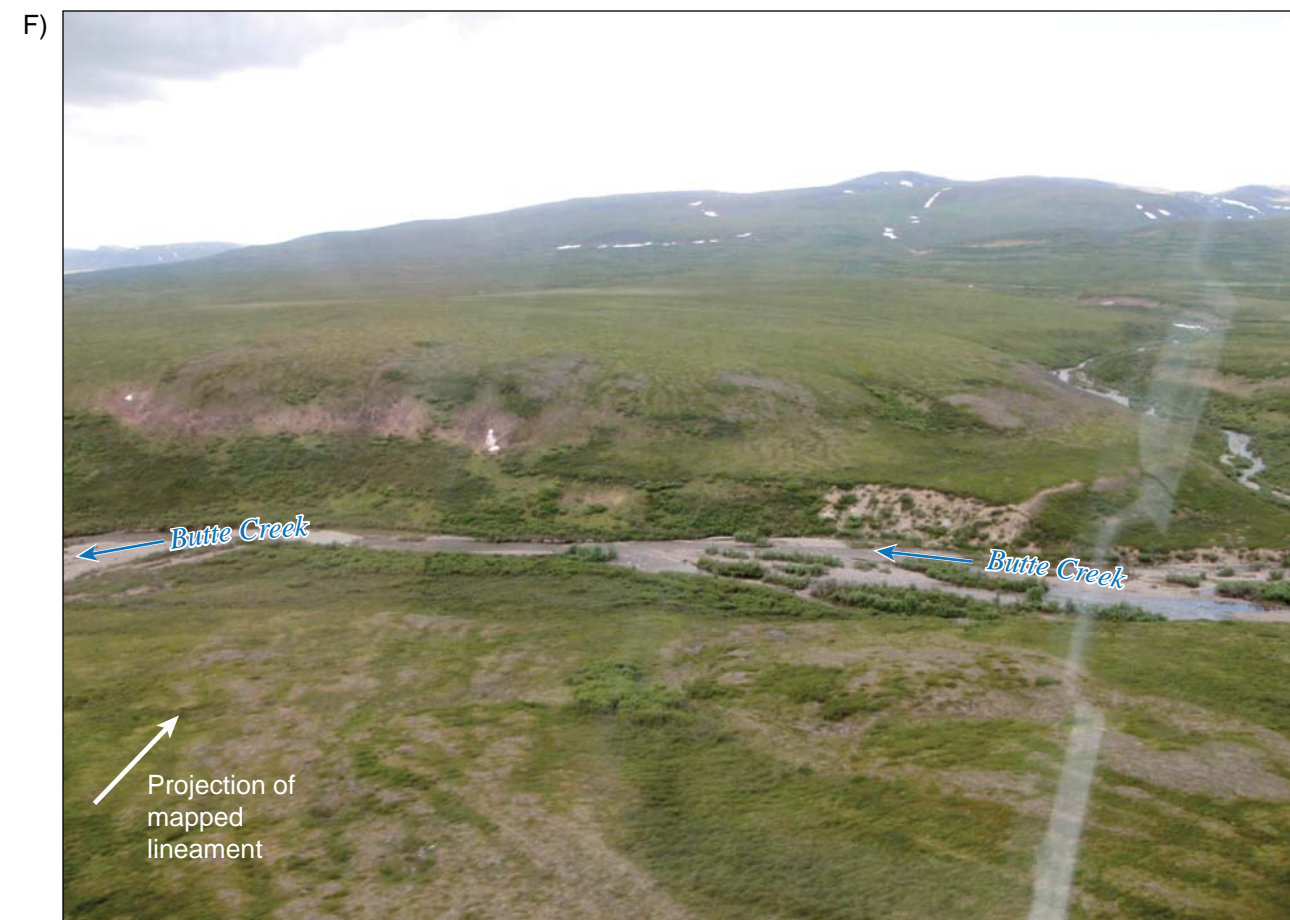
Photograph taken from location F looking west along trend of FCL mapped lineament to west of Butte Creek. Note no apparent deformation in right bank of stream or any expression of faulting in broad, flat terrace surface mapped as Qdt3 by Smith et al. (1988).

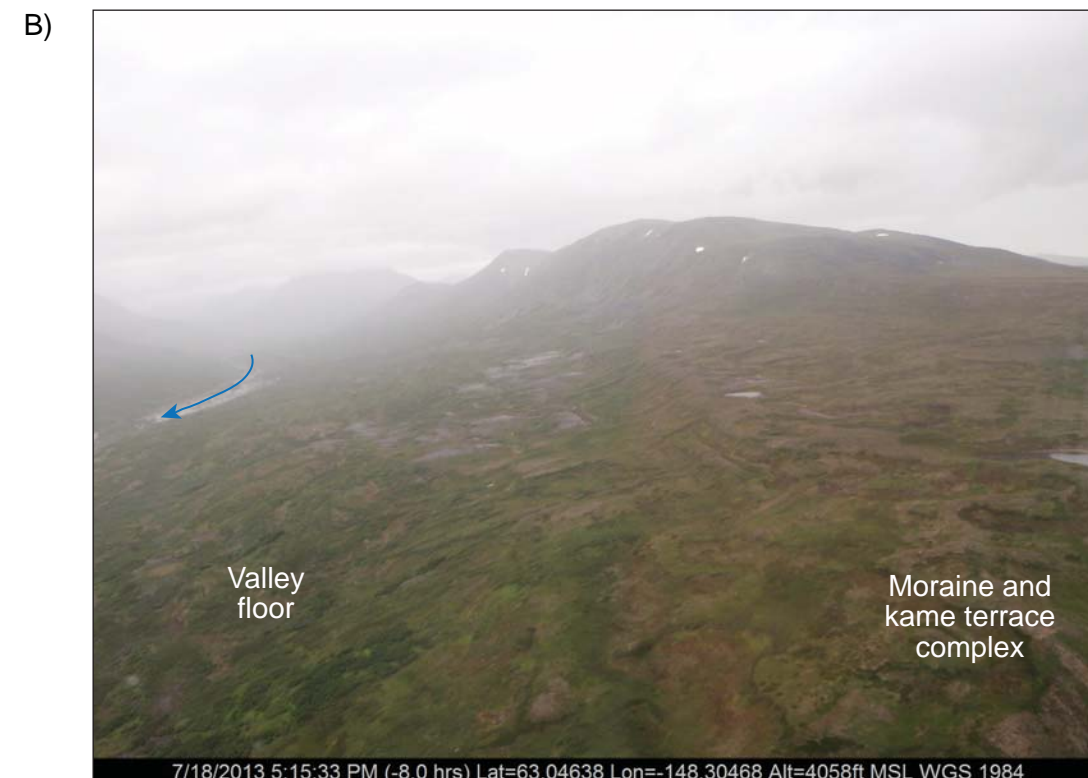
View looking north-northwest up-valley along the margin of the left-lateral moraine and kame terrace complex. No lineaments were observed cutting these deposits.

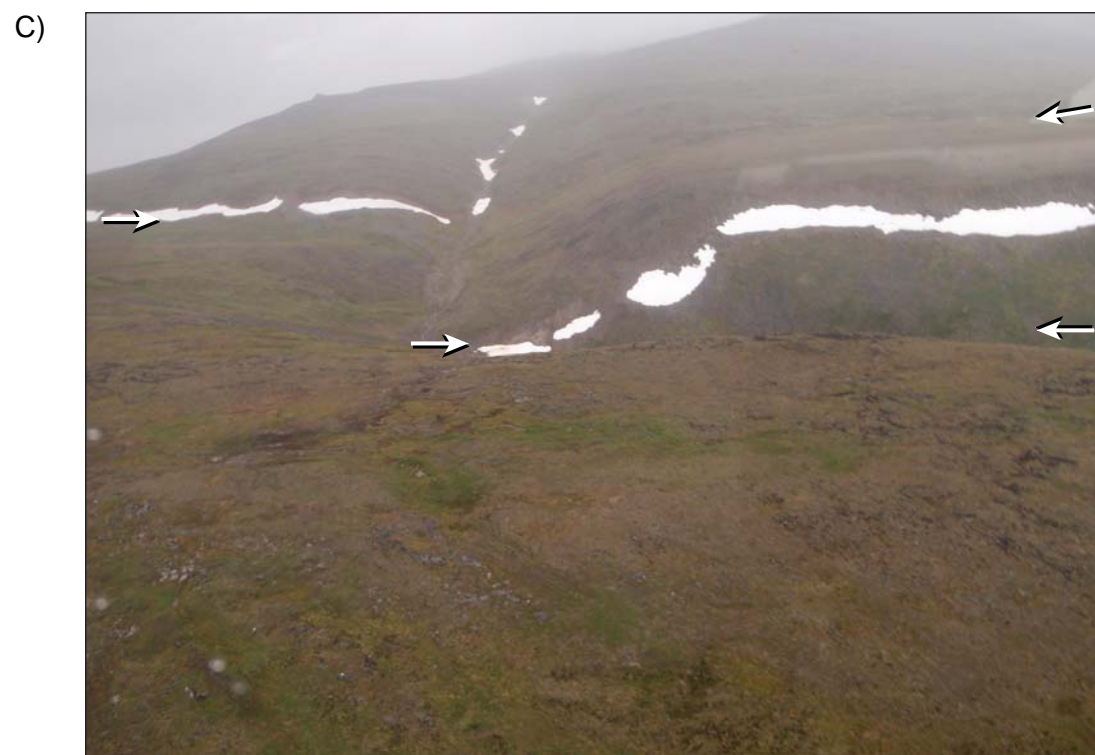
View looking north at deep drainages whose margins coincide with nivation terraces and hollows. The large size of these drainages is inconsistent with the weakly expressed lineaments located east of Deadman Creek. Such deeply incised drainages are interpreted to be a result of sub-ice erosion.
