SUSITNA-WATANA HYDRO

ALASKA ENERGY AUTHORITY

16-1401-TM-012014

Appendix B:
Strip Maps and Photographic Documentation
of Lineament Data for Lineaments Mapped by Reger et al. (1990)

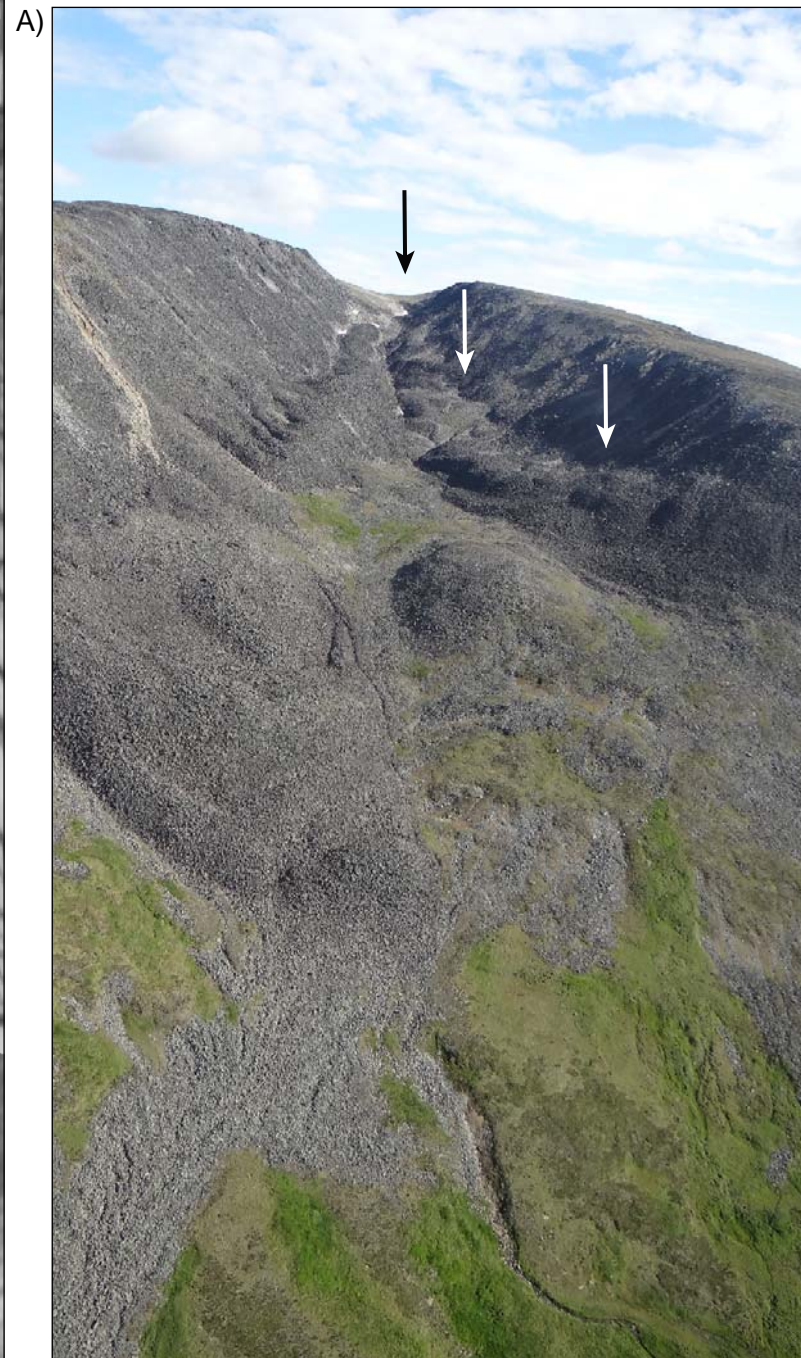
View looking northeast from location A. Arrows show location of mapped trace of lineament.

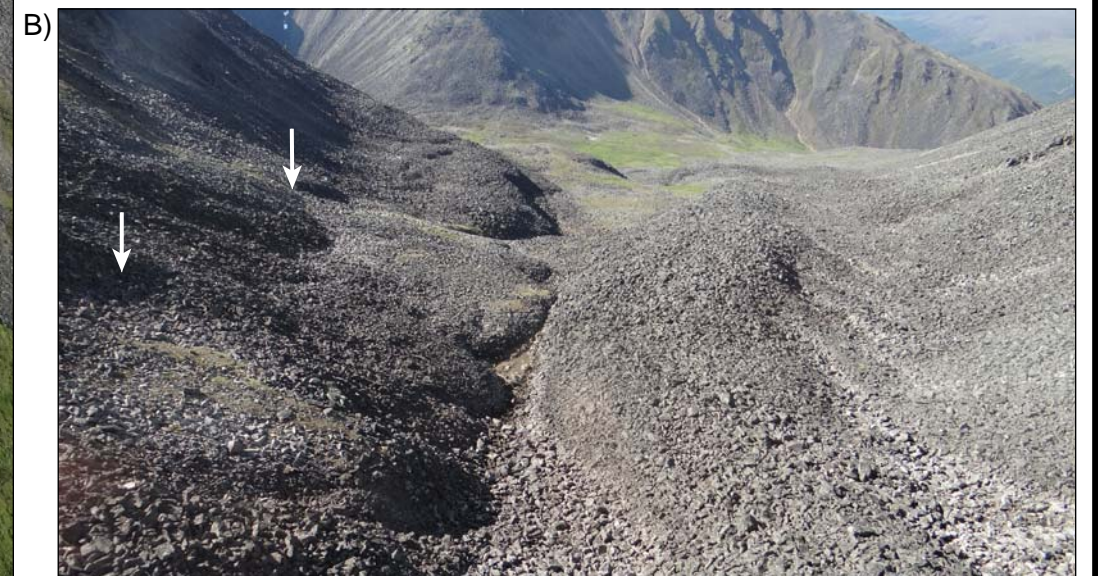
View looking southwest from location B. Arrows show the location of lineament. Note the semi-linear and lobate toe of talus deposit.

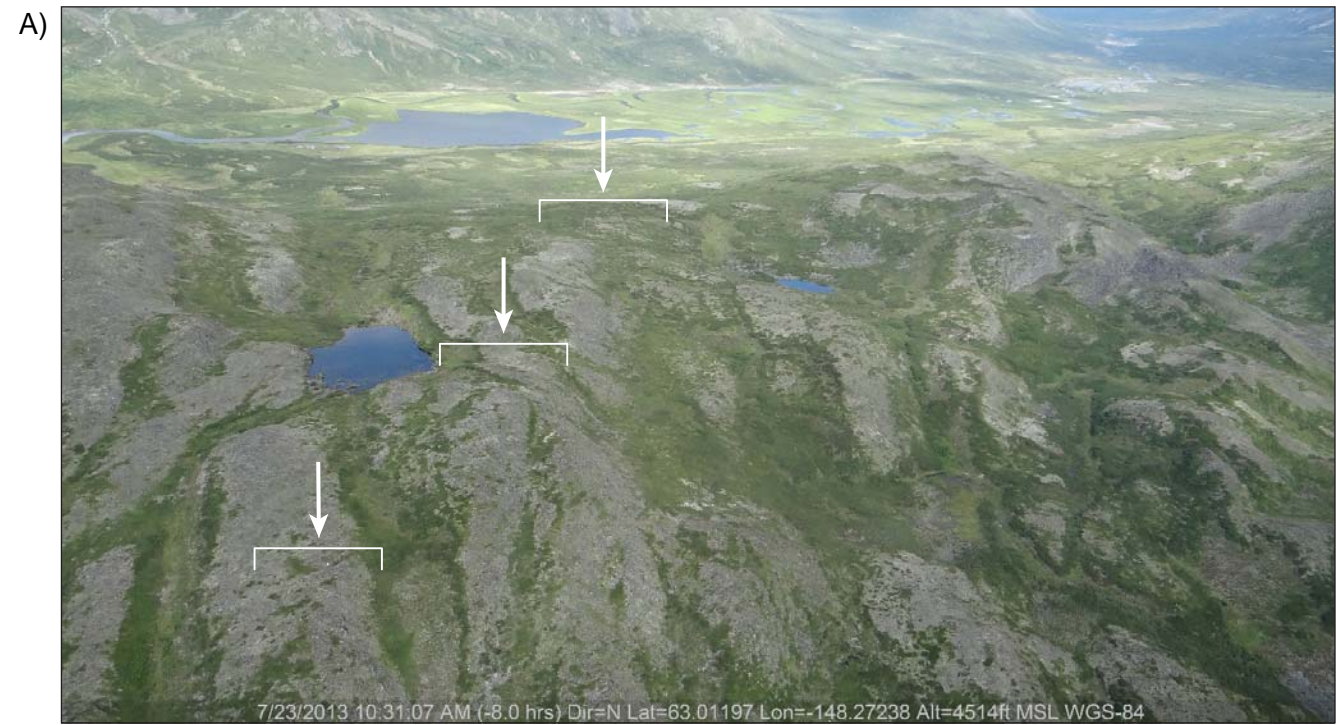
View looking northwest from location A. Arrows and brackets show projected trace of lineament. Note absence of continuous lineament across projected trace.

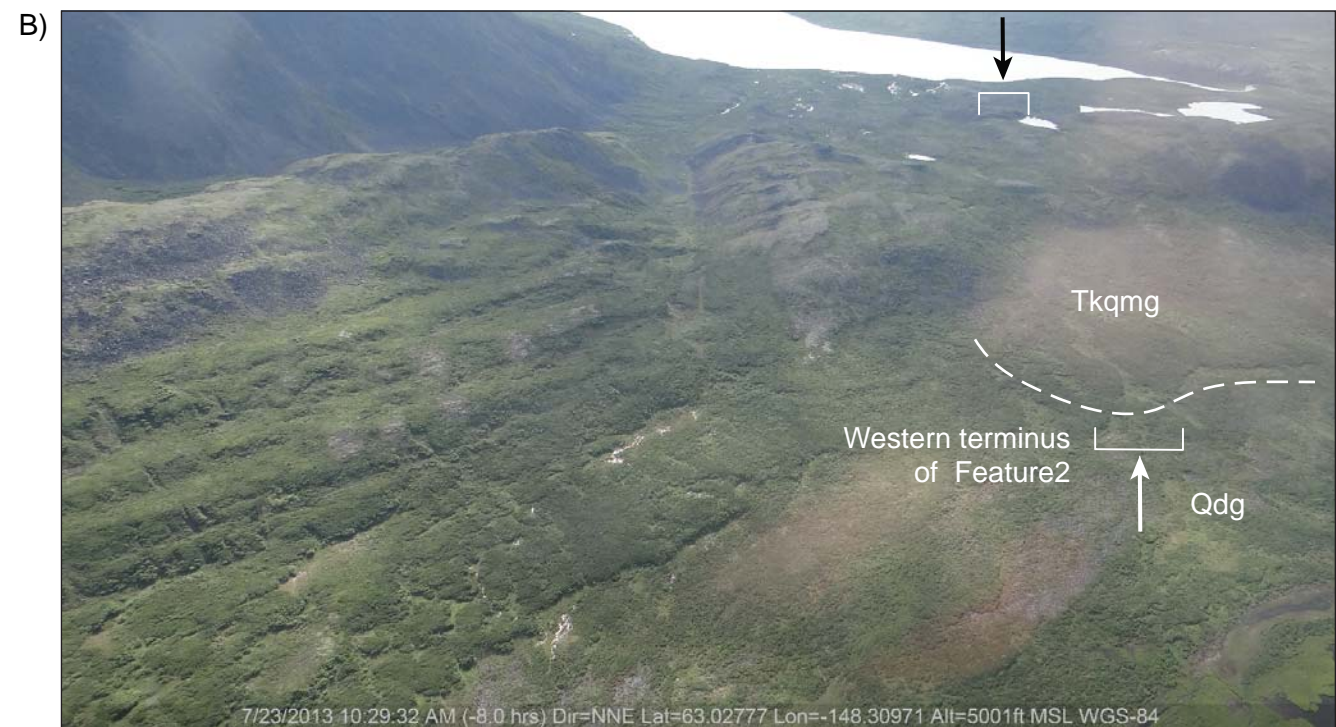
View looking southeast from location B. Arrows and brackets show projected trace of lineament. Note lack of deformation or lineament trace in foreground within Quaternary deposits.

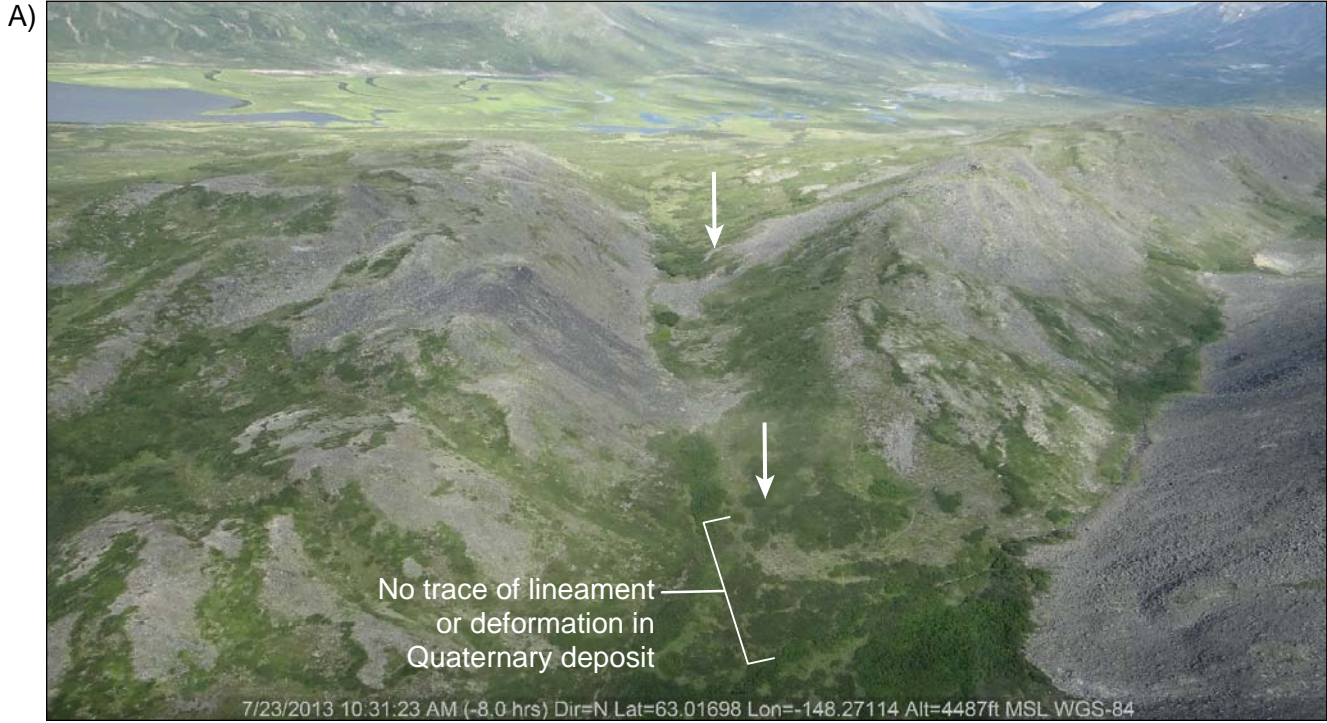
View looking northwest from location A. Arrows show the projected trace of lineament. Note absence of lineament or deformation in Quaternary deposits.

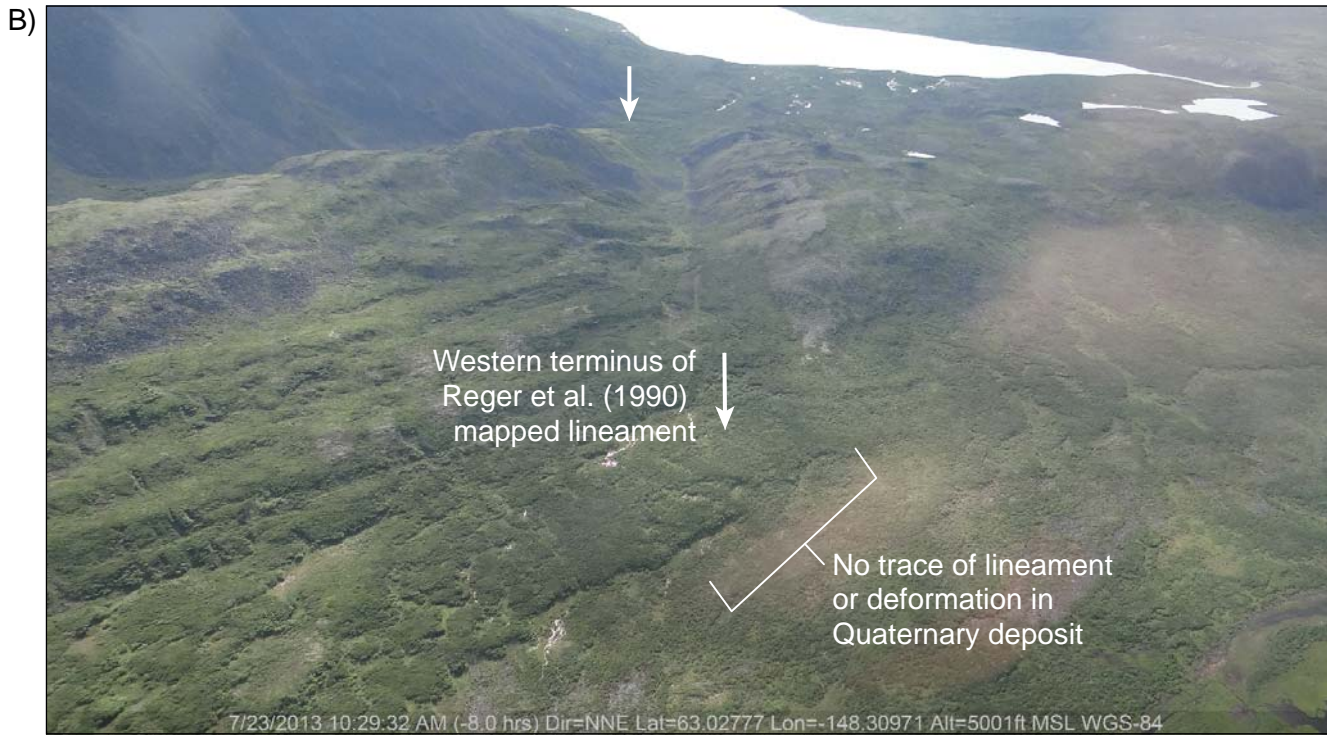
View looking southeast from location B. Arrows show the projected trace of lineament. Note absence of lineament or deformation in Quaternary deposits.

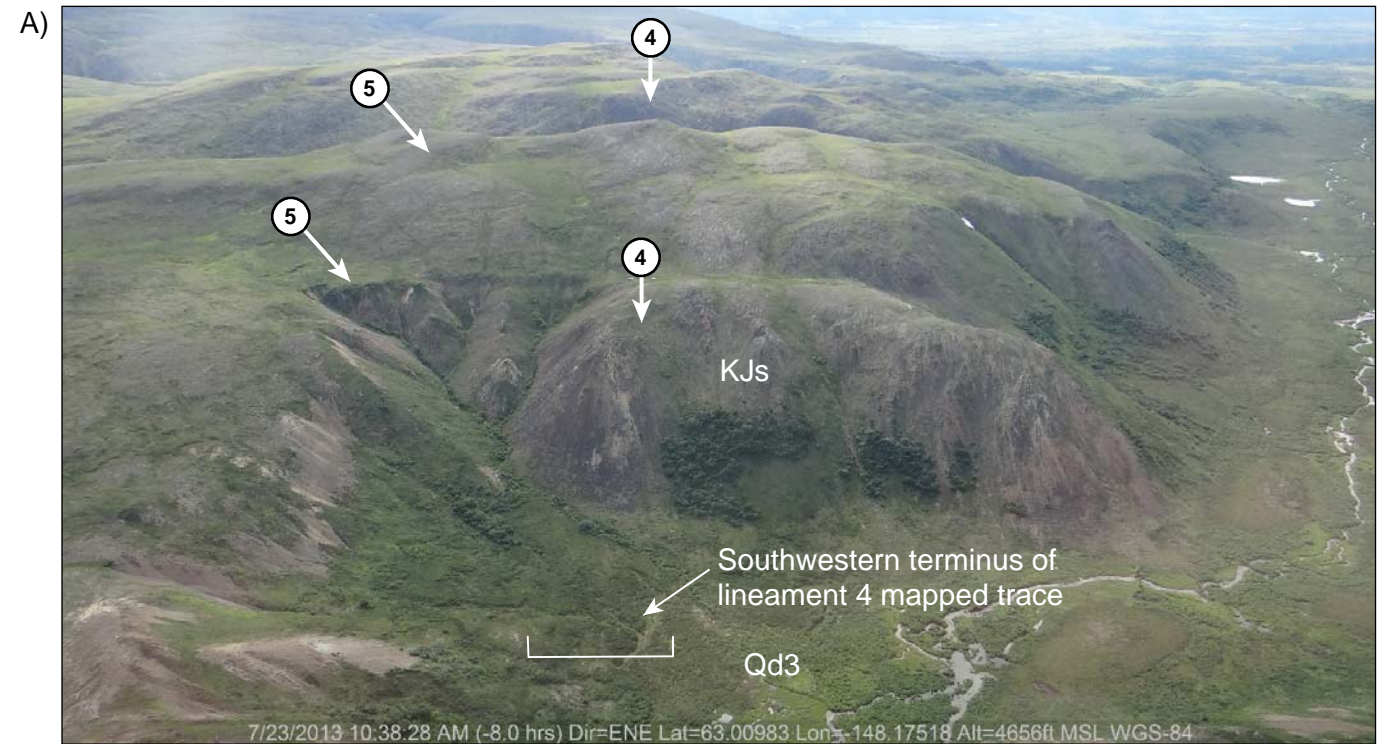
View looking southeast from location A. Arrows show the projected traces of Features 4 and 5. Note absence of lineament or deformation in Quaternary deposits in foreground.

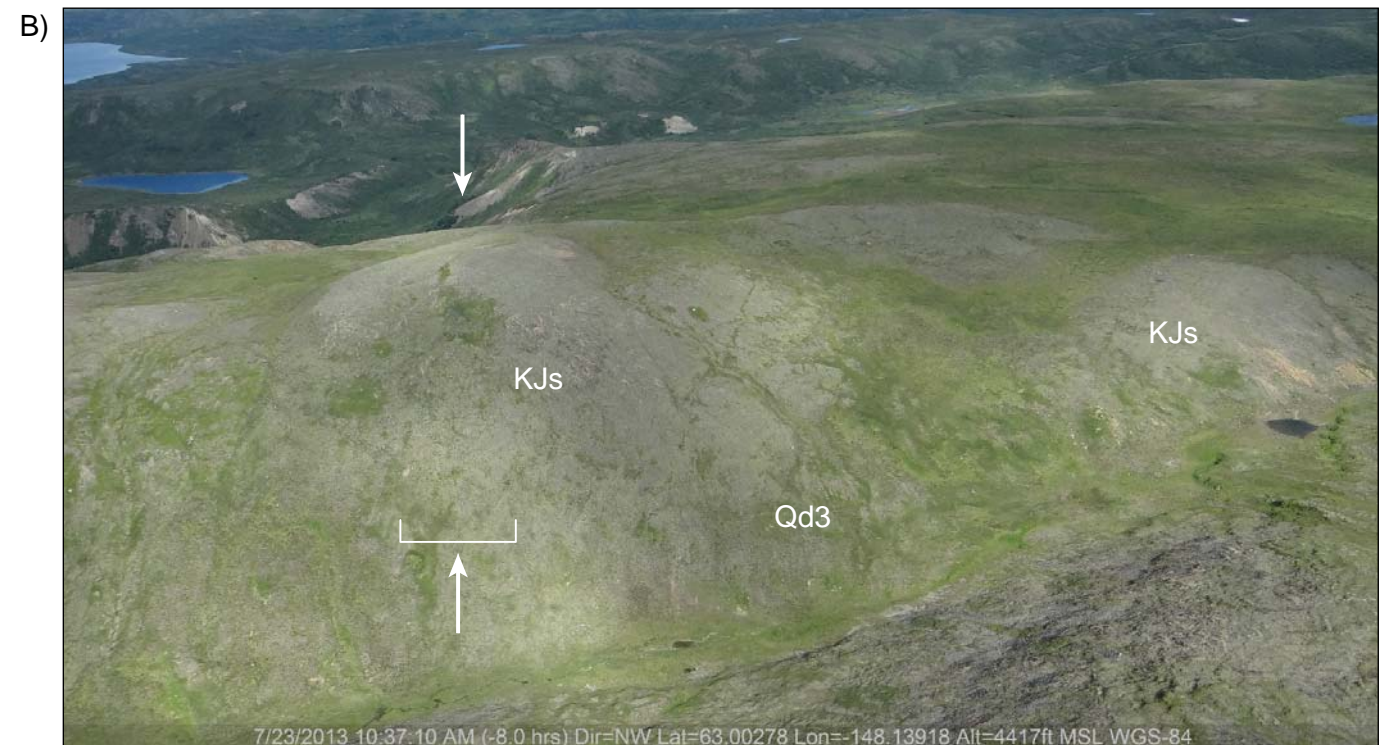
View looking northwest from location B. Arrows show the projected trace of Feature 5. Note absence of discernable lineament along mapped trace.

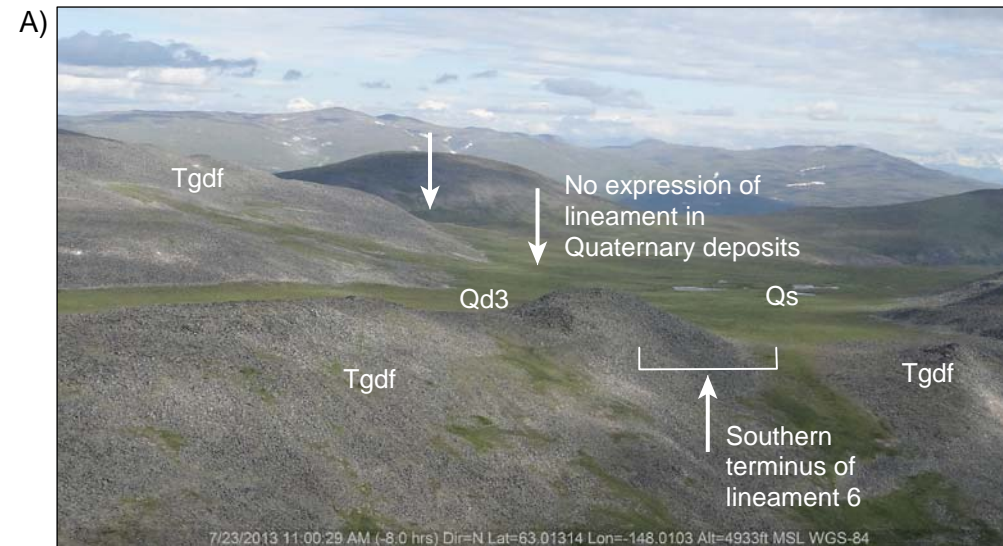
View looking northwest from location A. Arrows and brackets show the projected trace of mapped lineament. Note absence of lineament or deformation in Quaternary deposits.

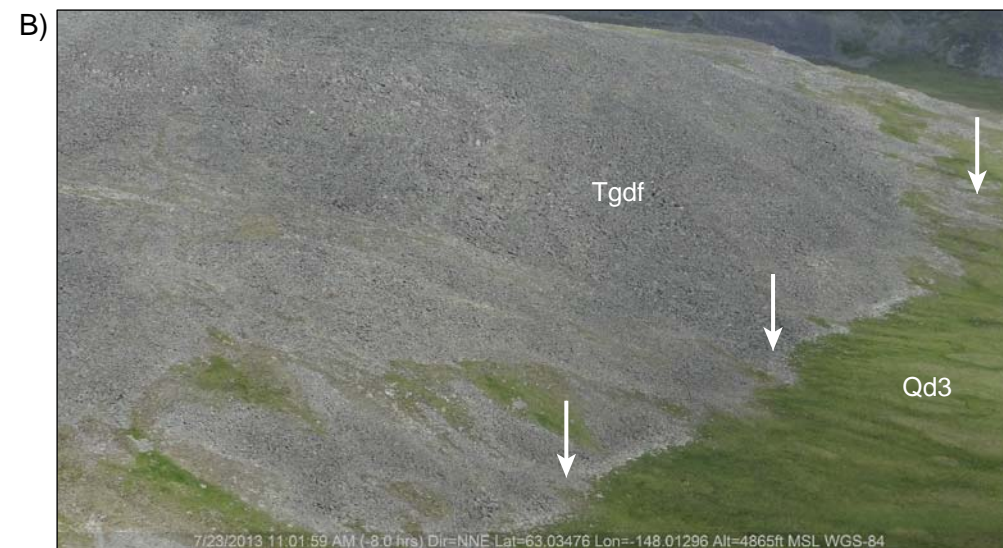
View looking northwest from location B. Arrows show the projected trace of lineament.

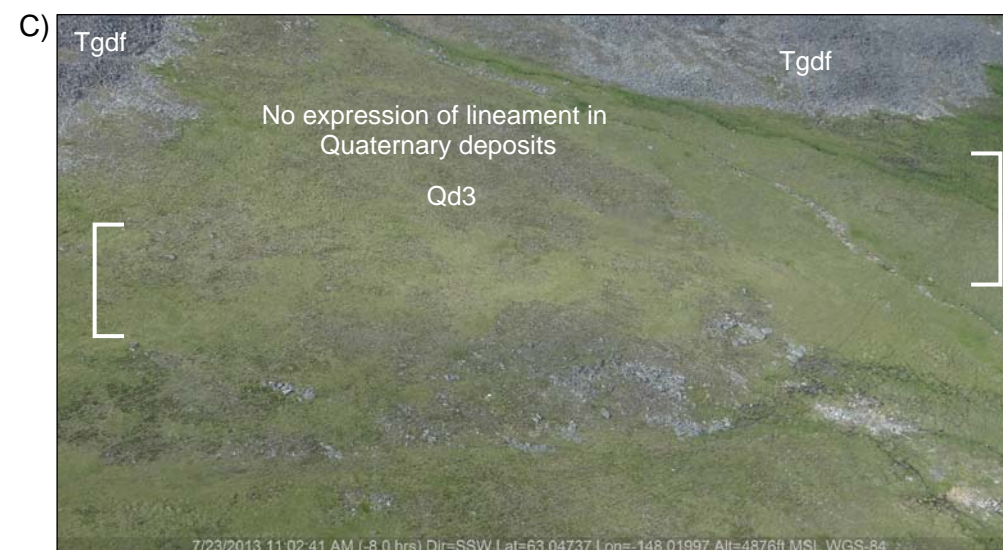
View looking west from location C. Brackets indicate the projected trace of lineament. Note absence of lineament or deformation in Quaternary deposits.

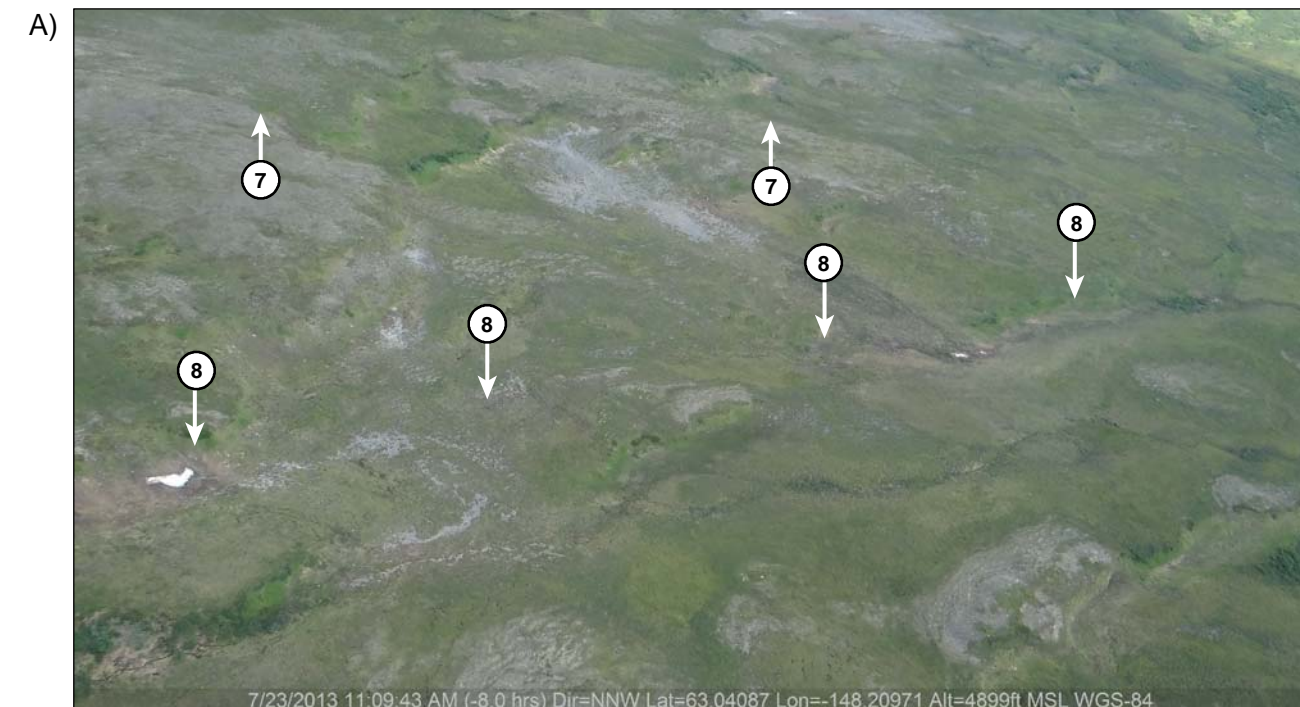
View looking northeast at lineaments 7 and 8 from photograph location A.

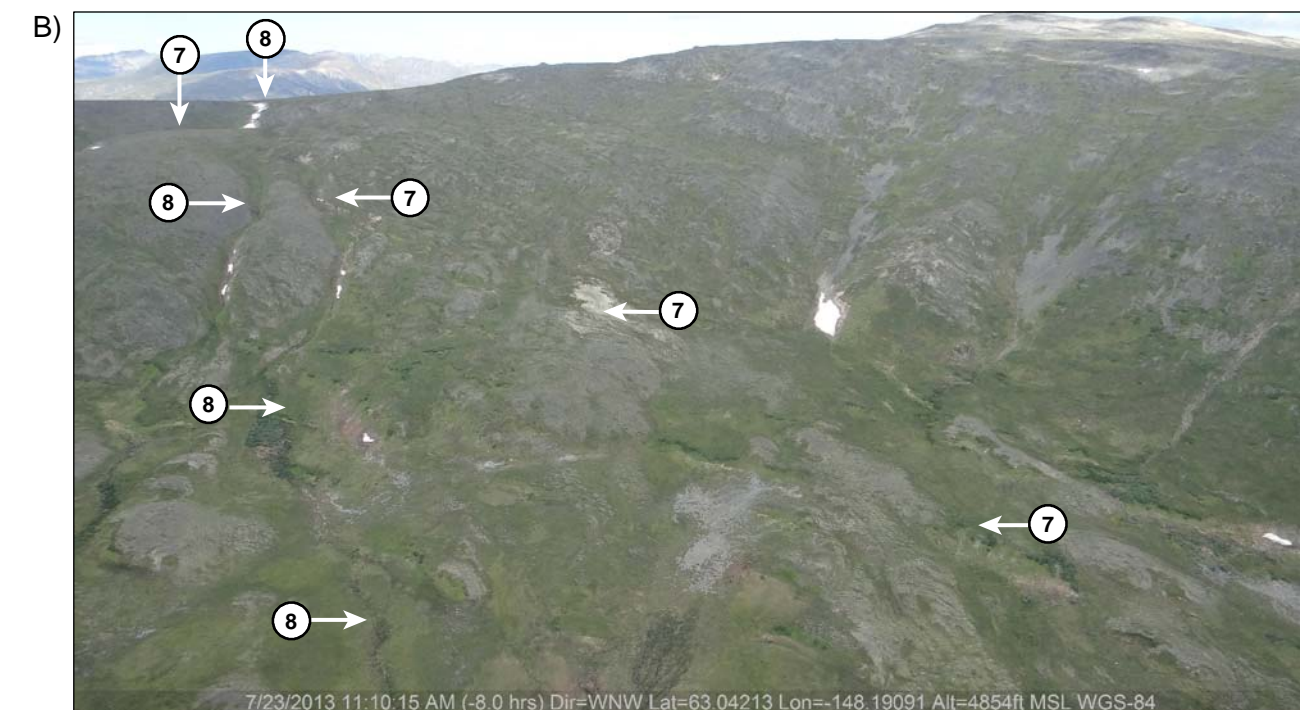
View looking west at lineaments 7 and 8 from photograph location B. Note that lineament 7 is a linear series of unrelated features.

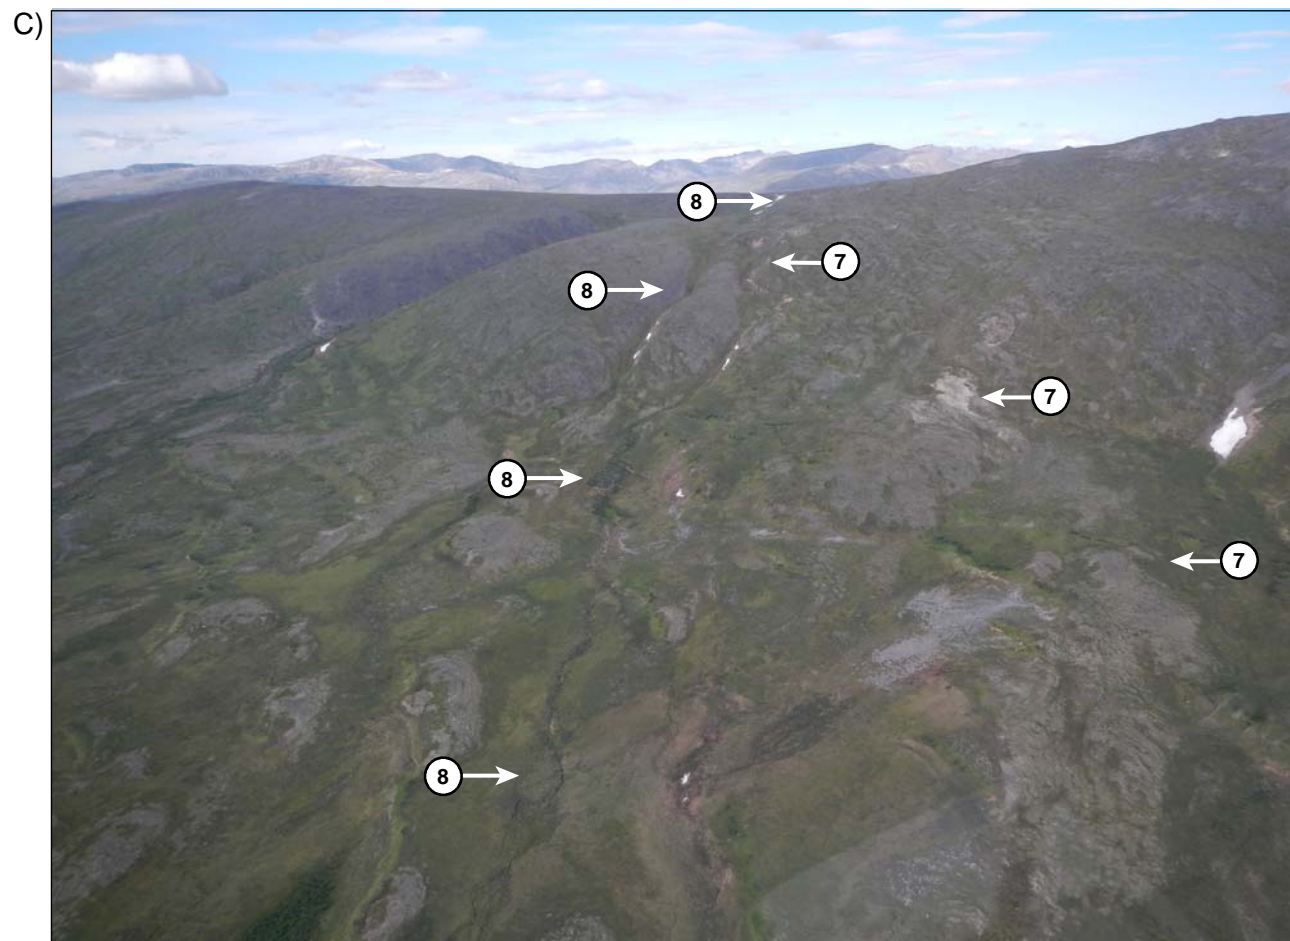
View looking southwest at lineaments 7 and 8 from photograph location C.

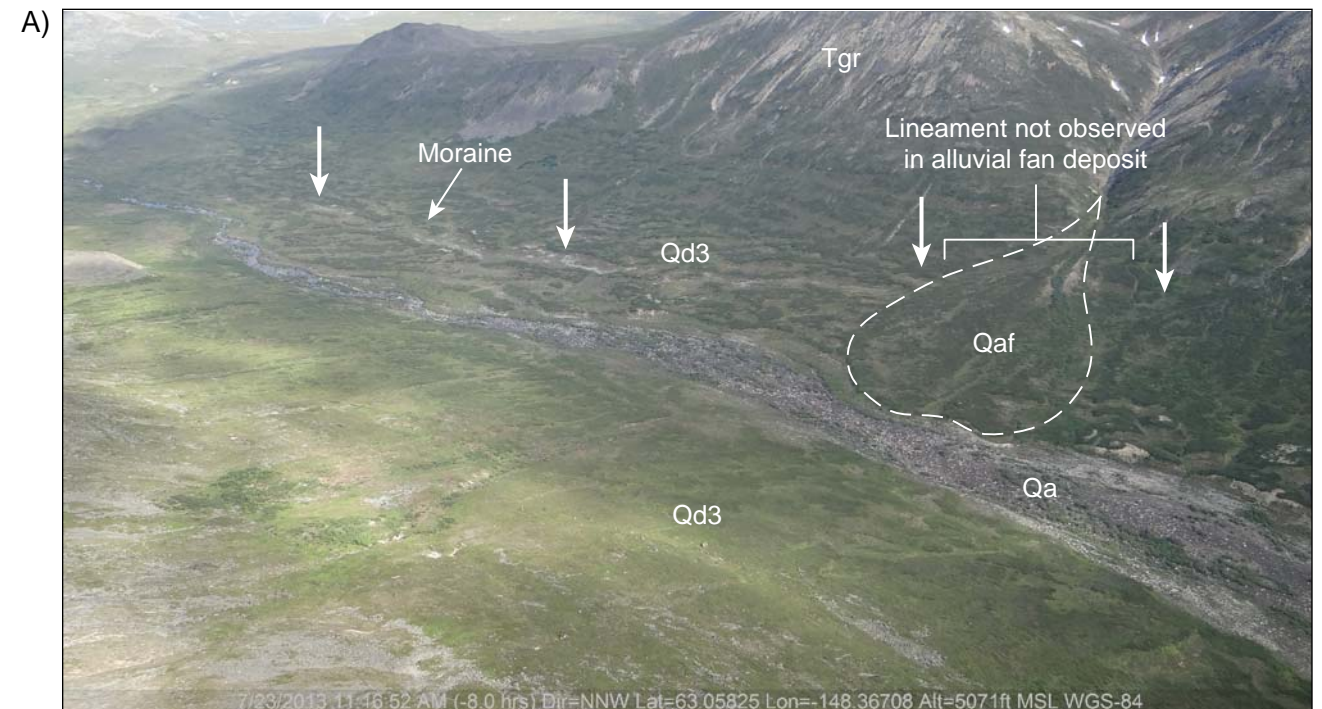
View looking north from location A. Arrows show projected trace of Feature 9 lineament. Note lineament is overprinted with Quaternary alluvial fan deposit.

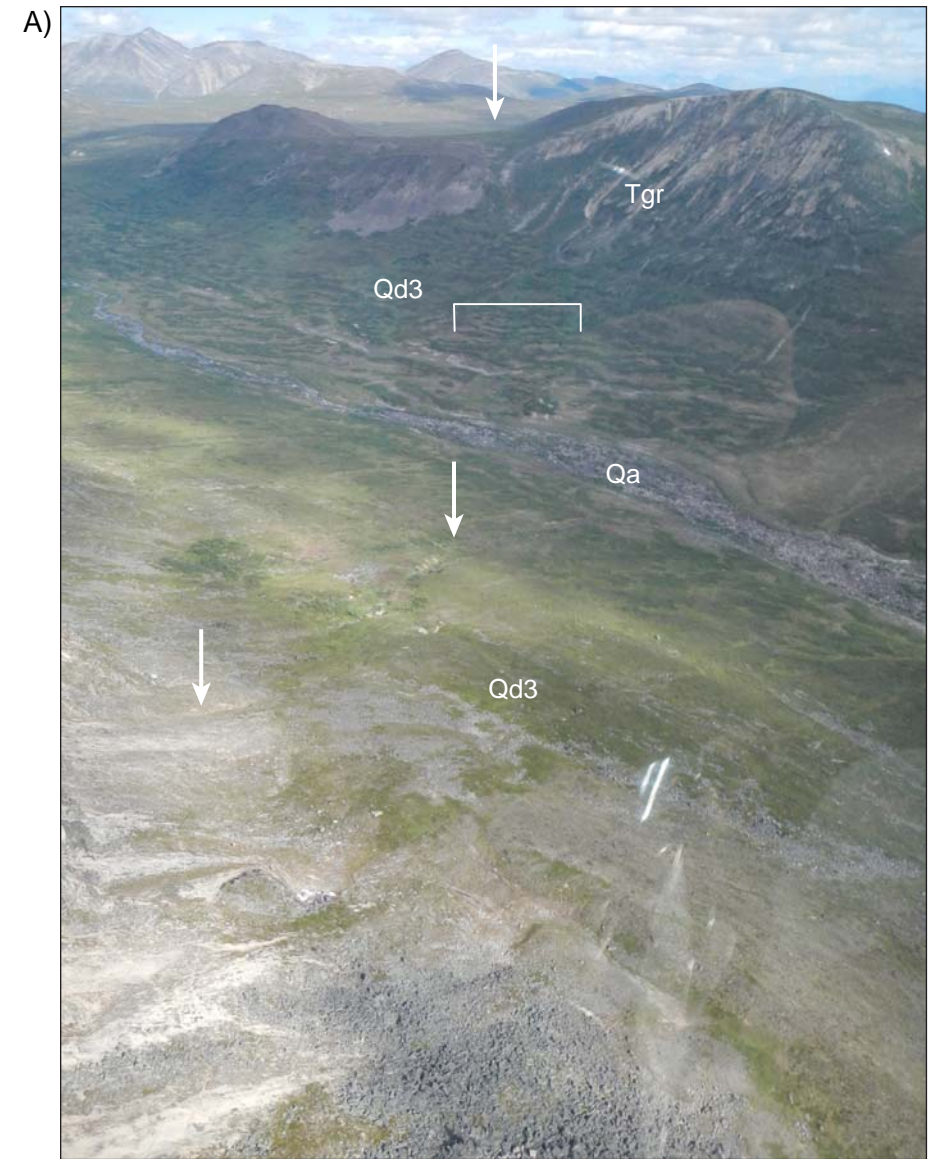
View looking north from location A. Arrows and brackets show the projected trace of lineament.

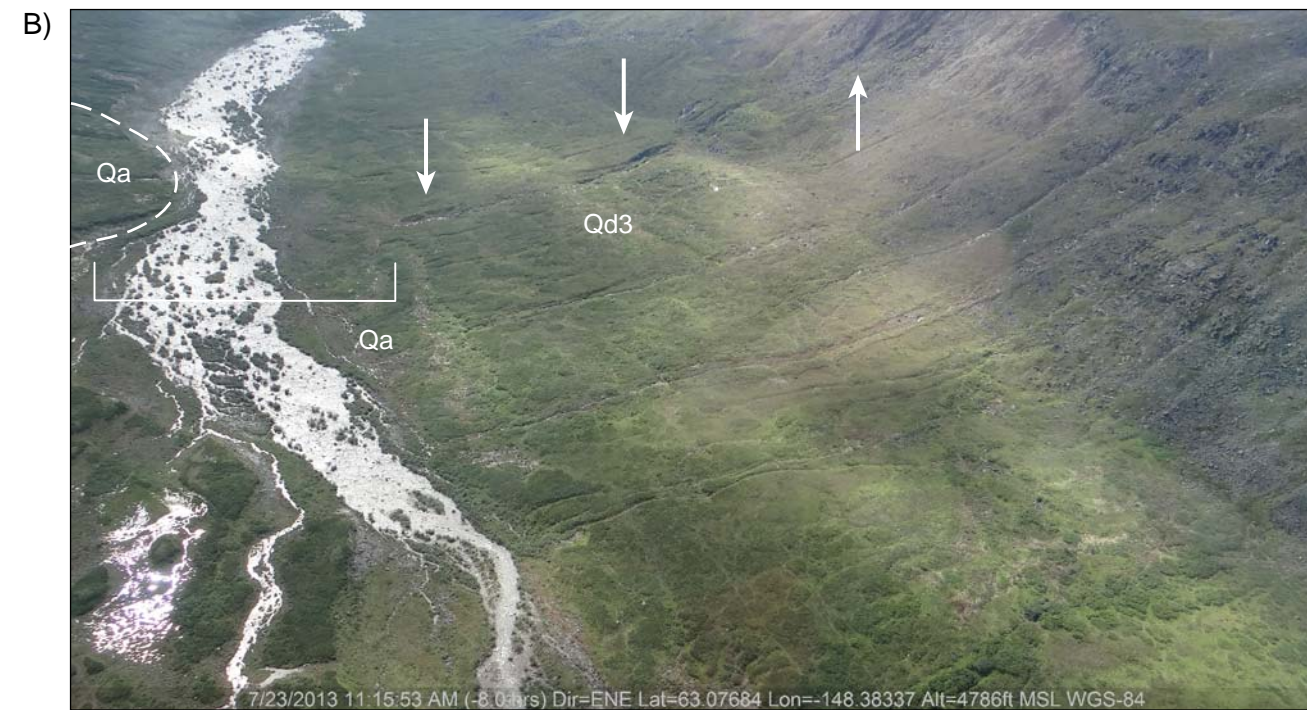
View looking south from photograph location B. Arrows show the projected trace of lineament. In Qd3 (till) the lineament is coincident with linear drainage in till deposit. Note absence of lineament in Qa deposit.

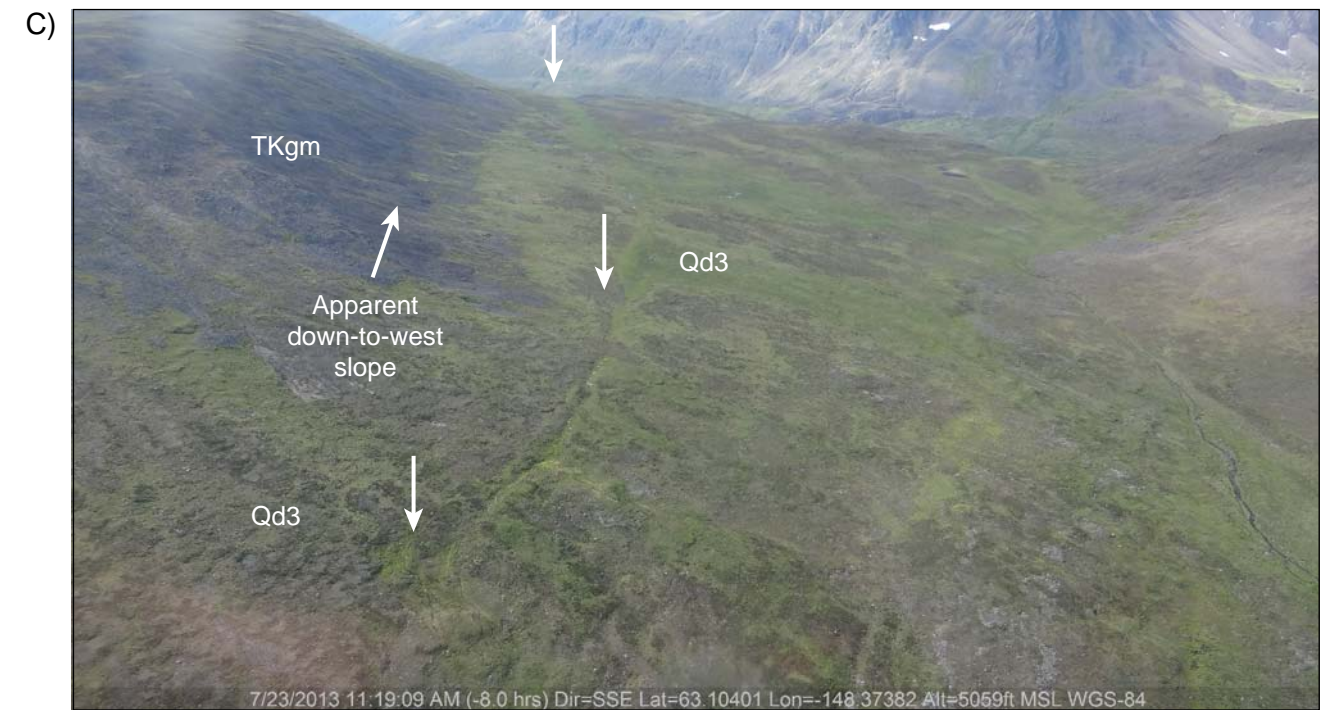
View looking south from photograph location C. Arrows show the projected trace of lineament. Note lineament is coincident with a linear drainage in this view.

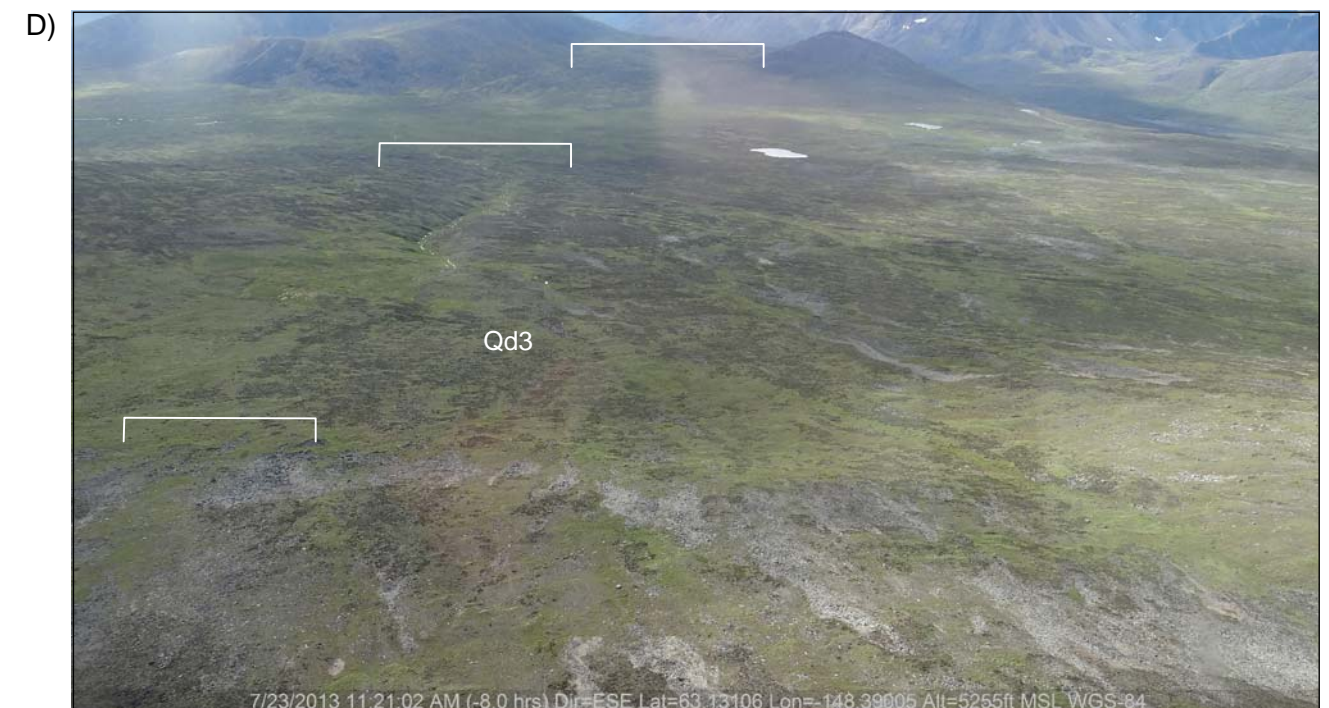
View looking south from location C. Brackets show the projected trace of lineament.

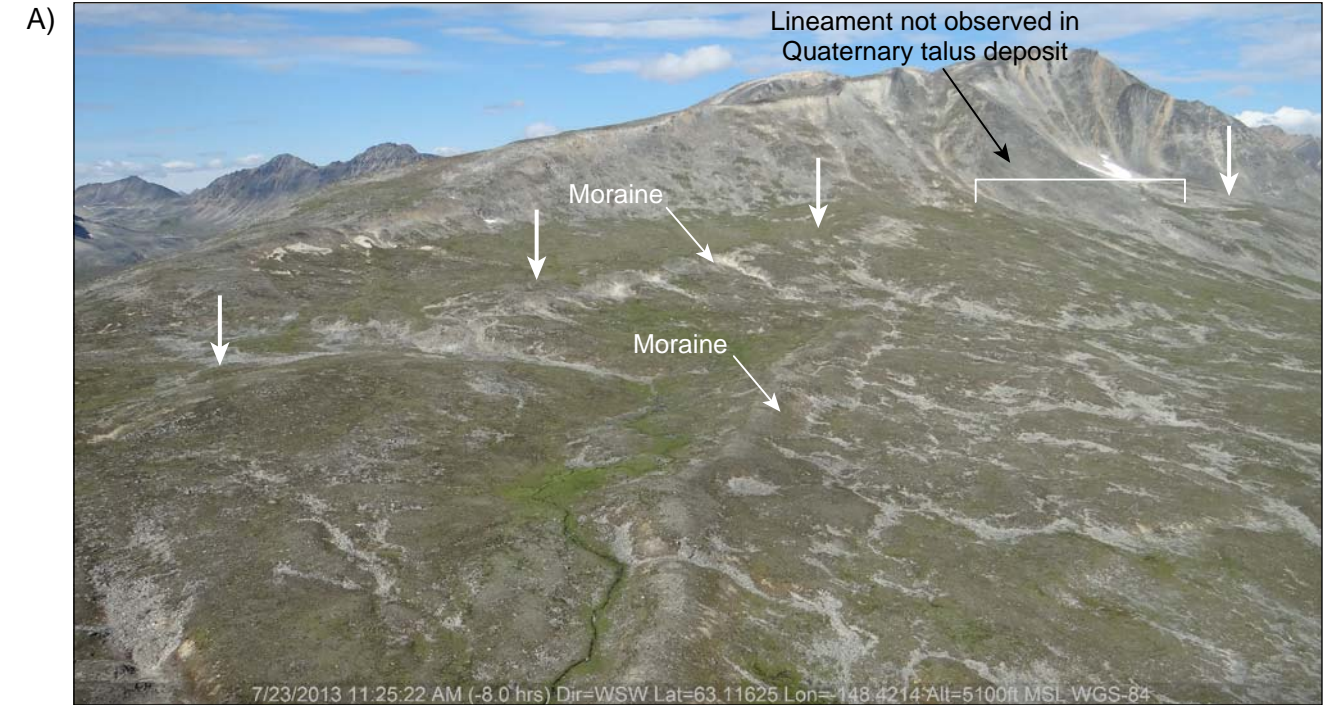
View looking west from location A. Arrows and brackets show projected trace of Feature 11 lineament. Note the mapped lineament correlates with a moraine crest.

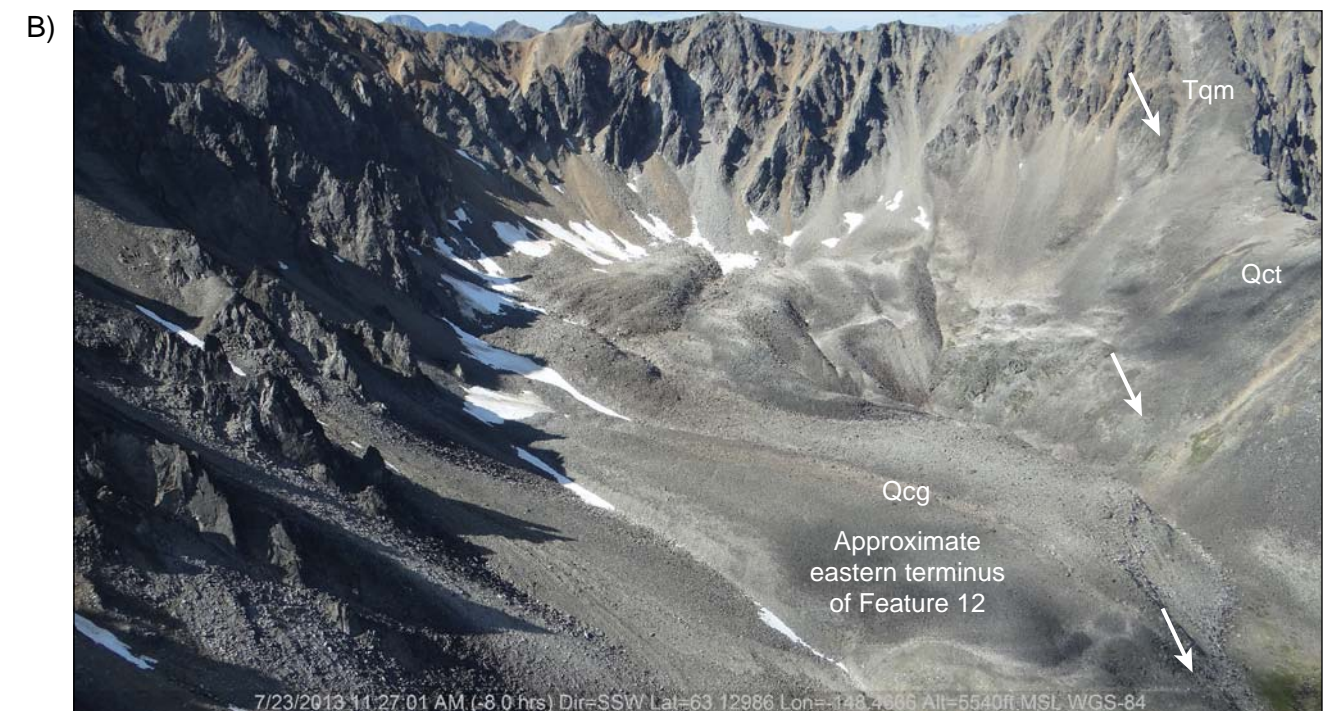
View looking west from location A. Brackets show projected trace of Feature 12 lineament. Note the trace of the lineament is a collection of unrelated features rather than a through-going feature.

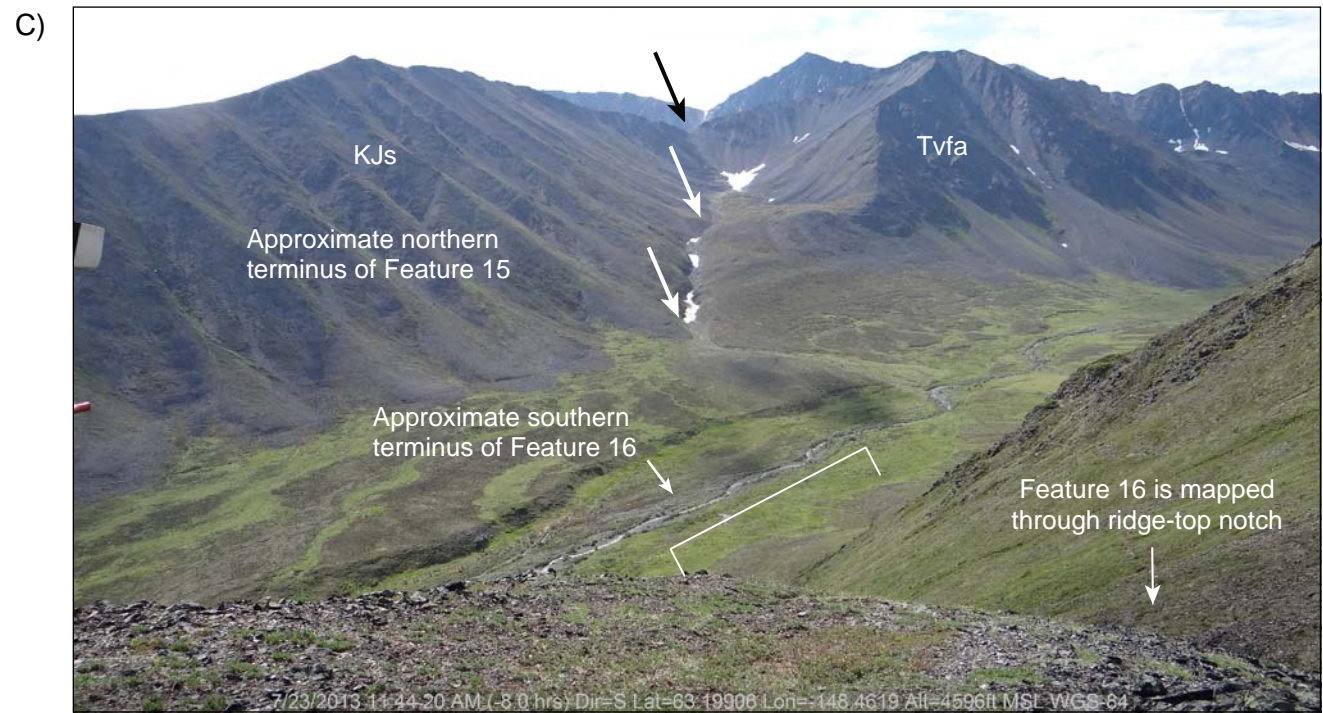
View looking south from location C. The arrows and bracket indicates the projected path of Feature 15 and 16 faults. Note absence of linear expression in valley floor within Quaternary deposits.
