**Susitna-Watana Hydroelectric Project  
(FERC No. 14241)**

**2012 Susitna River Water Temperature and  
Meteorological Field Study**

**Appendix A**

## APPENDIX A: PHOTOGRAPHS AND SITE INFORMATION

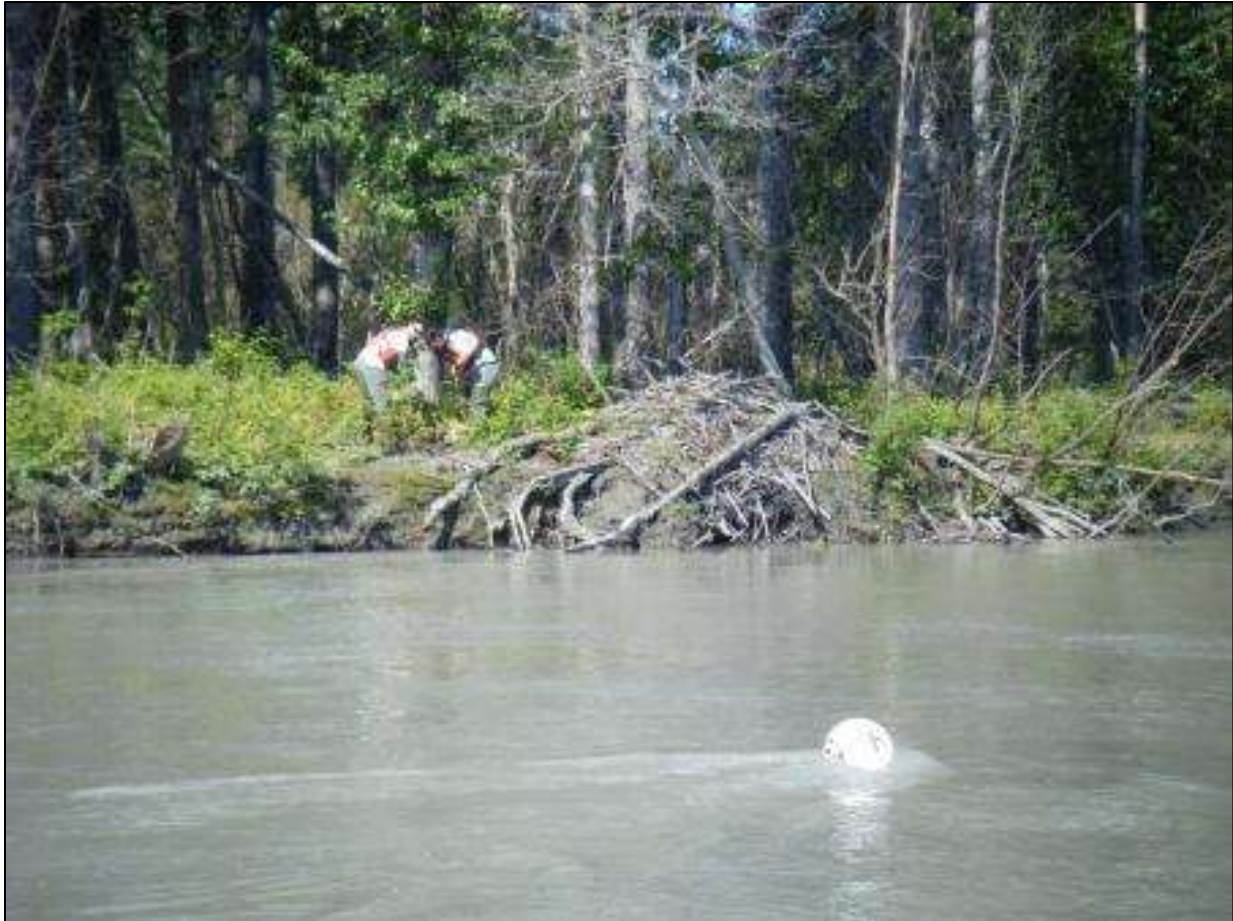
**Station Notes:** The buoy is deployed approximately 800 feet upriver of the proposed location due to an absence of anchoring trees or rocks. The system is anchored to shore with a cable, looped around a cottonwood tree and secured with cable clamps. The river gradient is quite low through this reach and eddy currents are not as obvious as locations upriver. A faint salty odor was observed emanating from the wake of the boat suggesting potential salt intrusion from Cook Inlet.

Buoy at RM 15.1 - Susitna above Alexander Creek

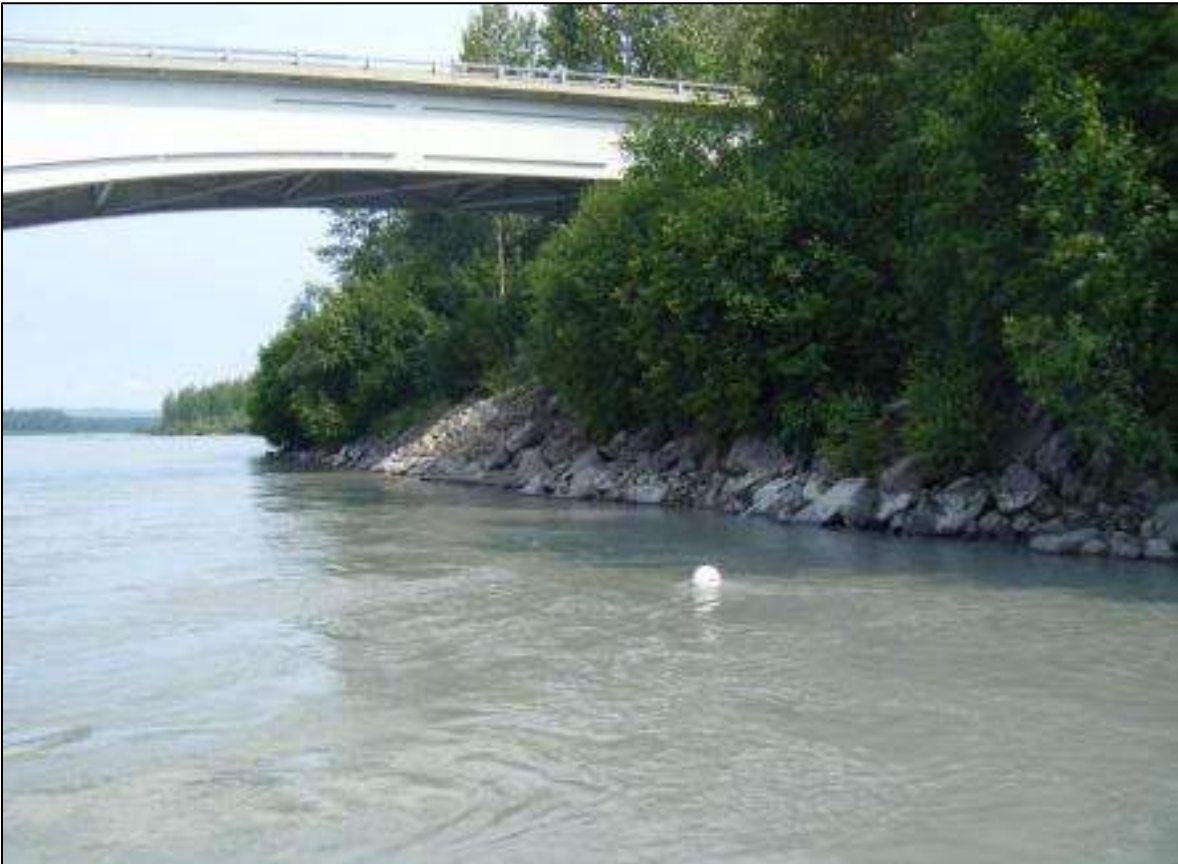
**Station Notes:** The buoy was deployed at the proposed location just south of the Parks Highway Bridge. The system was anchored to shore with a pipe clamp and lag bolts drilled into a boulder. The cable was looped around the pipe clamp and fastened with cable clamps.

August 28, 2012 – River was high, no buoy located, anchor stuck could not pull up. Bank mounted thermistor downloaded at 17:35 ADT.

October 16, 2012 – Downloaded at 11:00 ADT and removed summer buoy string with multiple data loggers. Replaced with winter, single data logger system (data logger # 10174234). Downloaded and extended pipe housing to 17 feet due to dropping water level. Pipe was found encased in frozen silt, and water level had dropped to six inches above the bottom of the pipe. Extended pipe 17 feet and increased thermistor cable length to 16.5 feet.

Buoy at RM 83.8 – Susitna at Parks Highway East

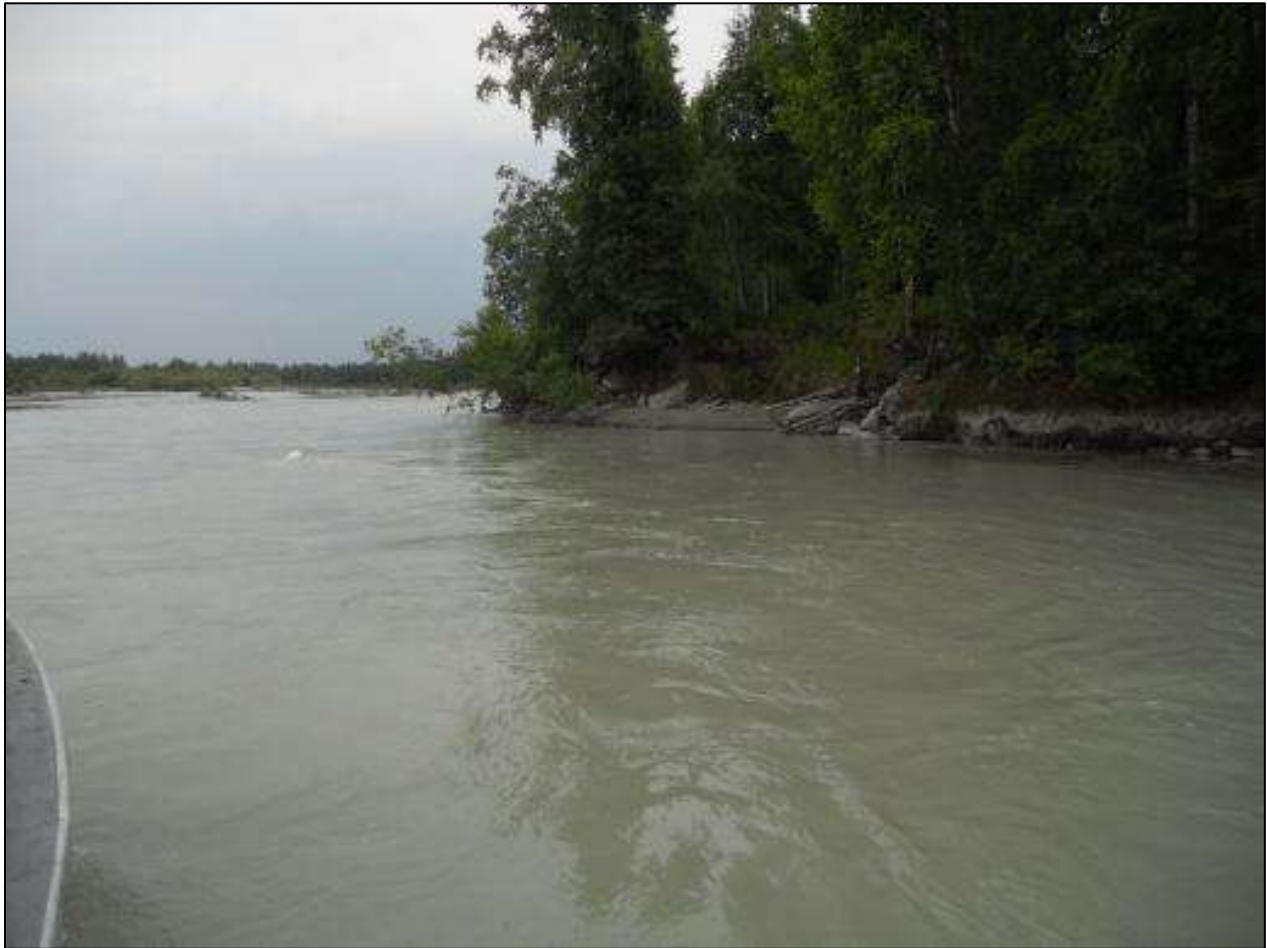
**August 28, 2012** – Buoy and anchor stuck and buoy missing. No download of buoy system. Pipe system was in good condition and thermistor was downloaded.

**September 28, 2012** – Missing buoy and cable to shore was covered with debris. Used wench to free system from debris. Data loggers were found to be in good condition and in place and were downloaded. Pipe system was found to be in good condition and was also downloaded.

**October 23, 2012** – Helicopter fly by only. Cable for buoy system was visible but no buoy visible (maybe under ice). Pipe was present but bent.

Buoy System at RM 95.8- Alternative to LRX 1

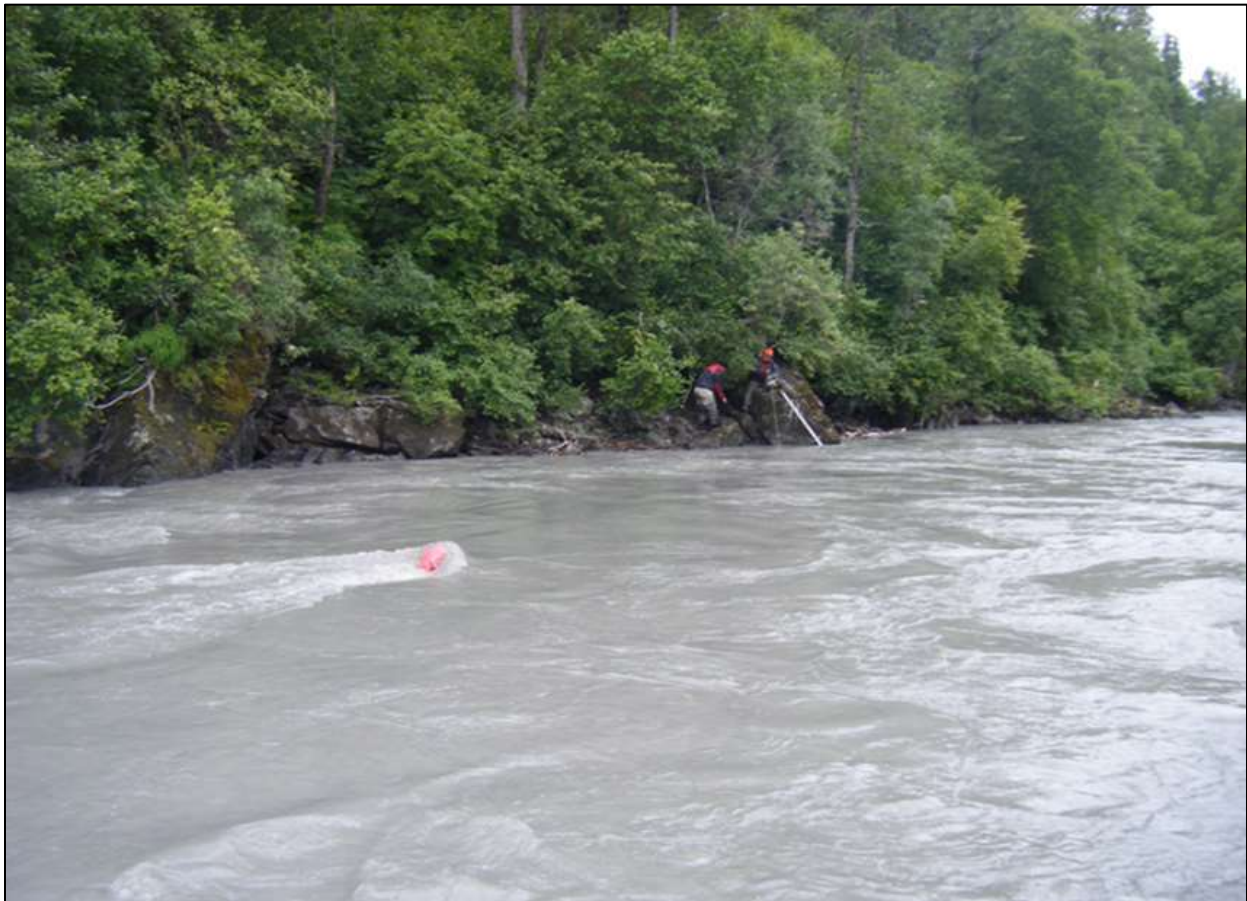
**October 17, 2012** – Both systems downloaded at 13:15 ADT. Sensor 10174257 is missing and likely lost. Buoy system had moved up against shore due to flooding. Upper thermistor in pipe was out of water and incased in frozen silt. Lower thermistor was in approx. 1 foot of water. Additional 7 foot section of pipe added to pipe setup (20 inches) and cable lengthened to 18 feet). Summer buoy system was removed and replaced with single data logger winter system.

Buoy at RM 98.1 – Chulitna River

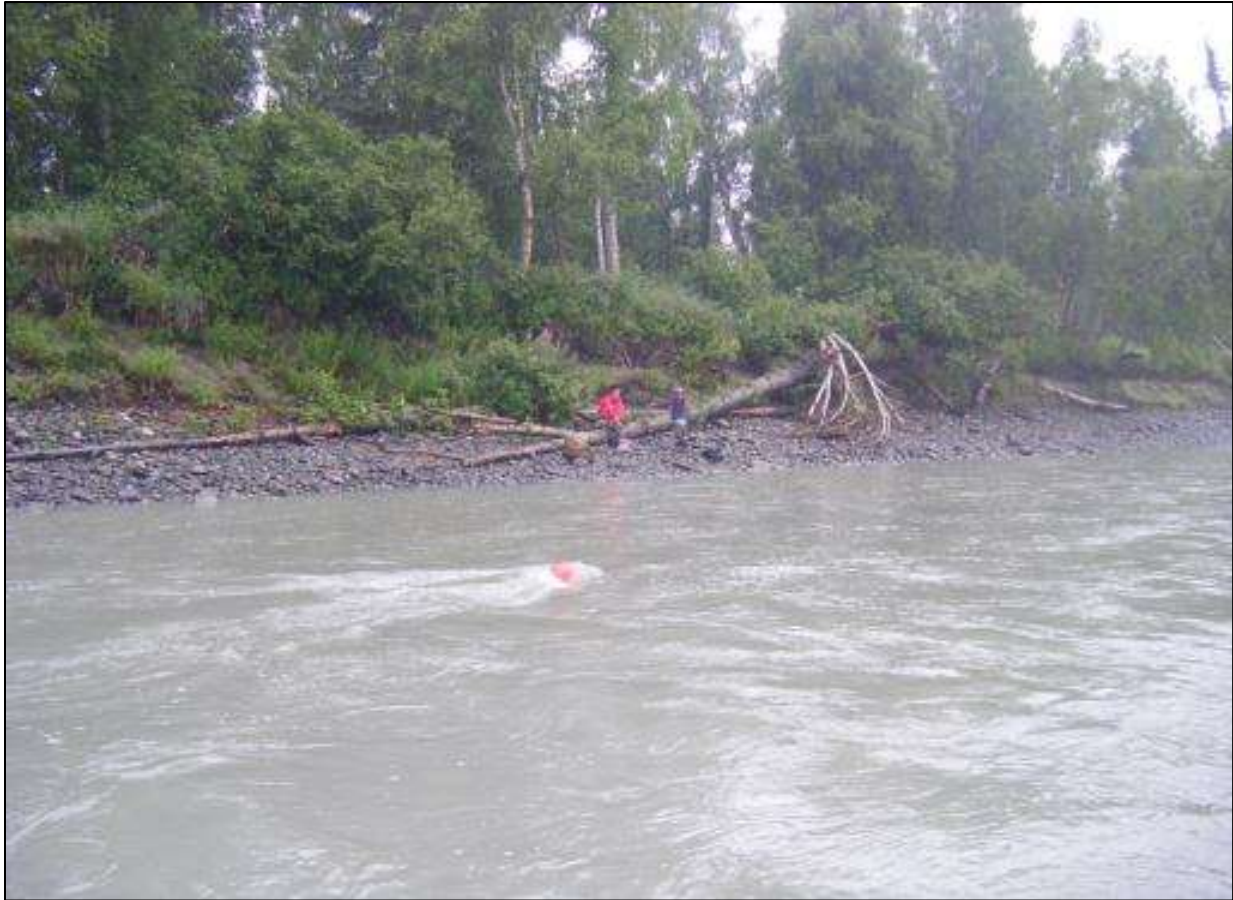
**September 27, 2012** – Buoy was missing. Replaced buoy, system was still intact and thermistor data was downloaded at 17:45 ADT.

**October 23, 2012** – Buoy system intact. Downloaded at 12:30 ADT and removed summer buoy string with multiple data loggers. Replaced with winter single data logger system (data logger # 10174249). Pipe system dry and data logger cable was frozen in pipe – could not remove for download. Left pipe in place.

Buoy at RM 103.3 – Talkeetna

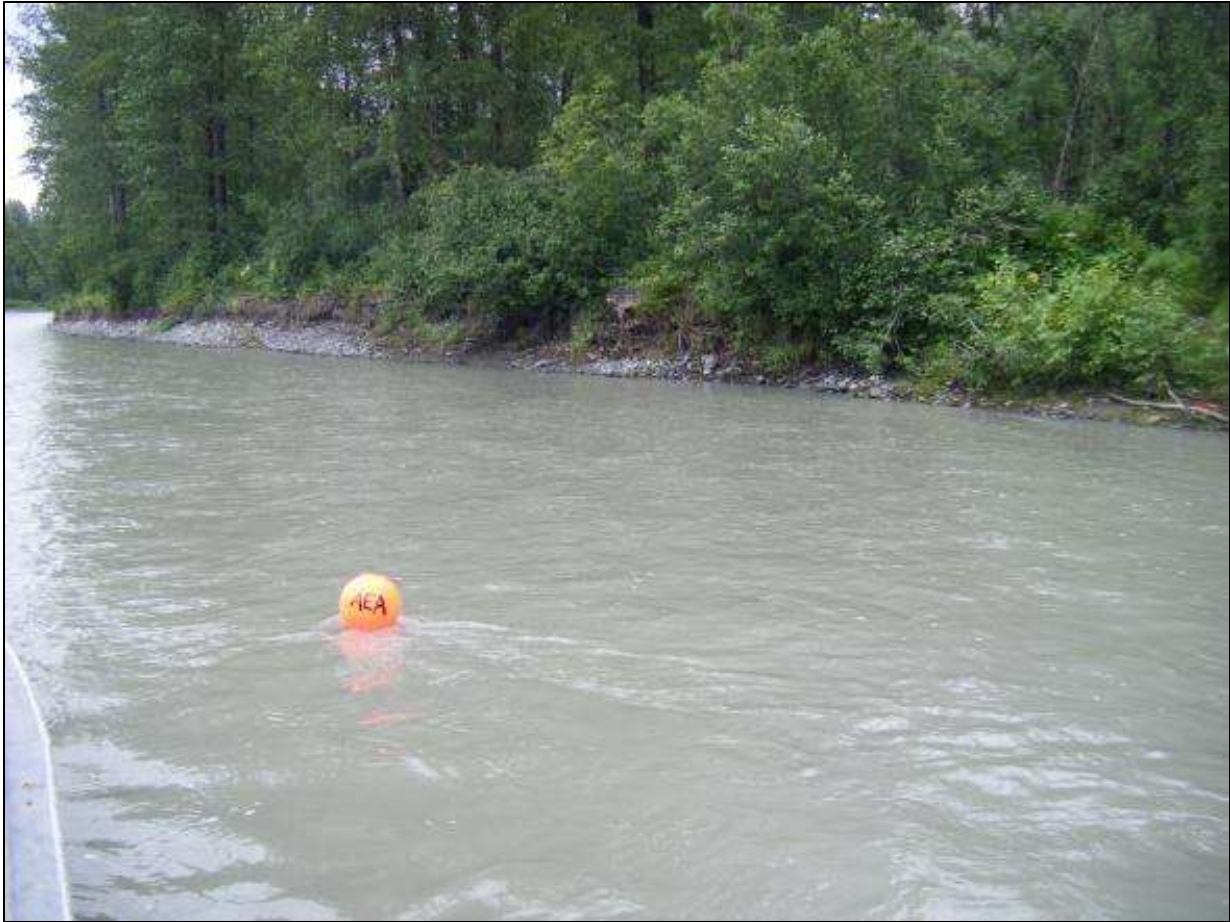
**September 27, 2012** – Buoy system came loose from anchor during flood but was found dry on bank down river and retrieved. Data logger 252 was missing remaining loggers were downloaded. System was not replaced due to lack of good anchor point.

Buoy System Installed at RM. 113- LRX 18

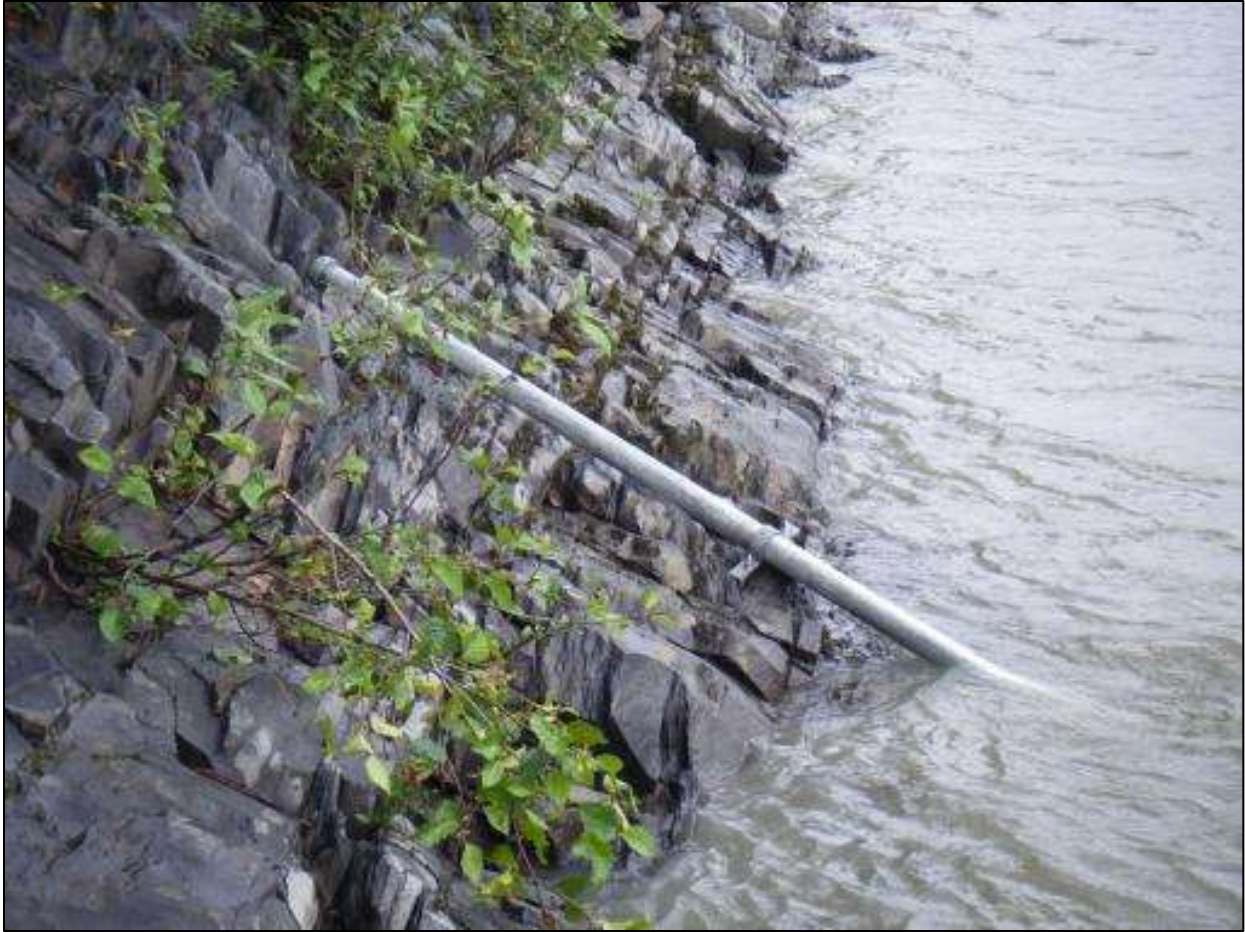
The housing pipe was fastened to shale with two pipe clamps and lag bolts slightly upstream of the buoy. The pipe houses 13 feet of cable with a thermistor attached by zip ties to a loop at the end. The thermistor was mounted to the cap at the end of the pipe in the river. The pipe was submerged 8 feet in the water at a 35° angle. The integrity of the shale is questionable; it may give way eventually.

RM 120.7 – Pipe Mounted at Curry Fishwheel Camp

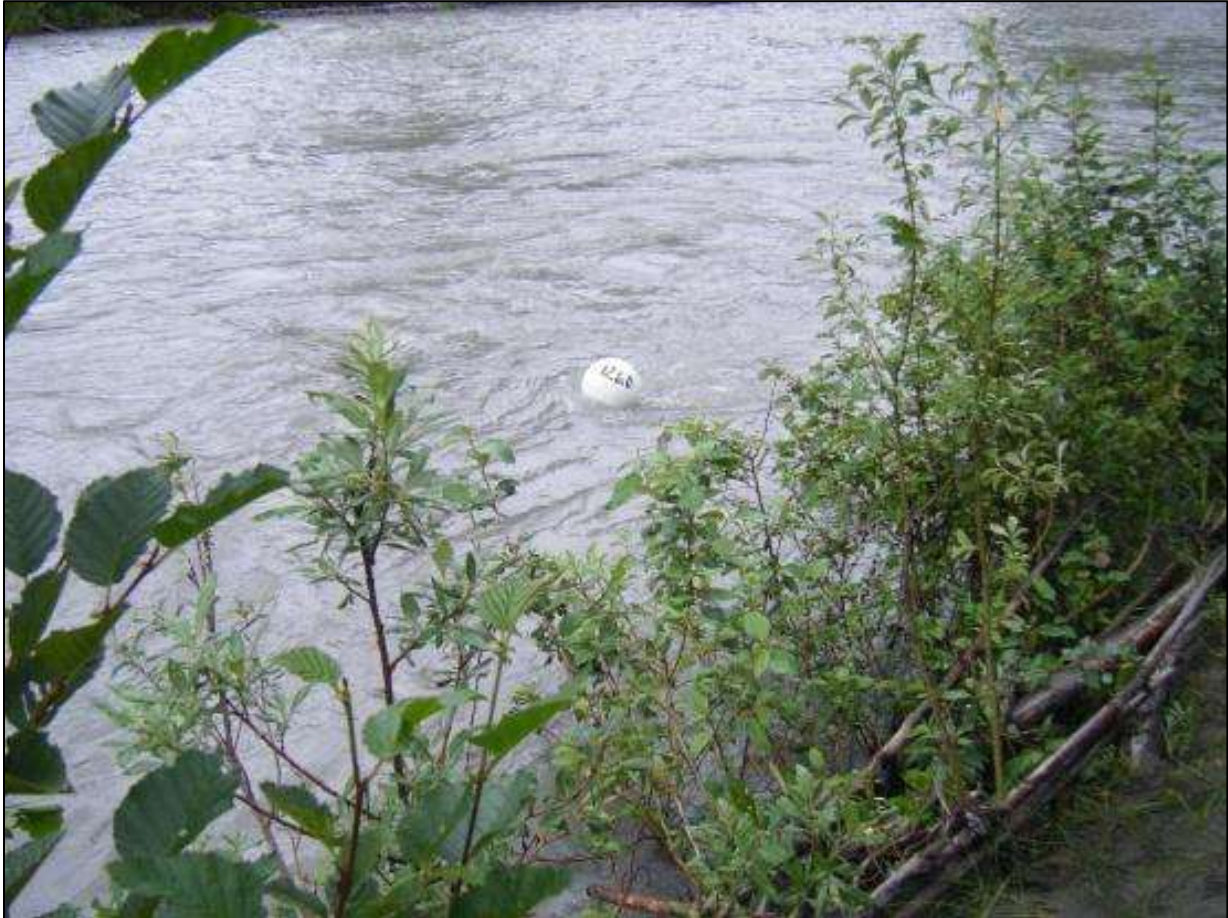
**October 15, 2012** – Buoy with complete data logger string was found in downstream slough. System was retrieved and downloaded at 13:45 ADT.

**October 23, 2012** – Helicopter flyby. The side channel where system was deployed was observed to be almost dry. No winter system deployed.

Buoy at RM 126.0 – Slough 8A

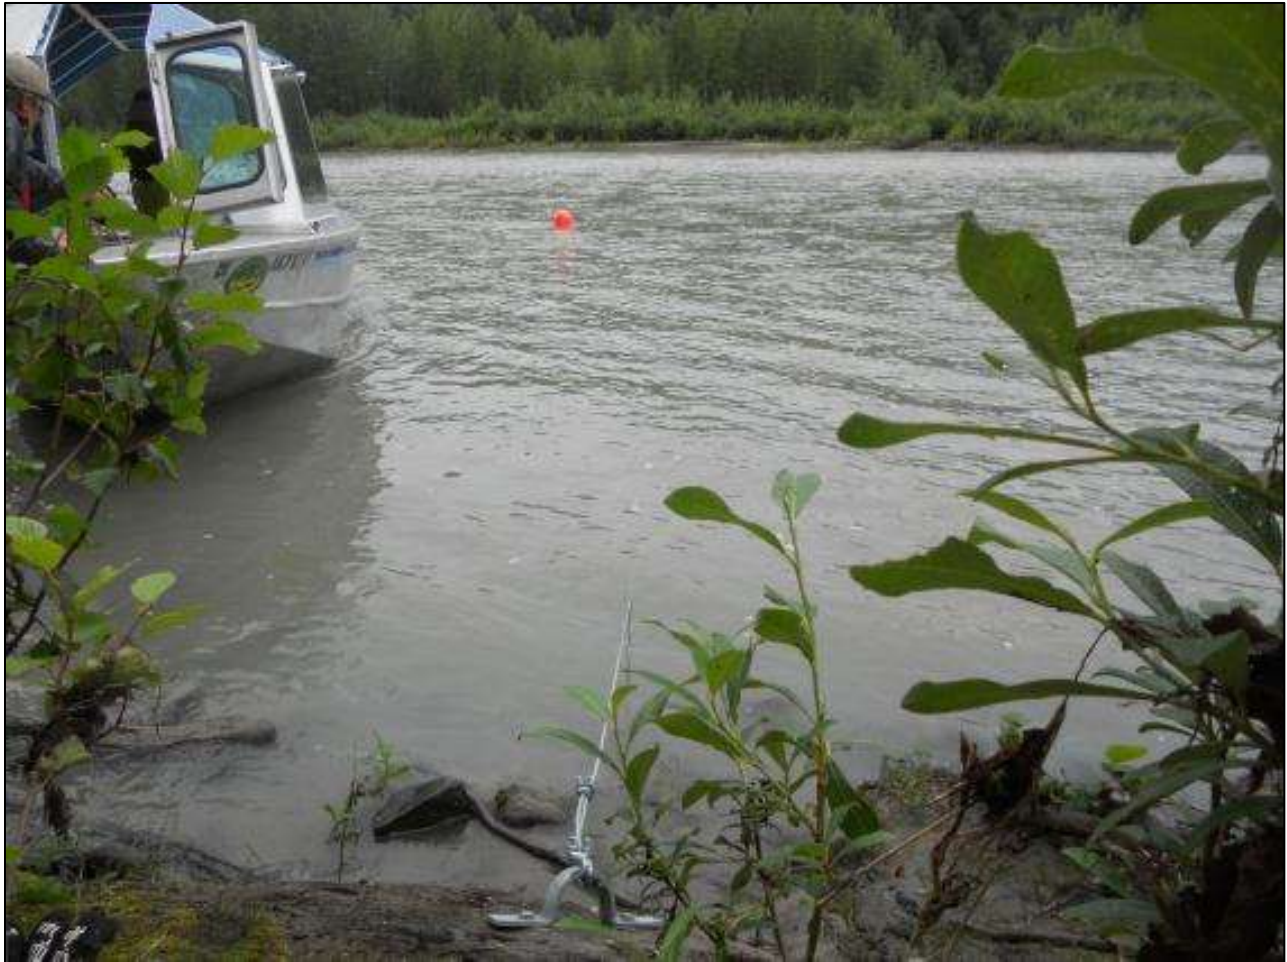
**August 27, 2012** – Downloaded system at 16:00 ADT. Buoy was missing.

**September 27, 2012** – Replaced buoy and downloaded data loggers at 16:20 ADT.

Buoy Install at RM 126- LRX 129

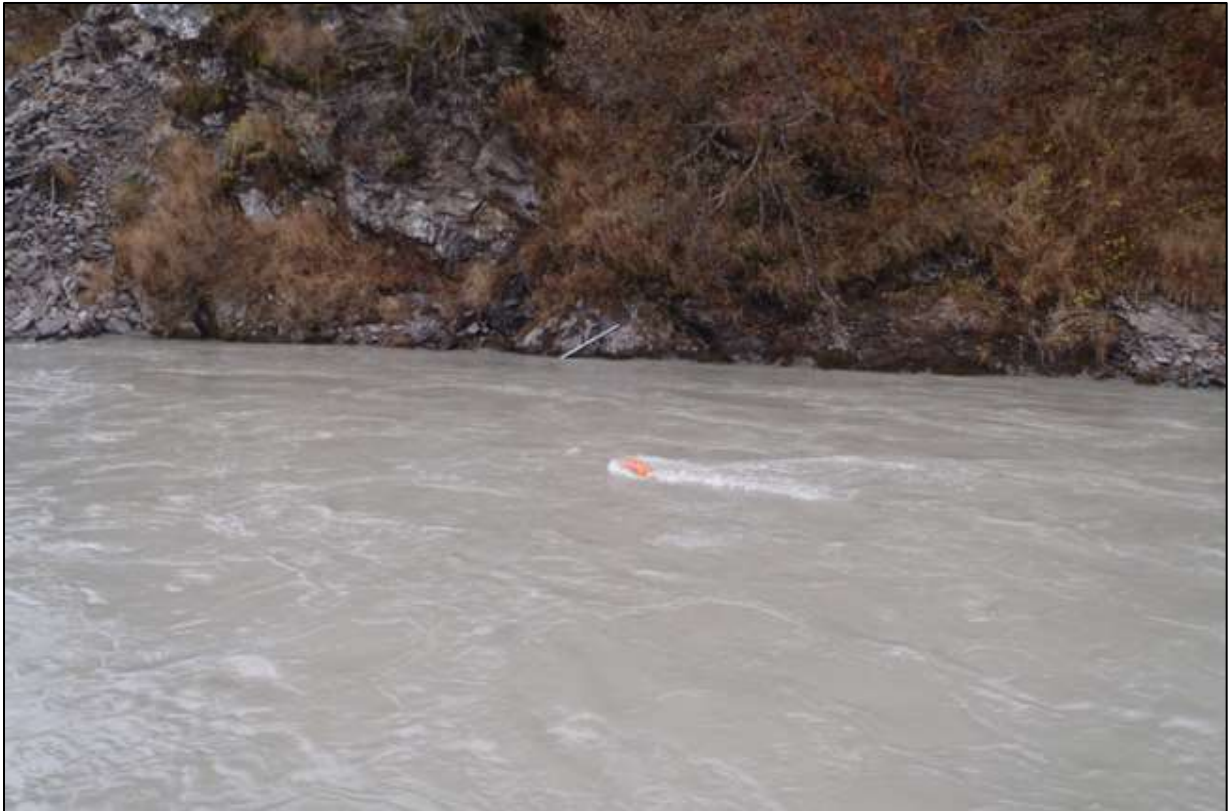
**September 27, 2012** – Buoy was missing but replaced. One data logger was missing (10174227) and not replaced. Both systems downloaded at 14:28 ADT.

**October 23, 2012** – Pipe was high and dry and tidbit cable was frozen in pipe and could not be removed, no download. Buoy system intact. Downloaded at 13:45 ADT and removed initial buoy string with multiple data loggers. Replaced with winter, single data logger system (data logger #10174227).

Buoy and Pipe Systems at RM 138.7 - Susitna above Indian Creek

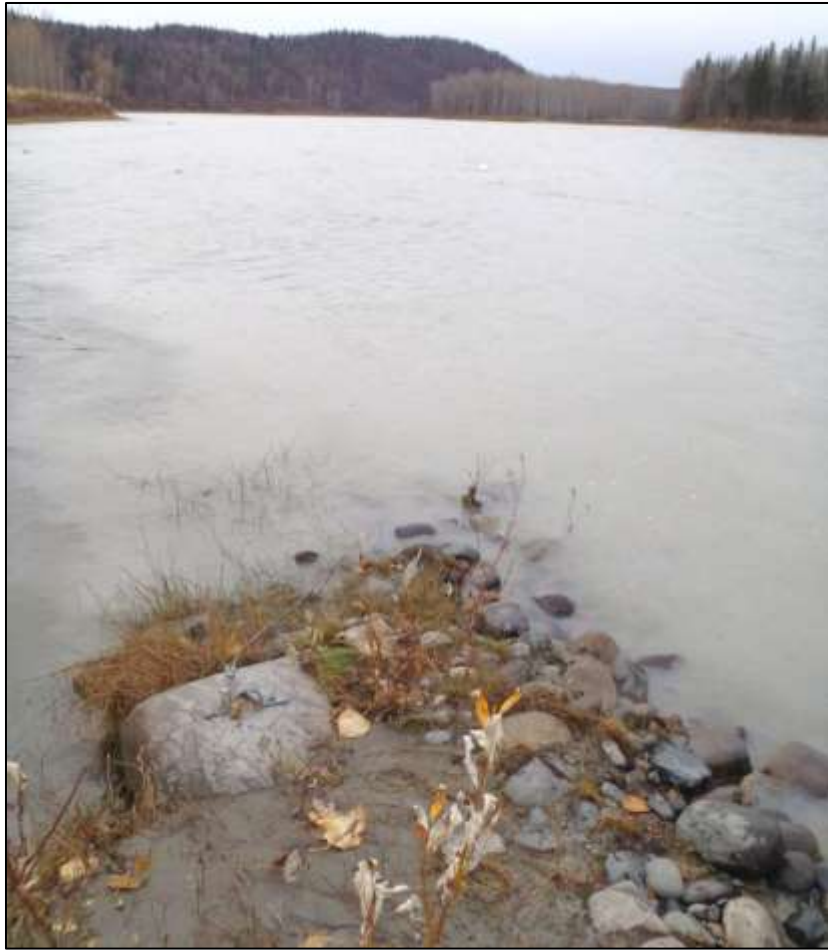
**August 27, 2012** – Buoy was missing but found downstream and reattached. System downloaded 14:10 ADT and re-deployed.

**October 22, 2012** – System intact but dry and incased in ice. System was downloaded at 12:00 ADT and removed from the river. No winter system deployed due to shallow water conditions.

Buoy system at RM 40.0 - Slough 19

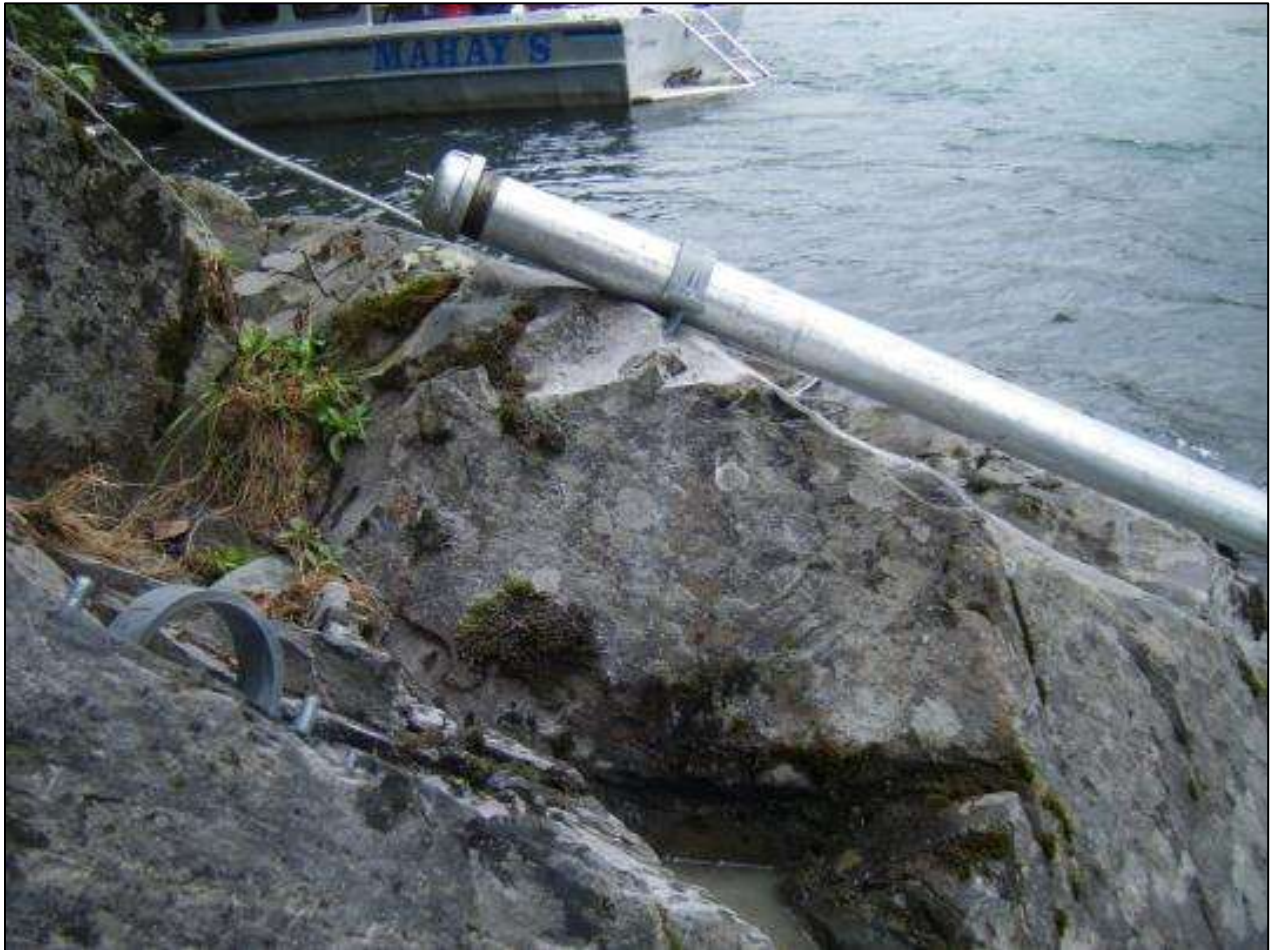
**October 22, 2012** – Internal cable is frozen in and cannot be removed for download. Leave system in place until spring.

Pipe System at RM 148.0 – Susitna below Portage Creek

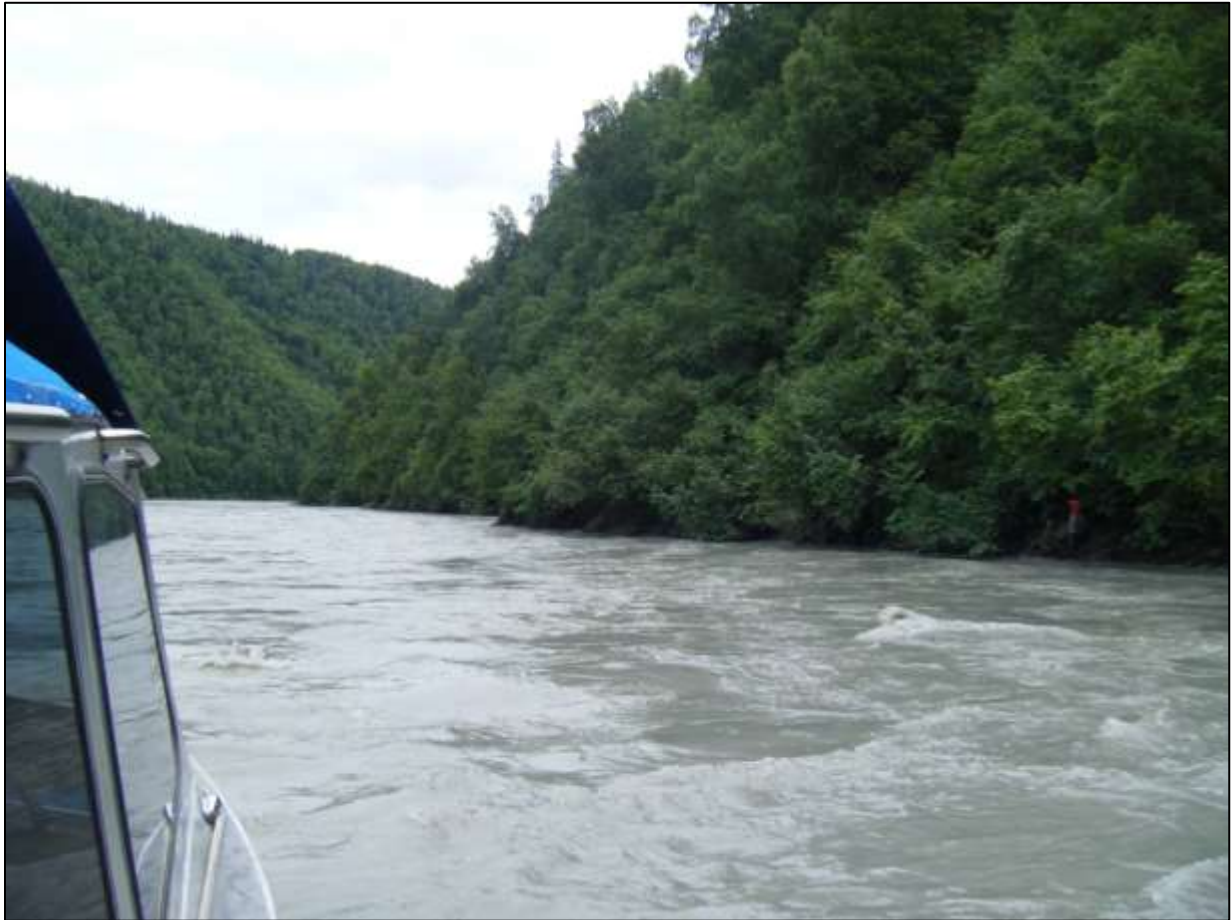
**August 28, 2012** – Buoy missing and replaced. System downloaded. At 12:21 ADT and redeployed.

Buoy Installation at RM 148.8- Above Portage Creek
