**Susitna-Watana Hydroelectric Project
(FERC No. 14241)**

**Study of Fish Passage Barriers in the Middle and
Upper Susitna River and Susitna Tributaries (9.12)**

**Appendix A
Tributary Geologic Barriers**

Initial Study Report

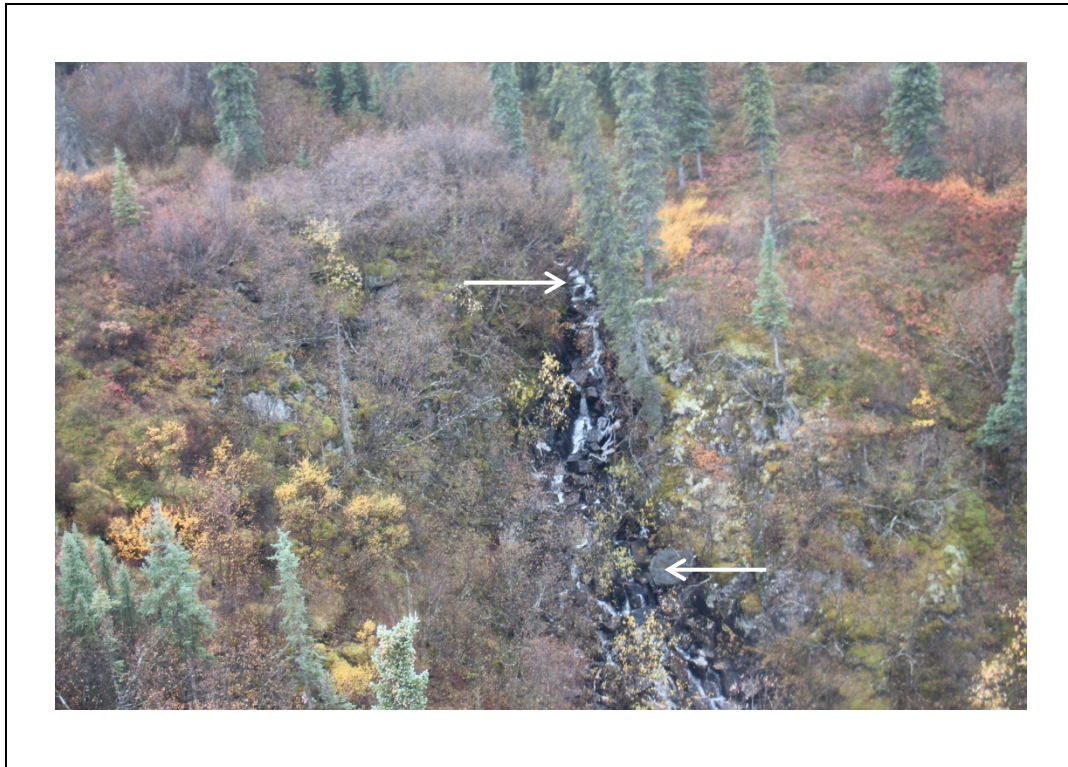
The potential barrier site was located at the upstream extent of a very high gradient reach of boulder dominated cascades (Figure A1). At the time of survey, flow conditions appeared to be very low, making it difficult to discern the true bottom of the barrier. The surveyed site appeared to be only slightly steeper than the immediate reach downstream, but both the surveyed site and downstream reach appeared to be a barrier to upstream migration.

The site was classified as a fixed seasonal boulder cascade and is likely a fixed permanent barrier. The average barrier height was 8.9 m (29 ft), and the average horizontal length was 10.9 m (36 ft) with an average channel gradient of 83 percent. Low flow conditions, large bed material, and the significant grade did not provide for a clean swim route up the cascade. Resting areas at the upstream and downstream ends of the barrier appeared minimal in the current flow conditions, and no downstream jump pool existed.

Figure A1. Barrier A in Unnamed Tributary 189.7. Fixed seasonal boulder cascade, 29 ft in height and horizontal length of 36 ft with an average channel gradient of 82 percent.

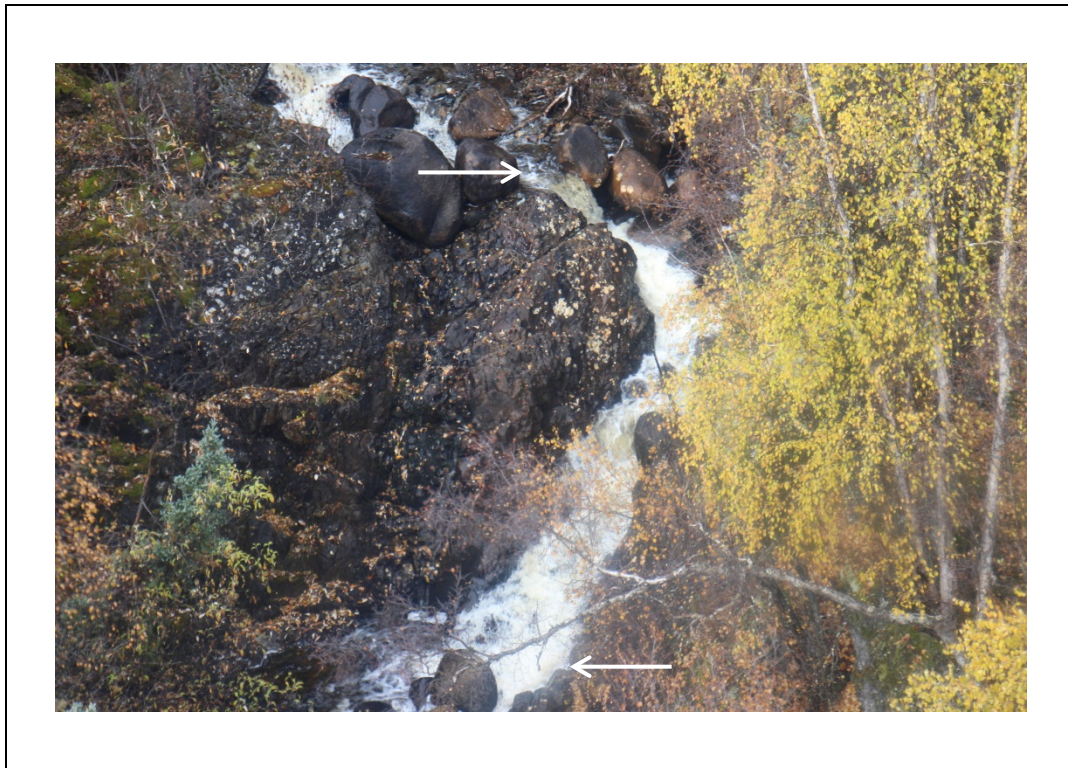
The potential barrier site was located at the upstream extent of a very high gradient reach of boulder dominated cascades (Figure A2). Flows appeared to moderate to low, and the stream bed was dominated by large boulders and exposed bedrock. Flows entered the cascade and made a 90 degree right turn towards the bottom, and a very minimal pool was located at the bottom.

The site was classified as a permanent fixed boulder cascade. The average barrier height was 13.8 ft (4.2 m), and the average horizontal length was 32 ft (9.8 m), resulting in an average channel gradient of 43 percent. Lower flow conditions, large bed material, and the significant grade did not provide for a clean swim route up the cascade. The barrier's height and length appeared to preclude leaping as a means of passage. Resting areas at the upstream and downstream ends of the barrier were minimal under the observed flow conditions with no downstream jump pool.

Figure A2. Barrier A in Unnamed Tributary 197.7. Fixed seasonal boulder cascade, 13.8 ft in height with a horizontal length of 32 ft and an average channel gradient of 43 percent.

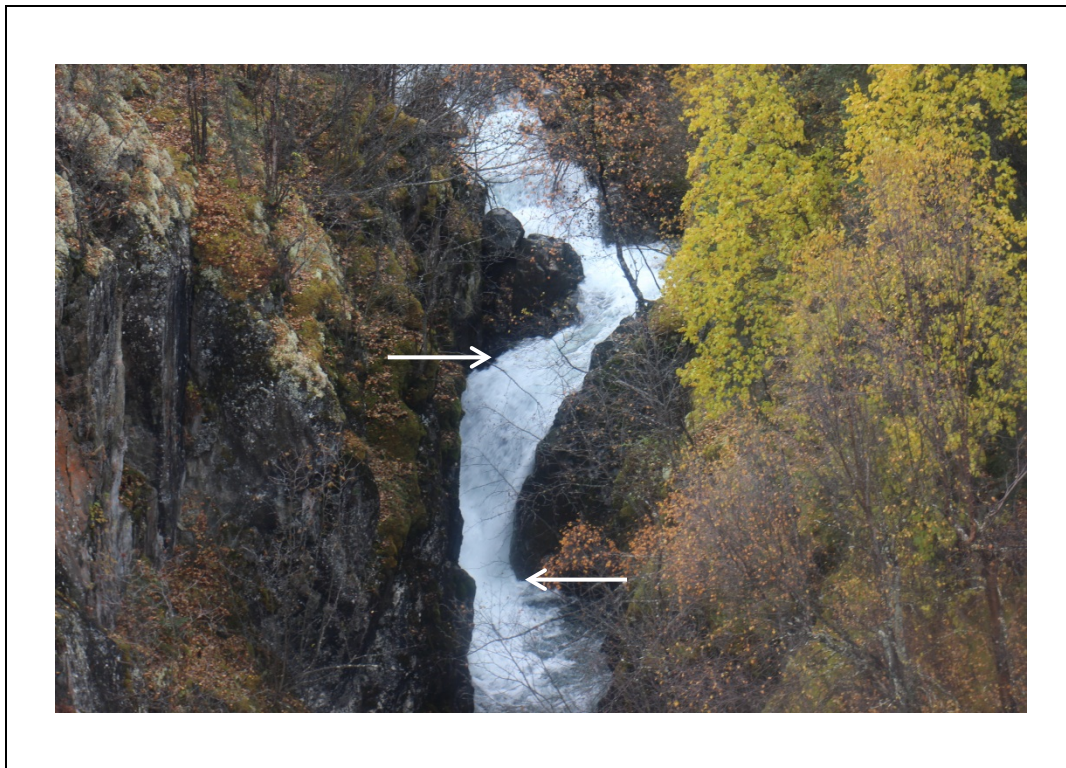
The potential barrier site was located amid a moderate to high gradient reach of stream dominated by boulder cascades (Figure A3). The site was classified as a fixed permanent single falls. The stream turbulence made it difficult to ascertain the bed material upstream and downstream of the feature, but the falls themselves were formed by an exposed bedrock sill.

As a single fall, and due to its location, only the height of the barrier was assessed. The average barrier height of 10.8 ft (3.3 m), including the measurement error (± 1 ft), is within the range of Chinook maximum leaping abilities as described by the US Forest Service (2001) but exceeds their leaping abilities as described by Powers and Orsborn (1984) and Reiser and Peacock (1985). A sizeable plunge pool was observed. While no depth could be determined, the pool had sufficient depth to dissipate most turbulence resulting from the plunge. The landing area above the feature appeared to be located in a short, high gradient reach with a small but turbulent resting eddy immediately below another smaller waterfall.

Figure A3. Barrier A in Unnamed Tributary 204.3. Fixed single fall, 10.8 ft in height.

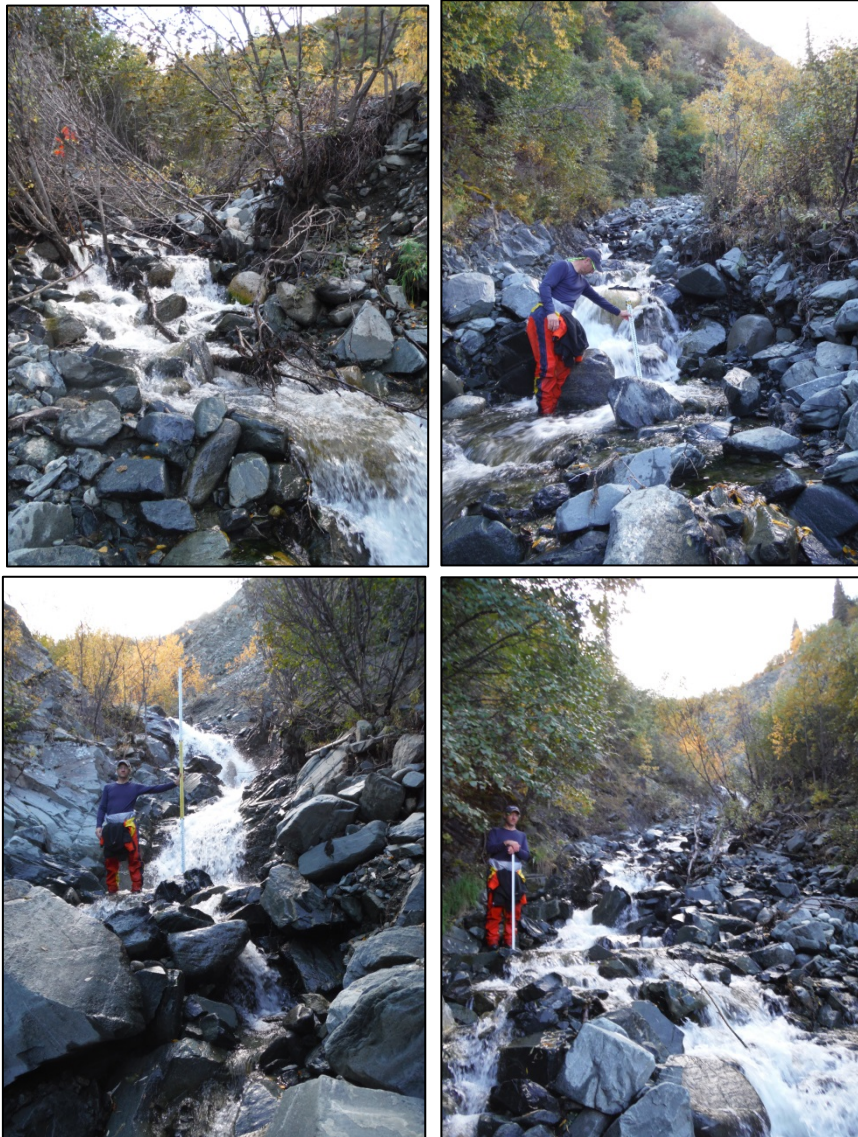
This barrier was surveyed by foot on September 12, 2013 and was located on a tributary entering the Susitna River on river left (Barrier ISR Figure 4.3-1a). The barrier was classified as a complex chute and turbulent cascade with an overall 29.7 m (97.4 ft) vertical drop over a horizontal distance of 177.8 m (583.3 ft). The gradient range was 10 to 15 percent for the bottom half of the falls, increasing to between 20 and 34 percent for the final 18 m (59 ft) vertical drop, with an overall slope of 17 percent. The combination of waterfalls and steep, turbulent, high-velocity chutes with limited resting areas or deep plunge pools confirmed this as a permanent fixed barrier for fish movement (Figure A5).

Figure A5. Barrier A in Unnamed Tributary 215.2. Clockwise from top left, views from bottom to top of a complex chute which spans 97 ft in vertical direction and 583 ft in horizontal direction. This is a permanent barrier to fish passage.

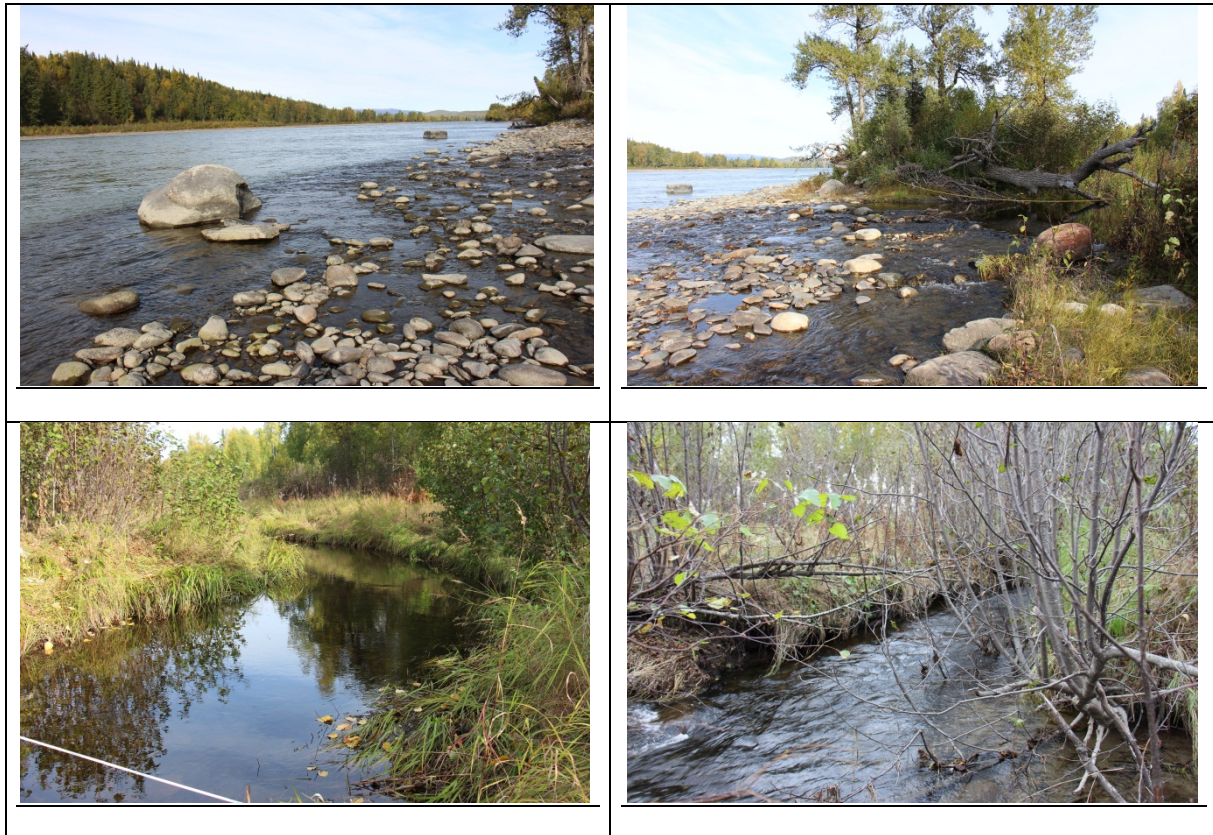
The mouth of Chase Creek was unique compared to the other tributaries surveyed. Although characterized by exposed boulders and cobbles, it did not resemble the large, bedload-deposited aprons seen elsewhere (Figure B1). The mouth exhibited a steepened slope due to the receding Susitna, but no defined channel had been formed in the exposed substrate (Figure B2). The creek flow was spread out across the exposed substrate with no clearly defined or continuous thalweg. A natural and irregular small boulder and cobble weir formed at the top of the mouth grade break, dispersing flow leaving the upstream pool (Table B1). It was likely that the low-gradient nature of this creek had limited the material deposited at the mouth, and that creek flows have not regularly carried enough energy to alter the geometry of the existing debris apron.

Figure B1. Chase Creek. From upper right: bottom of creek mouth; top of creek mouth; low gradient channel resulted in slow meandering reaches; and near top of creek survey.

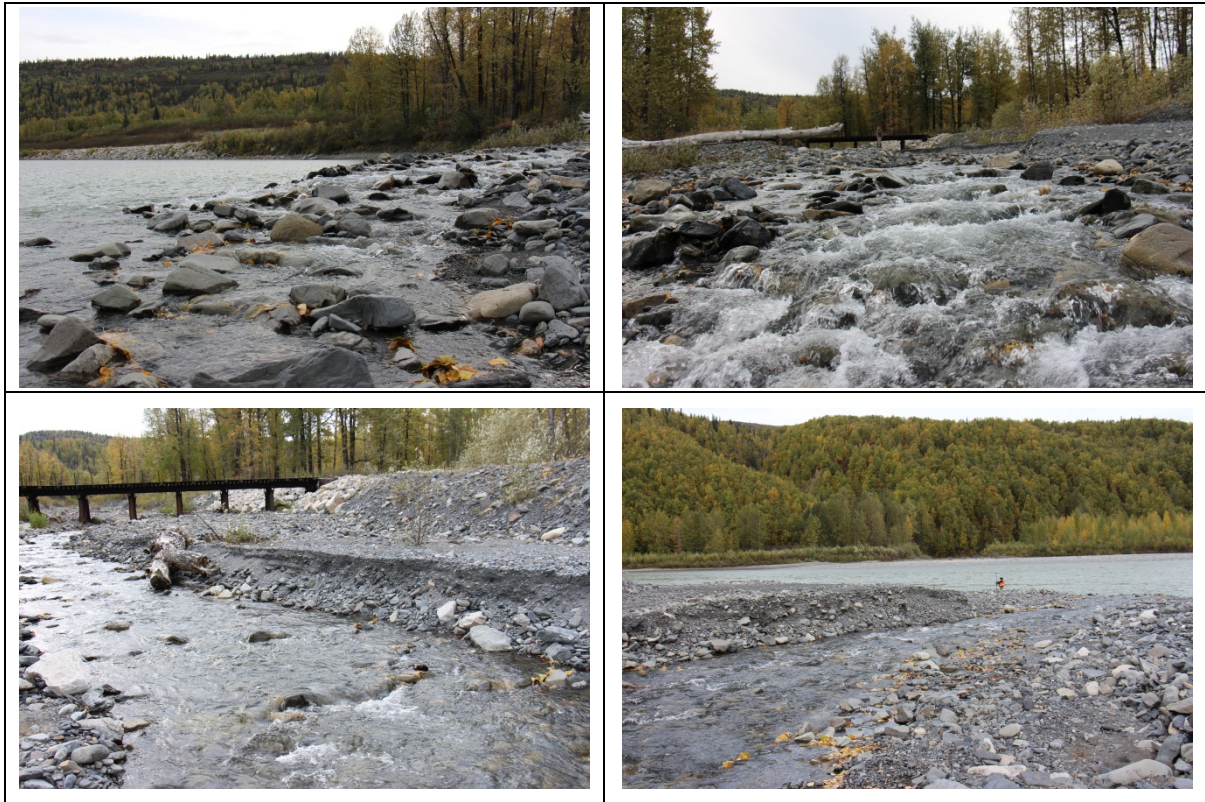
The mouth of Deadhorse Creek consisted of a large debris fan and single creek channel (Figure B5). The creek had incised the debris apron, but a final steep boulder cascade remained before reaching the Susitna (Figure B6). This noticeable perch was a result of low creek flows and the receding Susitna flow. Deposited material varied in gradation, material size and mixture throughout the fan (Table B3).

Figure B5. Deadhorse Creek. From upper right: bottom of creek mouth; looking upstream from Susitna from creek mouth; upstream extent of channel survey; and looking downstream – note channel incision through deposited apron material.

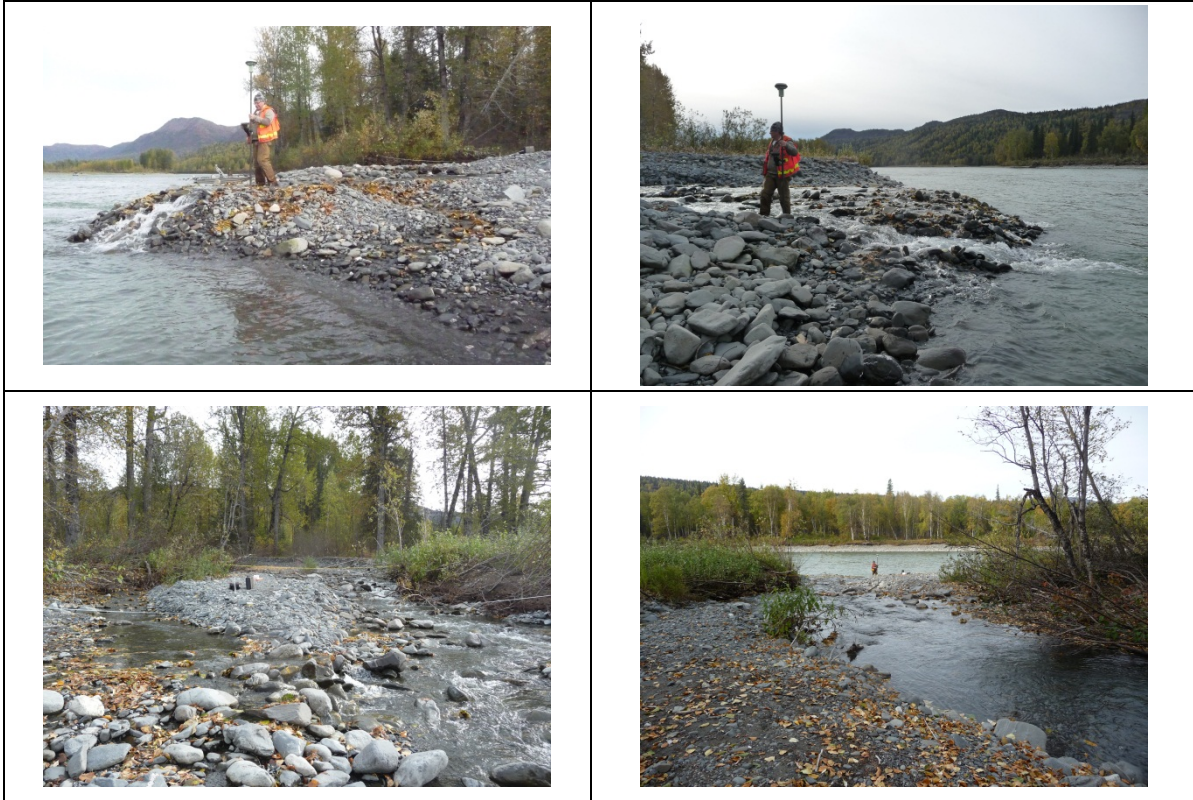
The mouth of Sherman Creek extended across a short debris fan (Figure B11). The stream crossed in a single channel, and upon reaching the perched edge of the fan, flow divided between a few main flow paths before reaching the Susitna (Figure B12, Table B6).

Figure B11. Sherman Creek. From upper right: bottom of creek mouth; multiple channels through creek mouth; riffle upstream of tributary apron; and looking downstream from top of survey.
