SUSITNA-WATANA HYDROELECTRIC PROJECT
 LINEAMENT GROUP 26
 MAP DATA

SUSITNA-WATANA HYDRO

AEA11-022

Appendix B:
Strip Maps and Photographic Documentation
of Lineament Data for Lineaments Mapped by Reger et al. (1990)

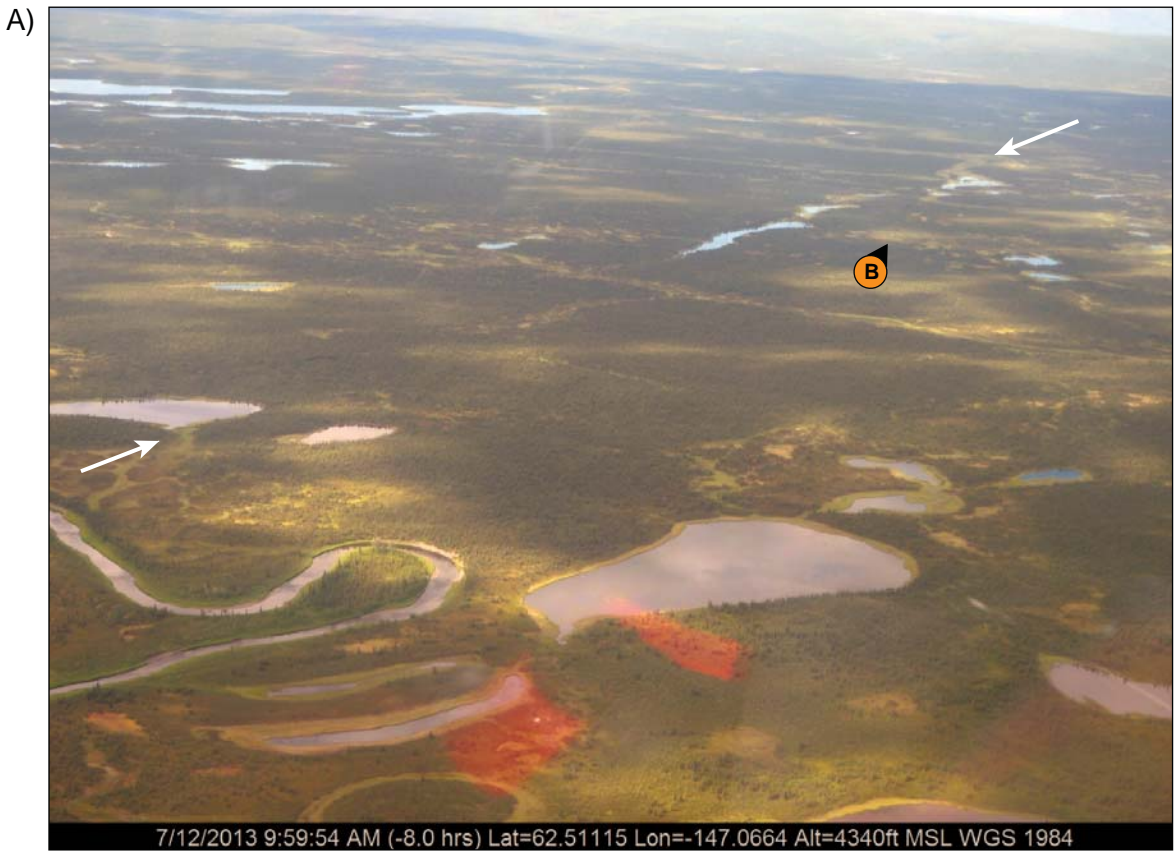
View looking west-southwest toward linear alignment of lakes. Arrows point along lineament. Note kettle lake terrain in the foreground.

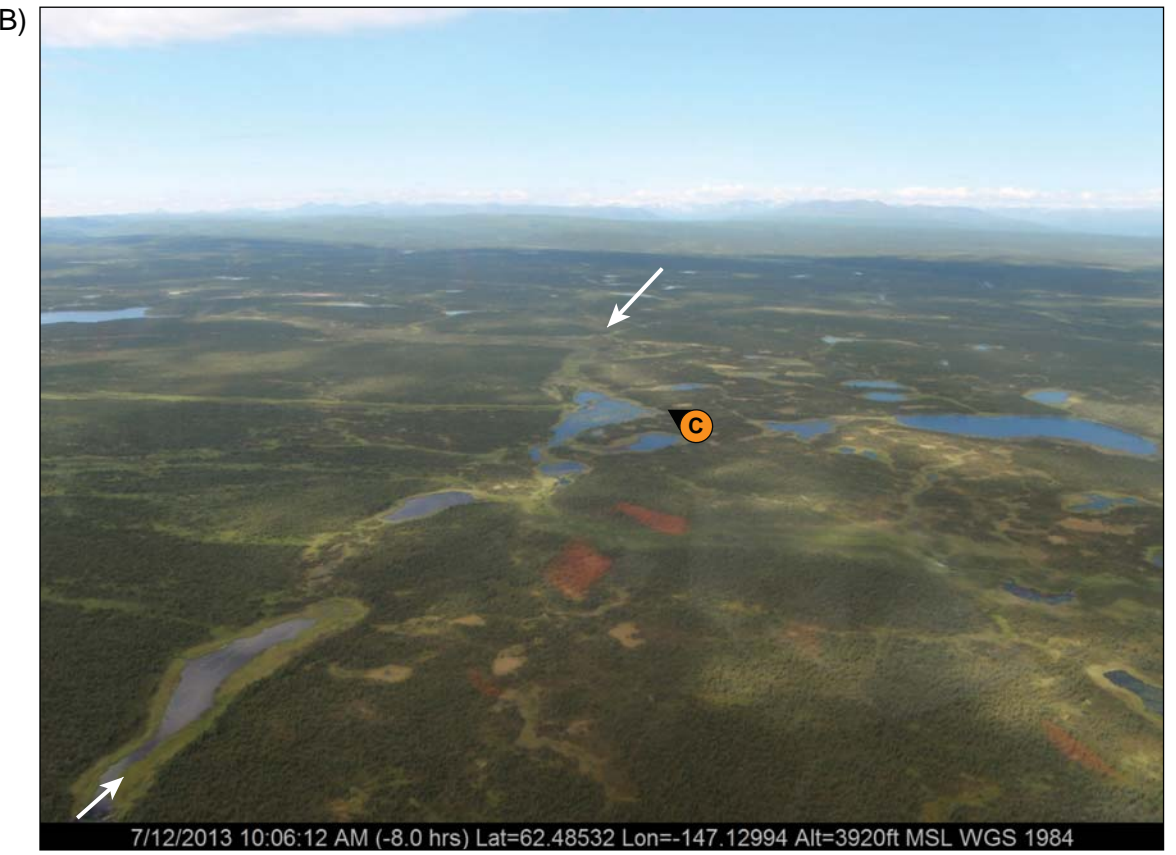
Close up view looking west-southwest along linear alignment of lakes in Photograph A. Arrows point along lineament.

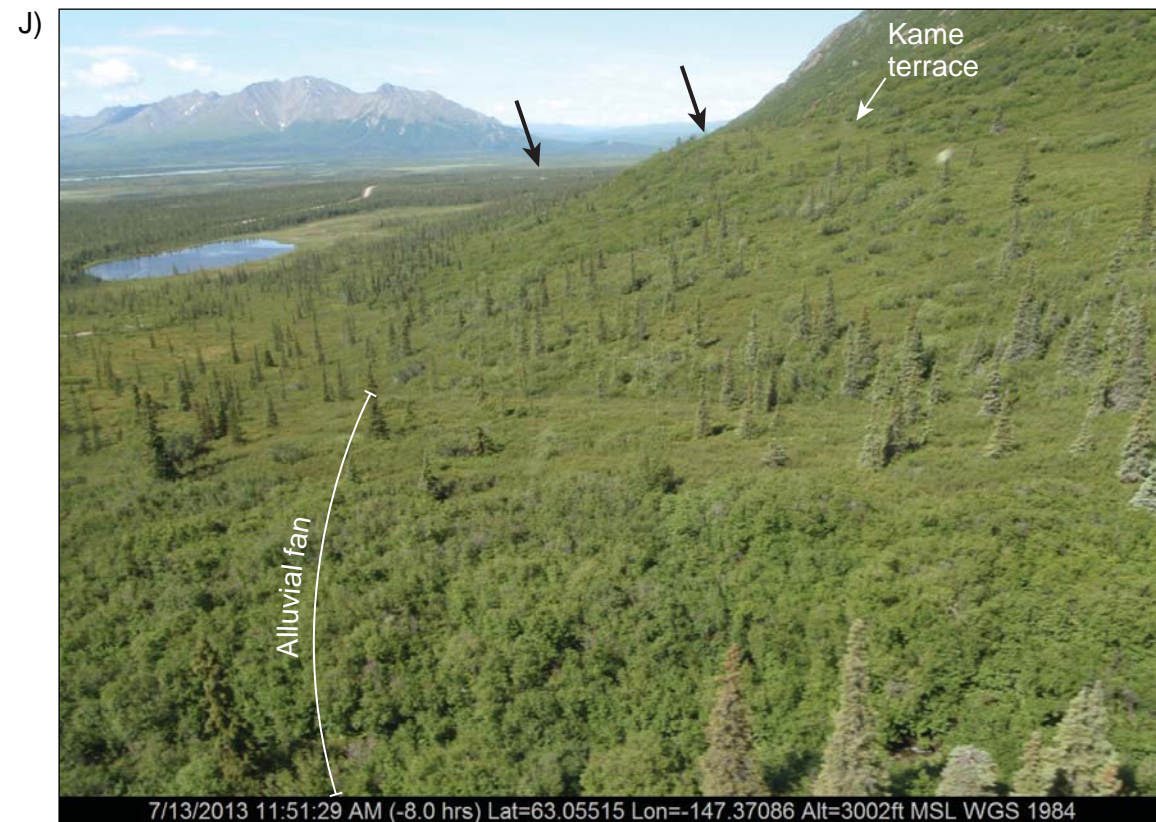
Close-up view looking west along FCL-mapped lineaments.

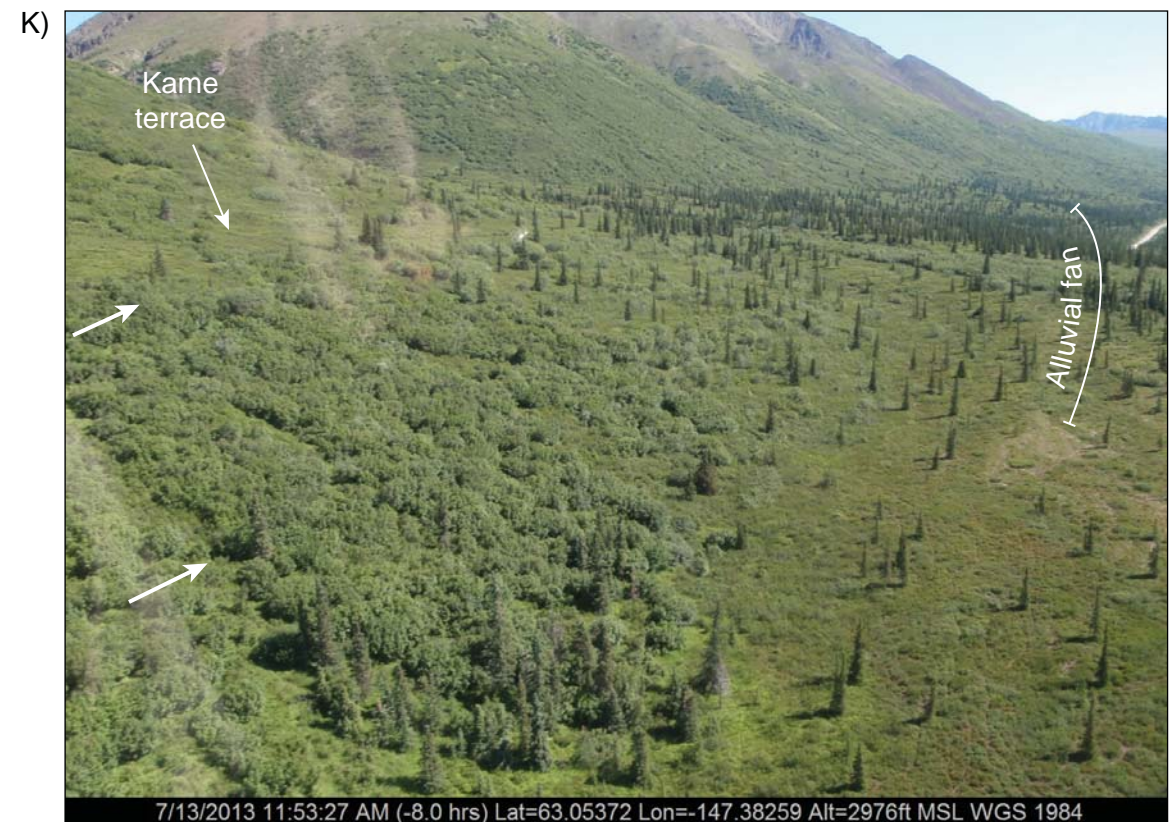
Close-up view looking east along FCL-mapped lineaments.

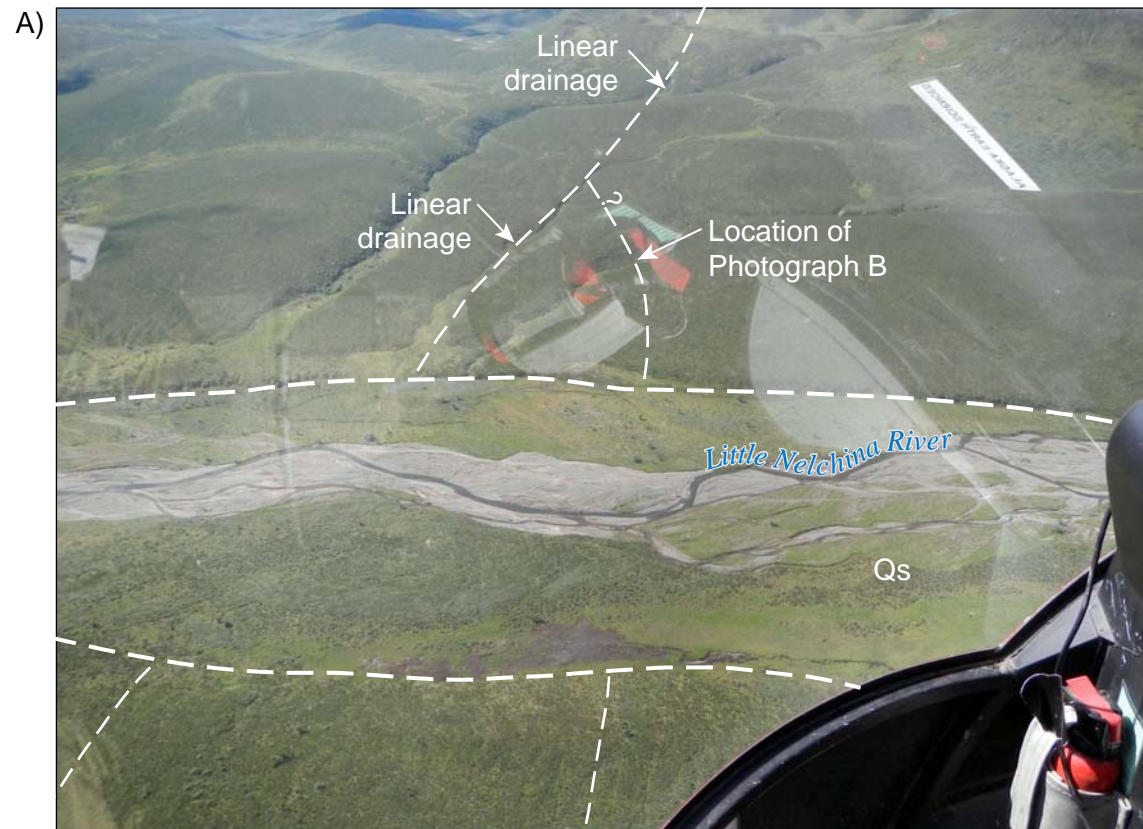
View looking southwest from location A, nearly along-strike with Csejtey et al. (1978) mapped faults. Note clear expression of linear features on bedrock landscape and absence of linear expression in Quaternary deposits.

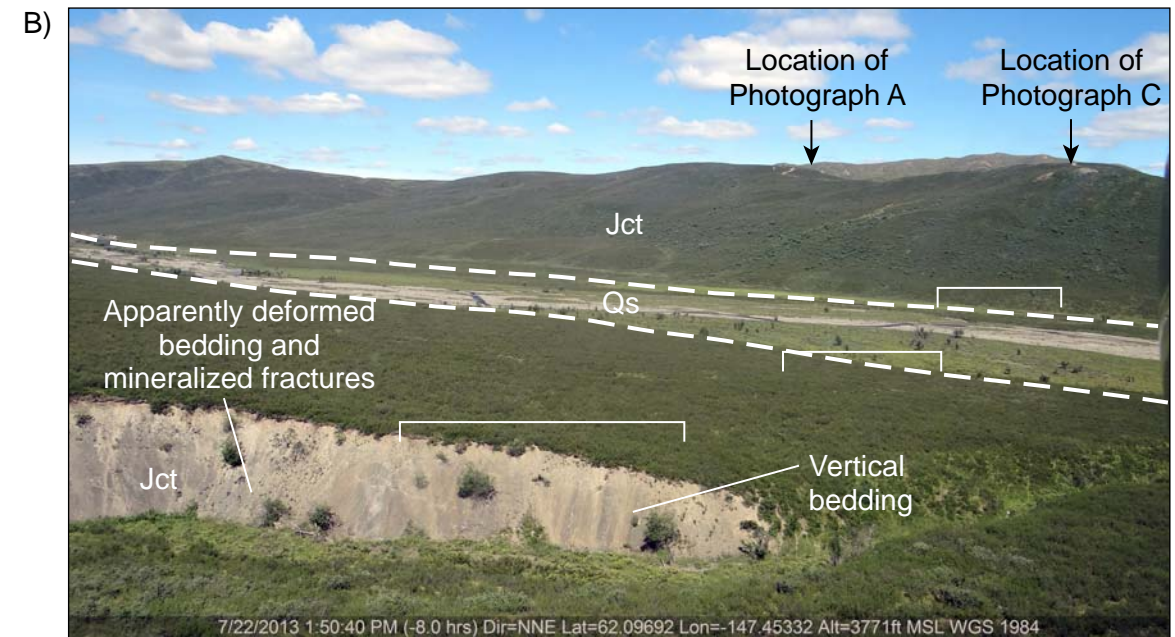
View looking northeast from location B nearly along-strike with Csejtey et al. (1978) mapped fault. The mapped fault segment projects through the vertical beds observed in the outcrop towards photograph location C. Note apparent undeformed hillslope and Quaternary deposits over projected trace of fault.

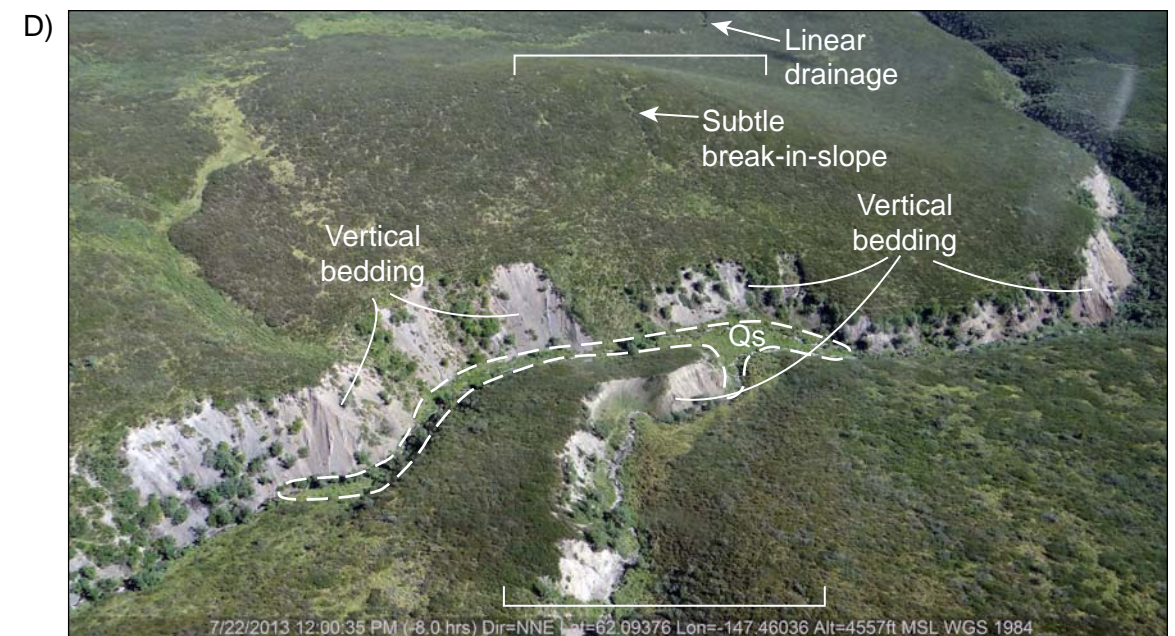
View looking northeast from location D along-strike with a Csejtey et al. (1978) mapped fault. A wide zone of deformation is expressed as vertical bedding exposed in outcrops. Note alignment of the break-in-slope on ridge crest, linear drainage, and the deformation zone.

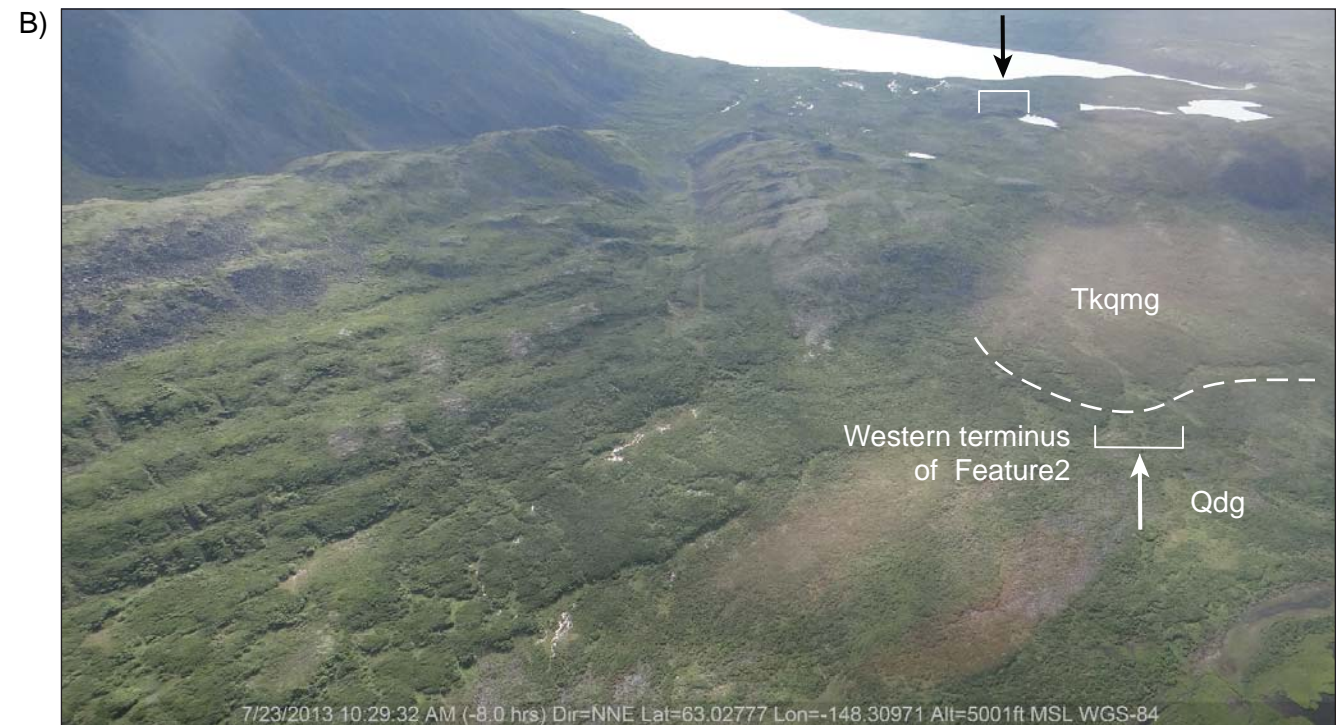
View looking southeast from location B. Arrows and brackets show projected trace of lineament. Note lack of deformation or lineament trace in foreground within Quaternary deposits.

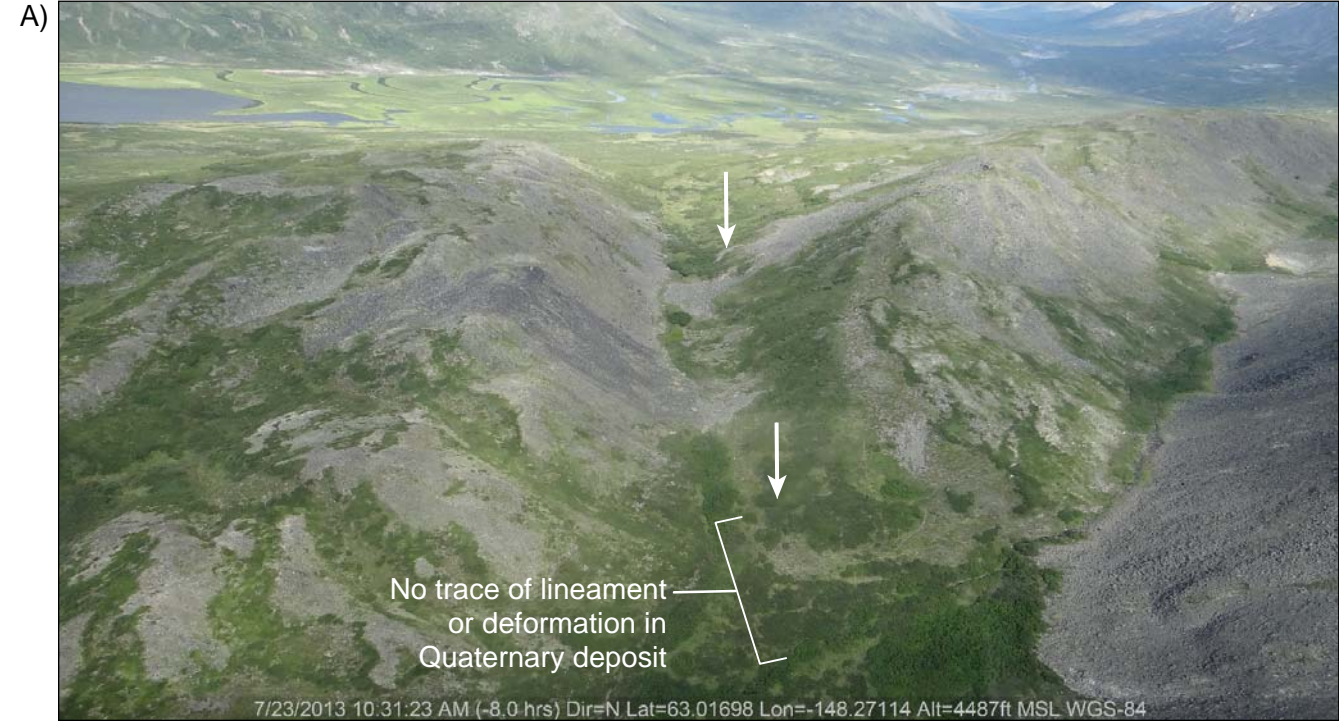
View looking northwest from location A. Arrows show the projected trace of lineament. Note absence of lineament or deformation in Quaternary deposits.

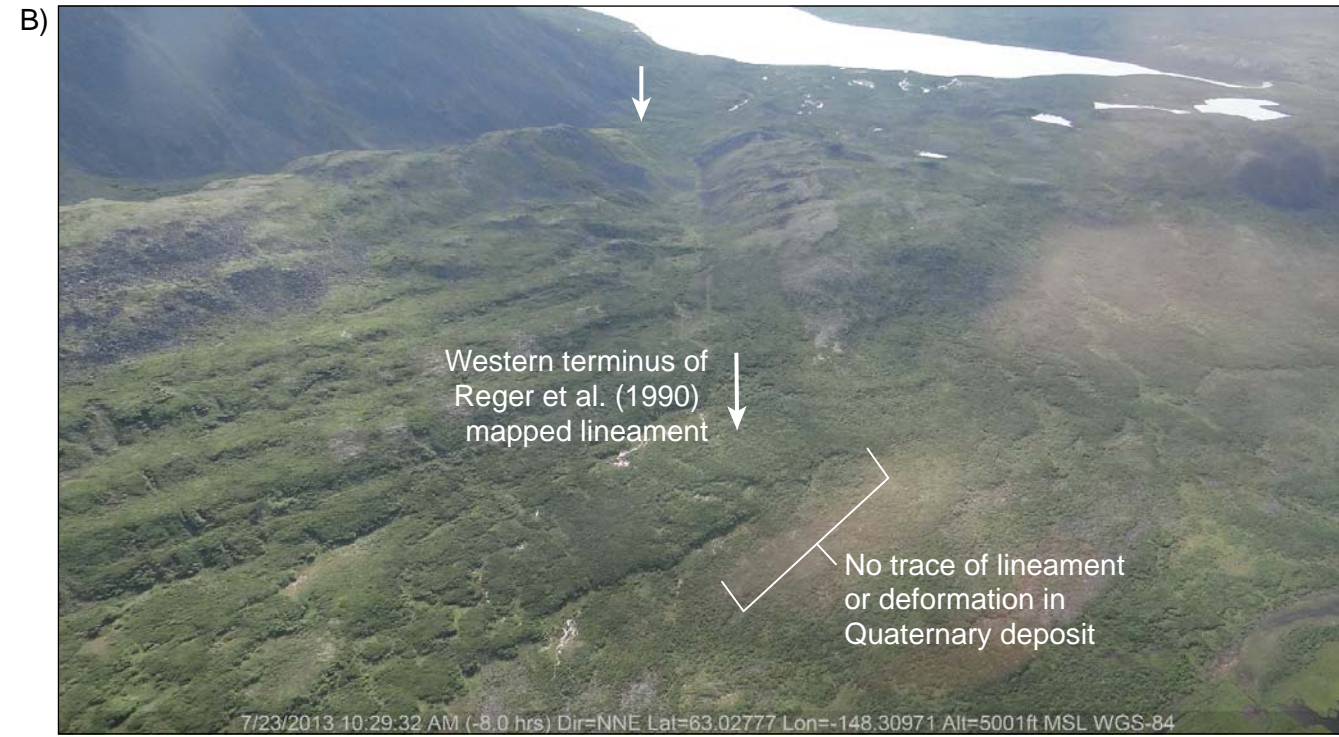
View looking southeast from location B. Arrows show the projected trace of lineament. Note absence of lineament or deformation in Quaternary deposits.

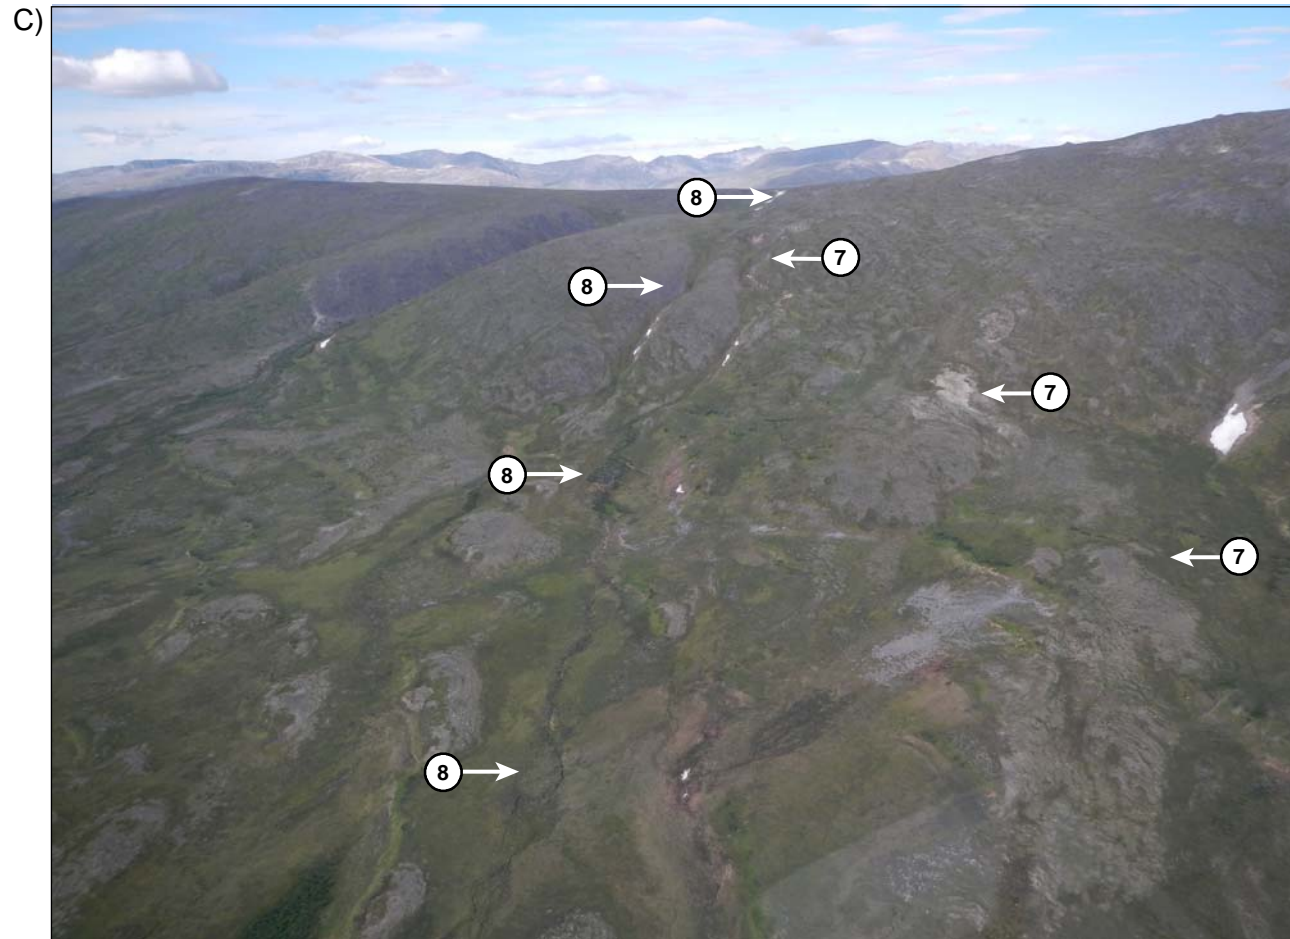
View looking southwest at lineaments 7 and 8 from photograph location C.

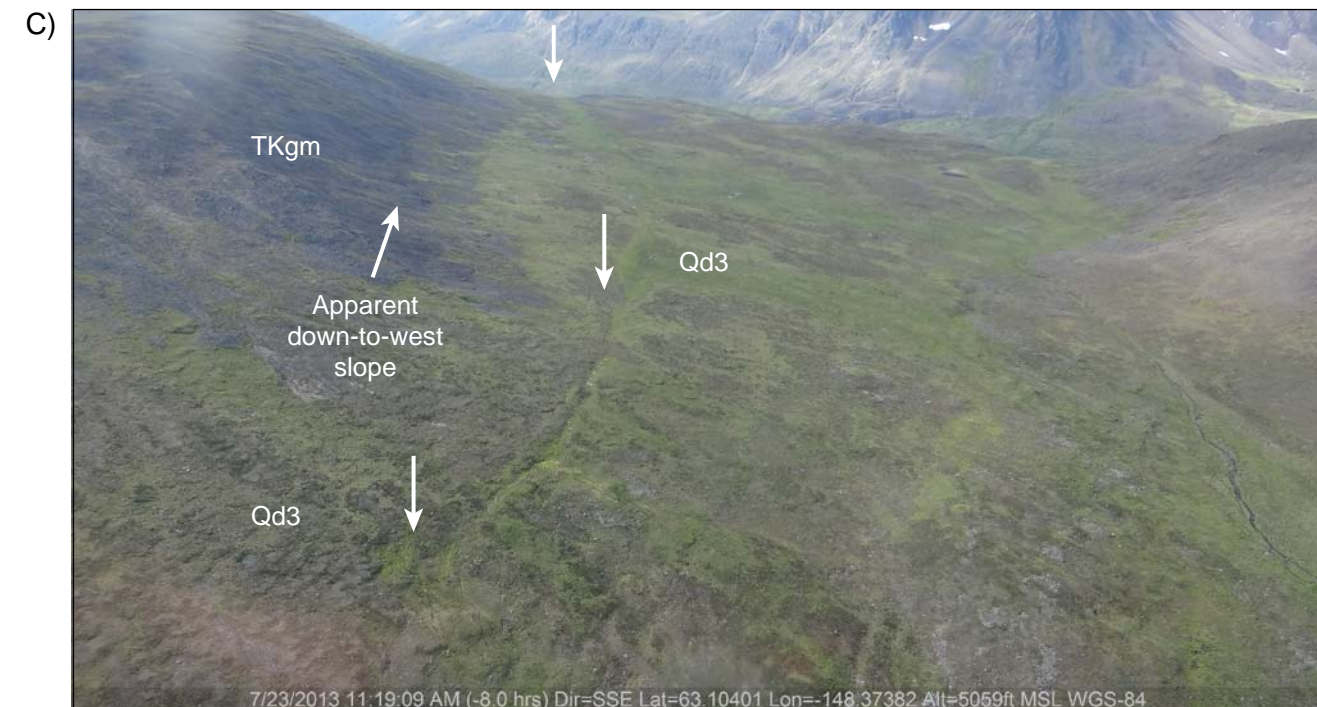
View looking south from photograph location C. Arrows show the projected trace of lineament. Note lineament is coincident with a linear drainage in this view.

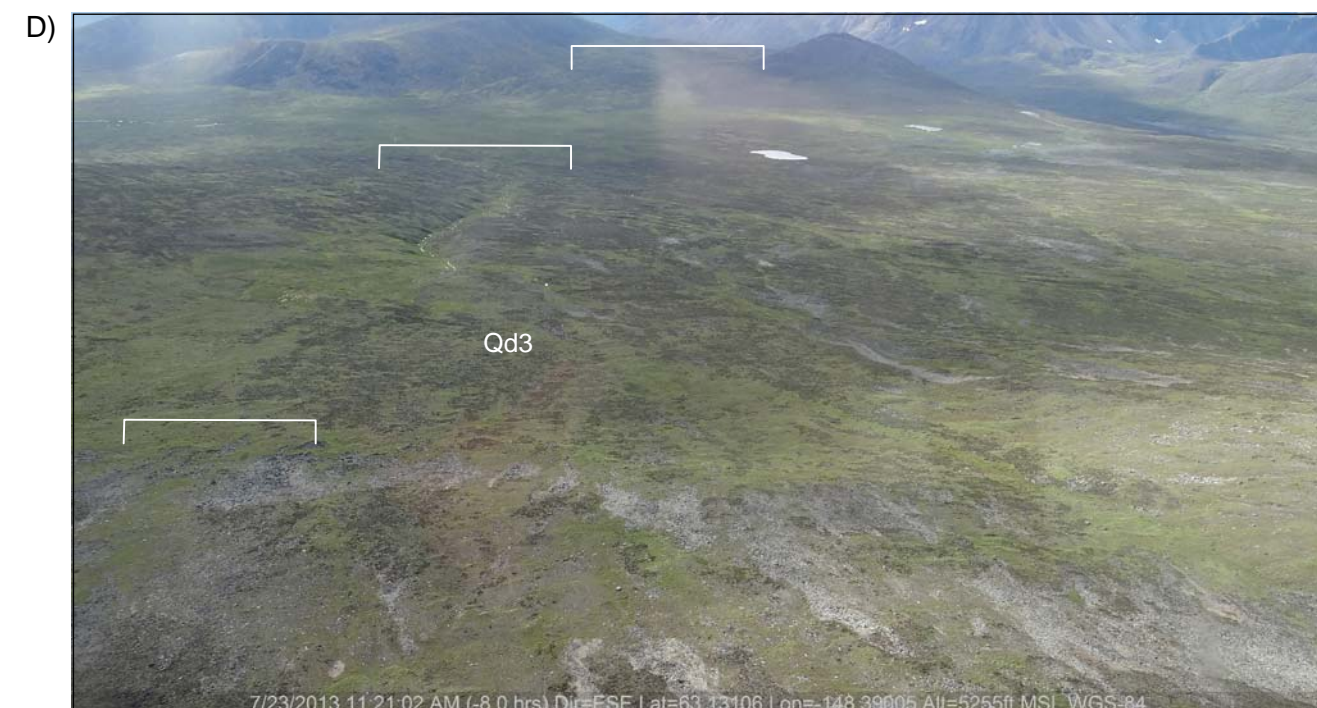
View looking south from location C. Brackets show the projected trace of lineament.

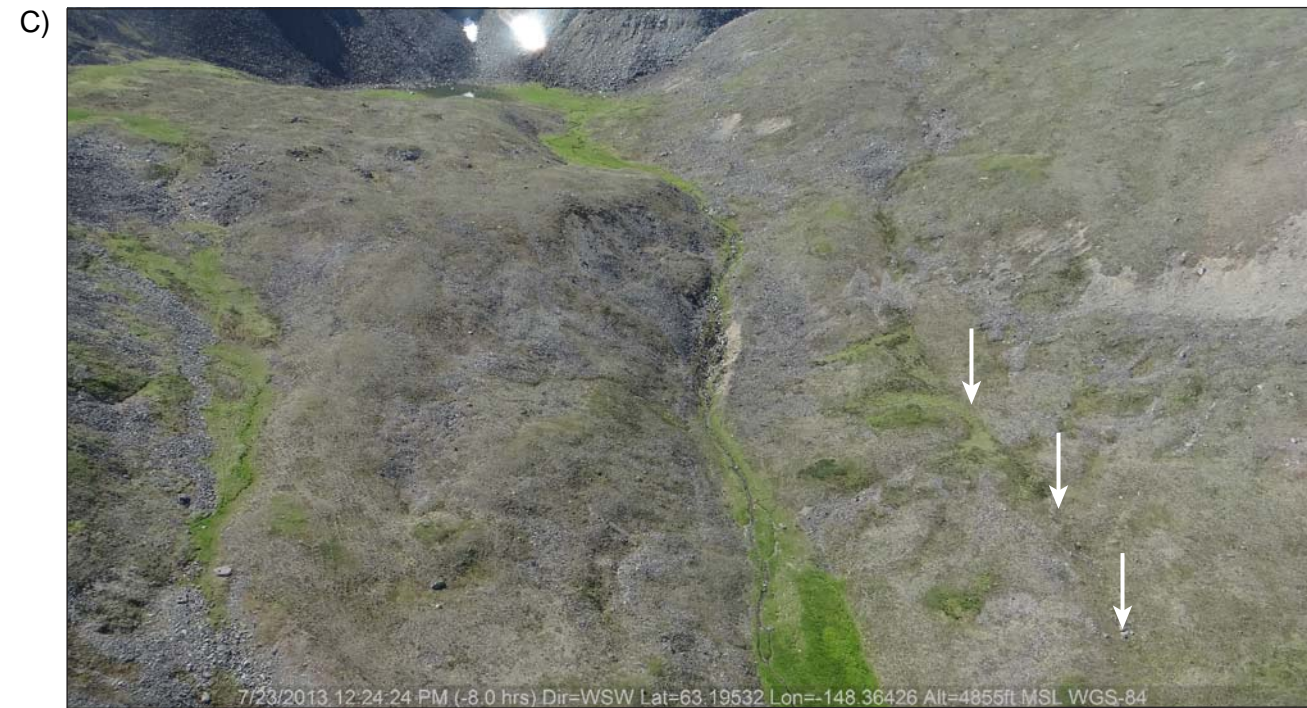
View looking southwest from photograph location C. The arrows indicate the projected path of Feature 19 lineament.

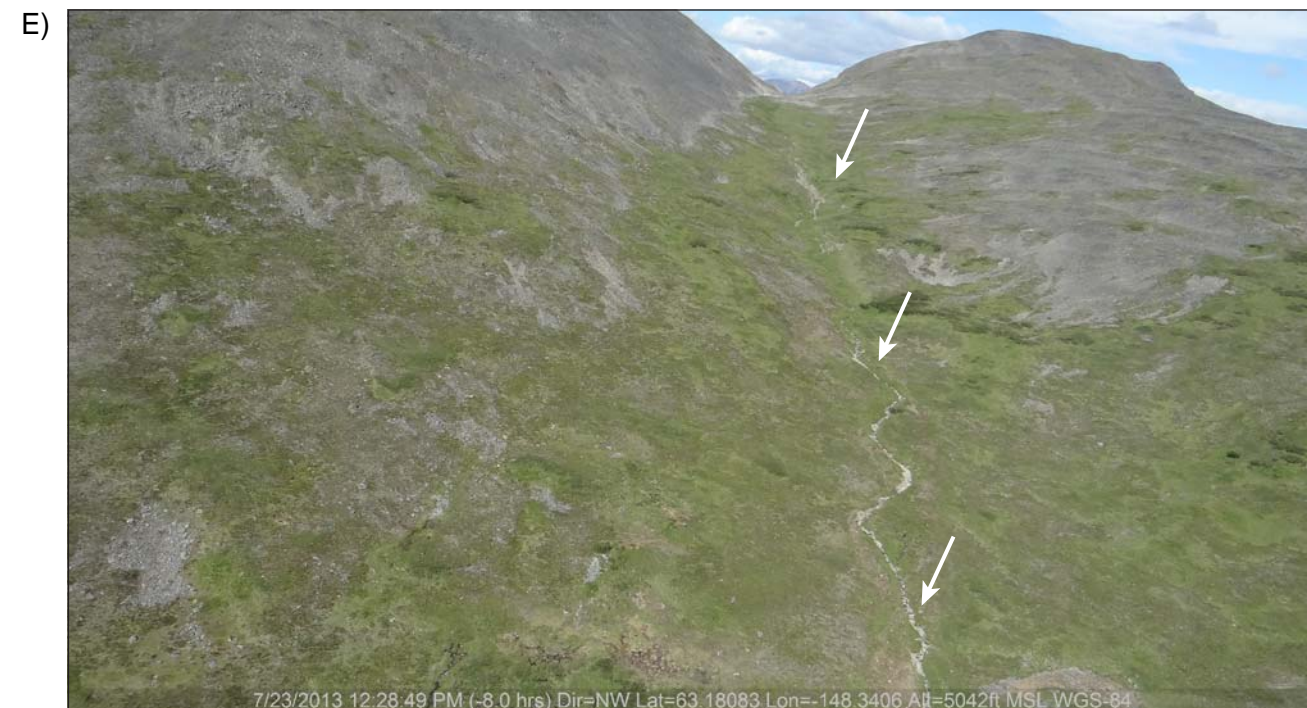
View looking northwest from photograph location E. Arrows show the mapped trace of Feature 20 lineament. Note mapped trace of Feature 20 is coincident with linear drainage.

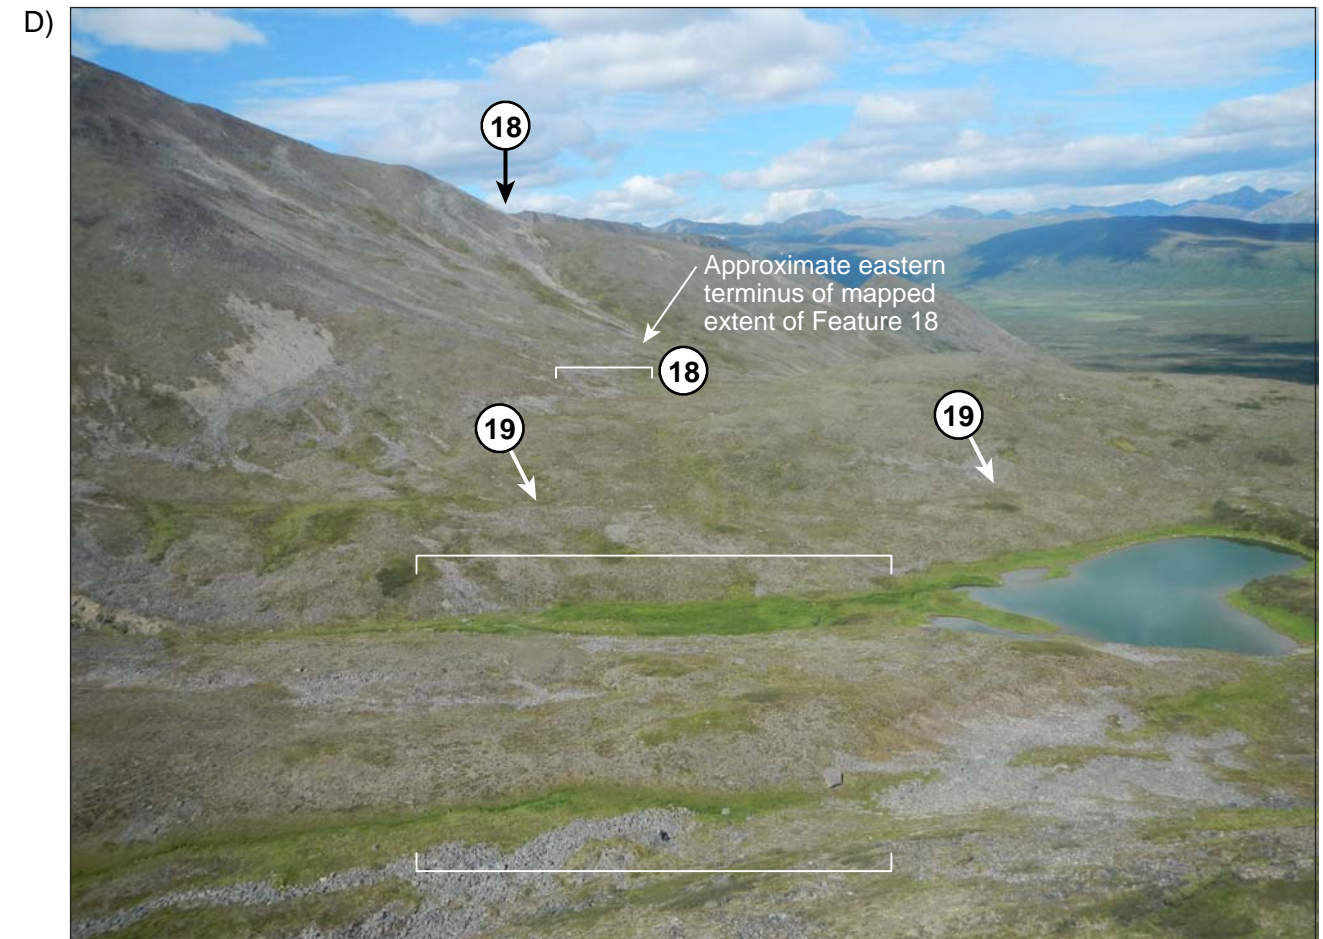
View looking northwest from photograph location D. Arrows show the mapped trace of Features 18 and 19. Note absence of lineaments or apparent deformation in Quaternary deposits between brackets in lower middle portion of photograph.

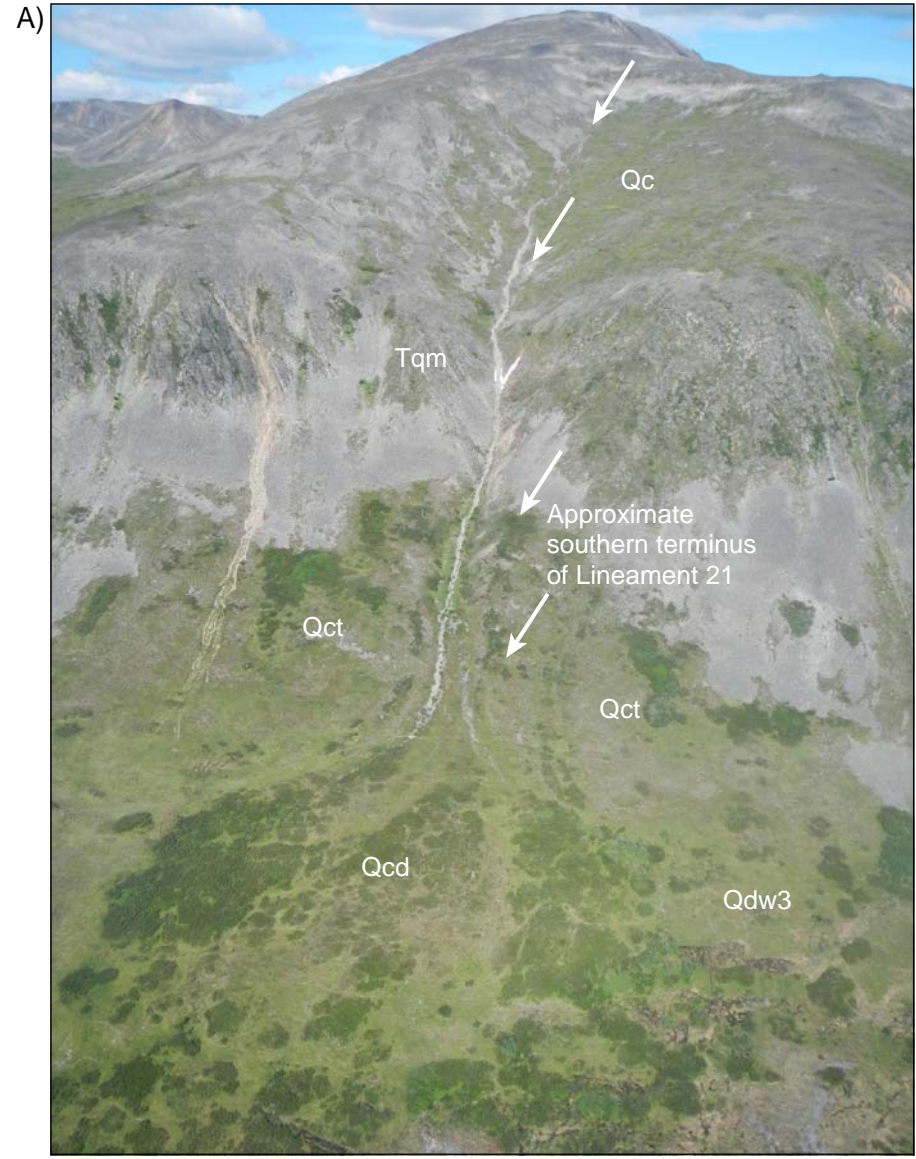
View looking northwest from photograph location A. Arrows indicate the projected path of Feature 21 lineament.

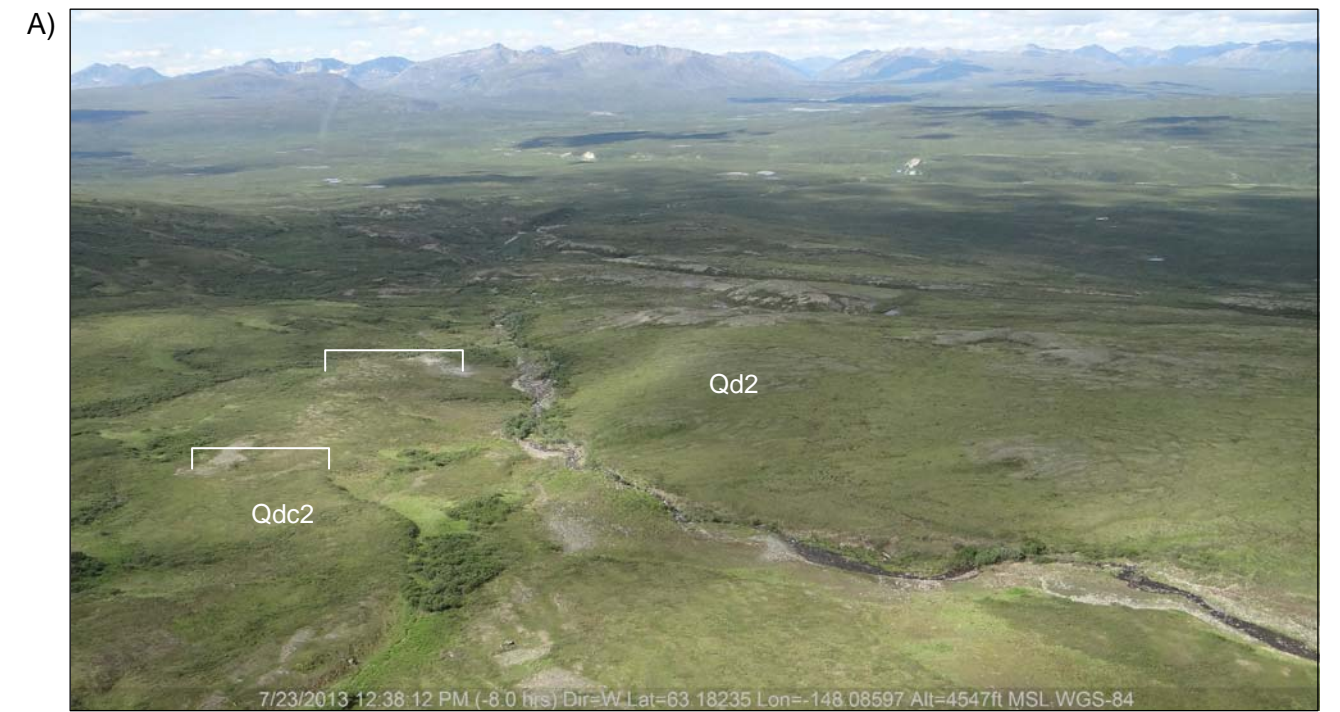
View looking west from photograph location A. Brackets show the projected trace of Feature 22. Note the absence of a continuous lineament along the projected trace and exposed till on low relief ridge crest between drainages.

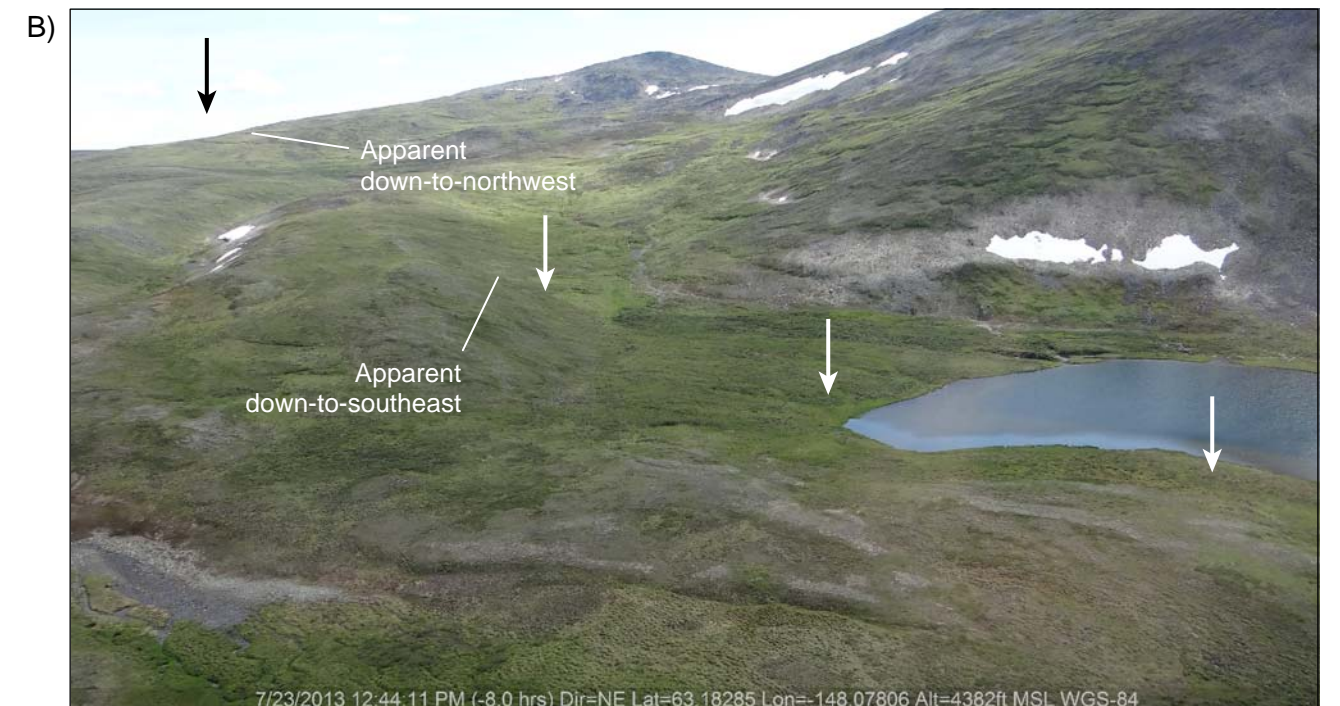
View looking east from photograph location B. Arrows and brackets indicate the projected path of Feature 22 lineament. Note change in apparent vertical displacement.

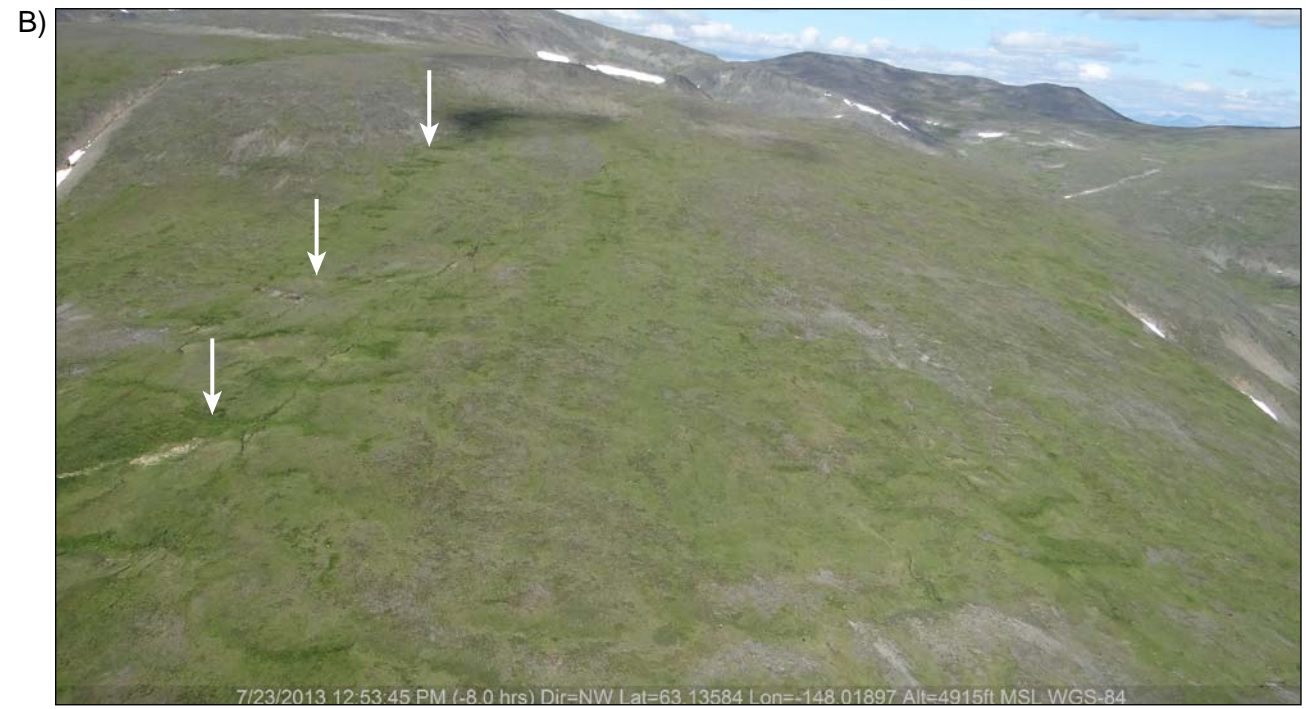
View looking west from photograph location C. Arrows indicate the projected path of the Feature 25 lineament.

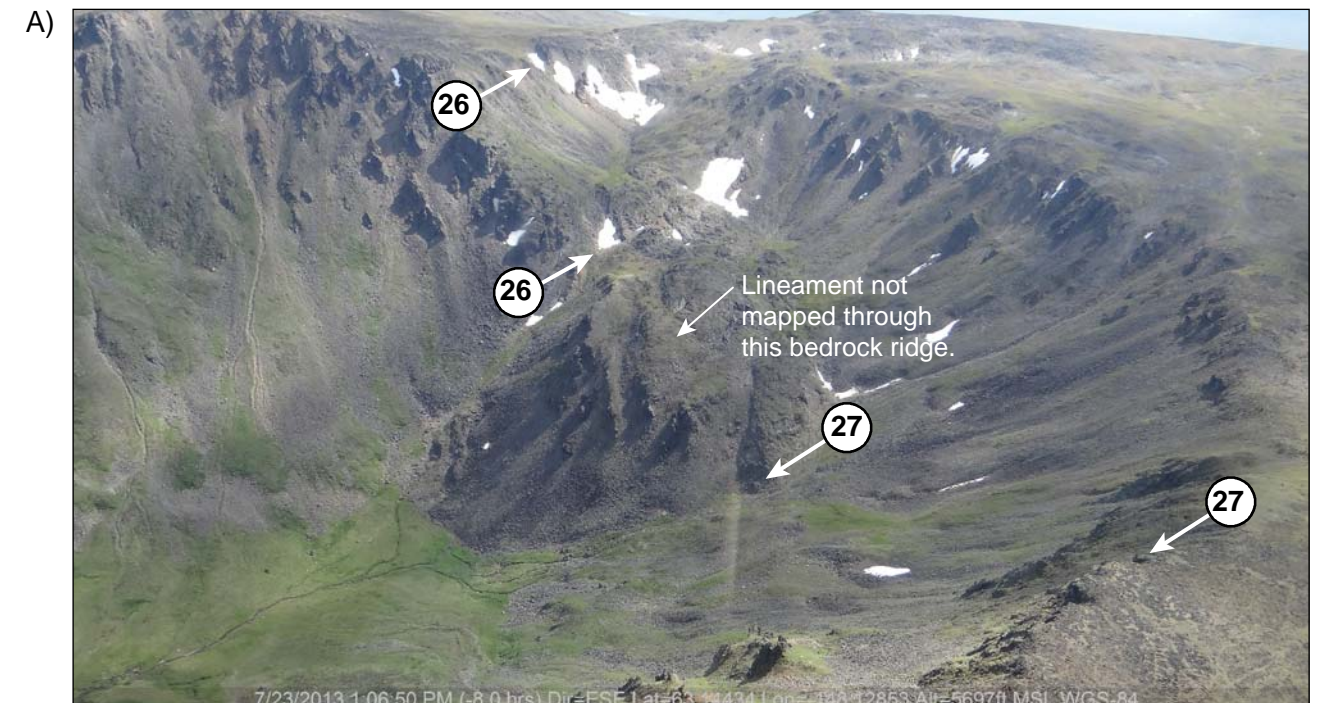
View looking west from photograph location A. Arrows show the projected trace of Features 26 and 27. Note the absence of a continuous and clear lineament along projected traces.

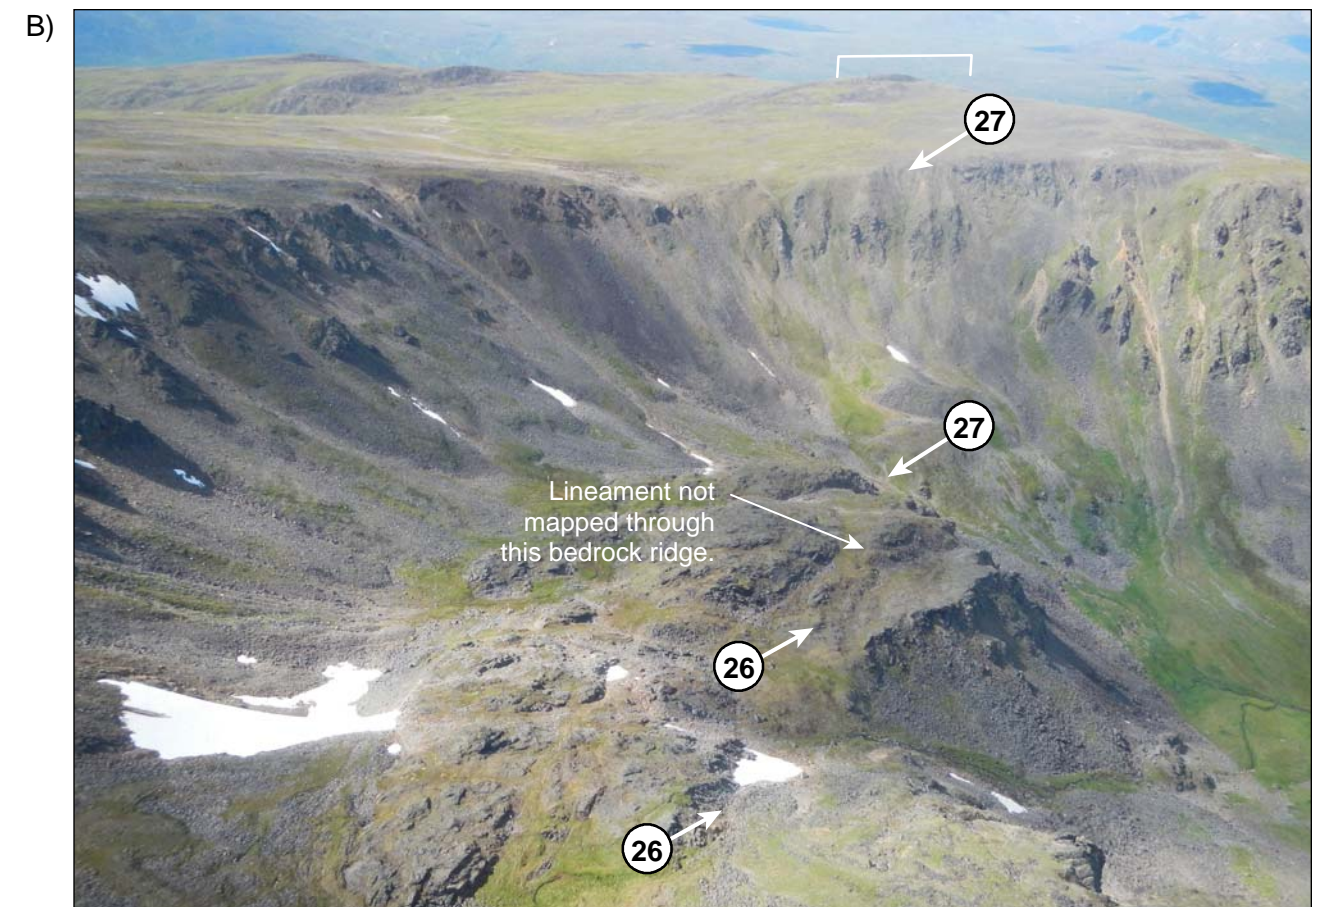
View looking east from photograph location B. Arrows and brackets indicate the projected path of Feature 26 and 27 lineaments. Note the absence of a continuous and clear lineament along projected traces.
