SUSITNA-WATANA HYDROELECTRIC PROJECT
 LINEAMENT GROUP 26
 MAP DATA

SUSITNA-WATANA HYDRO

AEA11-022

Appendix B:
Strip Maps and Photographic Documentation
of Lineament Data for Lineaments Mapped by Reger et al. (1990)

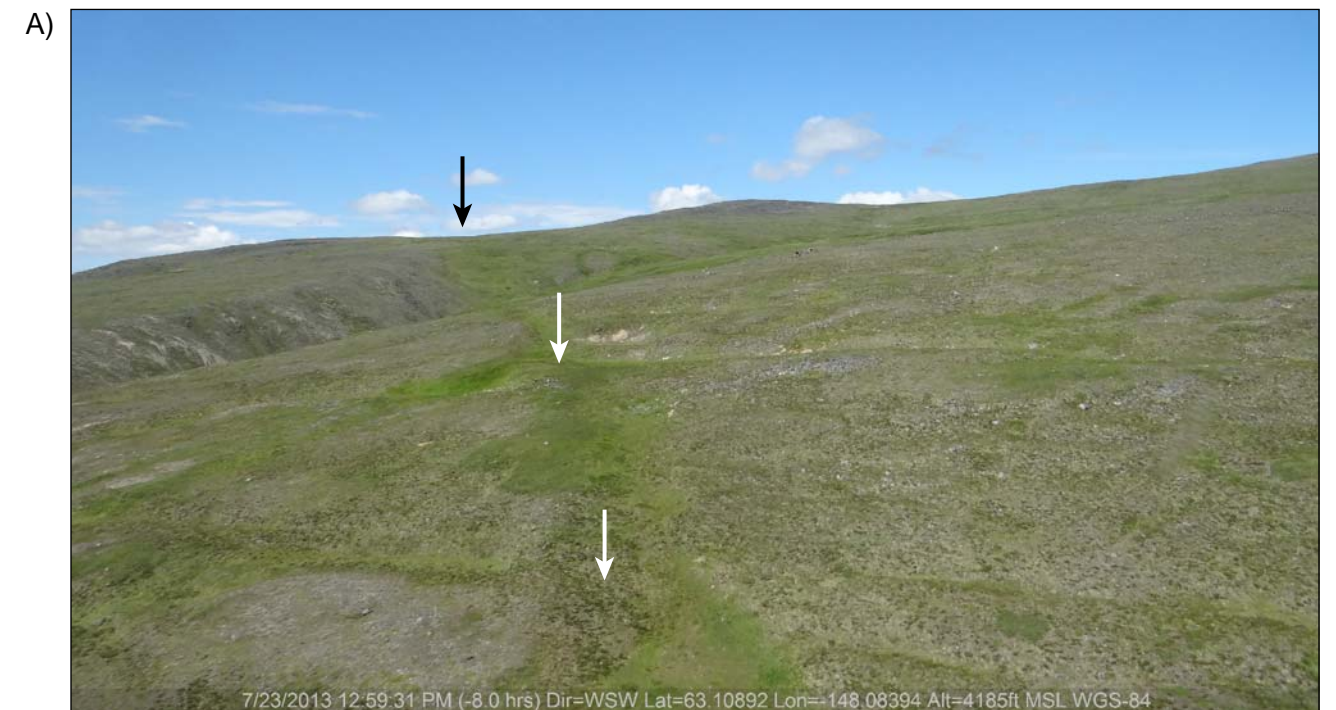
View looking west-northwest from photograph location A. Arrows show mapped trace of Feature 28. Note lineament corresponds to subtle linear trough and linear vegetation trend.

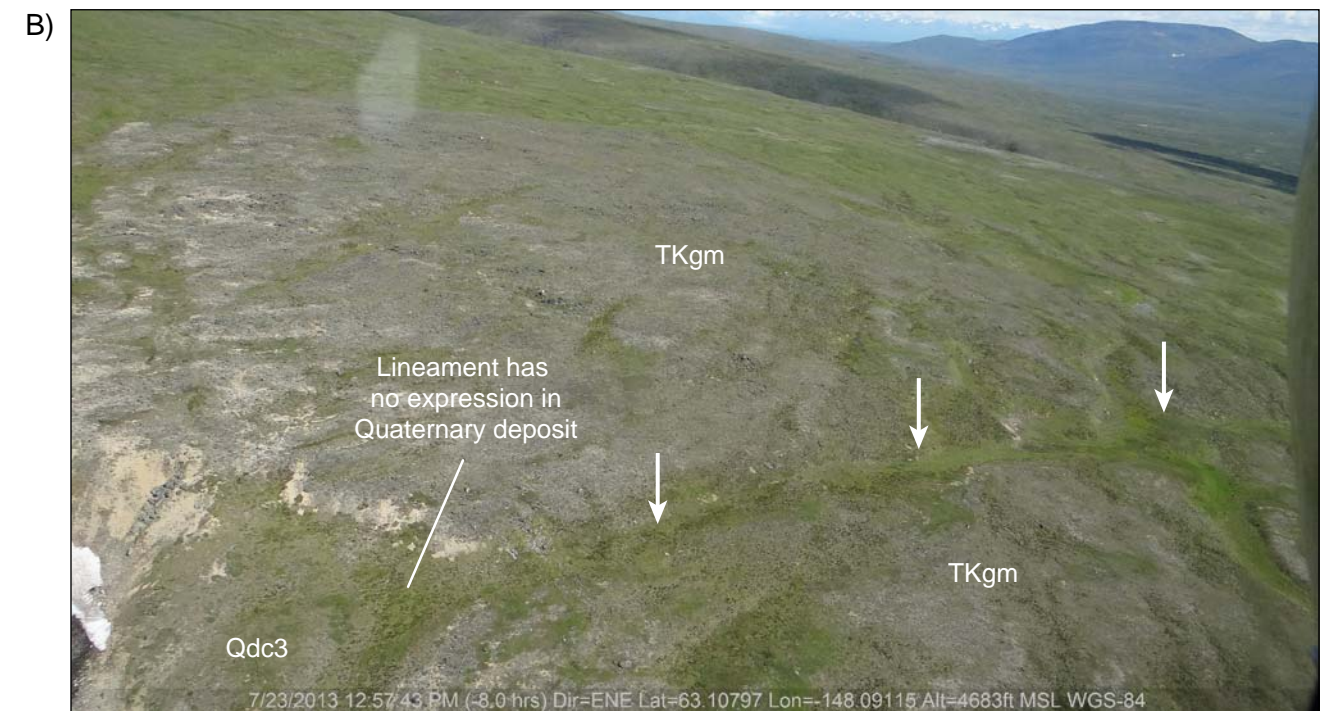
View looking east from photograph location B. Arrows indicate the mapped trace of Feature 28. Note absence of linear expression in Quaternary deposits.
