**Susitna-Watana Hydroelectric Project
(FERC No. 14241)**

**Study of Fish Passage Barriers in the Middle and
Upper Susitna River and Susitna Tributaries (9.12)**

**Part A - Appendix A
Tributary Geologic Barriers**

**Part A - Appendix B
Middle River Tributary Delta Surveys Outside of
Focus Areas**

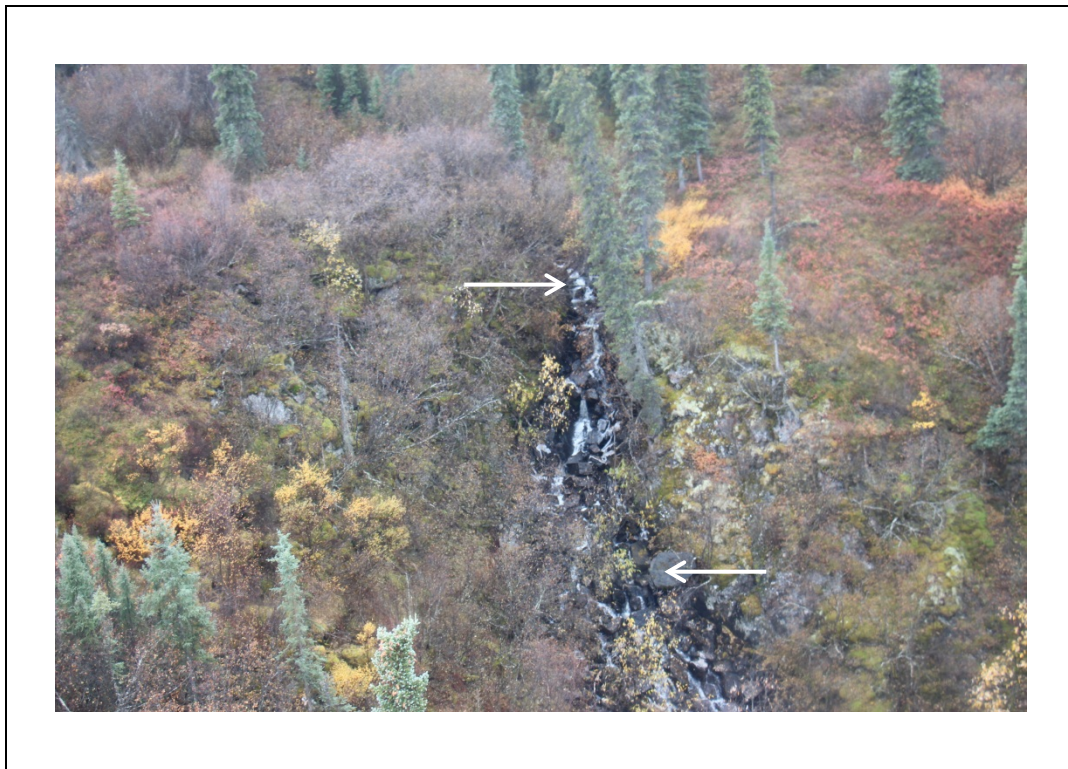
The potential barrier site was located at the upstream extent of a very high gradient reach of boulder dominated cascades (Figure A1). At the time of survey, flow conditions appeared to be very low, making it difficult to discern the true bottom of the barrier. The surveyed site appeared to be only slightly steeper than the immediate reach downstream, but both the surveyed site and downstream reach appeared to be a barrier to upstream migration.

The site was classified as a fixed seasonal boulder cascade and is likely a fixed permanent barrier. The average barrier height was 8.9 m (29 ft), and the average horizontal length was 10.9 m (36 ft) with an average channel gradient of 83 percent. Low flow conditions, large bed material, and the significant grade did not provide for a clean swim route up the cascade. Resting areas at the upstream and downstream ends of the barrier appeared minimal in the current flow conditions, and no downstream jump pool existed.

Figure A1. Barrier A in Unnamed Tributary 189.7. Fixed seasonal boulder cascade, 29 ft in height and horizontal length of 36 ft with an average channel gradient of 82 percent.

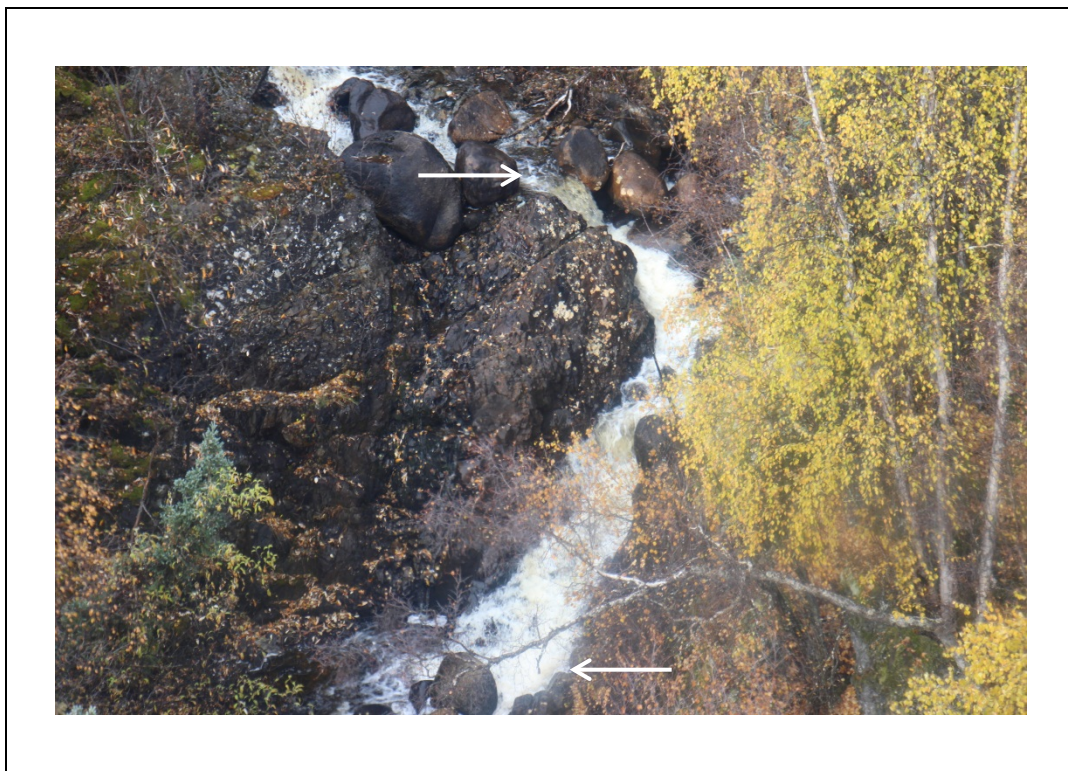
The potential barrier site was located at the upstream extent of a very high gradient reach of boulder dominated cascades (Figure A2). Flows appeared to moderate to low, and the stream bed was dominated by large boulders and exposed bedrock. Flows entered the cascade and made a 90 degree right turn towards the bottom, and a very minimal pool was located at the bottom.

The site was classified as a permanent fixed boulder cascade. The average barrier height was 13.8 ft (4.2 m), and the average horizontal length was 32 ft (9.8 m), resulting in an average channel gradient of 43 percent. Lower flow conditions, large bed material, and the significant grade did not provide for a clean swim route up the cascade. The barrier's height and length appeared to preclude leaping as a means of passage. Resting areas at the upstream and downstream ends of the barrier were minimal under the observed flow conditions with no downstream jump pool.

Figure A2. Barrier A in Unnamed Tributary 197.7. Fixed seasonal boulder cascade, 13.8 ft in height with a horizontal length of 32 ft and an average channel gradient of 43 percent.

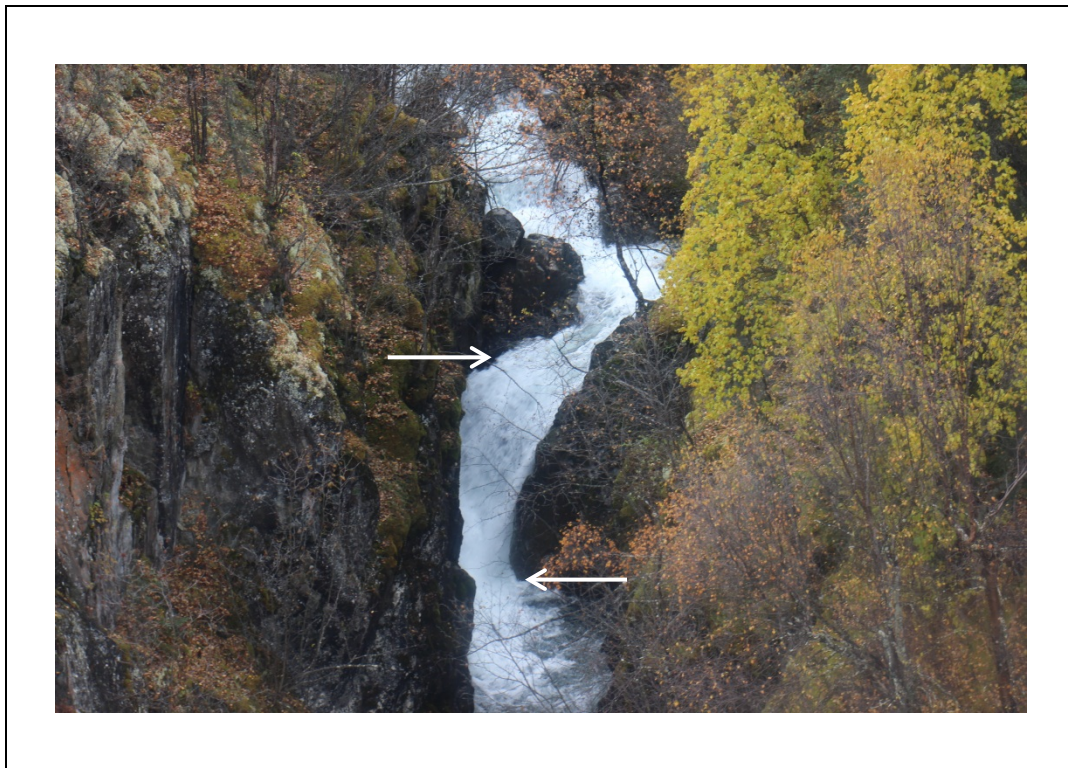
The potential barrier site was located amid a moderate to high gradient reach of stream dominated by boulder cascades (Figure A3). The site was classified as a fixed permanent single falls. The stream turbulence made it difficult to ascertain the bed material upstream and downstream of the feature, but the falls themselves were formed by an exposed bedrock sill.

As a single fall, and due to its location, only the height of the barrier was assessed. The average barrier height of 10.8 ft (3.3 m), including the measurement error (± 1 ft), is within the range of Chinook maximum leaping abilities as described by the US Forest Service (2001) but exceeds their leaping abilities as described by Powers and Orsborn (1984) and Reiser and Peacock (1985). A sizeable plunge pool was observed. While no depth could be determined, the pool had sufficient depth to dissipate most turbulence resulting from the plunge. The landing area above the feature appeared to be located in a short, high gradient reach with a small but turbulent resting eddy immediately below another smaller waterfall.

Figure A3. Barrier A in Unnamed Tributary 204.3. Fixed single fall, 10.8 ft in height.

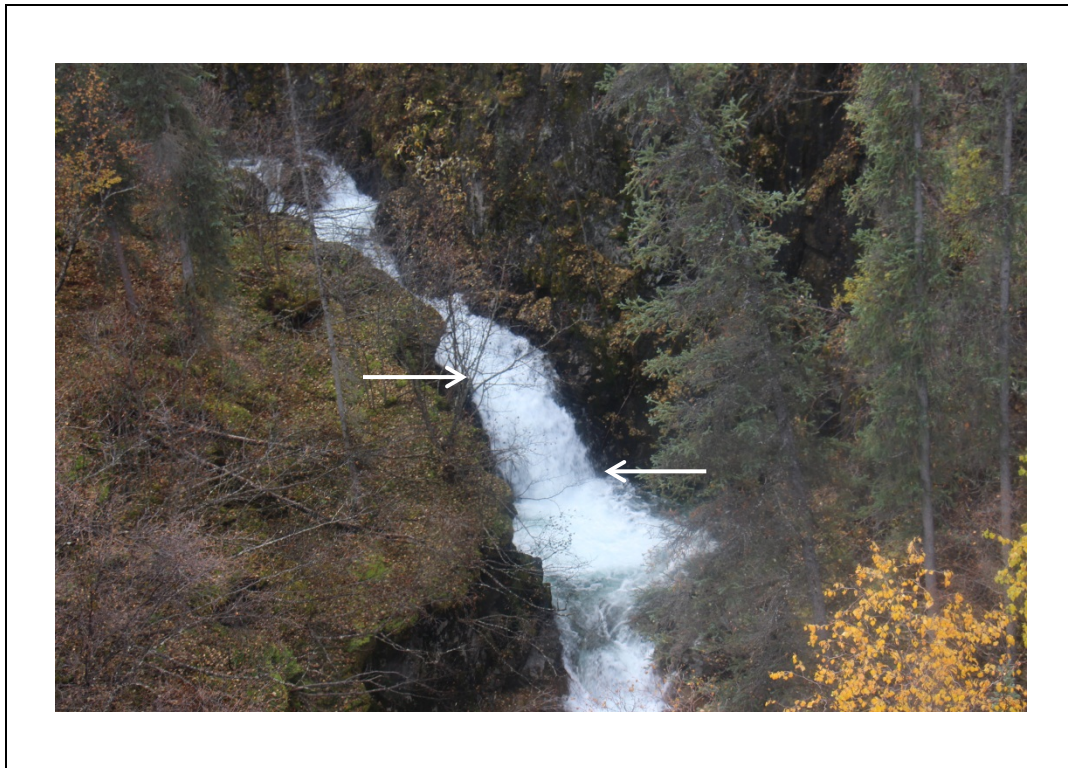
The potential barrier site was located upstream of Barrier A in Unnamed Tributary 204.3 amid a moderate to high gradient reach of stream dominated by boulder cascades. The site was classified as a fixed permanent single falls. The stream turbulence made it difficult to ascertain the bed material upstream and downstream of the feature, but the falls themselves were formed by an exposed bedrock sill (Figure A4).

As a single fall, and due to its location, only the height of the barrier was assessed. The average barrier height was 7.7 ft (2.3 m). A plunge pool existed below the feature. The pool appeared to be highly turbulent, with resting areas likely around the extreme periphery and possibly at depth. Exact depth could not be determined. A steep chute was located immediately upstream of the feature, allowing for difficult landing conditions. Another smaller cascade was located above this chute.

Figure A4. Barrier B in Unnamed Tributary 204.3. Fixed single fall, 7.7 ft in height.

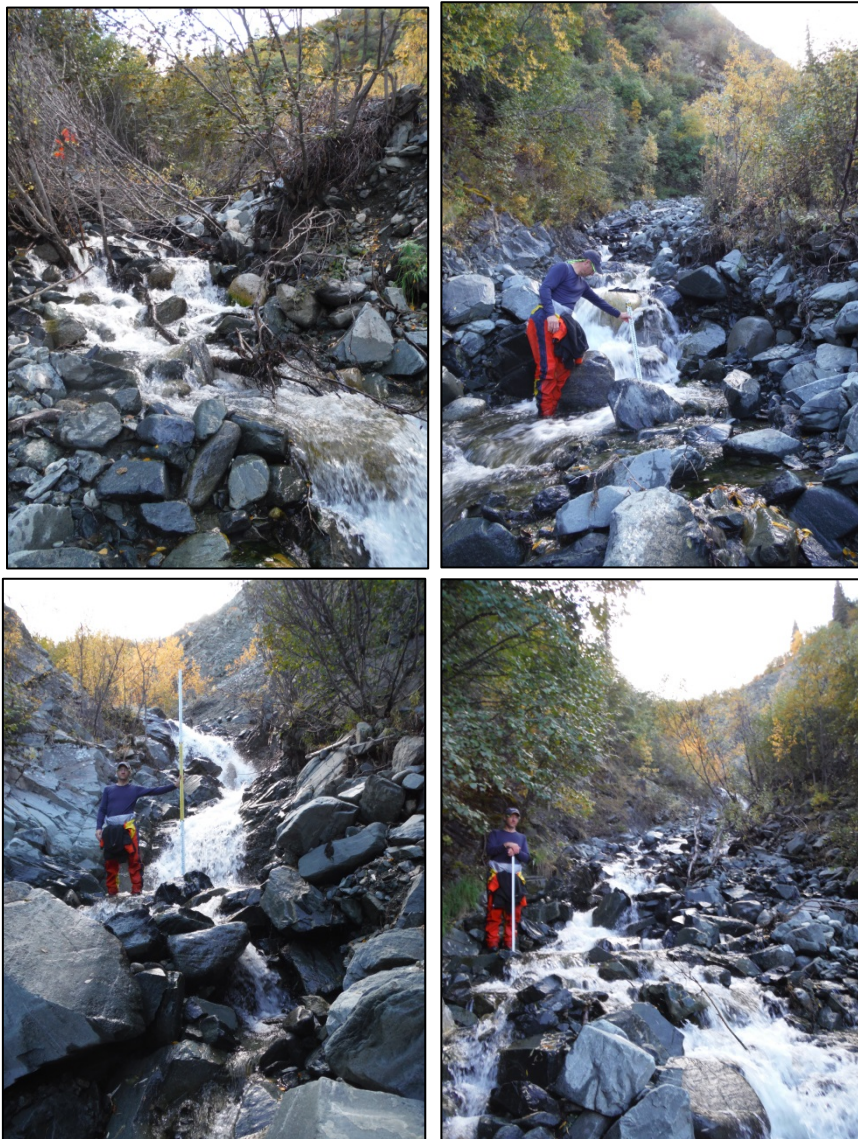
This barrier was surveyed by foot on September 12, 2013 and was located on a tributary entering the Susitna River on river left (Barrier ISR Figure 4.3-1a). The barrier was classified as a complex chute and turbulent cascade with an overall 29.7 m (97.4 ft) vertical drop over a horizontal distance of 177.8 m (583.3 ft). The gradient range was 10 to 15 percent for the bottom half of the falls, increasing to between 20 and 34 percent for the final 18 m (59 ft) vertical drop, with an overall slope of 17 percent. The combination of waterfalls and steep, turbulent, high-velocity chutes with limited resting areas or deep plunge pools confirmed this as a permanent fixed barrier for fish movement (Figure A5).

Figure A5. Barrier A in Unnamed Tributary 215.2. Clockwise from top left, views from bottom to top of a complex chute which spans 97 ft in vertical direction and 583 ft in horizontal direction. This is a permanent barrier to fish passage.

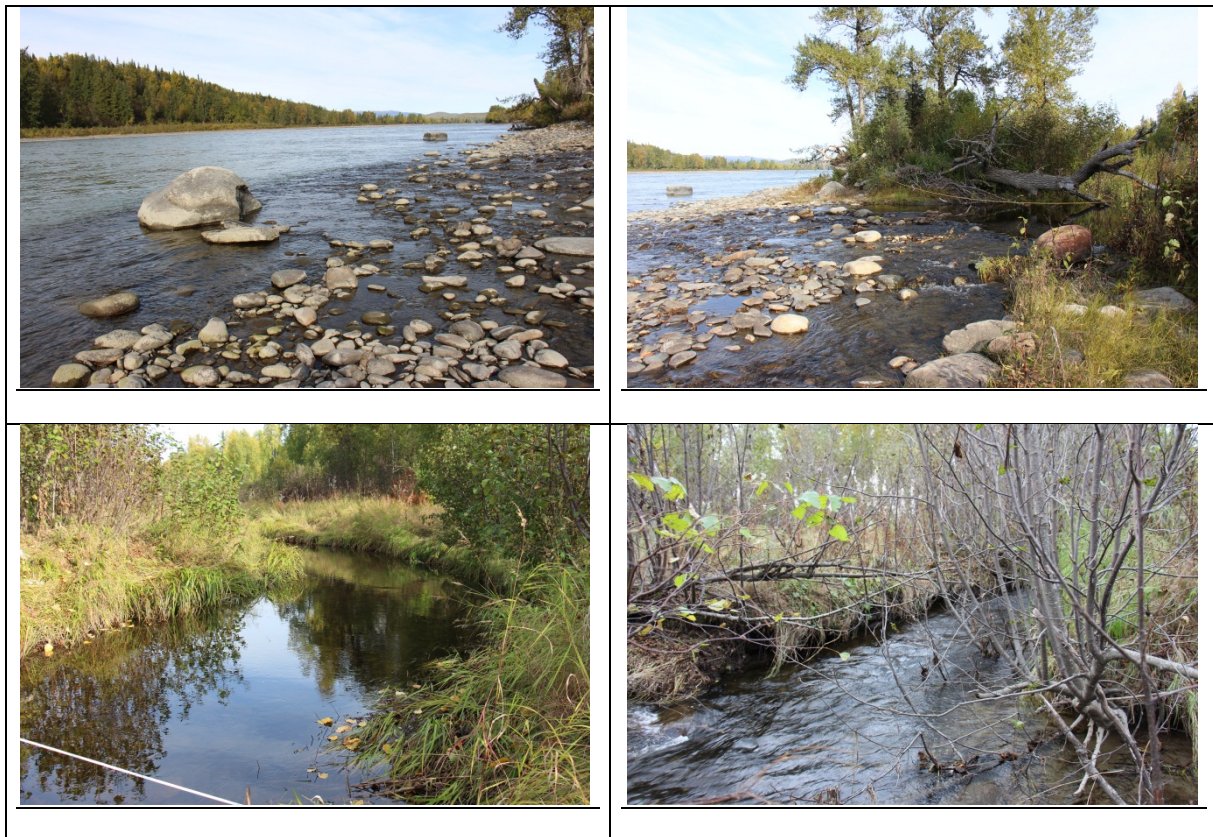
The mouth of Chase Creek was unique compared to the other tributaries surveyed. Although characterized by exposed boulders and cobbles, it did not resemble the large, bedload-deposited aprons seen elsewhere (Figure B1). The mouth exhibited a steepened slope due to the receding Susitna, but no defined channel had been formed in the exposed substrate (Figure B2). The creek flow was spread out across the exposed substrate with no clearly defined or continuous thalweg. A natural and irregular small boulder and cobble weir formed at the top of the mouth grade break, dispersing flow leaving the upstream pool (Table B1). It was likely that the low-gradient nature of this creek had limited the material deposited at the mouth, and that creek flows have not regularly carried enough energy to alter the geometry of the existing debris apron.

Figure B1. Chase Creek. From upper right: bottom of creek mouth; top of creek mouth; low gradient channel resulted in slow meandering reaches; and near top of creek survey.

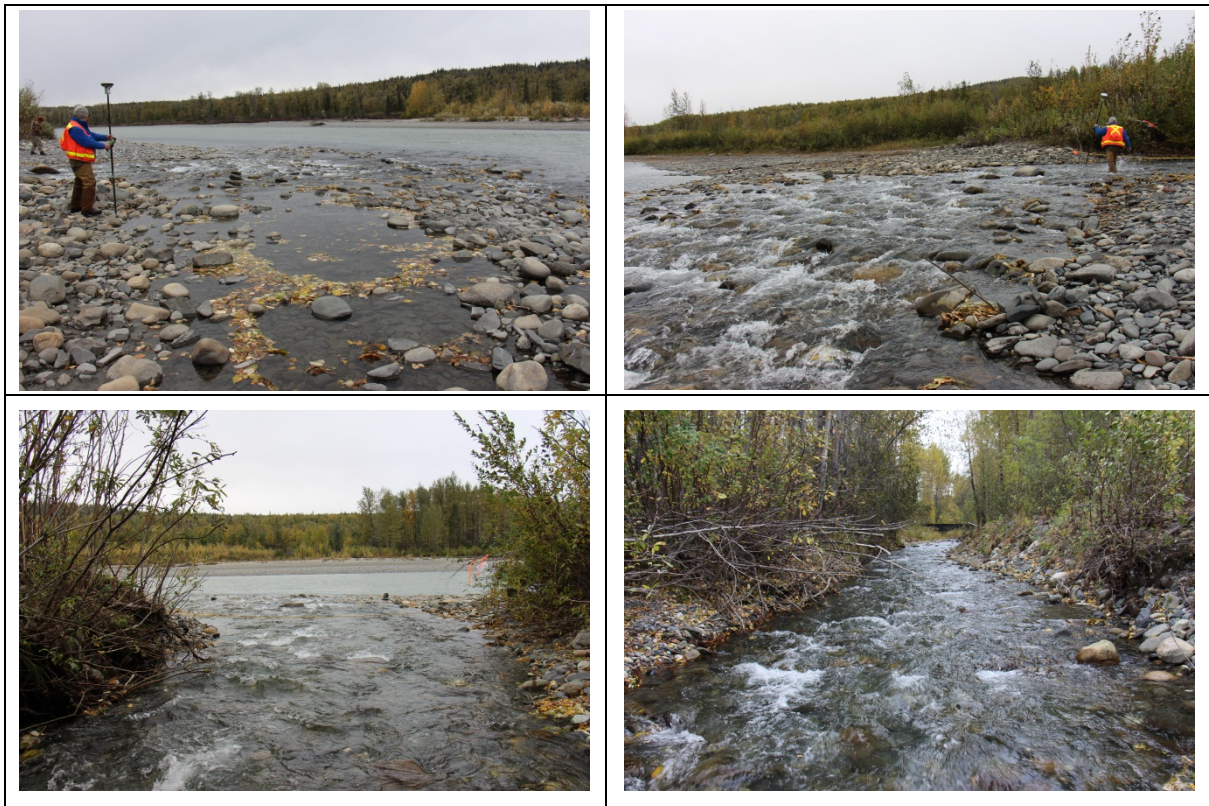
Lane Creek left a very confined and established channel only a short distance upstream of the creek mouth (Figure B3). During high Susitna flow conditions, it was likely that the creek met the river at the end of the confined channel reach (Figure B4). The creek mouth was characterized by large cobbles and small boulders with a debris apron (Table B2). Flows began to spread out across this small boulder apron as it passed the downstream extent of the confining creek bank before reaching the Susitna. No noticeable incision had occurred across the apron, and there was no distinct thalweg.

Figure B3. Lane Creek. From upper right: bottom of creek mouth; top of creek mouth; looking downstream to creek mouth; and looking upstream to top of survey- note uniform channel form.

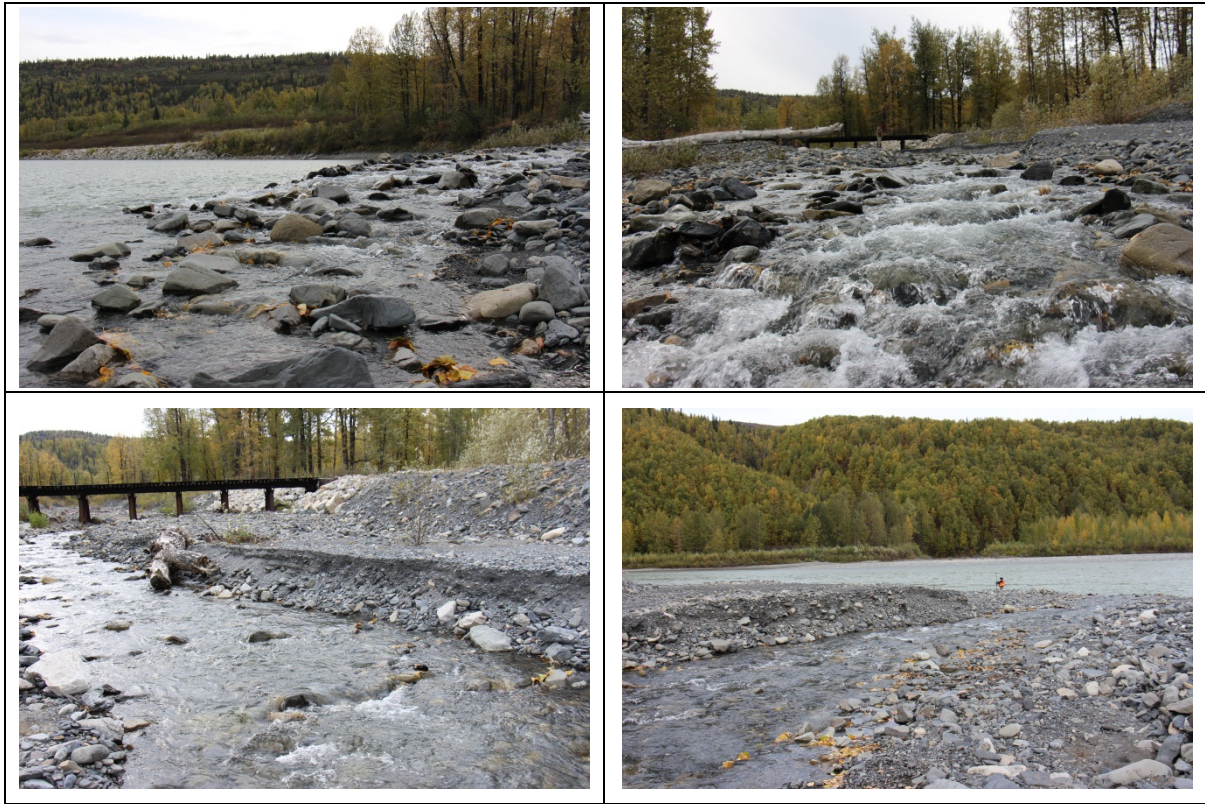
The mouth of Deadhorse Creek consisted of a large debris fan and single creek channel (Figure B5). The creek had incised the debris apron, but a final steep boulder cascade remained before reaching the Susitna (Figure B6). This noticeable perch was a result of low creek flows and the receding Susitna flow. Deposited material varied in gradation, material size and mixture throughout the fan (Table B3).

Figure B5. Deadhorse Creek. From upper right: bottom of creek mouth; looking upstream from Susitna from creek mouth; upstream extent of channel survey; and looking downstream – note channel incision through deposited apron material.

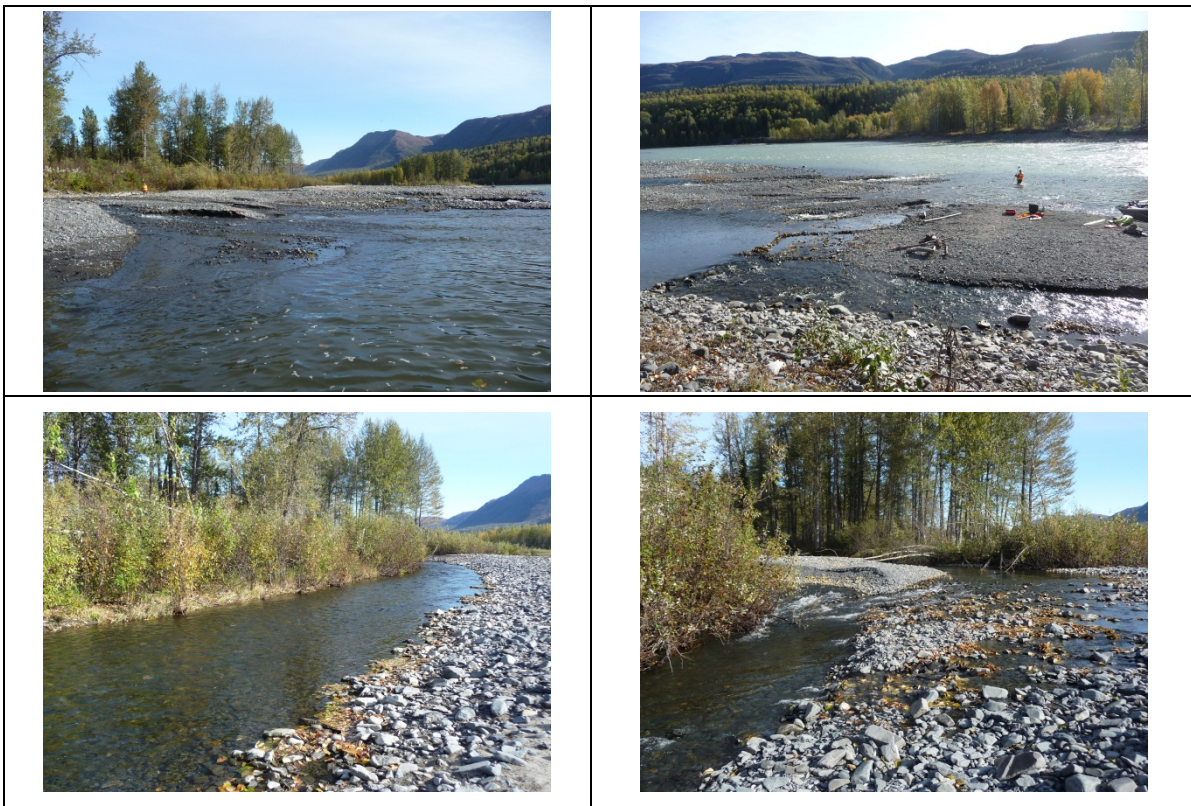
The lower channel of Fourth of July Creek flowed parallel to the Susitna, and was divided by a large gravel/cobble bar (Figure B9). As the creek approached its mouth, flow split into side channels before reaching the Susitna. Five or six significant channels, which varied in slope, length, and discharge, flowed from the creek over a distance of approximately 50 m (164 ft). The main channel carried approximately 25 percent of the creek flow to the Susitna. Some of the channels were actively eroding during the survey. While the mouth was still perched during the time of survey, the length of the multiple channels and the general geometry of the gravel/cobble bar did not create an abrupt drop as seen on several other creeks (Figure B10, Table B5).

Figure B9. Fourth of July Creek. From upper right: bottom of creek mouth; multiple channels through creek mouth; channel upstream of mouth – flowing parallel to the Susitna; and upstream confluence of channel split near top of survey.

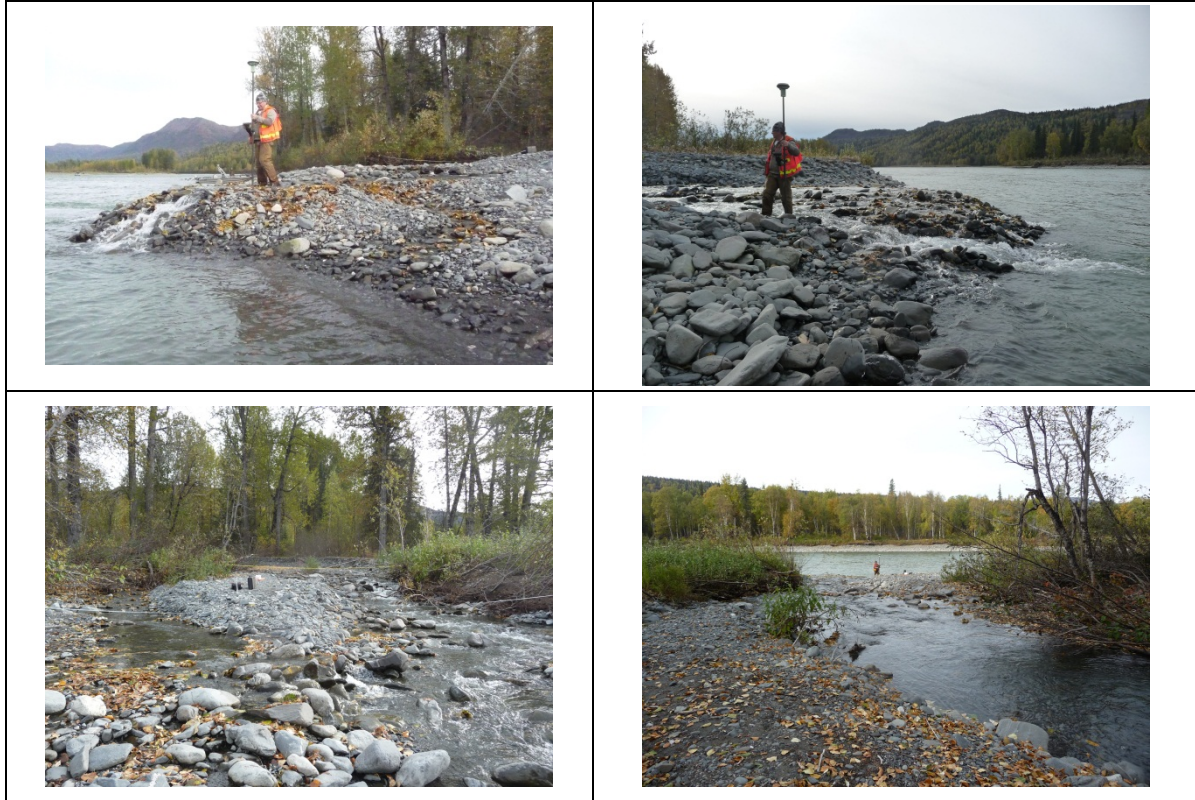
The mouth of Sherman Creek extended across a short debris fan (Figure B11). The stream crossed in a single channel, and upon reaching the perched edge of the fan, flow divided between a few main flow paths before reaching the Susitna (Figure B12, Table B6).

Figure B11. Sherman Creek. From upper right: bottom of creek mouth; multiple channels through creek mouth; riffle upstream of tributary apron; and looking downstream from top of survey.

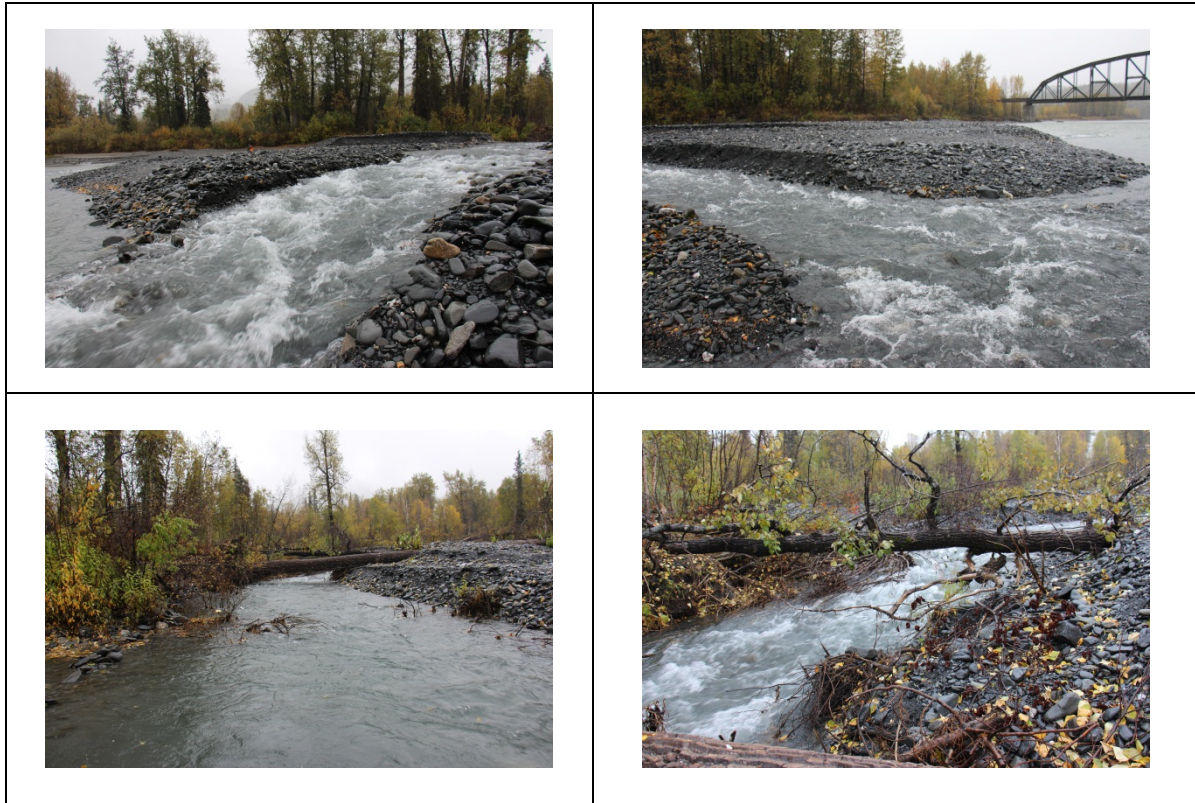
The mouth of Gold Creek consisted of a large debris fan and two stream channels (Figure B13). A steeper channel grade across the deposited apron was consistent with a perched condition, but channel incision on both the main and the secondary channel reduced the gradient of the final drop to the Susitna (Figure B14, Table B6). Flow between the two flow paths consisted of an approximate 60:40 split. Banks of the secondary channel were eroding during the time of survey.

Figure B13. Gold Creek. From upper right: bottom of creek mouth; bottom of mouth side channel; lower gradient reach upstream of tributary apron; and higher gradient reach near top of survey.
