SUSITNA-WATANA HYDROELECTRIC PROJECT LINEAMENT GROUP 8 PHOTOGRAPHS

SUSITNA-WATANA HYDROELECTRIC PROJECT LINEAMENT GROUP 9 PHOTOGRAPHS

SUSITNA-WATANA HYDROELECTRIC PROJECT LINEAMENT GROUP 17a PHOTOGRAPHS

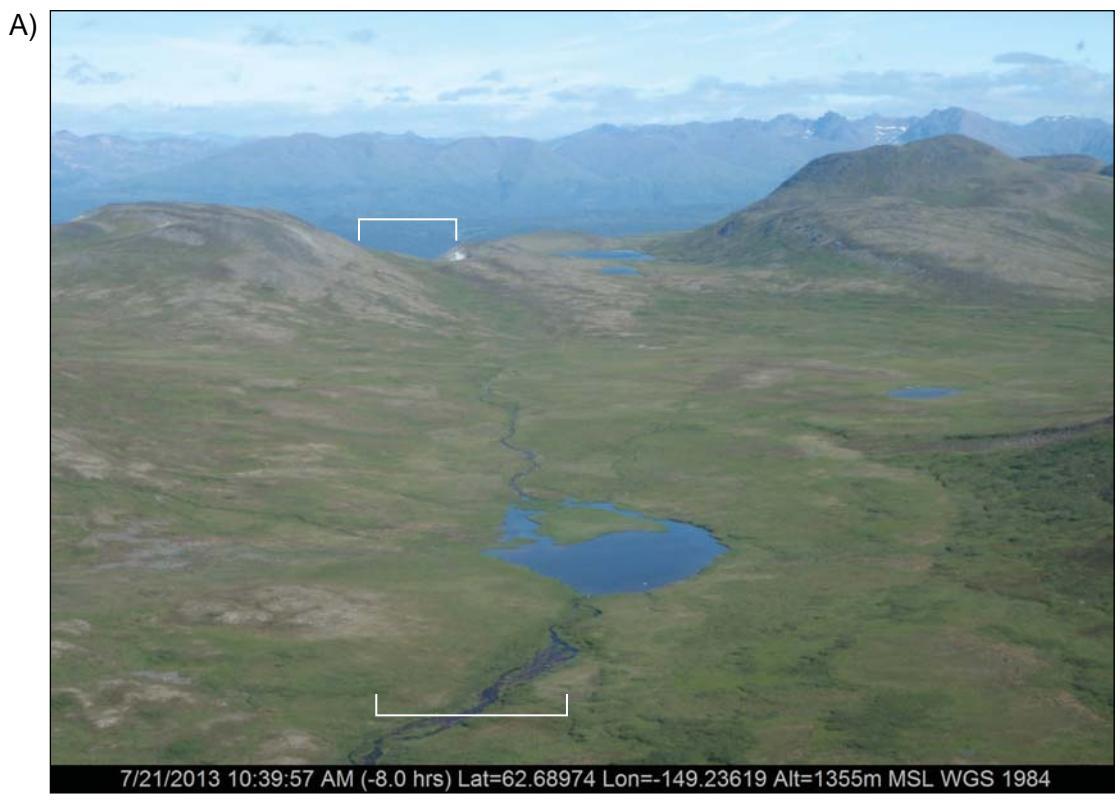
View looking north at middle portion of lineament group 8 along mapped inferred fault. Brackets show position of fault but note that no geomorphic expression of faulting is readily apparent.

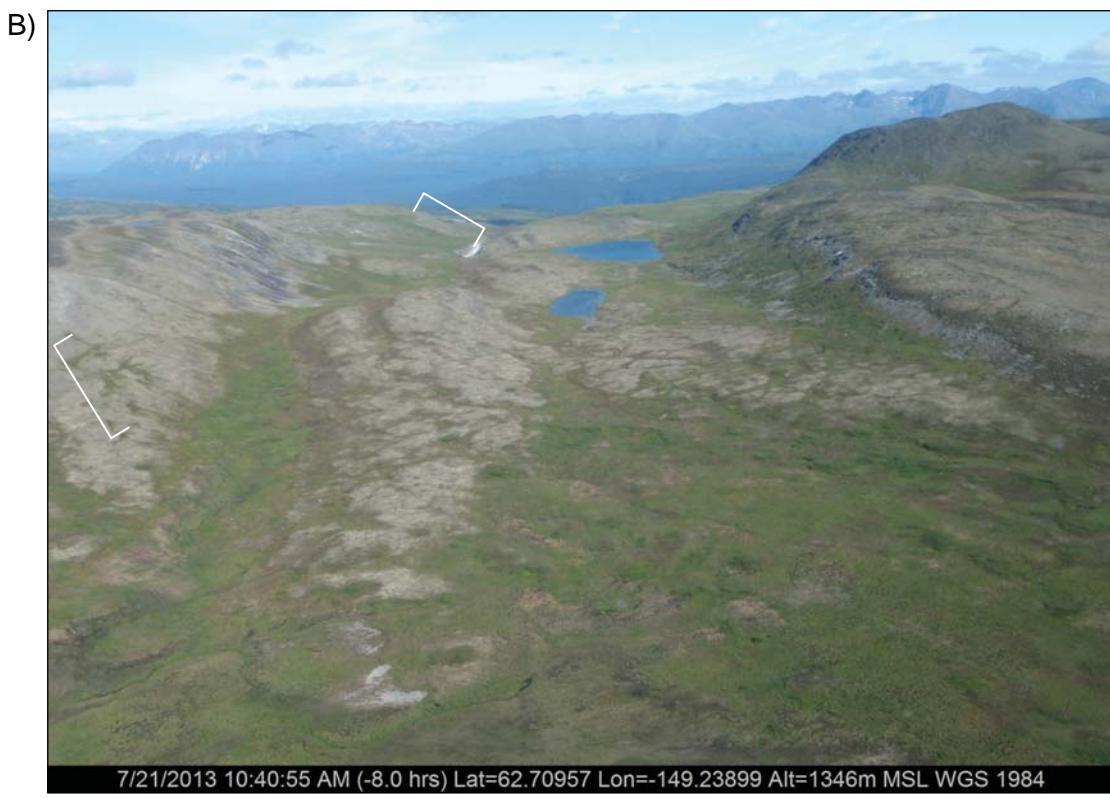
Close up view of saddle area shown in Photograph A. Brackets, again, show position of fault but note that no geomorphic expression of faulting is readily apparent.

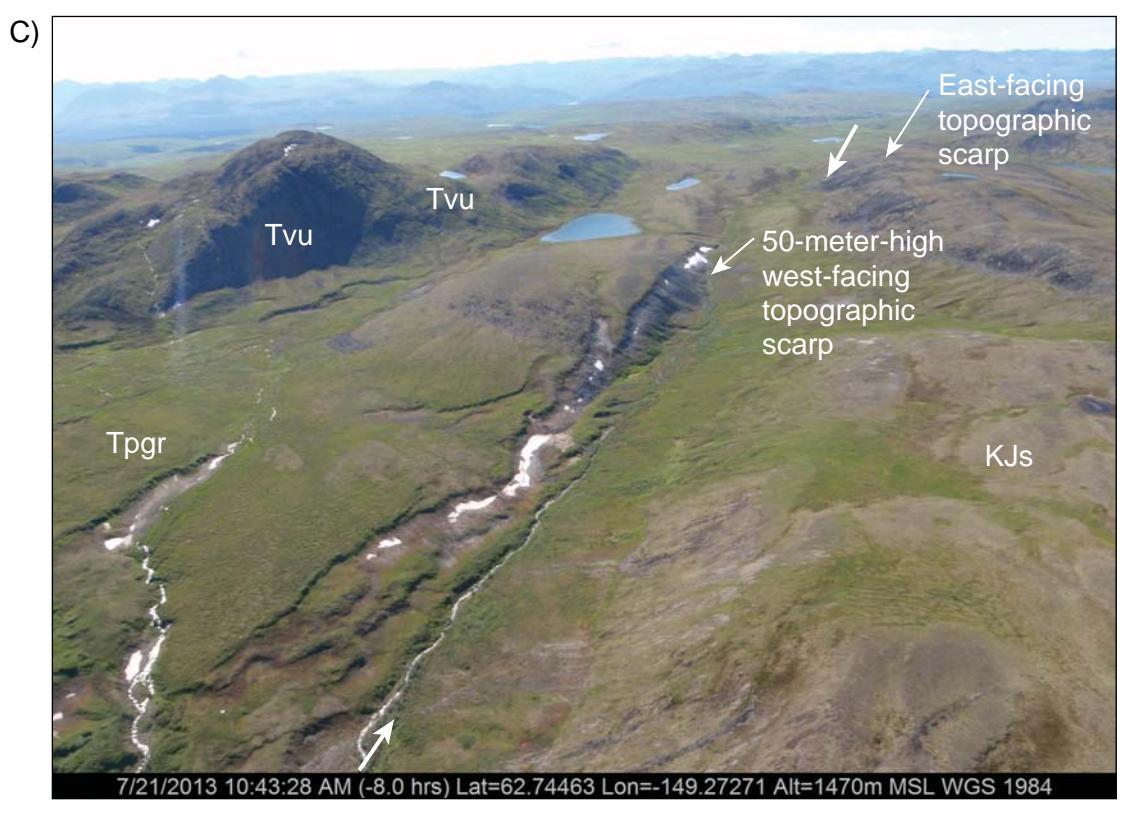
Possible contact between KJs and Tpgr KJs 7/15/2013 3:18:27 PM (-8.0 hrs) Lat=62.73436 Lon=-149.25245 Alt=4209ft MSI

View looking north down the prominent, deeply incised linear drainage. Mapped fault runs between large arrows.

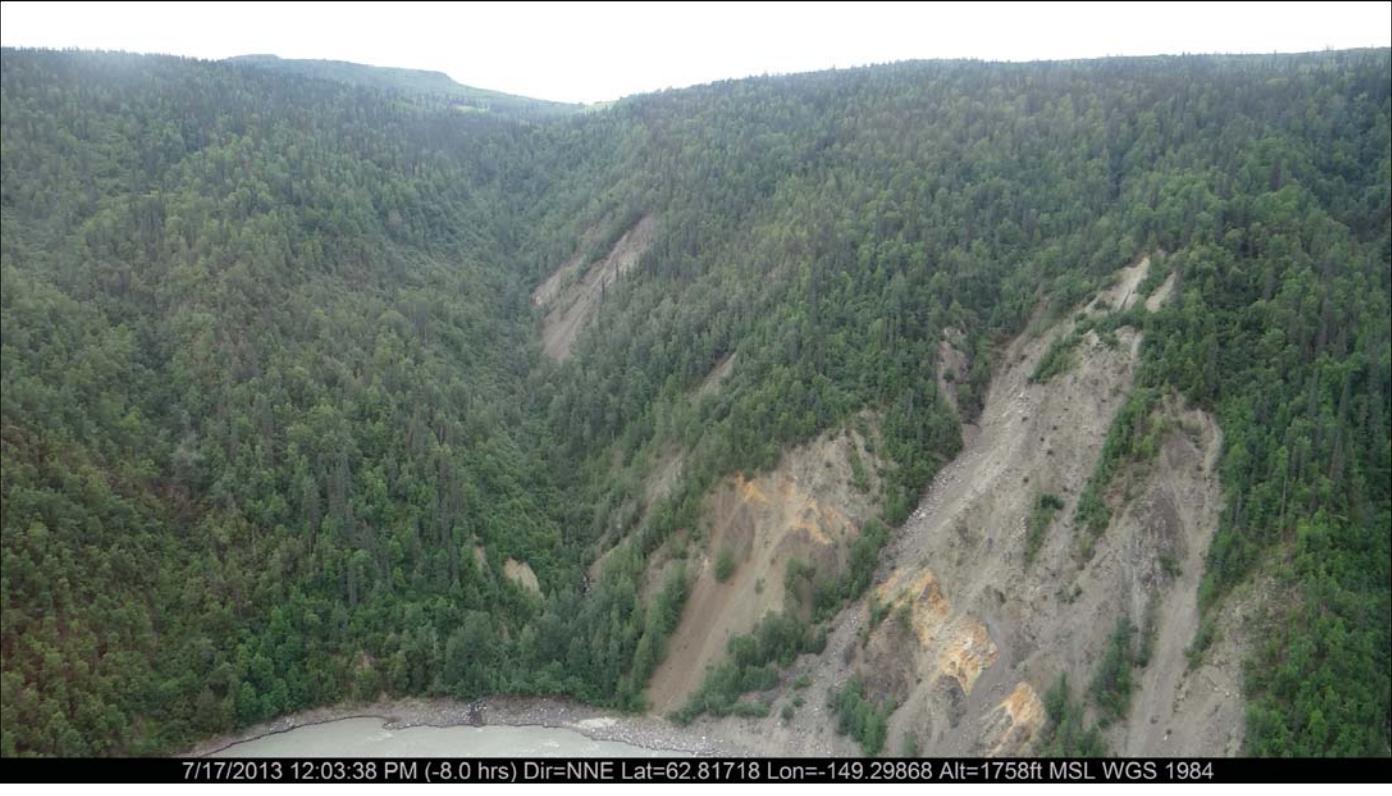
View looking north at north (right) bank of Susitna River showing oxidized mafic dike interpreted by WCC (1982) to not be truncated by the linear drainage.

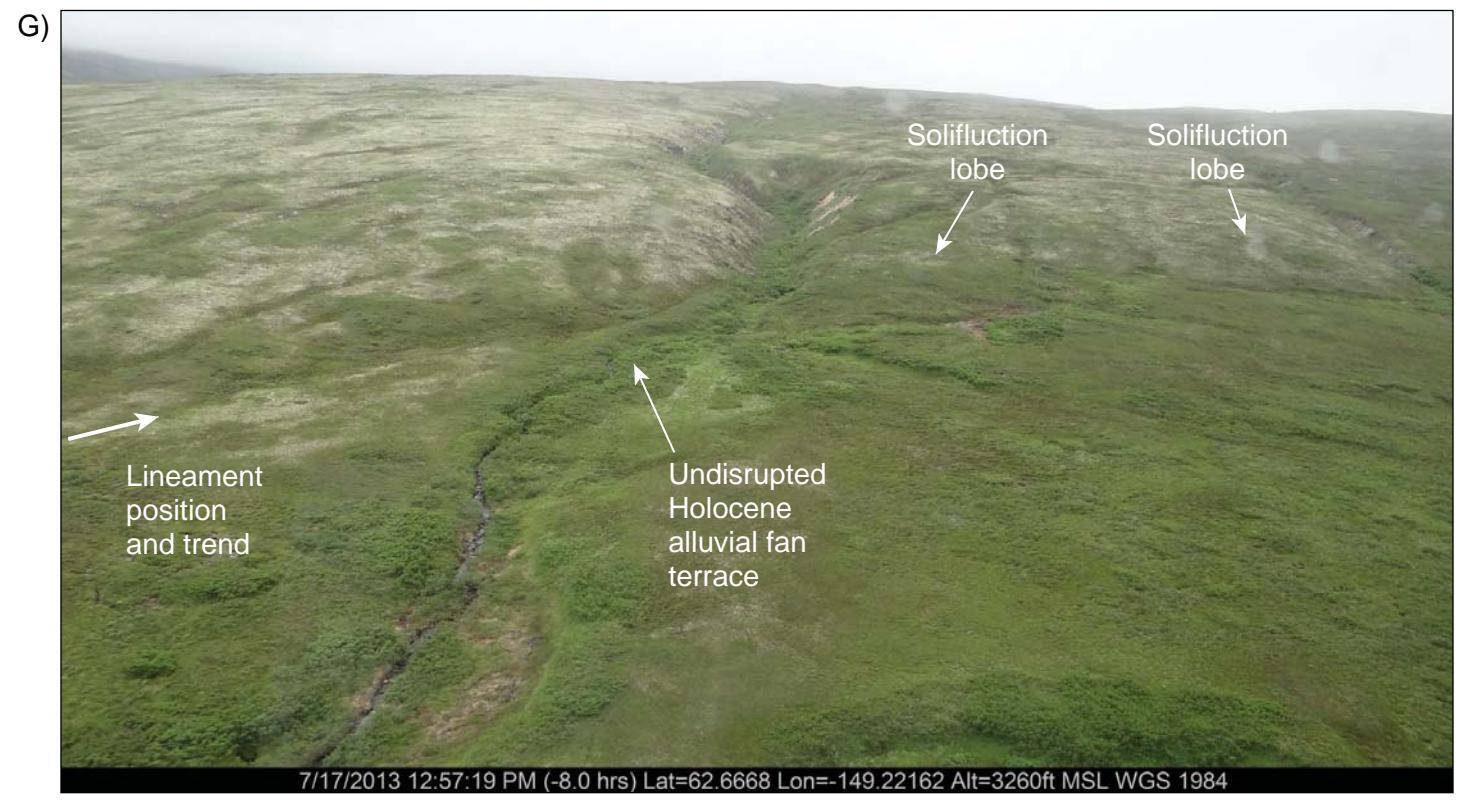
View looking west directly towards 1- to 2-m-high east-facing scarps shown in Photographs F and H. Large arrow points along mapped lineament.

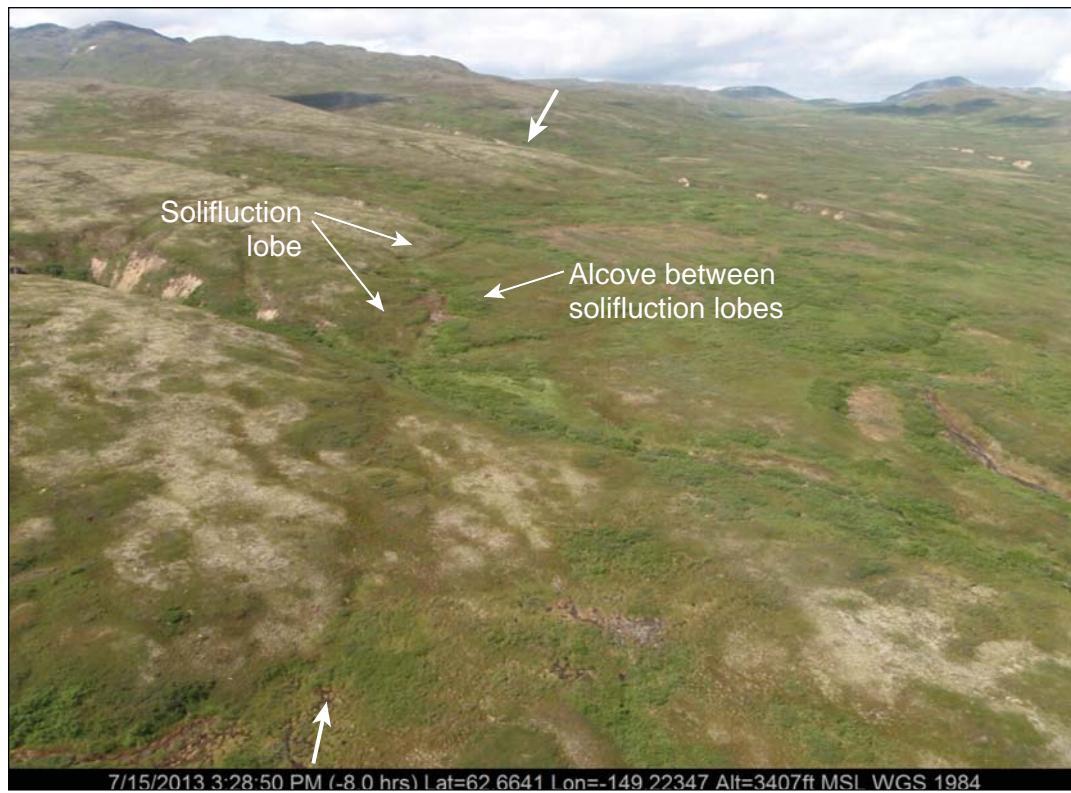
of solifluction lobes with an alcove or recession in between them that create an irregular and curving topographic scarp.

View looking north along 1- to 2-m-high east-facing scarps along southern portion of lineament group 8. Large arrows point along mapped lineament. Note the presence

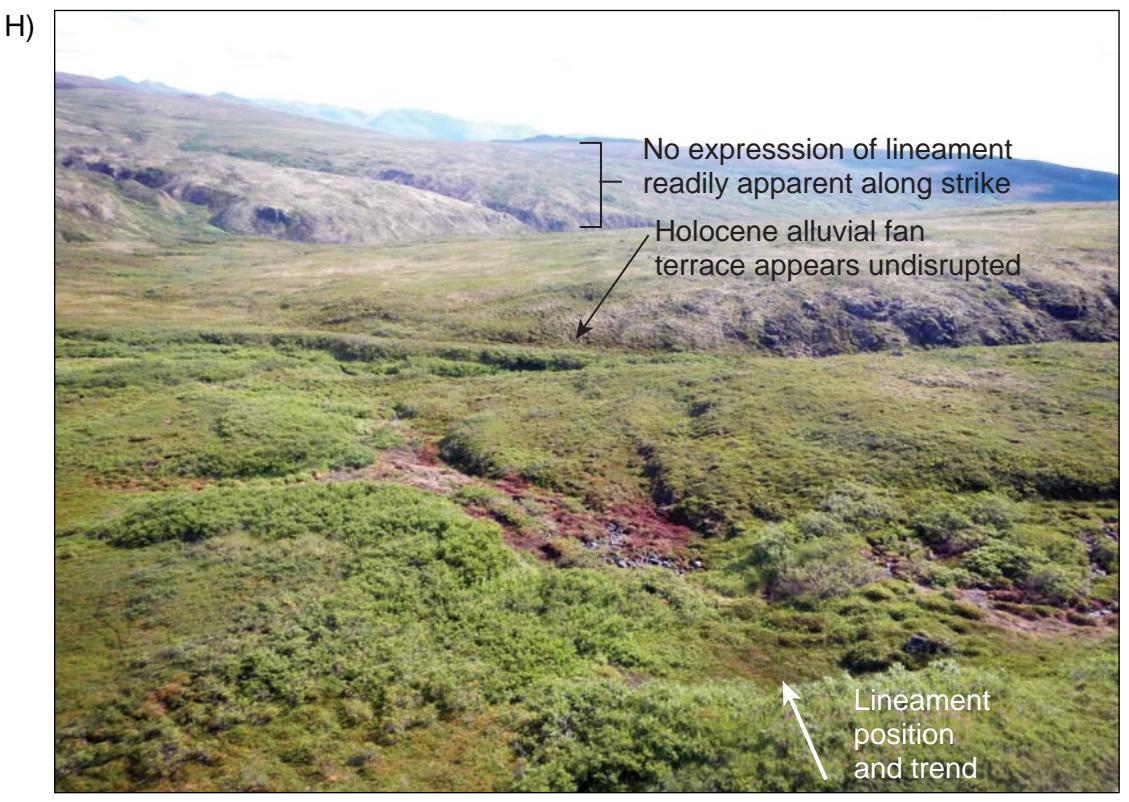
View looking south opposite that shown in Photograph F above. Large arrow points along lineament position and trend.

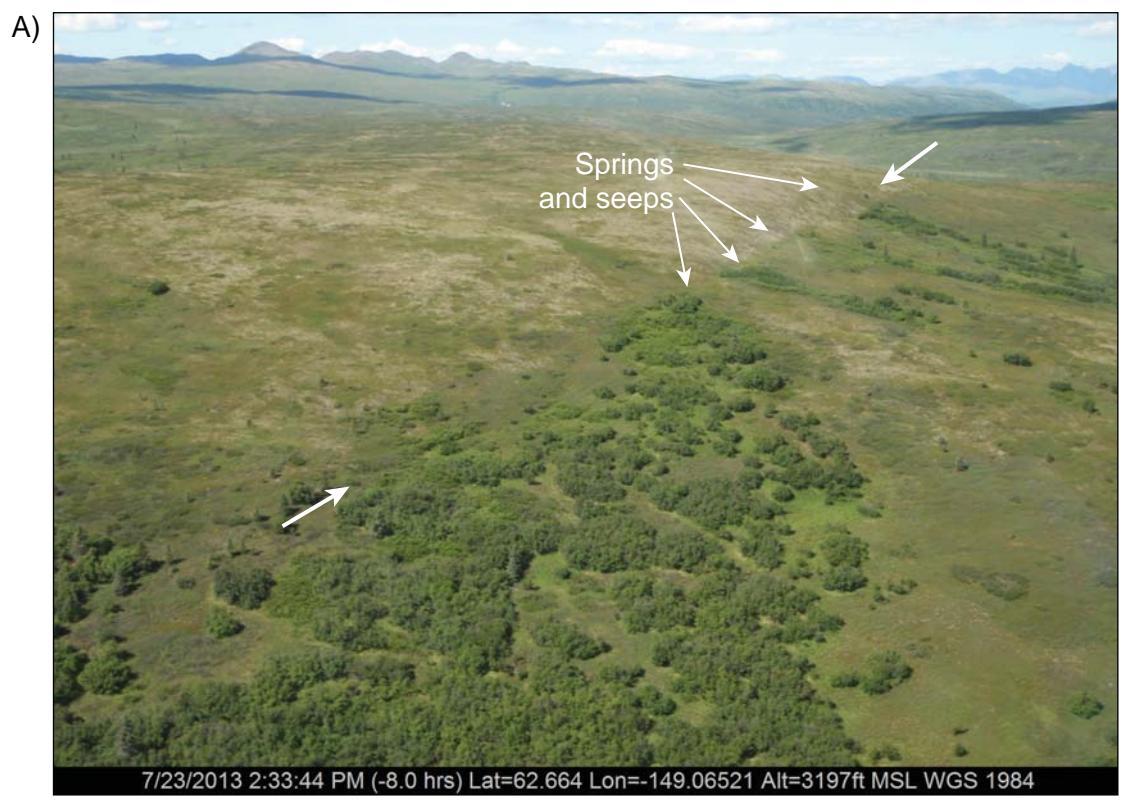
The first in a sequence of 5 photographs looking northwest taken along a series of north-trending, east-facing aligned slope breaks in the southernmost portion of lineament group 8. Large arrows point along lineament.

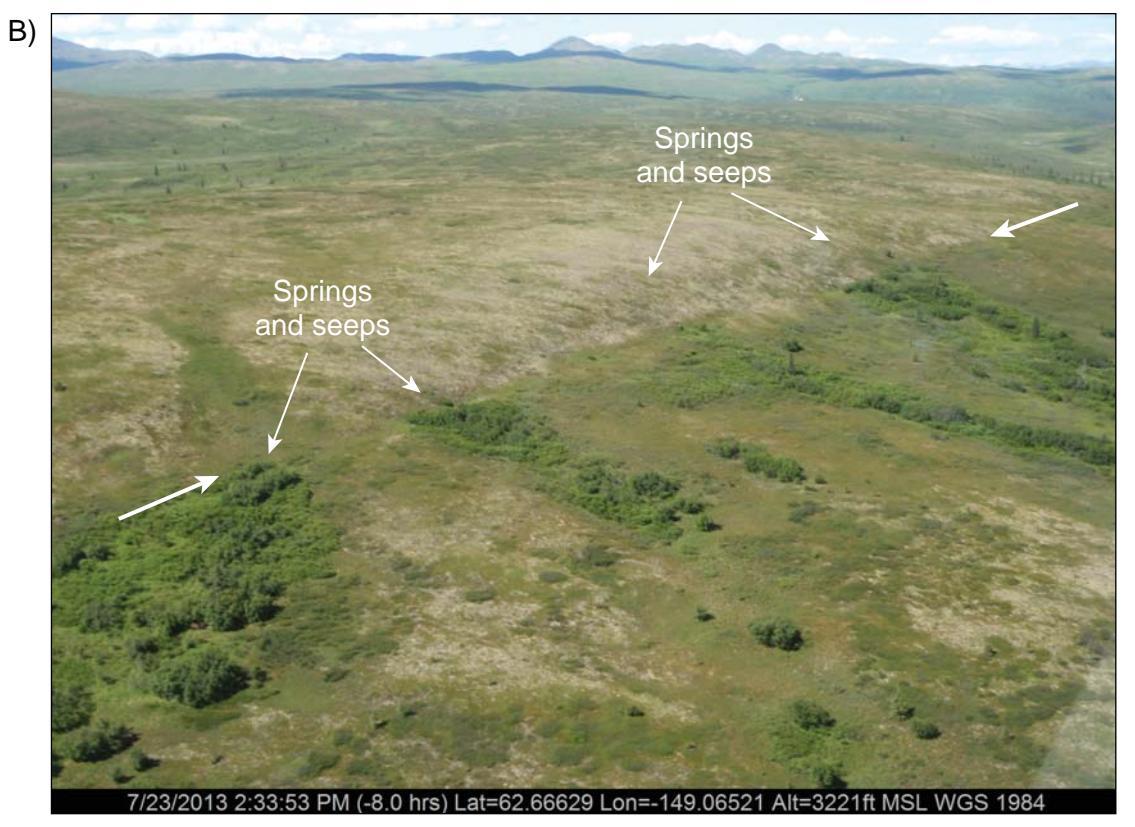
Photograph 2 of 5 looking northwest. Large arrows point along lineament.

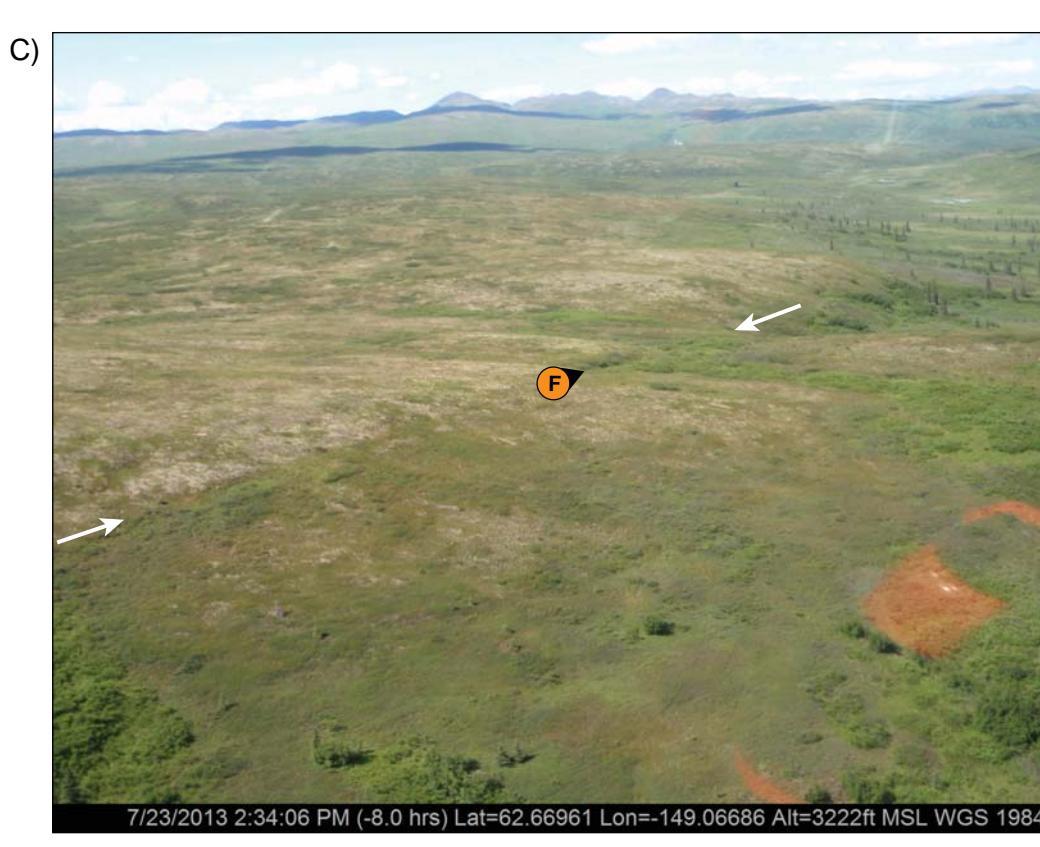
Photograph 3 of 5 looking northwest. Large arrows point along lineament.

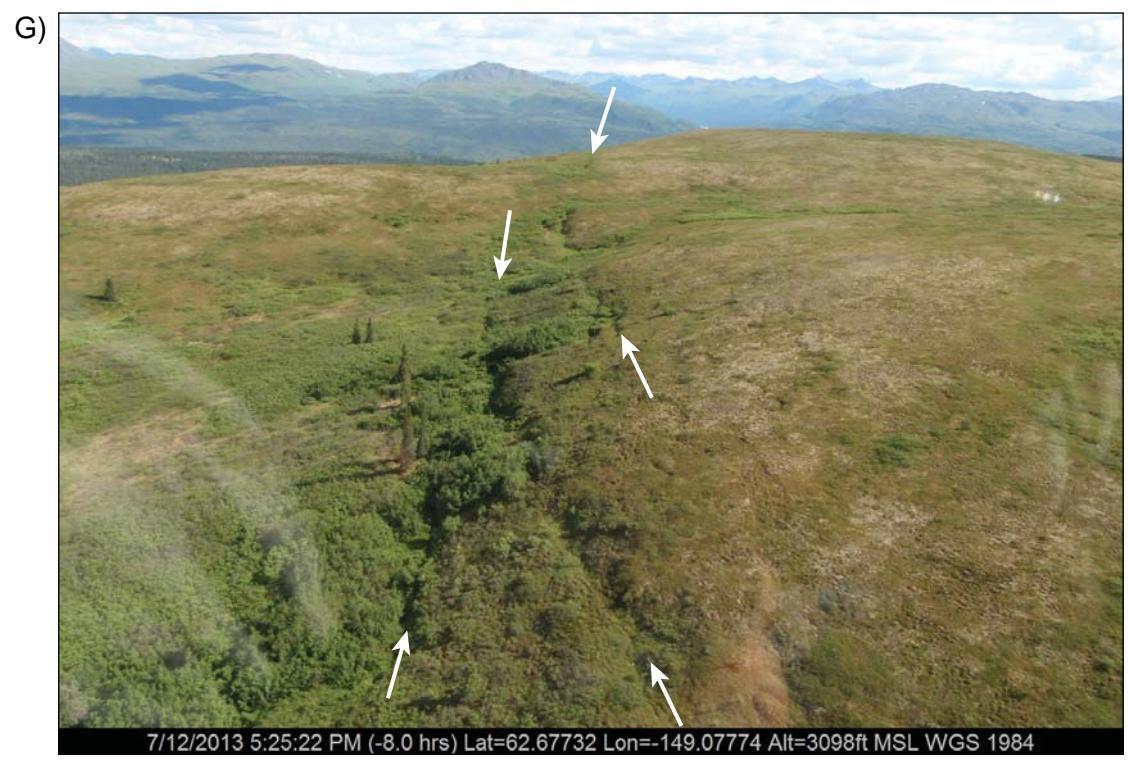
View looking almost 180 degrees from that shown in Photograph D. Large arrows point along lineaments.

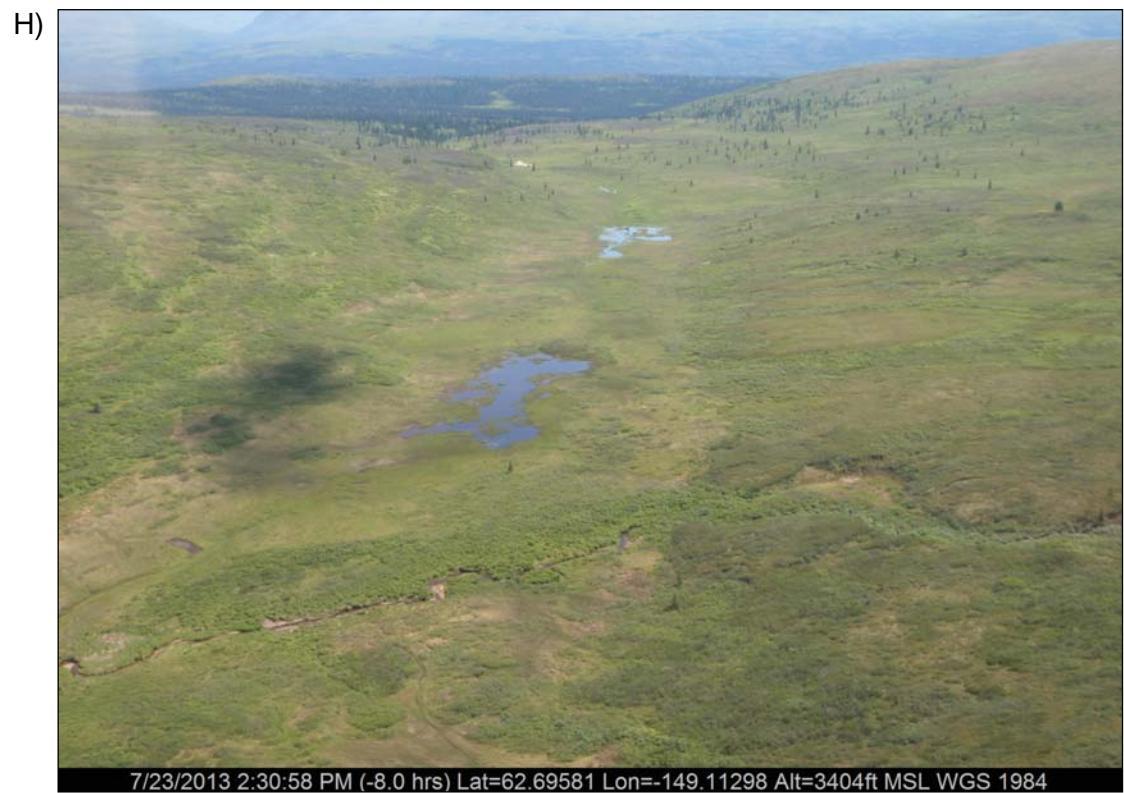
View looking south from location I across area within WCC's segment 3. Note the lack of expression of any lineaments in the broad depression.

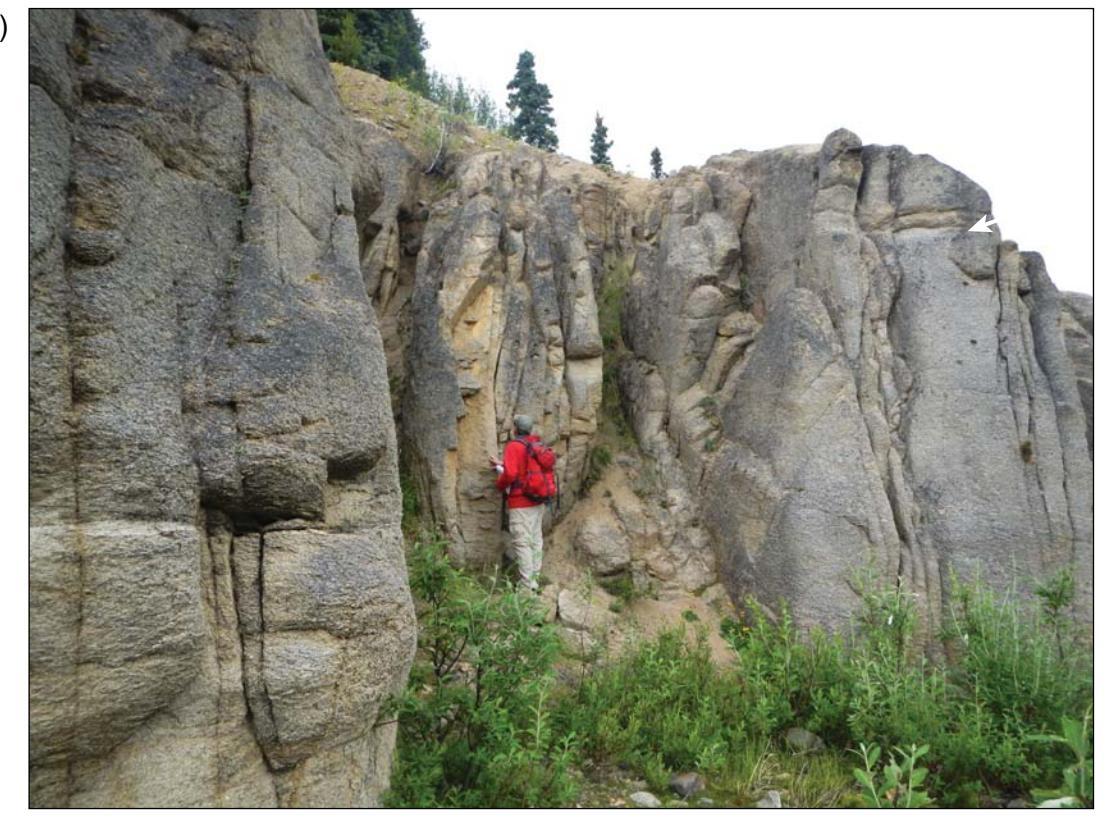
Exposures of widespread granodiorite in unnamed creek near GPS waypoint 176 in terrain mapped as flysch (map unit KJs) by Wilson et al. (2009). The geologist is approximately 175 cm tall.

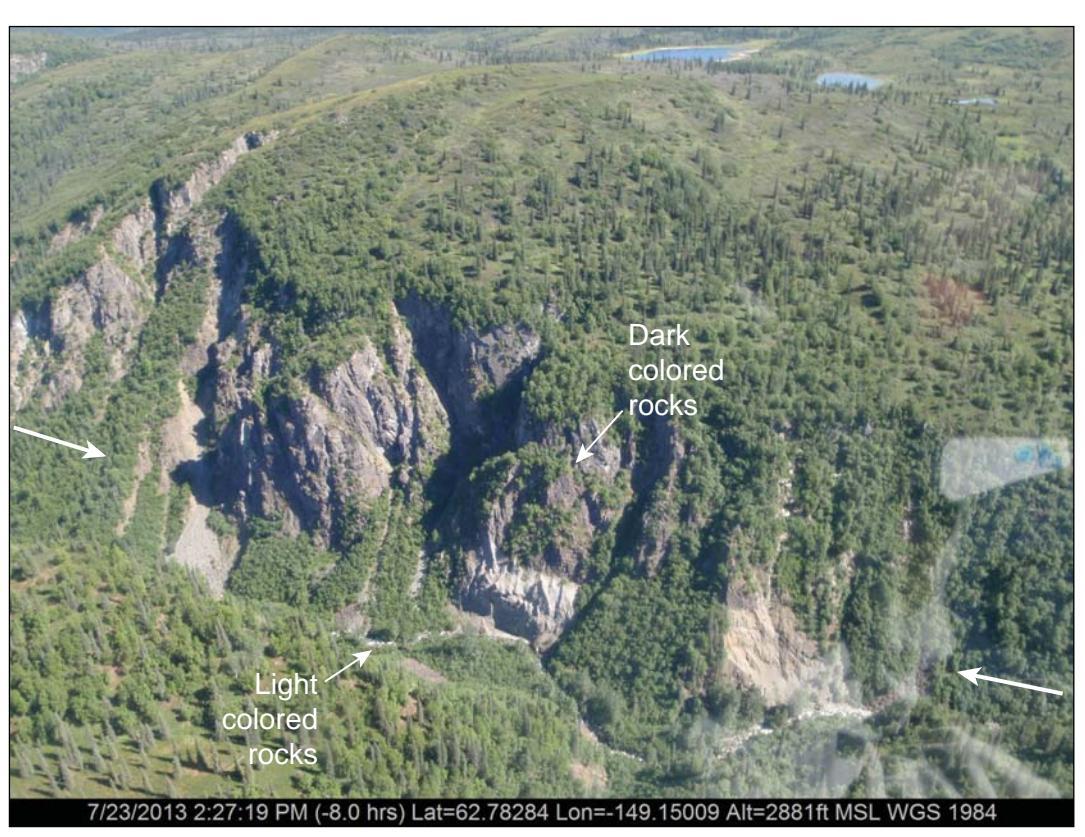
View looking northeast at right wall of linear v-shaped canyon. Large arrows point along apparent bedrock type contrast.

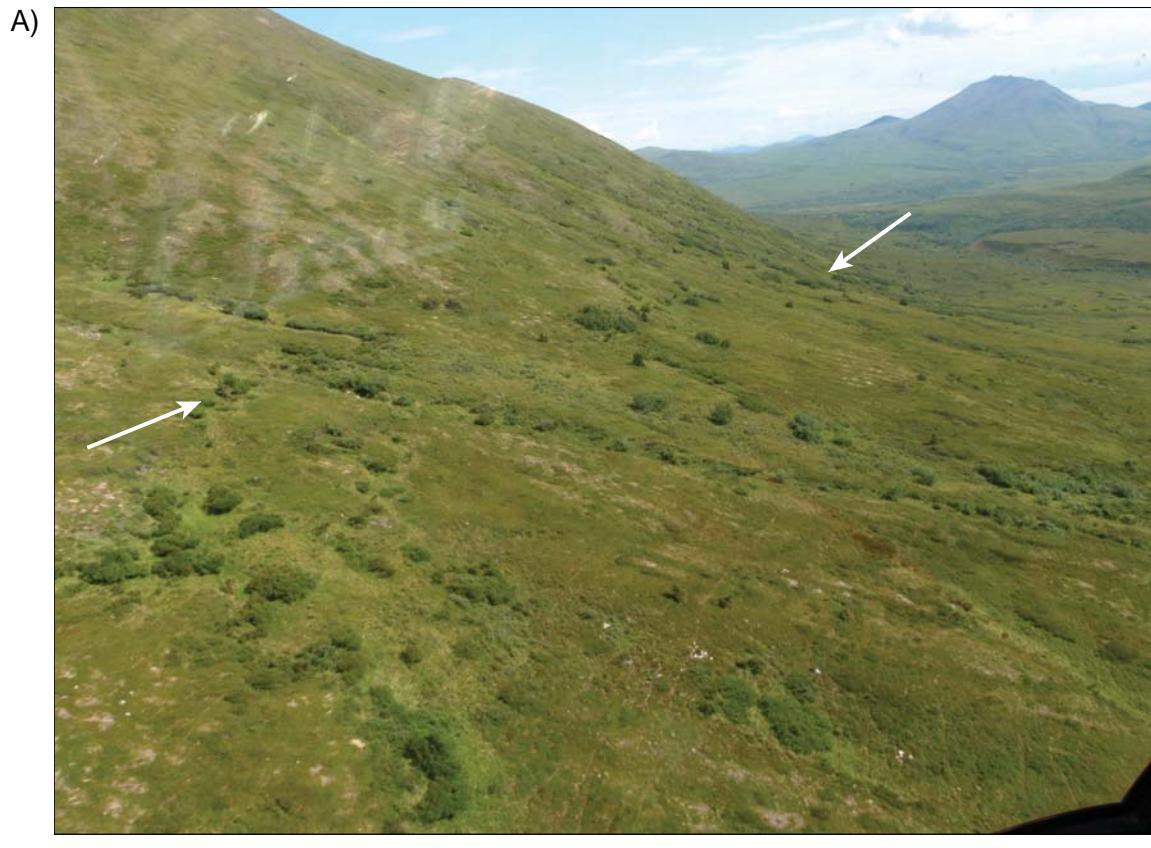
View looking northeasterly along lineaments. Arrows point along trend and position of lineaments.

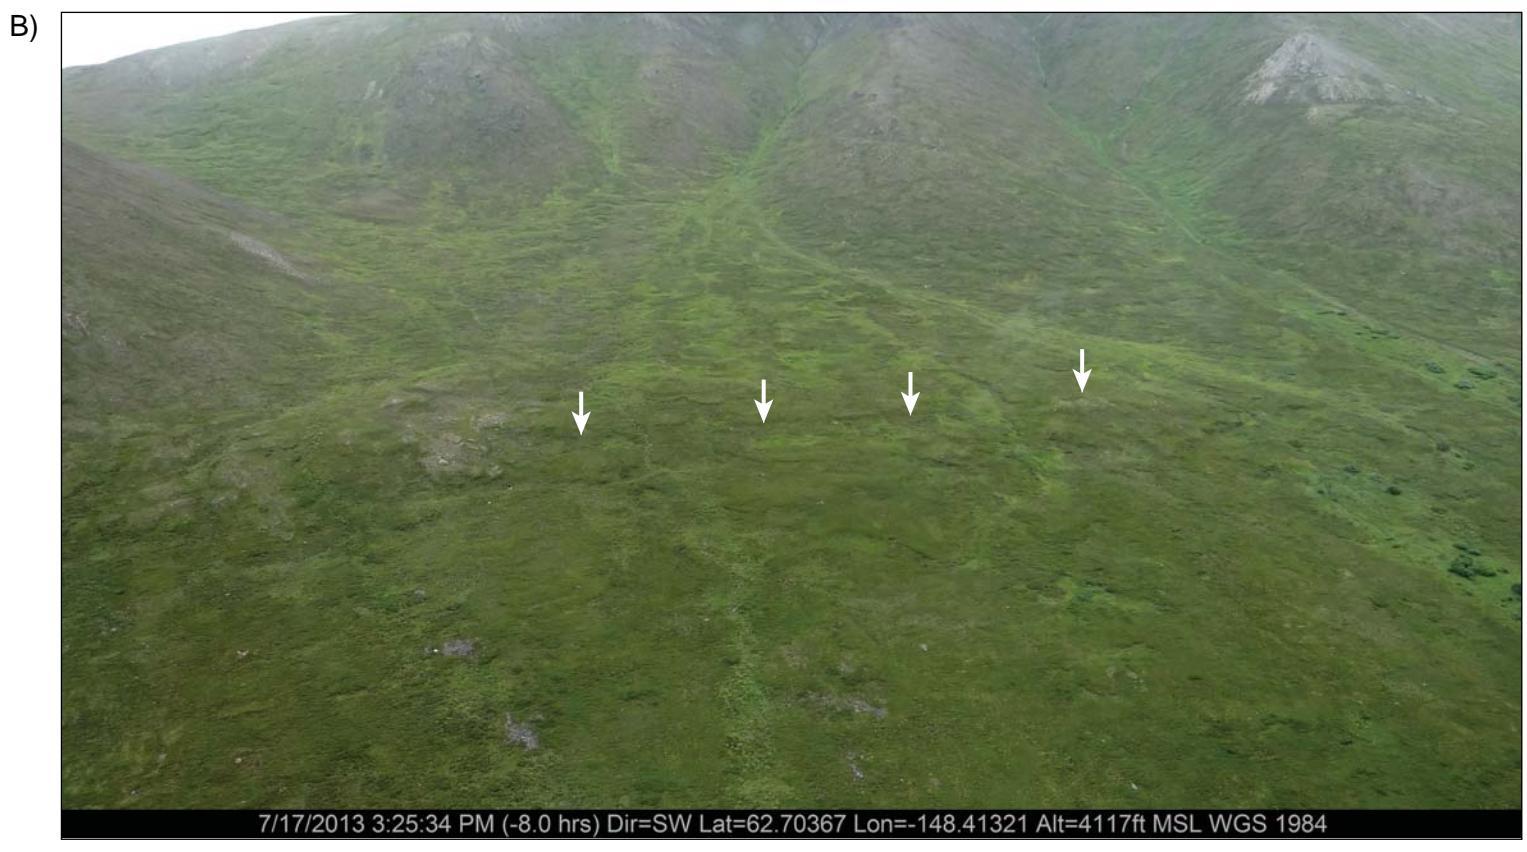
View of lineaments expressed in Quaternary sediment.

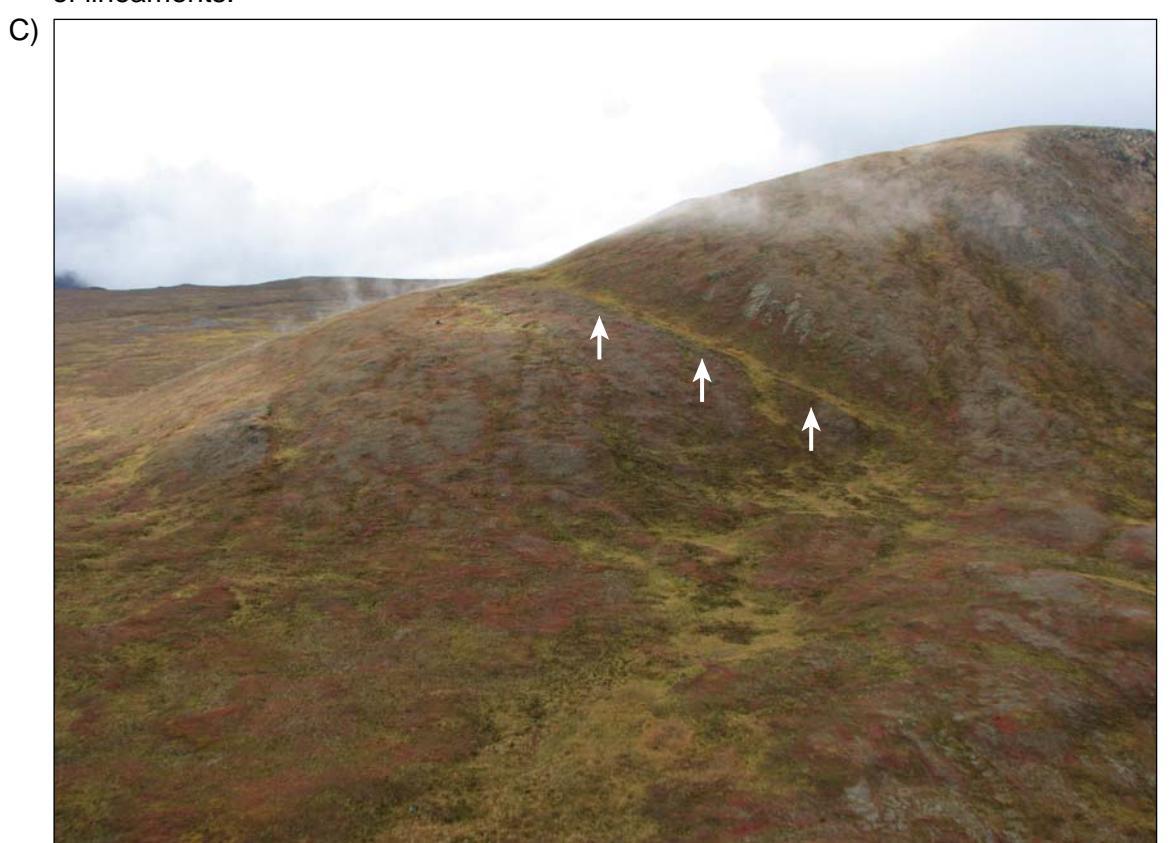
View looking at notch in bedrock with expression of apparent northwesterly dip.

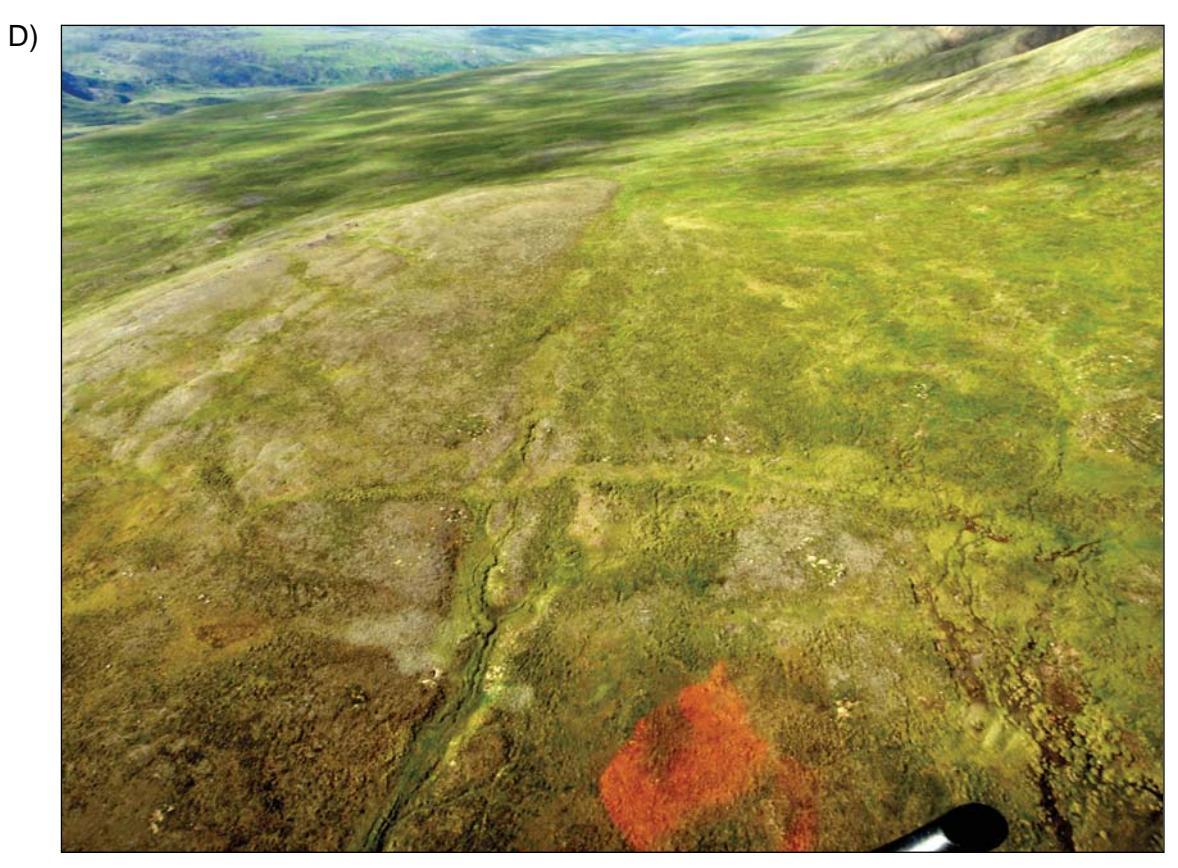
View looking southwesterly along glacially scoured surface.

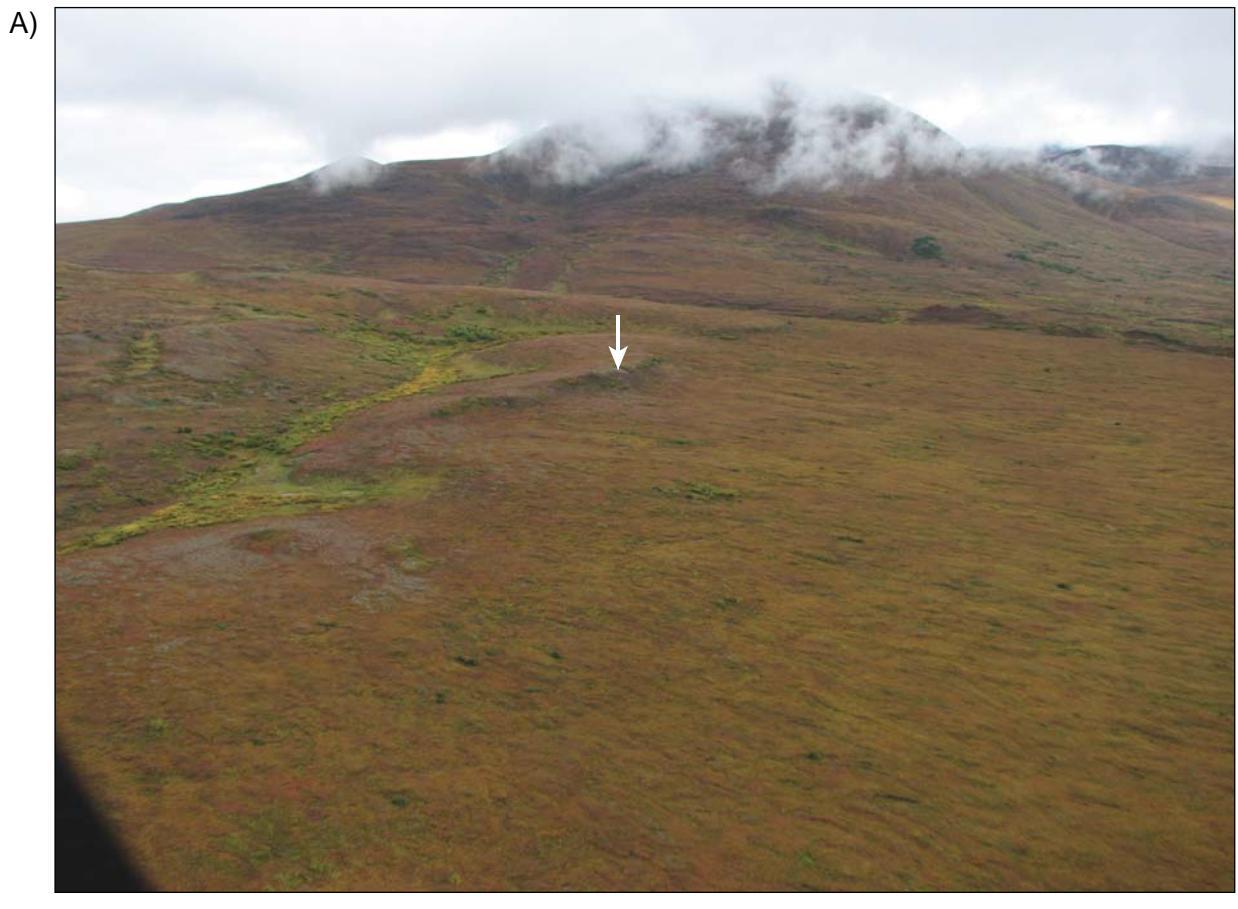
View looking northeast at erosional break-in-slope mapped as an individual lineament. Feature is absent in the background along projection of strike.

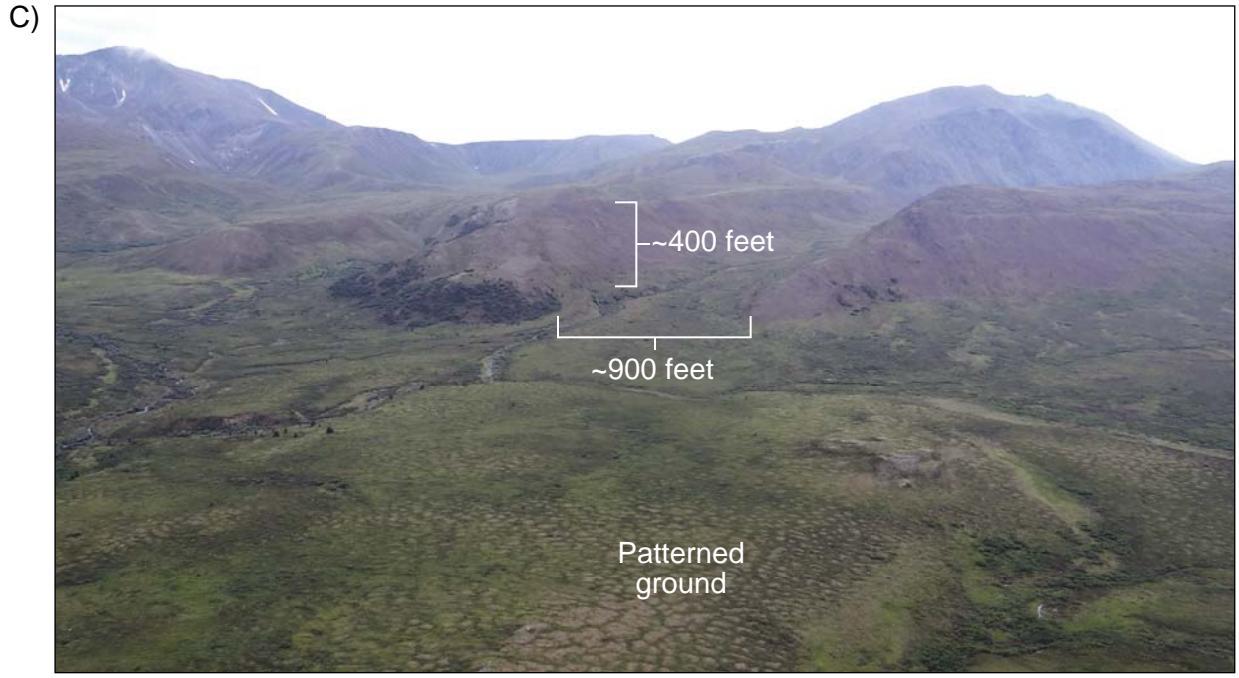
View southerly up-valley into glacial valley along lineaments geomorphically expressed as linear valley and drainage. Underfit creek in deep linear valley suggests landform created by sub-ice channel meltwater.

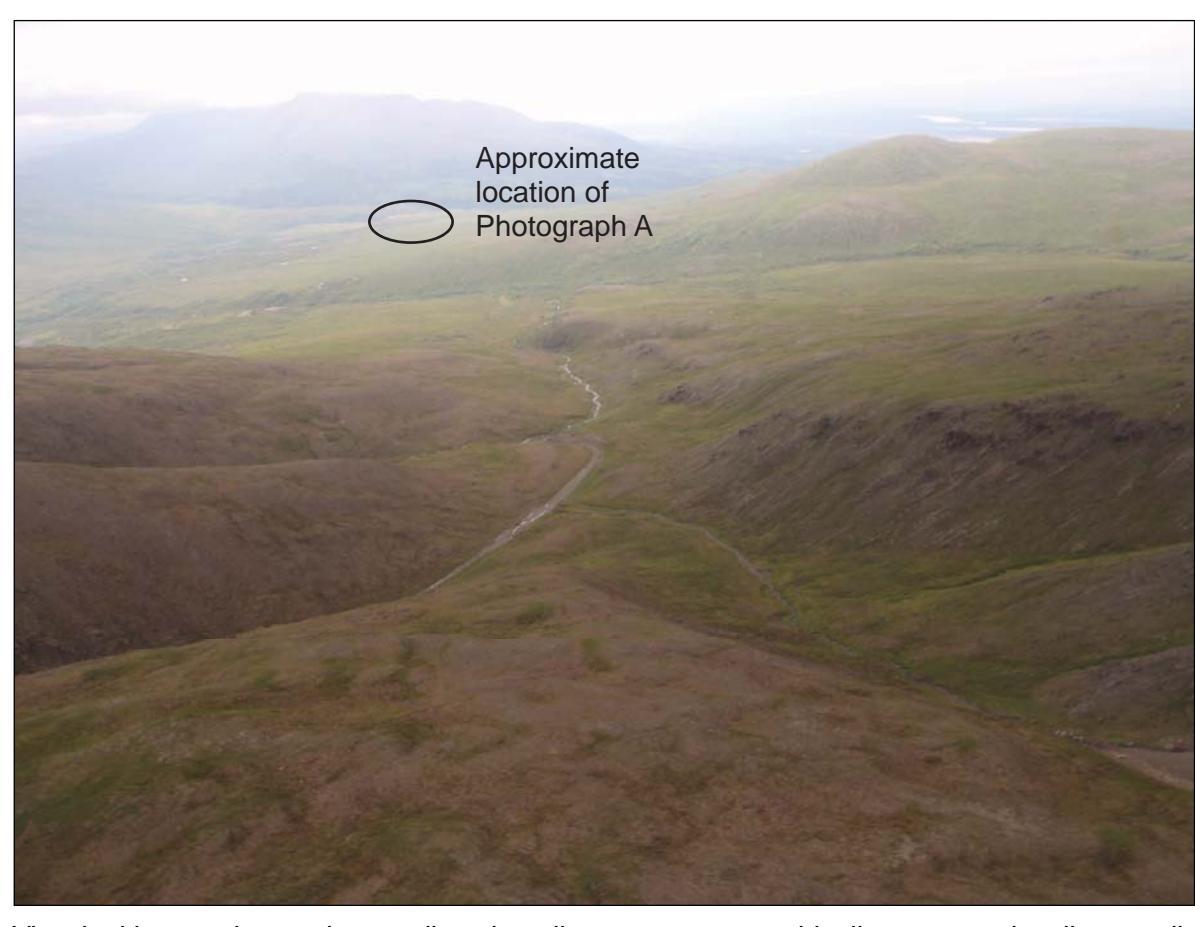
View looking southwest down-valley along lineament geomorphically expressed as linear valley. Very little alluvium has accumulated in the drainage, and glacially sculpted bedrock is shallow.

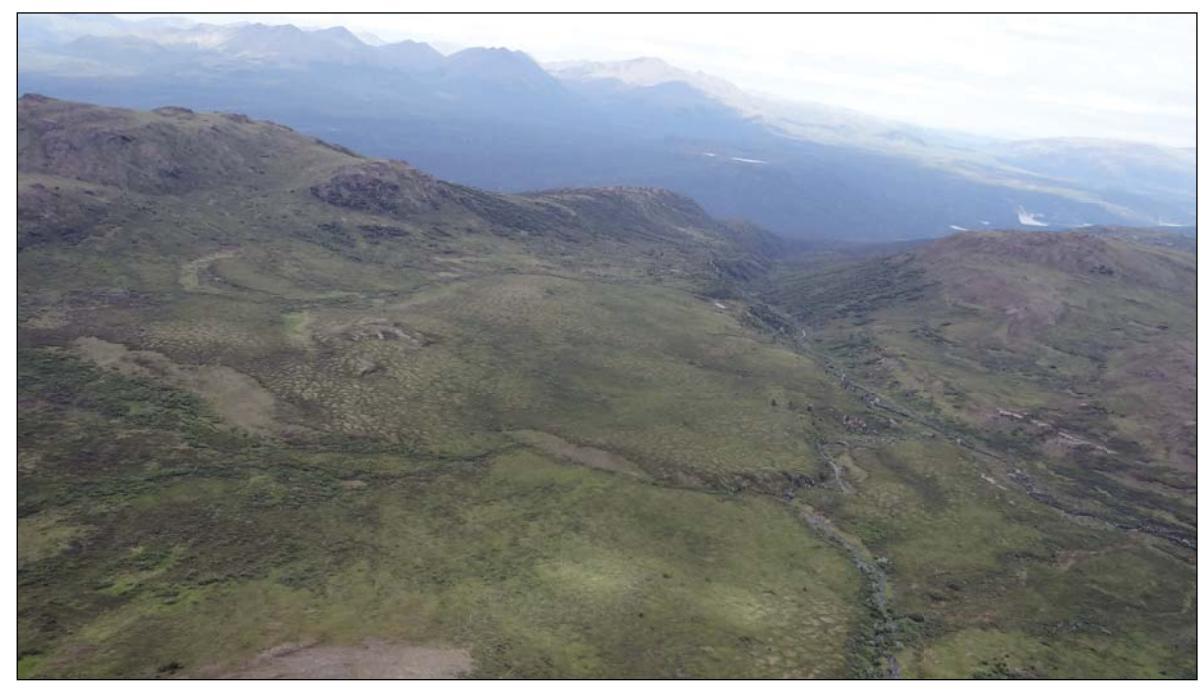
View northerly down-valley along lineaments geomorphically expressed as linear drainage. Thin cover of unconsolidated surficial sediment mantles the Paleozoic rocks.

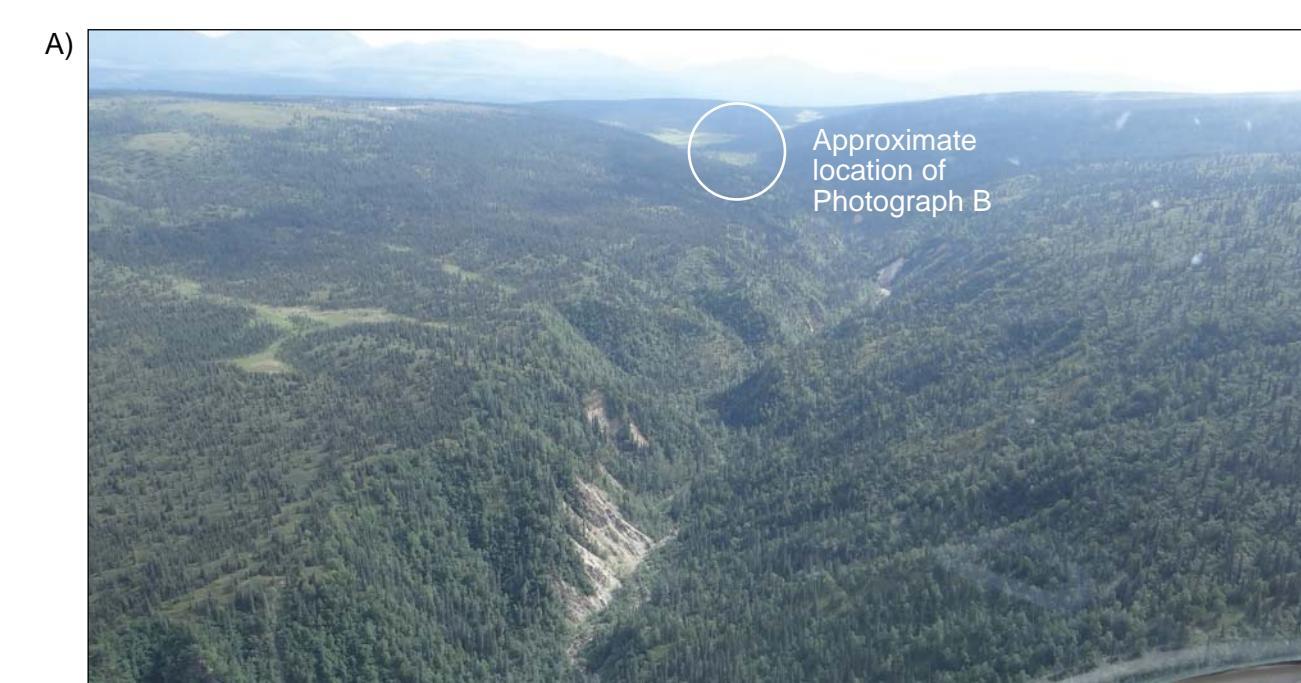
View looking south at linear canyon that is tributary to the Susitna River. Canyon bottom and creek drainage have sinuosity not apparent at smaller scales.
