SUSITNA-WATANA HYDROELECTRIC PROJECT LINEAMENT GROUP 8 PHOTOGRAPHS

SUSITNA-WATANA HYDROELECTRIC PROJECT LINEAMENT GROUP 9 PHOTOGRAPHS

SUSITNA-WATANA HYDROELECTRIC PROJECT LINEAMENT GROUP 17a PHOTOGRAPHS

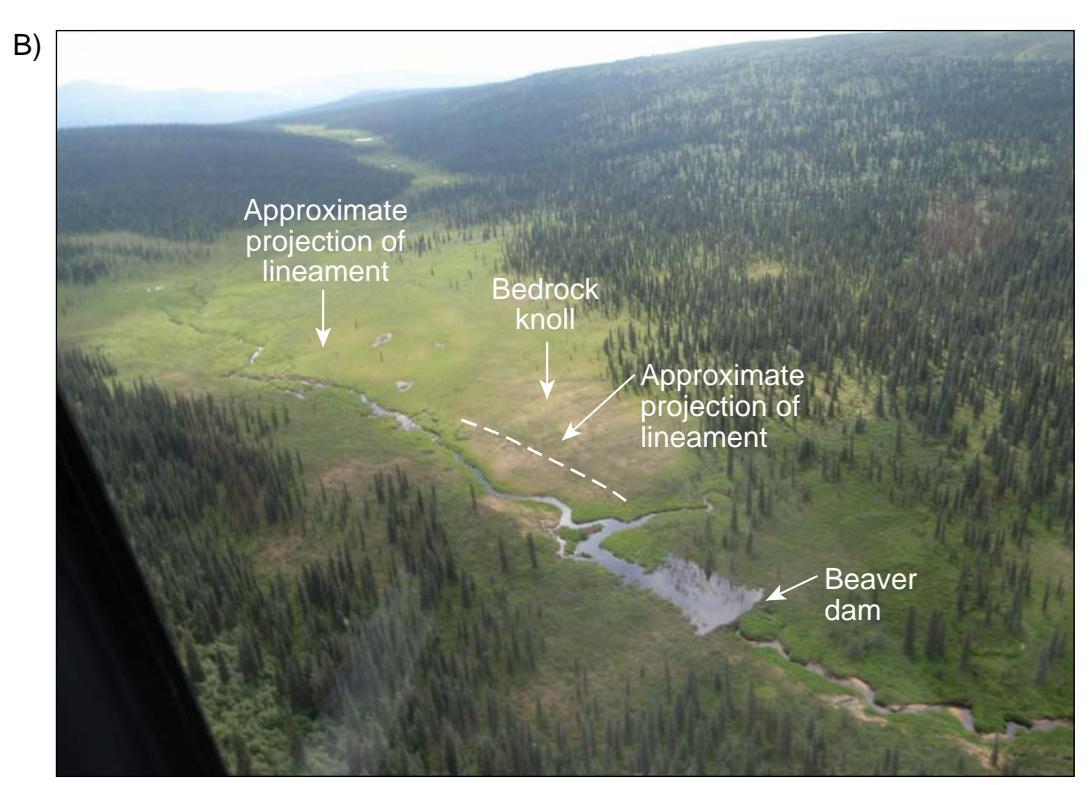
View looking north-northeast at creek in boggy (Holocene) drainage. Lineament is expressed as a depositional contact along the shallow bedrock knoll.

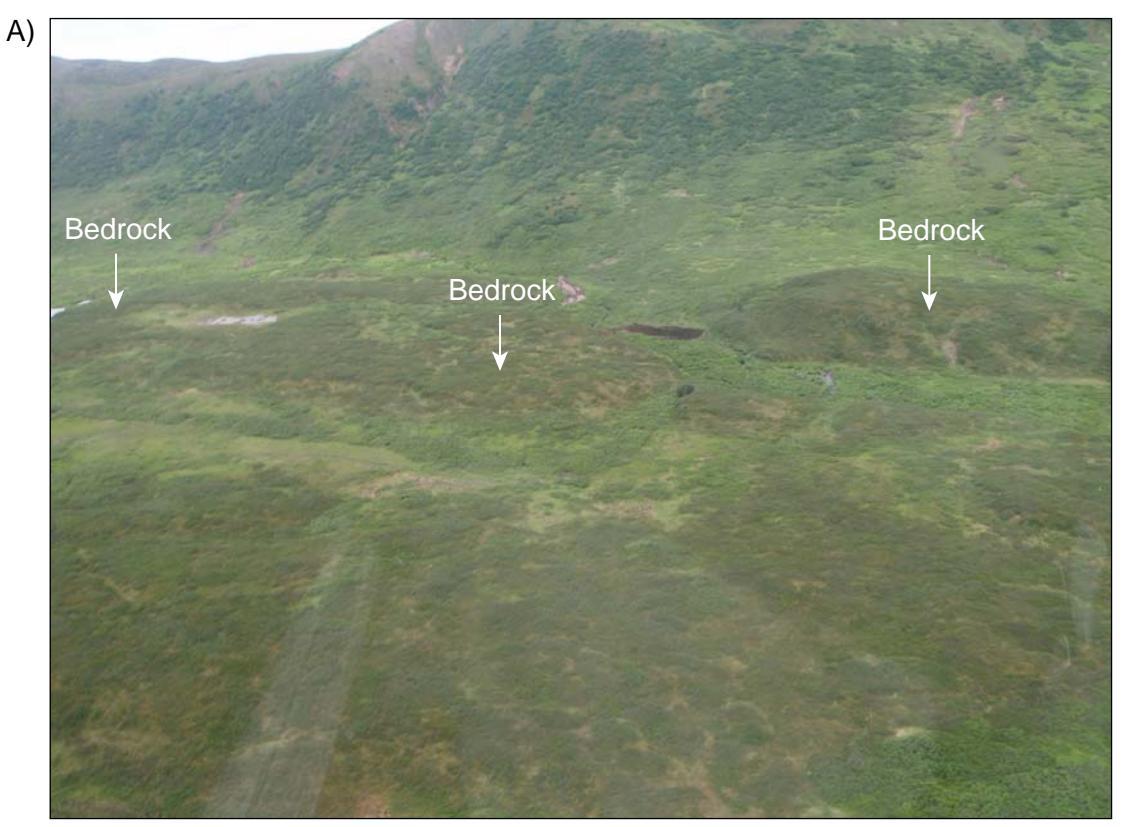
View looking westerly at break-in-slope at base of hillside and undulating glaciallyeroded bedrock knobs in foreground.

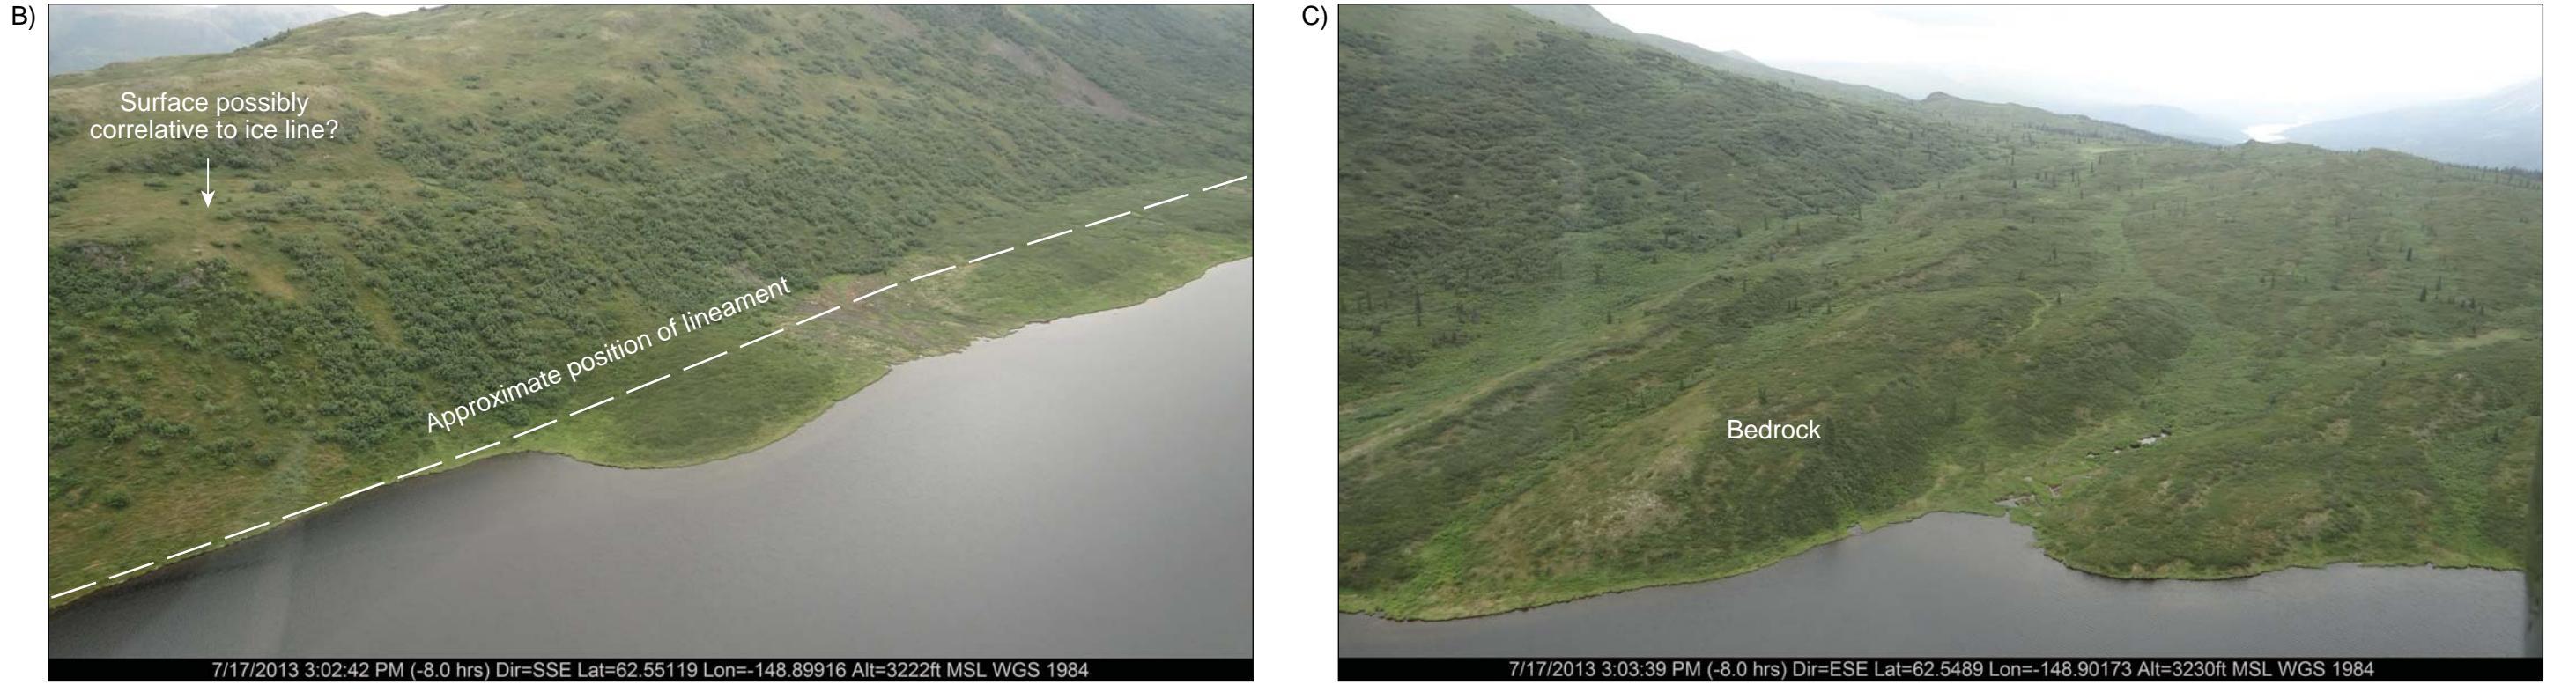
View looking south southwest at lake margin of glacial valley. Lineament was mapped at base of slope, and is not expressed as a scarp-type feature. Apparent colluvium along projection of lineament does not appear offset.

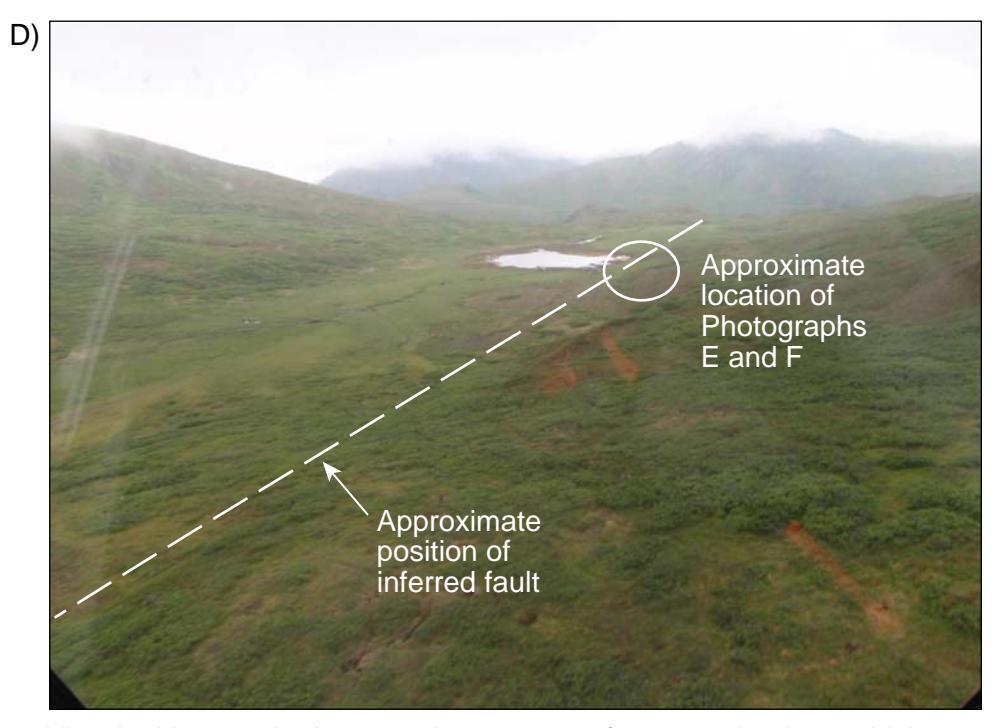
View looking south along southern extent of group 17b, along which an inferred bedrock fault is mapped by Wilson (2009). Photographs B and C are adjacent to lake.

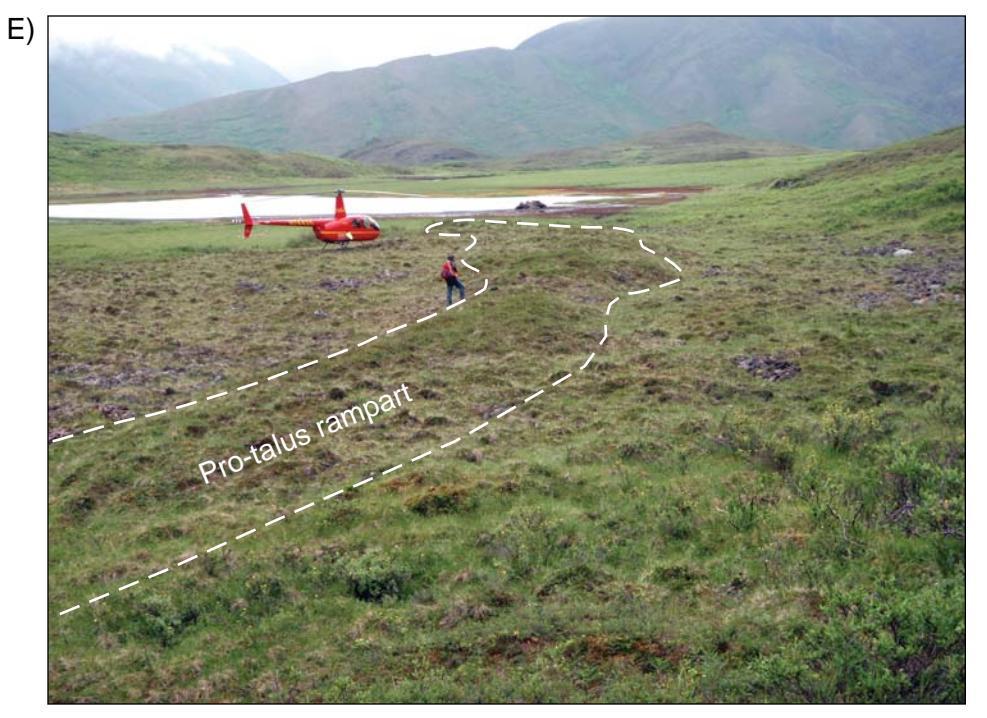
View looking south at pro-talus rampart and GPS waypoint 15. Note lateral distance between base of slope to crest of rampart. Geologist for scale is about 180 cm tall.

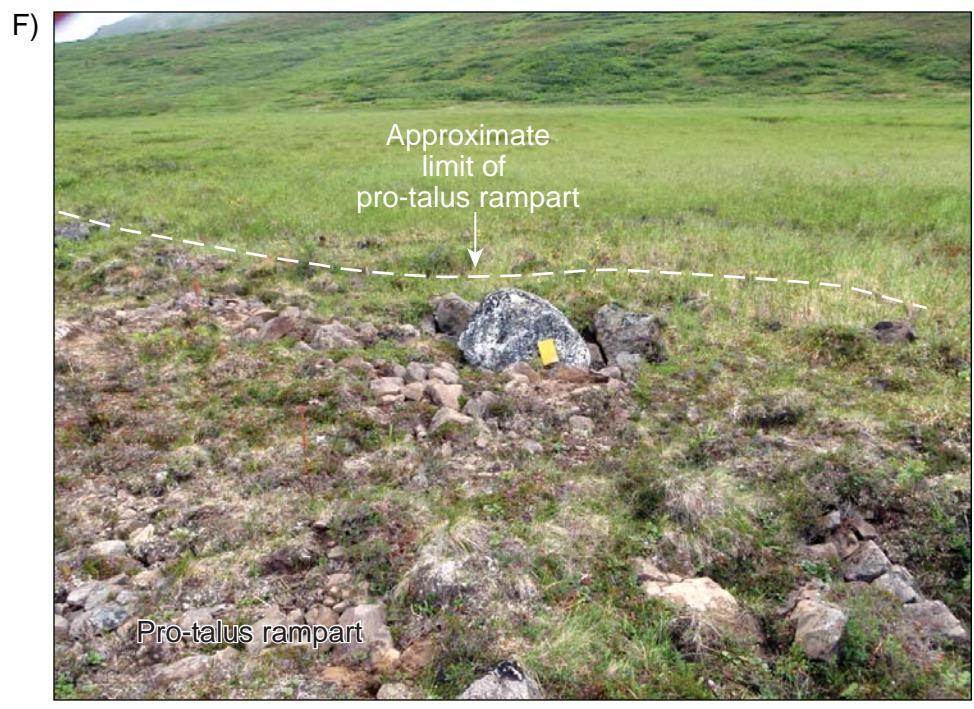
Photograph is centered on more sub-rounded glacial erratic (granitic) that is not similar to any of the local hillside lithologies. Field notebook is 19 cm tall.
