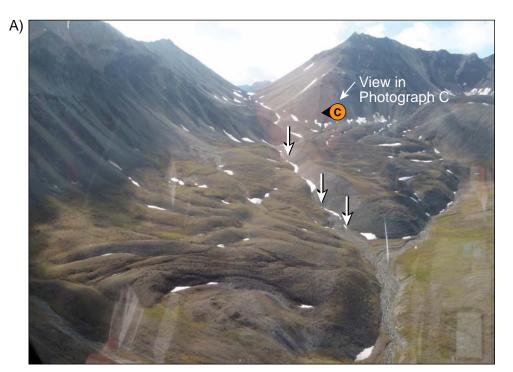
View looking southeasterly at lineament expressed at erosional drainage cutting through the likely Holocene rock glacier deposit.

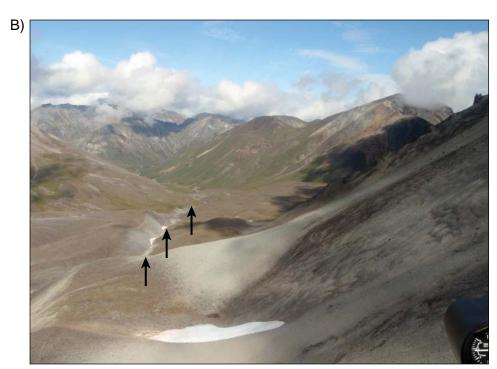
View looking northwesterly (opposite that in Photograph A) at lineament expressed as erosional drainage cutting through the likely Holocene rock glacier deposit.

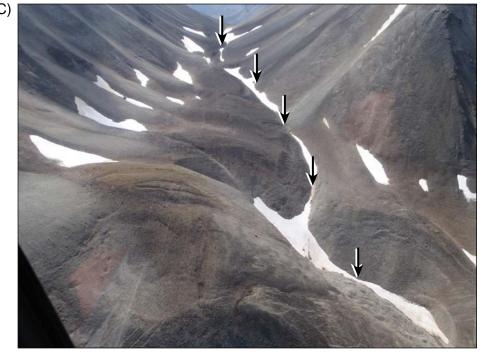
View looking southeasterly at lineament expressed as likely Holocene rock glacier deposit contacting the valley floor.

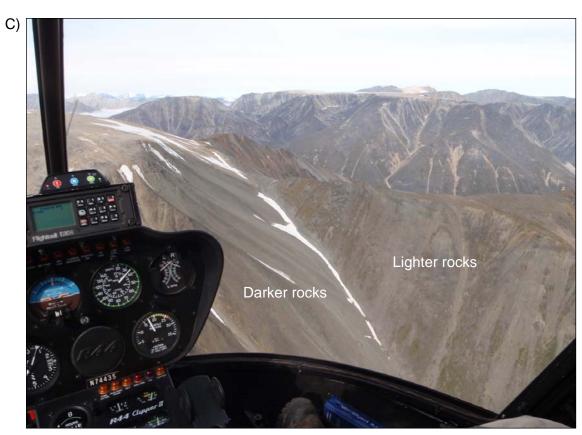
Photograph taken from location C looking west at head of steep-walled, v-shaped, linear drainage where mapped lineaments correspond to apparent rock contact.

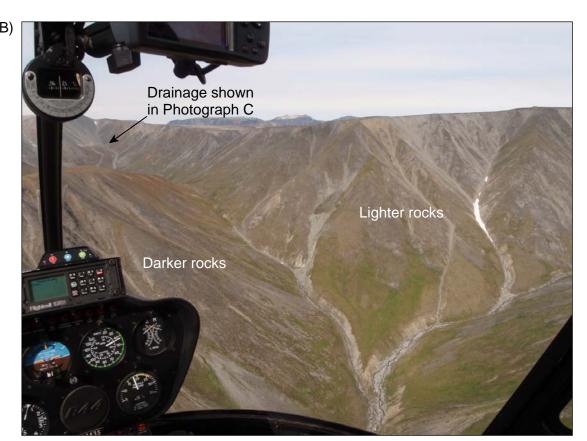
Photograph taken from location B looking west along mapped lineaments and apparent rock contact in steep-walled, v-shaped, linear drainages.

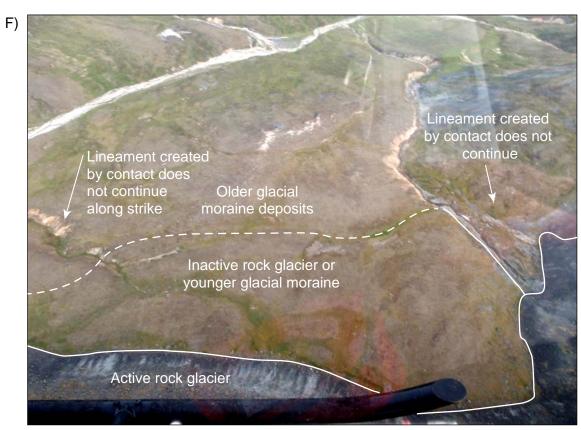
Photograph looking northwest from location F showing apparently undeformed rock glacier and/or glacial deposits along strike of the mapped lineaments and apparent rock contact shown in Photographs A through D.

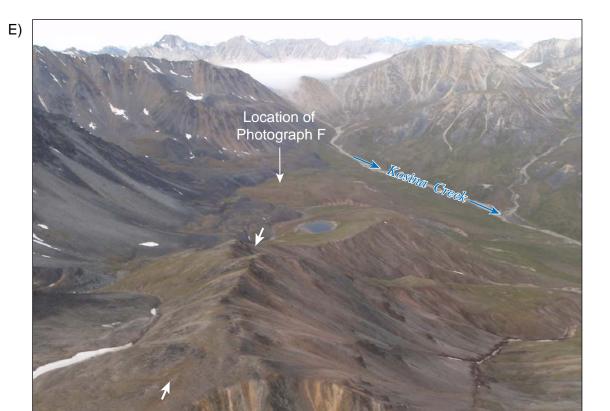
Photograph from location E looking southwest down the ridgeline shown in Photograph D. View is 180 degrees from that in Photograph D. Note presence of rock glacier and glacial deposits in valley bottom. Arrows point along apparent contact.

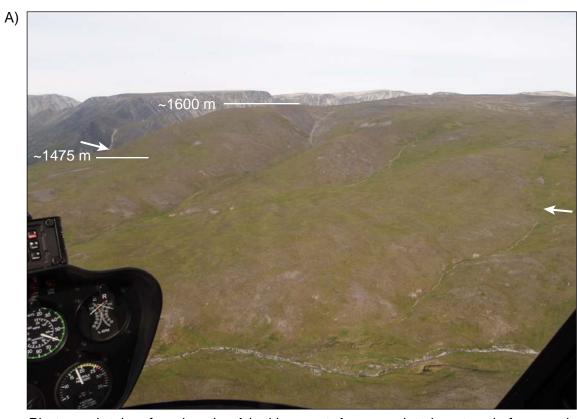
Photograph taken from location A looking west. Arrows point along trend of mapped lineaments along southwest-facing aligned break-in-slope. Note the rounded and subdued nature of break-in-slope. Relief across break-in-slope is ~125 m.

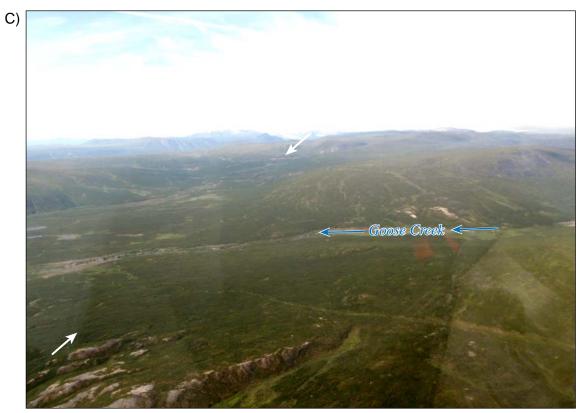
Overview photograph looking southwest from location C along alignment of mapped lineaments. Arrows point along trend of lineament group 19. Note absence of expression of lineaments within the landscape across the Goose Creek portion of the lineament group.

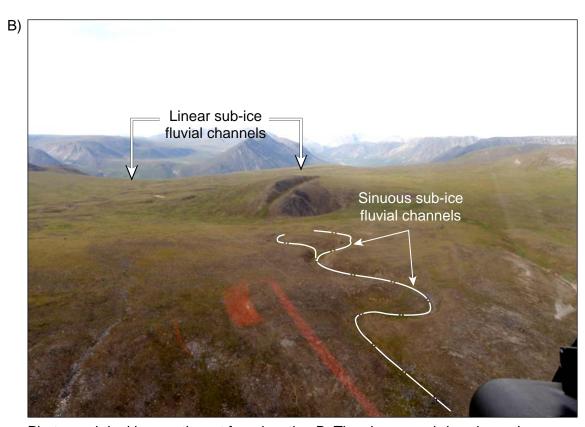
Photograph looking southwest from location B. The sinuous sub-ice channels are not large enough features to be seen on INSAR data.

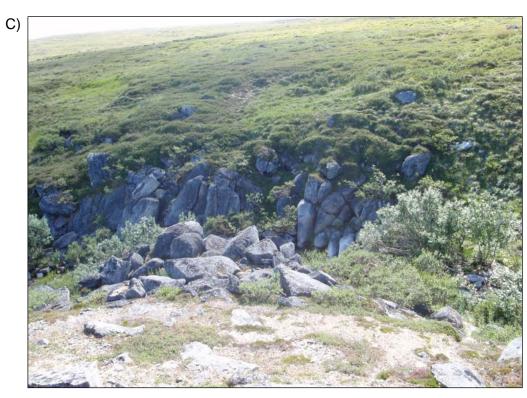
Photograph looking south-southwest from location C at widely spaced, near vertical, well-developed joints in trondhjemite (aka tonalite) bedrock. Joint spacing is 1 to 1.5 meters. Predominant orientations of joints are 042/80SE, 012/85SE, and 082/85SE but other orientations exist. Joint faces have clean surfaces with relief of minerals of 1 to 3 mm. No gouge or mineralization observed on joint surfaces, nor any sense of movement indicators (striae or mullions).

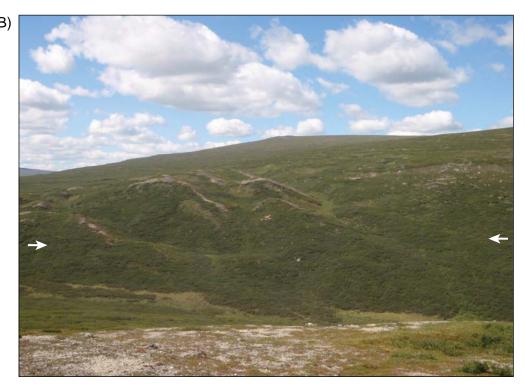
Photograph looking northwest from location B at sub-ice fluvially-eroded channels. Arrows point along the trend of mapped lineaments that make up group 19.

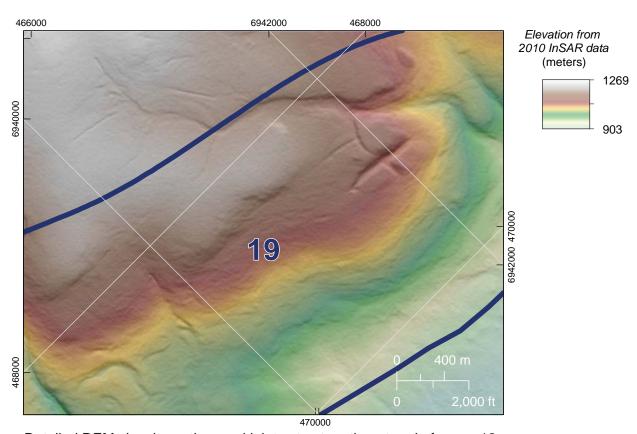
Detailed DEM showing orthogonal joint sets at northeast end of group 19.

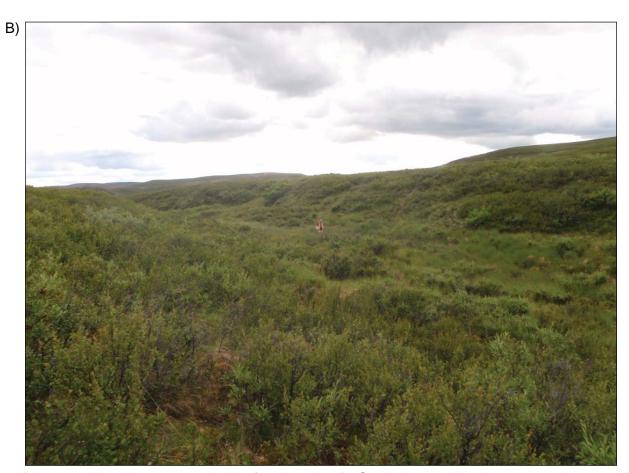
Photograph looking west-southwest from location B. Geologist standing in 3- to 6-m deepand ~30-m-wide swale. Swale only exists in saddle; it does not continue down either side of saddle.

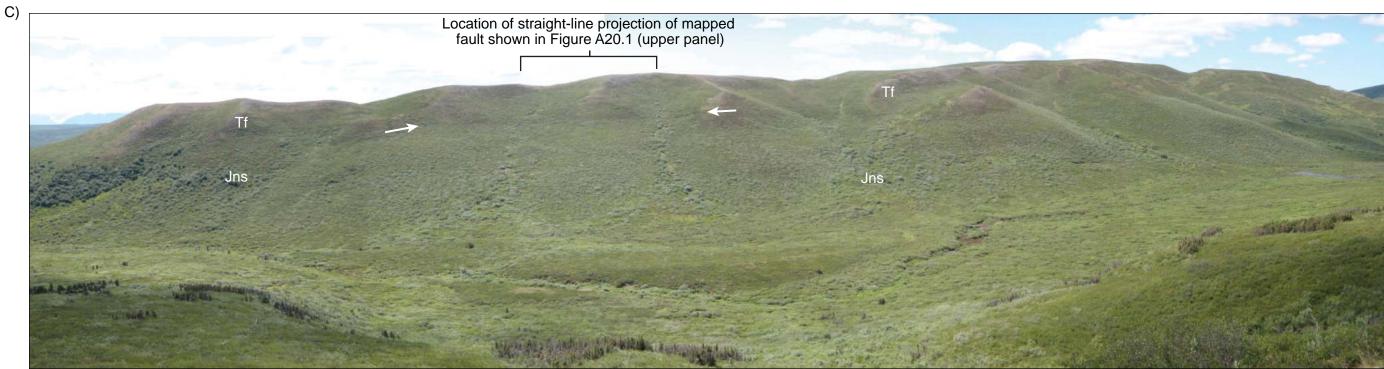
Photograph looking southwest from location C. Basal contact shown by arrows. Note that base of contact is not apparently deformed along projection of fault and that no expression of faulting in valley bottom is apparent.

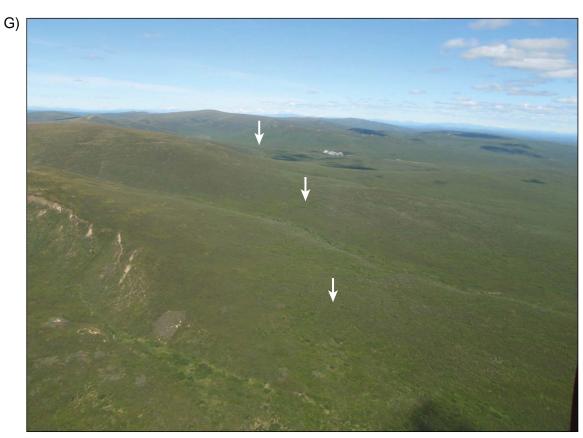
Photograph looking north from location G along mapped fault of Grantz (1960). Arrows point to approximate location of mapped fault. Note absence of apparent geomorphic expression fault.

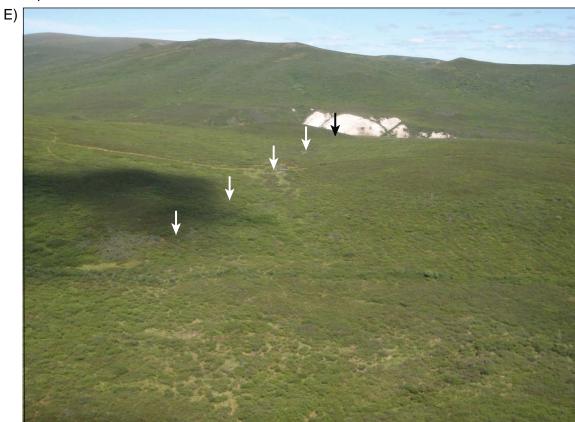
Arrows show location of FCL mapped lineament (shallow U-shaped swale). Note no apparent deformation of white-bedded sediments (glacial lake sediments) along projection of lineament.

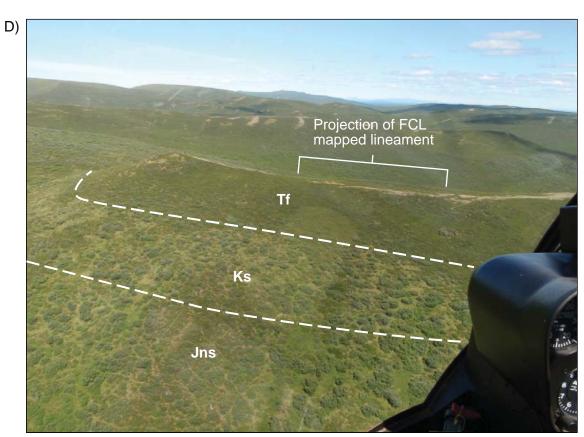
Photograph looking northeast from location D. Note absence of deformation in ridge line of Tf.

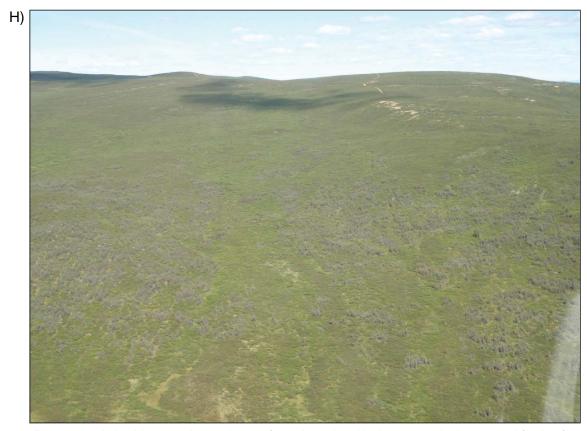
Photograph looking north-northeast from location H along queried mapped fault of Grantz (1960) that lies outside of lineament group. Note absence of fault expression.

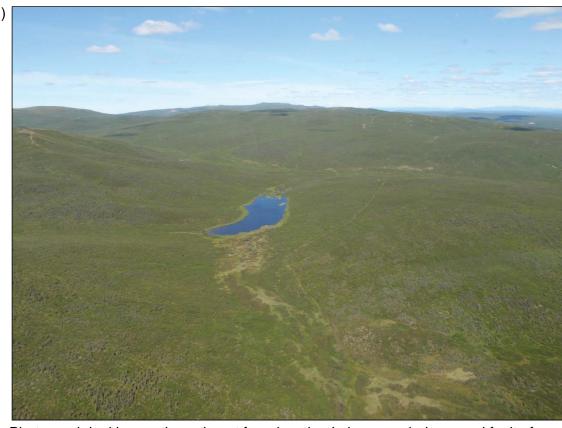
Photograph looking north-northeast from location I along queried mapped fault of Grantz (1960) that lies outside of lineament group. Note absence of fault expression.
