BUSTNA-WATANA HYDROELECTRIC PROJECT  
Broad Pass Area

DRAFT  
Plate A-BP

SUSITNA-WATANA HYDROELECTRIC PROJECT  
Clearwater Mountains Area

Plate A-CWM

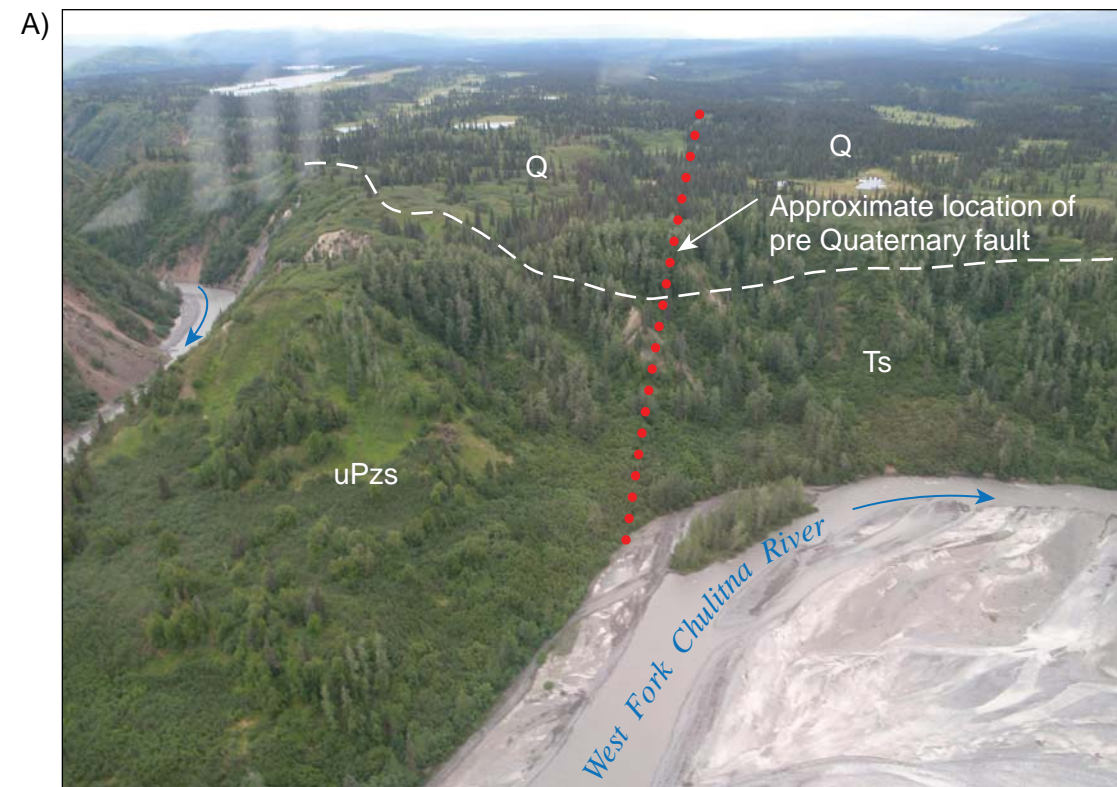
View looking north at location where mapped fault would traverse across Quaternary sediments.

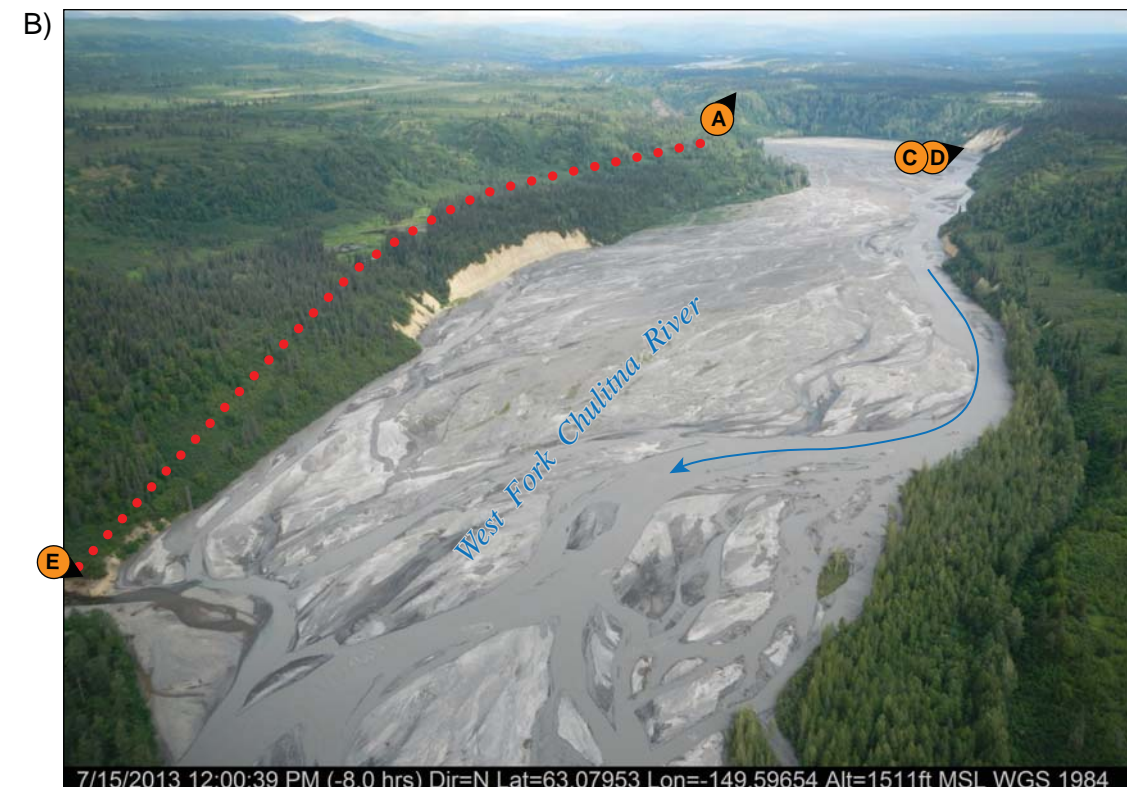
View looking north (upstream) along the West Fork Chulitna River valley at exposures described in text and photographs below.

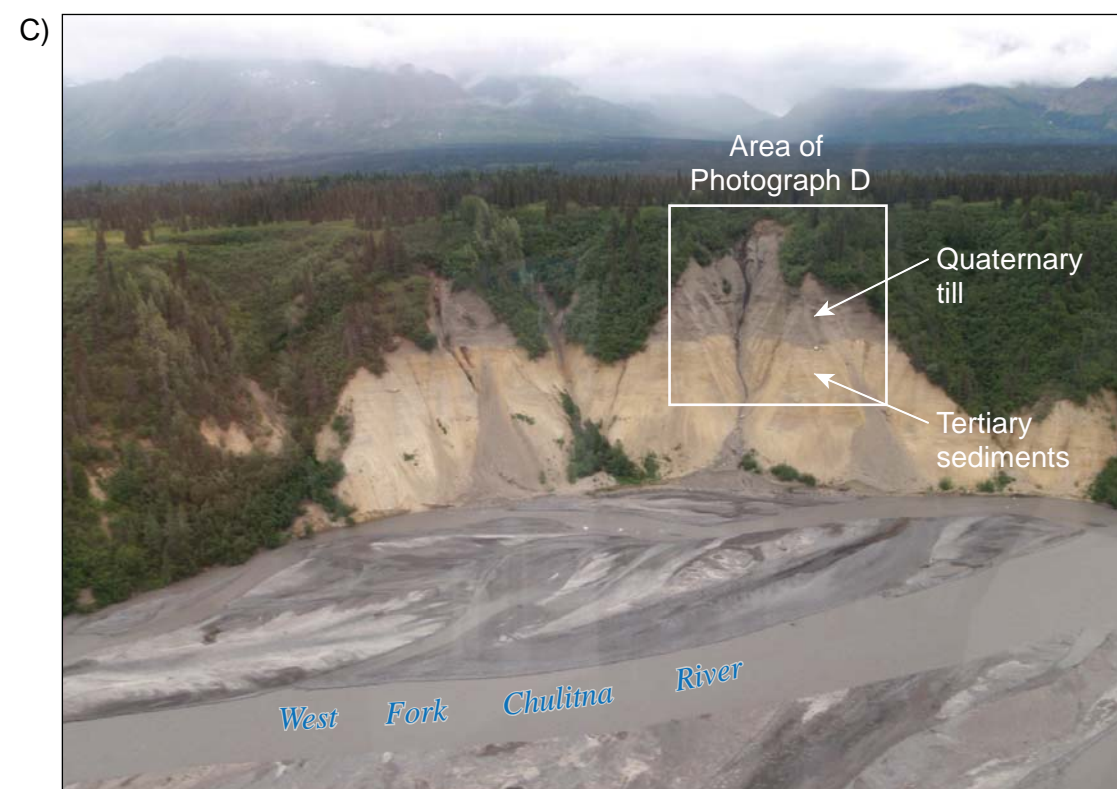
View looking west at exposure along east bank of the West Fork Chulitna River demonstrating Quaternary till overlying Tertiary fluvial sediments.

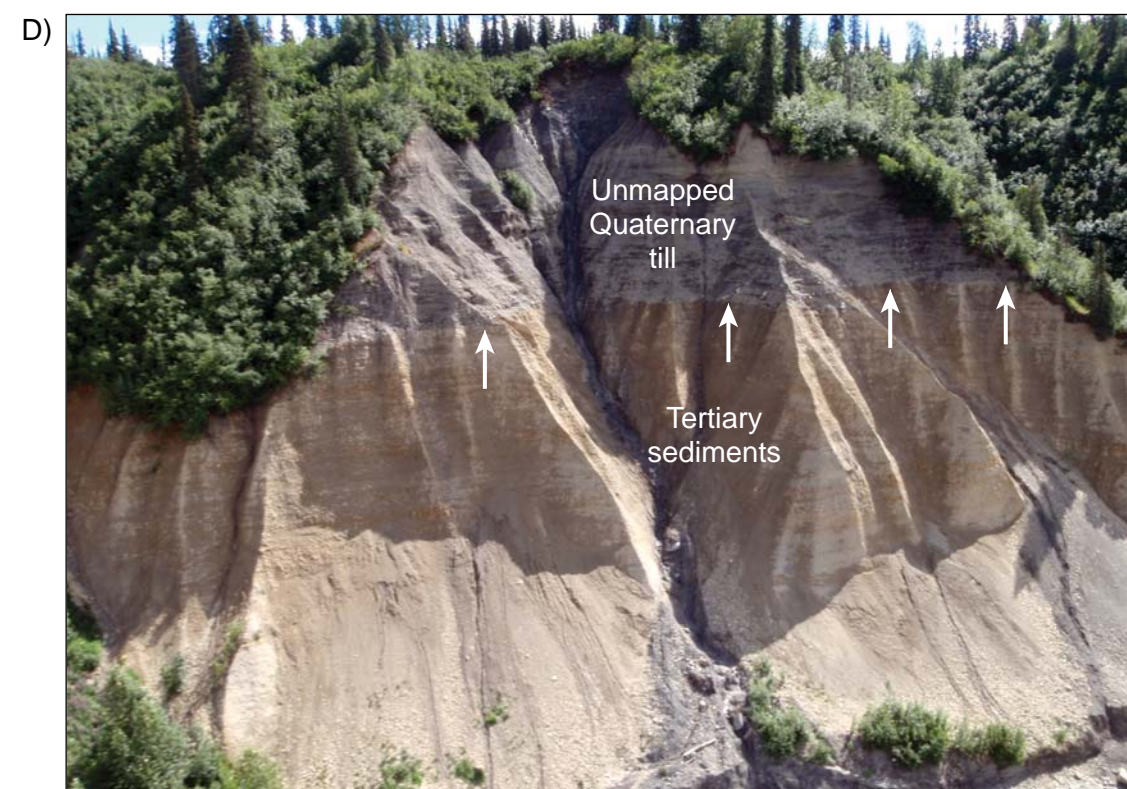
Close up view of exposure shown in Photograph C. Basal contact between overlying till and underlying fluvial deposits appears to be sub-horizontal.

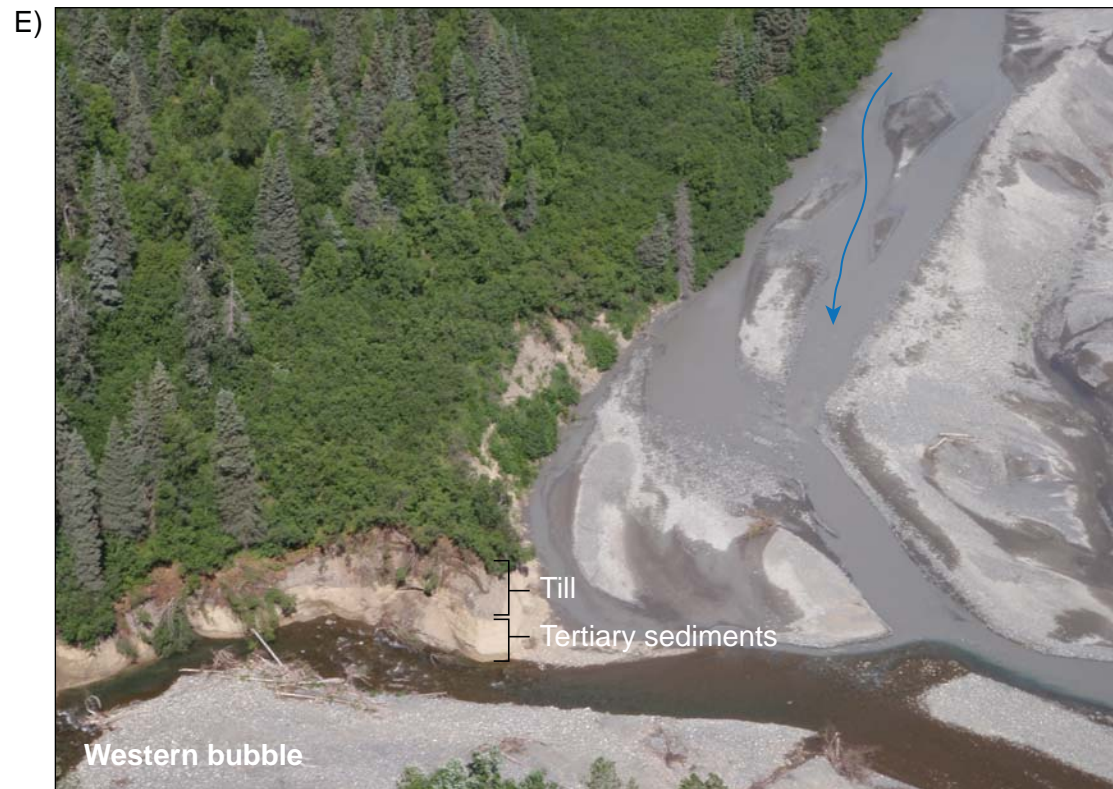
View looking northeast at subhorizontal contact between till and Tertiary sediments.

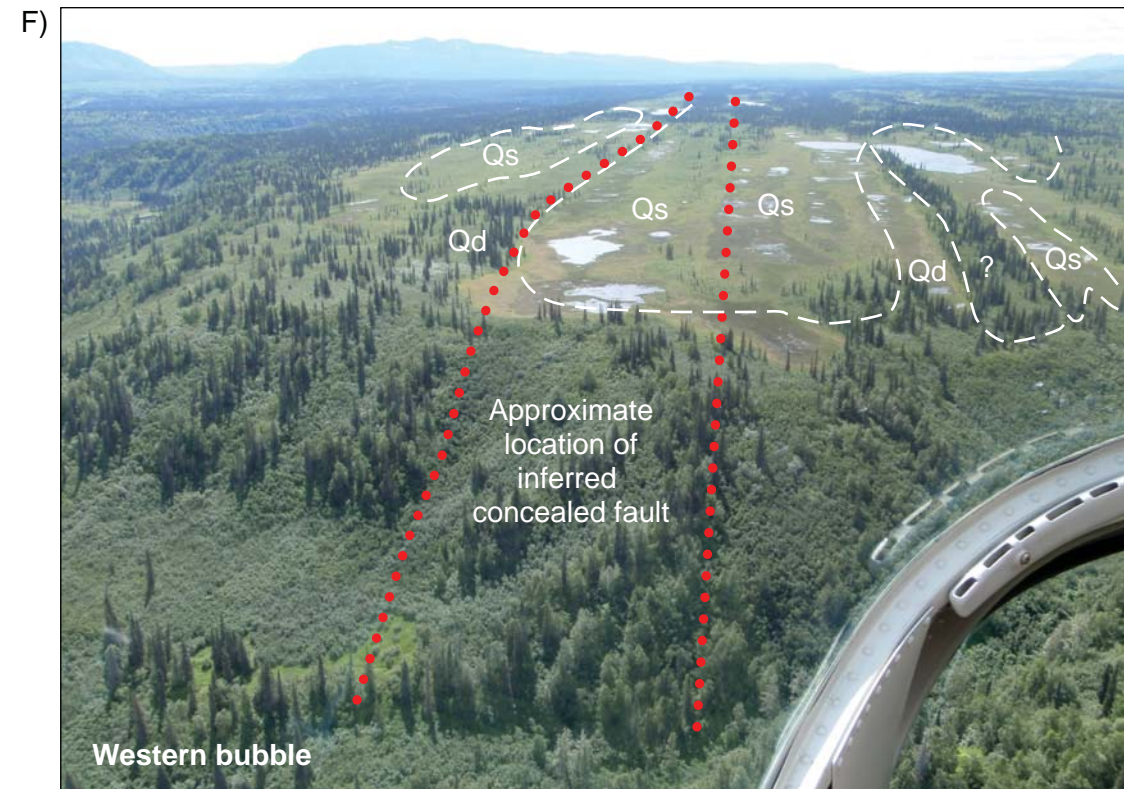
View looking south along Quaternary surface directly south of river valley. Marshy Quaternary sediments show no evidence of deformation or offset.

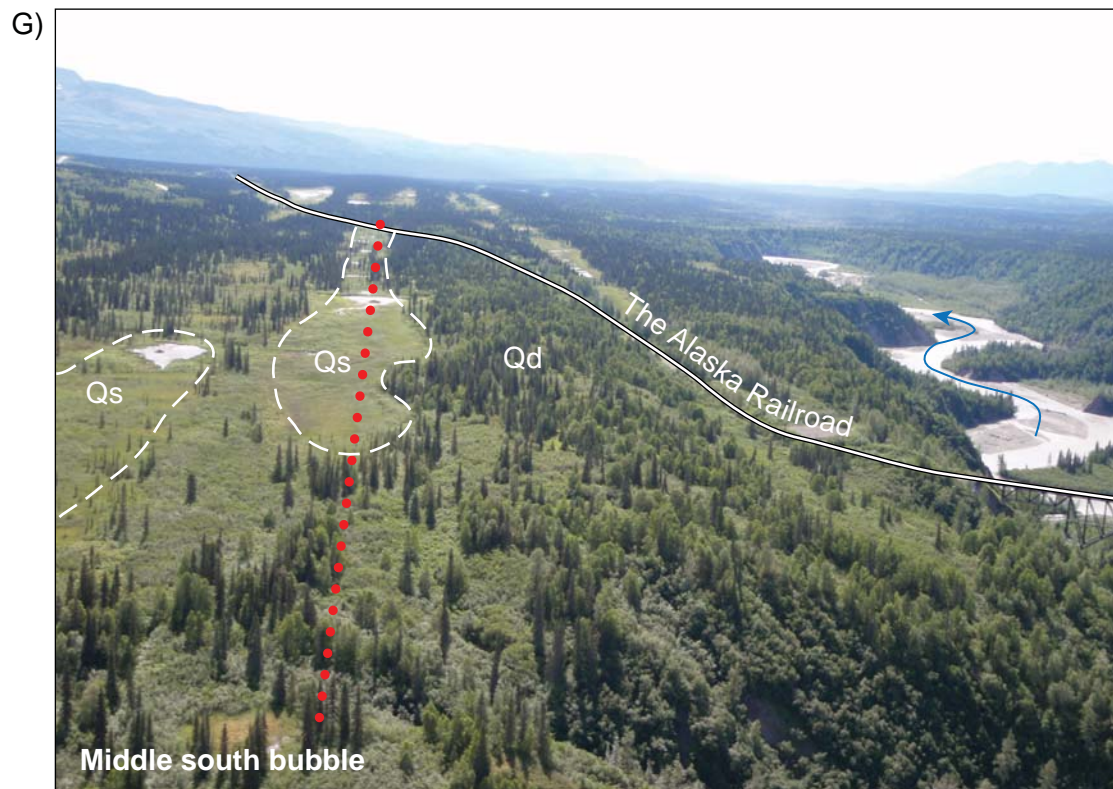
View looking south at location where inferred fault would traverse east of railroad tracks. Fault is mapped as juxtaposing Triassic and Cretaceous rocks outcropping in creek behind photograph. No evidence of faulting in Quaternary deposits.

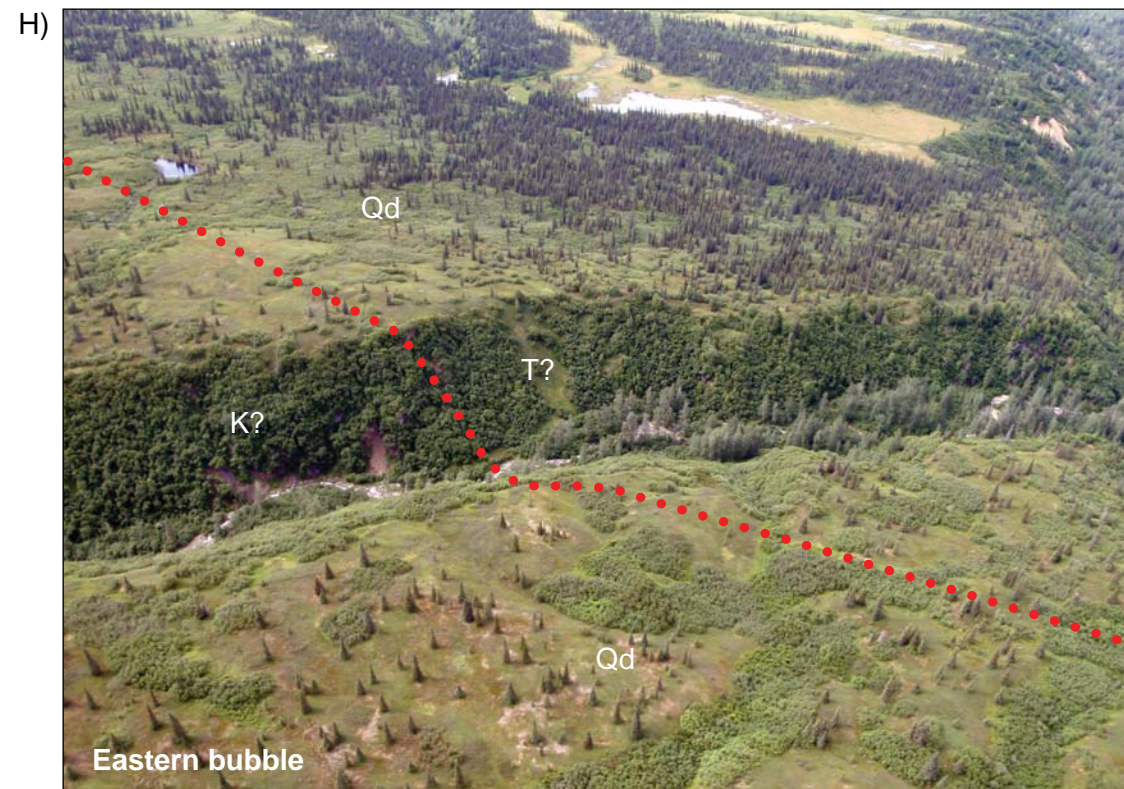
View looking west at creek exposure along projection of mapped fault that depicts Cretaceous/Tertiary juxtaposition. Undisturbed surfaces support absence of Quaternary faulting.

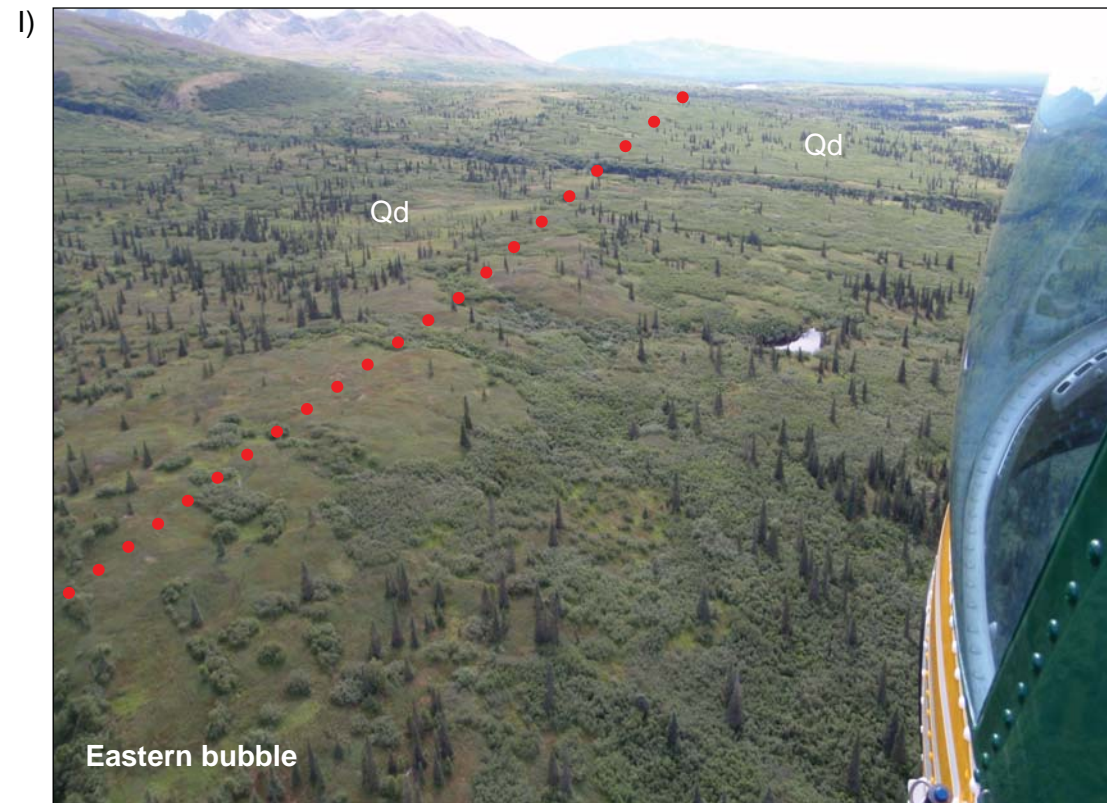
View looking west at creek exposure shown in Photograph H, Figure A-BP.2, showing morphology of Quaternary deposits along strike.

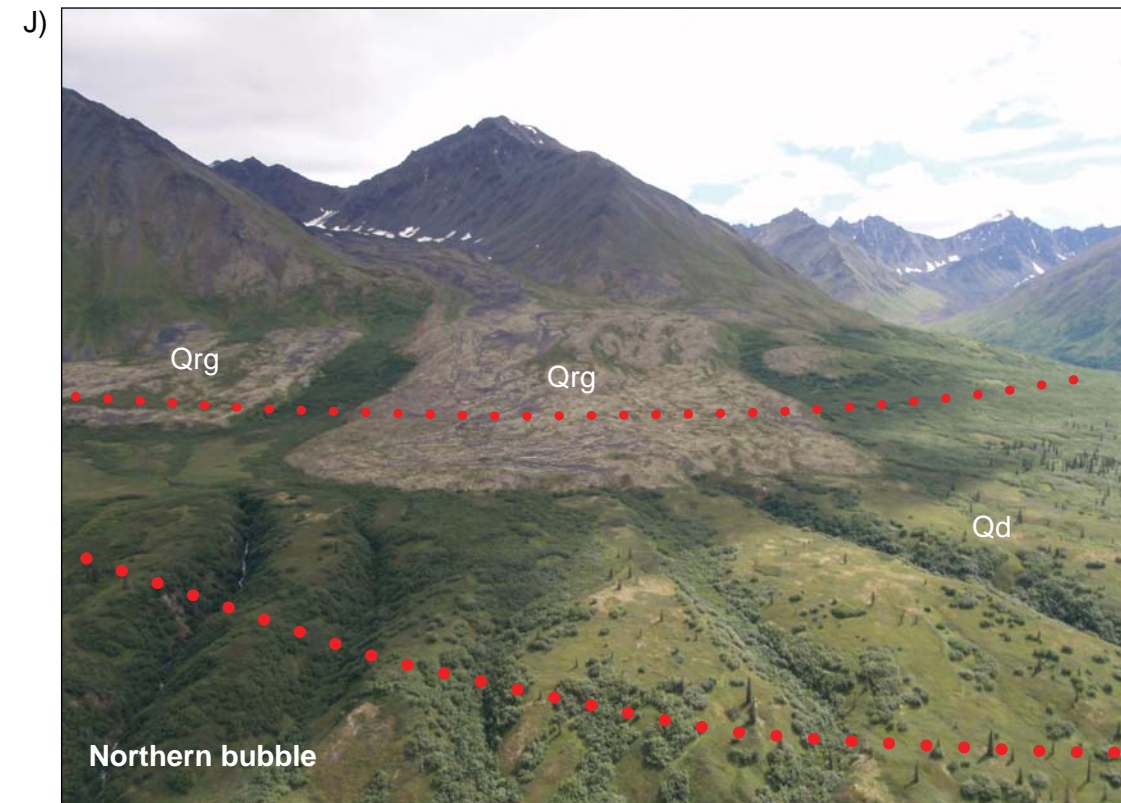
View looking east at uninterrupted interfluvial surfaces in dissected Quaternary glacial drift along with the mapped fault projects. Undisturbed surfaces support absence of Quaternary faulting.

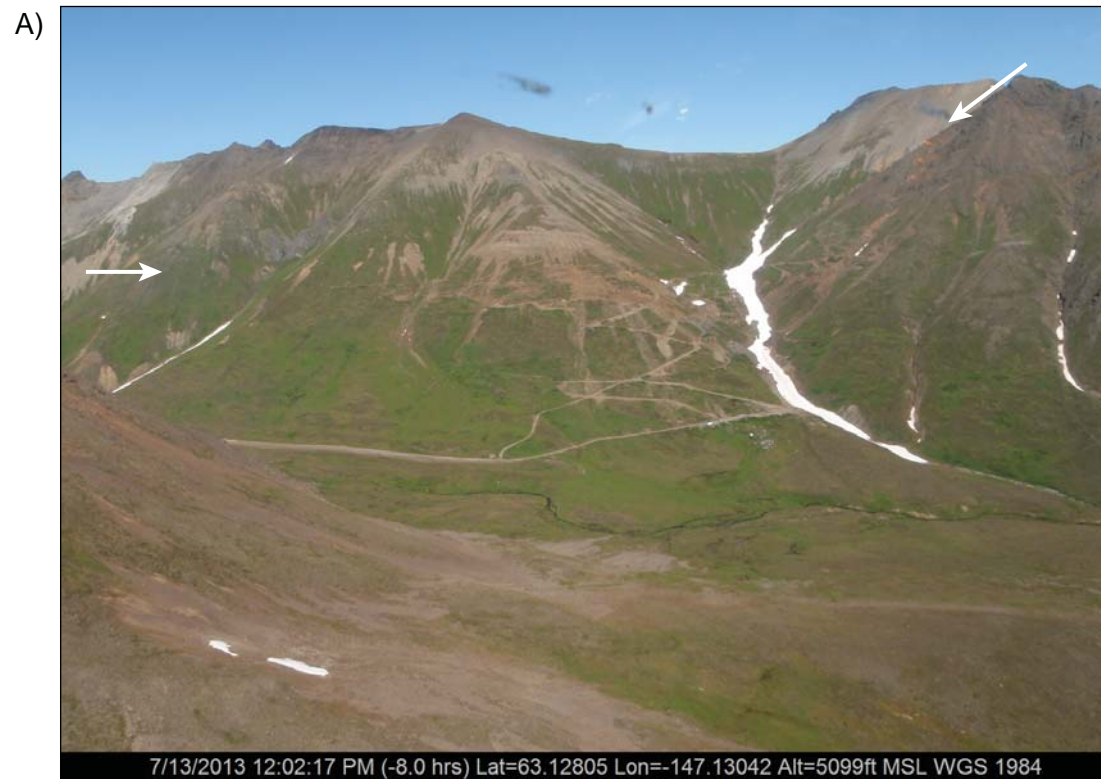
View looking northwest at mine site located along apparent rock type contrast and mapped fault. Arrows point along mapped fault.

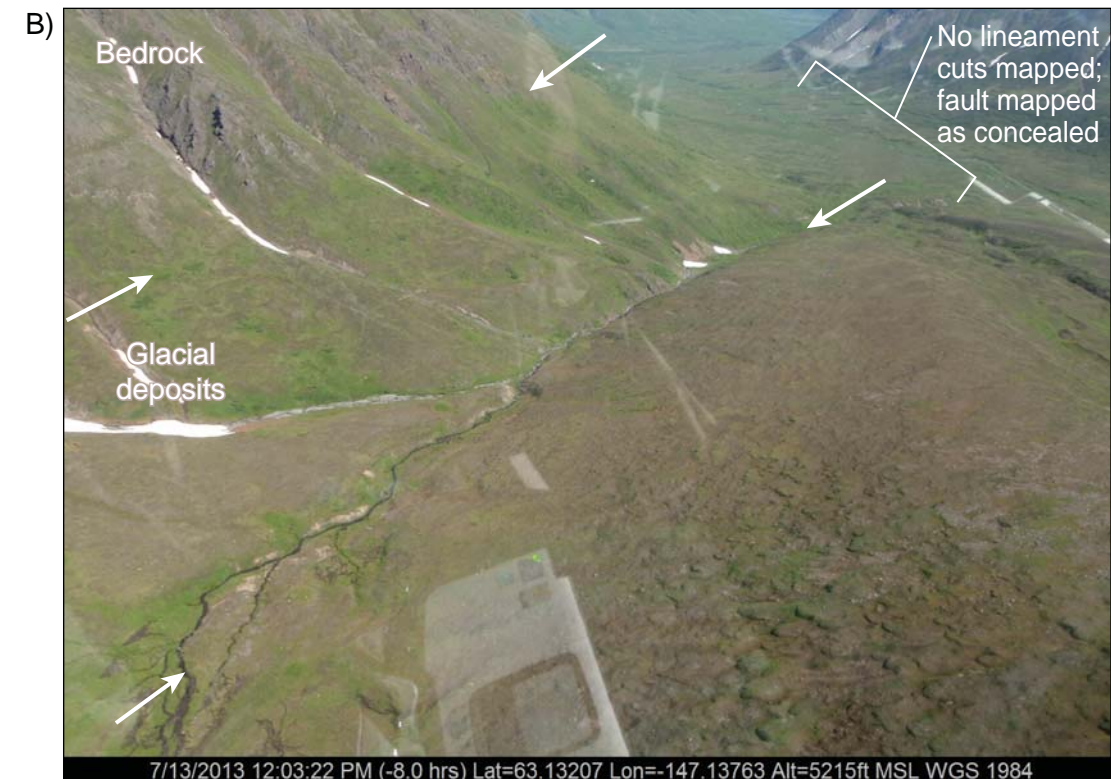
View looking northeast along linear drainage mapped as a lineament by FCL that coincides with a mapped fault. Another FCL-mapped lineament lies at the subtle break-in-slope and may correspond to the ice limit elevation.

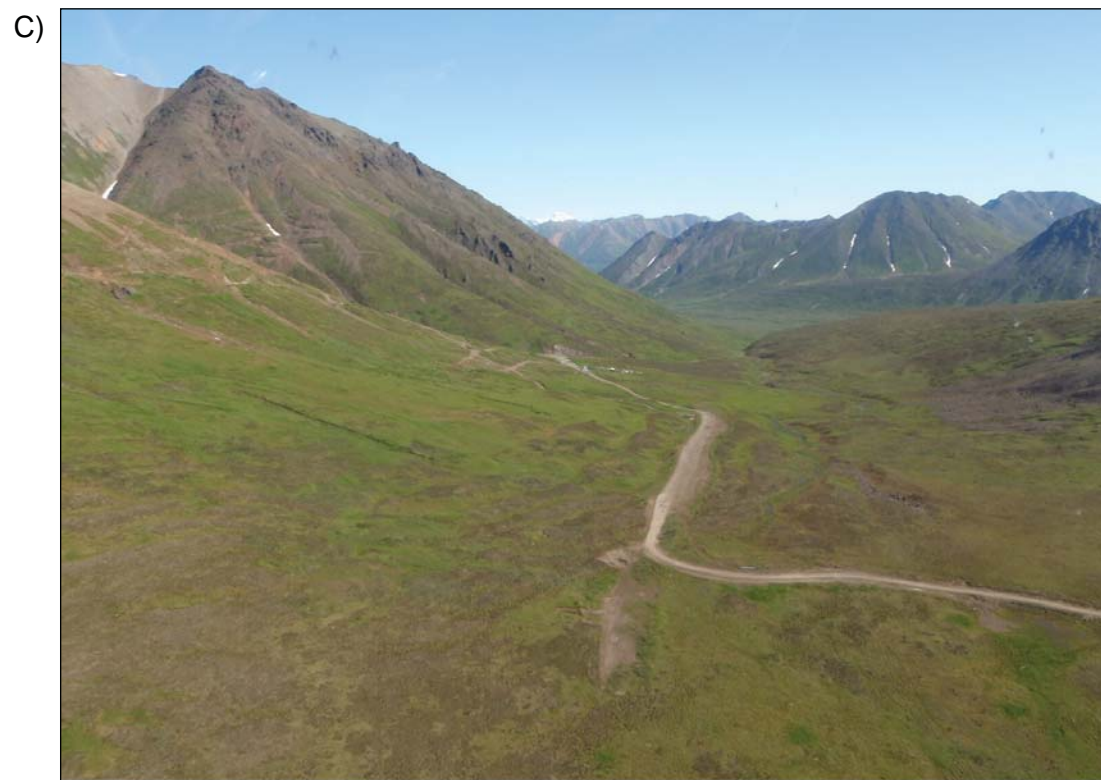
View looking northeast through the broad saddle at the head of the linear drainage shown in Photograph B. Note the absence of any tectonic geomorphic features.

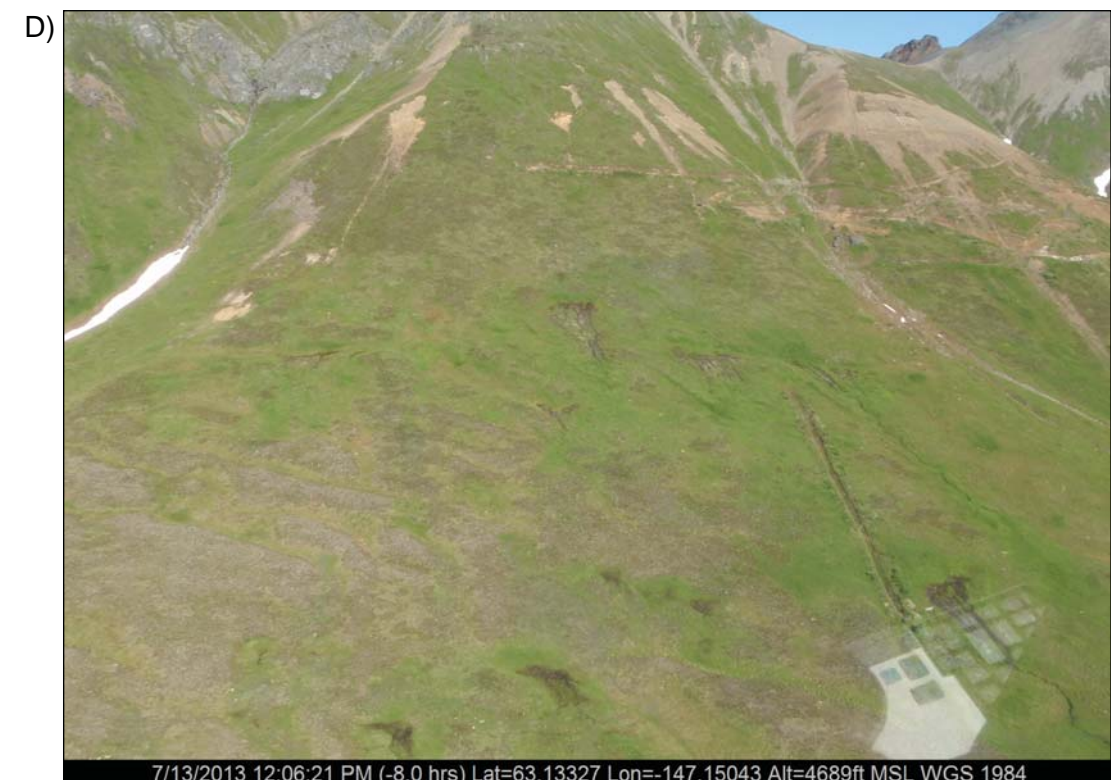
View looking northwest at location of FCL-mapped lineaments and mining roads partly shown in Photograph C. Note that FCL-mapped lineaments on the sidehill are not readily apparent and correspond to subtle break-in-slope like that shown in Photograph B.

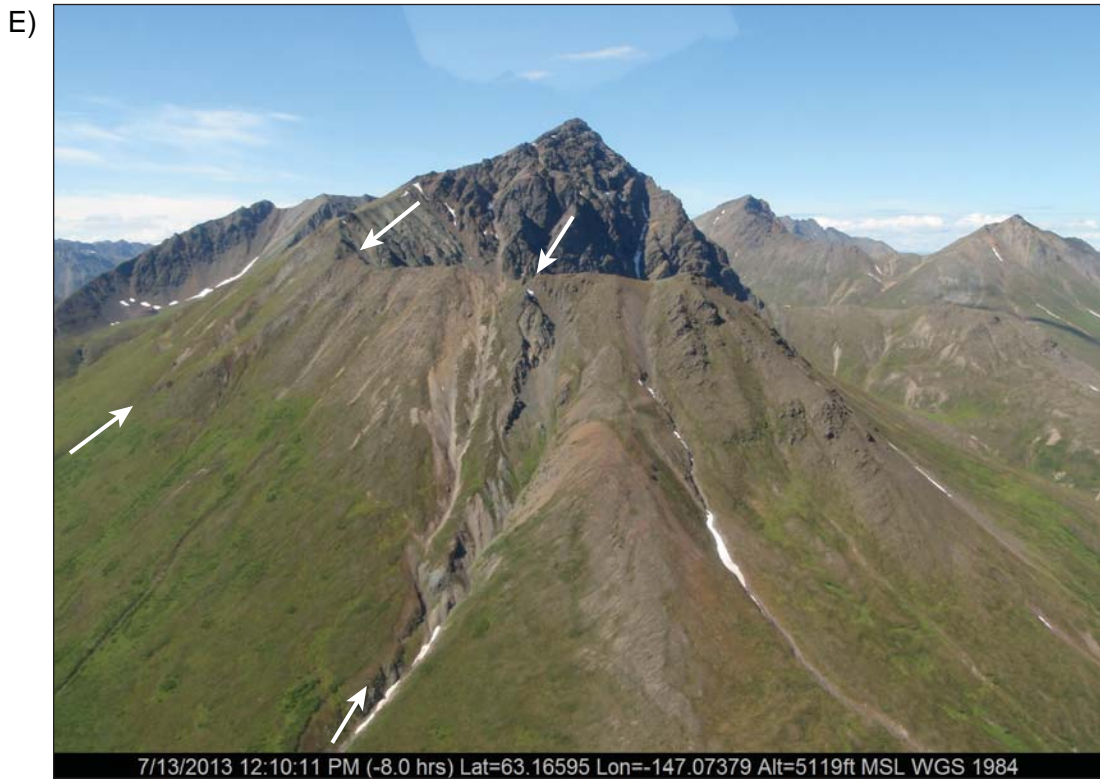
View looking southwest at several rock type contrasts (shown by arrows) that coincide with previously mapped faults.

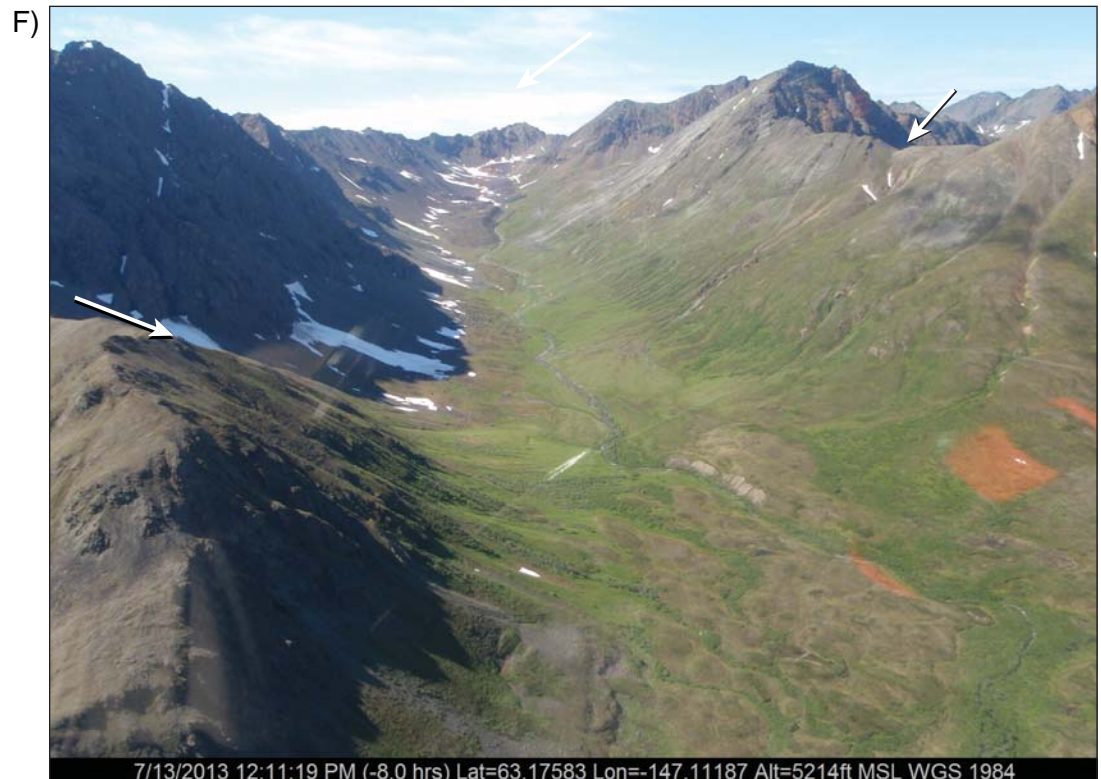
View looking south-southwest up glaciated valley that shows no expression of the mapped Black Creek fault that is present in adjacent bedrock ridges.

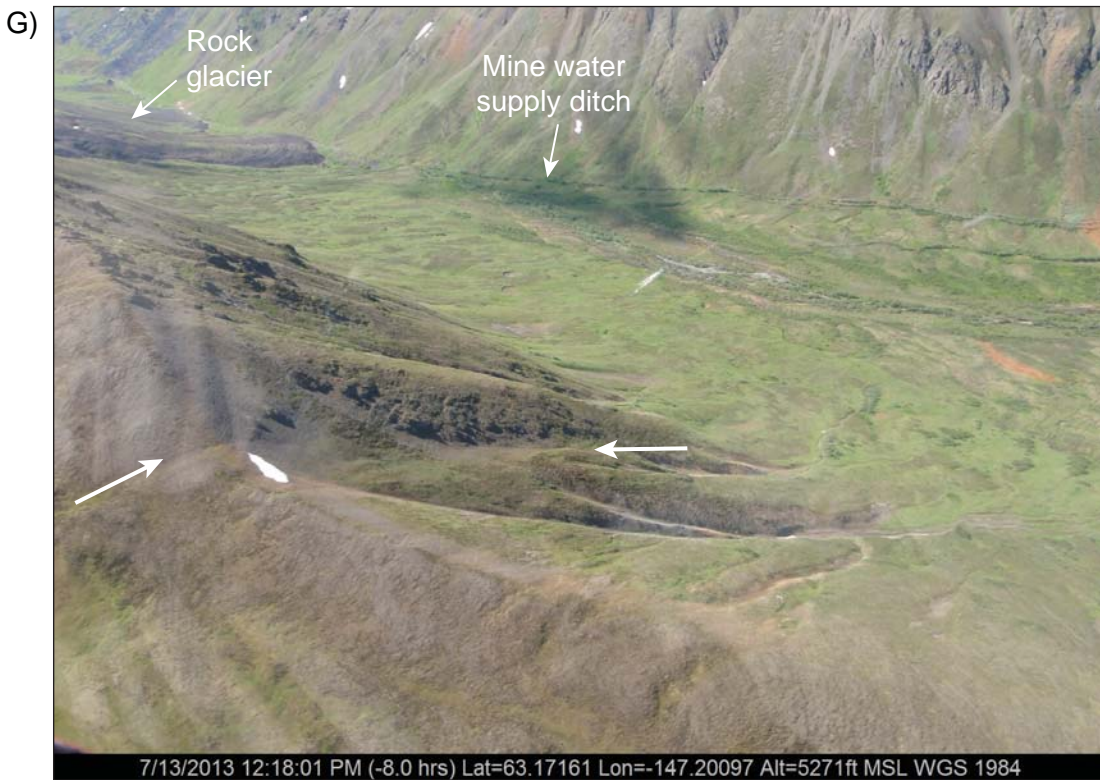
View looking southwest across an FCL-mapped lineament that corresponds to the trace of mapped Black Creek fault marked by a rock contrast. Note that no expression of faulting exists along trend in the glacial sediments of the valley floor.

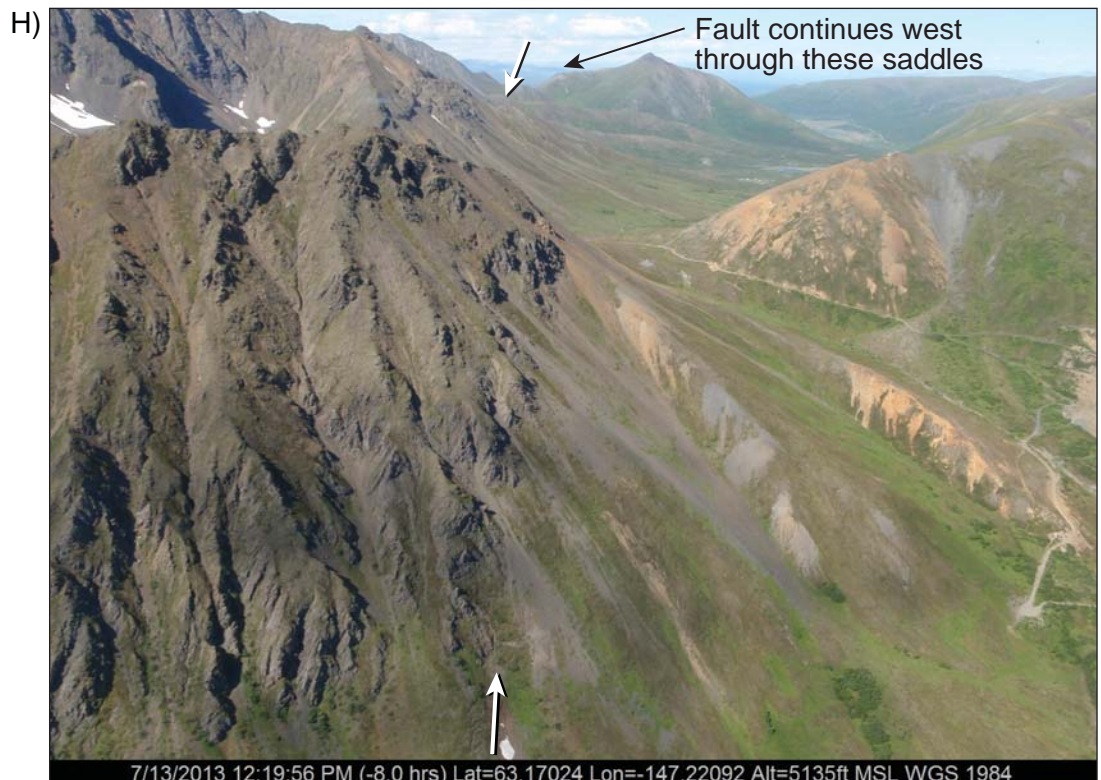
View looking west along the Black Creek fault. Note the obvious rock type contrast across the fault. Aerial reconnaissance confirmed the presence of the fault in bedrock ridges to the west and the lack of expression in glacial sediments in adjacent valley bottoms.

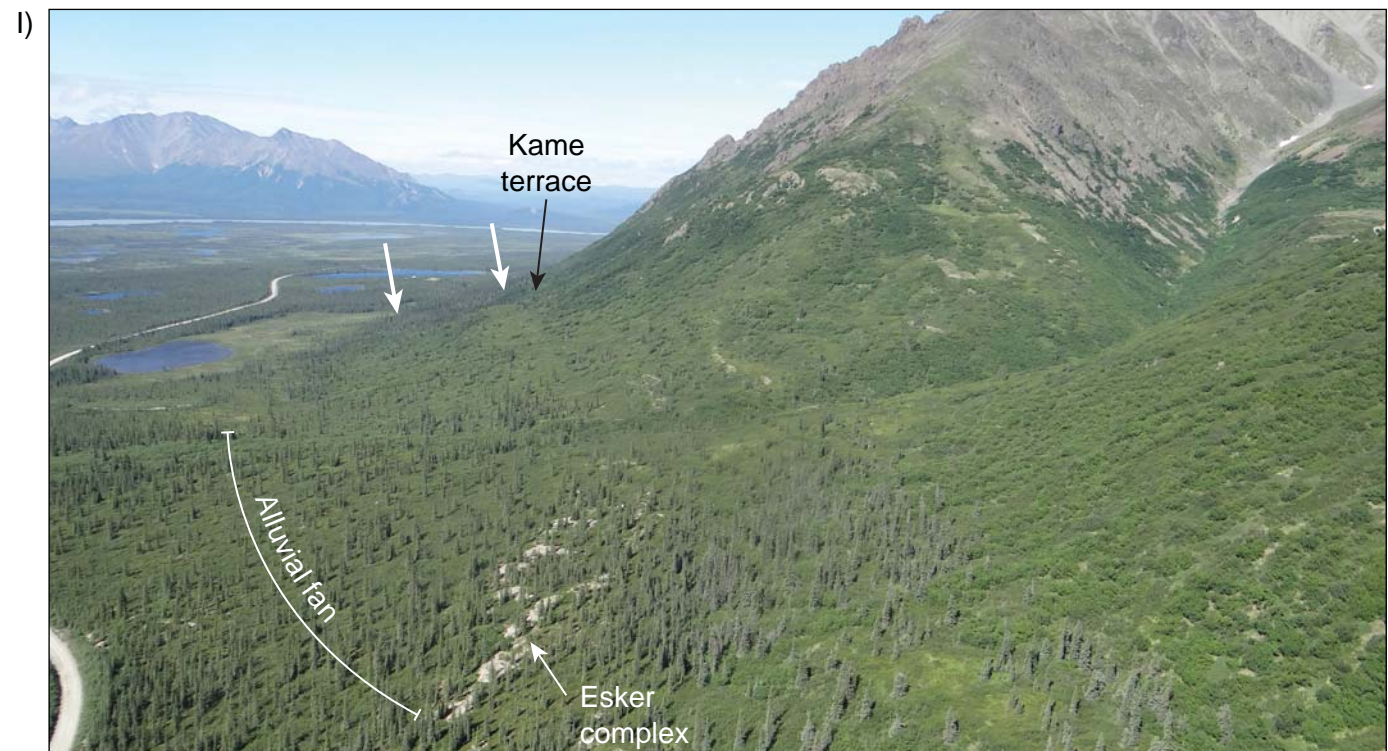
Overview looking west along mapped FCL-mapped lineaments that coincide with left-lateral moraines and kame terraces. The lineaments are interrupted by an alluvial fan and esker complex. Large arrows point along the mapped lineaments.

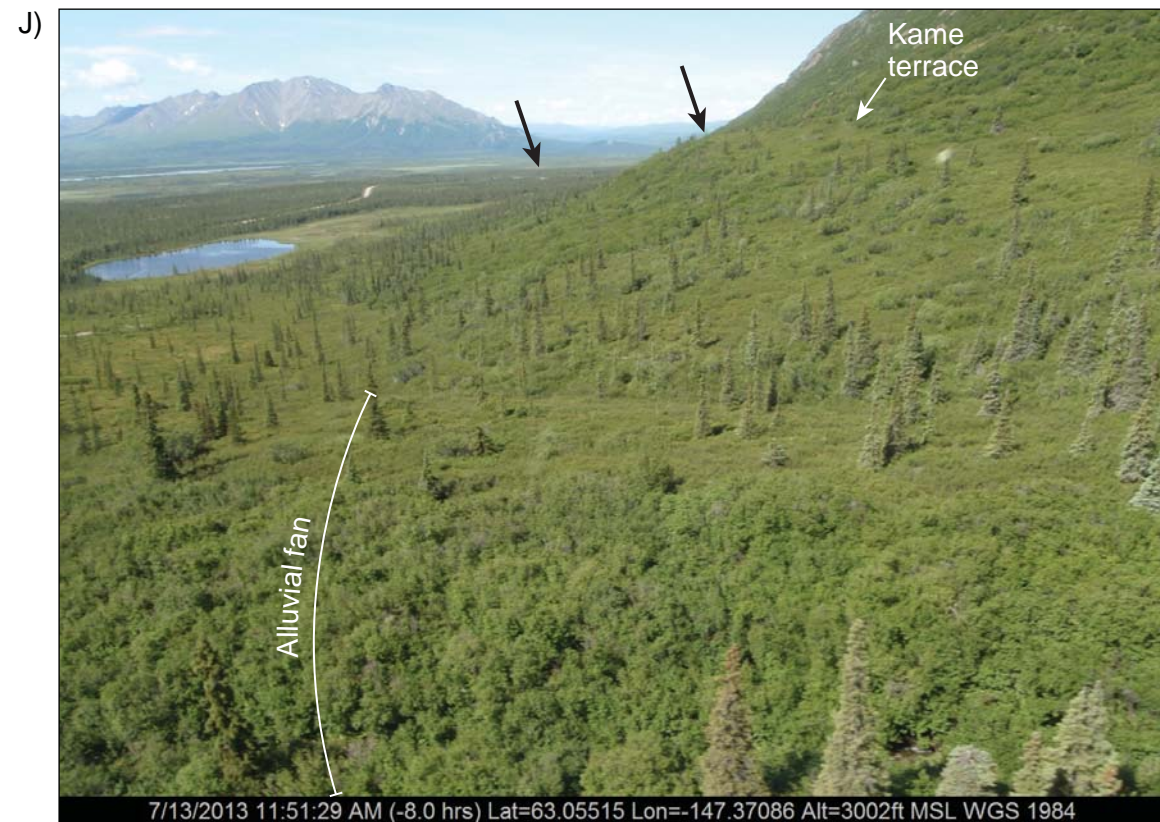
Close-up view looking west along FCL-mapped lineaments.

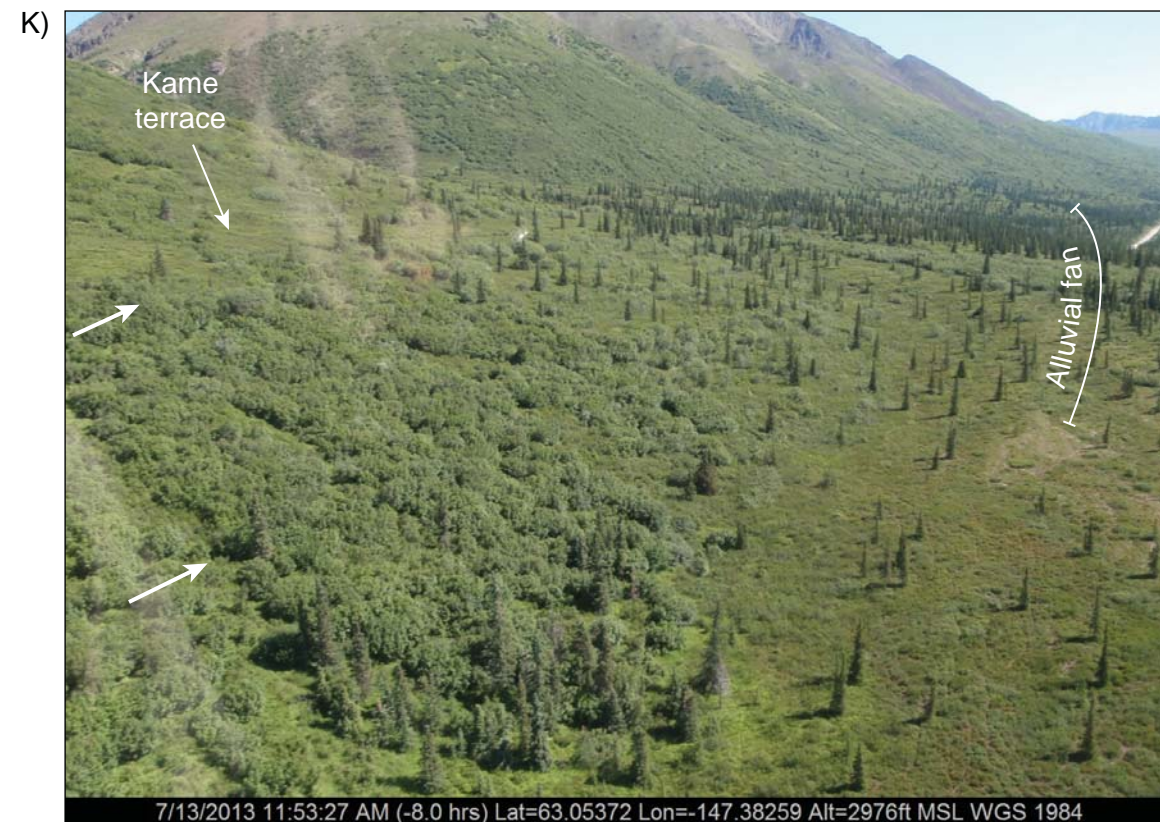
Close-up view looking east along FCL-mapped lineaments.
