SUSITNA-WATANA HYDROELECTRIC PROJECT  
**Castle Mountain Extension Area**

**Plate A-CME**

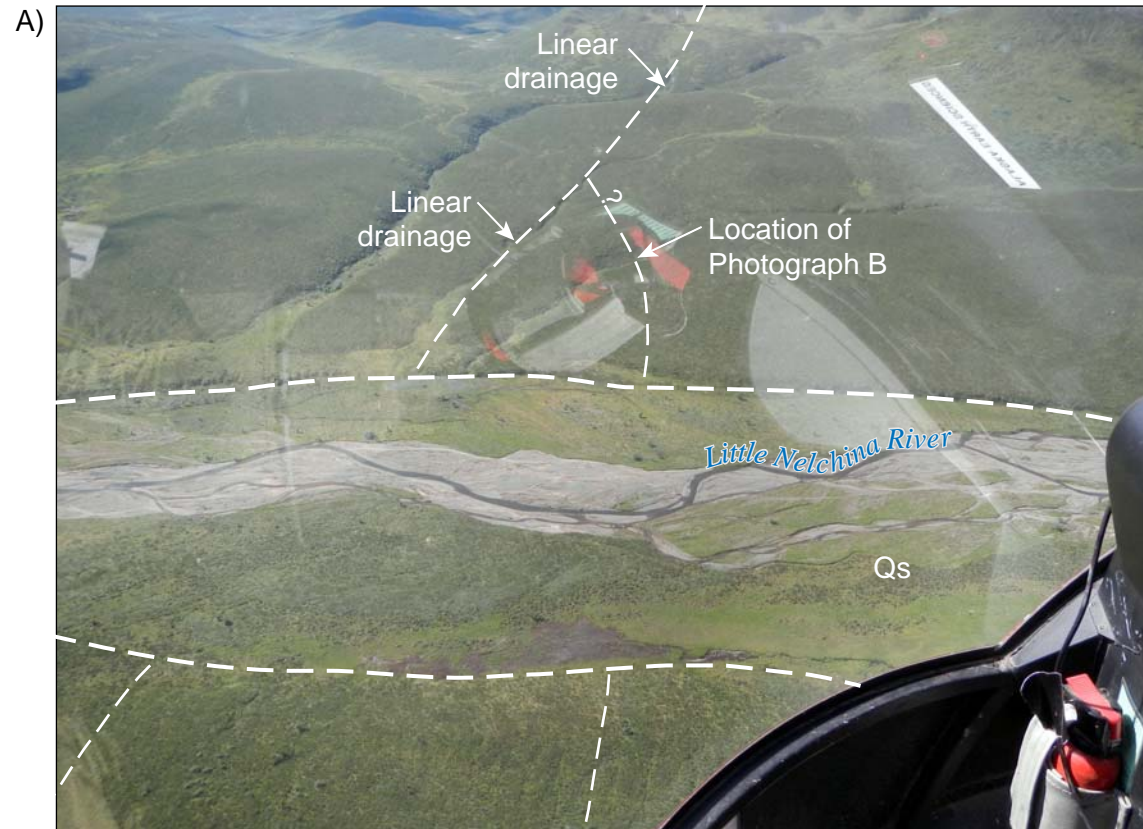
View looking southwest from location A, nearly along-strike with Csejtey et al. (1978) mapped faults. Note clear expression of linear features on bedrock landscape and absence of linear expression in Quaternary deposits.

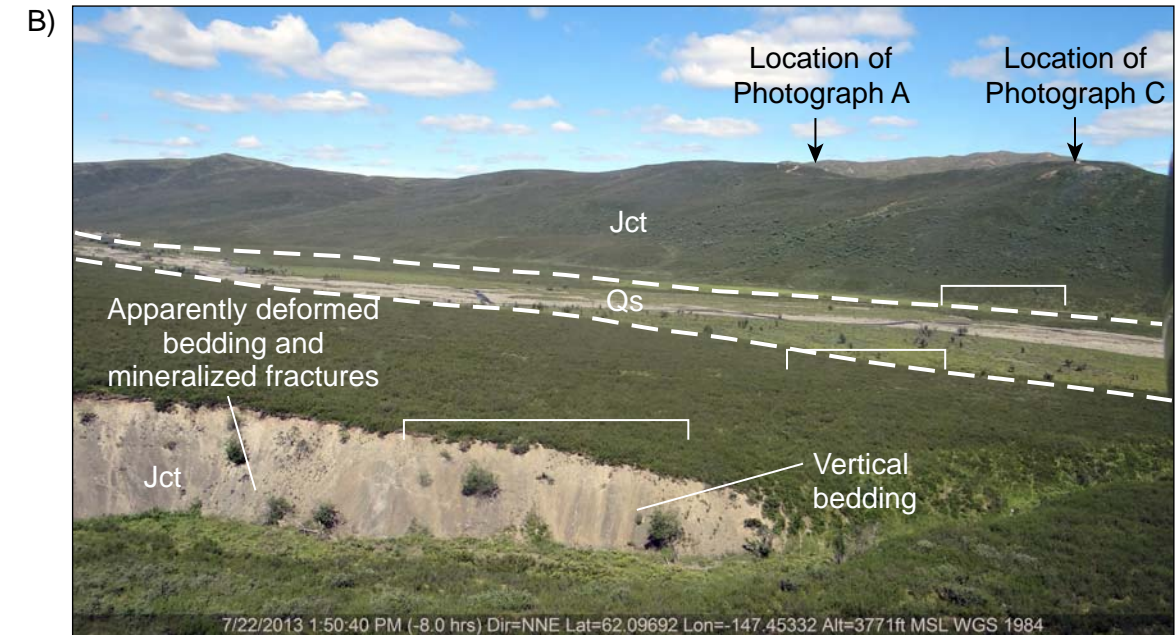
View looking northeast from location B nearly along-strike with Csejtey et al. (1978) mapped fault. The mapped fault segment projects through the vertical beds observed in the outcrop towards photograph location C. Note apparent undeformed hillslope and Quaternary deposits over projected trace of fault.

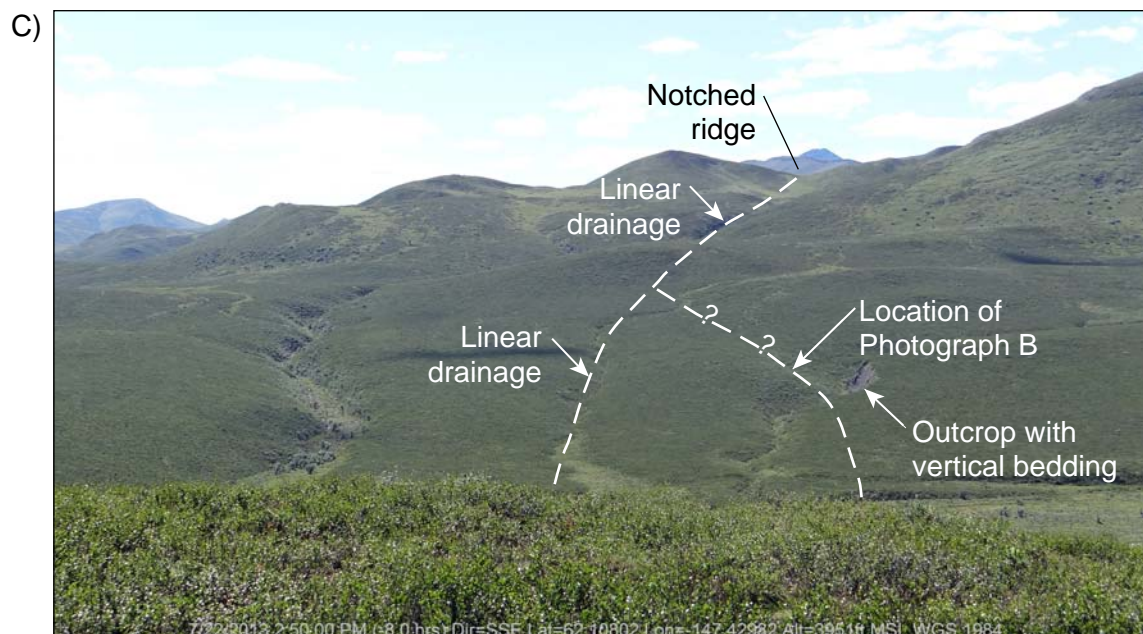
View looking southwest from location C. Note alignment of features over mapped trace of fault.

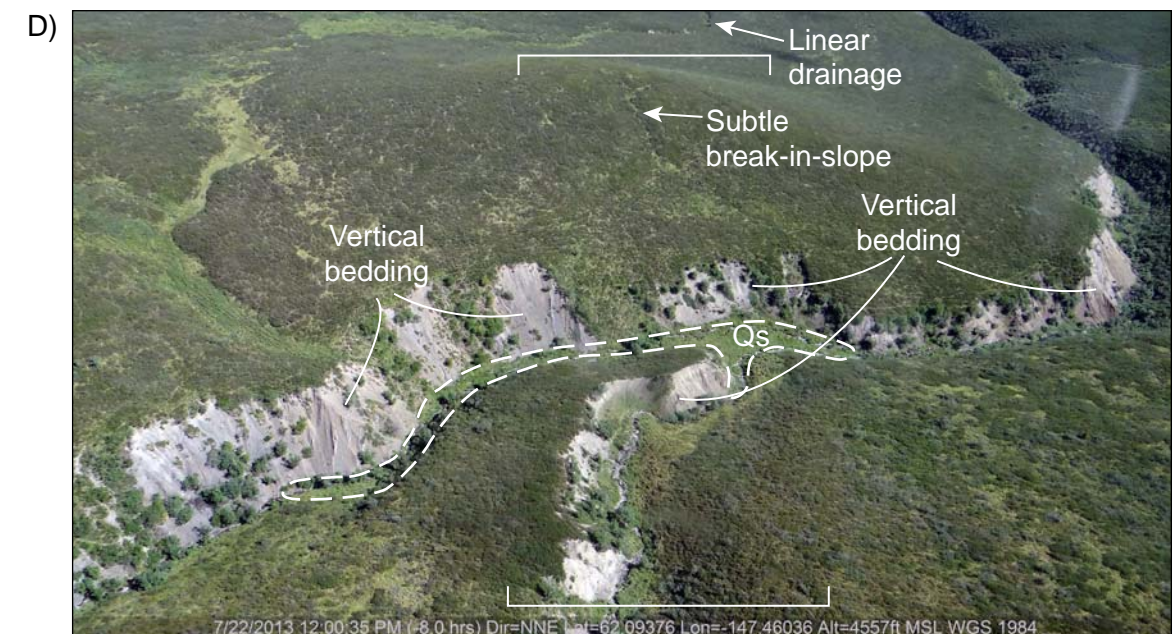
View looking northeast from location D along-strike with a Csejtey et al. (1978) mapped fault. A wide zone of deformation is expressed as vertical bedding exposed in outcrops. Note alignment of the break-in-slope on ridge crest, linear drainage, and the deformation zone.

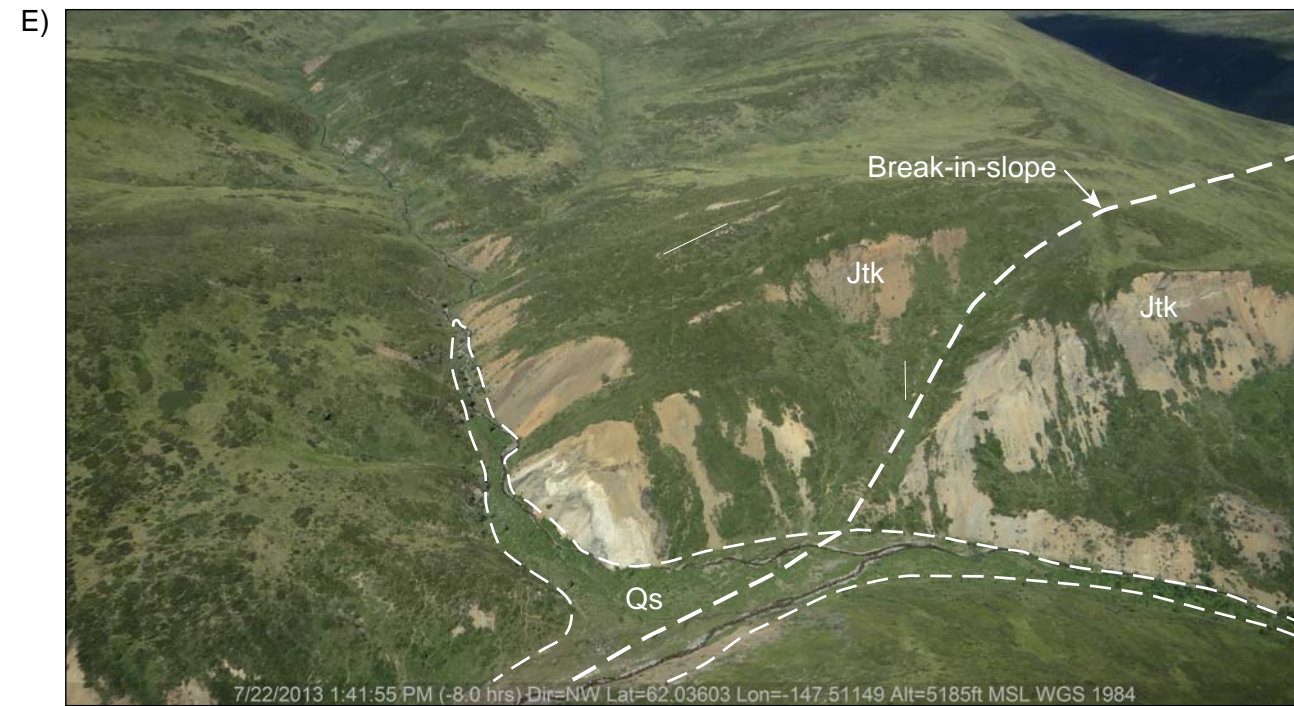
View looking northwest from location E at faulted Jurassic units. The fault occupies the linear valley then climbs the hill-slope where it correlates with a clear break-in-slope on the ridge crest.

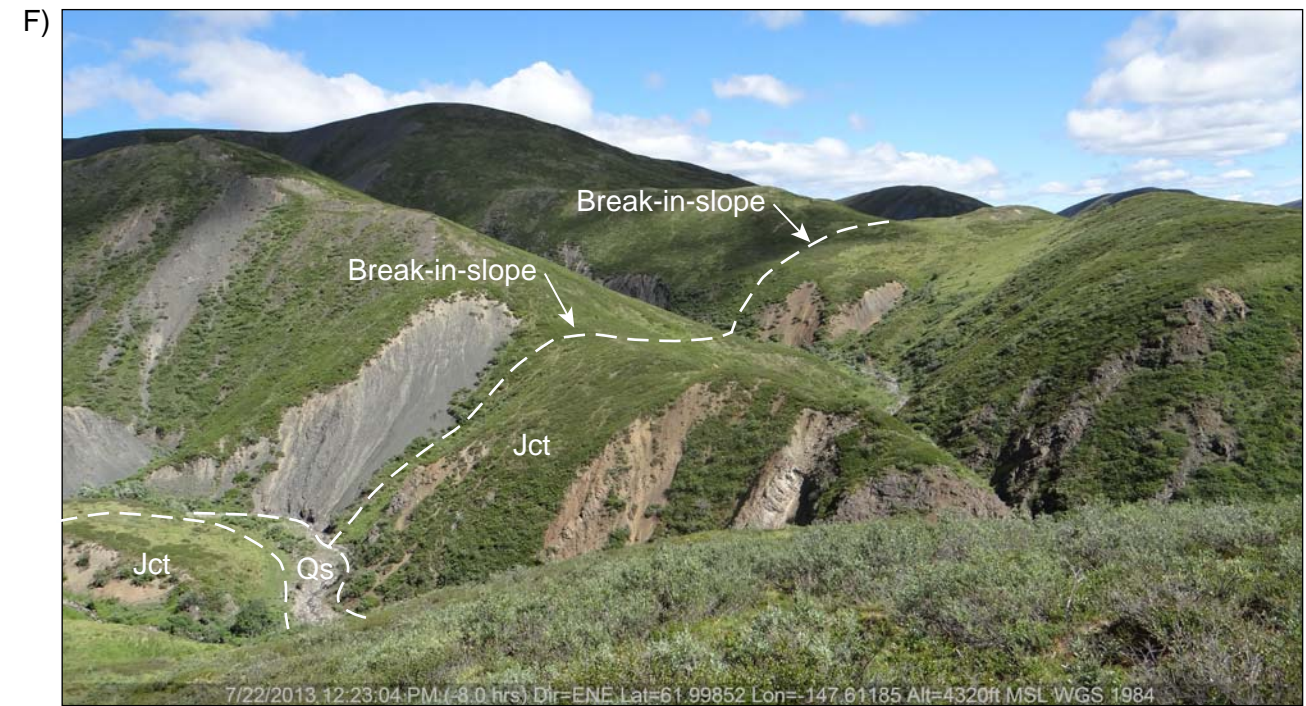
View looking north-northeast from location F. The fault juxtaposes Cretaceous against Jurassic bedrock and coincides with a break-in-slope on each ridge crest.
