## APPENDIX A: SUSITNA RIVER UPPER RIVER RECONNAISSANCE PHOTOGRAPHS

# 1. PHOTOGRAPHS OF THE SUSITNA RIVER UPSTREAM OF THE MACLAREN CONFLUENCE (PRM 291.8 TO PRM 261.3)

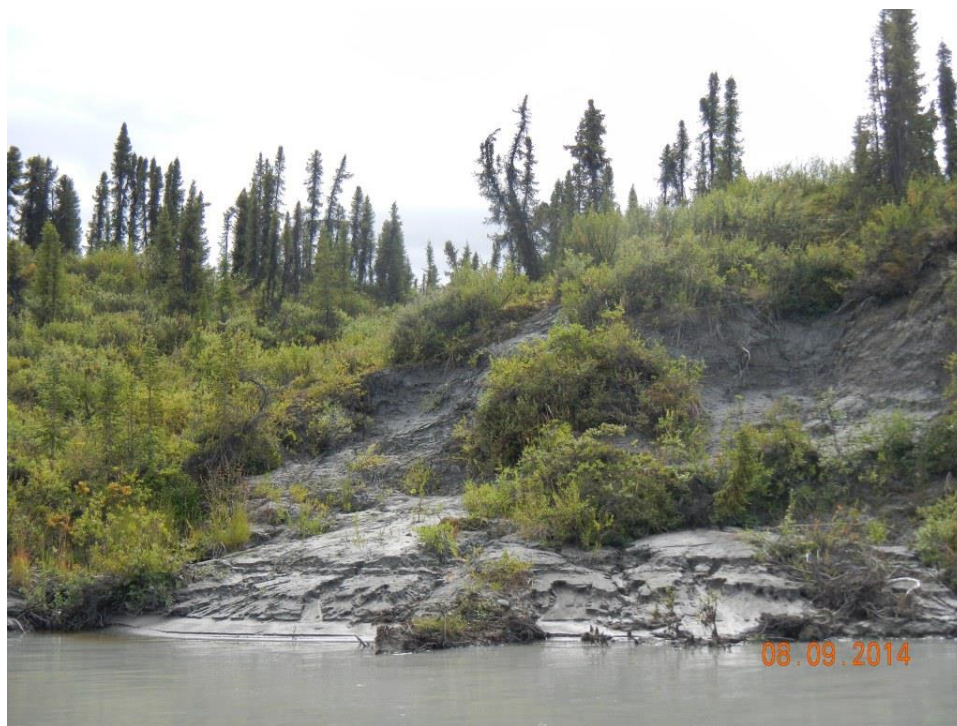
Figure A.1-14 – Active landslide in till near PRM 276. Failure may be due to melting of permafrost (P937).

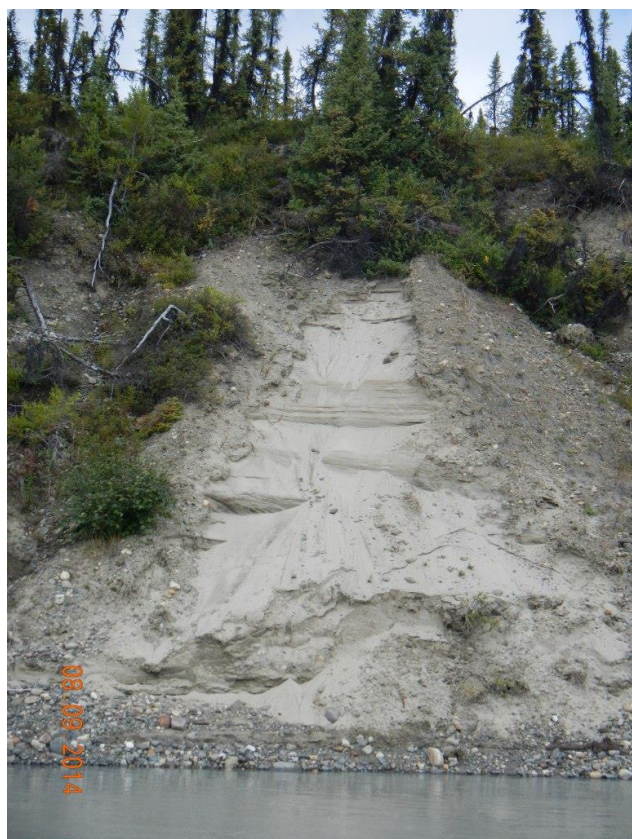
Figure A.1-15 – Active landslide near PRM 274.8 – sands and fine gravel in glacio-deltaic deposits (P956).

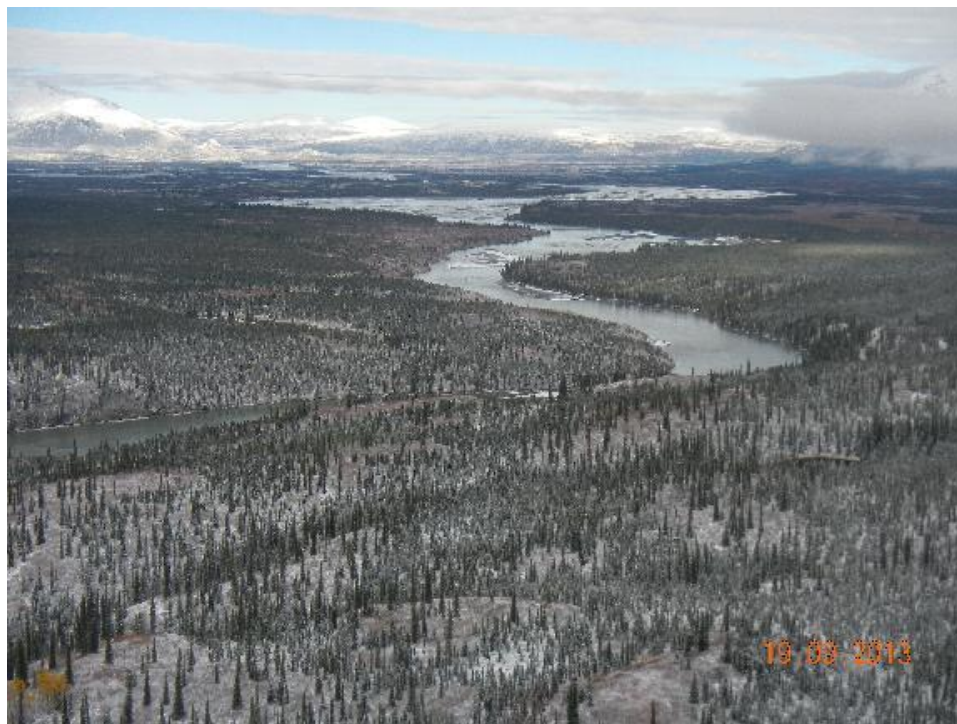
Figure A.1-16 – View upstream at PRM 274. Forced sinuosity due to presence of tills and bedrock (P5559).

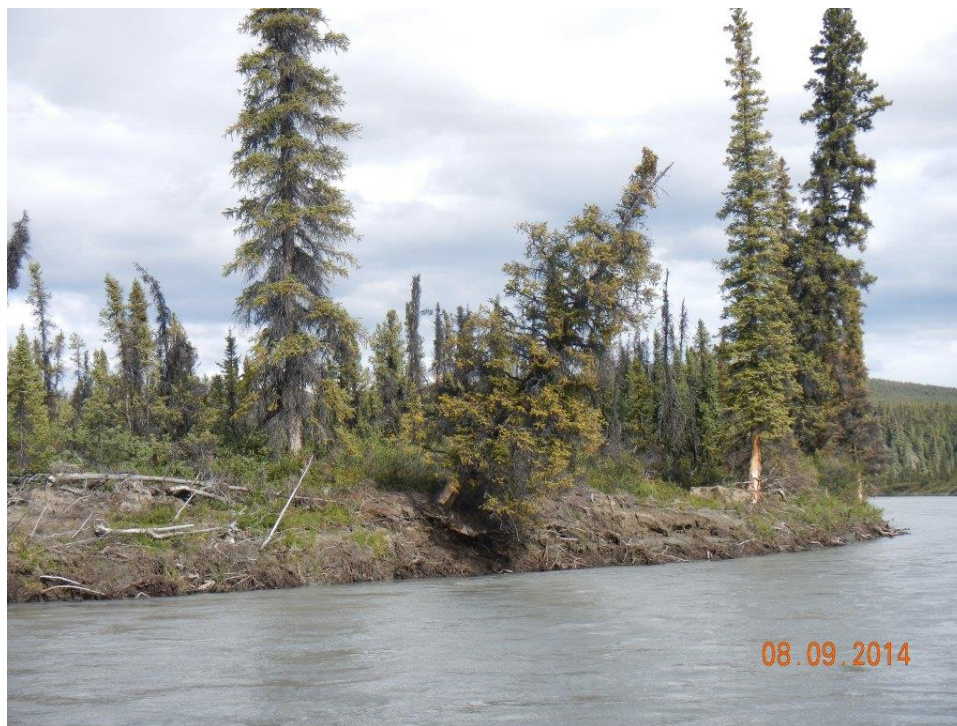
Figure A.1-17 – Bank effects of ice processes – tree scars and some erosion, vegetation push near PRM 272.5 (P992).

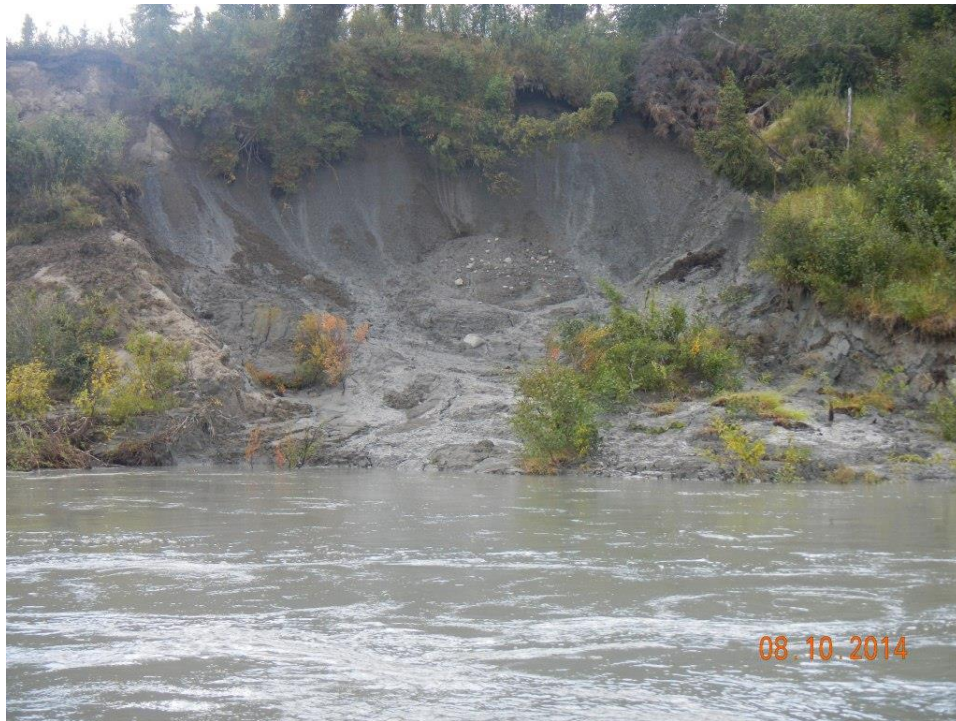
Figure A.2-5 – Surface and subsurface material at sediment sampling site at PRM 258.6. Median particle diameter ( $D_{50}$ ) of surface sediment is 40.5 mm. Median particle diameter ( $D_{50}$ ) of subsurface sediment is 10.1 mm (P821).

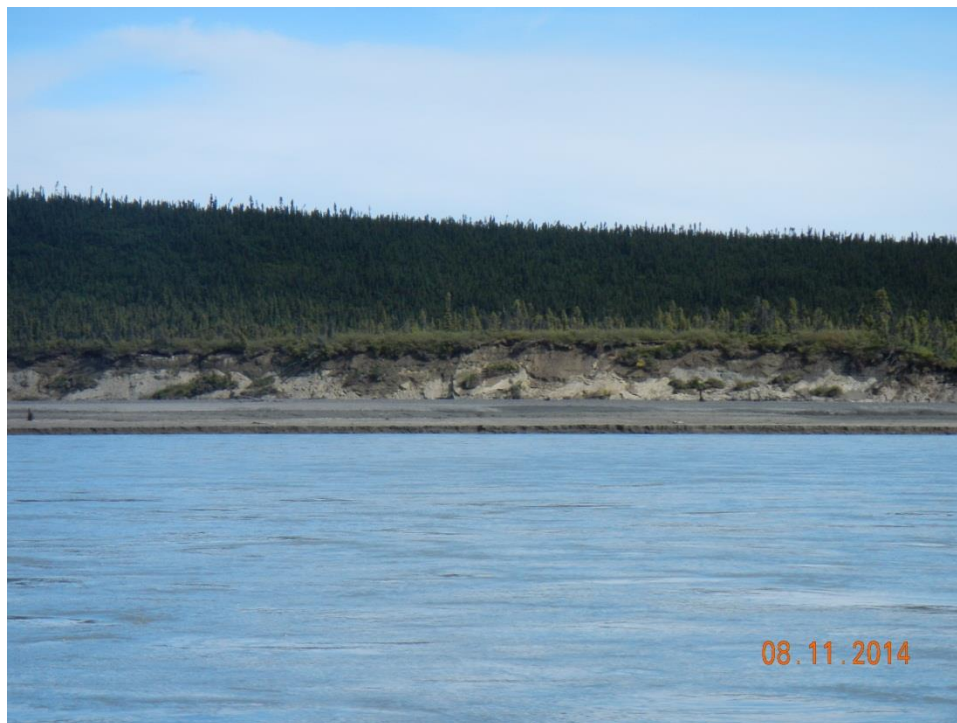
Figure A.2-20 – Slab failures along outwash surface near PRM 250. Note lateral moraine along the skyline (P440).

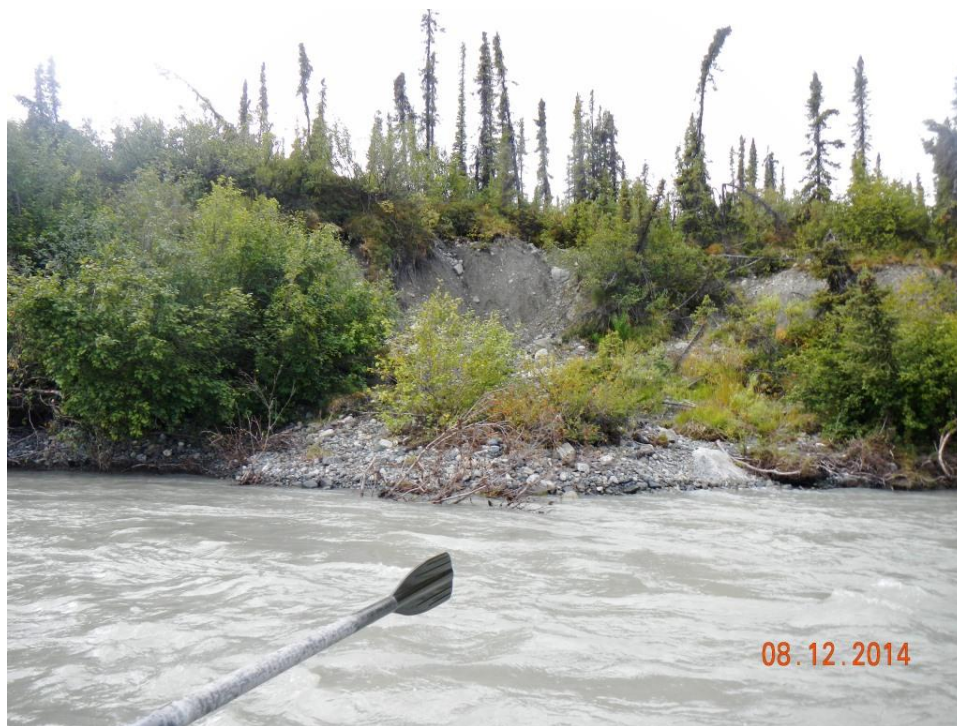
Figure A.2-31 – Pop out slide in till – local gravel source near PRM 240 (P554).

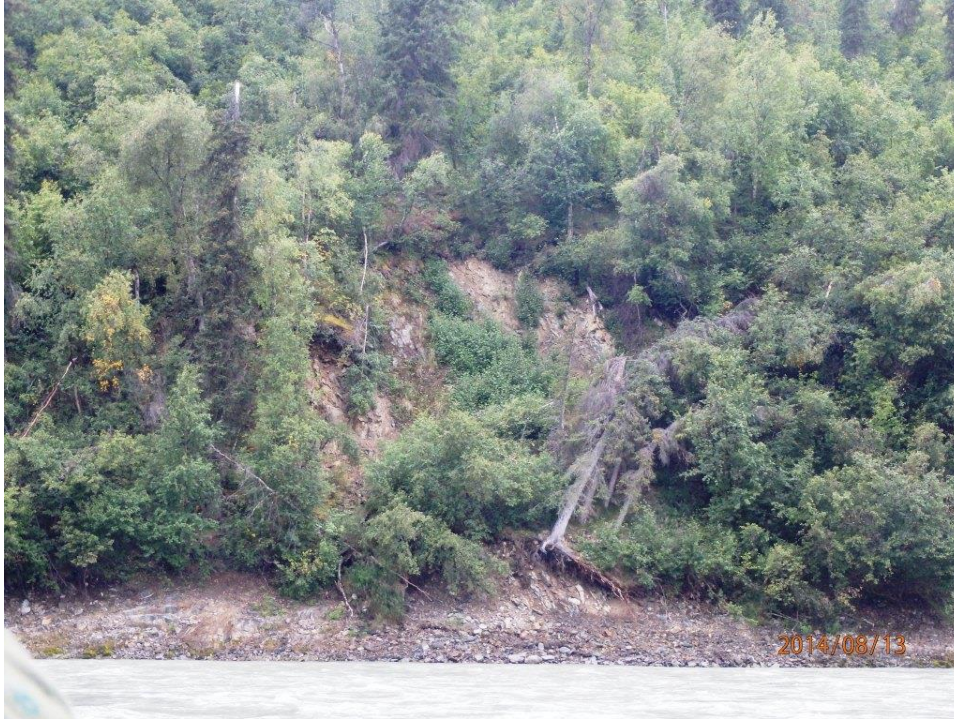
Figure A.2-43 – Shallow slide in colluvial materials overlying bedrock on hillslope near PRM 229.5 (P032).

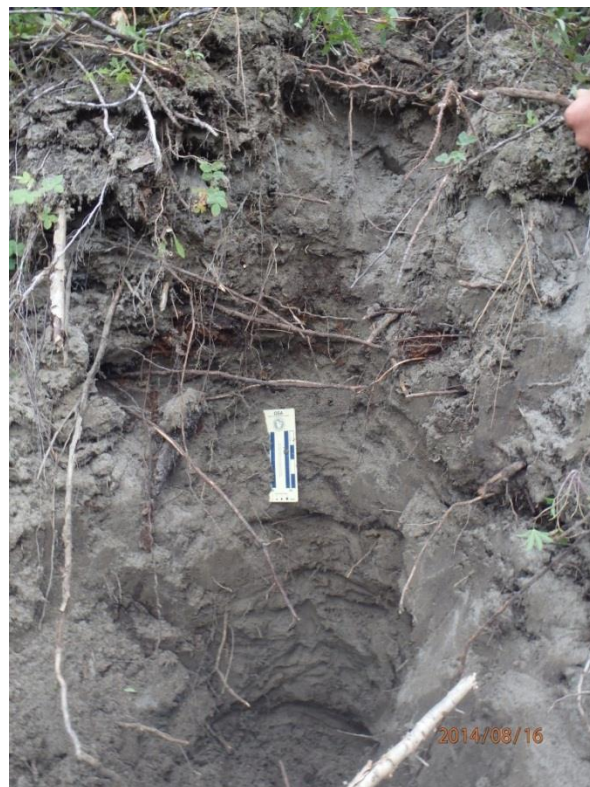
Figure A.2-87 – Bank stratification at PRM196.6. Note – This was the first observed occurrence of a relatively low floodplain in the Upper River Segment typical of those common in the Middle River Segment (approximately 6' from water surface on 8/16/14) (P432).

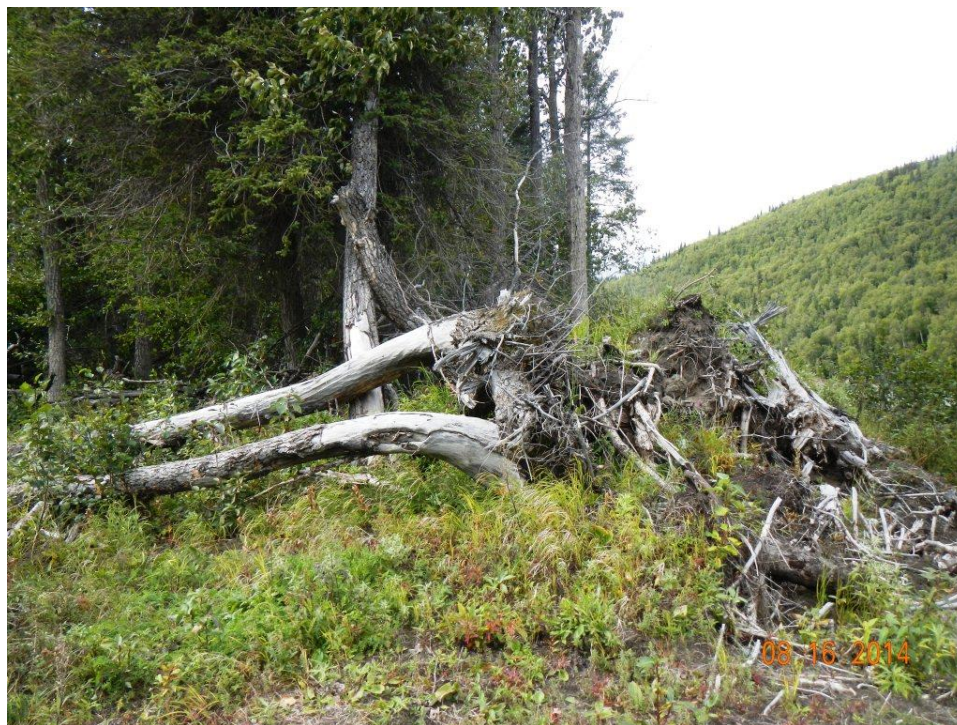
Figure A.2-92 – Ice ramping and vegetation scarring at head of island at PRM 190.1. Similar ice effects observed at the head of other islands within the UR-6 Geomorphic Reach (P486).
