Appendix A:

Strip Maps and Photographic Documentation of Lineament Data Presented in FCL (2013)

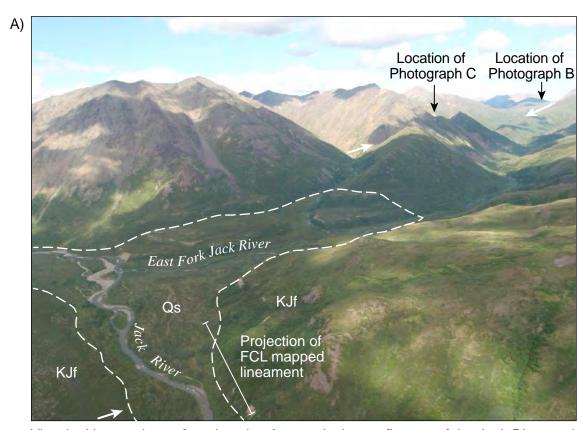
View looking northeast from location A towards the confluence of the Jack River and the East Fork Jack River. Arrows point along the alignment of mapped lineaments. Note absence of linear expression in Quaternary deposits.

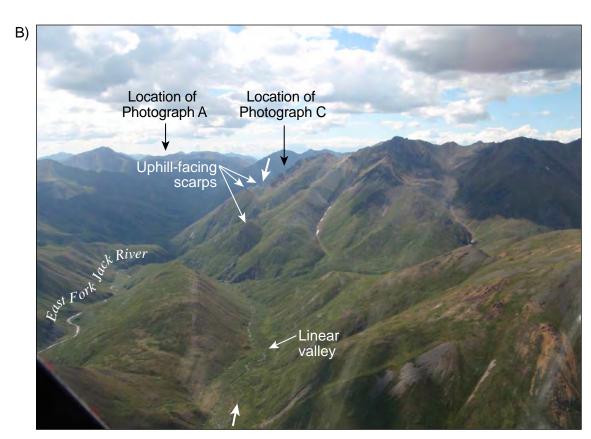
View looking southwest from location B along alignment of linear features. Arrows indicate the alignment of the mapped lineaments.

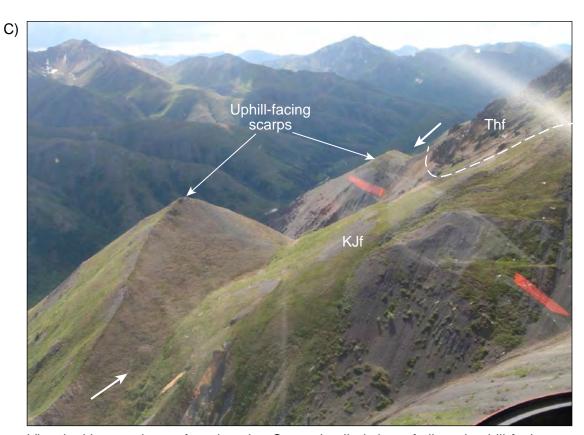
View looking southwest from location C at a detailed view of aligned uphill-facing scarps. Note Thf contact is up-slope from the scarp in the distance.

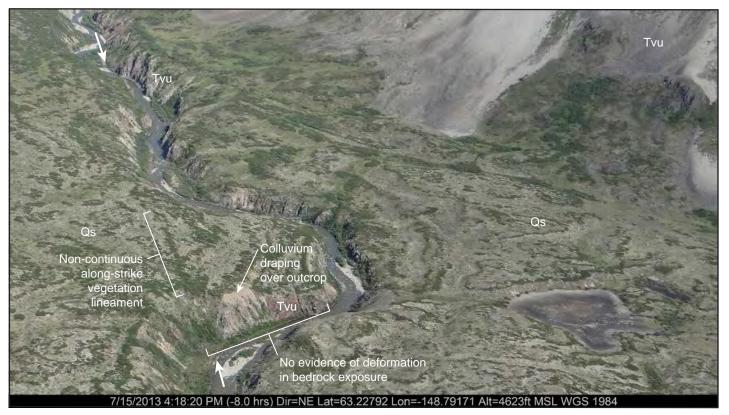
Photograph taken from location A looking east-northeast. Arrows show the alignment of FCL-mapped lineament. Note lack of apparent deformation in bedrock exposure along Jack River.

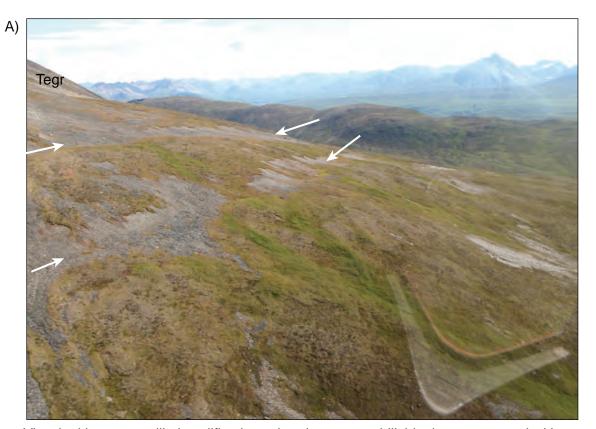
View looking east at likely solifluction-related scarps on hillside that correspond with mapped lineaments. Large arrows point along lineaments.

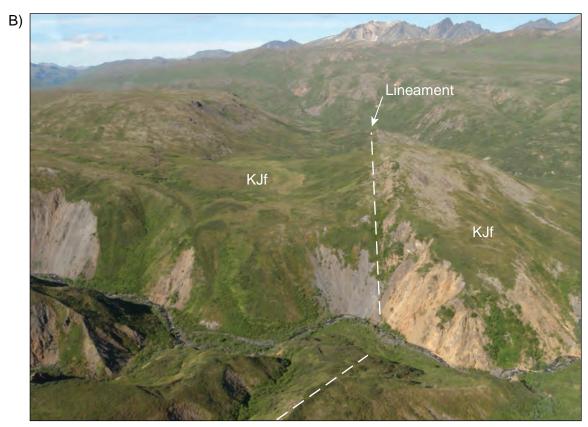
View looking west along 3a lineament expressed as sharp ridge within Kahlitna flysch (KJf). Apparent color change and topographic expression may suggest a geologic structure, however, none were previously mapped. The feature may be a result of weathering because of lithologic change within the flysch.

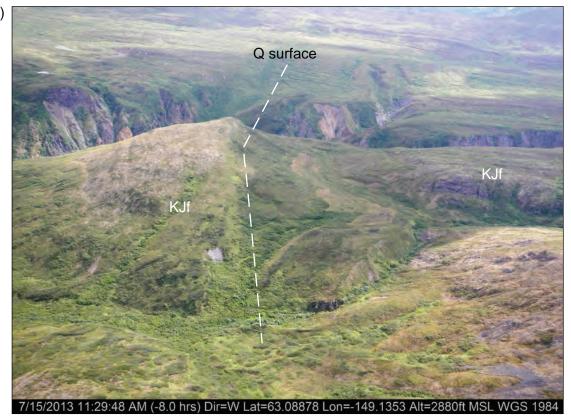
View looking east past ridge, with unfaulted Quaternary sediments in the foreground and far distances.

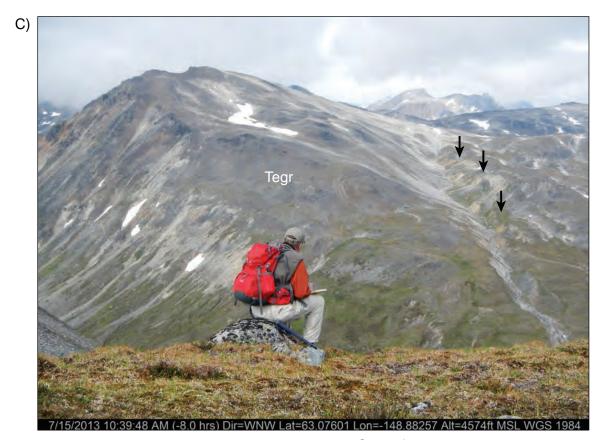
View looking west along lineament 3b projection. South-facing escarpment indicates a reversal in kinematic morphology.

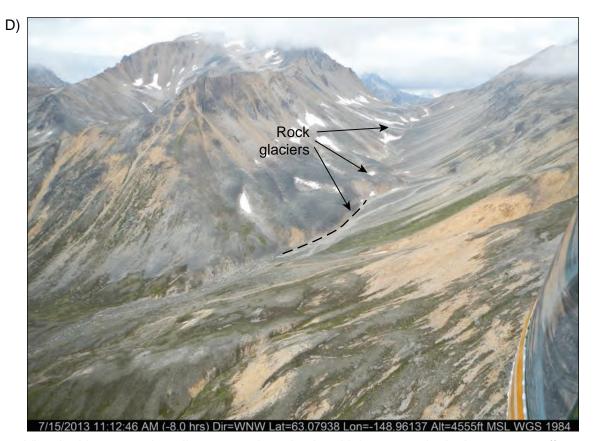
View looking west along lineament 3b projection. Holocene rock glaciers are not offset, and lineament is expressed as a linear valley.

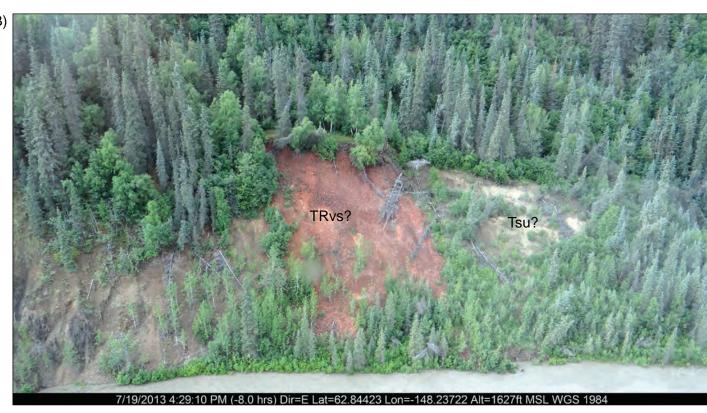
View looking east along lower river bank at apparent alternation zone distinguished by color contrast, possible juxtaposition of Triassic metabasalts and undifferentiated Tertiary sediments. This location is east of the mapped projections of the Talkeetna fault.

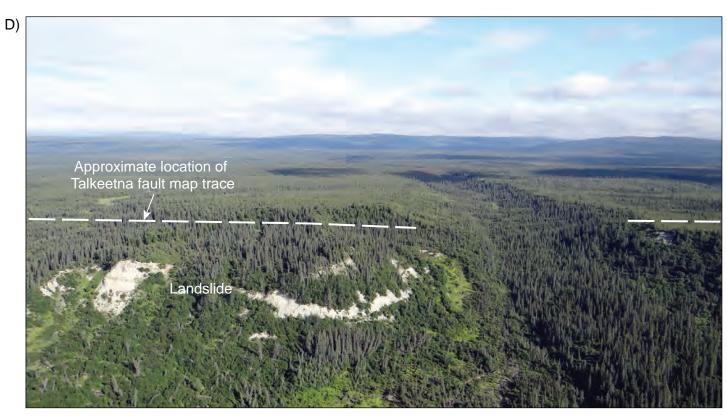
View looking west at projected trace of Talkeetna fault whose ground expression is absent in Quaternary surface.

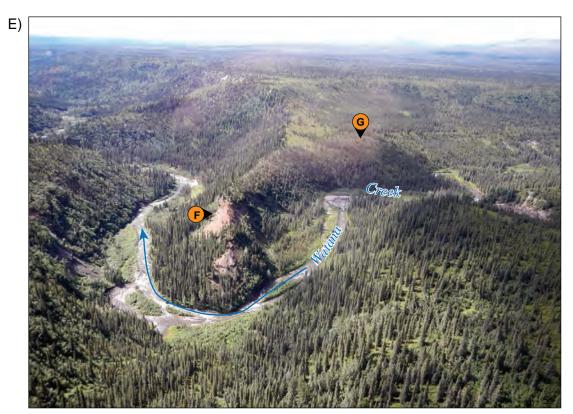
View looking south at erosion-resistant ridge of Tertiary sediments whose beds dip gently to the northwest but appear undisrupted.

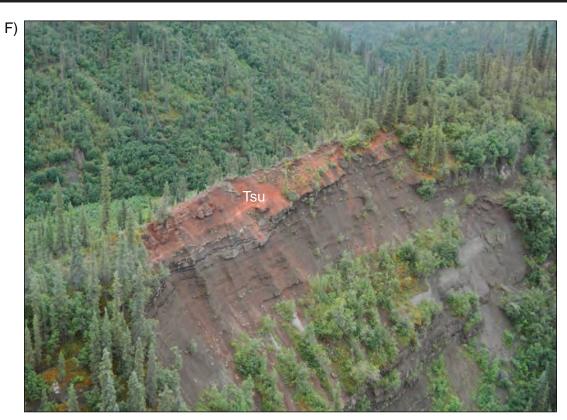
View looking west at apparently northwest-dipping beds in Tertiary sediments, relatively consistent with northwest dips measured by WCC (1982) in Tertiary sediments along west bank Watana Creek.

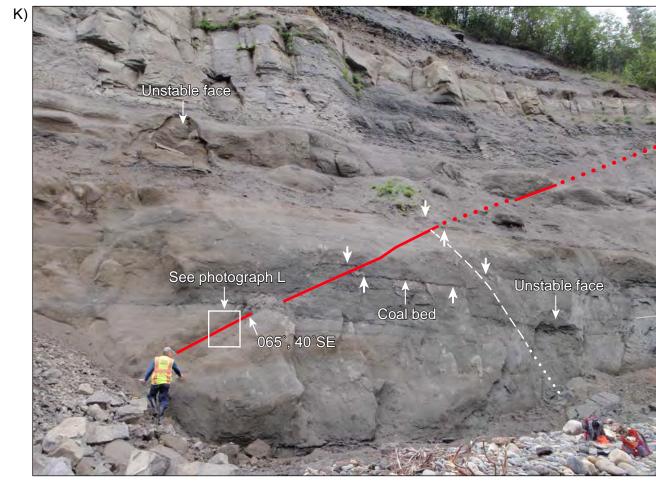
Photograph of faulted outcrop with coal bed. Visually estimated 60-80 cm of separation along the fault plane. Second fault appears to terminate against primary fault (065, 40°SE) extends across the outcrop.

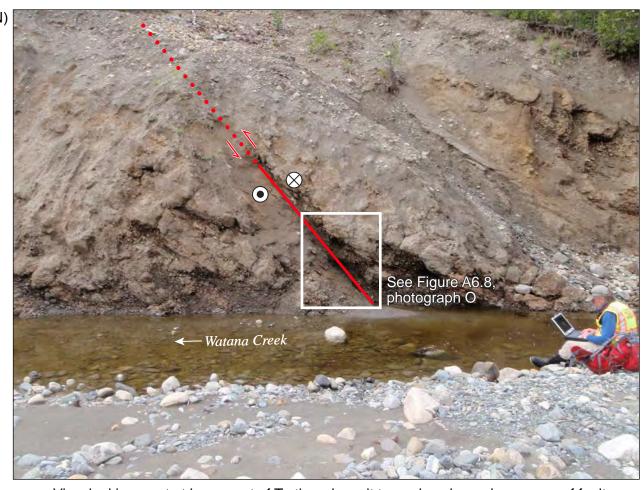
View looking west at lower part of Tertiary deposit toward uncleaned exposure of fault (065-080° strike; 65°N dip). Left-lateral oblique relative movement.

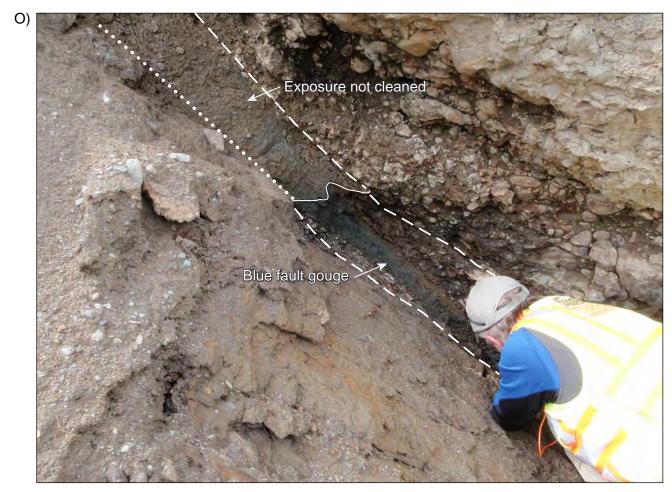
Close up of fault in cobble-rich Tertiary deposit.

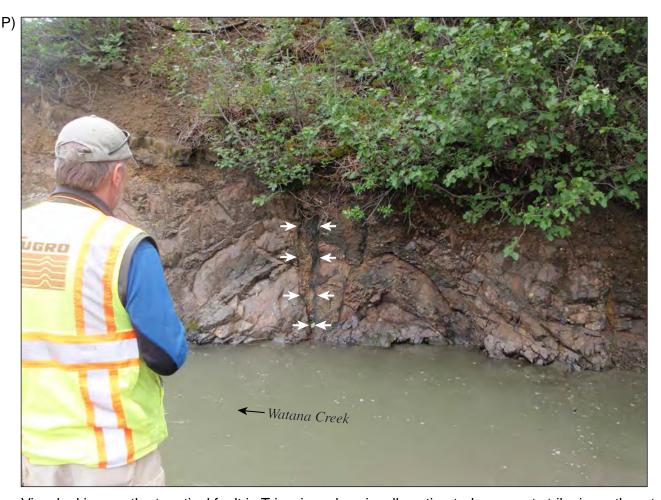
View looking south at vertical fault in Triassic rocks; visually estimated apparent strike is northeast.

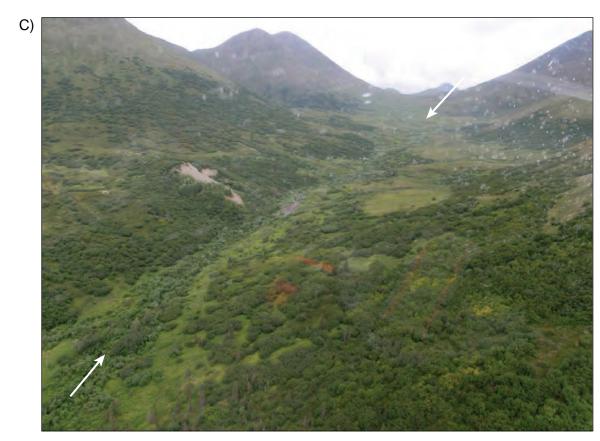
View looking up-valley at incised drainage that coincides with mapped lineament and previously mapped fault.

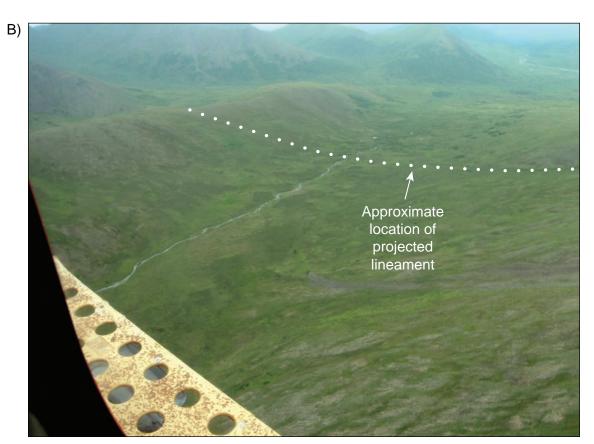
View looking west down-valley at apparent undeformed glacial sediments.

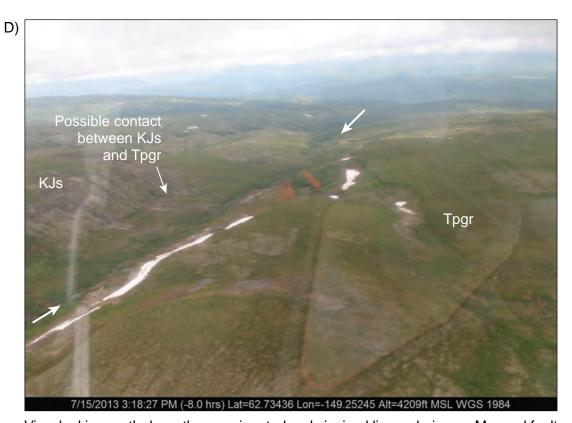
View looking north down the prominent, deeply incised linear drainage. Mapped fault runs between large arrows.

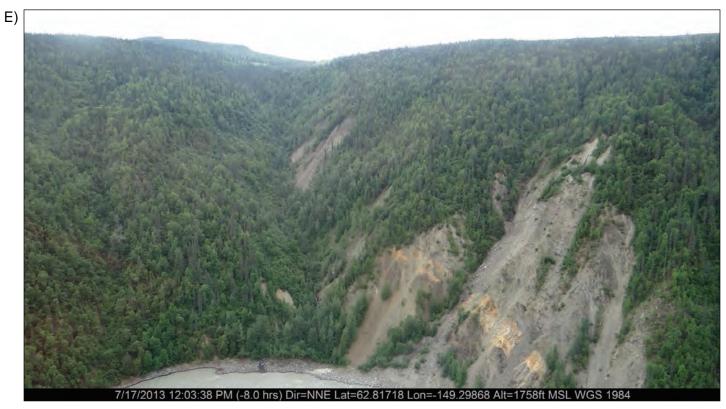
View looking north at north (right) bank of Susitna River showing oxidized mafic dike interpreted by WCC (1982) to not be truncated by the linear drainage.

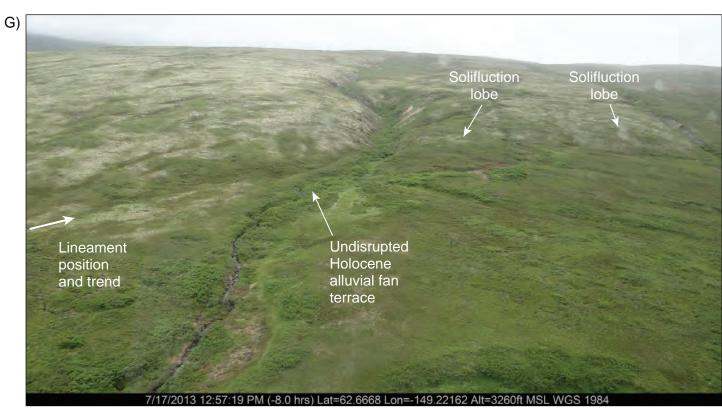
View looking west directly towards 1- to 2-m-high east-facing scarps shown in Photographs F and H. Large arrow points along mapped lineament.

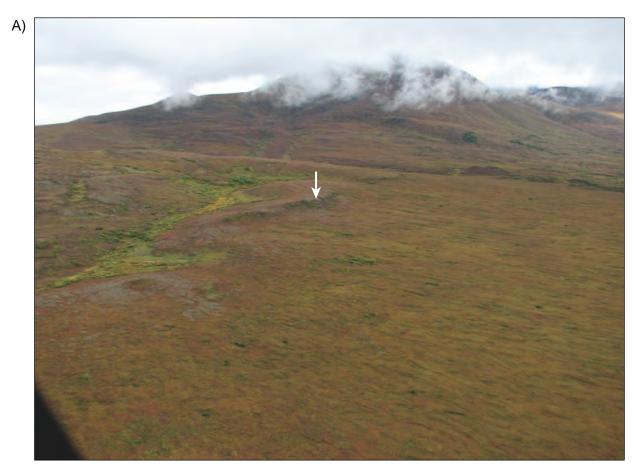
View looking northeast at erosional break-in-slope mapped as an individual lineament. Feature is absent in the background along projection of strike.

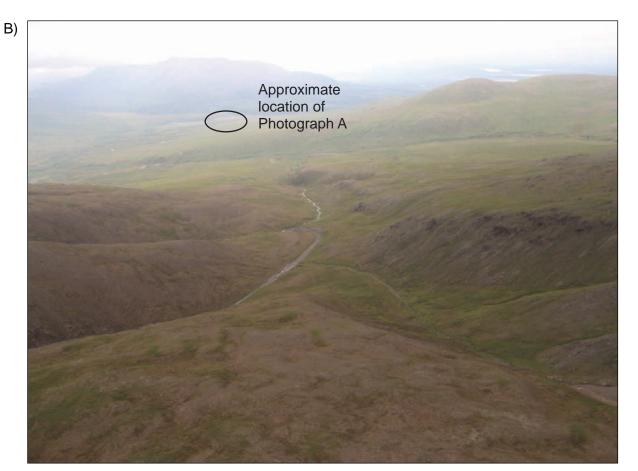
View looking southwest down-valley along lineament geomorphically expressed as linear valley. Very little alluvium has accumulated in the drainage, and glacially sculpted bedrock is shallow.

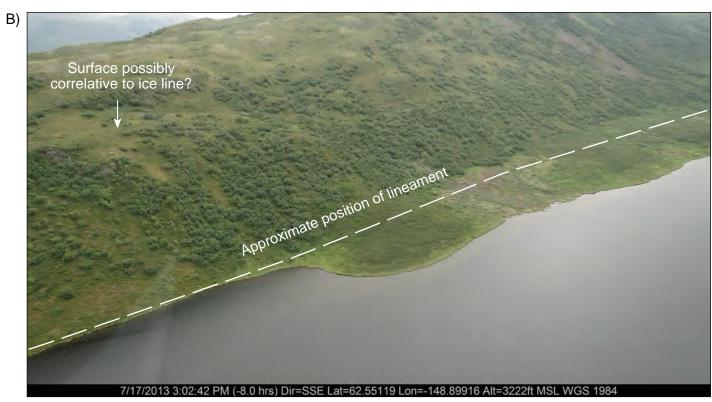
View looking south southwest at lake margin of glacial valley. Lineament was mapped at base of slope, and is not expressed as a scarp-type feature. Apparent colluvium along projection of lineament does not appear offset.

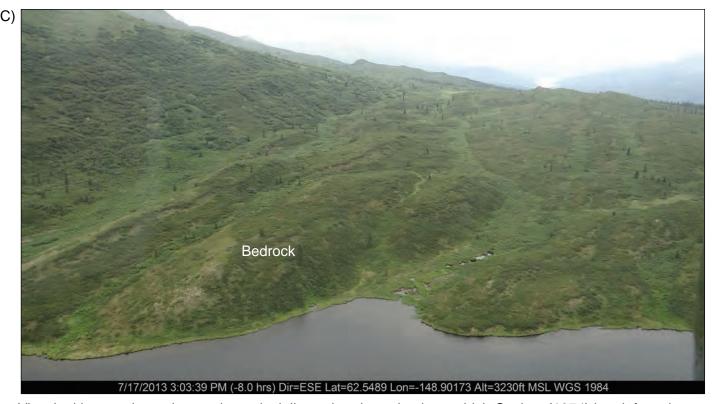
View looking south southeast along glacially-sculpted terrain along which Csejtey (1974) has inferred a fault within the glacial sediment that mantles the bedrock knolls (Figure A17b.1).

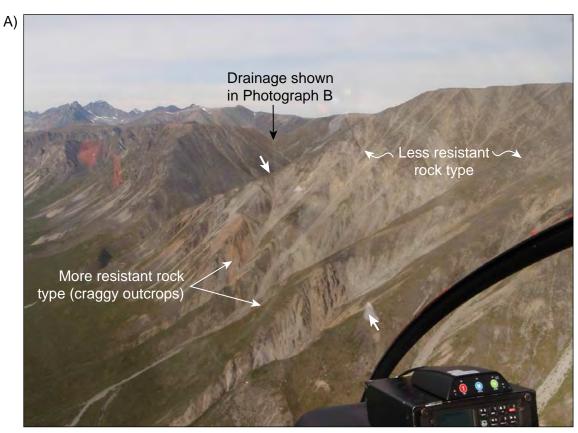
Photograph taken from location A looking southwest along apparent rock type contrast (contact?) and towards mapped lineaments in steep-walled, v-shaped, linear drainage. Arrows point along apparent contact between less-resistant rock on the north and more resistant and craggy outcrops on the south.

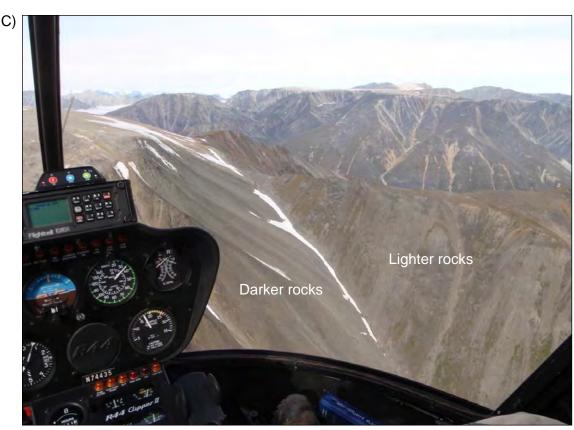
Photograph taken from location C looking west at head of steep-walled, v-shaped, linear drainage where mapped lineaments correspond to apparent rock contact.

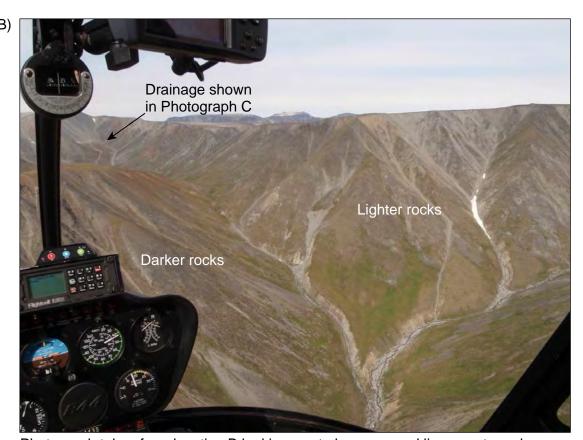
Photograph taken from location B looking west along mapped lineaments and apparent rock contact in steep-walled, v-shaped, linear drainages.

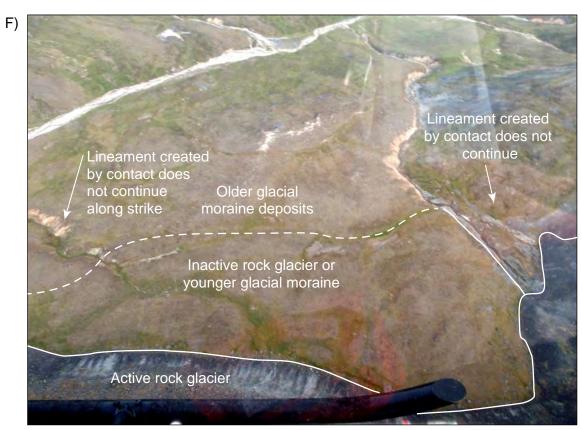
Photograph looking northwest from location F showing apparently undeformed rock glacier and/or glacial deposits along strike of the mapped lineaments and apparent rock contact shown in Photographs A through D.

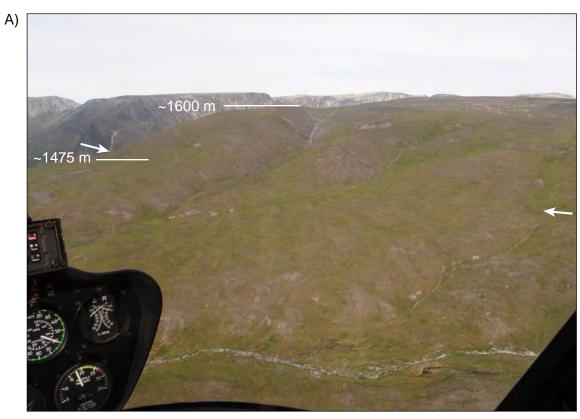
Photograph taken from location A looking west. Arrows point along trend of mapped lineaments along southwest-facing aligned break-in-slope. Note the rounded and subdued nature of break-in-slope. Relief across break-in-slope is ~125 m.

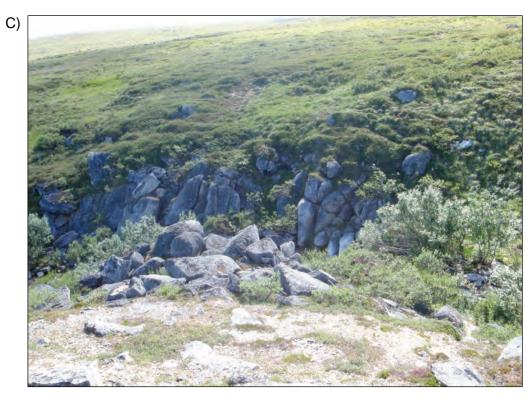
Photograph looking south-southwest from location C at widely spaced, near vertical, well-developed joints in trondhjemite (aka tonalite) bedrock. Joint spacing is 1 to 1.5 meters. Predominant orientations of joints are 042/80SE, 012/85SE, and 082/85SE but other orientations exist. Joint faces have clean surfaces with relief of minerals of 1 to 3 mm. No gouge or mineralization observed on joint surfaces, nor any sense of movement indicators (striae or mullions).

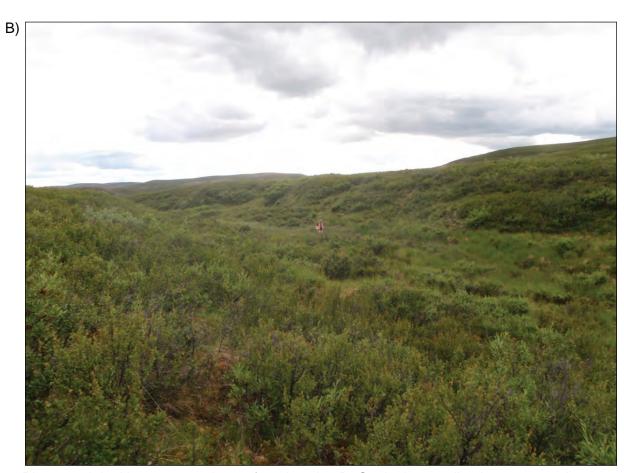
Photograph looking west-southwest from location B. Geologist standing in 3- to 6-m deepand ~30-m-wide swale. Swale only exists in saddle; it does not continue down either side of saddle.

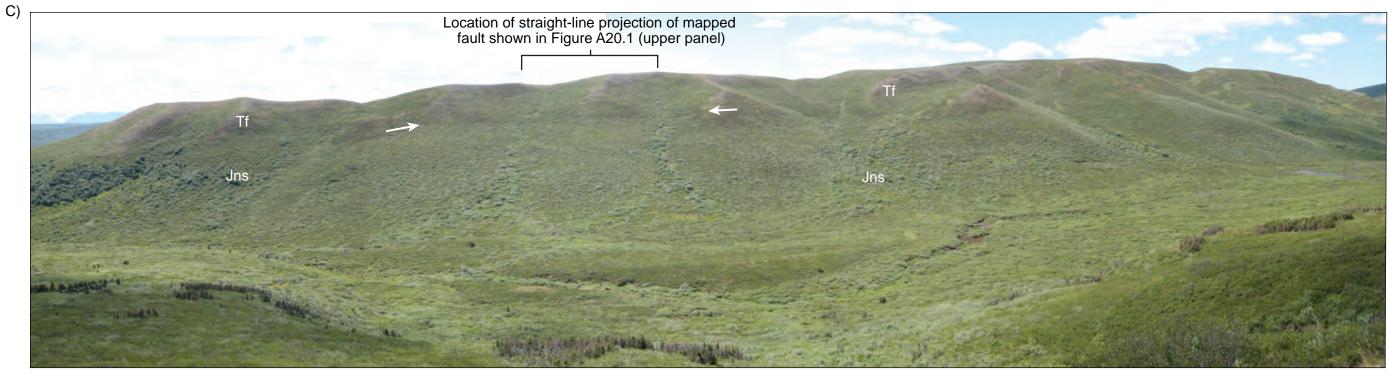
Photograph looking southwest from location C. Basal contact shown by arrows. Note that base of contact is not apparently deformed along projection of fault and that no expression of faulting in valley bottom is apparent.

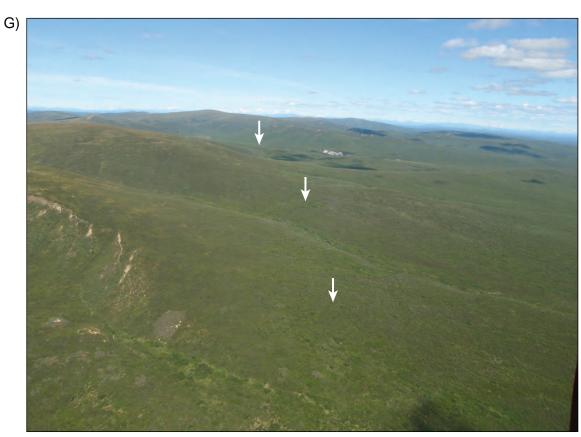
Photograph looking north from location G along mapped fault of Grantz (1960). Arrows point to approximate location of mapped fault. Note absence of apparent geomorphic expression fault.

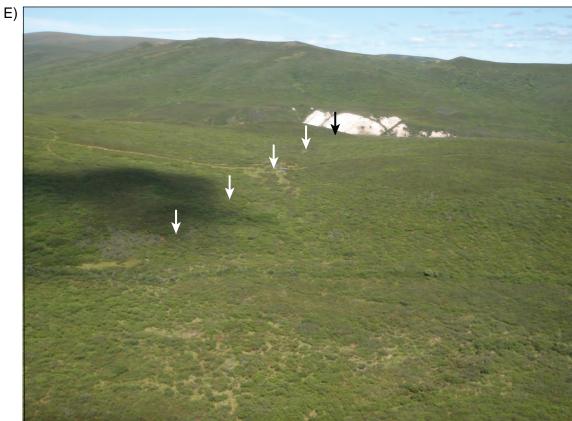
Arrows show location of FCL mapped lineament (shallow U-shaped swale). Note no apparent deformation of white-bedded sediments (glacial lake sediments) along projection of lineament.

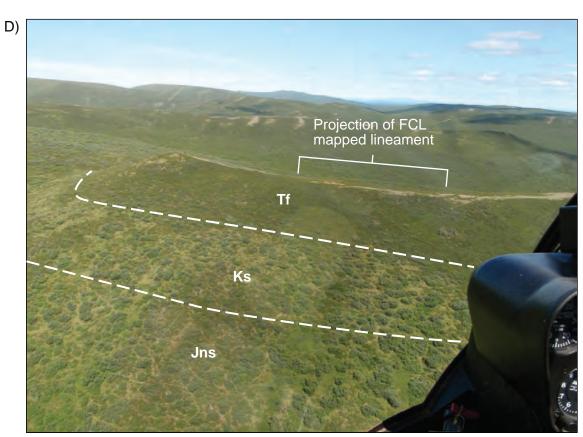
Photograph looking northeast from location D. Note absence of deformation in ridge line of Tf.

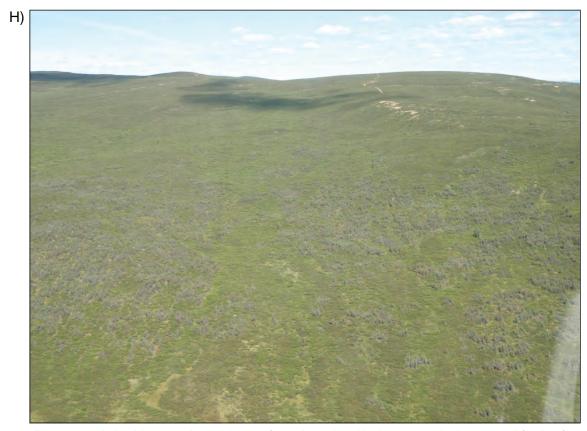
Photograph looking north-northeast from location H along queried mapped fault of Grantz (1960) that lies outside of lineament group. Note absence of fault expression.

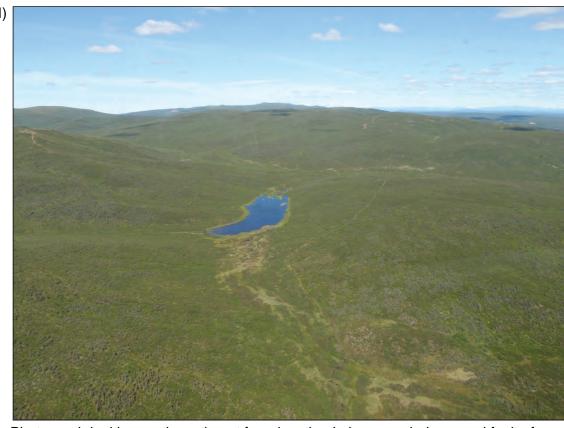
Photograph looking north-northeast from location I along queried mapped fault of Grantz (1960) that lies outside of lineament group. Note absence of fault expression.

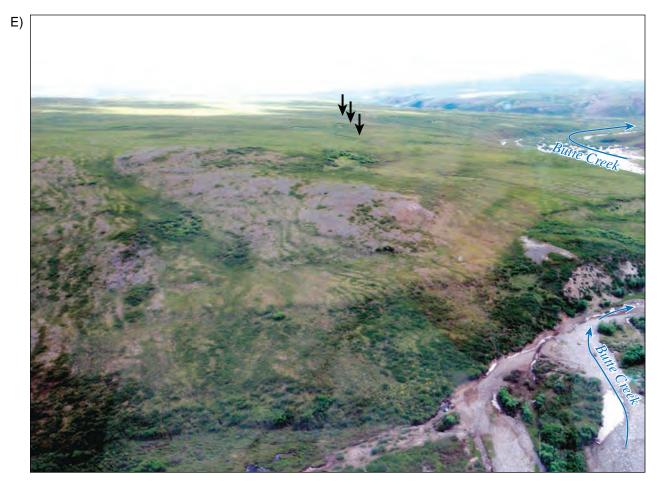
Photograph taken from location E looking east-southeast along trend of FCL mapped lineament (shown by arrows). Note absence of any apparent deformation in surficial deposits or in terrace riser on left bank of Butte Creek.

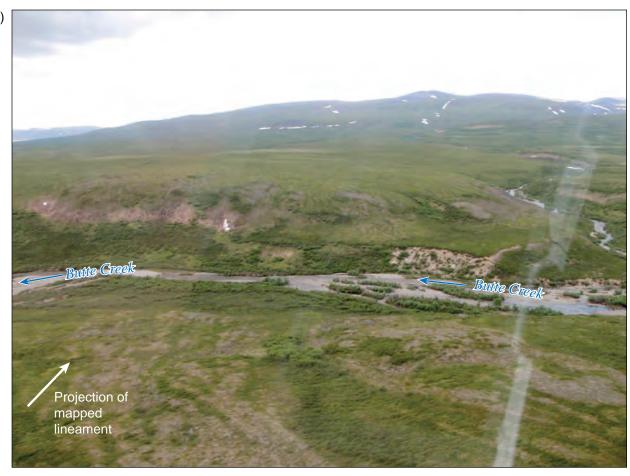
Photograph taken from location F looking west along trend of FCL mapped lineament to west of Butte Creek. Note no apparent deformation in right bank of stream or any expression of faulting in broad, flat terrace surface mapped as Qdt₃ by Smith et al. (1988).

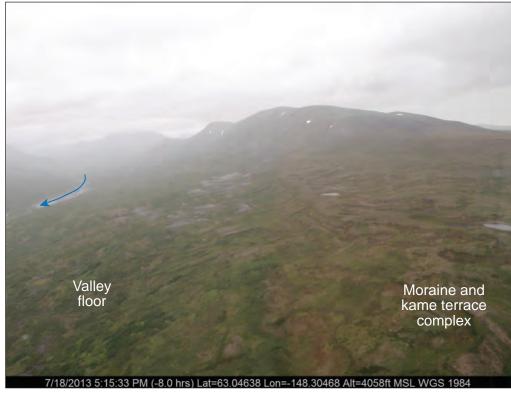
View looking north-northwest up-valley along the margin of the left-lateral moraine and kame terrace complex. No lineaments were observed cutting these deposits.

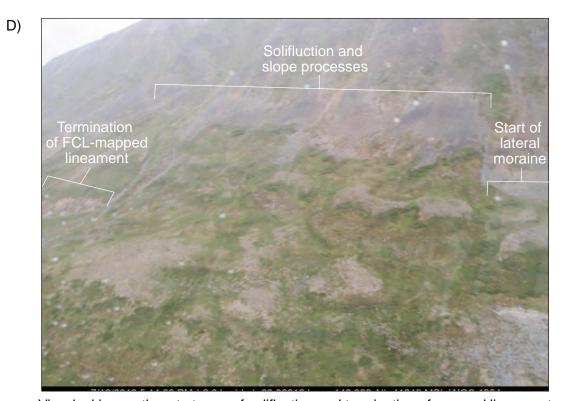
View looking northeast at area of solifluction and termination of mapped lineament.
