BUSTNA-WATANA HYDROELECTRIC PROJECT  
Broad Pass Area

SUSTITNA-WATANA HYDROELECTRIC PROJECT  
Castle Mountain Extension Area

SUSITNA-WATANA HYDROELECTRIC PROJECT  
Clearwater Mountains Area

**Appendix B:  
Strip Maps and Photographic Documentation  
of Lineament Data for Lineaments Mapped by Reger et al. (1990)**

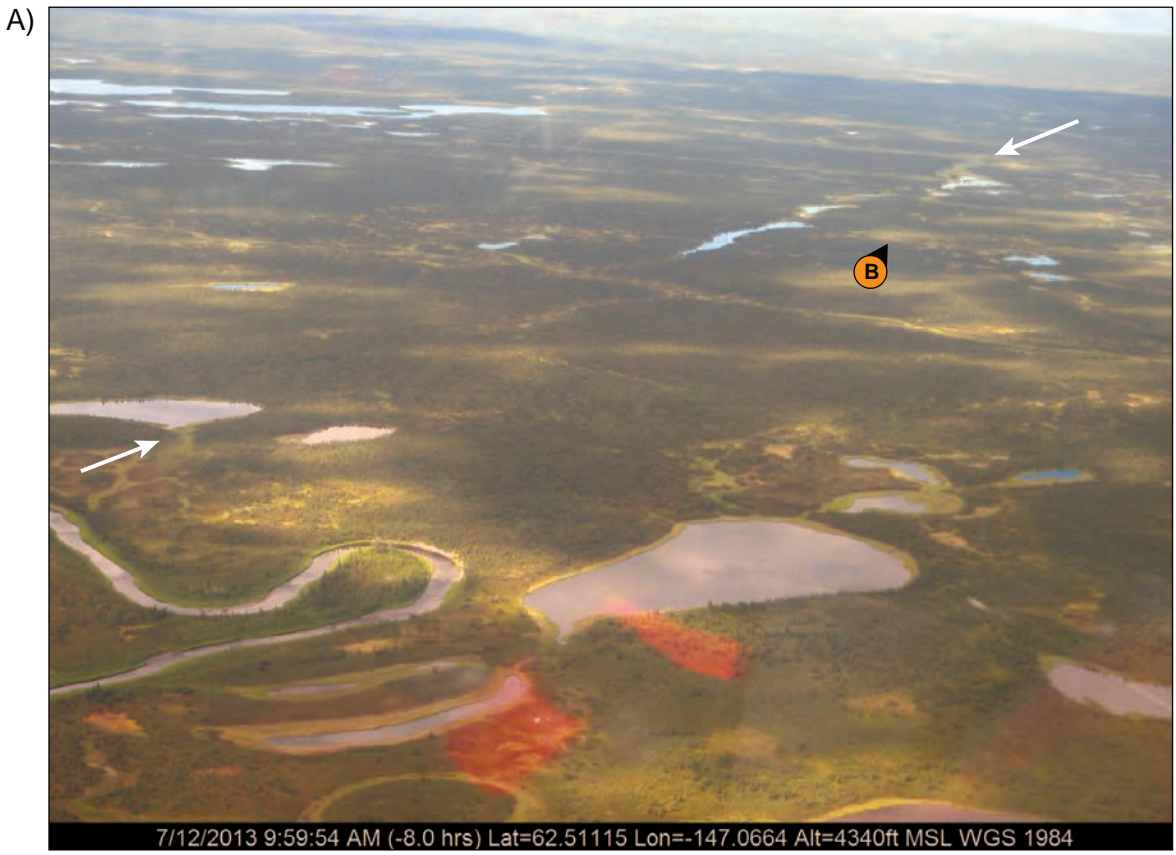
View looking west-southwest toward linear alignment of lakes. Arrows point along lineament. Note kettle lake terrain in the foreground.

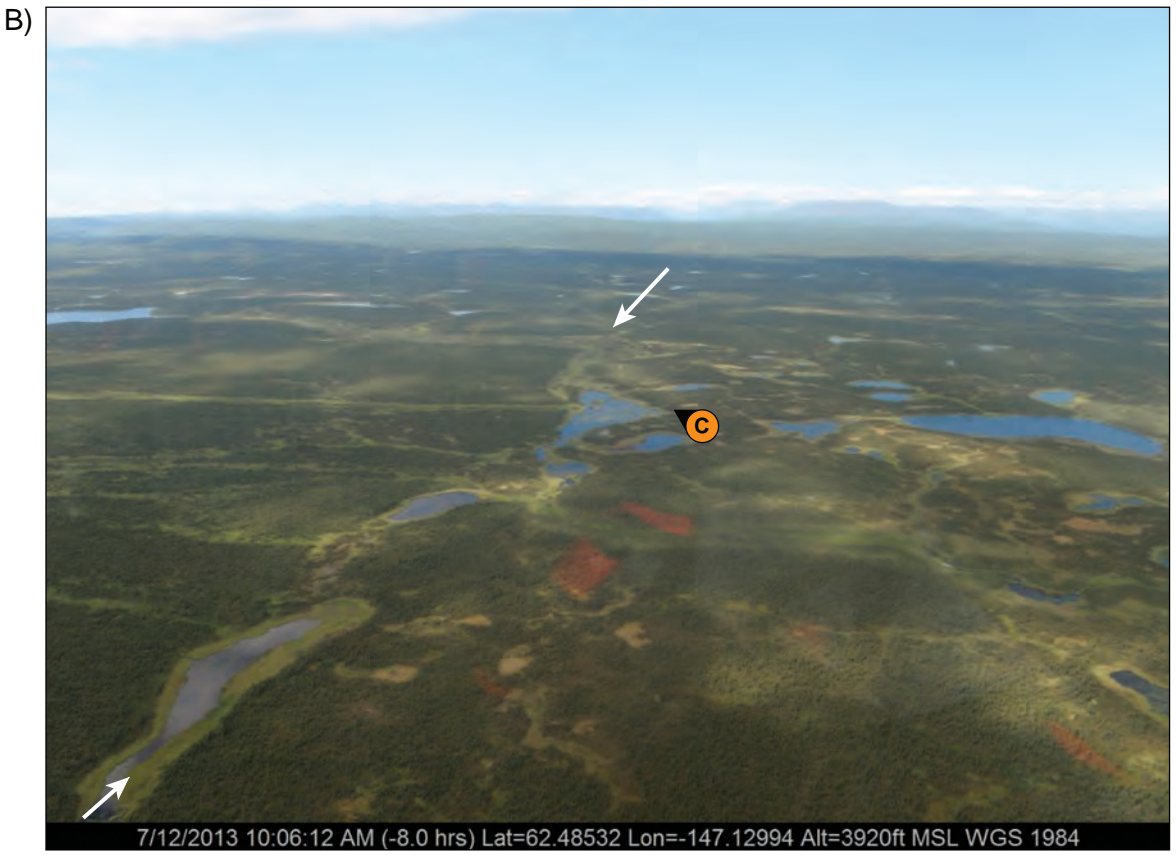
Close up view looking west-southwest along linear alignment of lakes in Photograph A. Arrows point along lineament.

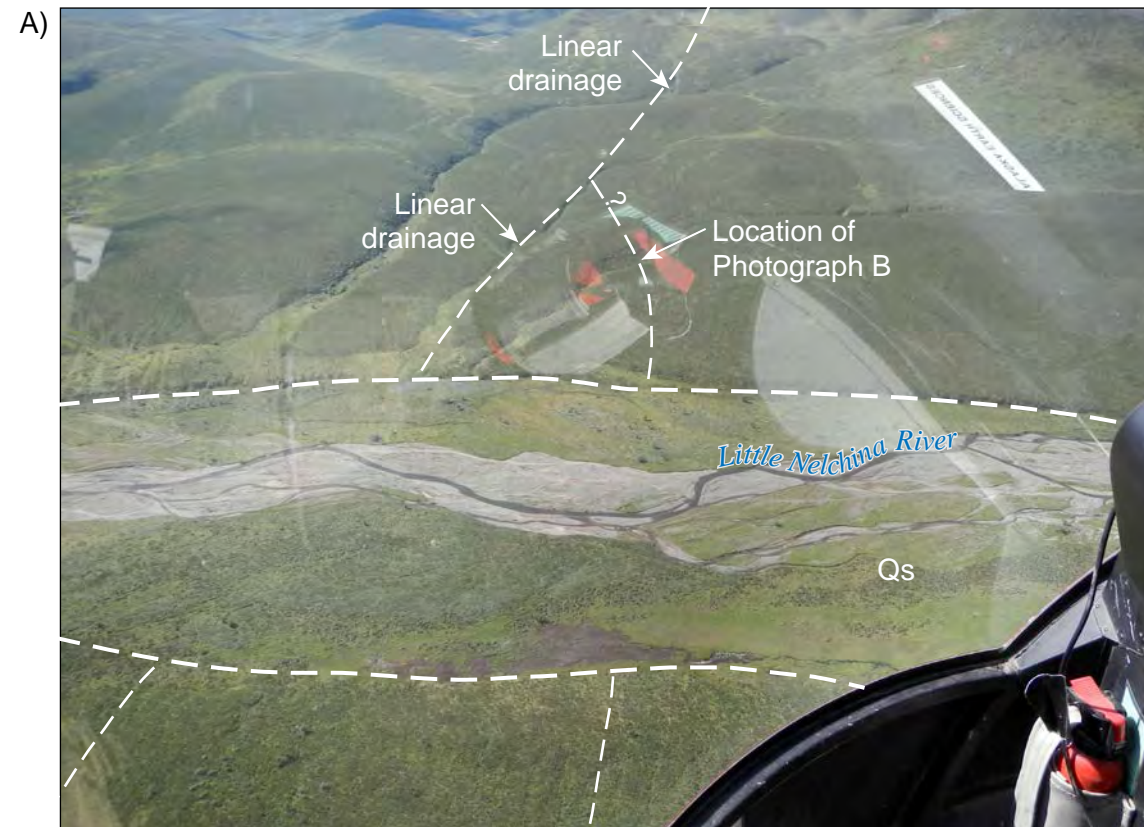
View looking southwest from location A, nearly along-strike with Csejtey et al. (1978) mapped faults. Note clear expression of linear features on bedrock landscape and absence of linear expression in Quaternary deposits.

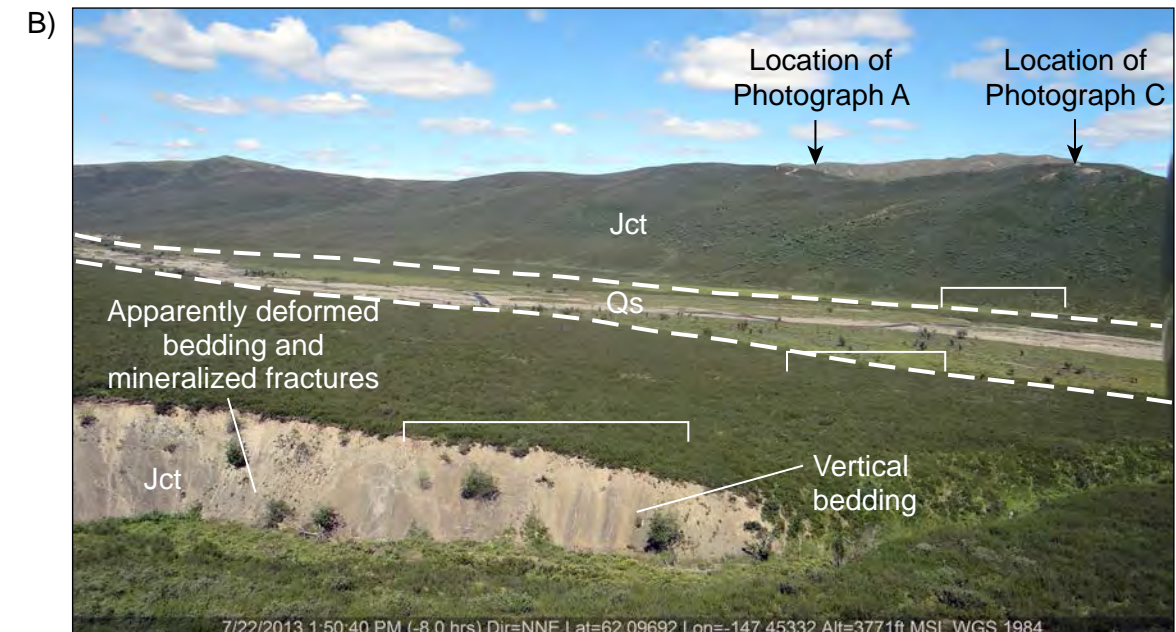
View looking northeast from location B nearly along-strike with Csejtey et al. (1978) mapped fault. The mapped fault segment projects through the vertical beds observed in the outcrop towards photograph location C. Note apparent undeformed hillslope and Quaternary deposits over projected trace of fault.

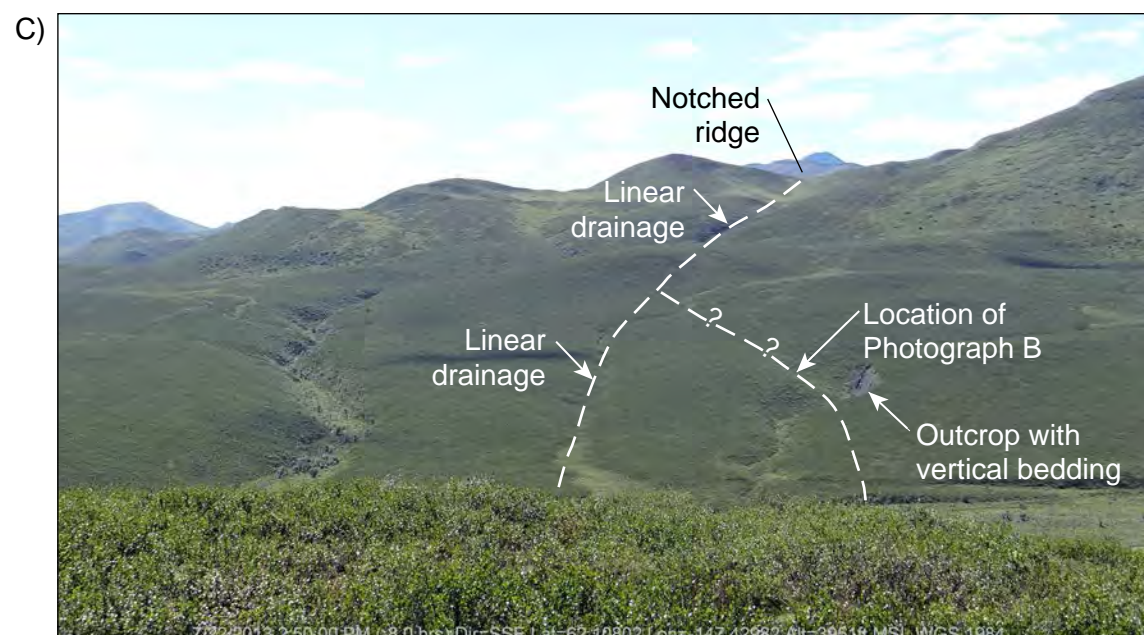
View looking southwest from location C. Note alignment of features over mapped trace of fault.

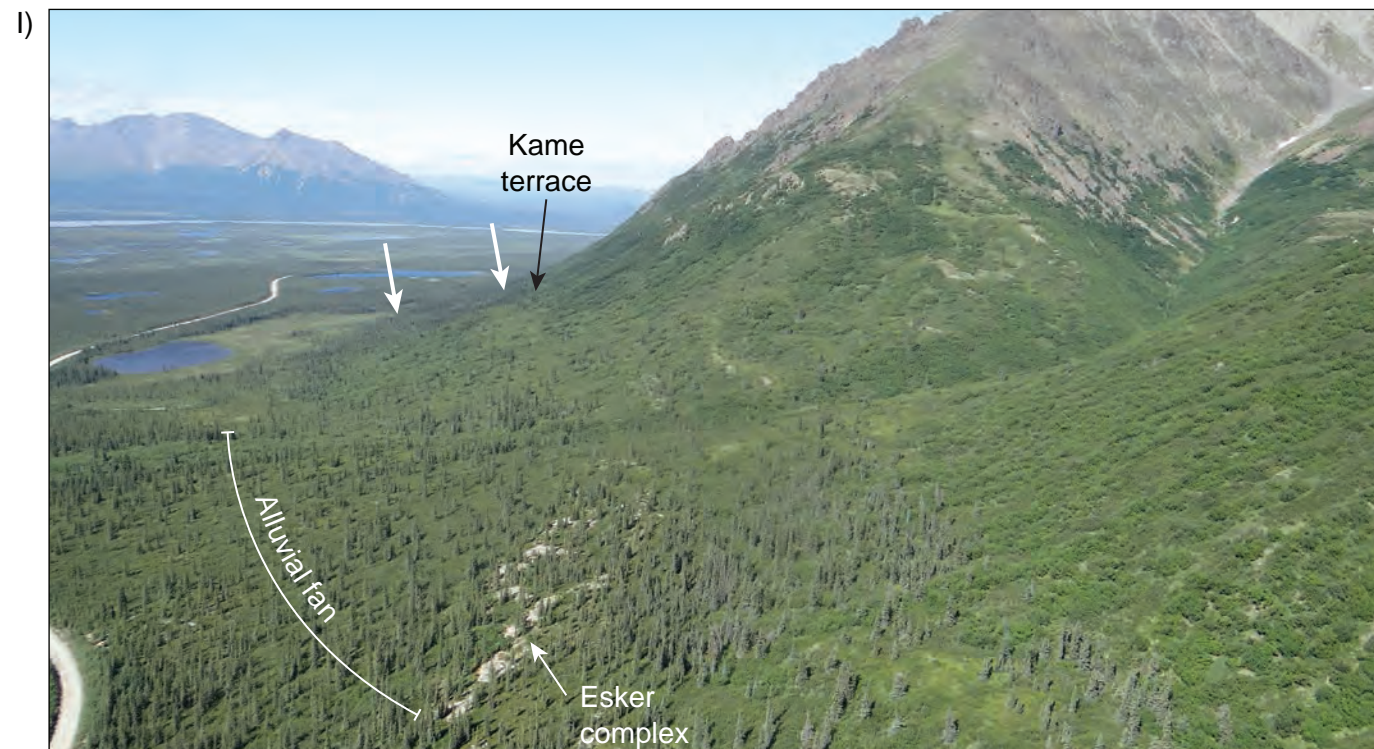
Overview looking west along mapped FCL-mapped lineaments that coincide with left-lateral moraines and kame terraces. The lineaments are interrupted by an alluvial fan and esker complex. Large arrows point along the mapped lineaments.

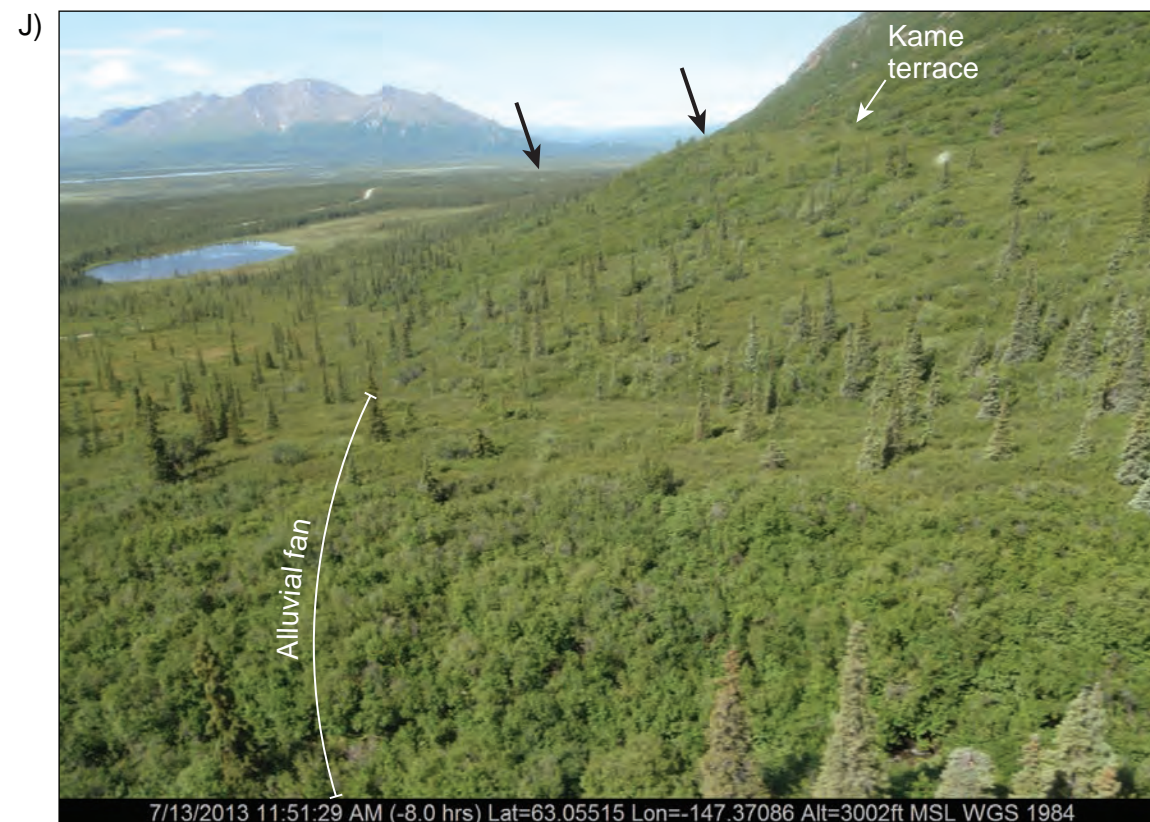
Close-up view looking west along FCL-mapped lineaments.

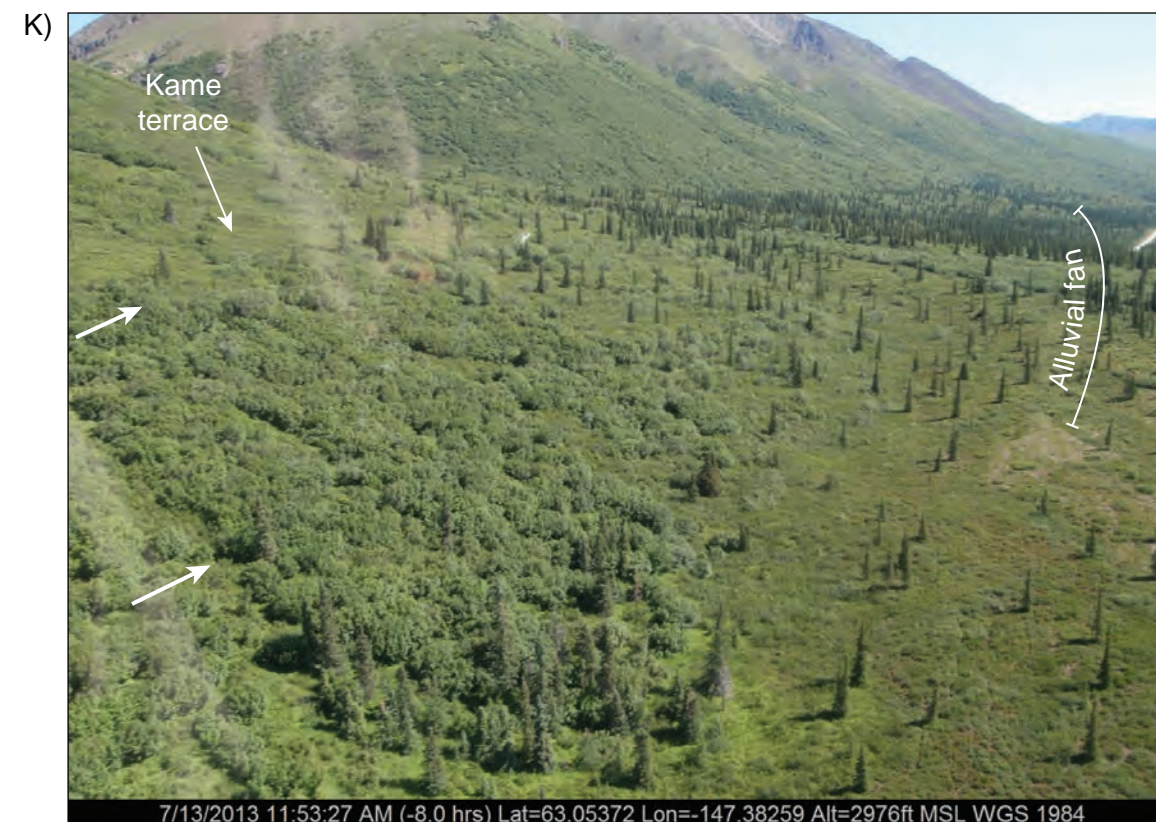
Close-up view looking east along FCL-mapped lineaments.

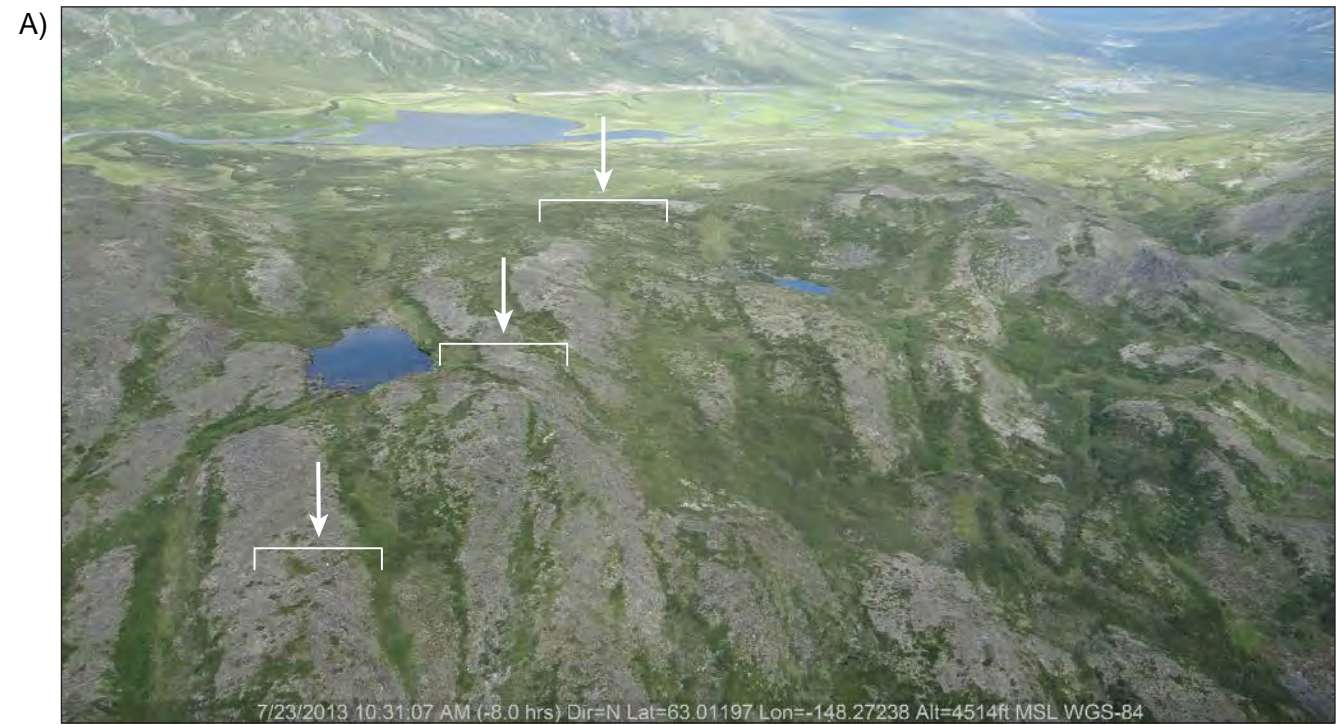
View looking northwest from location A. Arrows and brackets show projected trace of lineament. Note absence of continuous lineament across projected trace.

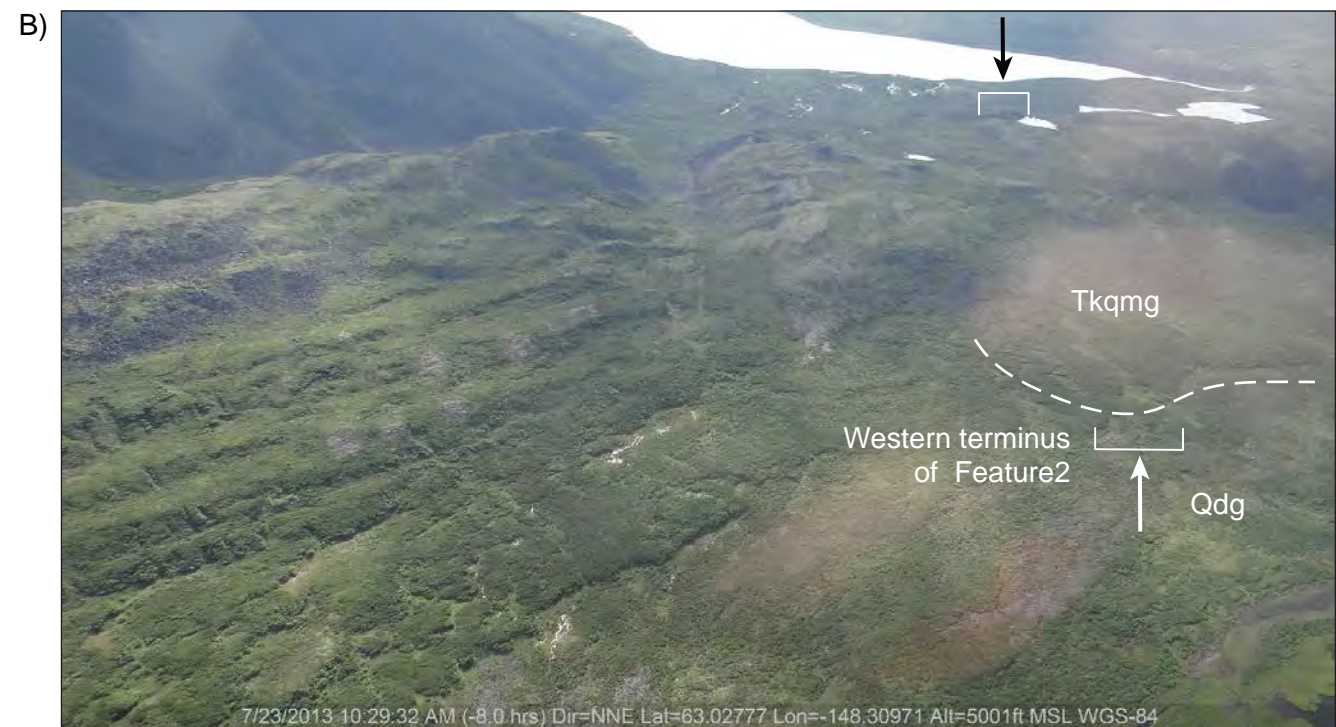
View looking southeast from location B. Arrows and brackets show projected trace of lineament. Note lack of deformation or lineament trace in foreground within Quaternary deposits.

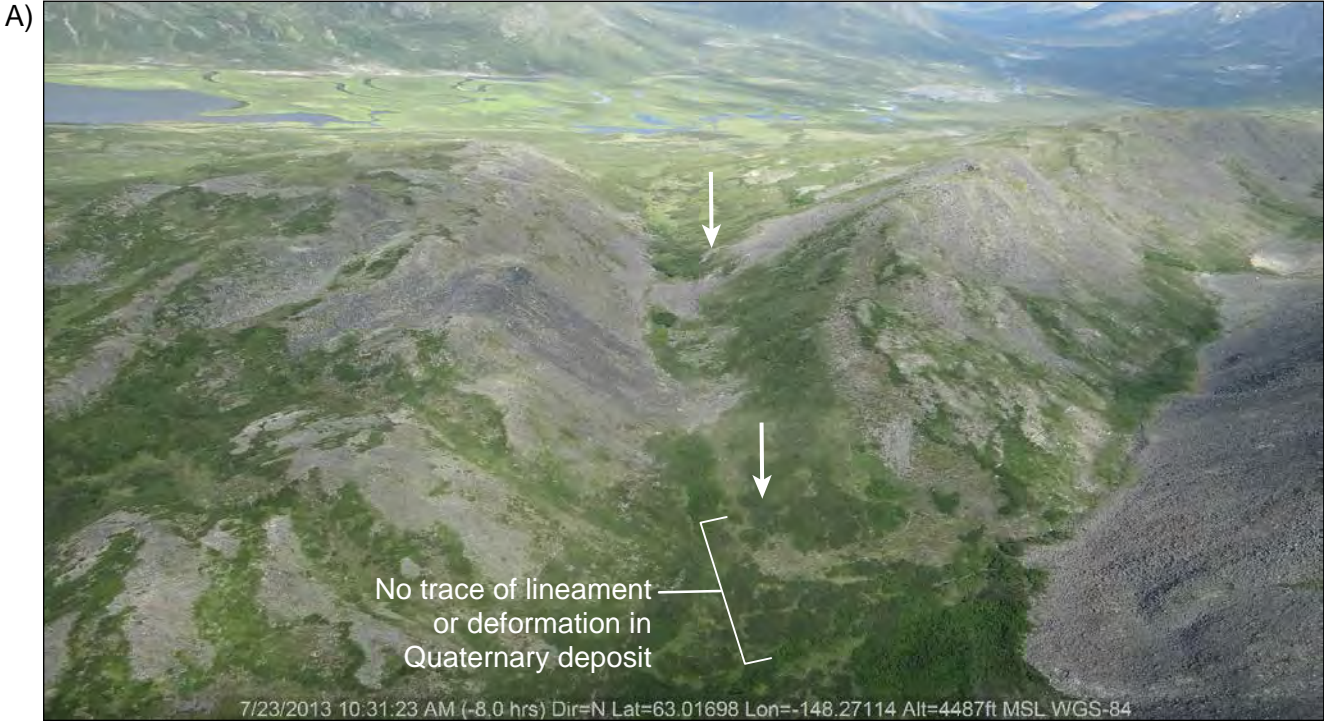
View looking northwest from location A. Arrows show the projected trace of lineament. Note absence of lineament or deformation in Quaternary deposits.

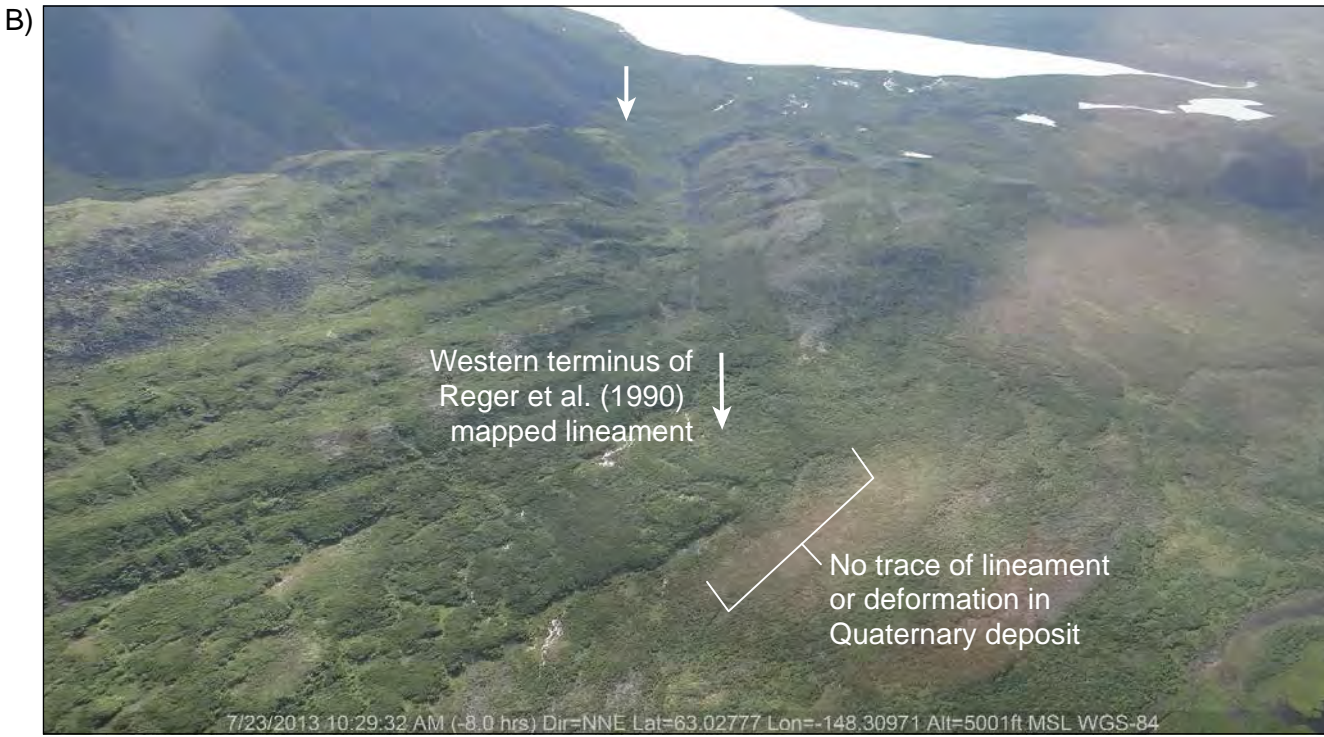
View looking southeast from location B. Arrows show the projected trace of lineament. Note absence of lineament or deformation in Quaternary deposits.

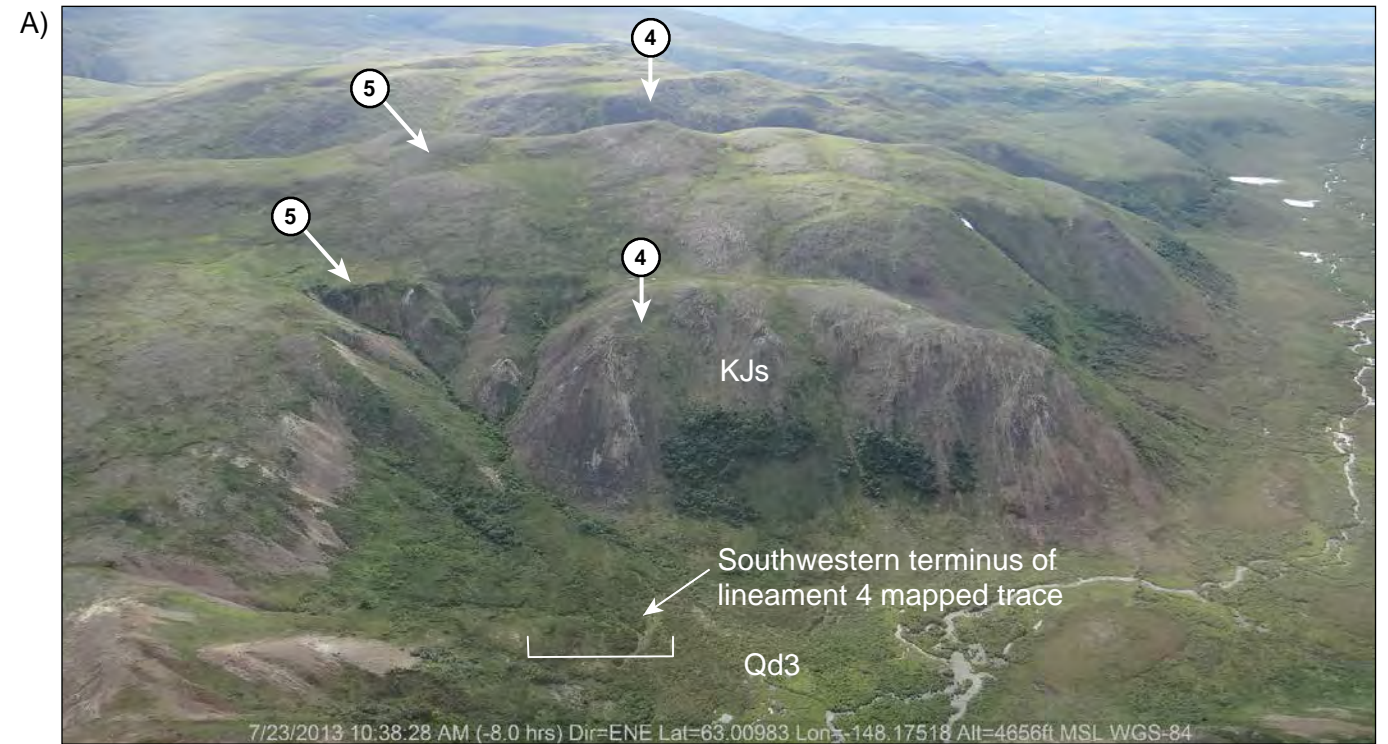
View looking southeast from location A. Arrows show the projected traces of Features 4 and 5. Note absence of lineament or deformation in Quaternary deposits in foreground.

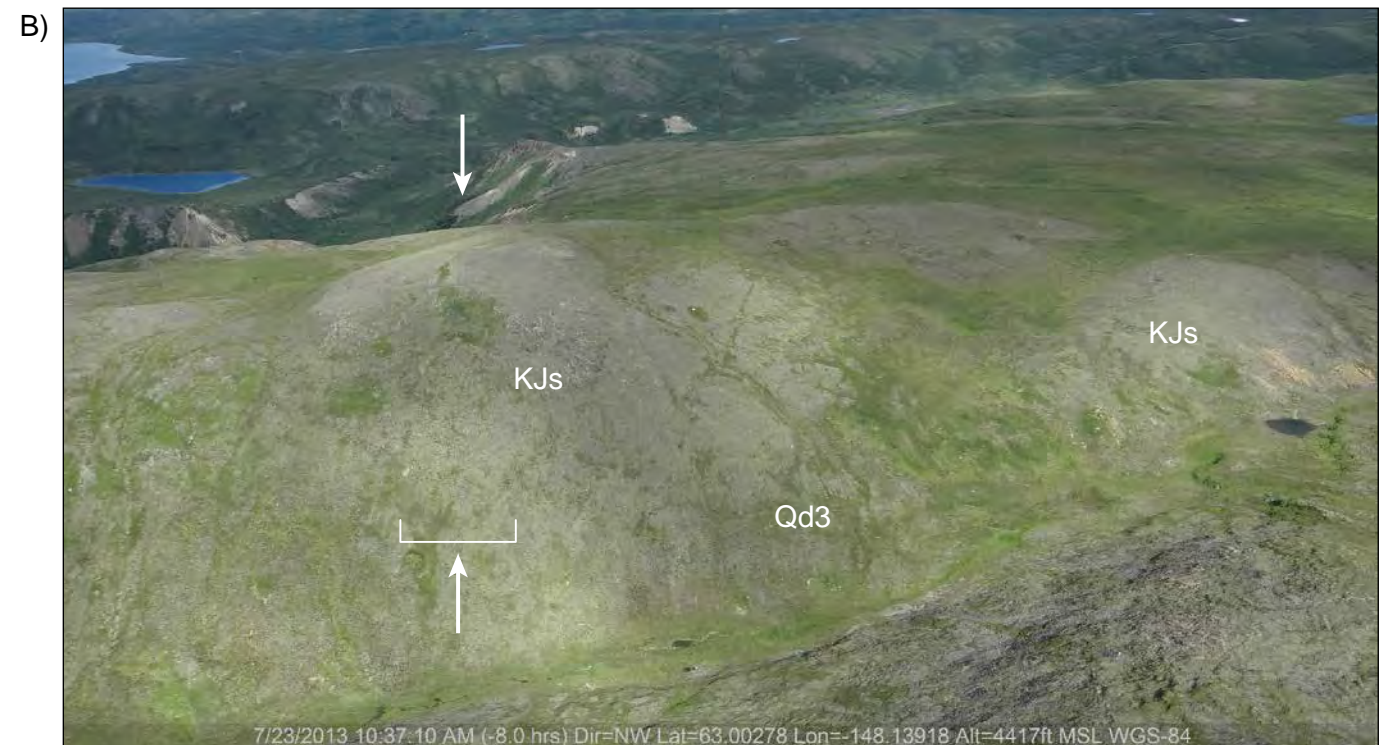
View looking northwest from location B. Arrows show the projected trace of Feature 5. Note absence of discernable lineament along mapped trace.

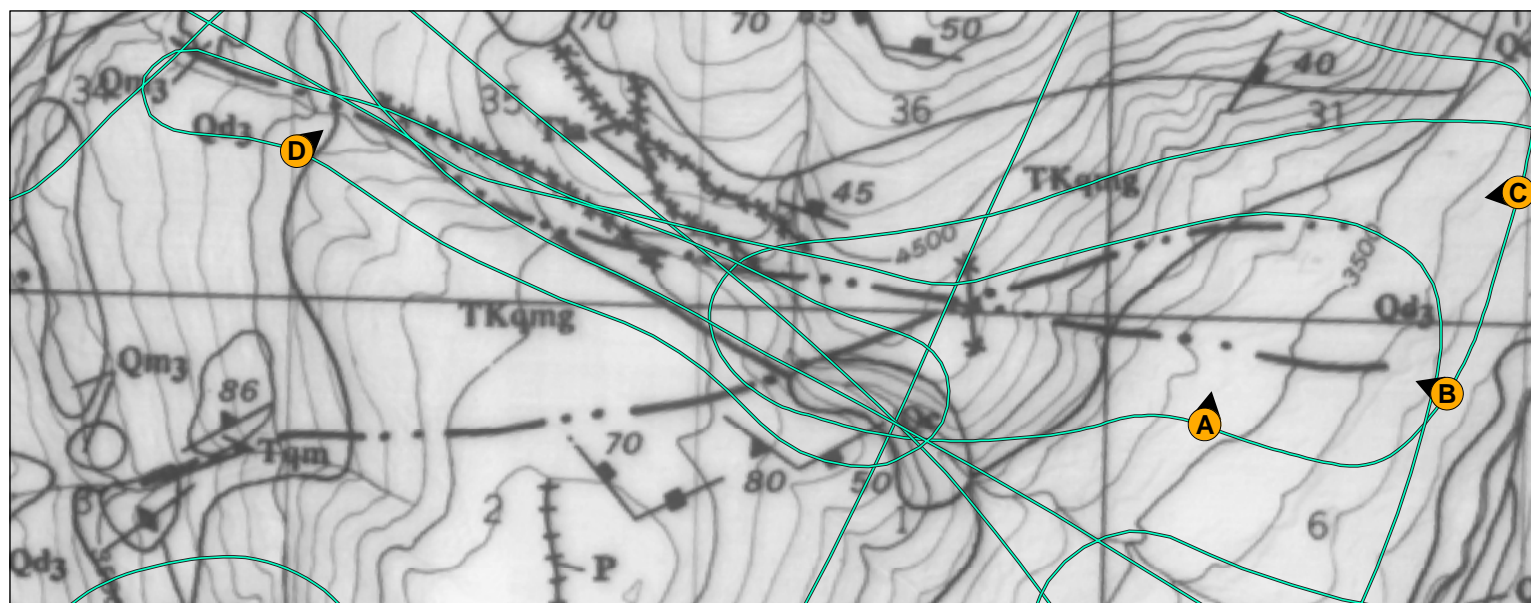
View looking northeast at lineaments 7 and 8 from photograph location A.

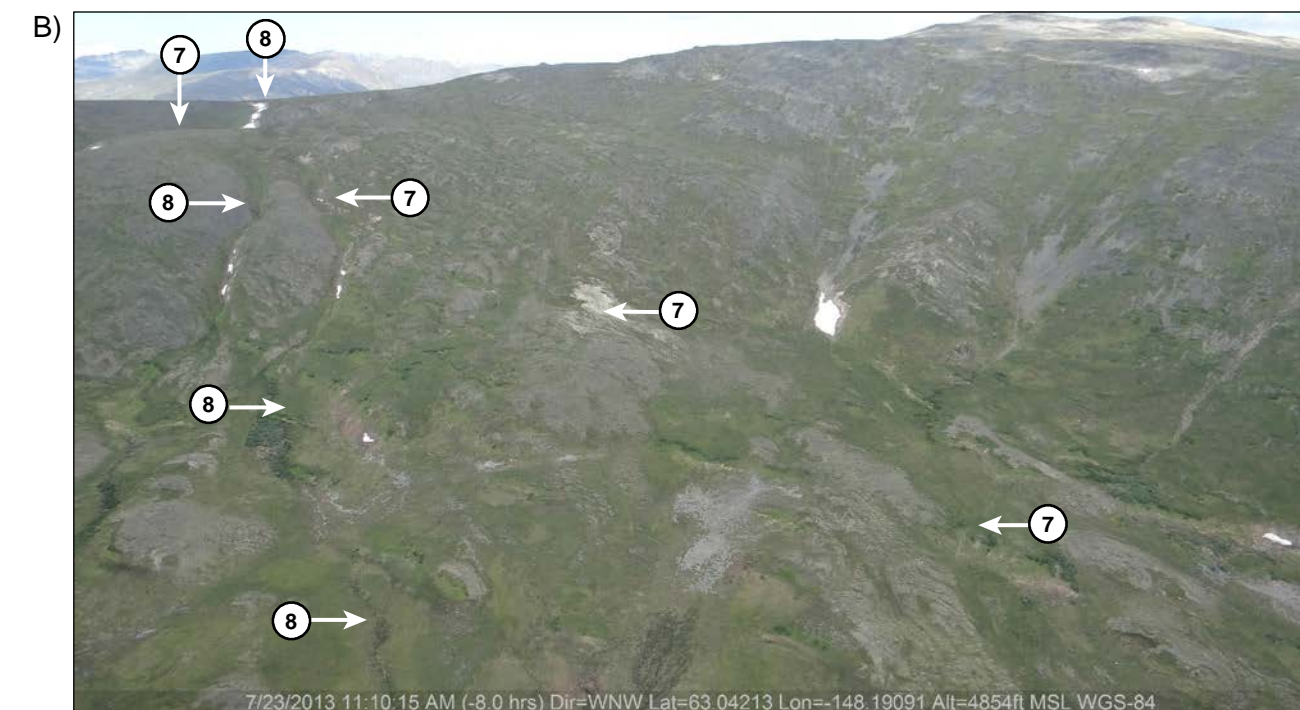
View looking west at lineaments 7 and 8 from photograph location B. Note that lineament 7 is a linear series of unrelated features.

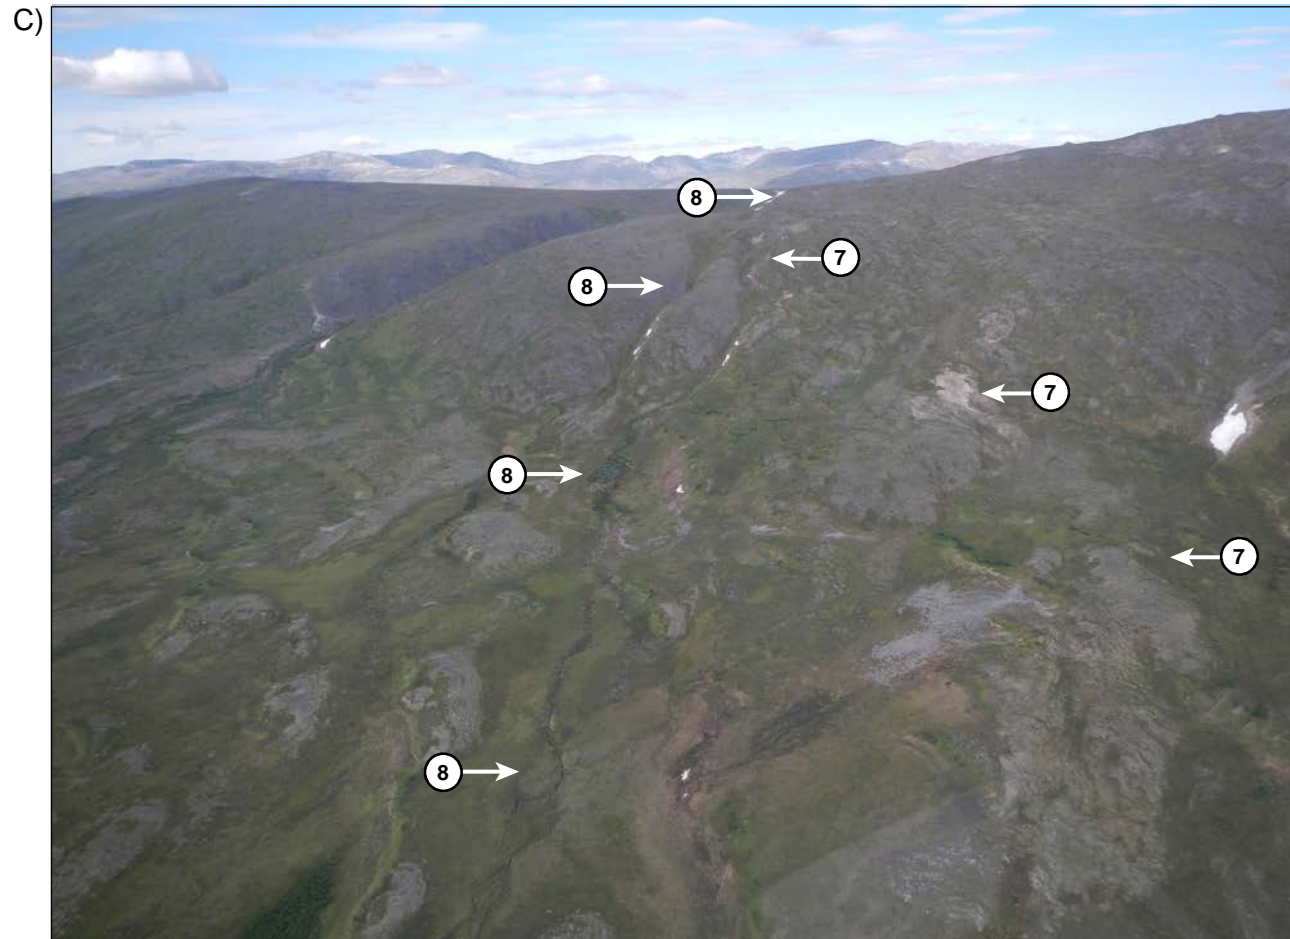
View looking southwest at lineaments 7 and 8 from photograph location C.

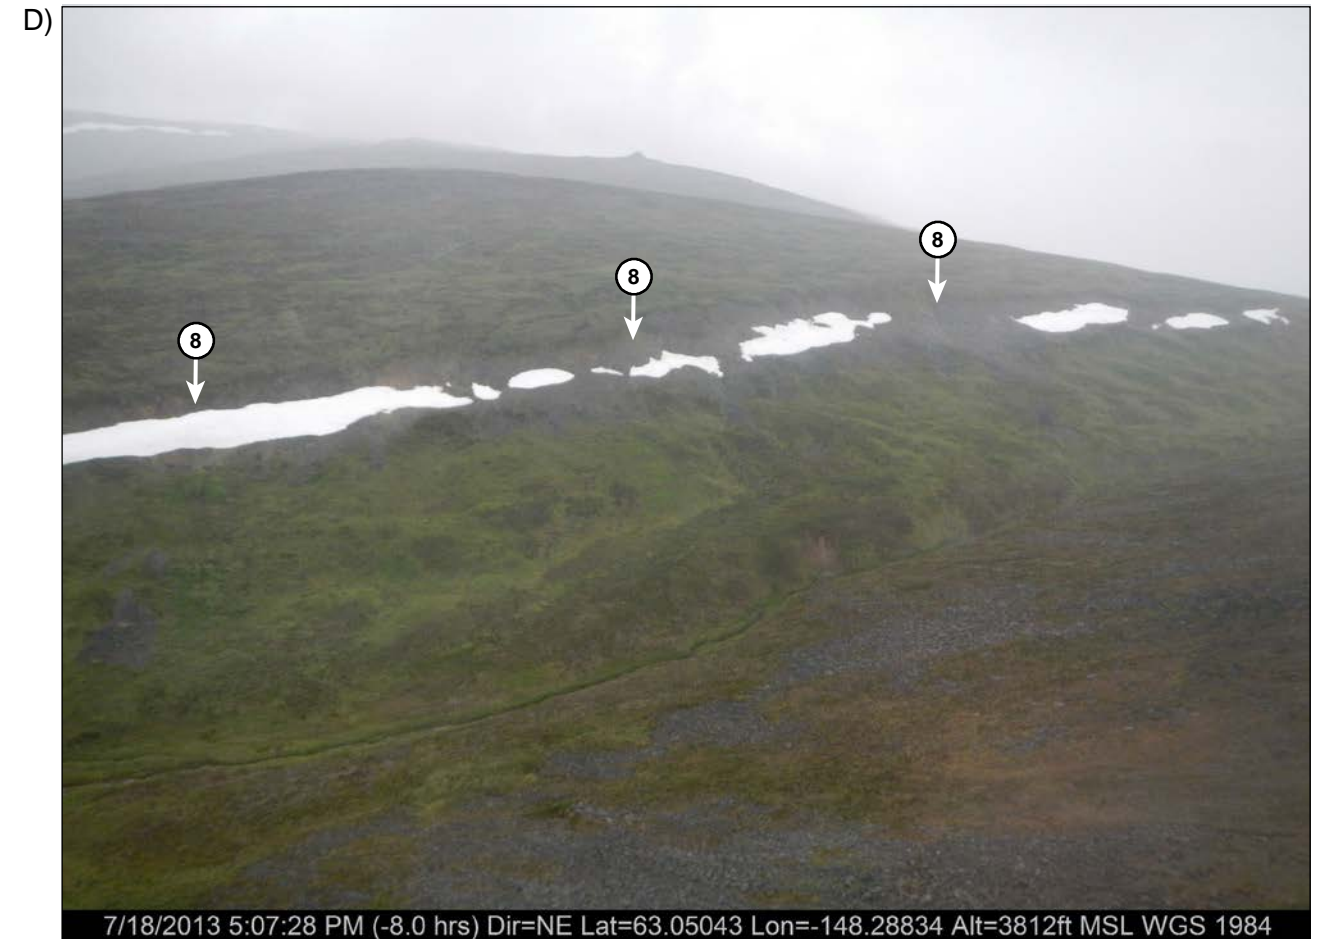
View looking northeast at lineament 7 from photograph location D.

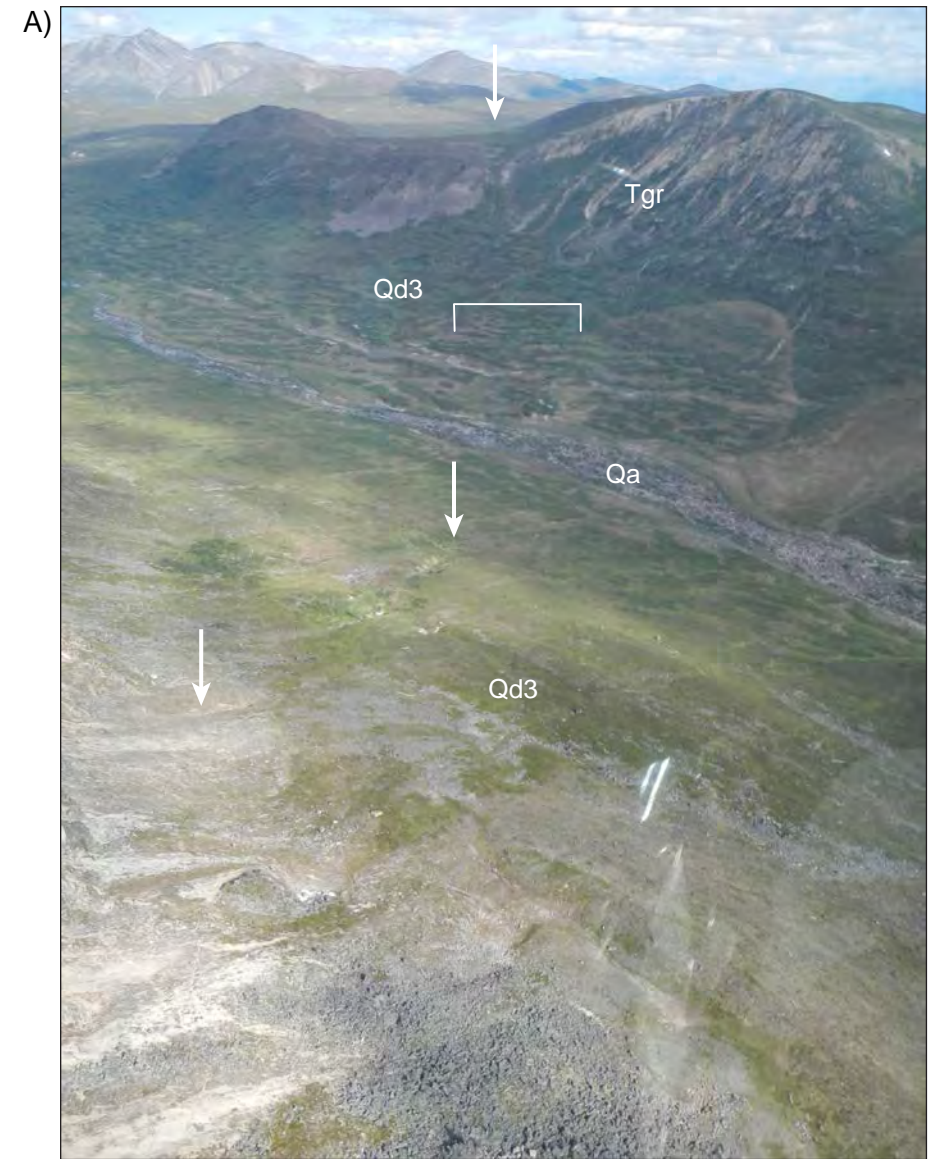
View looking north from location A. Arrows and brackets show the projected trace of lineament.

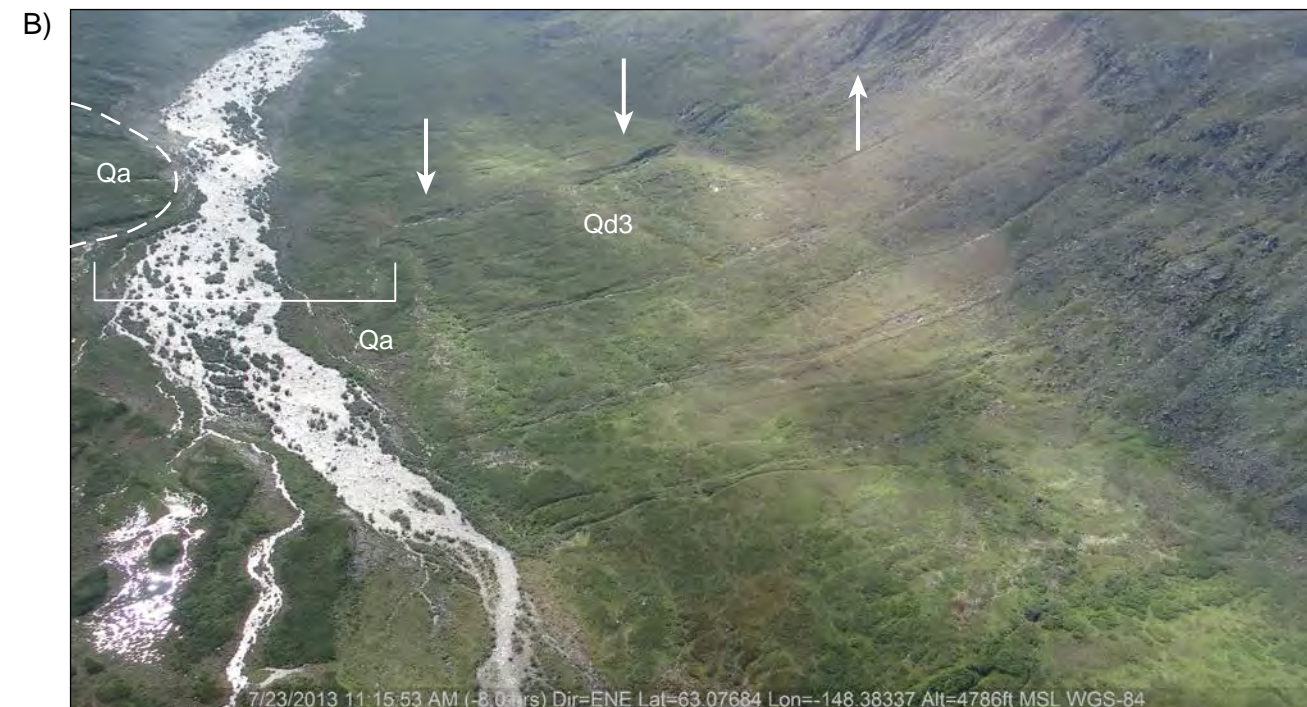
View looking south from photograph location B. Arrows show the projected trace of lineament. In Qd3 (till) the lineament is coincident with linear drainage in till deposit. Note absence of lineament in Qa deposit.

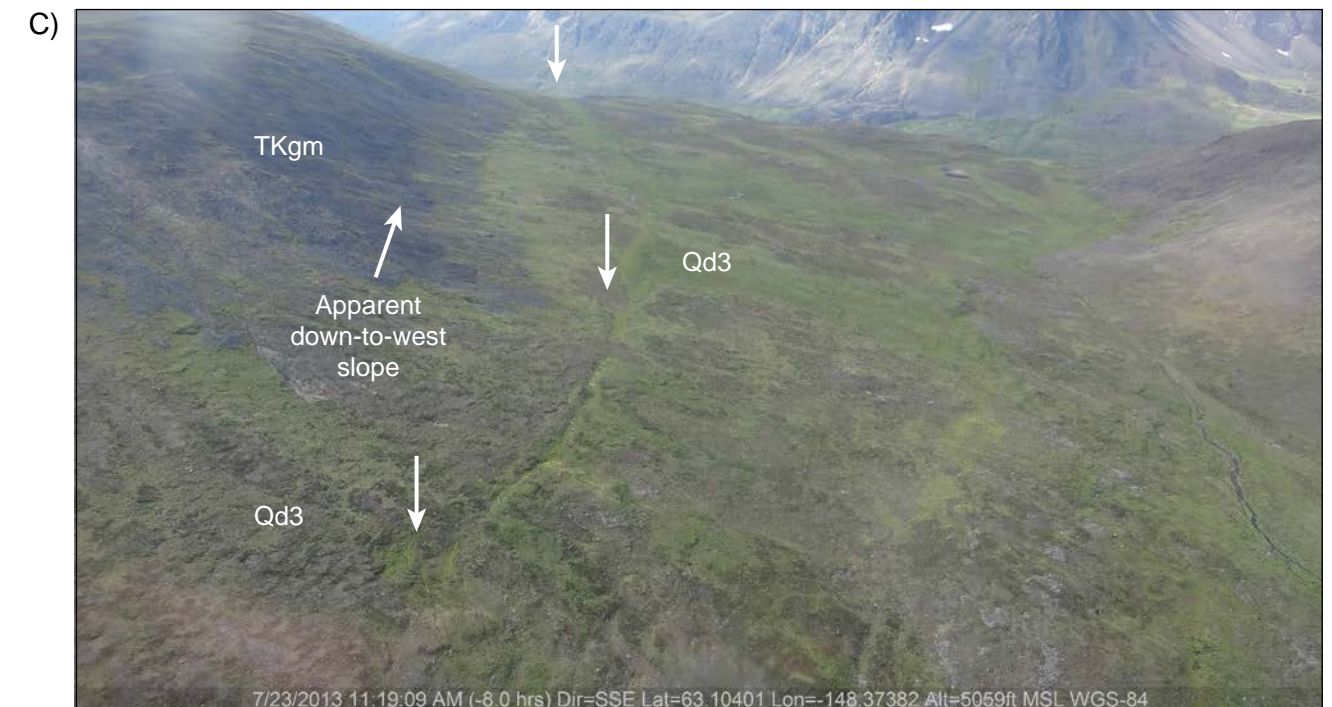
View looking south from photograph location C. Arrows show the projected trace of lineament. Note lineament is coincident with a linear drainage in this view.

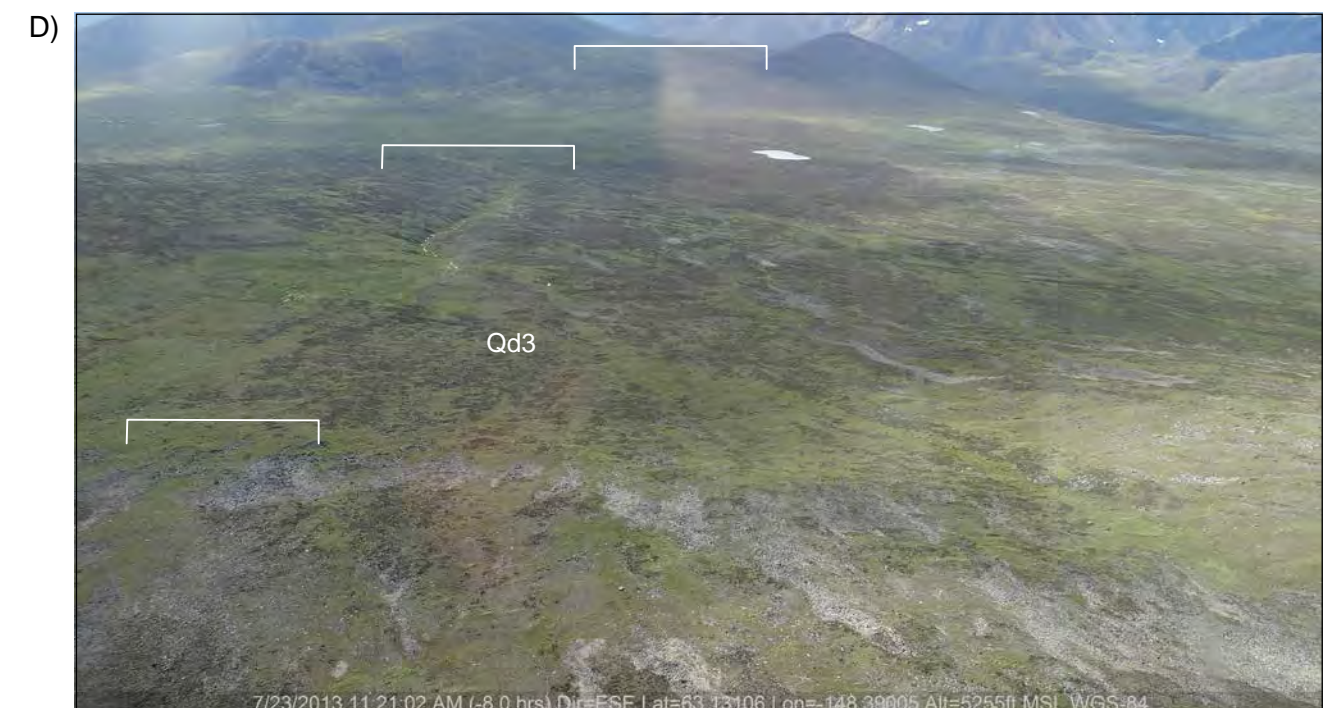
View looking south from location C. Brackets show the projected trace of lineament.
