BUSTNA-WATANA HYDROELECTRIC PROJECT  
Broad Pass Area

SUSTITNA-WATANA HYDROELECTRIC PROJECT  
Castle Mountain Extension Area

SUSITNA-WATANA HYDROELECTRIC PROJECT  
Clearwater Mountains Area

**Appendix B:  
Strip Maps and Photographic Documentation  
of Lineament Data for Lineaments Mapped by Reger et al. (1990)**

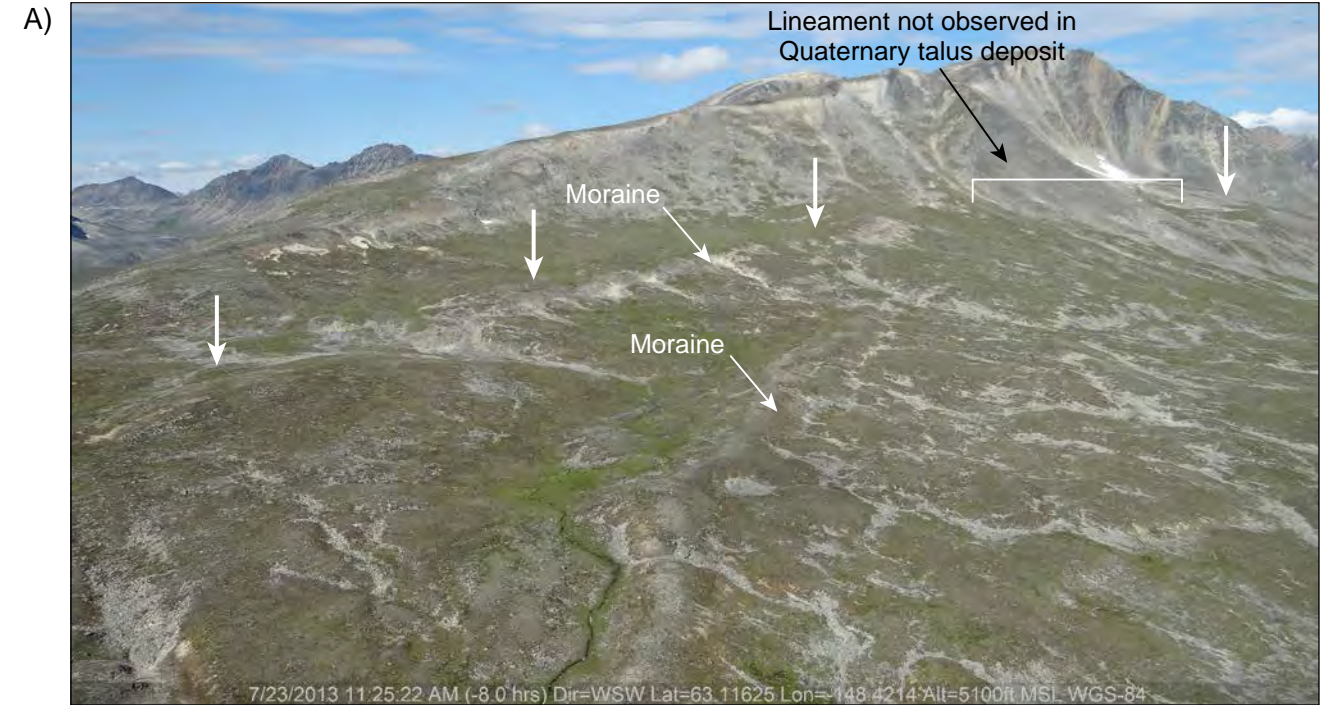
View looking west from location A. Arrows and brackets show projected trace of Feature 11 lineament. Note the mapped lineament correlates with a moraine crest.

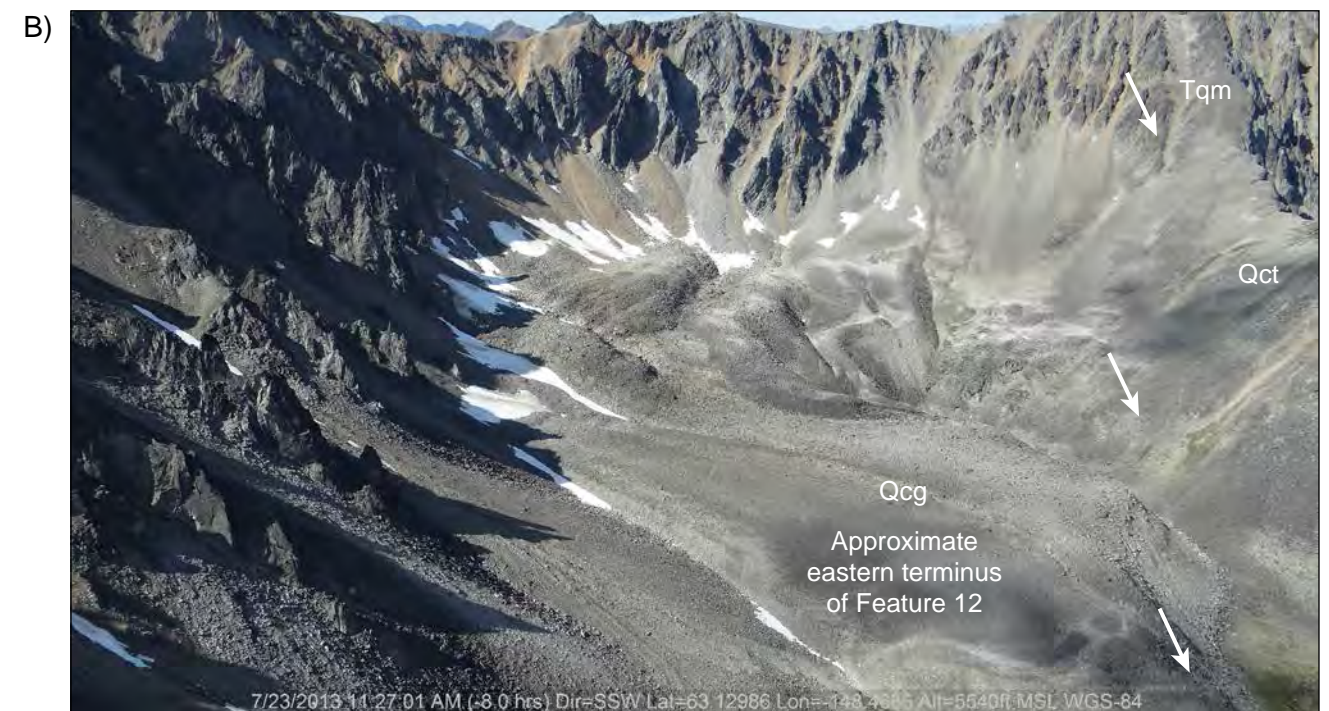
View looking west from location A. Brackets show projected trace of Feature 12 lineament. Note the trace of the lineament is a collection of unrelated features rather than a through-going feature.

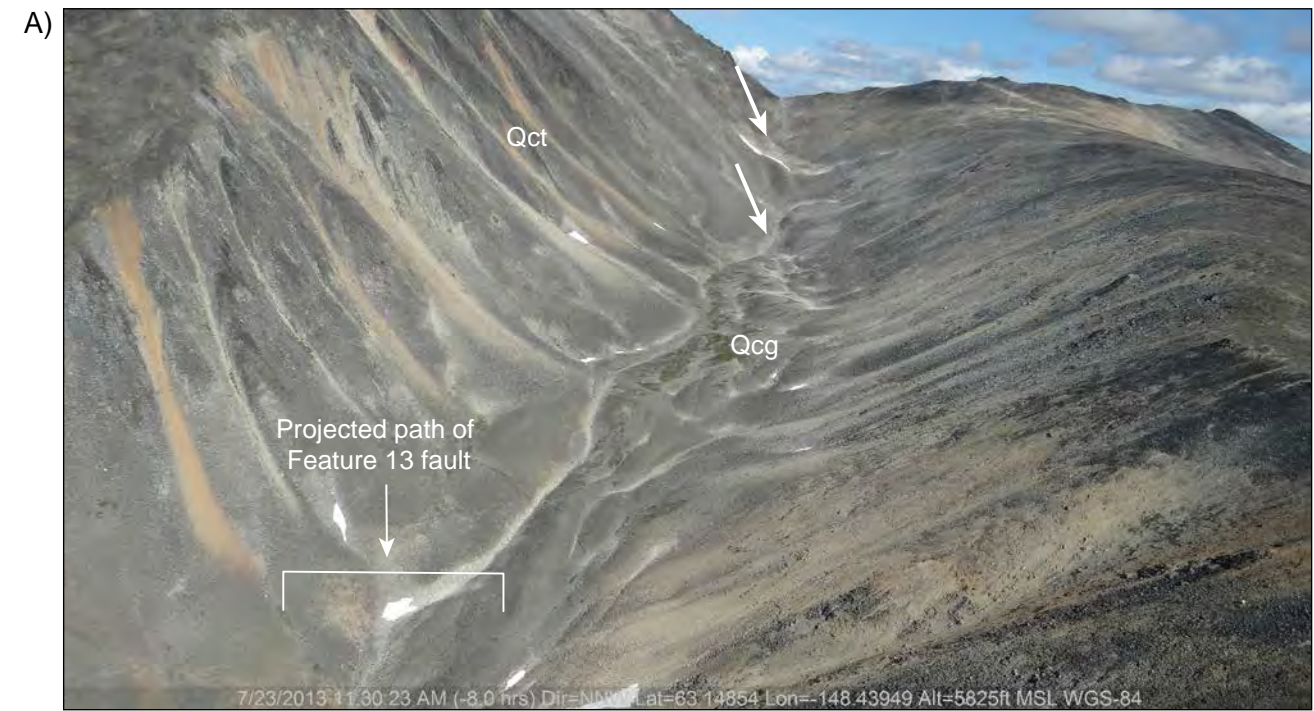
View looking north-northwest from location A. The bracket indicates the projected path of Feature 13 fault. Arrows show the projected trace of Feature 14 lineament. Note absence of evidence of fault under bracket in Quaternary deposits.

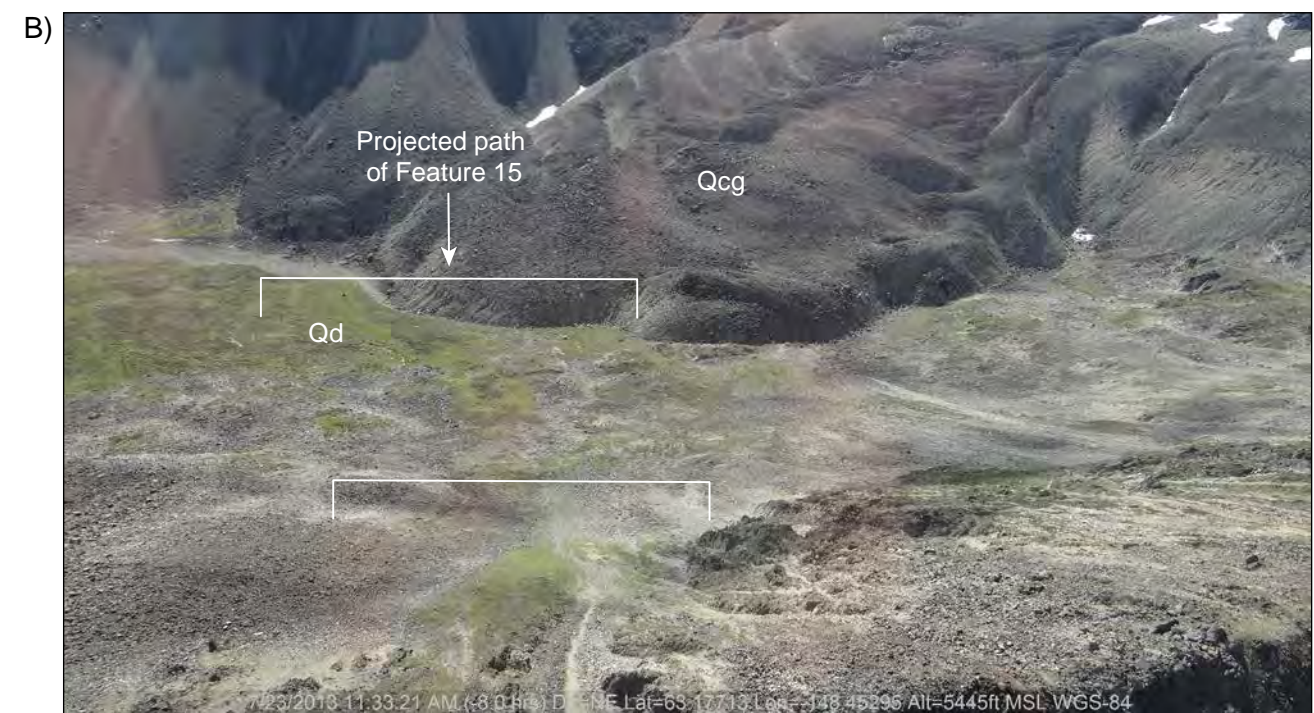
View looking southeast from photograph location B. The brackets indicates the projected path of Feature 15 fault. Note absence of evidence of fault under bracket in Quaternary deposits.

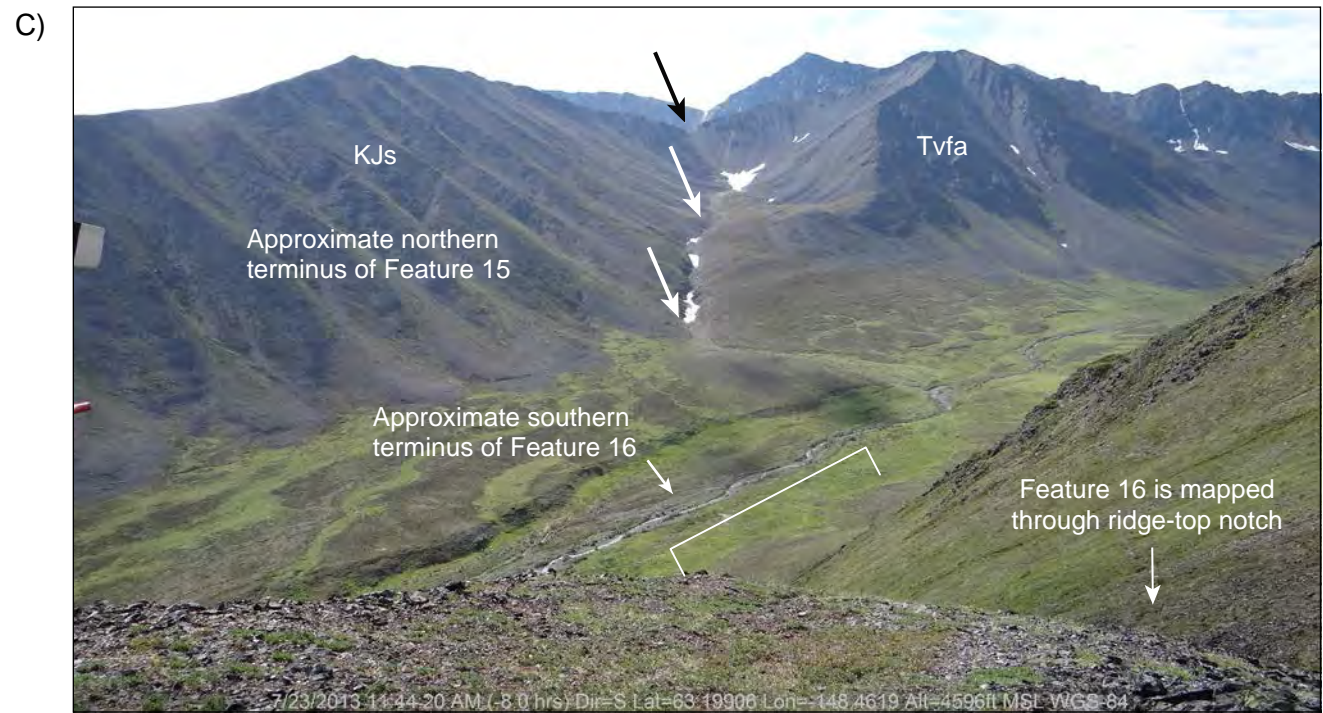
View looking south from location C. The arrows and bracket indicates the projected path of Feature 15 and 16 faults. Note absence of linear expression in valley floor within Quaternary deposits.

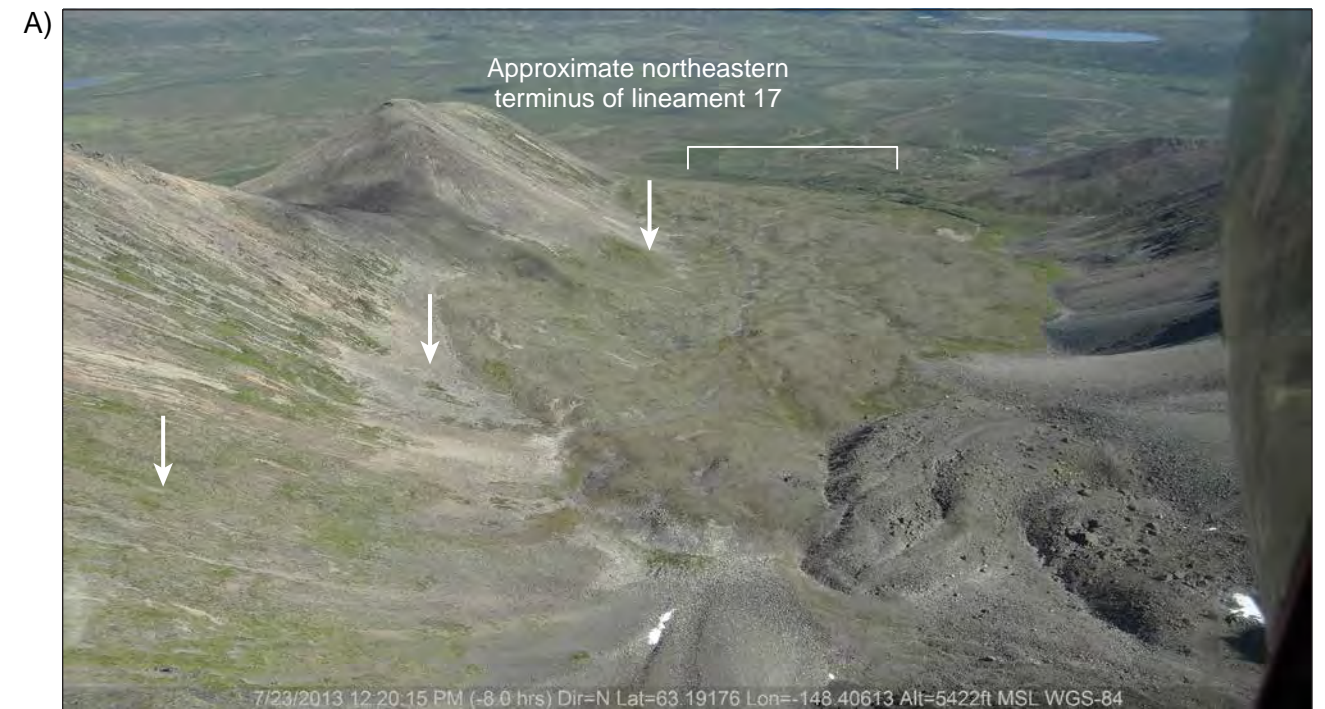
View looking northeast from location A. Arrows and brackets show projected trace of lineament 17.

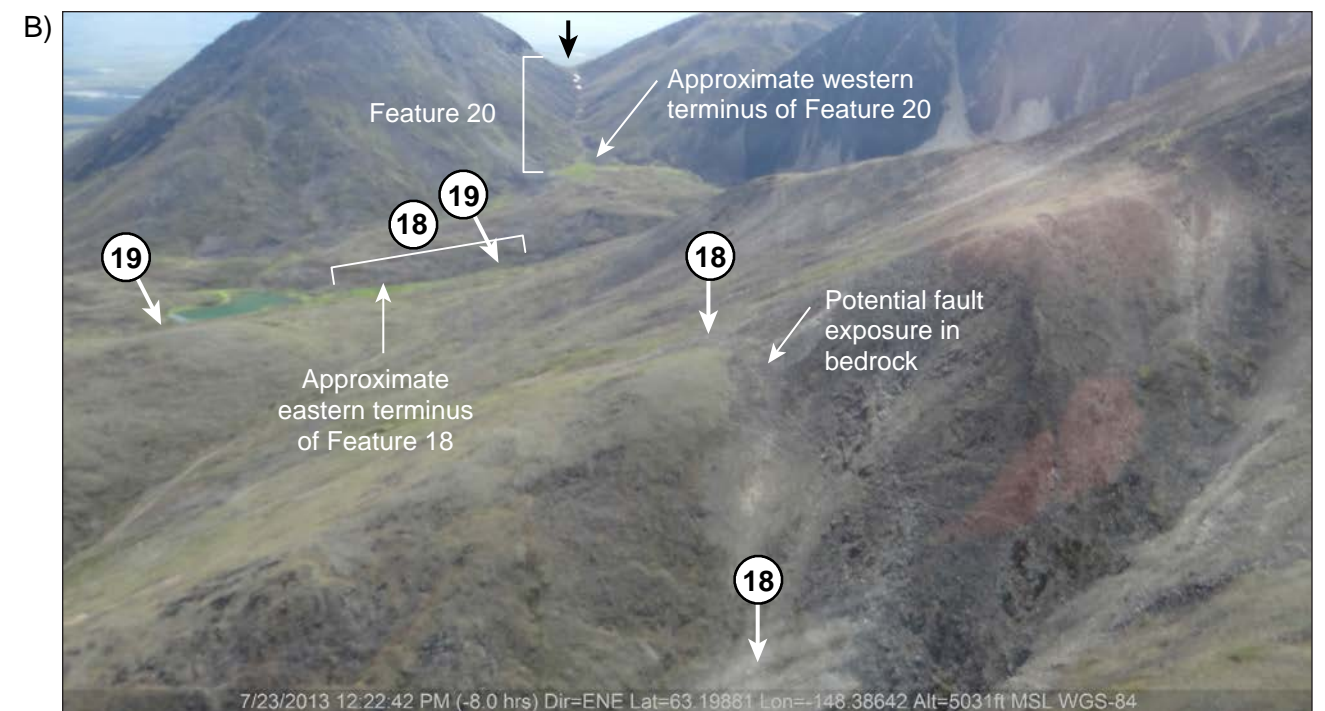
View looking southeast from photograph location B. Arrows and brackets indicated the projected trace of lineaments 18, 19, and 20.

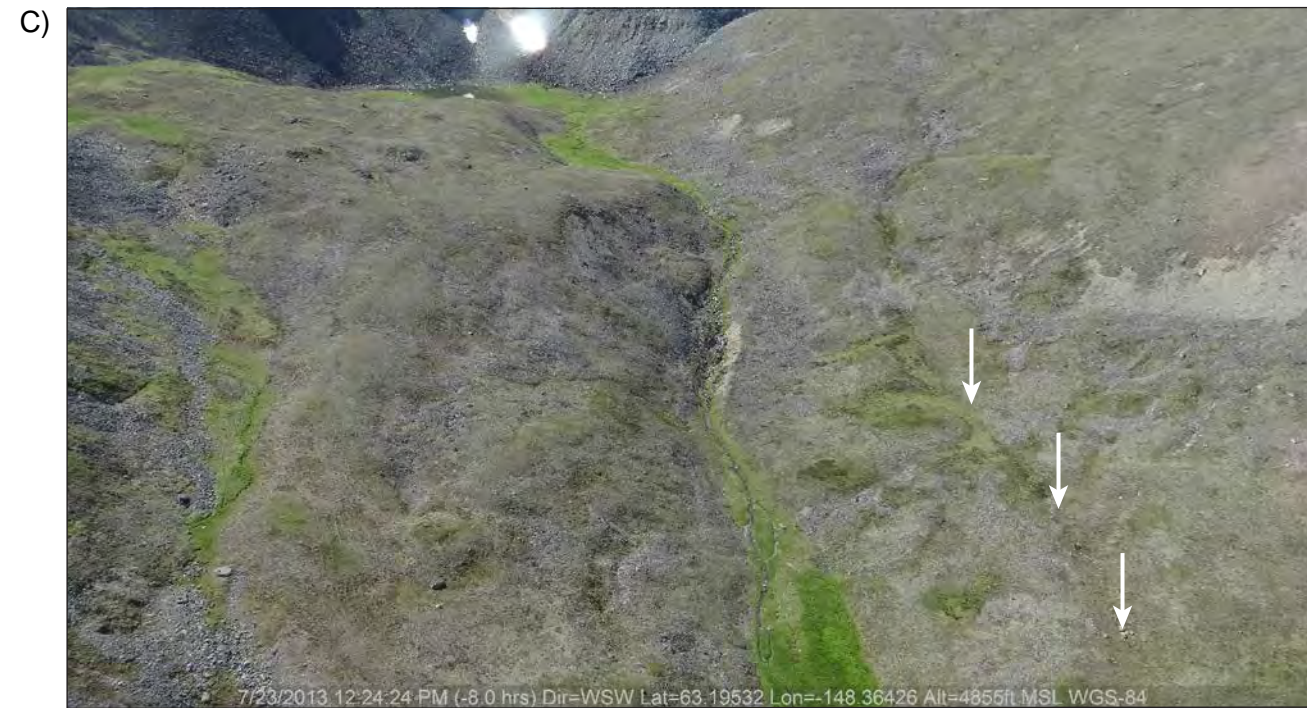
View looking southwest from photograph location C. The arrows indicate the projected path of Feature 19 lineament.

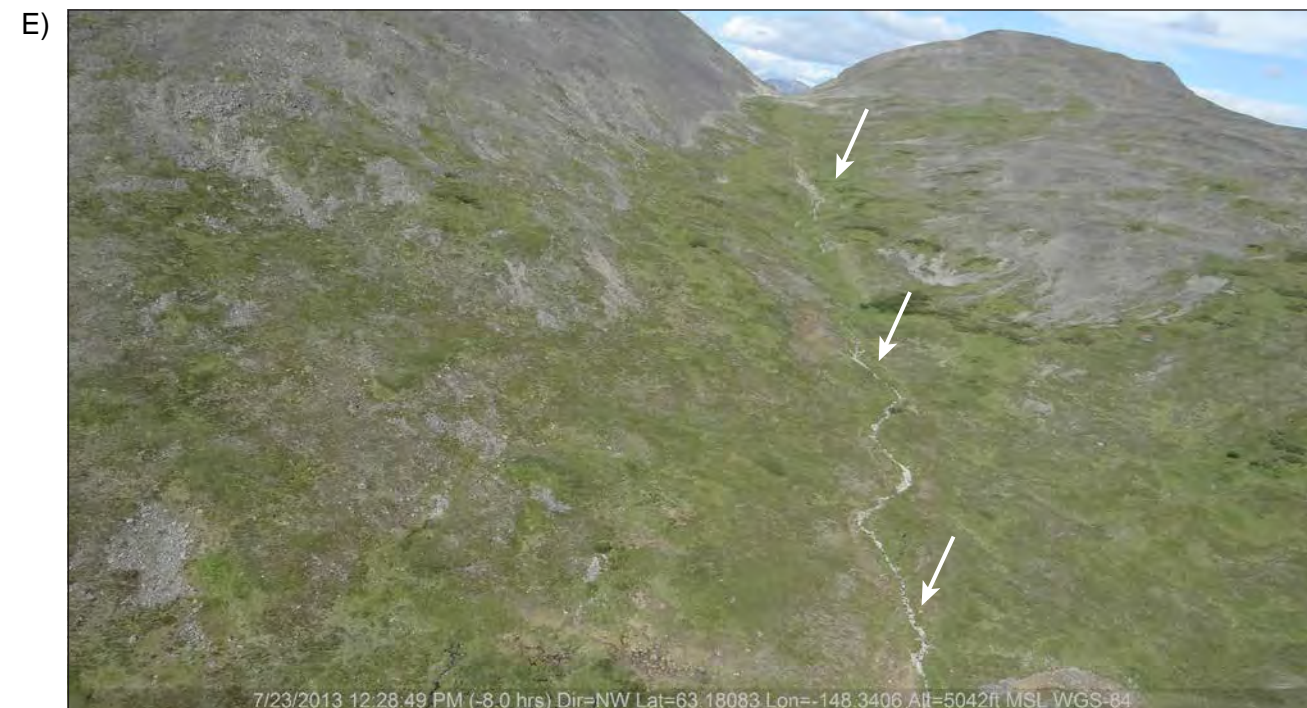
View looking northwest from photograph location E. Arrows show the mapped trace of Feature 20 lineament. Note mapped trace of Feature 20 is coincident with linear drainage.

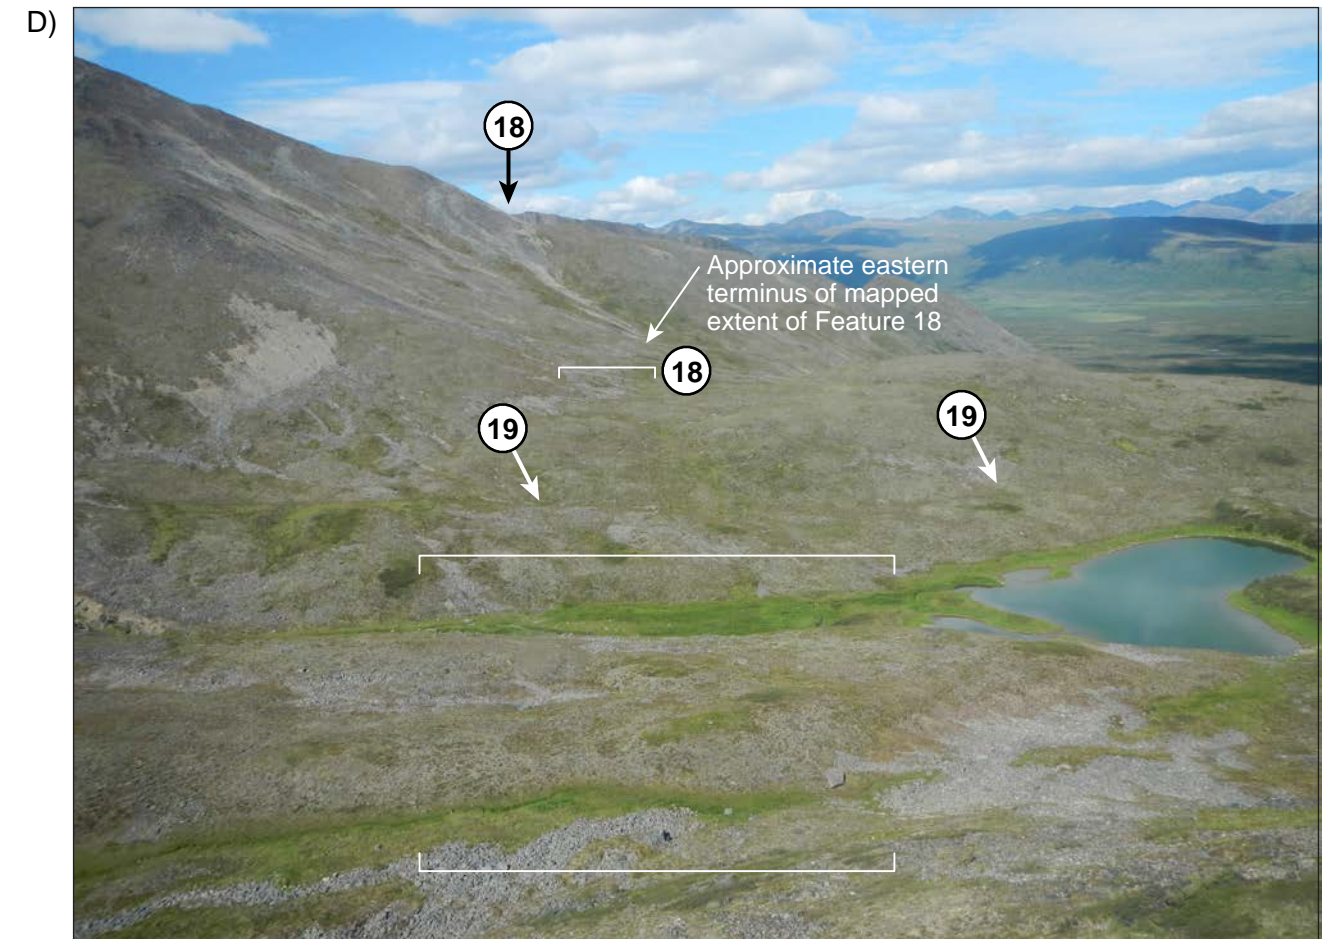
View looking northwest from photograph location D. Arrows show the mapped trace of Features 18 and 19. Note absence of lineaments or apparent deformation in Quaternary deposits between brackets in lower middle portion of photograph.

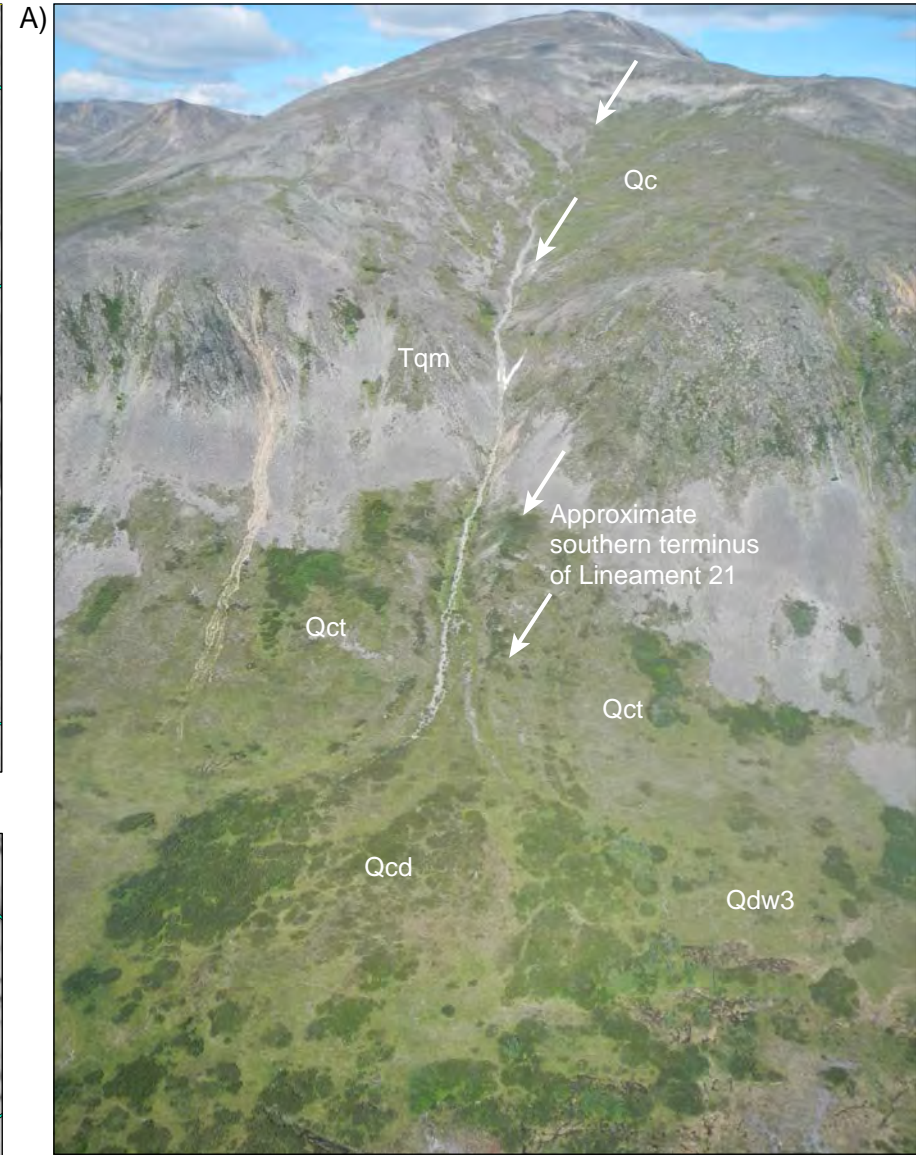
View looking northwest from photograph location A. Arrows indicate the projected path of Feature 21 lineament.

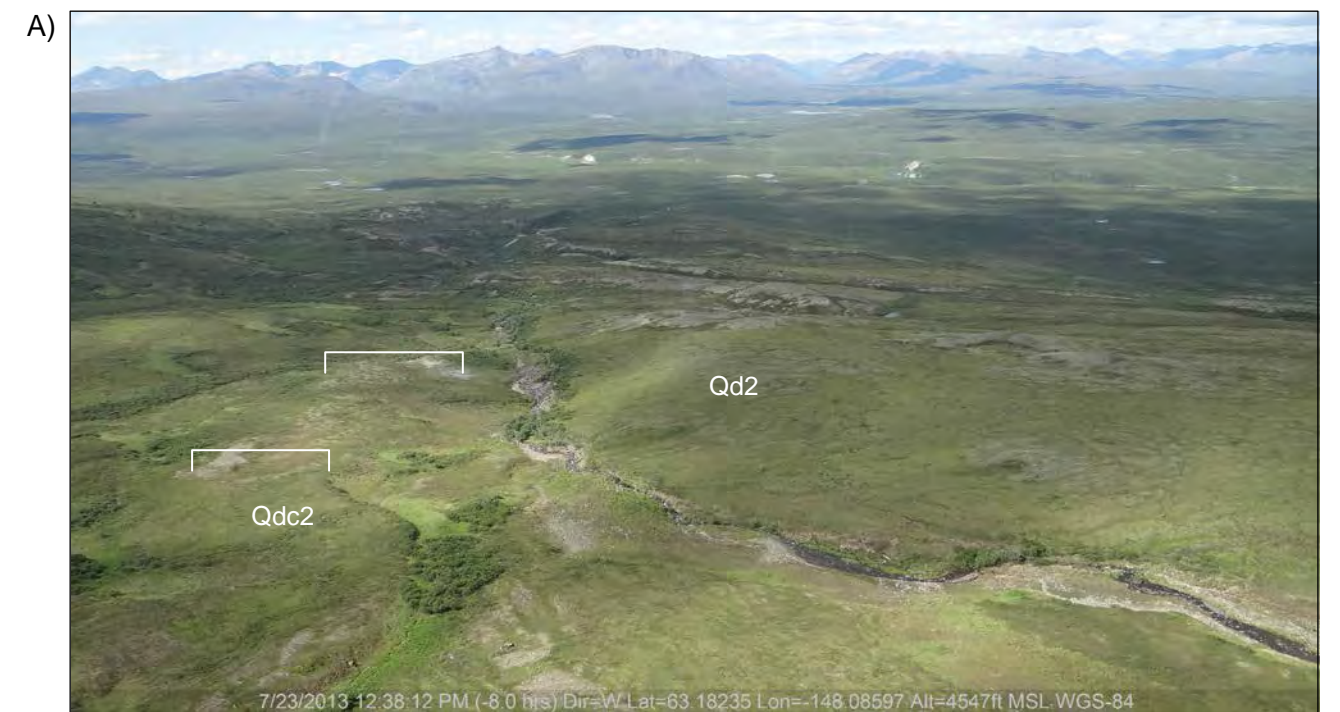
View looking west from photograph location A. Brackets show the projected trace of Feature 22. Note the absence of a continuous lineament along the projected trace and exposed till on low relief ridge crest between drainages.

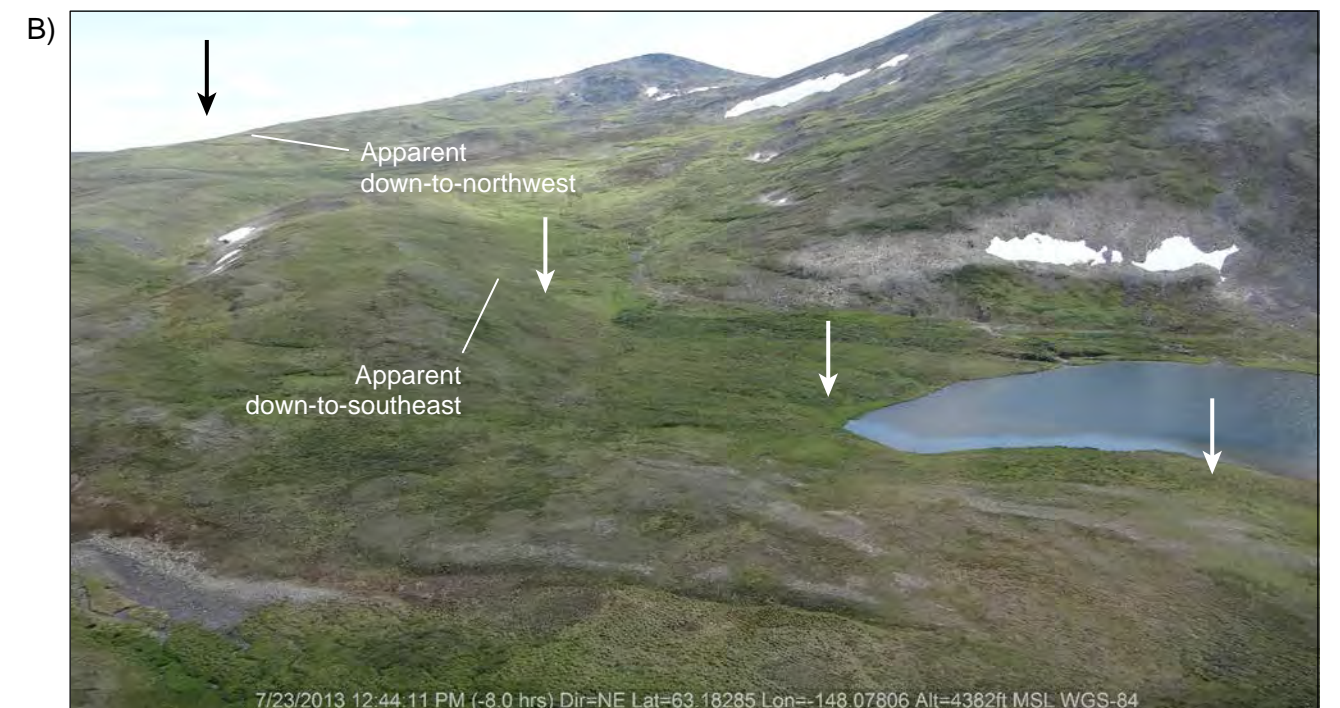
View looking east from photograph location B. Arrows and brackets indicate the projected path of Feature 22 lineament. Note change in apparent vertical displacement.

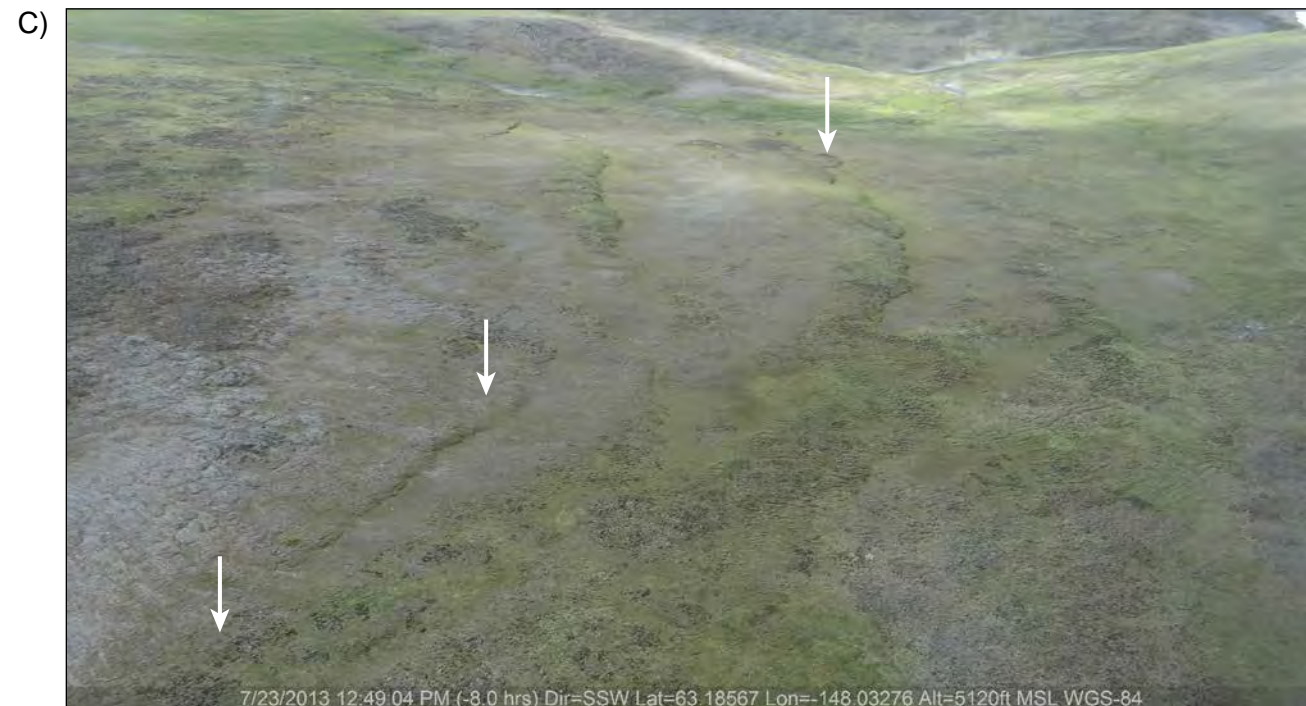
View looking west from photograph location C. Arrows show the projected trace of the Feature 22 lineament. Note linear expression is coincident with solifluction lobes and not continuous.

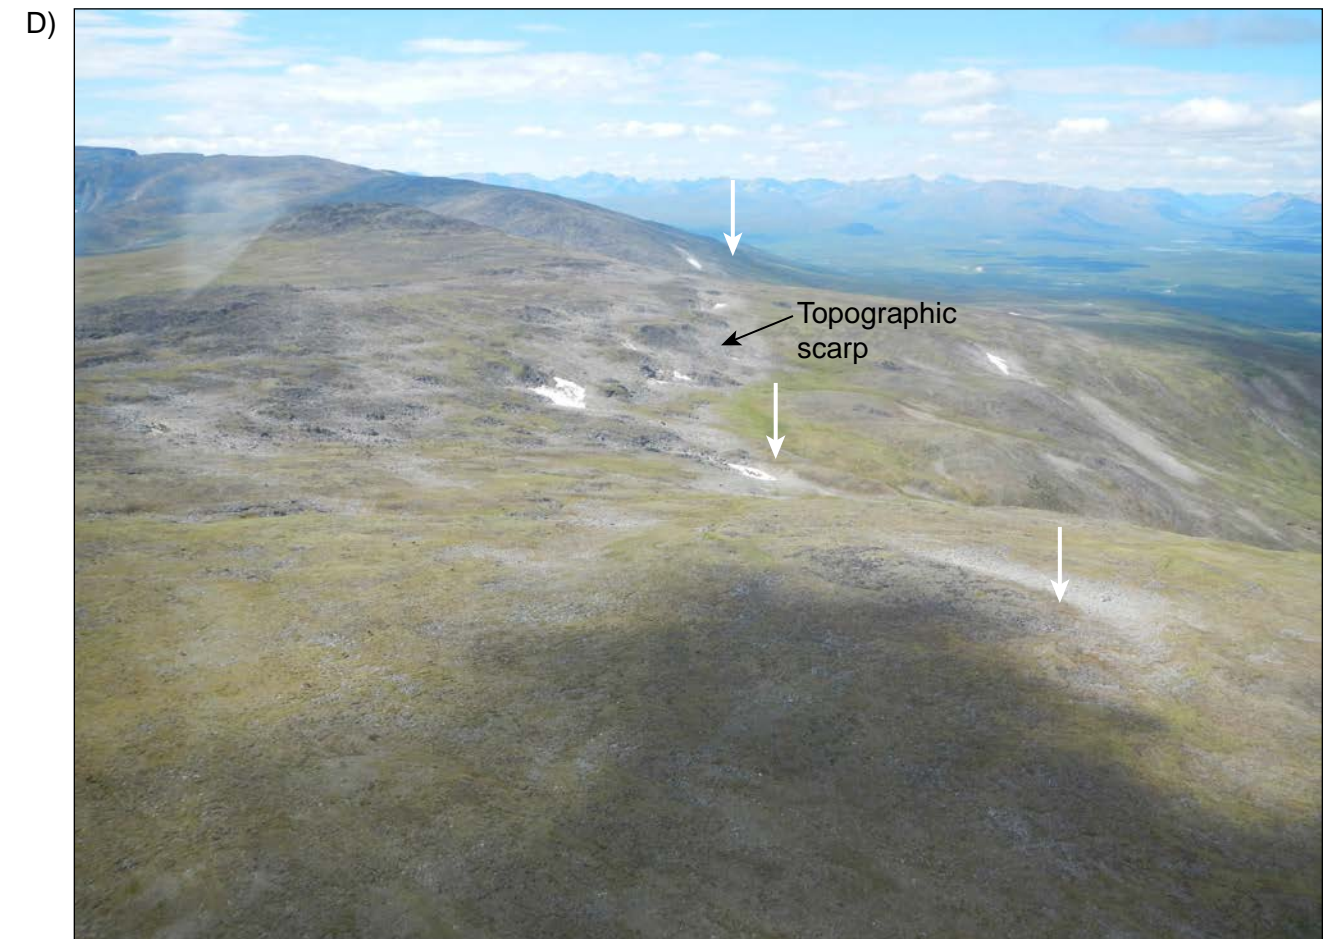
View looking west from photograph location C. Arrows show the projected trace of the Feature 22 lineament. Note topographic scarp in Photograph D is not proportional to minor scarps associated with solifluction in Photograph C.

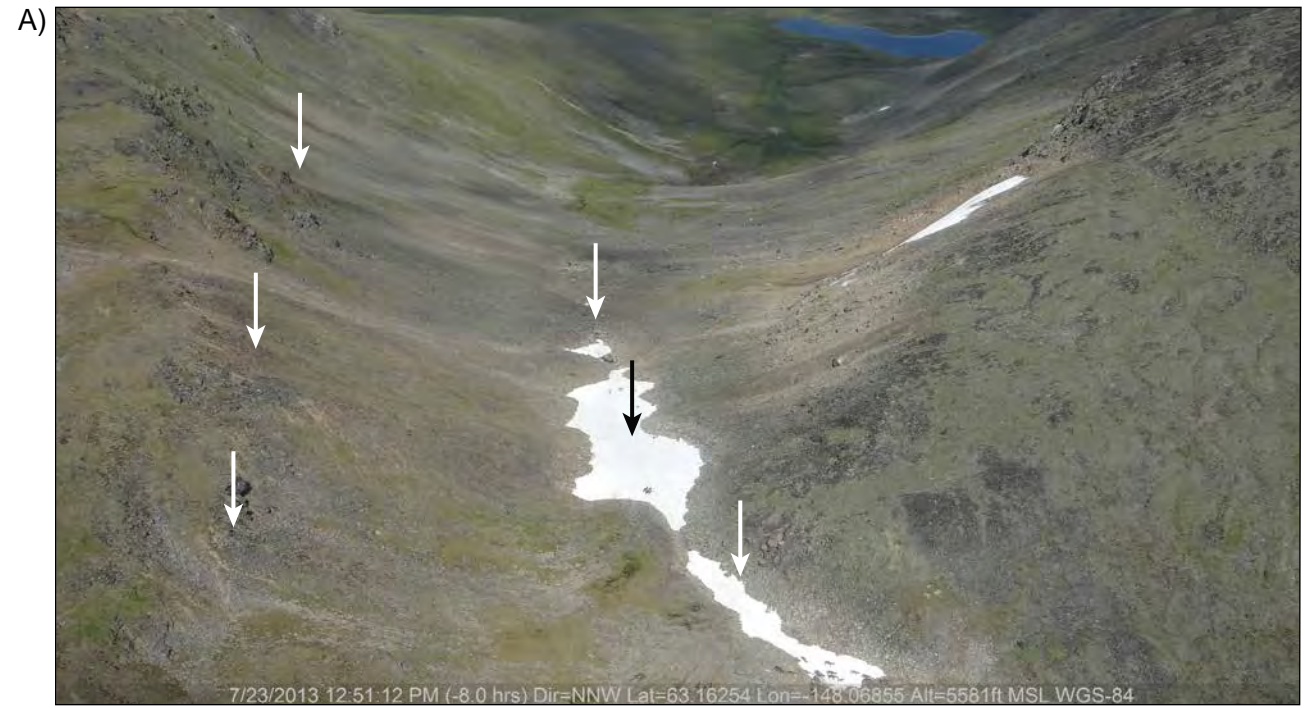
View looking west from photograph location C. Arrows indicate the projected path of the Feature 24 lineament.

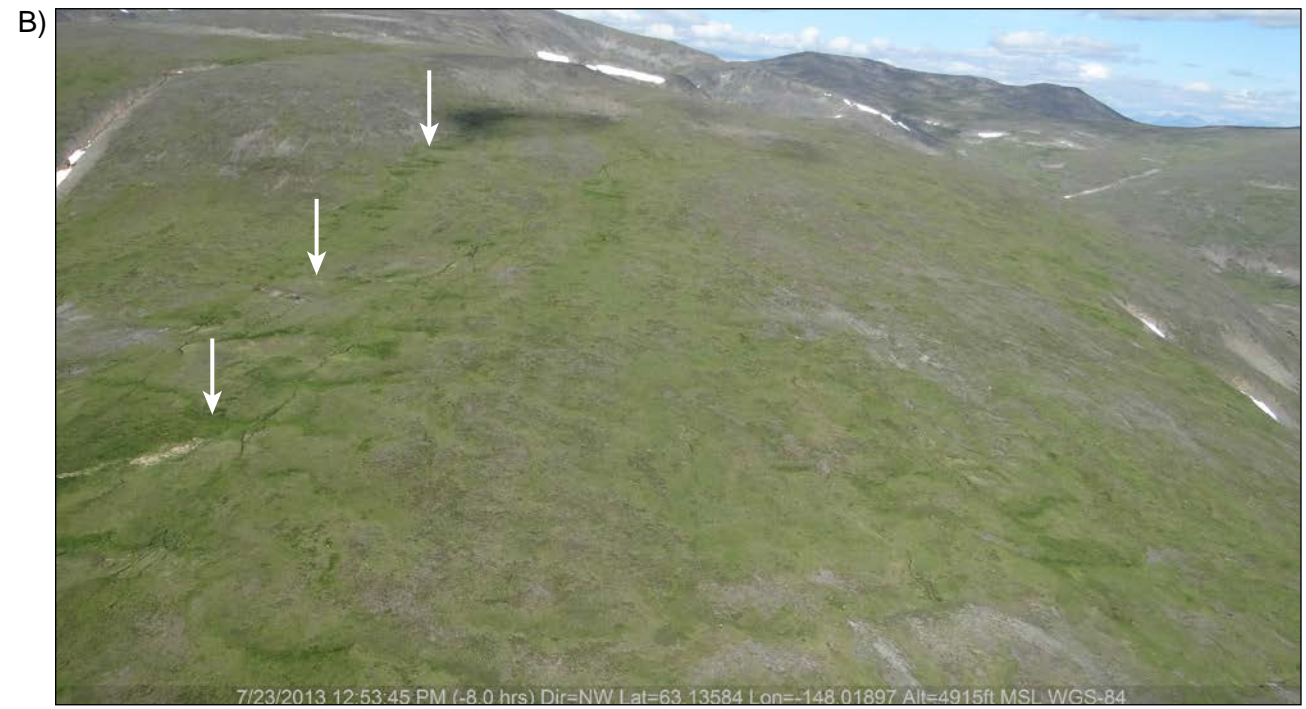
View looking west from photograph location C. Arrows indicate the projected path of the Feature 25 lineament.

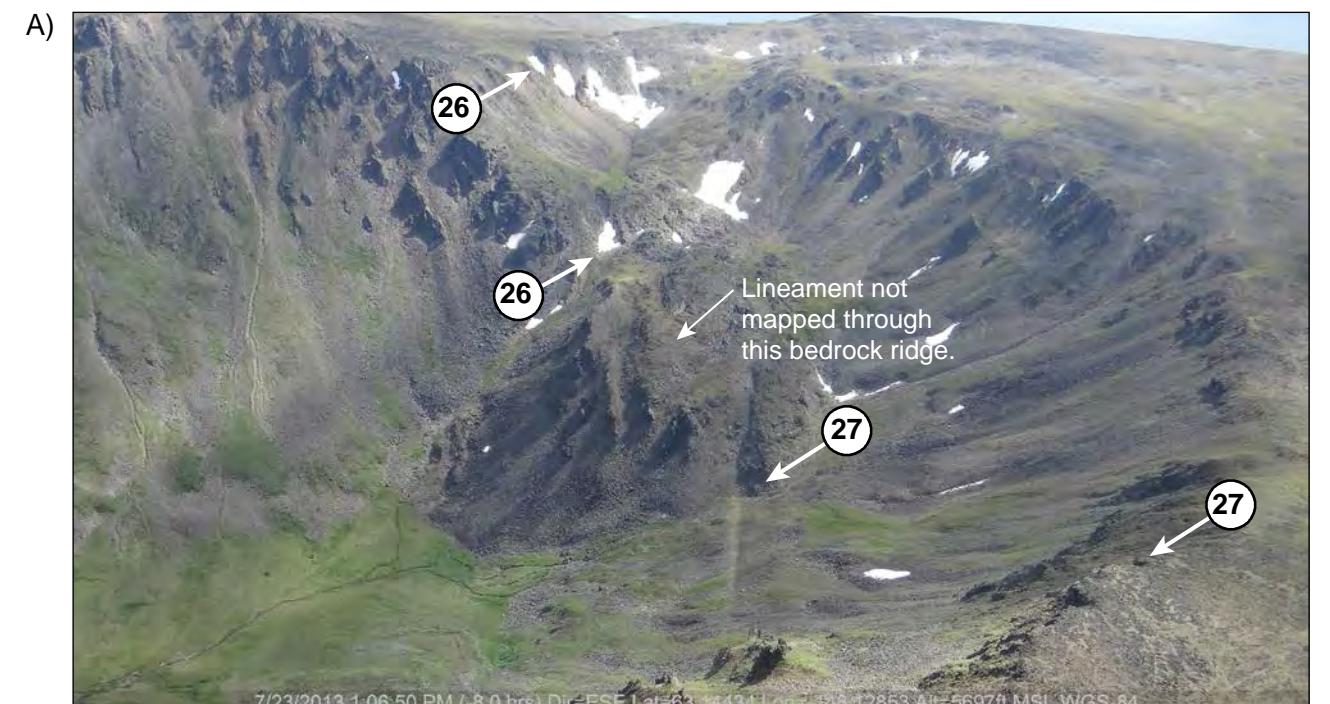
View looking west from photograph location A. Arrows show the projected trace of Features 26 and 27. Note the absence of a continuous and clear lineament along projected traces.

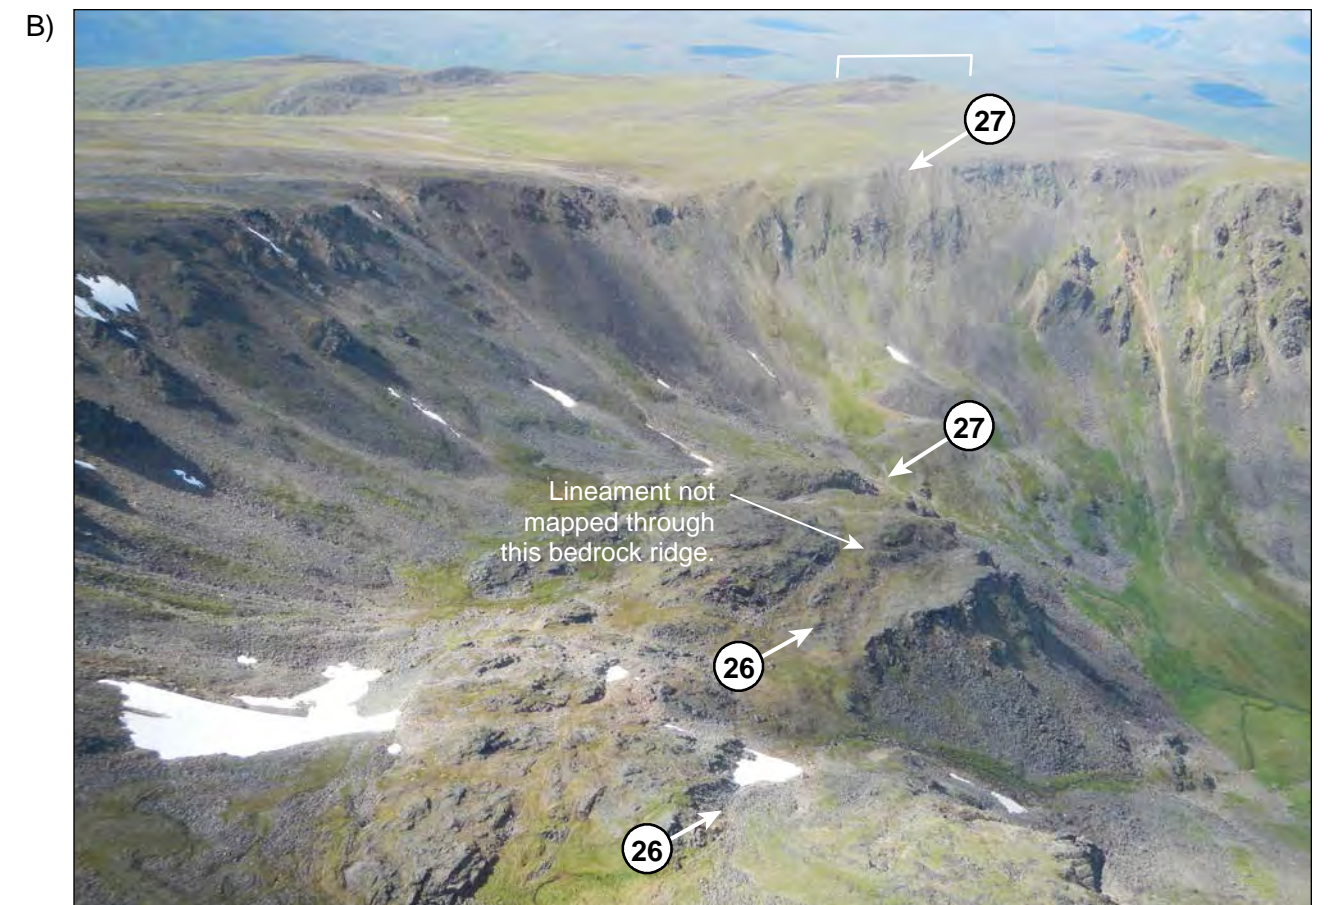
View looking east from photograph location B. Arrows and brackets indicate the projected path of Feature 26 and 27 lineaments. Note the absence of a continuous and clear lineament along projected traces.

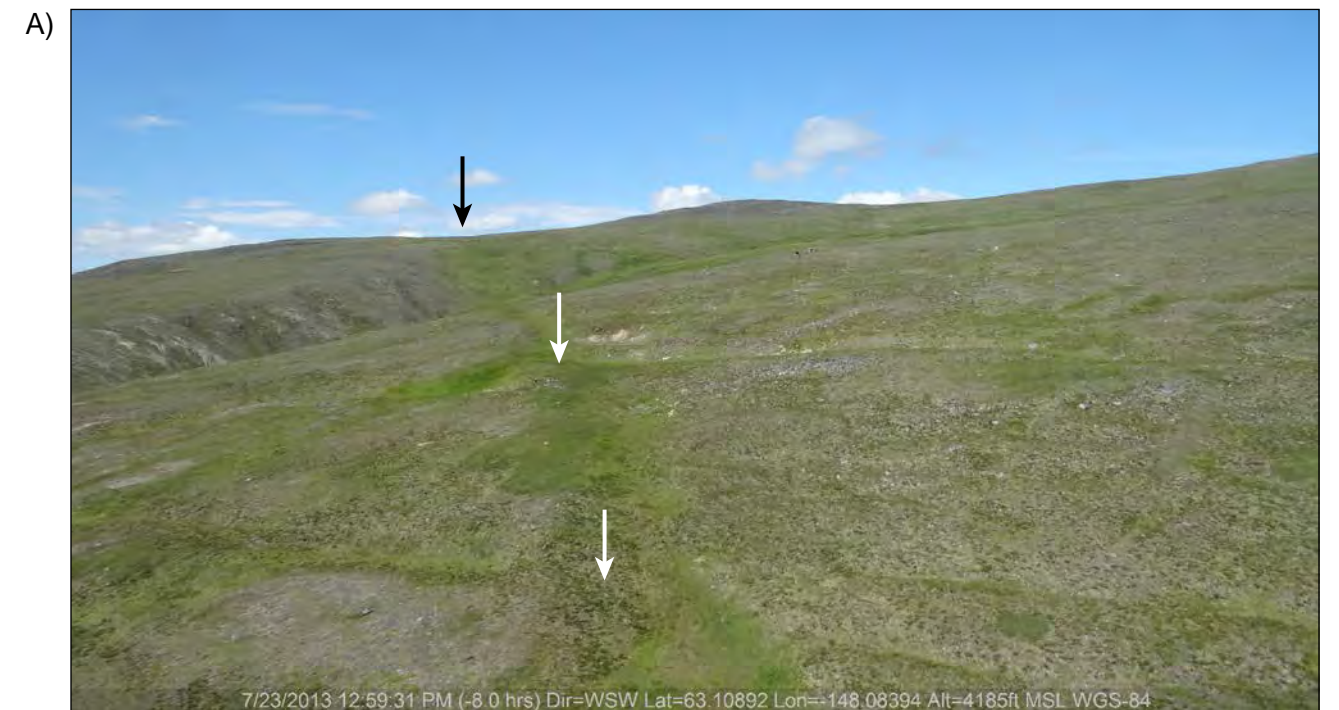
View looking west-northwest from photograph location A. Arrows show mapped trace of Feature 28. Note lineament corresponds to subtle linear trough and linear vegetation trend.

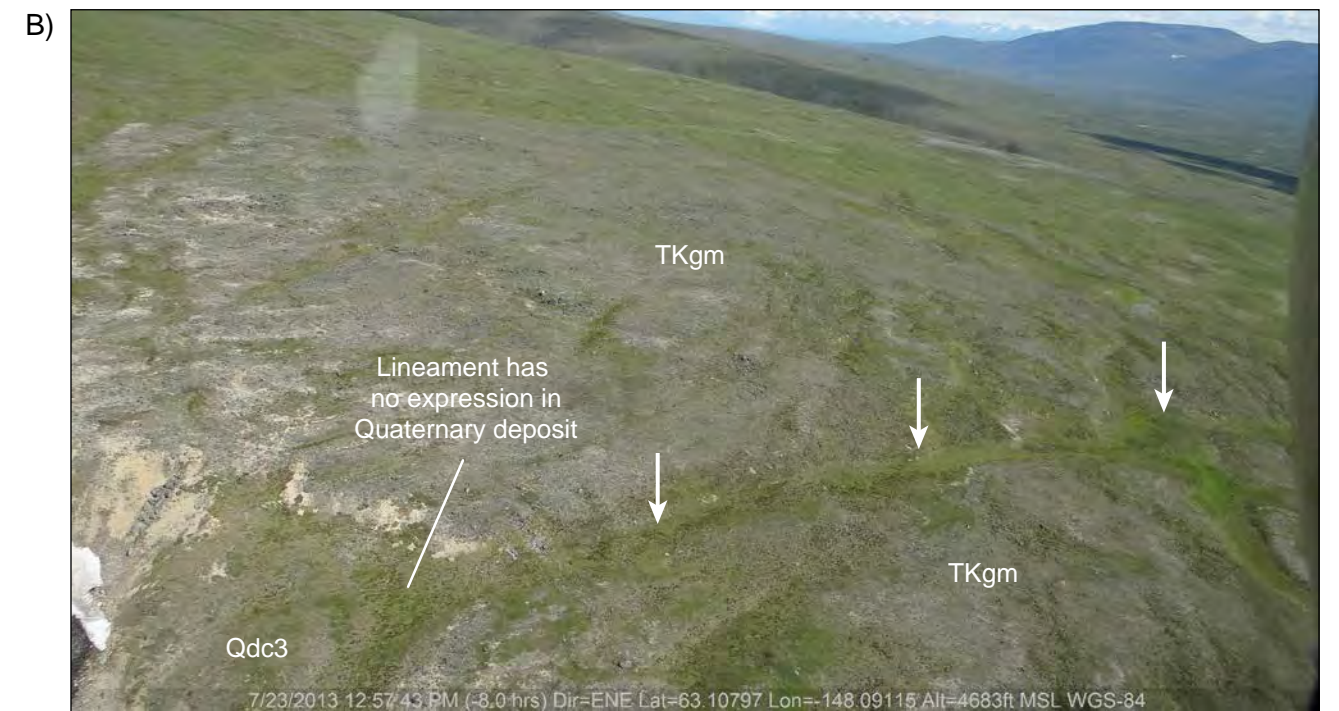
View looking east from photograph location B. Arrows indicate the mapped trace of Feature 28. Note absence of linear expression in Quaternary deposits.
