**Susitna-Watana Hydroelectric Project
(FERC No. 14241)**

Thermal Infrared Remote Sensing Pilot Test

URS Corporation
Watershed Sciences Inc.

February 2013

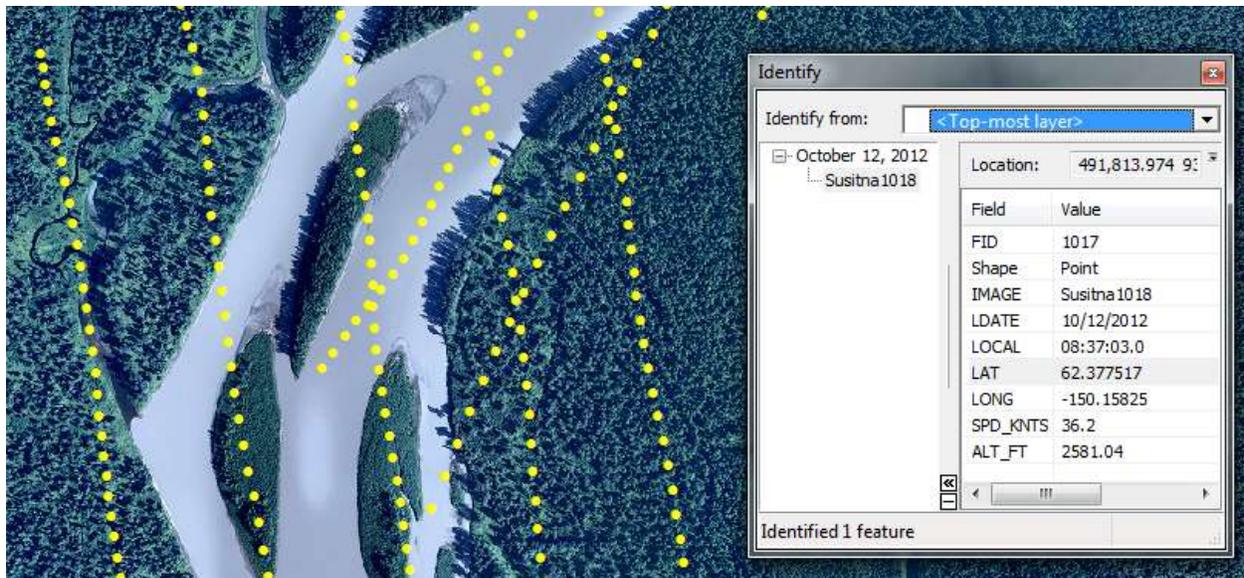
Figure 3. Thermal image locations.

Each location is represented by a yellow dot. The inset box shows the information recorded with each image during acquisition.

Thermal infrared images were recorded directly from the sensor to an on-board computer as raw counts which were then converted to radiant temperatures. The individual images were referenced with time, position, and heading information provided by a global positioning system (GPS) (Figure 3).

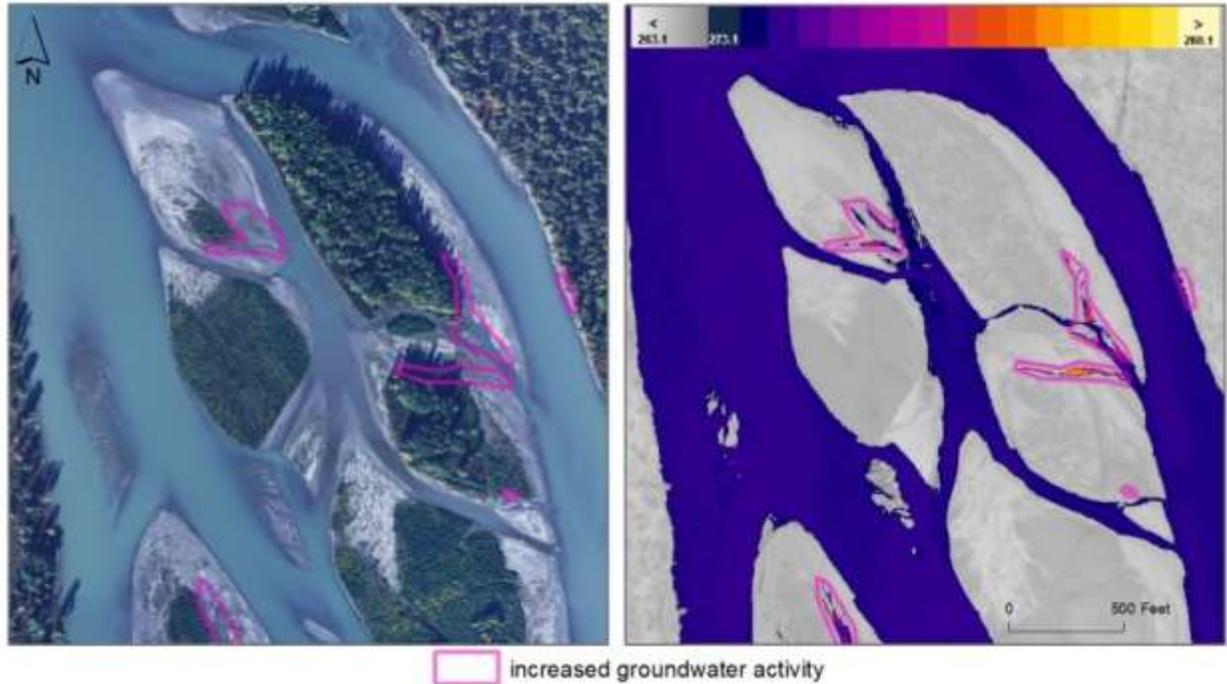
Figure 7. TIR/True Color Image Comparison.

The TIR/true color image pair above shows an example of the small hyporheic seeps that were detected in the thermal imagery, particularly in the exposed gravel beds.

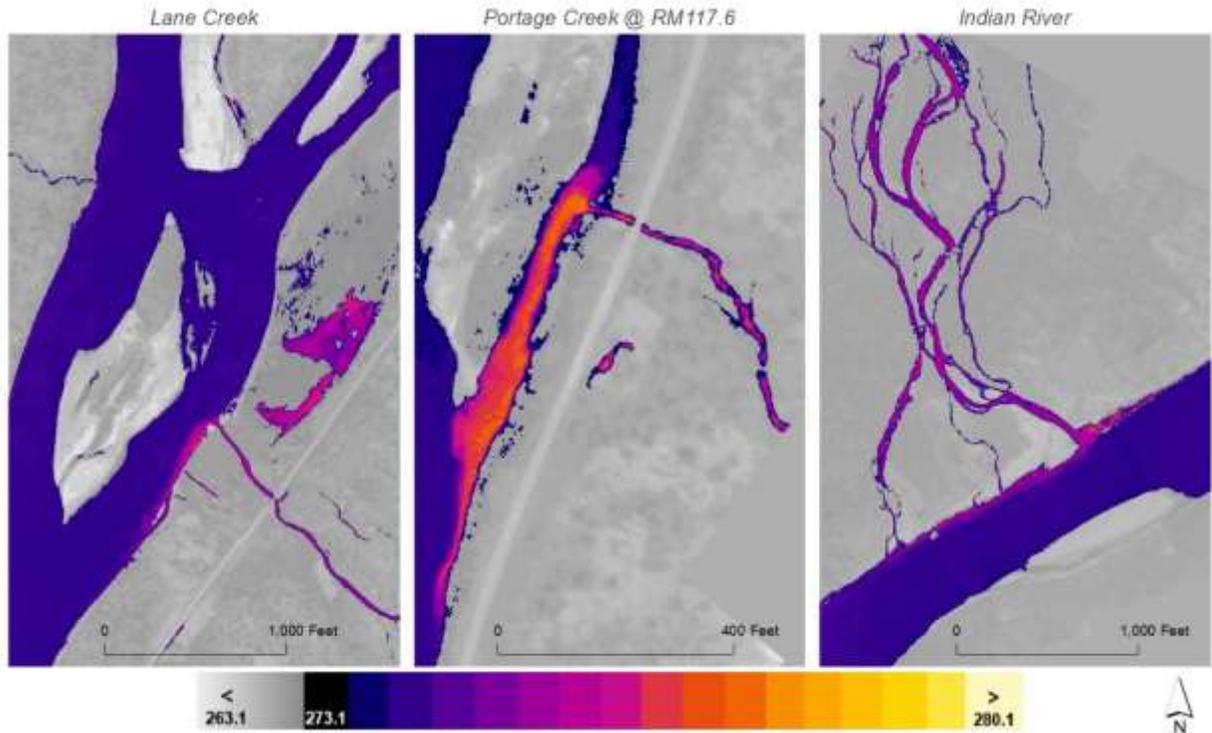
Figure 9. The TIR images of three significant tributaries to the Susitna River.

While the majority of tributaries were either frozen or at the same temperature as the mainstem, Lane Creek (RM 113.5), Portage Creek (lower) (RM 117.6), and Indian River (RM 138.6) were all contributing warmer water to the mainstem. Note there is more than one tributary named “Portage Creek” on the Susitna River. This map refers to the lower Portage Creek, near Talkeetna.

Though it is not obvious in the longitudinal profile, Lane Creek (RM 113.5), Lower Portage Creek at RM 117.6, and the Indian River (RM 138.6) are all contributing significantly warmer water to the mainstem (Figure 9). Ten sloughs of significant size and thermal influence were also noted in the imagery including Slough 8A (RM 126.0), Slough 9 (129.2), and Slough 21 (RM 142.0).

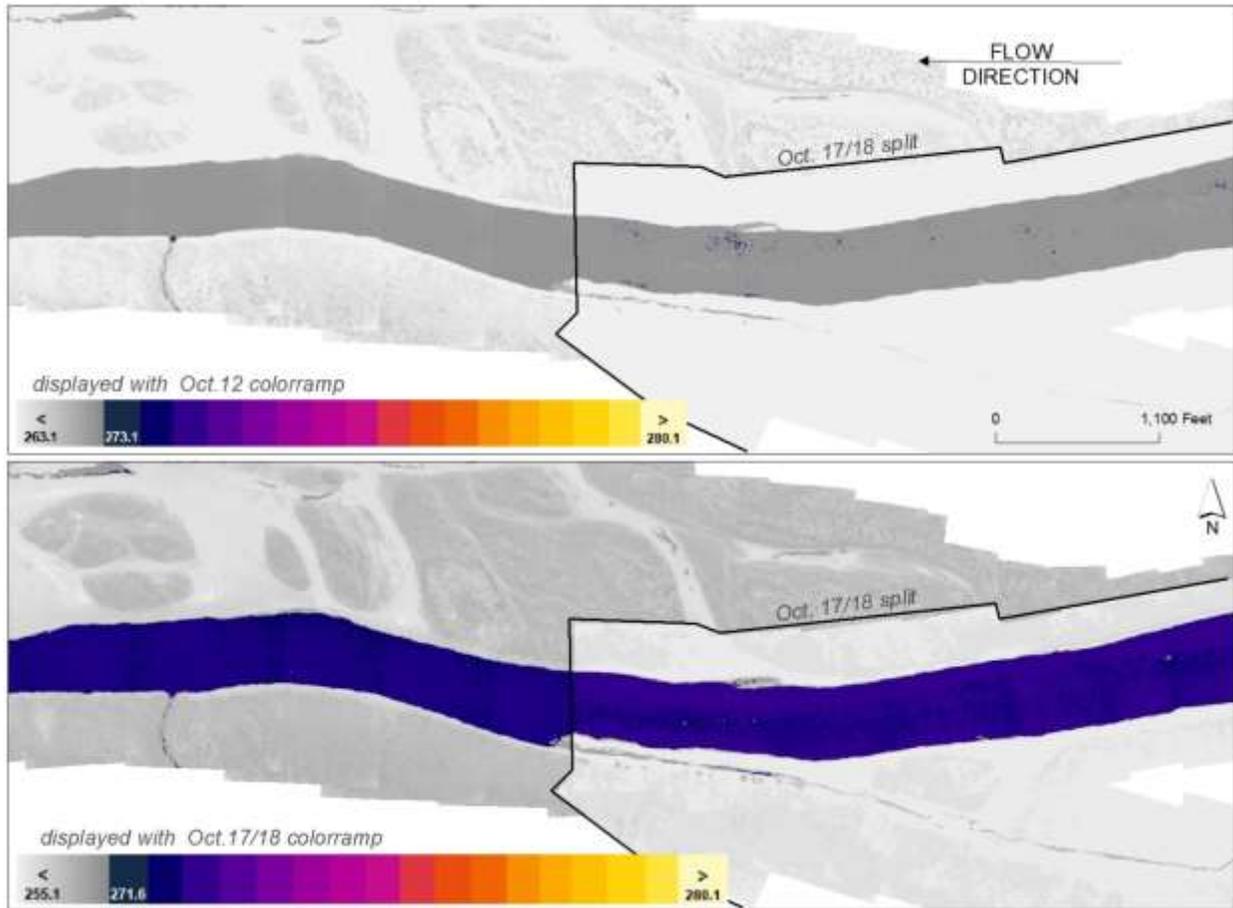
Figure 10. Junction between acquisition days October 17 and 18, 2012.

Air temperatures were colder on October 18, 2012, which affects the display of the terrestrial features in the imagery. Bulk water temperatures were significantly colder on October 17 and 18, 2012 when compared to October 12 and 13, 2012, requiring a color ramp that displayed water temperatures below freezing.

With air temperatures in the teens on October 18, parts of the river appeared to be freezing over, likely causing the increase in variability seen in the temperature profile on that date. The imagery also reflects the colder temperatures and the ‘colder’ color ramp that was necessary for the upper section of the river (Figure 10).
