Technical Memorandum

Susitna River Large Woody Debris Reconnaissance

Susitna- Watana Hydroelectric Project

March 1, 2013

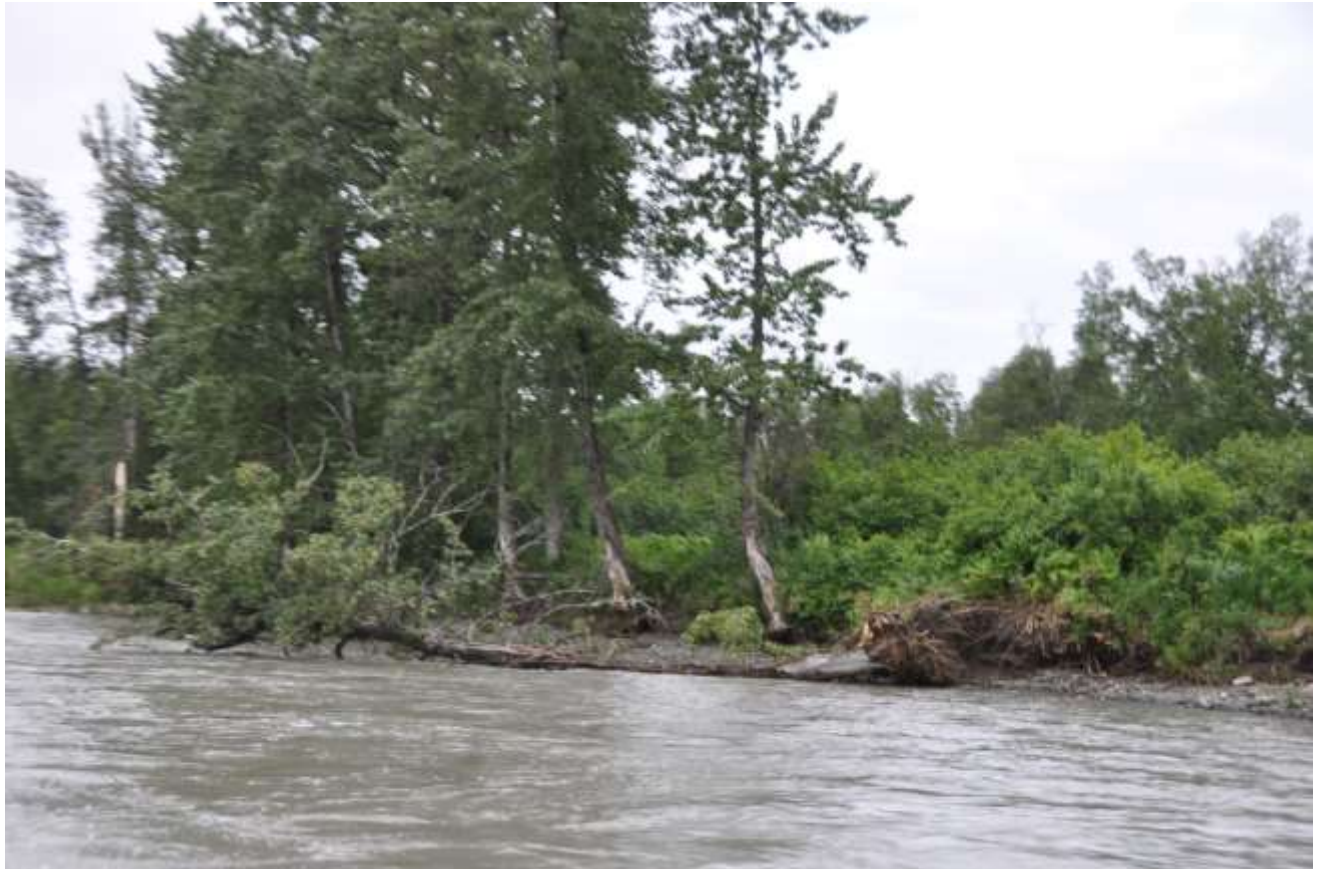
Photograph 2. June 26, 2012 Middle Susitna River between Three Rivers Confluence and Gold Creek. Bank erosion and wind throw balsam poplar wood recruitment.

Incremental wind throw and wind snap of large trees, primarily Balsam poplar, along floodplain margins, and incremental bank erosion were the primary recruitment processes observed in summer 2012 (Photographs 1-3). Many mid-channel trees observed being transported below the Three Rivers confluence have attached root wads, evidence of a recent bank erosion recruitment (Photographs 4-8). Although details were not documented for this report, the 78,000 cfs flood event of September 22, 2012 (Gold Creek gage) was observed in early October, 2012 to have caused large scale recruitment of trees to the river as a result of bank erosion.

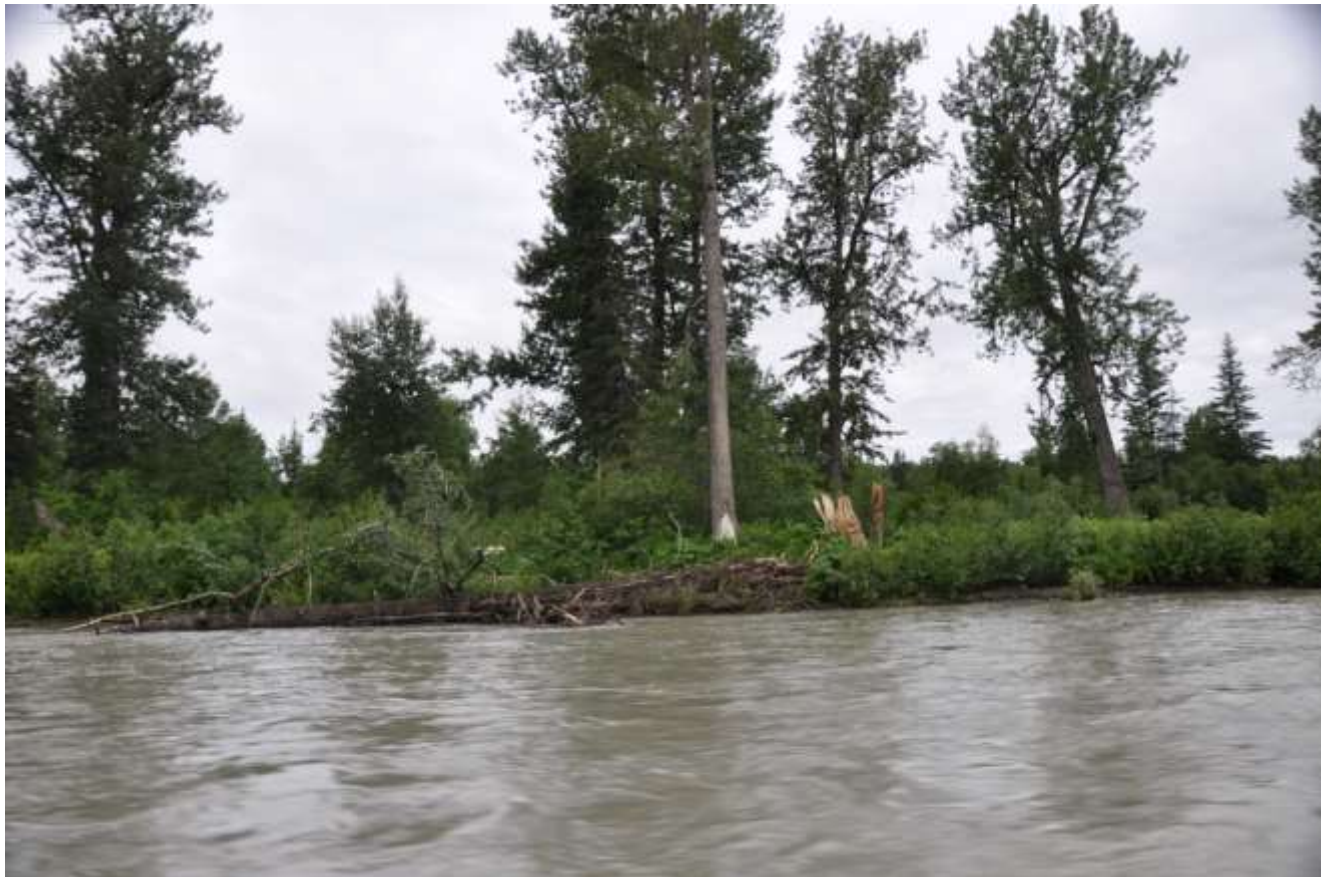
Photograph 3. June 26, 2012 Middle Susitna River between Three Rivers Confluence and Gold Creek. Wind snap balsam poplar recruitment.

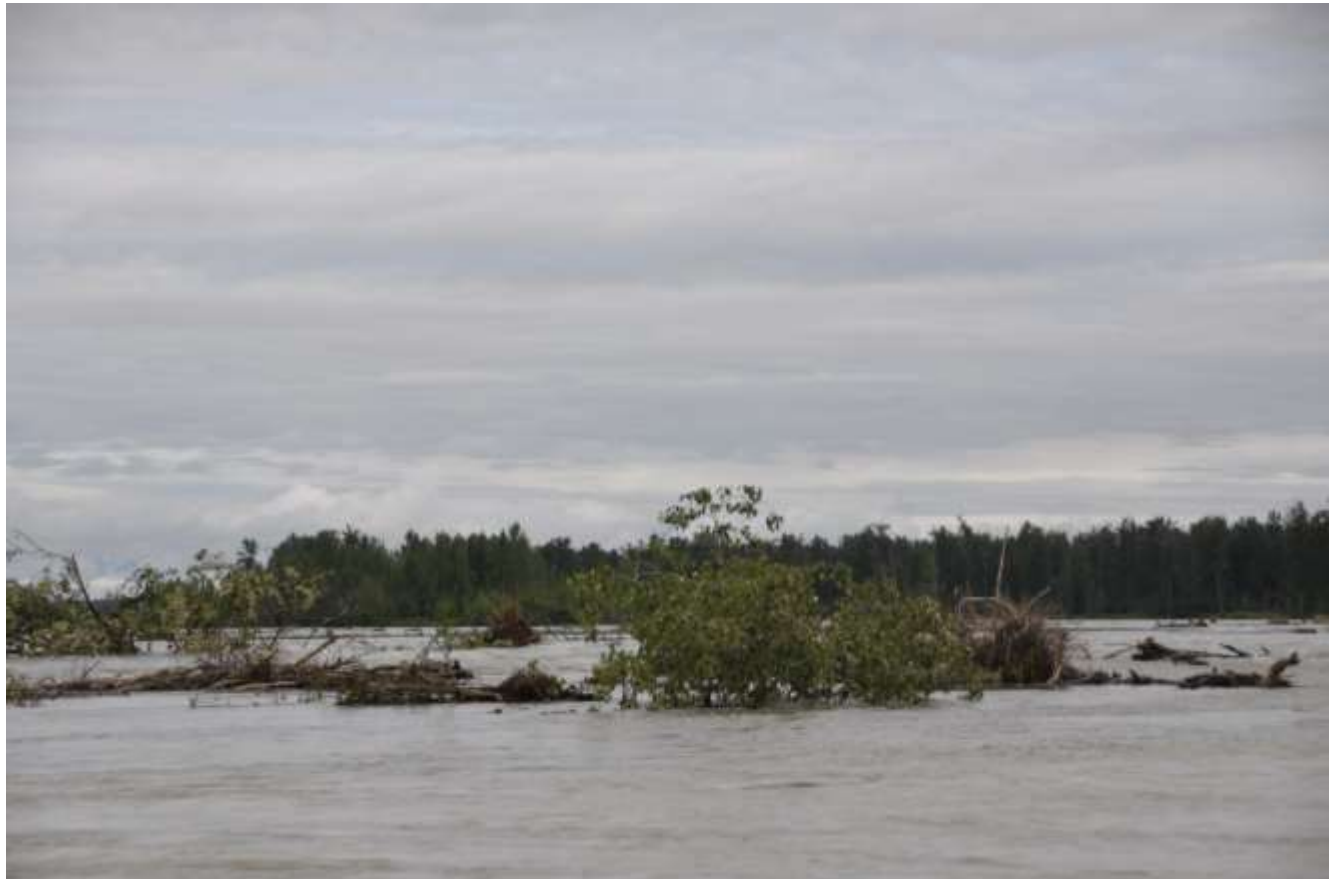
Photograph 4. June 26, 2012 Three Rivers (Susitna, Chulitna, and Talkeetna rivers) Confluence. Fresh recruited balsam poplar transport.

Wood transport, in June and July 2012, was observed to be predominantly occurring at and below the Three Rivers Confluence (Photographs 4, 5, 6, 9, 10). The Chulitna River appears to be a major source of the wood transported into the Lower Susitna River (Photographs 4-6) as large amounts of wood were observed in the main stem Chulitna River at Three Rivers Confluence. The braided reach below Three Rivers Confluence is a transport limited segment of the Susitna River as evidenced by both channel braiding and the large amount of deposited racked and unstable wood debris (Photographs 9 and 10). Wood transport was observed in the Middle Susitna; however, it was limited to single trees with root wads attached, evidence of incremental bank erosion recruitment (Photographs 7 and 8).

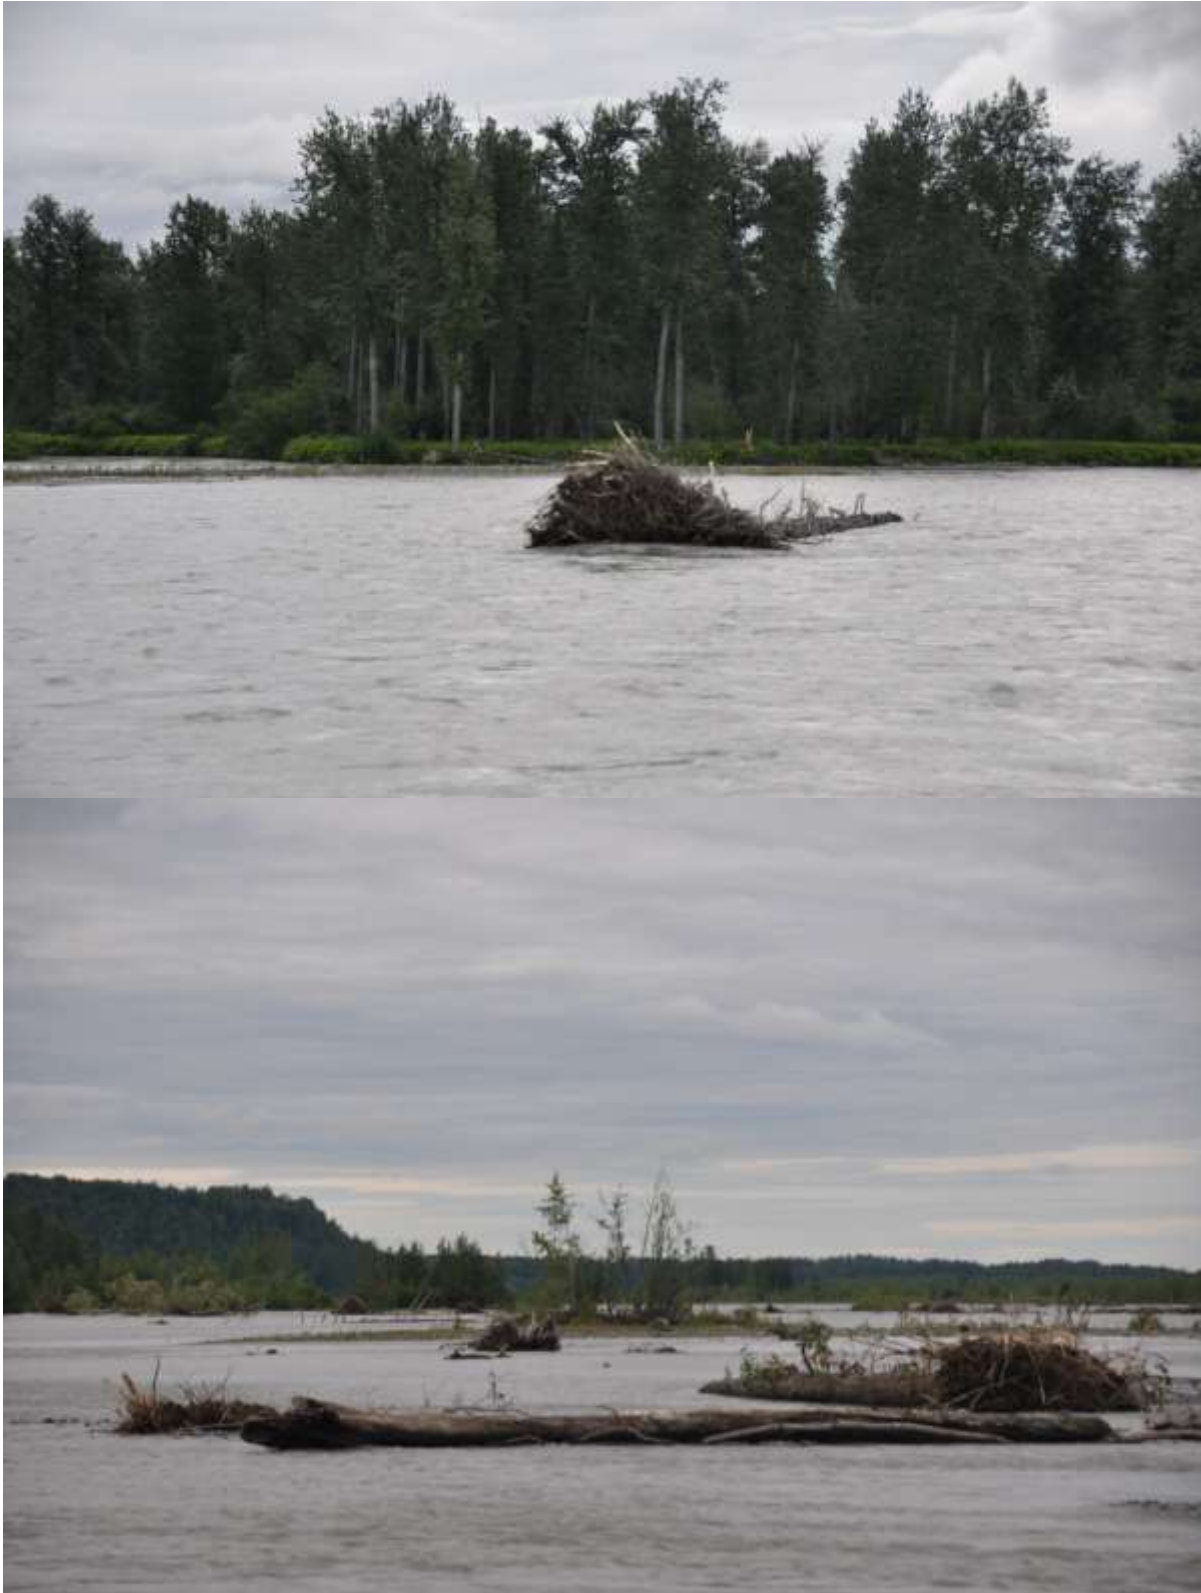
Photograph 6. June 26, 2012 Three Rivers (Susitna, Chulitna, and Talkeetna rivers) Confluence balsam poplar transport.

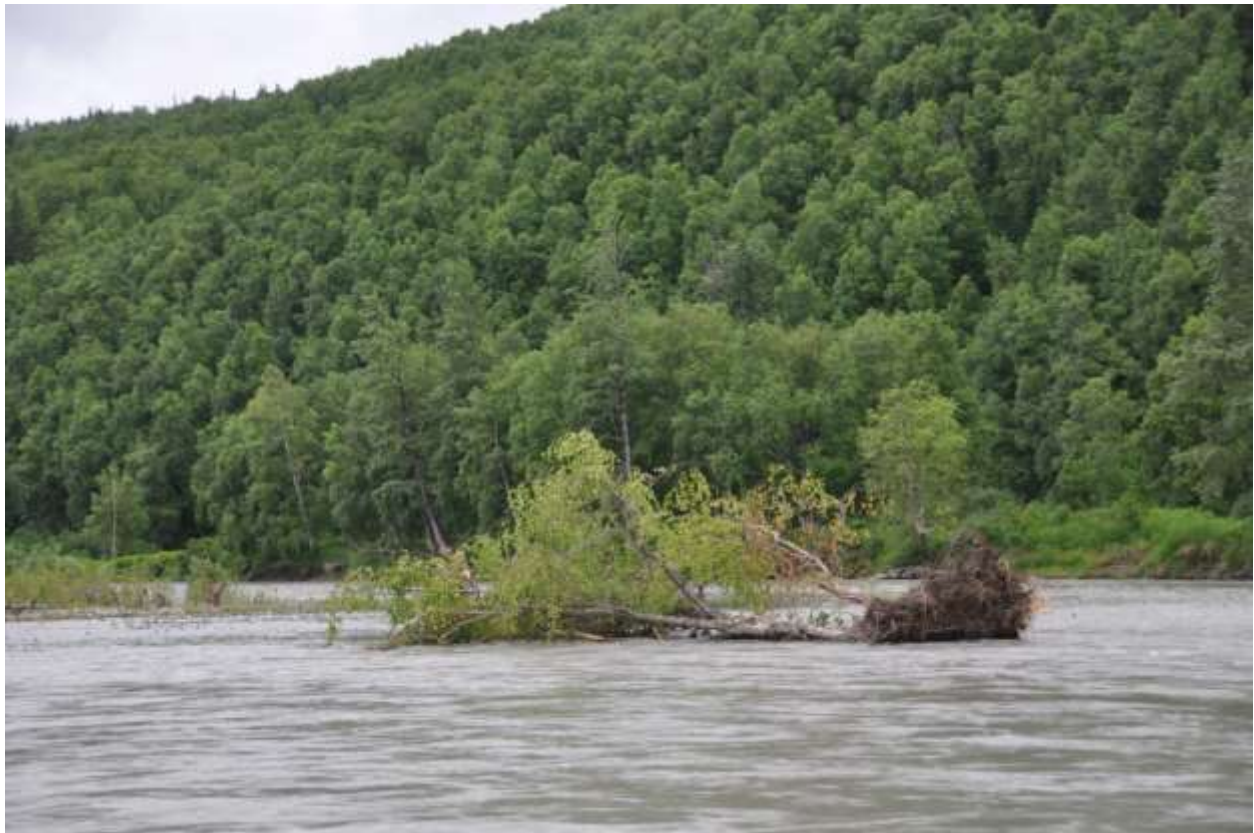
Photograph 8. June 26, 2012 Middle Susitna River wood transport. Paper birch deposited on a mid-channel island bar.

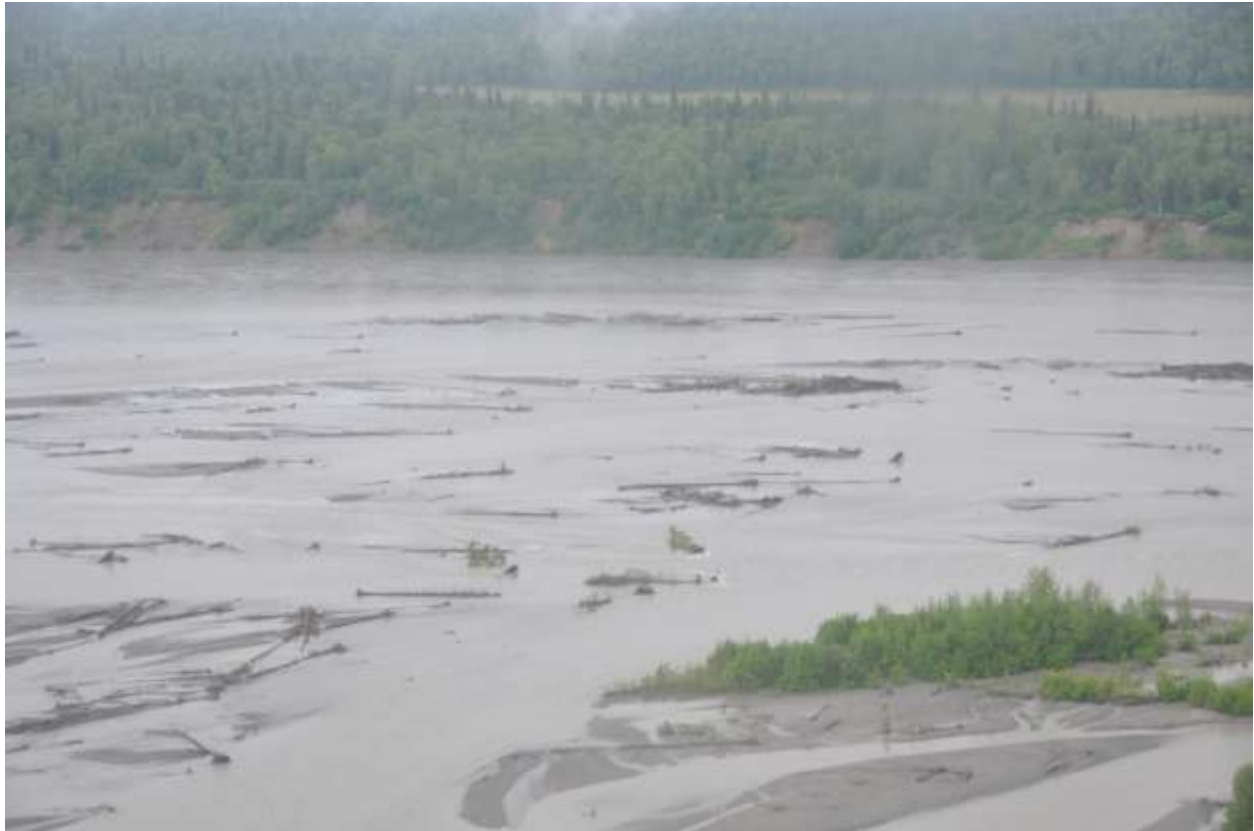
Photograph 9. June 30, 2012 Lower Susitna River between Talkeetna and Willow. Large wood transport and deposition. Root wads are facing upriver. Flow is from right to left.

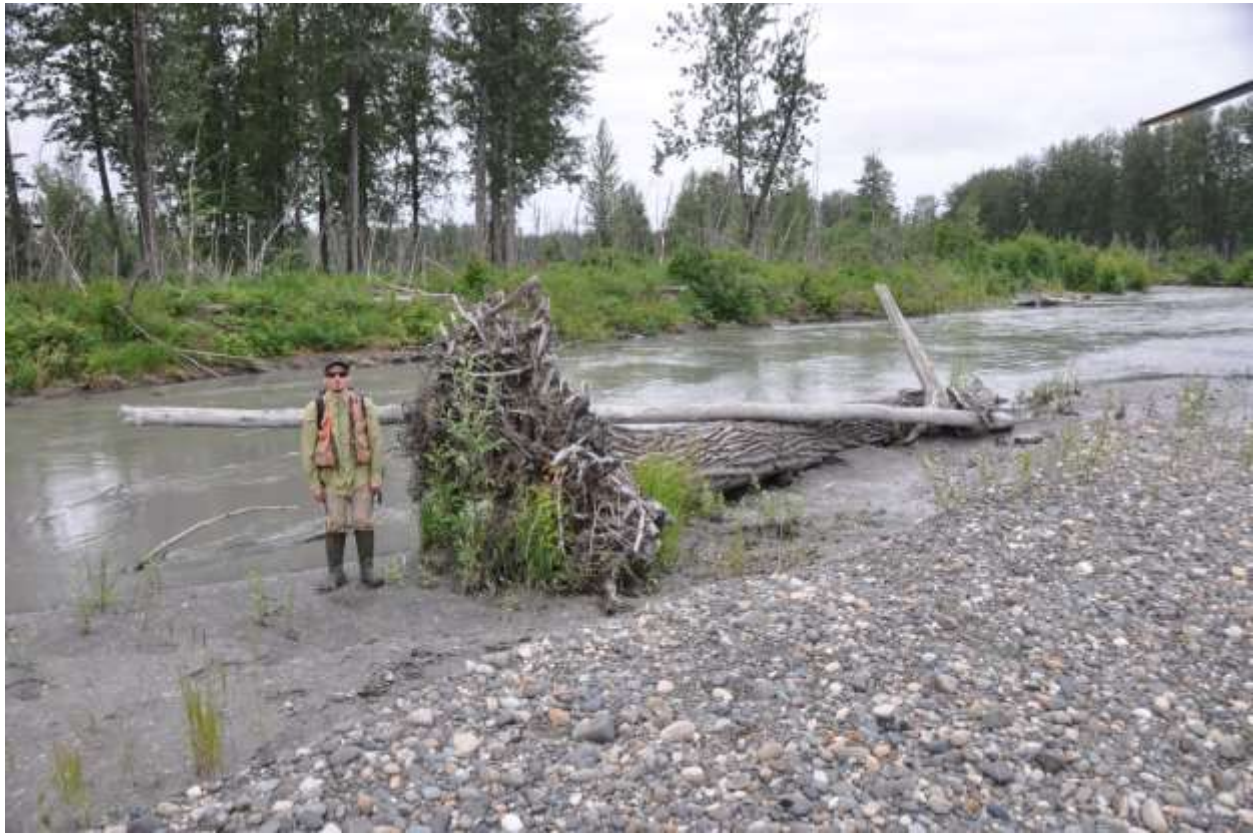
Photograph 11. July 2, 2012 Lower Susitna River below Talkeetna. Large balsam poplar (79 cm diameter, DBH) with root wad (210 cm diameter) and adjacent scour pool formation (Sample Plot T19_04).

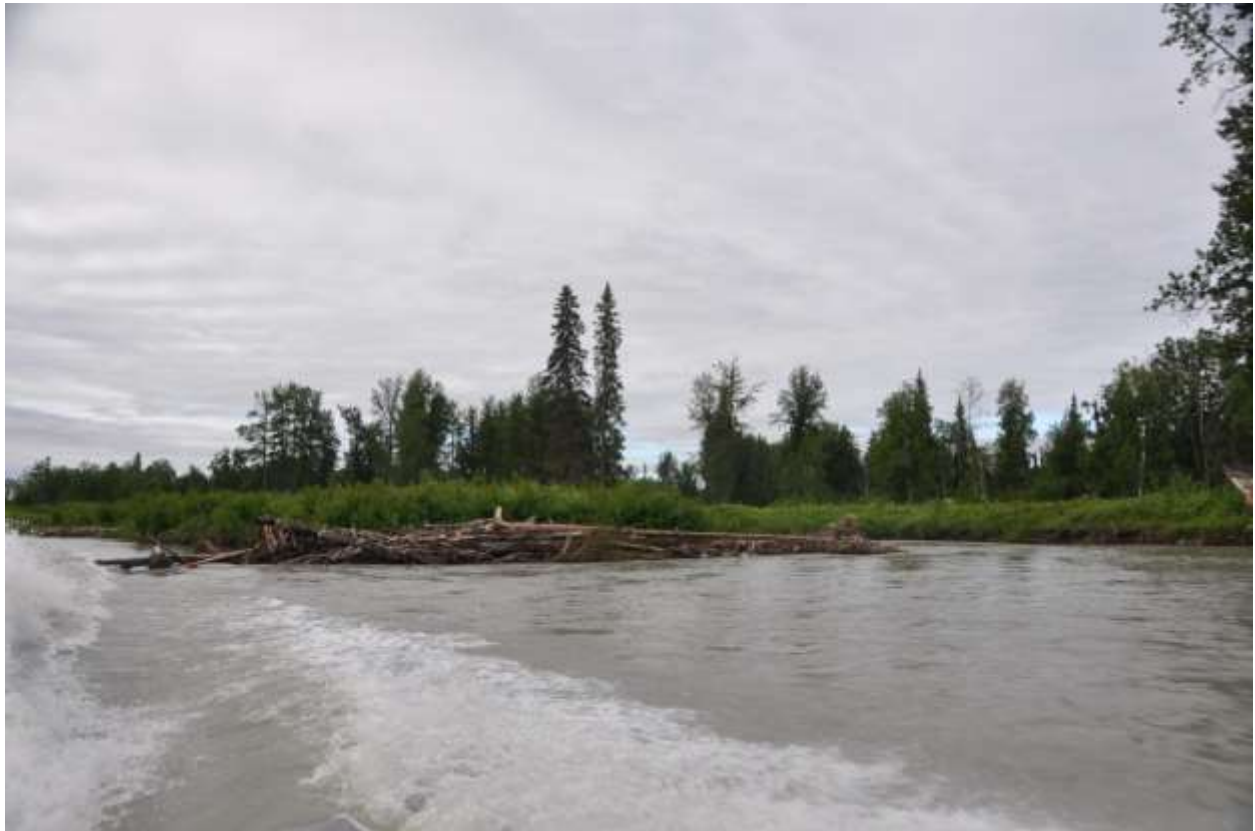
Photograph 13. June 26, 2012 Middle Susitna River wood jam at head of mid channel island and adjacent side-channel.

Also, observed stable wood jams were associated with scour pools, islands, channel embankments, and side channel complexes (Photographs 12-17, 19-30).

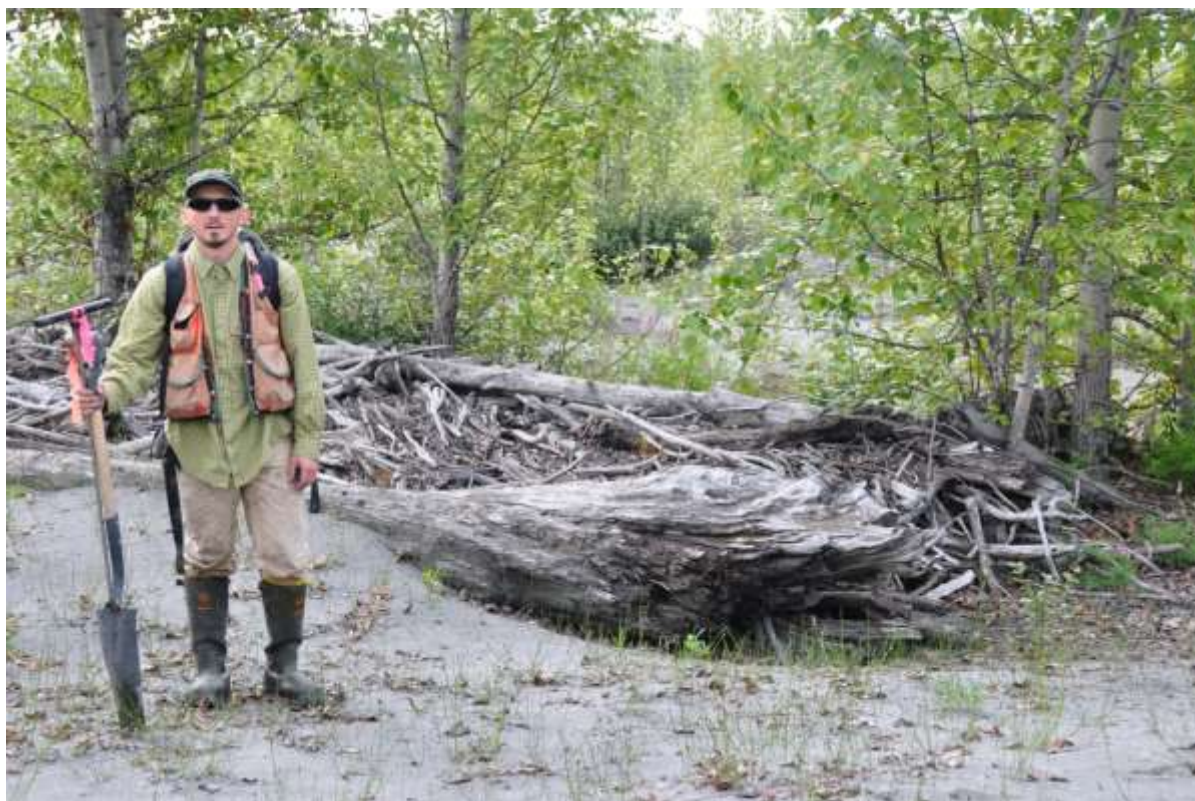
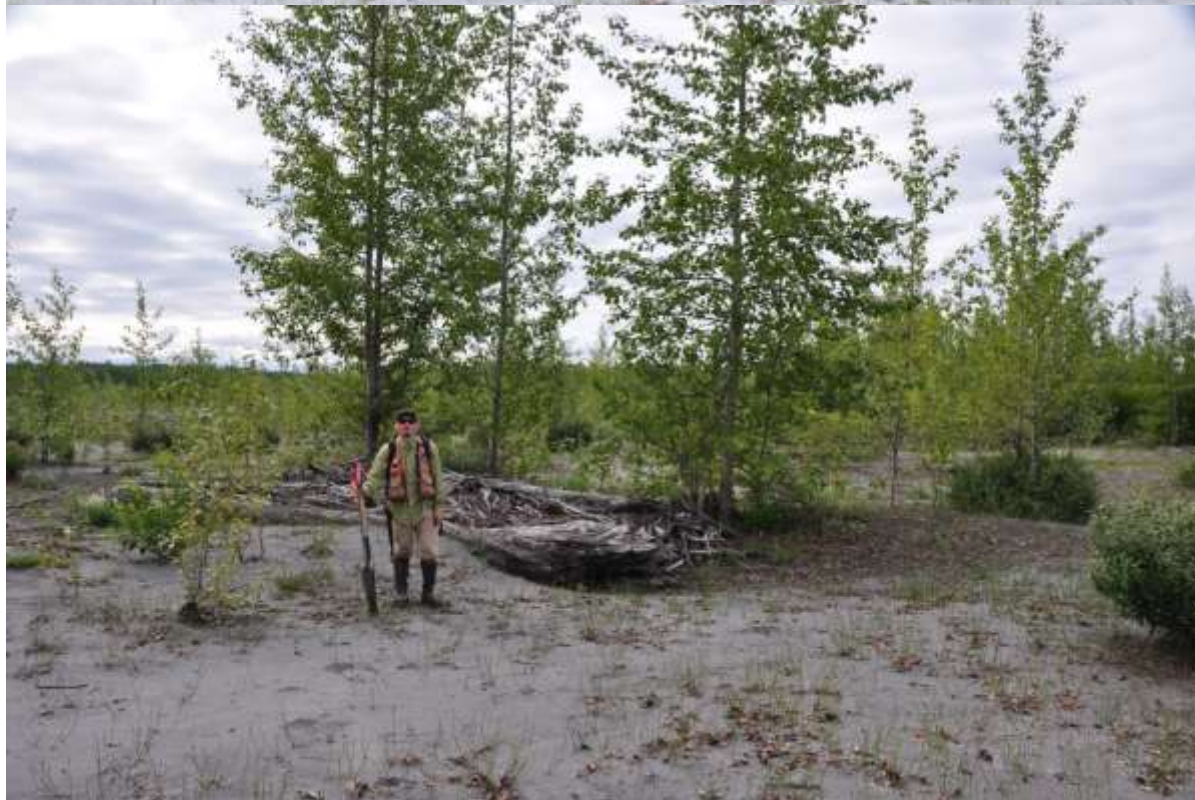
Photograph 14. July 2, 2012 Lower Susitna River near Talkeetna. Partially buried key member with racked members and unstable wood. Young balsam poplar establishment in association with wood jam.

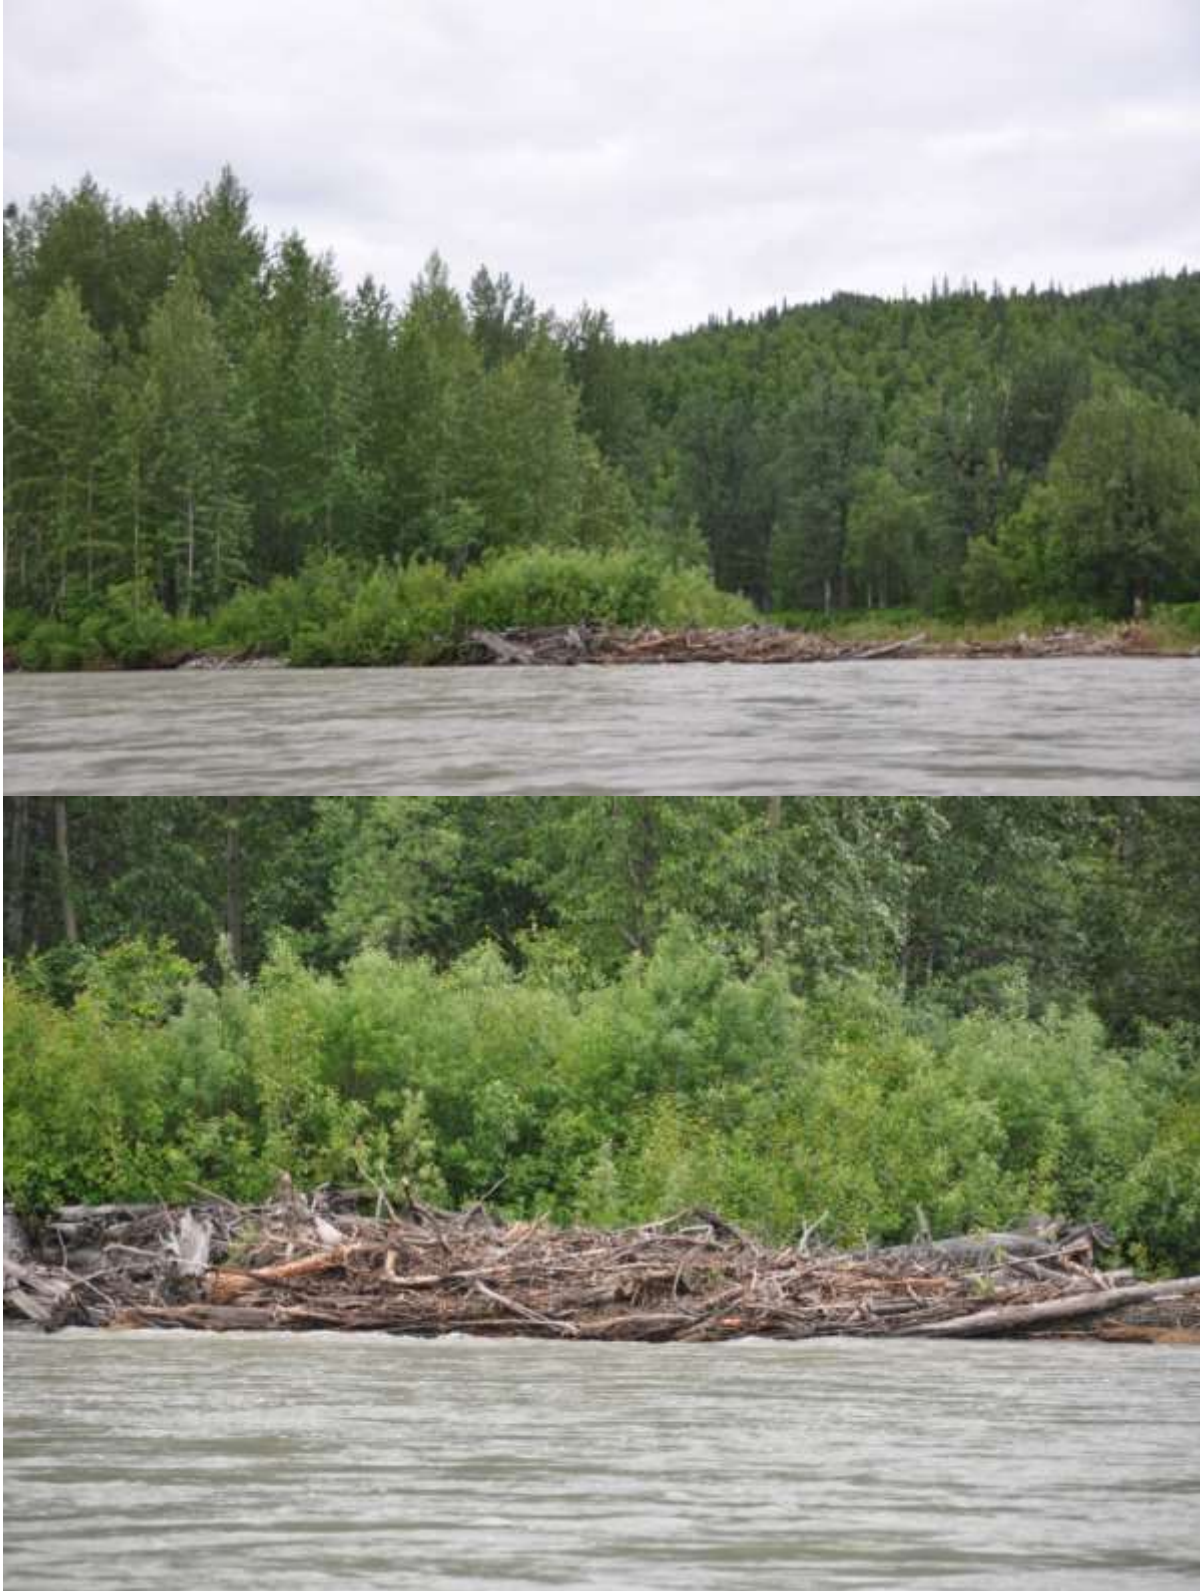
Photograph 15. June 26-27, 2012 Middle Susitna River above Three Rivers Confluence. Wood jam located at island apex and side channel entrance. Lower Photograph close up of wood jam with small diameter racked and loose members.

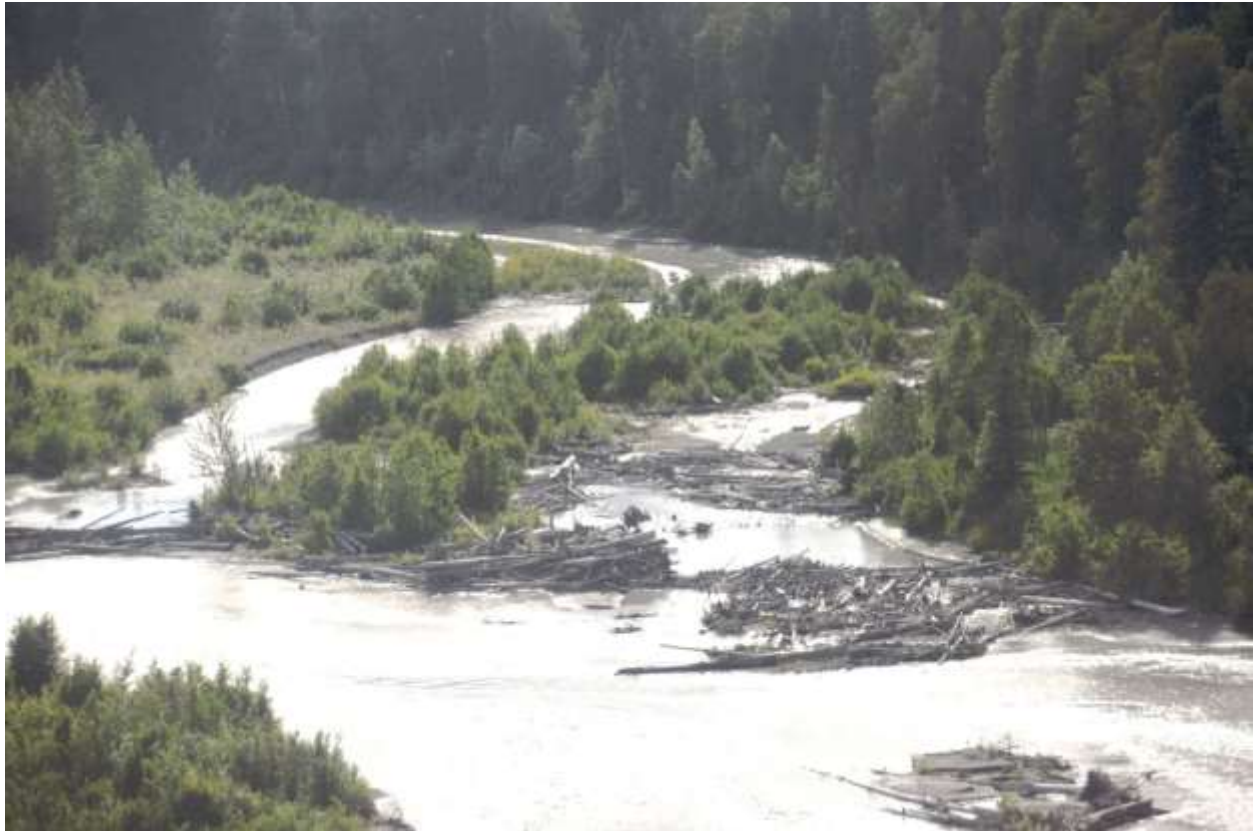
Photograph 16. June 30, 2012 Lower Susitna River below Talkeetna. Rafts of racked and unstable wood. Accumulations at island apex and main stem side-channels.

Bar top accumulations of unstable wood debris appear to be a defining characteristic of the Susitna River. Large quantities of unstable wood debris were observed throughout the Project study area with largest accumulations occurring in the Lower Susitna (Photographs 9, 10, 21) with apparently large contributions from the Chulitna River. However, unstable wood debris was observed throughout both Middle and Lower River segments during the 2012 aerial reconnaissance (Photographs 16, 21, 31, 32, 33, 34, 35, 36, 37). Loose, mobile wood was observed along river banks (Photographs 2, 3), mid channel islands (Photographs 18, 20), and throughout side channel complexes (Photographs 16, 17, 18, 21, 34).

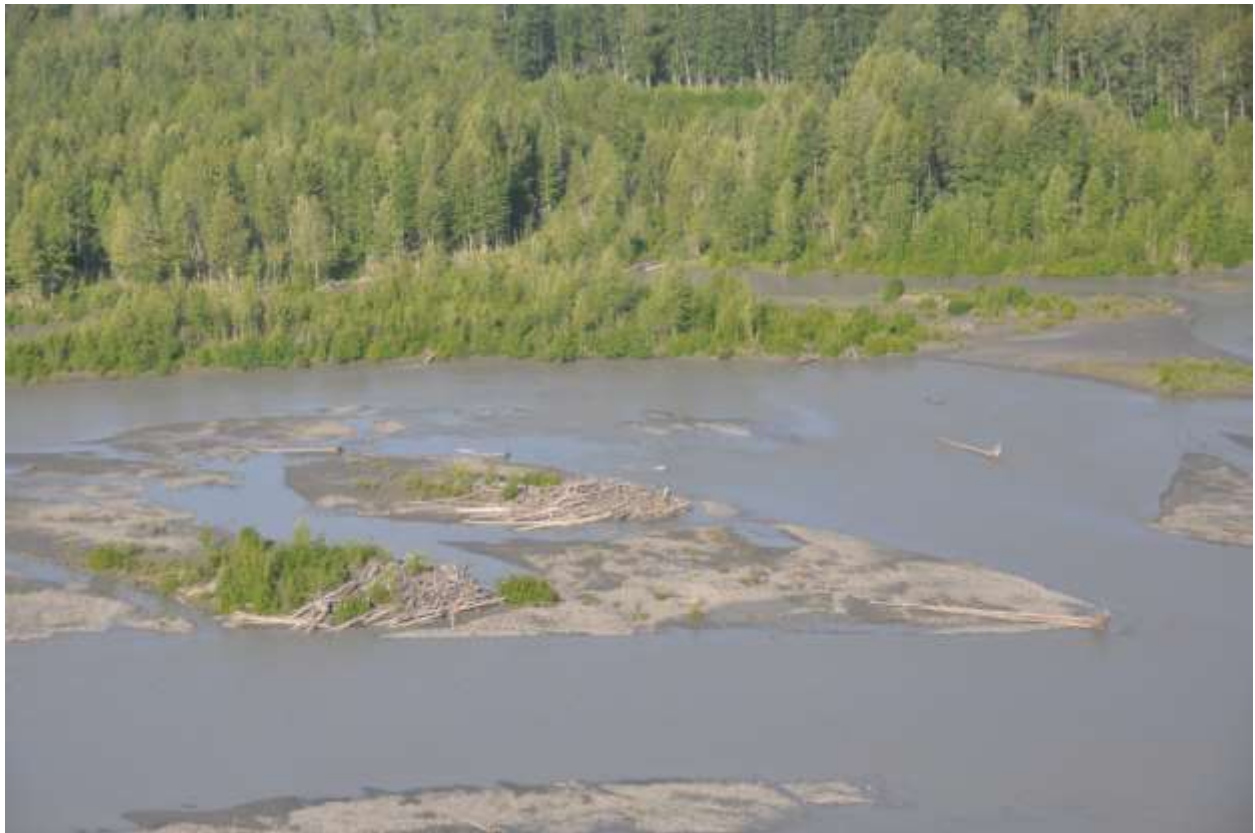
Photograph 20. June 30, 2012 Lower Susitna River between Talkeetna and Willow. Racked wood on mid channel islands.

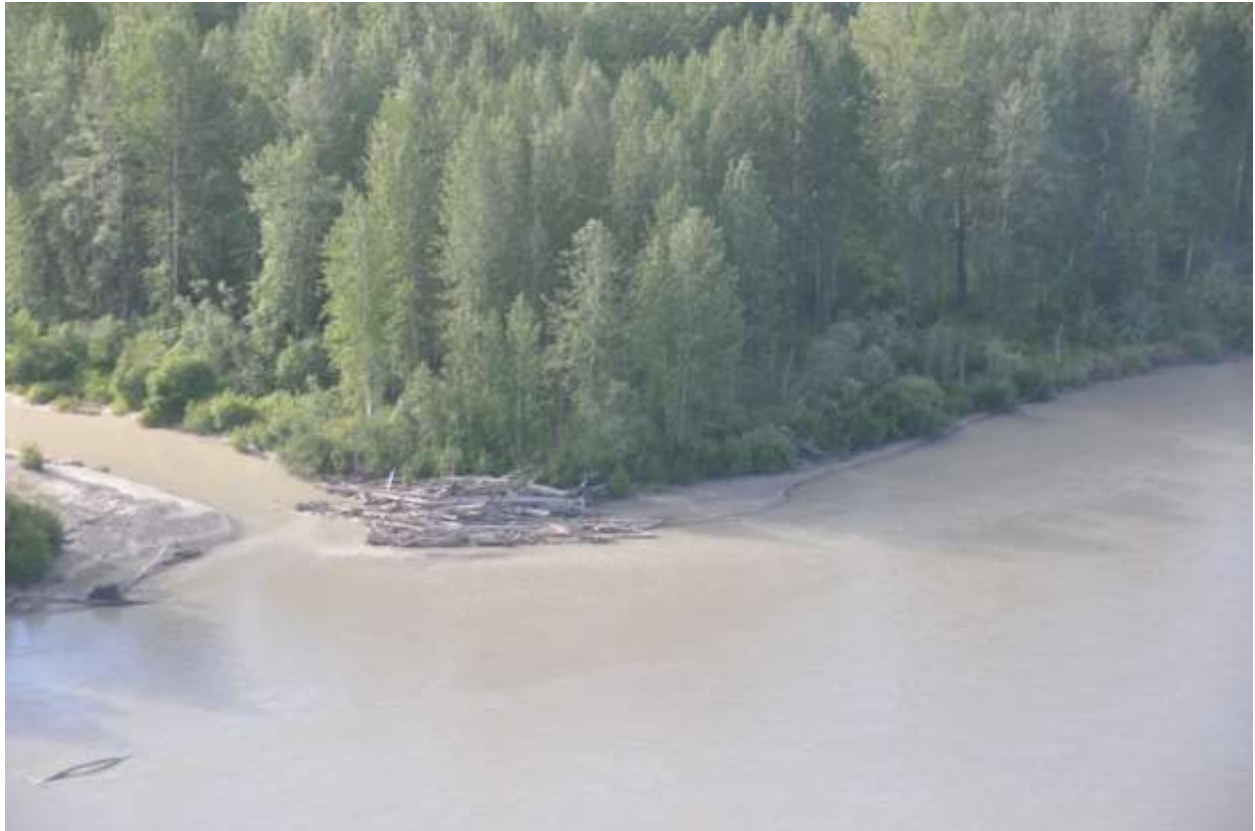
Photograph 24. June 30, 2012 Lower Susitna River between Talkeetna and Willow. Bar apex wood jam at side channel exit.

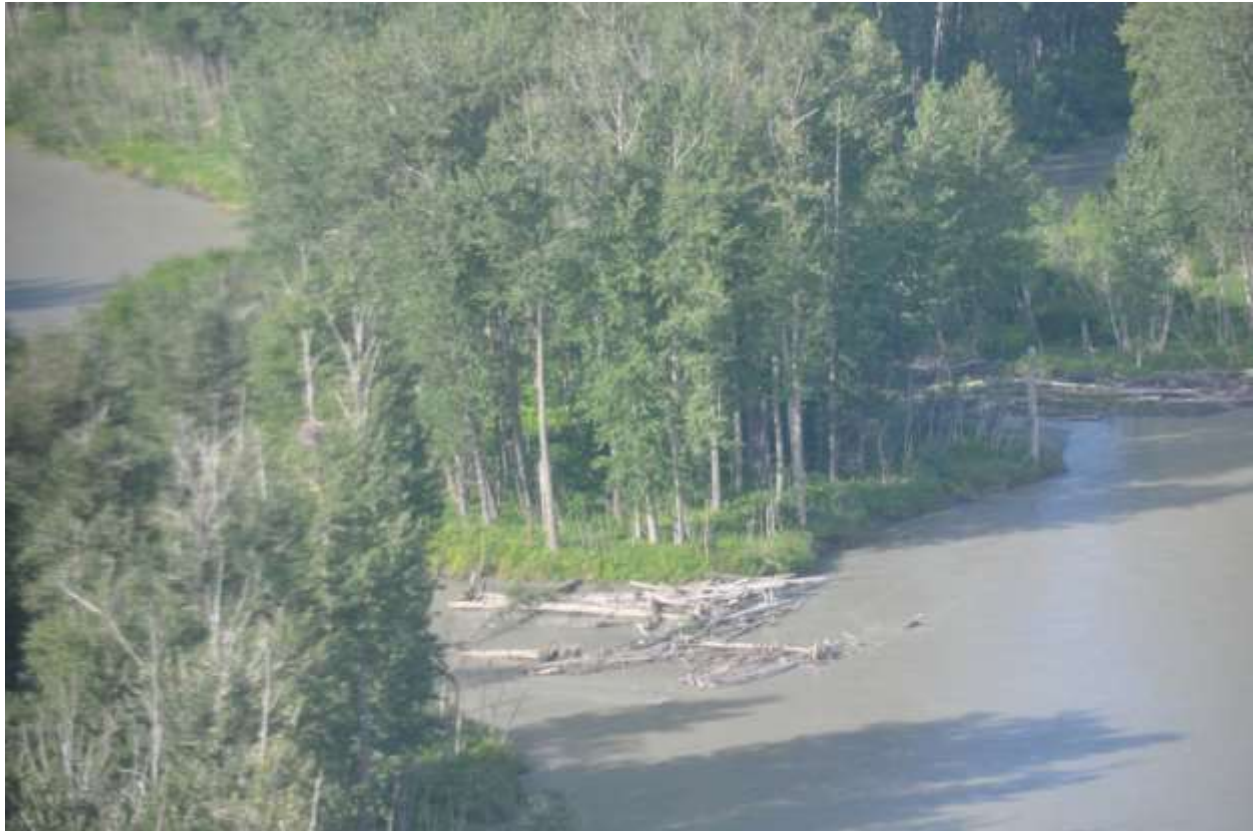
Photograph 25. June 30, 2012 Lower Susitna River between Talkeetna and Willow. Rafts of wood in side channel complex.

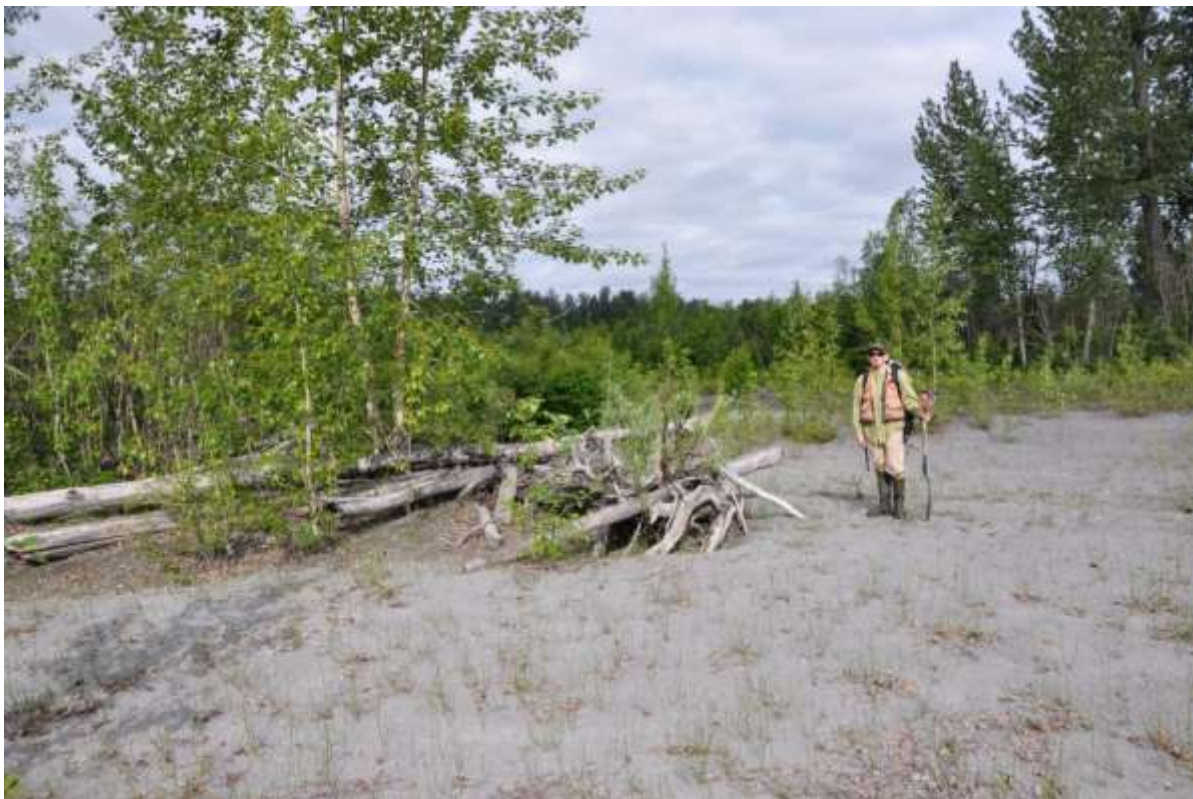
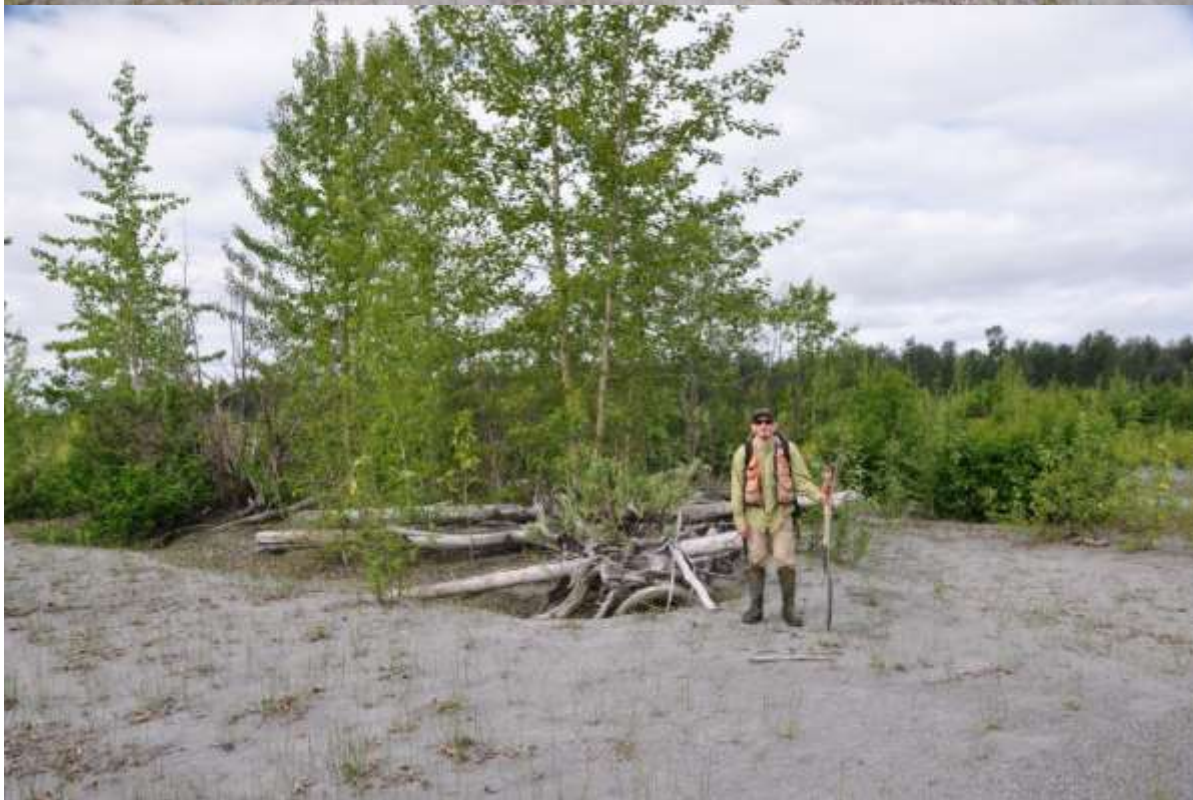
Photograph 26. July 2, 2012 Lower Susitna River below Talkeetna. Bar apex wood jam with buried key member and racked members. Young balsam poplar colonizing elevated wood jam surface.

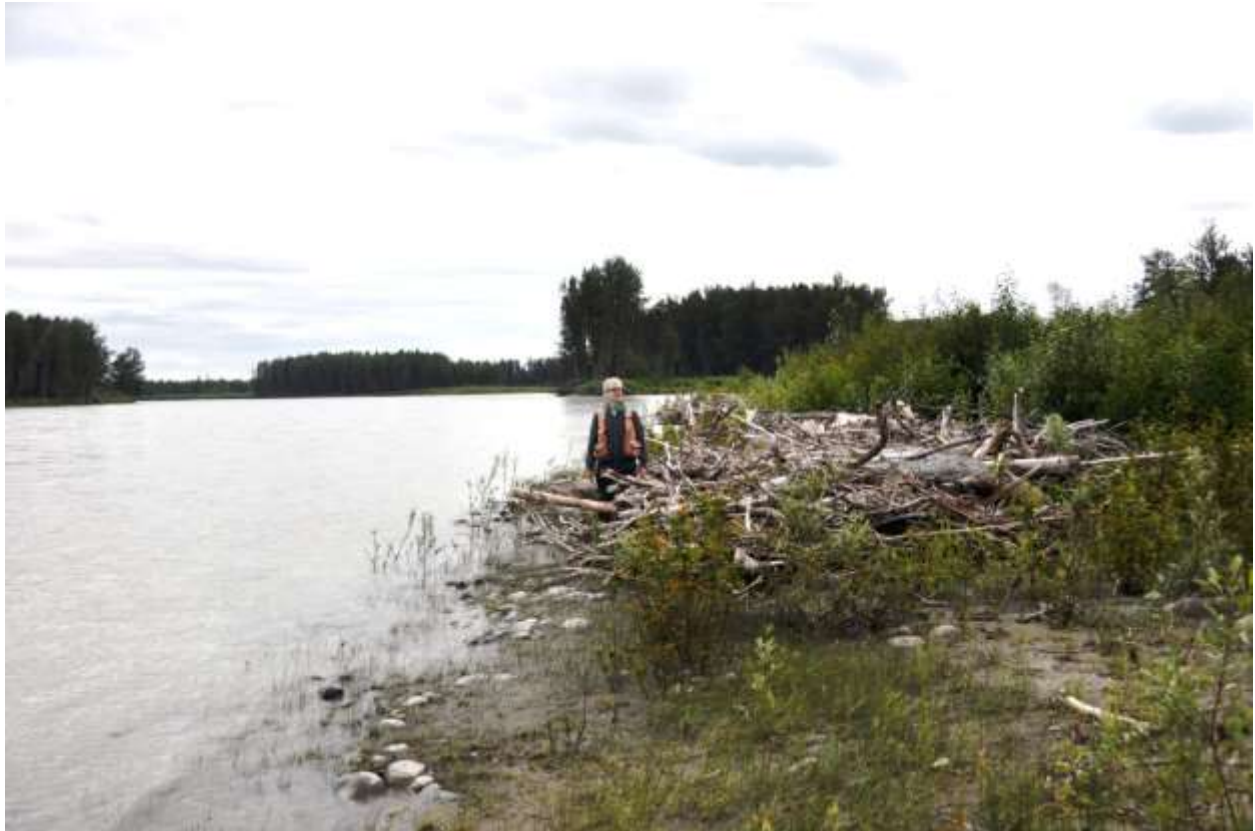
Photograph 29. July 1, 2012 Middle Susitna River immediately above Whiskers Slough. Bar apex jam with large accumulation of racked members upstream of jam.

In large alluvial rivers, such as the Susitna, recruitment of floodplain streamside trees through bank erosion can result in wood debris structures composed of logs hydraulically aligned parallel to the channel bank that become embedded into the floodplain further stabilizing channel banks (Abbe and Montgomery 2003; Photographs 12, 17, 27, 28, 29, 30). Additionally, loose mobile wood debris was observed accumulating along river embankments forming unstable wood debris accumulations (Photographs 12, 17, 28, 29, 30).

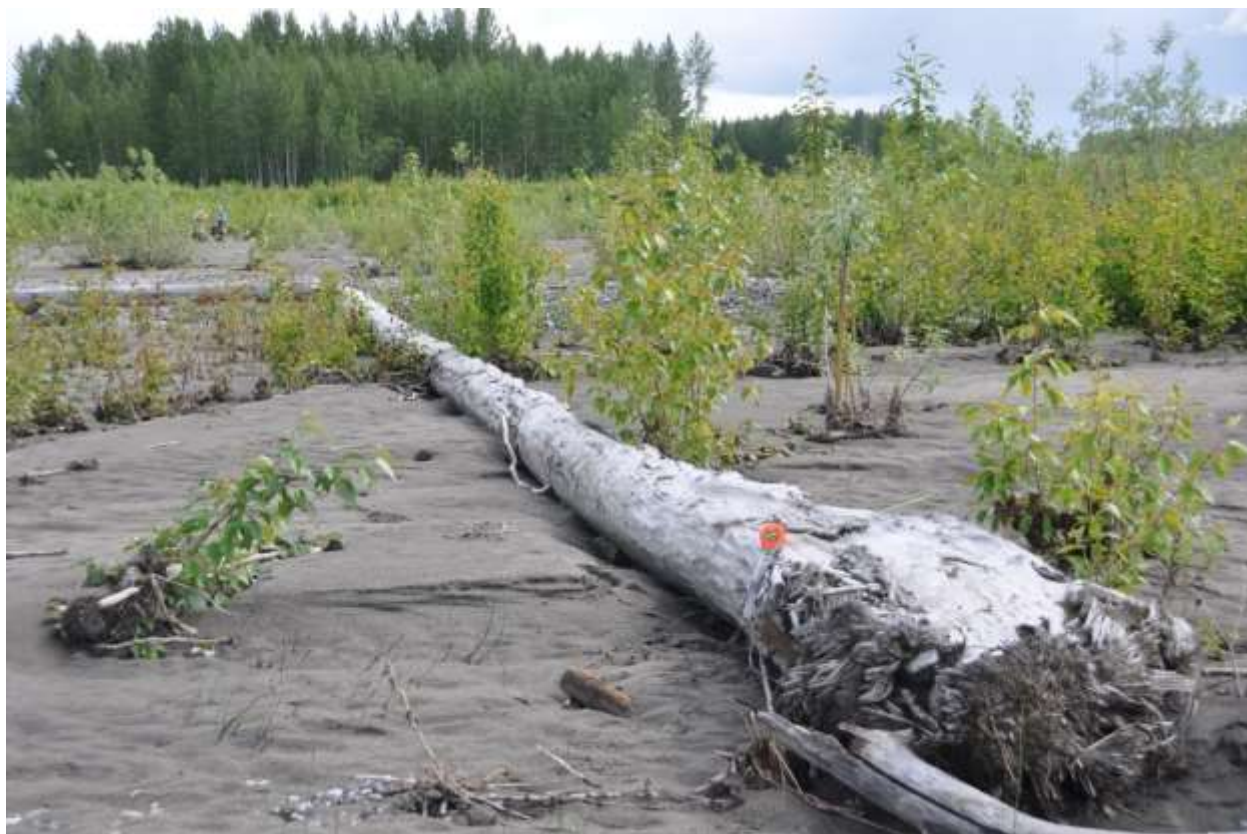
Photograph 31. July 2, 2012 Middle Susitna River immediately above Three Rivers Confluence. Typical unstable wood debris. Note orange tape measure for scale.
