Technical Memorandum

Susitna River Large Woody Debris Reconnaissance

Susitna- Watana Hydroelectric Project

March 1, 2013

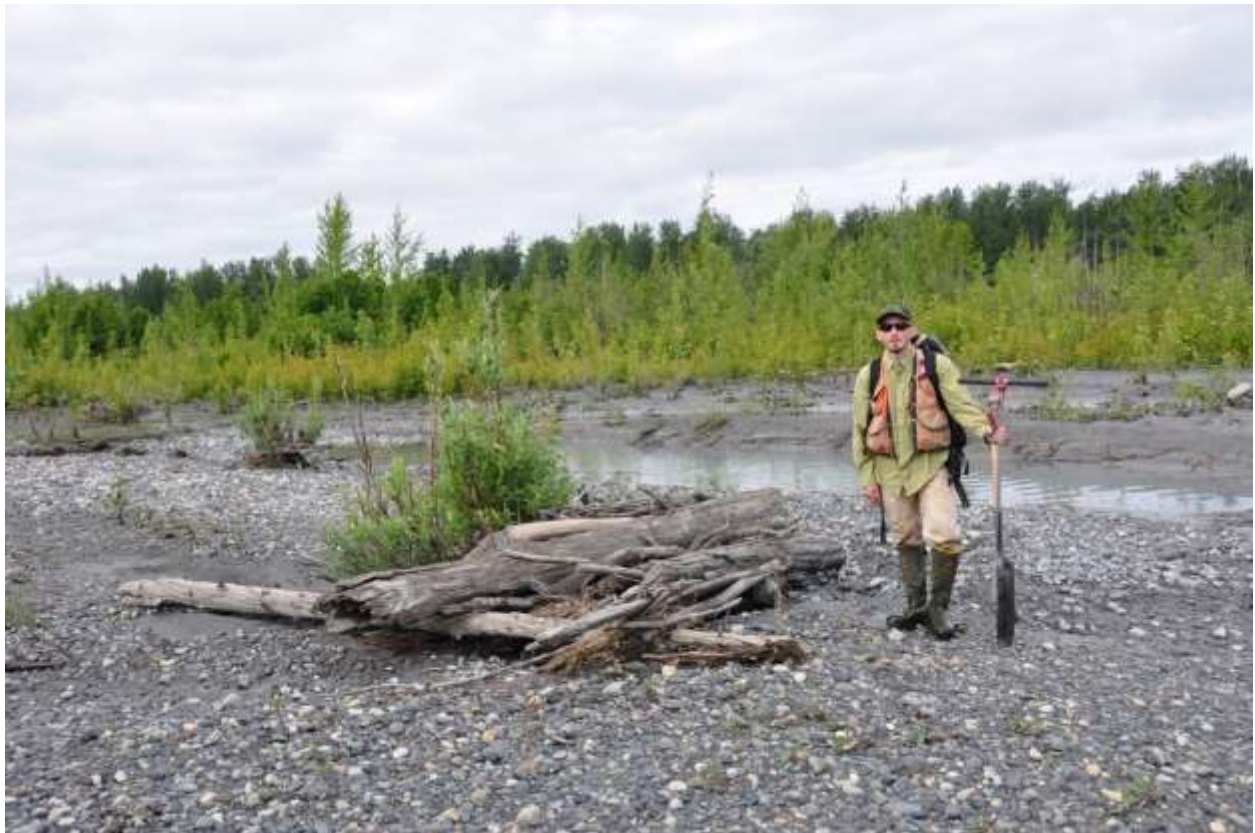
Photograph 32. July 2, 2012 Lower Susitna River below Talkeetna. Typical loose, unstable wood debris.

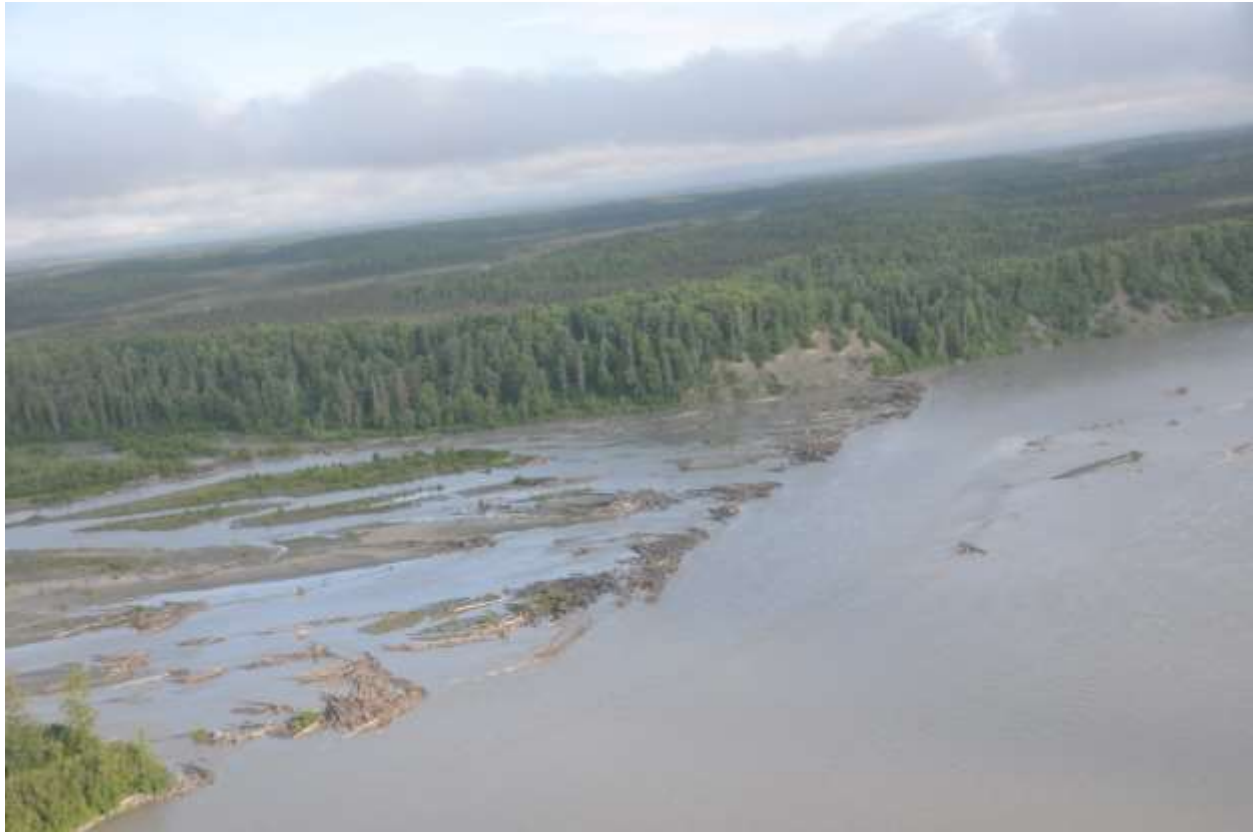
Photograph 34. June 30, 2012 Lower Susitna River between Talkeetna and Willow. Rafts of racked wood debris.

Bar top accumulations of unstable wood debris appear to be a defining characteristic of the Susitna River. Large quantities of unstable wood debris were observed throughout the Project study area with largest accumulations occurring in the Lower Susitna (Photographs 9, 10, 21) with apparently large contributions from the Chulitna River. However, unstable wood debris was observed throughout both Middle and Lower River segments during the 2012 aerial reconnaissance (Photographs 16, 21, 31, 32, 33, 34, 35, 36, 37). Loose, mobile wood was observed along river banks (Photographs 2, 3), mid channel islands (Photographs 18, 20), and throughout side channel complexes (Photographs 16, 17, 18, 21, 34).

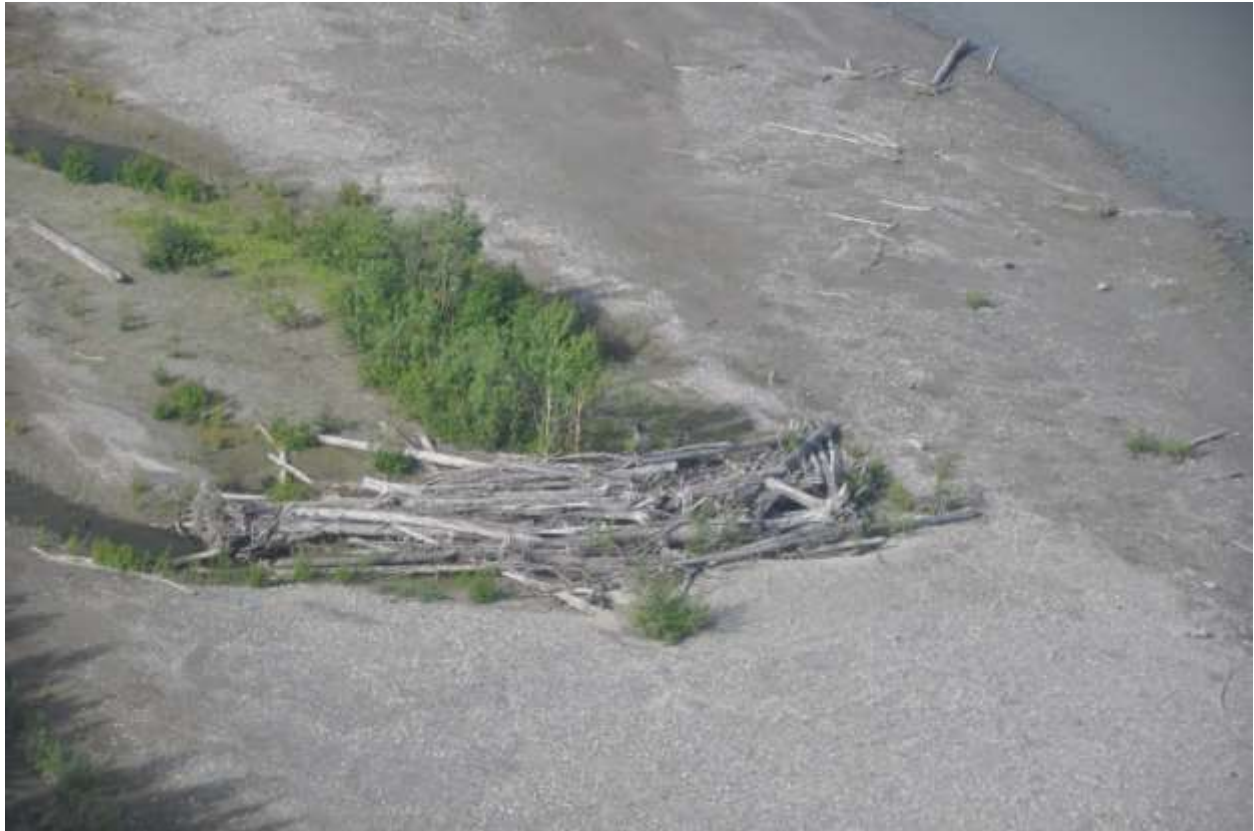
Photograph 35. June 30, 2012 Lower Susitna River between Talkeetna and Willow. Racked wood deposited at young balsam poplar/alder vegetation obstruction.
