# SUSITNA-WATANA HYDROELECTRIC PROJECT

## Water Resources Technical Work Group Meeting 2nd Quarter 2013 Ice Processes

June 26, 2013

Prepared by HDR Alaska, Inc.

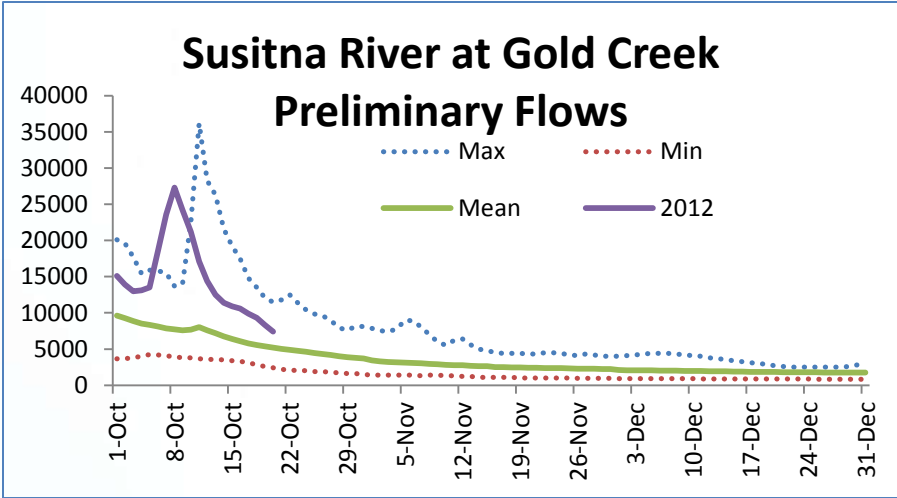
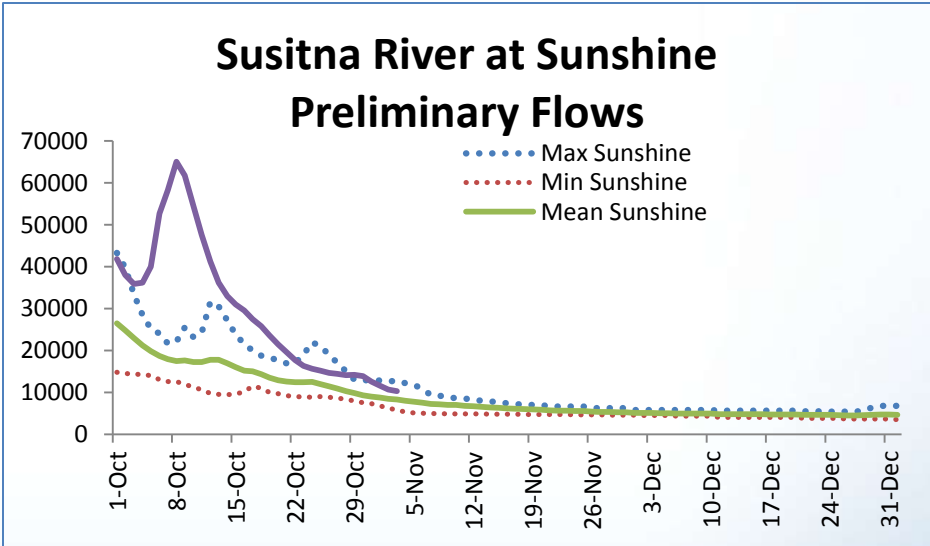
# 2012 Freeze-up Flows

- Higher than average flows during early ice formation dropping to normal winter flows
- Temperatures in November average, warmer December and January
- In the Lower River, a continuous ice cover progressed from tidewater upstream to PRM 121.
- In the Middle River, a second bridge at PRM 124 initiated ice cover to the mouth of Devils Canyon. Multiple bridges formed between Portage Creek and the proposed dam site.
- In the Upper River, a continuous ice cover progressed from PRM 194 to the Oshetna River.

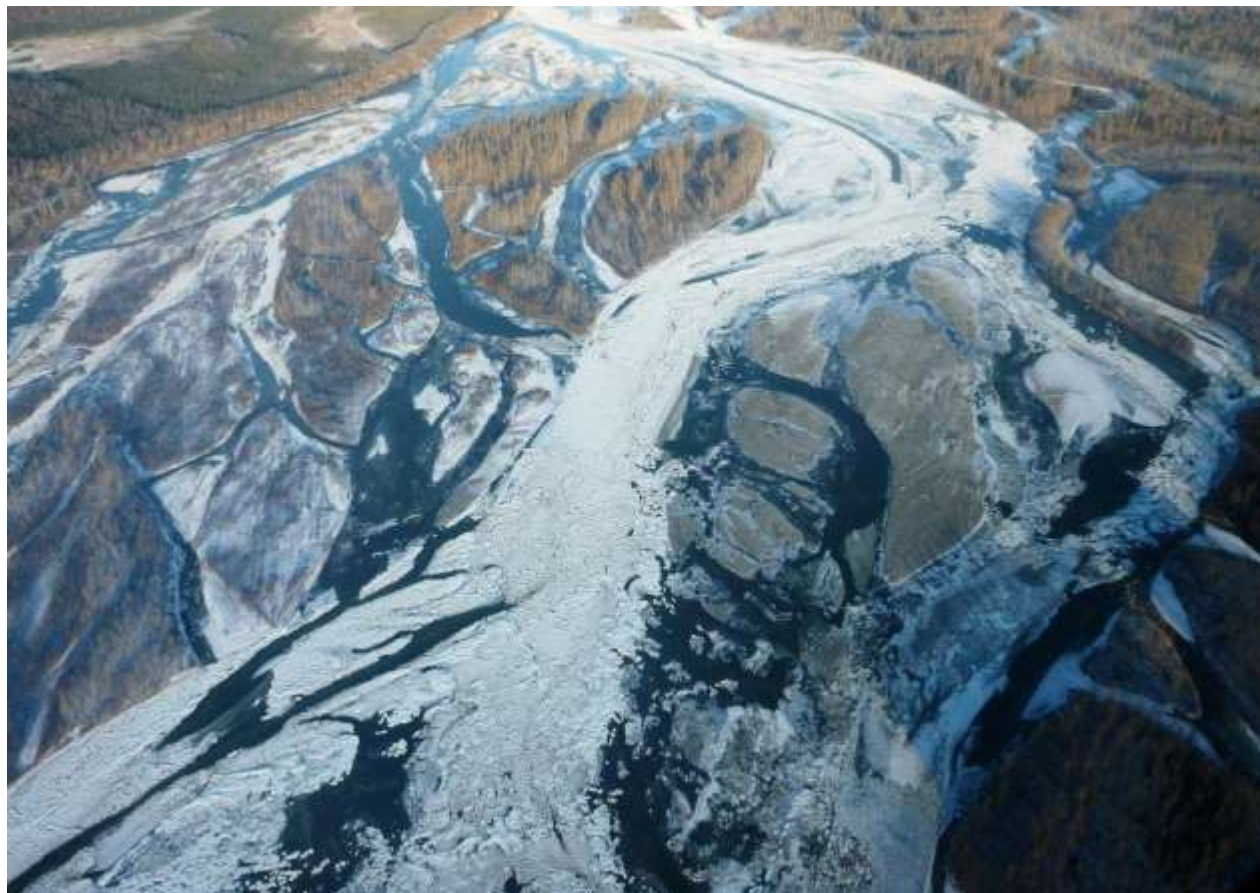
Ice cover progressed rapidly at first then slowed

- 11-12 miles/day up past the Yentna River,
- 7 miles/day past Sunshine Station,
- 4 miles/day to Talkeetna.

The thalweg filled with ice first, then flow was diverted to other channel braids.

Ice cover leading edge, PRM 72

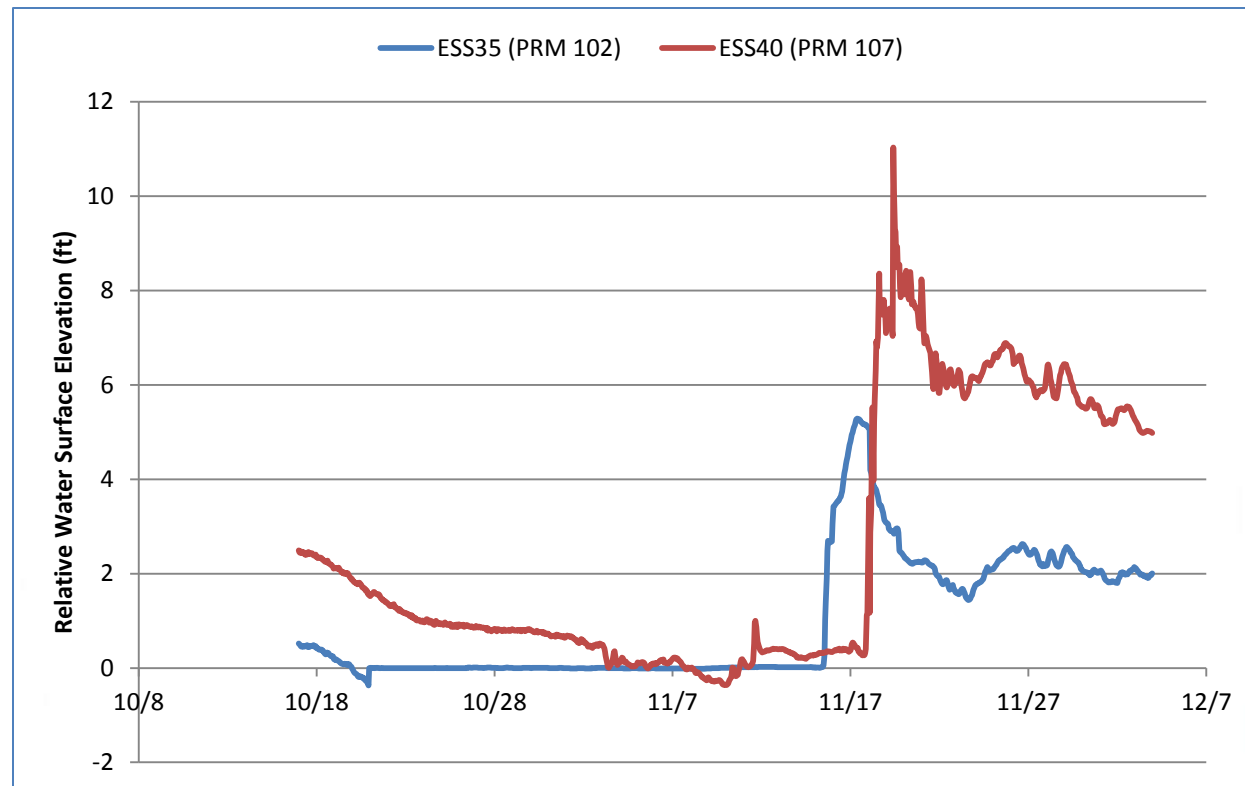
# 2012 Freeze-up Observations – Middle River Staging

Only two pressure transducers survived freeze-up in the Middle River.

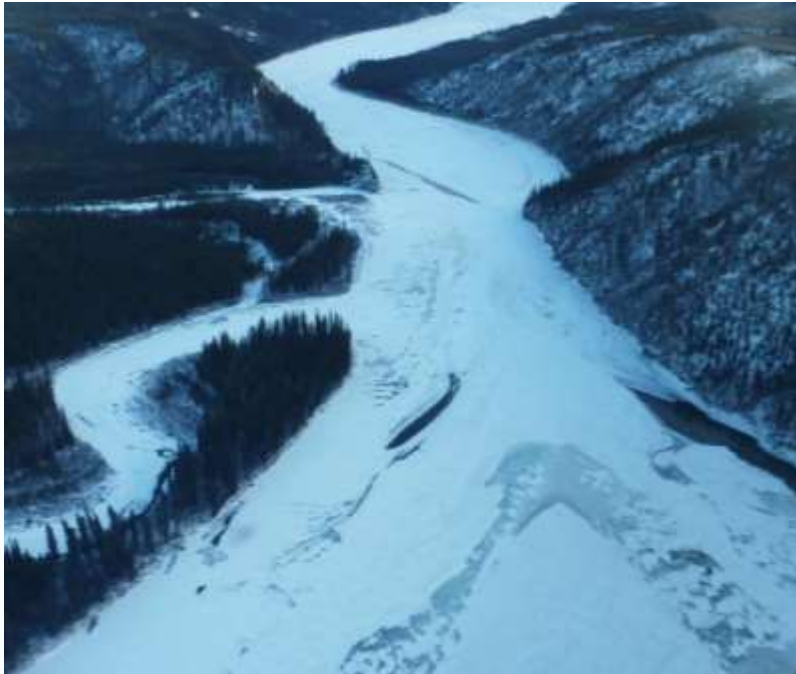
Above, Upper River ice bridge,  
PRM 196.6, November 15<sup>th</sup>

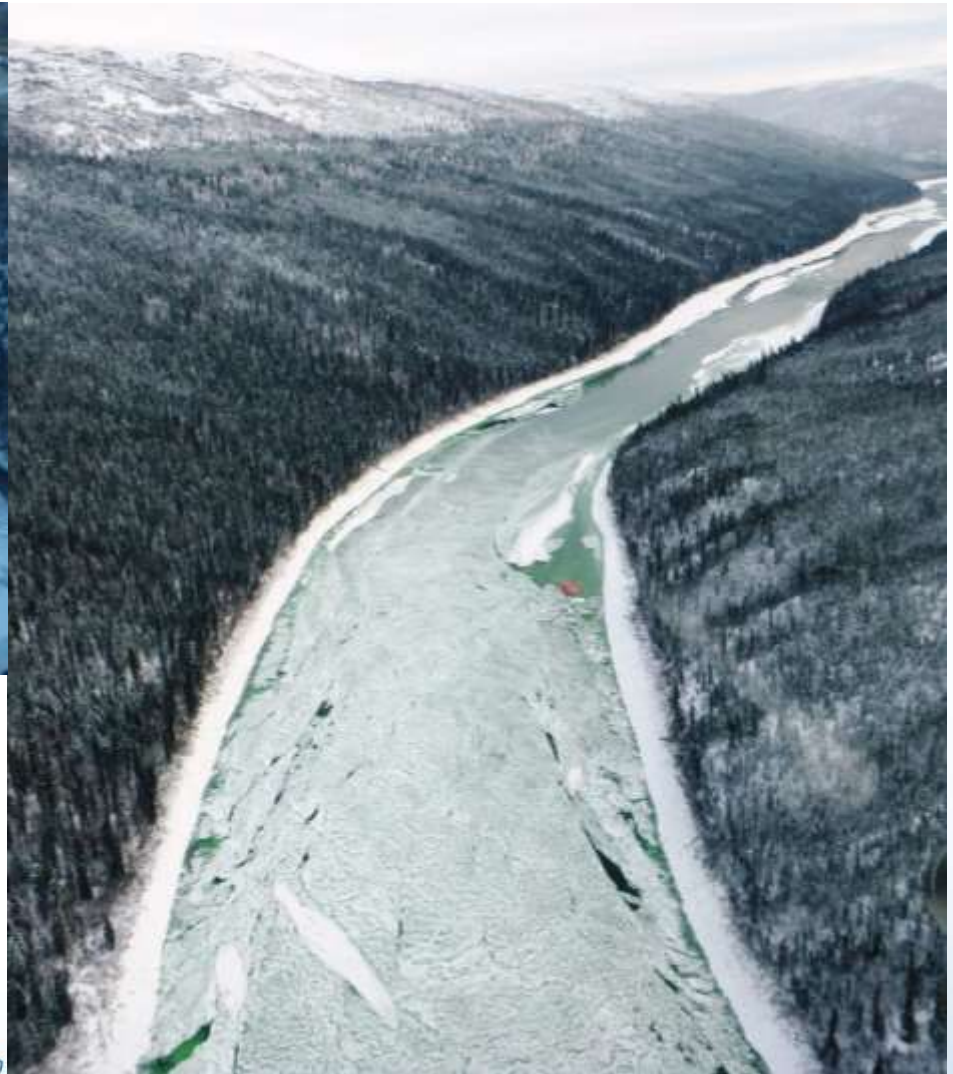
Right, Upper River ice front,  
PRM 217.5, November 15<sup>th</sup>

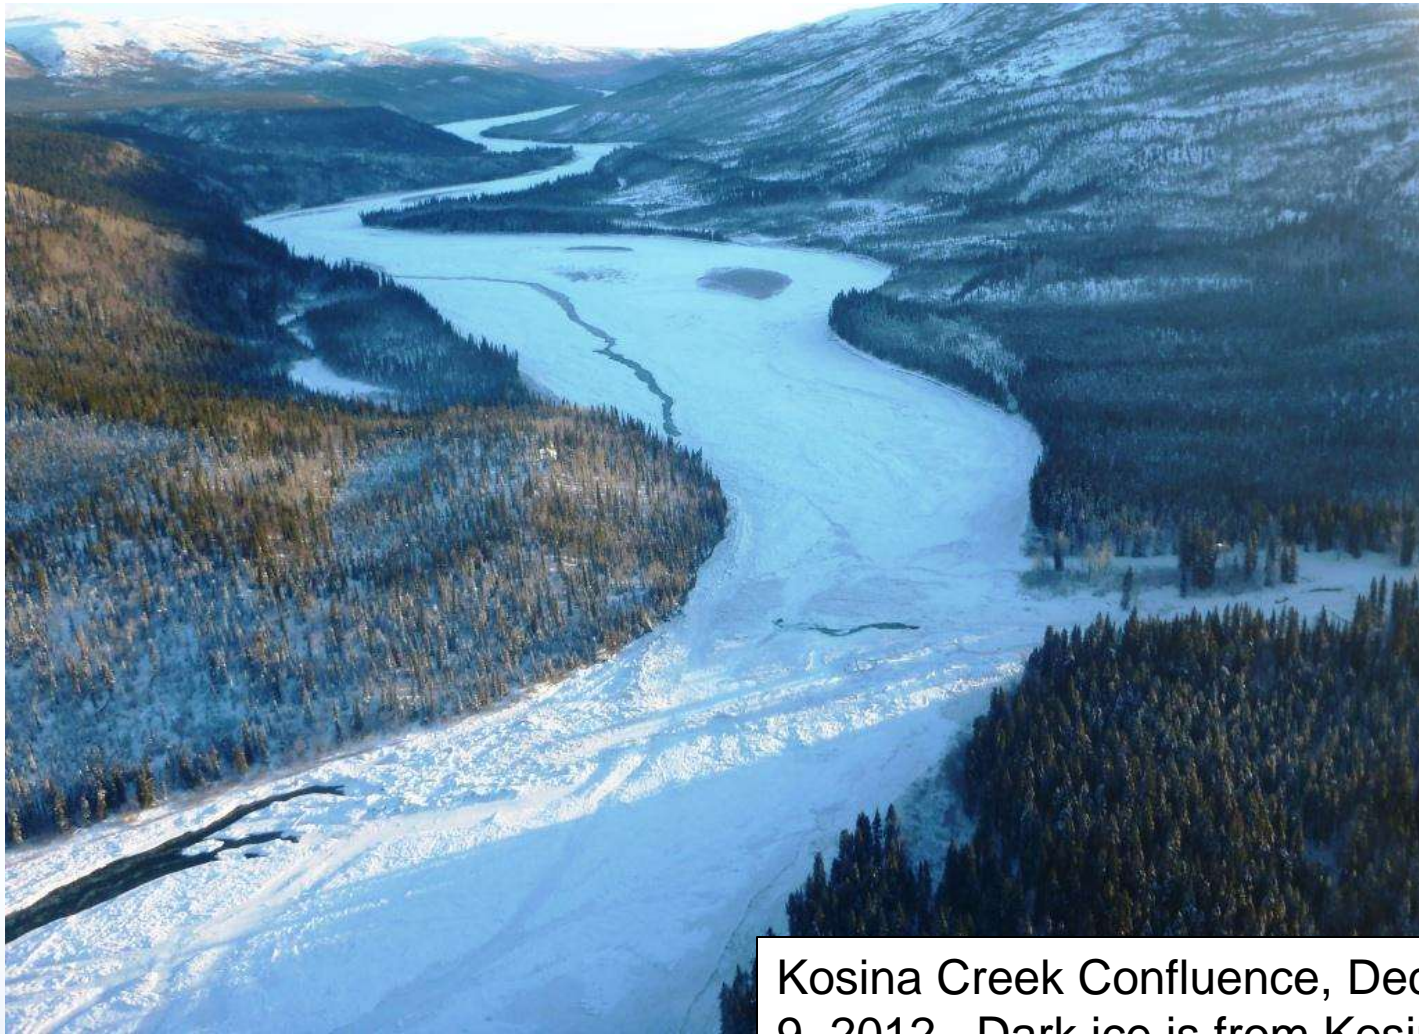
Kosina Creek Confluence, December 9, 2012. Dark ice is from Kosina Creek ice jam blowout.

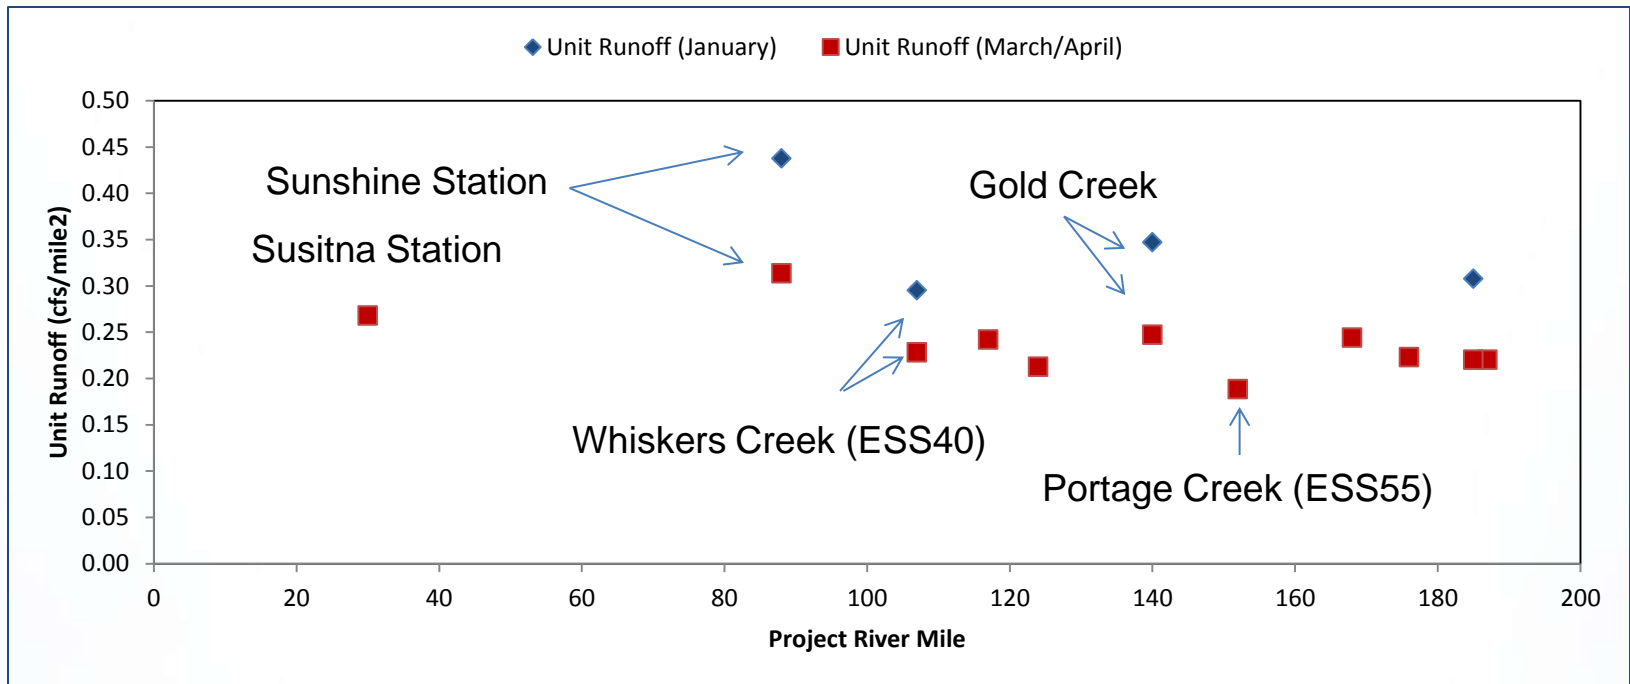
# Ice Covered Conditions – Winter Discharge Profile

- Winter discharges were consistent with USGS discharges measured in the past.
- Runoff per unit area (URO) varied along the river, with higher URO at Sunshine at Susitna Station, and lower URO at Portage Creek. There also appeared to be consistently higher URO at Gold Creek than near Whiskers Slough.

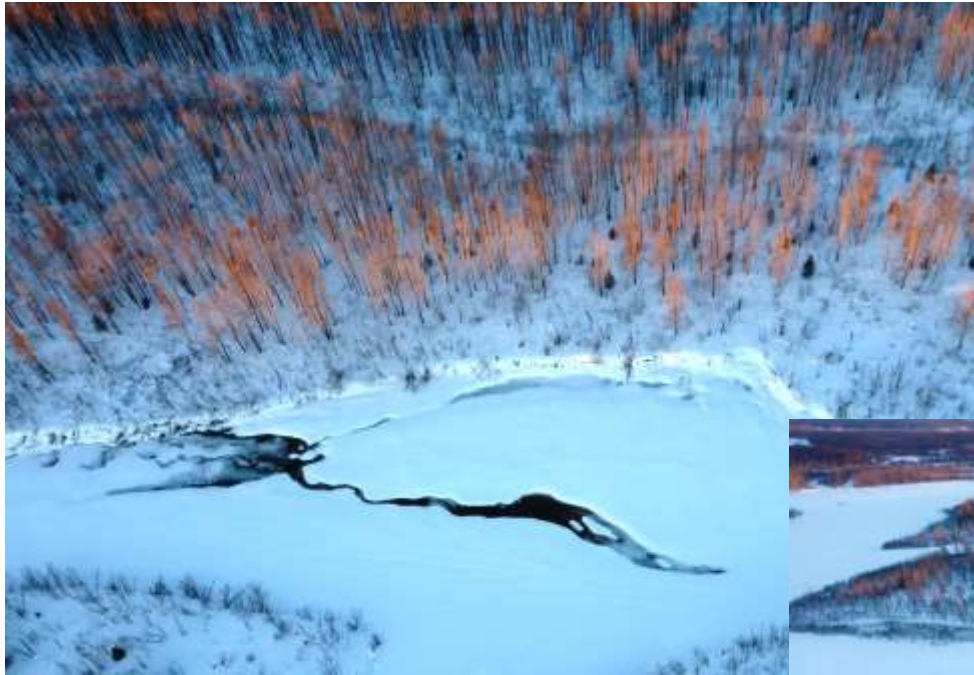
PRM 45 Thermal Lead – Side Channel. Visible gravel and wavy edges.

Watching progression of leads throughout winter was informative – velocity leads tended to fill in from the bottom up with flowing frazil, while thermal leads tended to remain static or open up more.

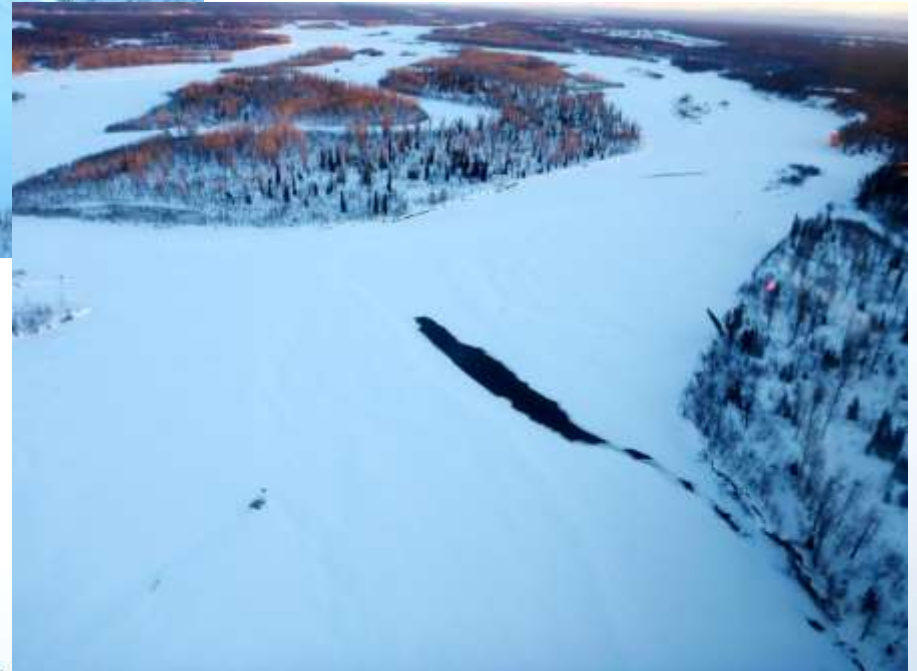
PRM 35 Velocity Lead – straight edges

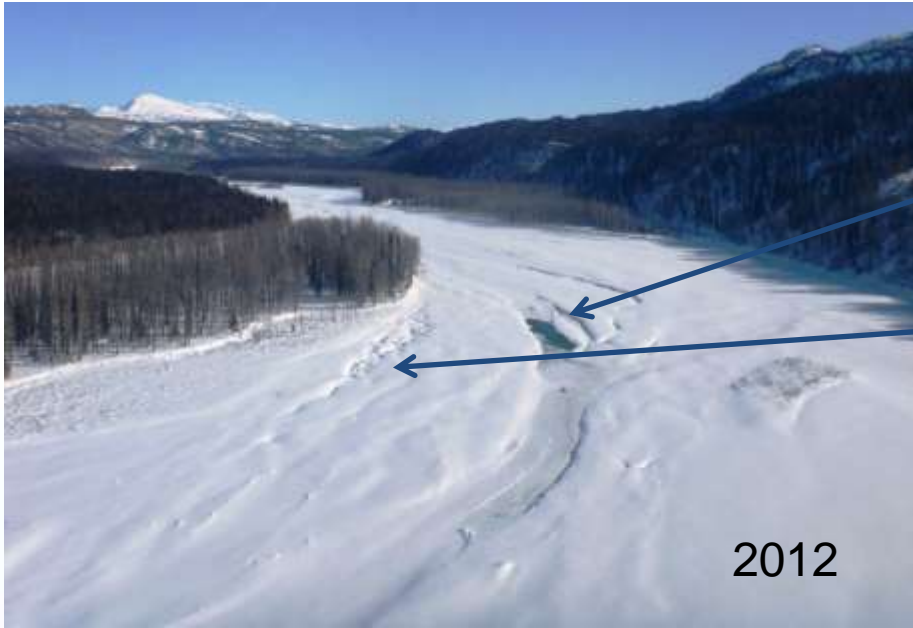
2012

Velocity Lead

Thermal Lead

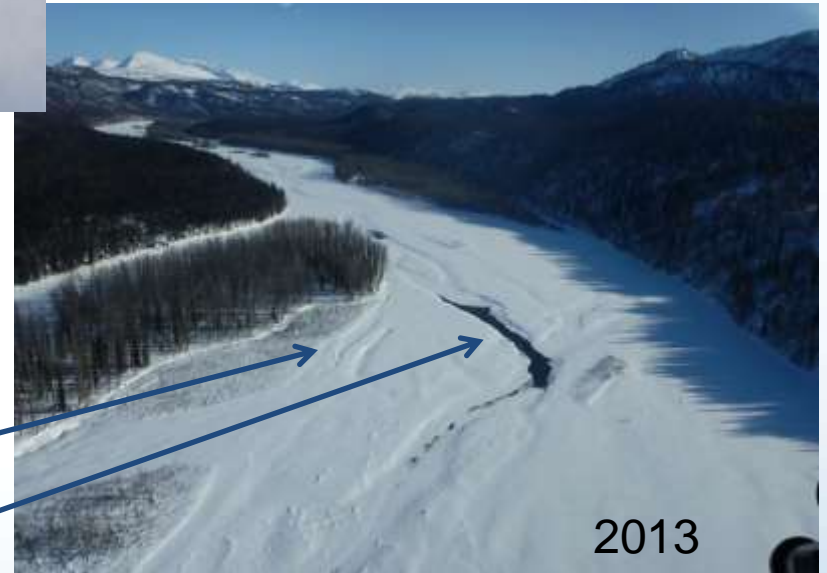
2013

Thermal Lead

Velocity Lead

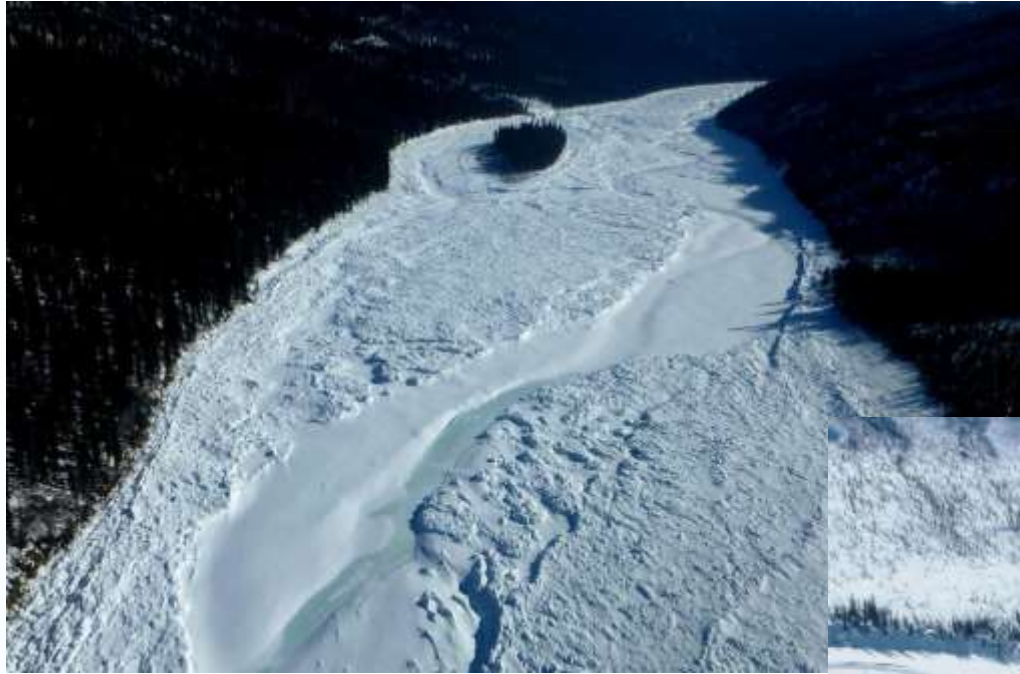
PRM 215 – smooth ice indicates former leads that have frozen over.

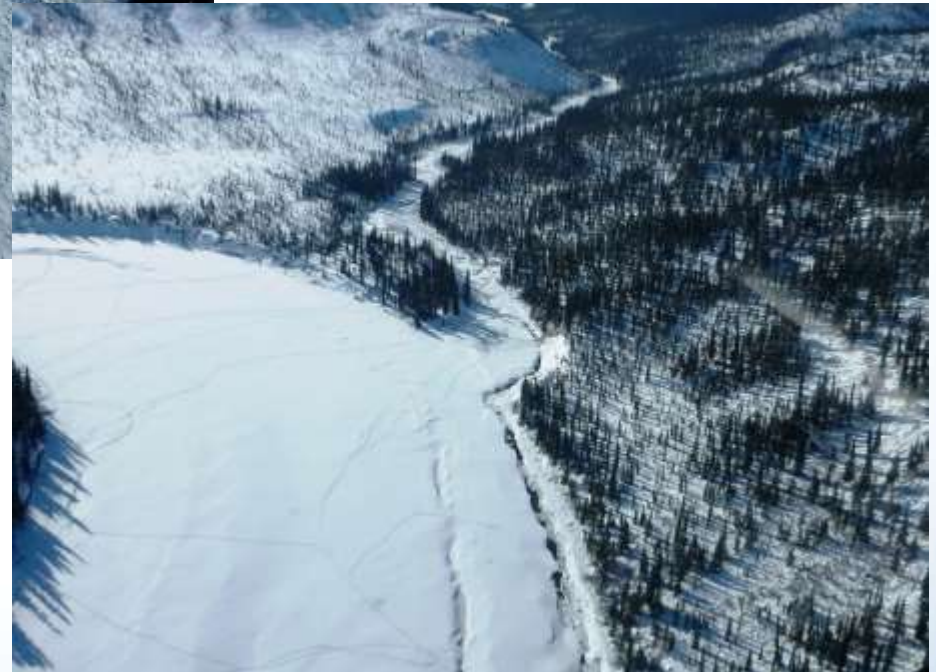
PRM 230 – Open lead downstream of Goose Creek. Many leads were associated with tributaries in the Upper River.

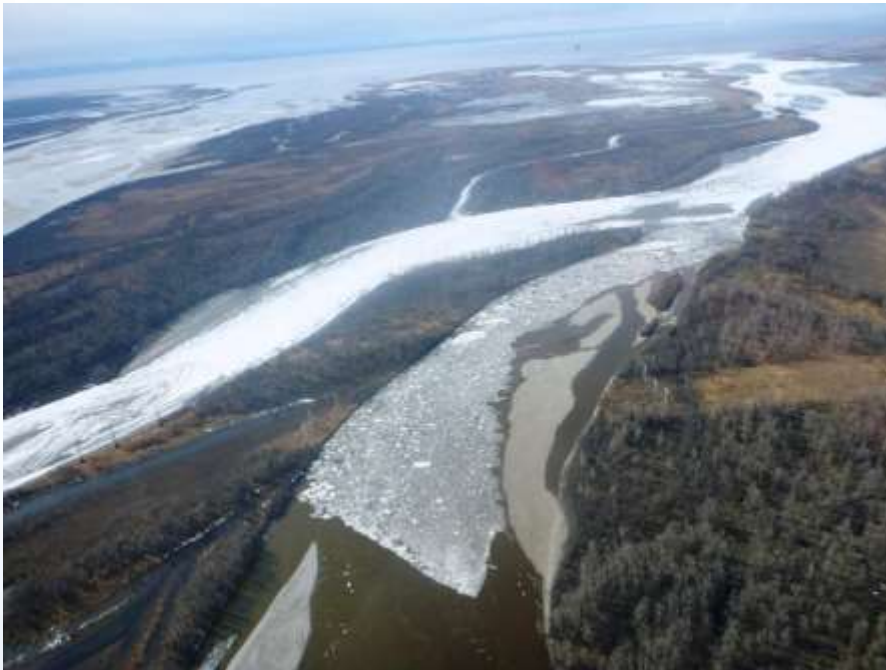
Jam at mouth of Alexander Slough,  
5/14/2013

Large tributaries broke up first.

- Alexander Creek and Deshka River broke up between May 11 and May 14.
- The Yentna River broke up May 19.

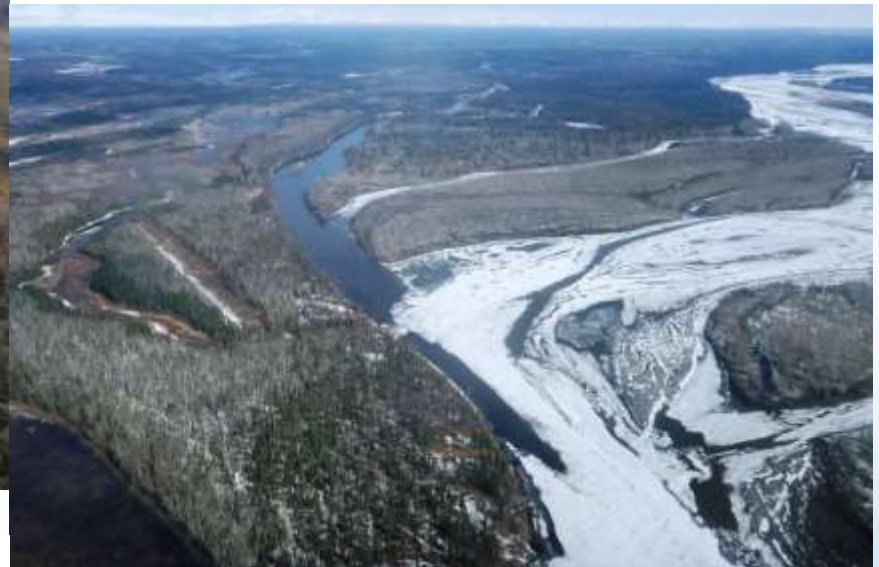
Mouth of Deshka River,  
5/14/2013

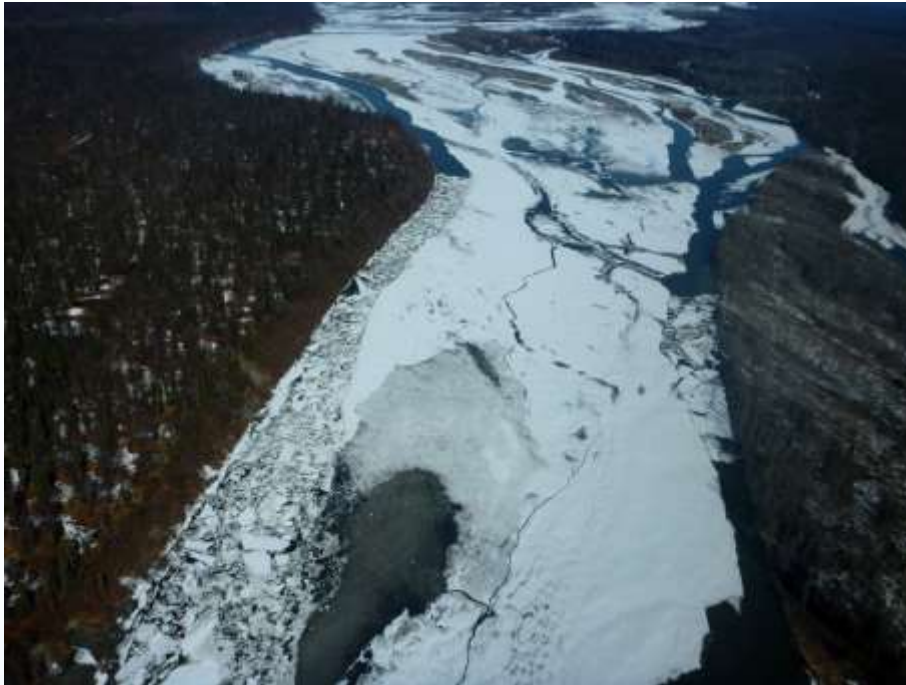
No apparent flooding was associated with breakup. Main flow moved to another braid where there were ice blockages.

← May 19, PRM 93

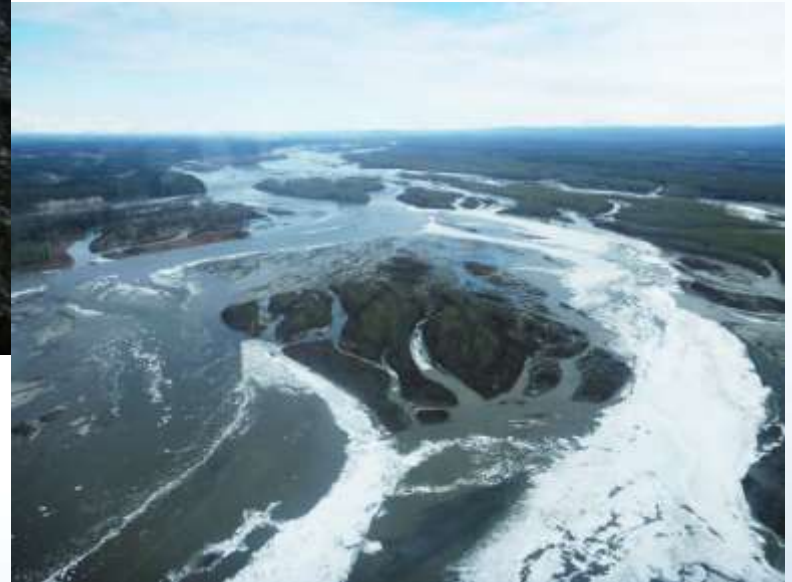
May 26, PRM 75 →

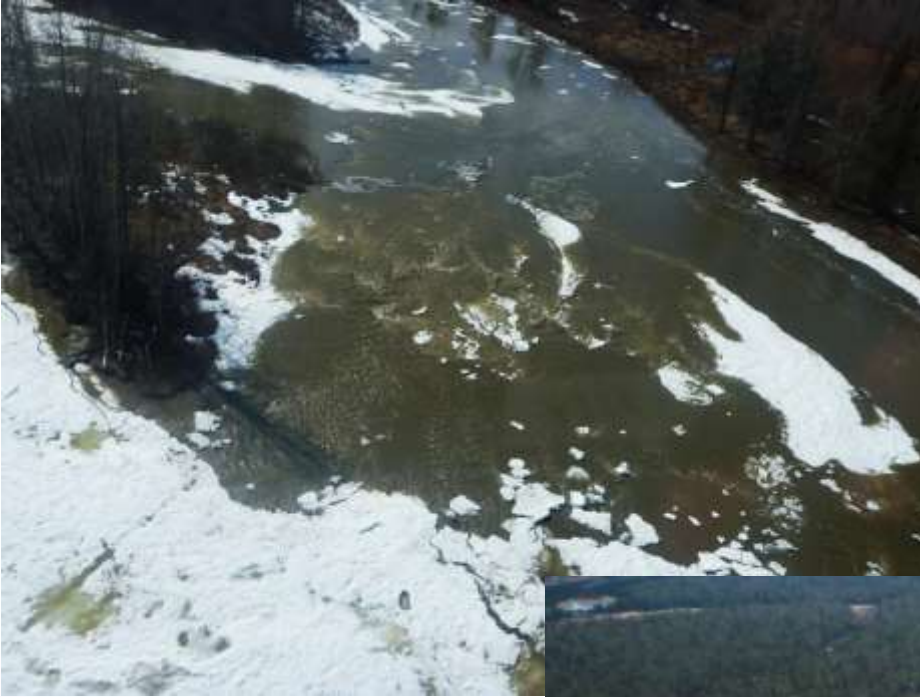
May 25 – water flowing into Whiskers from jam in main channel

- Major jams occurred Memorial Day weekend (May 25-27) during rapid warming. The biggest jams with flooding into the vegetation were at Whiskers Slough (extending up to PRM 113), PRM 131-134, PRM 134-136, and PRM 180-181.
- Several sloughs were overtopped or affected by ice jams during breakup, but not all of them. Sloughs that had ice flow into them included Whiskers Slough and Slough 9. Slough 8A, Slough 11, and Slough 21 had ice flow into side channels but not enter the sloughs.

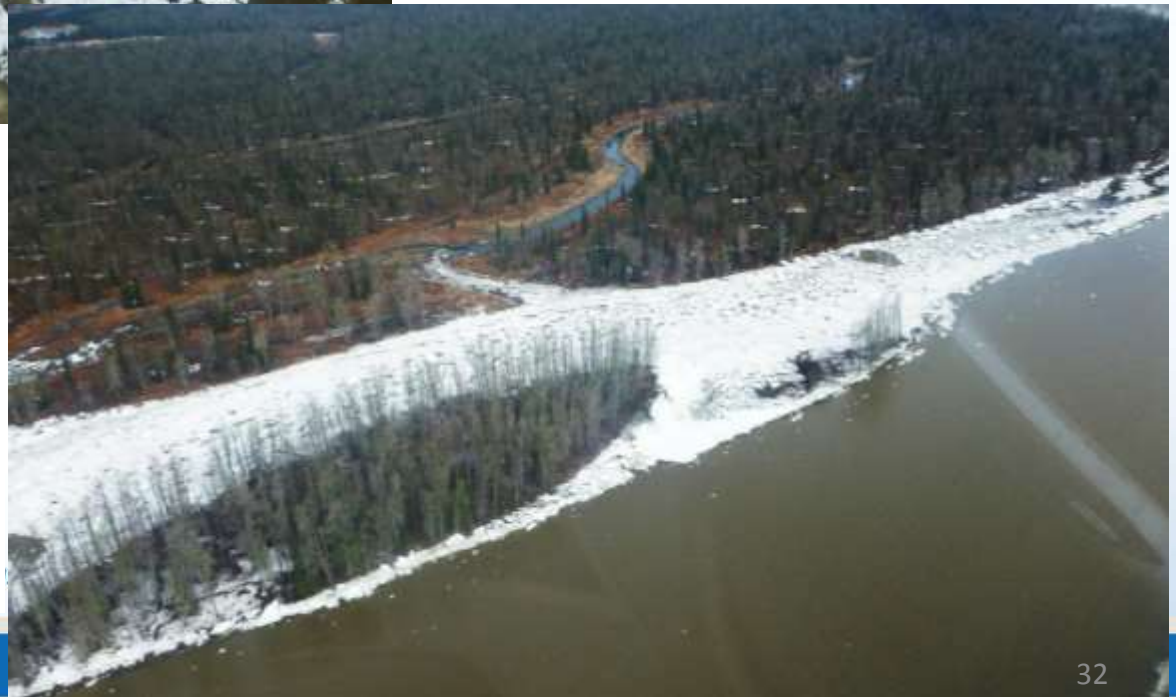
May 26 – ice remaining in Whiskers Slough
