Susitna-Watana Hydroelectric Project
(FERC No. 14241)

Ice Processes in the Susitna River Study
(Study 7.6)

Detailed Ice Observations
October 2013 – May 2014
Technical Memorandum

HDR Alaska, Inc.

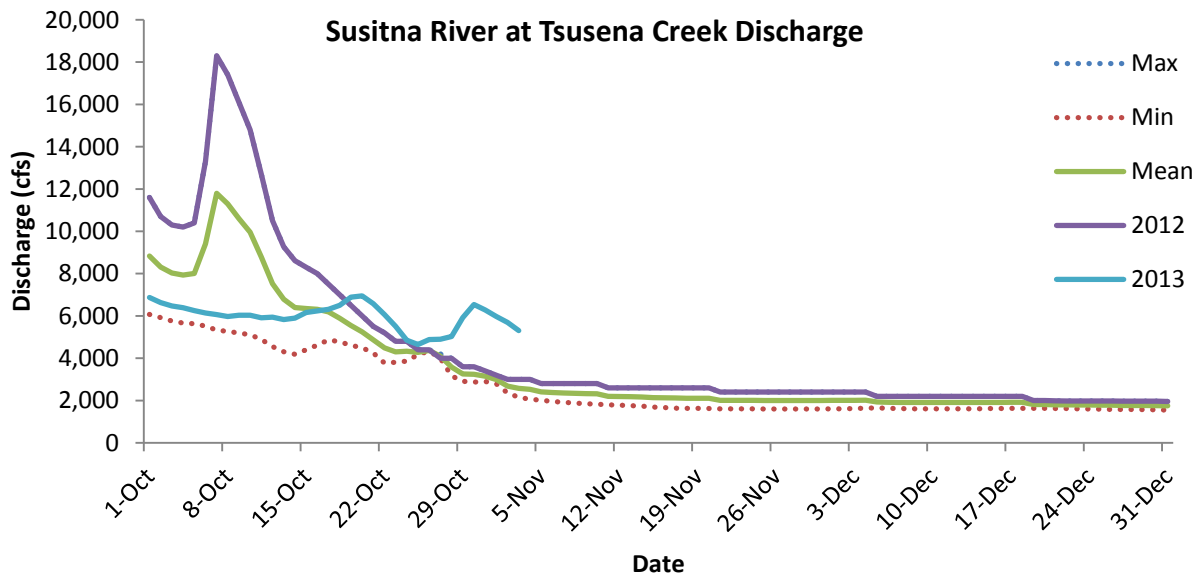
Figure 5.1 - 1. Susitna River at Tsusena Creek USGS Gage, #152917000. Note: 2012 Discharge was Maximum discharge for period of record

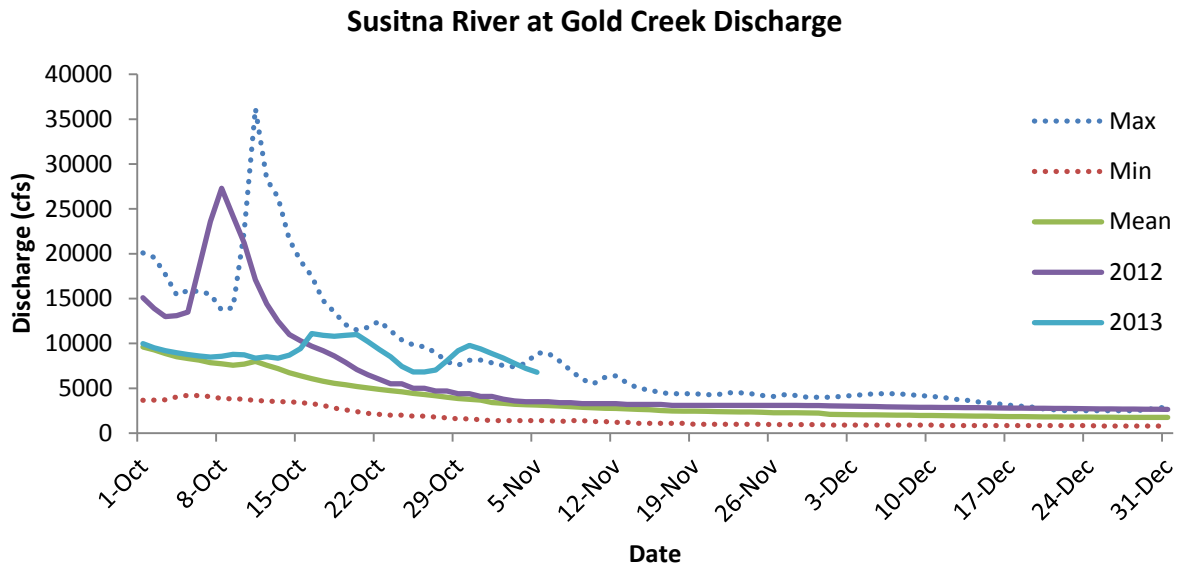
Figure 5.1 - 2. Susitna River at Gold Creek USGS Gage, #15292400

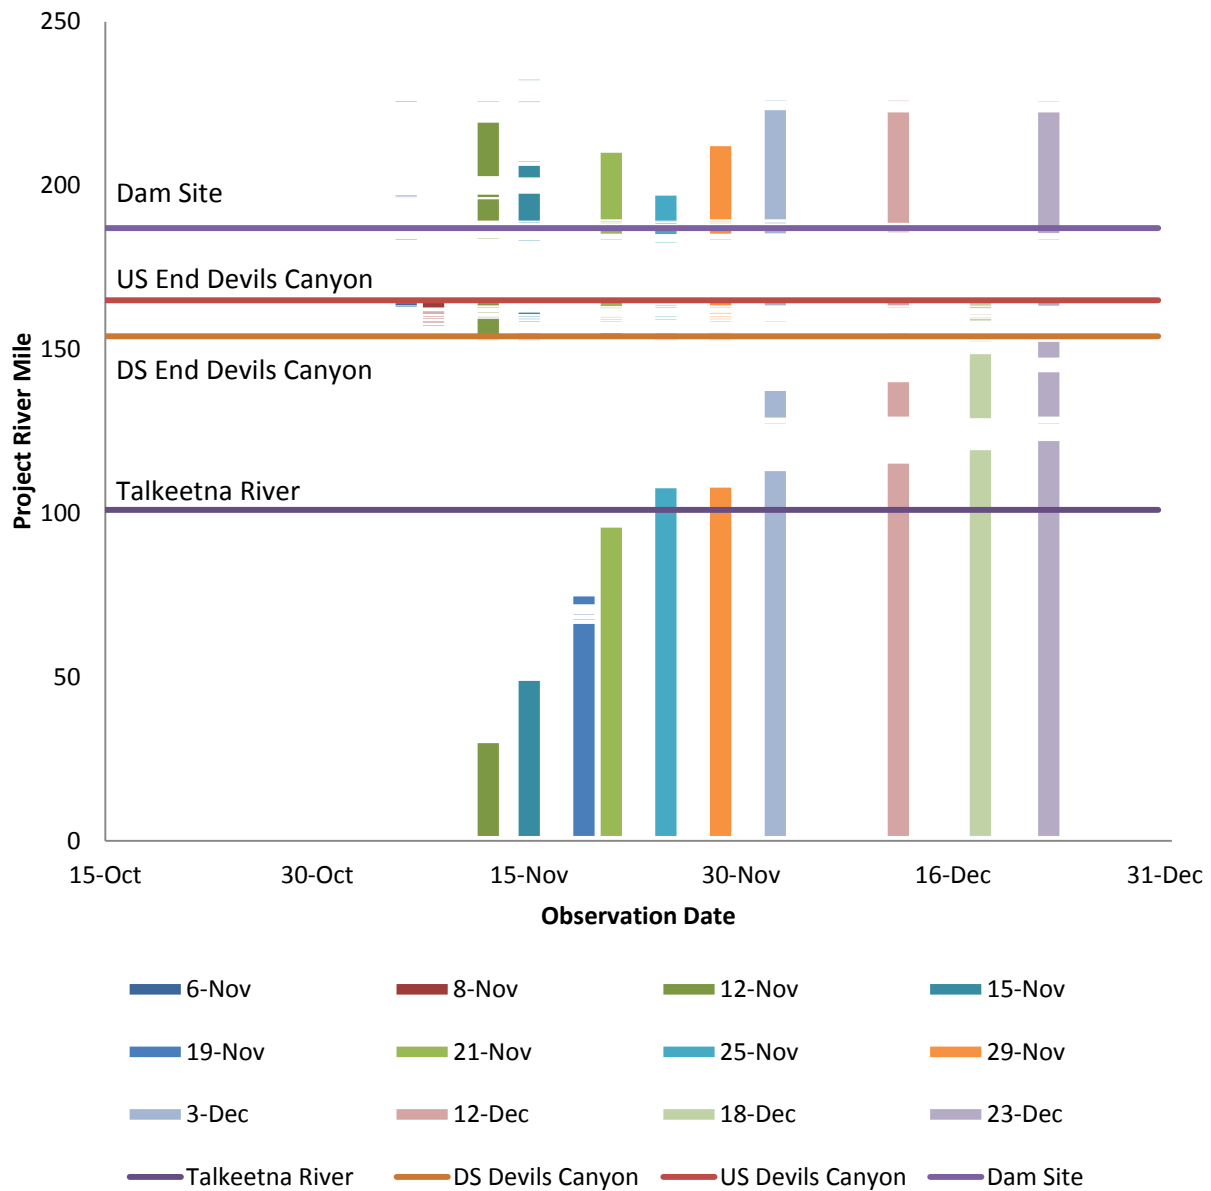
Figure 5.1 - 6. Ice Front Progression and Ice Bridge Locations – Freeze-up 2013

Overall, freeze-up was characterized by ice progression from downstream to upstream with few significant jamming or overbank events. Frazil flow was first observed in the Middle River at PRM 145.7 on October 23, 2013 when a field crew was installing time-lapse cameras. As temperatures dropped over the Basin, frazil ice production formed bridges with the earliest ice bridges being short, thick frazil ice bridges in Devils Canyon, which did not progress upstream. Again, ice cover in the Lower River was initiated by bridging in the lower 5 miles of the River which was similar to observed freeze-up in 2012. The Lower River ice cover progressed steadily to the Three Rivers confluence then slowed as it progressed farther upstream. Ice cover on the upper reaches of the Middle River and Upper River formed and progressed steadily upstream until the River was primarily ice covered by the end of December 2013. Figures 5.1-5 and 5.1-6 illustrate the ice front progression and ice bridge locations as observed over freeze-up in 2012 and 2013, respectively.

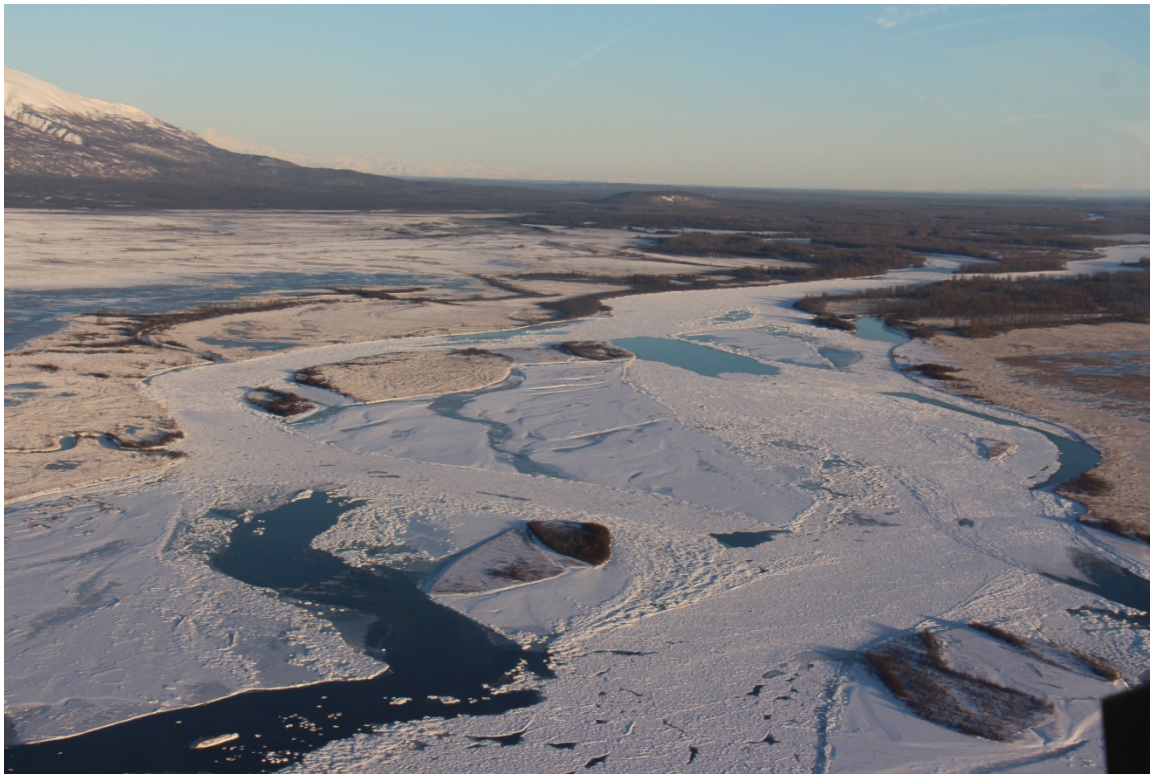
Figure 5.1 - 7. Ice bridge formed near the mouth of the Susitna river on November 12, 2013

November 12: An ice bridge formed at the mouth of the river and the ice front had progressed to PRM 29.8 since the previous flight on November 8. The ice cover was formed from consolidated pans on the main channel while many side channels were open through the highly braided reach. Frazil continued to move into the Lower River and was observed through most open channel locations as shown in Figure 5.1-8. Border ice growth on the Lower River was isolated but present.

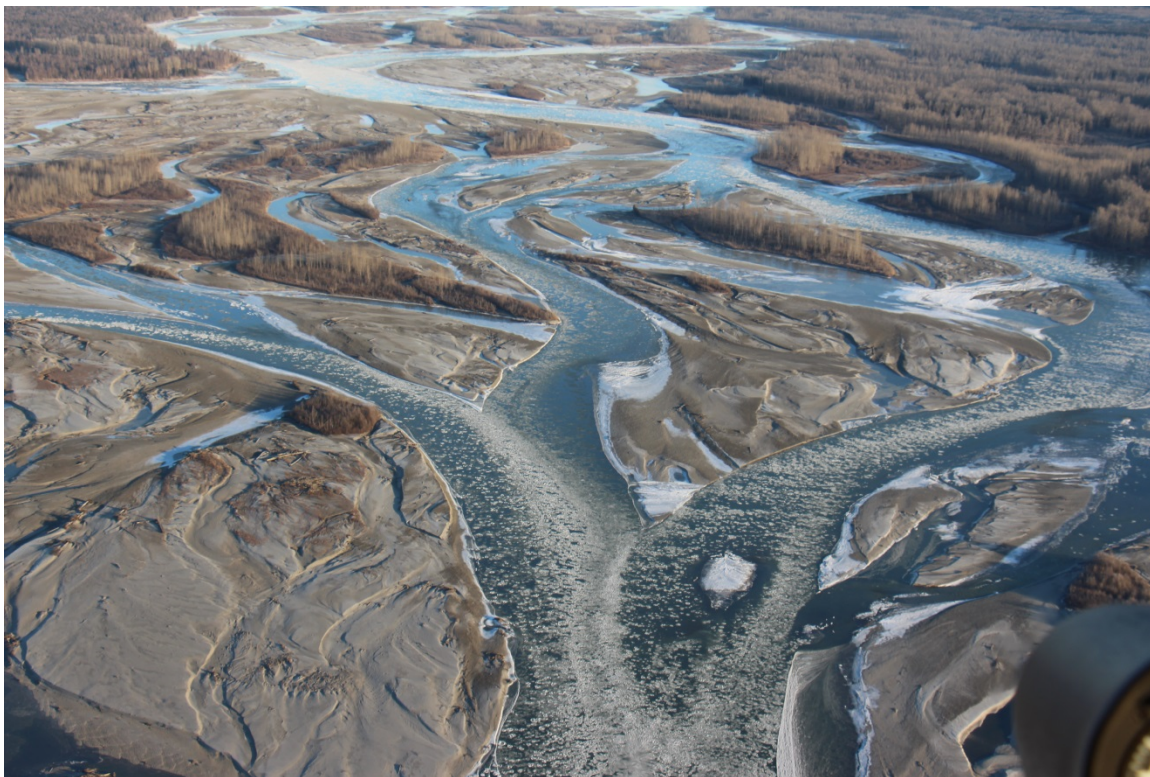
Figure 5.1 - 8. Frazil ice moving through the Delta Islands area

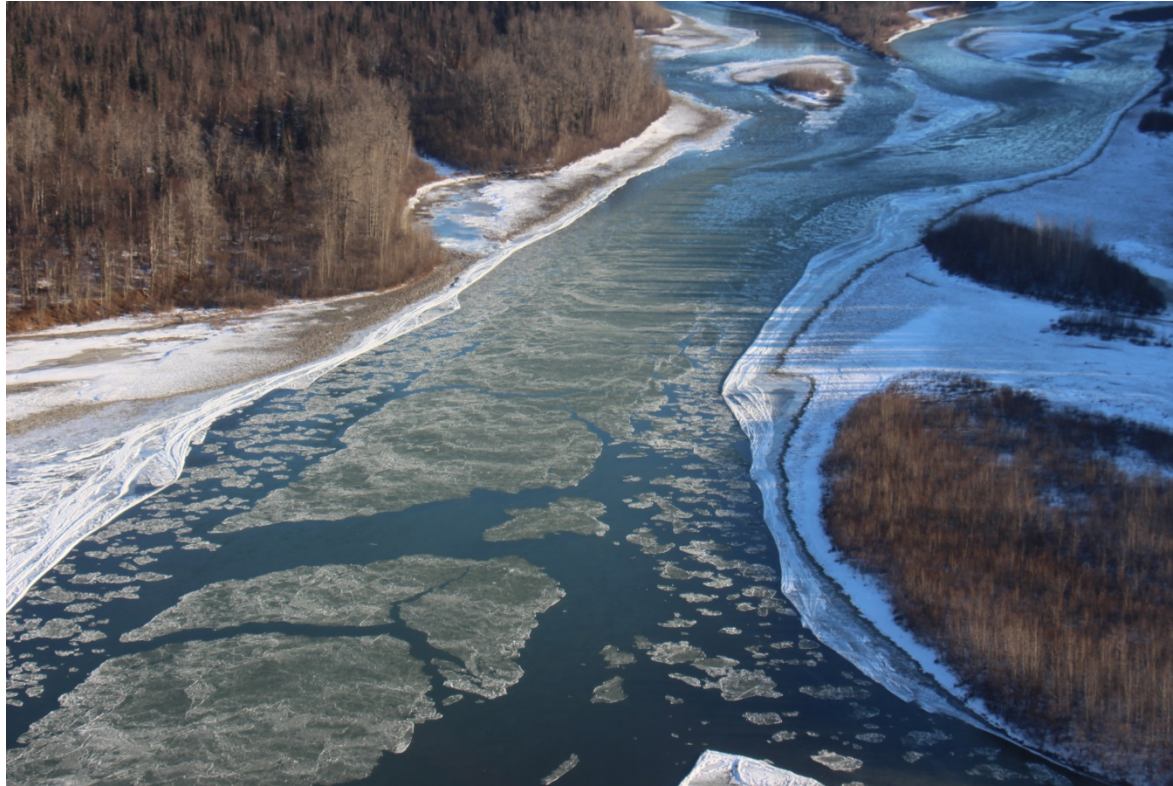
Figure 5.1 - 9. Heavy frazil and border ice growth on Middle River on November 8, 2013

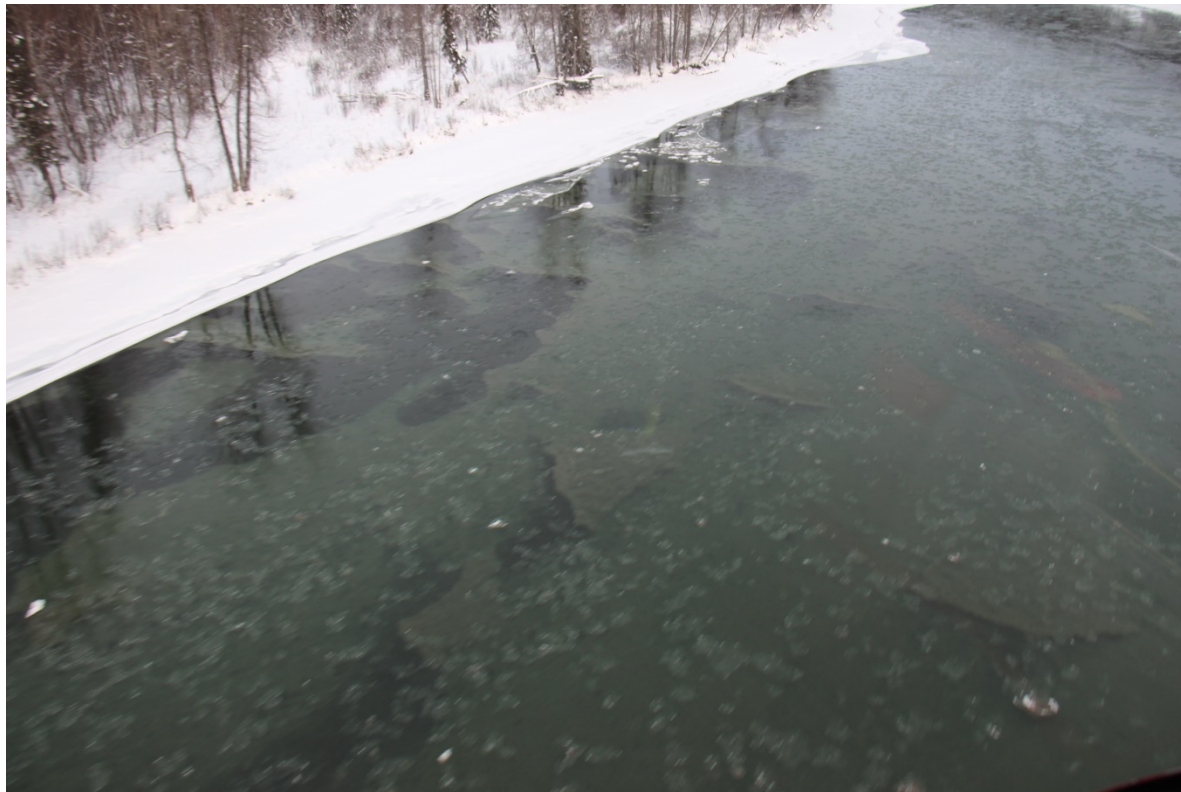
Figure 5.1 - 10. Anchor ice deposits on the bed on December 3, 2013

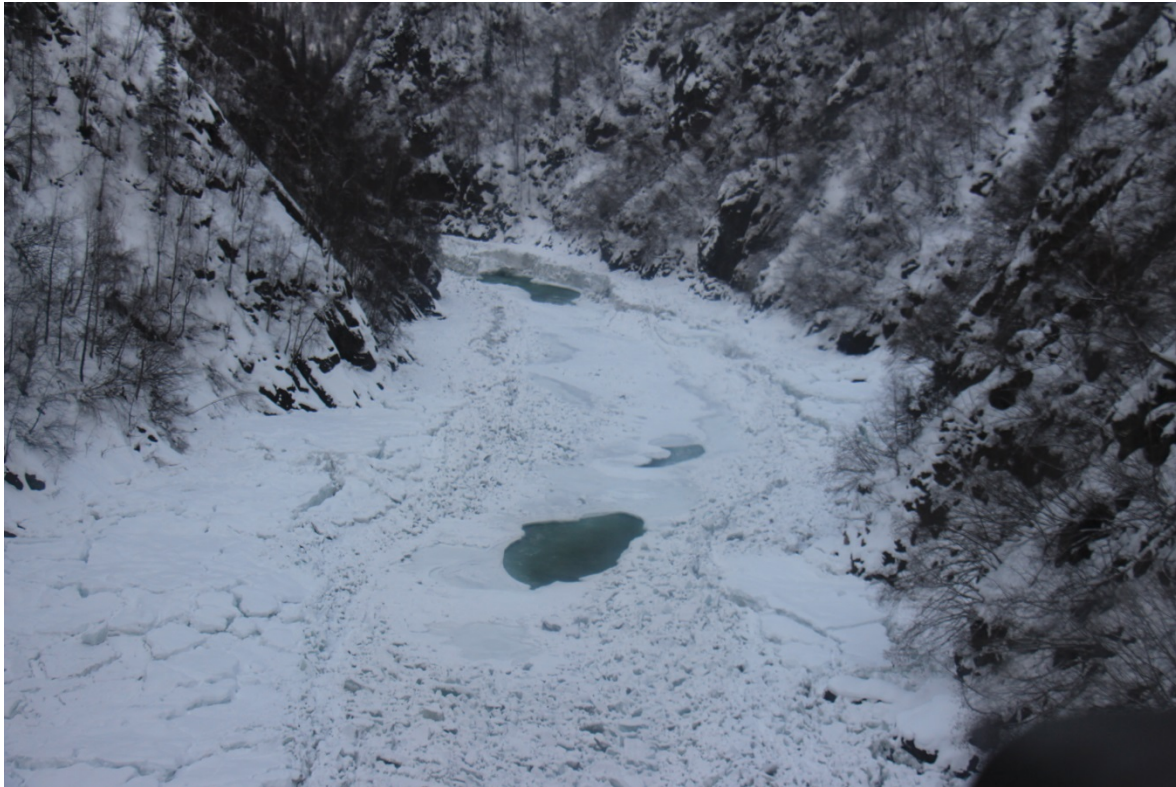
Figure 5.1 - 11. Shear walls and frazil jams in Devils Canyon on December 18, 2013

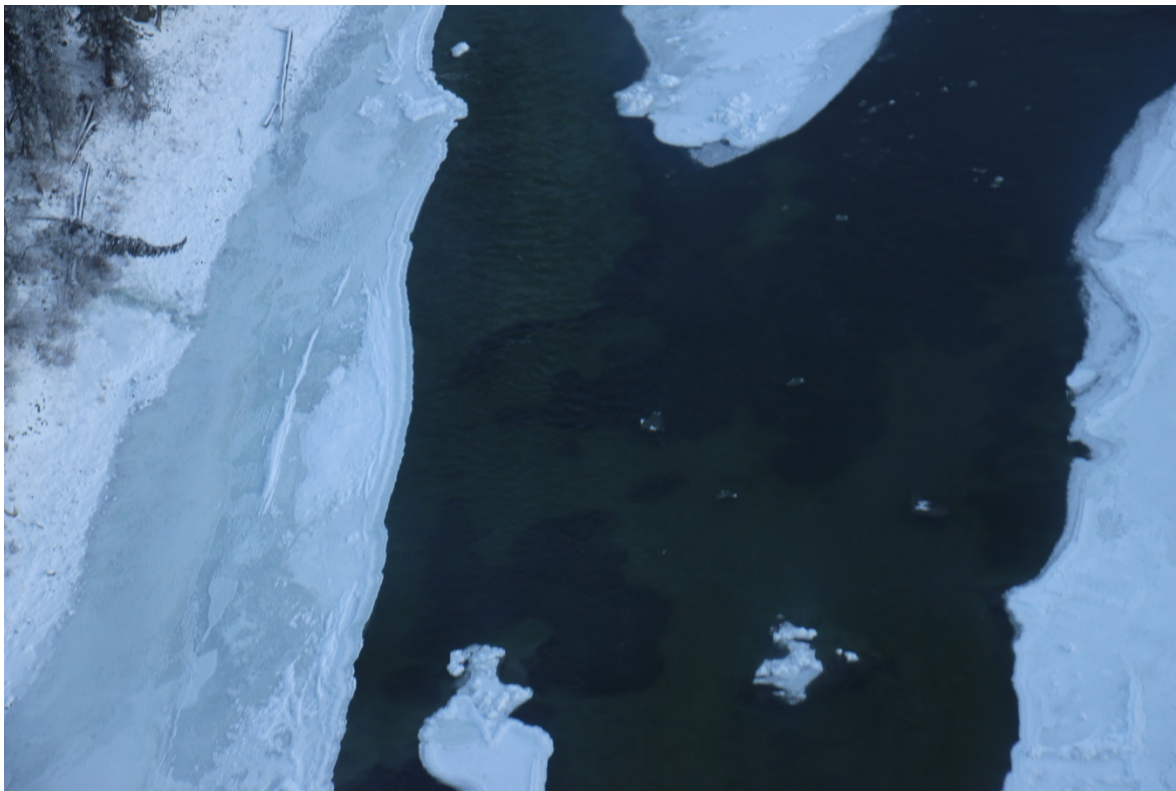
Figure 5.1 - 12. Anchor ice and border ice growth on the Upper River on November 19, 2013

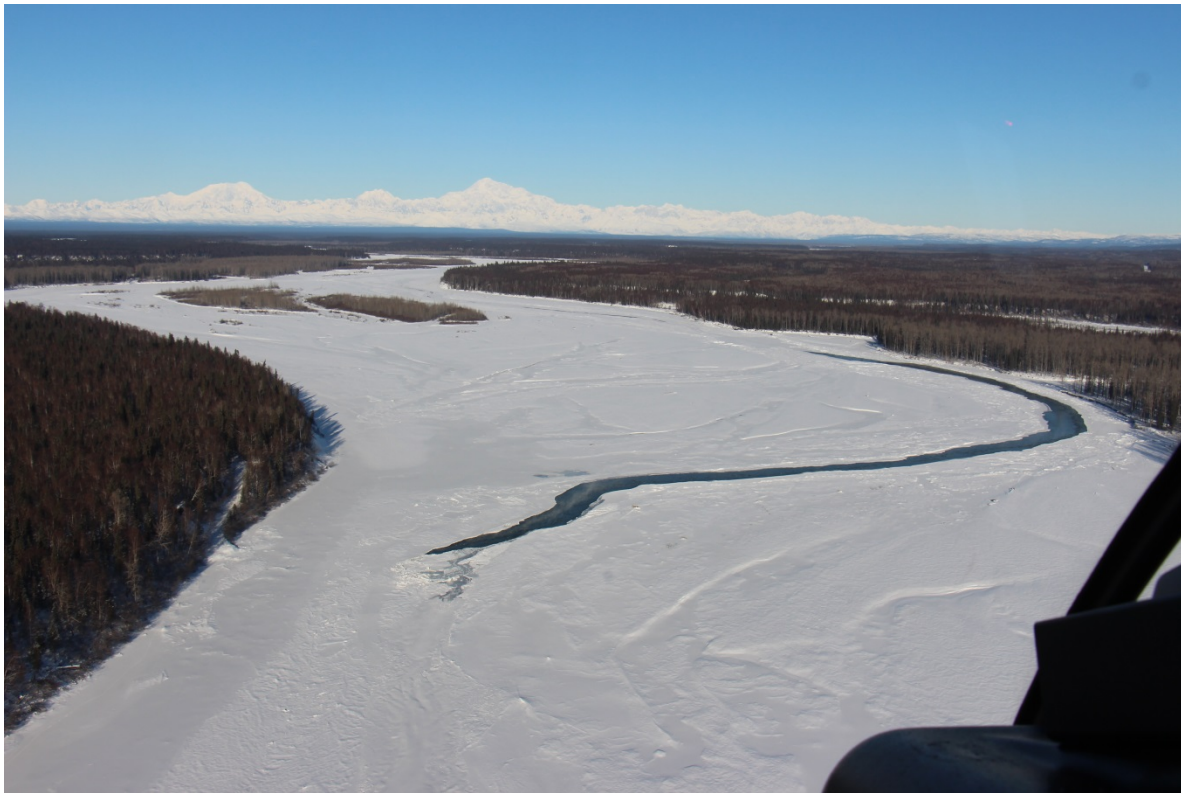
Figure 5.2 - 1. Open velocity lead following thalweg in Lower River on February 21, 2014

Open leads in the Lower River during the February 21 and April 2 surveys included both those of velocity and thermal origin. In general, the velocity leads were either located in the main channel thalweg or on the outside of bends as shown in Figure 5.2-1. Several of these velocity leads could be characterized as elongated ‘holes’ caused by turbulence or upwelling water. Some of the side channels/sloughs were introducing warmer water, resulting in small thermal leads that would often blend into a velocity lead in the main channel. The thermal leads were either groundwater upwelling in the bottom of a side channel or slough, groundwater seepage off of bluffs/ river banks (Figure 5.2-2), from upland sources, or input from tributaries.

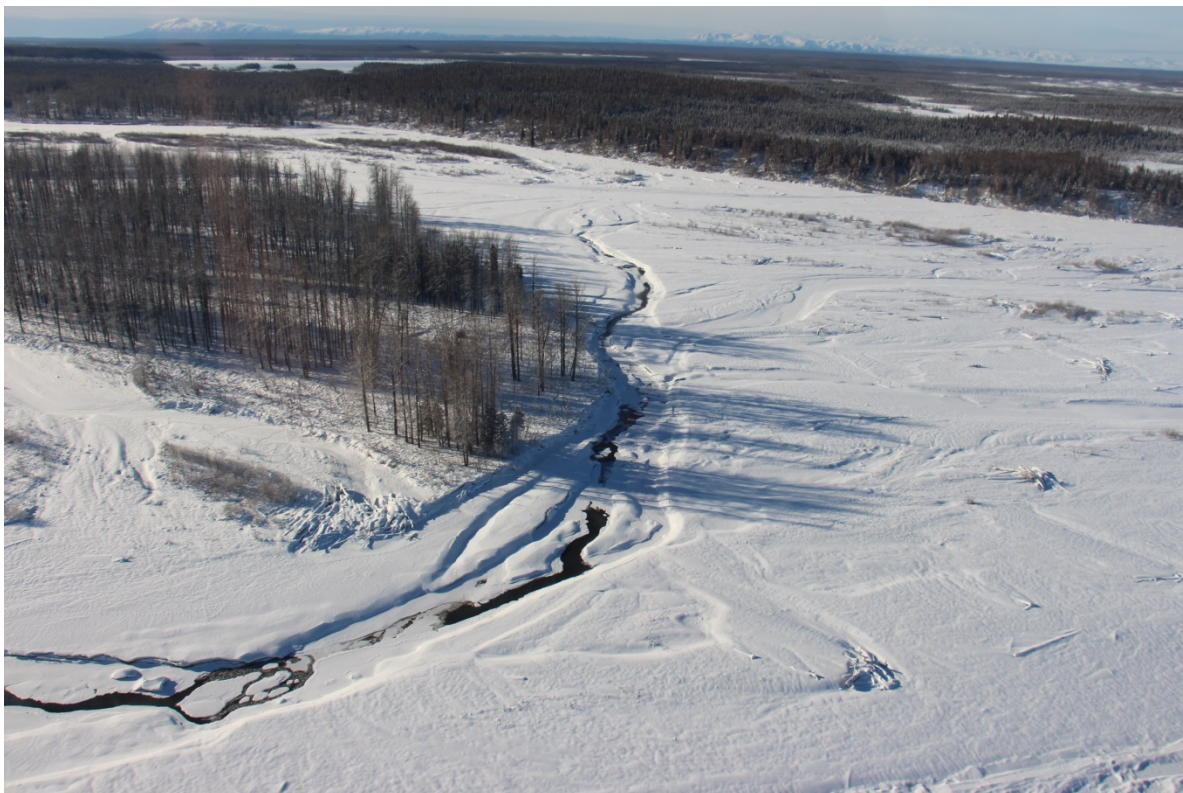
Figure 5.2 - 2. Open thermal lead following edge of island on February 21, 2014

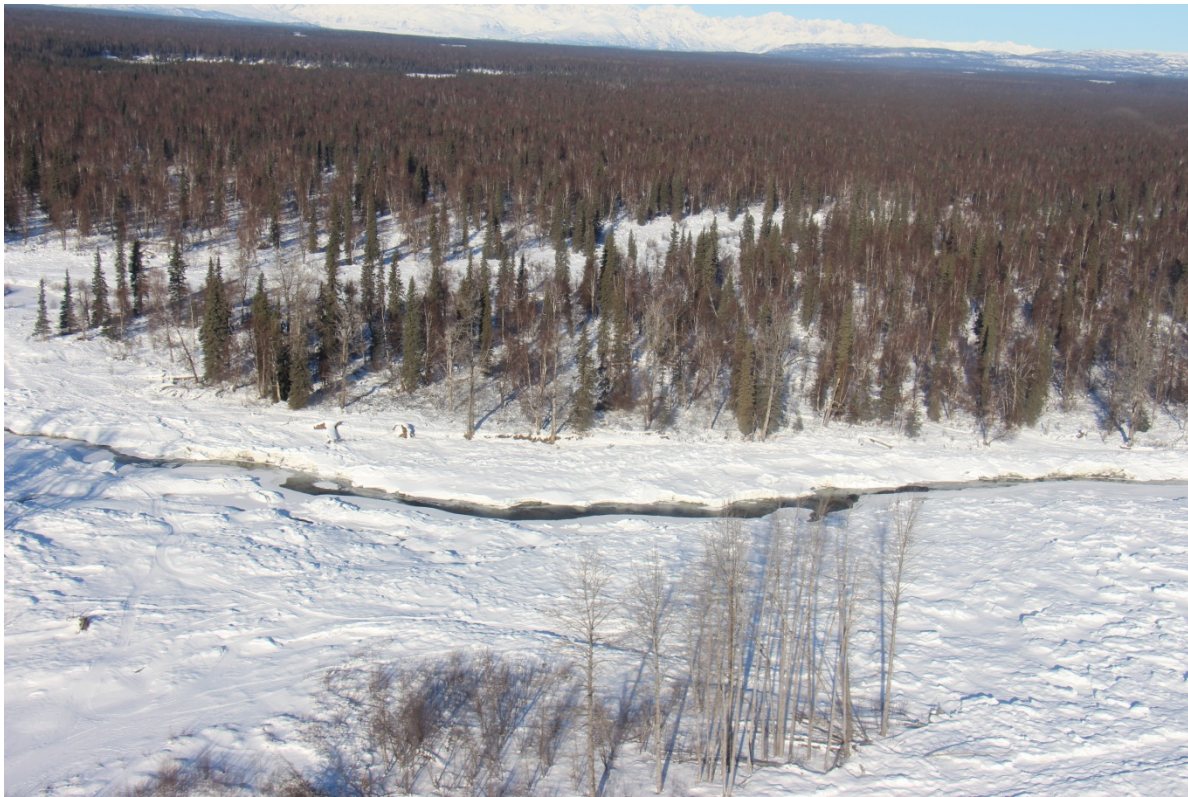
Figure 5.2 - 3. Thermal lead along right bank at FA-104 on February 21, 2014

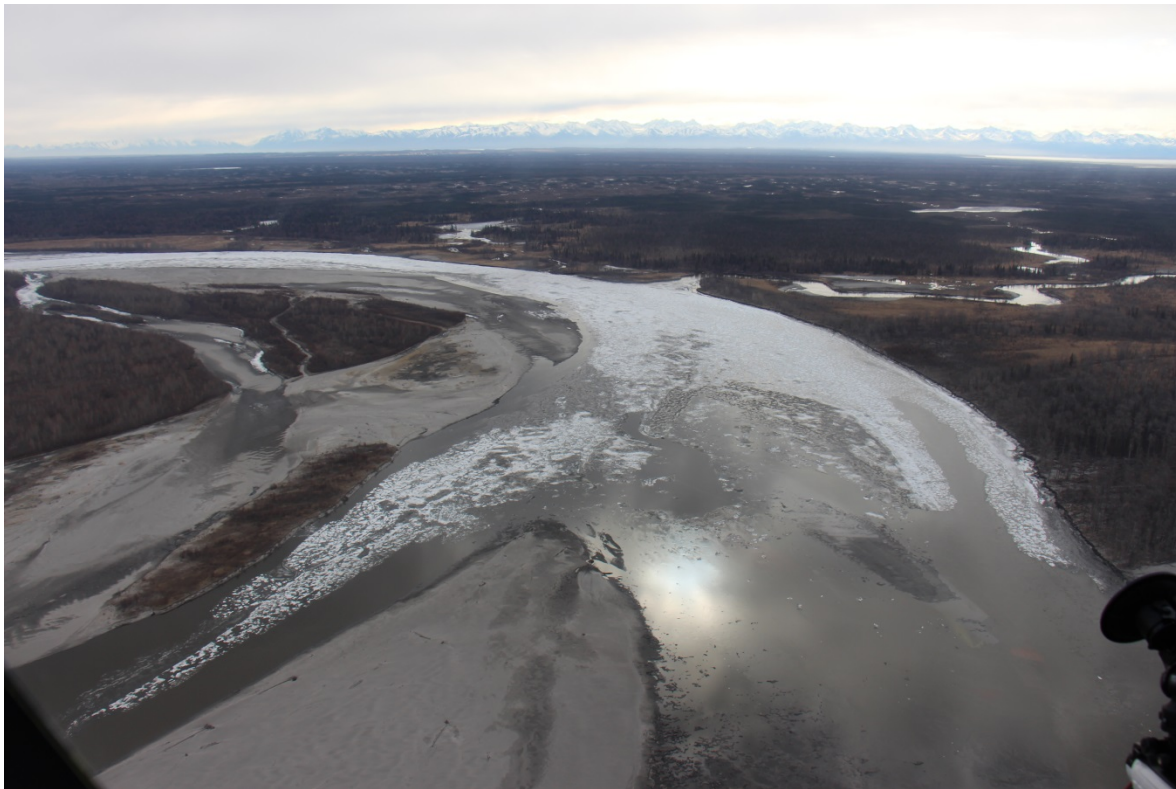
Figure 5.3 - 1. Downstream edge of ice cover in Lower River on April 28, 2014

April 28: The mouth was open and the short section of ice cover observed on April 25 was gone. The intact ice cover began at PRM 16.5 above Alexander Slough as shown in Figure 5.3-1. The Yentna River was still ice covered at the confluence of the Susitna River. Through the Delta Islands, PRM 46, there was again a significant increase in the open interconnectivity of the thermal leads in off channel sections, creating braided flow channels that were discharging into to the main channel of the Susitna River. Open leads continued to widen and lengthen in the main channel between Susitna Landing, PRM 65, and Talkeetna, PRM 100. Larger ice chunks were building up in the downstream ends of the open channels; water levels were starting to rise upstream of these developing jams. At Talkeetna, off the approach end of runway 36, the open lead had grown enough to be considered an open channel. The developing jam in the downstream end was larger and the water was rising all the way up to the Chulitna confluence. The Talkeetna River stage has increased yet still had a small section of ice separating it from the Susitna as shown in Figure 5.3-2. The water level in the Chulitna River was slightly higher and open leads at the confluence with the Susitna had become larger.

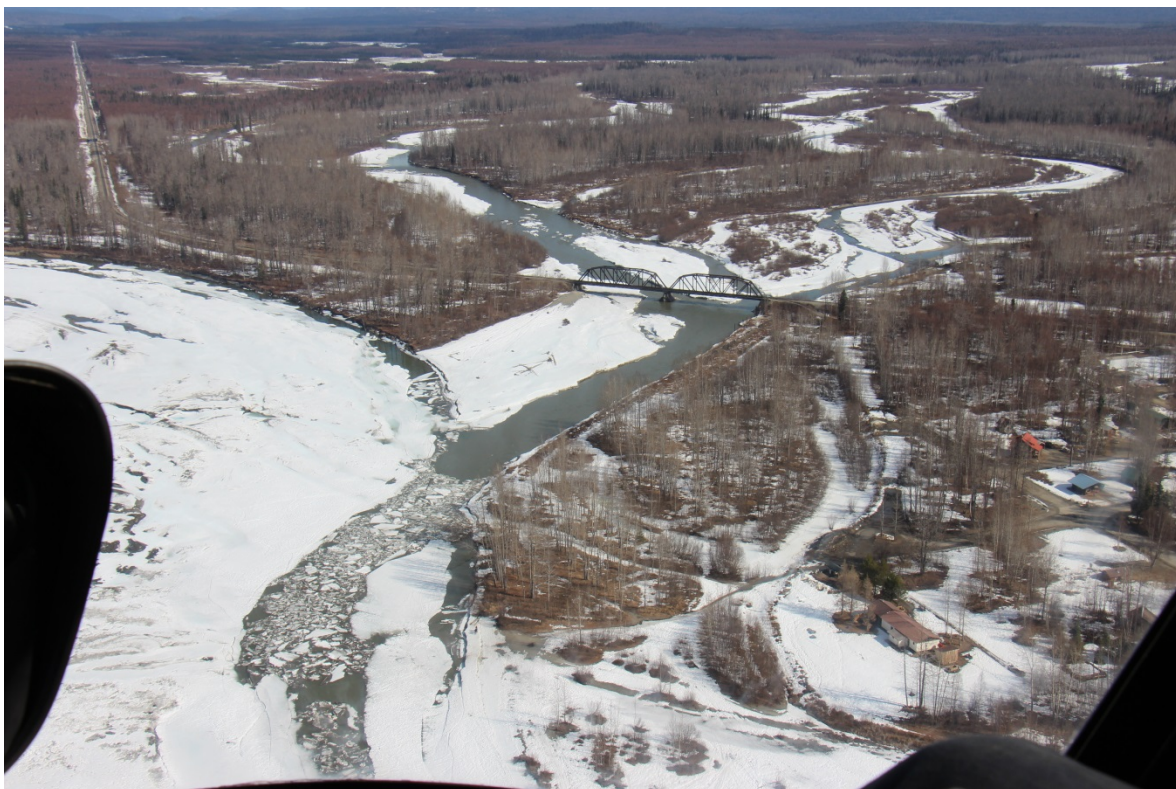
Figure 5.3 - 2. Mouth of the Talkeetna river on April 28, 2014

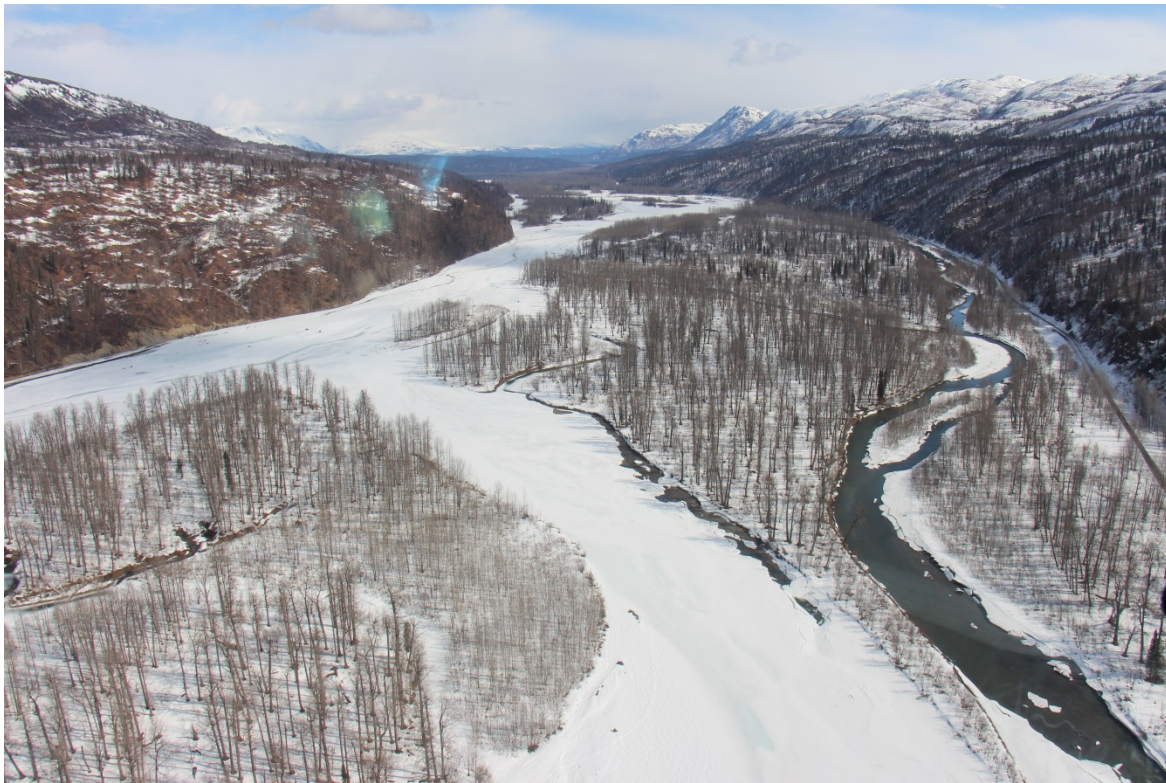
Figure 5.3 - 3. FA-128 showing Slough 8A open on April 25, 2014

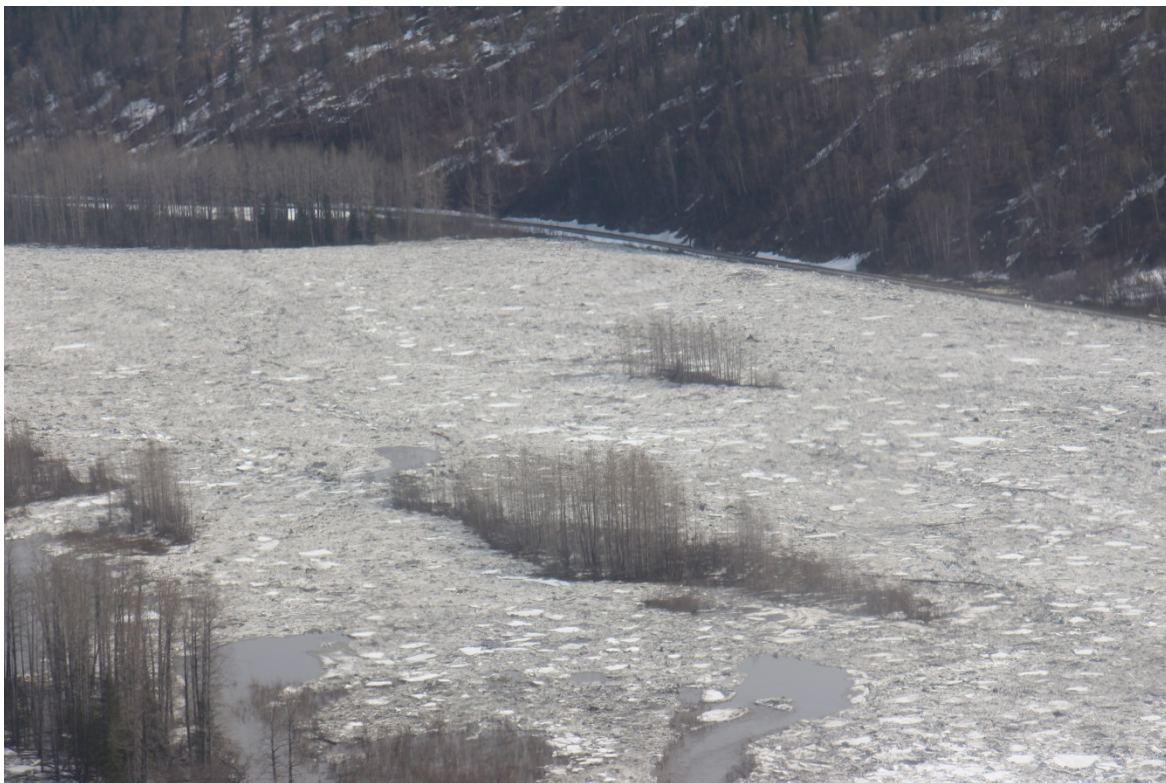
Figure 5.3 - 4. Ice jam and overbank flooding upstream of FA-128 on May 5, 2014

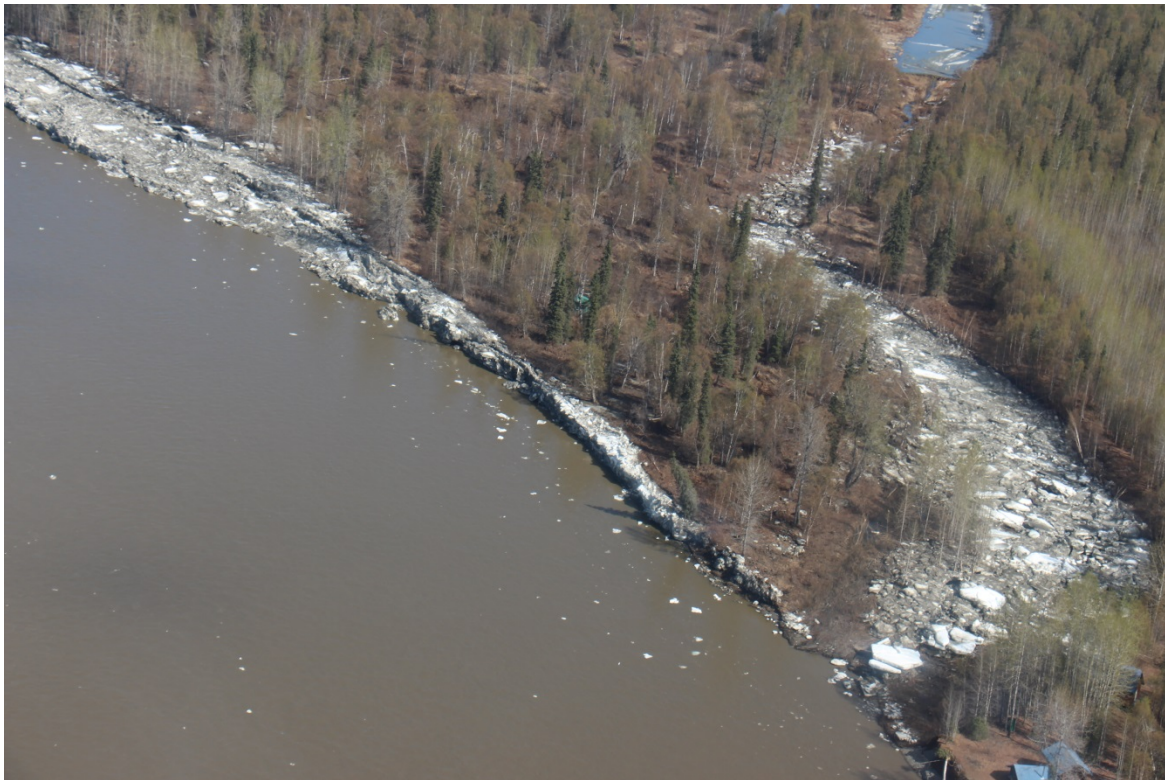
Figure 5.3 - 5. Shear walls upstream of FA-104 on May 8, 2014

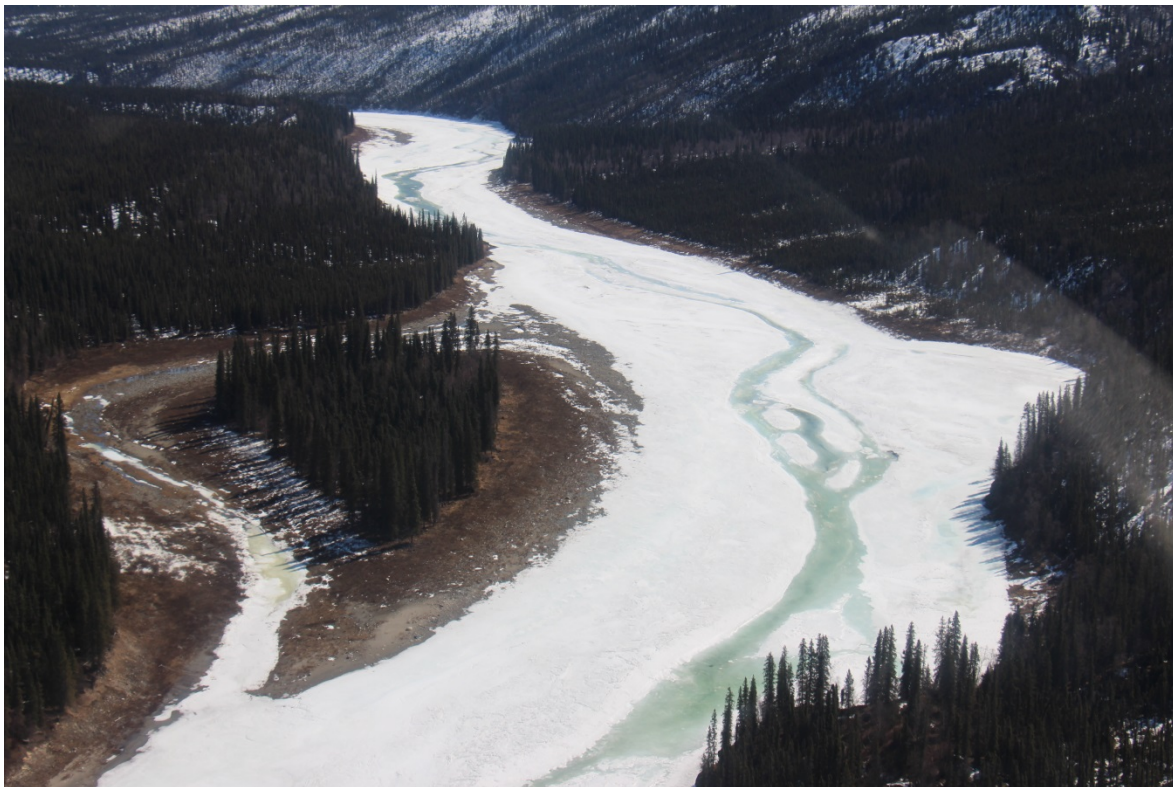
Figure 5.3 - 6. Flooded ice surface at thalweg, Upper River on April 23, 2014

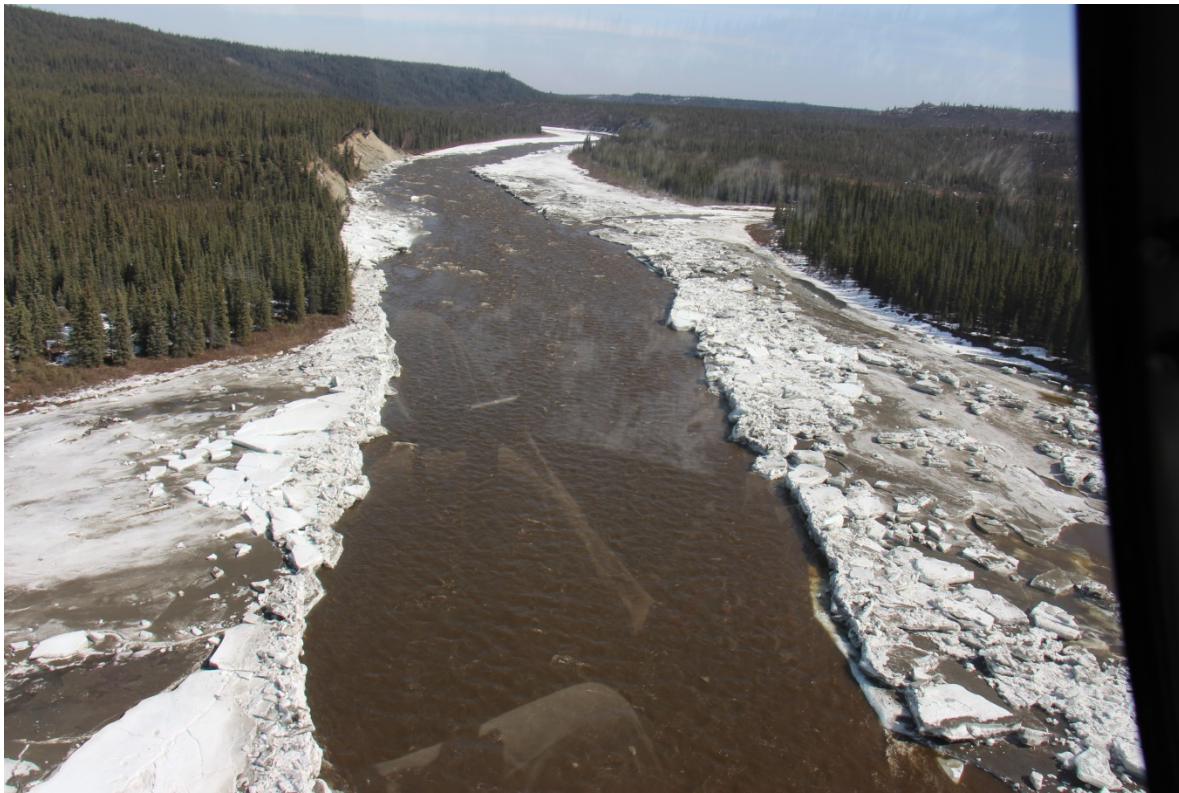
Figure 5.3 - 7. Evidence of previous jam at mouth of the Oshetna River on May 2, 2014

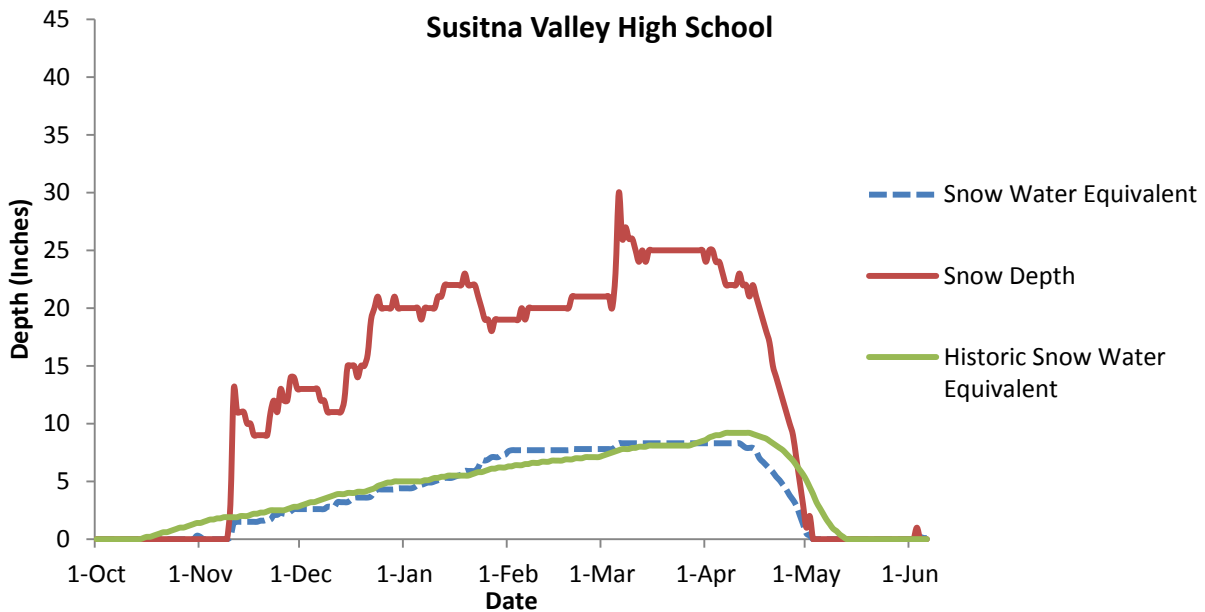
Susitna Valley High SNOTEL Site Daily Measurements of Snow Depth and Snow Water Equivalent, 2013-2014. Data collected by the NRCS.

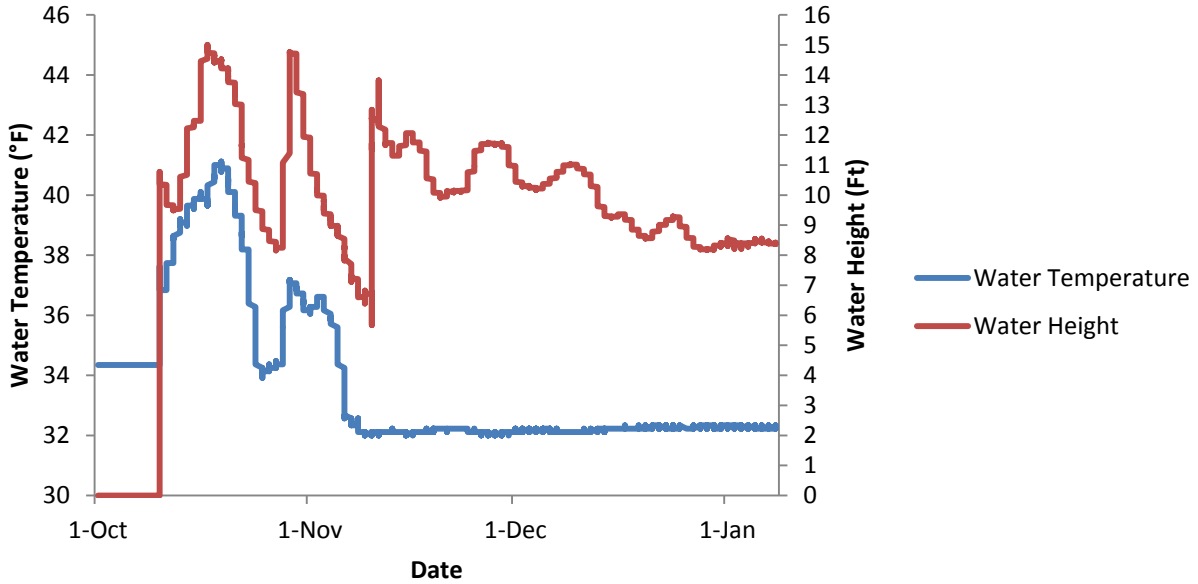
PRM 15.8 – Flathorn Lake (ESS10)

Appendix B-2
Surface Water Temperature (°F) and Preliminary Stream Stage
for the Susitna River during Freeze up 2013

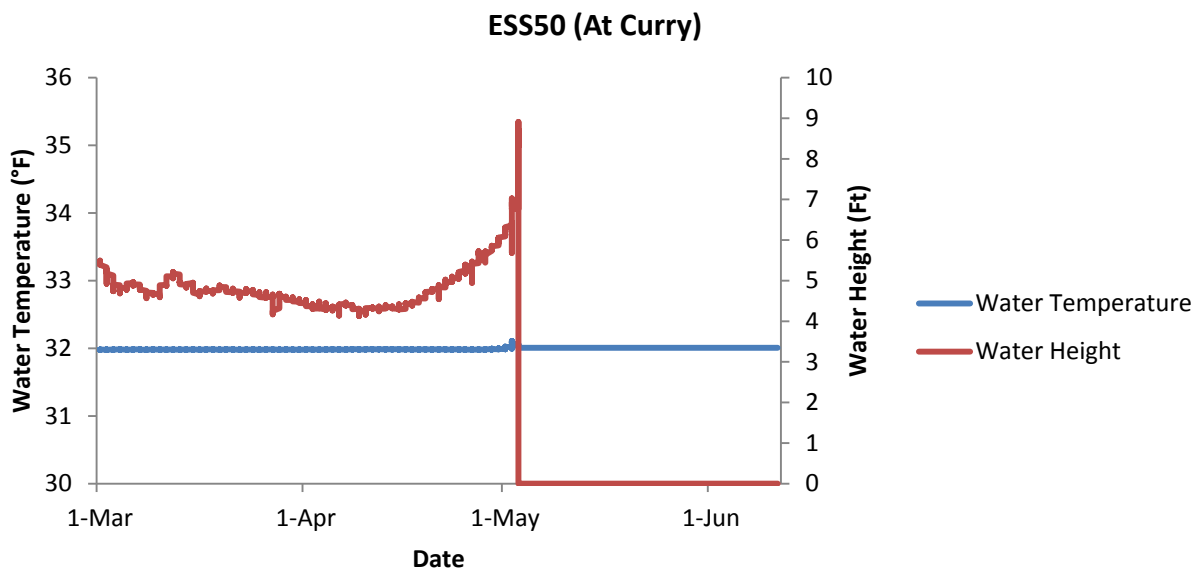
PRM 124.2, Curry Slough (ESS50): Water temperature sensor at the station malfunctioned during the winter 2013; the water height sensor appears to have malfunctioned on May 3rd, during breakup.
