SUSITNA-WATANA HYDROELECTRIC PROJECT  
 LINEAMENT GROUP 27  
 MAP DATA

FIGURE  
 A27-1.1

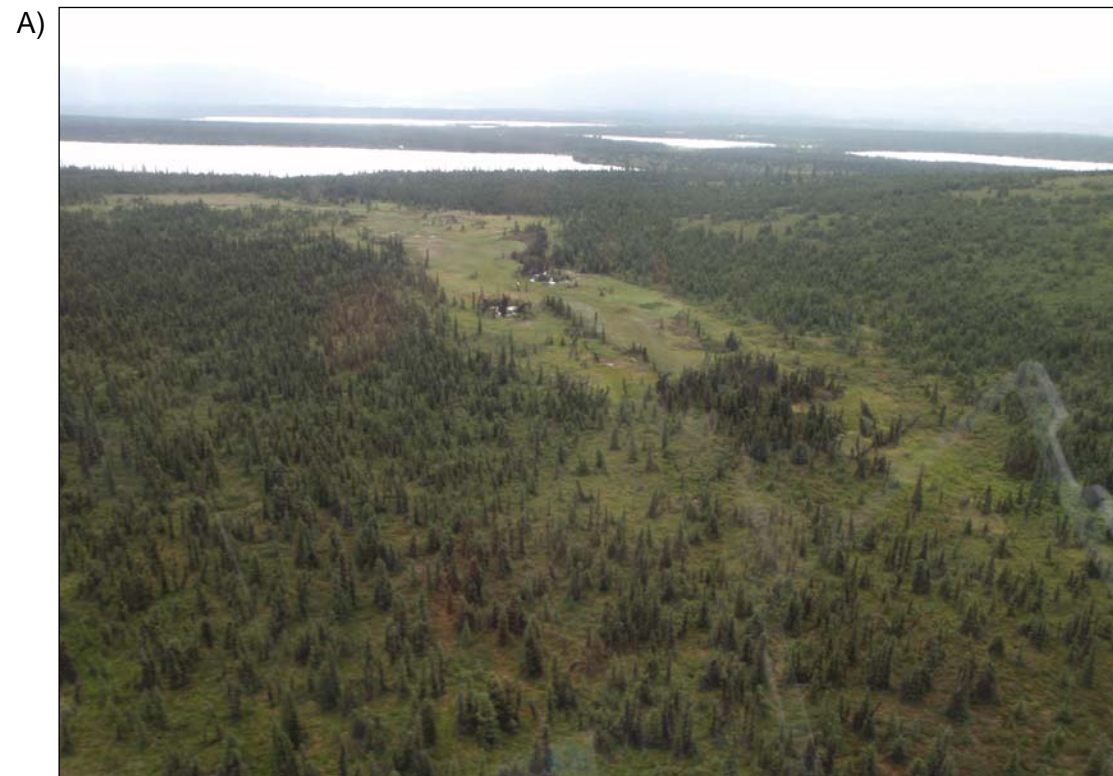
View looking southeast at esker landform that projects across mapped lineaments and appears undeformed or offset.

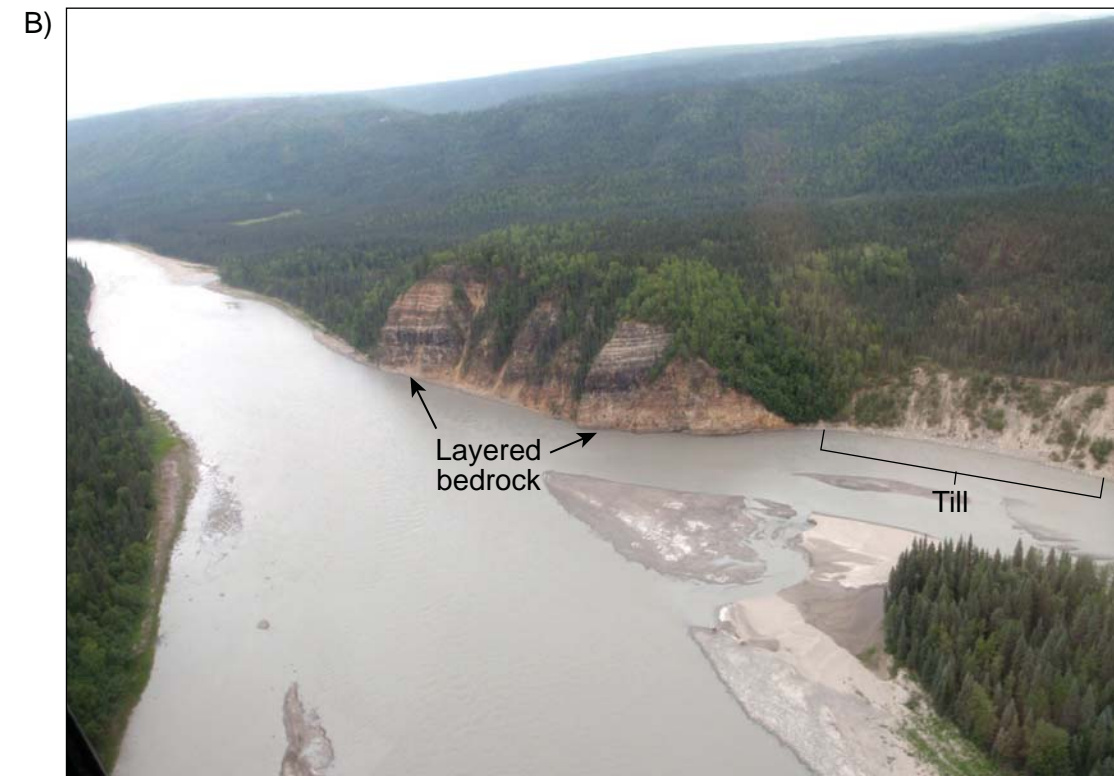
View looking northwest at layered bedrock (on left) with apparently undisrupted horizontally-bedded till (on right).

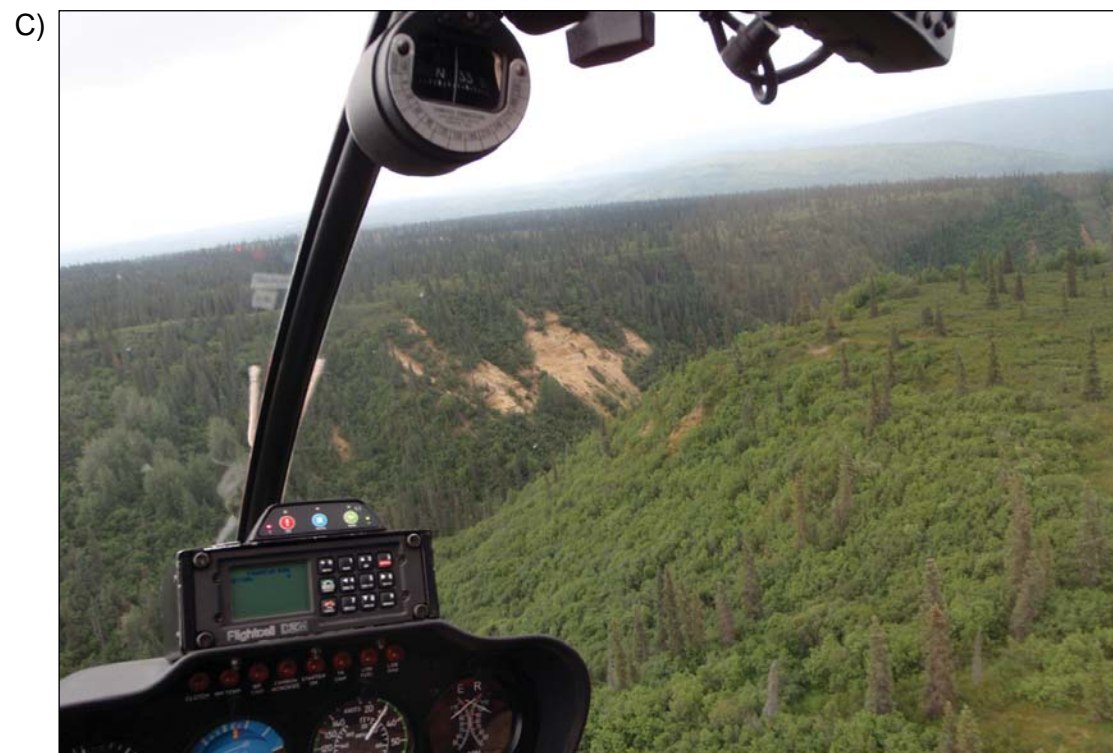
View looking southeast at exposure in left bank of unnamed drainage creek where till apparently overlies lake sediments and fluvial washout gravel. The lenticular beds in the fluvial gravel appear horizontal but are not laterally extensive.

Close up view of exposure shown in Photograph (B). Note the apparently sub-horizontal basal contact between overlying till and underlying lacustrine deposits. Note sediments on the left of the image are influenced by landslide processes and not in-place locally.

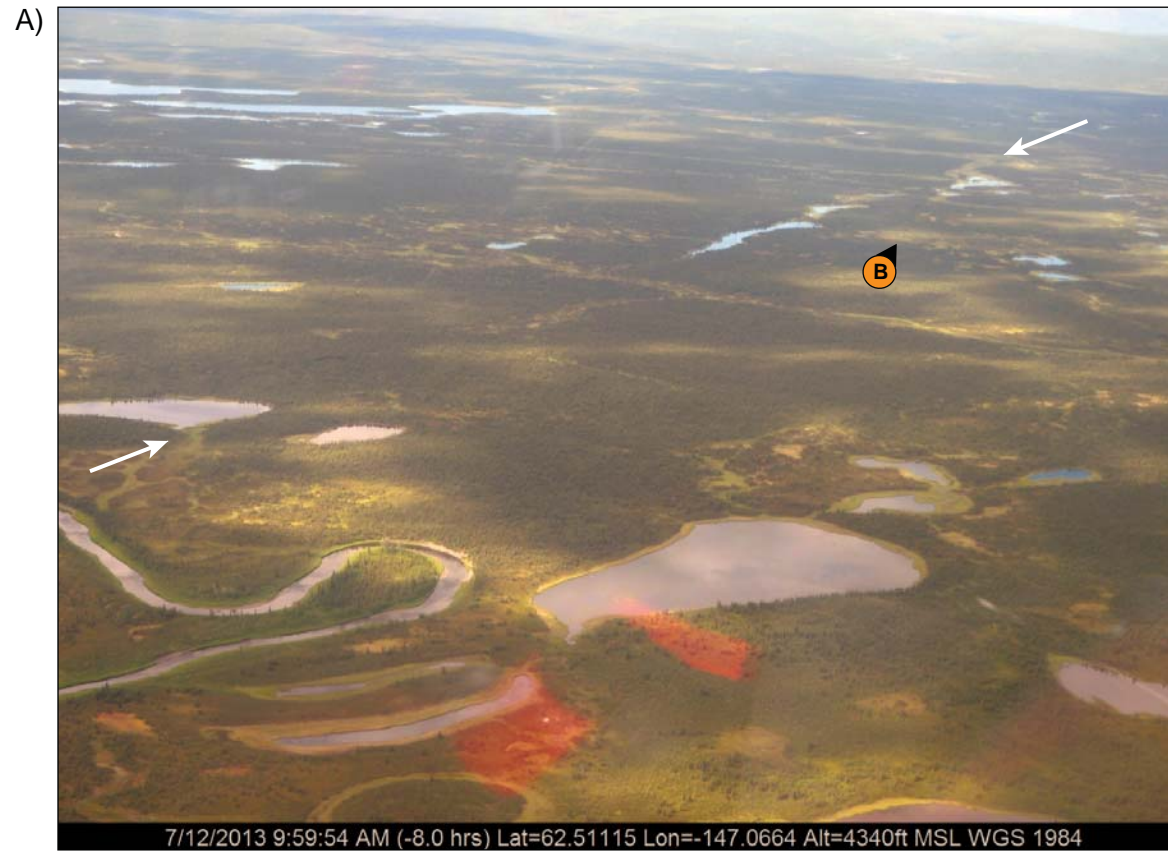
View looking west-southwest toward linear alignment of lakes. Arrows point along lineament. Note kettle lake terrain in the foreground.

Close up view looking west-southwest along linear alignment of lakes in Photograph A. Arrows point along lineament.

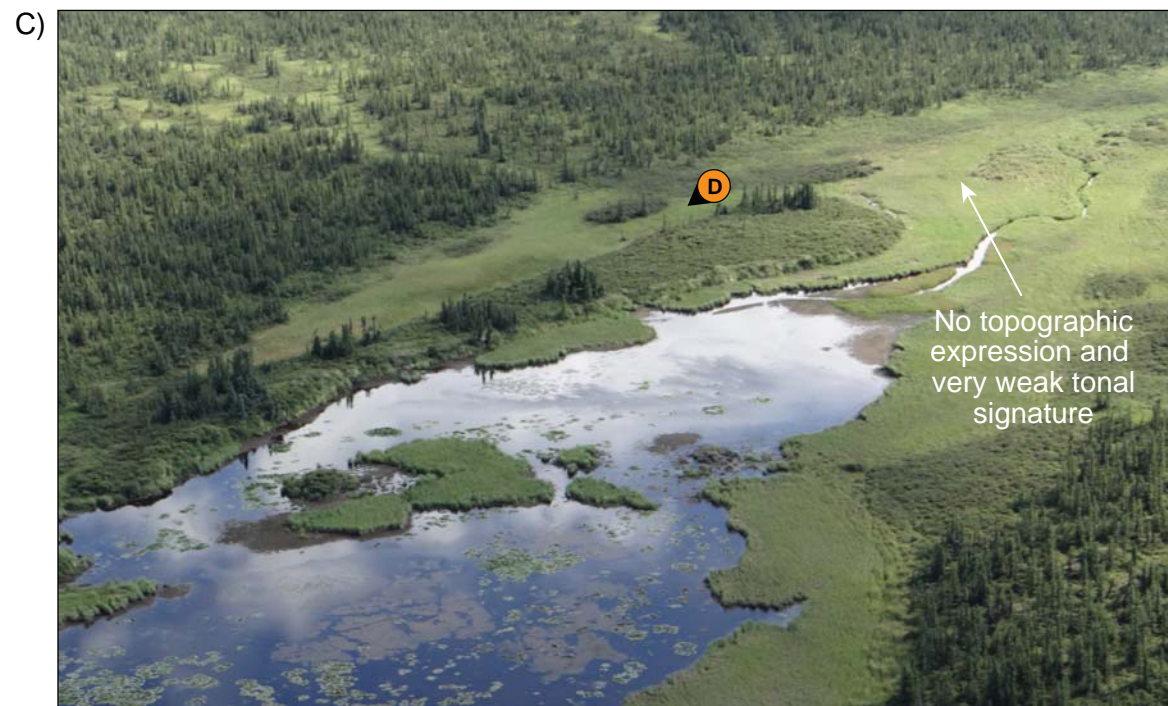
View looking south across strong vegetation lineament associated with a ~2-meter-high linear ridge. Note that topographic expression of ridge abruptly dies out and does not continue to the west.

View looking northeast along south side of vegetation lineament and ~2-meter-high linear ridge shown in Photograph C. Positive feedback of vegetation growth and organic matter accumulation on the linear ridge may accentuate the apparent relief of the ridge.
