79_218900_Alaska_Railbelt/2189_Lineament Report October 2013, modified 10.18.13

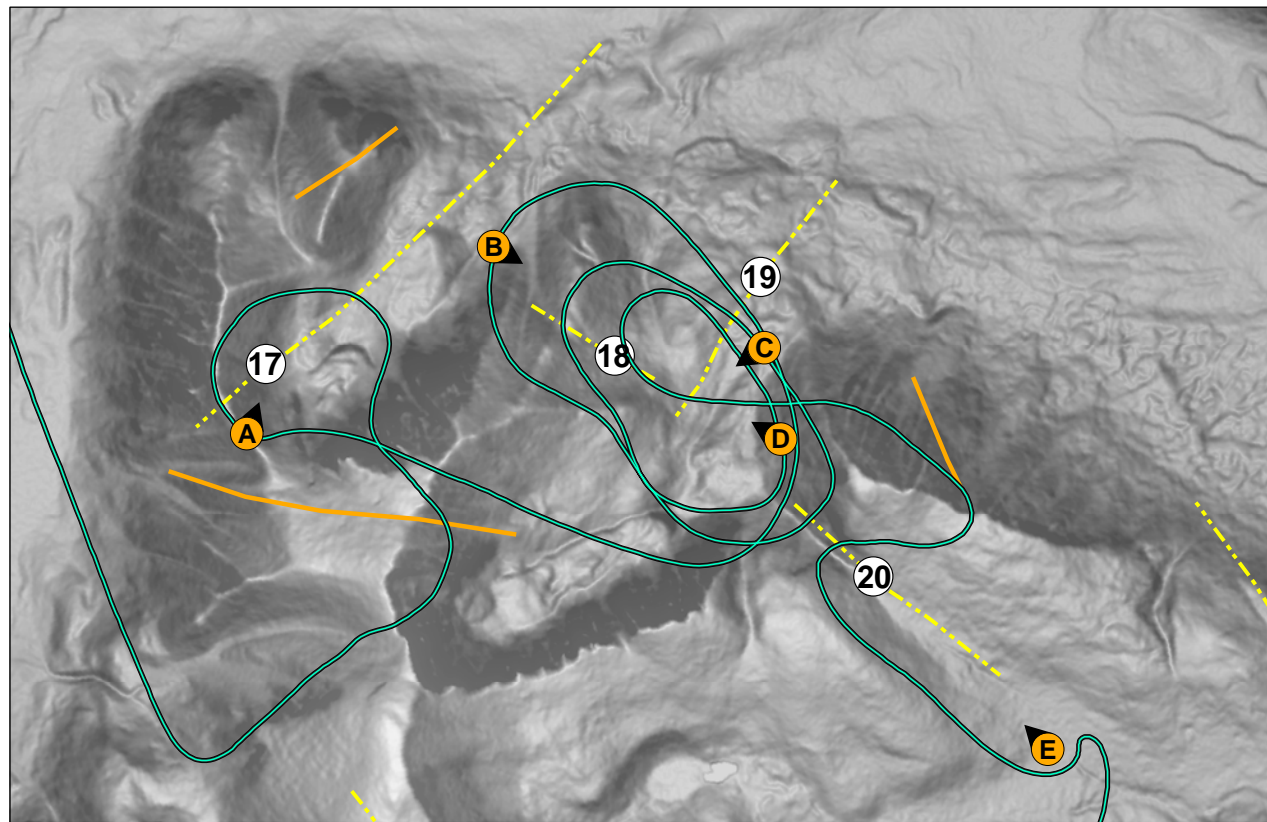
View looking northeast from location A. Arrows and brackets show projected trace of lineament 17.

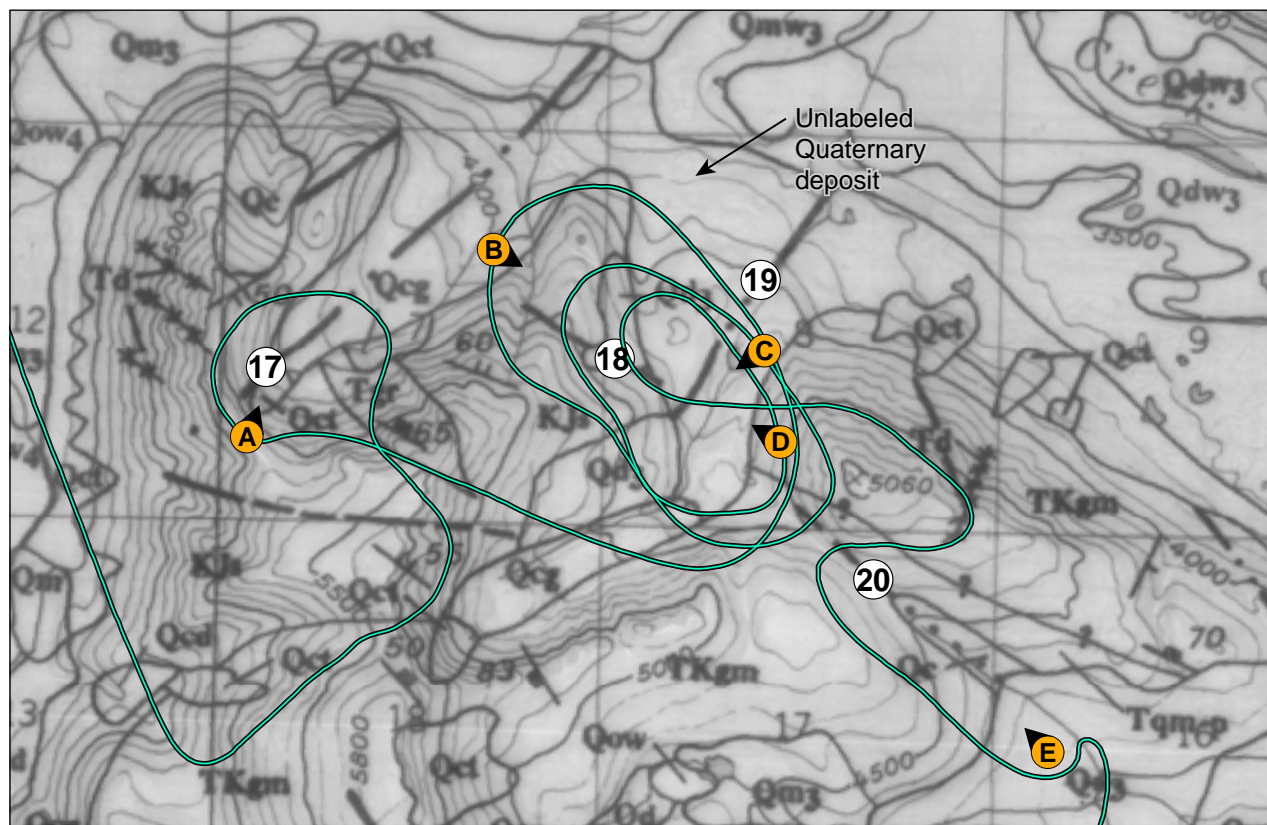
View looking southeast from photograph location B. Arrows and brackets indicated the projected trace of lineaments 18, 19, and 20.

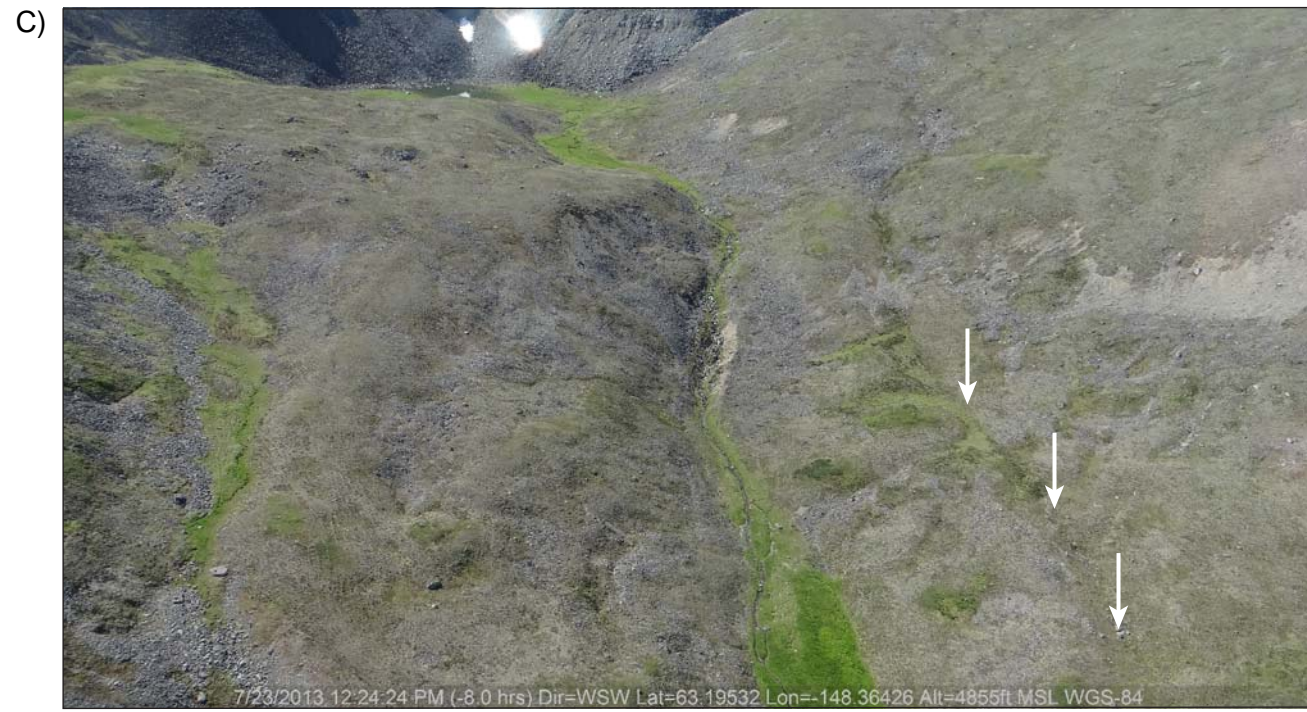
View looking southwest from photograph location C. The arrows indicate the projected path of Feature 19 lineament.

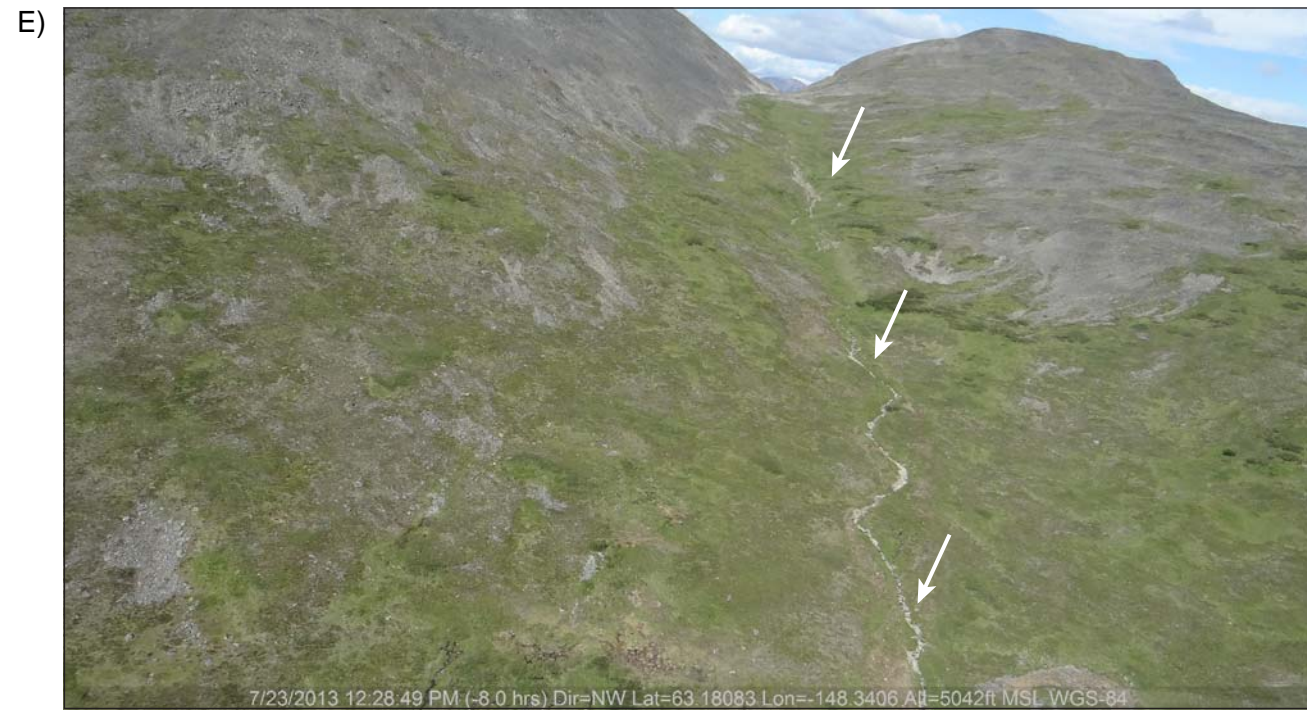
View looking northwest from photograph location E. Arrows show the mapped trace of Feature 20 lineament. Note mapped trace of Feature 20 is coincident with linear drainage.

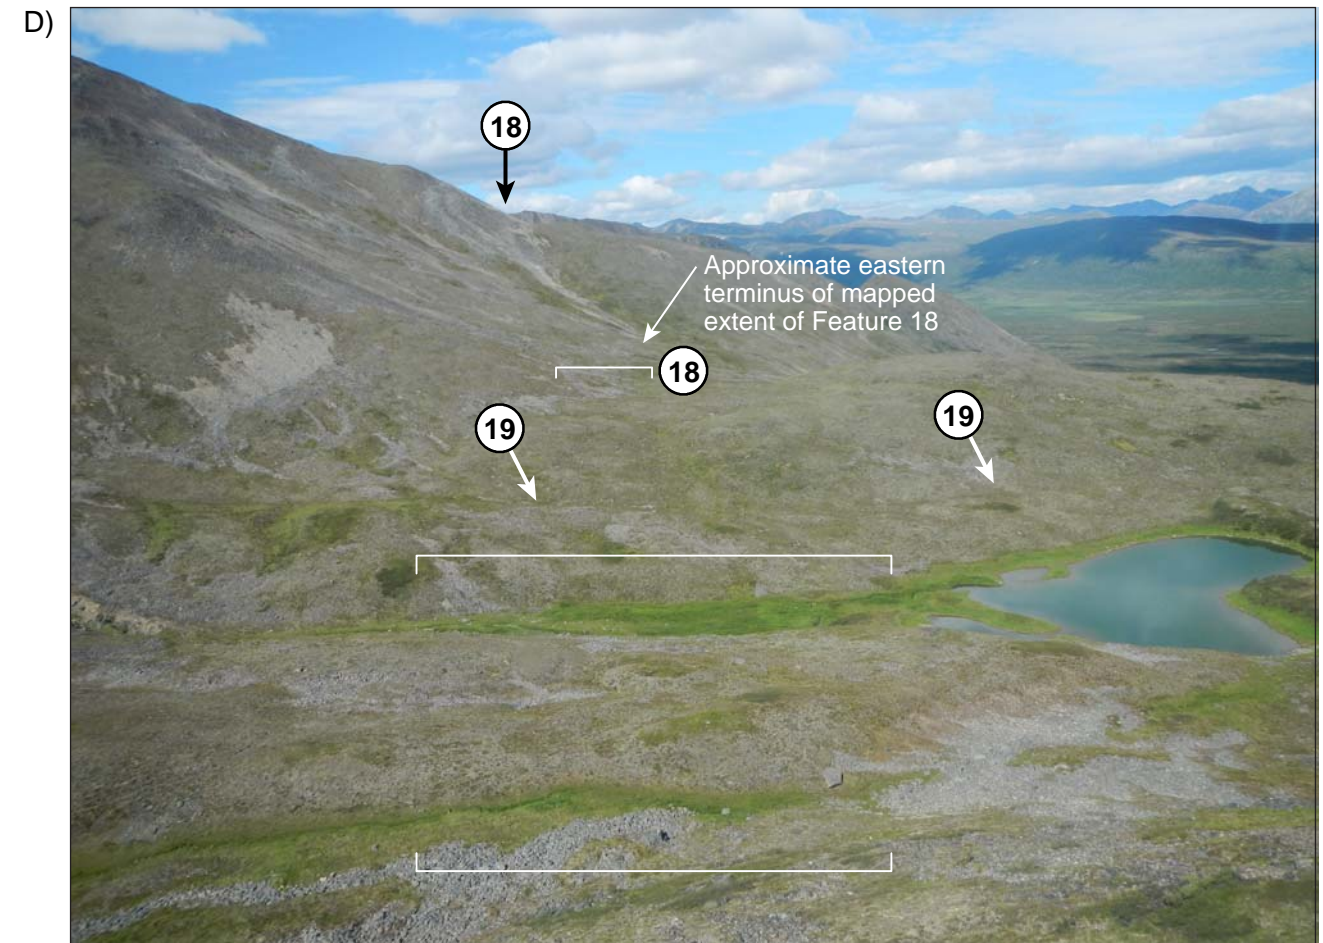
View looking northwest from photograph location D. Arrows show the mapped trace of Features 18 and 19. Note absence of lineaments or apparent deformation in Quaternary deposits between brackets in lower middle portion of photograph.

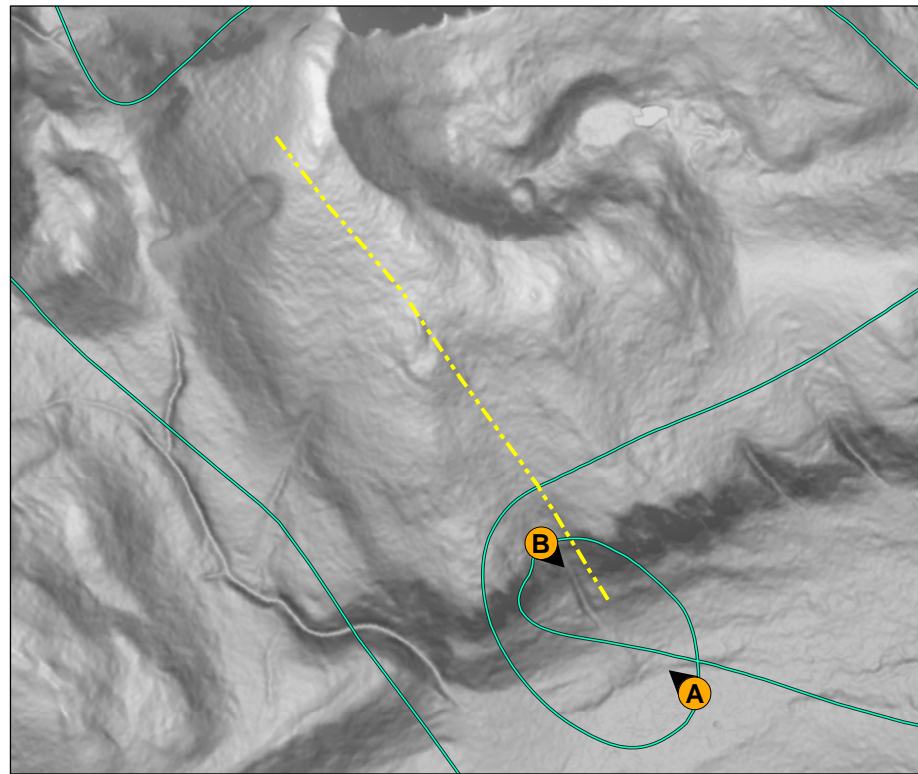
View looking northwest from photograph location A. Arrows indicate the projected path of Feature 21 lineament.

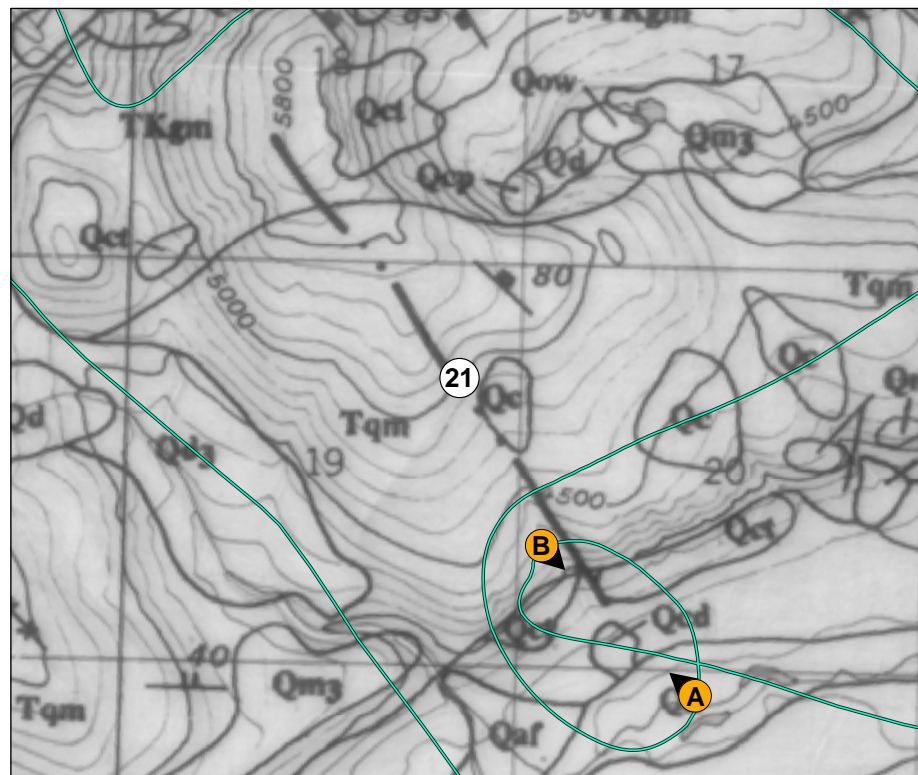
View looking southeast from photograph location B. Arrows show the projected trace of Feature 21 lineament.

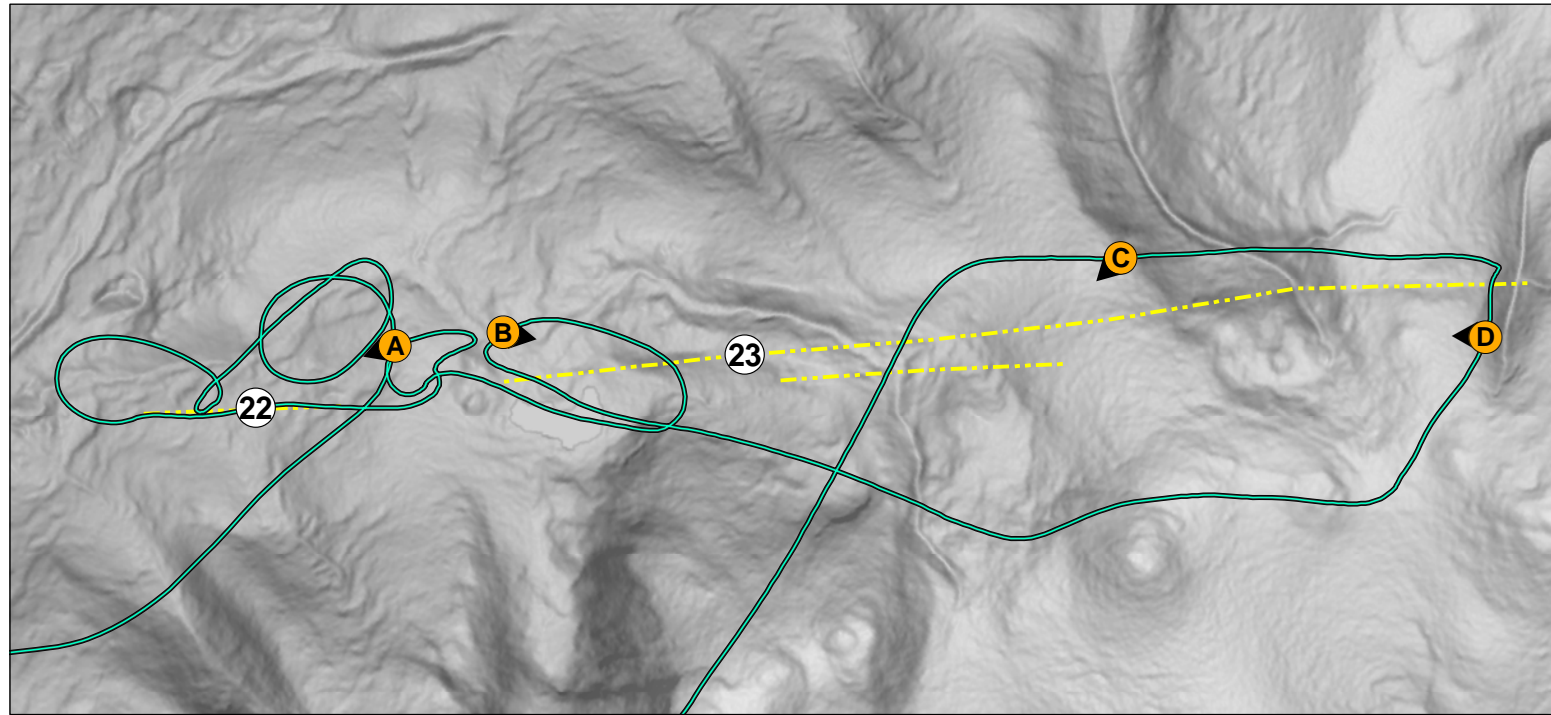
A) View looking west from photograph location A. Brackets show the projected trace of Feature 22. Note the absence of a continuous lineament along the projected trace and exposed till on low relief ridge crest between drainages.

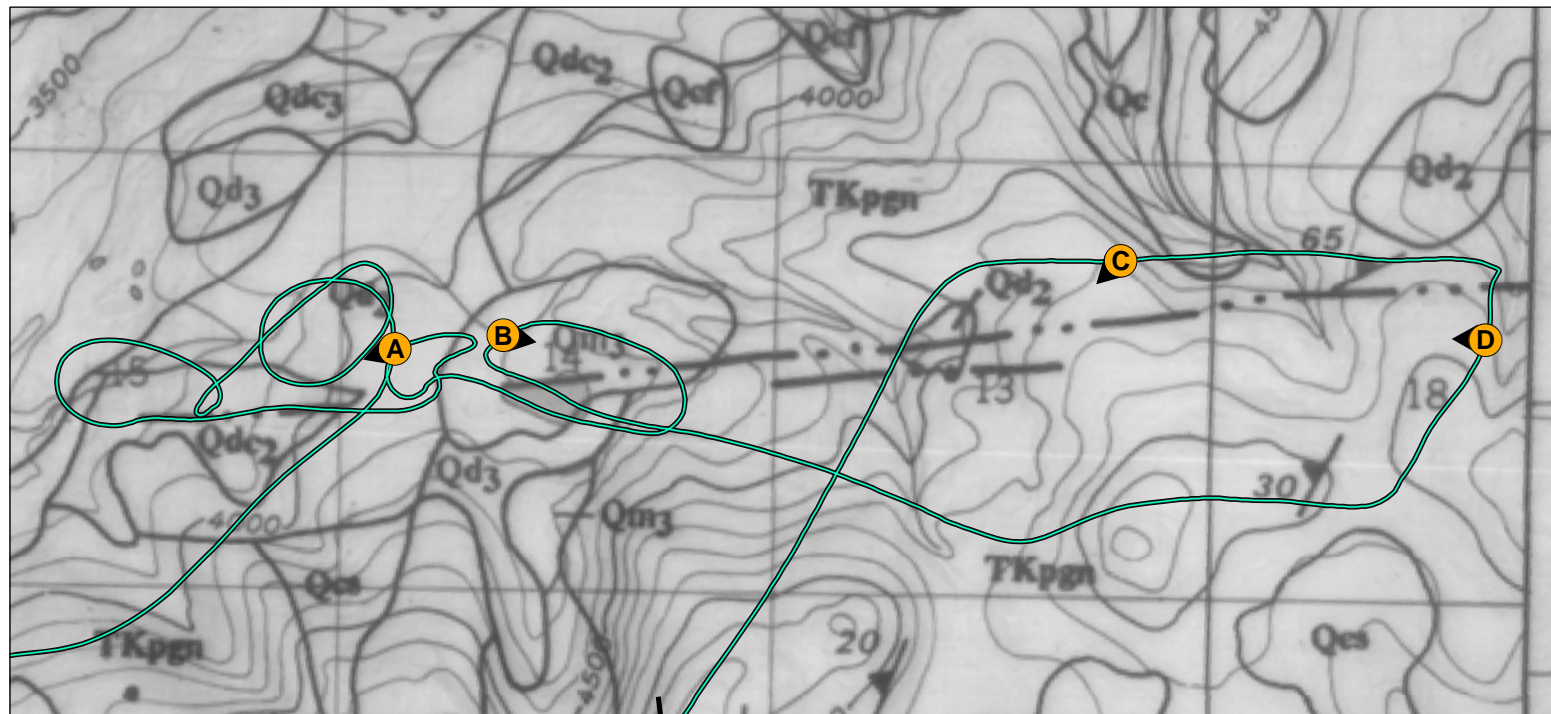
B) View looking east from photograph location B. Arrows and brackets indicate the projected path of Feature 22 lineament. Note change in apparent vertical displacement.

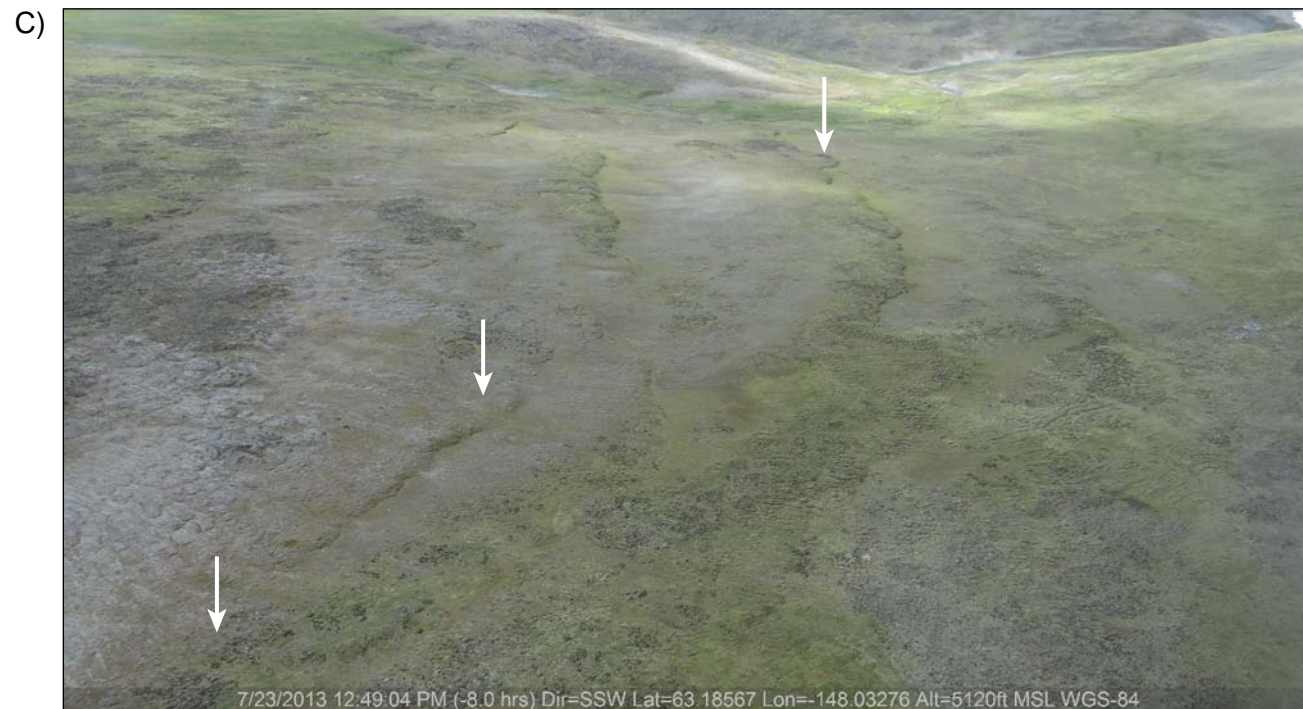
View looking west from photograph location C. Arrows show the projected trace of the Feature 22 lineament. Note linear expression is coincident with solifluction lobes and not continuous.

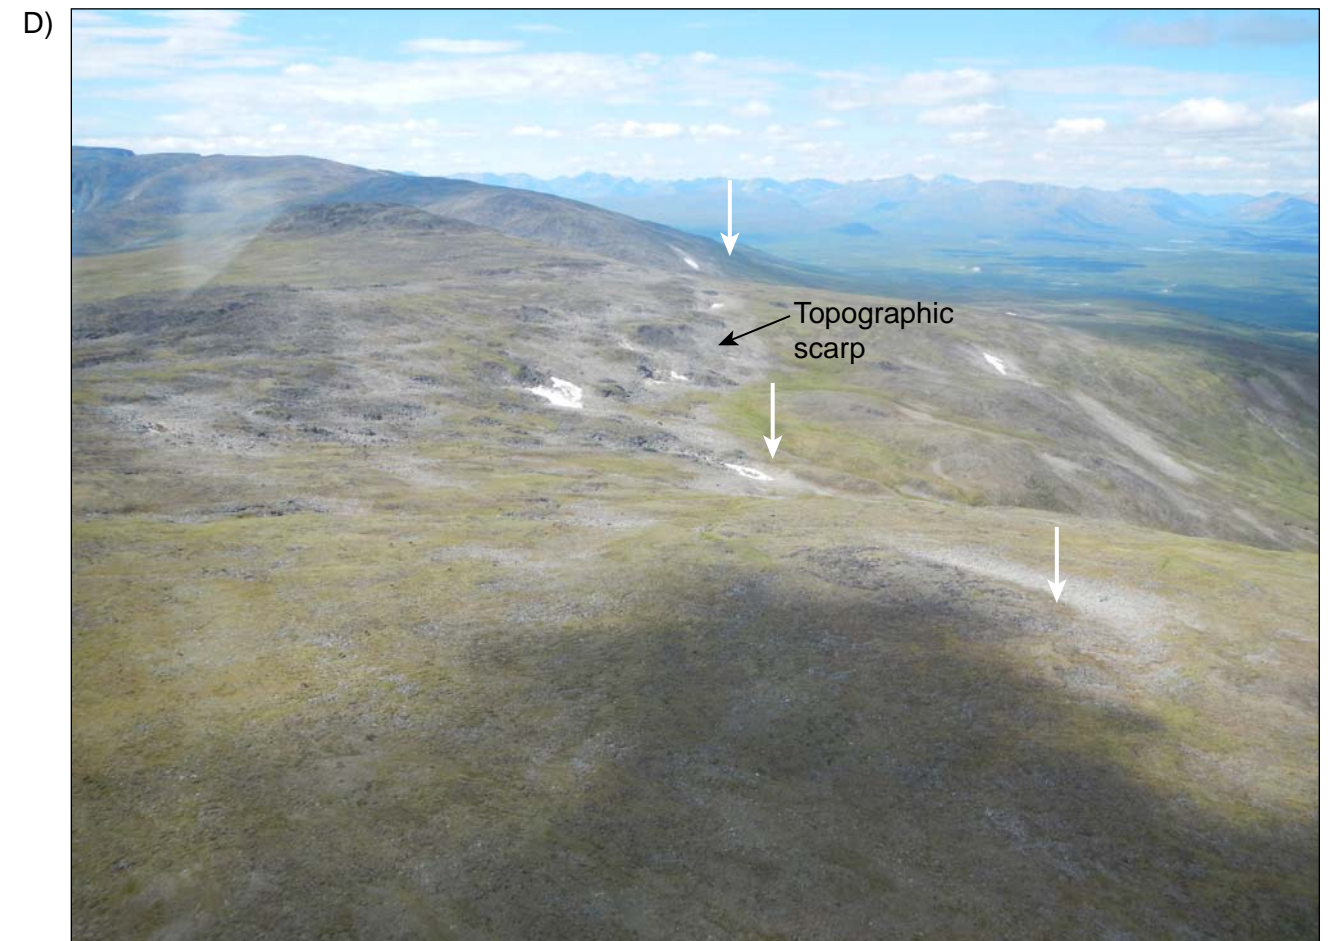
View looking west from photograph location C. Arrows show the projected trace of the Feature 22 lineament. Note topographic scarp in Photograph D is not proportional to minor scarps associated with solifluction in Photograph C.

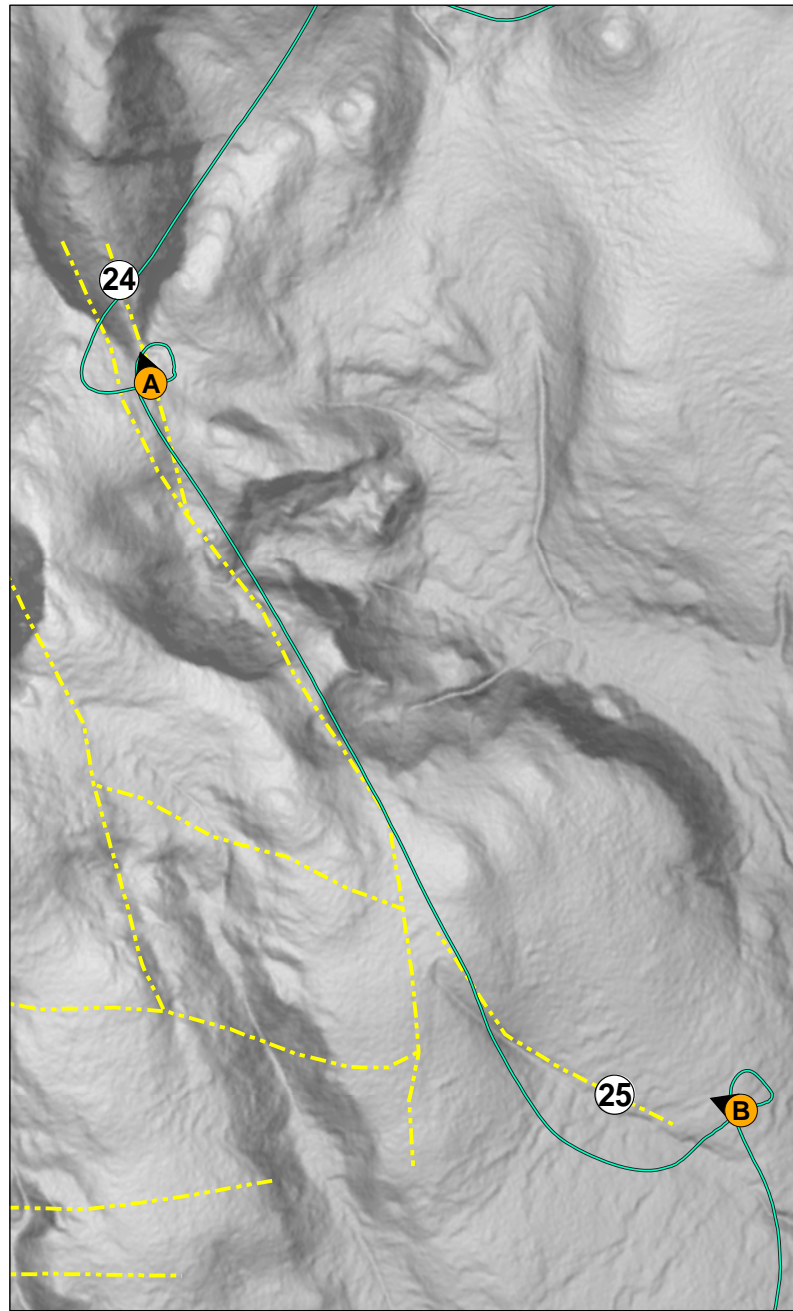
A) View looking west from photograph location C. Arrows indicate the projected path of the Feature 24 lineament.

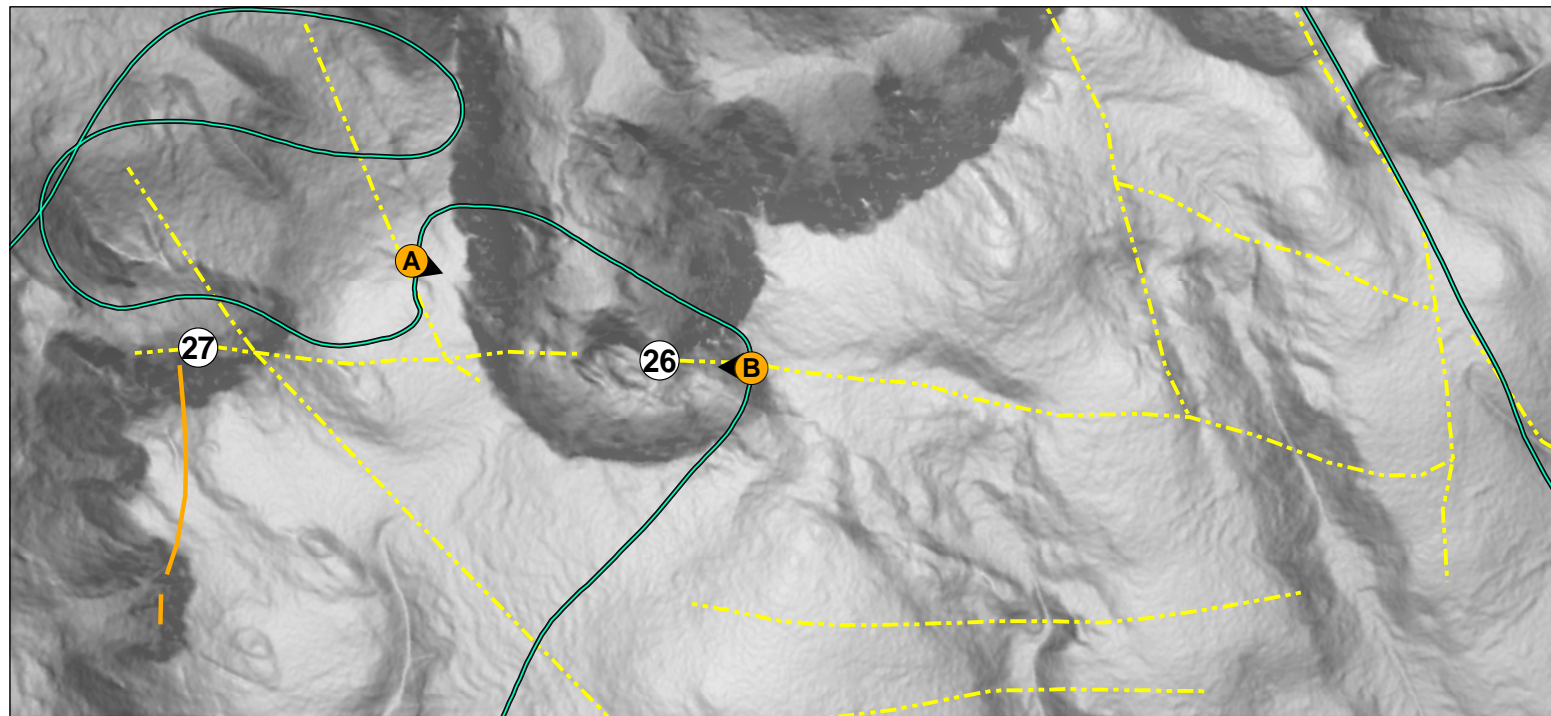
A) View looking west from photograph location A. Arrows show the projected trace of Features 26 and 27. Note the absence of a continuous and clear lineament along projected traces.

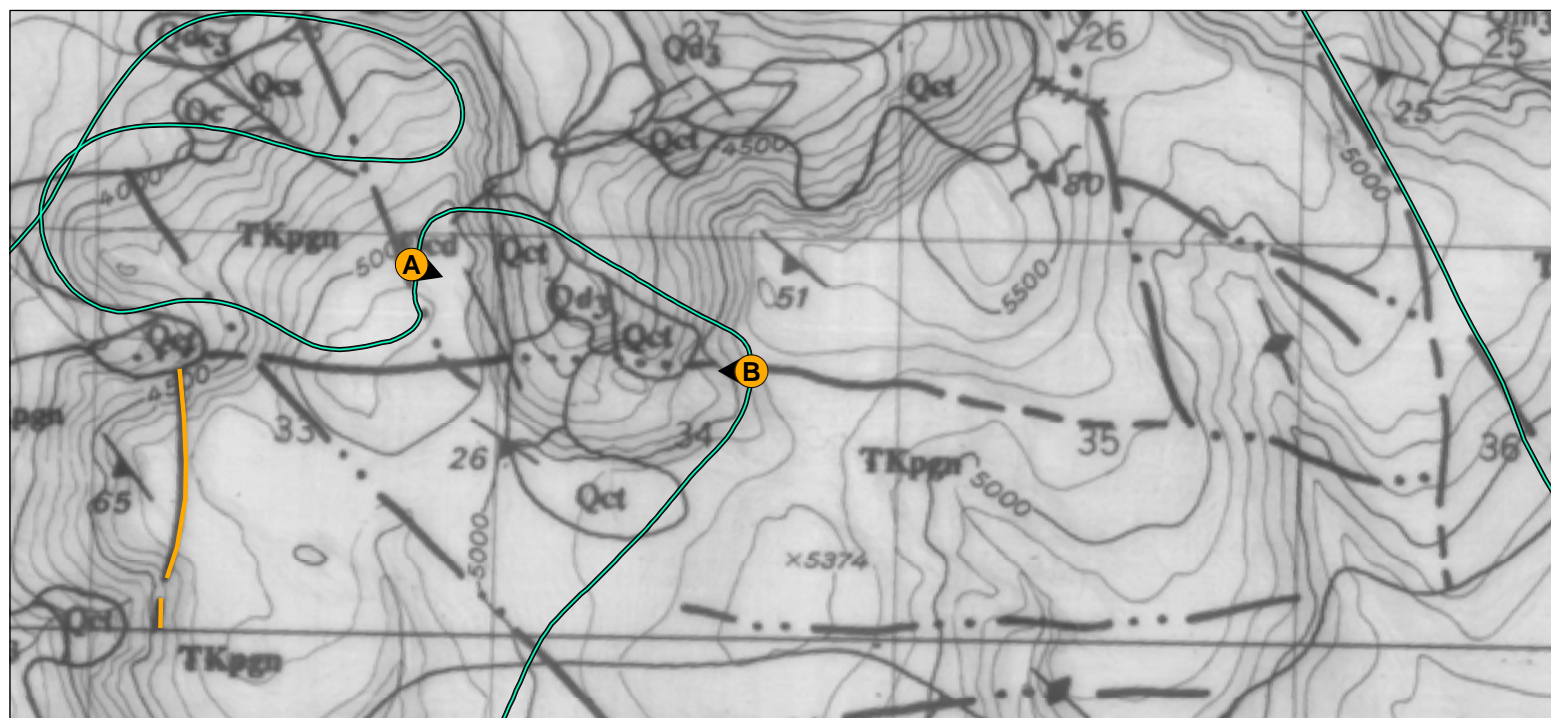
B) View looking east from photograph location B. Arrows and brackets indicate the projected path of Feature 26 and 27 lineaments. Note the absence of a continuous and clear lineament along projected traces.

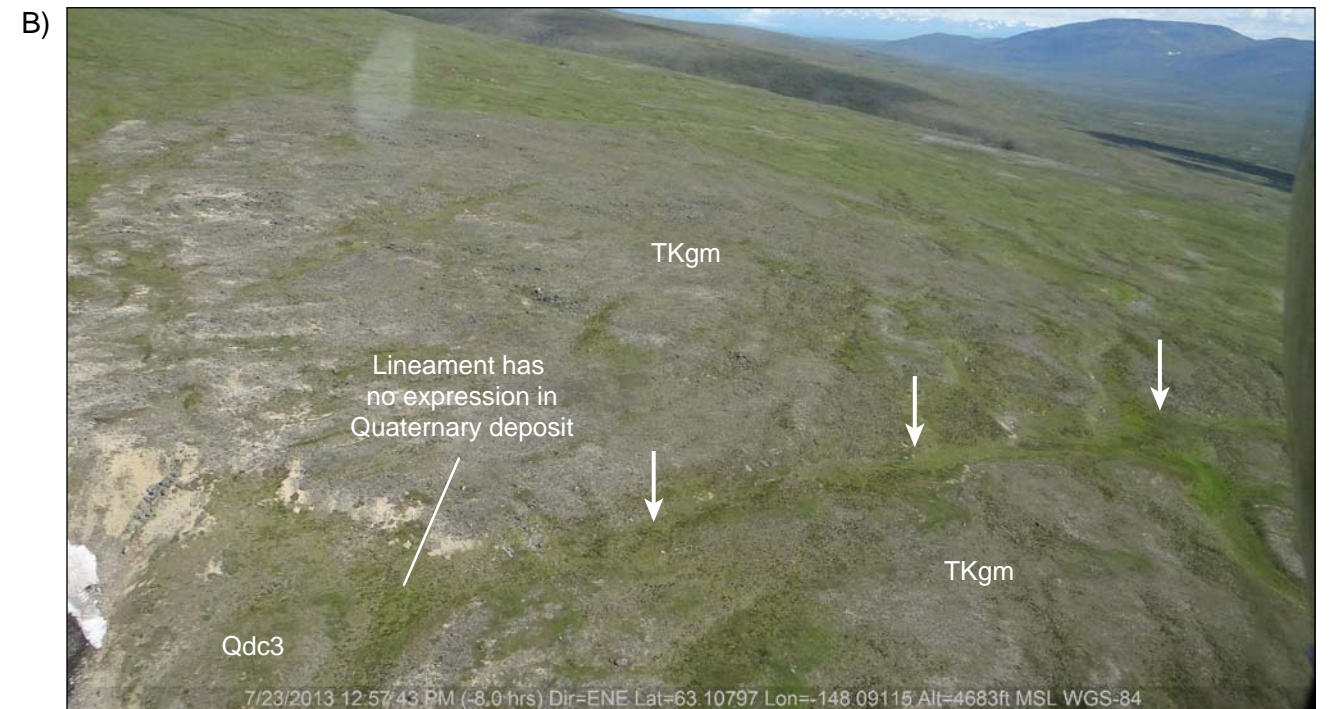
B) View looking east from photograph location B. Arrows indicate the mapped trace of Feature 28. Note absence of linear expression in Quaternary deposits.
