**Susitna-Watana Hydroelectric Project
(FERC No. 14241)**

**Fish Passage Barriers in the Middle and Upper
Susitna River and Susitna Tributaries
Study Plan Section 9.12**

2014 Study Implementation Report

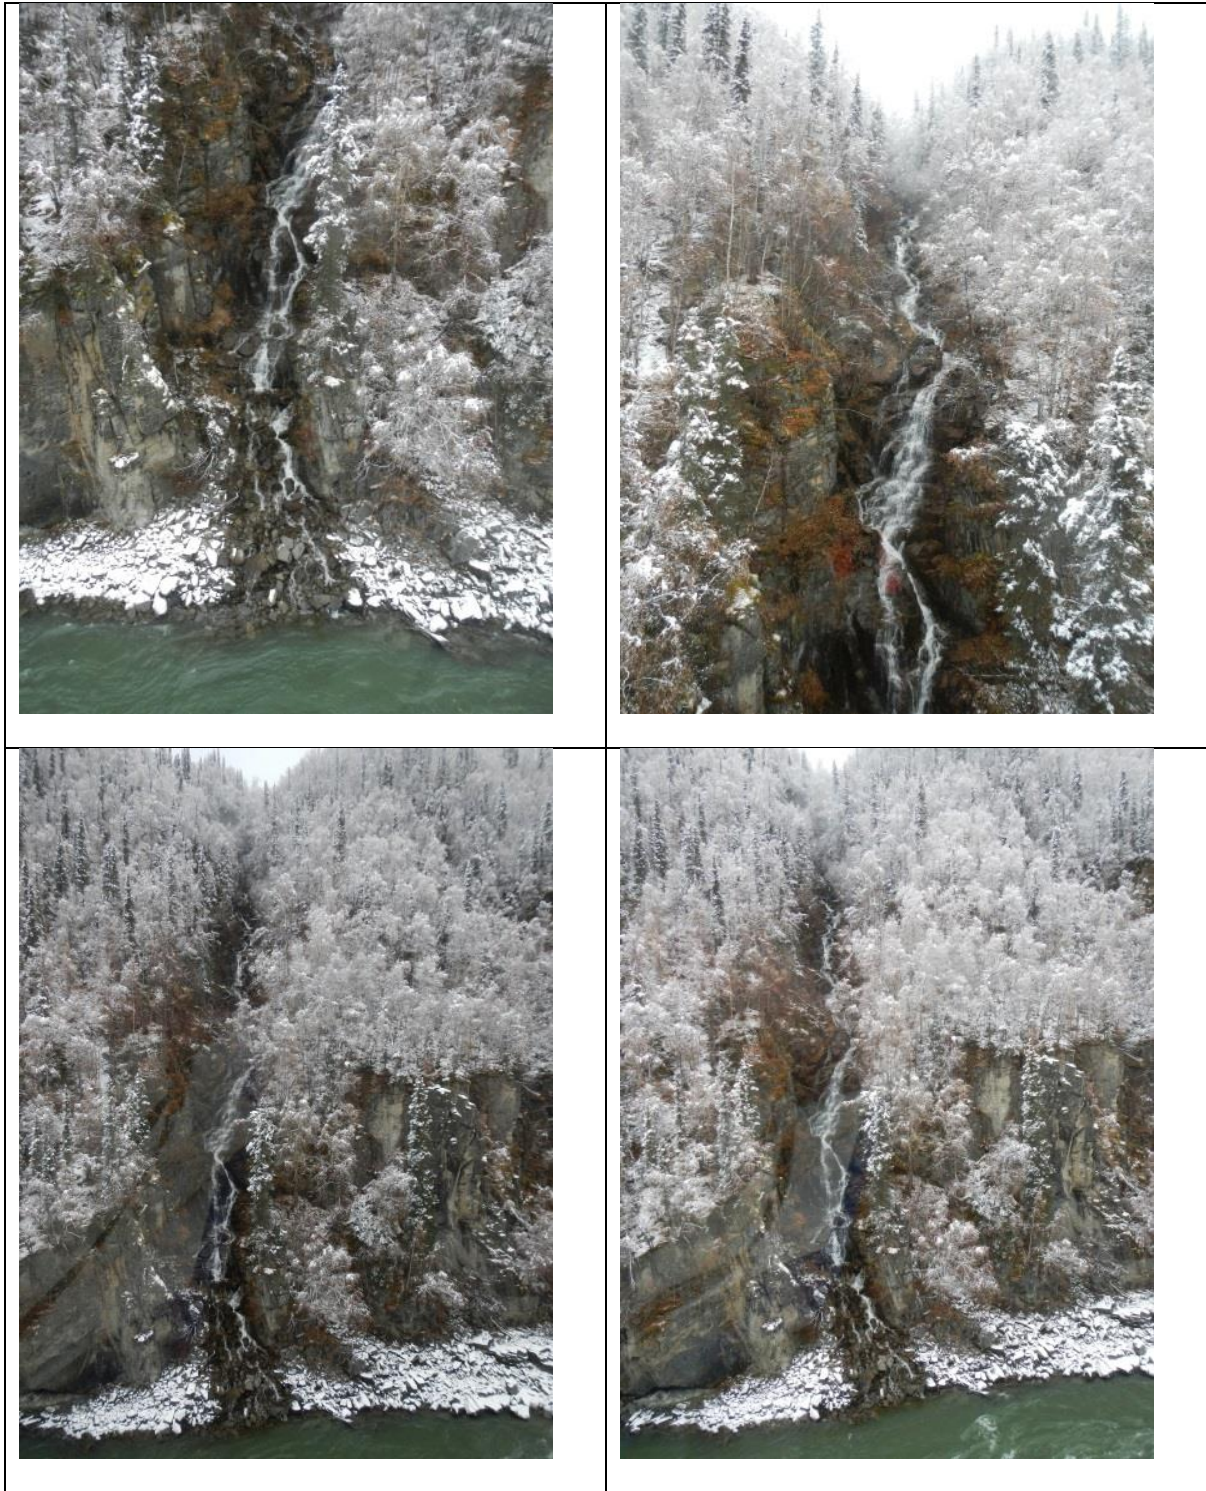
Figure 5.2-2. Photos of PB155.3-C, October 4, 2014. Clockwise from upper left: lower section of cascade; upper section of cascade; full section of cascade view #1; full section of cascade view #2.

The potential barrier was located in an unnamed tributary that flows into the Susitna River at PRM 158.7 on river right. The barrier survey was flown on October 4, 2014. The stream section surveyed contained a continuous steep cascade estimated to be greater than 250 ft long and with a gradient estimated at more than 45 degrees (Figure 5.2-2). The site was re-classified, as a Fixed Permanent Boulder Cascade barrier to upstream fish passage due to excessive gradient.

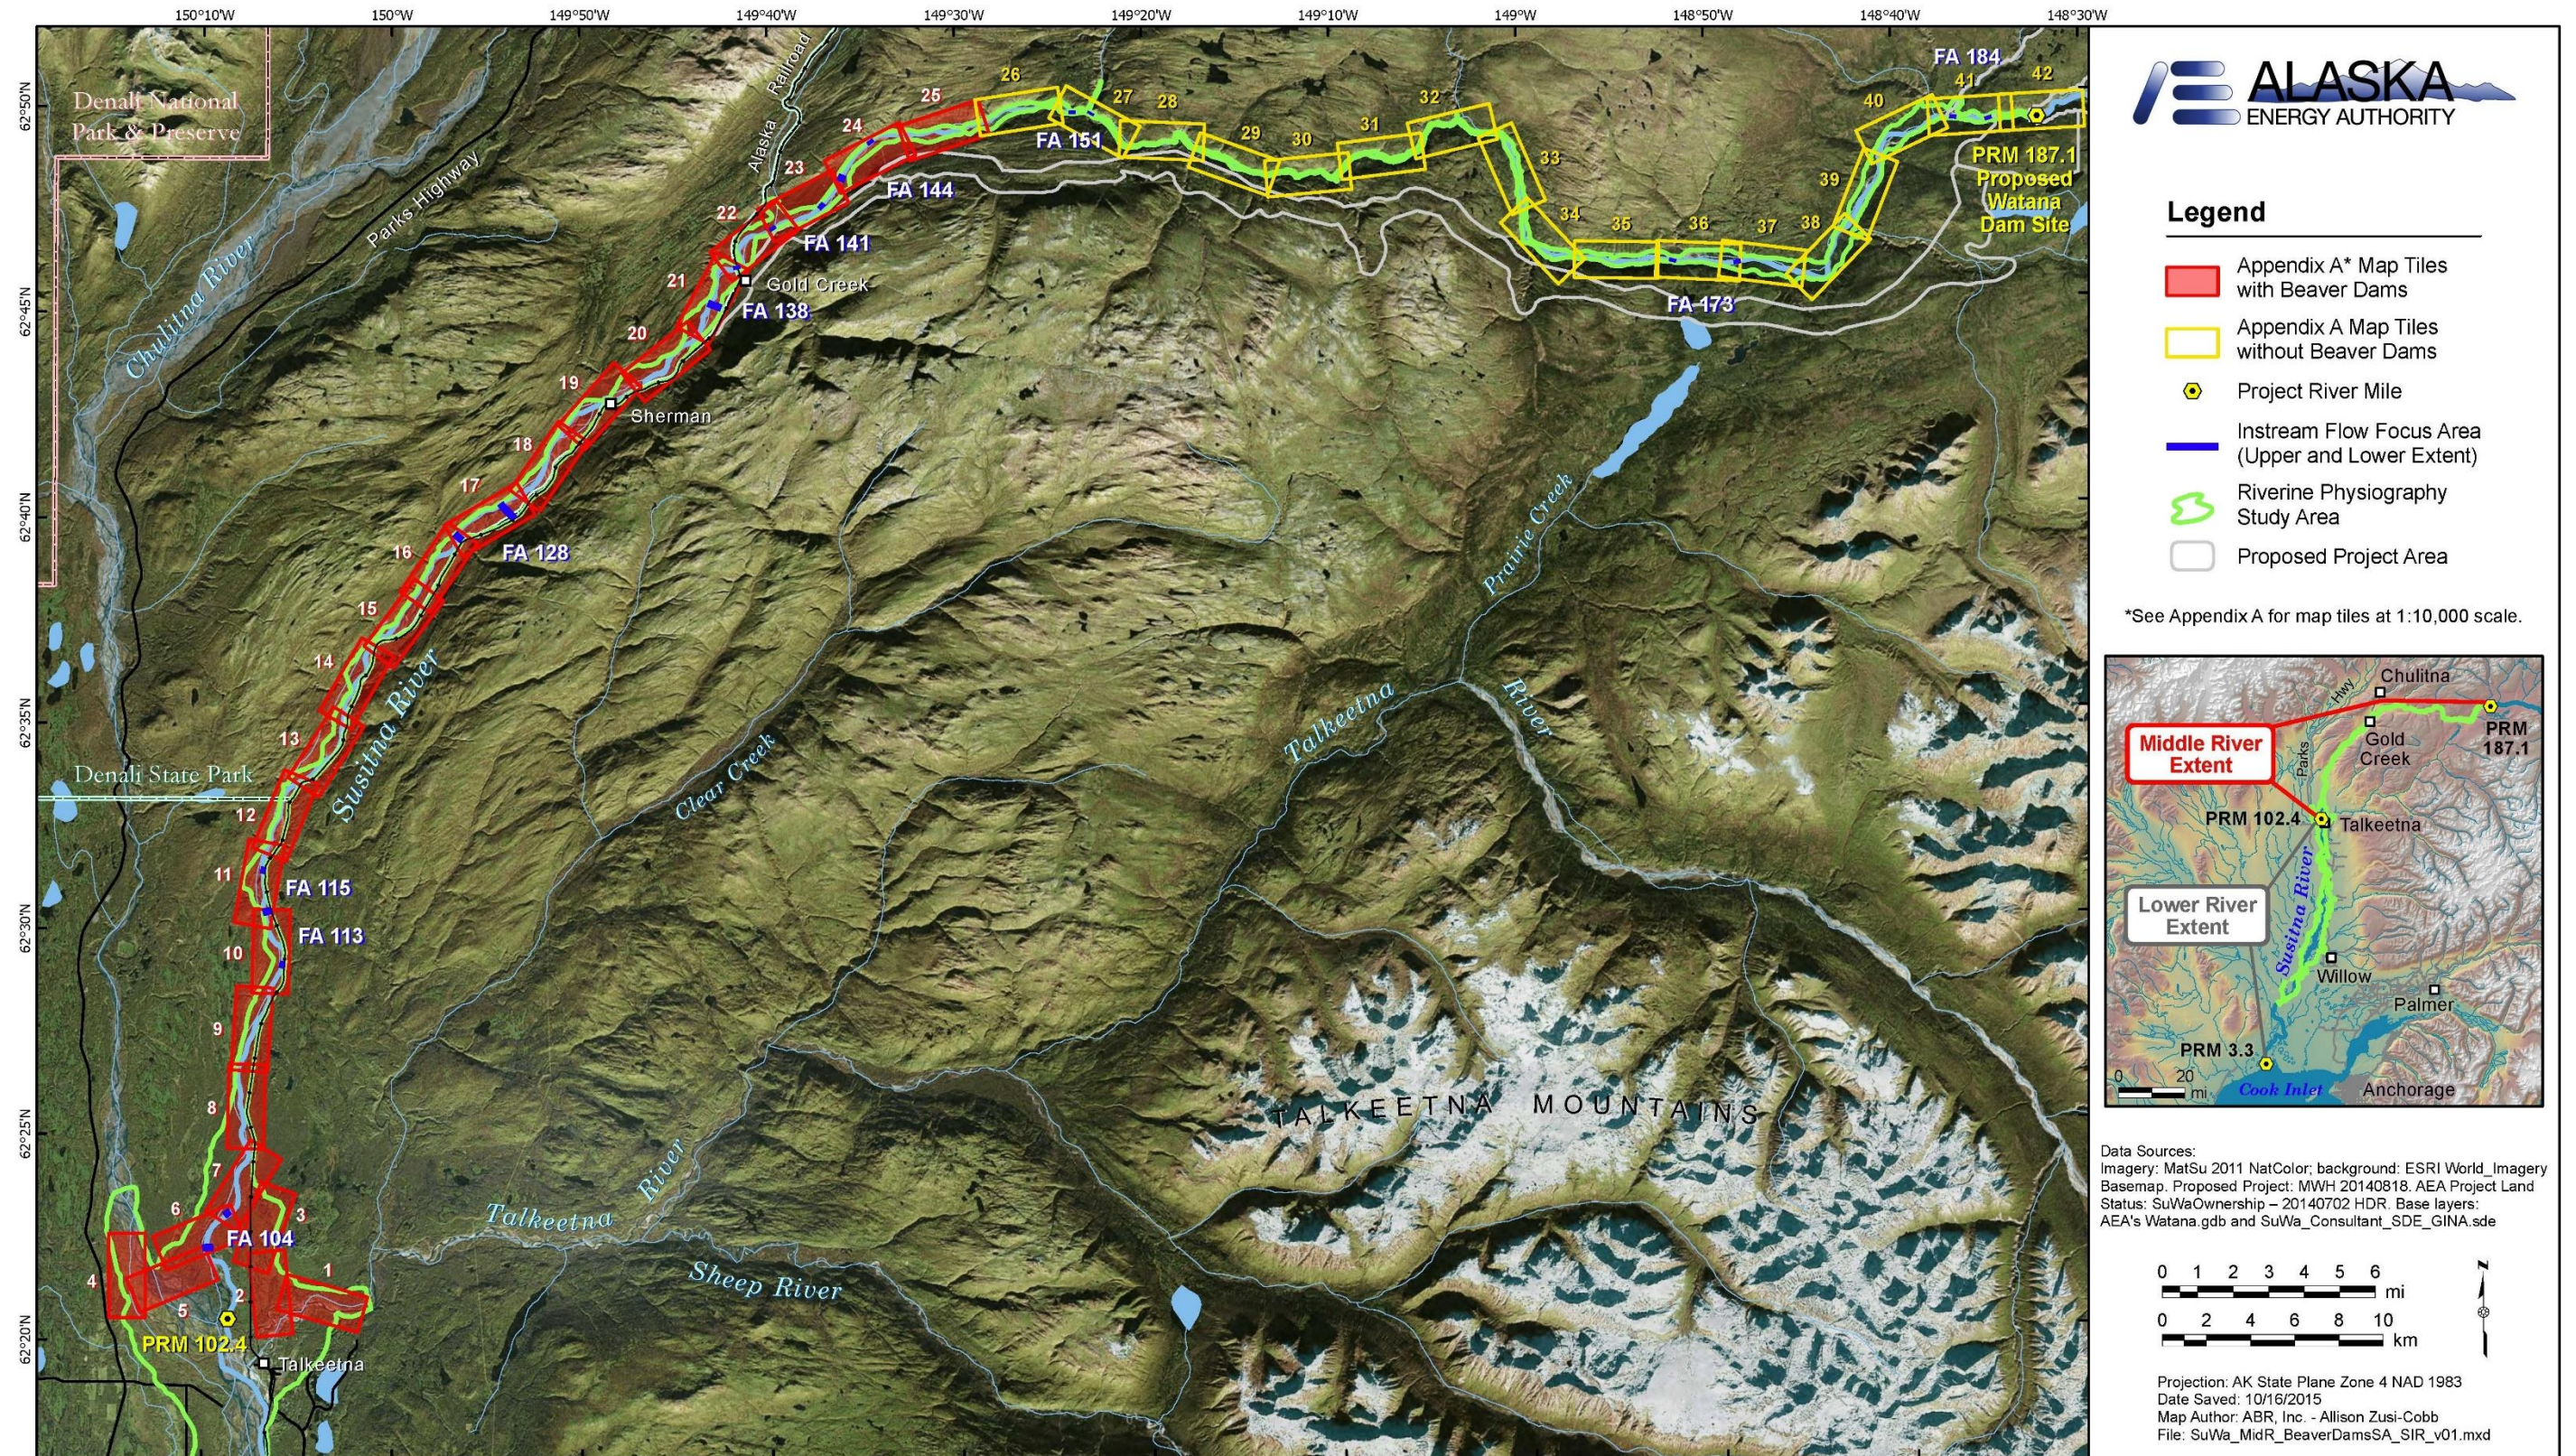
Figure 5.3-1. Overview of 2014 Remote Beaver Dam Mapping.

Review of remote imagery for approximately 89 miles of the Middle River identified 433 potential beaver dams (Figure 5.3-1). The assessment of structural integrity of the dams identified 164 intact dams, 34 partial dams, and 147 not intact dams. The integrity of 88 dams could not be determined from remote imagery. The dam locations are presented in 19 of the 43 reach maps depicting the results of the review (Appendix A) and these detailed maps also indicate the dams within Focus Areas where field verification occurred as part of Study 6.6. Dam. Heights and status of the field verified dams is reported in Table 5.3-1.

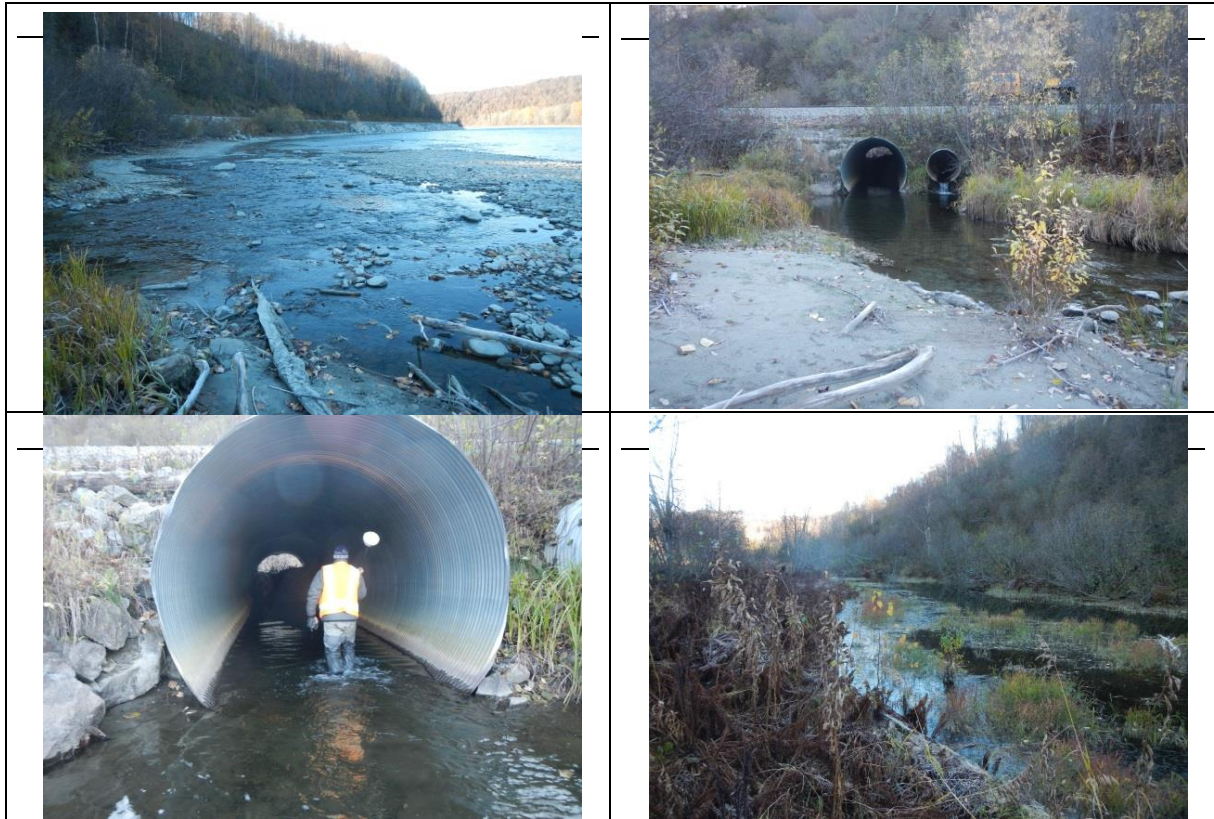
Lower McKenzie Creek/Slough enters into the mainstem Susitna River on the left bank at PRM 119.7. The stream channel was surveyed for a distance of 343.7 ft on September 30, 2014. At the upstream end of the survey, upstream of a culvert under the Alaska Railroad, the stream was flooded by a beaver dam partially blocking the culvert (Figure 5.4-1).

Figure 5.4-1. Photos of Lower McKenzie Creek/Slough, September 30, 2014. Clockwise from upper left: bottom of creek mouth; upstream view to culvert; culvert and beaver dam; and beaver dam above culvert and upstream of Alaska Railroad tracks.

During the survey, survey staff were accompanied by personnel from the Alaska Railroad. They indicated that the beaver would be re-located from this location prior to freeze-up. The geometry and composition of Lower McKenzie Creek/Slough likely will change after removal of the beaver(s).

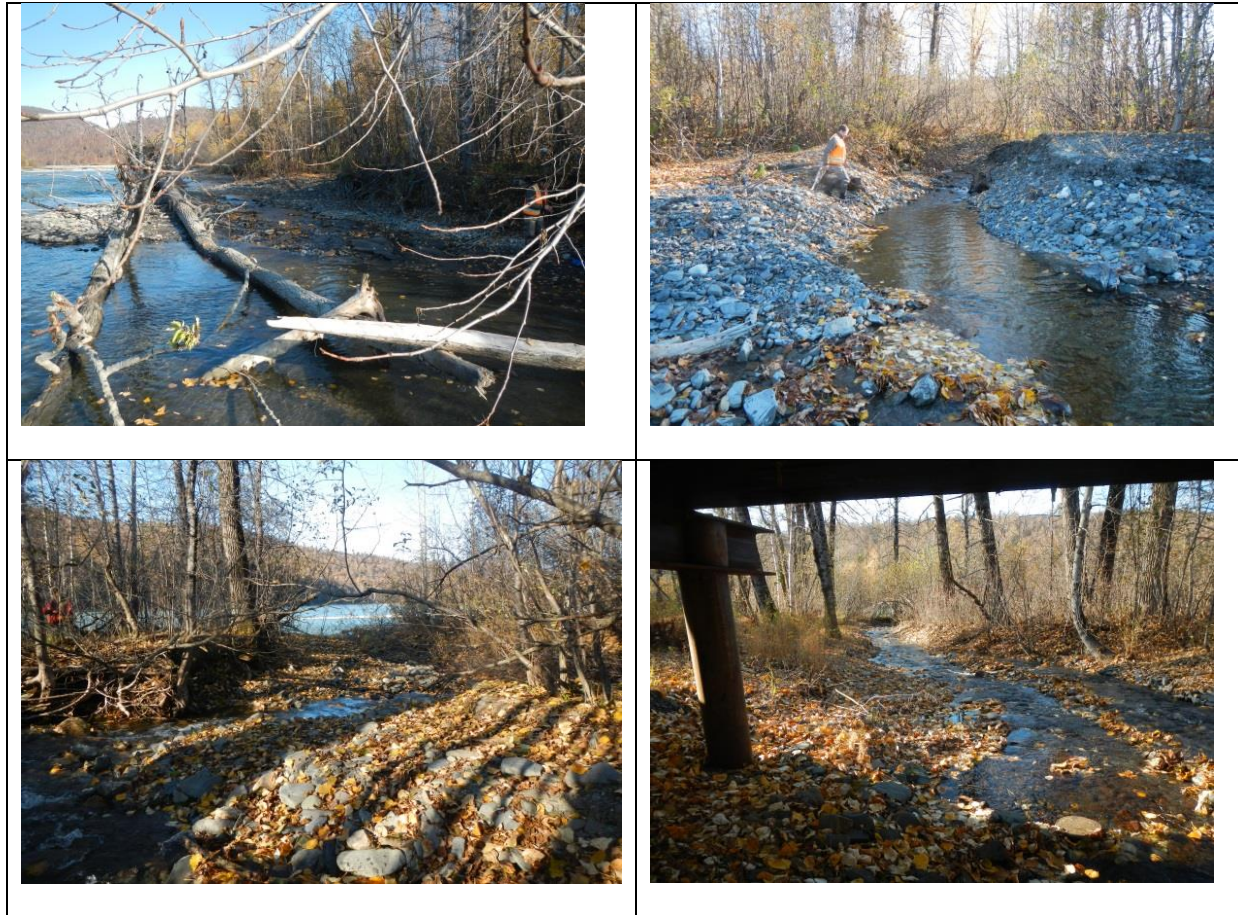
Figure 5.4-3. Photos of McKenzie Creek, September 30, 2014. Clockwise from upper left: bottom of creek mouth and debris apron from mainstem Susitna River; bottom of creek mouth; looking downstream to creek mouth; and looking downstream from Alaska Railroad bridge.

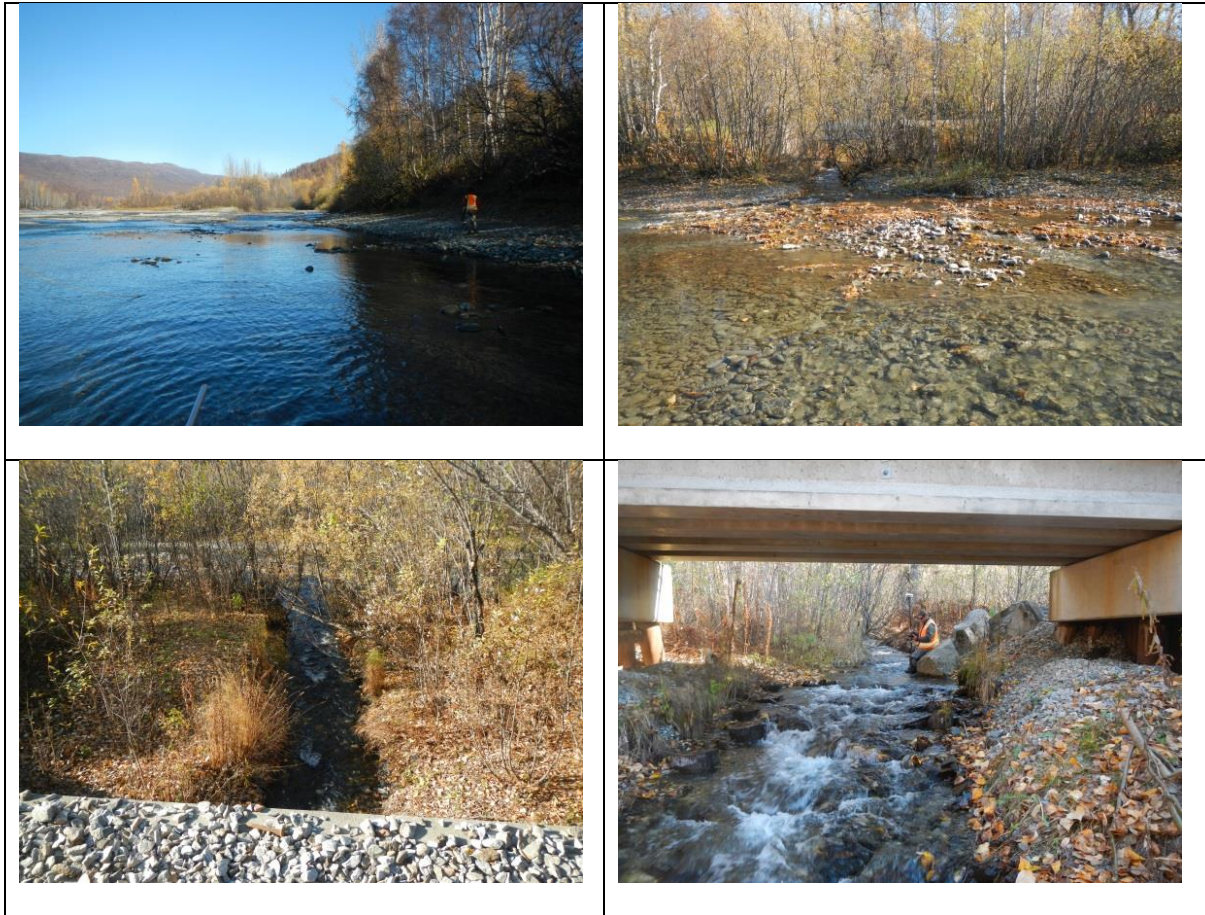
Figure 5.4-5. Photos of Little Portage Creek, September 30, 2014. Clockwise from upper left: looking upstream to creek mouth from mainstem Susitna River; creek mouth and debris apron; and looking upstream under Alaska Railroad bridge, looking downstream to creek mouth from Alaska Railroad bridge.

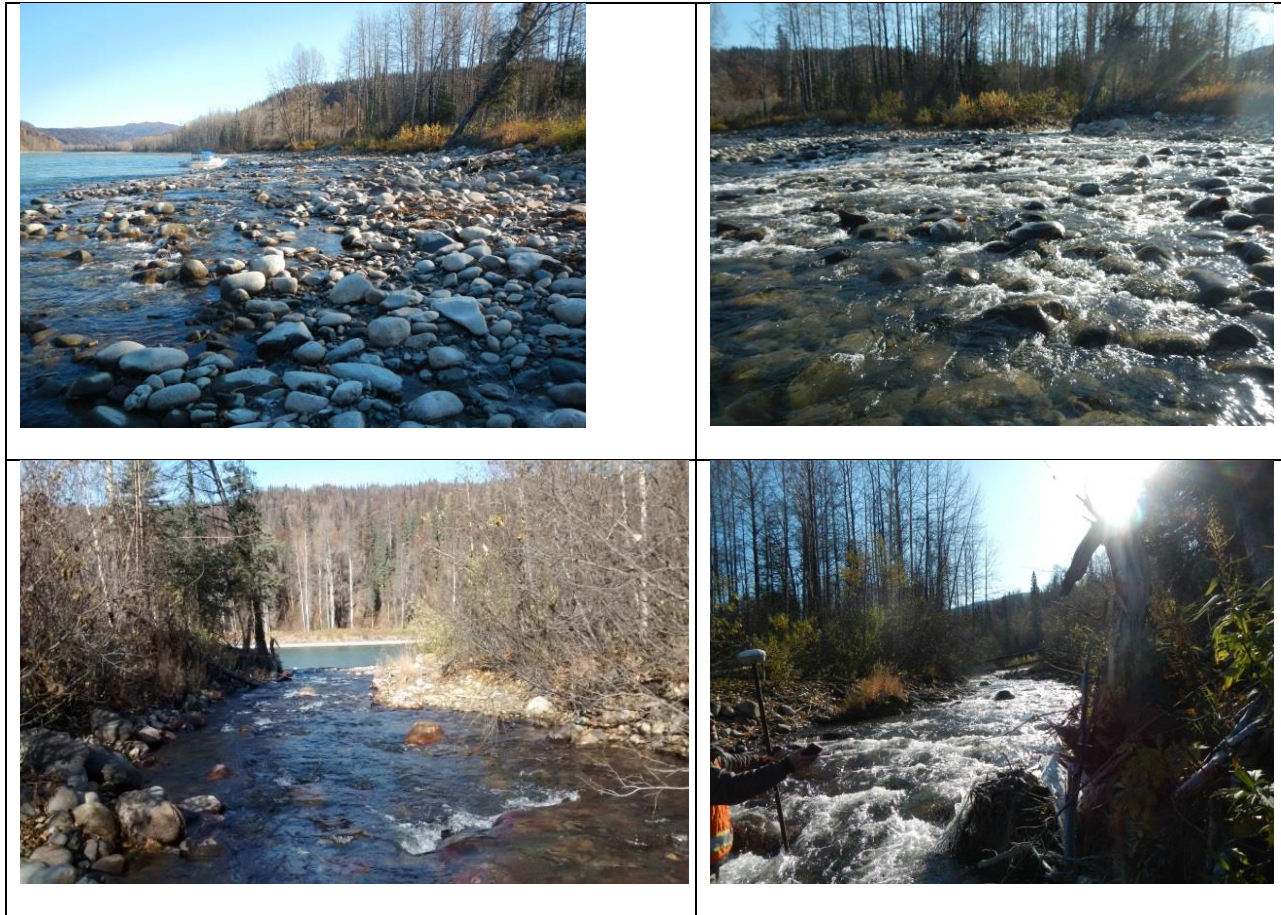
Figure 5.4-7. Photos of Jack Long Creek, October 1, 2014. Clockwise from upper left: looking upstream from Susitna River to creek mouth; flow over debris apron; flow above creek mouth; downstream view to creek mouth from top survey station.

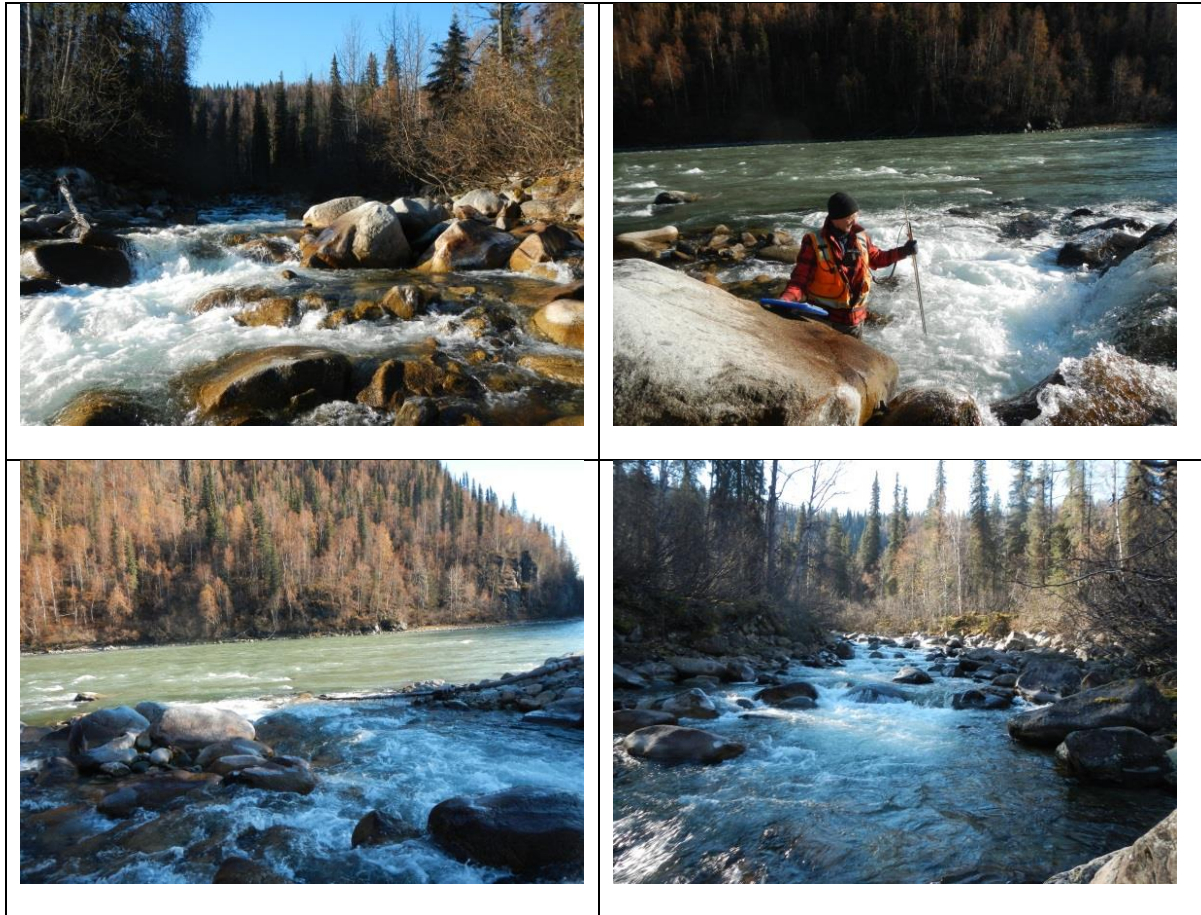
Figure 5.4-9. Photos of Cheechako Creek, October 2, 2014. Clockwise from upper left: bottom of creek mouth; multiple channels through creek mouth; riffle upstream of tributary apron; and looking downstream from top of survey.

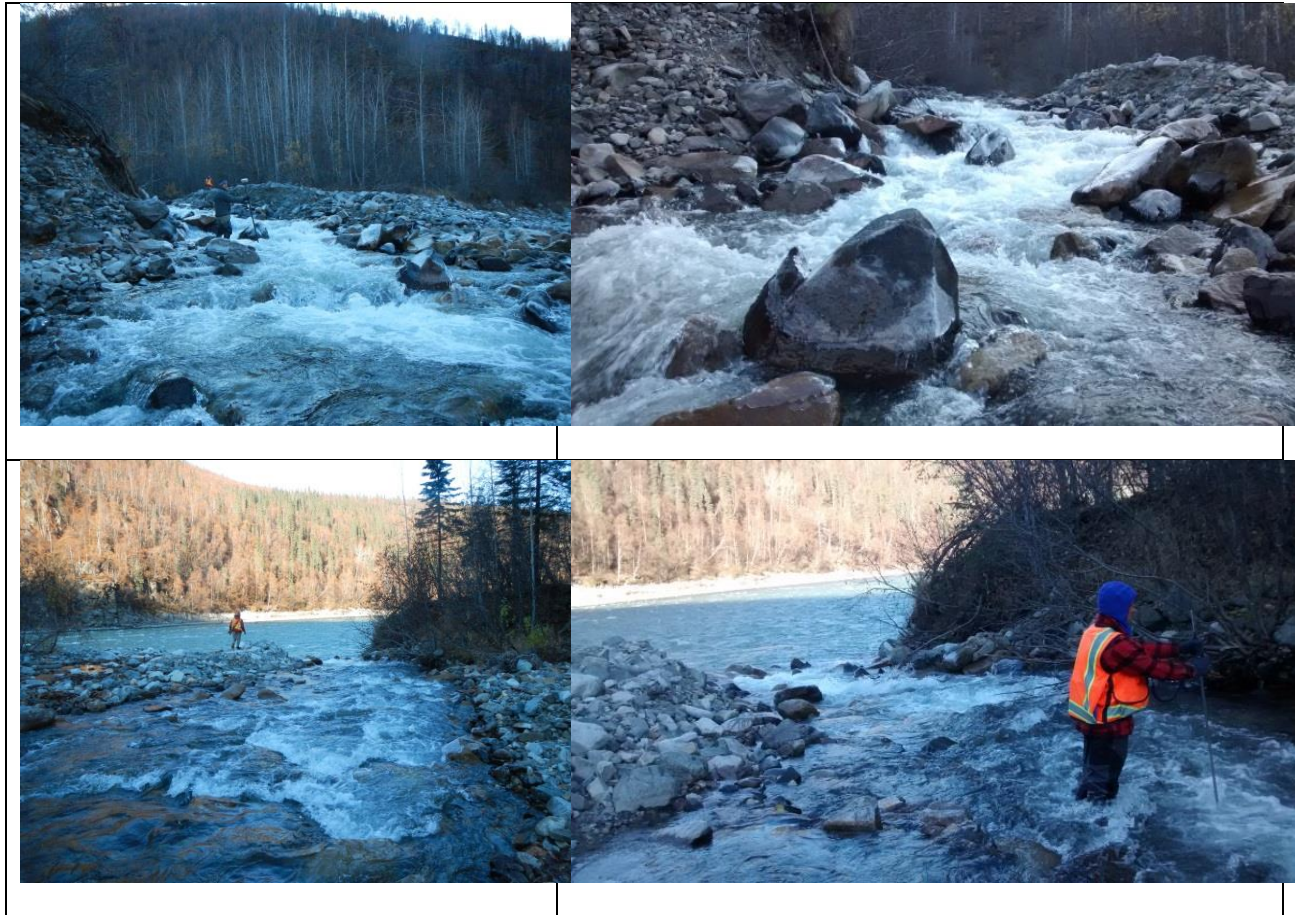
Figure 5.4-11. Photos of Chinook Creek, October 2, 2014. Clockwise from upper left: bottom of creek mouth from mainstem Susitna River; upstream view from creek mouth; downstream view of creek mouth; downstream view from top survey station.

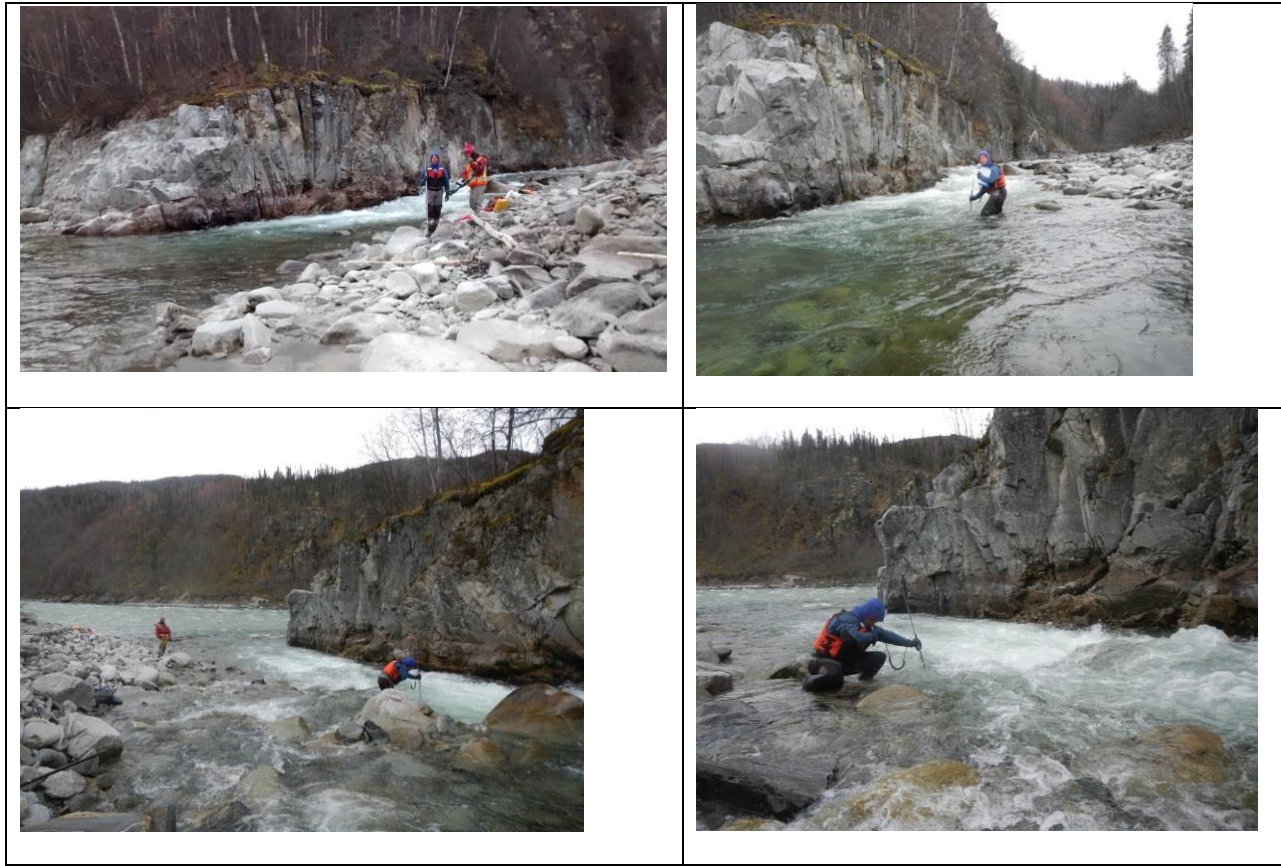
Figure 5.4-13. Photos of Devil Creek, October 3, 2014. Clockwise from upper left: bottom of creek mouth from mainstem Susitna River; upstream view from creek mouth; downstream view of creek mouth; downstream view from top survey station.

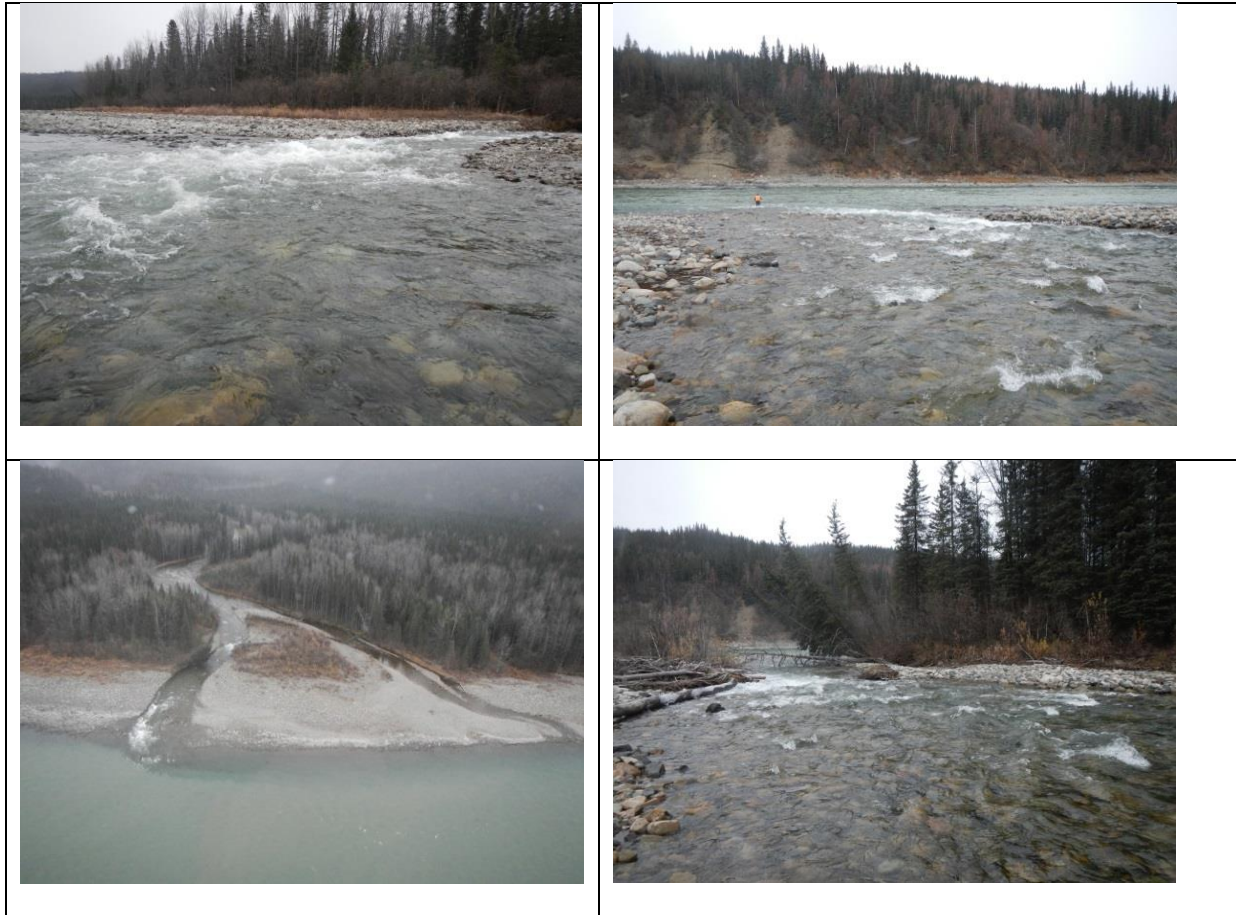
Figure 5.4-15. Photos of Fog Creek, October 3, 2014. Clockwise from upper left: bottom of creek mouth from mainstem Susitna River; view of creek mouth from middle of transect; downstream view from top survey station; aerial view of main surveyed channel and a secondary channel.
