**Susitna-Watana Hydroelectric Project  
(FERC No. 14241)**

**Aesthetic Resources Study  
Study Plan Section 12.6**

**2014 Study Implementation Report**

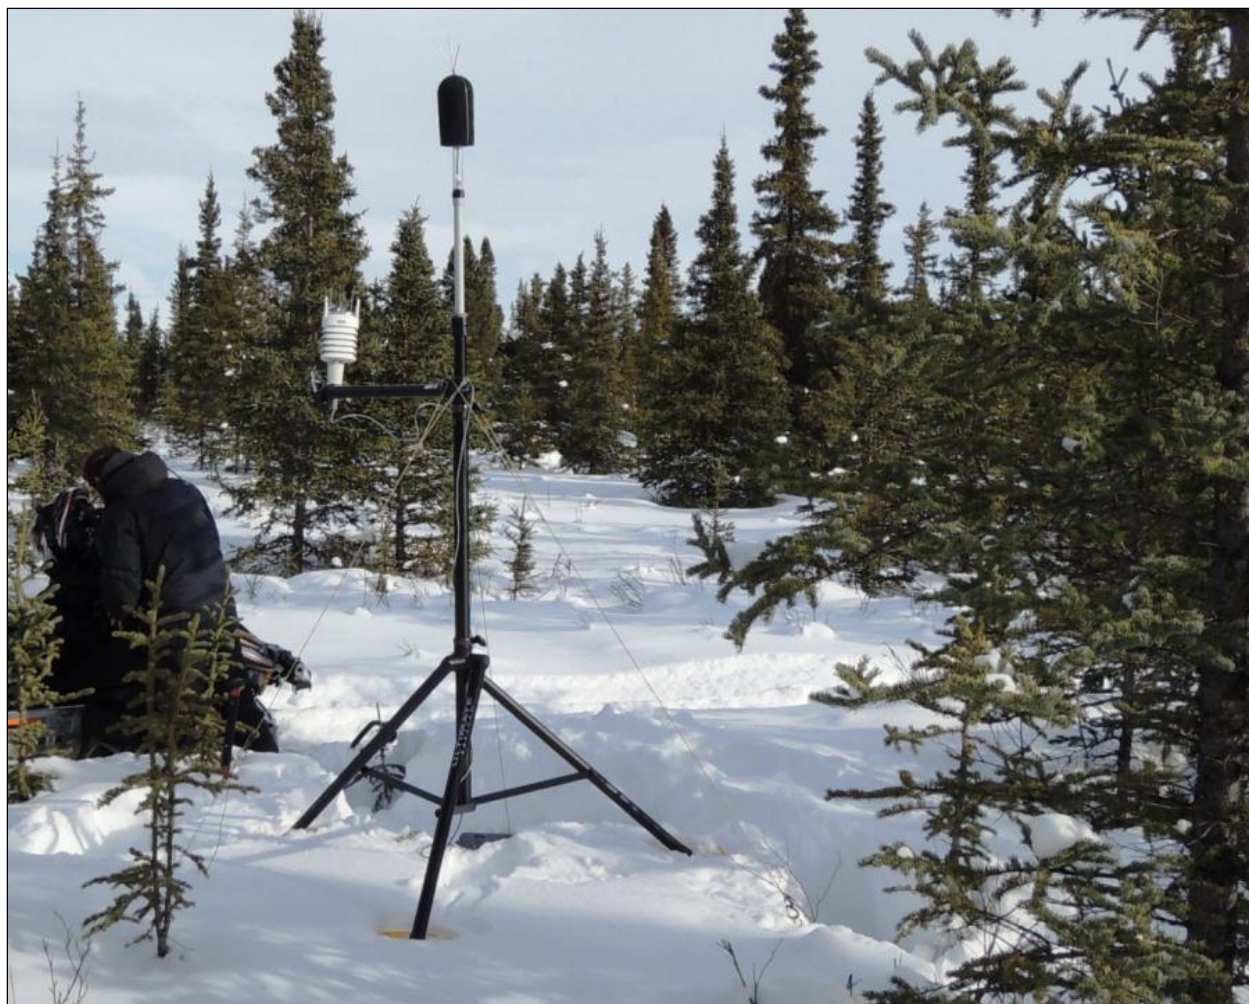
Figure 5-3. Photo of Long-Term Sound Monitor Winter LT2 Location

The Winter LT2 soundscape monitor was located approximately 200 feet south of the Denali Highway (Figure 5-3). This station is approximately 240 feet from Brushkana Creek. It was deployed on March 7, 2013. Data were collected from March 8 through March 11, 2013. Table 5-2 provides summary information on Winter LT2.

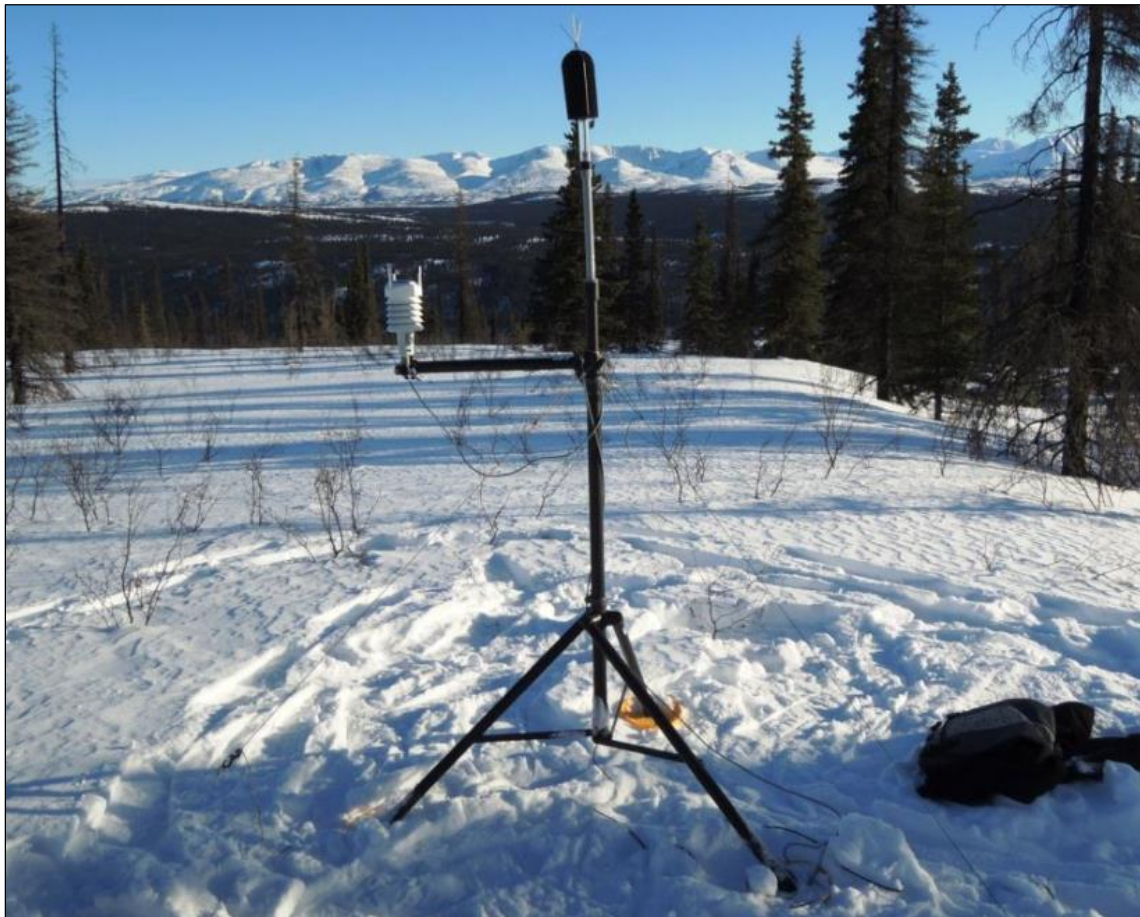
**Figure 5-4. Photo of Long-Term Sound Monitor Winter LT4 Location****Table 5-3. Long-Term Sound Monitor Winter LT4 Summary**

The Winter LT4 soundscape monitor was located on a remote hillside, approximately 1 mile north of the Susitna River and 3.5 miles west of the proposed dam site (Figure 5-4). This location was accessed via helicopter. The monitor was deployed on March 8, 2013, and data were collected on March 9 through March 10, 2013. Table 5-3 provides summary information on Winter LT4.

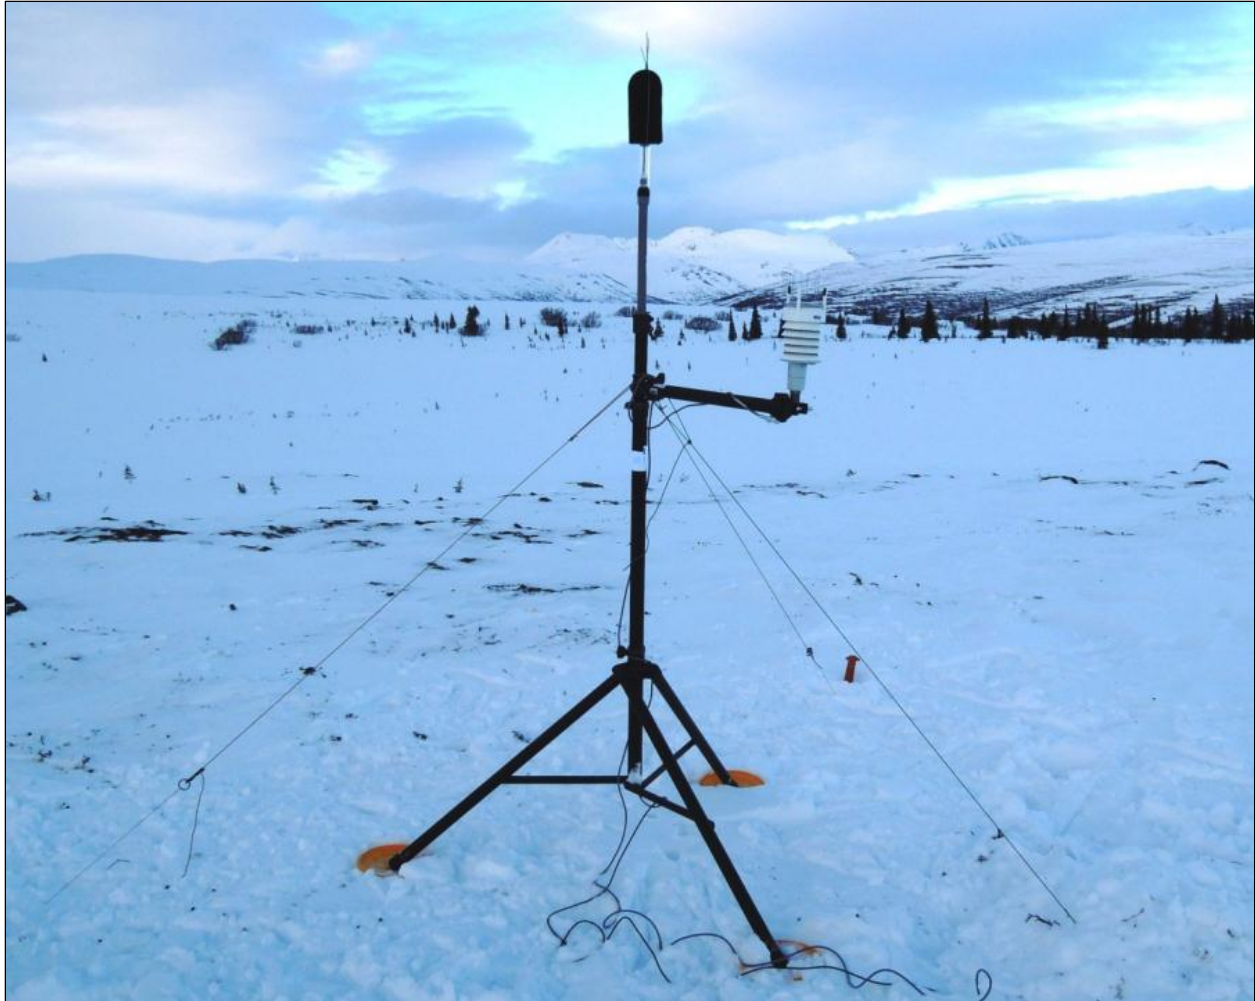
Figure 5-5. Photo of Long-Term Sound Monitor Winter LT5 Location

The Winter LT5 soundscape monitor was located on a hillside approximately 0.6 miles east of High Lake (Figure 5-5). It was deployed on March 8, 2013. Data were collected on March 9 through 11 and March 13 and 14, 2013. Table 5-4 provides summary information on Winter LT5.

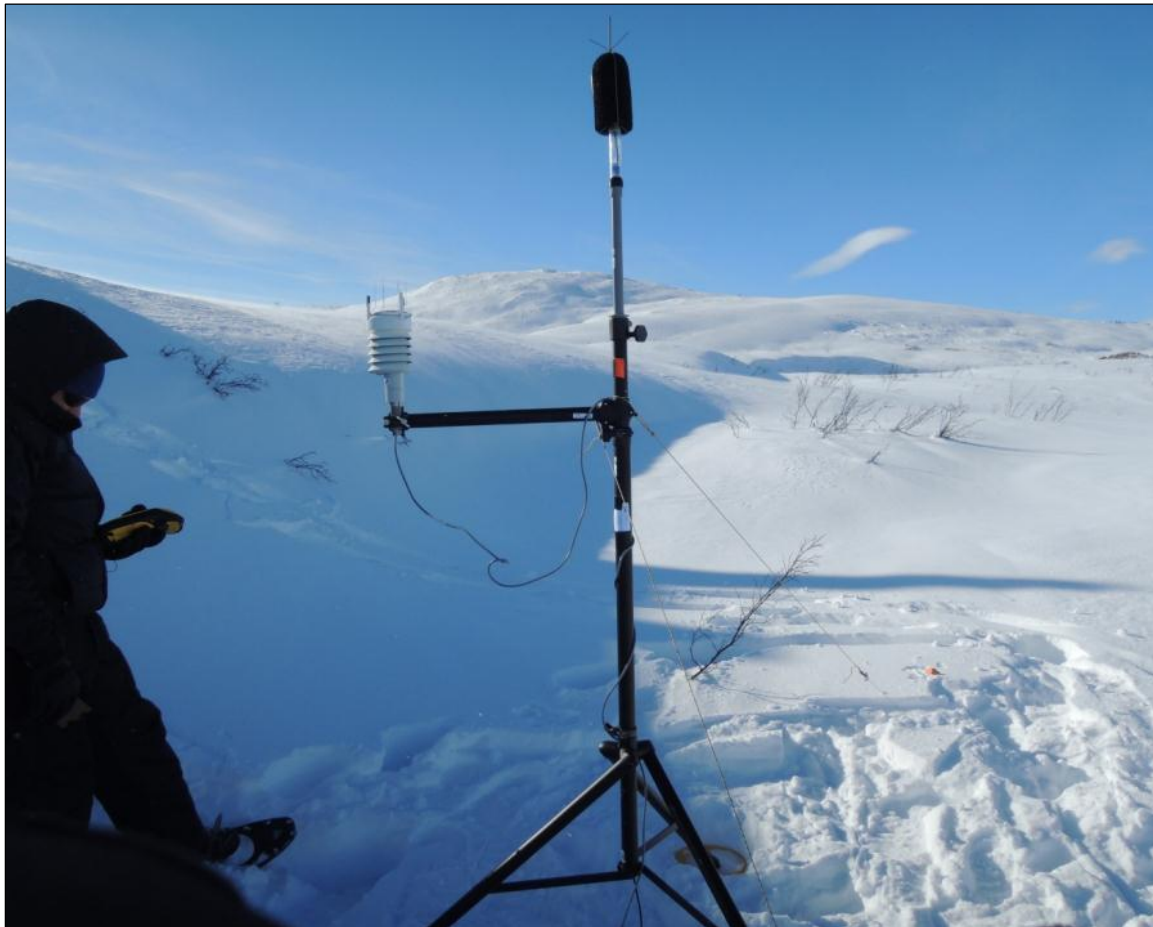
Figure 5-6. Photo of Long-Term Sound Monitor Winter LT7 Location

The Winter LT7 soundscape monitor was located approximately 9 miles southwest of the Denali Highway, 25 miles north of the proposed dam site, and approximately 23 miles west of the Susitna River (Figure 5-6). The instrument was deployed on March 11, 2013. Data were recorded for six consecutive days between March 12 and March 17, 2013. Table 5-5 provides summary information on Winter LT7.

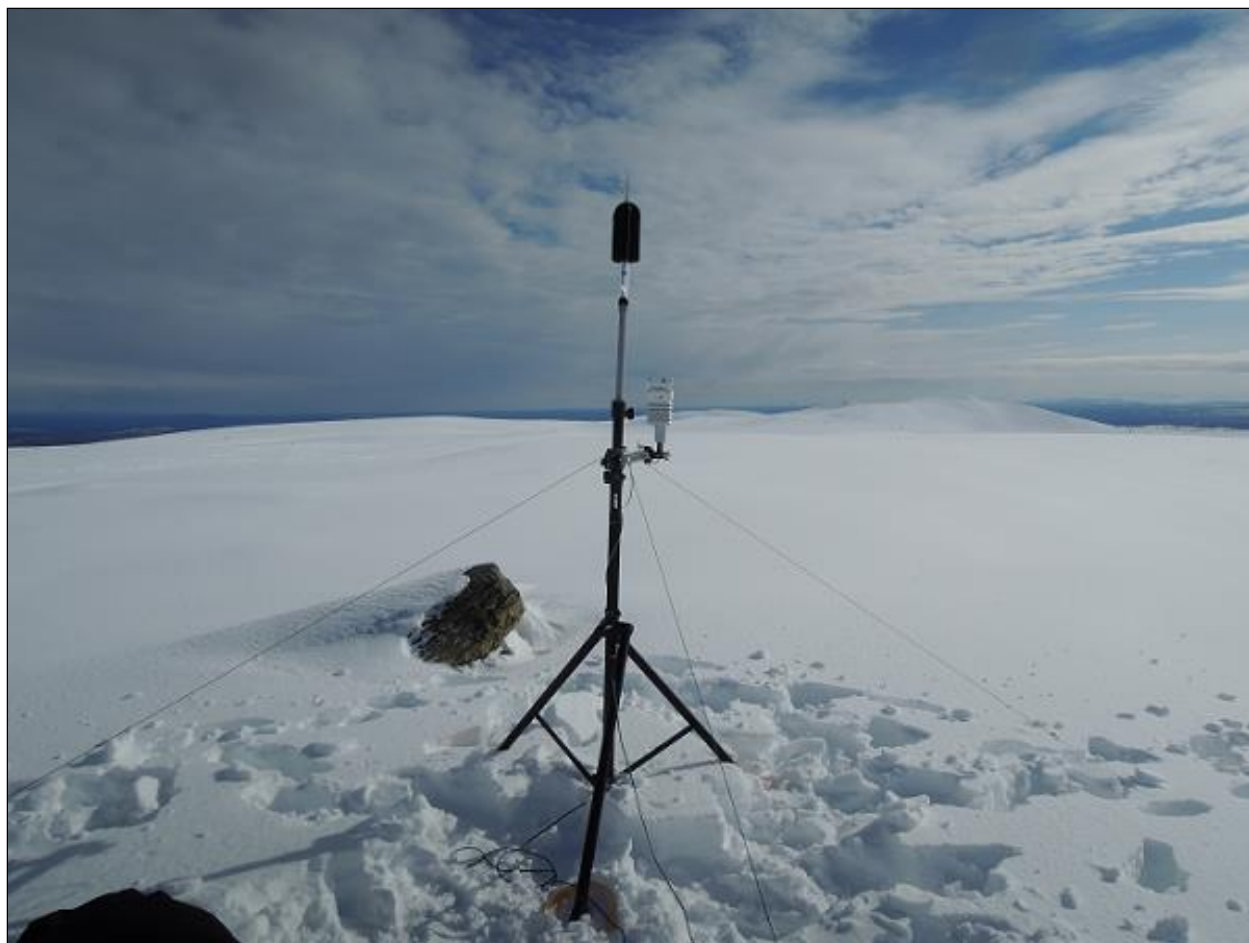
Figure 5-7. Photo of Long-Term Sound Monitor Spring LT1 Location

The Spring LT1 soundscape monitor was located 4 miles east of the Parks Highway and 2.25 miles northwest of the Susitna River and the Alaska Railroad (Figure 5-7) for five consecutive days from May 19 through May 23, 2013. Table 5-6 provides summary information on Spring LT1.

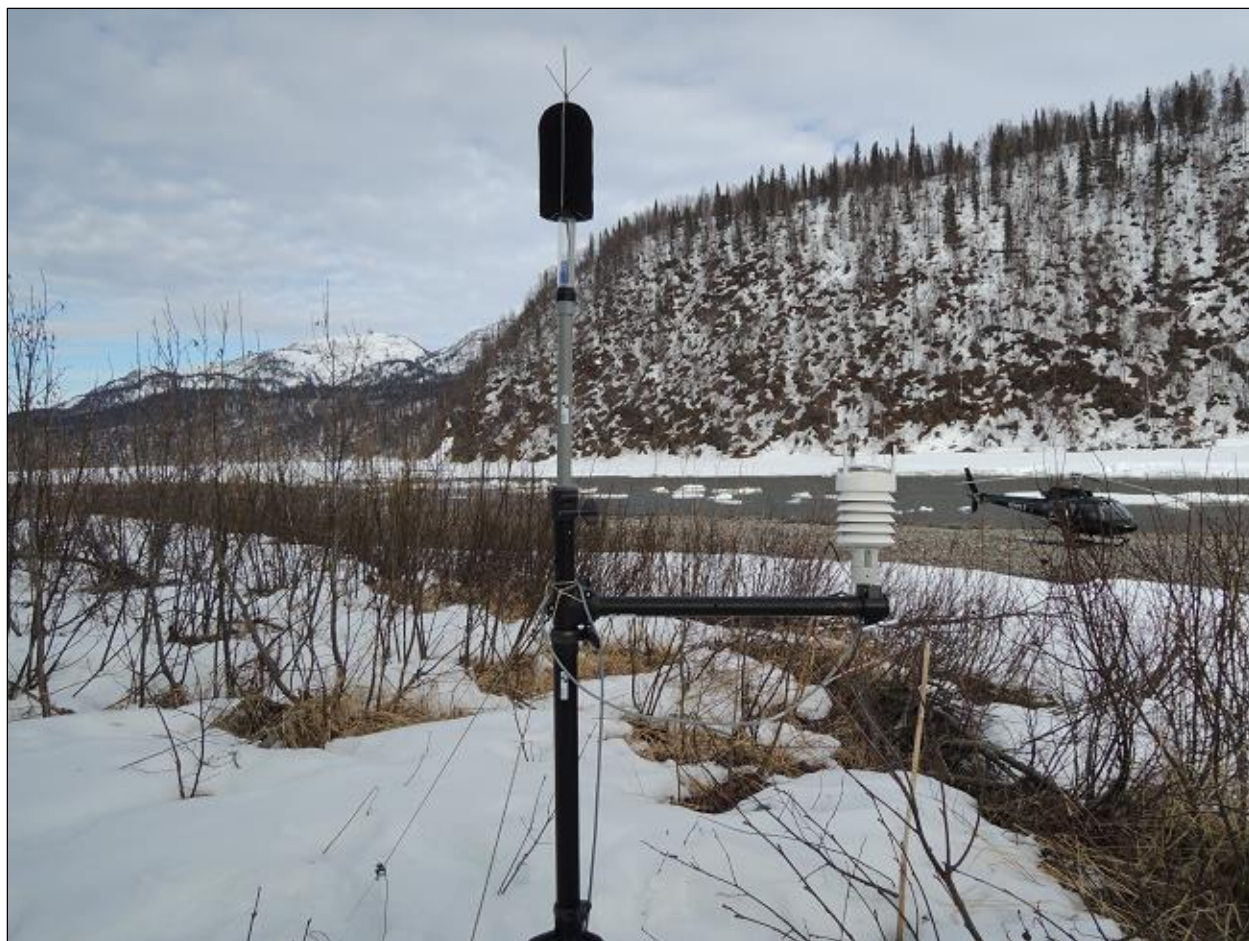
Figure 5-8. Photo of Long-Term Sound Monitor Spring LT2 Location

The Spring LT2 soundscape monitor was located on the banks of the Susitna River at the confluence of the Indian River, approximately 8 miles southeast of the Parks Highway (Figure 5-8). The instrument was deployed on May 18, 2013. Data were collected for five consecutive days between May 19 and May 23, 2013. Table 5-7 provides summary information on Spring LT2.

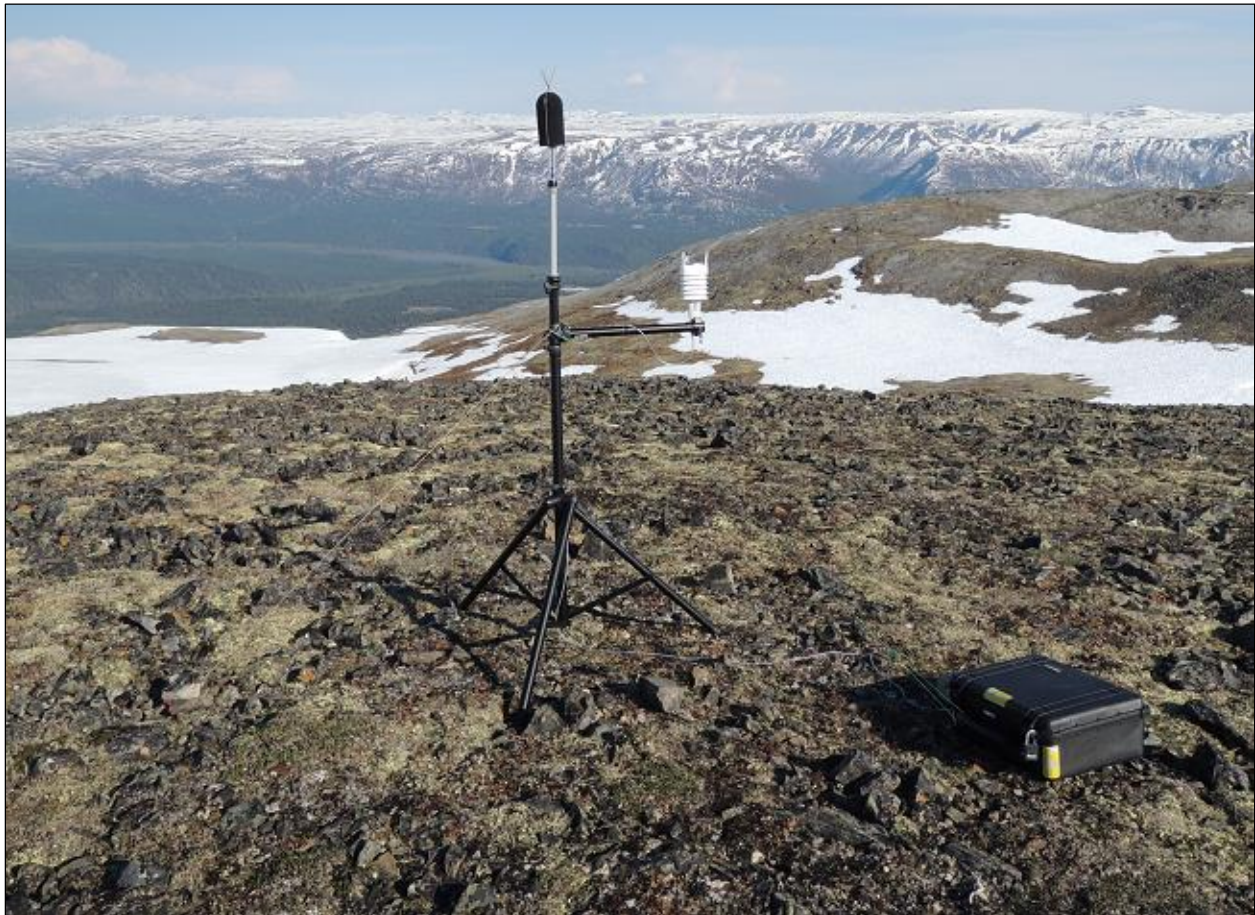
Figure 5-9. Photo of Long-Term Sound Monitor Spring LT3 Location

The Spring LT3 soundscape monitor was located approximately 4.5 miles southeast of the Parks Highway, 3.5 miles northwest of the Susitna River, and 40 miles west of the proposed dam site (Figure 5-9). It was deployed on May 20, 2013. Data were collected for six consecutive days between May 21 and May 26, 2013. Table 5-8 provides summary information on Spring LT3.

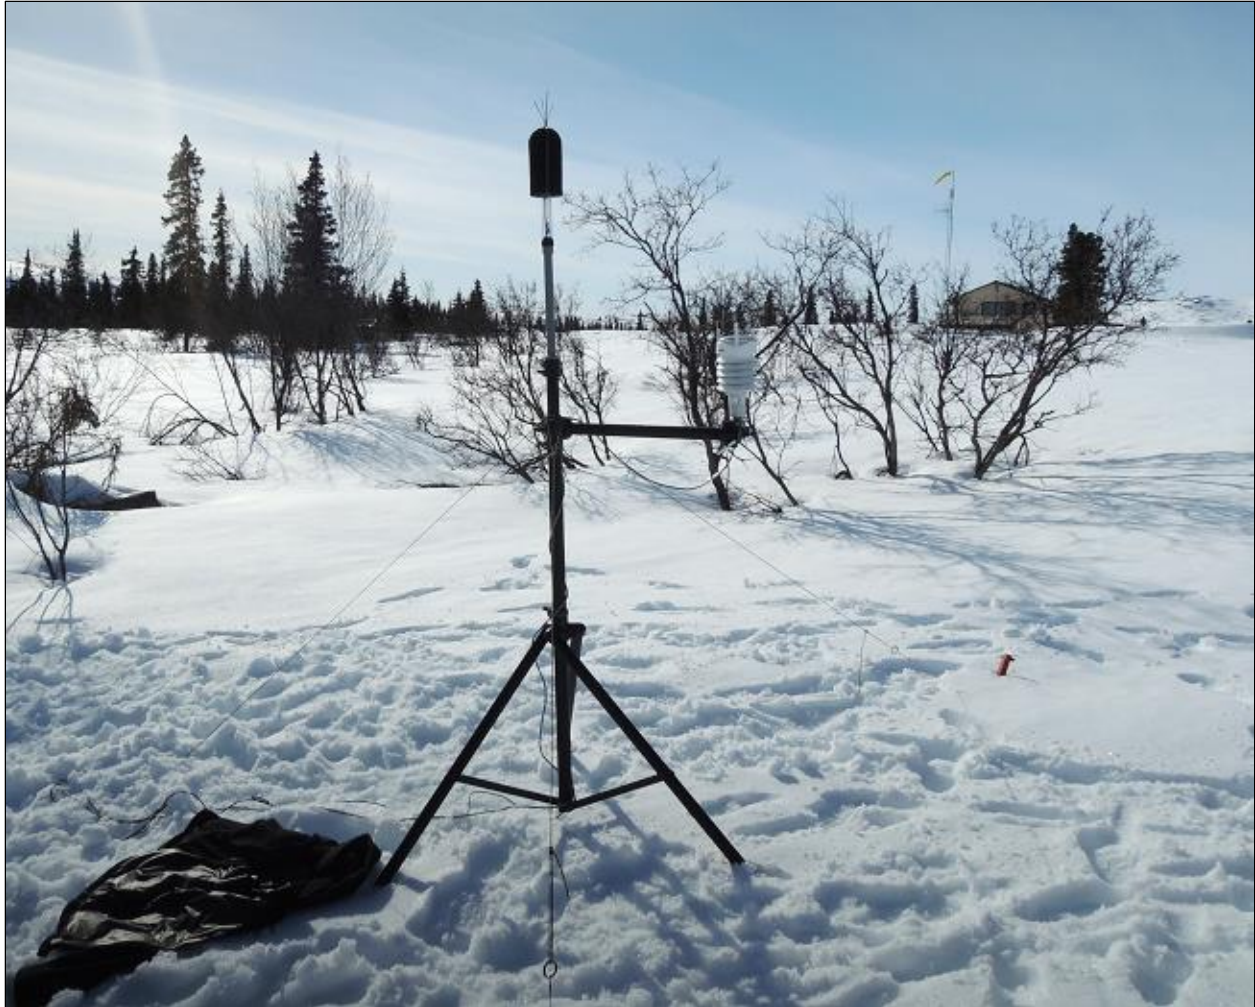
Figure 5-10. Photo of Long-Term Sound Monitor Spring LT4 Location

The Spring LT4 soundscape monitor was located at the High Lake Lodge and airstrip, approximately 2 miles north of the Susitna River and 19 miles west of the proposed dam site (Figure 5-10). The instrument was deployed on May 20, 2013. Data were collected between May 21 and May 27, 2013. Table 5-9 provides summary information on Spring LT4.

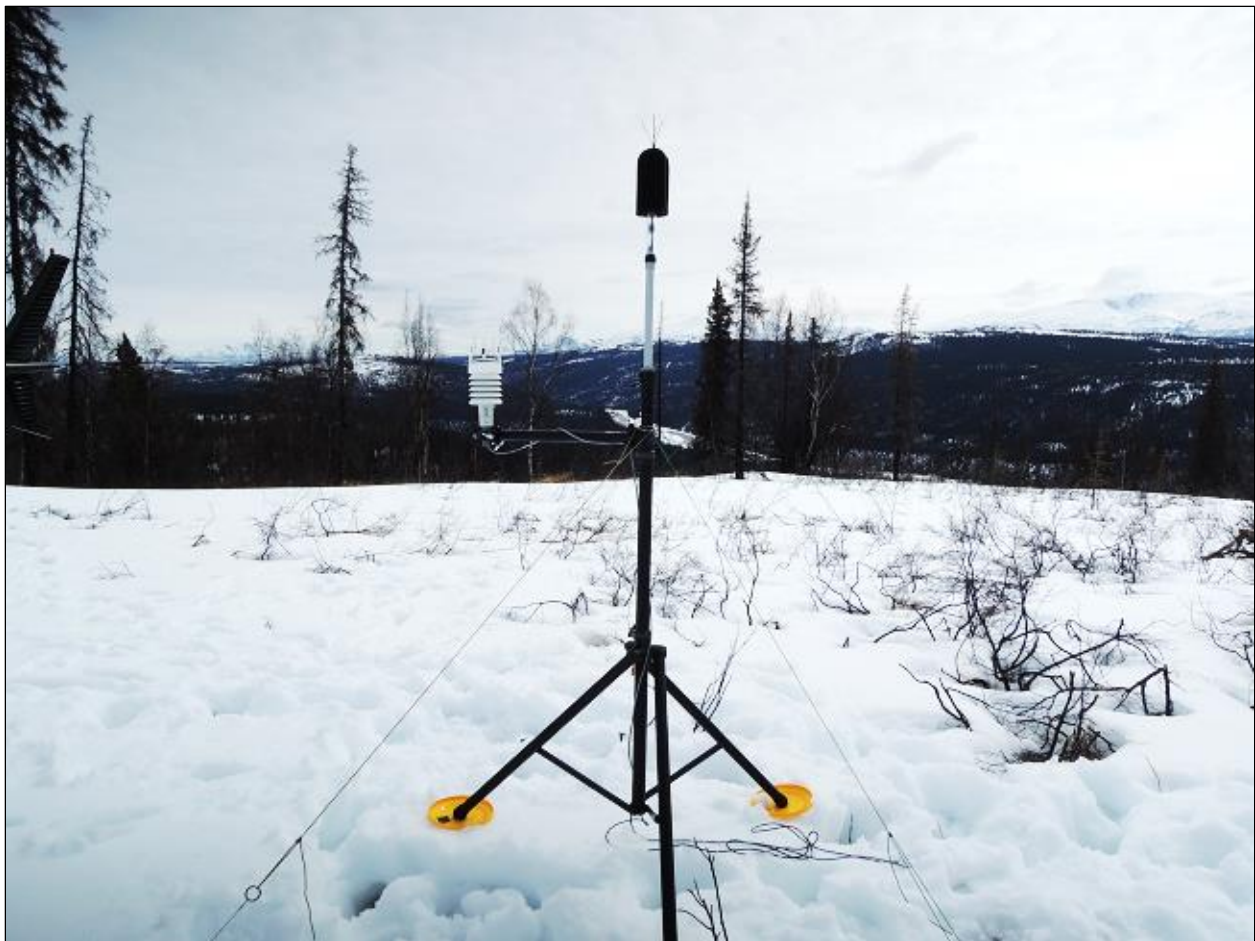
Figure 5-11. Photo of Long-Term Sound Monitor Spring LT5 Location

The Spring LT5 soundscape monitor was located approximately 1 mile northwest of the Susitna River, and approximately 3.25 miles west of the proposed dam site (Figure 5-11). The instrument was deployed May 23, 2013. Data were collected between May 24 and May 28, 2013. Table 5-10 provides summary information on Spring LT5.

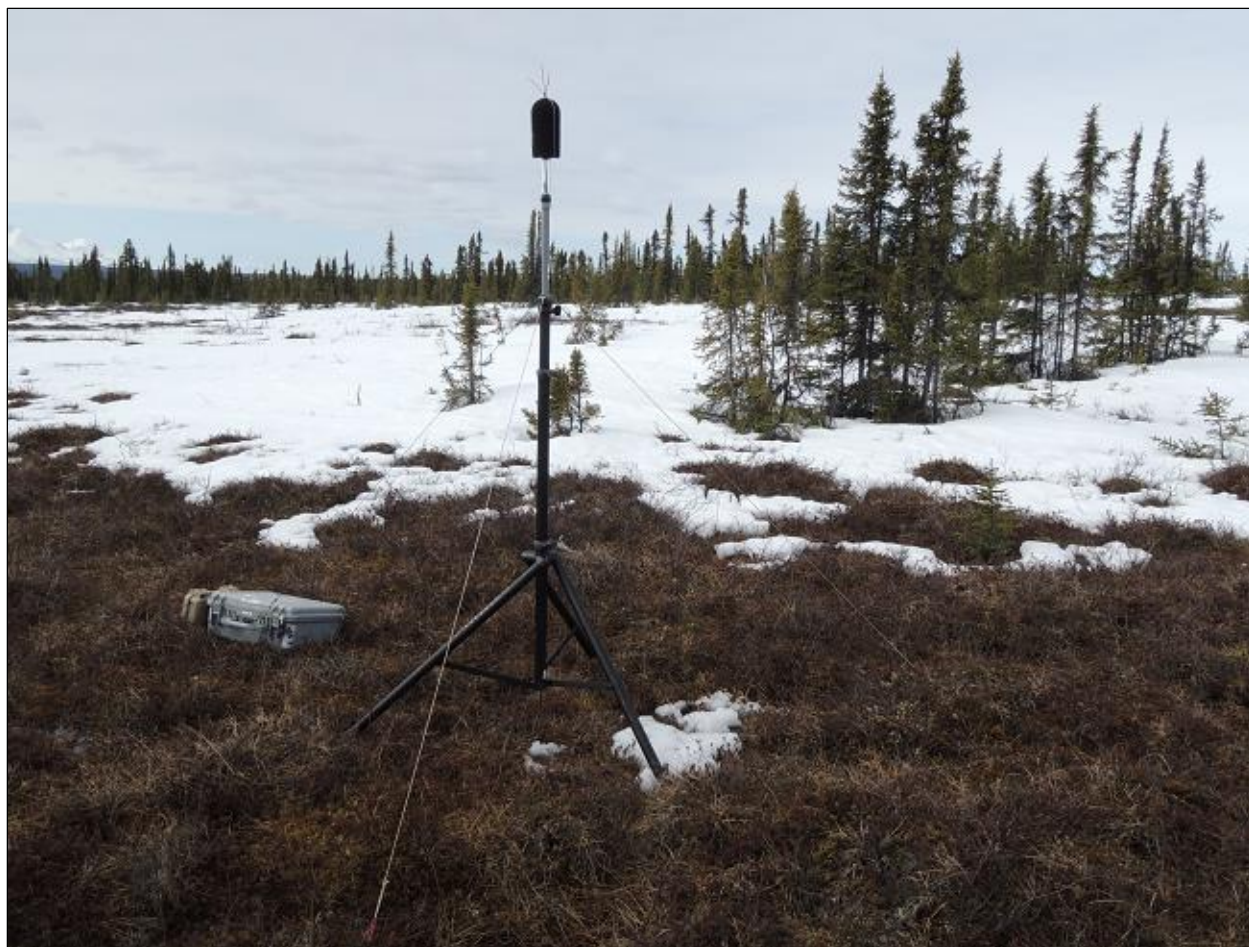
Figure 5-12. Photo of Long-Term Sound Monitor Spring LT6 Location

The Spring LT6 soundscape monitor was located on a hillside approximately 2.5 miles north of the Susitna River and 1.25 miles northwest of the Watana Creek (Figure 5-12). The instrument was deployed on May 23, 2013. Data were recorded between May 24 and May 30, 2013. Table 5-11 provides summary information on Spring LT6.

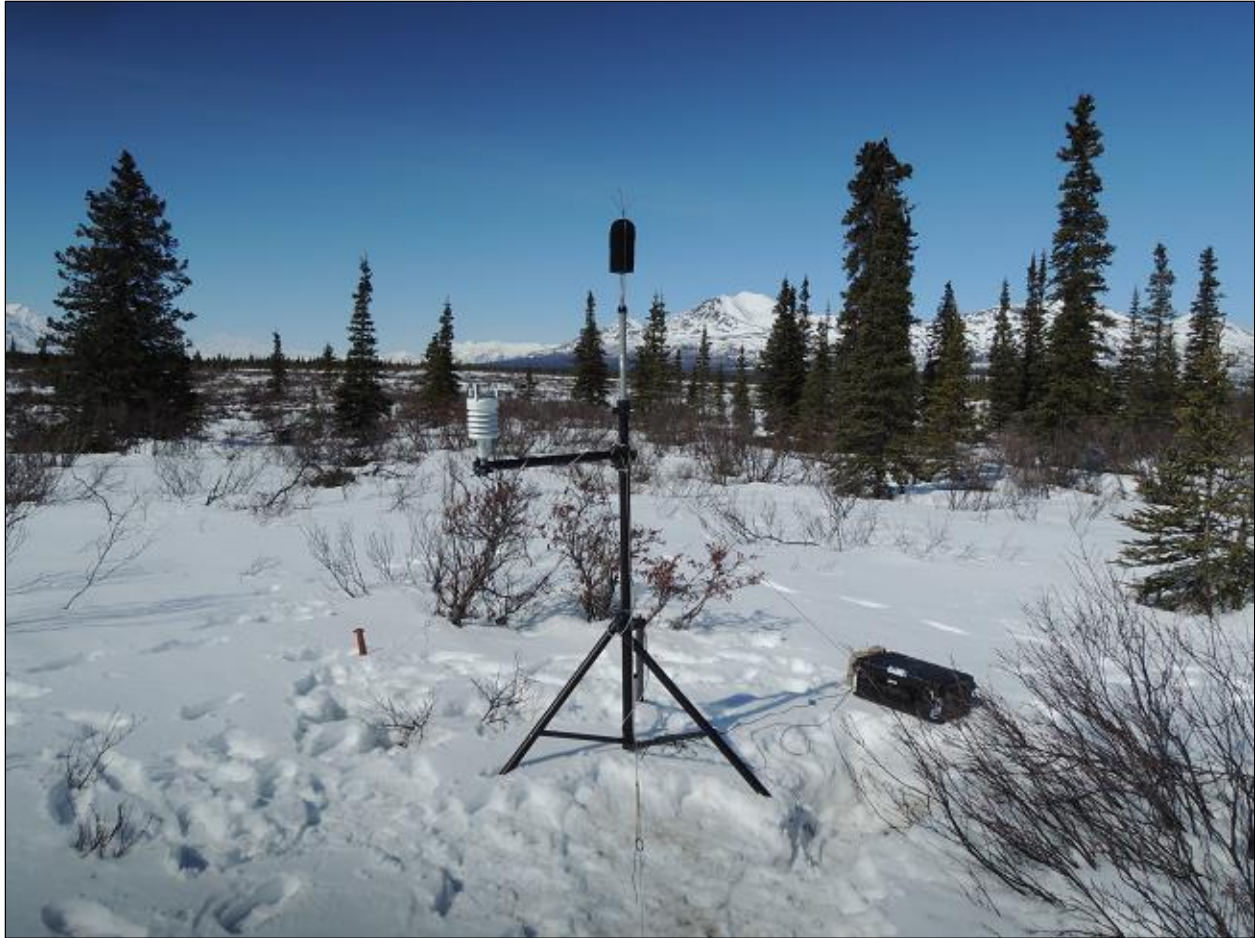
Figure 5-13. Photo of Long-Term Sound Monitor Spring LT7 Location

The Spring LT7 soundscape monitor was located along the Denali Highway, 0.5 mile south of the Nenana River, and 10.5 miles east of the Denali and Parks Highway intersection near Cantwell (Figure 5-13). The instrument was deployed on May 21, 2013. Data were collected from May 22 through May 25, 2013. Table 5-12 provides summary information on Spring LT7.

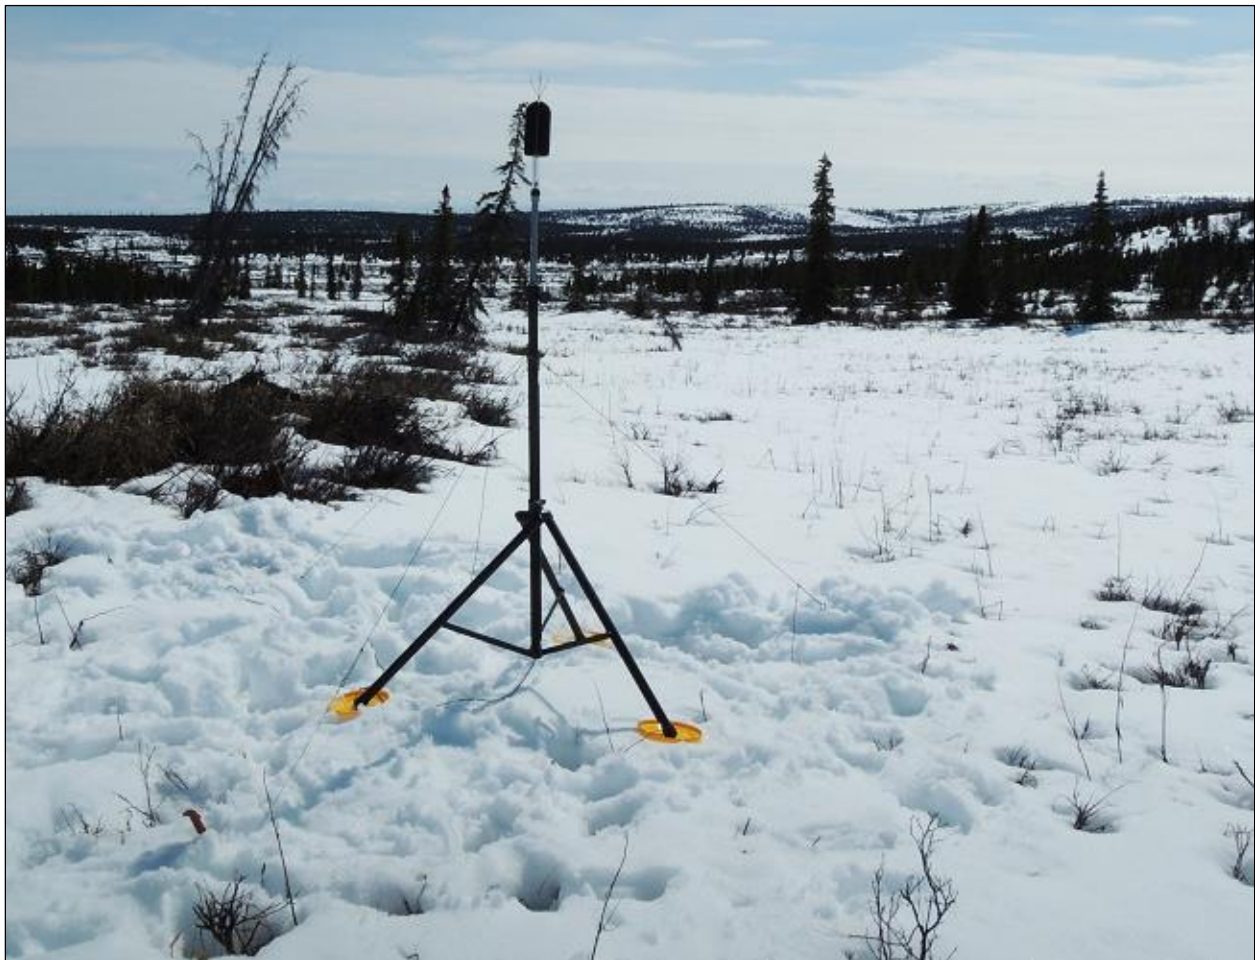
Figure 5-14. Photo of Long-Term Sound Monitor Spring LT9 Location

The Spring LT9 soundscape monitor was located approximately 1.5 miles south of the Susitna River (Figure 5-14). The instrument was deployed on May 23, 2013. Data were collected from May 24 through May 30. Table 5-13 provides summary information on Spring LT9.

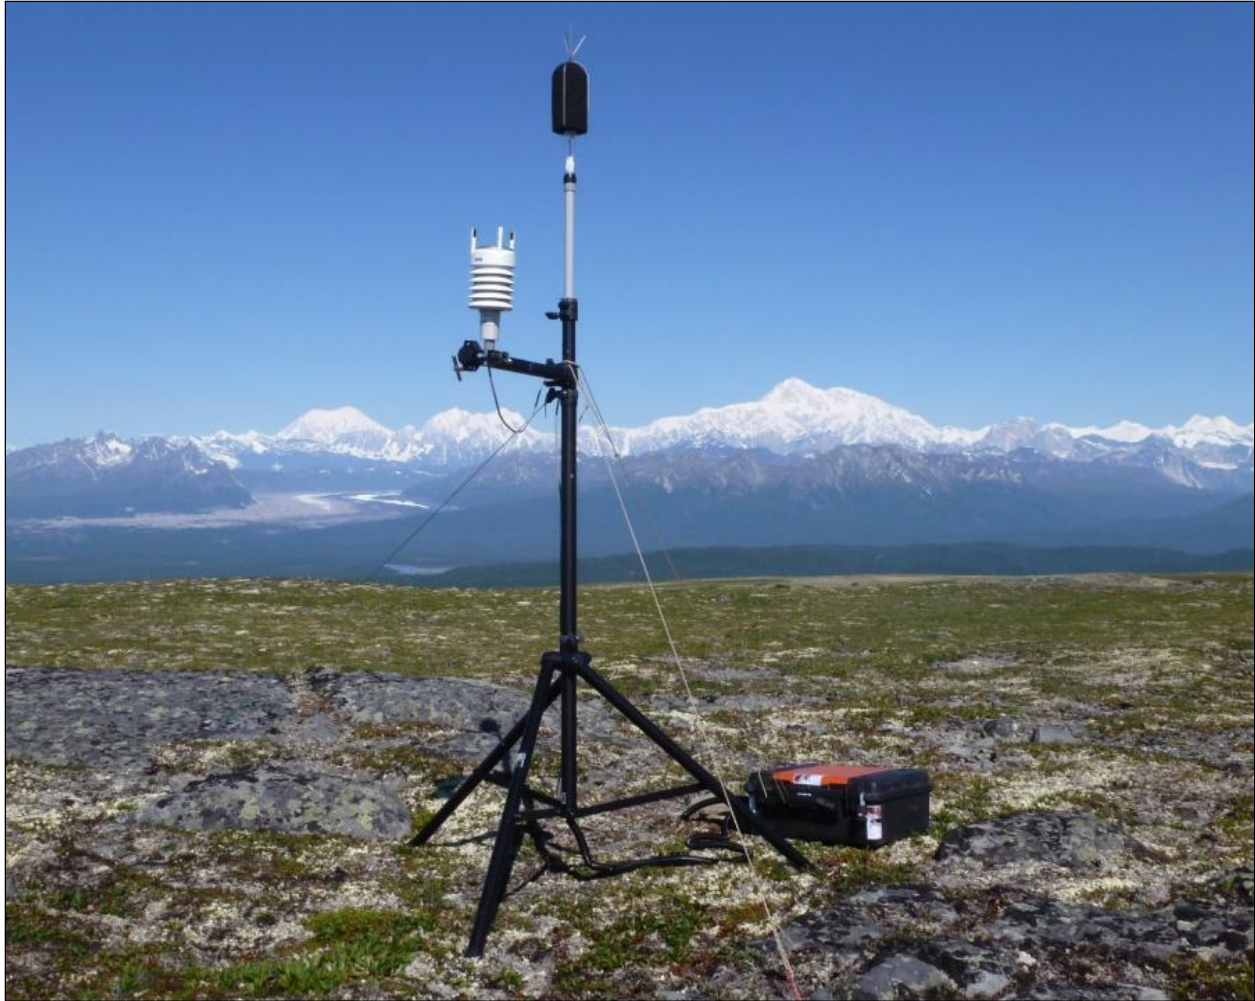
Figure 5-15. Photo of Long-Term Sound Monitor Summer LT1 Location

The Summer LT1 soundscape monitor was located approximately 4 miles east of the Parks Highway, approximately 2.25 miles northwest of the Susitna River and the Alaska Railroad (Figure 5-15). The instrument was deployed on July 12, 2013. Data were collected July 13 through 15 and July 17 and 18, 2013. Its position was located, and is only 35 feet west of the Spring LT1 monitoring position. Table 5-14 provides summary information on Summer LT1.

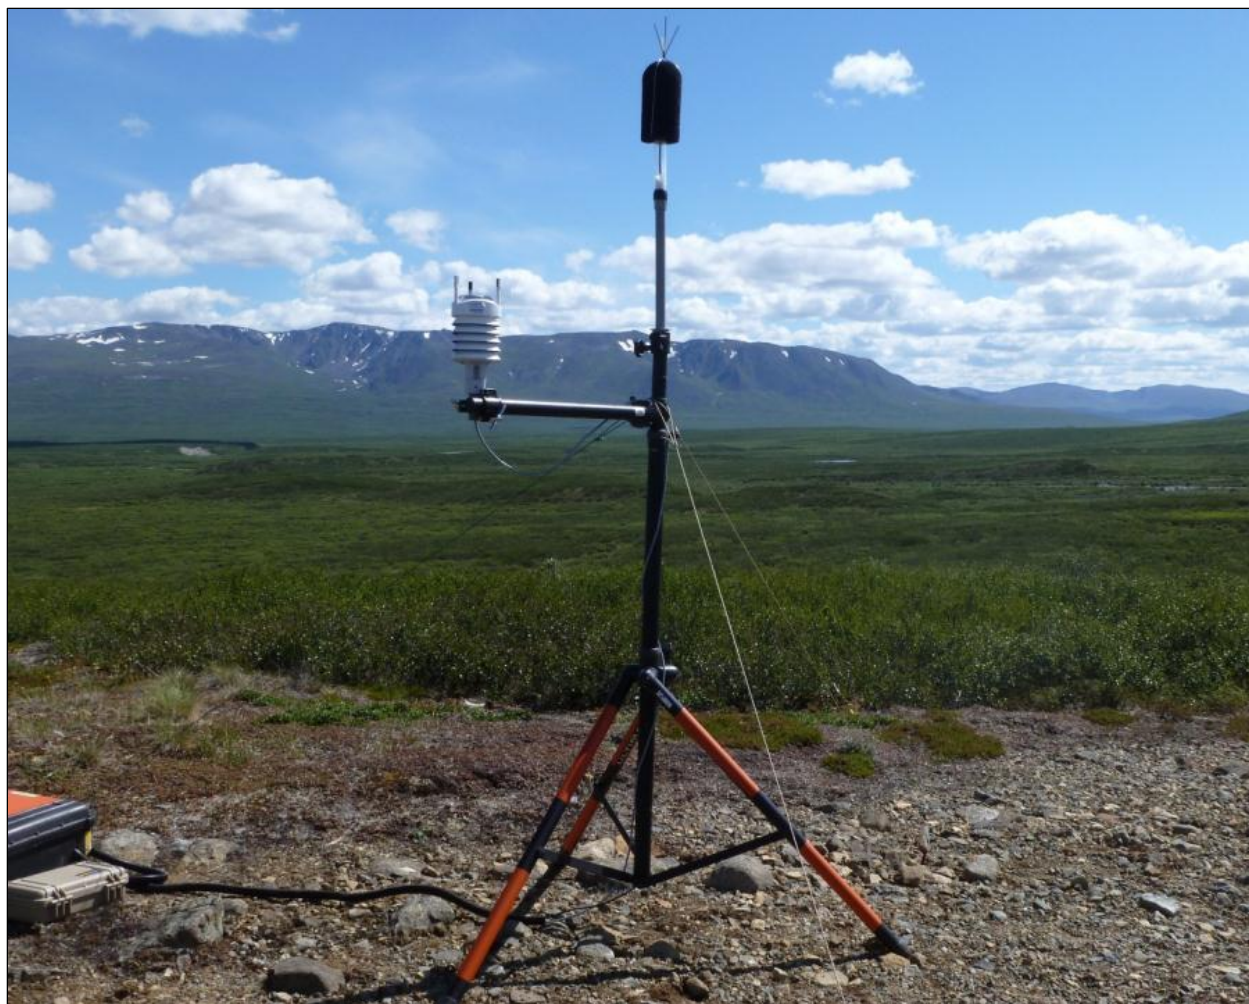
Figure 5-16. Photo of Long-Term Sound Monitor Summer LT3 Location

The Summer LT3 soundscape monitor was located approximately 8.5 miles southwest of the Denali Highway (Figure 5-16). The instrument was deployed on July 12, 2013. Data were recorded from July 13 through July 18, 2013. Table 5-15 provides summary information on Summer LT3.

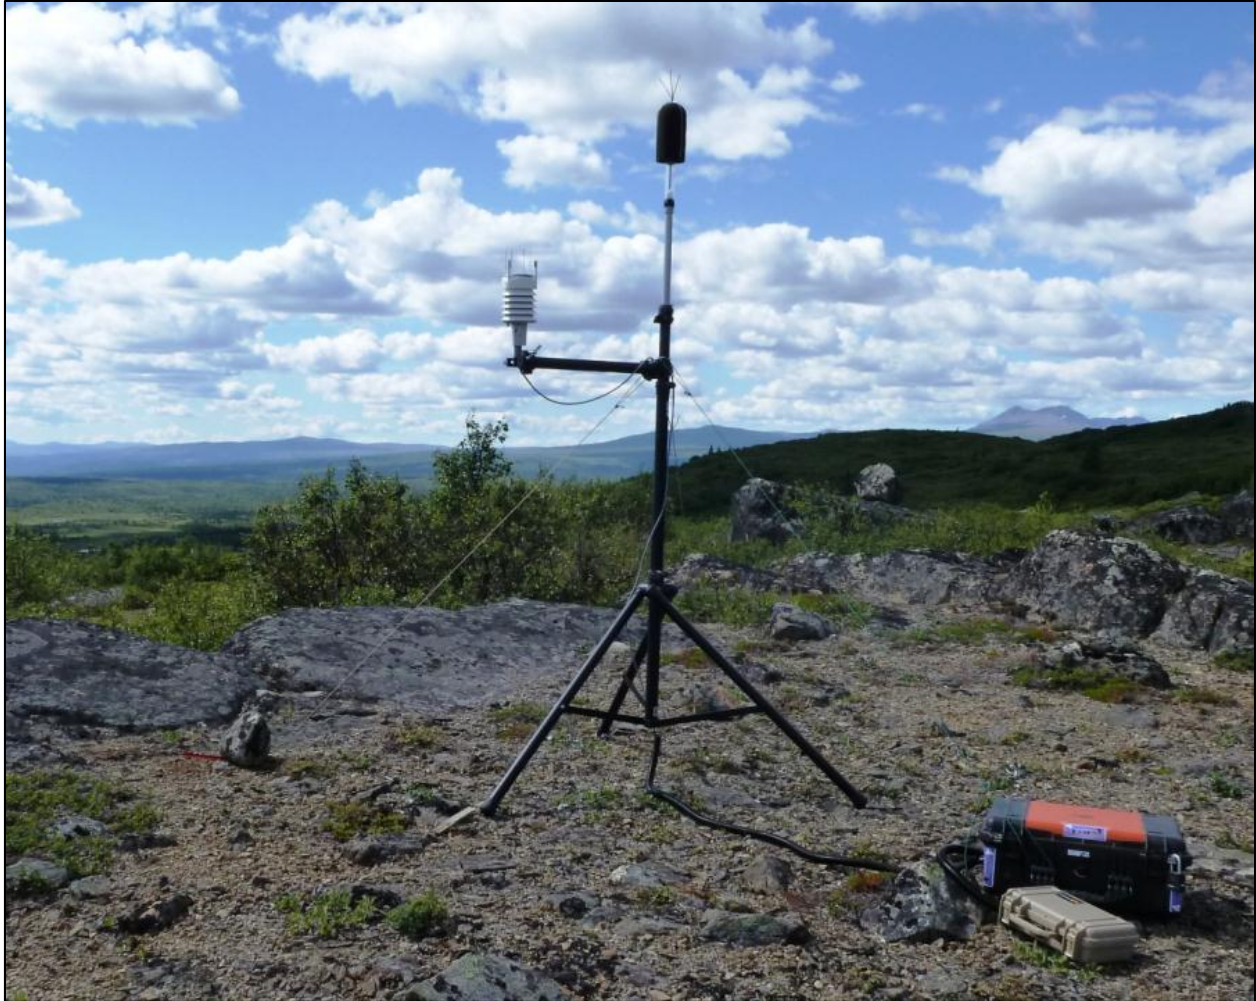
Figure 5-17. Photo of Long-Term Sound Monitor Summer LT4 Location

The Summer LT4 soundscape monitor was located approximately 3.3 miles north of the Susitna River (Figure 5-17). The instrument was deployed on July 12, 2013. Data were collected from July 13 to July 17, 2013. Table 5-16 provides summary information on Summer LT4.

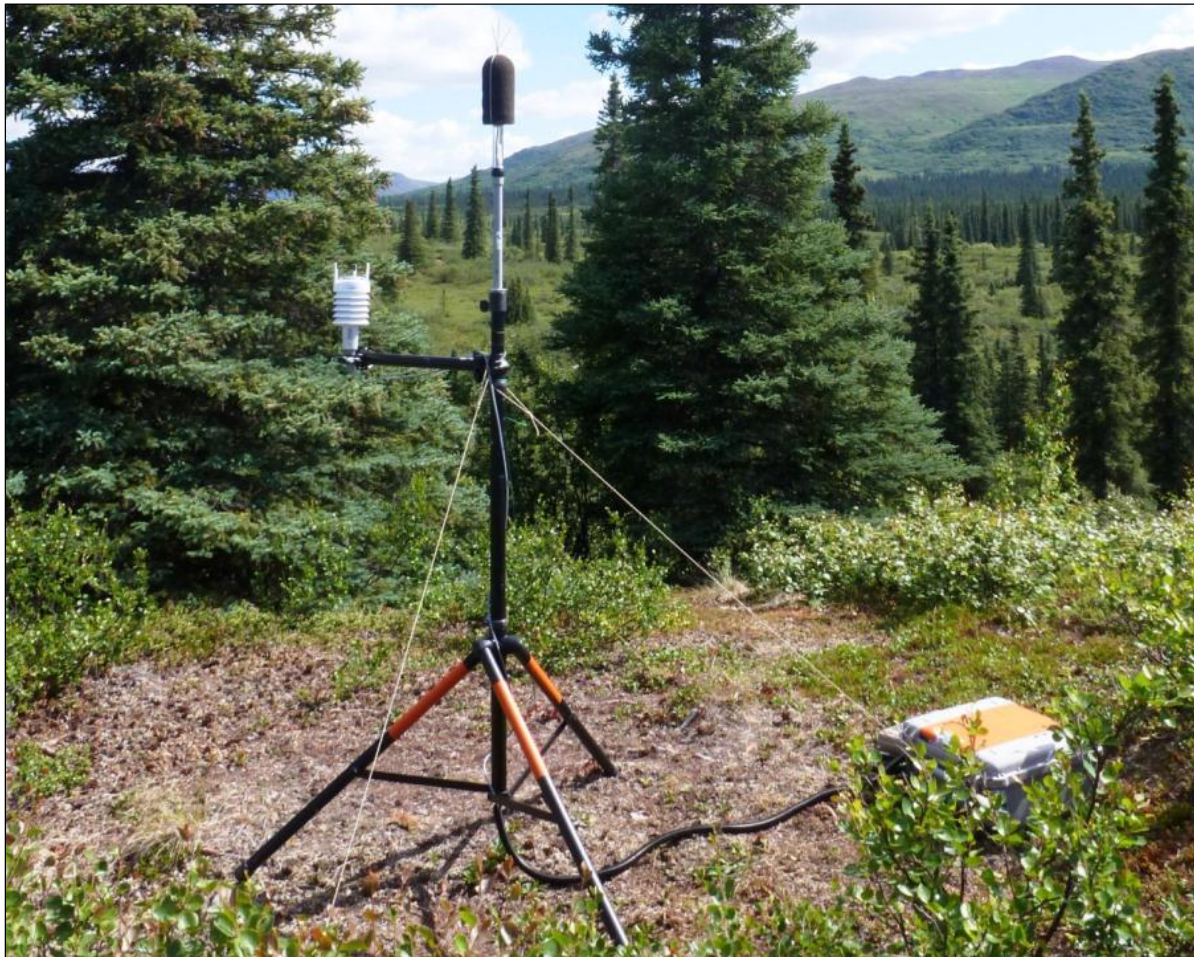
**Figure 5-18. Photo of Long-Term Sound Monitor Summer LT5 Location**

The Summer LT5 soundscape monitor was located approximately 4.25 miles south of the Susitna River (Figure 5-18). It was deployed on July 12, 2013. Data were collected from July 13 through 15 and July 17 through 19, 2013. Table 5-17 provides summary information on Summer LT5.

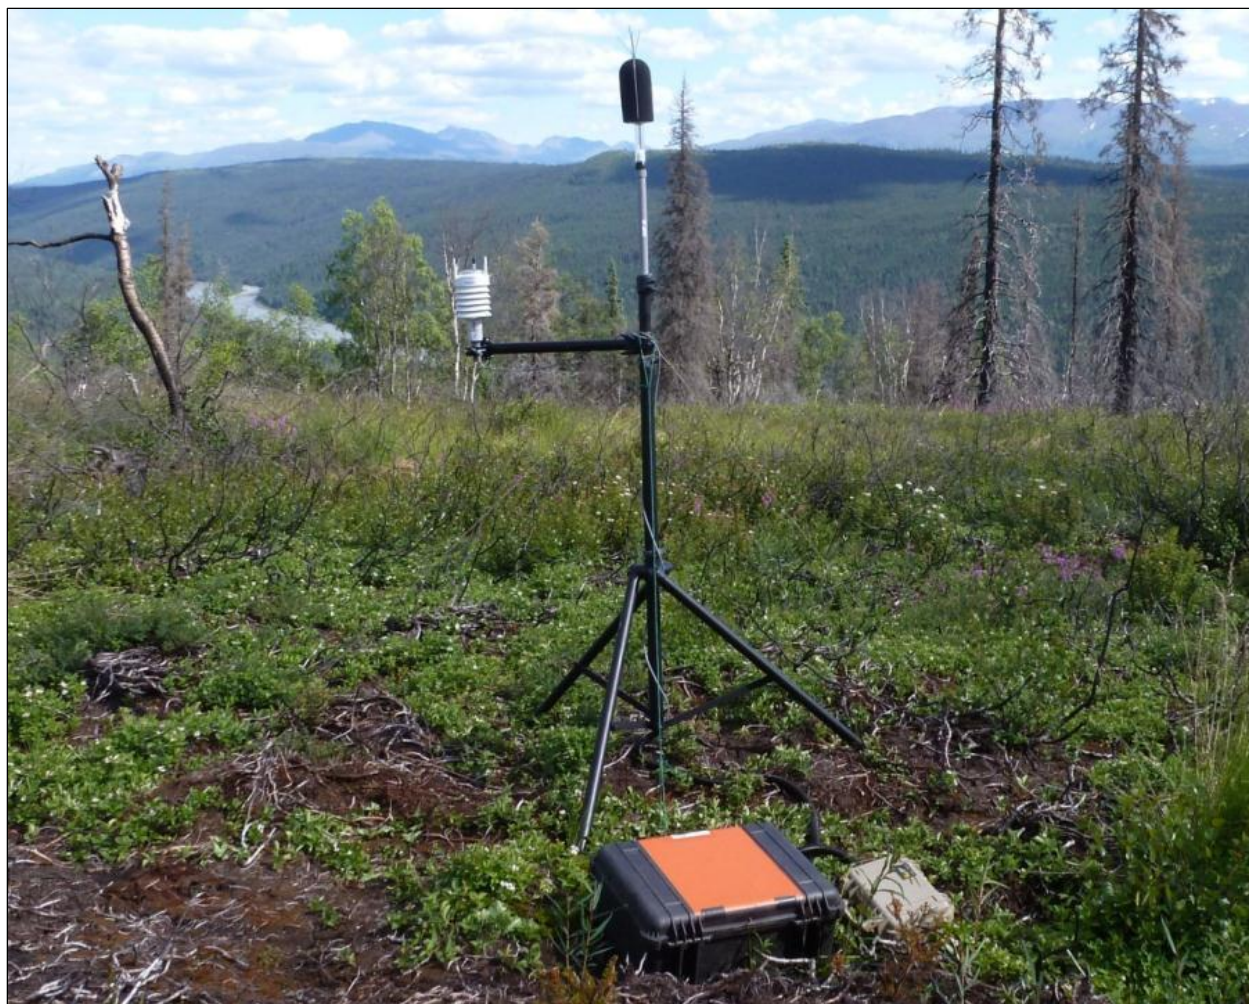
Figure 5-19. Photo of Long-Term Sound Monitor Summer LT6 Location

The Summer LT6 soundscape monitor was located approximately 1 mile northwest of the Susitna River (Figure 5-19). This location was 40 feet north of Spring LT5 and 0.25 miles east of Winter LT4. The monitor was deployed on July 12, 2013. Data were collected from July 13 through 15 and July 17, 2013. Table 5-18 provides summary information on Summer LT6.
