**Susitna-Watana Hydroelectric Project  
(FERC No. 14241)**

**Aesthetic Resources Study  
Study Plan Section 12.6**

**2014 Study Implementation Report**

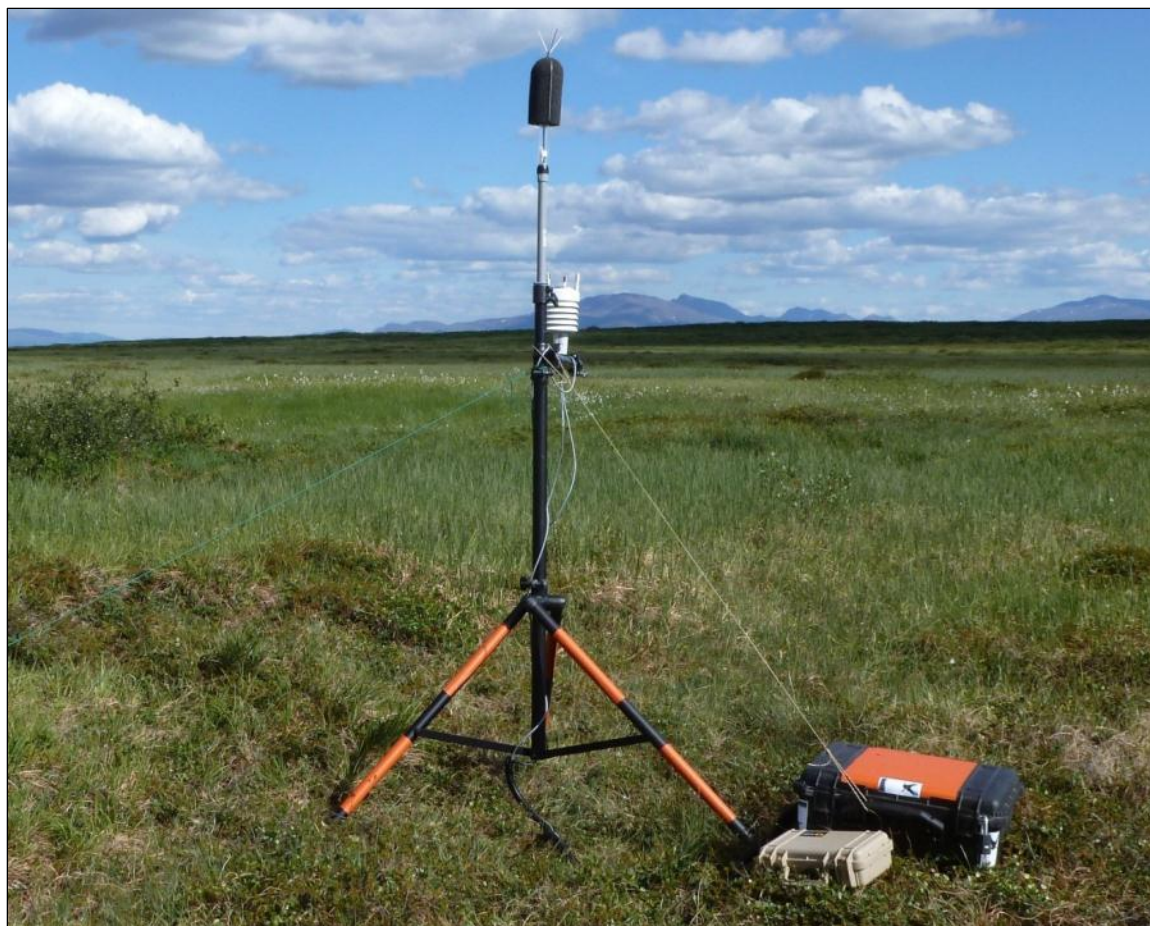
Figure 5-20. Photo of Long-Term Sound Monitor Summer LT7 Location

The Summer LT7 soundscape monitor was located on a hillside approximately 3.75 miles north of the Susitna River (Figure 5-20). The monitor was deployed on July 12, 2013. Data were collected from July 13 through July 18, 2013. Table 5-19 provides summary information on Summer LT7.

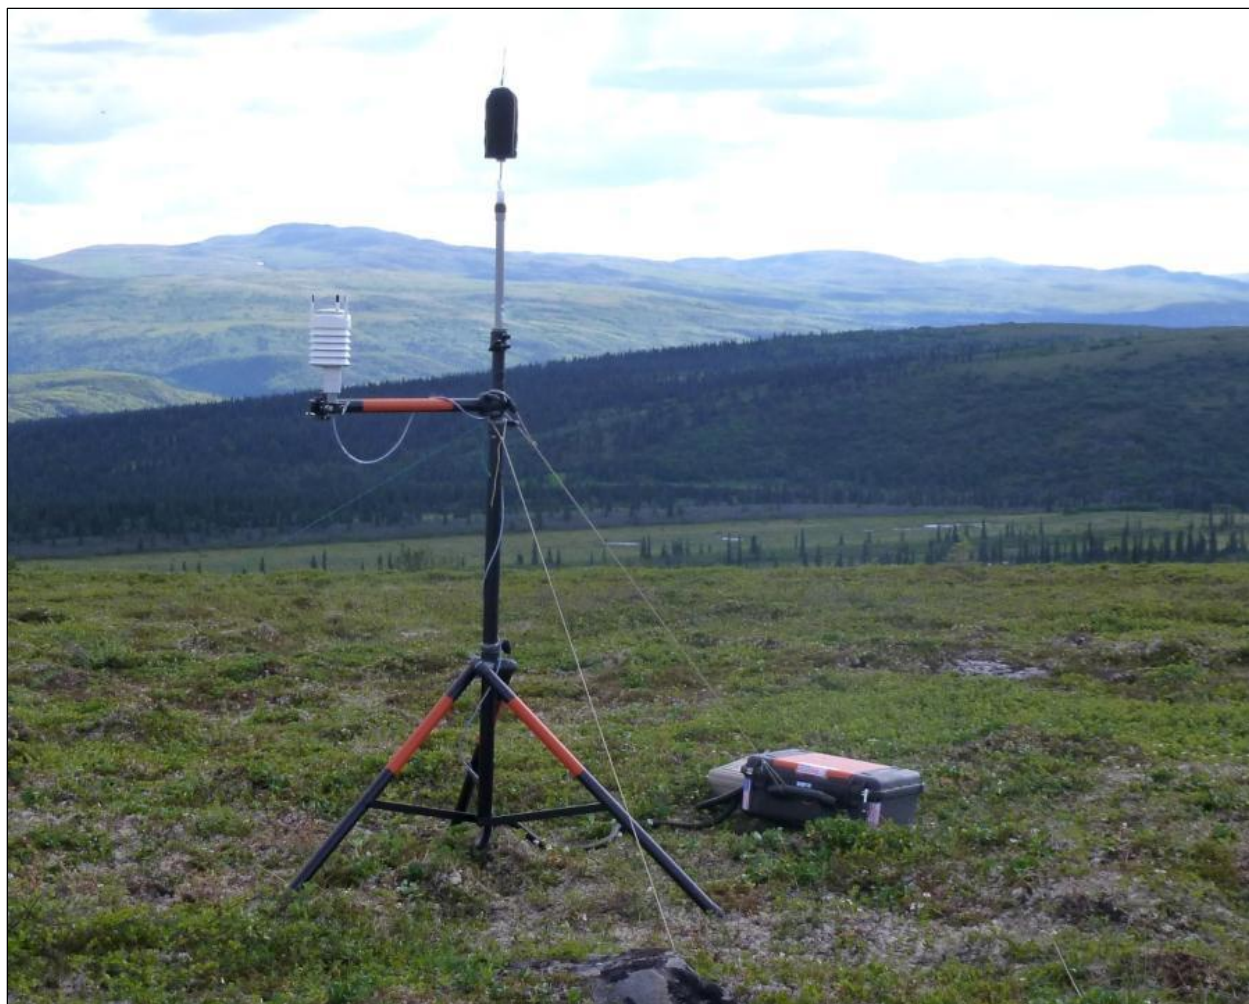
Figure 5-21. Photo of Long-Term Sound Monitor Summer LT8 Location

The Summer LT8 soundscape monitor was located approximately 2 miles north of the Susitna River (Figure 5-21). This location was 250 feet west of Winter LT5 and 0.8 miles northeast of Spring LT4. The monitor was deployed on July 12, 2013. Data were collected from July 13 through 15 and July 17 through 19, 2013. Table 5-20 provides summary information on Summer LT8.

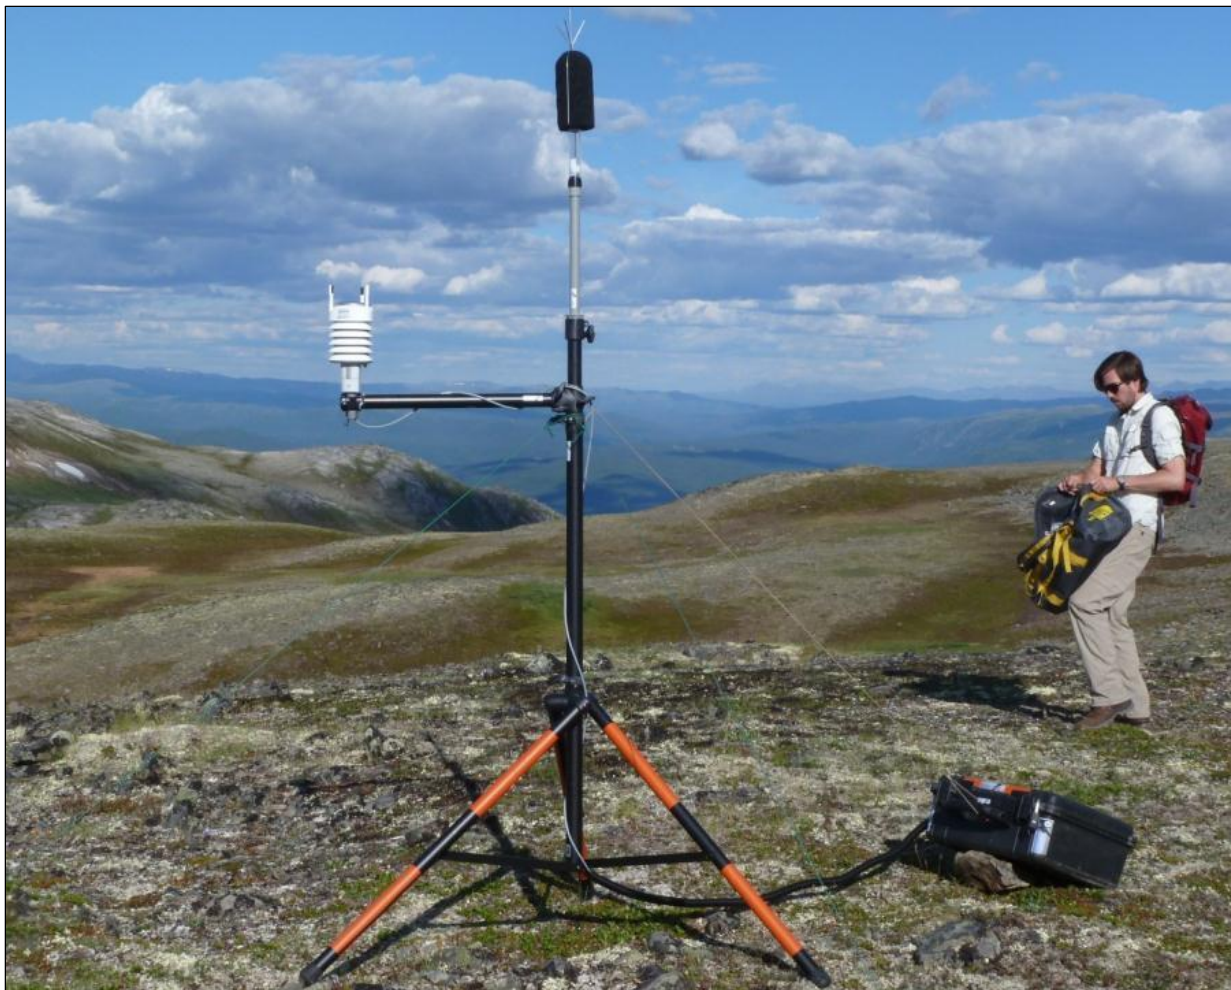
**Figure 5-22. Photo of Long-Term Sound Monitor Summer LT9 Location**

The Summer LT9 soundscape monitor was located approximately 3.75 miles northwest of the Susitna River (Figure 5-22). This location was 0.25 miles northwest of Spring LT3. The monitor was deployed on July 12, 2013. Data were collected from July 13 through July 13 through 15 and July 17, 2013. Table 5-21 provides summary information on Summer LT9.

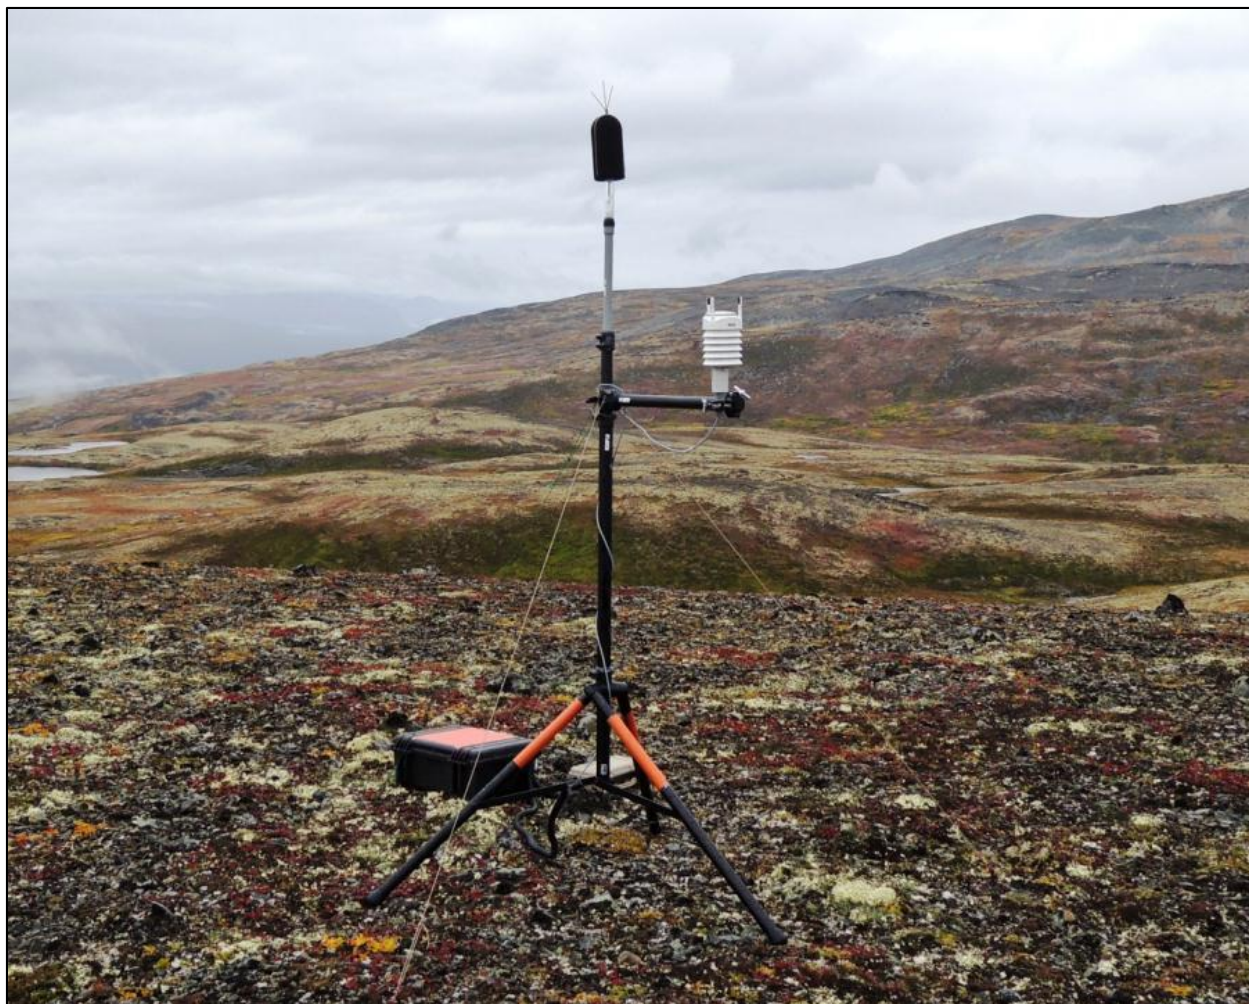
Figure 5-23. Photo of Long-Term Sound Monitor Fall LT1 Location

The Fall LT1 soundscape monitor was located 3.75 miles northwest of the Susitna River and 4.25 miles south of the Parks Highway (Figure 5-23). The monitor was deployed on September 7, 2013. Data were collected on September 8, 2013. Table 5-22 provides summary information on Fall LT1.

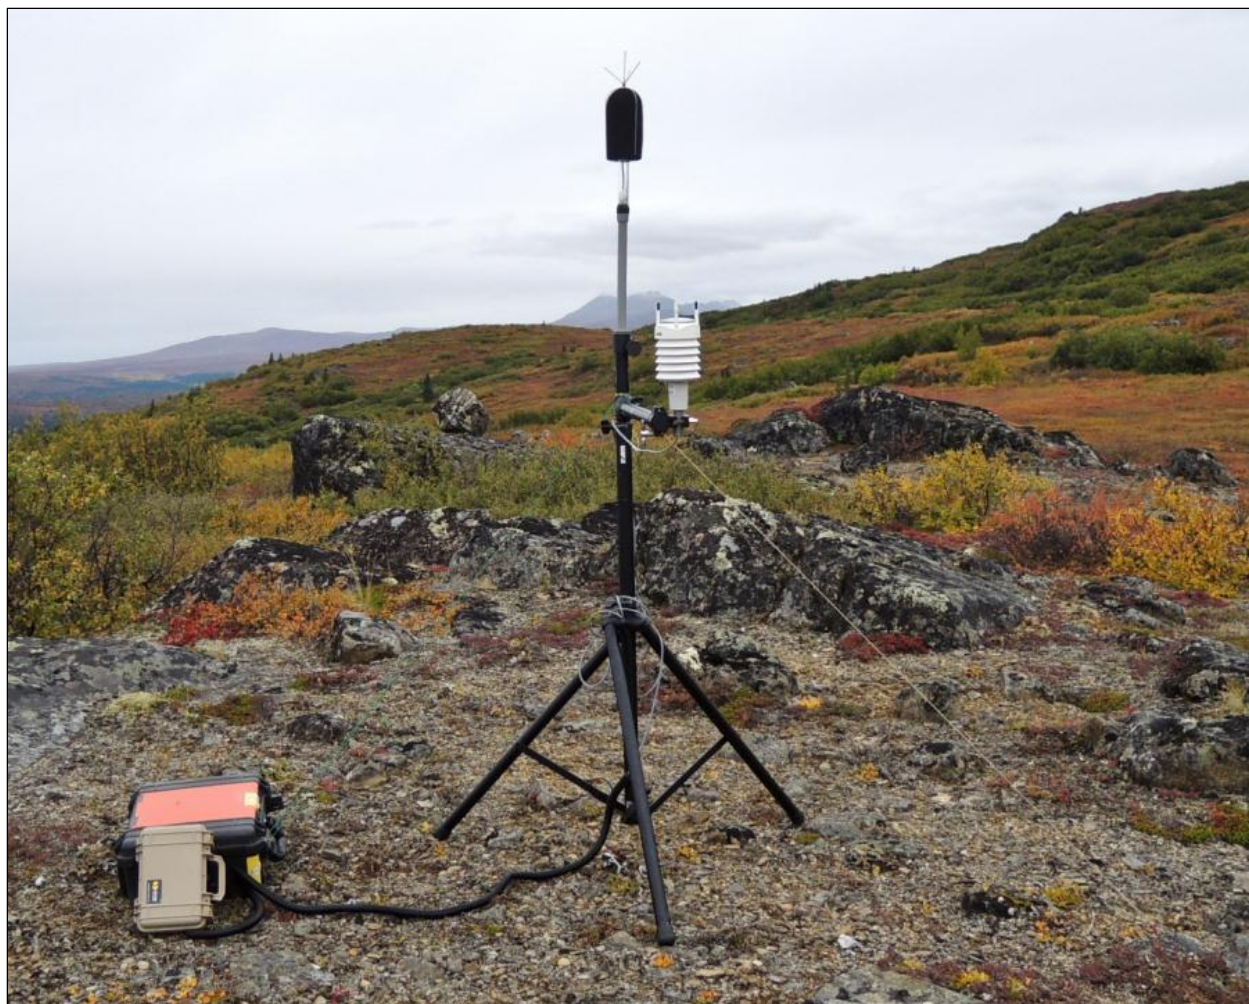
Figure 5-25. Photo of Long-Term Sound Monitor Fall LT3 Location

The Fall LT3 soundscape monitor was located 3.3 miles north of the Susitna River, in the same location as Summer LT4 (Figure 5-25). The monitor was deployed on September 7, 2013. Data were collected on September 8, 2013. Table 5-24 provides summary information on Fall LT3.

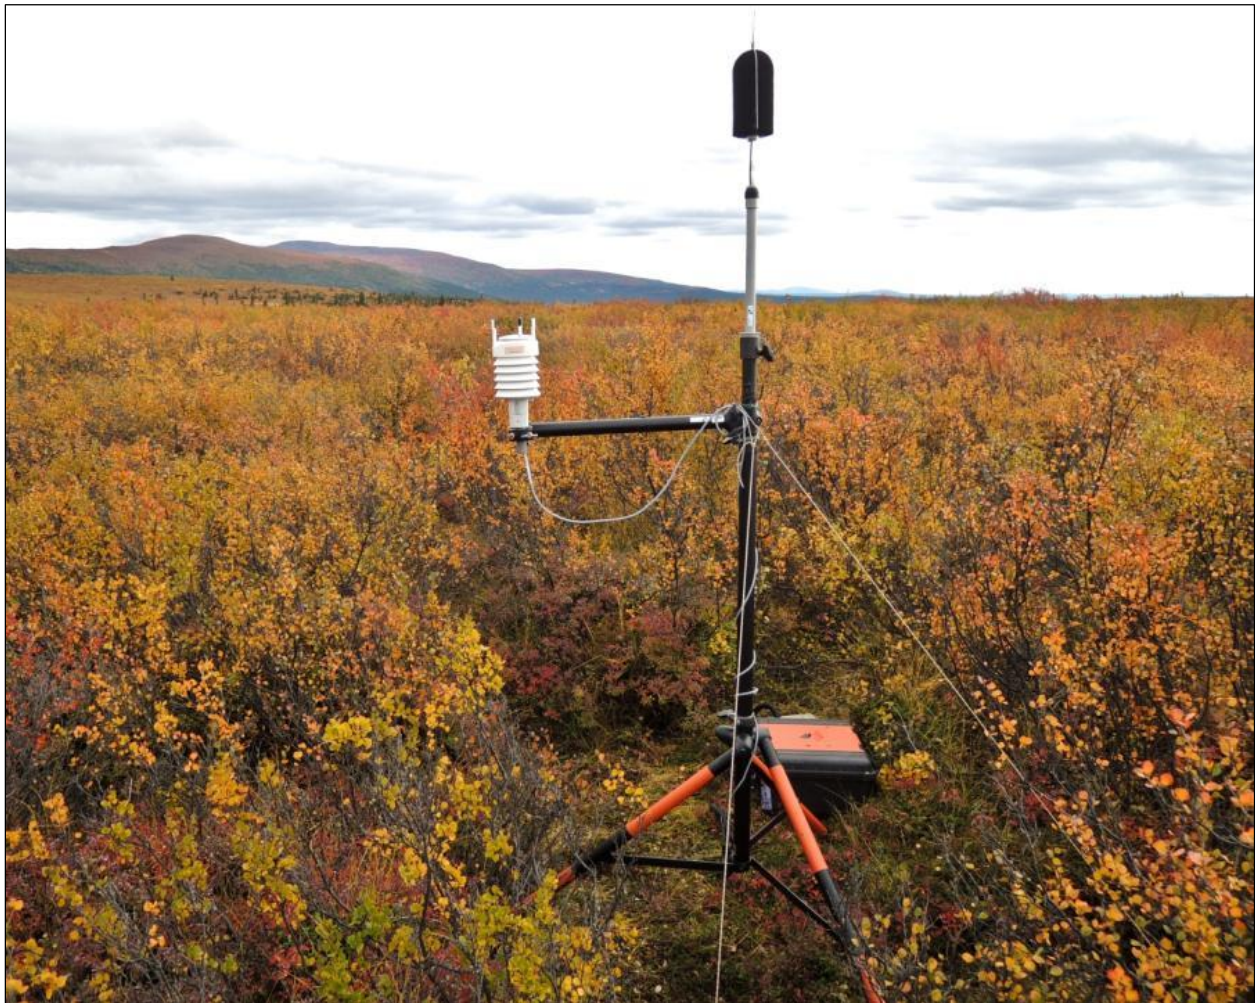
Figure 5-26. Photo of Long-Term Sound Monitor Fall LT4 Location

The Fall LT4 soundscape monitor was located 1 mile north of the Susitna River (Figure 5-26). The monitor was deployed on September 7, 2013. Data were collected on September 8, 2013. Table 5-25 provides summary information on Fall LT4.

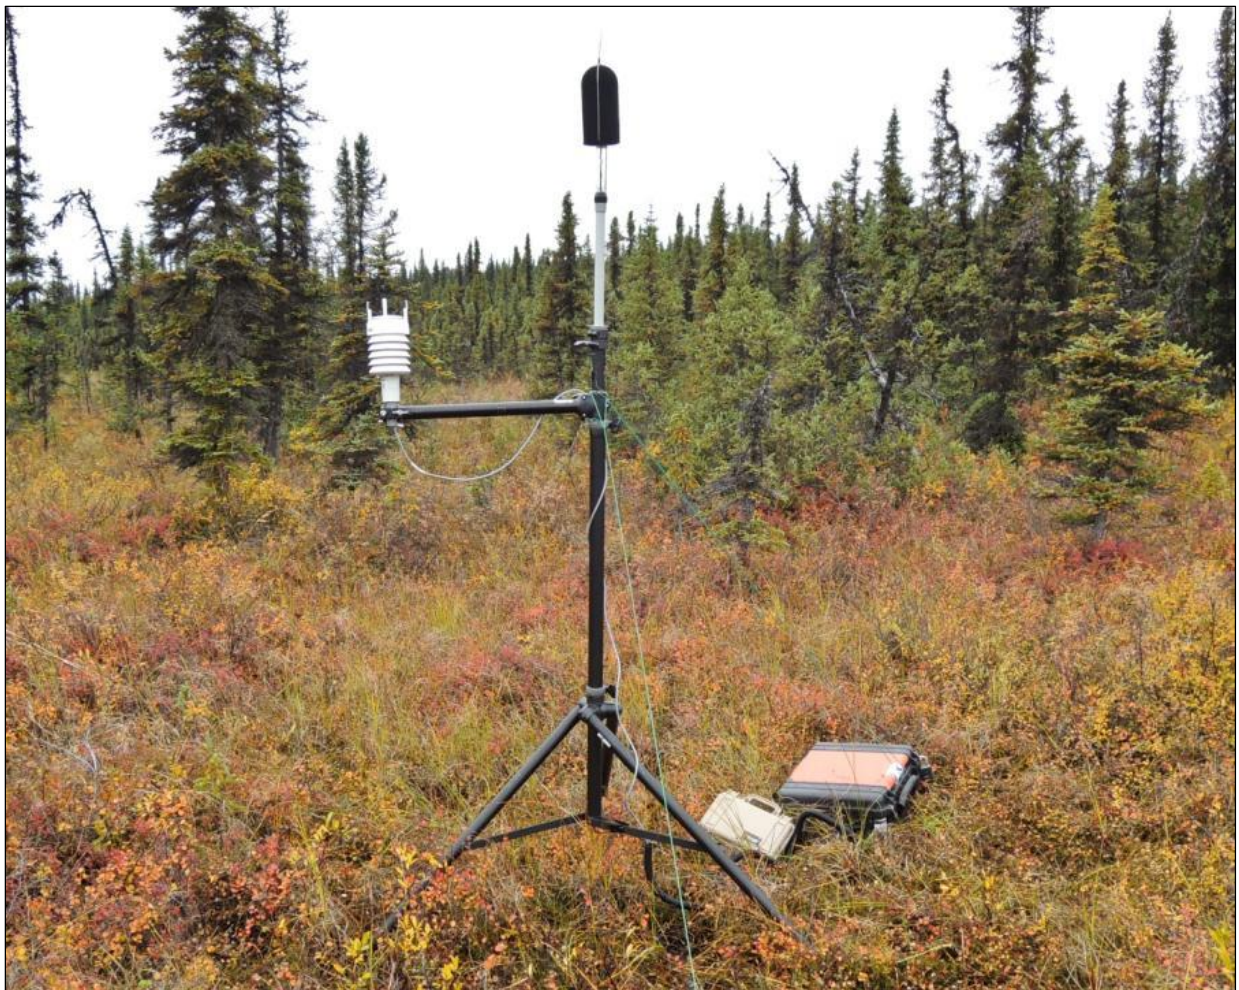
Figure 5-28. Photo of Long-Term Sound Monitor Fall LT7 Location

The Fall LT7 soundscape monitor was located approximately 0.75 mile northwest of the Susitna River (Figure 5-28). The monitor was deployed on September 7, 2013. Data were collected from September 8 through September 13, 2013. Table 5-27 provides summary information on Fall LT7.

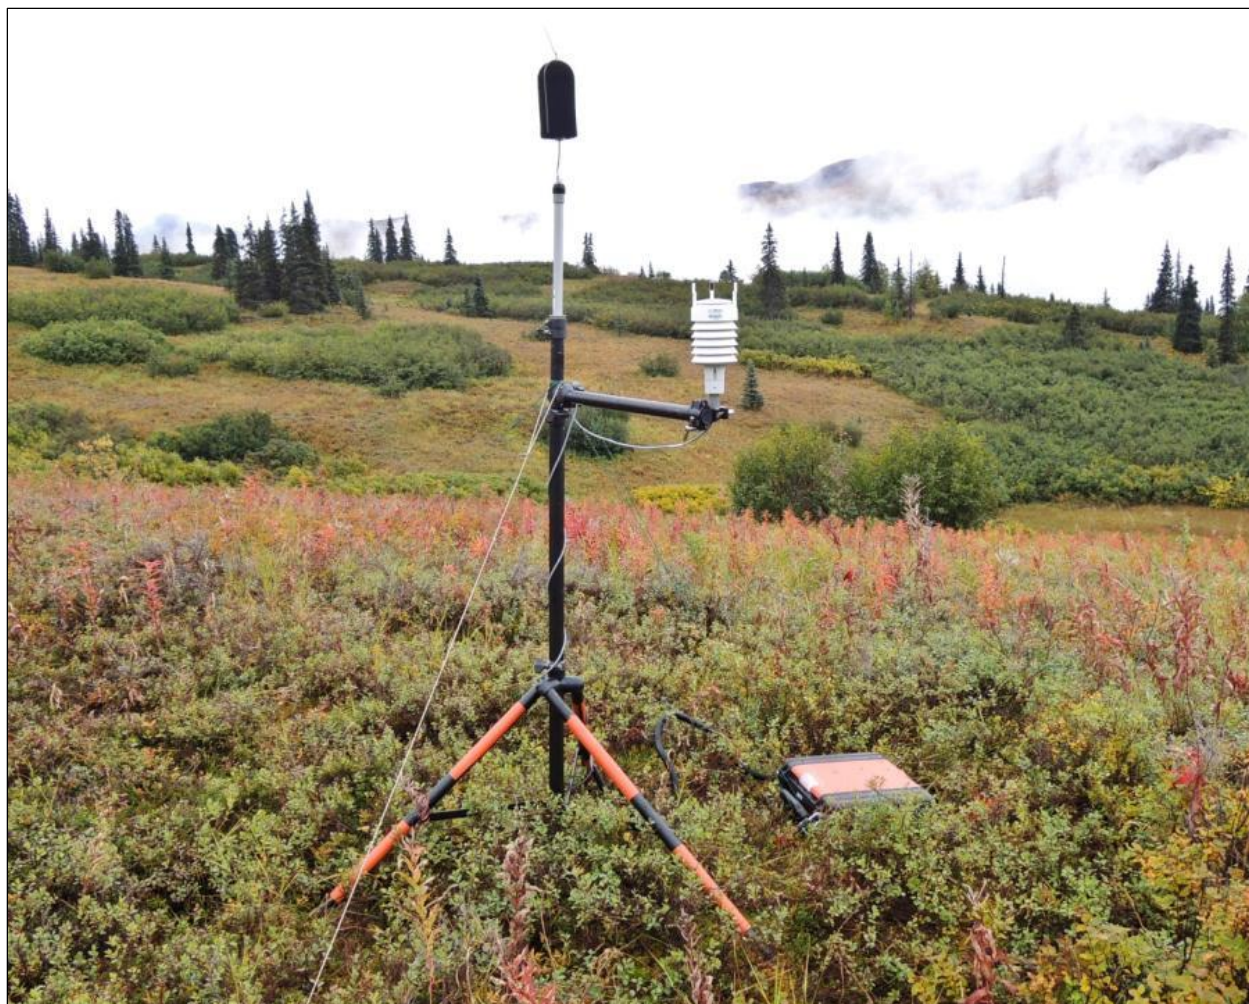
Figure 5-29. Photo of Long-Term Sound Monitor Fall LT8 Location

The Fall LT8 soundscape monitor was located approximately 8.75 miles north of the Susitna River (Figure 5-29). The monitor was deployed on September 7, 2013. Data were collected on September 8, 9, and 11, 2013. Table 5-28 provides summary information on Fall LT8.

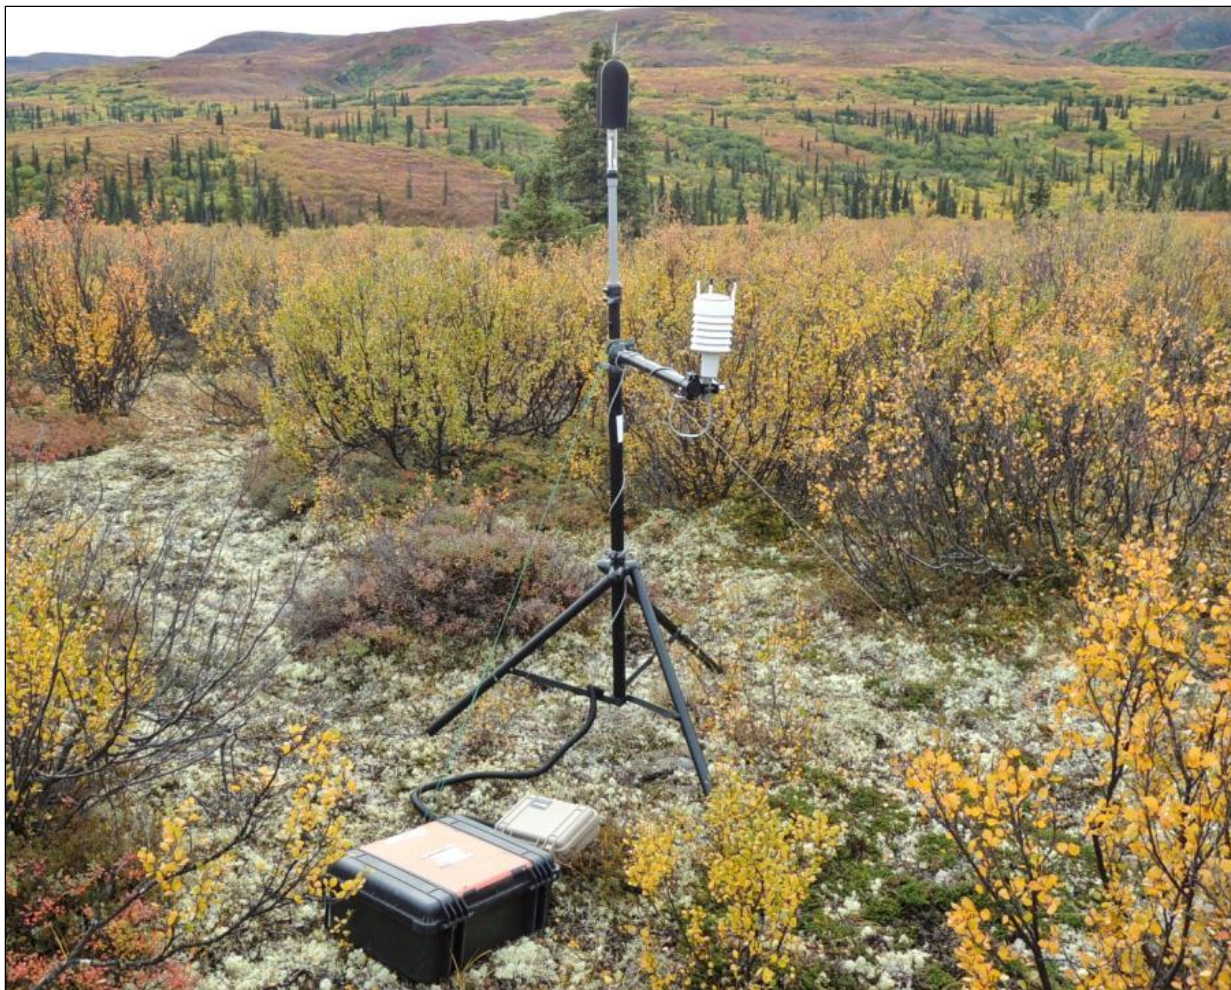
Figure 5-30. Photo of Long-Term Sound Monitor Fall LT9 Location

The Fall LT9 soundscape monitor was located approximately 0.25 mile south of the Denali Highway (Figure 5-30). The monitor was deployed on September 7, 2013. Data were collected on September 8, 9, 11, and 12, 2013. Table 5-29 provides summary information on Fall LT9.
