**Susitna-Watana Hydroelectric Project  
(FERC No. 14241)**

**2012 Susitna River Water Temperature and  
Meteorological Field Study**

**Appendix A**

## APPENDIX A: PHOTOGRAPHS AND SITE INFORMATION

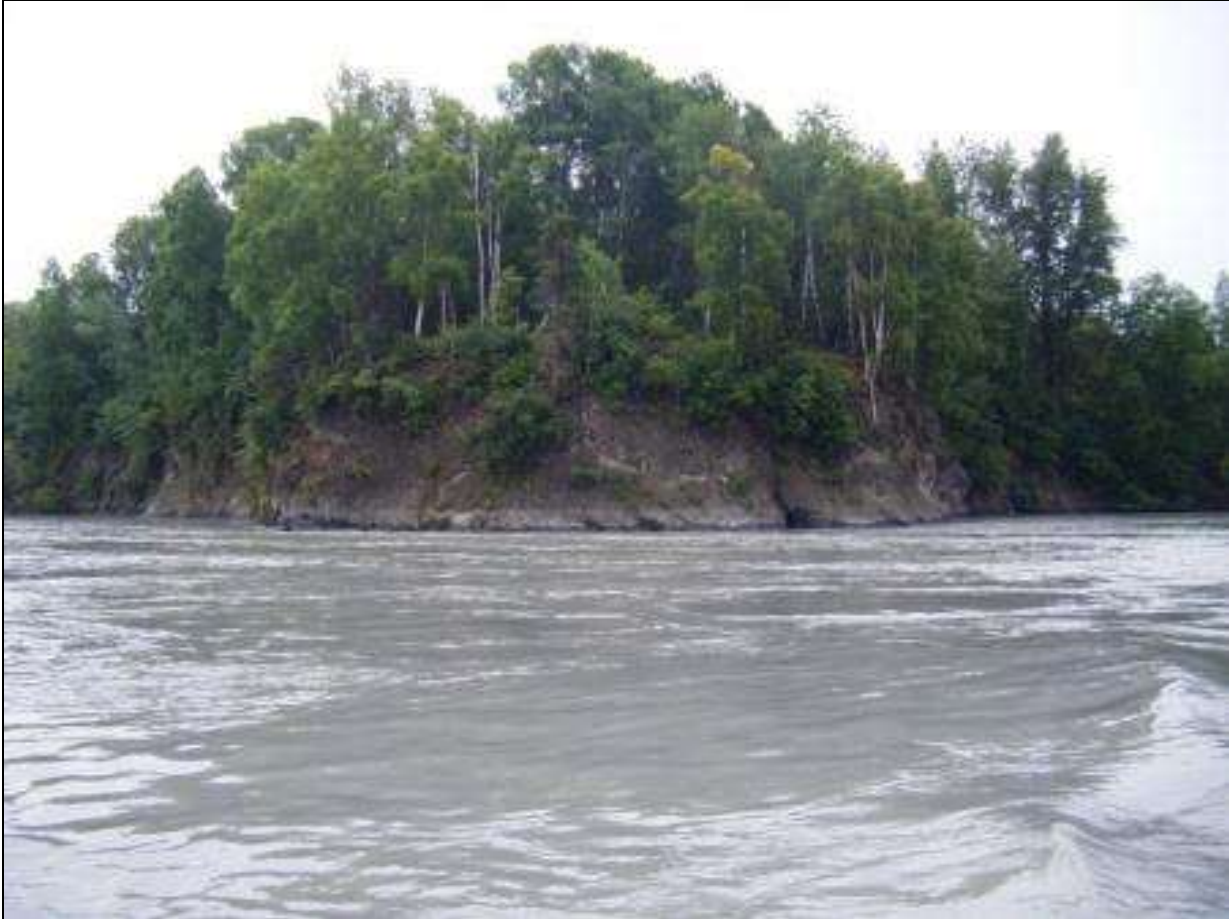
Proposed location for RM 25.8 – Susitna River at Susitna Station

The anchor-and-buoy installation method is not feasible at this location. Swift current from around the point presented a boating hazard and safe entry into the proposed area was compromised, as well, retrieval of the monitoring equipment was prohibitive. Establishing apparatus for bank installations and for the buoy system was not possible given conditions observed once reaching the site. Alternate equipment for deployment of the temperature probes might include a larger buoy that maintains a position above the water surface. Preliminary depth readings at the site showed the area was deep (~36 feet). The bank at the point was high (~20 feet) and unstable and access to an anchoring point (tree) from the river bank was unsafe. Access appeared to also be an issue from any point other than directly from the river.

If the monitoring location is deemed crucial to the 2013-2014 baseline water quality study, an alternative buoy system would be required here. Alternatively, the site could be moved up or downstream at a safer and more accessible location for continuous monitoring equipment installation.

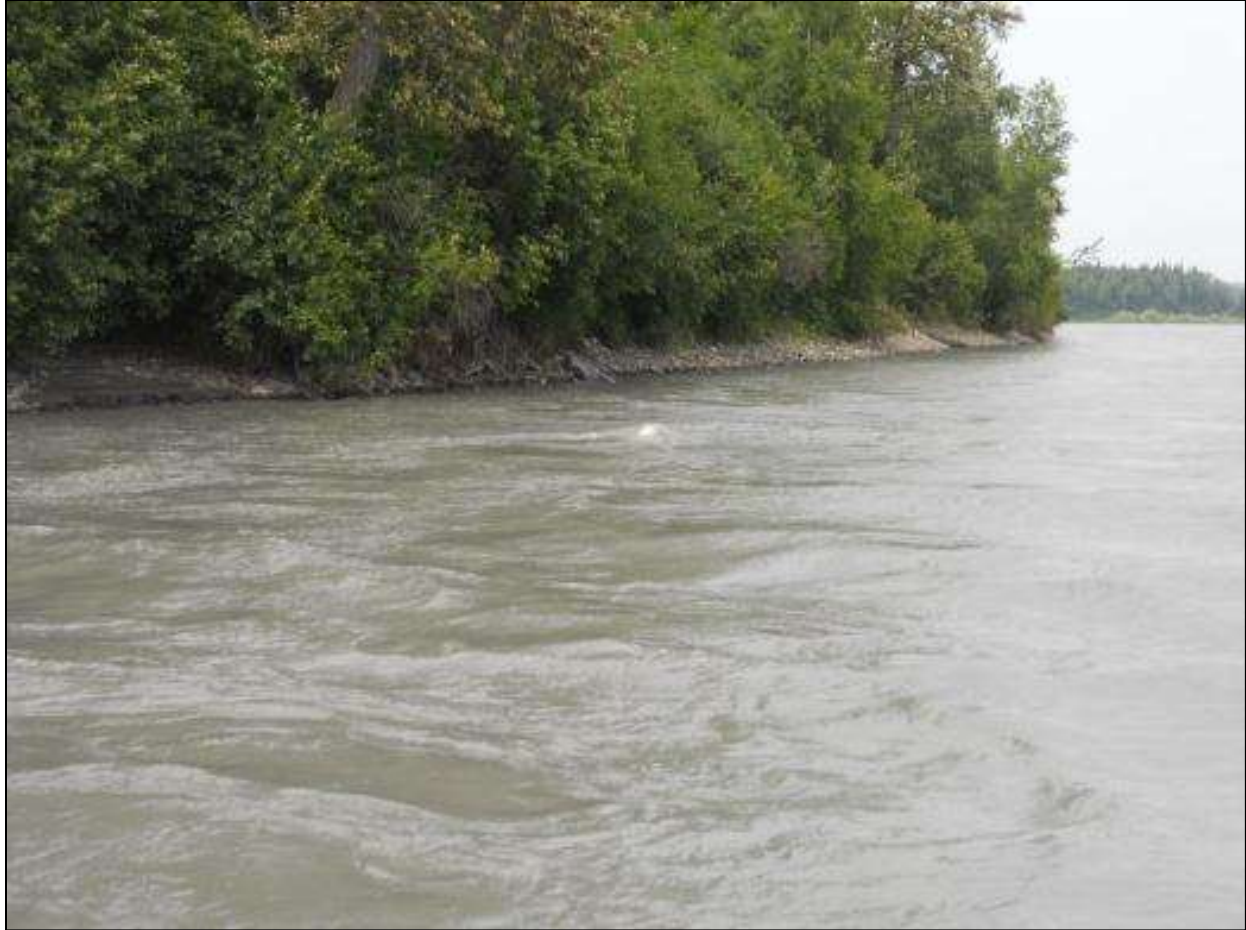
Buoy System at RM 83.9- Susitna at Parks Highway West

**September 28, 2012** – Buoy was pushed to bank, tidbits still in 1 foot of water. Data downloads complete at 12:30 ADT.

**October 16, 2012** – Downloaded at 15:15 ADT and removed summer buoy string with multiple data loggers. Replaced with winter, single data logger system (data logger # 10174230). Downloaded pipe system at 15:15 ADT.

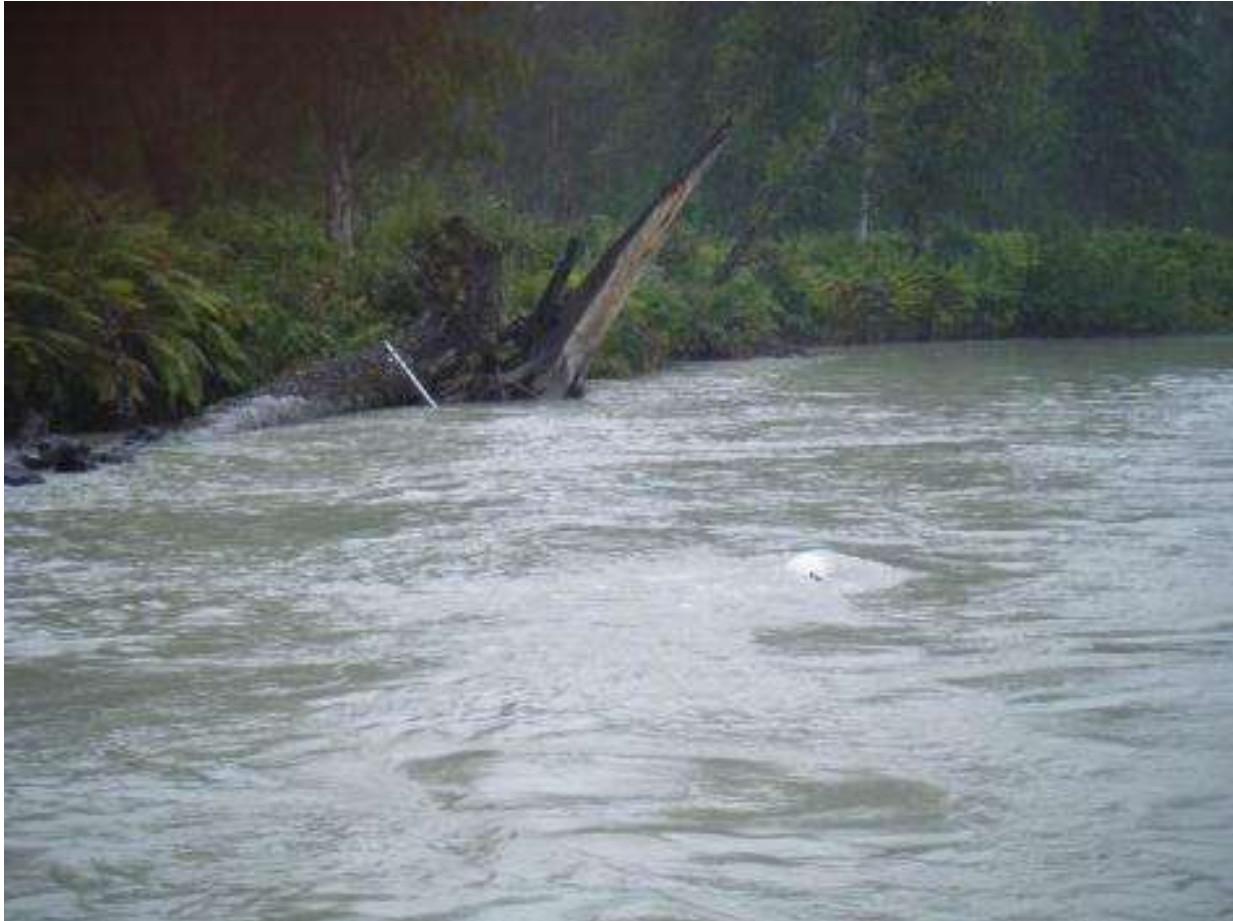
Buoy and Pipe System at RM 97.2 – Talkeetna River

**September 28, 2012** – System was gone, bank washed out buoy and pipe installation gone. Bank cut 10 plus feet.

**October 15, 2012** – Installed winter buoy system at location of original deployment.

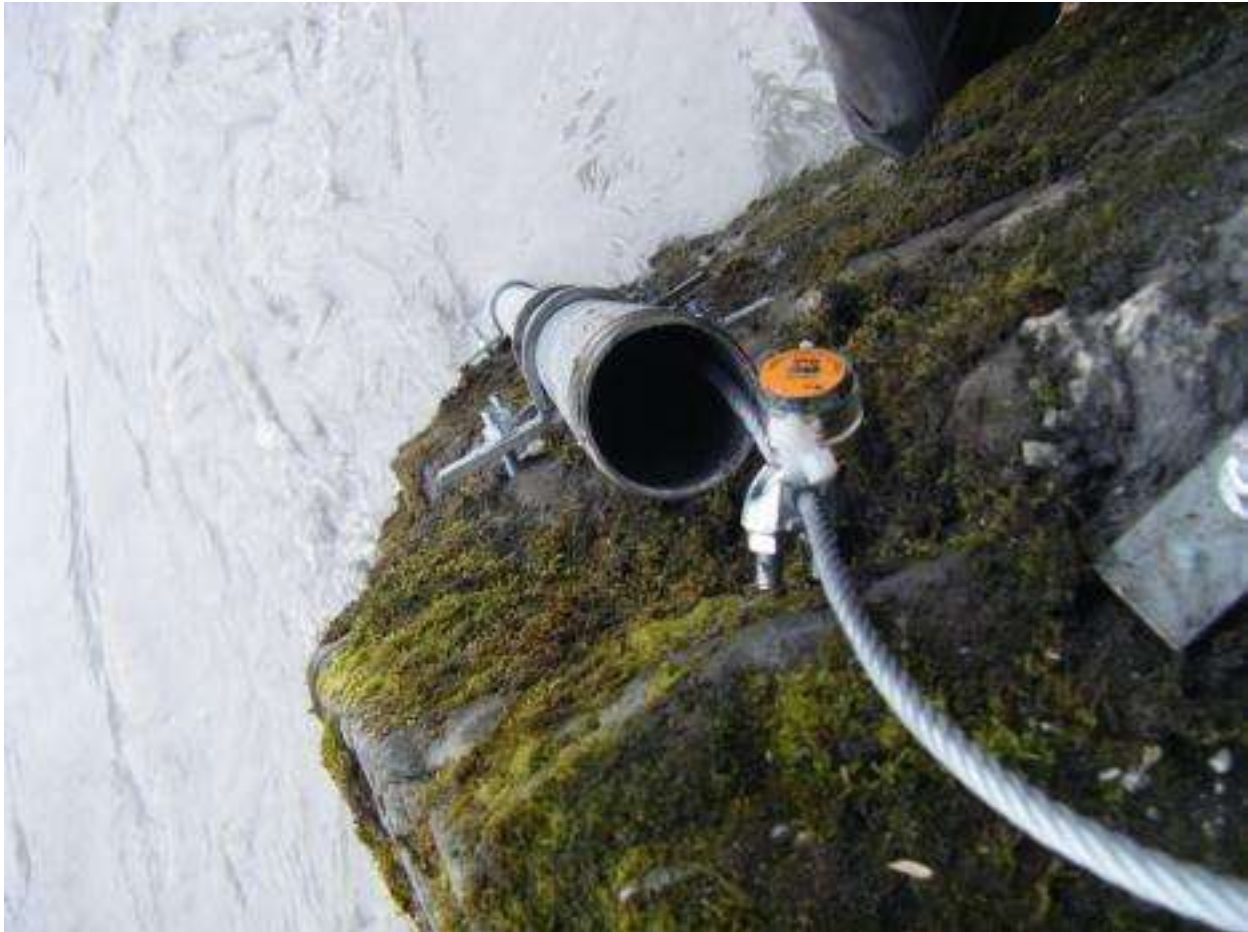
Pipe Mounted at RM 98.1 – Chulitna River

**October 17, 2012** – Both systems downloaded at 13:15 ADT. Sensor 10174257 is missing and likely lost. Buoy system had moved up against shore due to flooding. Upper thermistor in pipe was out of water and incased in frozen silt. Lower thermistor was in approx. 1 foot of water. Additional 7 foot section of pipe added to pipe setup (20 inches) and cable lengthened to 18 feet). Summer buoy system was removed and replaced with single data logger winter system.

The housing pipe was fastened to a rock with three pipe brackets and lag bolts slightly upstream of the buoy. The pipe houses 13 feet of cable with thermistors attached to the cable along intervals. One thermistor was mounted to the cap at the end of the pipe in the river. The top two thermistors have been exposed to air over the course of this study- use 4180 for the permanent record.

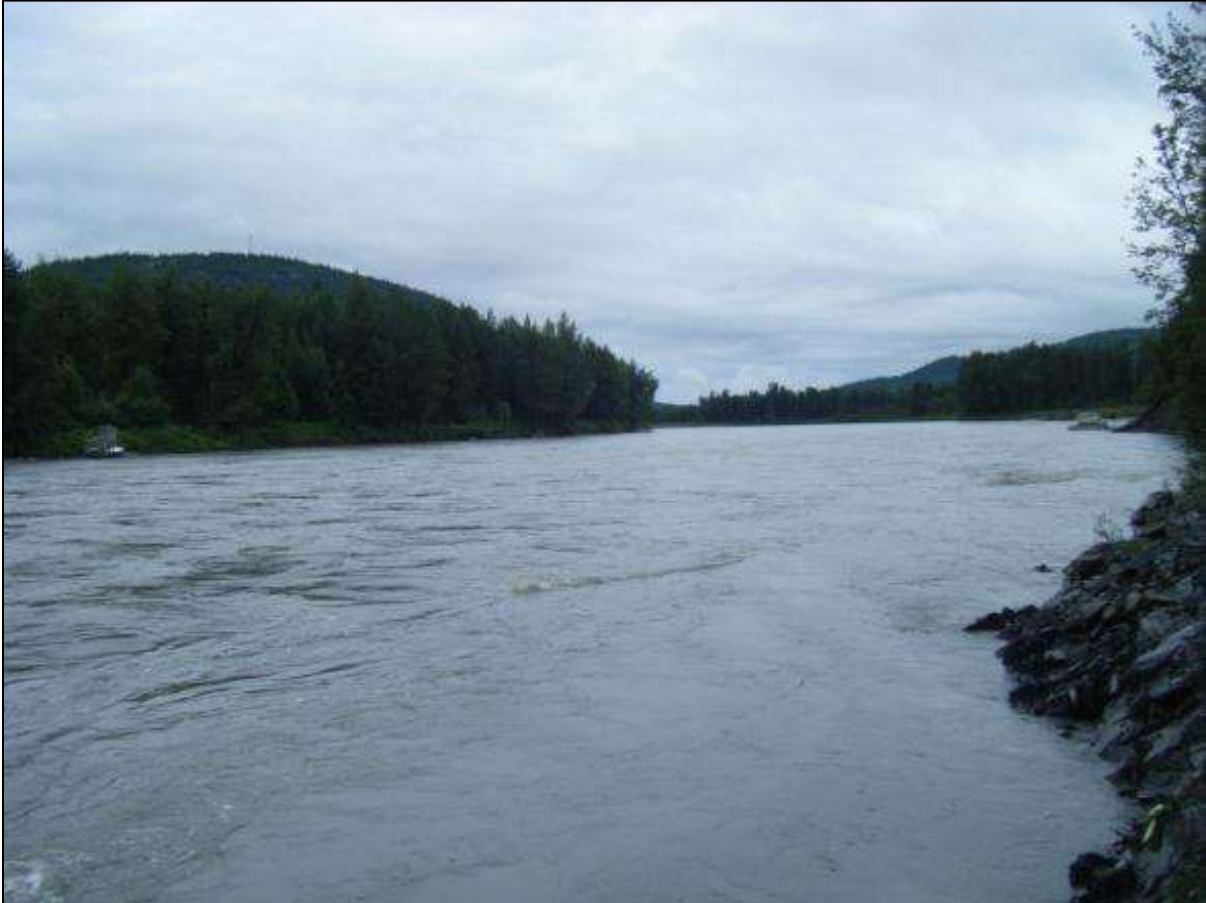
Buoy System Installed at RM 120.7- Up-River of Curry Fishwheel Camp

**September 27, 2012** – Buoy was missing and was replaced. System still intact, tidbits downloaded at 16:45 ADT, but missing data for 10174269. Pipe downloaded.

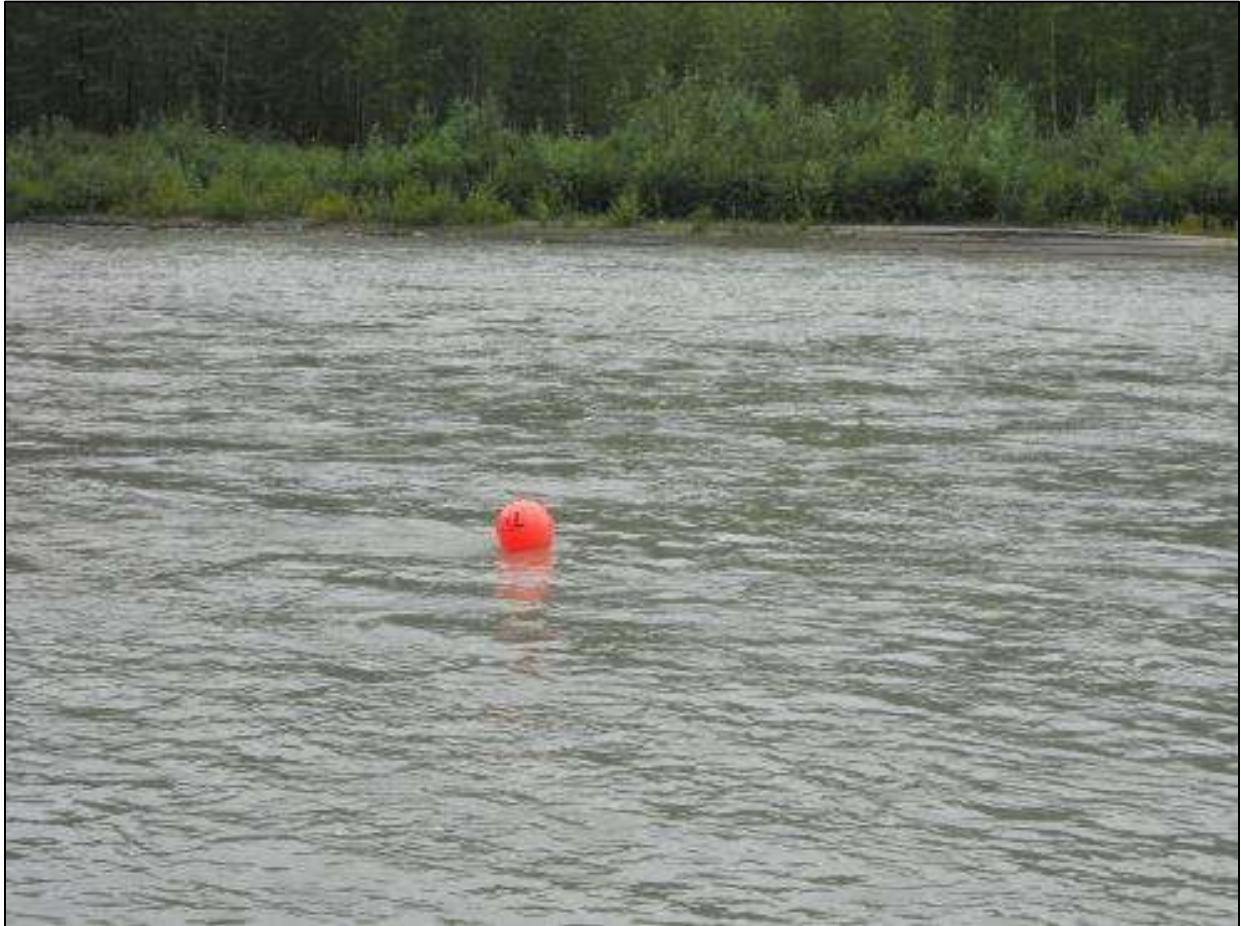
Buoy at RM 129.2 – Slough 9

**September 27, 2012** – System pushed towards shore, all tidbits still in water, system intact. System downloaded at 15:50 and redeployed.

**October 23, 2012** – Buoy system intact, buoy froze in ice but data loggers in 1 foot of flowing water. System downloaded at 10:15 ADT and removed. No winter system deployed – too shallow.

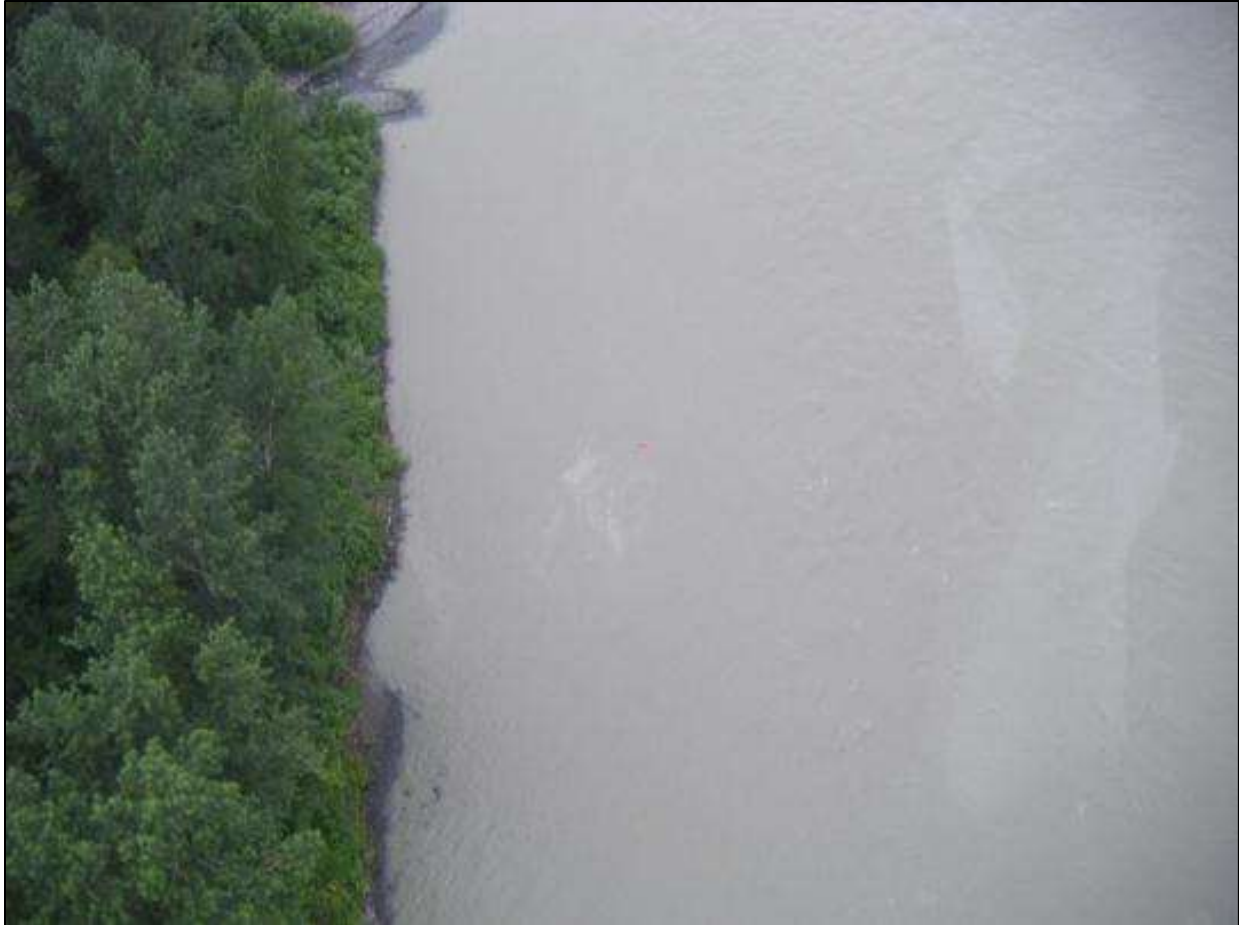
Buoy at RM 130.8- LRX 35

**September 27, 2012** – System intact but swung closer to shore, but still in deep water. Downloaded at 15:30 ADT.

**October 22, 2012** – Buoy and shore cable iced in but data loggers were ice free in approx. 2.5 feet of flowing water. Able to free system of debris and downloaded top two tidbits at 15:45 ADT. Removed buoy and redeployed.

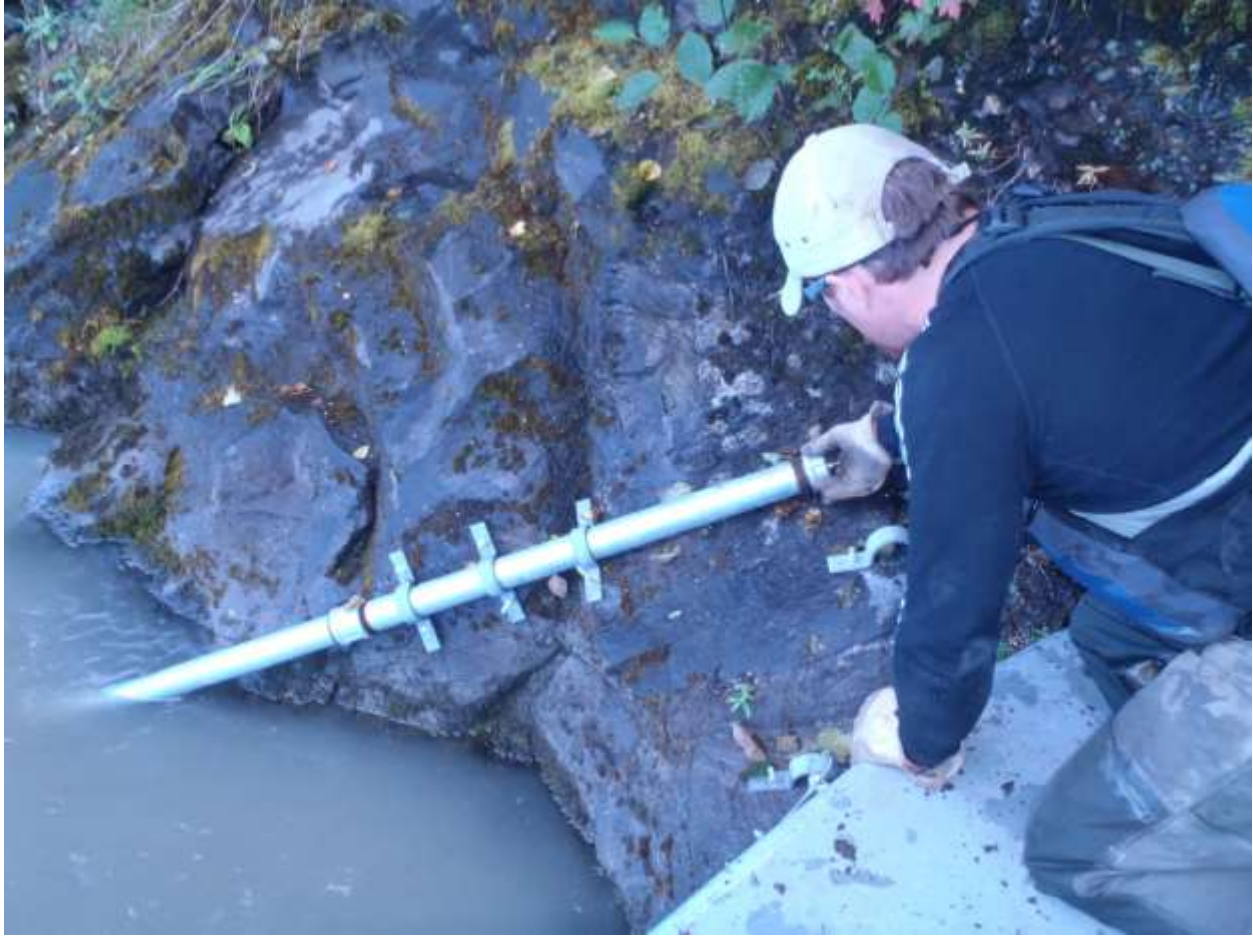
RM 138.7 – Pipe Mounted at Susitna above Indian Creek

**October 23, 2012** – Pipe was high and dry and tidbit cable was frozen in pipe and could not be removed, no download. Buoy system intact. Downloaded at 13:45 ADT and removed initial buoy string with multiple data loggers. Replaced with winter, single data logger system (data logger #10174227).

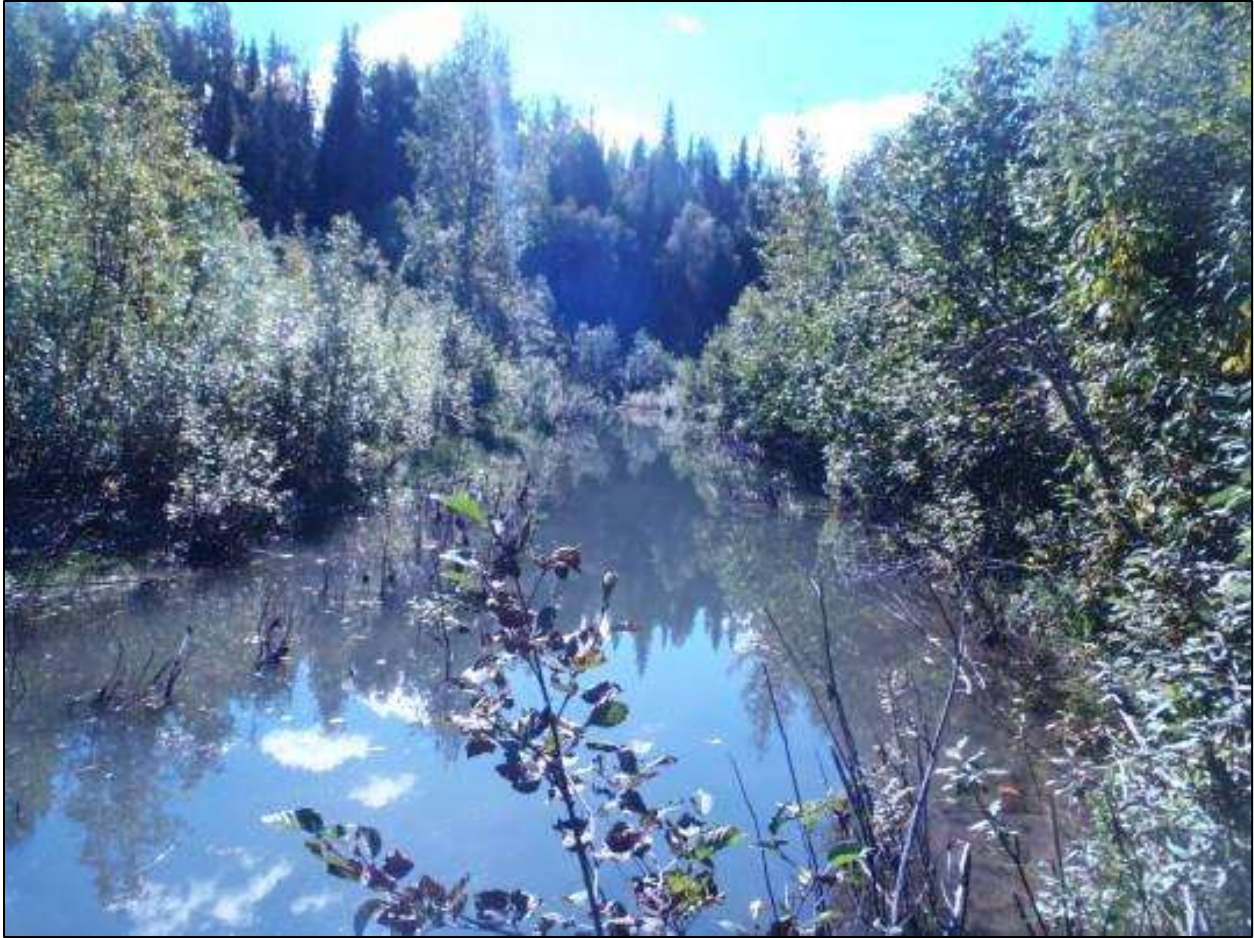
Buoy Installation Site at RM 142- Slough 21

**Station Notes:** A thermistor with no buoy or anchor line attached was deployed at this site. The site was moved 400 feet past the proposed site which was a dry river channel. This is a still water slough with a depth of 2 feet and a beaver dam at the south end. There is no flowing water, and it will freeze solid this winter.

**October 22, 2012** – System present and in approx. 2 feet of water. Downloaded and redeployed at 12:30 ADT.

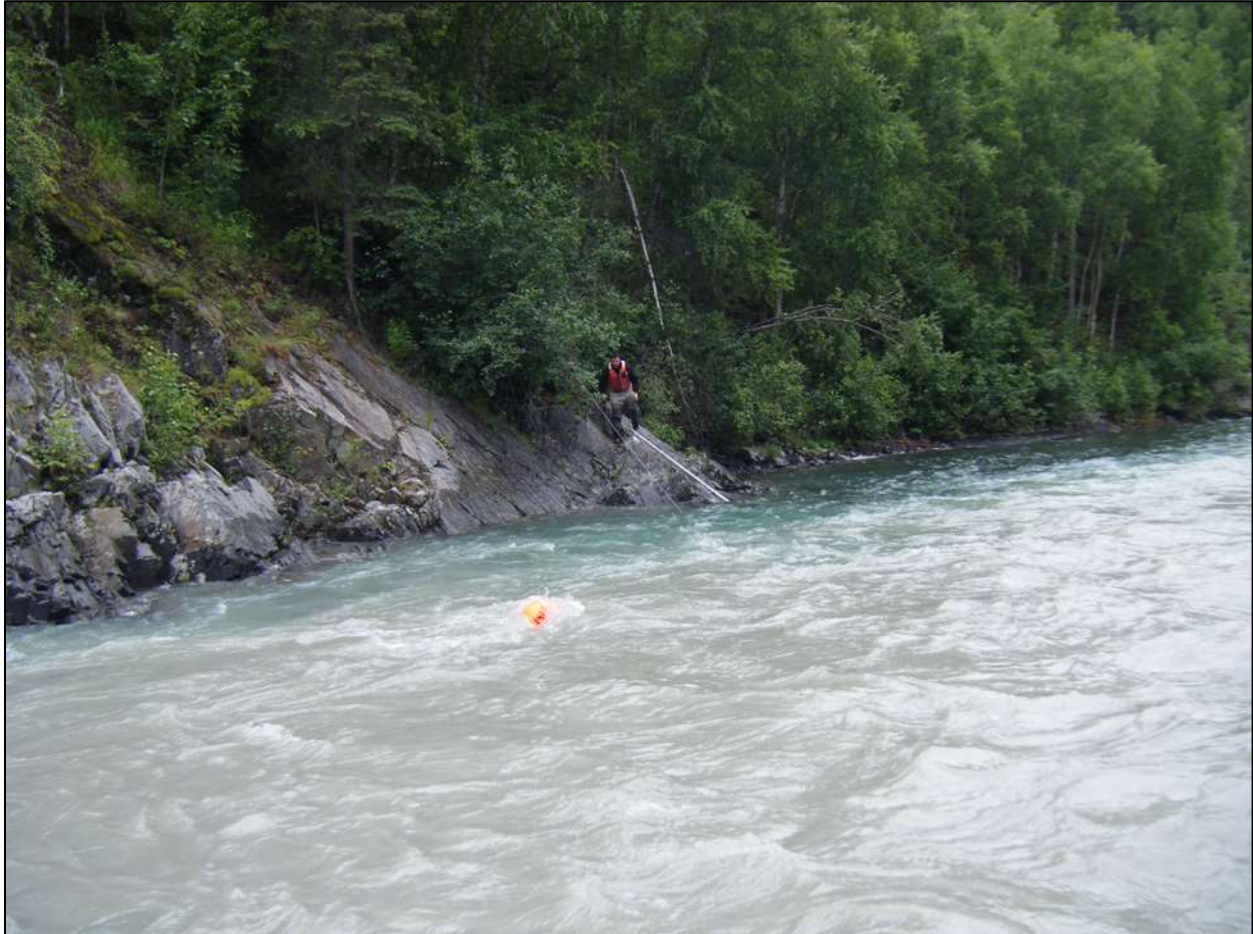
Buoy and Pipe Systems at RM 148.0 – Susitna below Portage Creek

**September 27, 2012** – Buoy has migrated to shore. Redeploy. Anchor 1 tidbit downloaded. Pipe silted in bottom 4 feet of pipe.

**October 22, 2012** – Buoy System present and in approx. 2 feet of water. Downloaded and removed system at 11:48 ADT. No winter system deployed due to shallow river conditions.

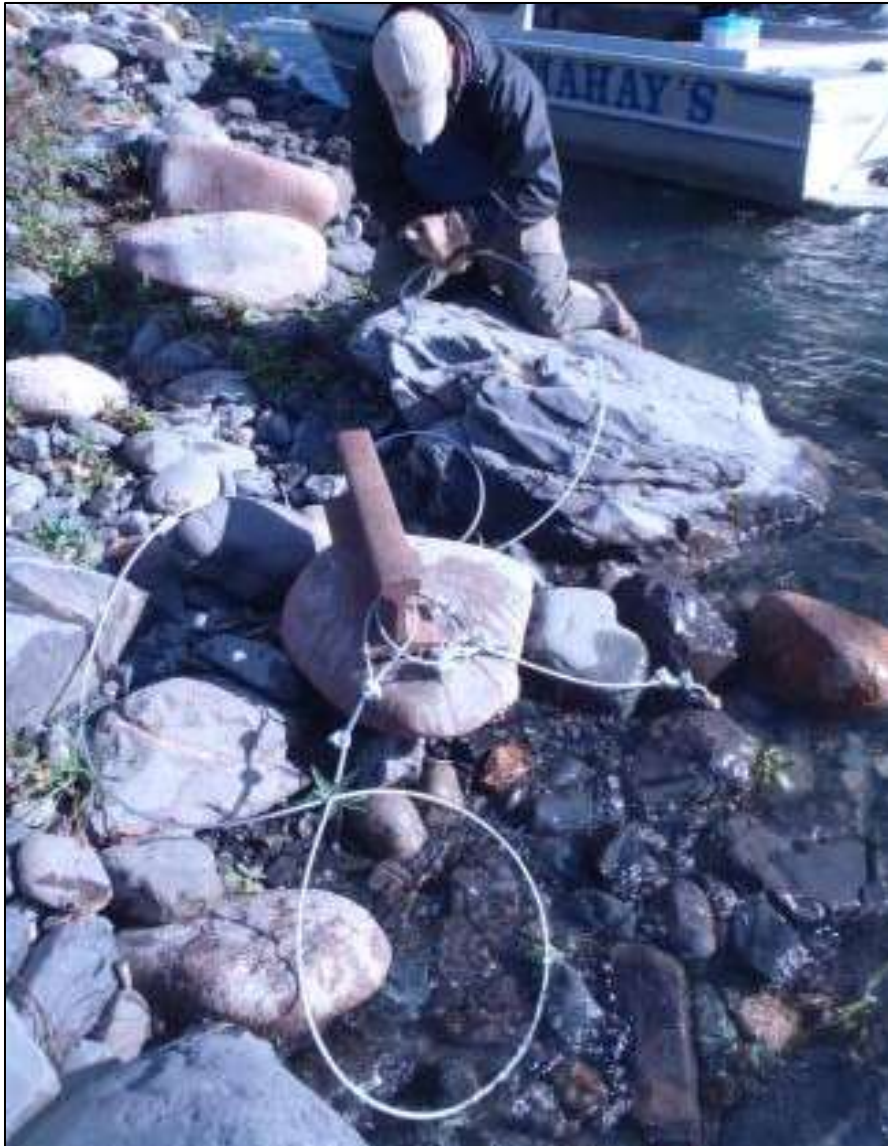
Buoy Installation at RM 148.8- Portage Creek

**September 27, 2012** – Downloaded system at 12:34 ADT. Thermistor migrated to mid-stream.

**October 22, 2012** – Shallow water observed. Downloaded system and re-deployed system at 11:55 ADT.

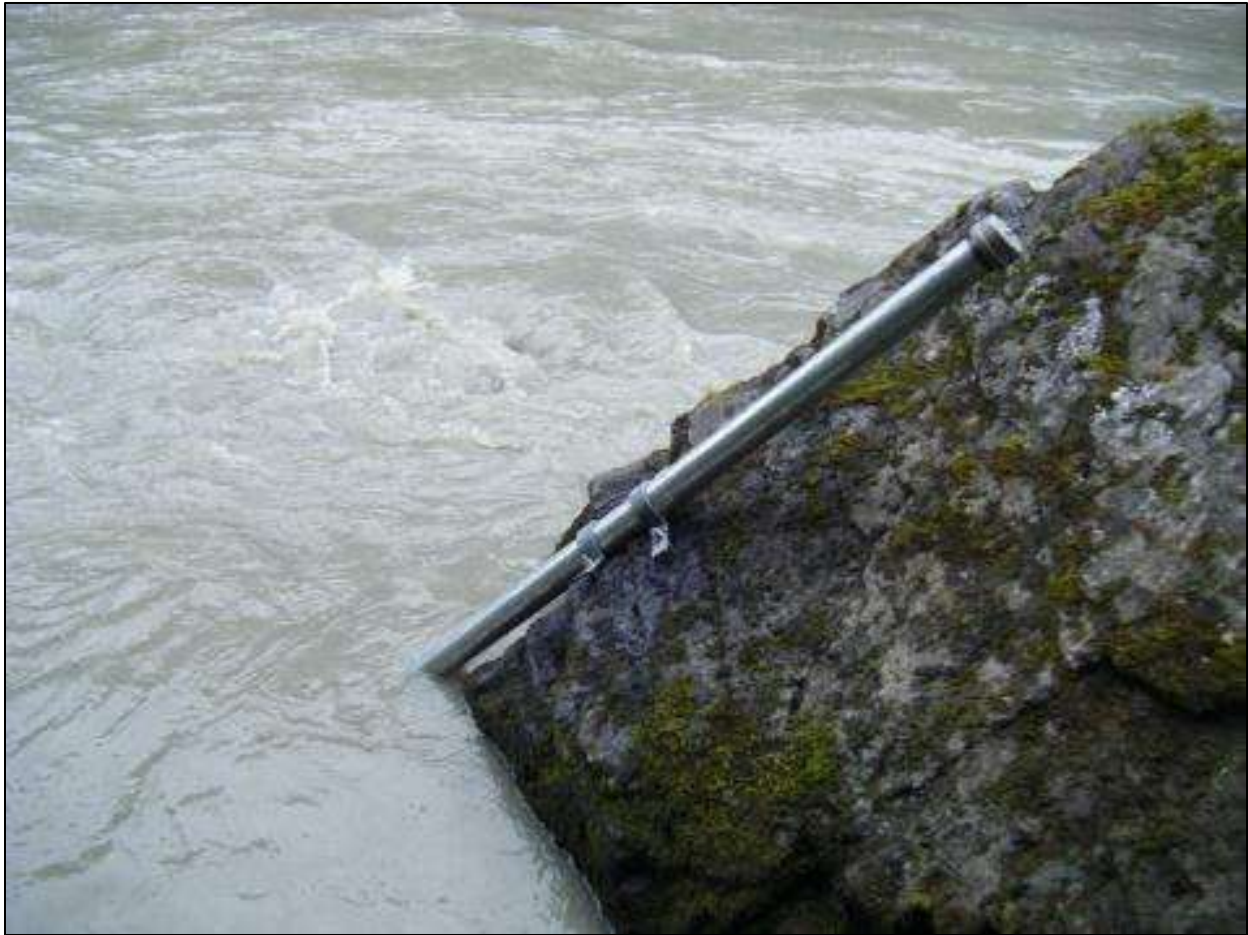
Pipe Installation at RM 148.8- Above Portage Creek

Station Note: 10174171 may have exposure to air. Use 10174169 for water temperature.

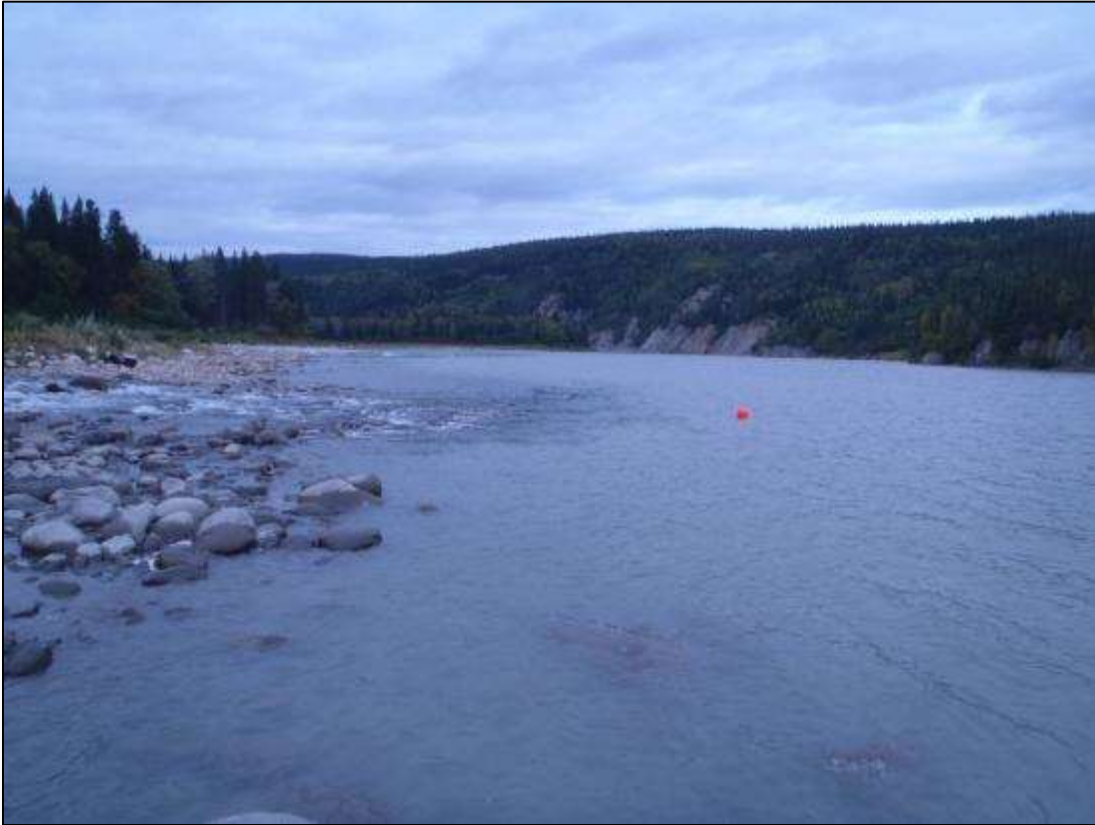
Buoy Installed at RM 206.8 – Kosina Creek

**Station Notes:** Two thermistors were installed at this site, attached to a 6 feet cable and then to a buoy. The system was deployed at the mouth of the smaller of the two channels shown on the map. The best location for this system would be in the main stem of the creek, due to the shallowness of the current location.

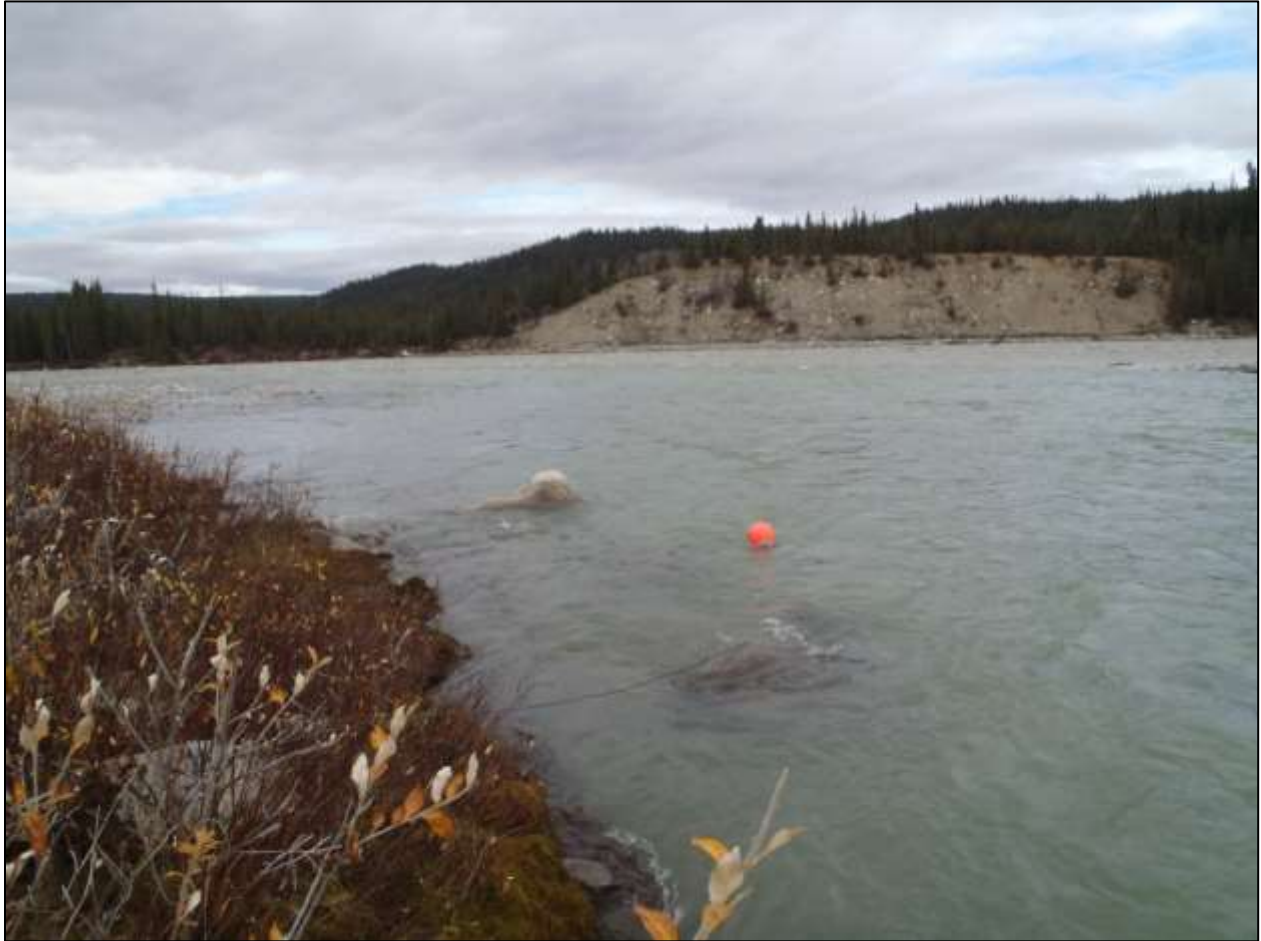
Buoy System Installed at RM 233.4 –Oshetna River

**September 25, 2012** – System intact but had moved down stream slightly but in at least 2 feet of water. Downloaded sensors at 14:00 ADT and removed summer buoy string. Replaced with winter, single data logger system (data logger # 10174278).
