**Susitna-Watana Hydroelectric Project
(FERC No. 14241)**

**Study of Fish Passage Barriers in the Middle and
Upper Susitna River and Susitna Tributaries (9.12)**

**Appendix A
Tributary Geologic Barriers**

Initial Study Report

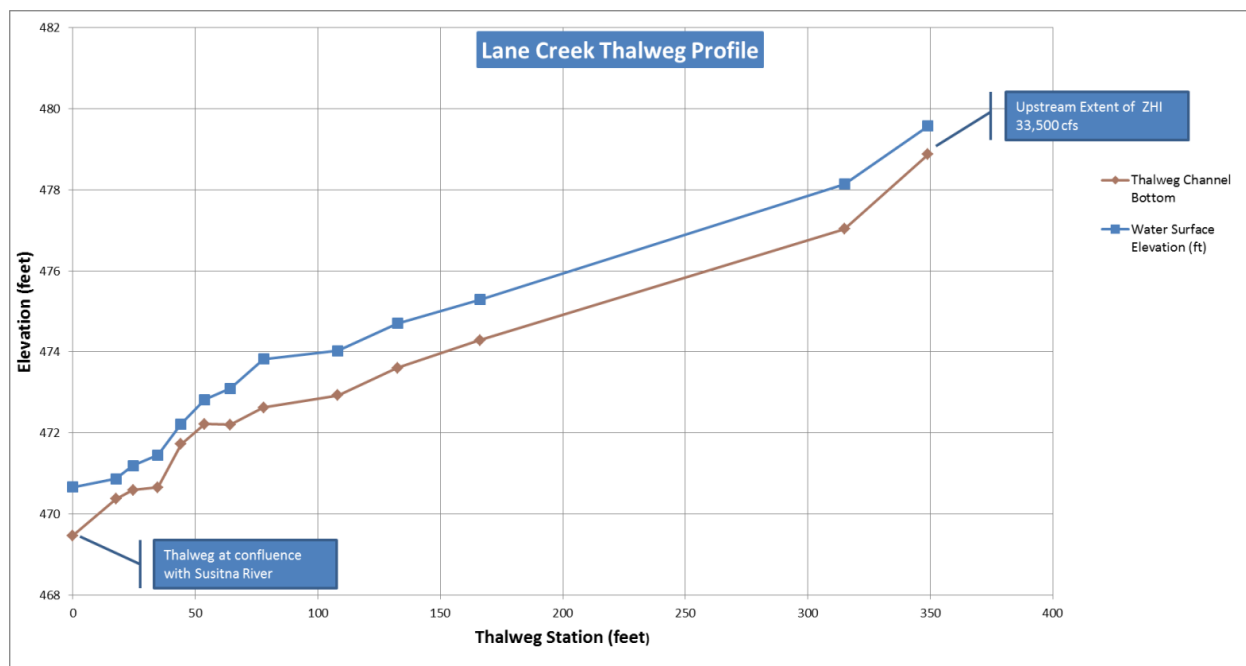
Figure B4. Lane Creek thalweg profile.

Lane Creek left a very confined and established channel only a short distance upstream of the creek mouth (Figure B3). During high Susitna flow conditions, it was likely that the creek met the river at the end of the confined channel reach (Figure B4). The creek mouth was characterized by large cobbles and small boulders with a debris apron (Table B2). Flows began to spread out across this small boulder apron as it passed the downstream extent of the confining creek bank before reaching the Susitna. No noticeable incision had occurred across the apron, and there was no distinct thalweg.

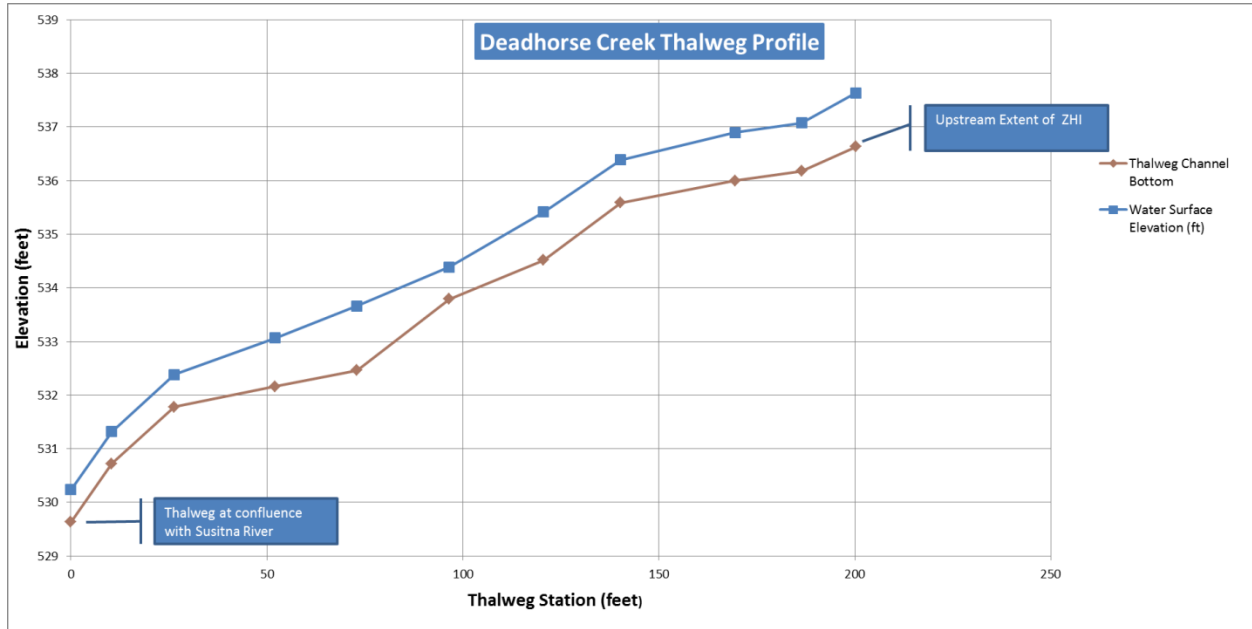
Figure B6. Deadhorse Creek thalweg profile.

The mouth of Deadhorse Creek consisted of a large debris fan and single creek channel (Figure B5). The creek had incised the debris apron, but a final steep boulder cascade remained before reaching the Susitna (Figure B6). This noticeable perch was a result of low creek flows and the receding Susitna flow. Deposited material varied in gradation, material size and mixture throughout the fan (Table B3).
