SUSITNA-WATANA HYDROELECTRIC PROJECT
 LINEAMENT GROUP 8
 MAP DATA

FIGURE
 A8-2.1

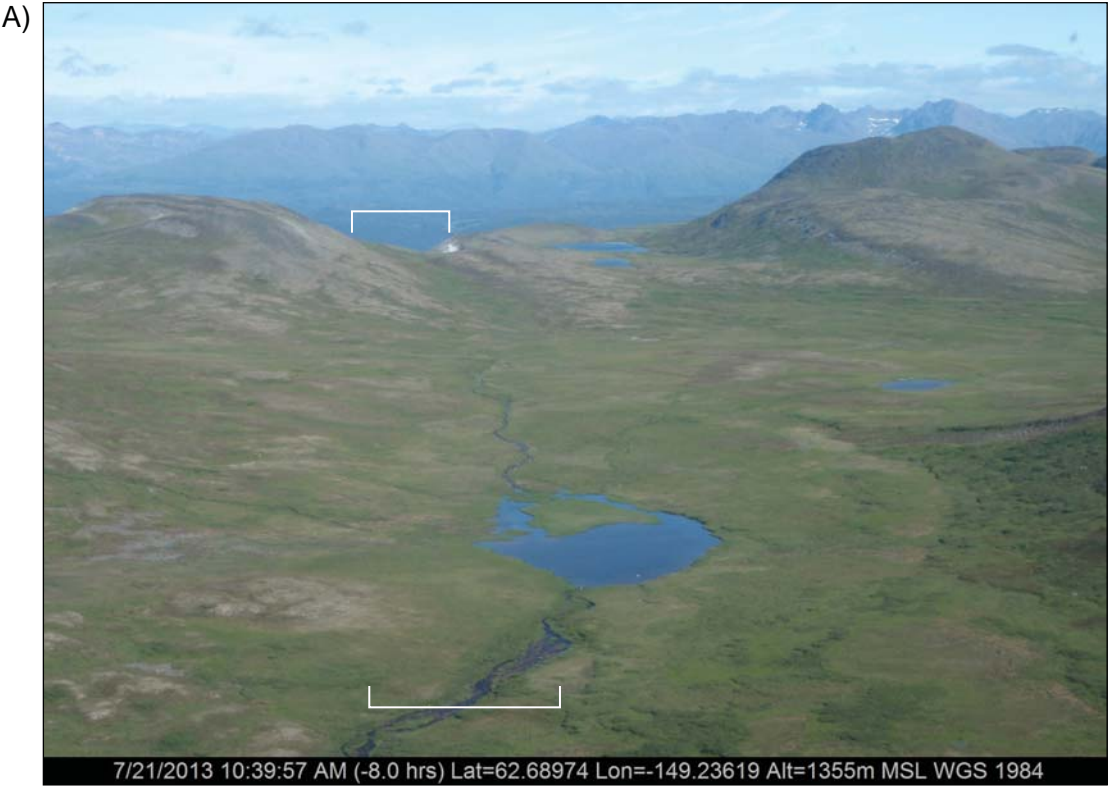
View looking north at middle portion of lineament group 8 along mapped inferred fault. Brackets show position of fault but note that no geomorphic expression of faulting is readily apparent.

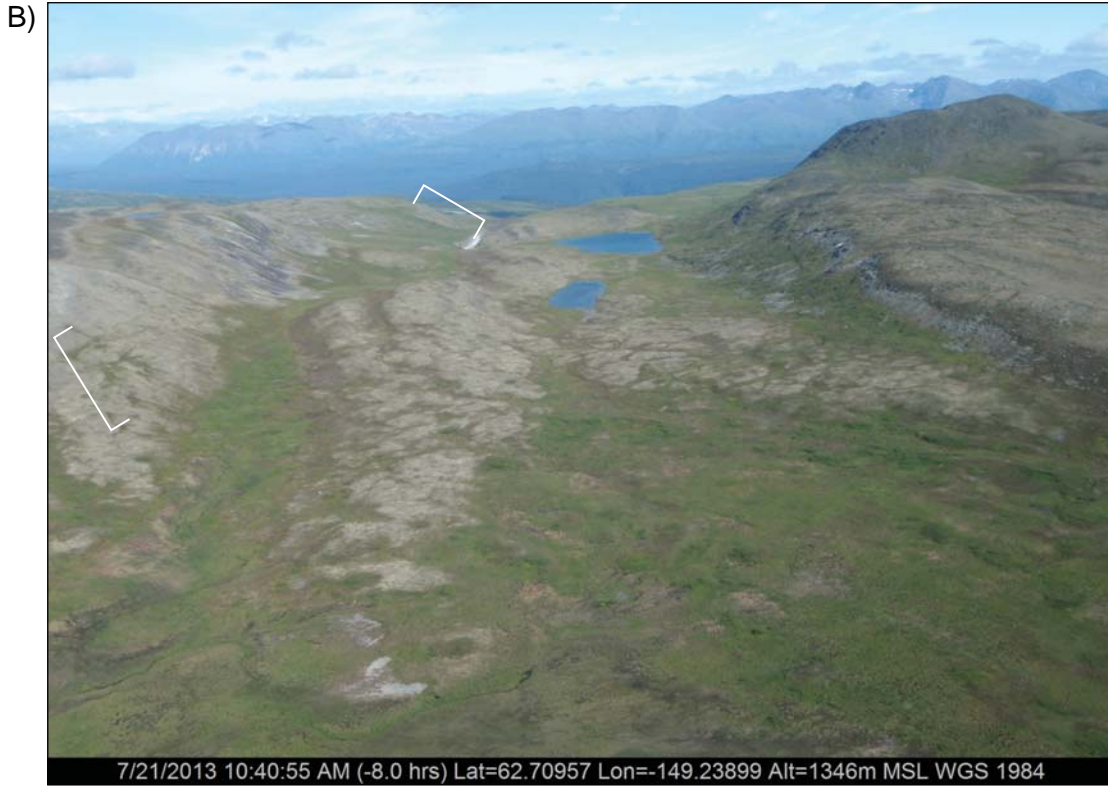
Close up view of saddle area shown in Photograph A. Brackets, again, show position of fault but note that no geomorphic expression of faulting is readily apparent.

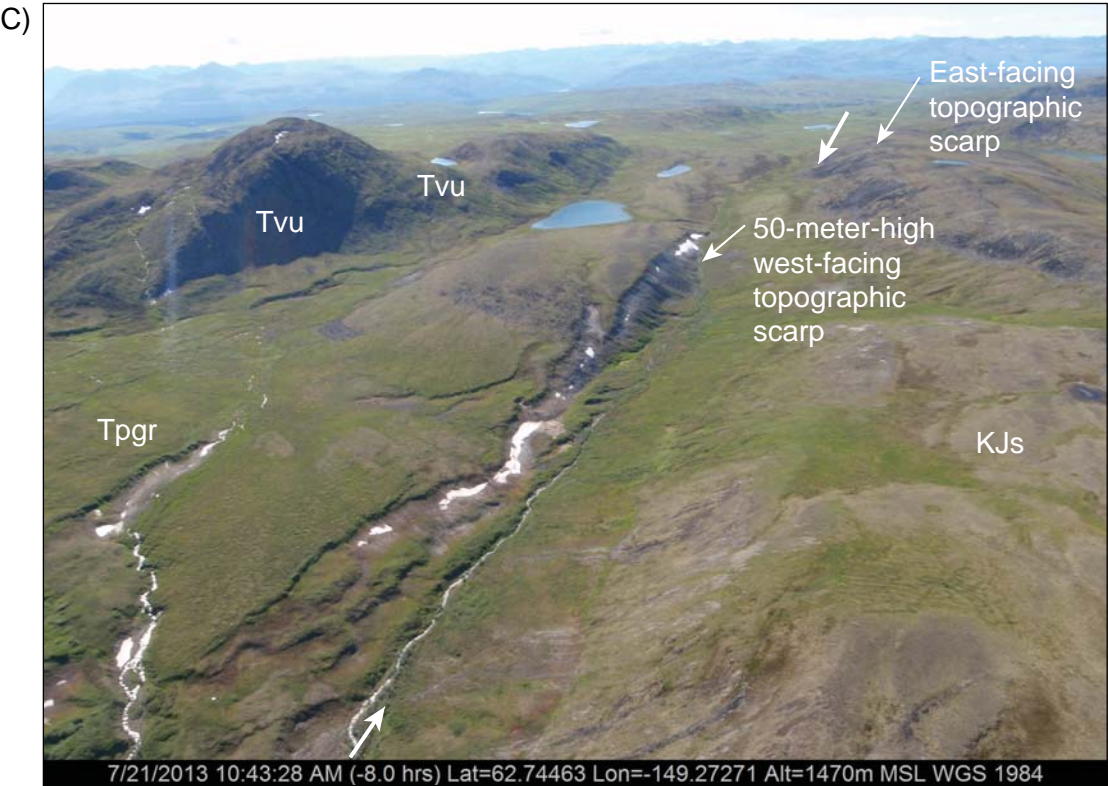
View looking south opposite that shown in Photograph B above. Mapped fault runs between large arrows. Note presence of many solifluction scarps in the landscape.

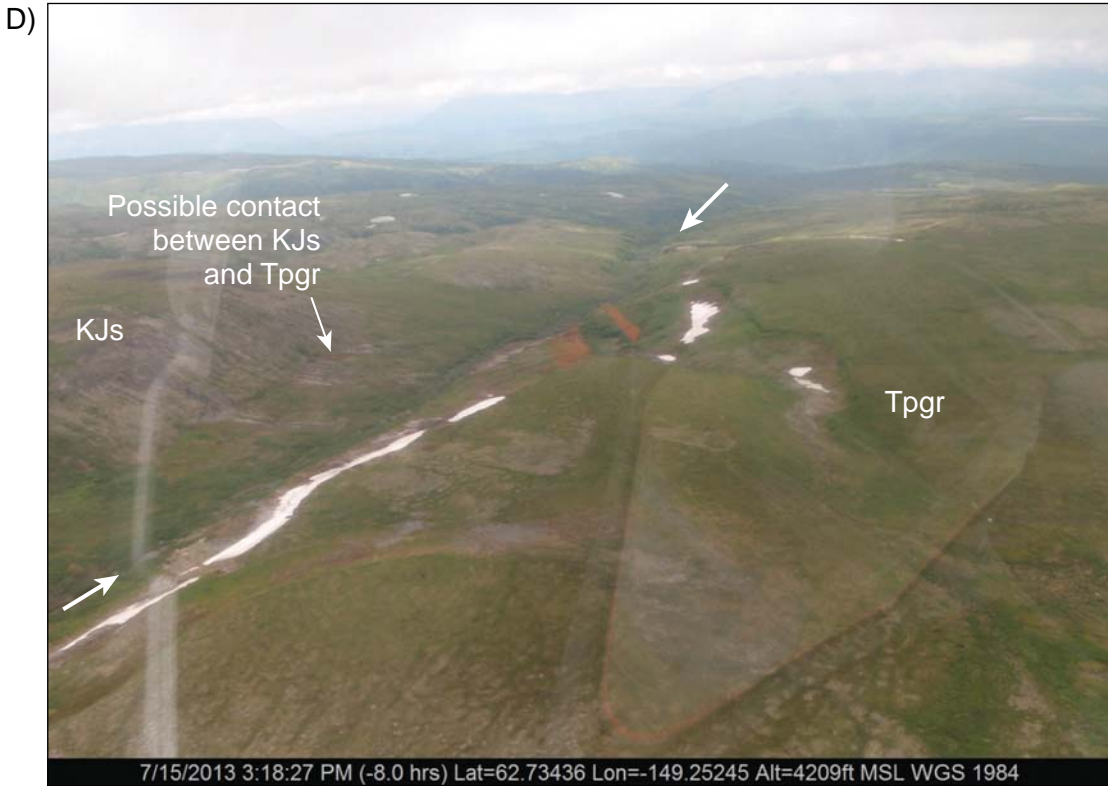
View looking north down the prominent, deeply incised linear drainage. Mapped fault runs between large arrows.

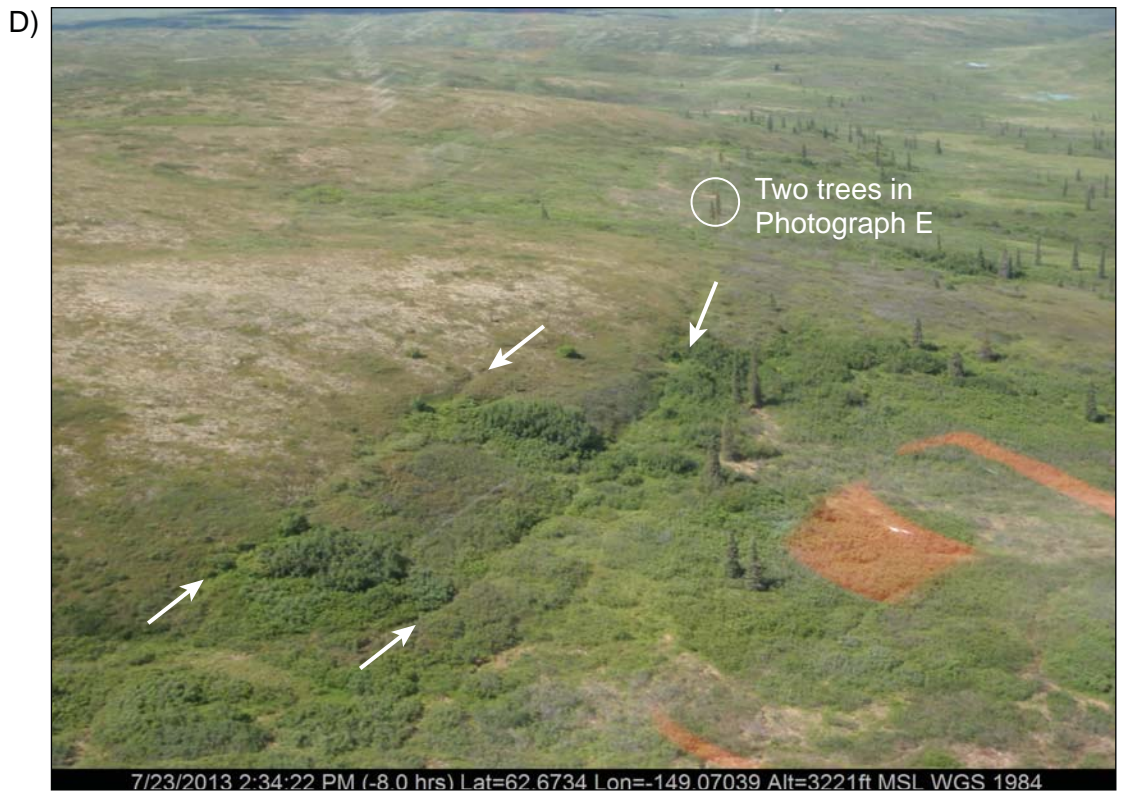
Photograph 4 of 5 with view looking northwest. Large arrows point along lineaments.

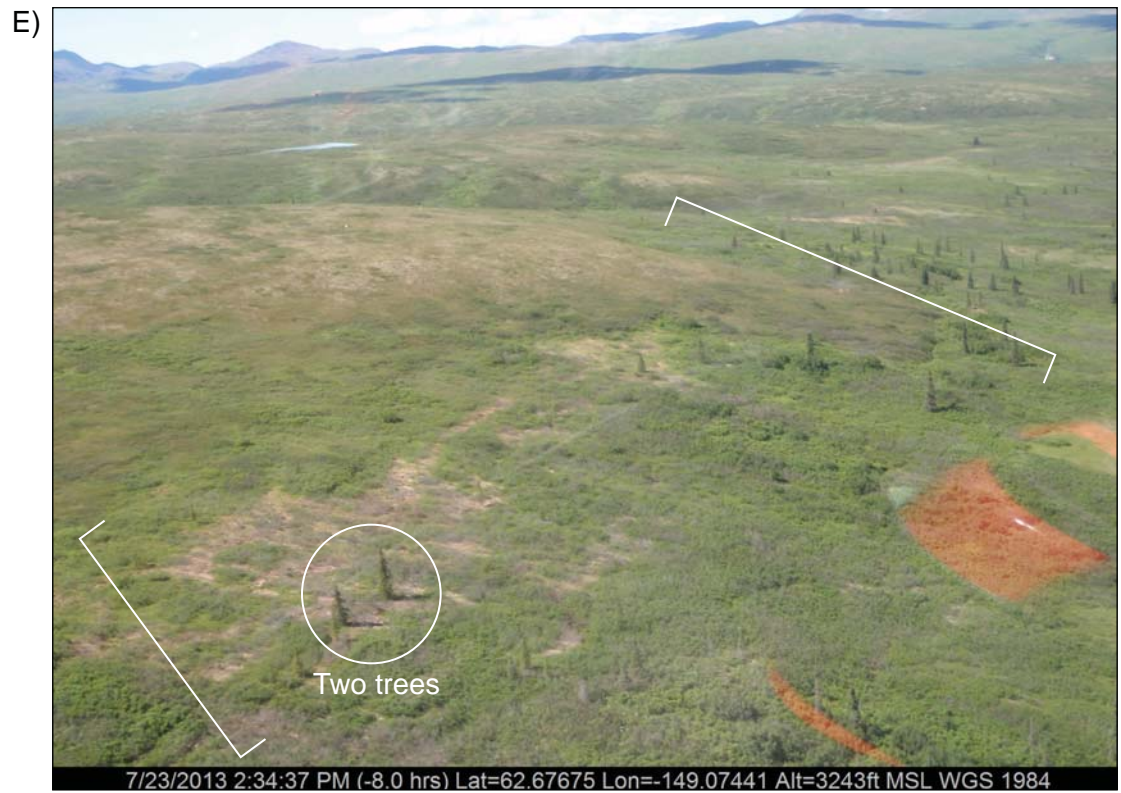
Photograph 5 of 5 with view looking northwest. Note that lineament expression has died out and brackets bound the location of its projection.

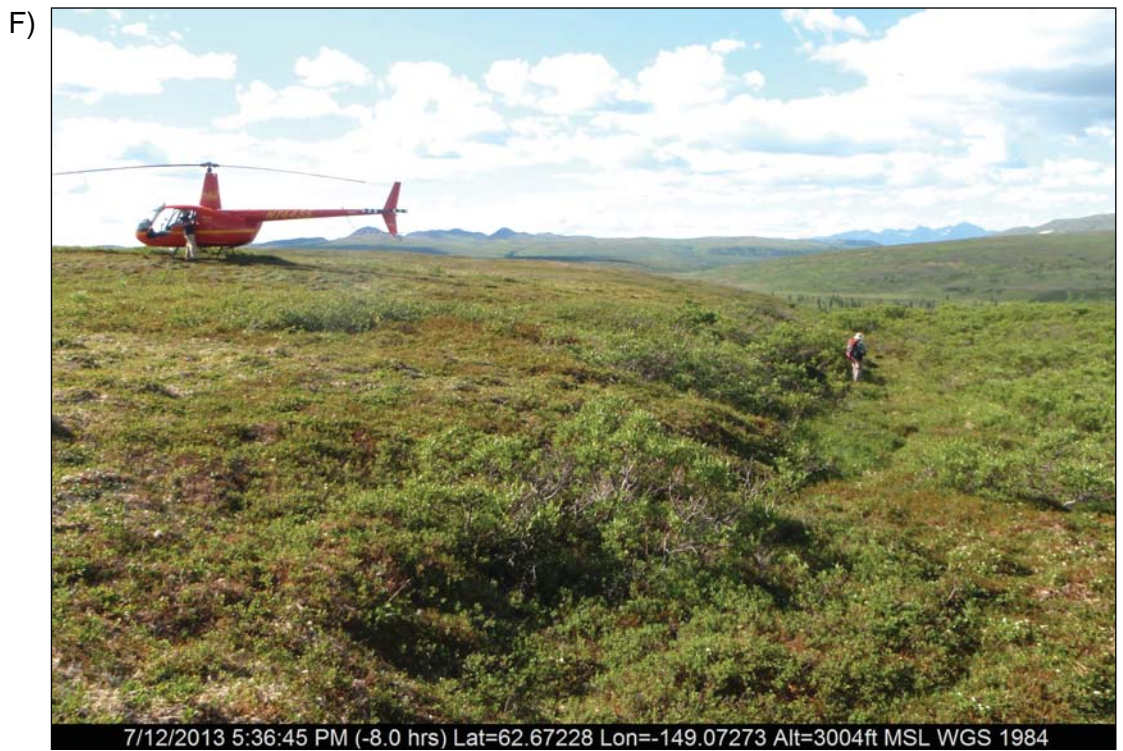
View looking north from location F. Geologist at base of east-facing break-in-slope is 170 cm tall.

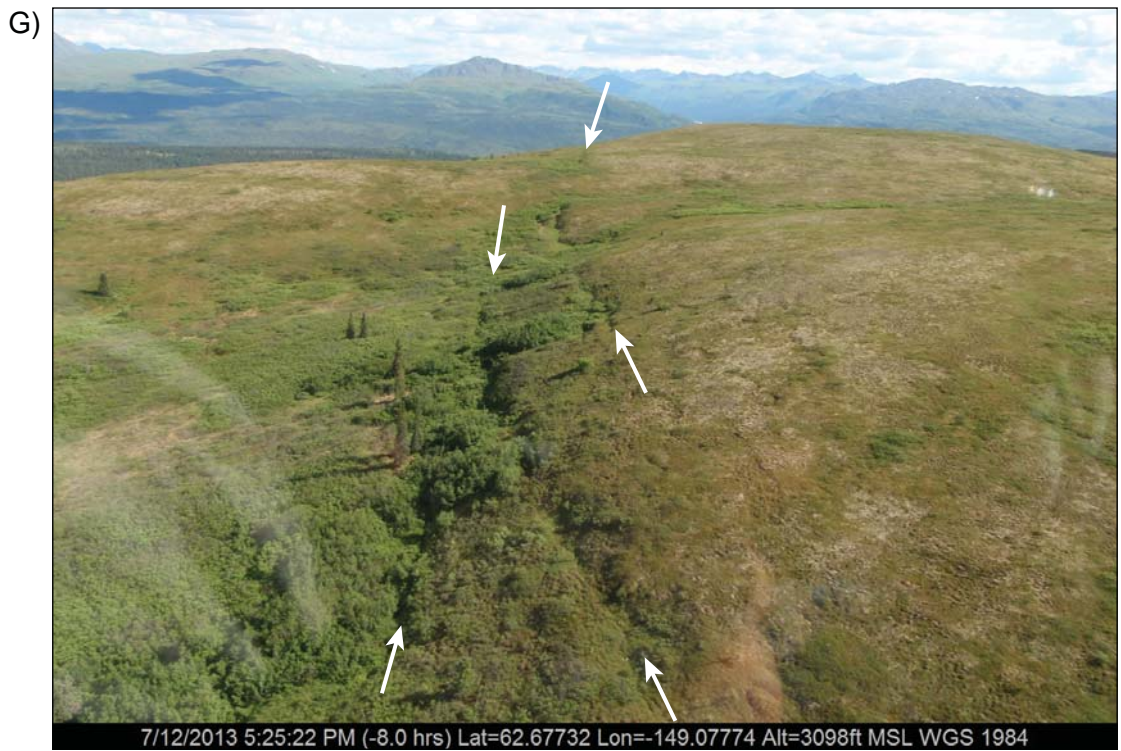
View looking almost 180 degrees from that shown in Photograph D. Large arrows point along lineaments.

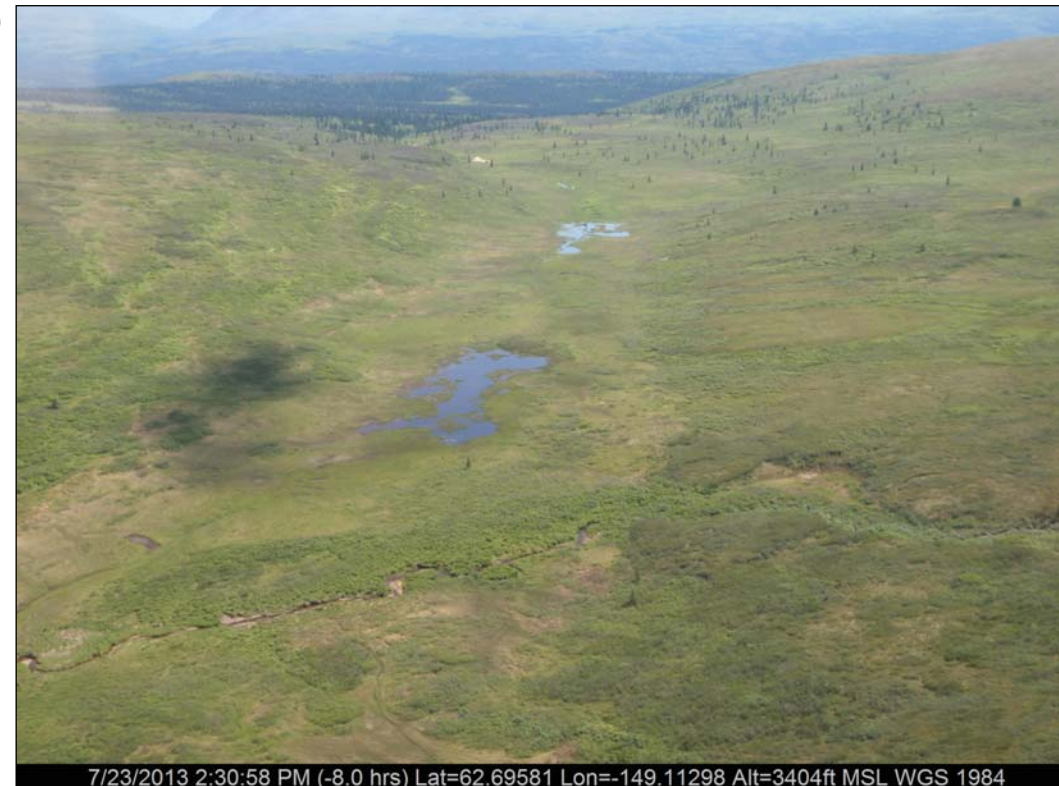
H)

View looking south from location I across area within WCC's segment 3. Note the lack of expression of any lineaments in the broad depression.

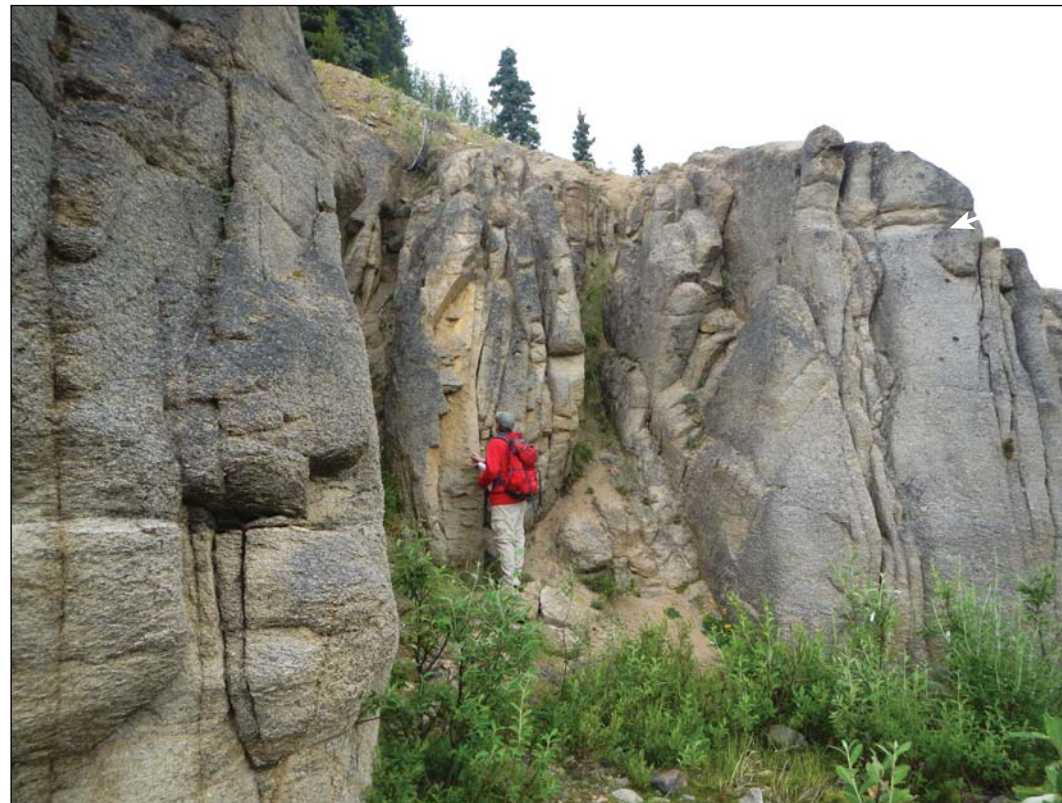
I)

Exposures of widespread granodiorite in unnamed creek near GPS waypoint 176 in terrain mapped as flysch (map unit KJs) by Wilson et al. (2009). The geologist is approximately 175 cm tall.

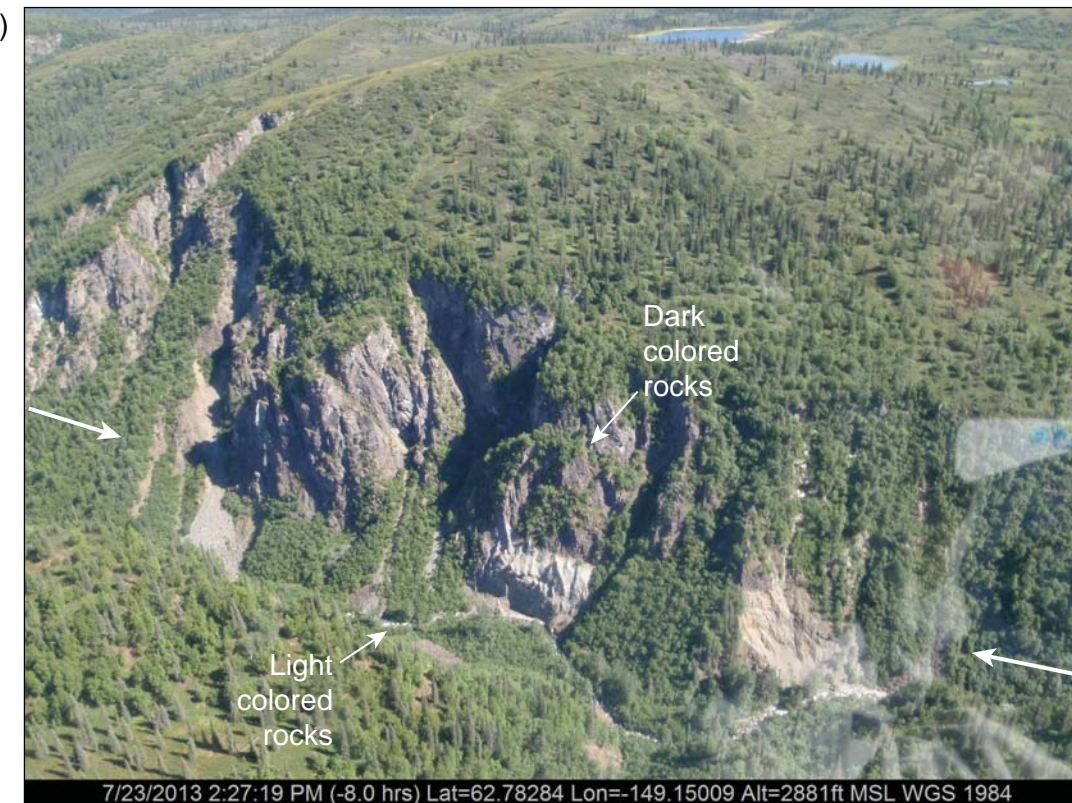
J)

View looking northeast at right wall of linear v-shaped canyon. Large arrows point along apparent bedrock type contrast.

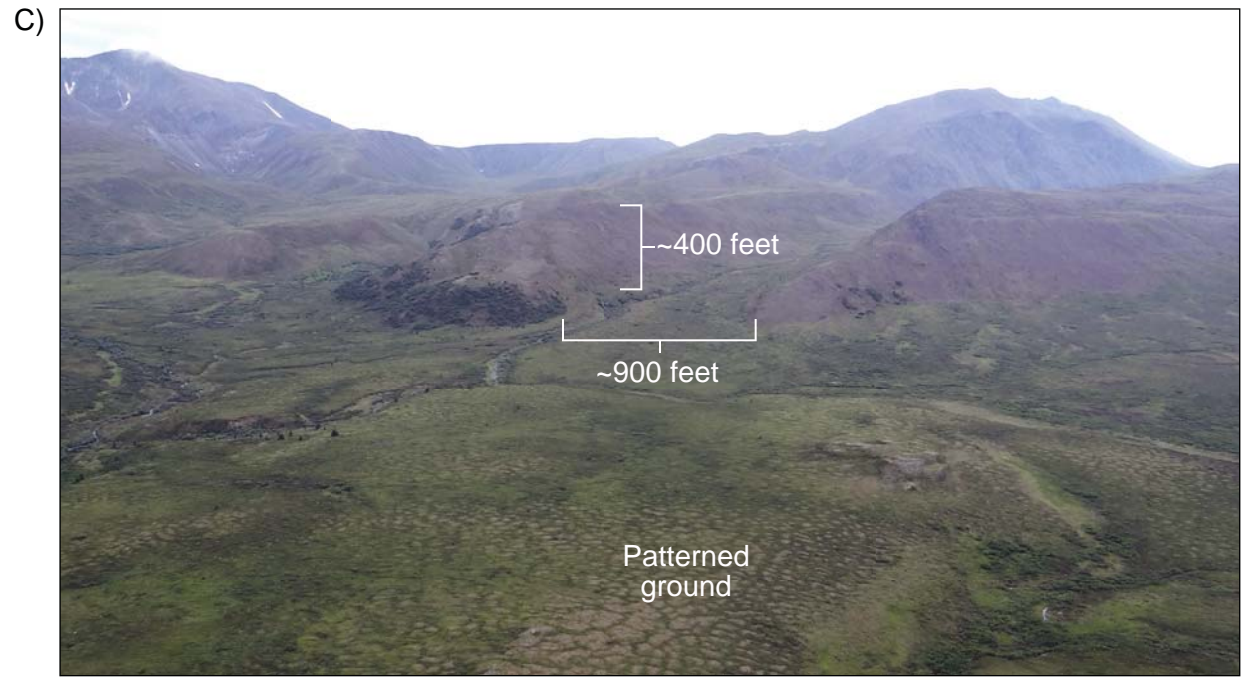
View southerly up-valley into glacial valley along lineaments geomorphically expressed as linear valley and drainage. Underfit creek in deep linear valley suggests landform created by sub-ice channel meltwater.

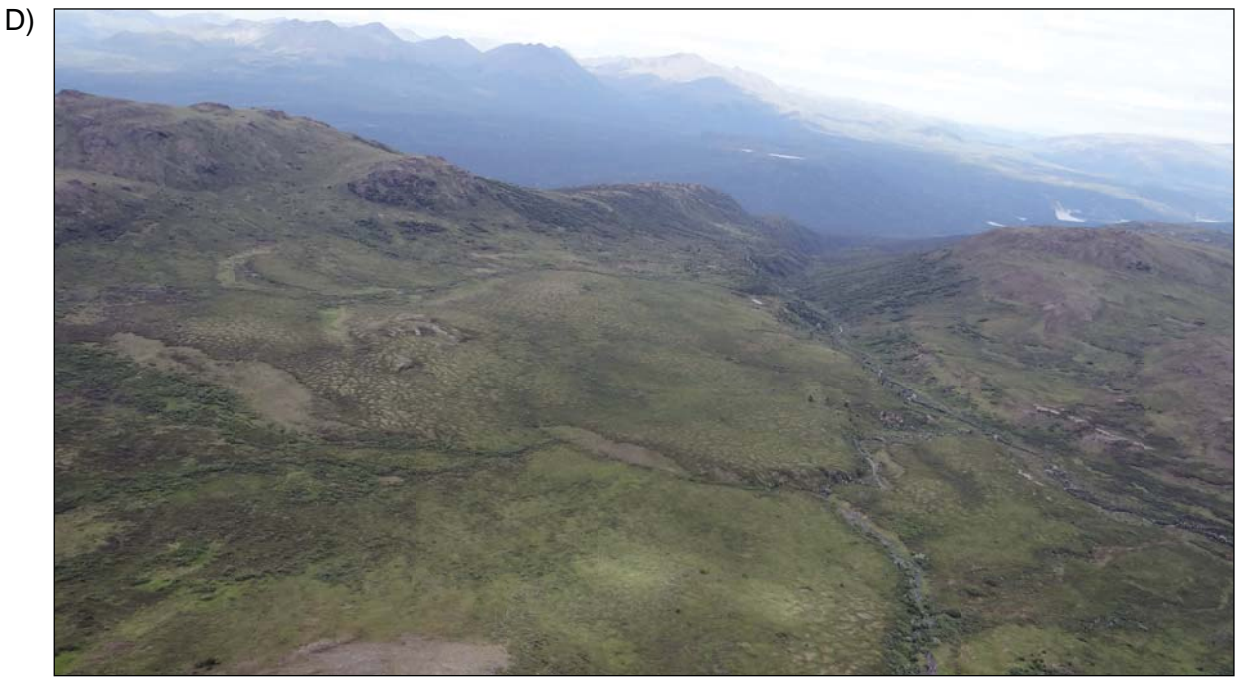
View northerly down-valley along lineaments geomorphically expressed as linear drainage. Thin cover of unconsolidated surficial sediment mantles the Paleozoic rocks.

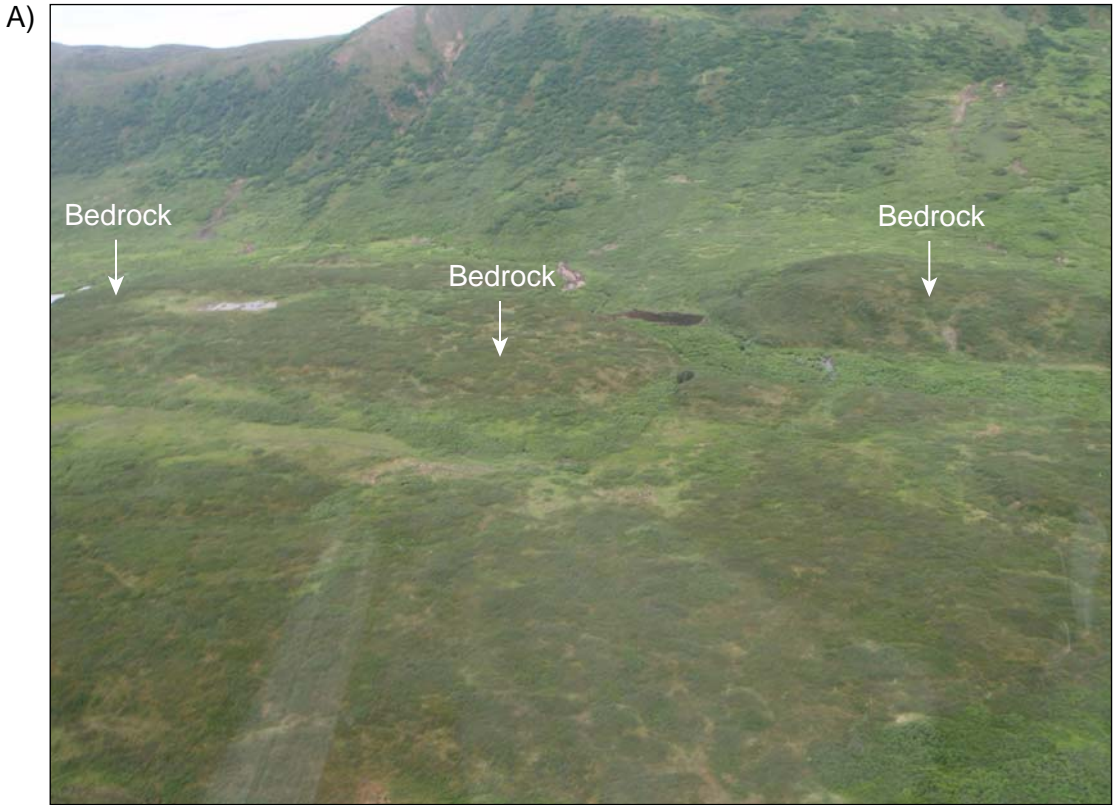
View looking westerly at break-in-slope at base of hillside and undulating glacially-eroded bedrock knobs in foreground.

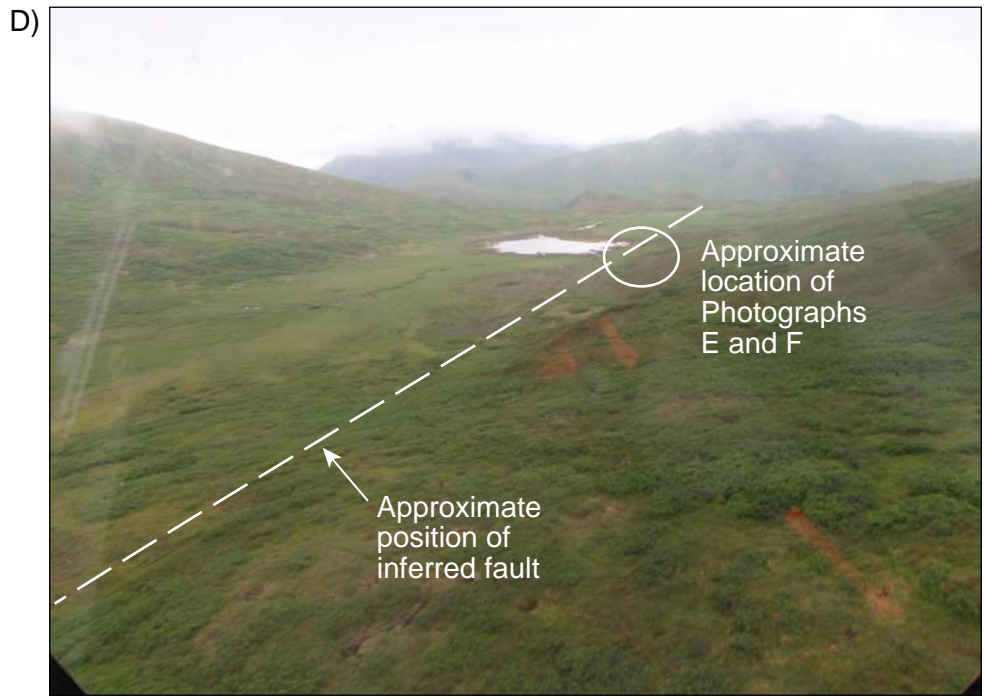
View looking south along southern extent of group 17b, along which an inferred bedrock fault is mapped by Wilson (2009). Photographs B and C are adjacent to lake.

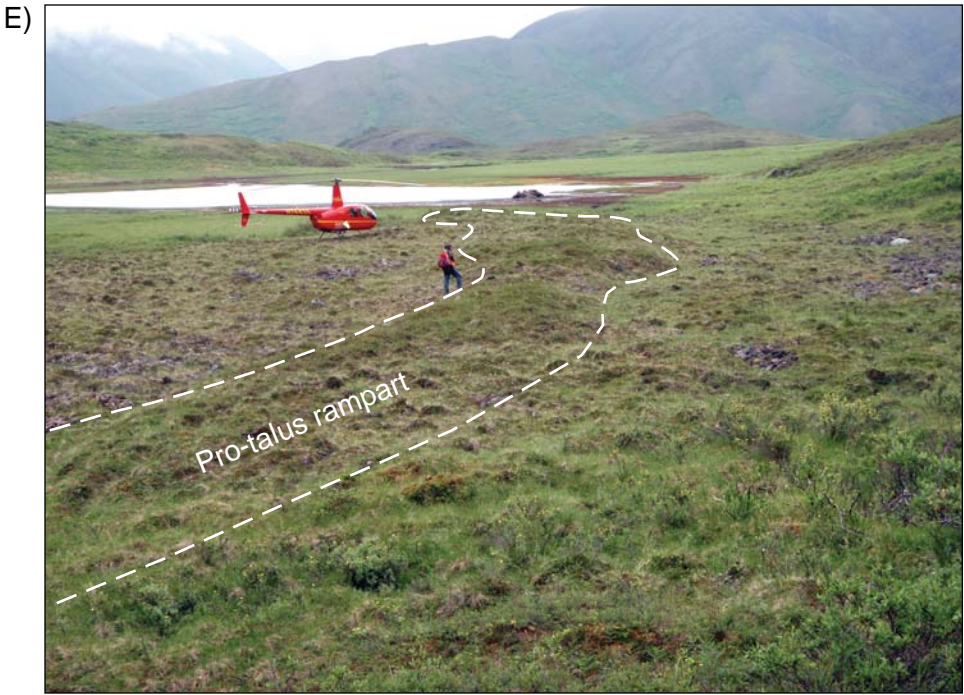
View looking south at pro-talus rampart and GPS waypoint 15. Note lateral distance between base of slope to crest of rampart. Geologist for scale is about 180 cm tall.

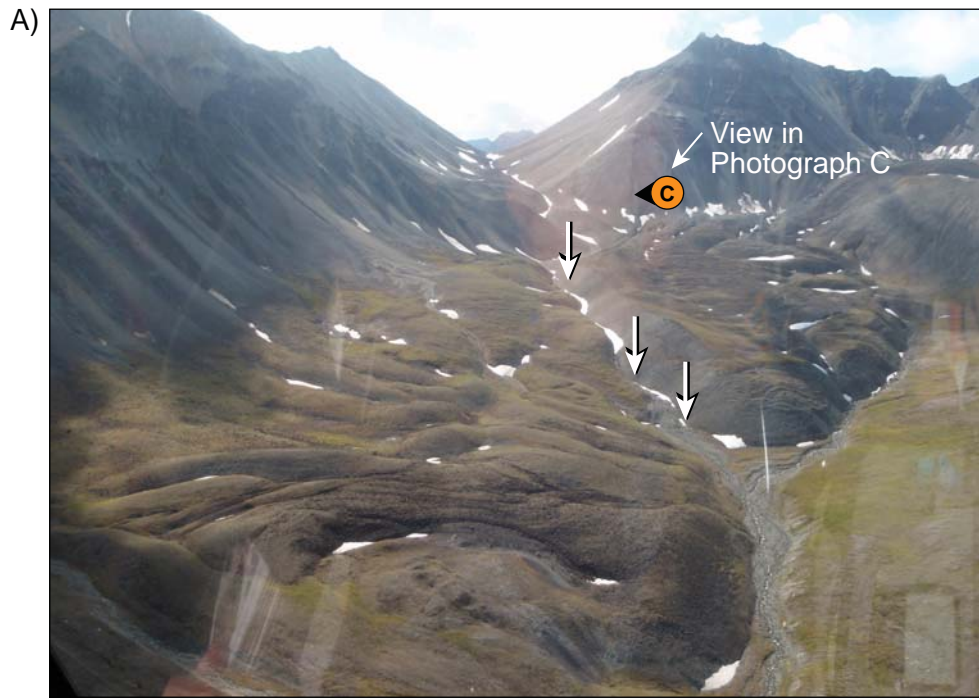
View looking southeasterly at lineament expressed at erosional drainage cutting through the likely Holocene rock glacier deposit.

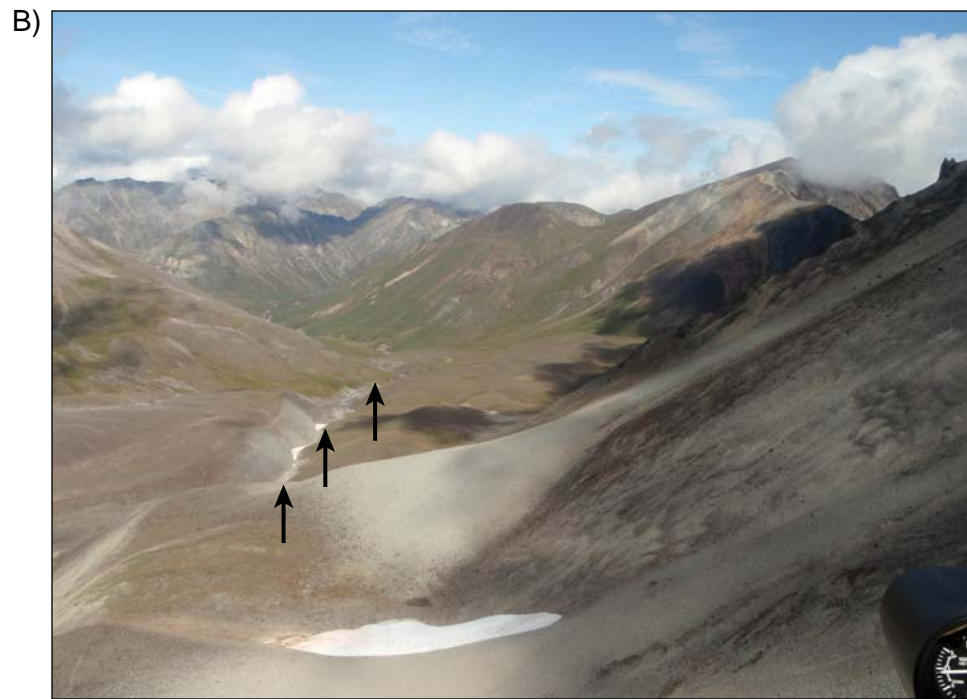
View looking northwesterly (opposite that in Photograph A) at lineament expressed as erosional drainage cutting through the likely Holocene rock glacier deposit.

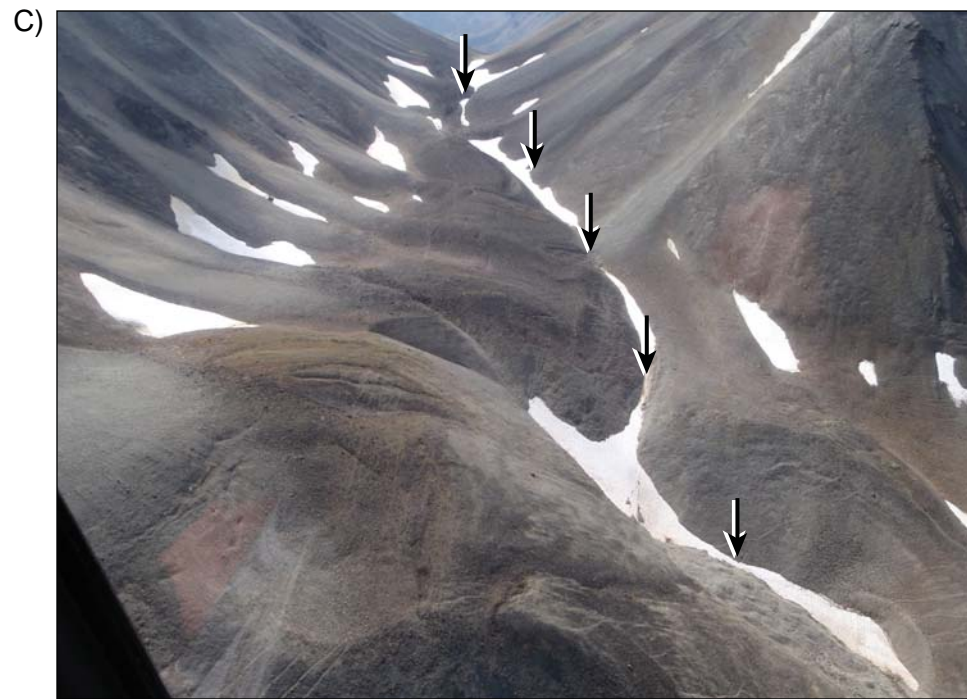
View looking southeasterly at lineament expressed as likely Holocene rock glacier deposit contacting the valley floor.

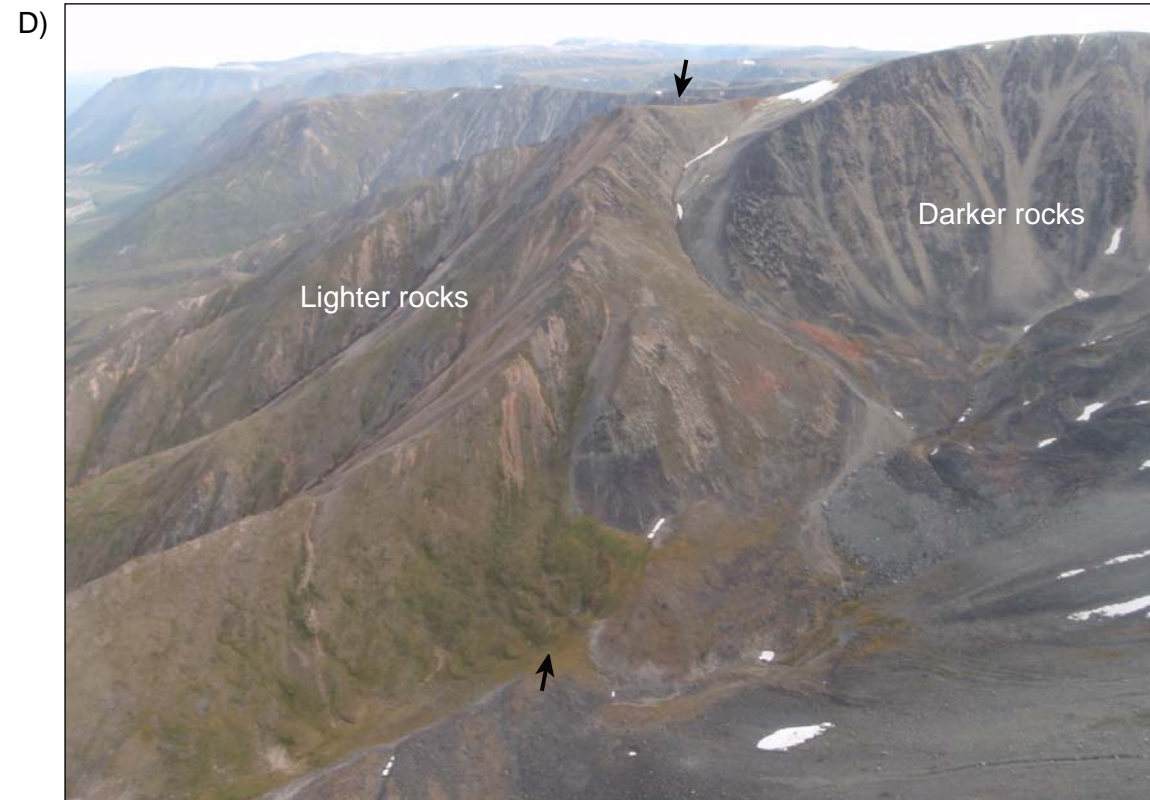
Photograph looking northeast from location D along the western continuation of the apparent rock type contrast shown in Photographs A, B, and C. Arrows point along apparent contact.

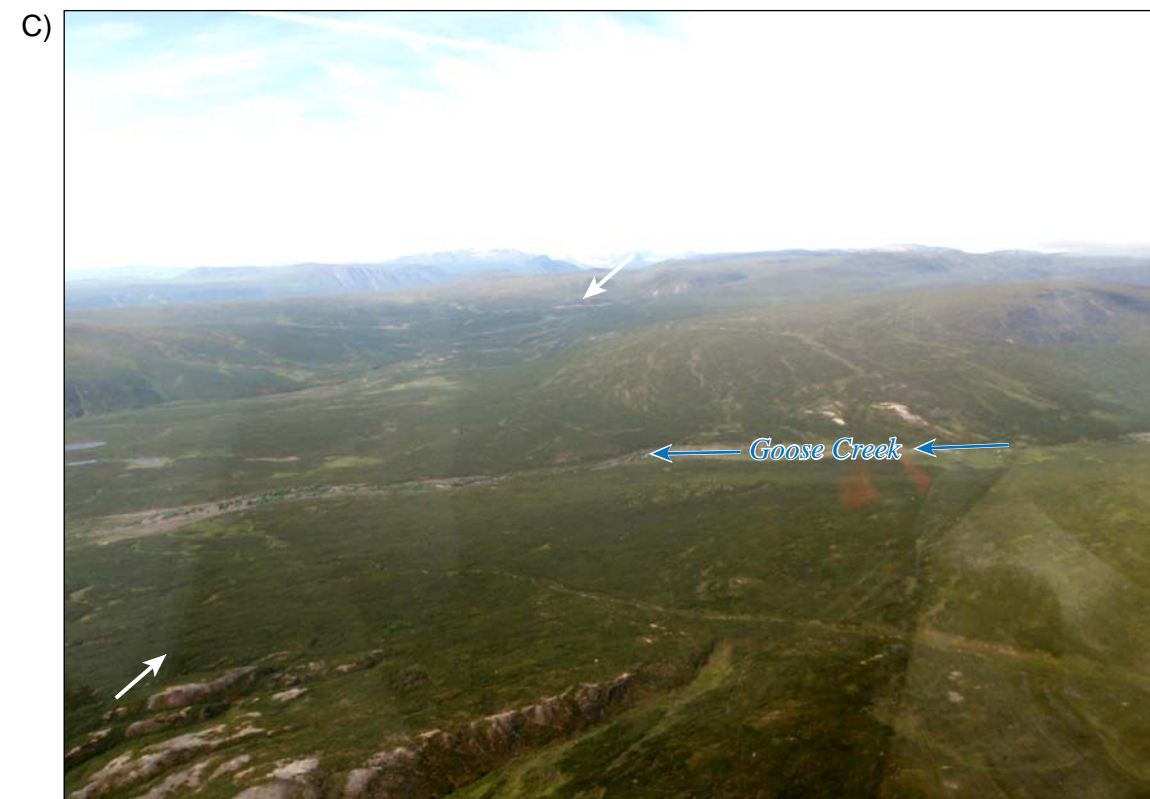
Overview photograph looking southwest from location C along alignment of mapped lineaments. Arrows point along trend of lineament group 19. Note absence of expression of lineaments within the landscape across the Goose Creek portion of the lineament group.

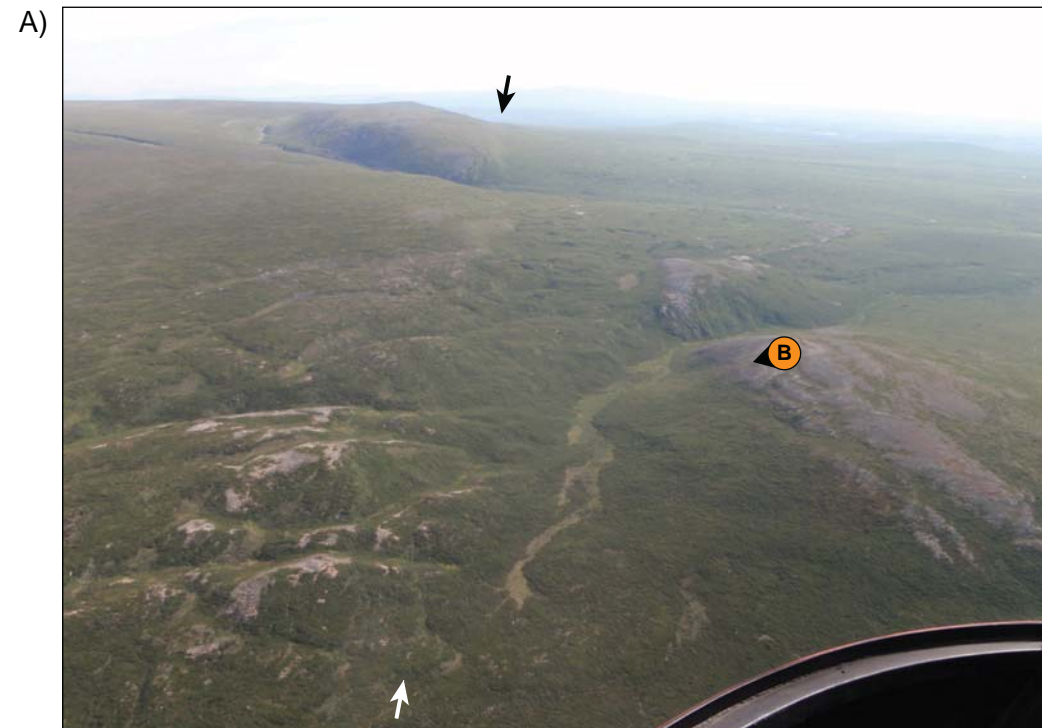
Photograph looking north-northeast from location A along the east-facing break-in-slope that defines the northeast portion of LG 19. Arrows point along alignment of mapped lineaments.

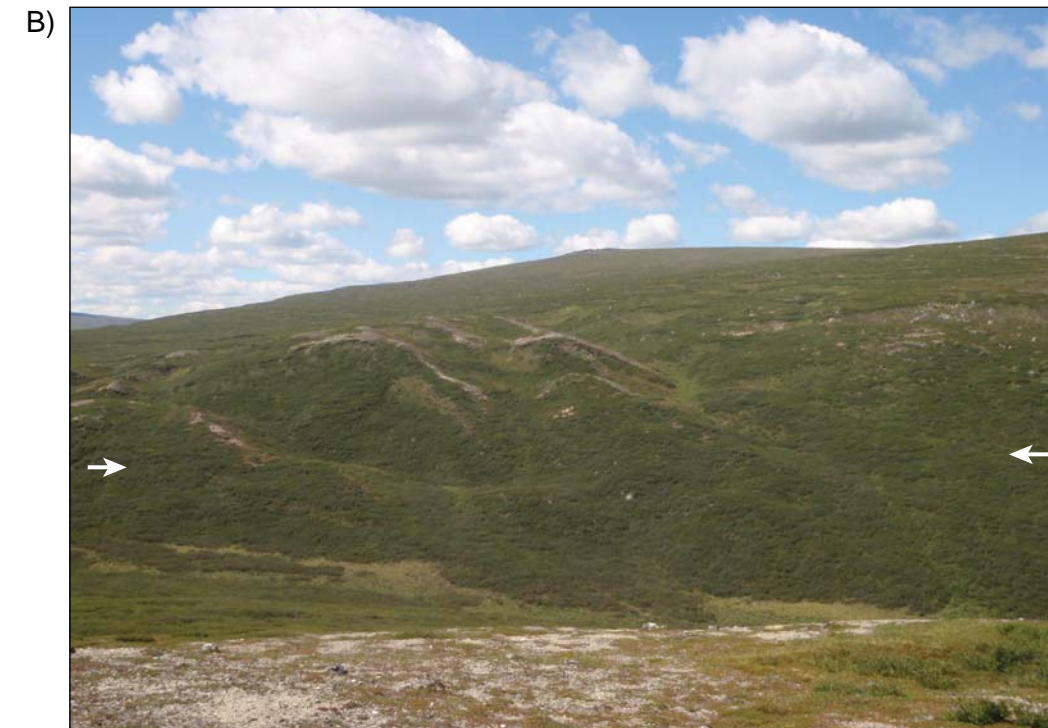
Photograph looking northwest from location B at sub-ice fluvially-eroded channels. Arrows point along the trend of mapped lineaments that make up group 19.

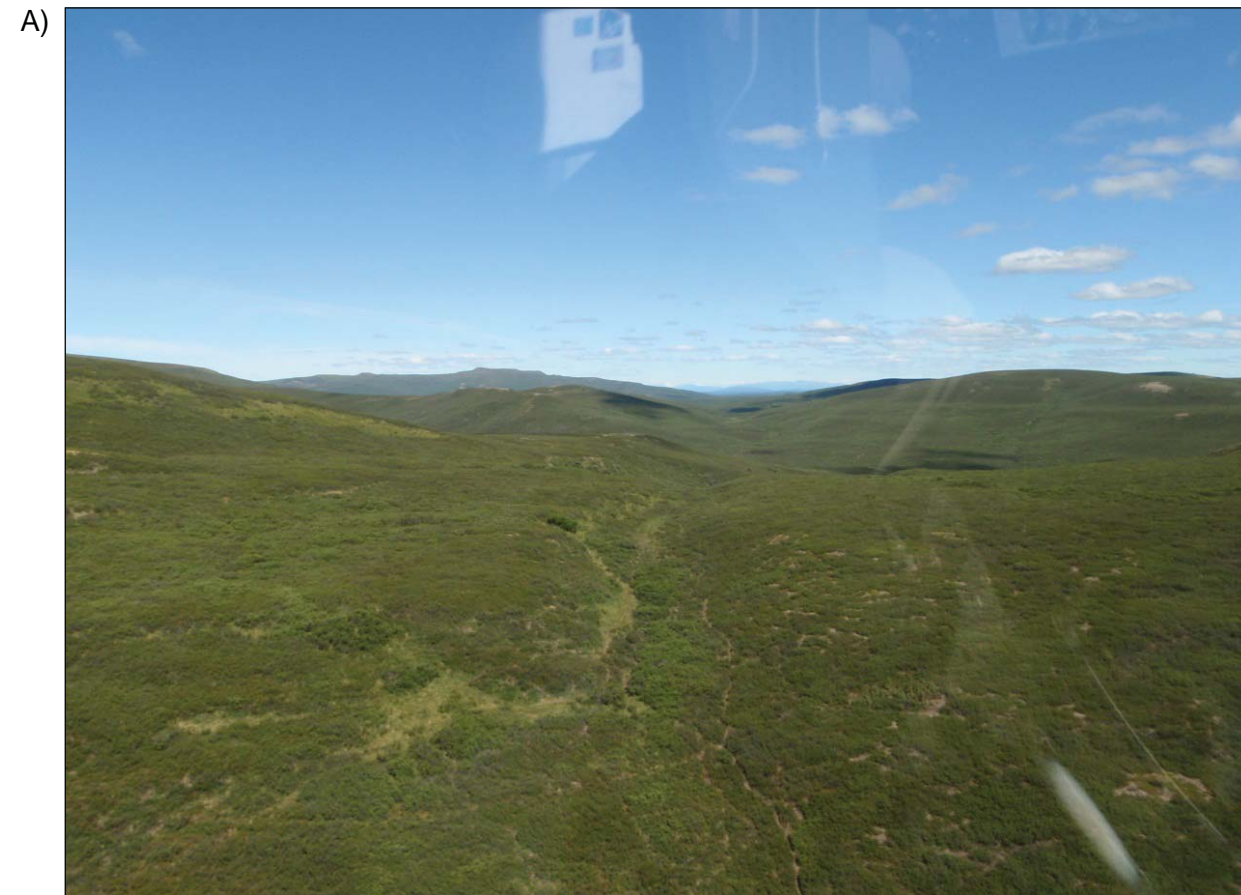
Photograph looking northeast from location A.

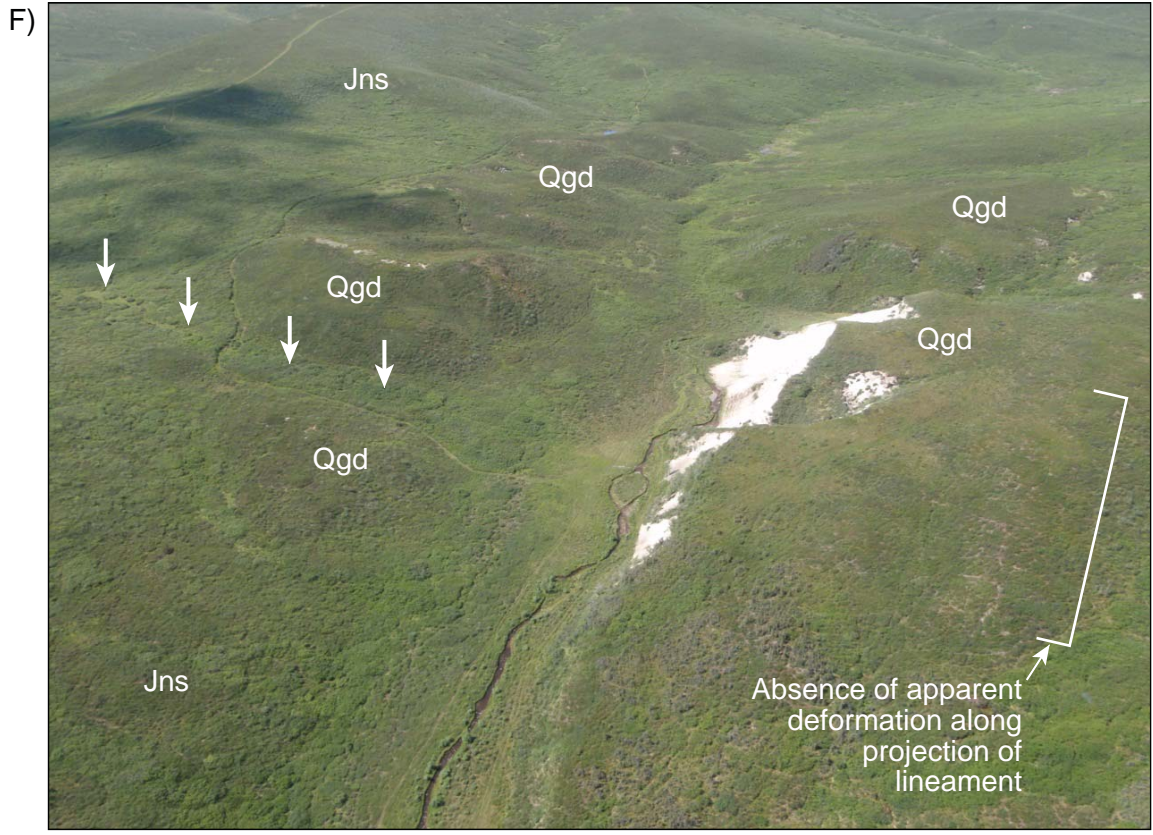
Photograph looking northwest from location F.

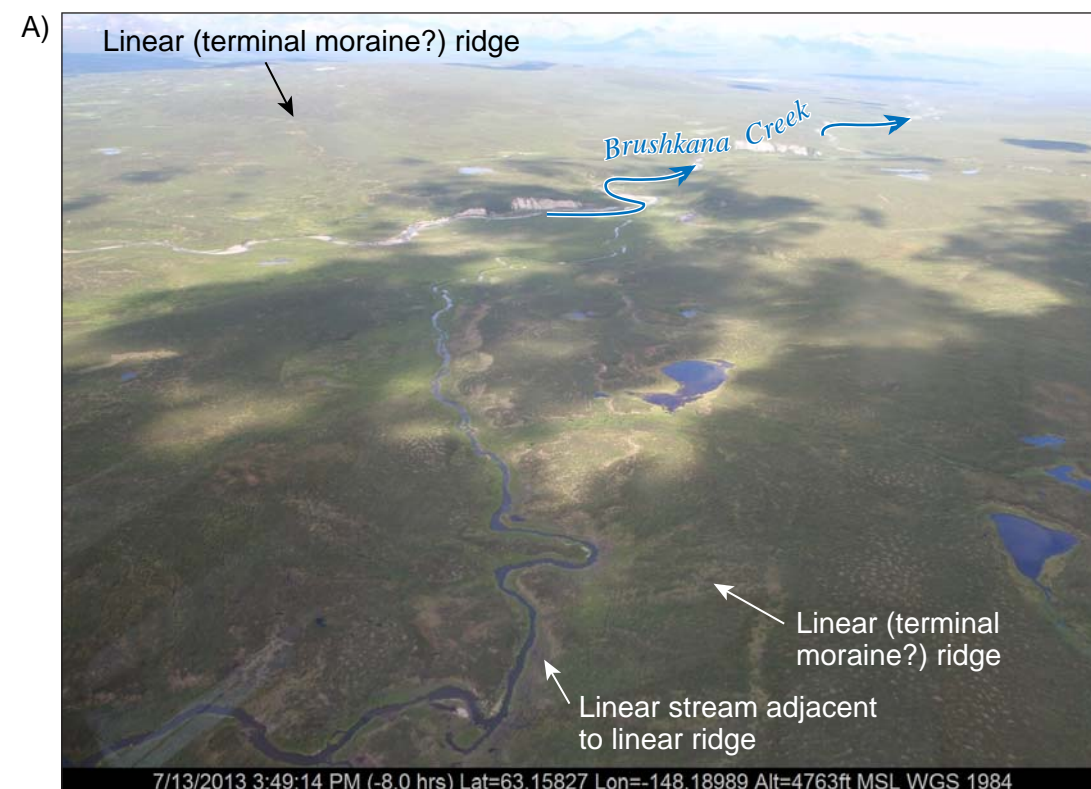
View looking north across Brushkana Creek along north-trending linear ridge and roughly linear stream. Arrows point along alignment of ridges interpreted to be terminal moraine from northeasterly flowing ice.
