SUSITNA-WATANA HYDROELECTRIC PROJECT
 LINEAMENT GROUP 8
 MAP DATA

FIGURE
 A8-2.1

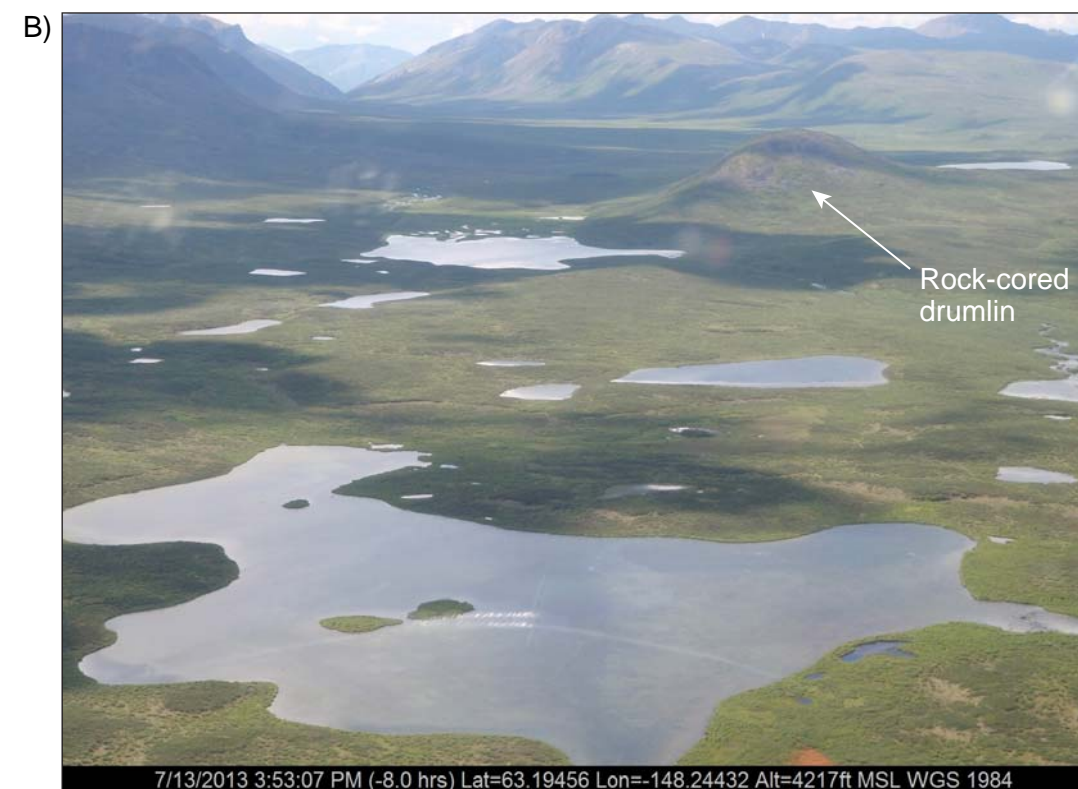
View looking northwest across western portion of lineament group 21a towards approximately 120-meter-tall rock-cored drumlin. View is looking up the Brushkana Creek valley. Note lack of obvious expression of mapped lineaments in the foreground.

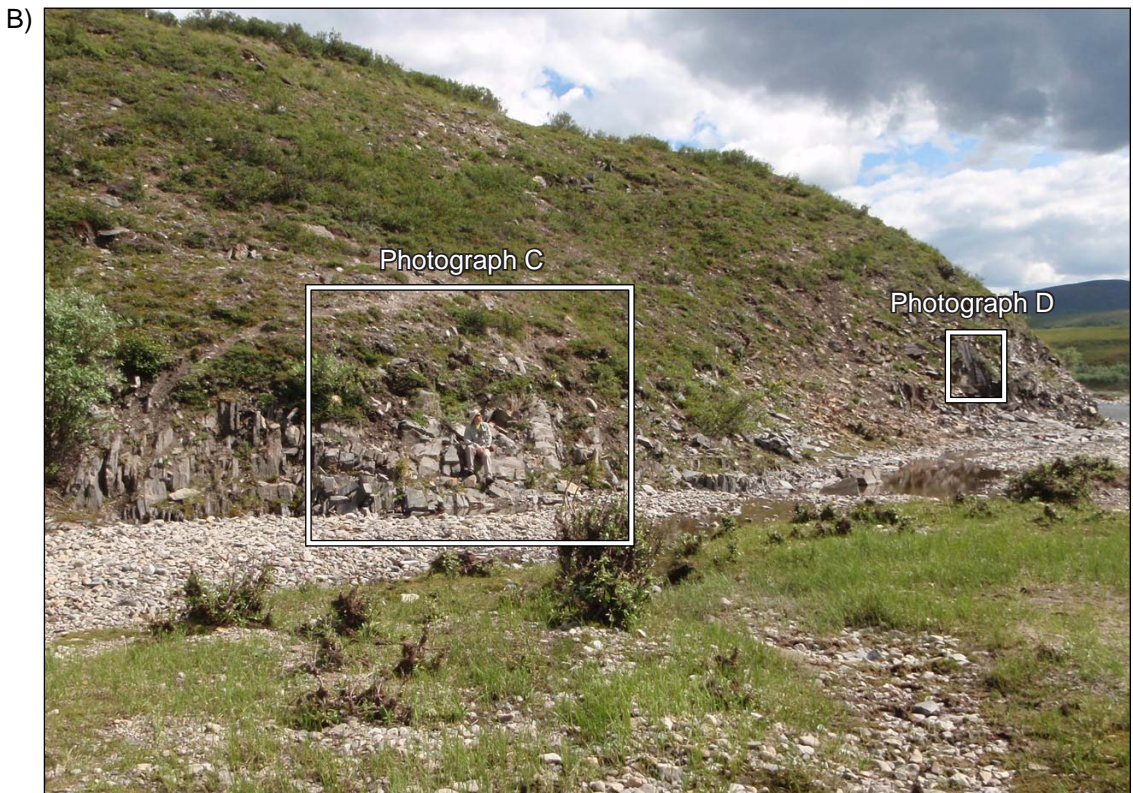
Overview of east-southeast striking, vertically-dipping phyllite exposures located at GPS waypoint 009.

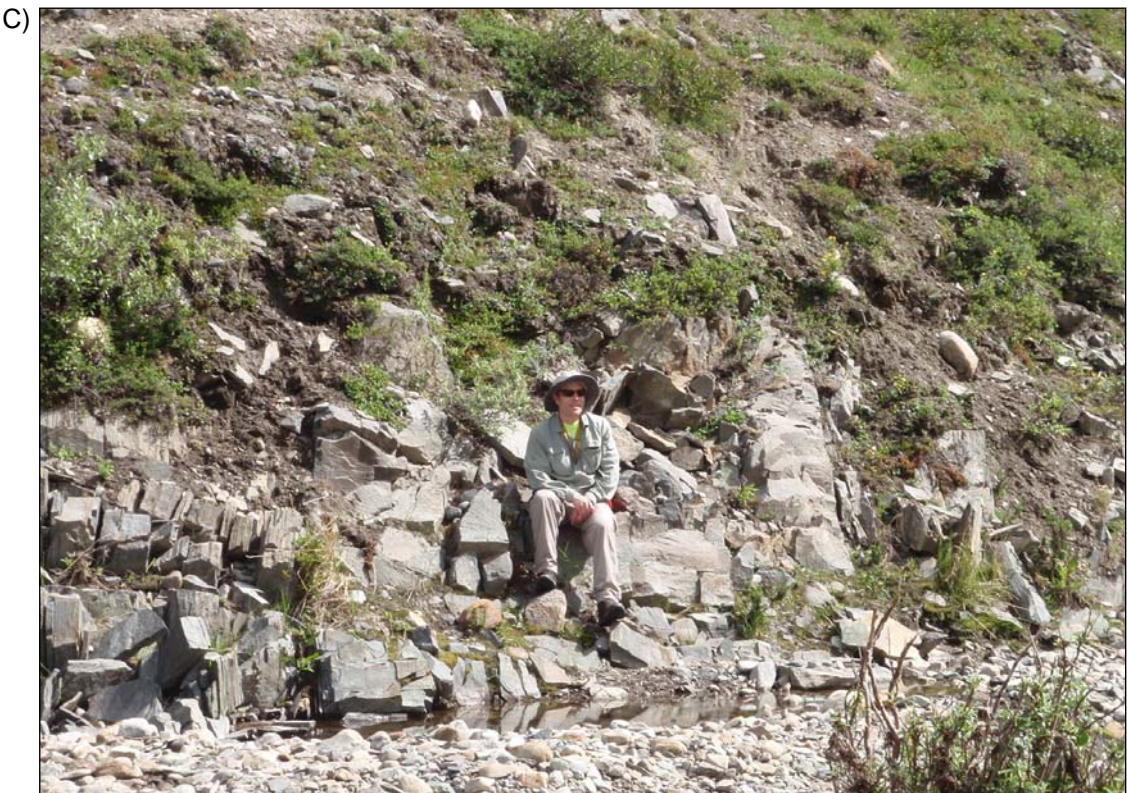
Detail of phyllite exposure showing ~3-meter-wide resistant bed of metamorphosed fine to medium sand. Thick, resistant beds, such as this, are interpreted to create the lineament shown by small arrows in Photograph A above. Geologist for scale.

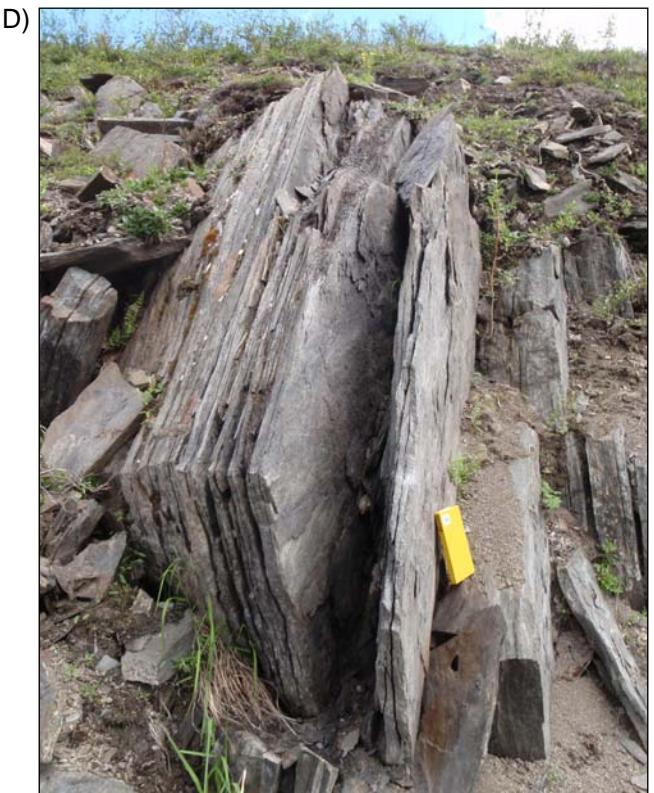
Detail of vertically-dipping phyllite.

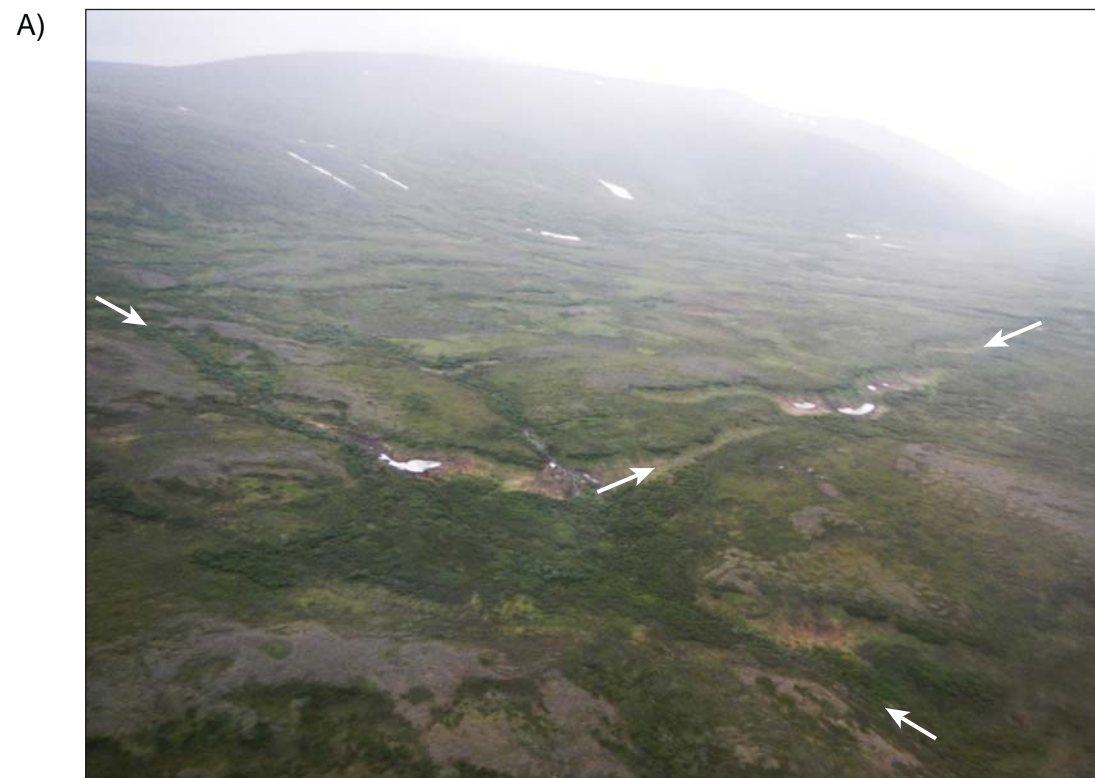
View looking north-northeast up the Deadman Creek valley. Note the numerous downhill-facing solifluction scarps. Large arrows point along mapped lineaments.

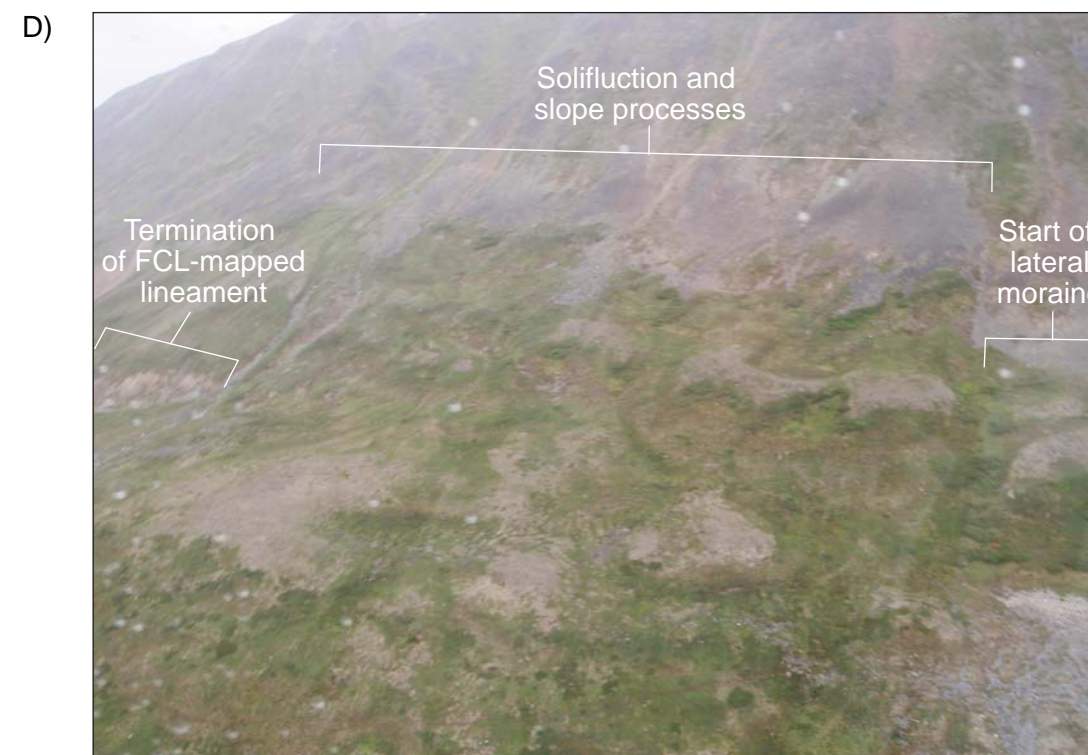
View looking northeast at area of solifluction and termination of mapped lineament.
