SUSITNA-WATANA HYDROELECTRIC PROJECT
 LINEAMENT GROUP 26
 MAP DATA

SUSITNA-WATANA HYDRO

AEA11-022

Appendix B:
Strip Maps and Photographic Documentation
of Lineament Data for Lineaments Mapped by Reger et al. (1990)

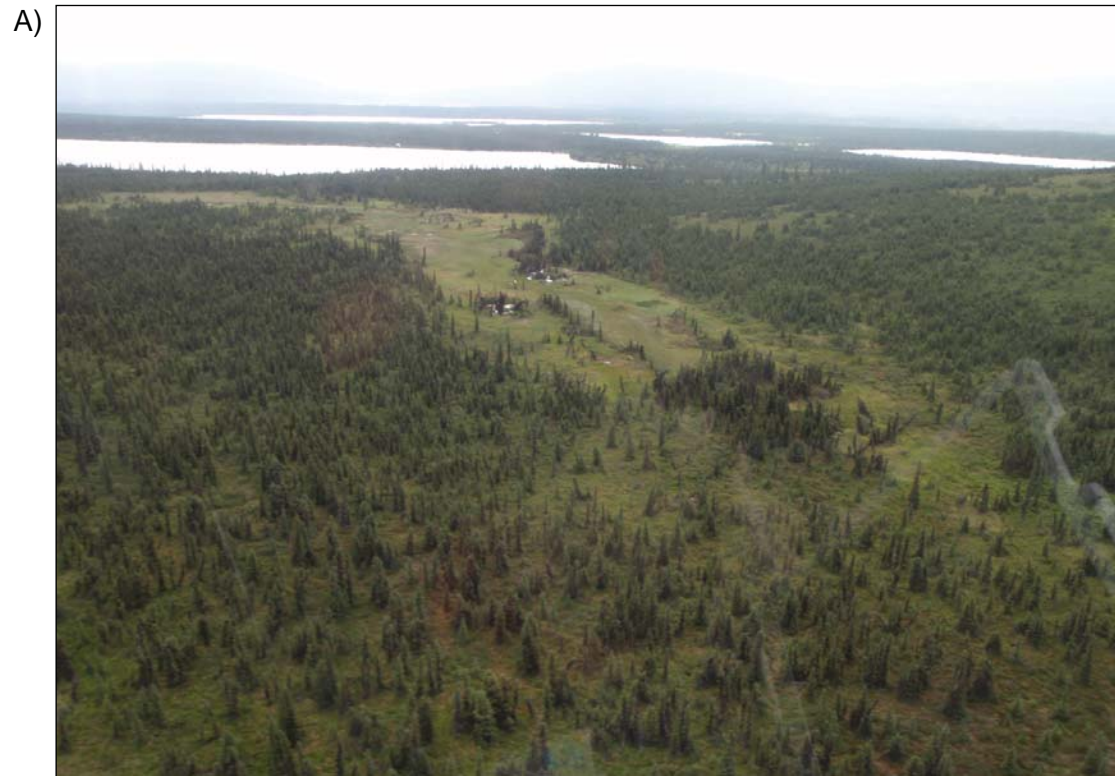
View looking southeast at esker landform that projects across mapped lineaments and appears undeformed or offset.

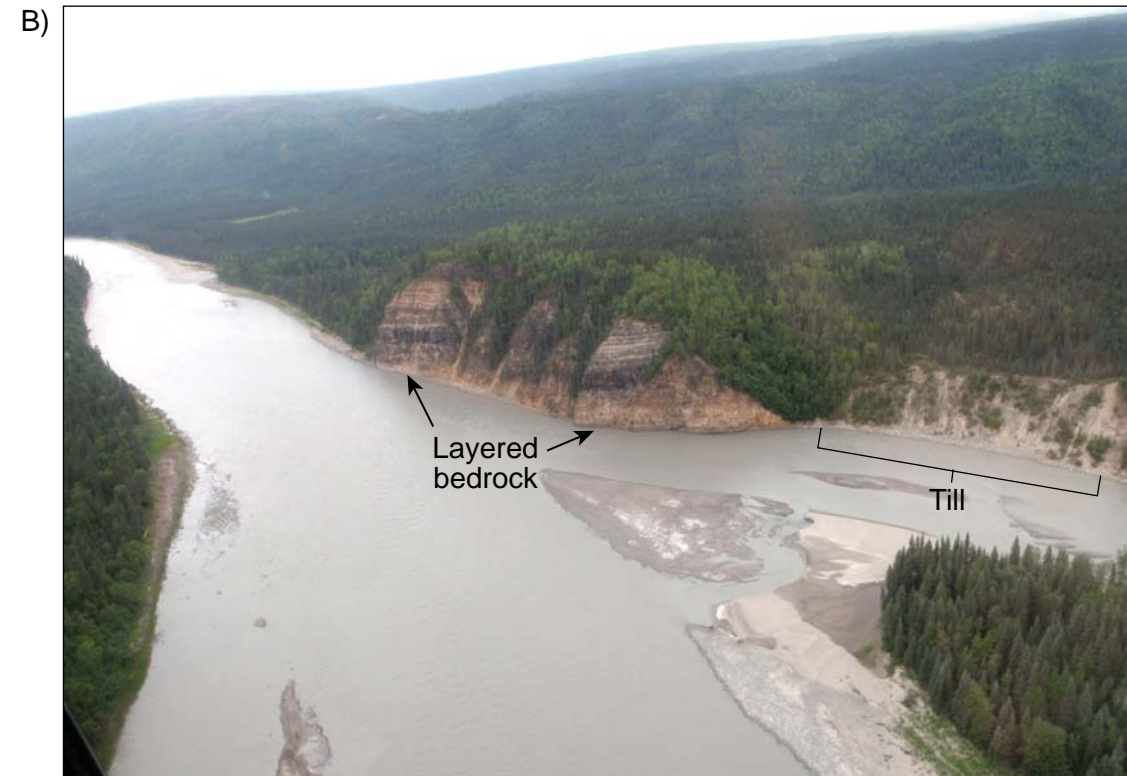
View looking northwest at layered bedrock (on left) with apparently undisrupted horizontally-bedded till (on right).

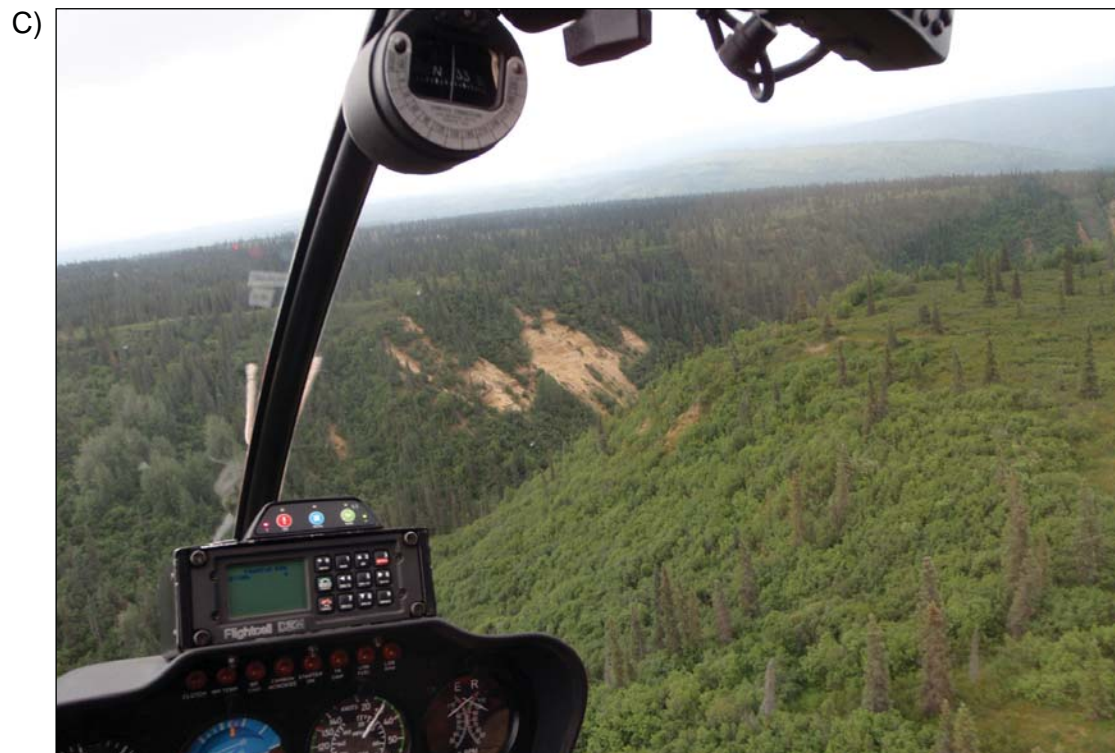
View looking southeast at exposure in left bank of unnamed drainage creek where till apparently overlies lake sediments and fluvial washout gravel. The lenticular beds in the fluvial gravel appear horizontal but are not laterally extensive.

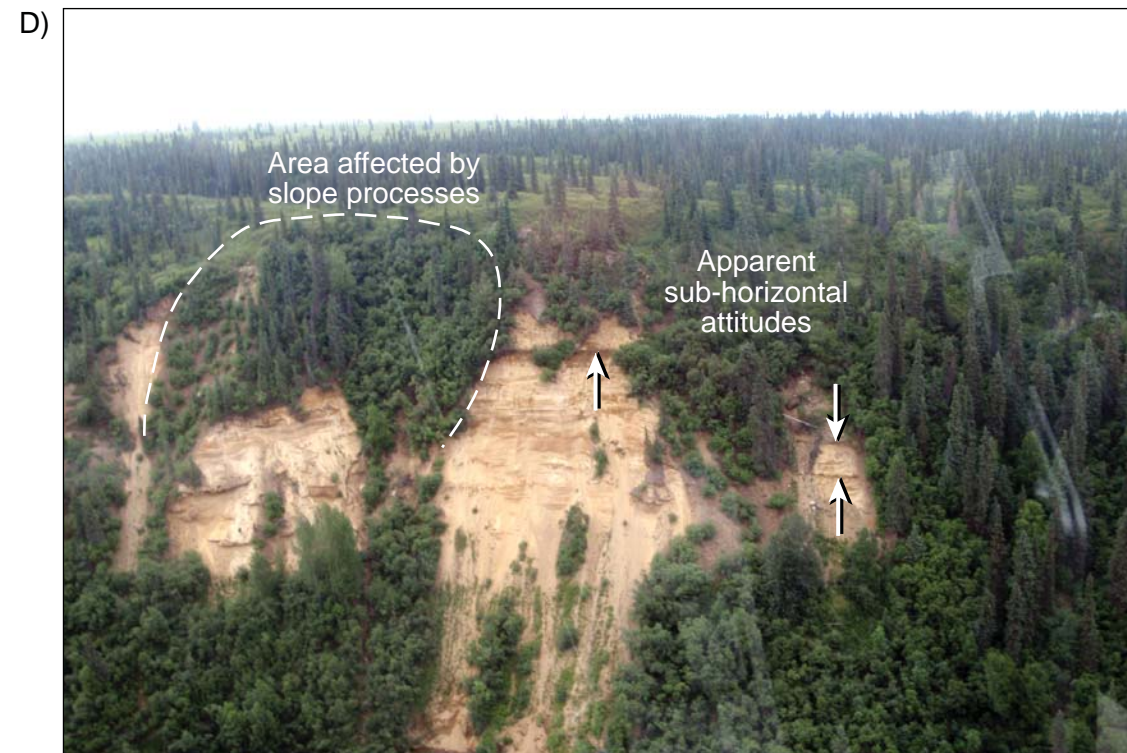
Close up view of exposure shown in Photograph (B). Note the apparently sub-horizontal basal contact between overlying till and underlying lacustrine deposits. Note sediments on the left of the image are influenced by landslide processes and not in-place locally.

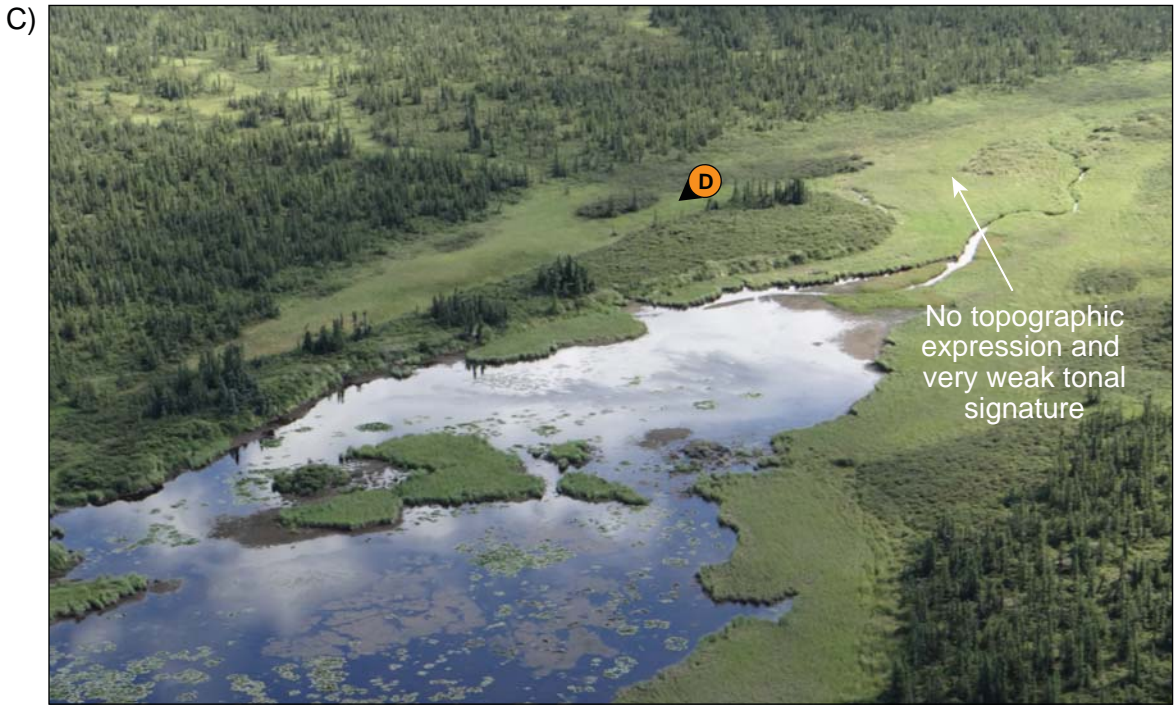
View looking south across strong vegetation lineament associated with a ~2-meter-high linear ridge. Note that topographic expression of ridge abruptly dies out and does not continue to the west.

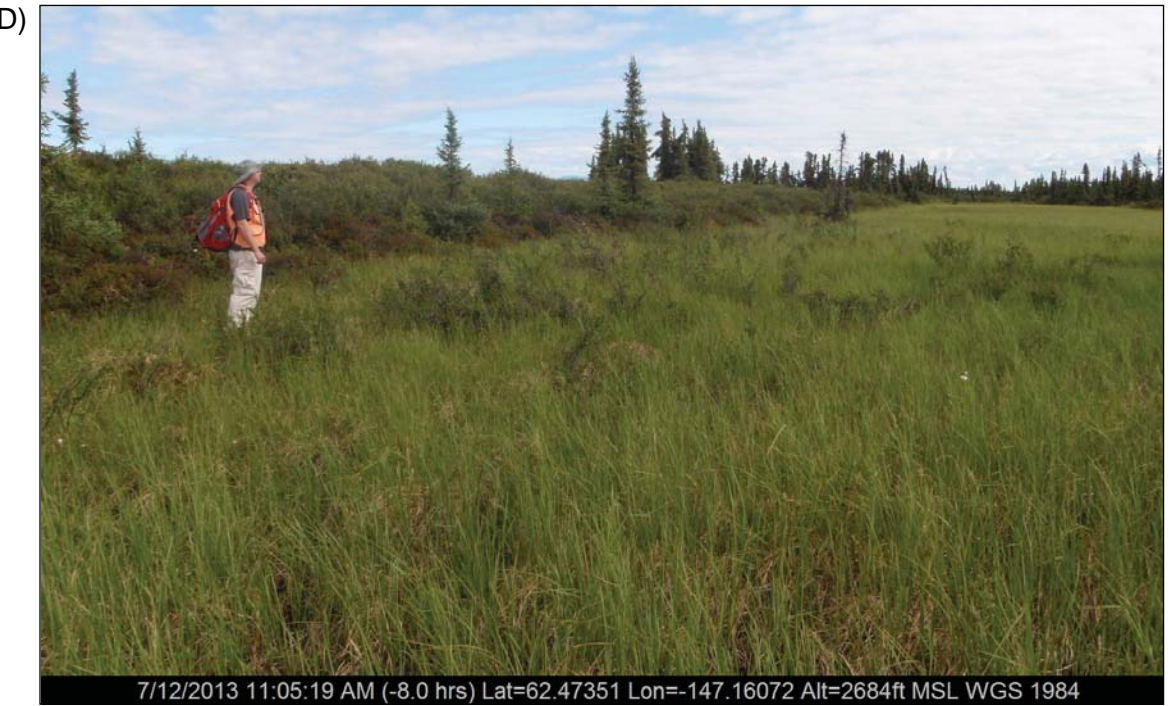
View looking northeast along south side of vegetation lineament and ~2-meter-high linear ridge shown in Photograph C. Positive feedback of vegetation growth and organic matter accumulation on the linear ridge may accentuate the apparent relief of the ridge.

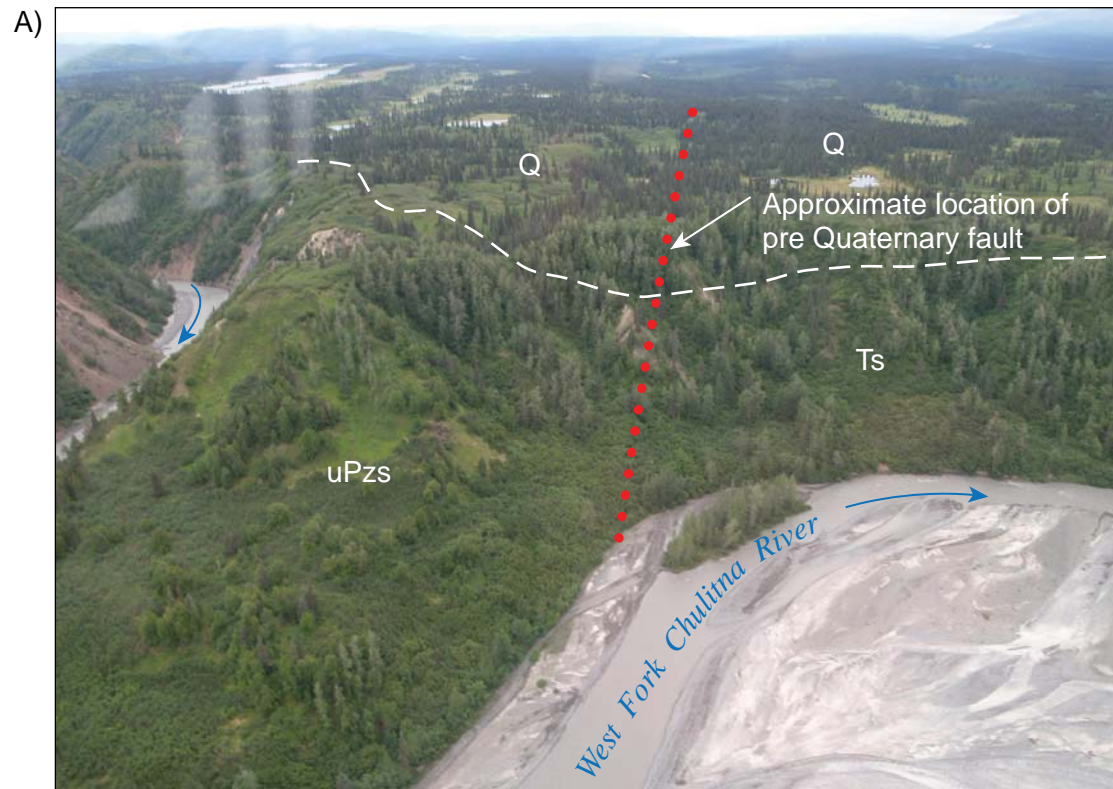
View looking north at location where mapped fault would traverse across Quaternary sediments.

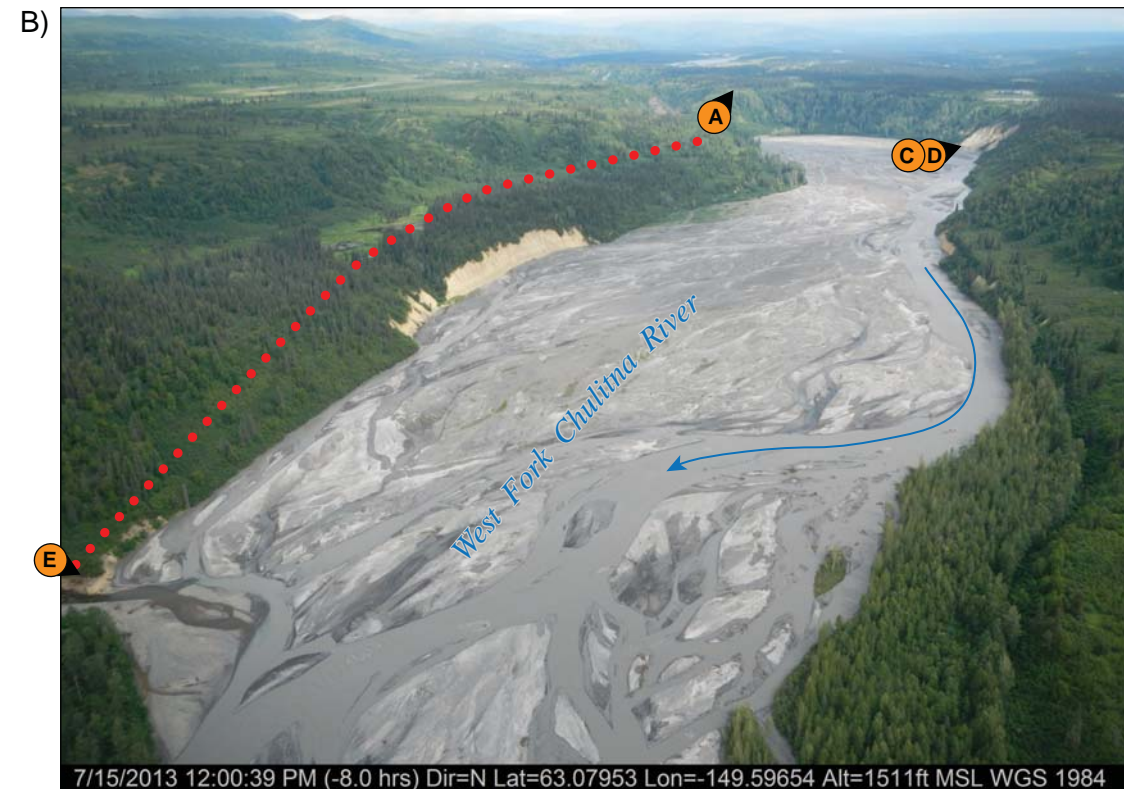
View looking north (upstream) along the West Fork Chulitna River valley at exposures described in text and photographs below.

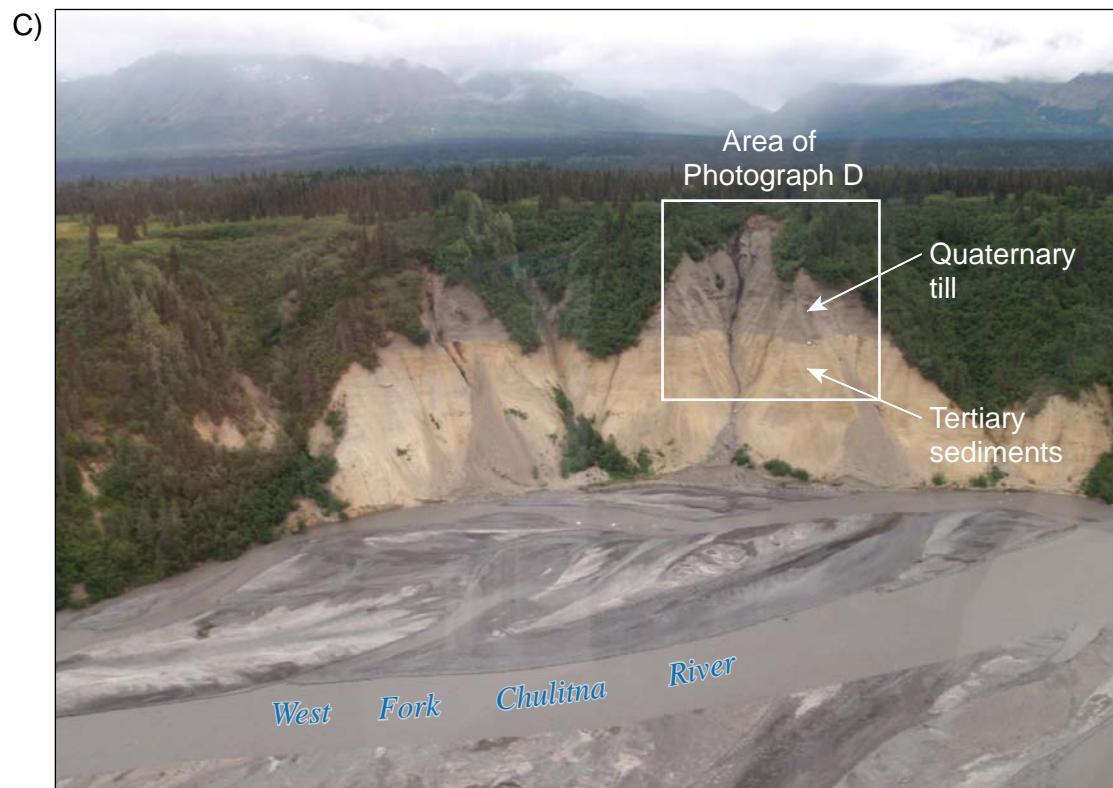
View looking west at exposure along east bank of the West Fork Chulitna River demonstrating Quaternary till overlying Tertiary fluvial sediments.

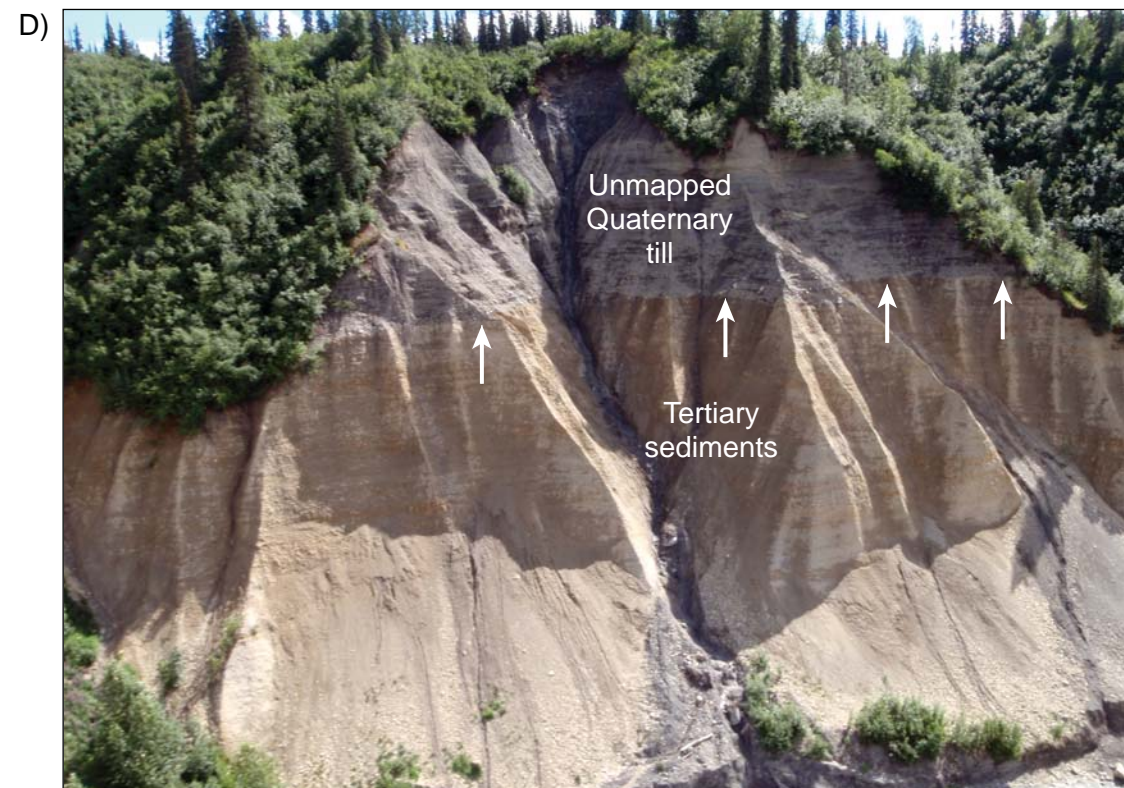
Close up view of exposure shown in Photograph C. Basal contact between overlying till and underlying fluvial deposits appears to be sub-horizontal.

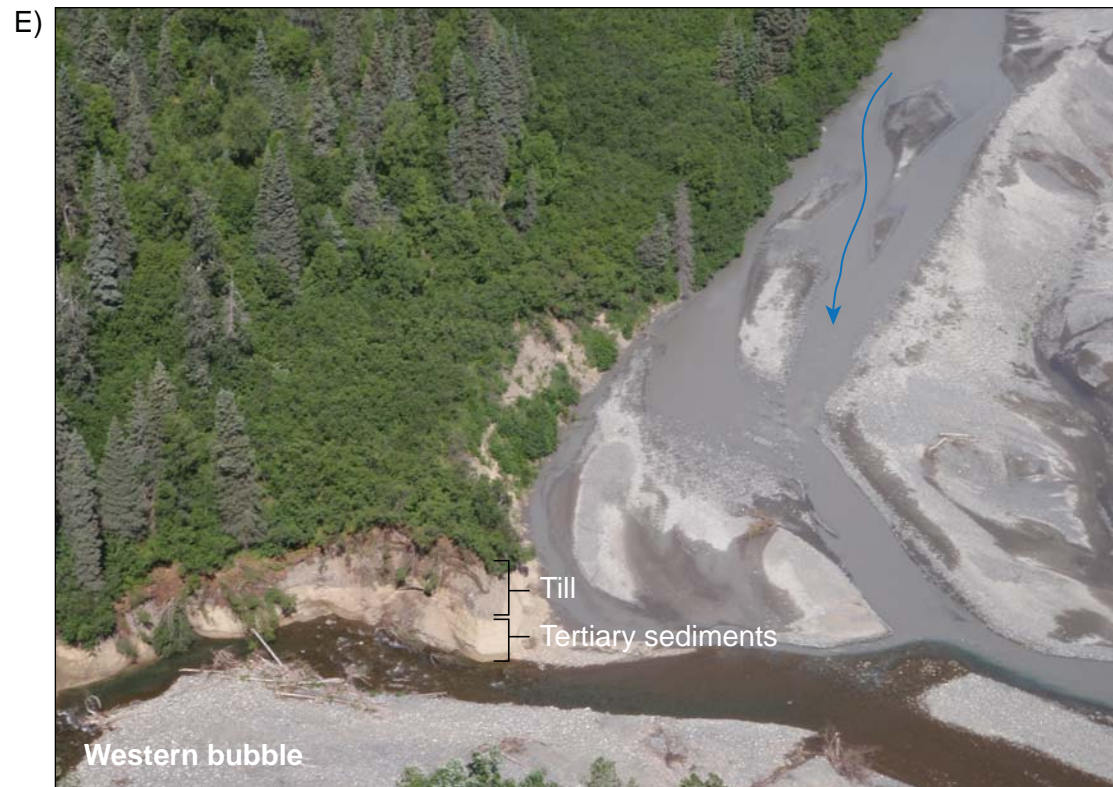
View looking northeast at subhorizontal contact between till and Tertiary sediments.

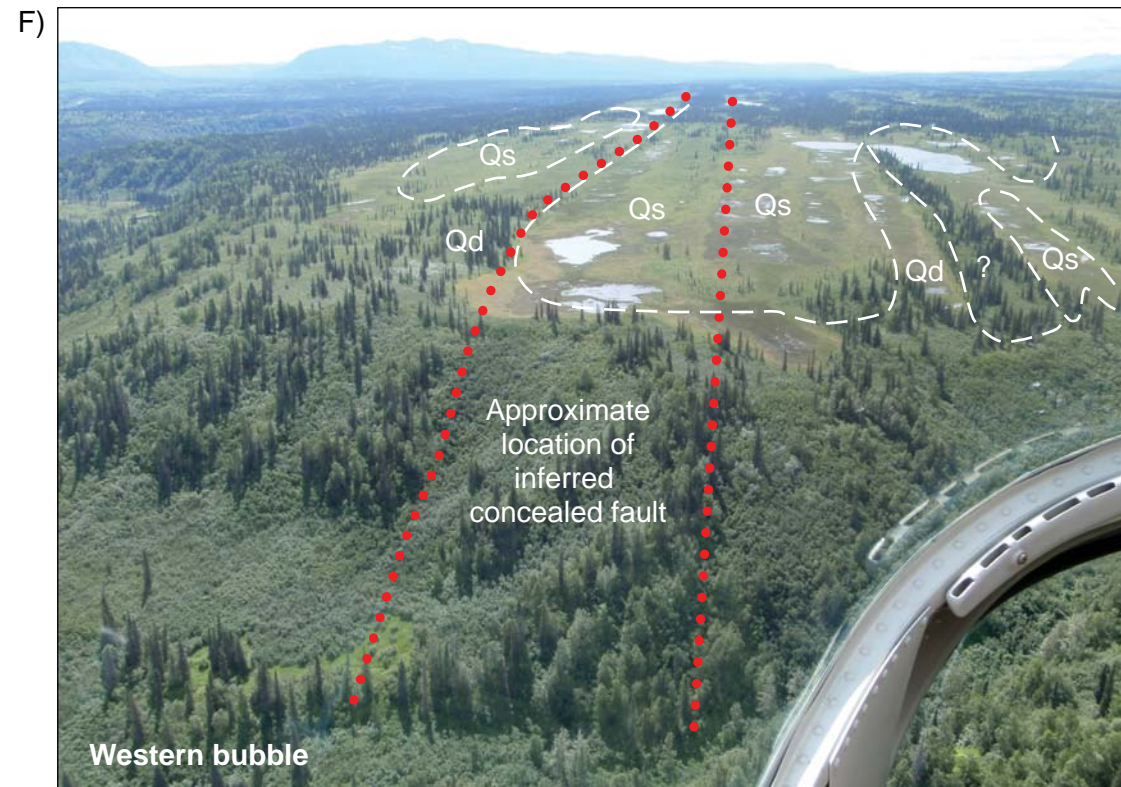
View looking south along Quaternary surface directly south of river valley. Marshy Quaternary sediments show no evidence of deformation or offset.

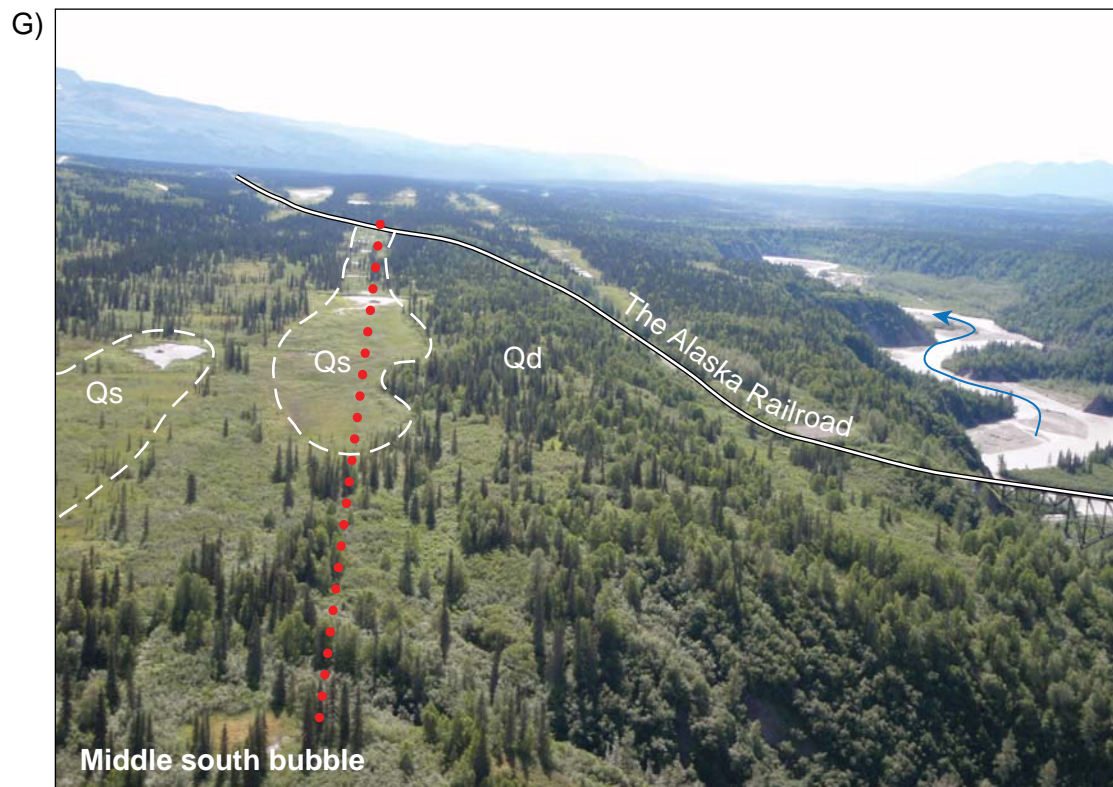
View looking south at location where inferred fault would traverse east of railroad tracks. Fault is mapped as juxtaposing Triassic and Cretaceous rocks outcropping in creek behind photograph. No evidence of faulting in Quaternary deposits.

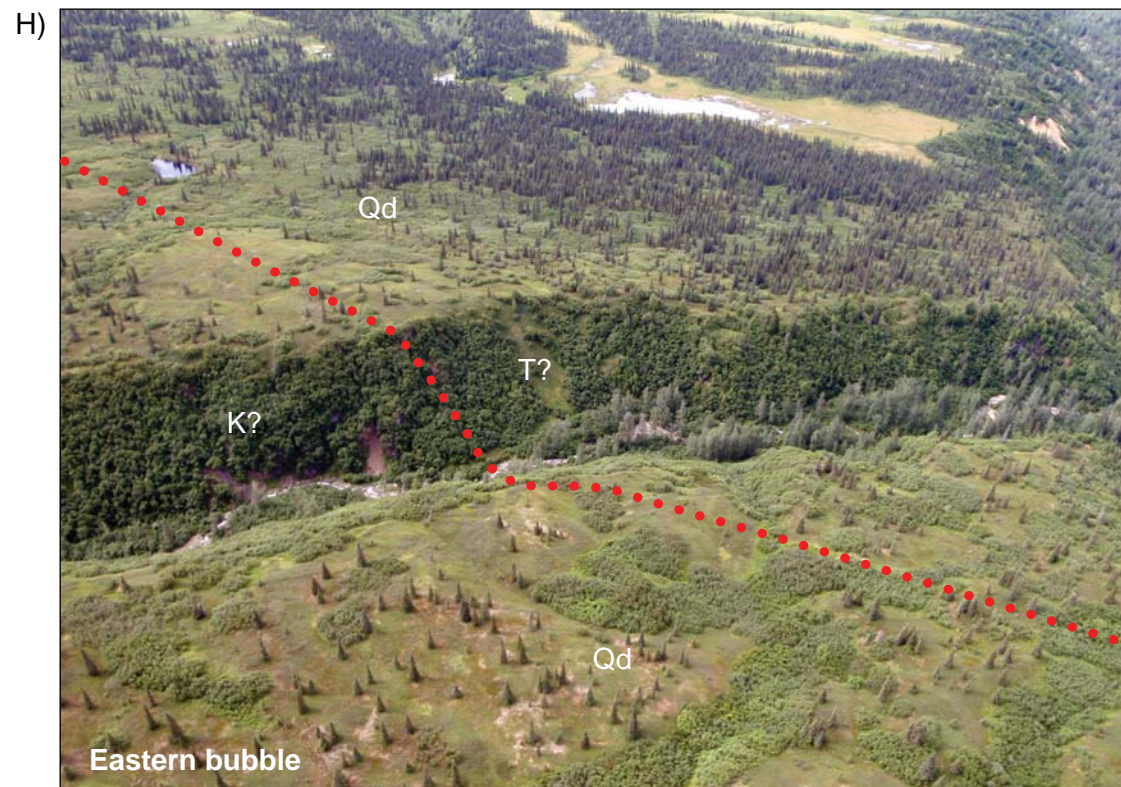
View looking west at creek exposure along projection of mapped fault that depicts Cretaceous/Tertiary juxtaposition. Undisturbed surfaces support absence of Quaternary faulting.

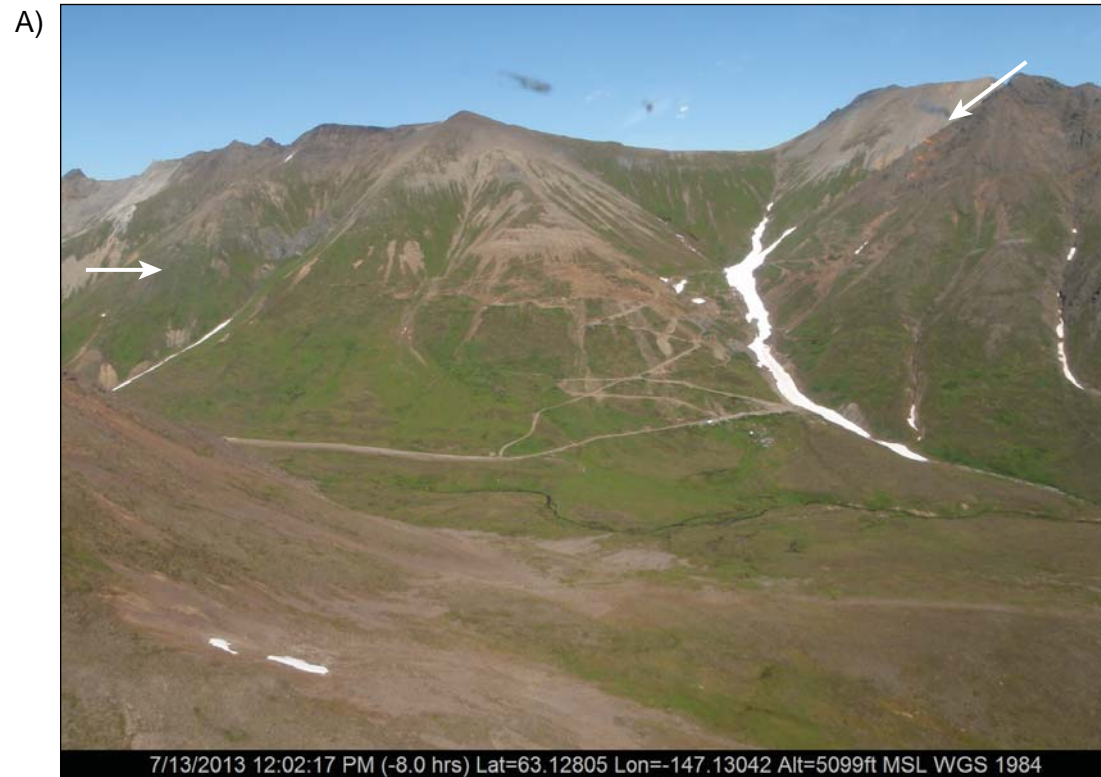
View looking northwest at mine site located along apparent rock type contrast and mapped fault. Arrows point along mapped fault.

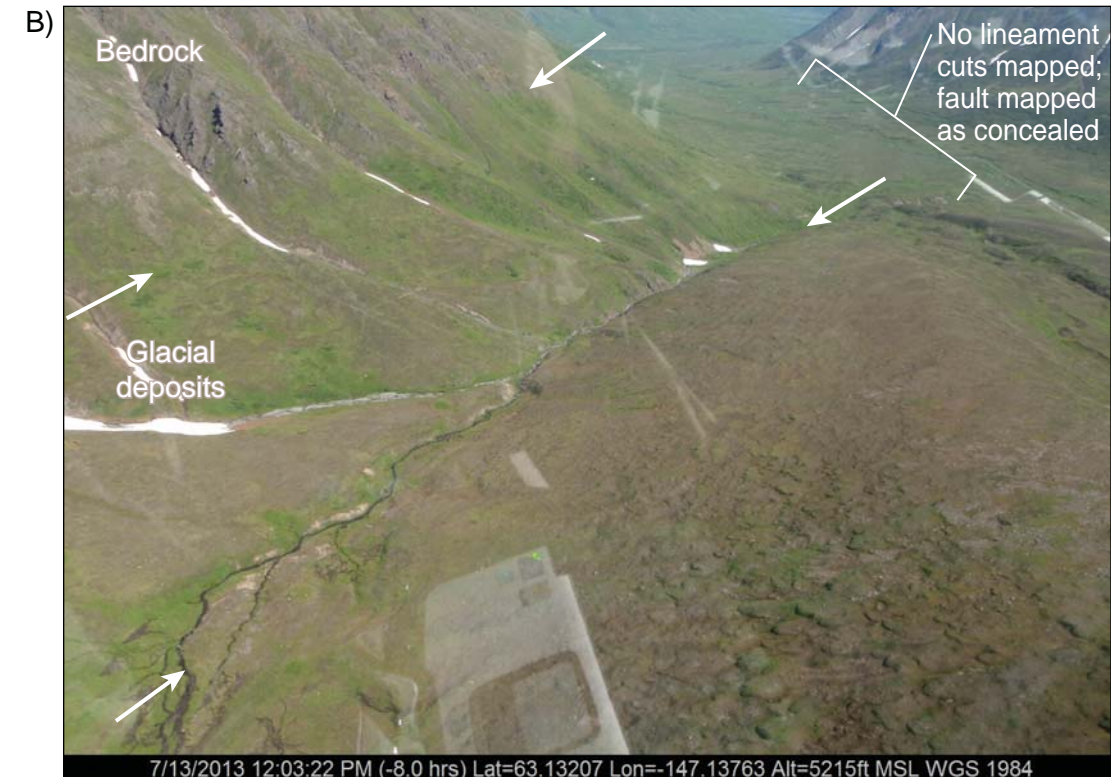
View looking northeast along linear drainage mapped as a lineament by FCL that coincides with a mapped fault. Another FCL-mapped lineament lies at the subtle break-in-slope and may correspond to the ice limit elevation.

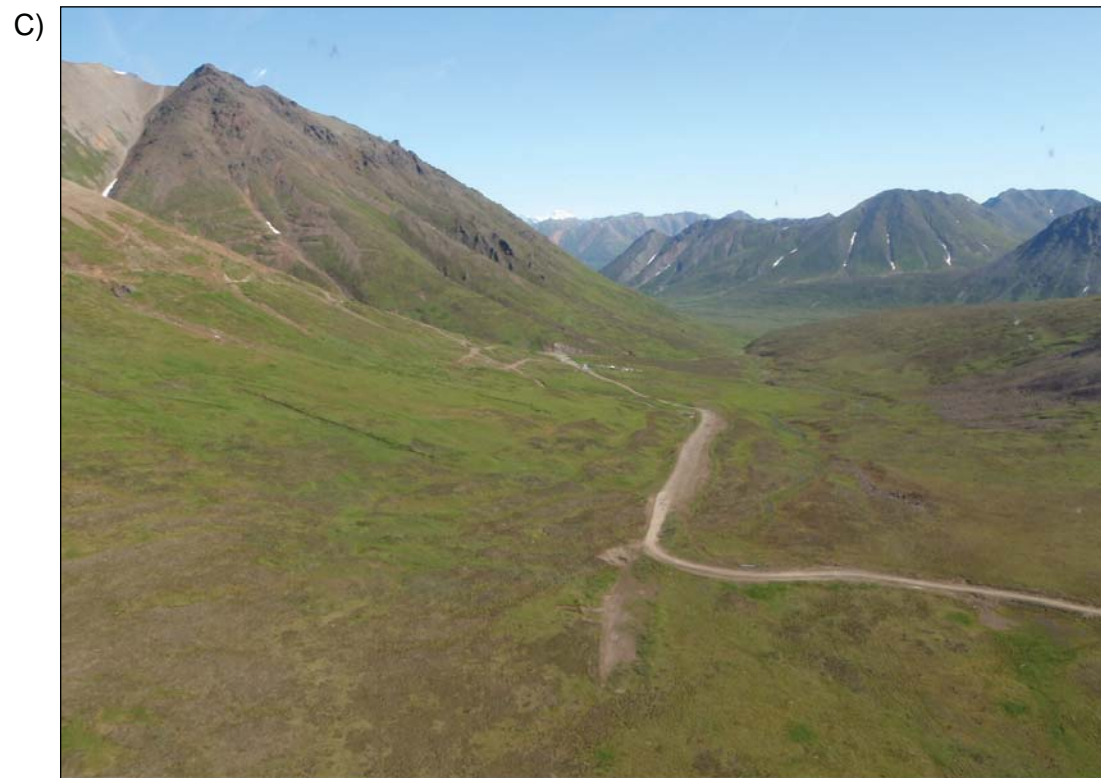
View looking northeast through the broad saddle at the head of the linear drainage shown in Photograph B. Note the absence of any tectonic geomorphic features.

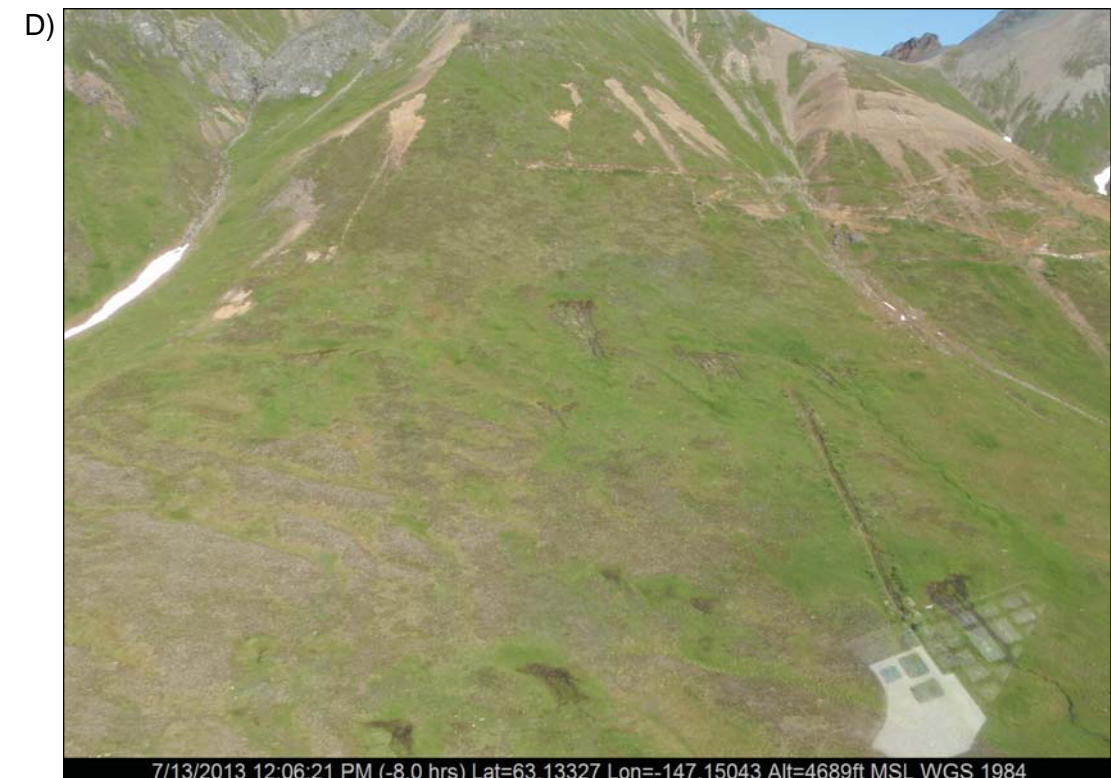
View looking northwest at location of FCL-mapped lineaments and mining roads partly shown in Photograph C. Note that FCL-mapped lineaments on the sidehill are not readily apparent and correspond to subtle break-in-slope like that shown in Photograph B.

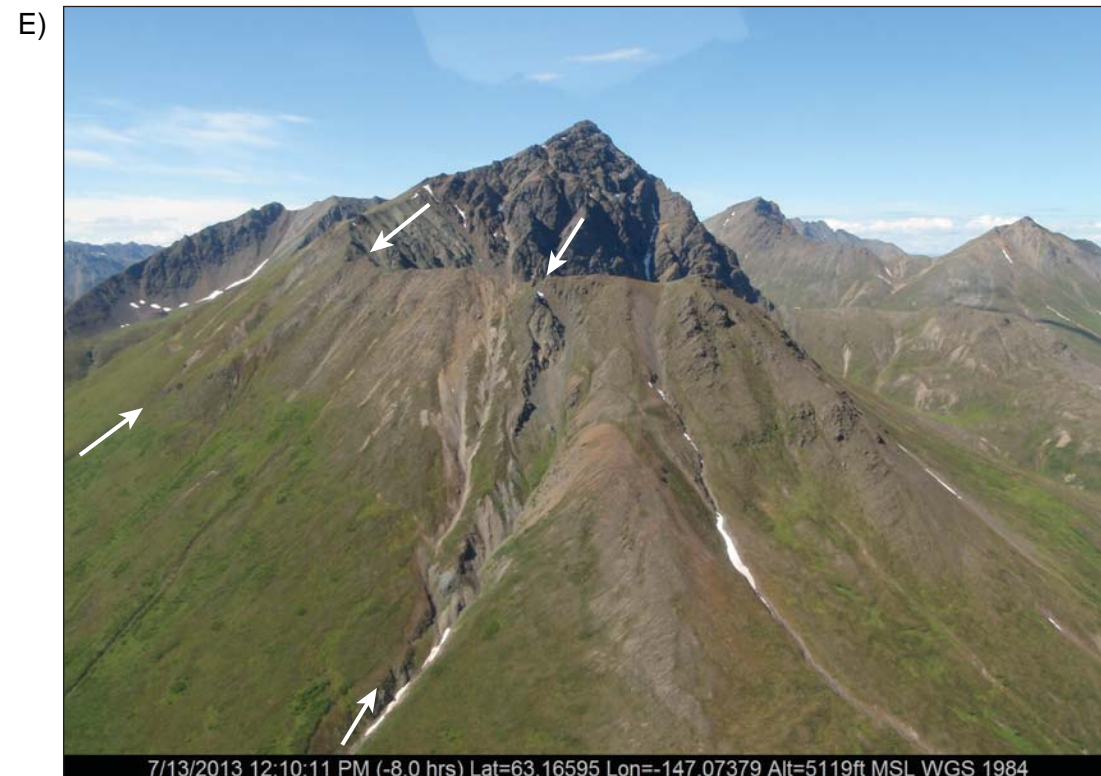
View looking southwest at several rock type contrasts (shown by arrows) that coincide with previously mapped faults.

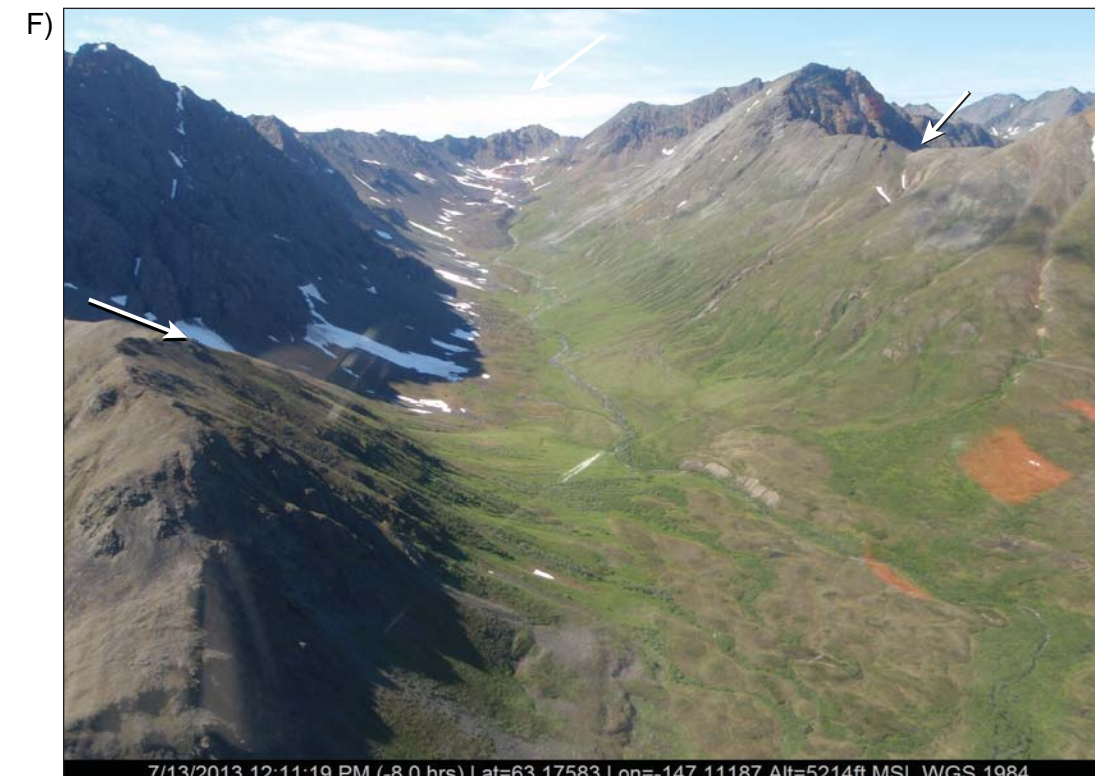
View looking south-southwest up glaciated valley that shows no expression of the mapped Black Creek fault that is present in adjacent bedrock ridges.

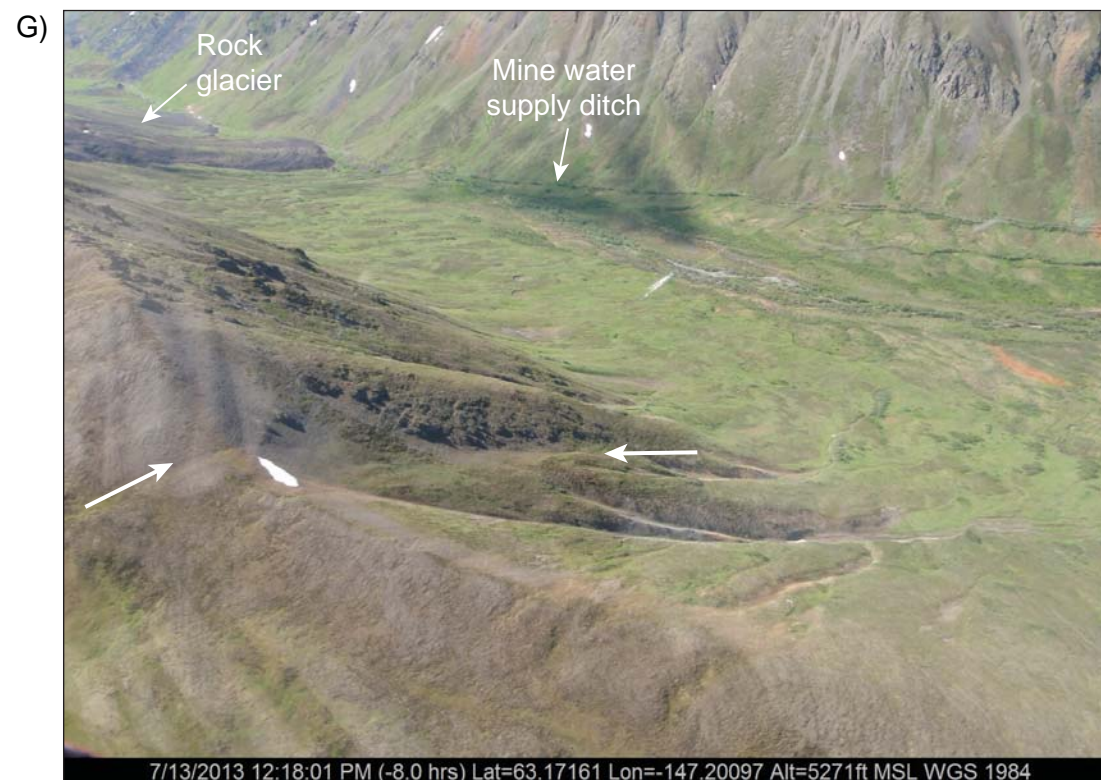
View looking southwest across an FCL-mapped lineament that corresponds to the trace of mapped Black Creek fault marked by a rock contrast. Note that no expression of faulting exists along trend in the glacial sediments of the valley floor.

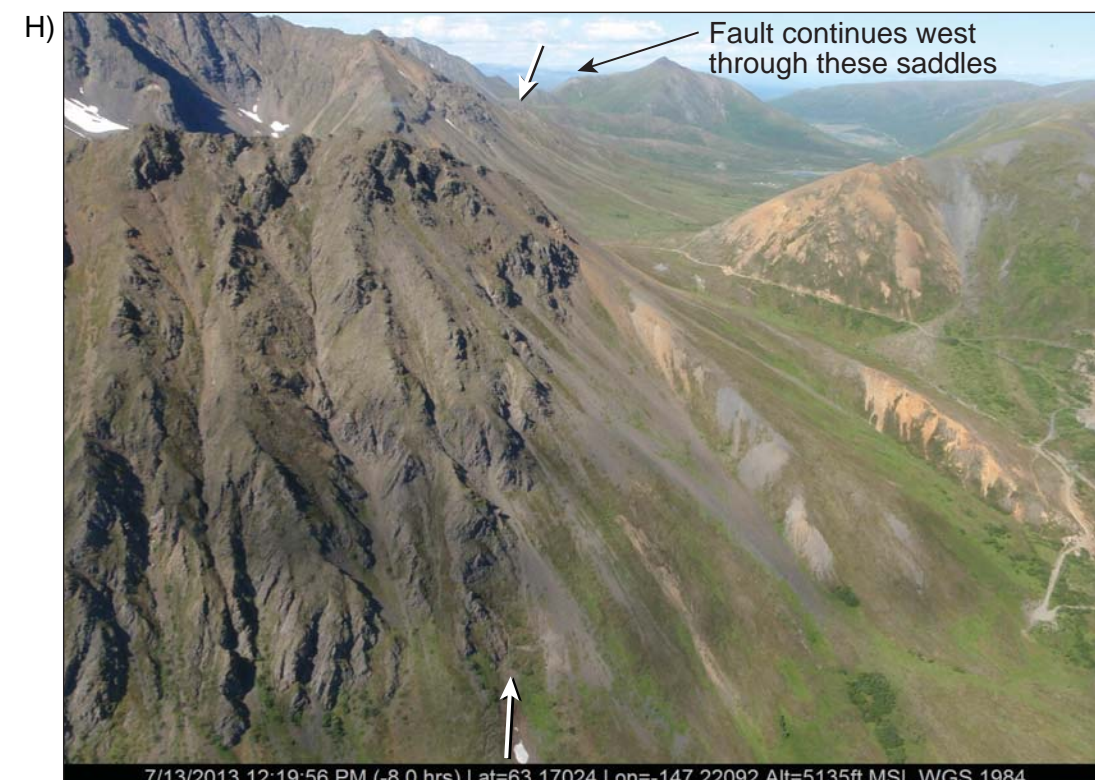
View looking west along the Black Creek fault. Note the obvious rock type contrast across the fault. Aerial reconnaissance confirmed the presence of the fault in bedrock ridges to the west and the lack of expression in glacial sediments in adjacent valley bottoms.

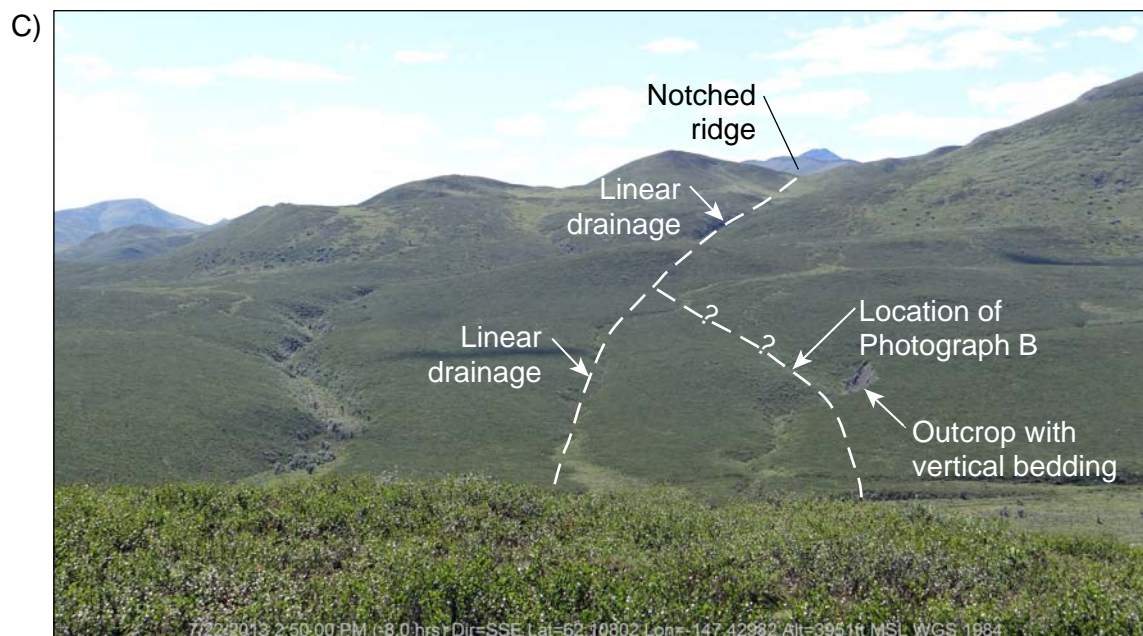
View looking southwest from location C. Note alignment of features over mapped trace of fault.

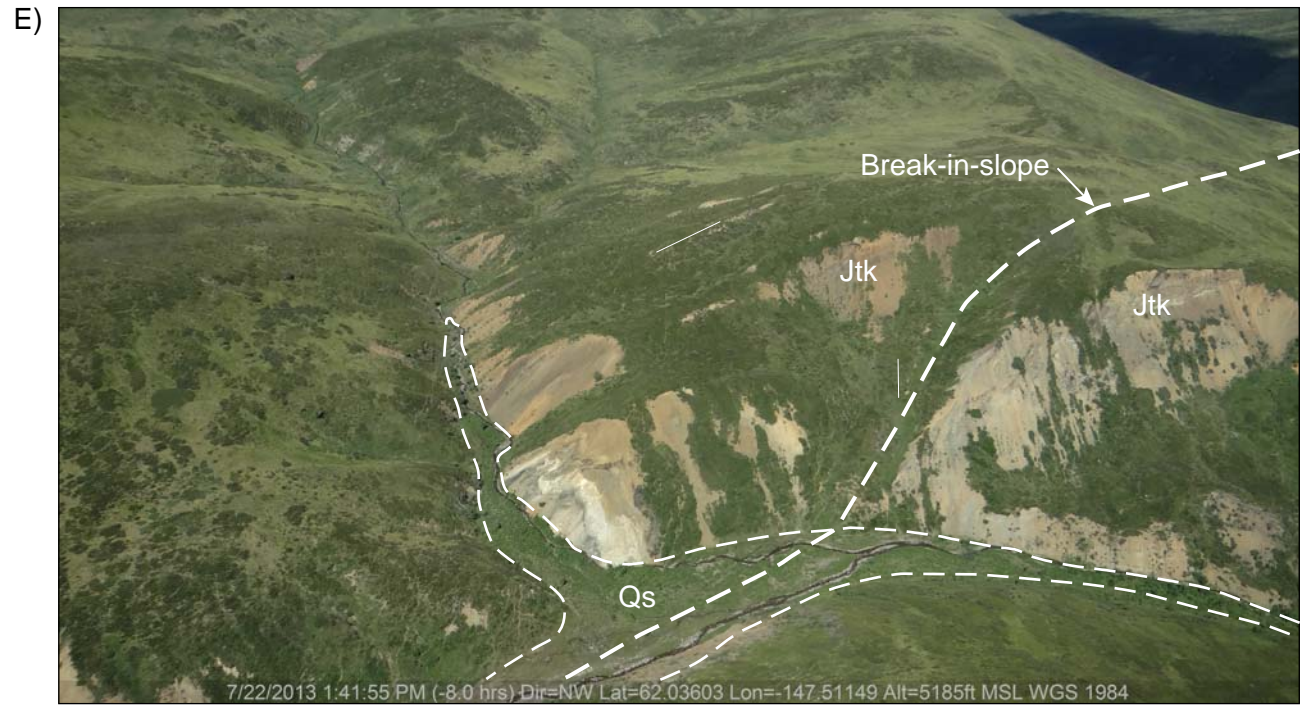
View looking northwest from location E at faulted Jurassic units. The fault occupies the linear valley then climbs the hill-slope where it correlates with a clear break-in-slope on the ridge crest.

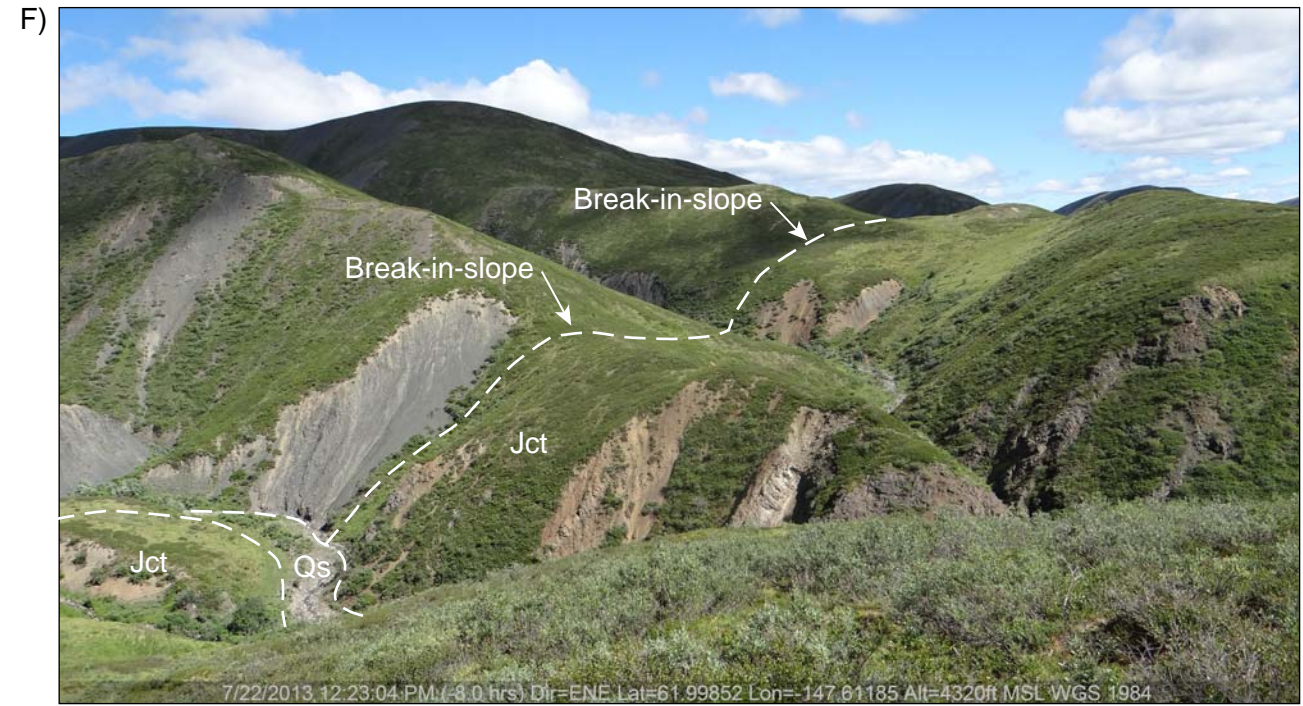
View looking north-northeast from location F. The fault juxtaposes Cretaceous against Jurassic bedrock and coincides with a break-in-slope on each ridge crest.
