SUSITNA-WATANA HYDROELECTRIC PROJECT
 LINEAMENT GROUP 26
 MAP DATA

SUSITNA-WATANA HYDRO

AEA11-022

Appendix B:
Strip Maps and Photographic Documentation
of Lineament Data for Lineaments Mapped by Reger et al. (1990)

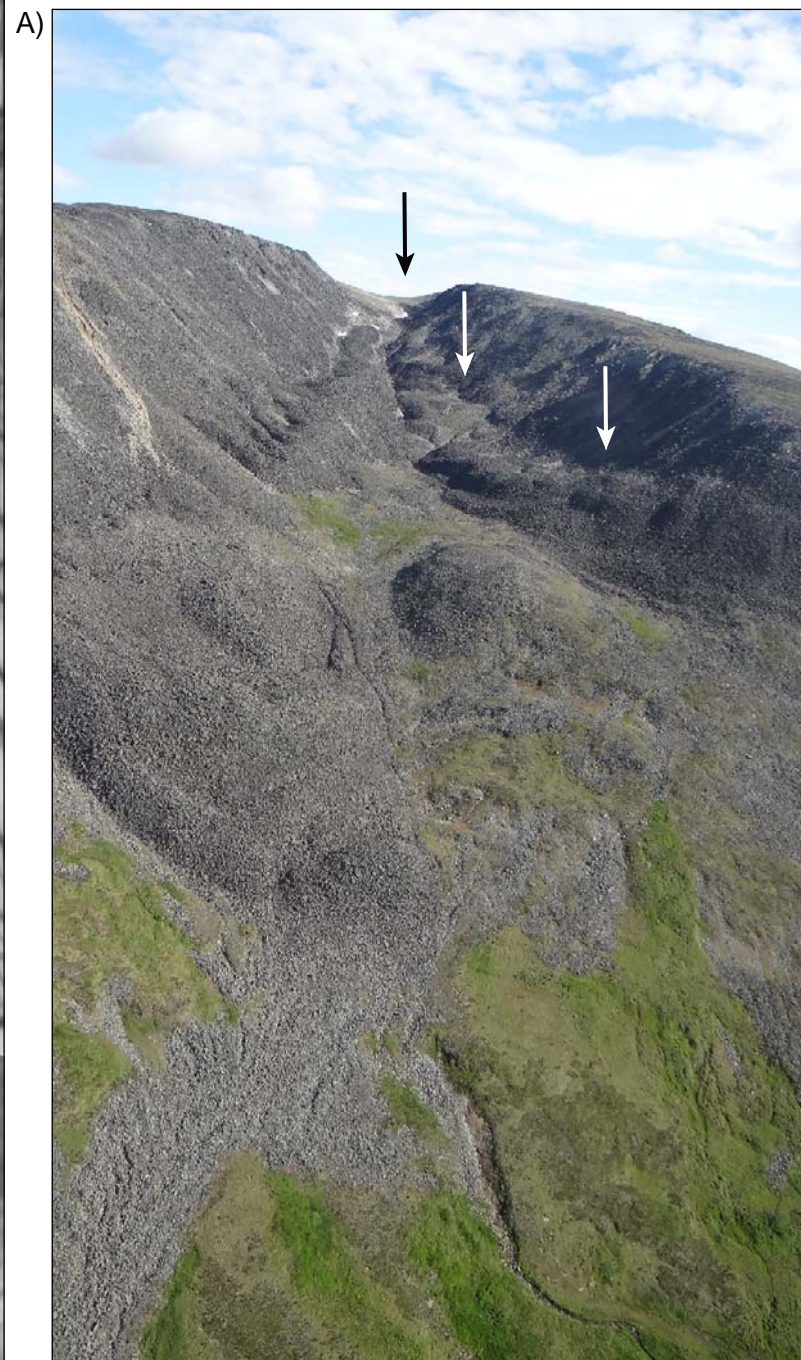
View looking northeast from location A. Arrows show location of mapped trace of lineament.

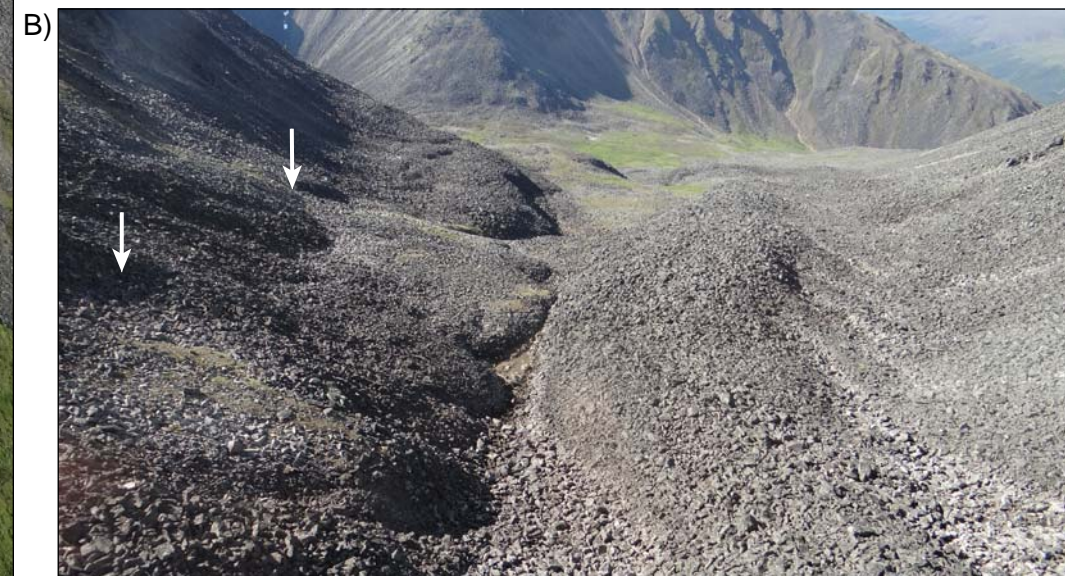
View looking southwest from location B. Arrows show the location of lineament. Note the semi-linear and lobate toe of talus deposit.

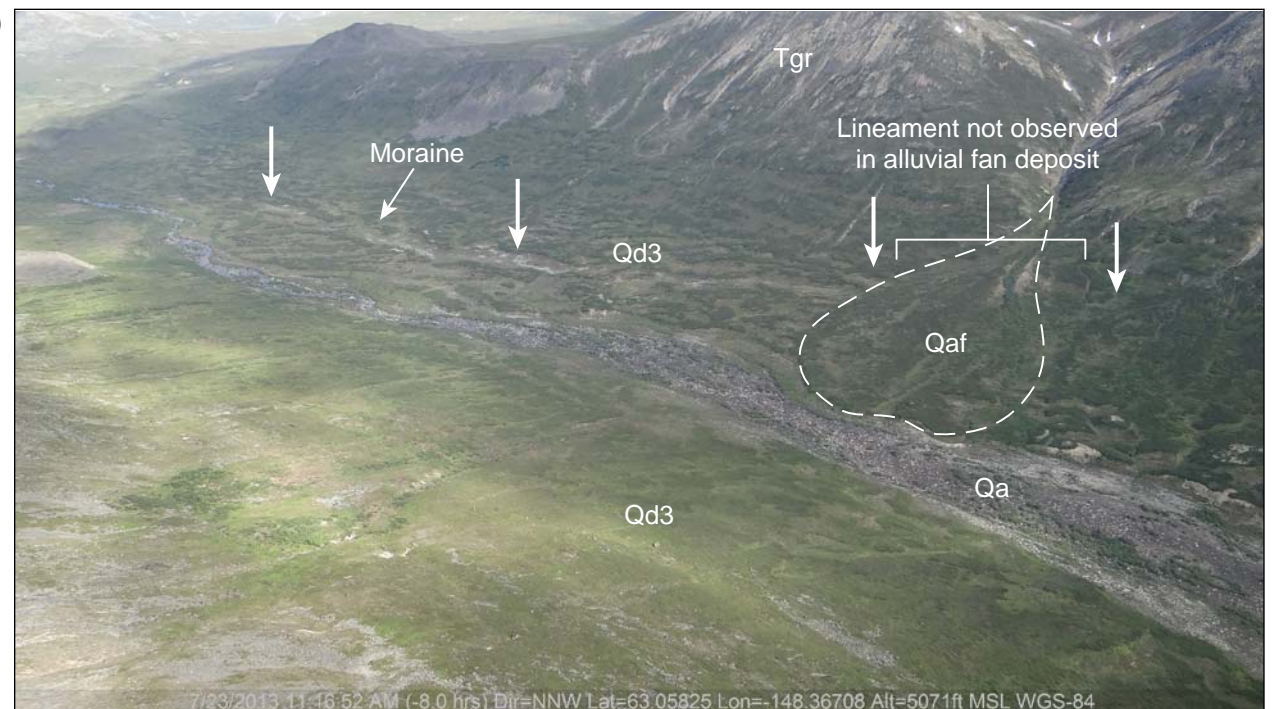
A)

View looking north from location A. Arrows show projected trace of Feature 9 lineament. Note lineament is overprinted with Quaternary alluvial fan deposit.

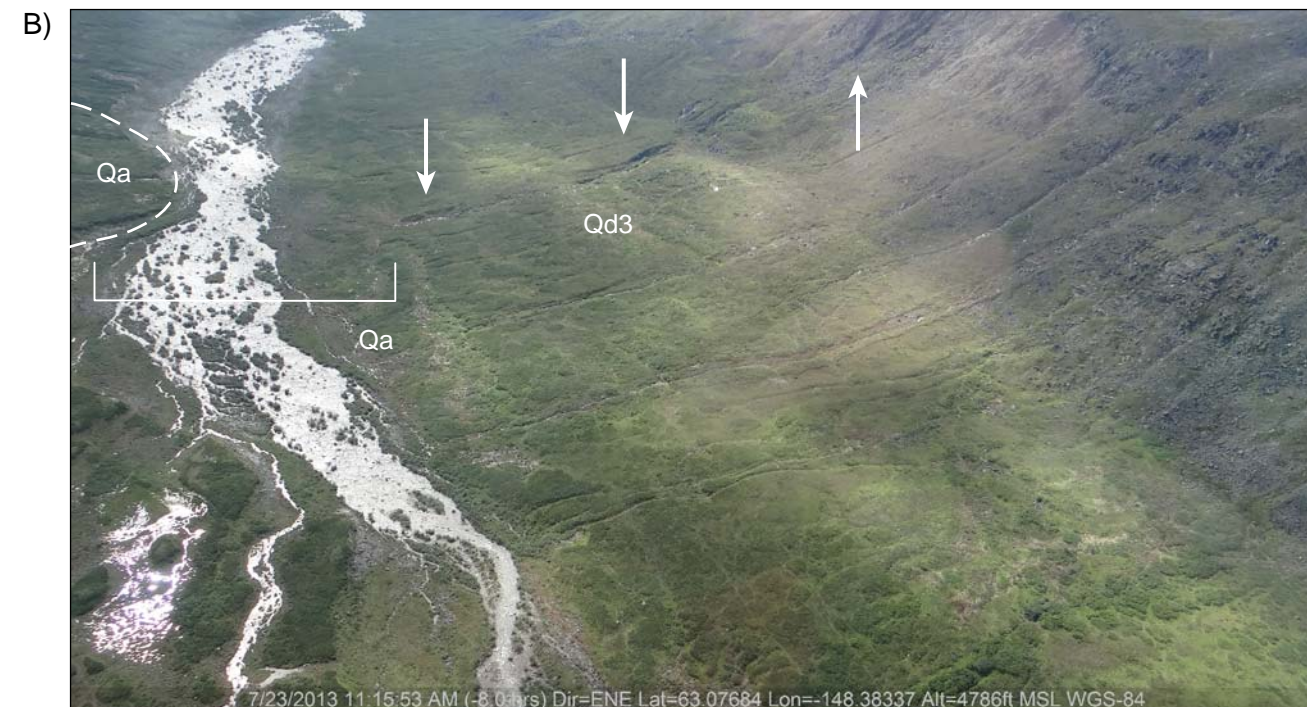
View looking south from photograph location B. Arrows show the projected trace of lineament. In Qd3 (till) the lineament is coincident with linear drainage in till deposit. Note absence of lineament in Qa deposit.

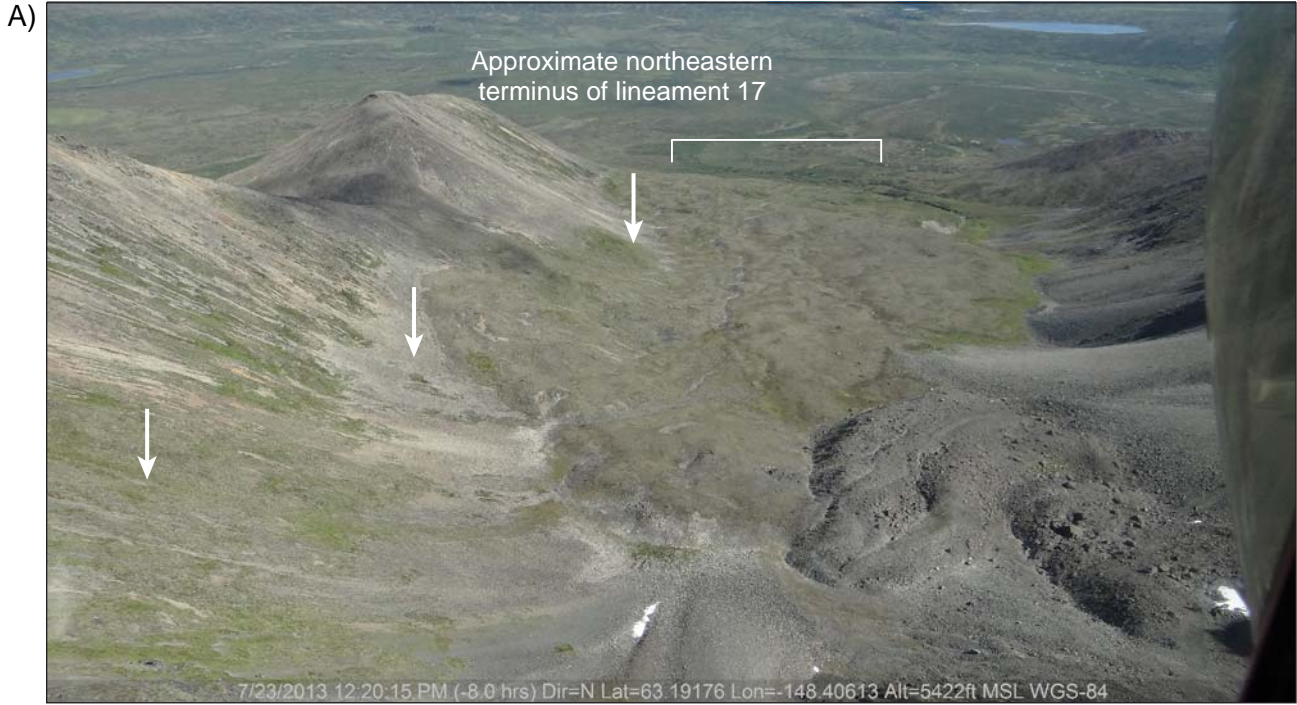
View looking northeast from location A. Arrows and brackets show projected trace of lineament 17.

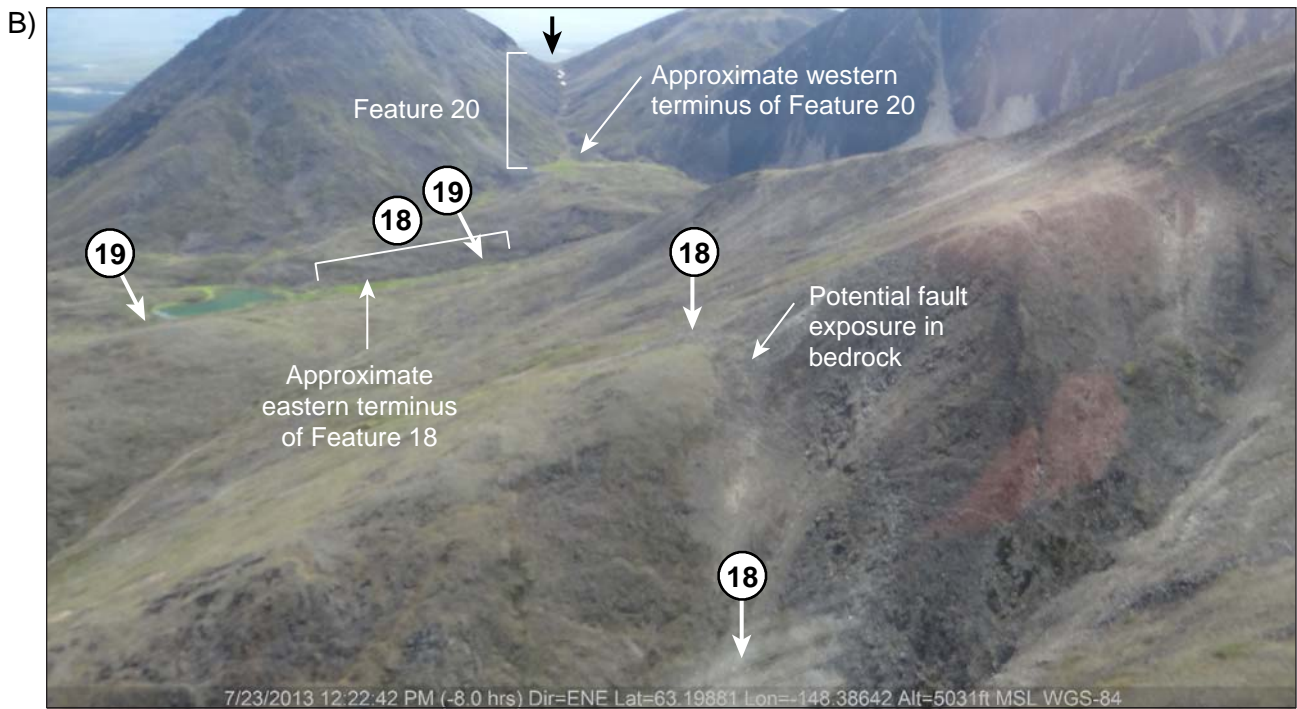
View looking southeast from photograph location B. Arrows and brackets indicated the projected trace of lineaments 18, 19, and 20.

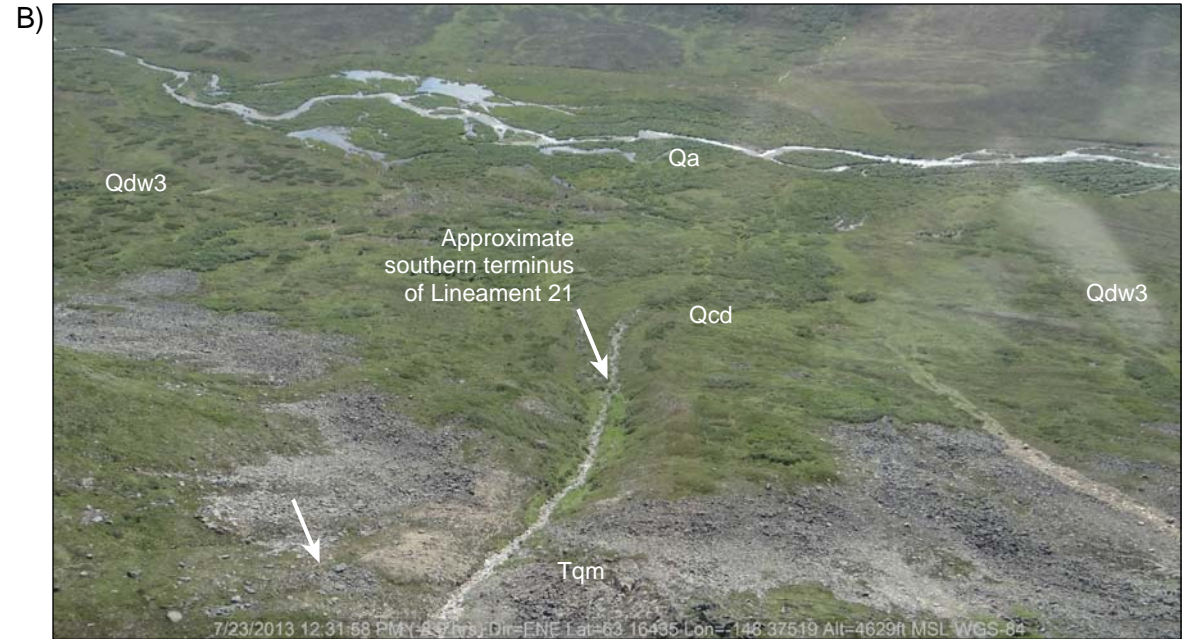
View looking southeast from photograph location B. Arrows show the projected trace of Feature 21 lineament.

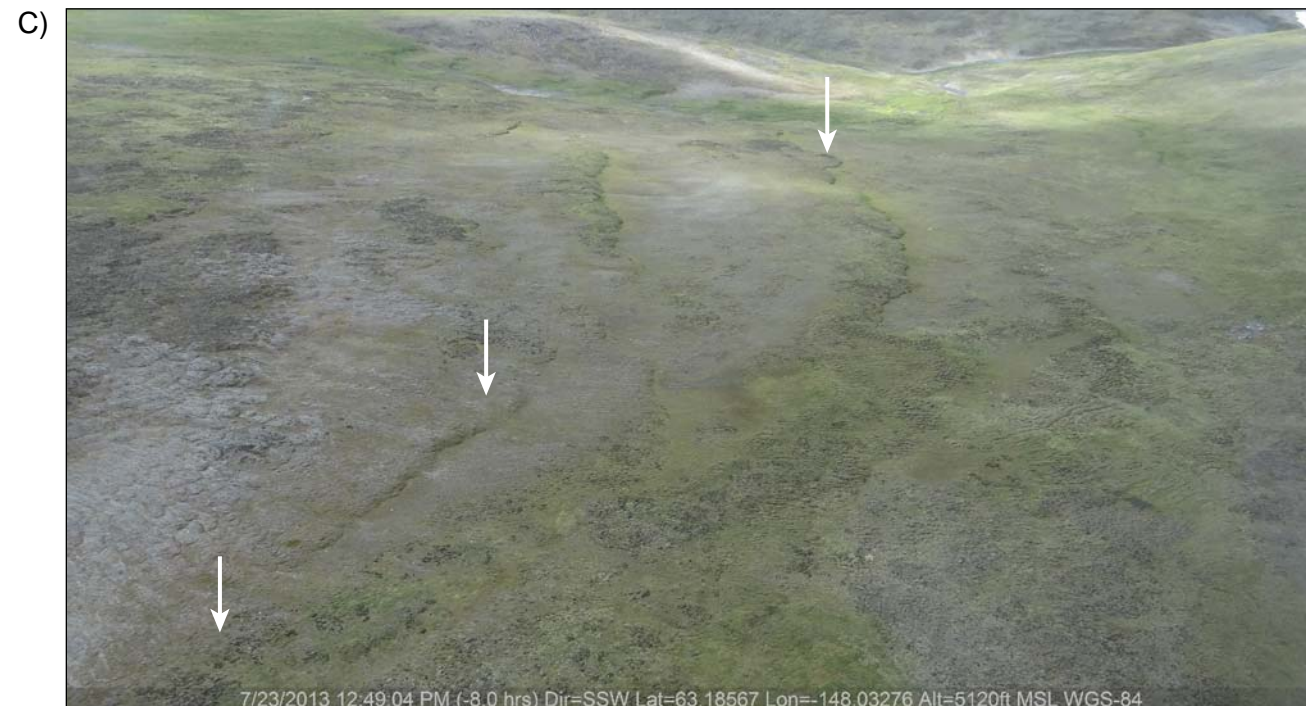
View looking west from photograph location C. Arrows show the projected trace of the Feature 22 lineament. Note linear expression is coincident with solifluction lobes and not continuous.

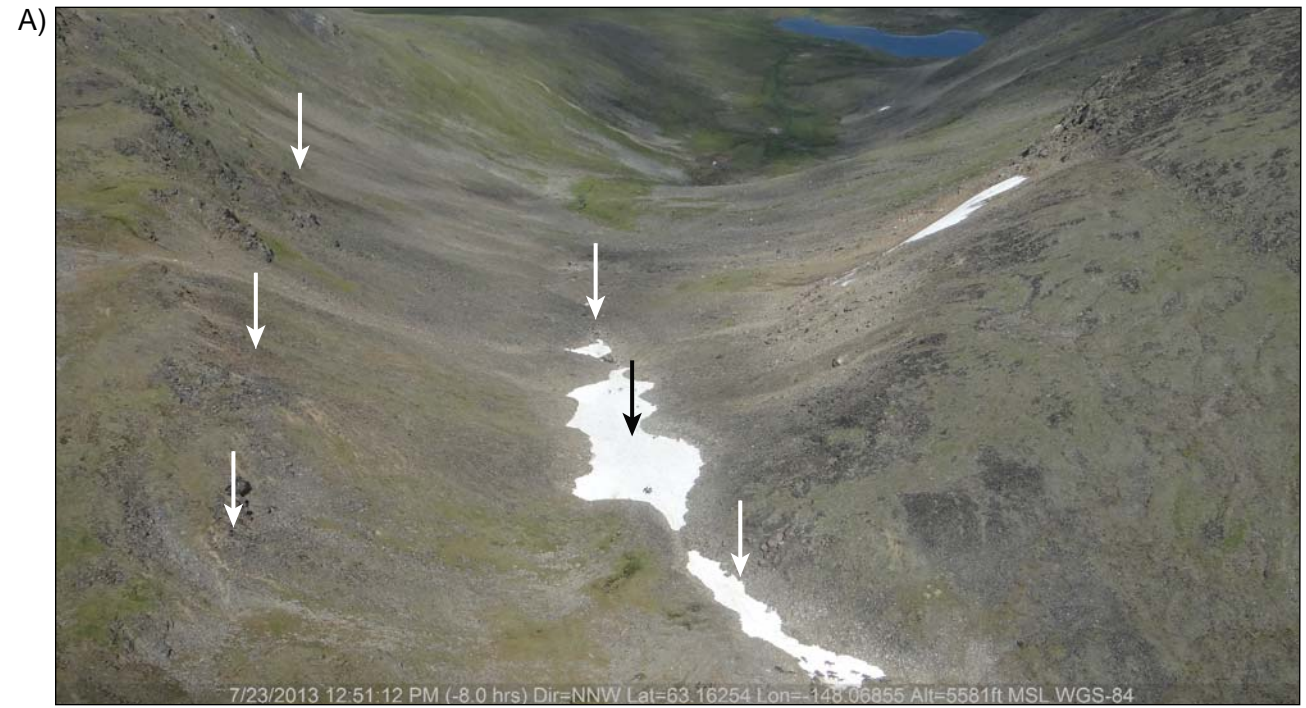
View looking west from photograph location C. Arrows indicate the projected path of the Feature 24 lineament.

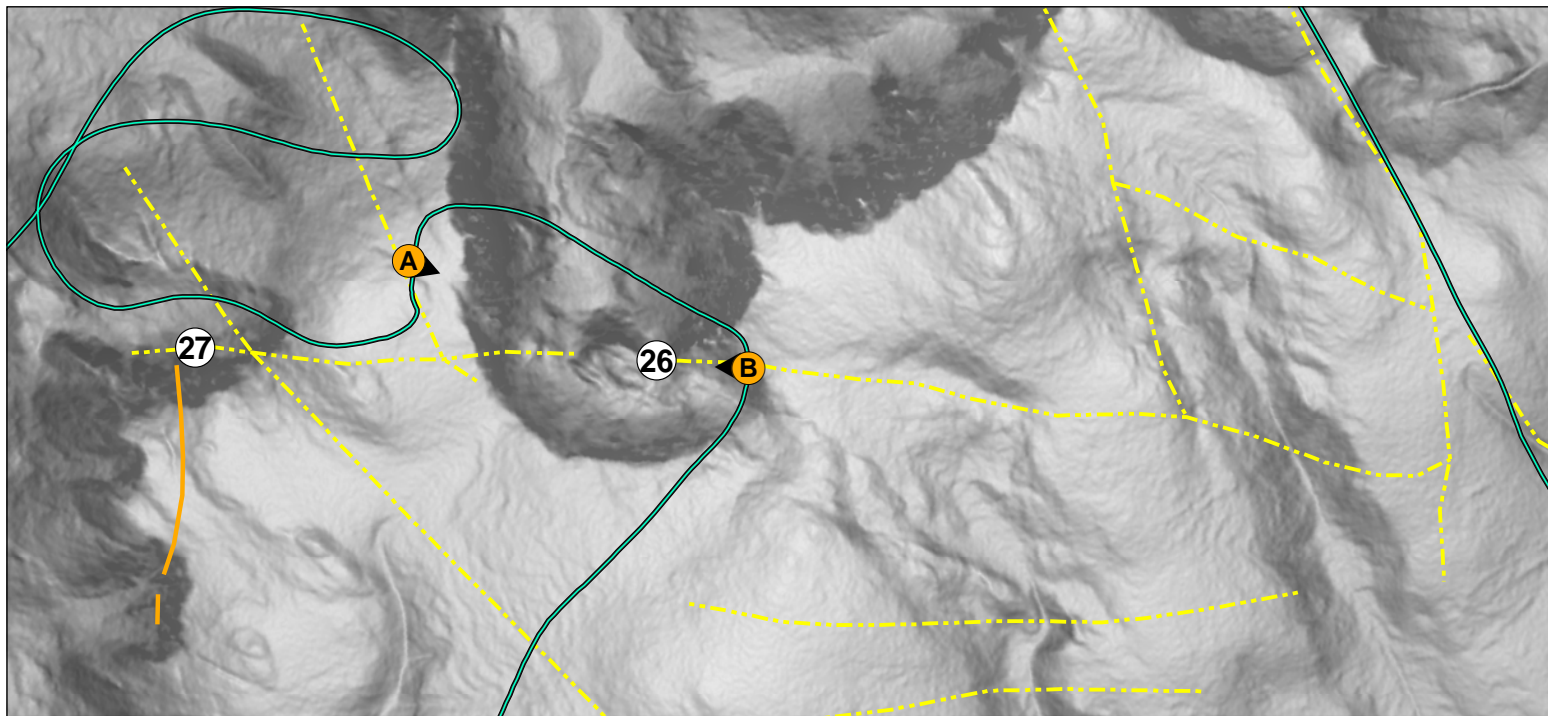
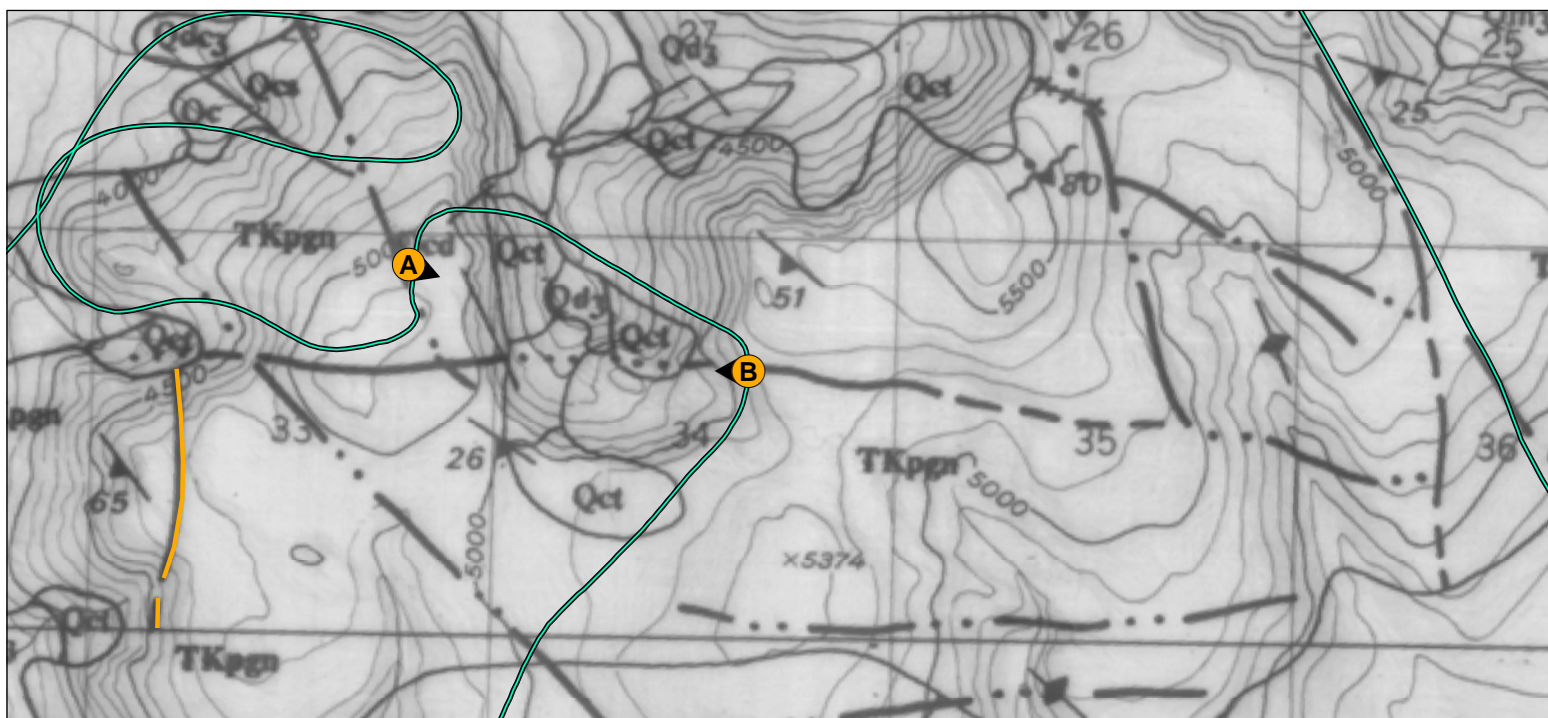
View looking west from photograph location A. Arrows show the projected trace of Features 26 and 27. Note the absence of a continuous and clear lineament along projected traces.

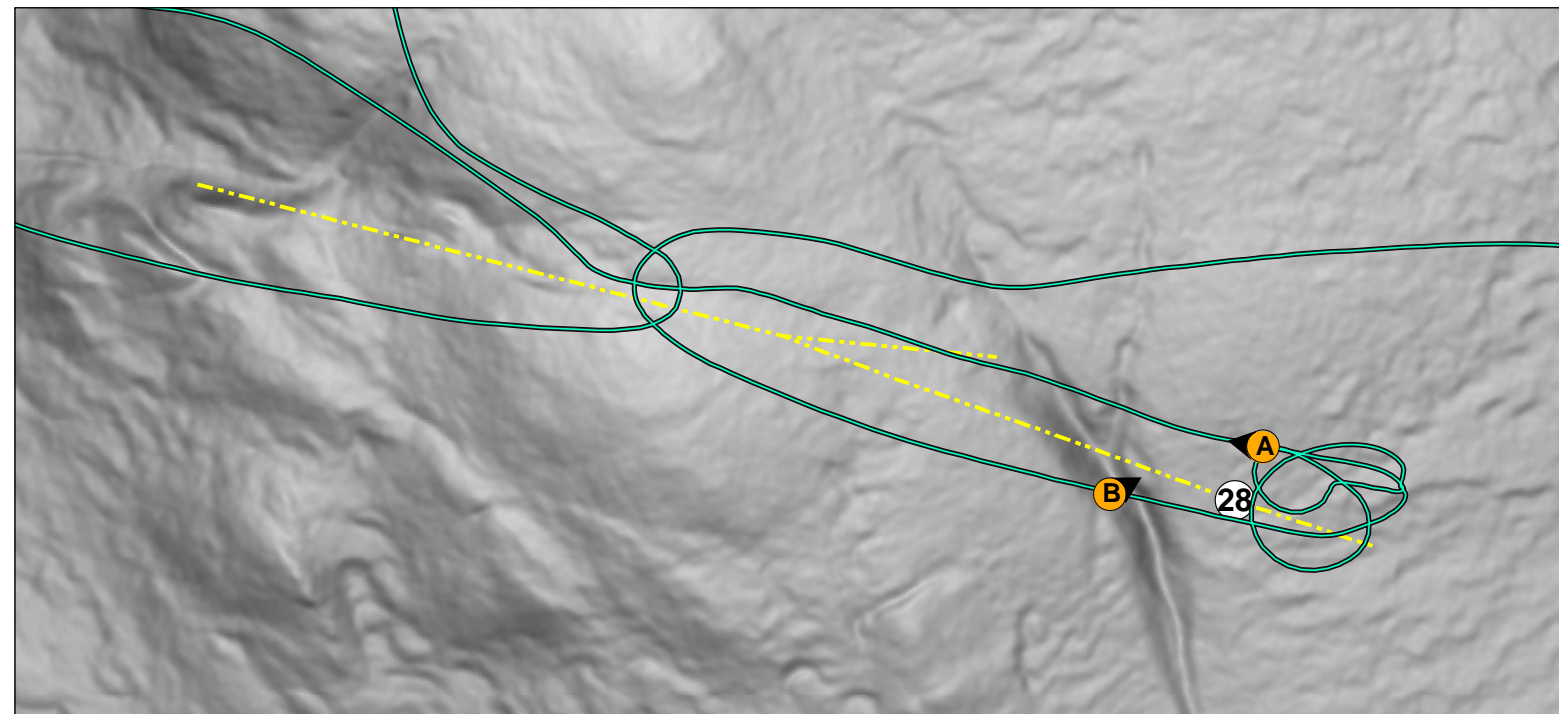
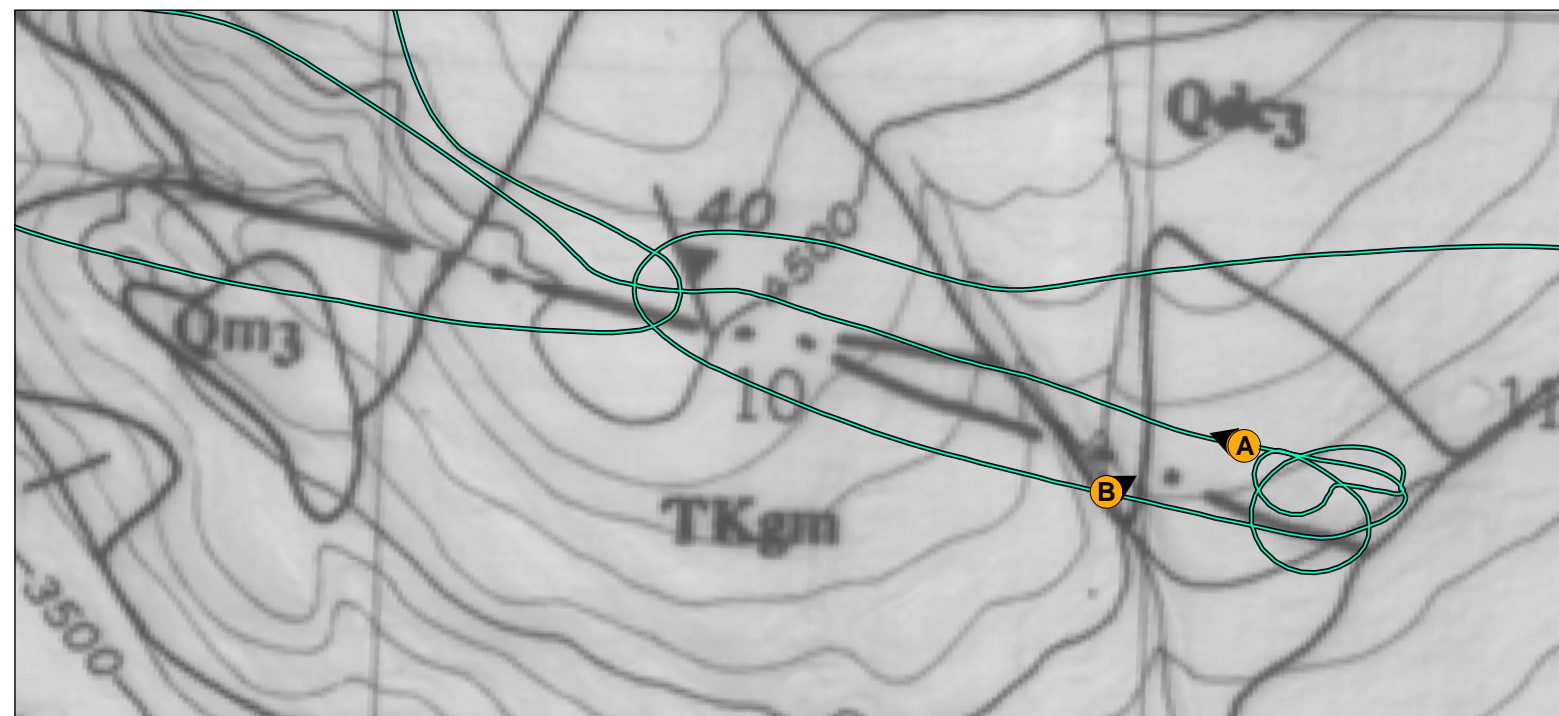
View looking west-northwest from photograph location A. Arrows show mapped trace of Feature 28. Note lineament corresponds to subtle linear trough and linear vegetation trend.
