**Susitna-Watana Hydroelectric Project
(FERC No. 14241)**

**Study of Fish Passage Barriers in the Middle and
Upper Susitna River and Susitna Tributaries (9.12)**

**Part A - Appendix A
Tributary Geologic Barriers**

**Part A - Appendix B
Middle River Tributary Delta Surveys Outside of
Focus Areas**

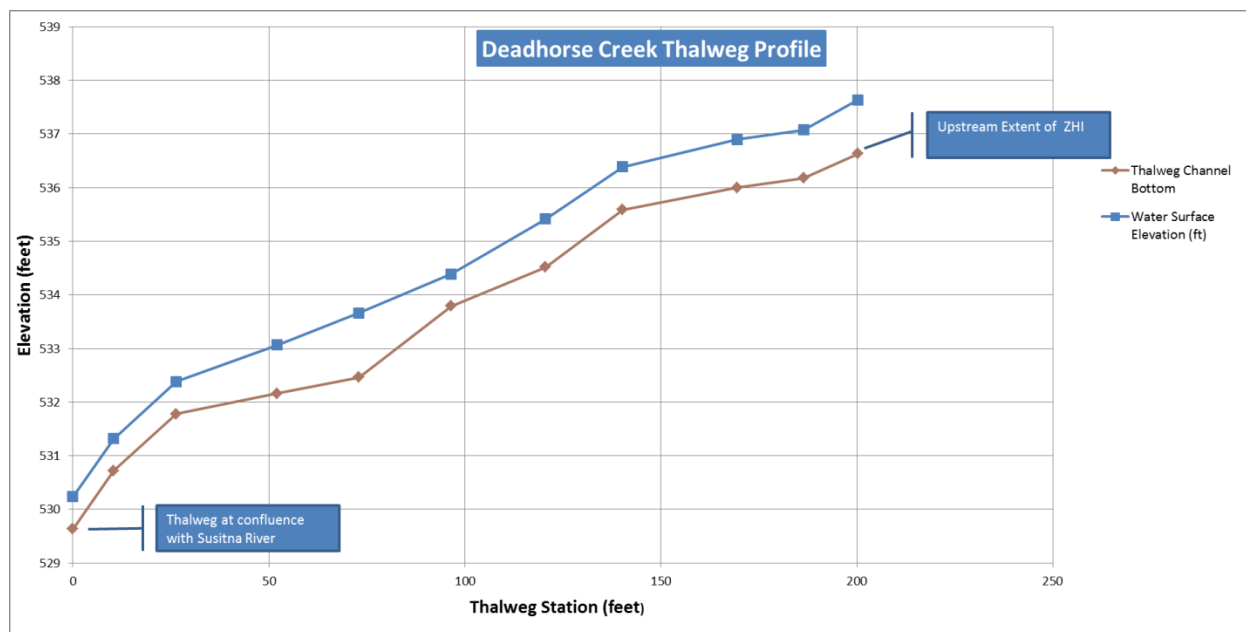
Figure B6. Deadhorse Creek thalweg profile.

The mouth of Deadhorse Creek consisted of a large debris fan and single creek channel (Figure B5). The creek had incised the debris apron, but a final steep boulder cascade remained before reaching the Susitna (Figure B6). This noticeable perch was a result of low creek flows and the receding Susitna flow. Deposited material varied in gradation, material size and mixture throughout the fan (Table B3).

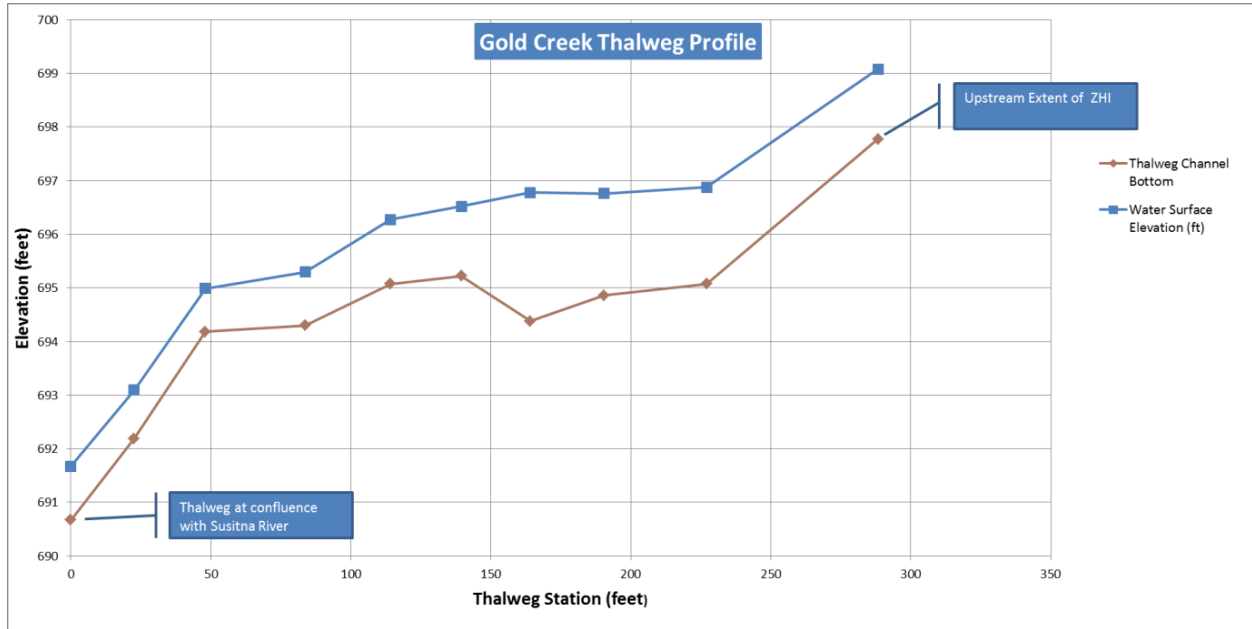
Figure B14. Gold Creek thalweg profile.

The mouth of Gold Creek consisted of a large debris fan and two stream channels (Figure B13). A steeper channel grade across the deposited apron was consistent with a perched condition, but channel incision on both the main and the secondary channel reduced the gradient of the final drop to the Susitna (Figure B14, Table B6). Flow between the two flow paths consisted of an approximate 60:40 split. Banks of the secondary channel were eroding during the time of survey.
