SUSITNA-WATANA HYDRO

ALASKA ENERGY AUTHORITY

16-1401-TM-012014

Appendix B:
Strip Maps and Photographic Documentation
of Lineament Data for Lineaments Mapped by Reger et al. (1990)

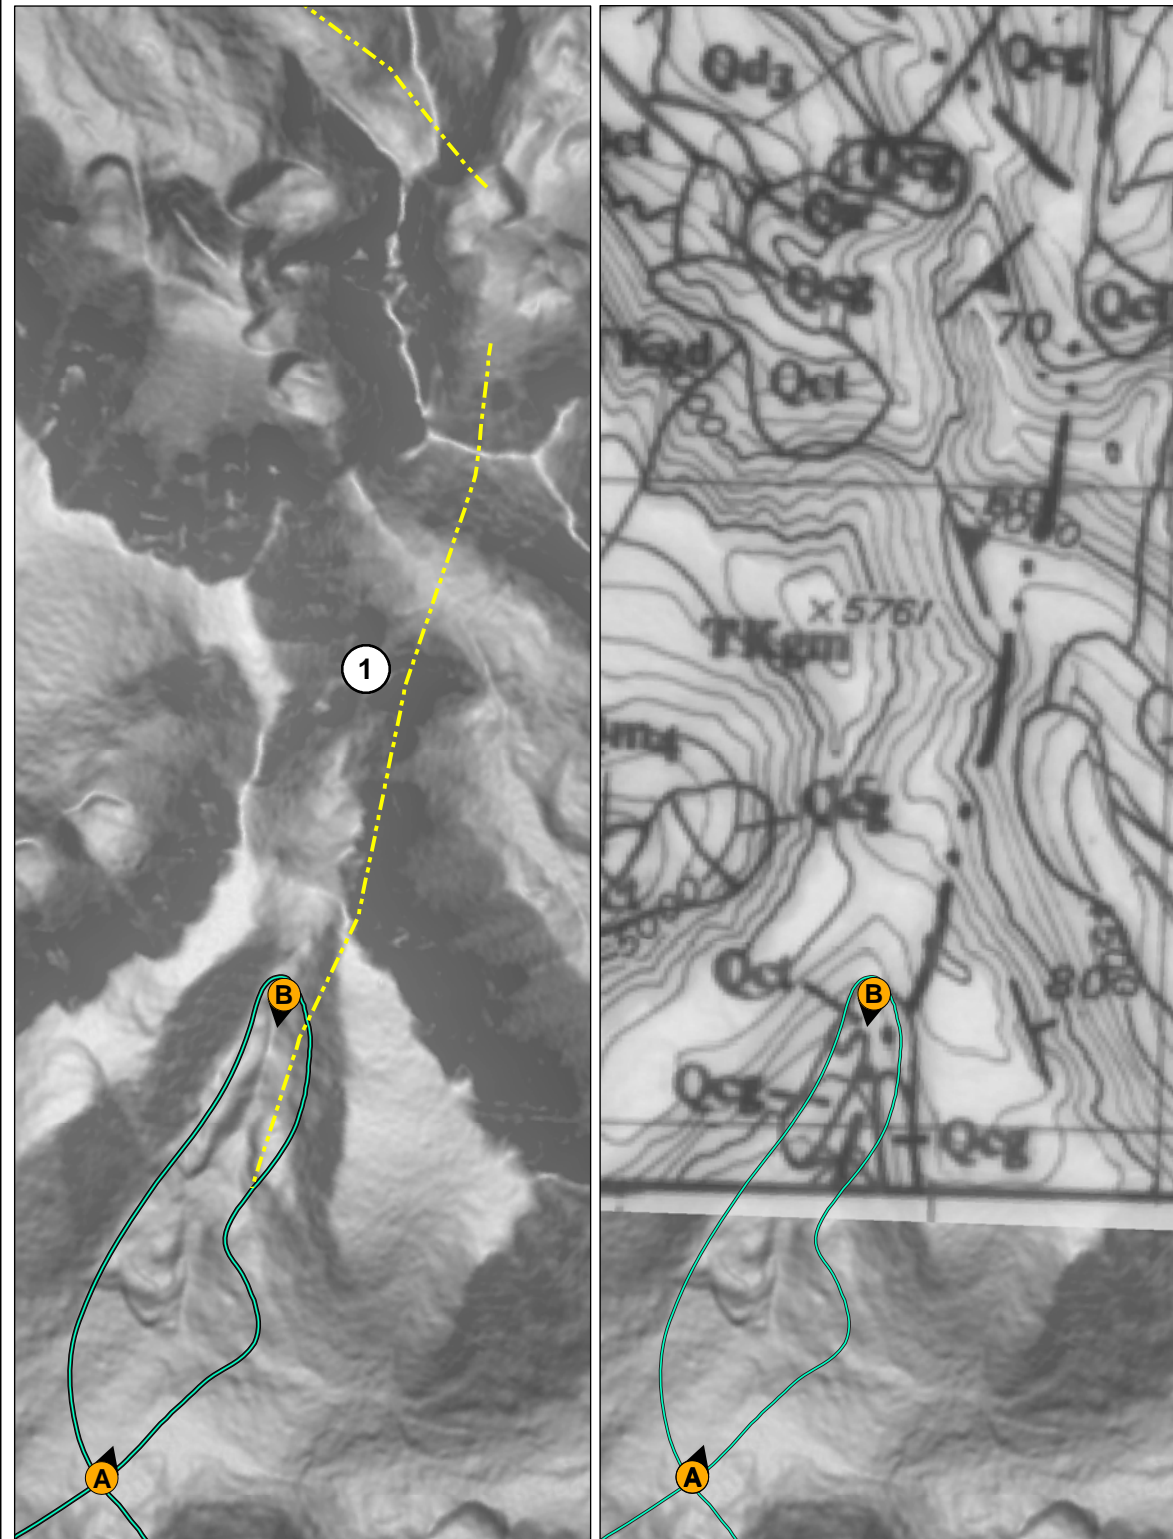
View looking northeast from location A. Arrows show location of mapped trace of lineament.

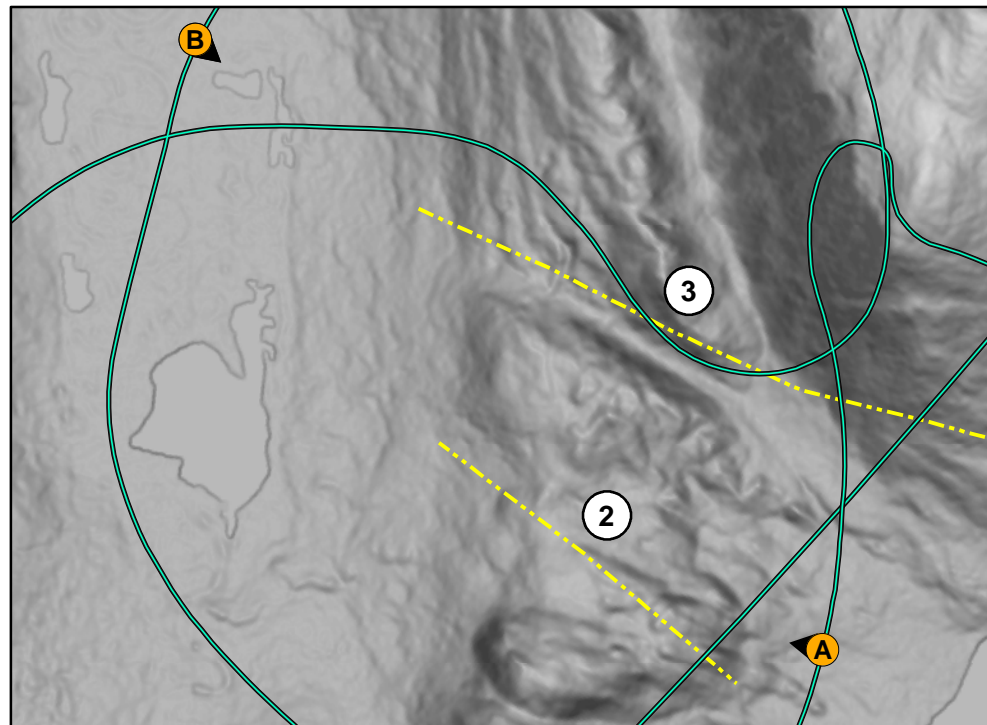
View looking northwest from location A. Arrows and brackets show projected trace of lineament. Note absence of continuous lineament across projected trace.

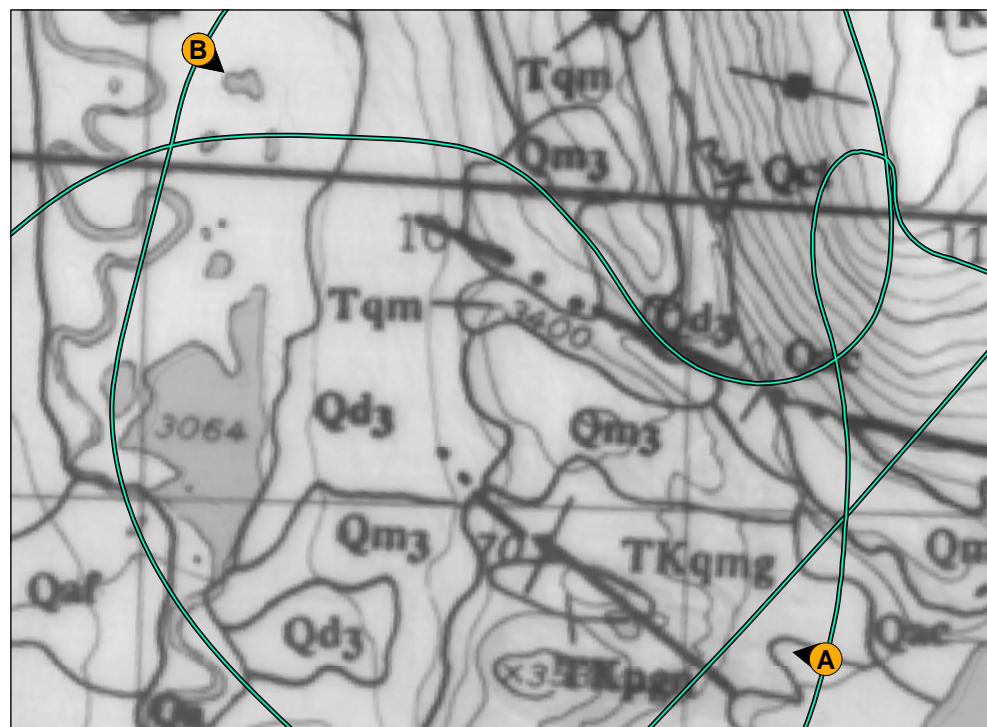
View looking southeast from location B. Arrows and brackets show projected trace of lineament. Note lack of deformation or lineament trace in foreground within Quaternary deposits.

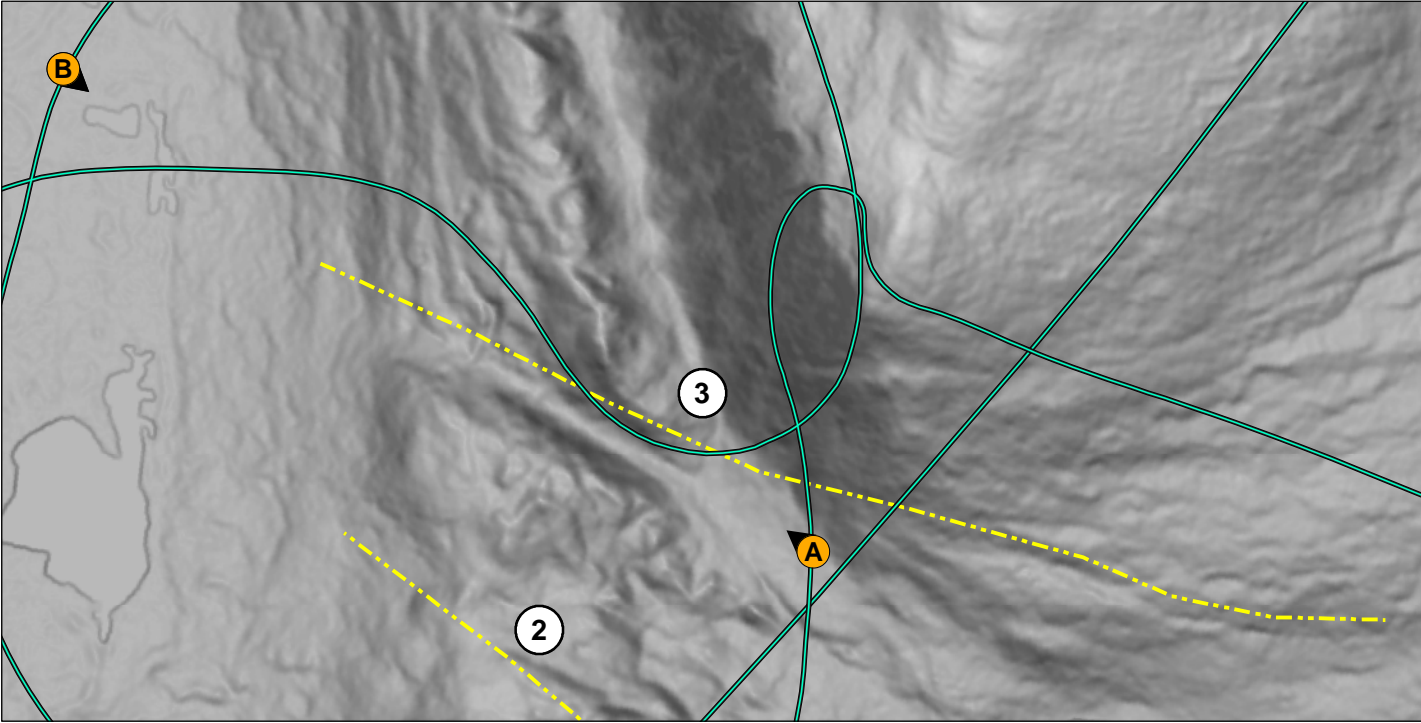
View looking northwest from location A. Arrows show the projected trace of lineament. Note absence of lineament or deformation in Quaternary deposits.

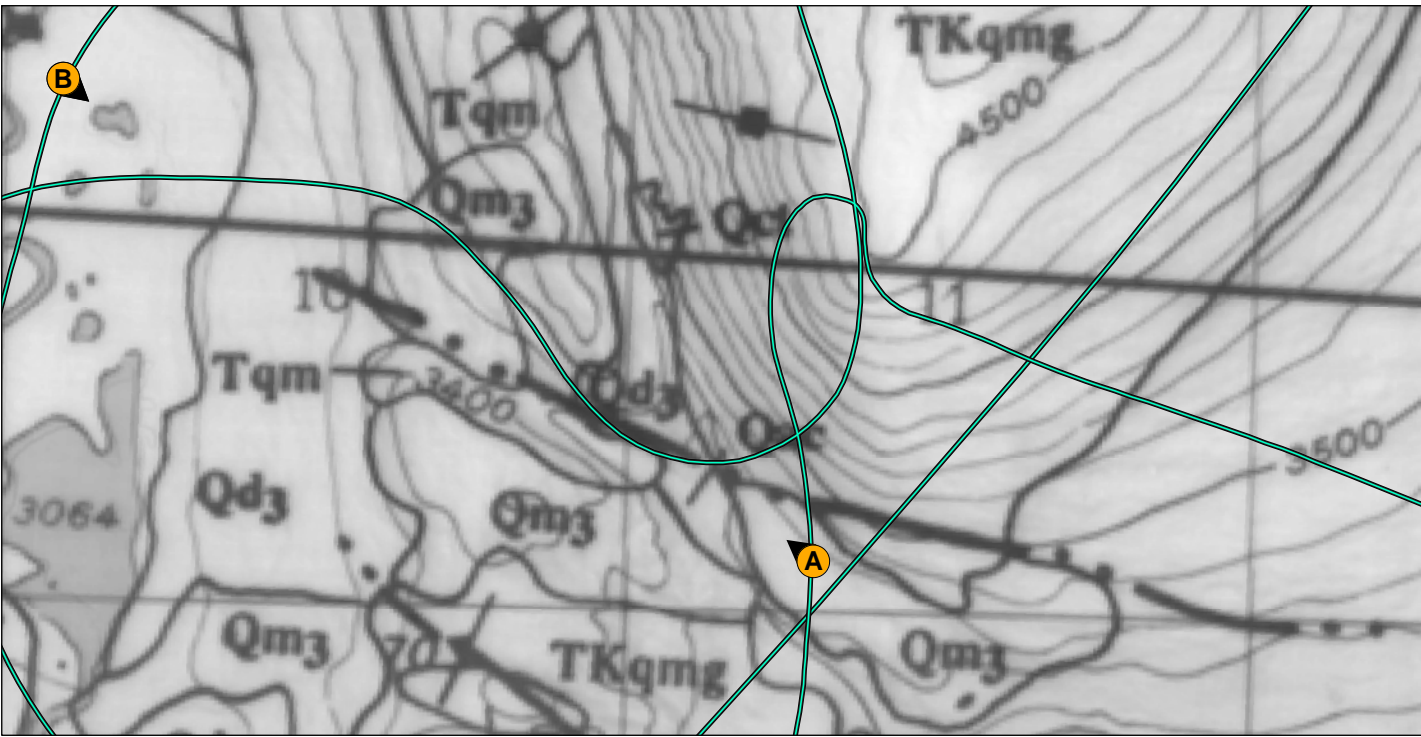
View looking southeast from location B. Arrows show the projected trace of lineament. Note absence of lineament or deformation in Quaternary deposits.

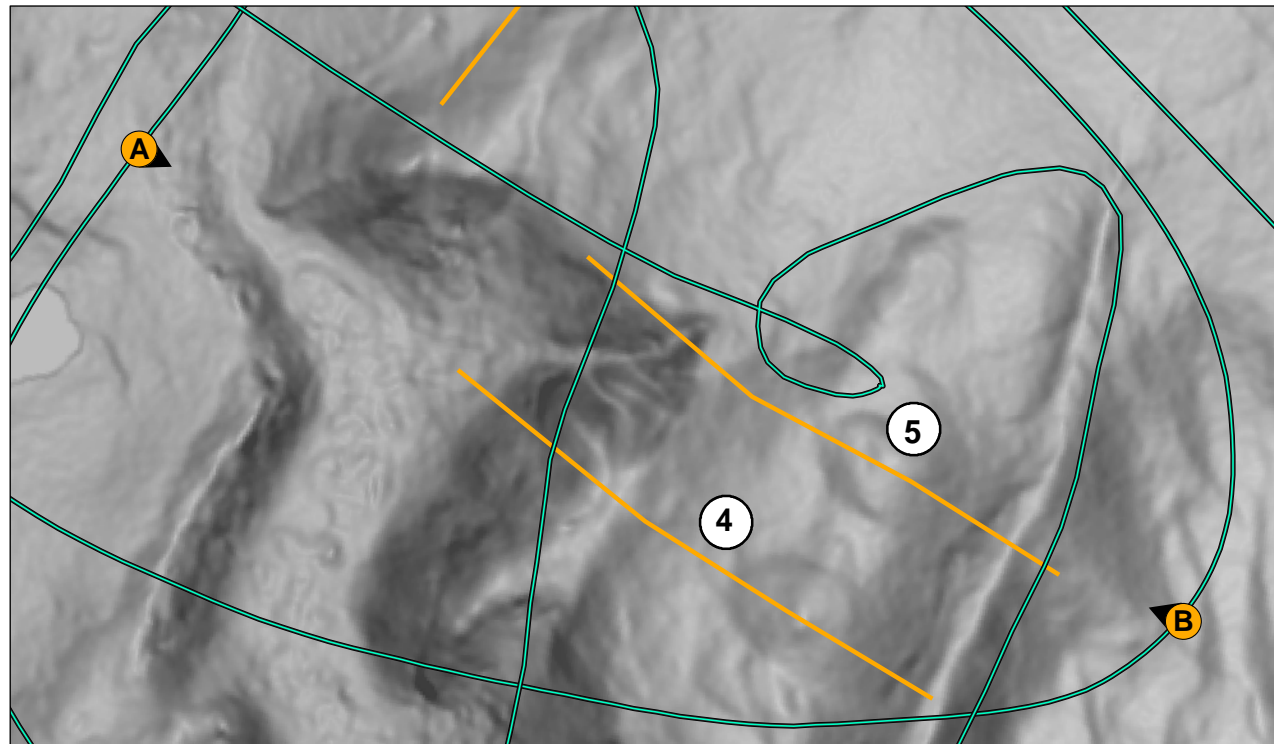
View looking southeast from location A. Arrows show the projected traces of Features 4 and 5. Note absence of lineament or deformation in Quaternary deposits in foreground.

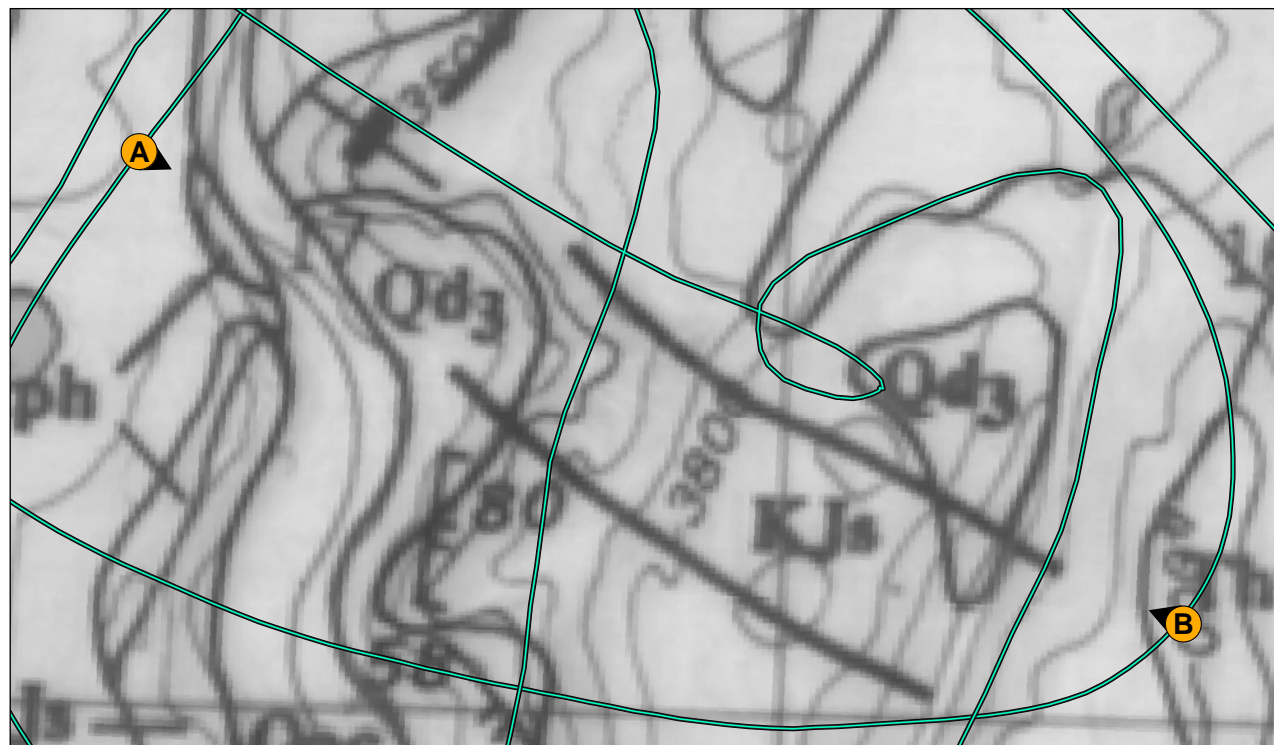
View looking northwest from location B. Arrows show the projected trace of Feature 5. Note absence of discernable lineament along mapped trace.

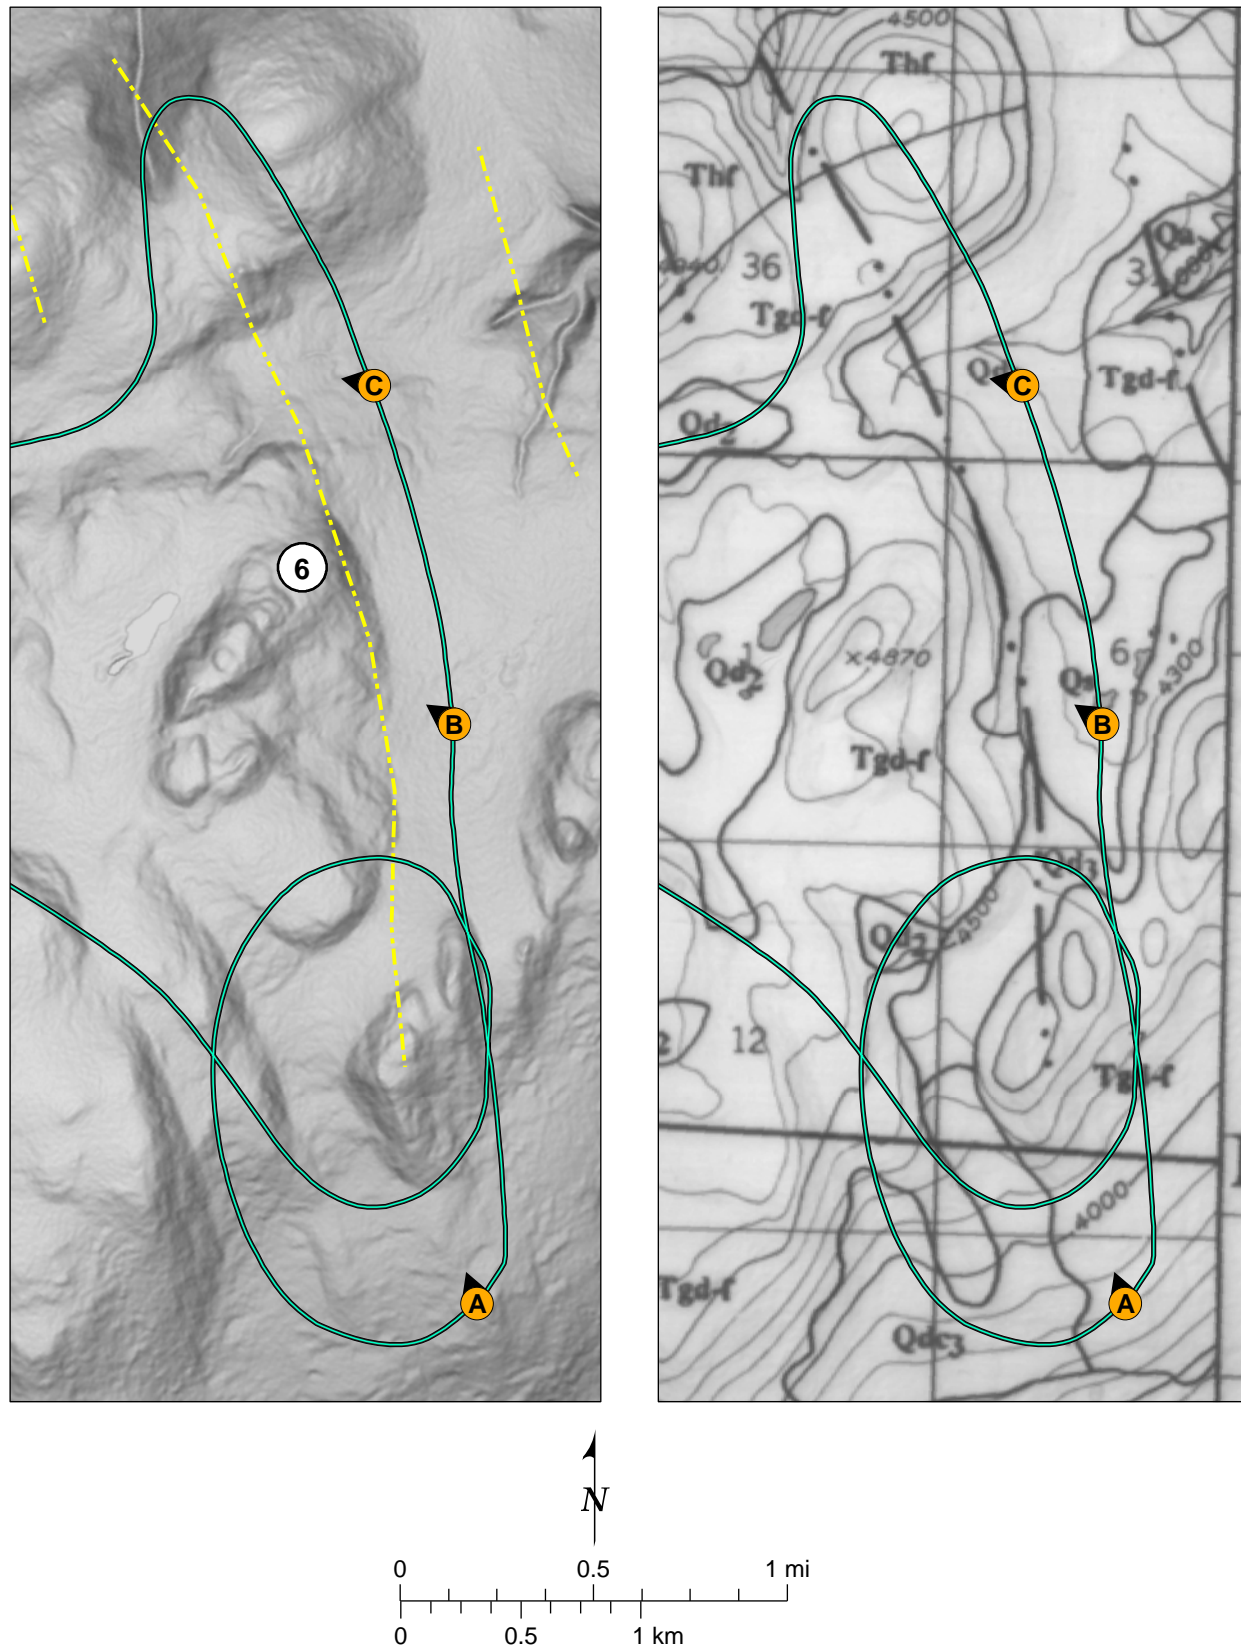
View looking northwest from location A. Arrows and brackets show the projected trace of mapped lineament. Note absence of lineament or deformation in Quaternary deposits.

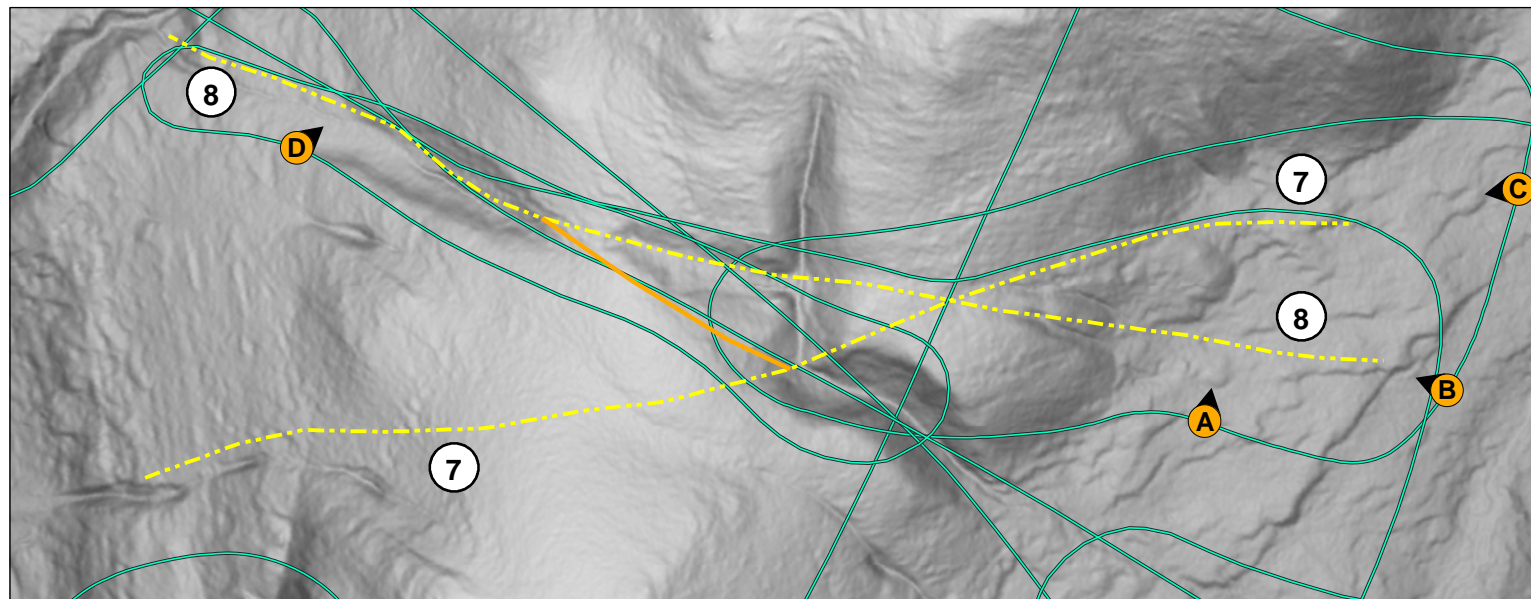
View looking northeast at lineaments 7 and 8 from photograph location A.

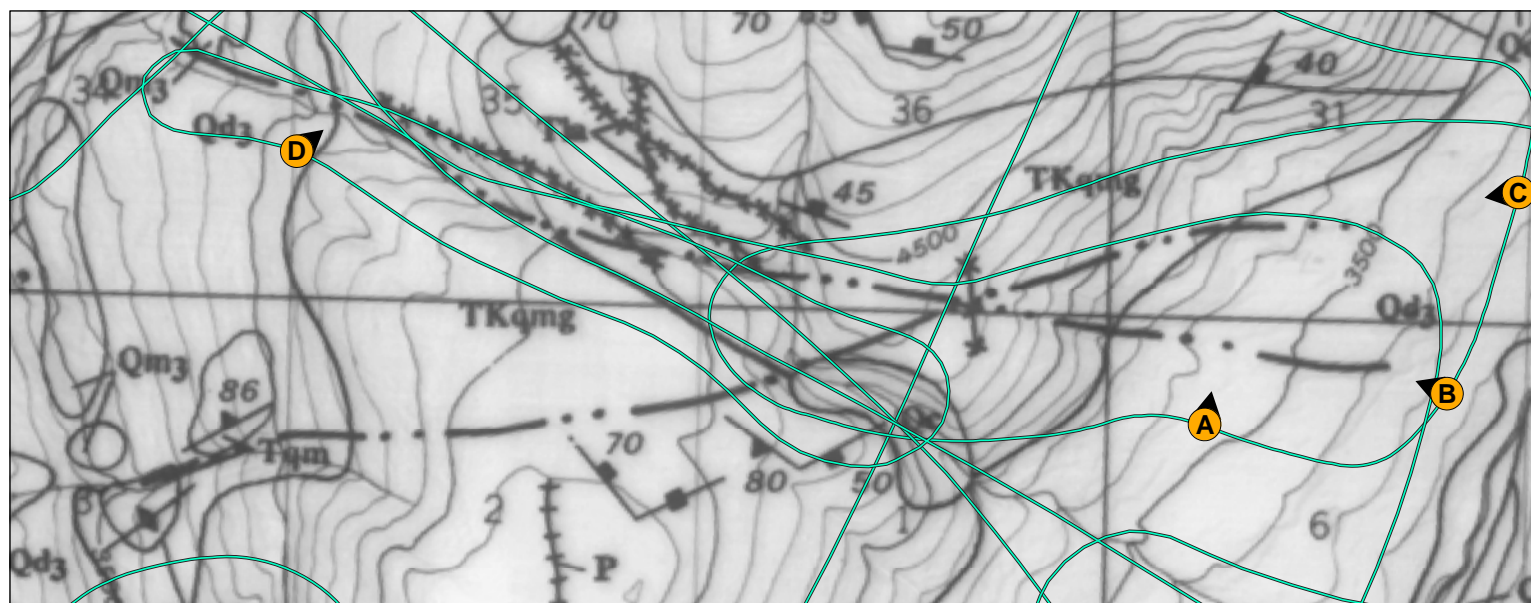
View looking west at lineaments 7 and 8 from photograph location B. Note that lineament 7 is a linear series of unrelated features.

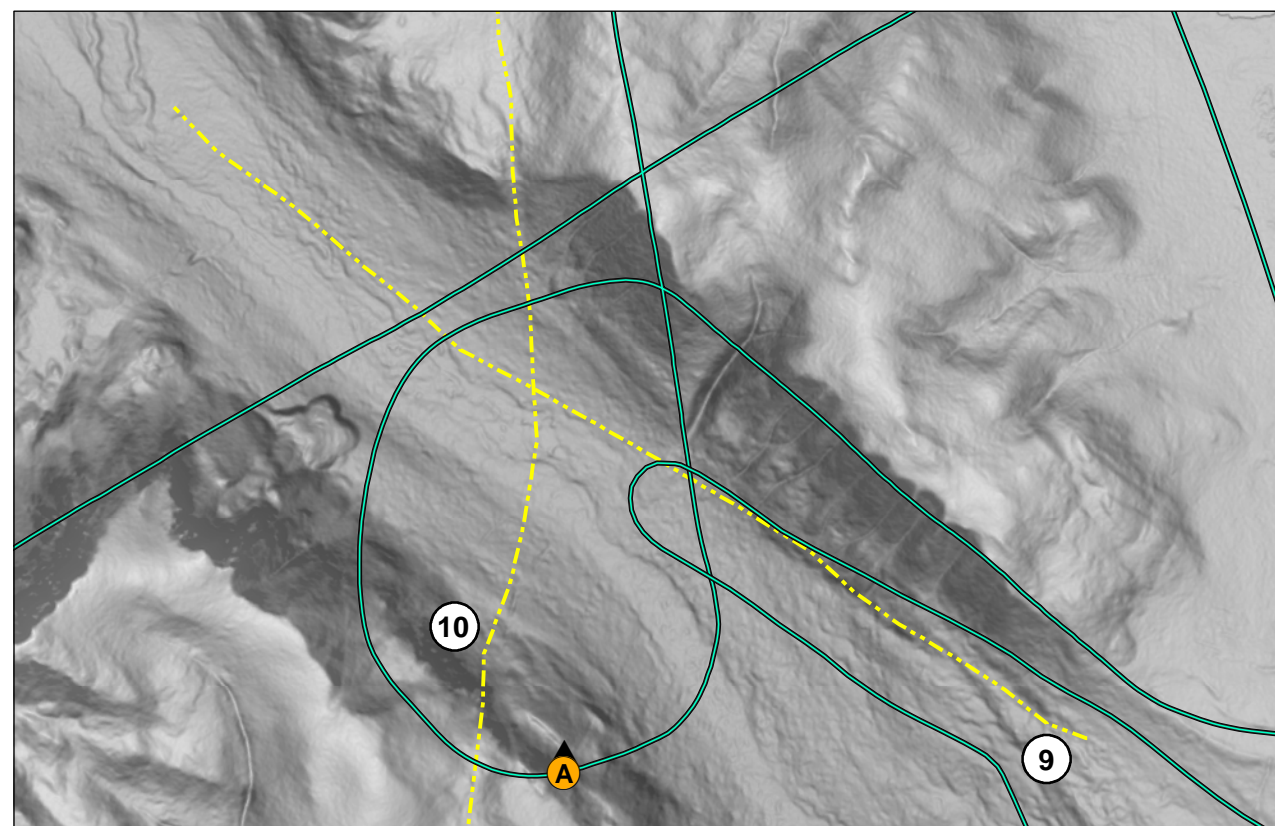
View looking north from location A. Arrows show projected trace of Feature 9 lineament. Note lineament is overprinted with Quaternary alluvial fan deposit.

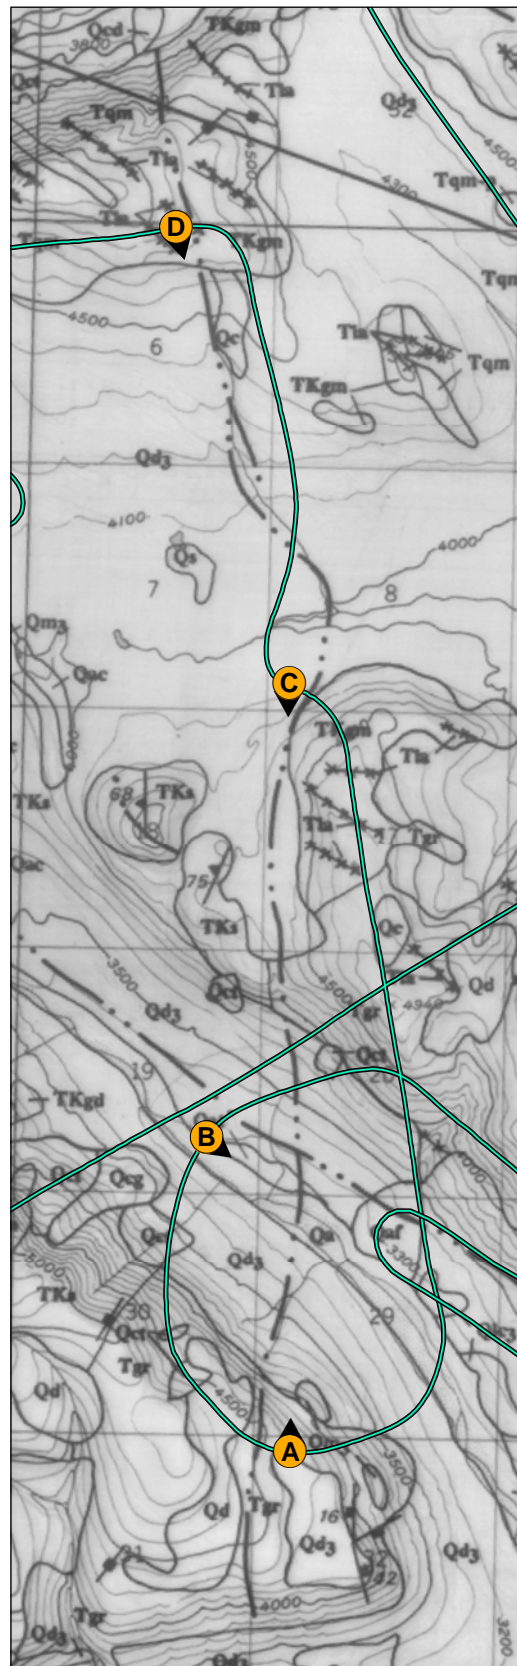
View looking north from location A. Arrows and brackets show the projected trace of lineament.

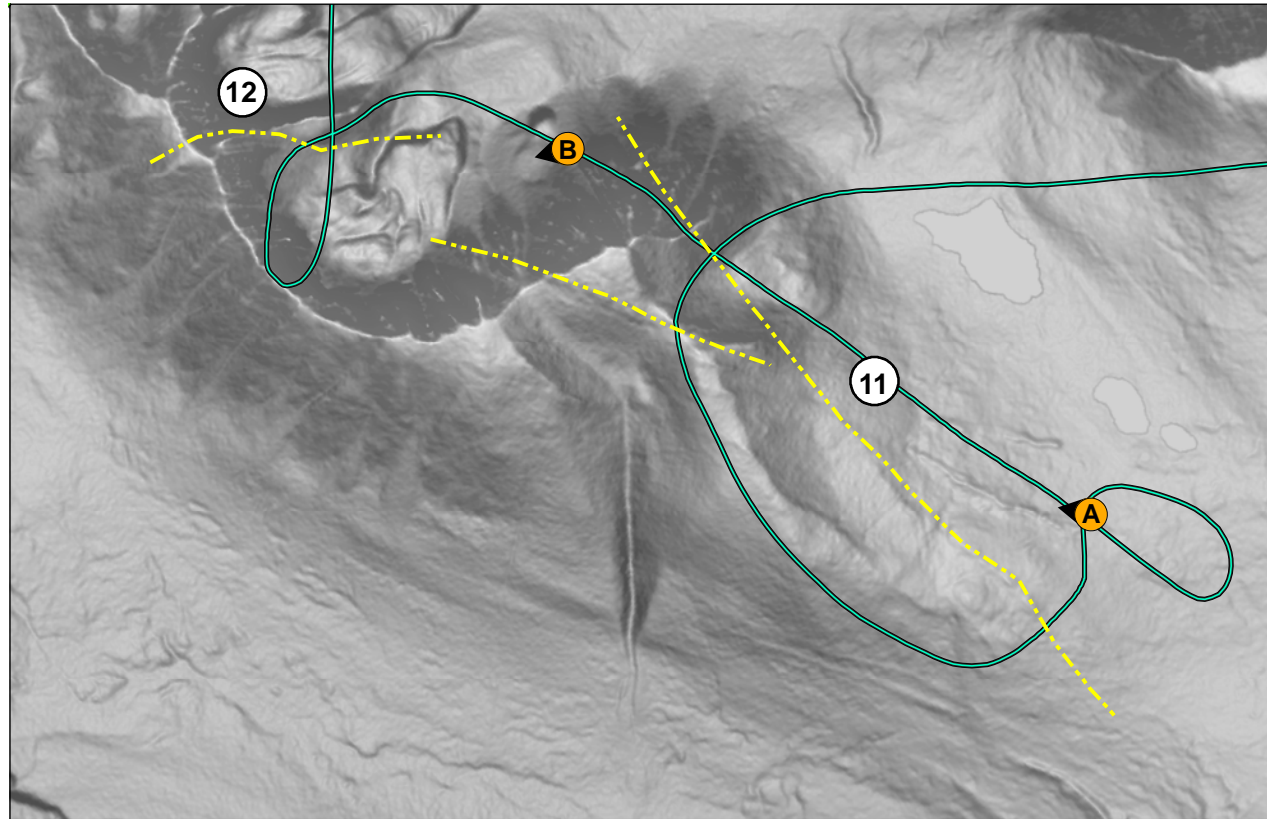
View looking west from location A. Arrows and brackets show projected trace of Feature 11 lineament. Note the mapped lineament correlates with a moraine crest.
