## APPENDIX A: SUSITNA RIVER UPPER RIVER RECONNAISSANCE PHOTOGRAPHS

# 1. PHOTOGRAPHS OF THE SUSITNA RIVER UPSTREAM OF THE MACLAREN CONFLUENCE (PRM 291.8 TO PRM 261.3)

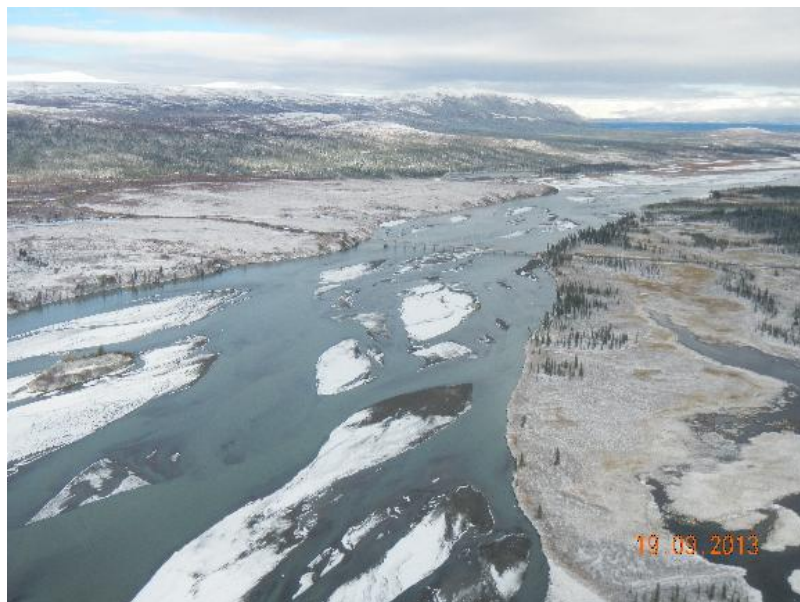
Figure A.1-1 – View upstream towards Denali Highway Bridge at PRM 292 (P5580)<sup>1</sup>.

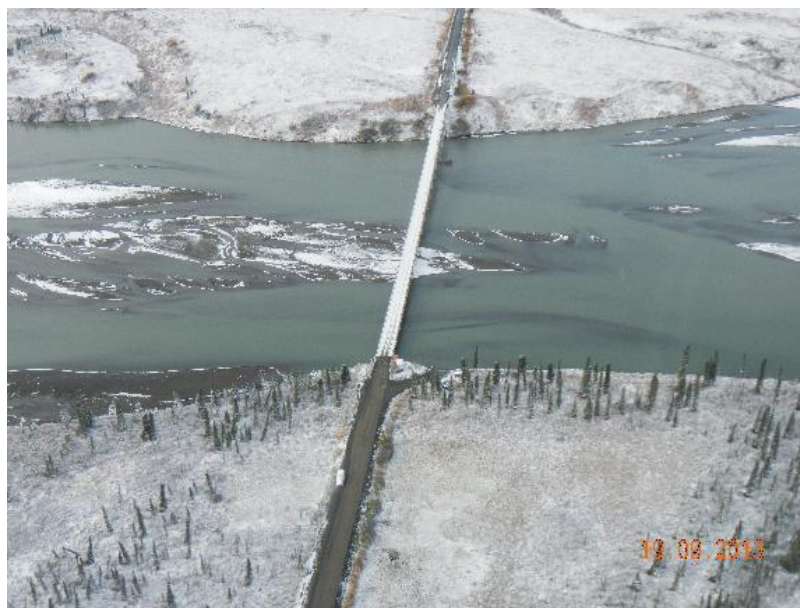
Figure A.1-2 – View east of Denali Highway Bridge at PRM 292. Susitna River, flow from right to left (P5582).

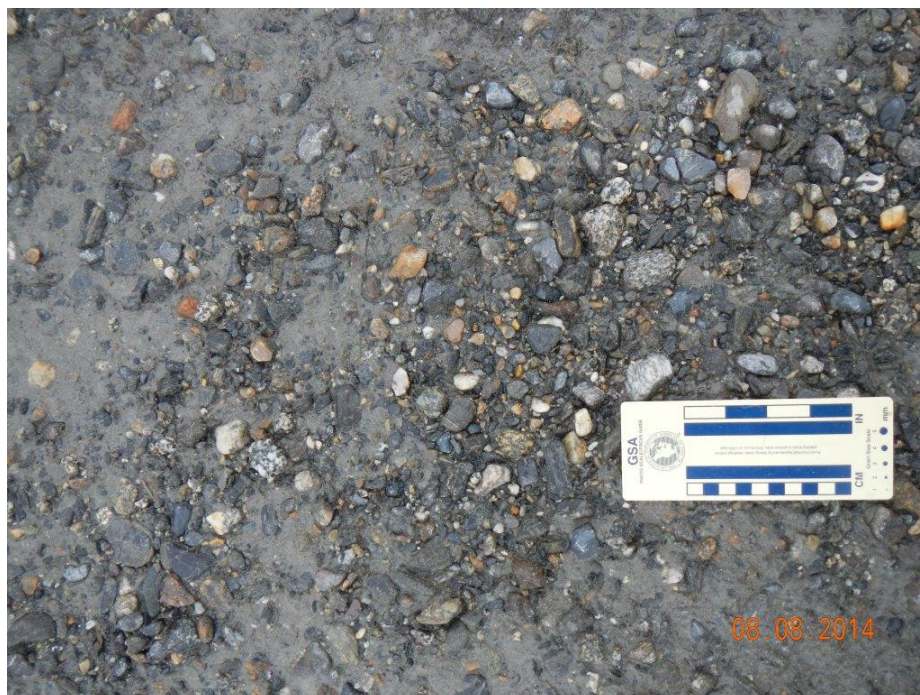
**Figure A.1-3 – Surface material on mid-channel bar near PRM 291. Largest bar head particle diameter (b-axis) approximately 22mm (P774).**

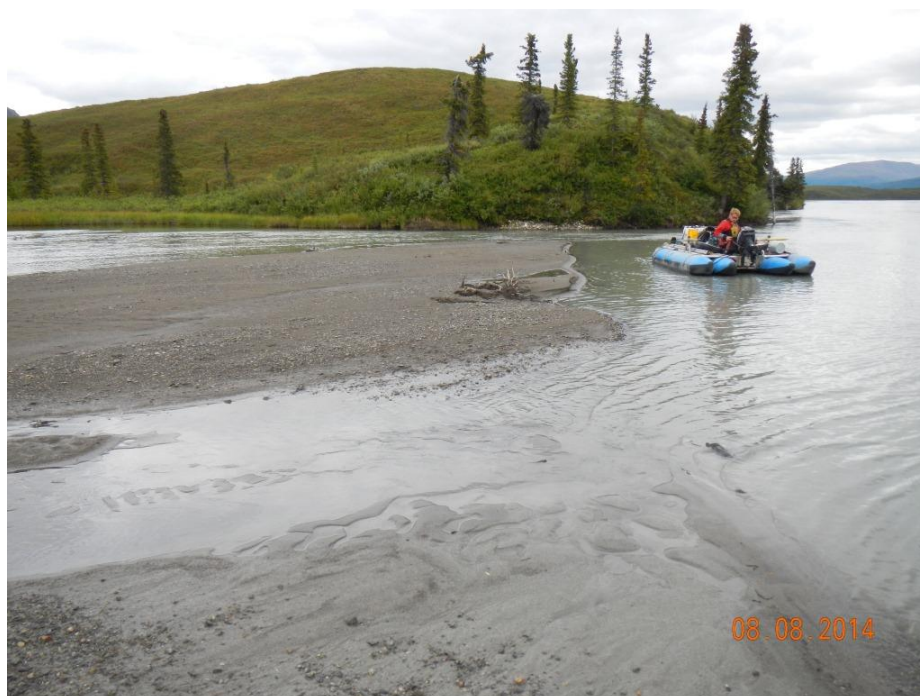
**Figure A.1-4 – View of mid-channel bar near PRM 291 (P775).**

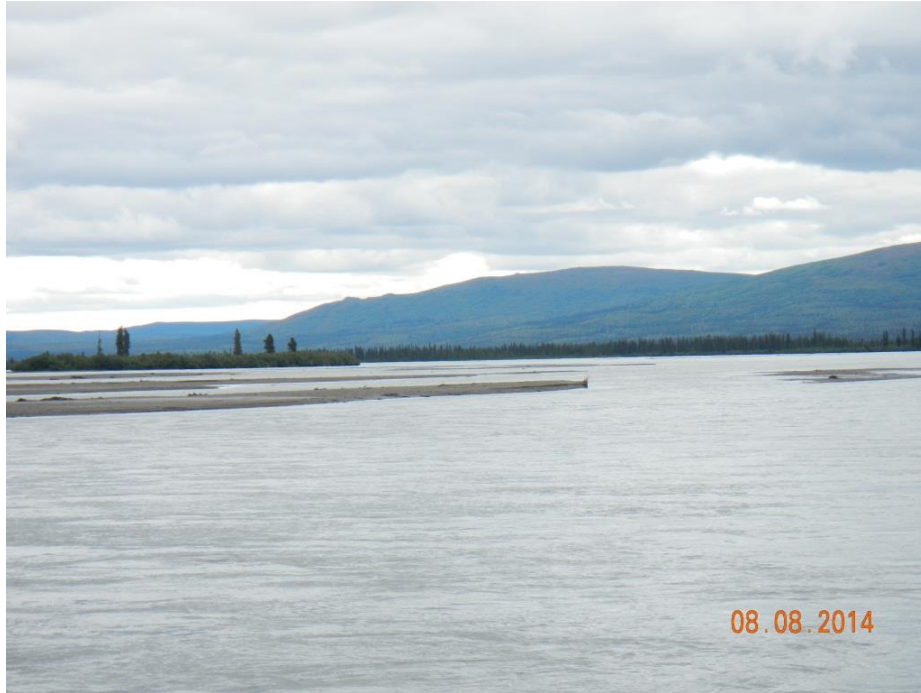
Figure A.1-5 – View of flow expansion zone and low relief mid-channel sand bars near PRM 288 (P805).

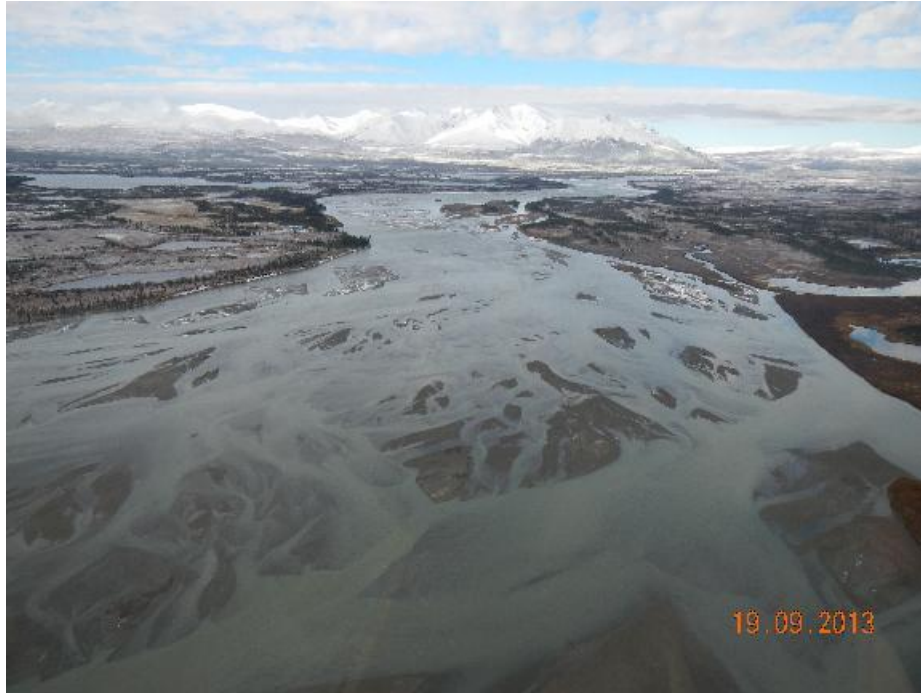
**Figure A.1-7 – View upstream near PRM 281. Note very wide channel and extensive sandy braid bars (P5570).**

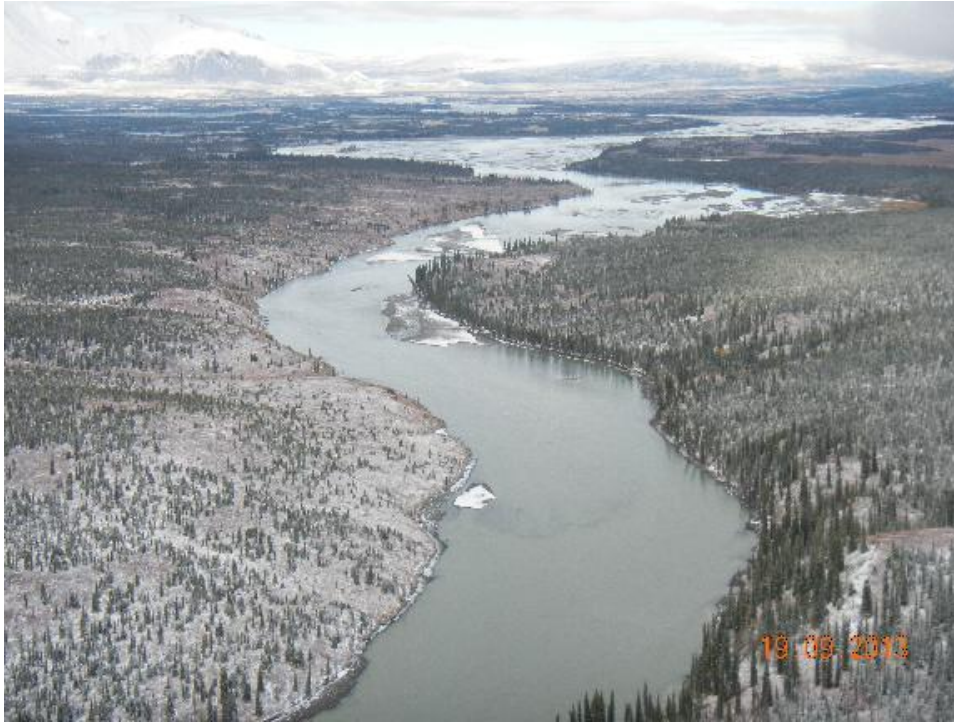
Figure A.1-8 – View upstream towards constriction in the area of PRM 278.9 (P5560).

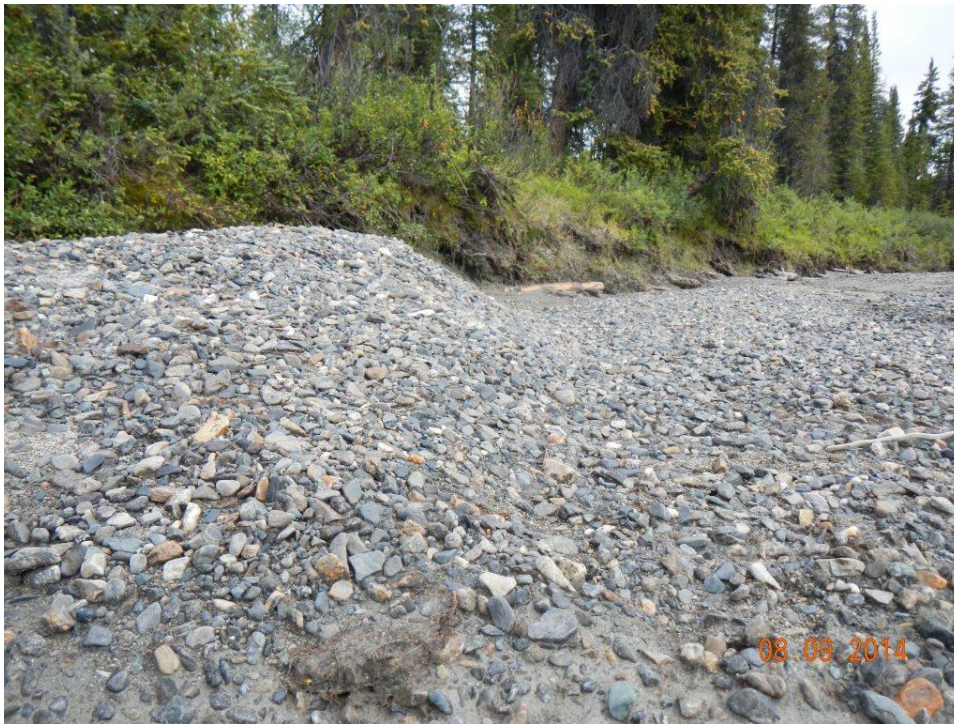
Figure A.1-9 – Fine gravel lobes at PRM 276.2. Grab sample location - median bed material diameter ( $D_{50}$ ) is 4.2 mm (P927).

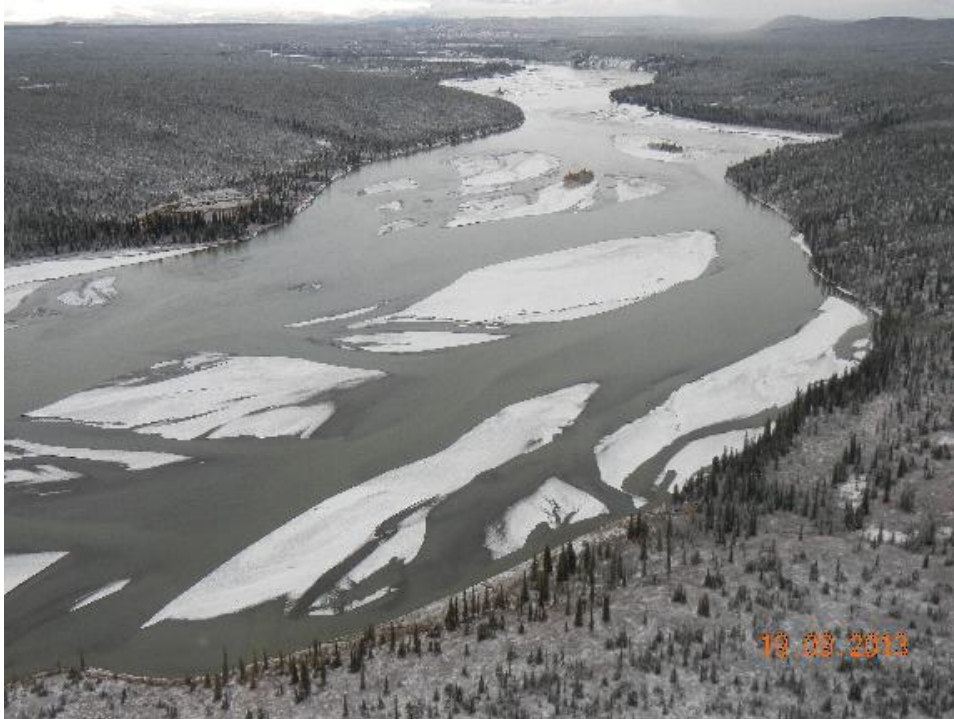
Figure A.1-26 – View upstream from PRM 267 of expansion zone and mid-channel braid bars (P5554).

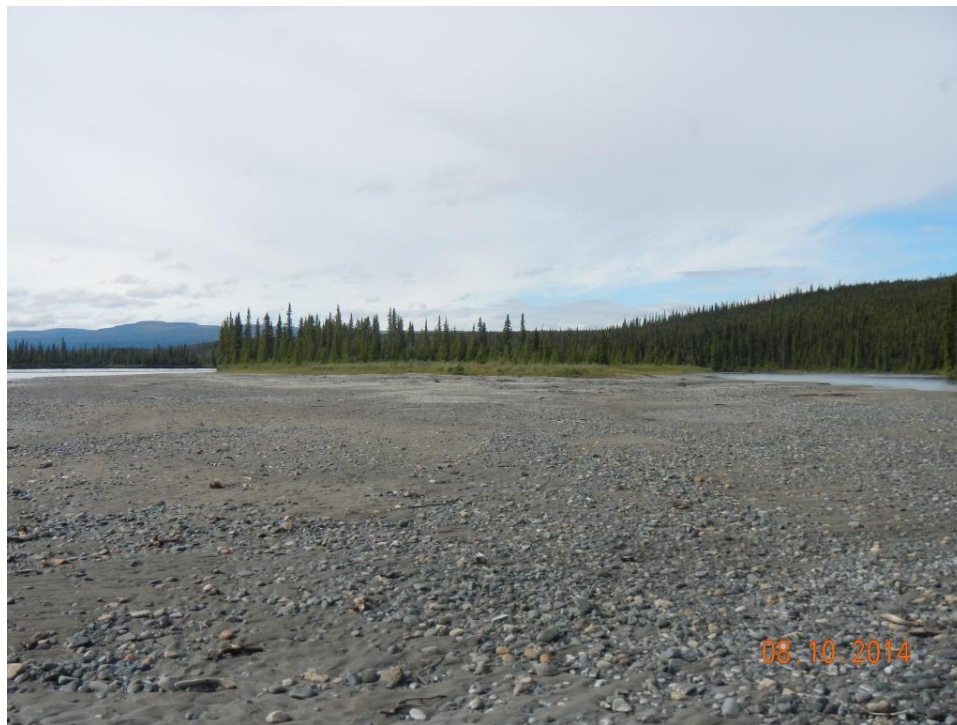
Figure A.1-28 – Very large gravel bar and first observed mid-channel island in expansion zone near PRM 266 (P080).

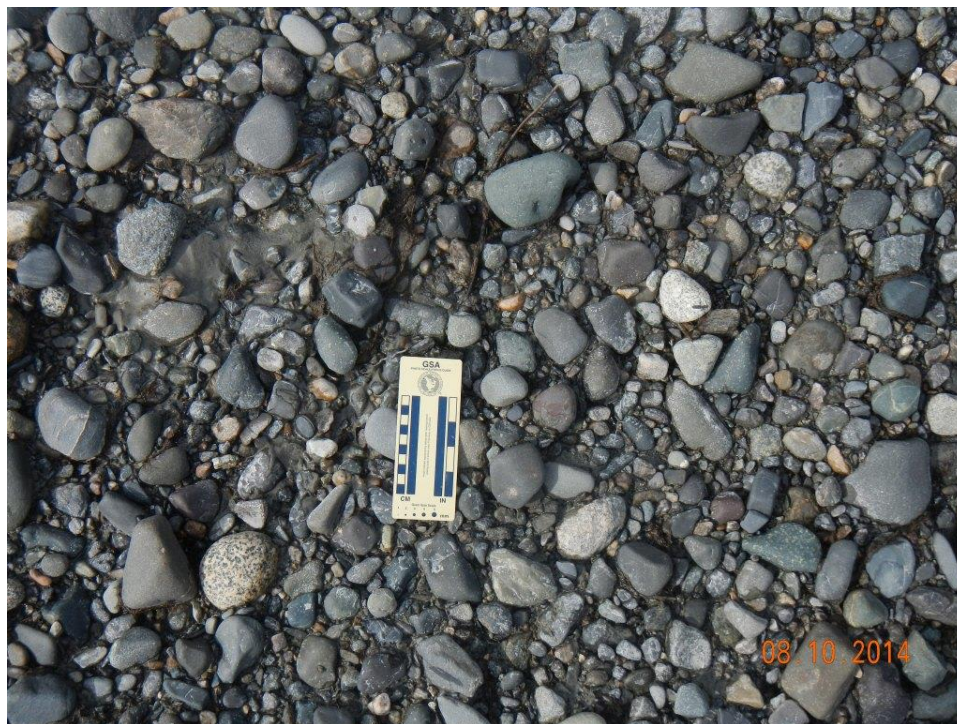
Figure A.1-29 – Gravel on mid-channel bar in expansion zone near PRM 266. Most gravel observed on the mid-channel bar ranged from 32 mm to 45 mm in diameter with some gravel sized at 64 mm to 90 mm (P082).

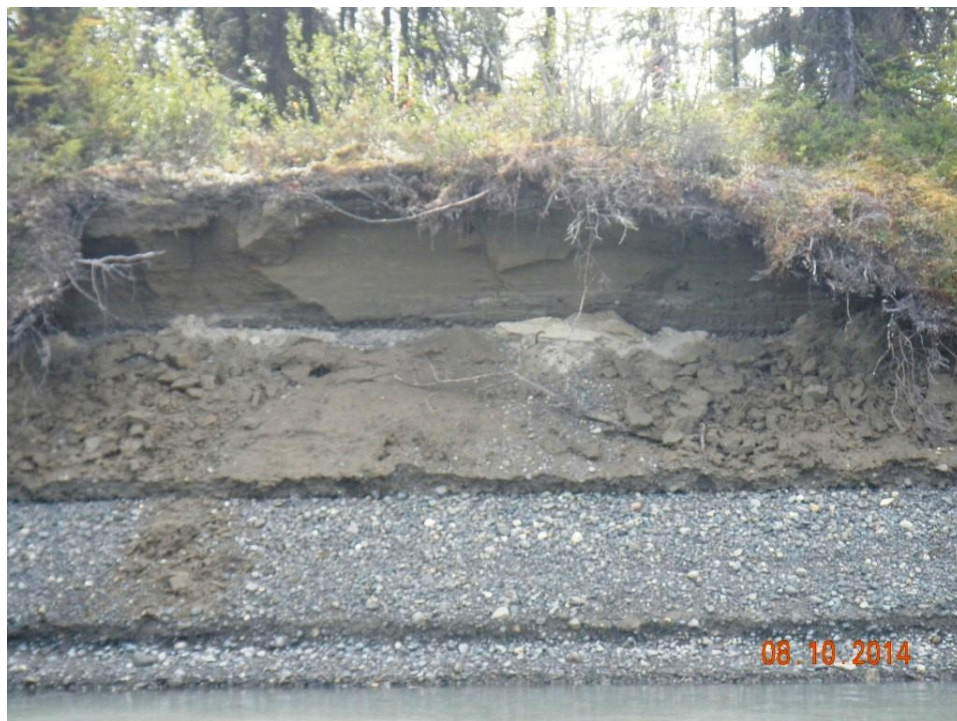
Figure A.1-30 – Eroding terrace near PRM 266 – source of fine grained material and fine gravels (P090).

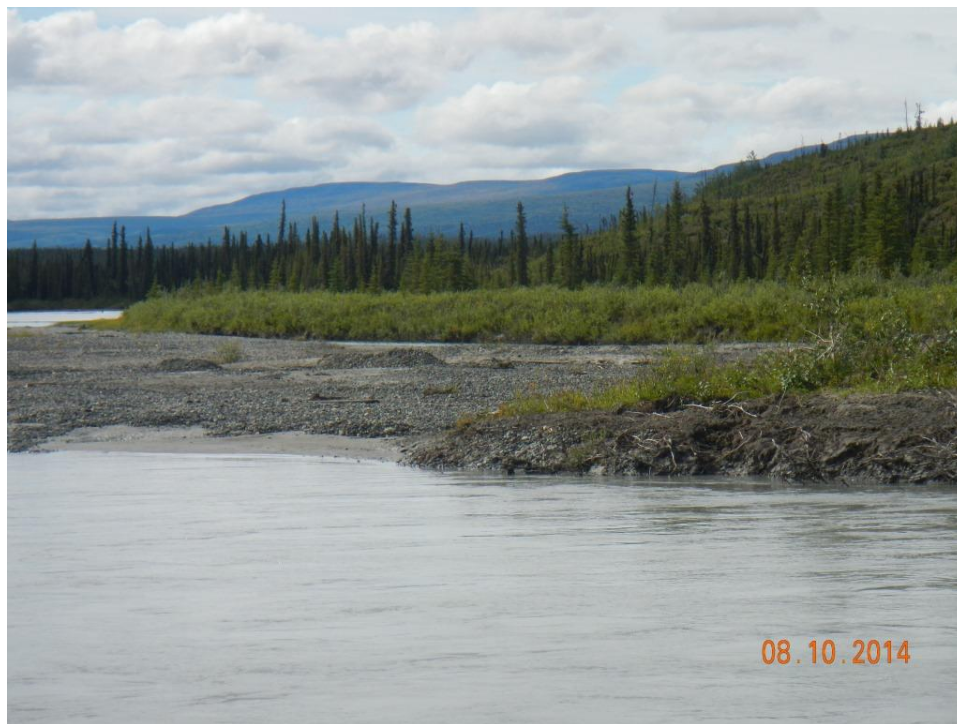
Figure A.1-31 – Ice pushed ridges in gravel deposits on mid-channel bar near PRM 265. Presence of vegetated bars not observed upstream where bars were composed of sand (P112).

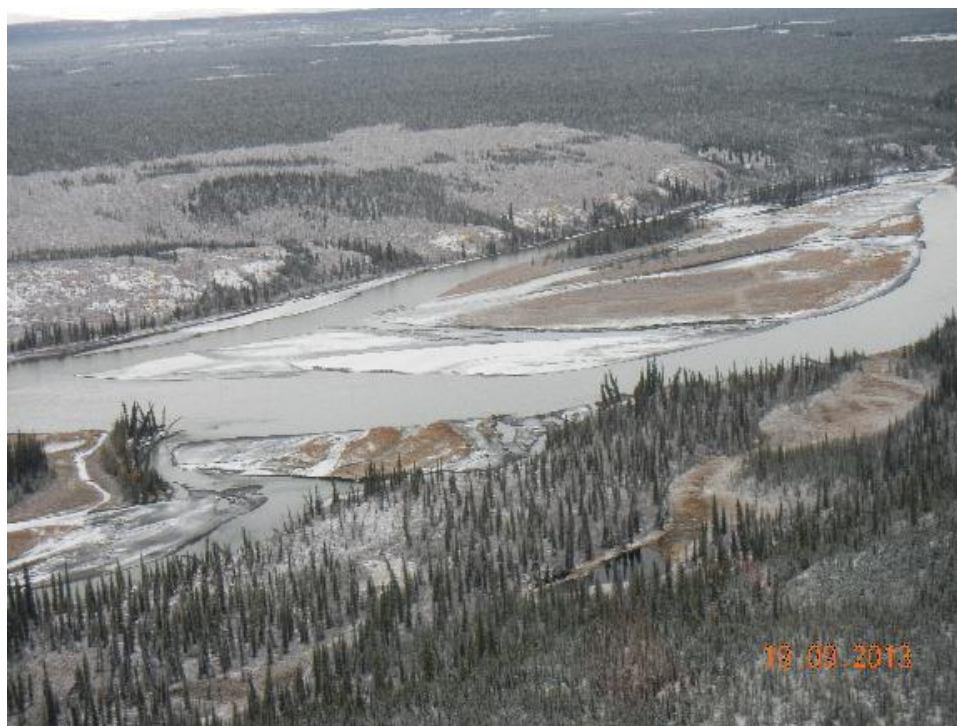
Figure A.1-33 – View upstream of expansion zone and mid-channel bars and islands near PRM 264 (P5551).

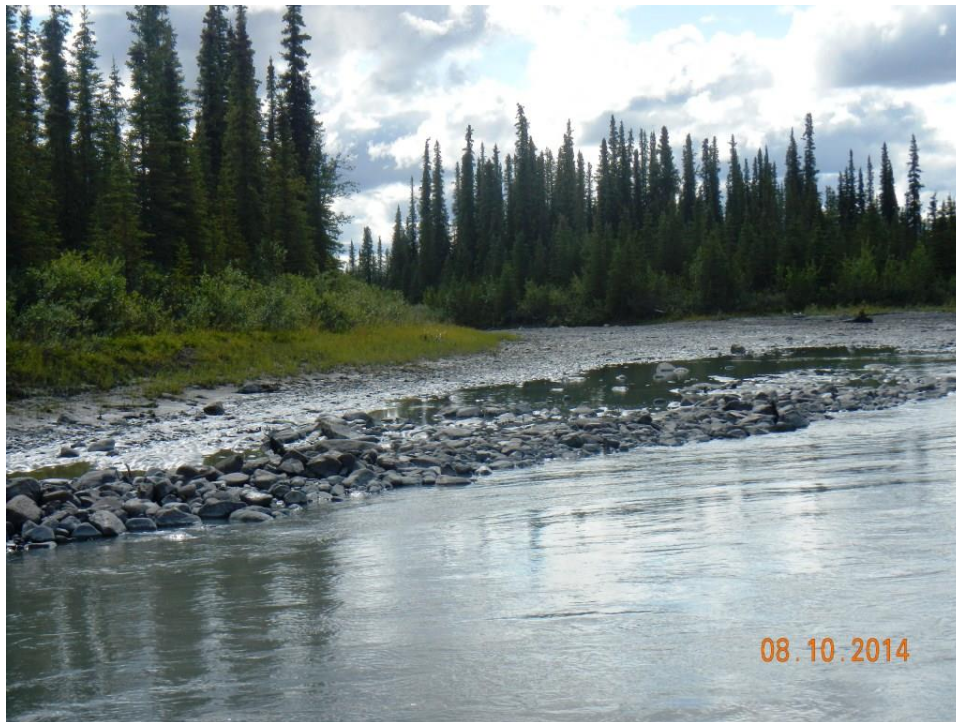
Figure A.1-37 – Angular boulder formed lateral weir upstream of Maclaren River confluence near PRM 261.7 (P167).

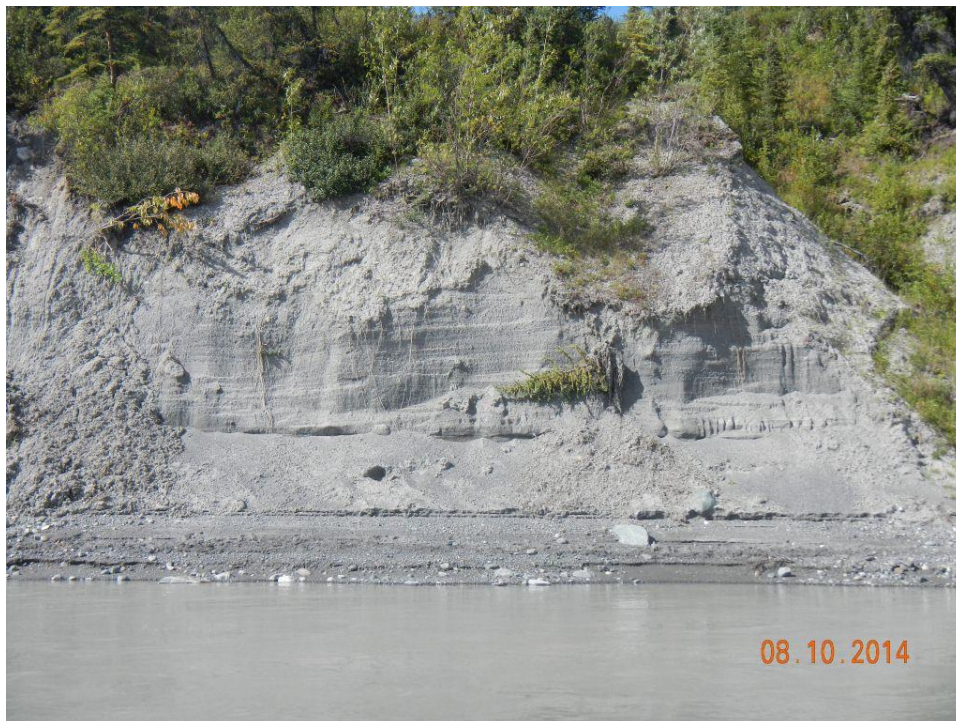
Figure A.1-38 – Eroding outwash terrace surface near PRM 261.5– topsets visible in profile (P176).

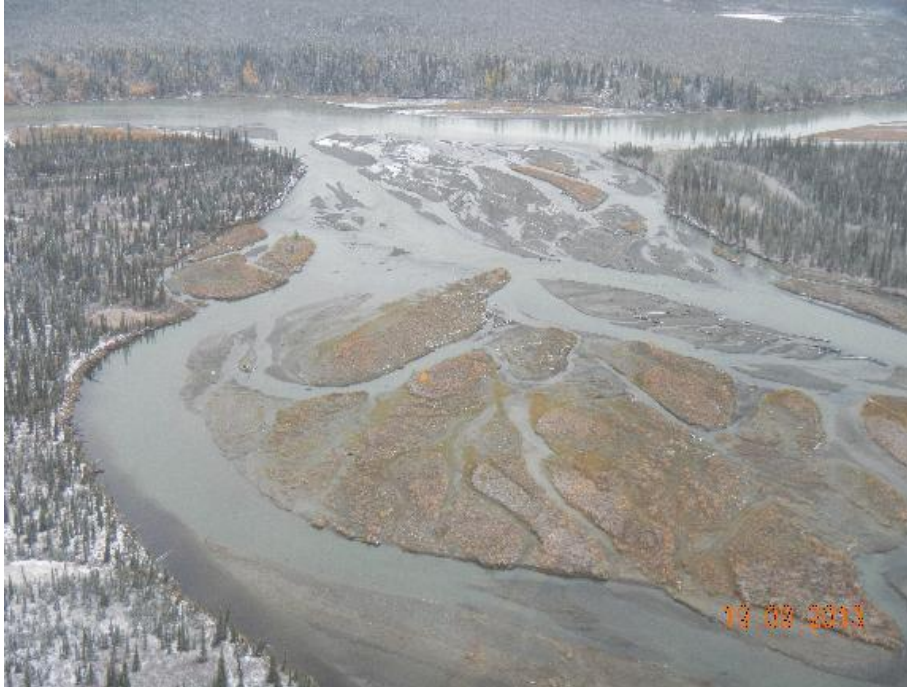
Figure A.2-1 –View down Maclaren River towards confluence with Susitna River at PRM 261.1. Source of gravels to Susitna River (P5547).

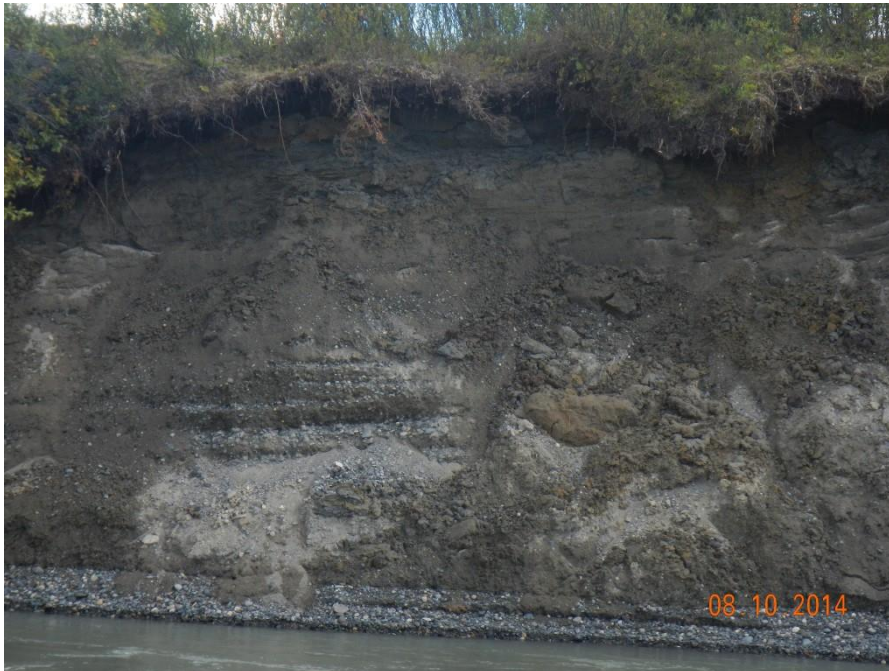
Figure A.2-2 – Eroding outwash terrace near PRM 260 (P213).

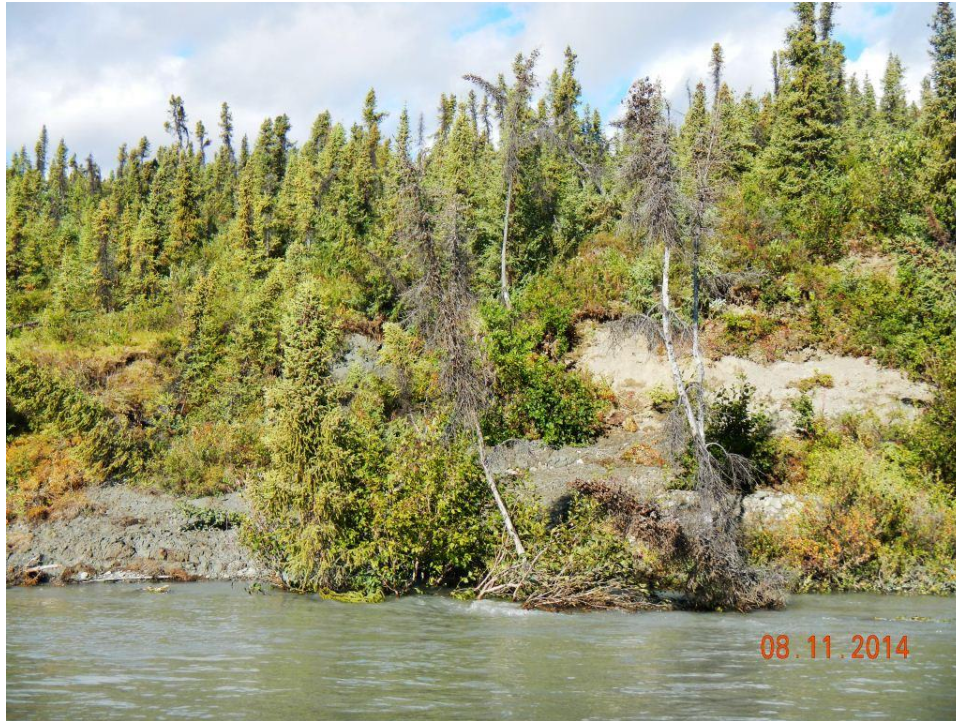
Figure A.2-7 – Active landslide area above constriction at PRM 256 (P245).

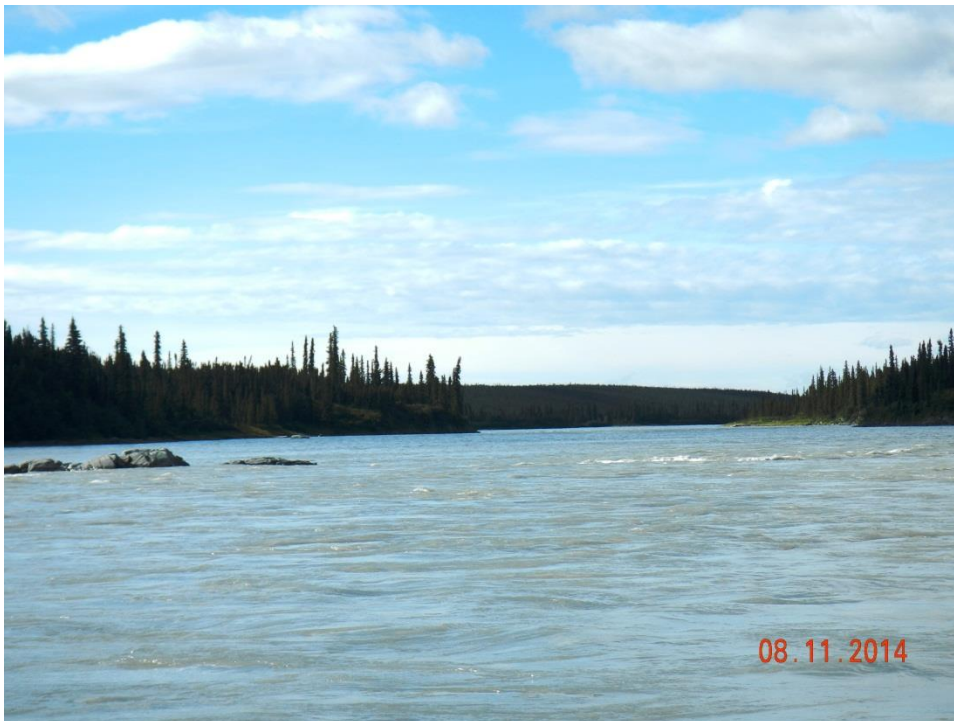
Figure A.2-10 - Bedrock sill across the river at PRM 255.4 (P273).

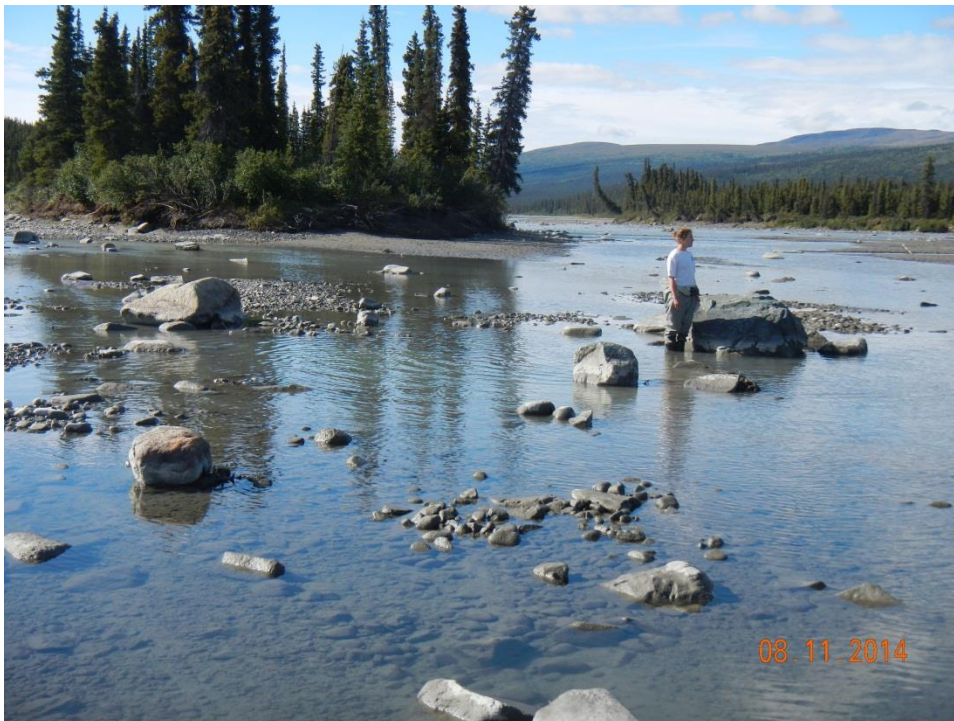
Figure A.2-12 – Large boulders in ice driven side channels near PRM 254.5 (P314).

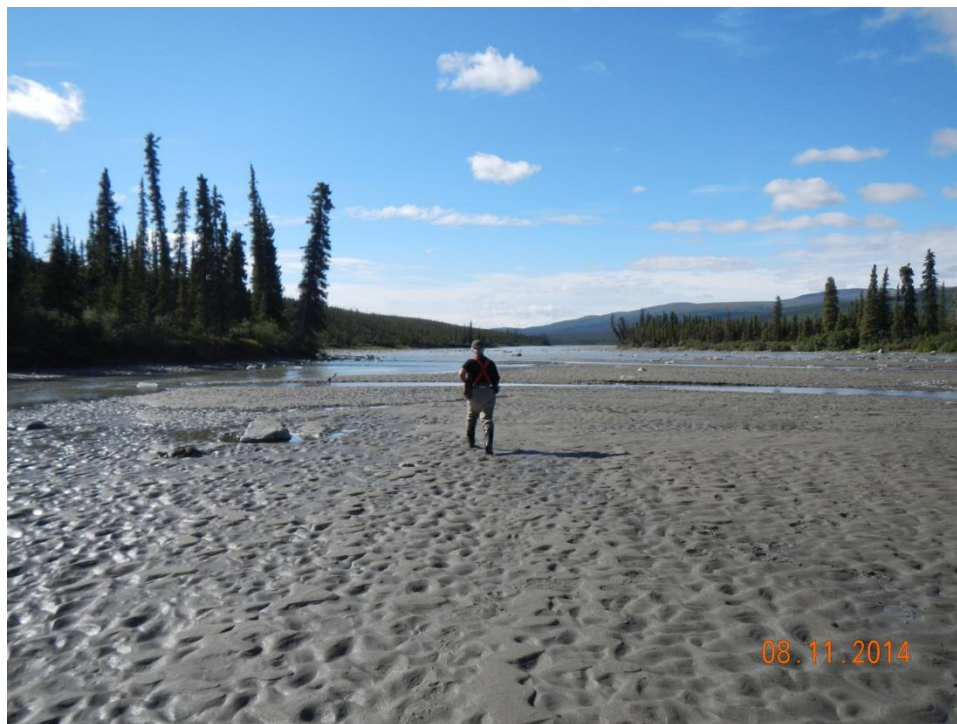
Figure A.2-13 – Sand lobe at downstream end of ice-driven side channel near PRM 254.5 (P315).

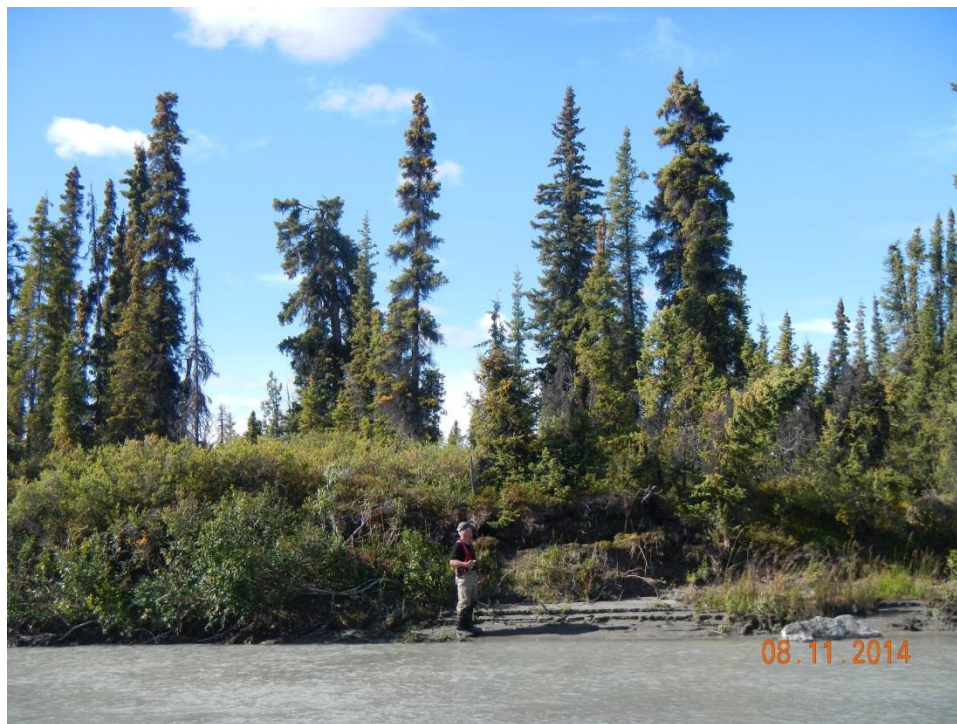
Figure A.2-15 – Terrace elevation mid-channel islands in expansion zone at PRM 254 are typical terrace heights – note person standing in foreground for scale (P319).

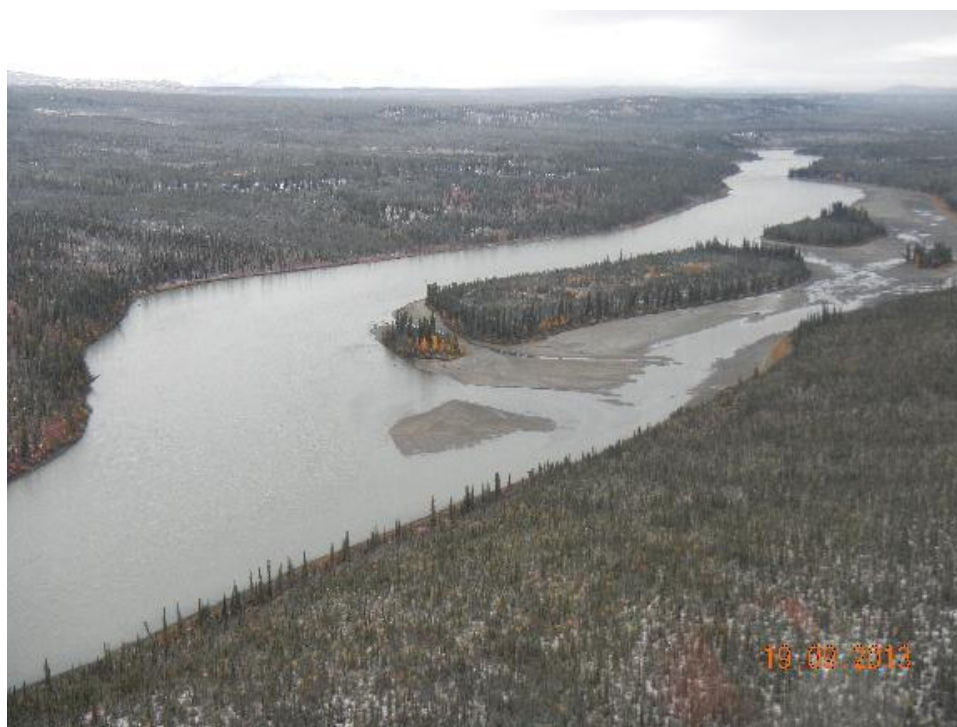
Figure A.2-16 – View upstream of vegetated islands and bars upstream of constriction near PRM 254 (P5538).

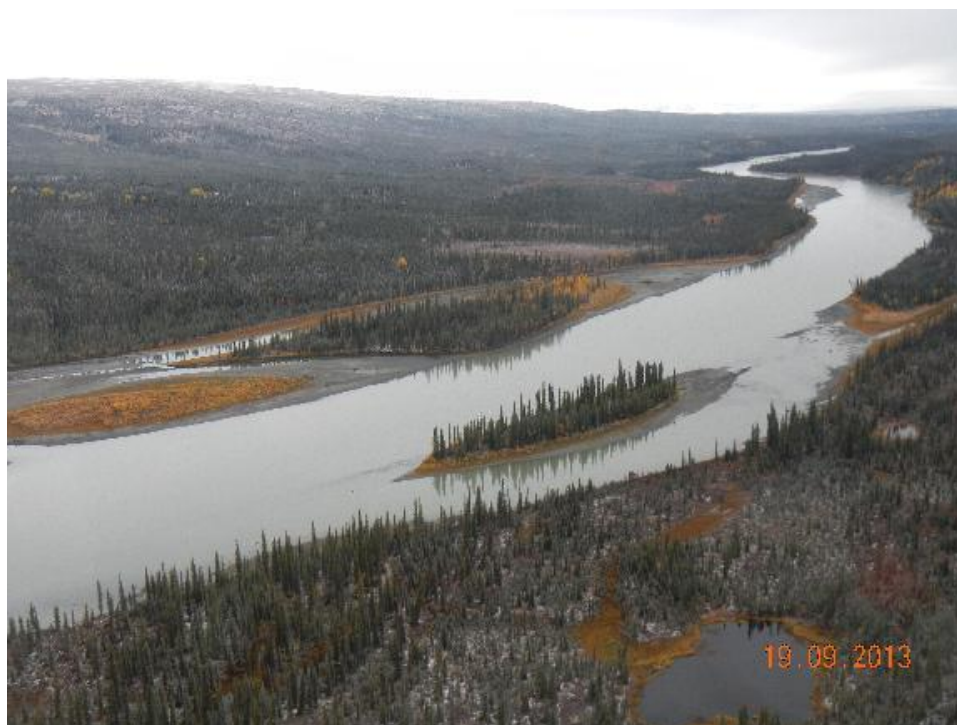
Figure A.2-18 – View upstream of vegetated islands and bars in expansion zone near PRM 250 (P5536).

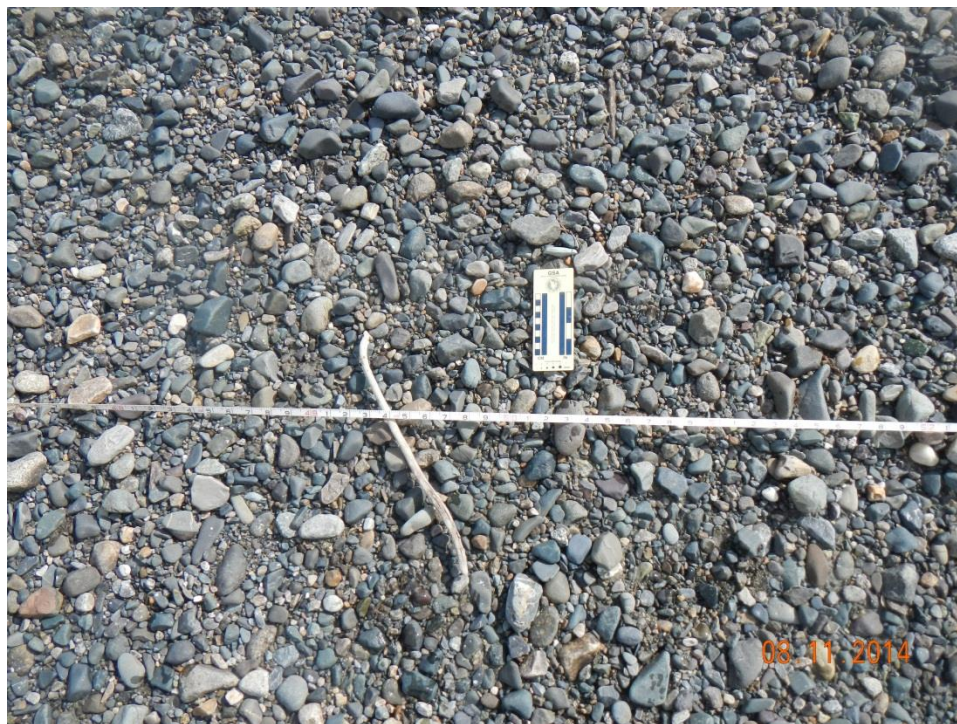
Figure A.2-19 – Surface material on bar surface at PRM 250.9. Median particle diameter ( $D_{50}$ ) is 30.0 mm (P425).

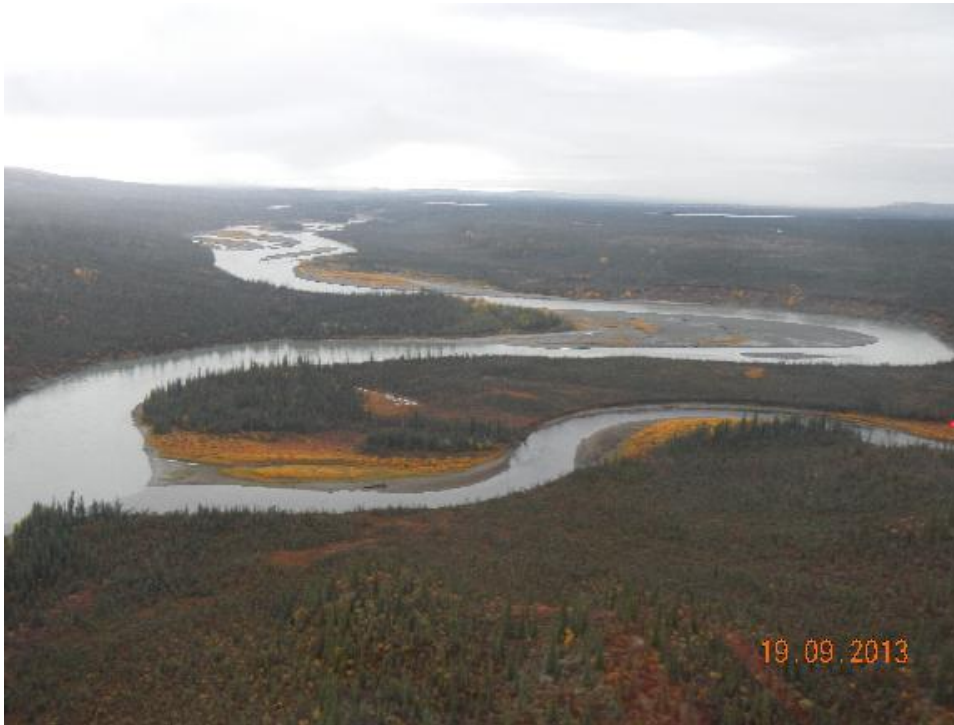
Figure A.2-21 – View upstream near PRM 247 illustrating forced sinuosity at UR-2/UR-3 reach break and Tyone River confluence at lower end of photo (P5529).

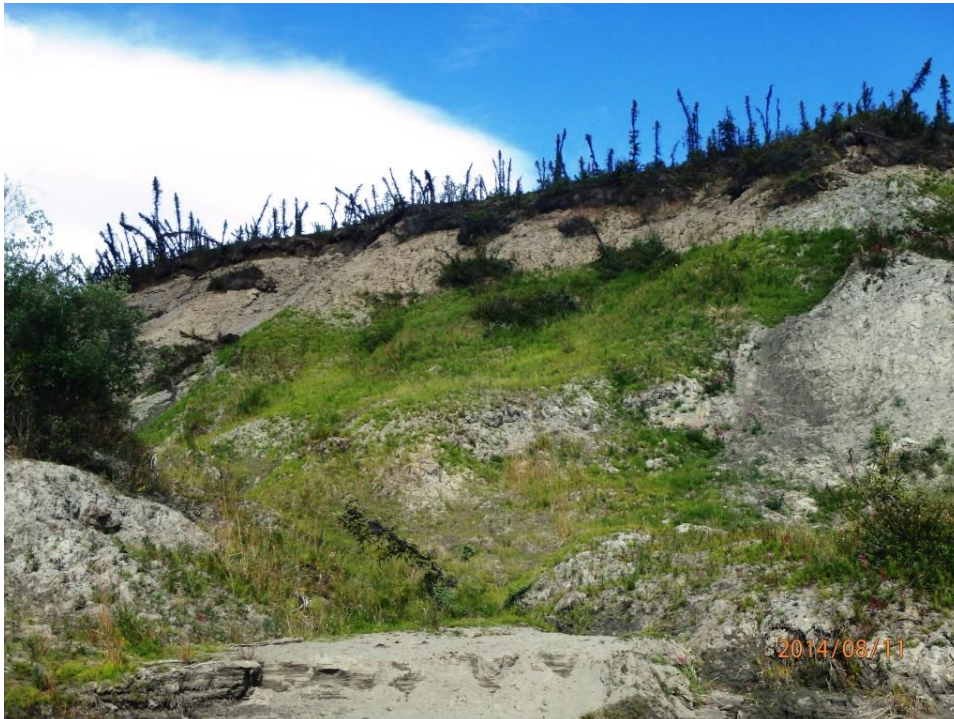
Figure A.2-24 – Vegetation unable to establish on very actively eroding unstable bank face (P903).

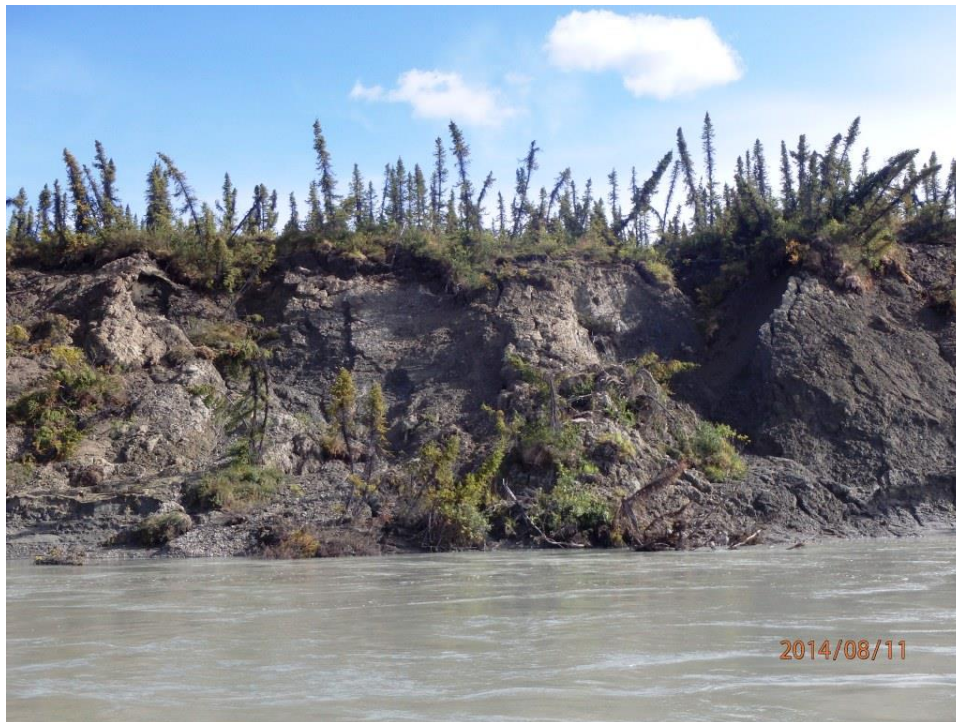
**Figure A.2-25 – Fine-grained materials and gravel sourcing from eroding outwash terrace surface near PRM 247.7 (P918).**

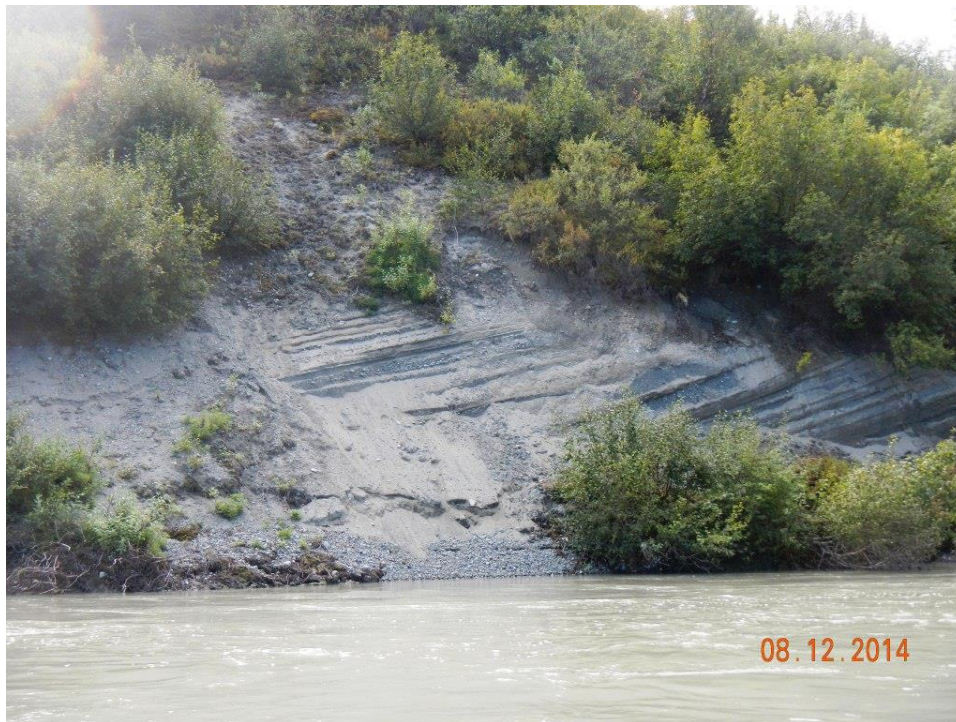
Figure A.2-27 – Eroding supply of fine grained sediment and gravels from glacio-lacustrine sediments at PRM 245.2 (P448).

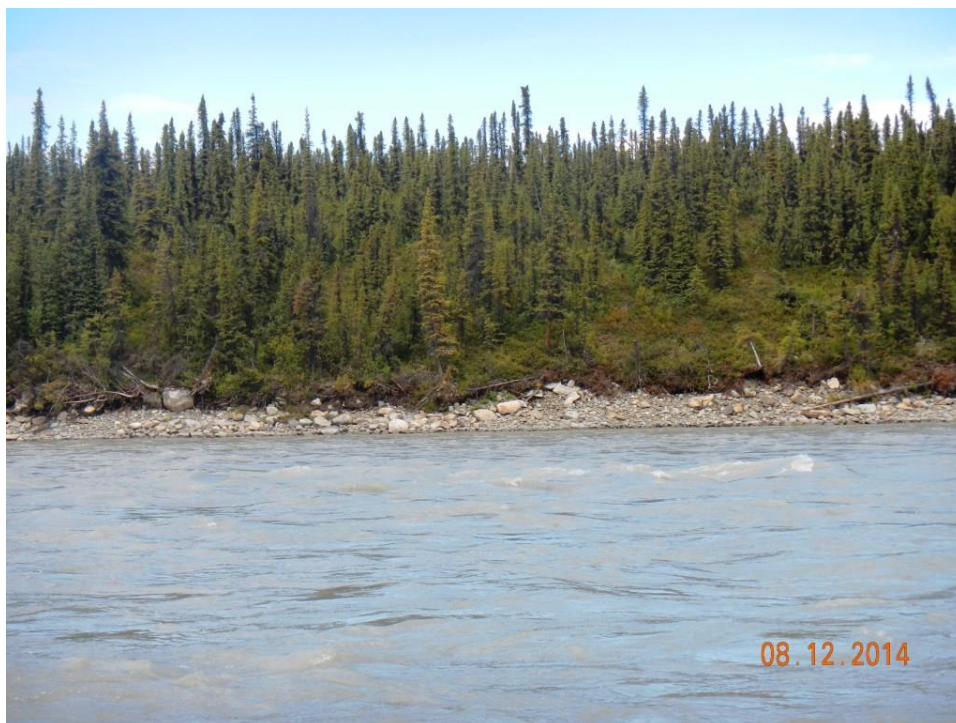
Figure A.2-28 – Typical ice scraped bank with large cobble and boulder deposits and ice pushed vegetation near PRM 244.5 (P458).

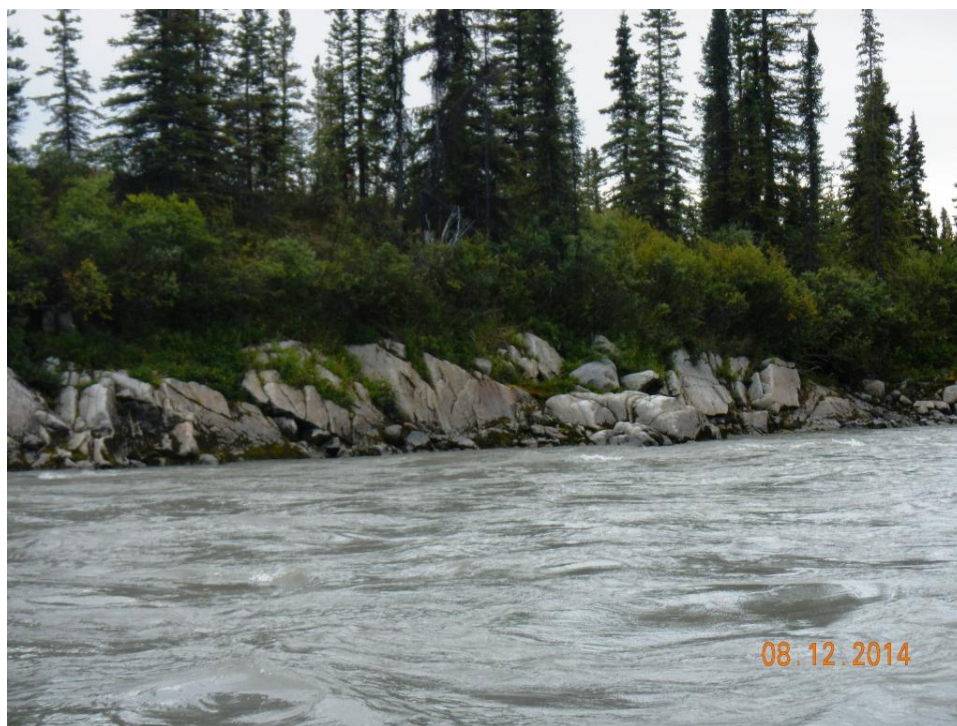
**Figure A.2-29 – Bedrock outcrop in right bank near PRM 243.5 (P473).**

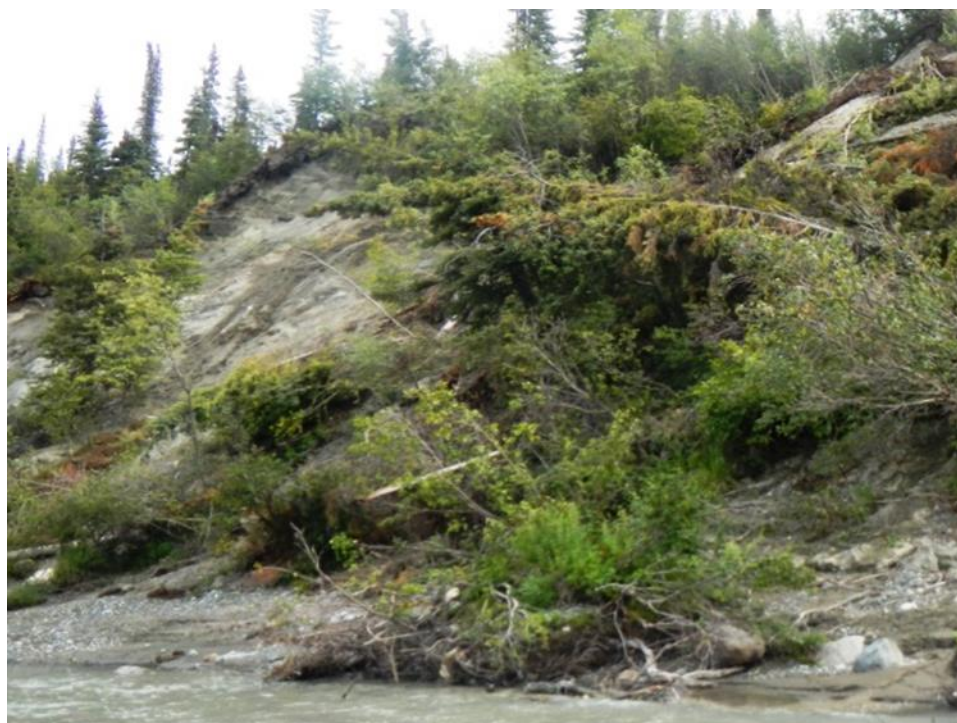
**Figure A.2-30 - Active landslide in till supplying fine sediment, gravels, cobbles, and large wood near PRM 242.5 (P507).**
