## APPENDIX A: SUSITNA RIVER UPPER RIVER RECONNAISSANCE PHOTOGRAPHS

# 1. PHOTOGRAPHS OF THE SUSITNA RIVER UPSTREAM OF THE MACLAREN CONFLUENCE (PRM 291.8 TO PRM 261.3)

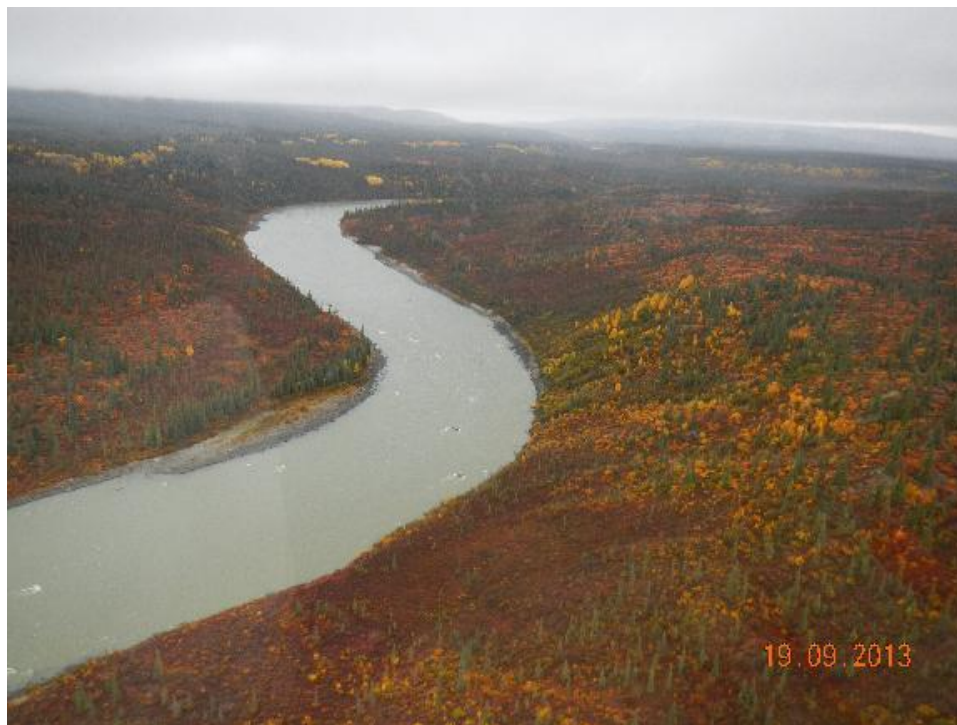
Figure A.2-32 – Confined channel with no islands or bars at PRM 240. Note large ice-deposited boulders in channel (indicated by surface disturbance in flow) (P5526).

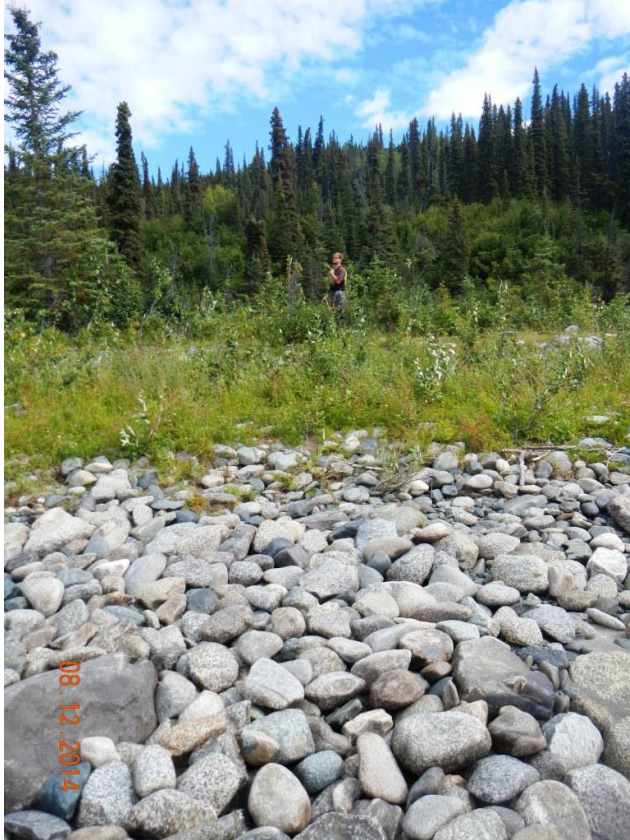
Figure A.2-33 – Ice paved bank on high island surface with mowed vegetation near PRM 238.2 (P618).

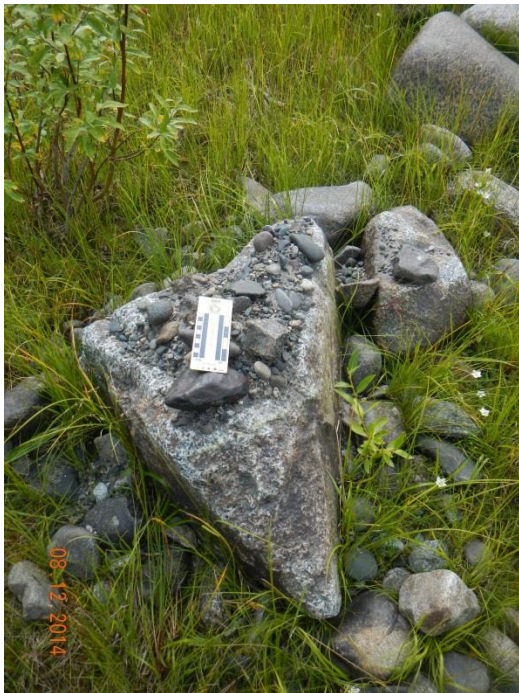
Figure A.2-34 – Ice deposited material on top of high island surface near PRM 238.2 (P611).

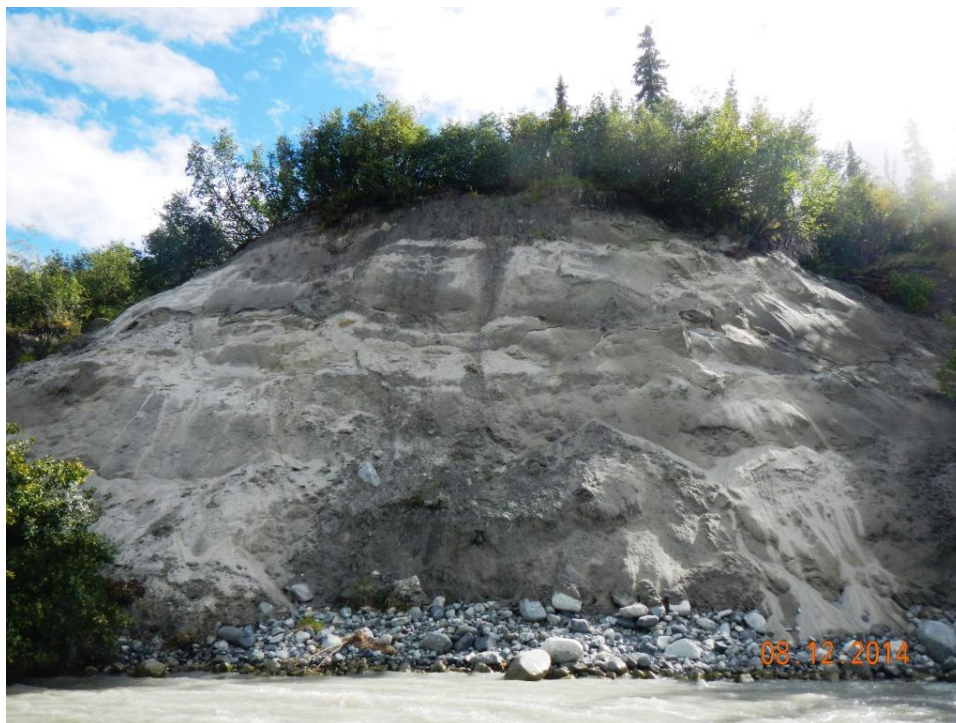
Figure A.2-36 – Large, primarily fine grained (sand) sediment source near PRM 235.6 (P699).

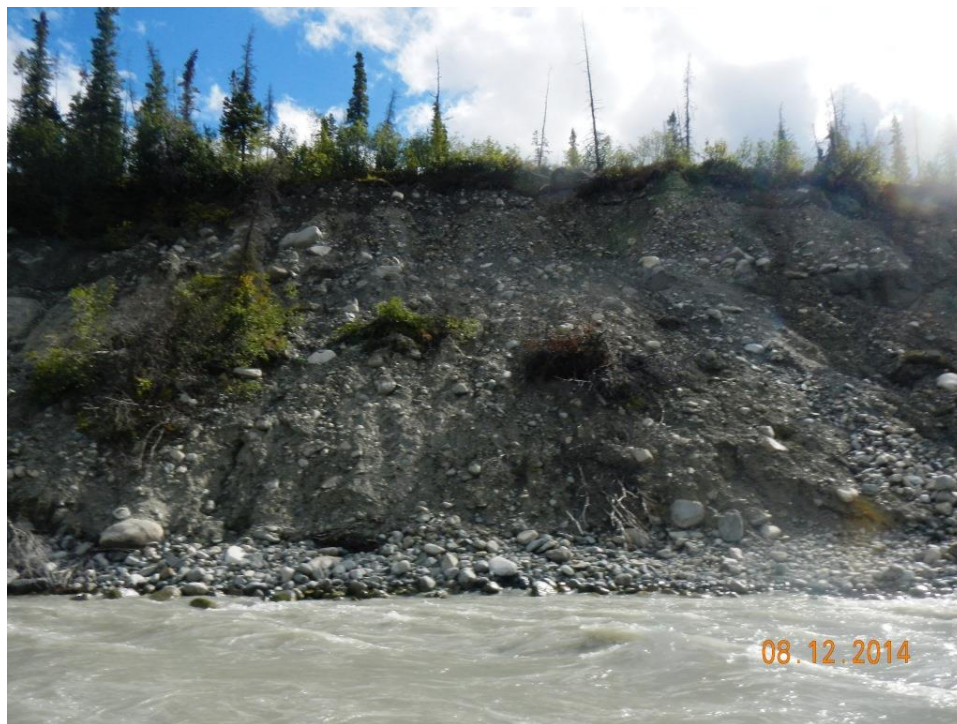
Figure A.2-37 - Course grained sediment (cobbles and boulders) source (till) near PRM 235.6 (P701).

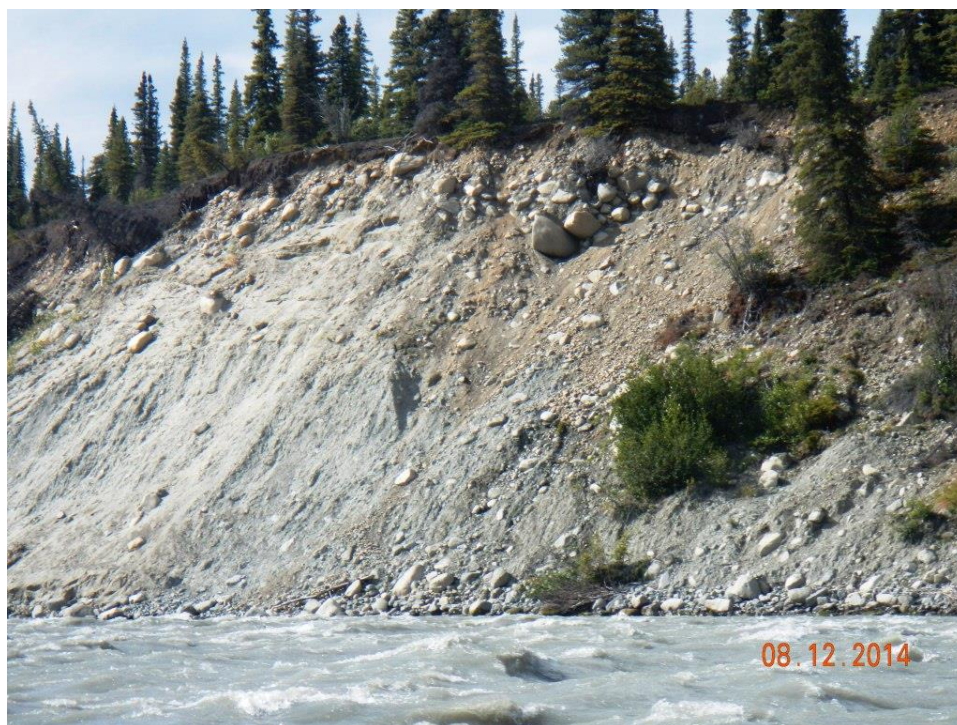
Figure A.2-38- High eroding lateral moraine with large cobbles and boulders at PRM 235 (P714).

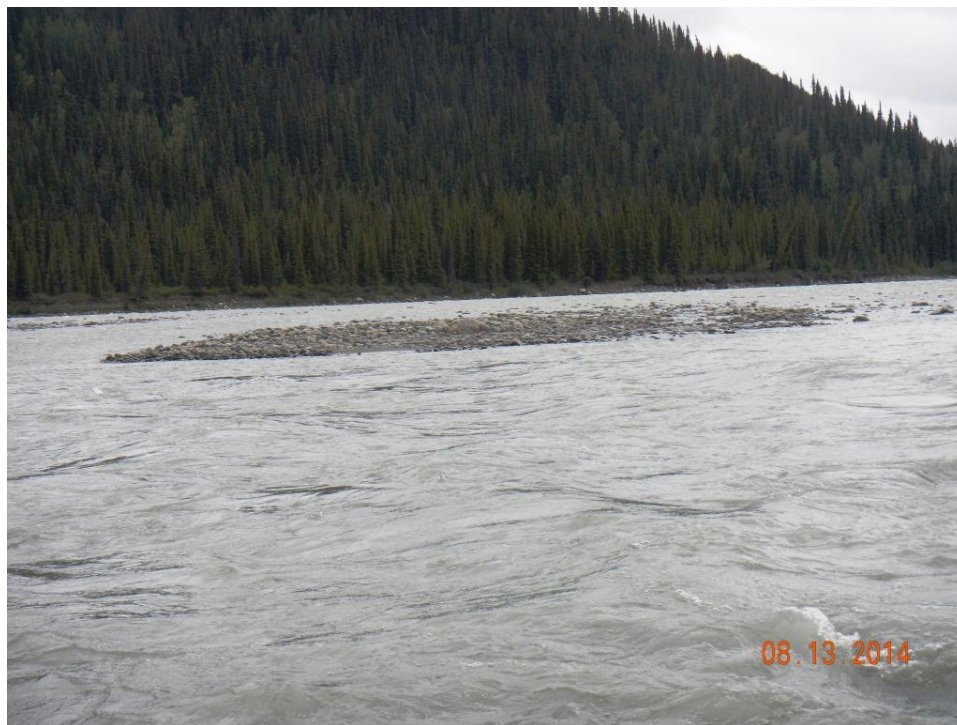
Figure A.2-39- Fine to medium gravel storage in mid-channel bar in expansion zone near PRM 233.5 (P782).

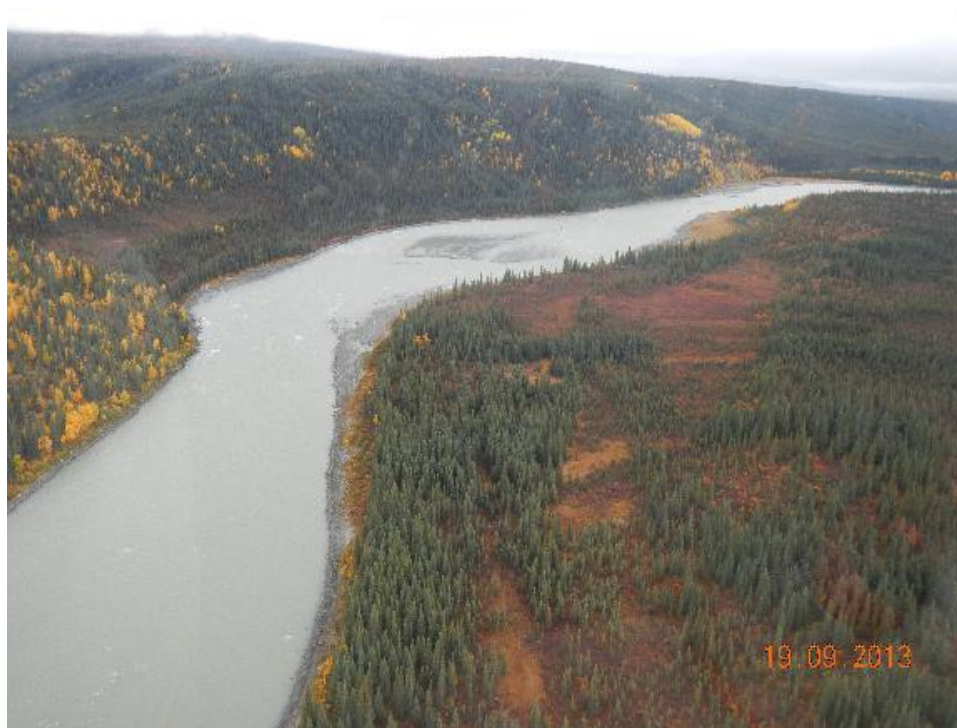
Figure A.2-40 – View upstream near PRM 233.5 to first expansion zone with mid-channel bar since UR-1 (P5516).

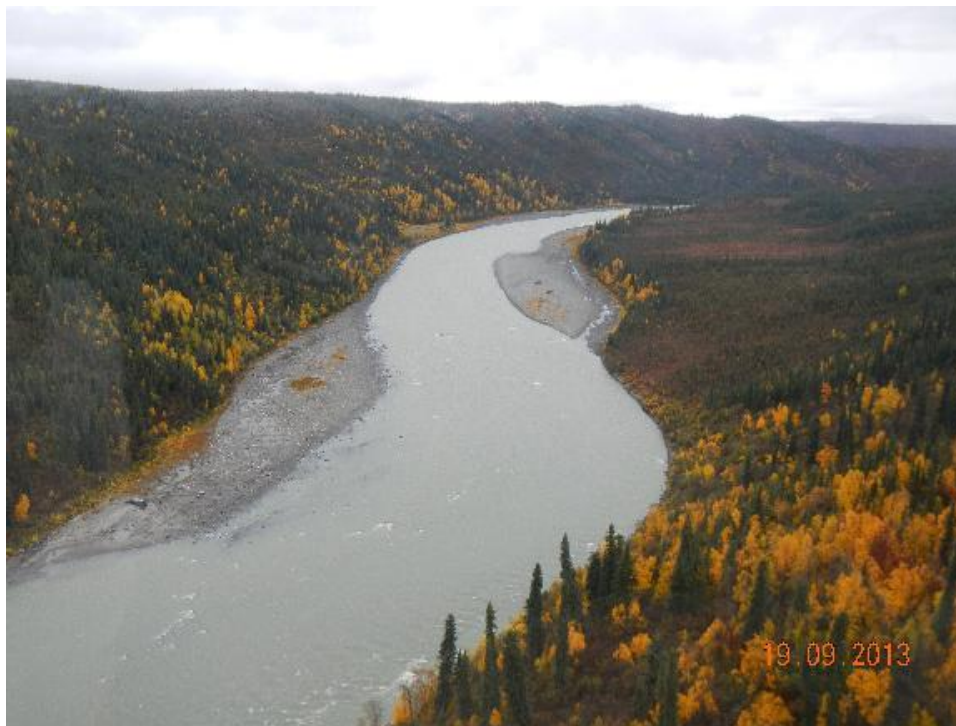
Figure A.2-41 – View upstream at PRM 230.5 – ice paved bank-attached gravel bars – vegetated bedrock banks. Old fan surface observed on left bank (P5512).

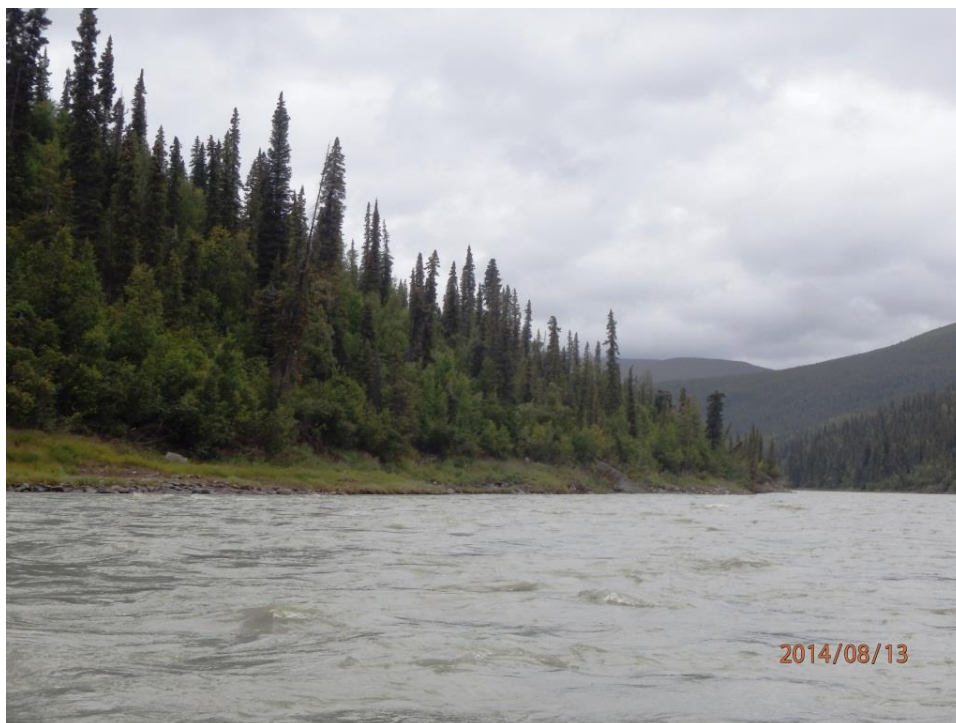
Figure A.2-42 – Typical vegetated hillslope (PRM 229.5) observed throughout reach. Note height of ice trim line about 10-20 feet above water surface (P033).

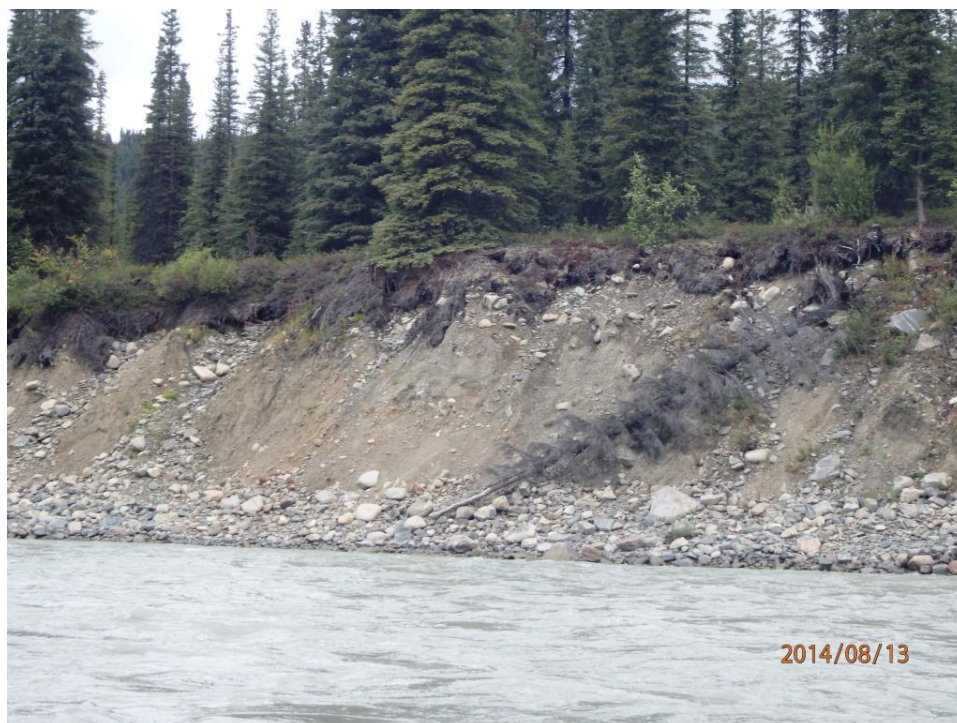
Figure A.2-45 - Eroding outwash terrace near PRM 229 – local fine and coarse grain sediment supply (P069).

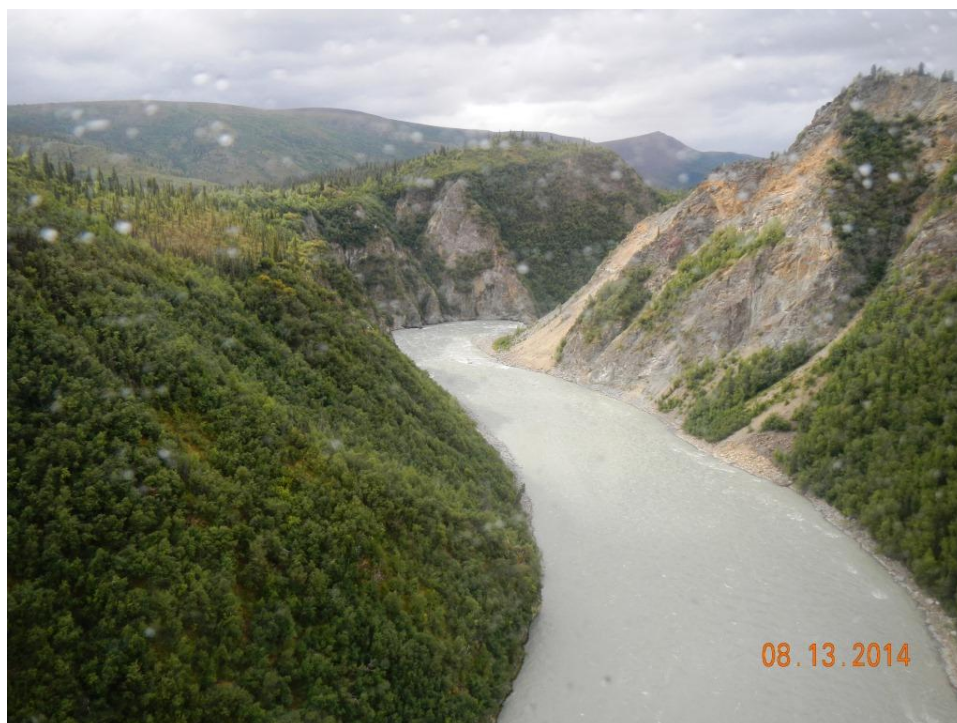
Figure A.2-46 – View downstream at PRM 226 of bedrock outcrop and vegetated bedrock slopes on right and left banks in Vee Canyon (P750).

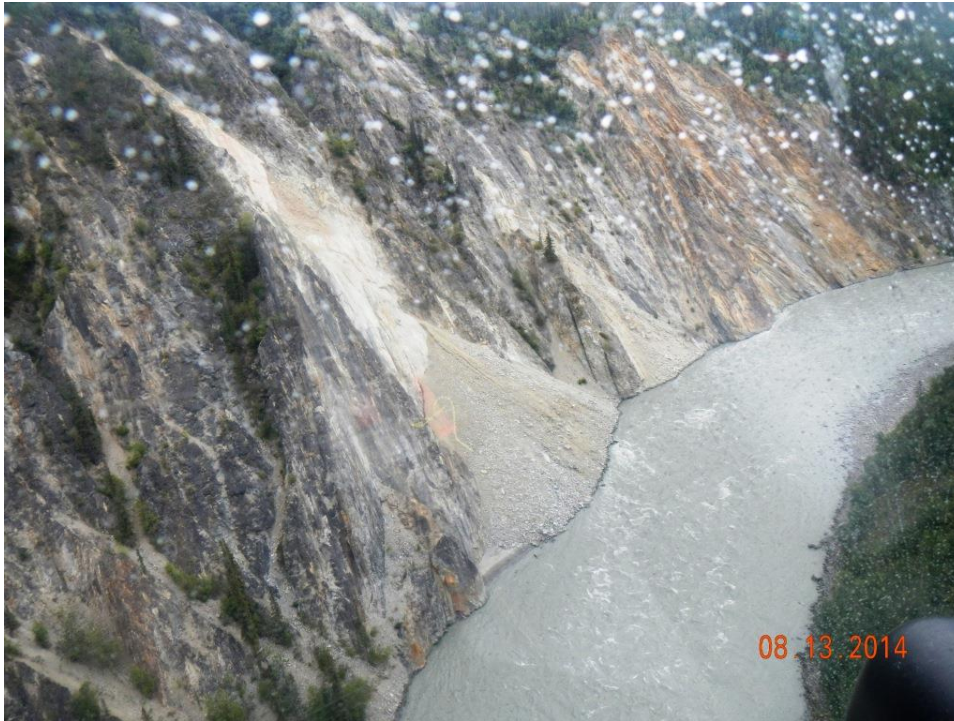
**Figure A.2-47 – View upstream near PRM 226 at right bank colluvial cones in Vee Canyon – local bedrock source of large sediment (P757).**

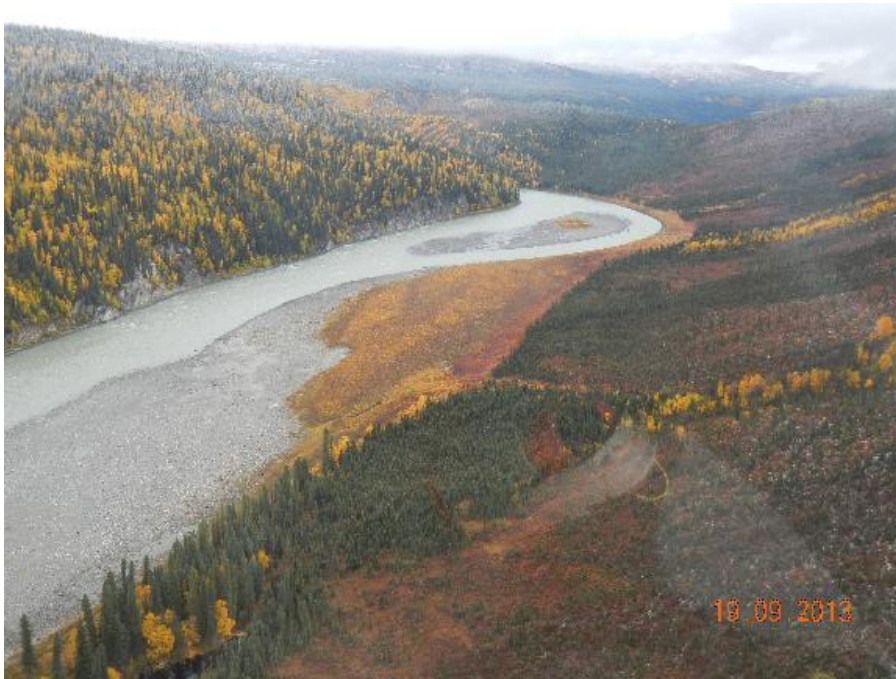
Figure A.2-48 – View upstream of the expansion zone in UR-4 at the bottom end of Vee Canyon (UR-3/UR-4 reach break) (P5498).

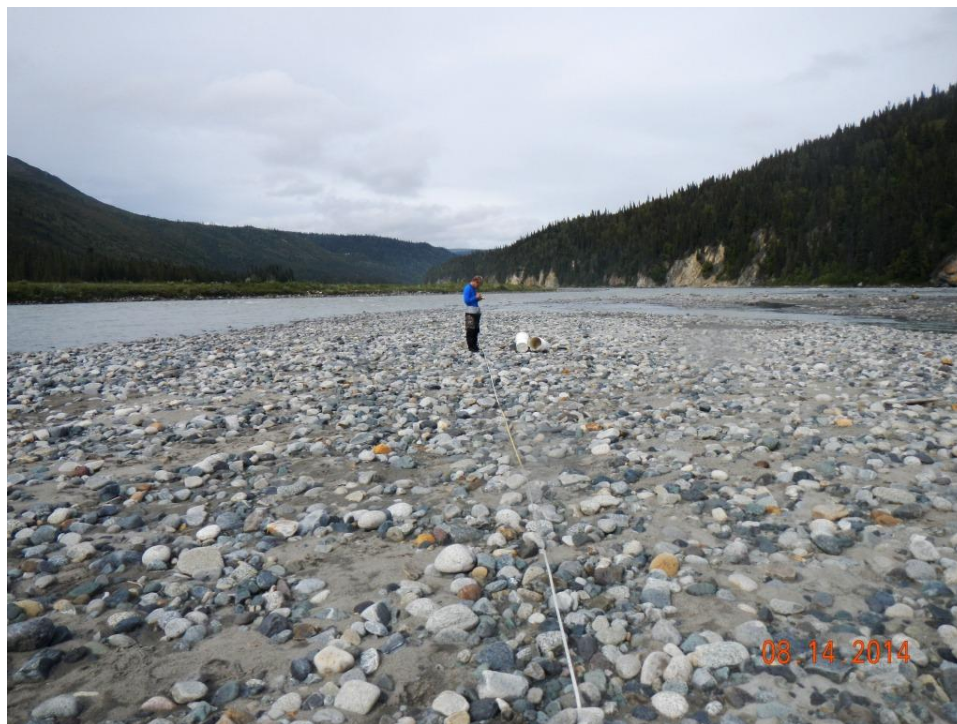
Figure A.2-50 – Imbricated surface material on gravel bar (PRM 224.6) in expansion zone downstream of Vee Canyon. Site of surface and subsurface sampling. Median particle diameter ( $D_{50}$ ) of surface bed material is 68.3 mm. Median particle diameter ( $D_{50}$ ) of subsurface bed material is 27.3 mm (P877).

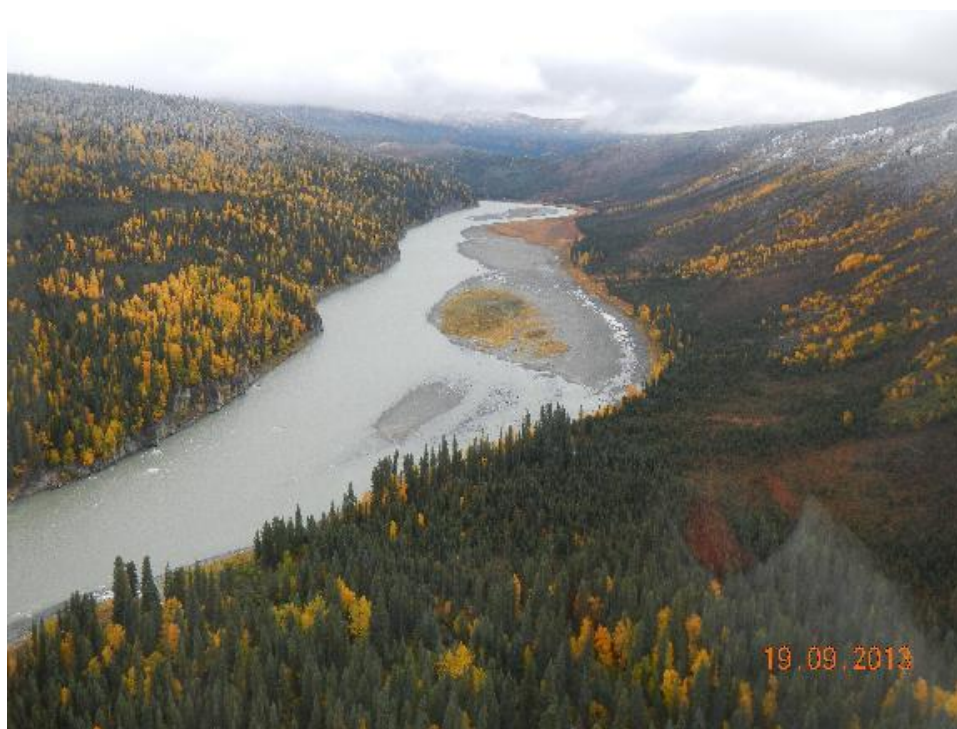
Figure A.2-51 – View upstream at PRM 223 of an expansion zone and vegetated island (P223).

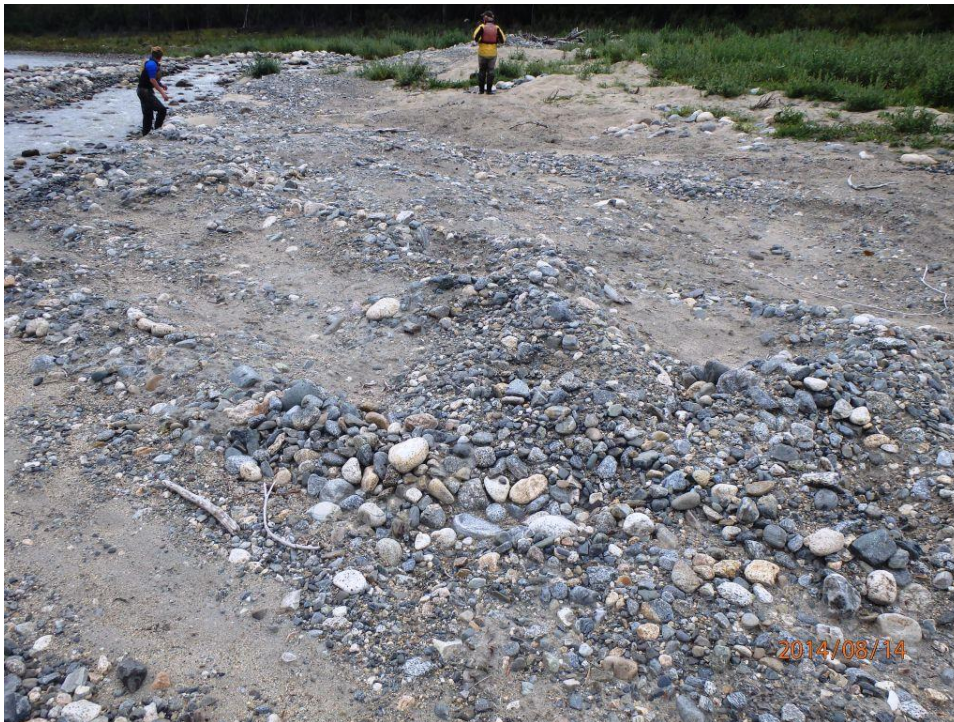
Figure A.2-53 – Ice pushed ridges on fan surface of Unnamed Tributary at PRM 221.2 (P121).

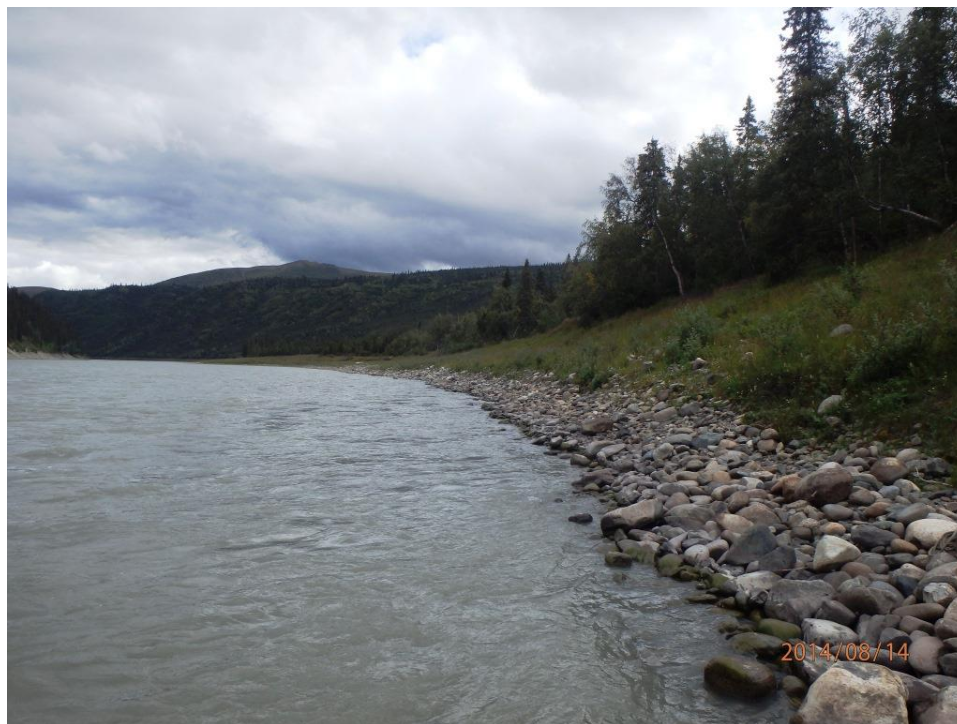
Figure A.2-56 – View upstream at PRM 220.7 of ice paved gravels and ice-sheared vegetation. Trim line about 15 feet above water surface (P161).

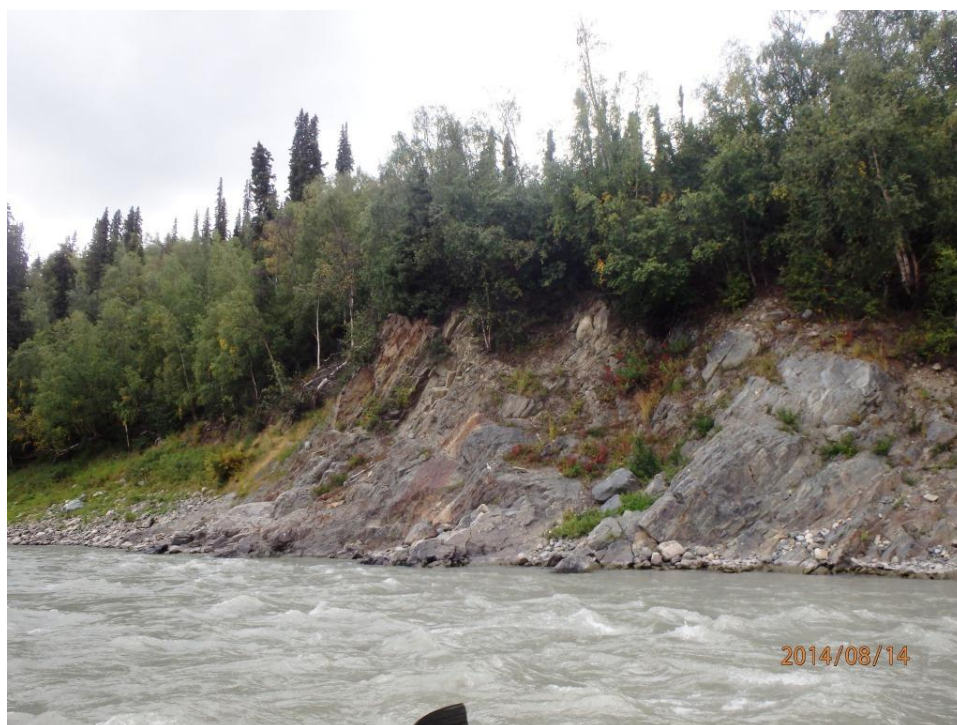
Figure A.2-57 – Bedrock outcrop near PRM 220.2. Ice shear line present on vegetated surface and outcrop surface on right bank (P177).

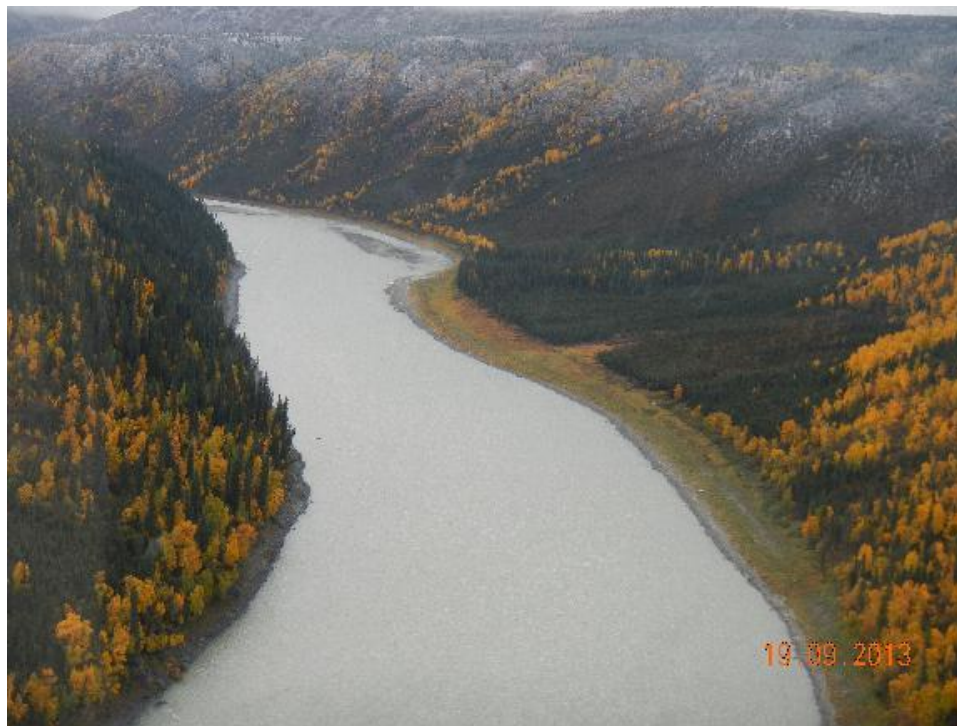
Figure A.2-58 – View upstream at PRM 220. Old fan surface illustrated on left bank (P5491).

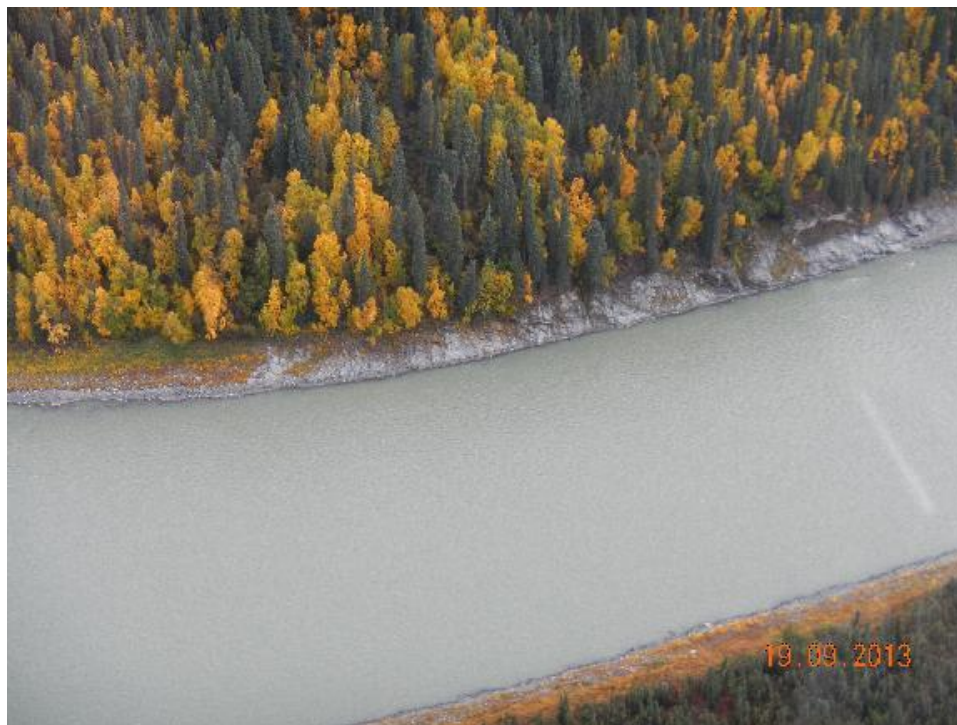
Figure A.2-59 – Aerial view of lateral bedrock controlled channel at PRM 219 (P5490).

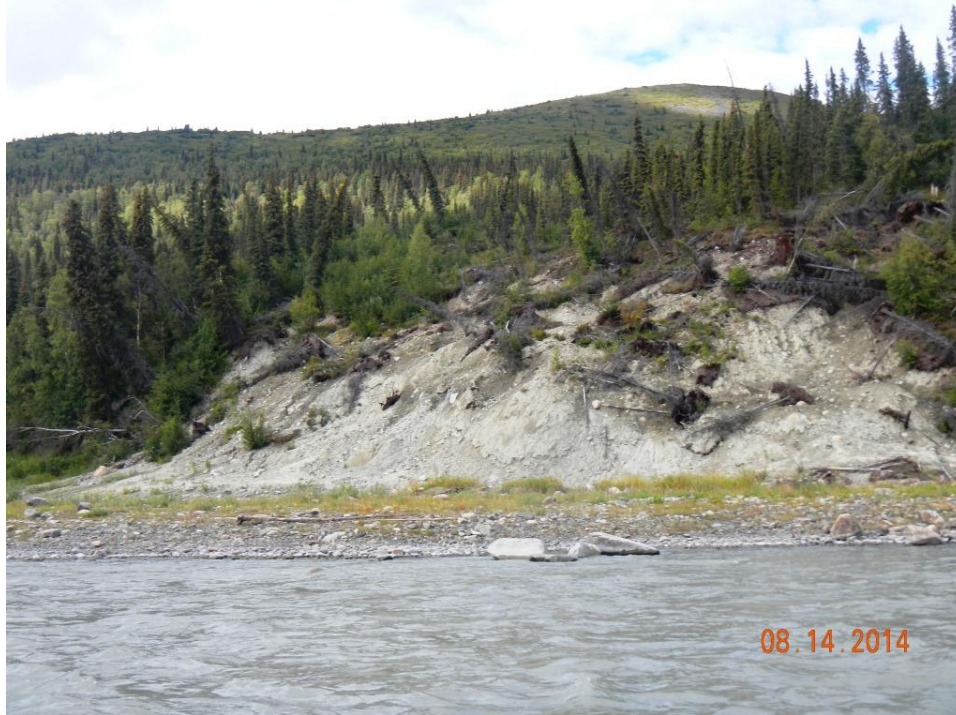
Figure A.2-60 - Active landslide in till at PRM 217 (P964).

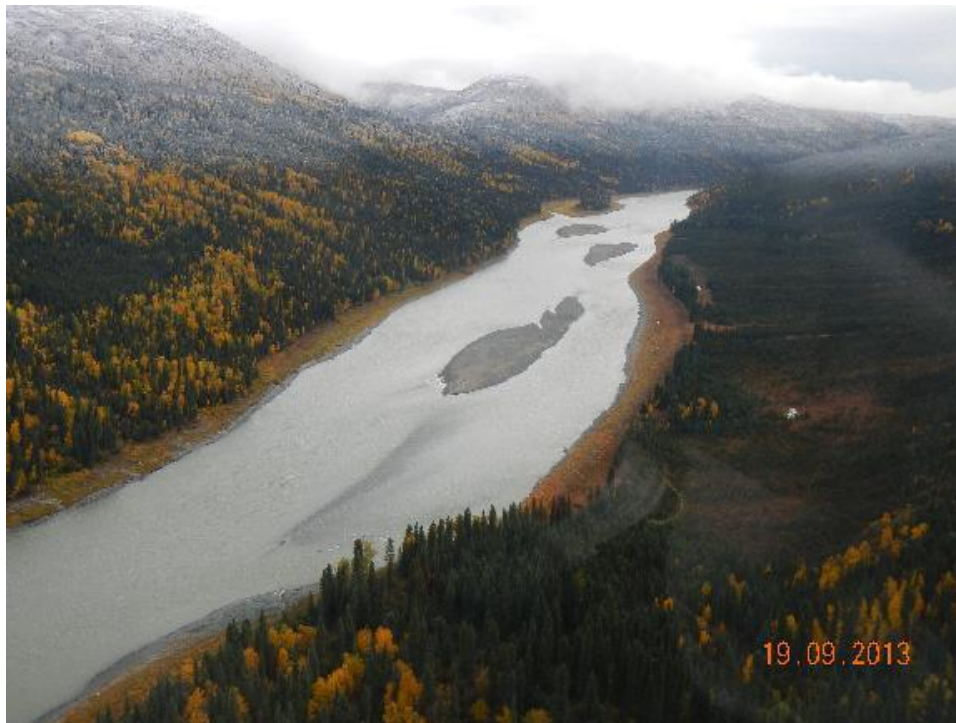
Figure A.2-61 – View upstream of mid-channel bars at PRM 215. Bedrock outcrop along right bank (P5484).

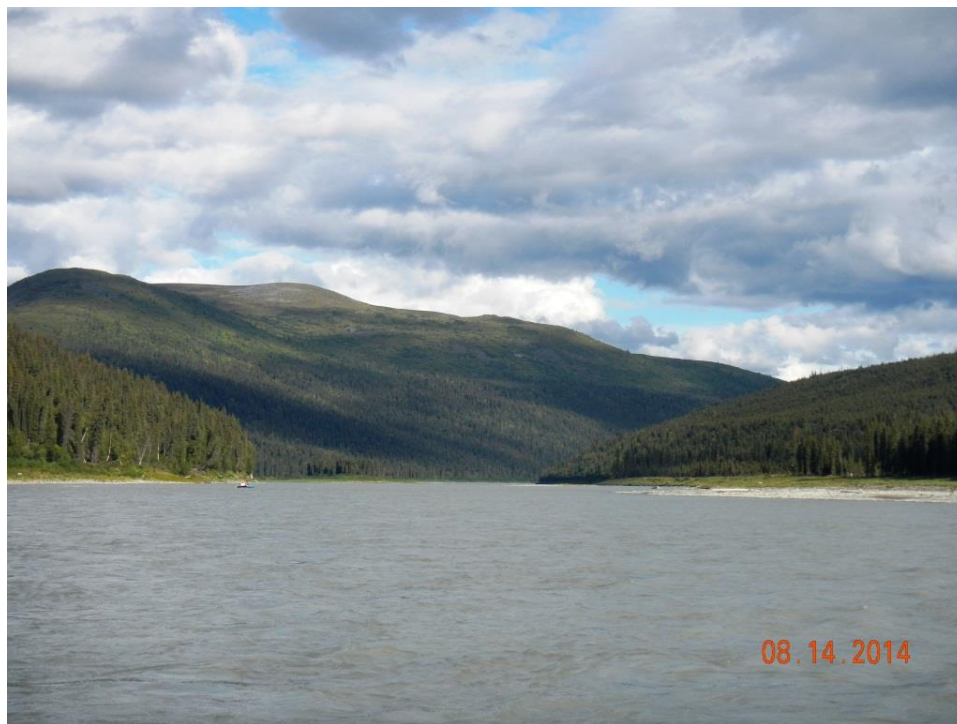
Figure A.2-62 – View upstream at PRM 215 of vegetated hillslopes in wider valley (P996).

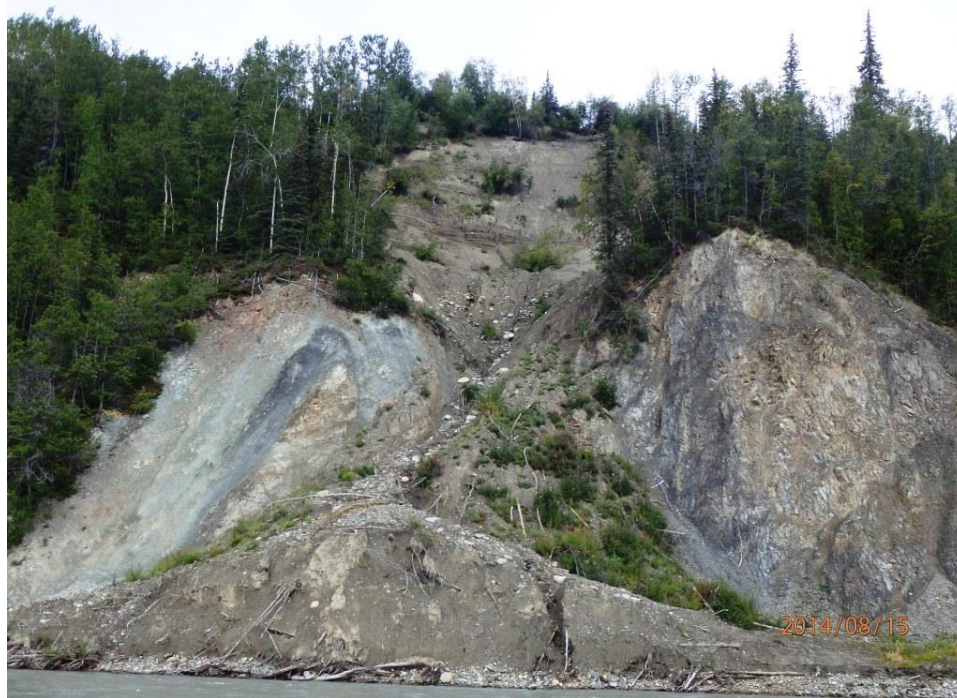
Figure A.2-64 – Active landslide zone on bend near PRM 209 – till over bedrock (P371).

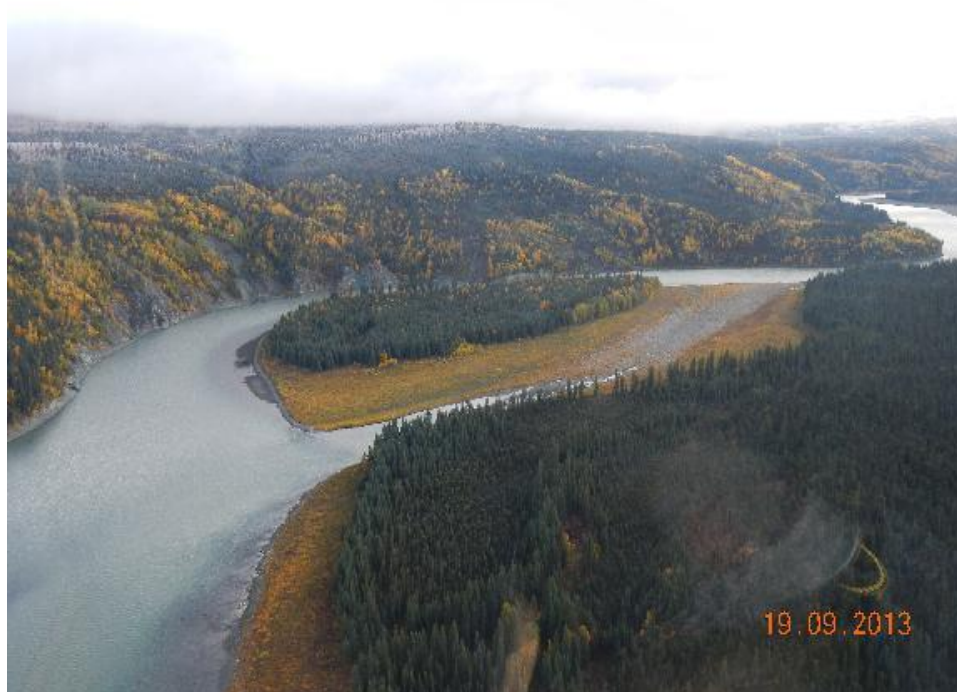
Figure A.2-65 – View upstream near PRM 208.5 of terrace height island and side channel. Lateral weir at head of channel and vegetating side channel bed. Active landslide zone and local sediment supply on outside bend (river right) (P5473).

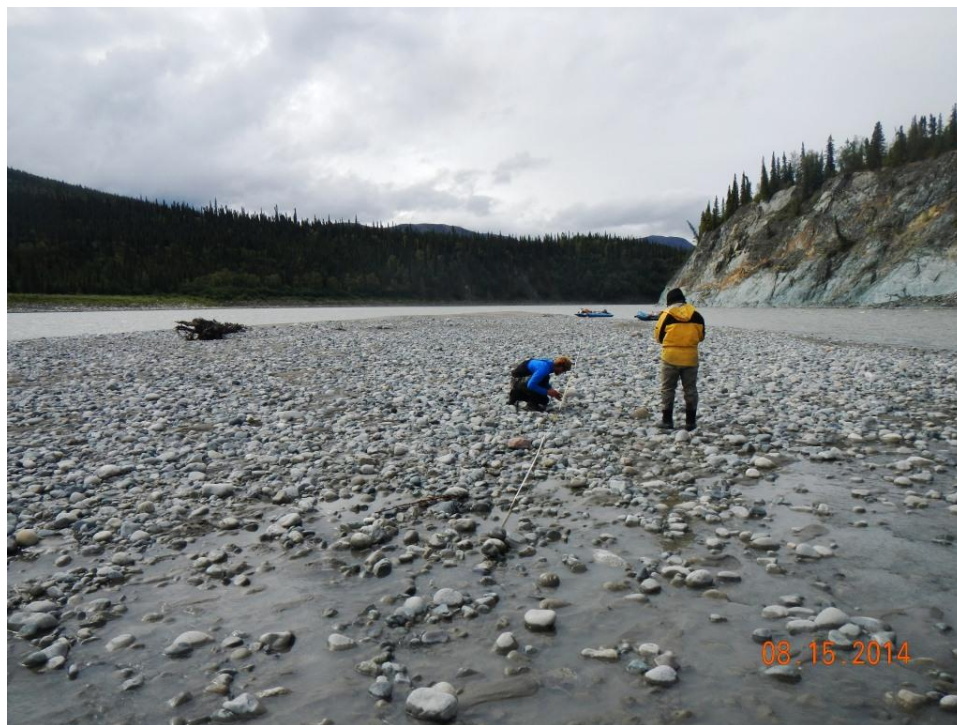
Figure A.2-66 – Surface material at head of bar at sediment sampling site at PRM 208.0. Bedrock outcrop on river right. Median particle diameter ( $D_{50}$ ) is 47.5 mm (P127).

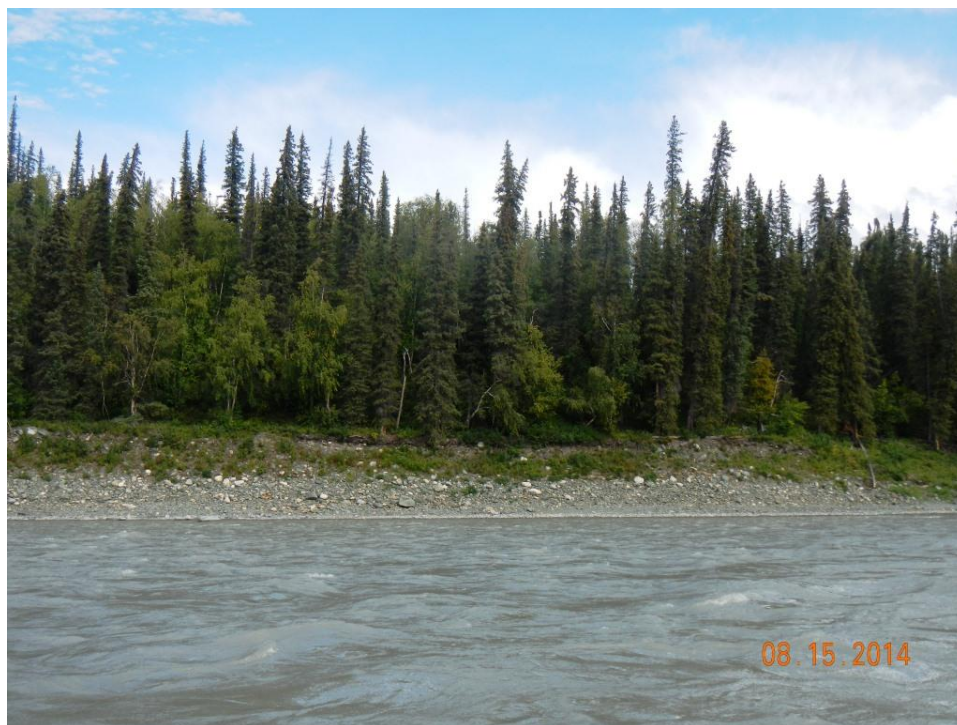
Figure A.2-67 – Ice shear line along vegetated bank typical throughout Geomorphic Reach UR-5 (photo near PRM 207.6) (P134).

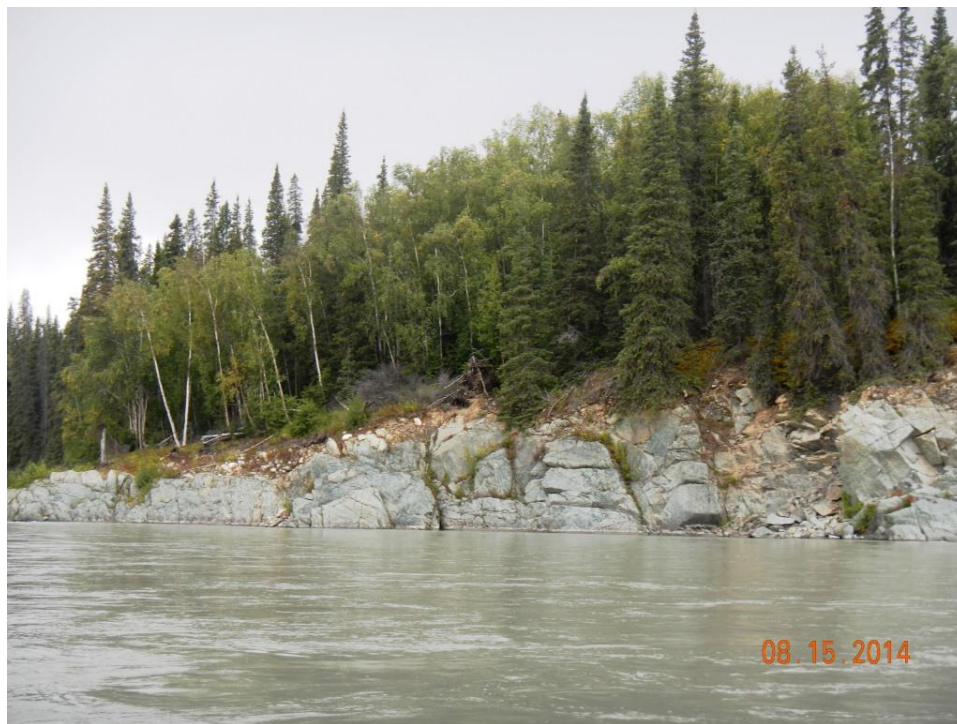
Figure A.2-72 – Bedrock outcrop with overlying strath deposits at PRM 205.5 on right bank (P188).

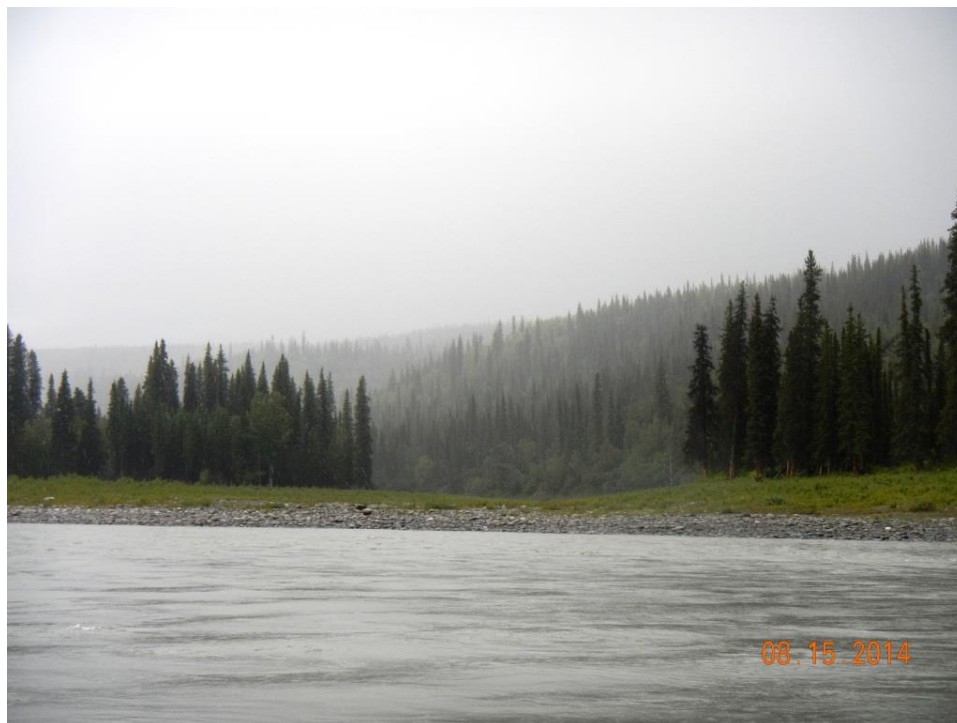
**Figure A.2-75 – High island surfaces (typical terrace height) with lateral weir and vegetating side channel near PRM 203.9. View looking downstream at inlet to side channel (P218).**

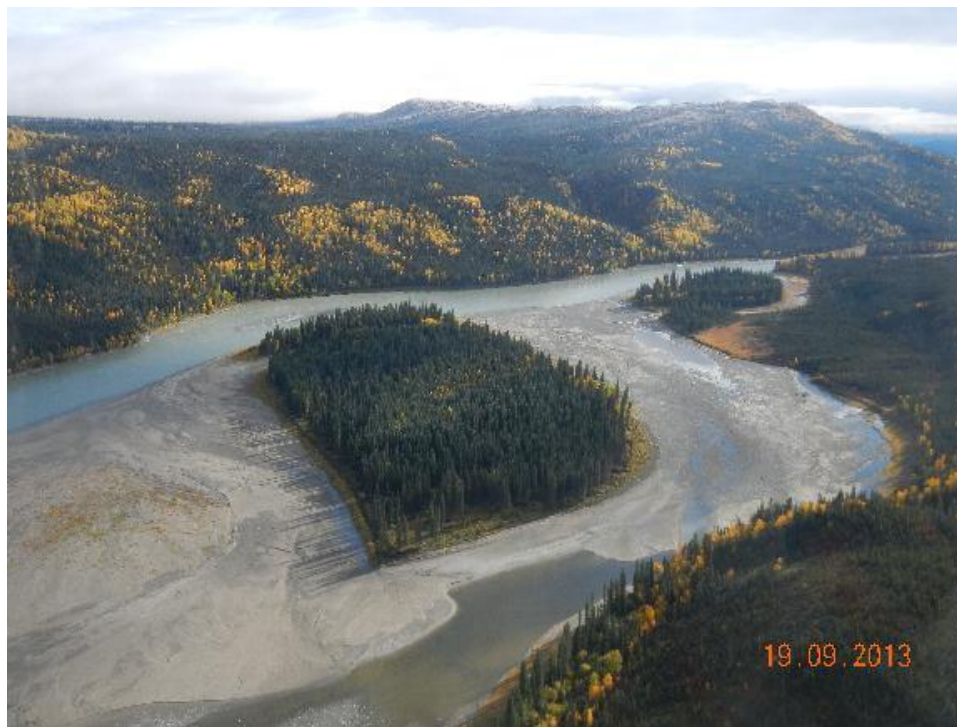
Figure A.2-76 - View upstream towards UR-5/UR-6 boundary of expansion zone in UR-6 (P5462).

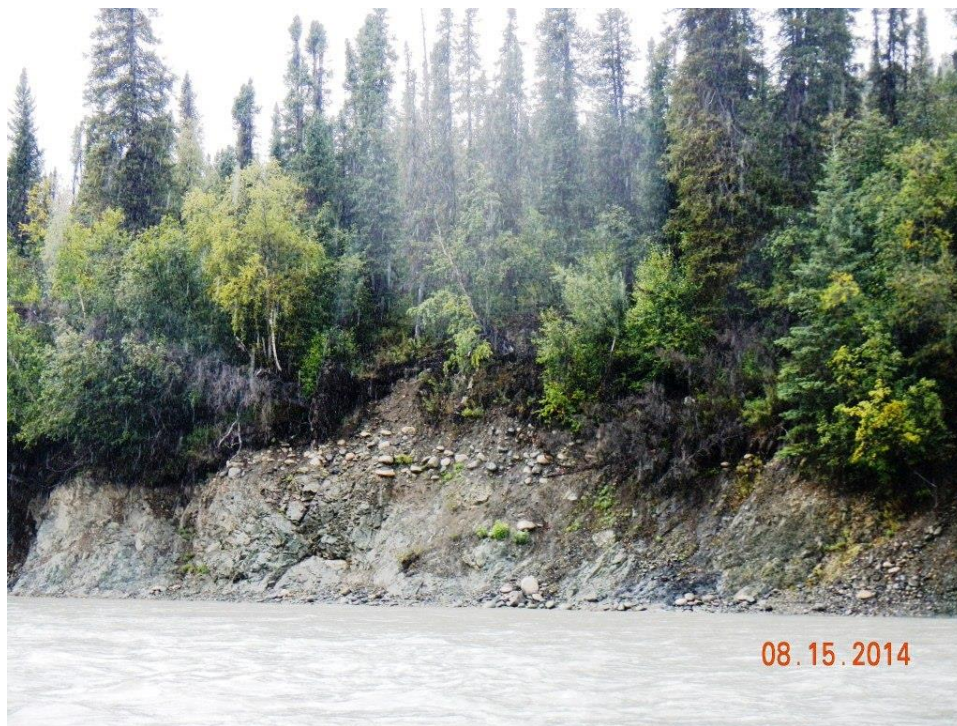
Figure A.2-77 - Susitna River right bank at PRM 202.7. Ice line on vegetation present in addition to eroded bedrock and outwash material (P250).
