## APPENDIX A: SUSITNA RIVER UPPER RIVER RECONNAISSANCE PHOTOGRAPHS

# 1. PHOTOGRAPHS OF THE SUSITNA RIVER UPSTREAM OF THE MACLAREN CONFLUENCE (PRM 291.8 TO PRM 261.3)

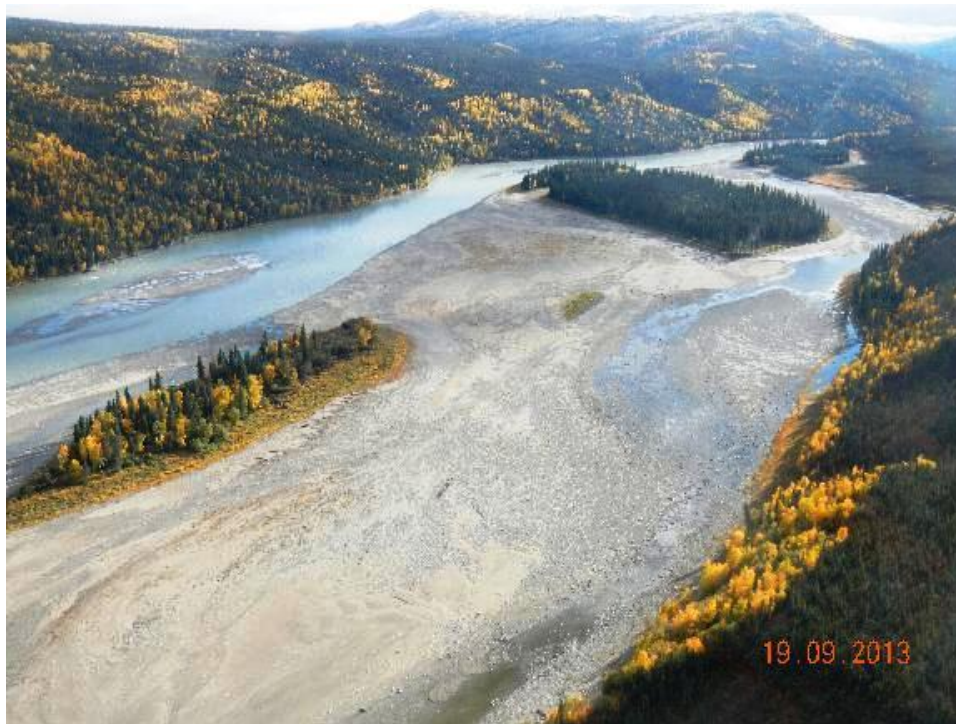
Figure A.2-78 – View upstream of expansion zone near PRM 202 (P5461).

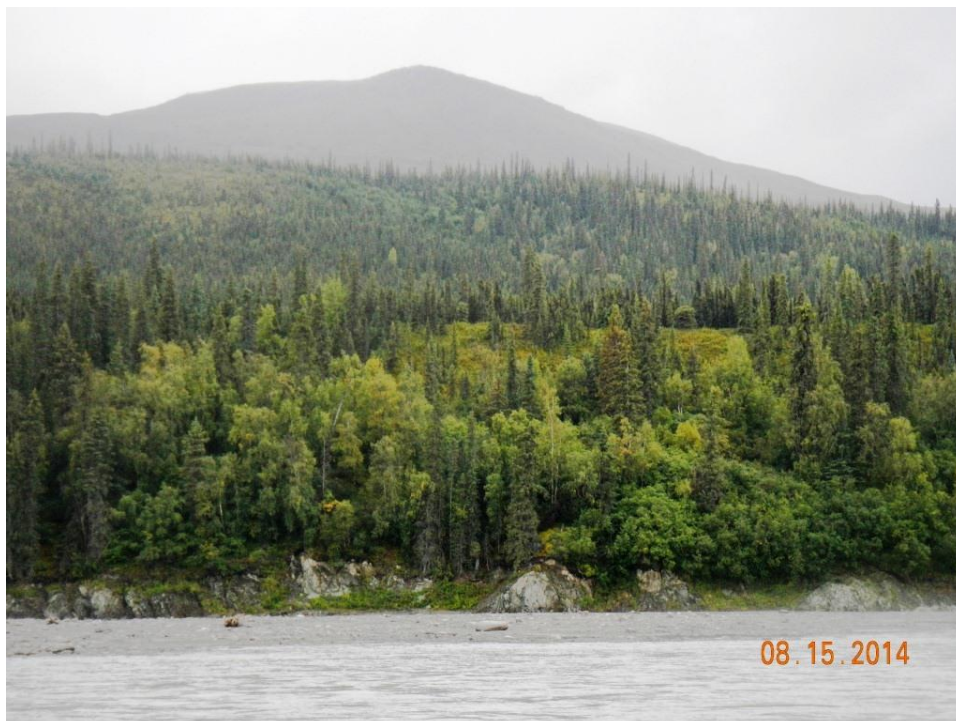
Figure A.2-79 – View of Susitna River left bank near PRM 202. Wide bedrock bound valley floor with vegetated overlying outwash or till (P268).

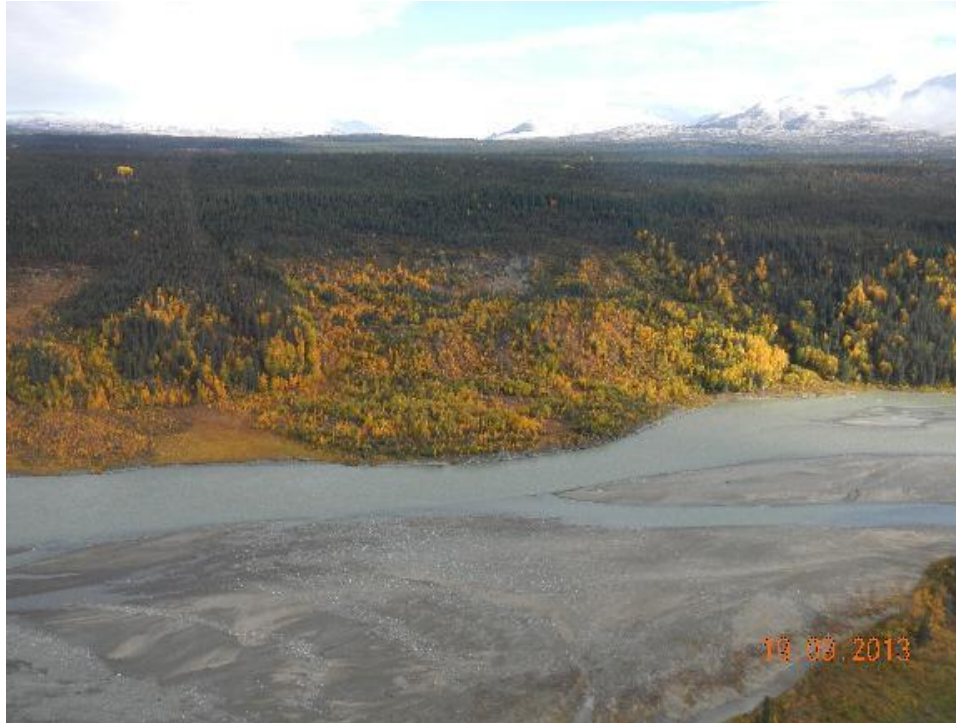
**Figure A.2-80 – Active Landslide in till near PRM 200 – Susitna River right bank (P5459).**

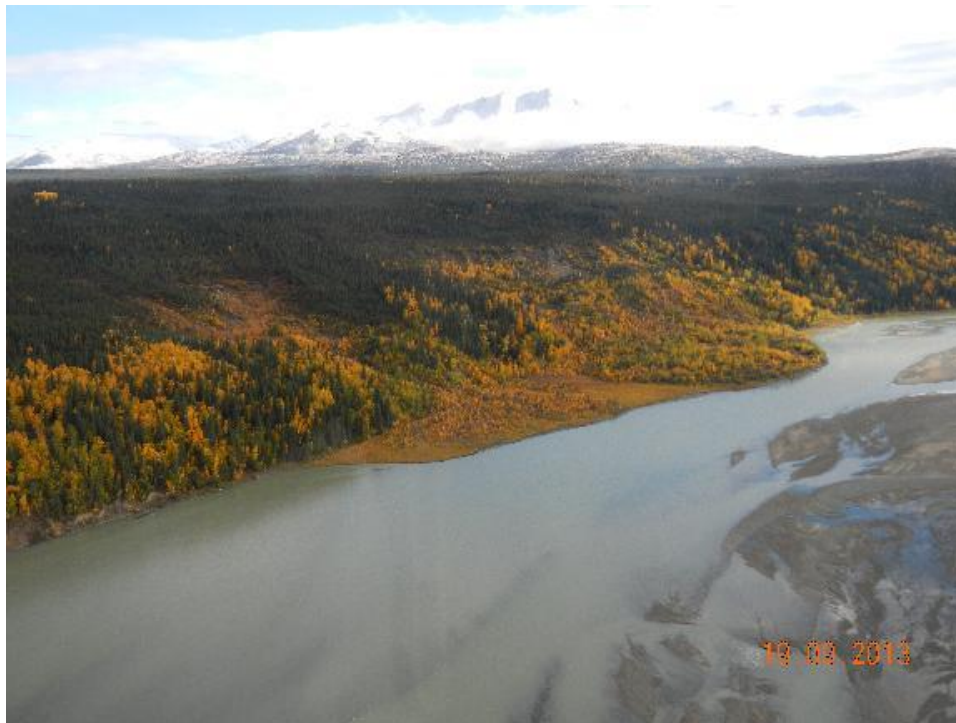
**Figure A.2-81 – View upstream of active landslides in till near PRM 200 – Susitna River right bank (P5456).**

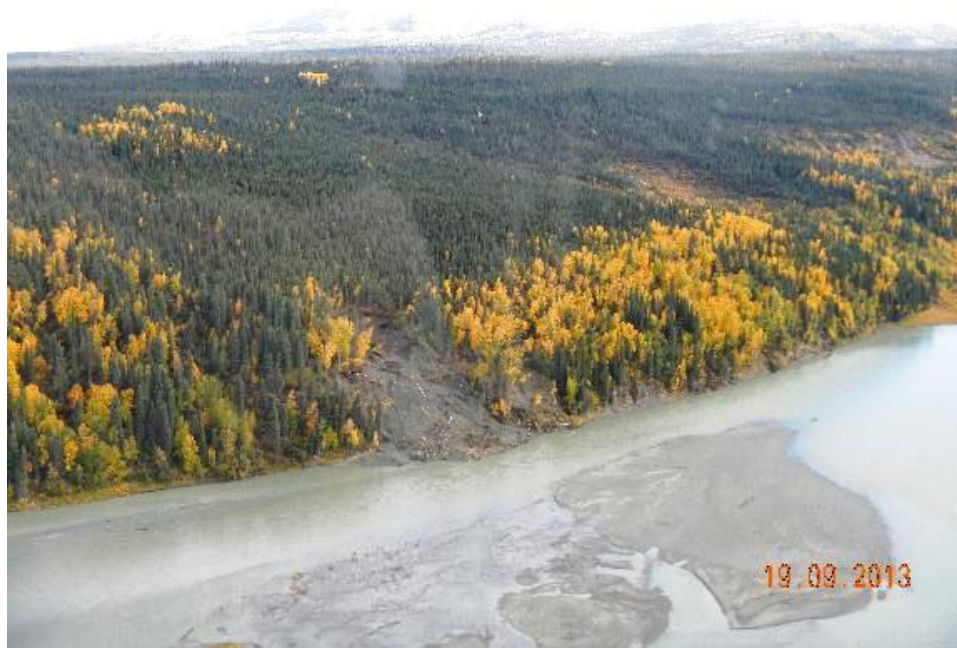
Figure A.2-82 - Active landslide in till near PRM 199.5 – Susitna River right bank (P5454).

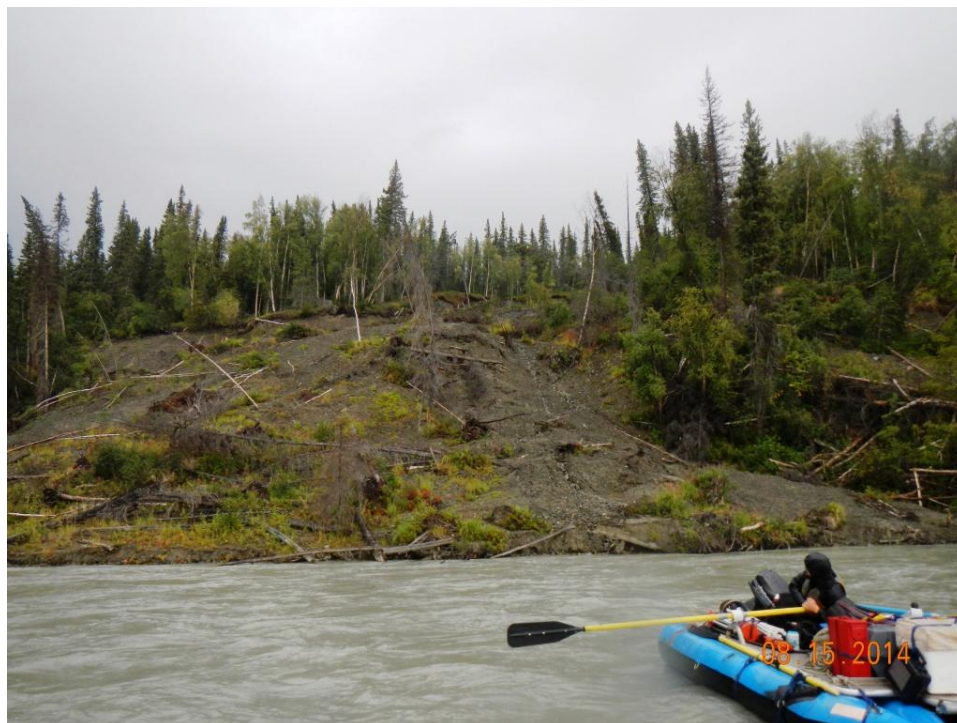
Figure A.2-83 – View of active landslide in till near PRM 199.5 (P325)

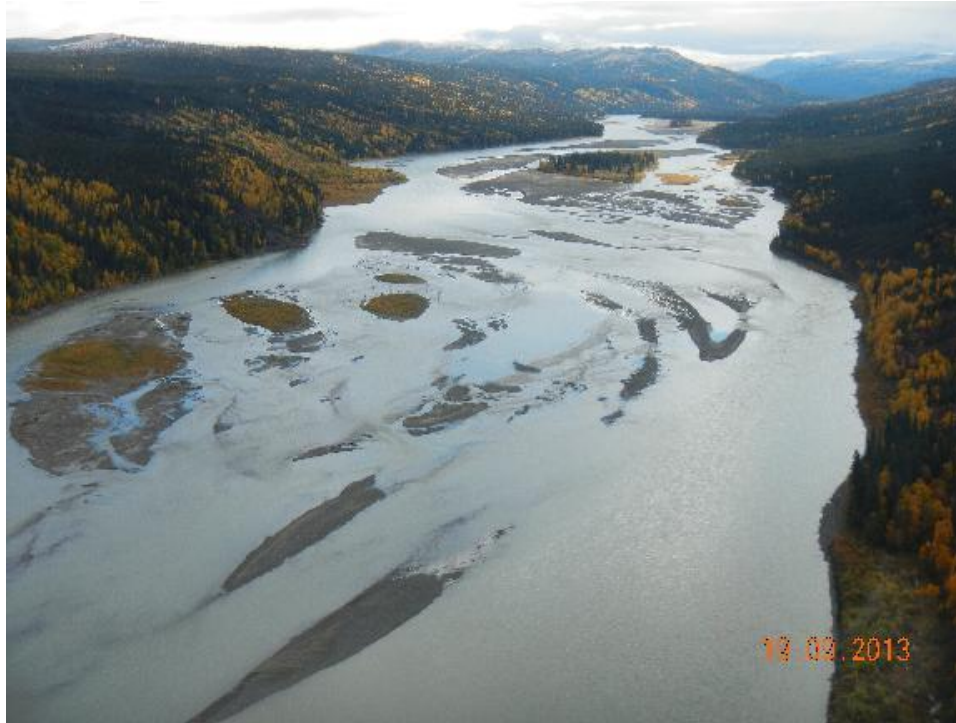
**Figure A.2-84 - View upstream of expansion zone near PRM 199. Vegetated landslide material evident on Susitna river right bank (left side of photo) (P5453).**

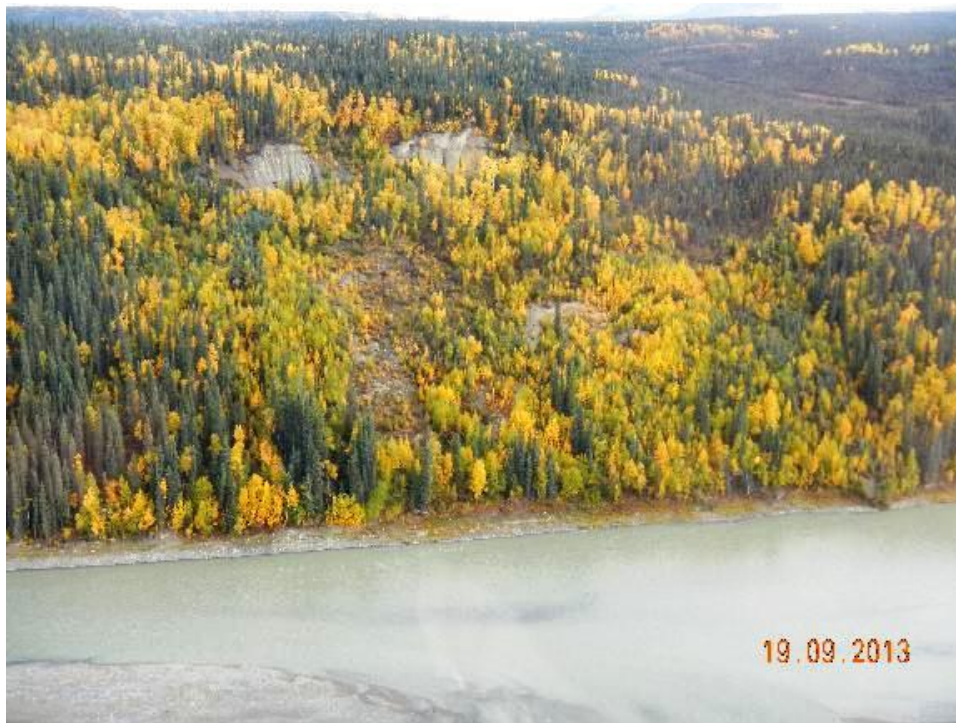
**Figure A.2-85 – Active landslide in till near PRM 197.5 – Susitna River right bank (P5451).**

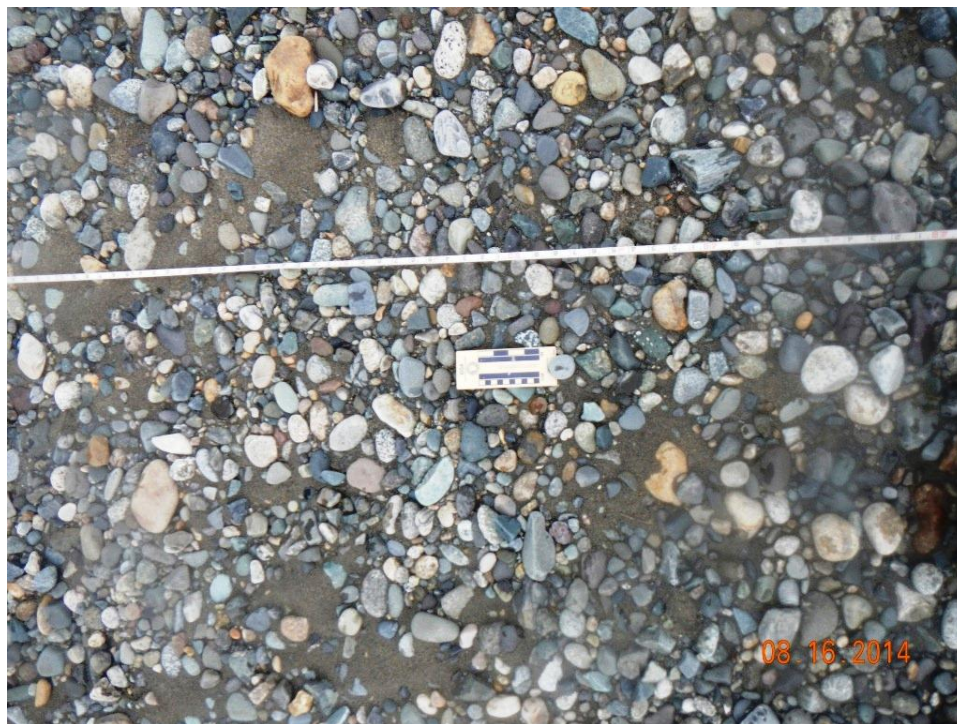
Figure A.2-88 – Surface material at sediment sample location at PRM 196.5 – first exposed mid-channel bar downstream of Watana Creek. Median particle diameter ( $D_{50}$ ) is 26.1 mm (P374).

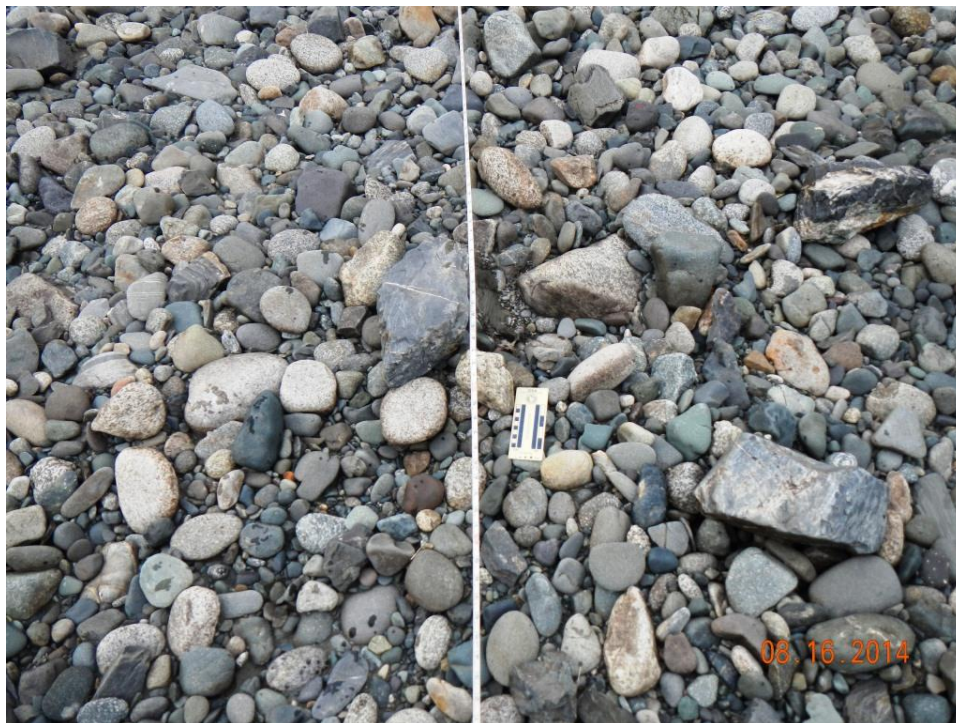
Figure A.2-91 – Surface material sediment sampling site at PRM 190.1. Median particle diameter ( $D_{50}$ ) is 56.7 mm (P484).

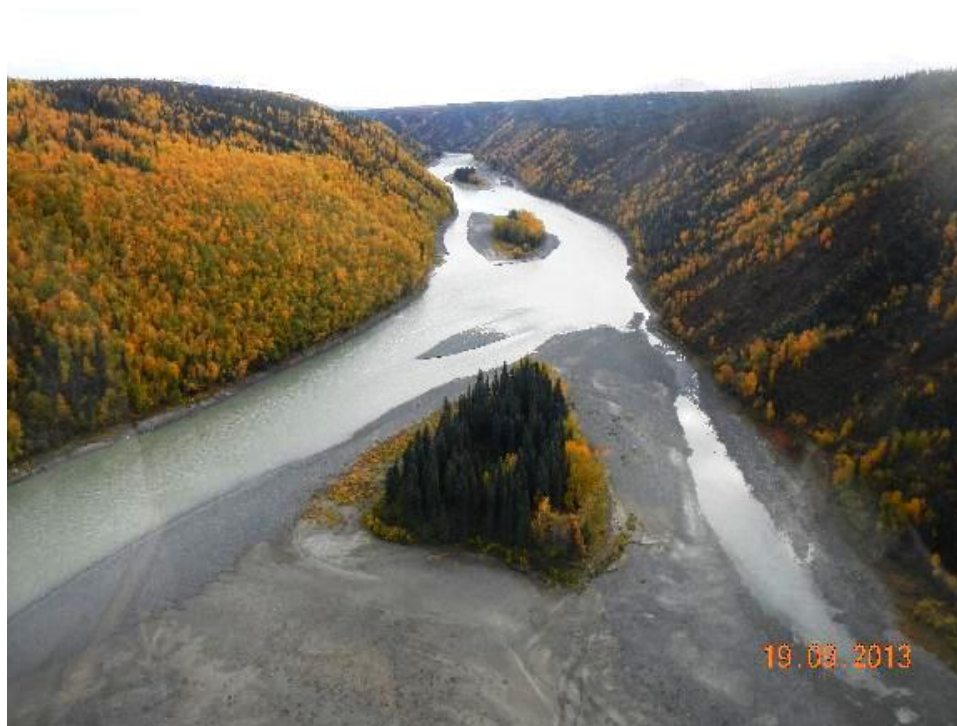
Figure A.2-93 – View upstream from expansion zone upstream of Deadman Creek near PRM 190 (P5435).
