Appendix A:

Strip Maps and Photographic Documentation of Lineament Data Presented in FCL (2013)

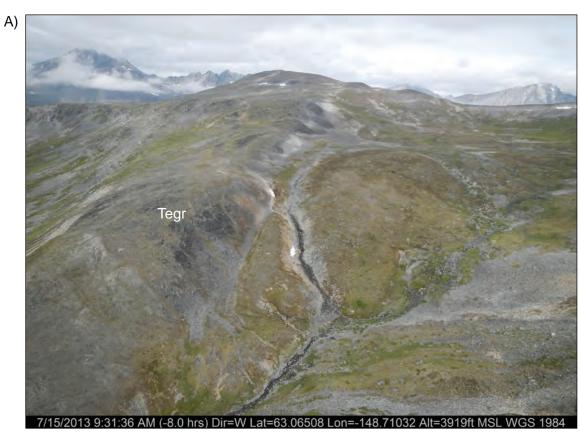
View looking west along north-facing escarpment in Eocene granitics.

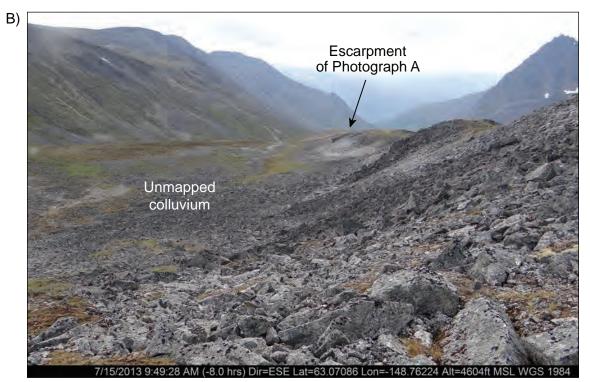
View looking east along lower talus scree field that shows decreasing relief at west end of lineament 3b.

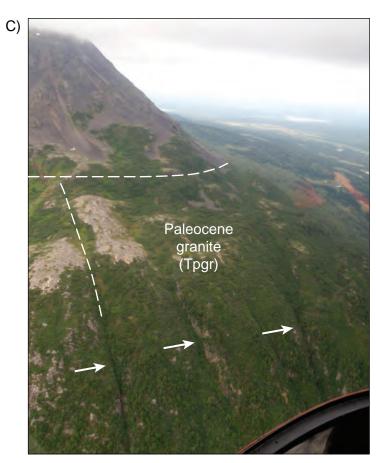
View of linear gullies developed on bedrock slope. Mapped lineament approximately shown.

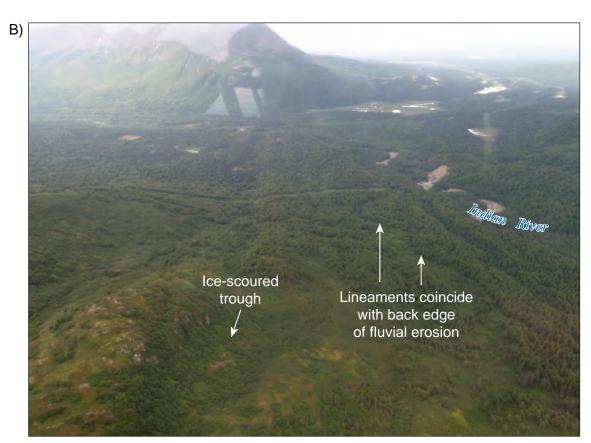
View looking west along ice-scoured terrain, with the Indian River flowing from right to left.

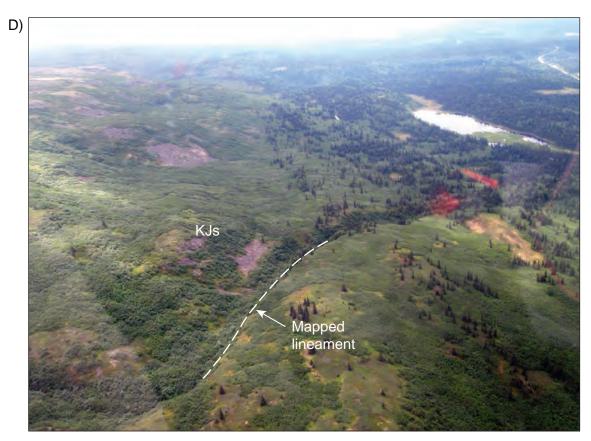
View of drainage with mapped lineament approximately shown.

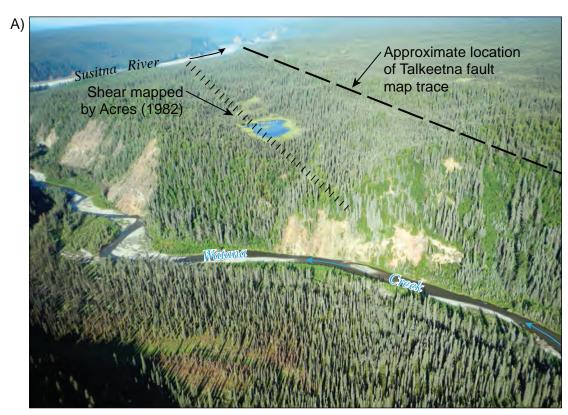
View looking west along oblique to projection of Talkeetna fault

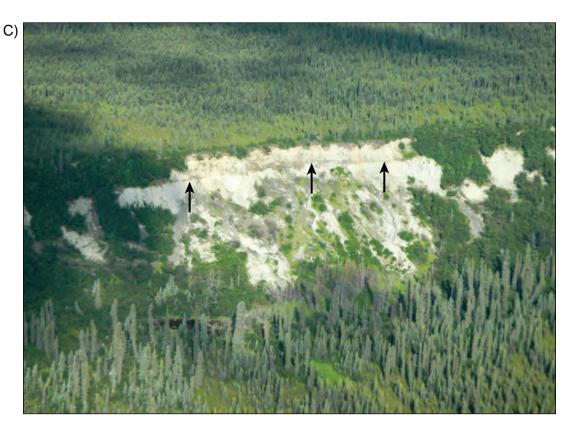
View looking east at apparent flat-lying contact between Quaternary lake sediments (above) and Quaternary till (below). Arrows point to contact.

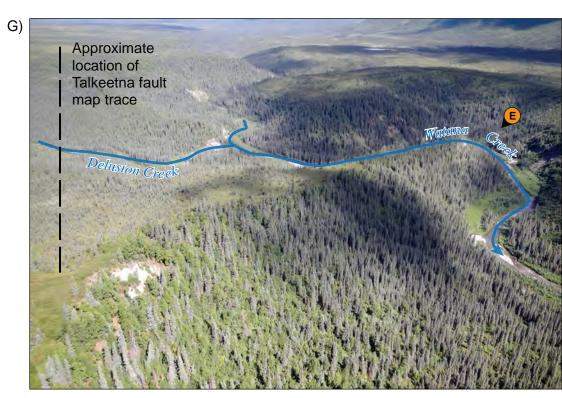
View looking north-northeast past ridge, with flat and apparently undisturbed Quaternary sediments in the background.

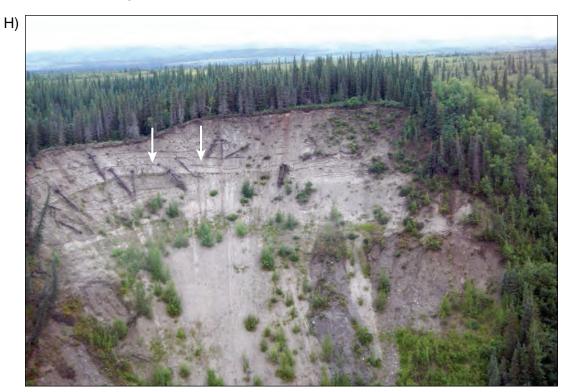
View looking west at bedded (lake?) stratigraphy exposed in eroding bluff. Beds appear relatively horizontal, but may have a sense of non-planar geometry because of semi-circular outcrop. Note fallen trees that indicate erosion/slope movement.

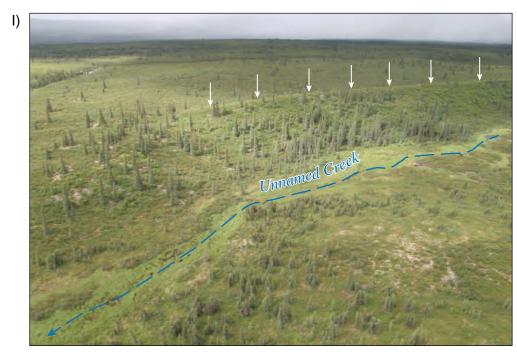
View looking north at linear esker nearly coincident with map projection of Talkeetna fault. See Figure A6.1 for location. Arrows point to esker crest.

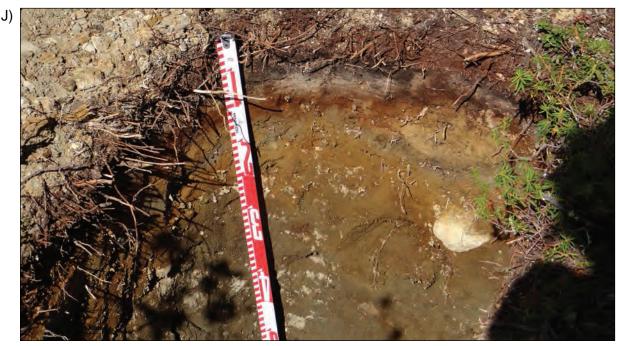
View looking at shallow soil pit dug in esker crest. Upper black, gray, and reddish soil layers are Holocene tephras. Scale is in centimeters; the upper 45 centimeters of the pit are in view.

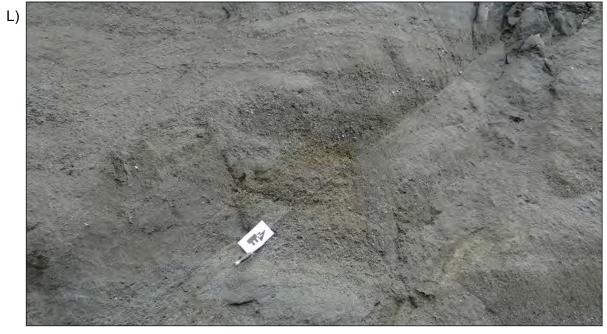
Detail of fault plane. Placard is 6 inches (15 cm) in length; fault plane is approximately 1 cm wide.

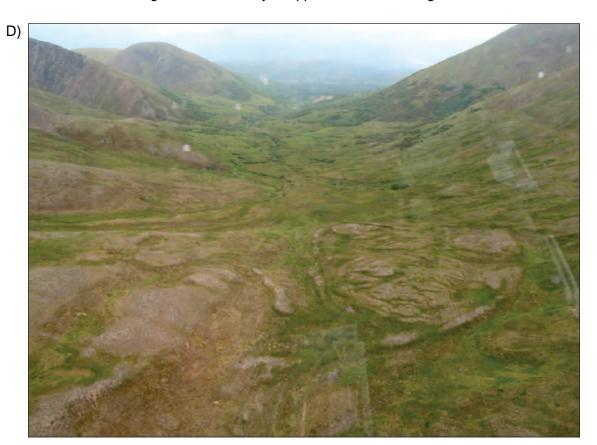
View looking down-valley from the top of the drainage seen in Photograph C.

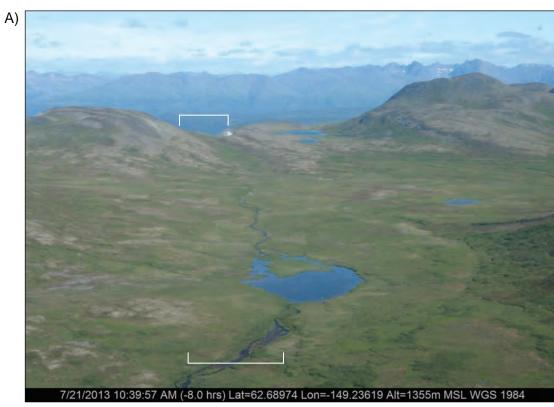
View looking north at middle portion of lineament group 8 along mapped inferred fault. Brackets show position of fault but note that no geomorphic expression of faulting is readily apparent.

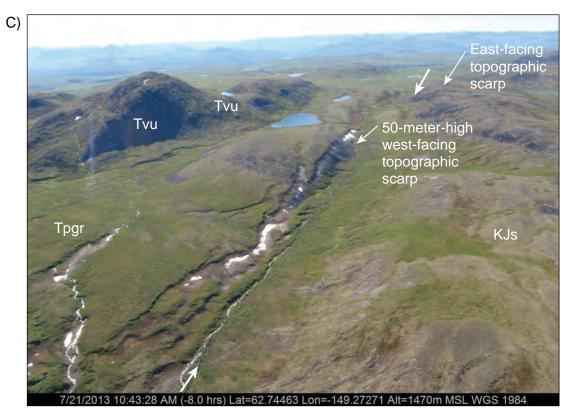
View looking south opposite that shown in Photograph B above. Mapped fault runs between large arrows. Note presence of many solifluction scarps in the landscape.

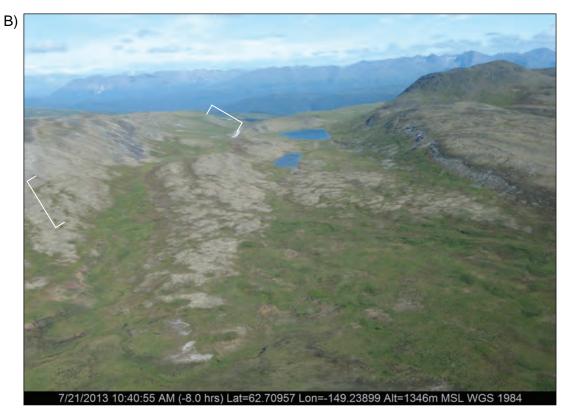
Close up view of saddle area shown in Photograph A. Brackets, again, show position of fault but note that no geomorphic expression of faulting is readily apparent.

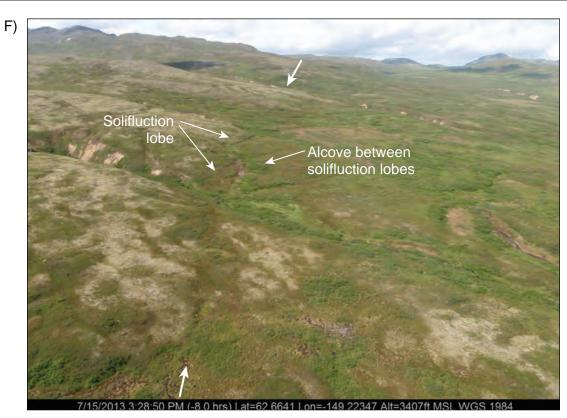
View looking north along 1- to 2-m-high east-facing scarps along southern portion of lineament group 8. Large arrows point along mapped lineament. Note the presence of solifluction lobes with an alcove or recession in between them that create an irregular and curving topographic scarp.

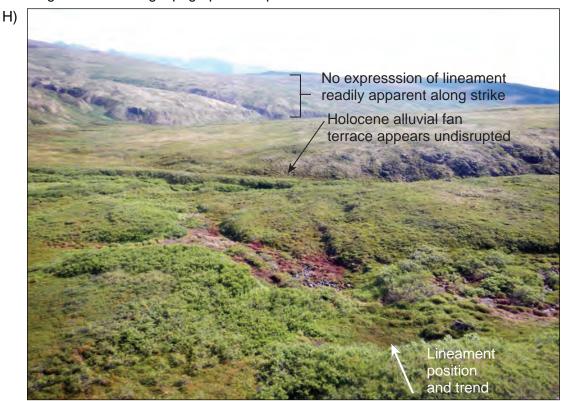
View looking south opposite that shown in Photograph F above. Large arrow points along lineament position and trend.

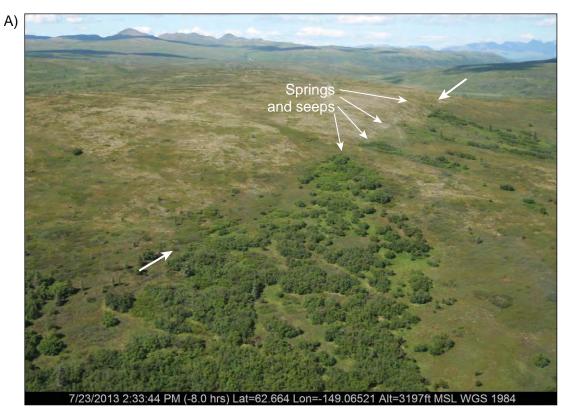
The first in a sequence of 5 photographs looking northwest taken along a series of north-trending, east-facing aligned slope breaks in the southernmost portion of lineament group 9. Large arrows point along lineament.

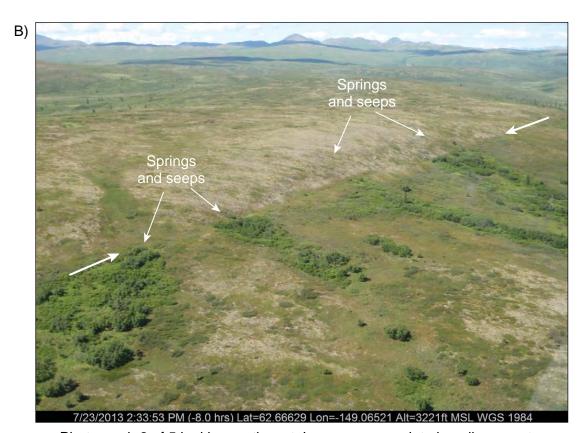
Photograph 2 of 5 looking northwest. Large arrows point along lineament.

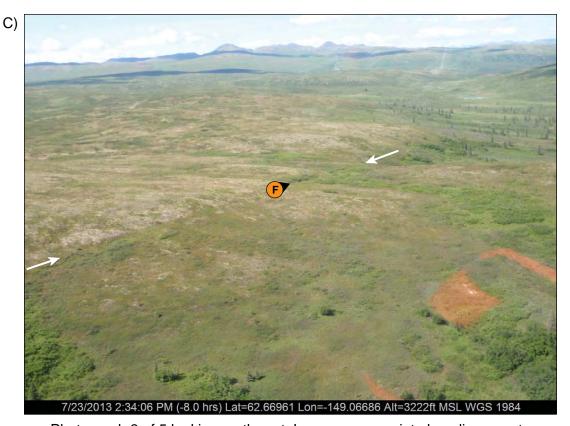
Photograph 3 of 5 looking northwest. Large arrows point along lineament.

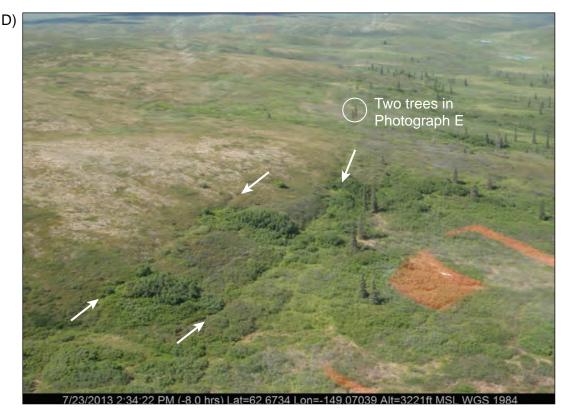
Photograph 4 of 5 with view looking northwest. Large arrows point along lineaments.

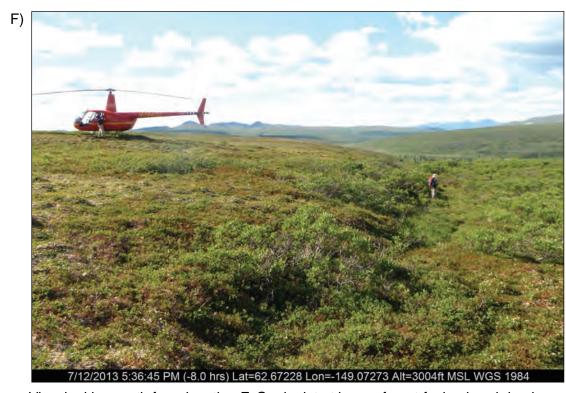
View looking north from location F. Geologist at base of east-facing break-in-slope is 170 cm tall.

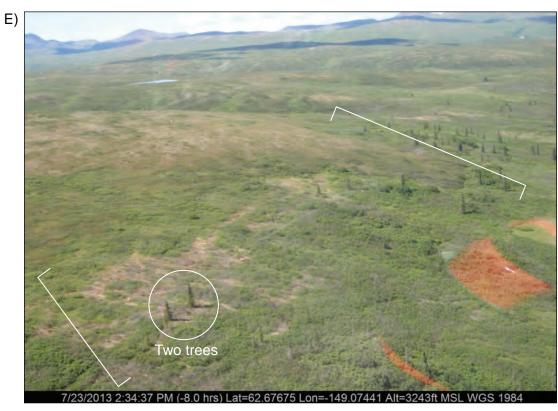
Photograph 5 of 5 with view looking northwest. Note that lineament expression has died out and brackets bound the location of its projection.

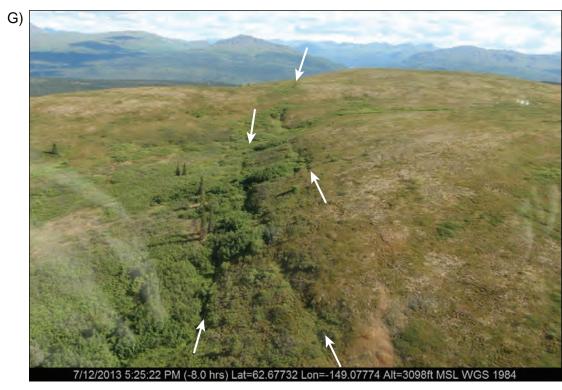
View looking almost 180 degrees from that shown in Photograph D. Large arrows point along lineaments.

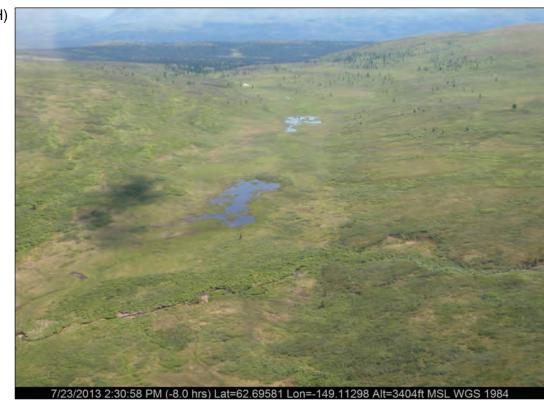
View looking south from location I across area within WCC's segment 3. Note the lack of expression of any lineaments in the broad depression.

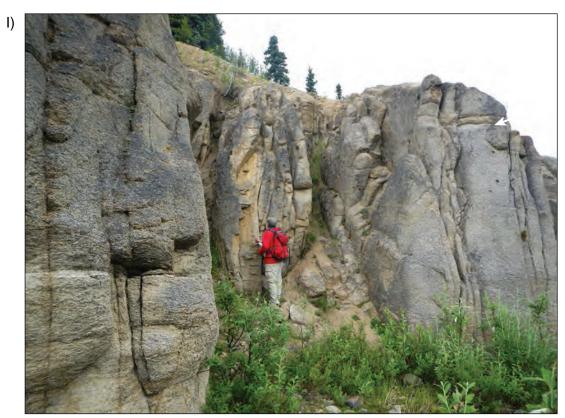
Exposures of widespread granodiorite in unnamed creek near GPS waypoint 176 in terrain mapped as flysch (map unit KJs) by Wilson et al. (2009). The geologist is approximately 175 cm tall.

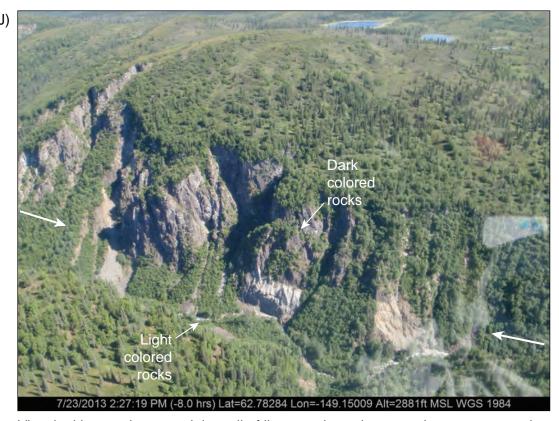
View looking northeast at right wall of linear v-shaped canyon. Large arrows point along apparent bedrock type contrast.

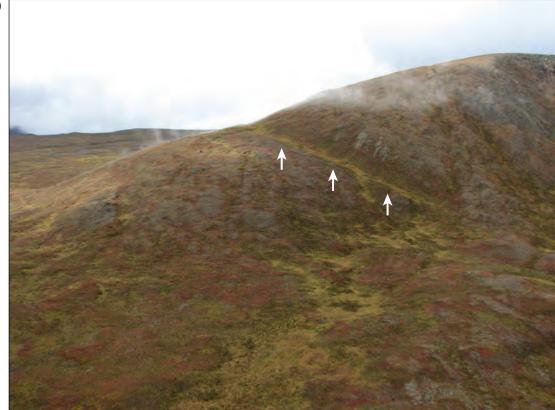
View looking at notch in bedrock with expression of apparent northwesterly dip.

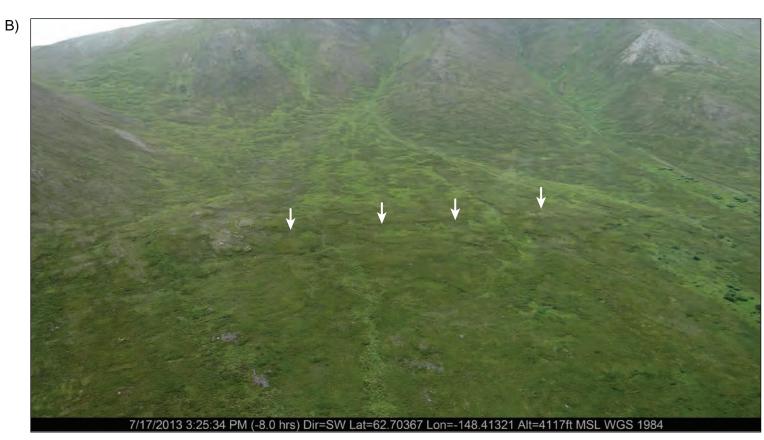
View of lineaments expressed in Quaternary sediment.

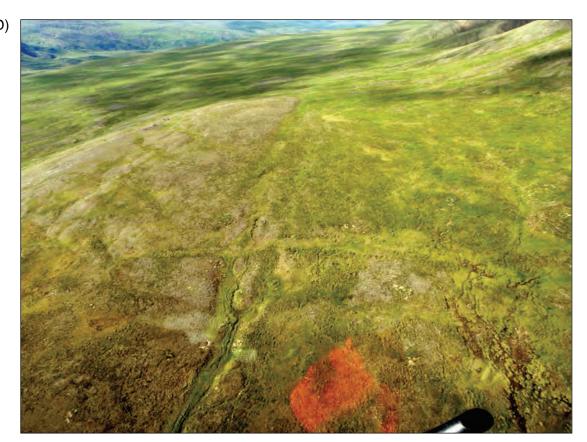
View looking southwesterly along glacially scoured surface.

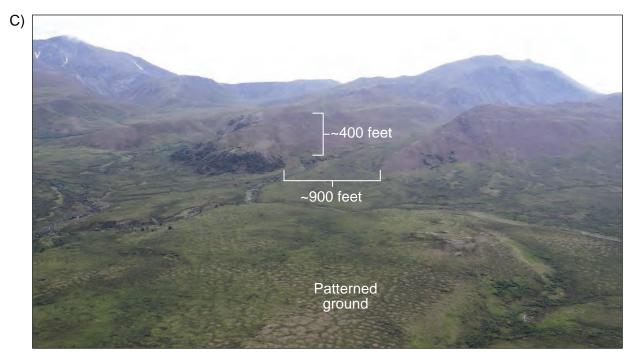
View southerly up-valley into glacial valley along lineaments geomorphically expressed as linear valley and drainage. Underfit creek in deep linear valley suggests landform created by sub-ice channel meltwater.

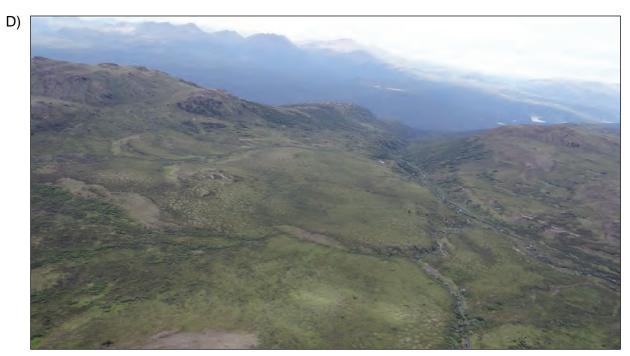
View northerly down-valley along lineaments geomorphically expressed as linear drainage. Thin cover of unconsolidated surficial sediment mantles the Paleozoic rocks.

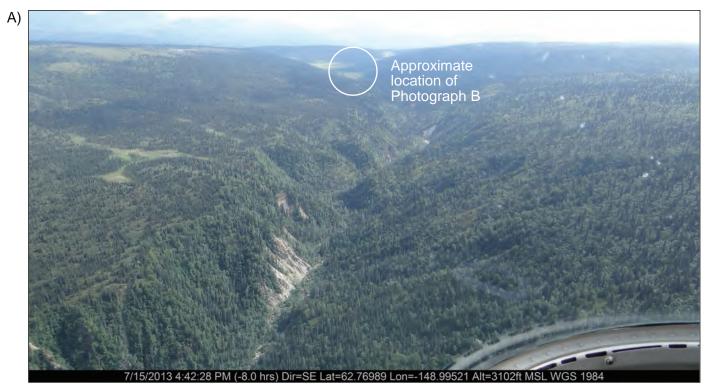
View looking south at linear canyon that is tributary to the Susitna River. Canyon bottom and creek drainage have sinuosity not apparent at smaller scales.

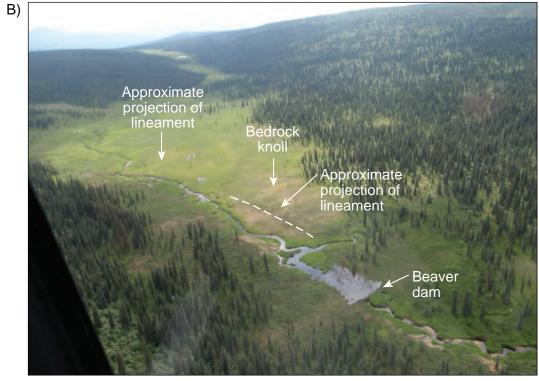
View looking north-northeast at creek in boggy (Holocene) drainage. Lineament is expressed as a depositional contact along the shallow bedrock knoll.

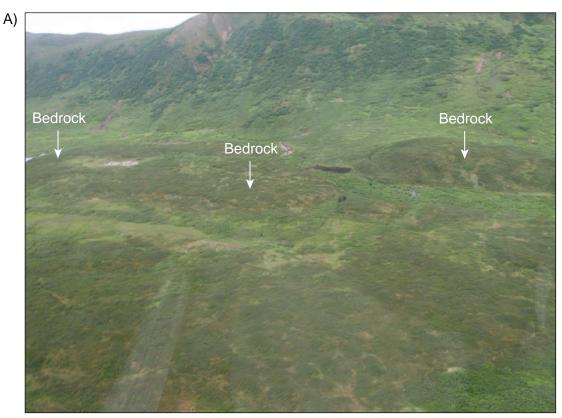
View looking westerly at break-in-slope at base of hillside and undulating glacially-eroded bedrock knobs in foreground.

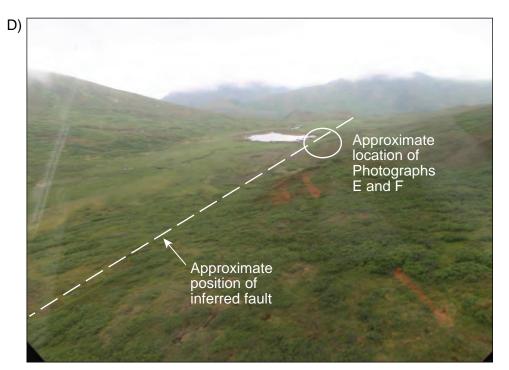
View looking south along southern extent of group 17b, along which an inferred bedrock fault is mapped by Wilson (2009). Photographs B and C are adjacent to lake.

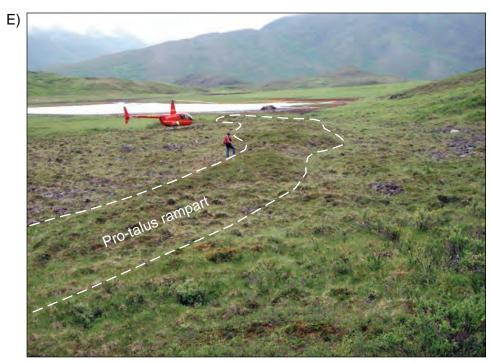
View looking south at pro-talus rampart and GPS waypoint 15. Note lateral distance between base of slope to crest of rampart. Geologist for scale is about 180 cm tall.

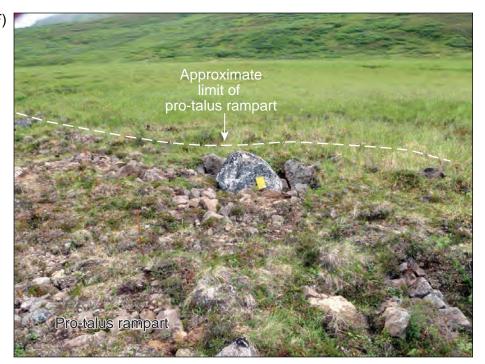
Pro-talus rampart constructed from blocky, frost-shattered volcanic rocks. Photograph is centered on more sub-rounded glacial erratic (granitic) that is not similar to any of the local hillside lithologies. Field notebook is 19 cm tall.

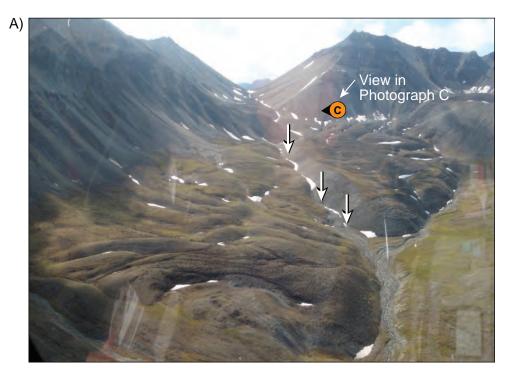
View looking southeasterly at lineament expressed at erosional drainage cutting through the likely Holocene rock glacier deposit.

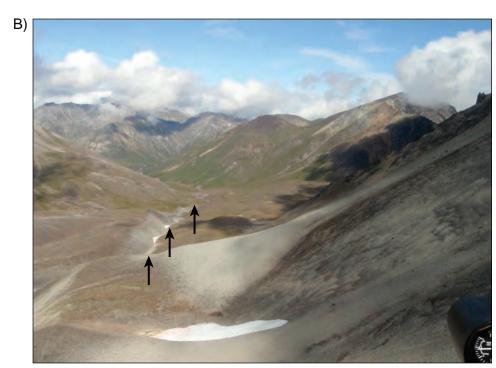
View looking northwesterly (opposite that in Photograph A) at lineament expressed as erosional drainage cutting through the likely Holocene rock glacier deposit.

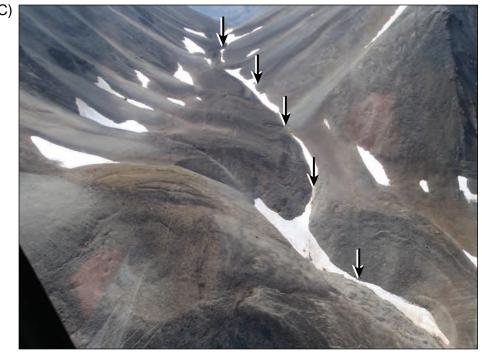
View looking southeasterly at lineament expressed as likely Holocene rock glacier deposit contacting the valley floor.

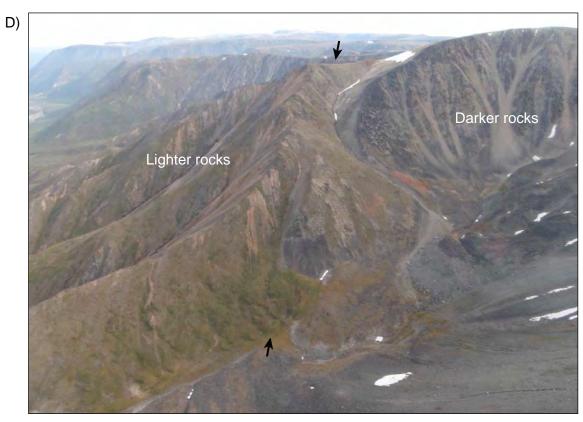
Photograph looking northeast from location D along the western continuation of the apparent rock type contrast shown in Photographs A, B, and C. Arrows point along apparent contact.

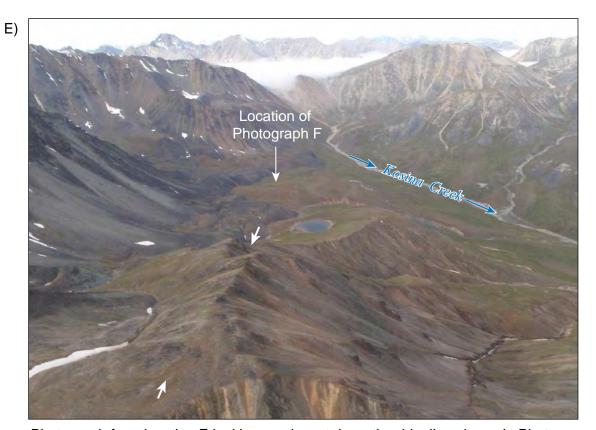
Photograph from location E looking southwest down the ridgeline shown in Photograph D. View is 180 degrees from that in Photograph D. Note presence of rock glacier and glacial deposits in valley bottom. Arrows point along apparent contact.

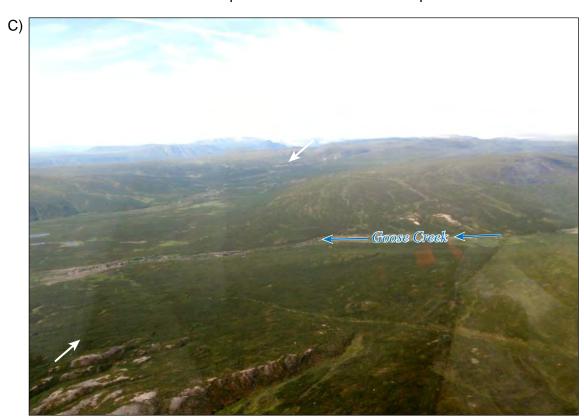
Overview photograph looking southwest from location C along alignment of mapped lineaments. Arrows point along trend of lineament group 19. Note absence of expression of lineaments within the landscape across the Goose Creek portion of the lineament group.

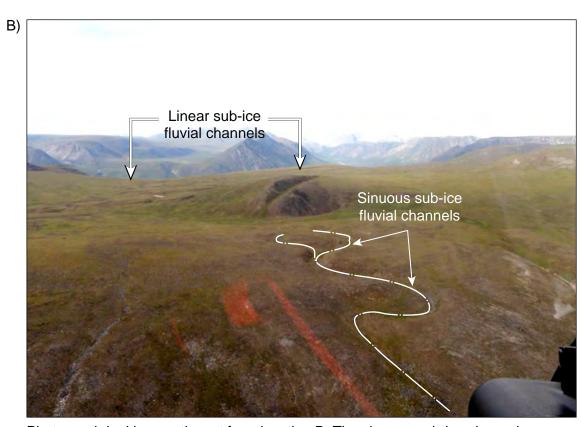
Photograph looking southwest from location B. The sinuous sub-ice channels are not large enough features to be seen on INSAR data.

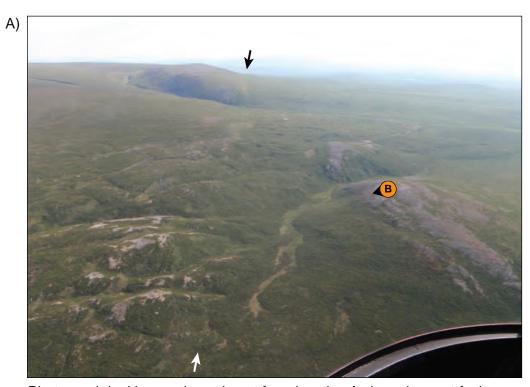
Photograph looking north-northeast from location A along the east-facing break-in-slope that defines the northeast portion of LG 19. Arrows point along alignment of mapped lineaments.

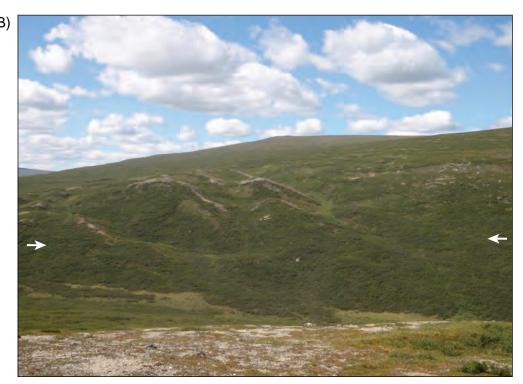
Photograph looking northwest from location B at sub-ice fluvially-eroded channels. Arrows point along the trend of mapped lineaments that make up group 19.

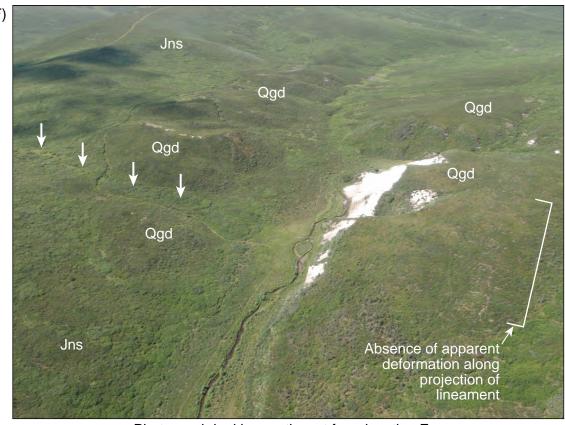
Photograph looking northwest from location F.

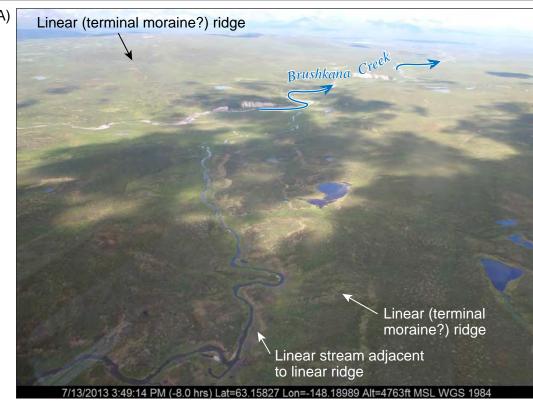
View looking north across Brushkana Creek along north-trending linear ridge and roughly linear stream. Arrows point along alignment of ridges interpreted to be terminal moraine from northeasterly flowing ice.

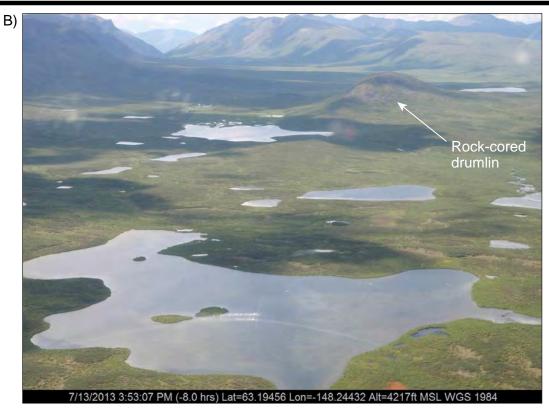
View looking northwest across western portion of lineament group 21a towards approximately 120-meter-tall rock-cored drumlin. View is looking up the Brushkana Creek valley. Note lack of obvious expression of mapped lineaments in the foreground.

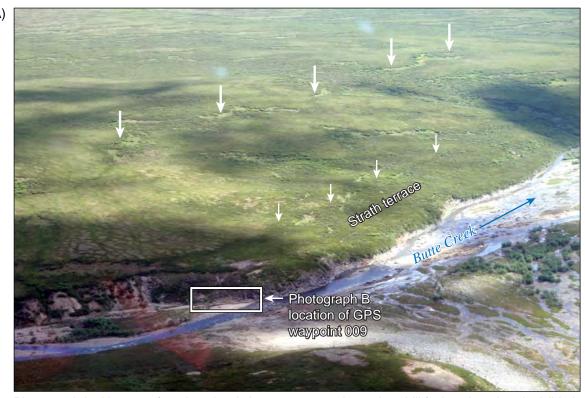
Photograph looking east from location A. Large arrows point to downhill facing slope break visible in INSAR and mapped by Fugro (2013). Field reconaissance revealed smaller lineament (not visible in INSAR data) lies along the small arrows and projects toward the vertically-dipping bedrock exposed in the creek bank shown in Photograph B.

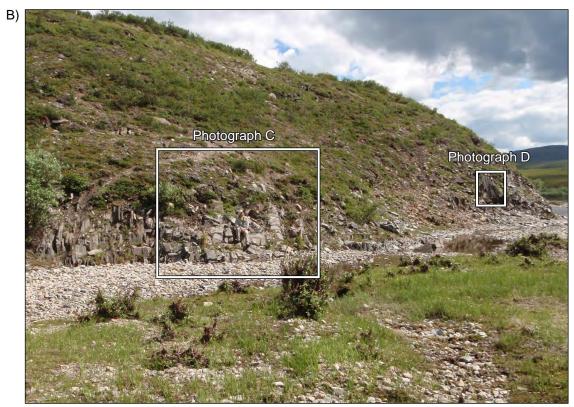
Overview of east-southeast striking, vertically-dipping phyllite exposures located at GPS waypoint 009.

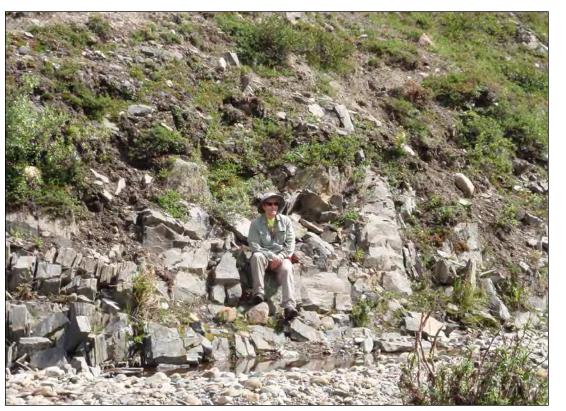
Detail of phyllite exposure showing ~3-meter-wide resistant bed of metamorphosed fine to medium sand. Thick, resistant beds, such as this, are interpreted to create the lineament shown by small arrows in Photograph A above. Geologist for scale.

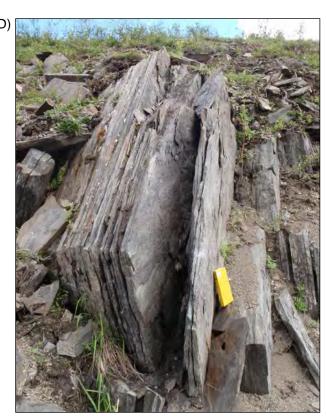
Detail of vertically-dipping phyllite.

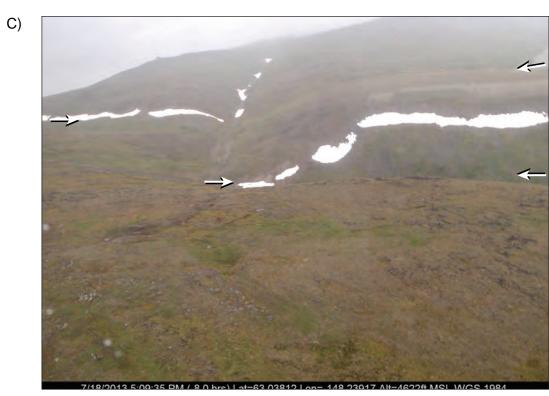
View looking north at deep drainages whose margins coincide with nivation terraces and hollows. The large size of these drainages is inconsistent with the weakly expressed lineaments located east of Deadman Creek. Such deeply incised drainages are interpreted to be a result of sub-ice erosion.

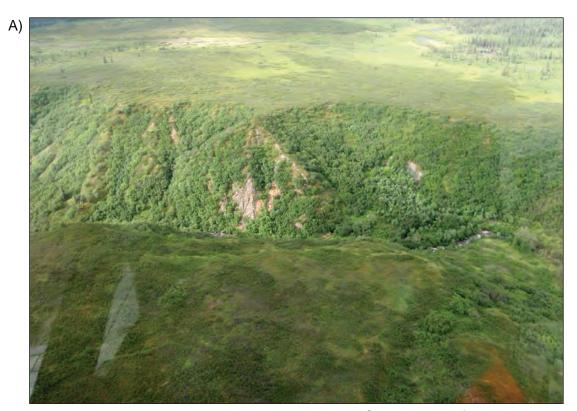
View looking west at unnamed canyon and smooth Quaternary surface in the background.

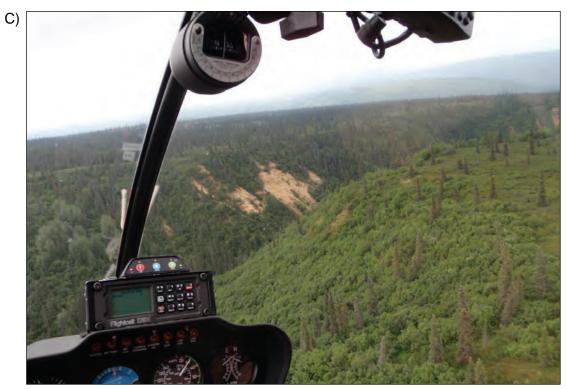
View looking southeast at exposure in left bank of unnamed drainage creek where till apparently overlies lake sediments and fluvial washout gravel. The lenticular beds in the fluvial gravel appear horizontal but are not laterally extensive.

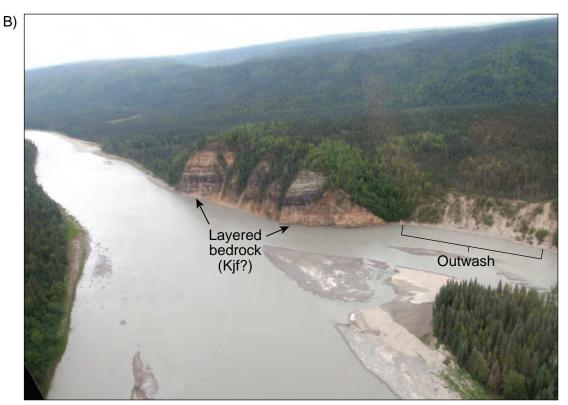
View looking northwest at layered bedrock (on left) with apparently undisrupted horizontally-bedded outwash (on right).

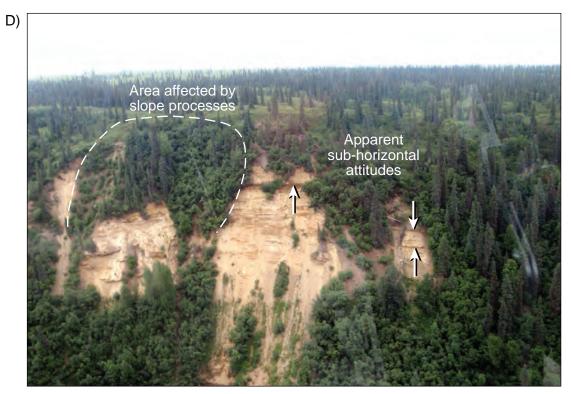
Close up view of exposure shown in Photograph (B). Note the apparently subhorizontal basal contact between overlying till and underlying lacustrine deposits. Note sediments on the left of the image are influenced by landslide processes and not in-place locally.

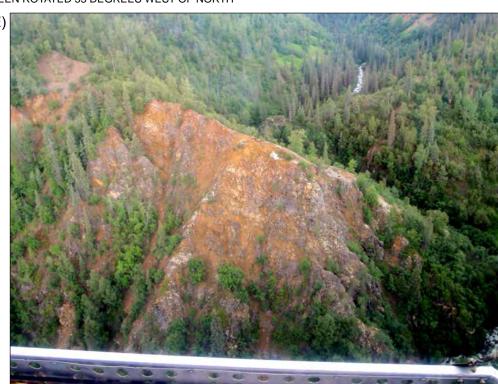
View looking north at ridge along projection of mapped lineaments. Orange color is attributed to chemical weathering of rock. Lithologies appear consistent across ridge and discontinuities or shear zones absent.

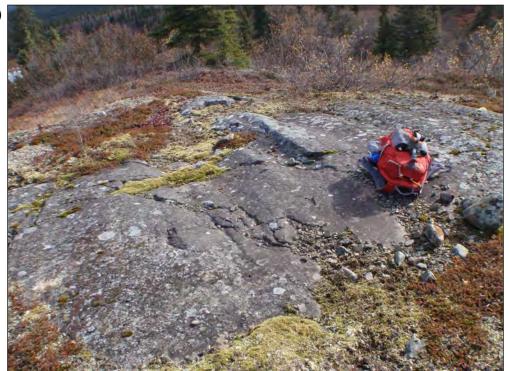
Photograph of fluted ice-scoured rock surface with cracks and joints.
