BUSTNA-WATANA HYDROELECTRIC PROJECT  
Broad Pass Area

SUSTITNA-WATANA HYDROELECTRIC PROJECT  
Castle Mountain Extension Area

SUSITNA-WATANA HYDROELECTRIC PROJECT  
Clearwater Mountains Area

**Appendix B:  
Strip Maps and Photographic Documentation  
of Lineament Data for Lineaments Mapped by Reger et al. (1990)**

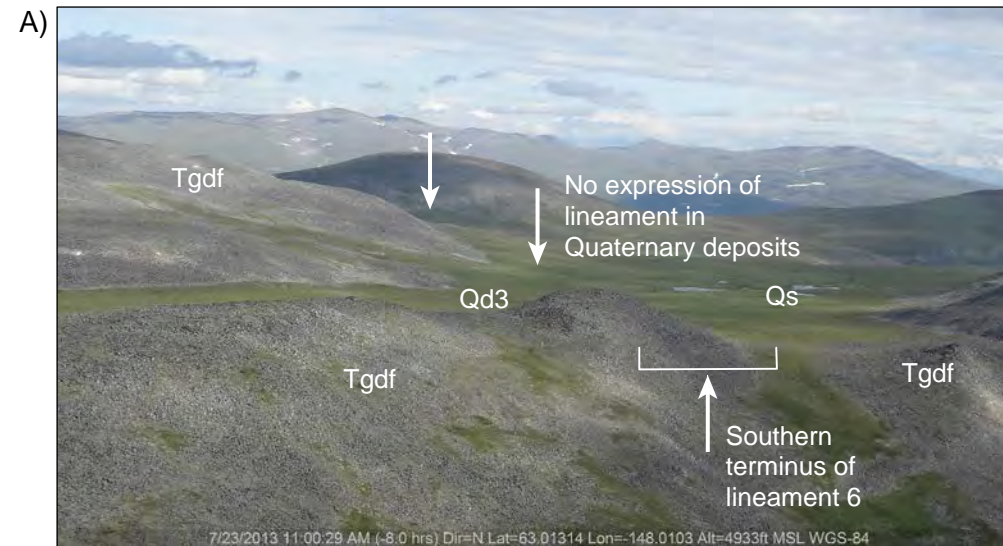
View looking northwest from location A. Arrows and brackets show the projected trace of mapped lineament. Note absence of lineament or deformation in Quaternary deposits.

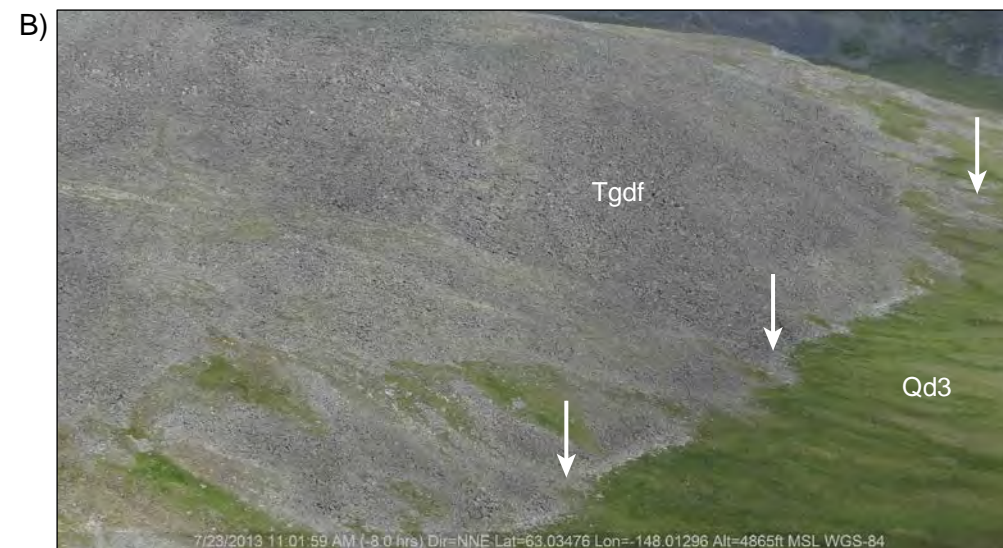
View looking northwest from location B. Arrows show the projected trace of lineament.

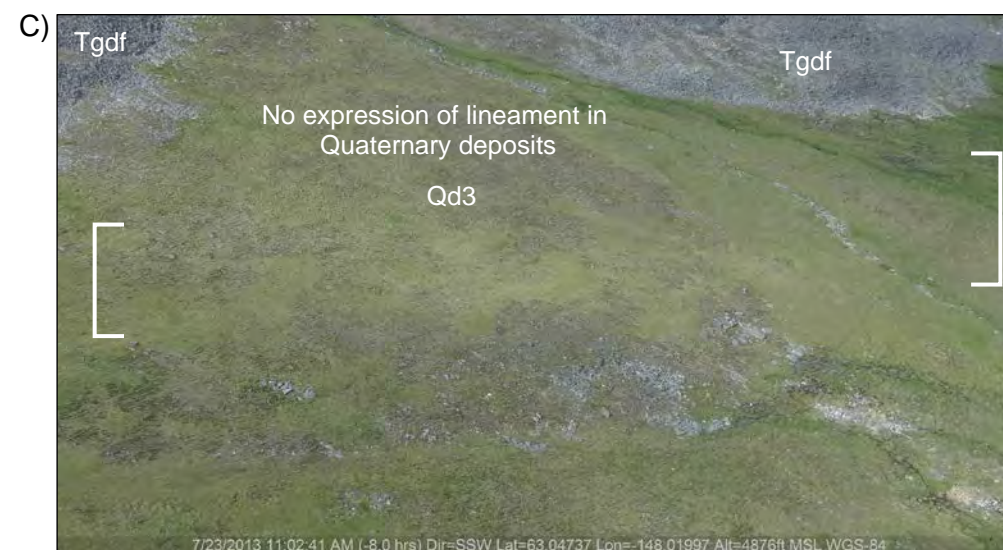
View looking west from location C. Brackets indicate the projected trace of lineament. Note absence of lineament or deformation in Quaternary deposits.

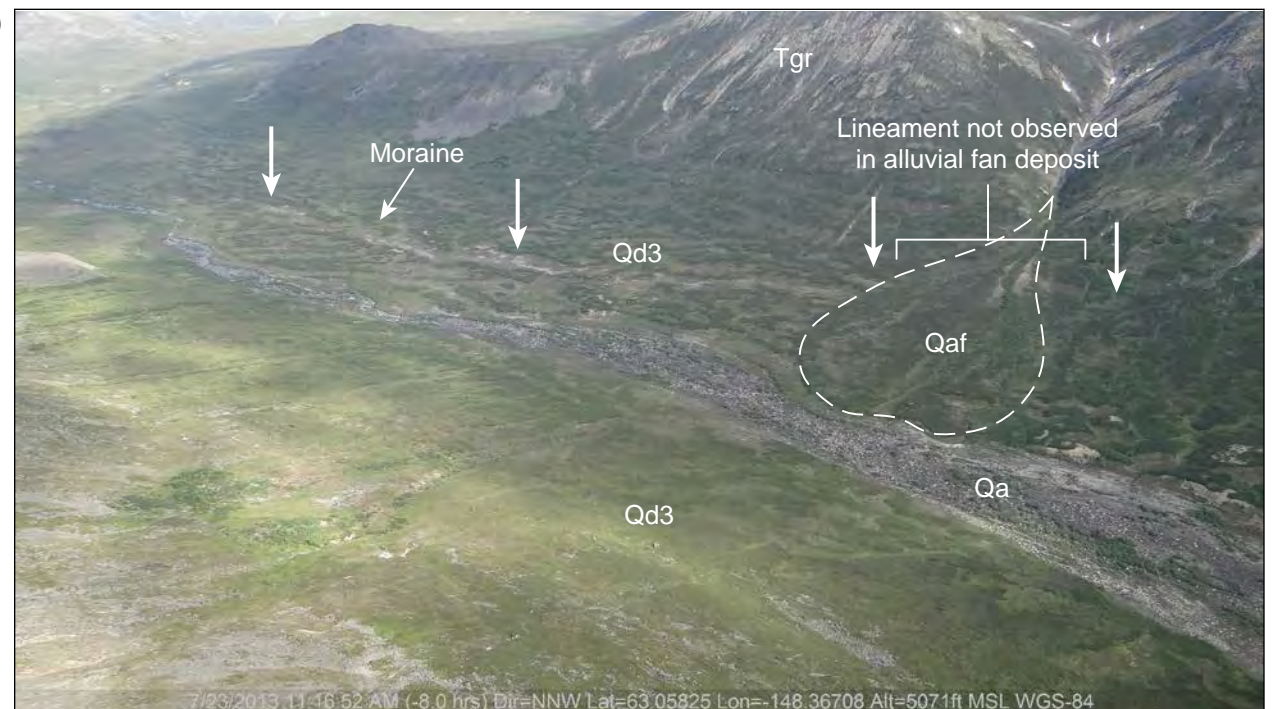
View looking north from location A. Arrows show projected trace of Feature 9 lineament. Note lineament is overprinted with Quaternary alluvial fan deposit.

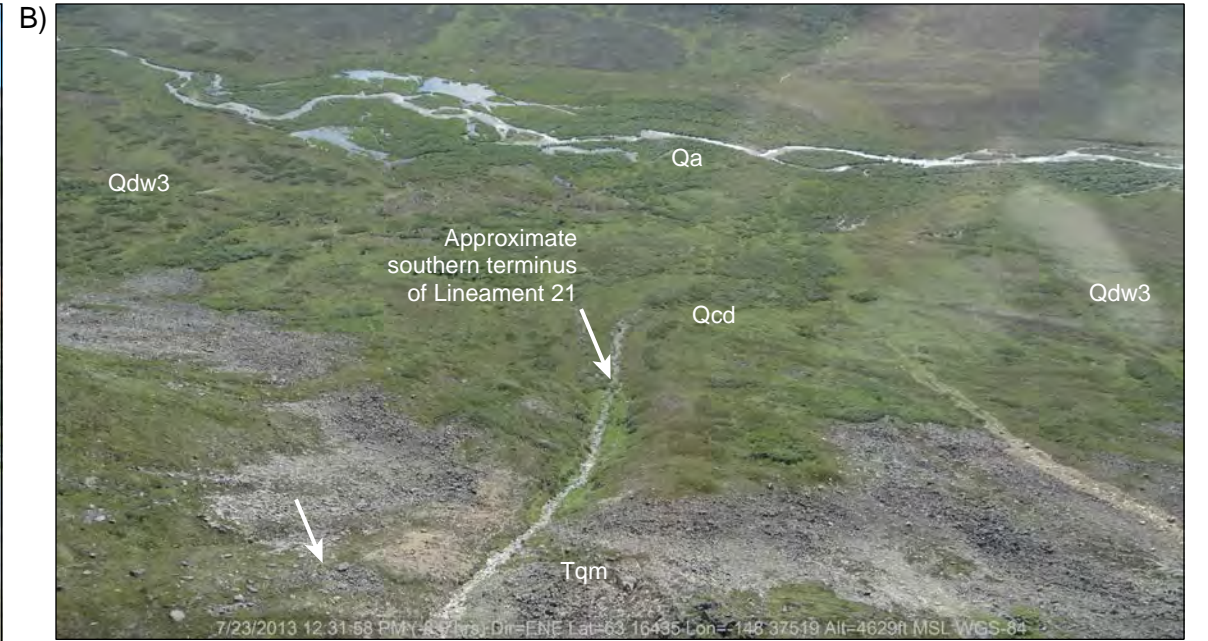
View looking southeast from photograph location B. Arrows show the projected trace of Feature 21 lineament.
