6. SUSITNA BASIN AND DAM SITE CHARACTERISTICS

6.1. Climatology

6.2. Hydrology

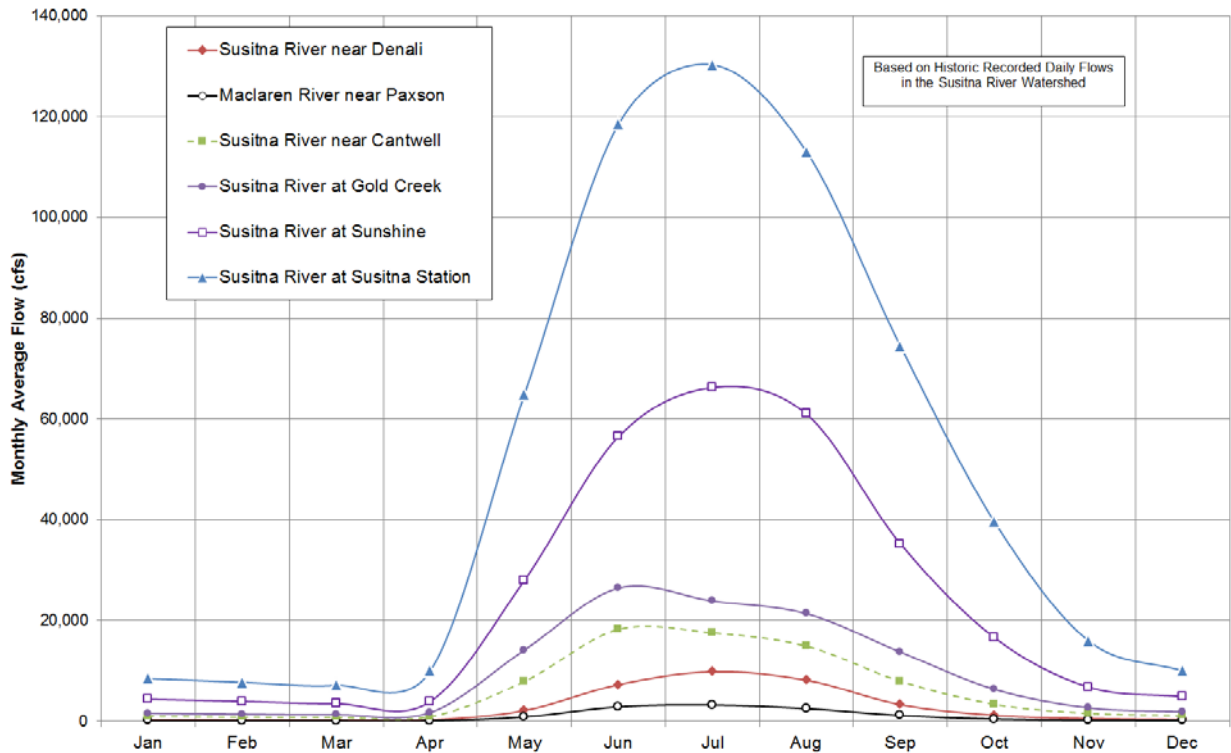
Figure 6.2-3. Average Monthly Flows in the Susitna Watershed

Average monthly flows over the period of record for the main stem Susitna River plus the Paxson River, which is tributary to the Watana Dam site, are presented on Table 6.2-2. As shown in Table 6.2-2 and in Figure 6.2-3, flow in the Susitna River and its tributaries is highly seasonal, with peak flows in July corresponding with summer snow melt conditions, and low winter flows occurring when much precipitation is stored in the watershed as snow.

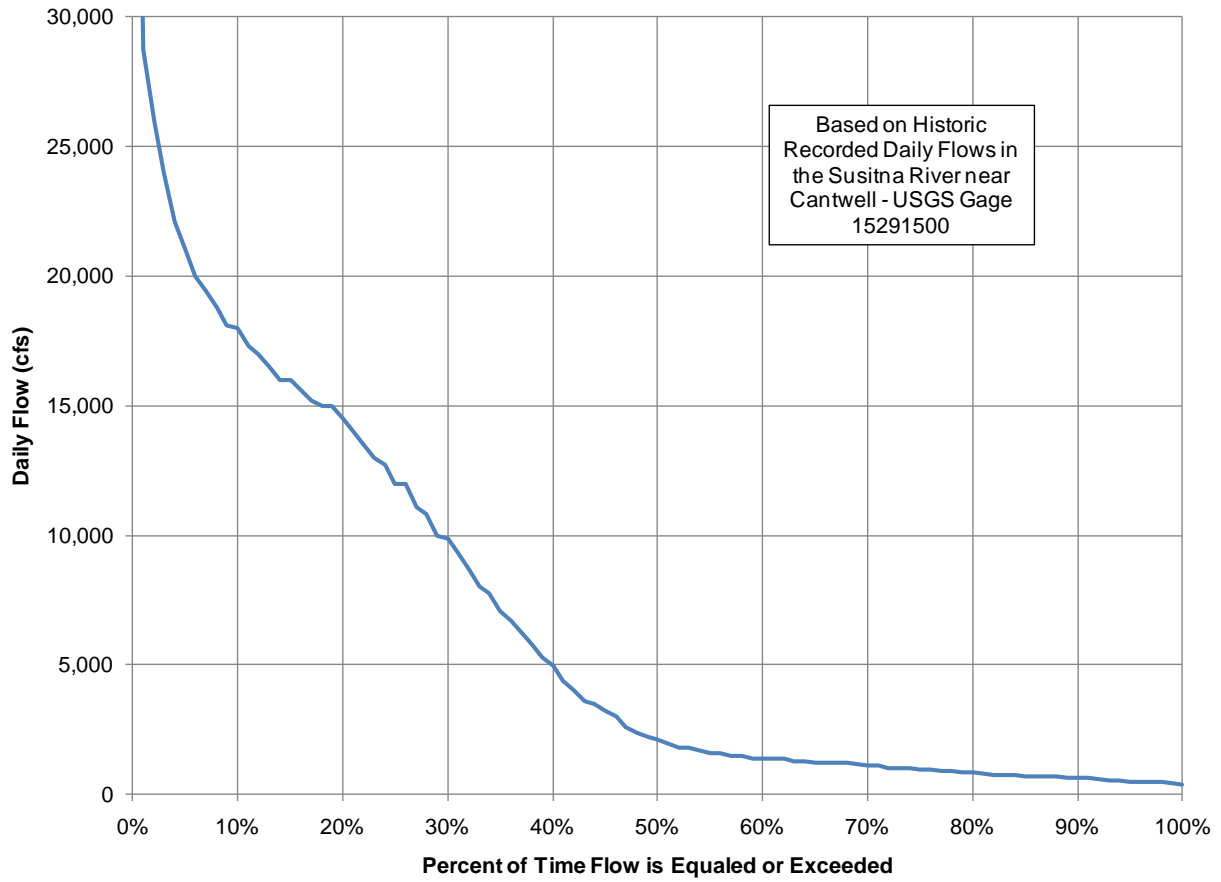
Figure 6.2-5. Susitna River Flow Duration at Cantwell

The nearest long-term gaging stations upstream and downstream from Watana Dam were used to create flow frequency and flow duration plots. USGS gaging station 15291700 Susitna River above Tsusena Creek is located about two miles downstream from the Watana Dam site, but flow records began in water year 2012 so the period of record is inadequate for determining average flows or flow frequency data. Daily flow data at Cantwell and Gold Creek on the Susitna River was used; these stations are 41 river miles upstream and 47 river miles downstream respectively. Table 6.2-3 and Table 6.2-4 present monthly flow frequencies for flows in the Susitna River at Cantwell and Gold Creek, respectively. The flow frequency was calculated at five percent exceedance intervals except at the high and low flow ends where 1 percent exceedance intervals were used to provide additional definition where the flow duration values change rapidly.

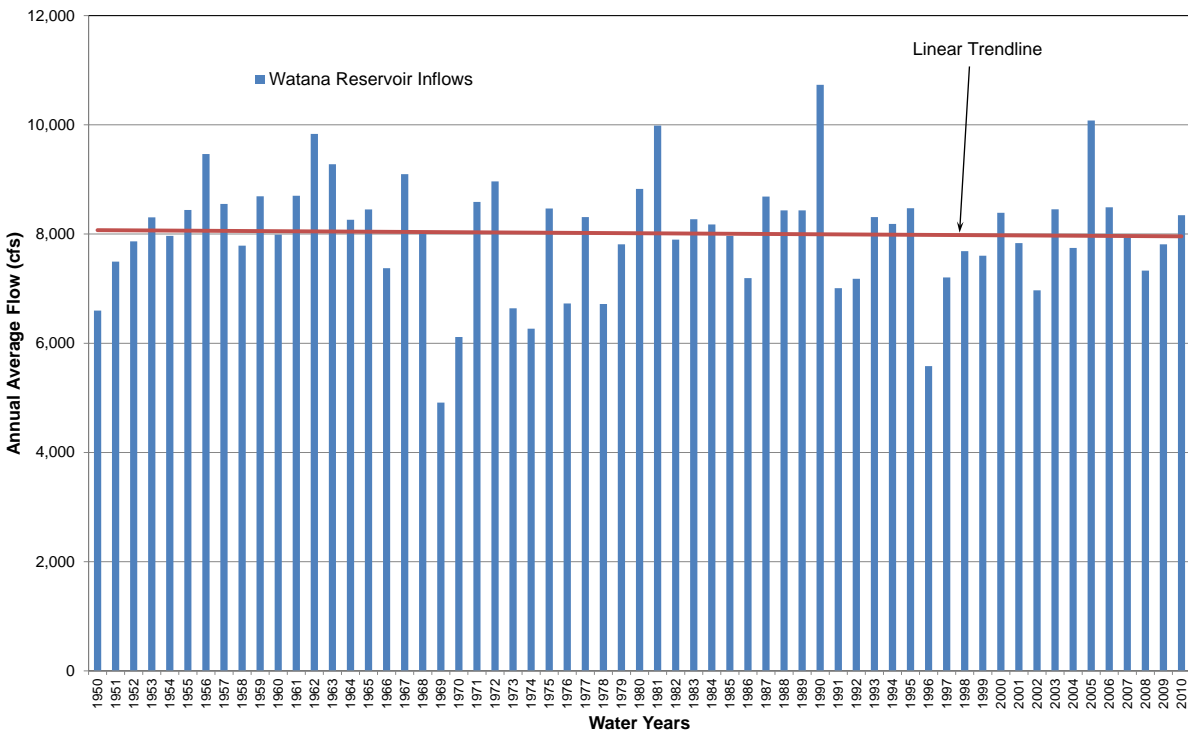
Figure 6.2-13. Watana Reservoir Annual Inflows and Trendline

Preliminary hydrology studies conducted to date indicates that there has been no historic trend in annual flows. Figure 6.2-13 plots the annual Susitna Reservoir inflows presented on Table 6.2-5. The lack of historic trend is indicated by the trendline, which is essentially horizontal. There has been an observed seasonal trend toward earlier snow and glacier melt runoff in the Susitna River basin. Analysis of the long-term record of annual average flows at Gold Creek indicates that there is no statistically significant trend.

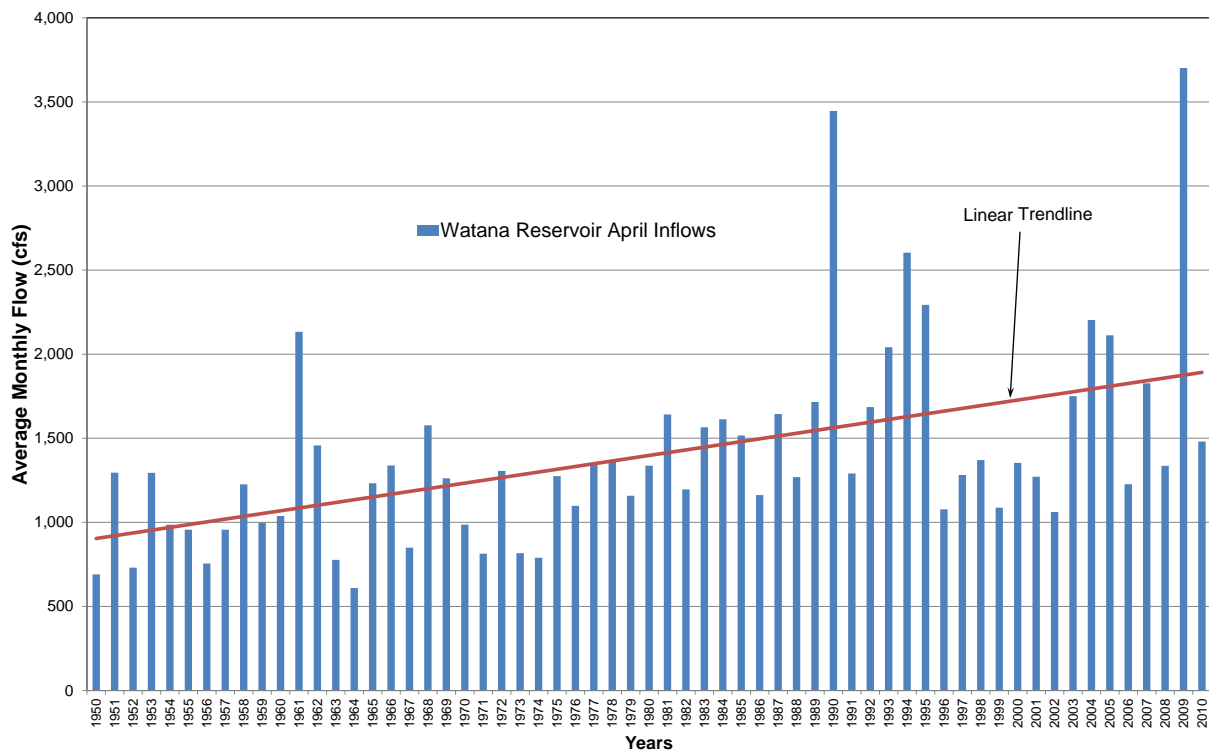
Figure 6.2-14. Example Month with Trend toward Increasing Flows – April

Statistically significant streamflow trends are most prevalent and consistently upward during the cool season months. This is likely due to more precipitation falling as rain rather than snow, and more frequent periods of snowmelt during the cool months. The month of April, as shown on Figure 6.2-14, has the most pronounced upward trend that is also due to an earlier onset of significant snowmelt in recent years. There is a consistent trend toward decreasing runoff in the months of June, as shown in Figure 6.2-15, through August. The net effect is that the increasing flows in some months and decreasing flow in other months balance out such that total annual flows remain approximately the same. Projecting the continued historic monthly trends to the year 2050 will result in a changed monthly flow distribution. The shape and relative magnitude of projected changes in monthly flows at Watana Dam are very similar to those that are expected to occur for the snowmelt runoff dominated Columbia River (Climate Impacts Group 2009). If the seasonal shift of flow continues to occur without any change in average annual flow, it would result in a small increase of a few percent in the available winter energy from the project.

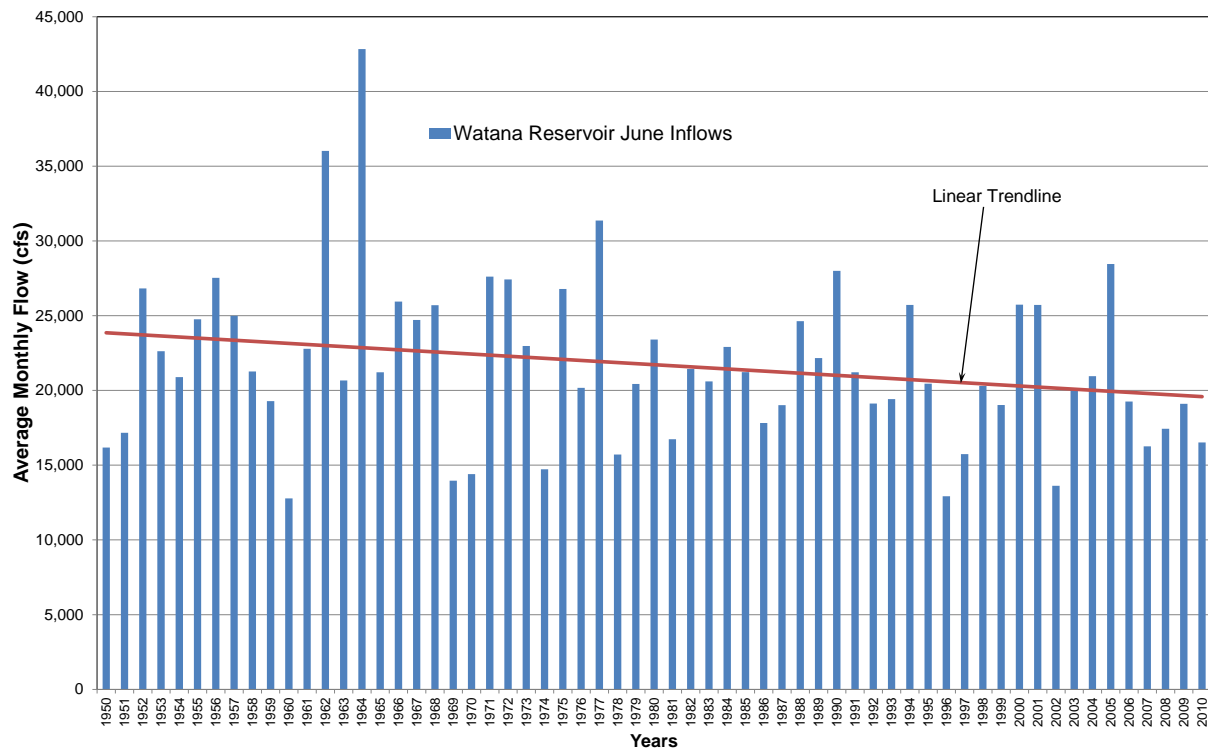
Figure 6.2-15. Example Month with Trend toward Decreasing Inflows – June

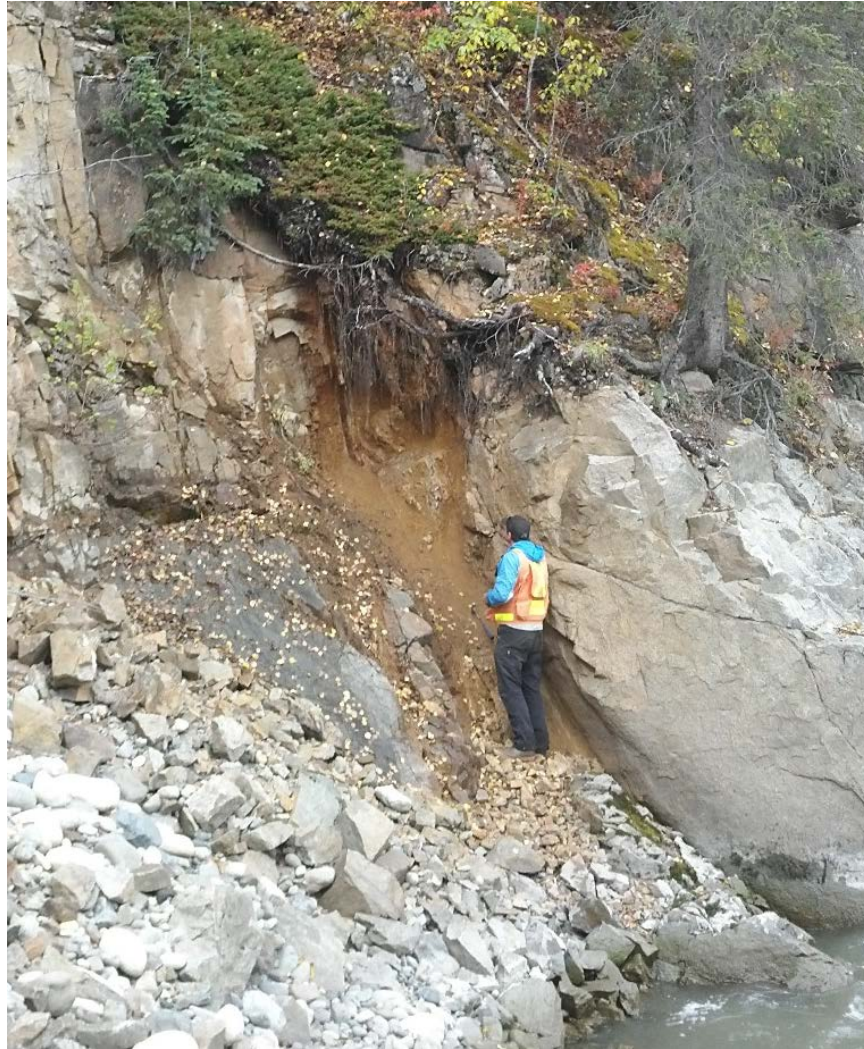
Figure 6.3-18. Shear Zone in Outcrop at GF1.

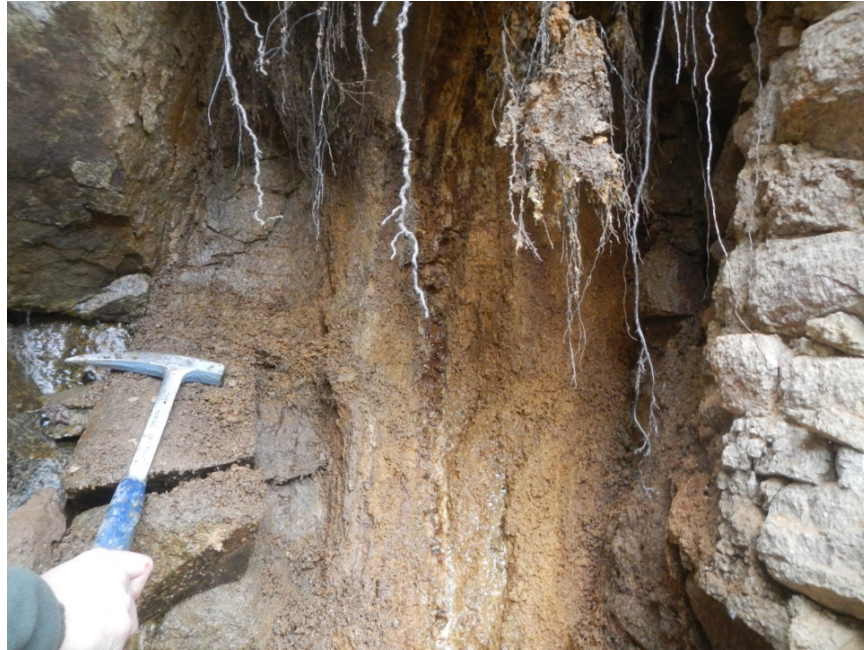
Figure 6.3-19. Close-up of 3 to 4 ft. Wide Shear Zone at GF1

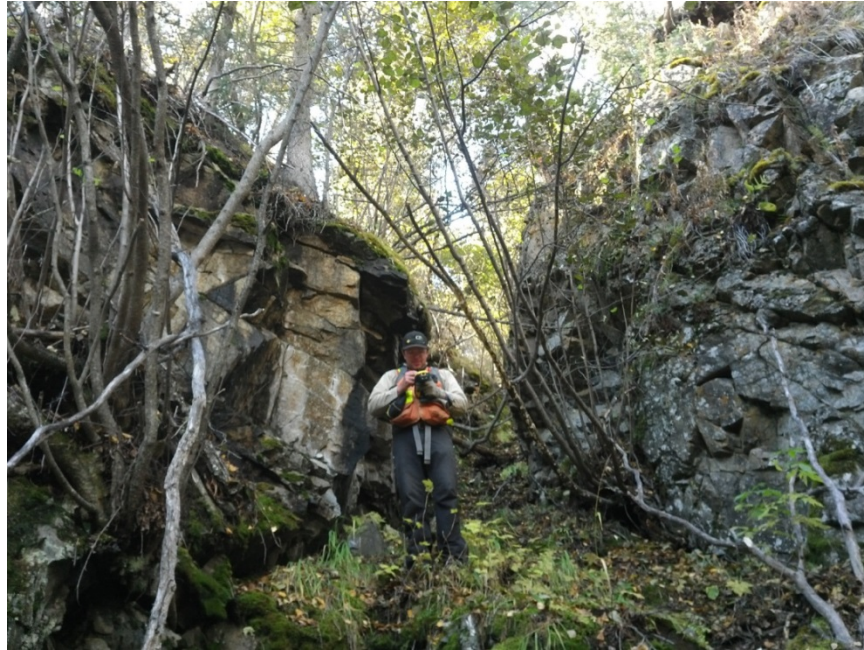
Figure 6.3-20. Northwest Trending Gully of GF4B (width of fracture zone is constrained by the gully width)

Although fracture zones were not directly observed in outcrop, the drilling information and particularly observations from mapping support the interpretation that GF4B consists of multiple narrower fracture zones trending in the northwest-southeast to north-south directions. Mapping within the gullies suggests that the gullies formed by preferential erosion of narrower fracture zones (with or without minor shear zones) that were enhanced and widened by weathering processes. Continued removal of rock blocks and wedges by erosional processes such as stress relief along steep joints and freeze-thaw, has created the present geomorphic surface and filled the gully floors with boulder talus. For example, Figure 6.3-20 shows an approximately 5 to 7 ft. wide gully between outcrops of competent diorite. This width constrains the maximum width of the fracture zone to these dimensions.

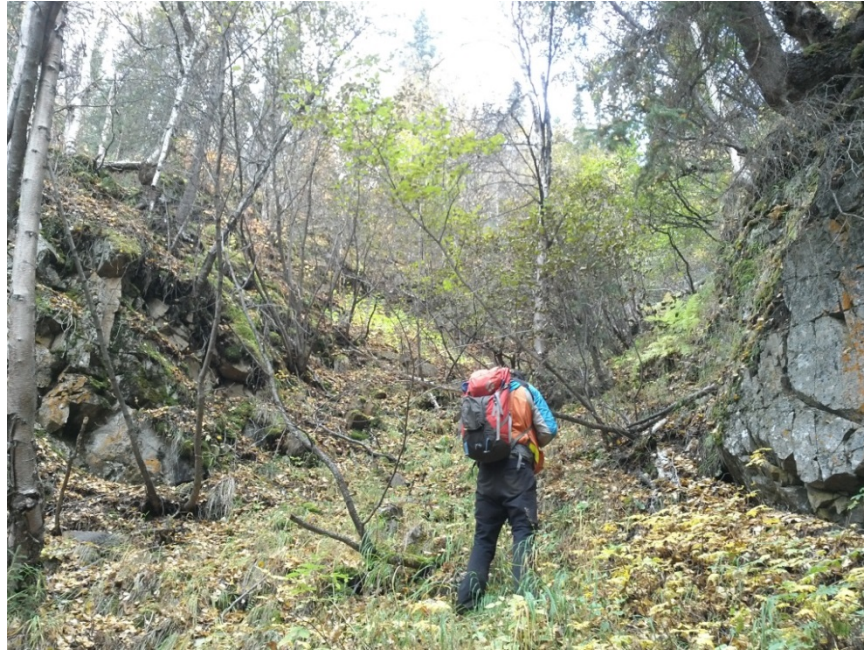
Figure 6.3-21. North-northwest Trending Gully of GF4B

Another example of gully formation on the right abutment is shown in Figure 6.3-21. The gully appears to have formed along a narrower zone of weaker geologic materials (e.g., fracture zone), but has been widened by erosion. On the left side of the photo (west) is an outcrop of competent rock with prominent joint set dipping 35° to 55° to the east (toward the gully), and on the right side of the photo (east) the outcrop has joints that dip steeply to the southwest (into the gully). The line of intersection of these joint sets trends to about 345° (nearly north-northwest to south-southeast), which parallels the trend of this gully. This observation supports the notion that the gullies were likely initiated by erosion of a relatively narrow fracture zones consisting of weaker rock. Projecting the major joints from each outcrop to the gully floor, constrains the maximum width of this fracture zone to about 10 ft. The gully has likely been widened by erosion of blocks from both outcrops and talus blocks are deposited in the gully floor.

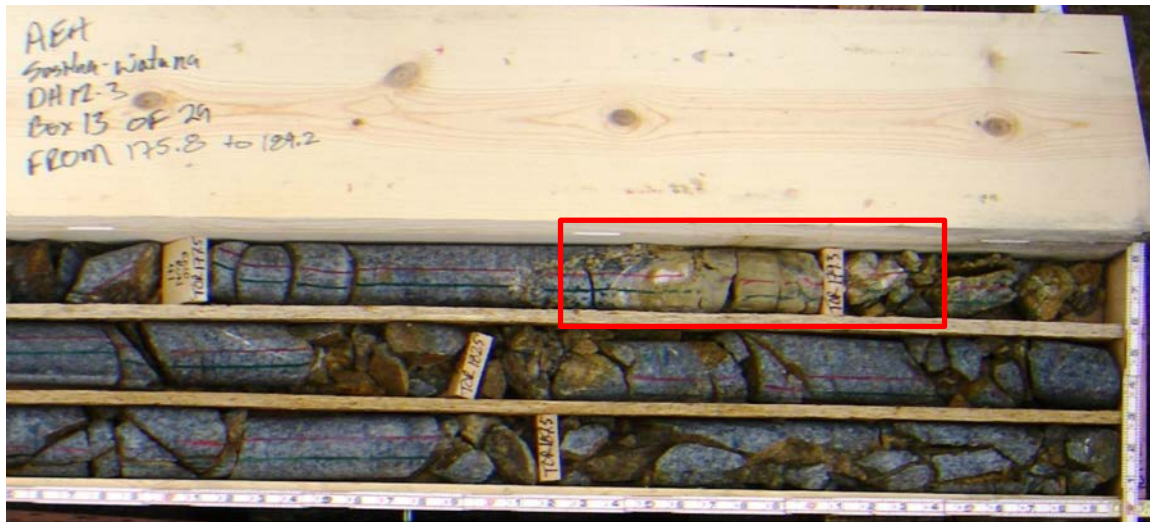
Figure 6.3-22. Rock Core from DH12-3 with Closely Fractured Rock and Shear Zone at Depth of about 179 ft. (red box)

Although fracture zones are not readily observed at the ground surface, the conditions are better represented in the rock cores. Several fracture zones with breccia and gouge can be observed in the rock core from DH12-3, which is believed to cross several fractures zones comprising GF4B on the north abutment. For example, at a depth of 179 ft. a northwest-southeast trending fracture zone consisting of close to very closely fractured rock and eight-inch thick zone of clay gouge shown in Figure 6.3-22 was encountered. Although these fracture and shear zones are considered relatively minor features with respect to the dimensions of the dam, the project structures have been moved slightly downstream, to reduce the potential that this or similar structural features will impact the dam or require foundation treatment.

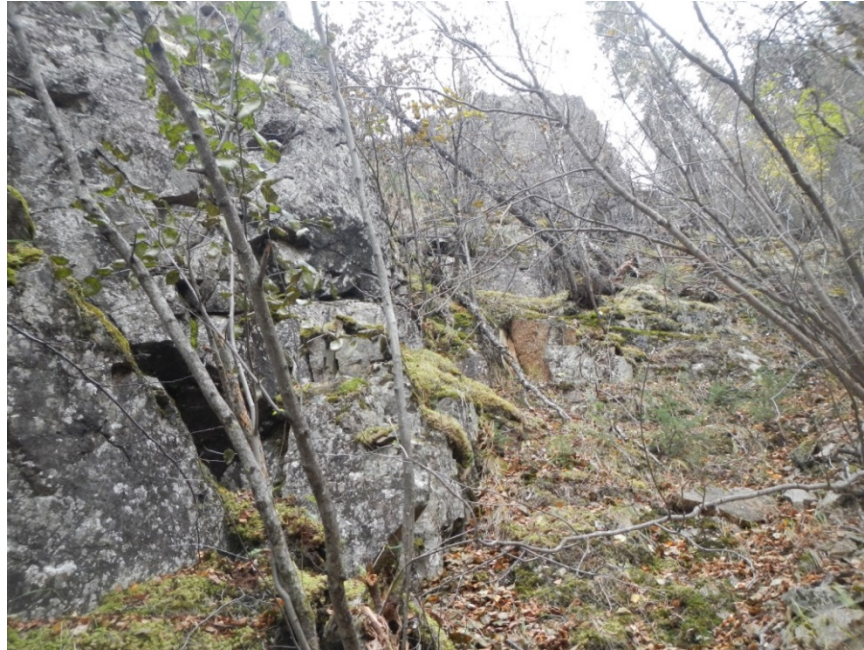
Figure 6.3-23. 75 ft. High Cliff on Right Abutment Forming the Downstream (Southwest) Boundary of GF5

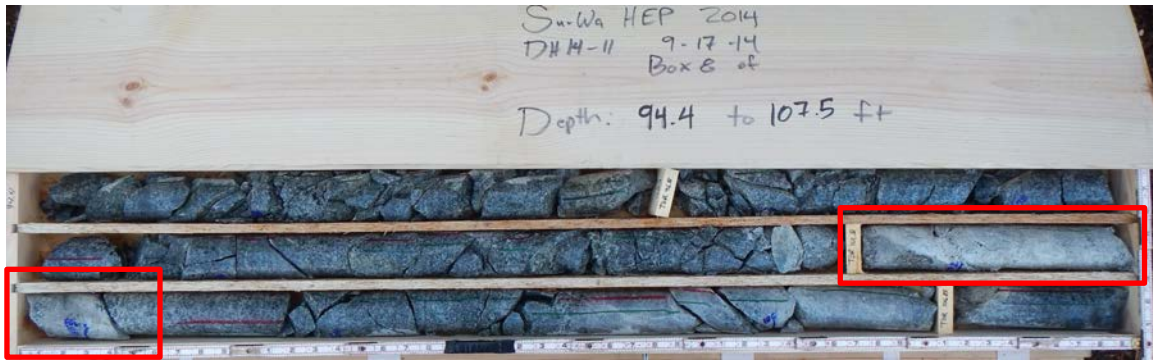
Figure 6.3-24. Rock Core from DH14-11 with Closely Fractured Rock and Shear Zone at Depth of about 102 ft. (red box)

Because fracture zones in GF5 are readily observed at the ground surface, the conditions are best observed in the rock cores. In DH14-11 at a depth of 102 ft. a northwest-southeast trending fracture zone consisting of close to very closely fractured rock and approximately 20 inch wide shear zone (apparent width) of moderately to completely weathered and friable and brecciated rock as shown Figure 6.3-24. Although considered relatively minor features with respect to the dimensions of the dam, due to the location and trend of this and similar fracture zones and shear zones in GF4B, the project structures were moved slightly downstream, to reduce the potential impacts that this or similar structural features could have on the dam foundation.

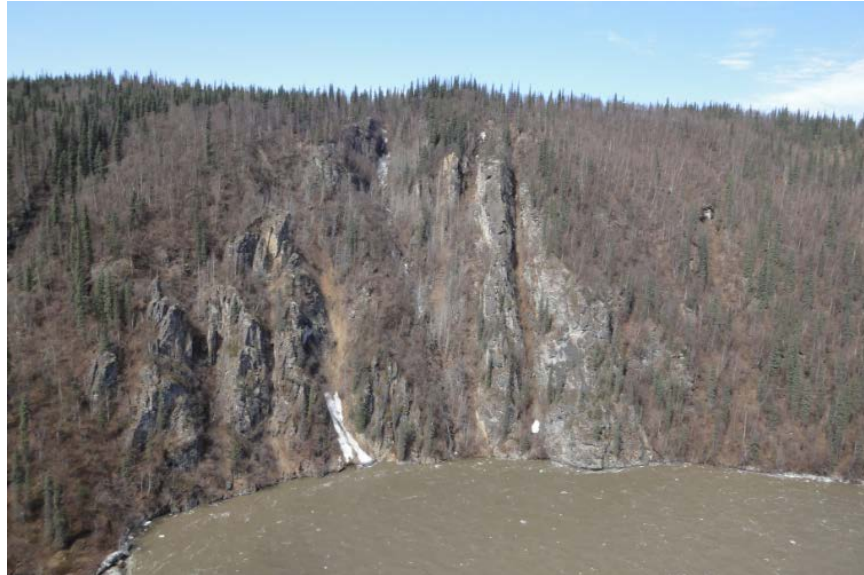
Figure 6.3-25. GF1 Located 2,200 ft. Upstream of the Dam Axis (view looking northwest)

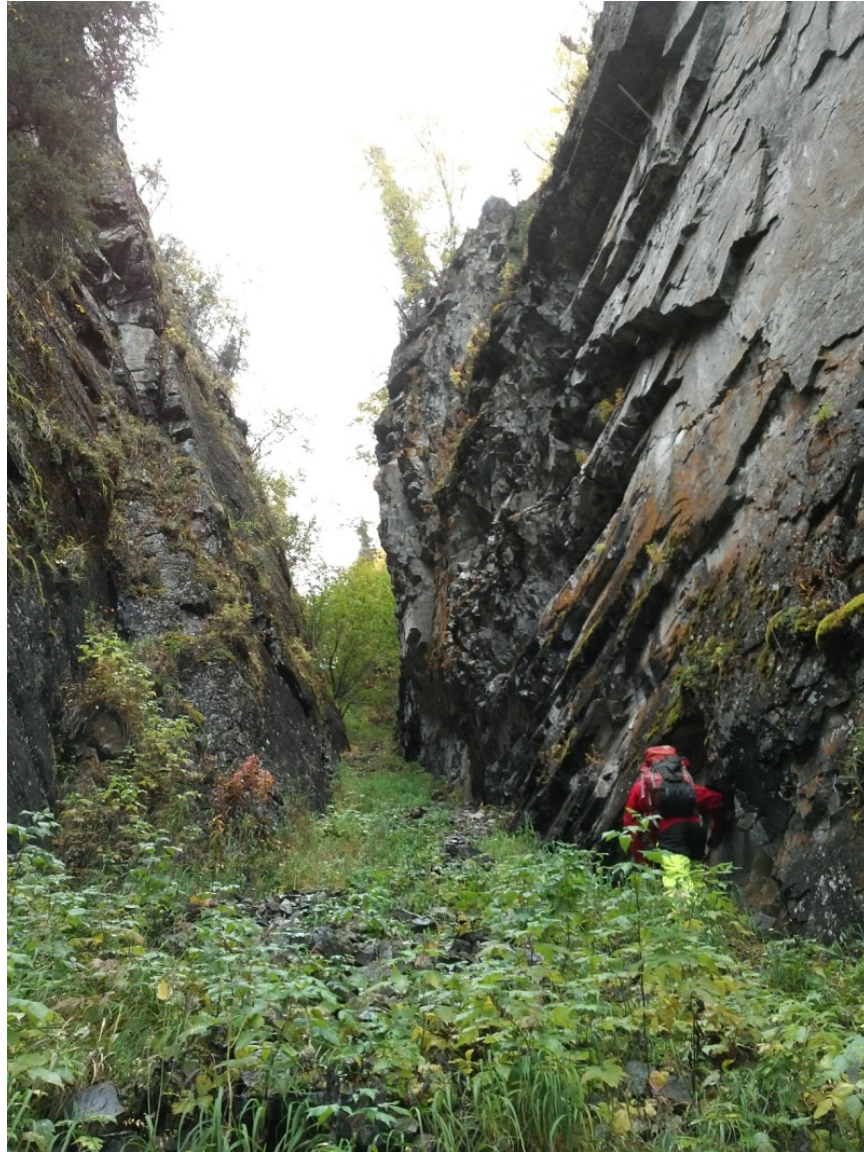
Figure 6.3-26. Narrow Gully in Area of GF1

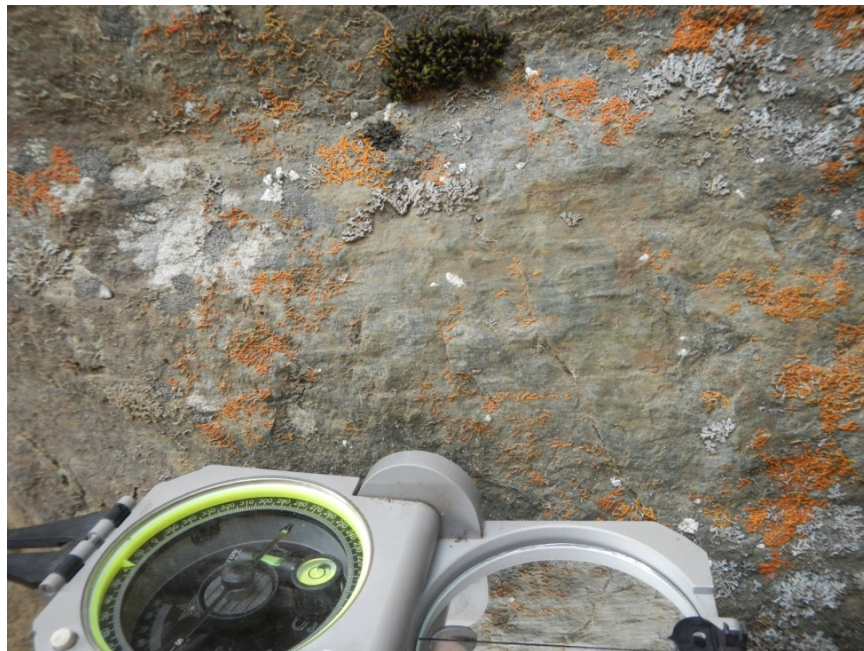
Figure 6.3-27. Subhorizontal Slickensides along Outcrop Surface near GF7Q

GF7Q is correlated to a prominent gully on the south bank. However, no surface exposures of the fracture and shear zones were observed in this gully, instead only talus filled gullies were encountered. However, the east face of the gully, oriented 294° and dipping 70° to the southwest, exhibited slickensides (Figure 6.3-27) plunging about 3° to 294°.

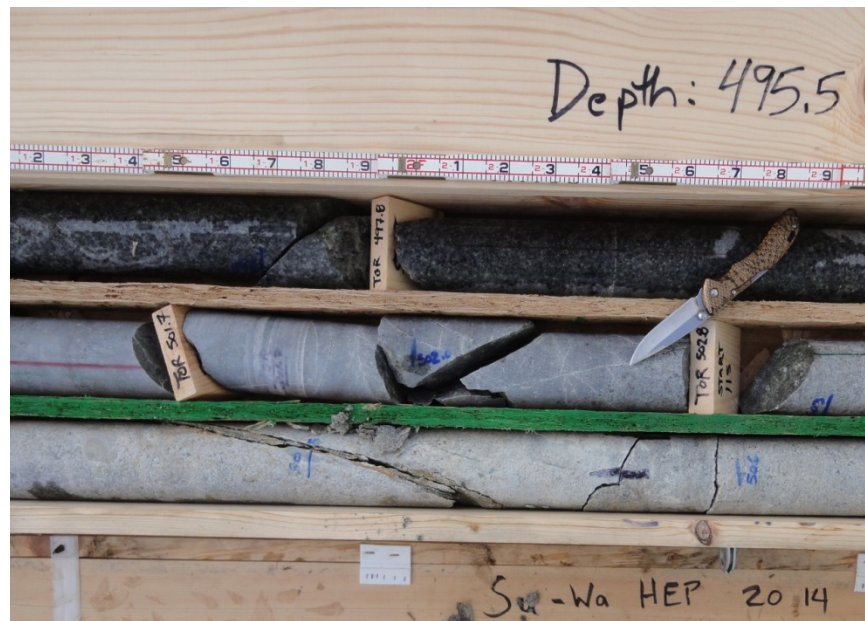
Figure 6.3-28. Narrow Shear Zone with Slickensides, Calcite Filling in DH14-10 at a Depth of 507 ft.

with one to two inches of brecciated rock and clay gouge were encountered in DH14-9b at about 146 ft., 633 ft., and 660 ft. depth and in DH14-10 at depths of about 142 ft., 225 ft., and 507 ft. (Figure 6.3-28 and Figure 6.3-29), and included slickensides. These shear or shear/alterated zones are not anticipated to be sources of major structural weaknesses in the otherwise sound bedrock foundation. The drilling encountered no large-scale shears zones or faulting beneath the river.

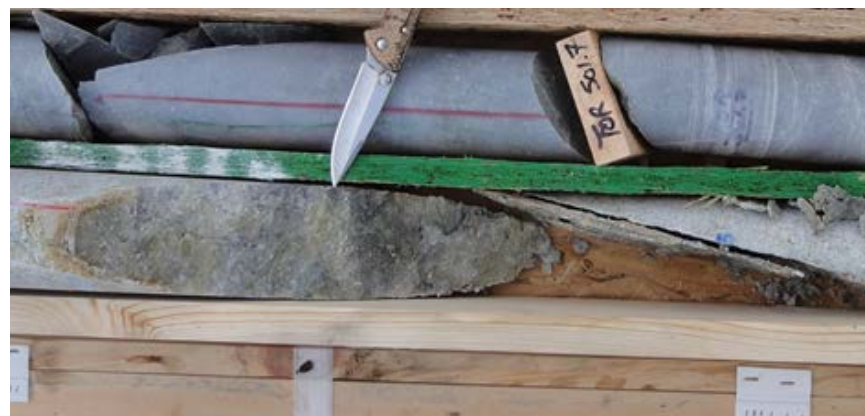
Figure 6.3-29. Close-up of Shear Zone with Slickensides in DH14-10 at Depth of 507 ft.

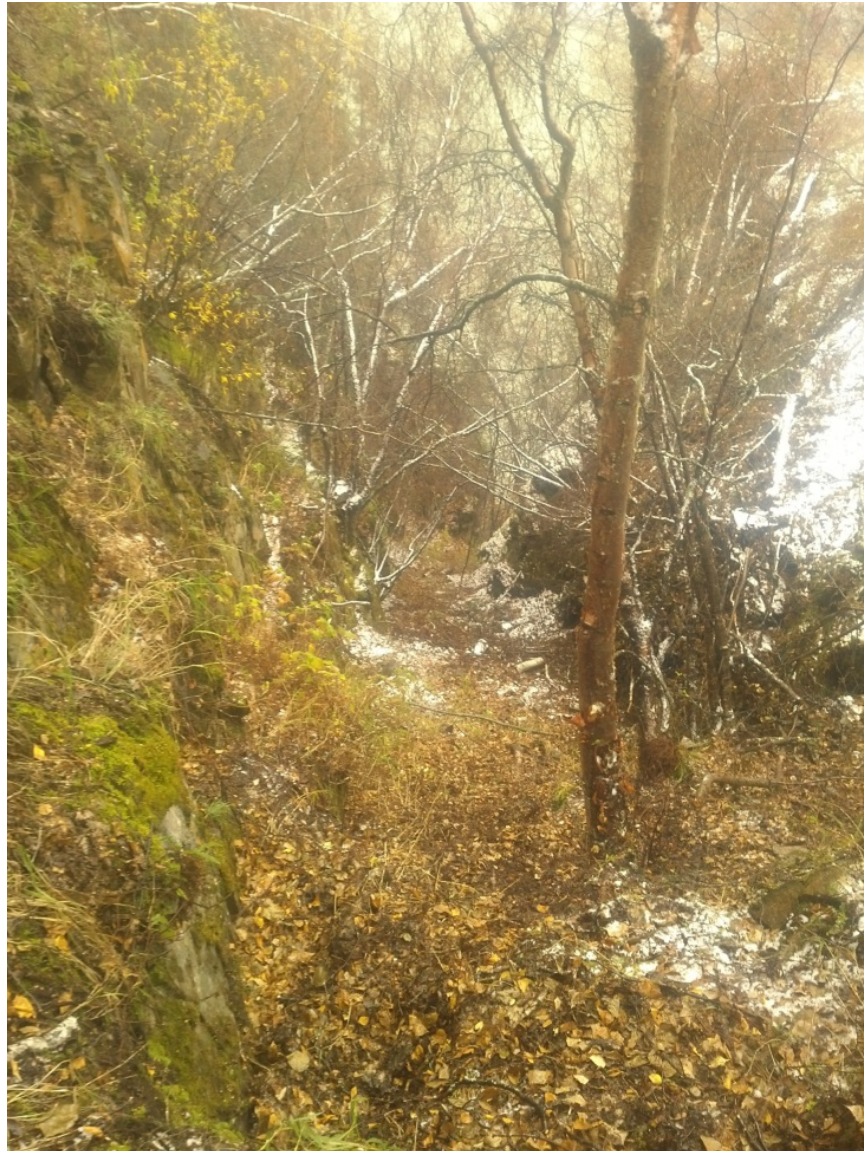
Figure 6.3-30. Gully Downstream (west) Boundary of GF5 on the North Bank (view to southeast)

A narrow gully appears on the north bank approximately 220 ft. downstream of GF5 (Drawing 01-01GT006). This gully appears similar in character and orientation to those of GF4B and GF5, but is only 10 to 20 ft. wide on the gully floor (Figure 6.3-30). In 2014, borehole DH14-12 was drilled perpendicular to this gully to intersect the discontinuities and to characterize the geologic structure that may have contributed to this geomorphic feature.

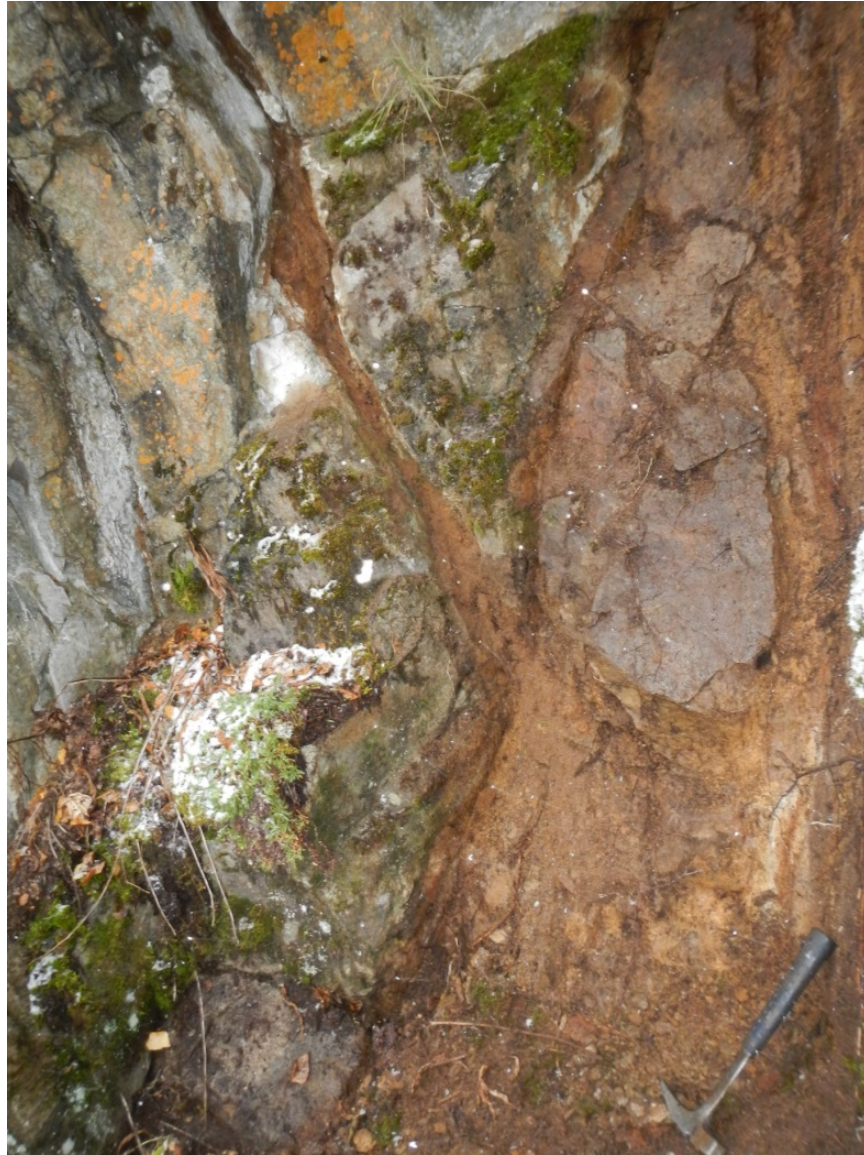
Figure 6.3-31. Shear Zone near BS 36, Main Shear Zone on Right with Inclined Shear Zone Splay

During mapping within this gully a shear zone was identified on the southwest wall of the gully and oriented approximately 290° and dipping about 70° to the southwest (Figure 6.3-31). The shear zone is approximately nine-inches wide and contains brecciated diorite and a two-inch wide central zone of clay gouge-breccia with angular sand size rock fragments. The brecciated rock is orange-brown and gouge is orange-yellow-tan. Eight inches on either side of the shear zone is moderately weathered and stained with iron oxide.
