**Susitna-Watana Hydroelectric Project  
(FERC No. 14241)**

**Geology and Soils Characterization Study  
Study Plan Section 4.5**

**2014-2015 Study Implementation Report**

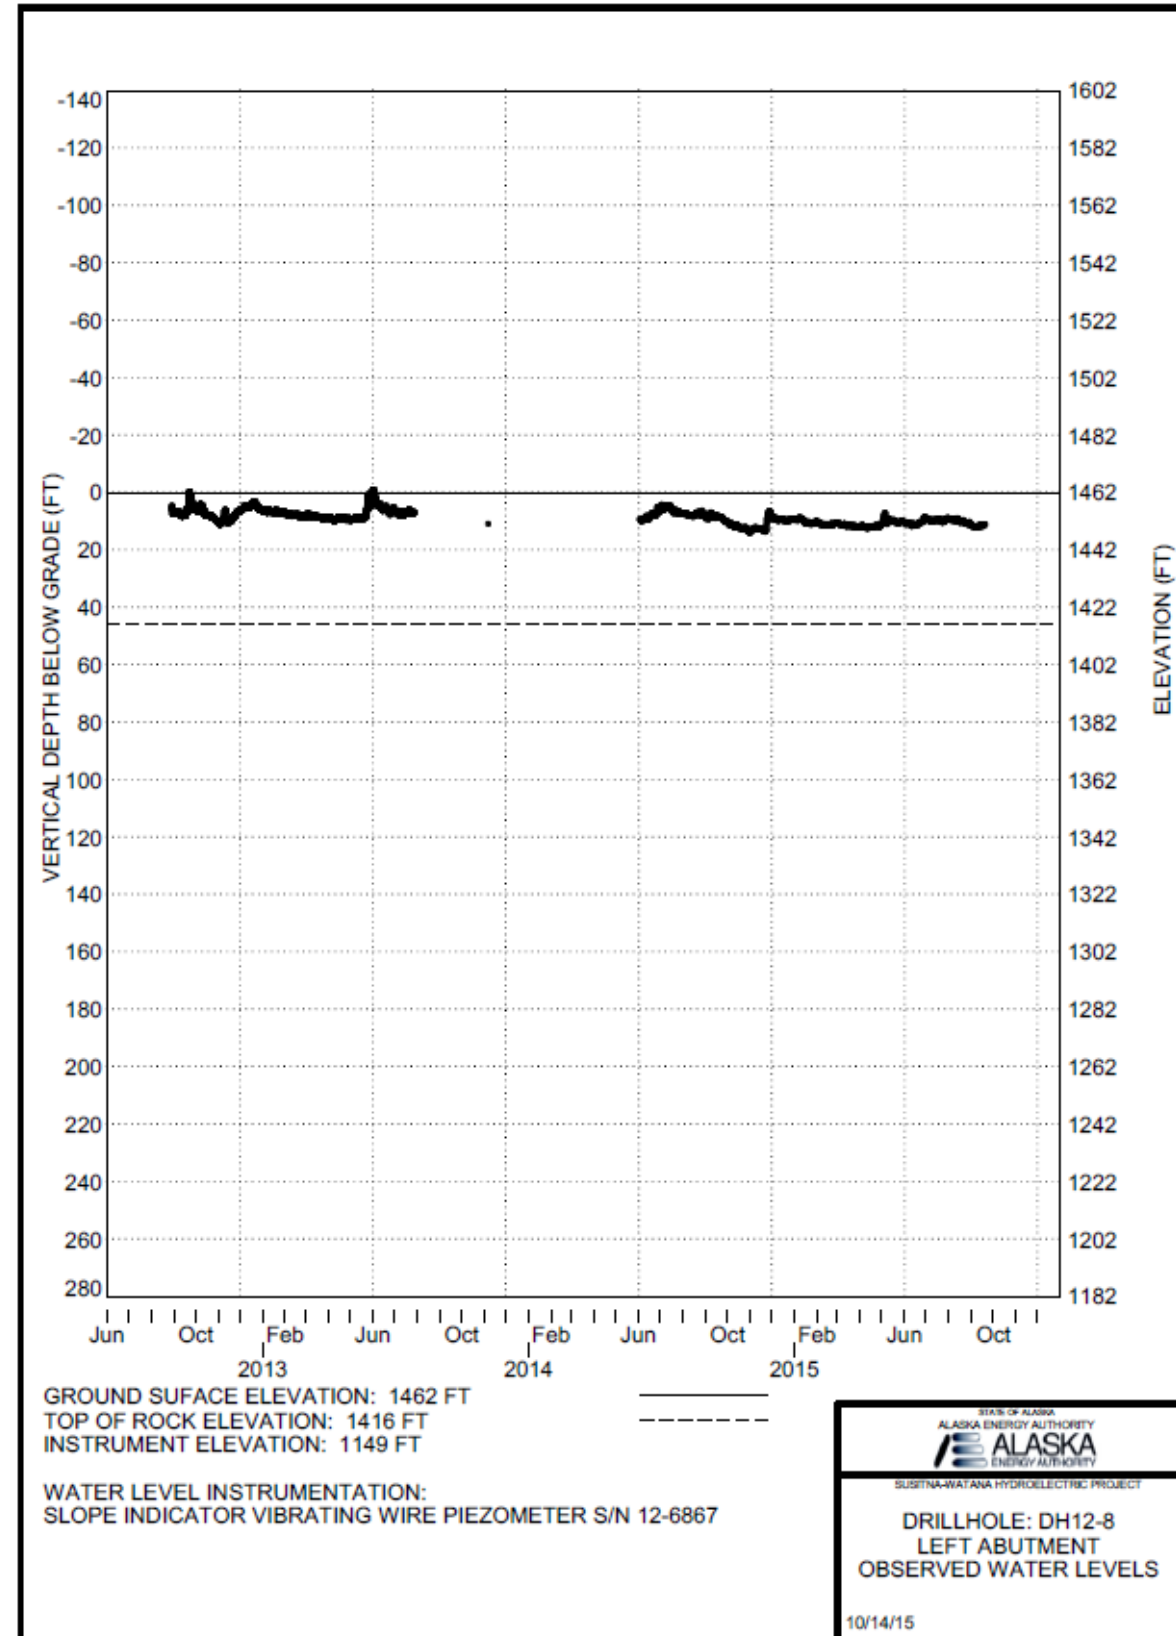
Figure 5.3-2. Groundwater Levels and Dam Site (DH12-3, DH12-8)

The groundwater table at the dam site typically follows the shape of the surface topography. Groundwater movement in the subsurface is largely a function of movement through fractures and joints in the rock mass or in some instances along the top of bedrock (MWH 2014). The groundwater conditions are complicated by the presence of frozen ground particularly on the left (south) abutment and in the lower right abutment (see subsection 5.3.4). On the right abutment, the groundwater level is quite variable but is generally found within bedrock except for local areas where artesian conditions were encountered in borings (e.g., DH84-8) (MWH 2015a; Golder 2015). In the lower elevations, below about elevation 1800, table generally is 30 to 160 feet (9m to  $\approx$ 50m) below the ground surface but may be deeper in places (Figure 5.3-2). On the left abutment, where groundwater levels are influenced by permafrost, groundwater is deep within the abutment, at a depth of about 170 to more than 200 feet (53m to  $>$ 60m) except for the “perched” water due to thawing of the active layer and the impermeable nature of the frozen ground. Locally, isolated artesian conditions were observed at boring BH-12. Boring DH12-8 which is located just above the river level and was drilled south into the left abutment, the groundwater level approximates the water level in the river. Groundwater levels general indicate seasonal variations of about 10 to 20 feet (3 to 6.1m).
