**Susitna-Watana Hydroelectric Project
(FERC No. 14241)**

**Aquatic Resources Study within the Access Alignment,
Transmission Alignment, and Construction Area
Study Plan Section 9.13**

**Initial Study Report
Part A: Sections 1-6, 8-10**

June 2014

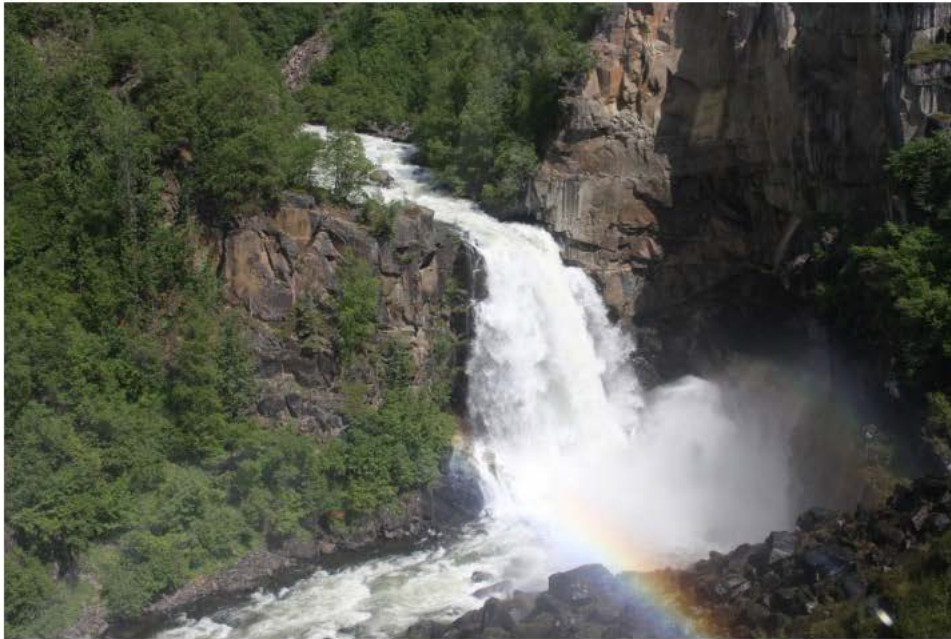
Figure 5-3. Barrier Falls on Deadman Creek

Stream: RM 186.6 – Deadman Creek
Latitude: N
Longitude: W
Barrier ID: 186.6 A

Adult salmon passage barrier 186.6 A, 6/20/2012.

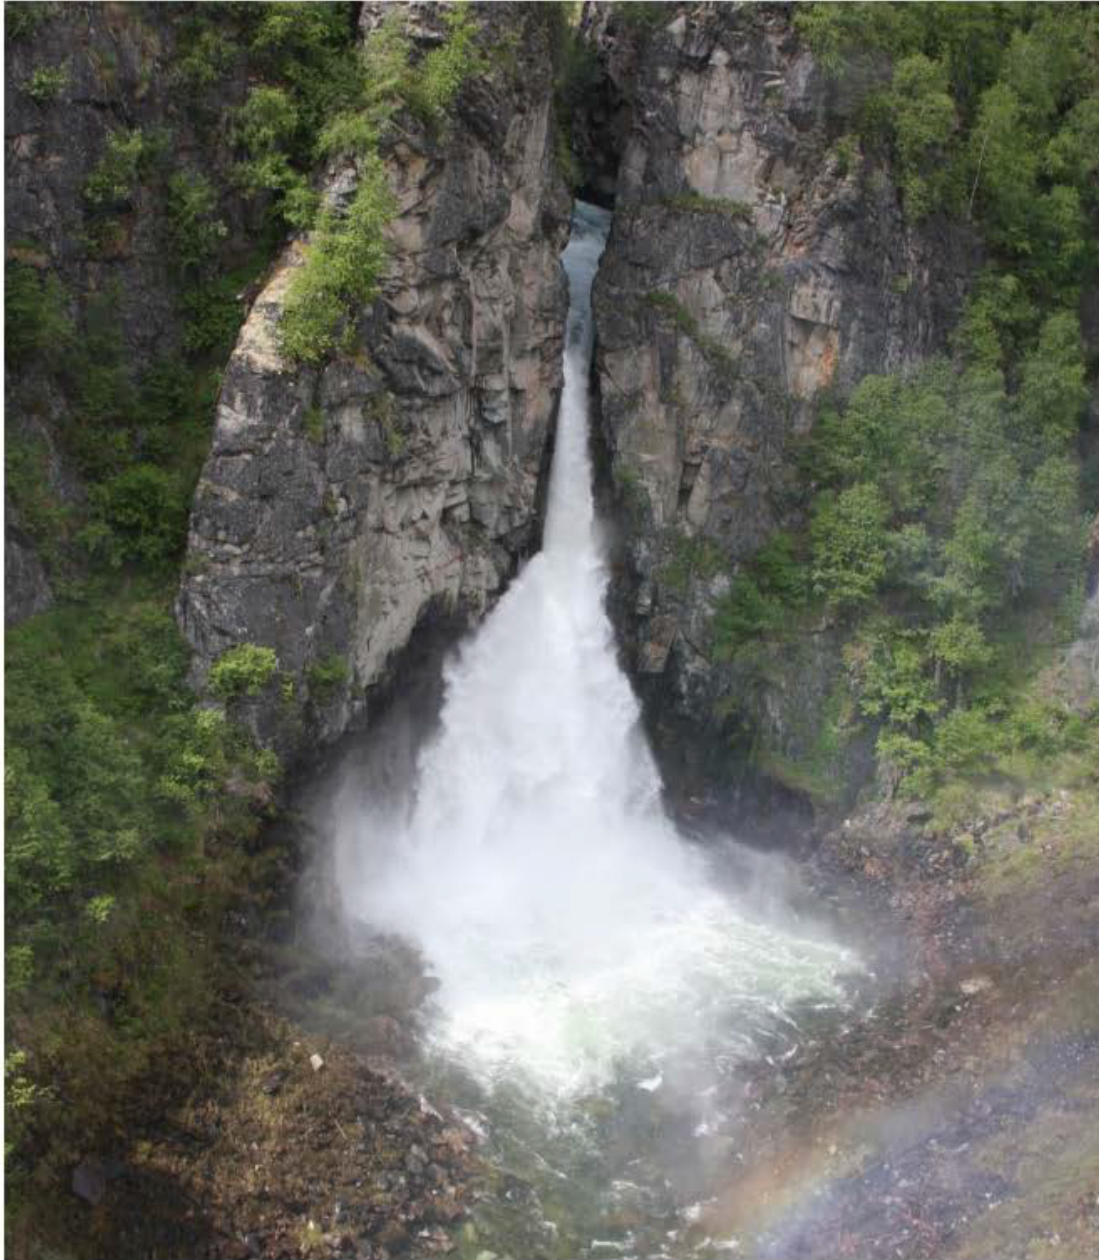
Figure 5-5. Barrier Falls on Devil Creek

Stream: RM 161.5 – Devils Creek
Latitude: N
Longitude: W
Barrier ID: 161.5 A

RM adult salmon passage barrier, 6/19/2012.

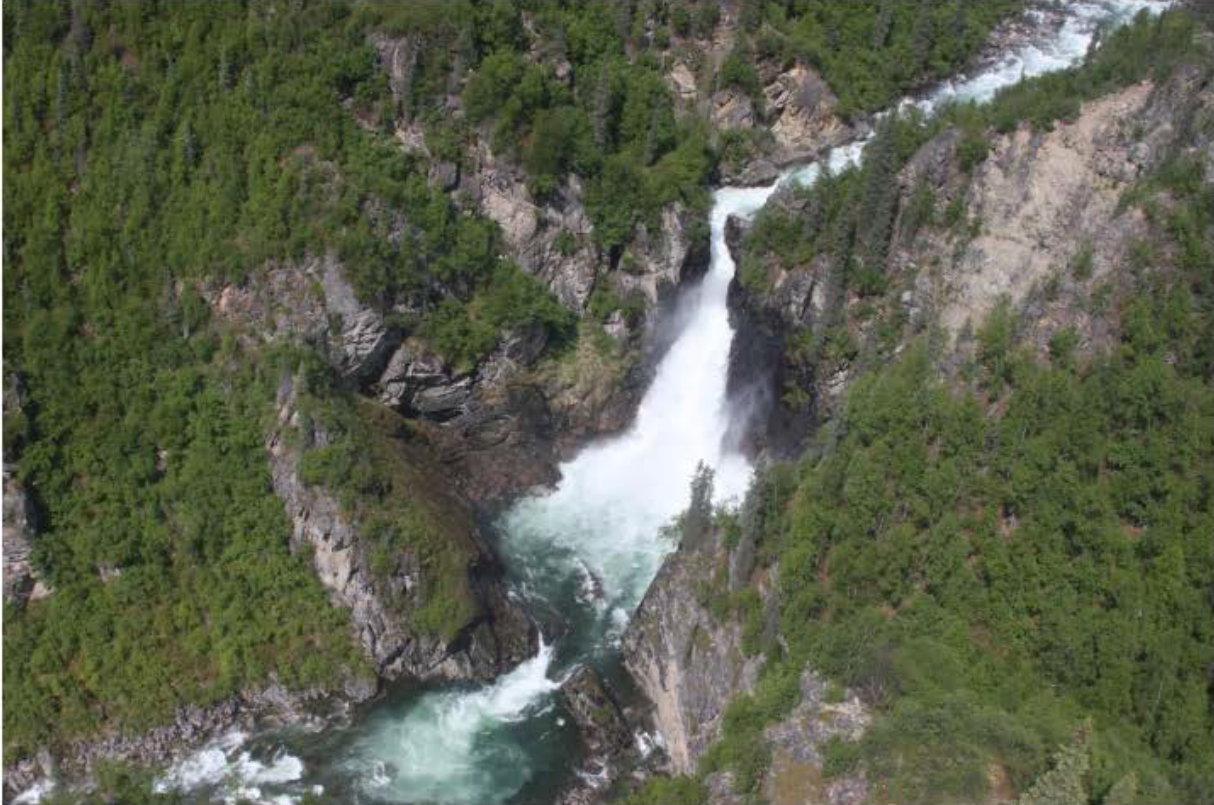
Figure 5-6. Barrier Falls on Tsusena Creek

Stream: RM 181.8 Tsusena Creek
Latitude: N
Longitude: W
Barrier ID: 181.8 A

Adult salmon passage barrier 181.8 A, 6/20/2012.
