## APPENDIX A: SUSITNA RIVER UPPER RIVER RECONNAISSANCE PHOTOGRAPHS

# 1. PHOTOGRAPHS OF THE SUSITNA RIVER UPSTREAM OF THE MACLAREN CONFLUENCE (PRM 291.8 TO PRM 261.3)

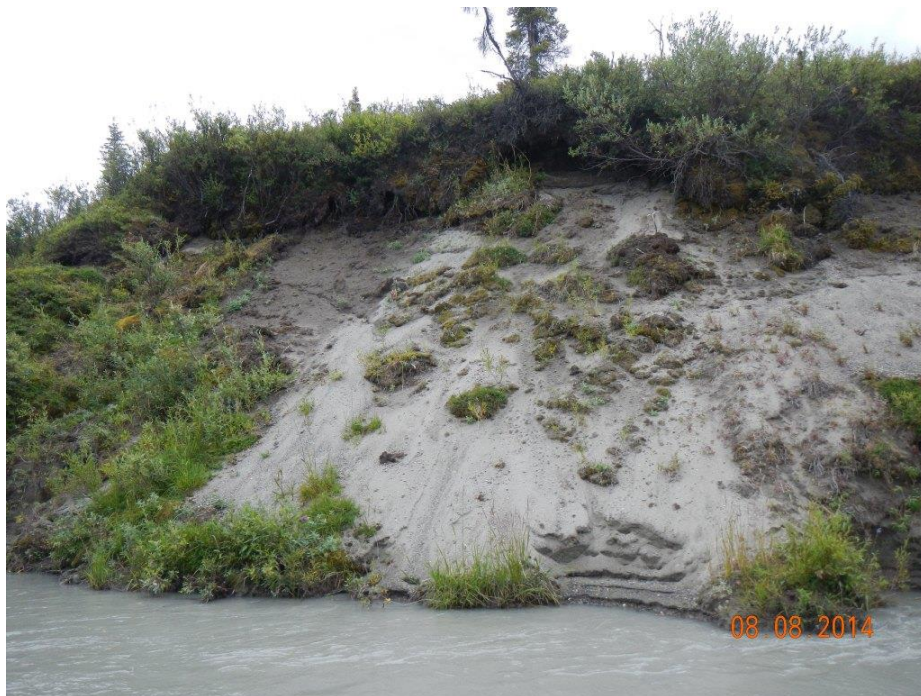
Figure A.1-6 – Local sediment source (sand) at PRM 286– terrace erosion (P871).

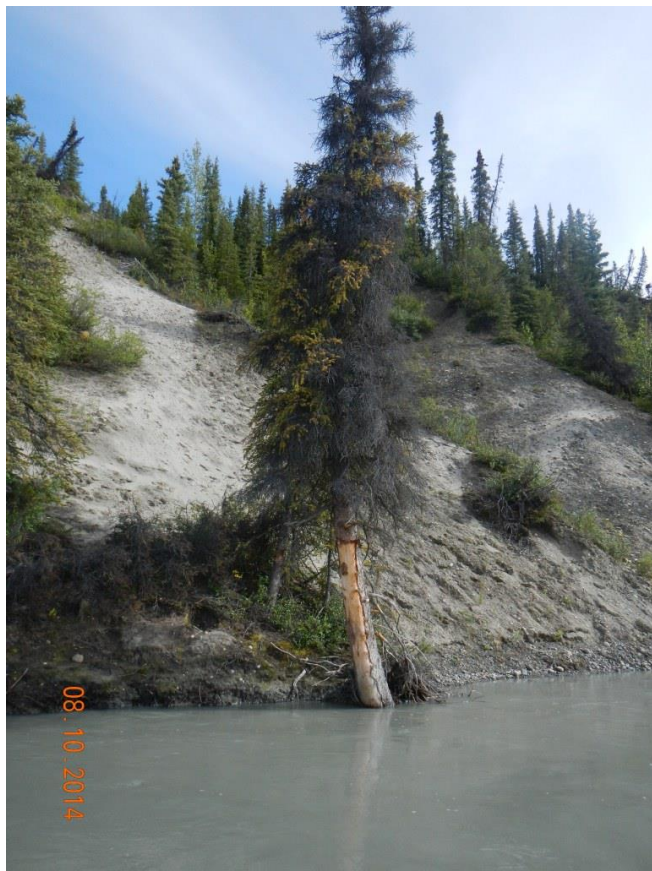
Figure A.1-20 – Ice scarred tree and eroding moraine at PRM 269 (P038).

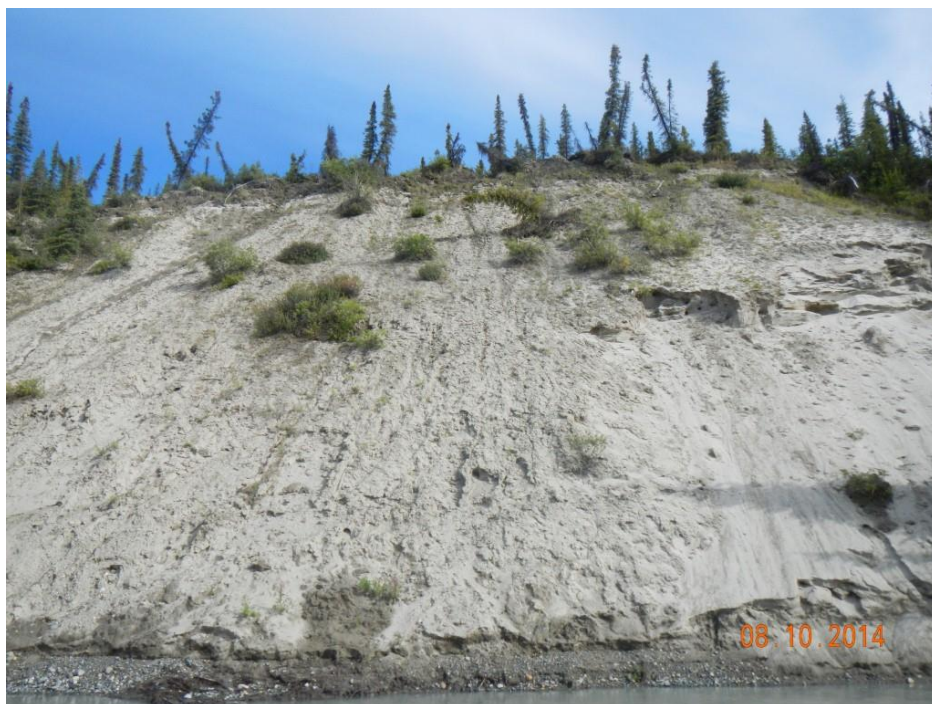
Figure A.1-21 – Local sediment source – rill erosion moraine surface near PRM 269 (P040).

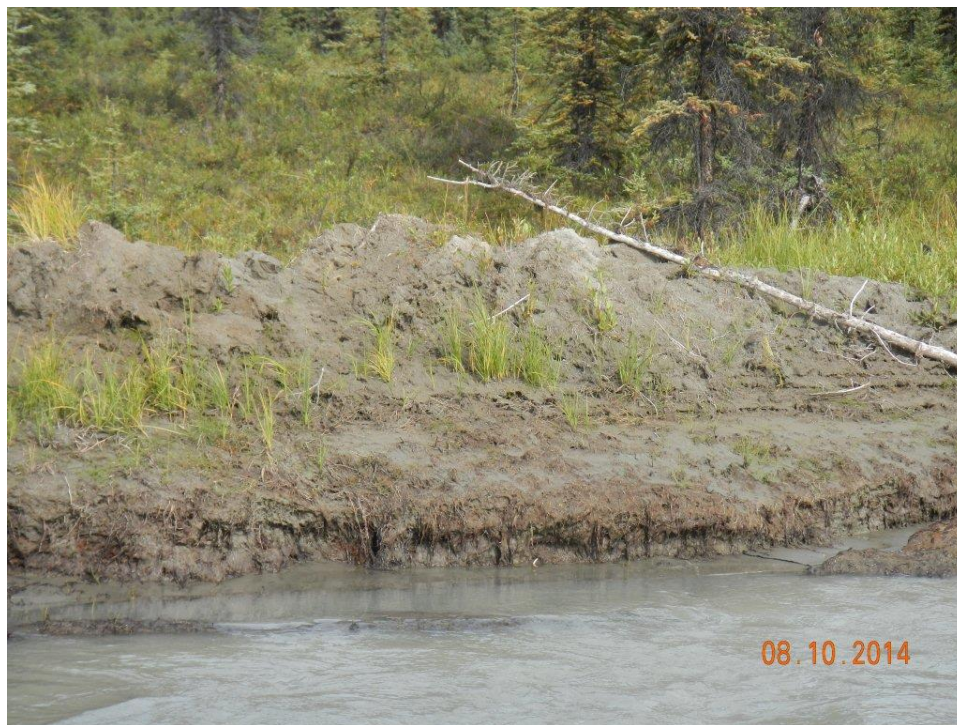
Figure A.1-27 – Ice-deposited sand on floodplain near PRM 266.5 (P074).

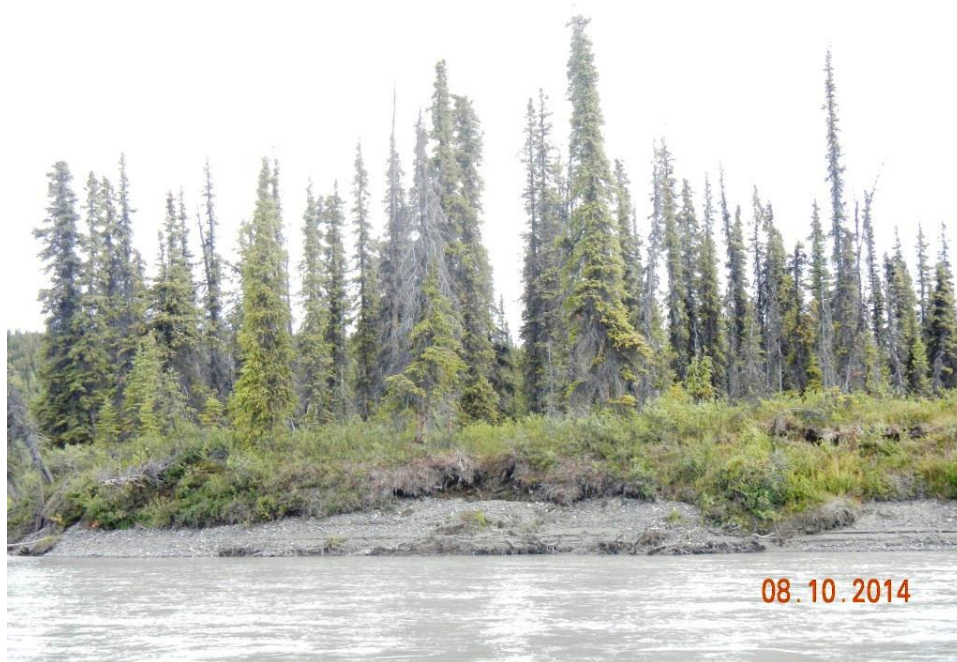
Figure A.1-32 – Gravel-covered mid-channel island near PRM 264 (P138).

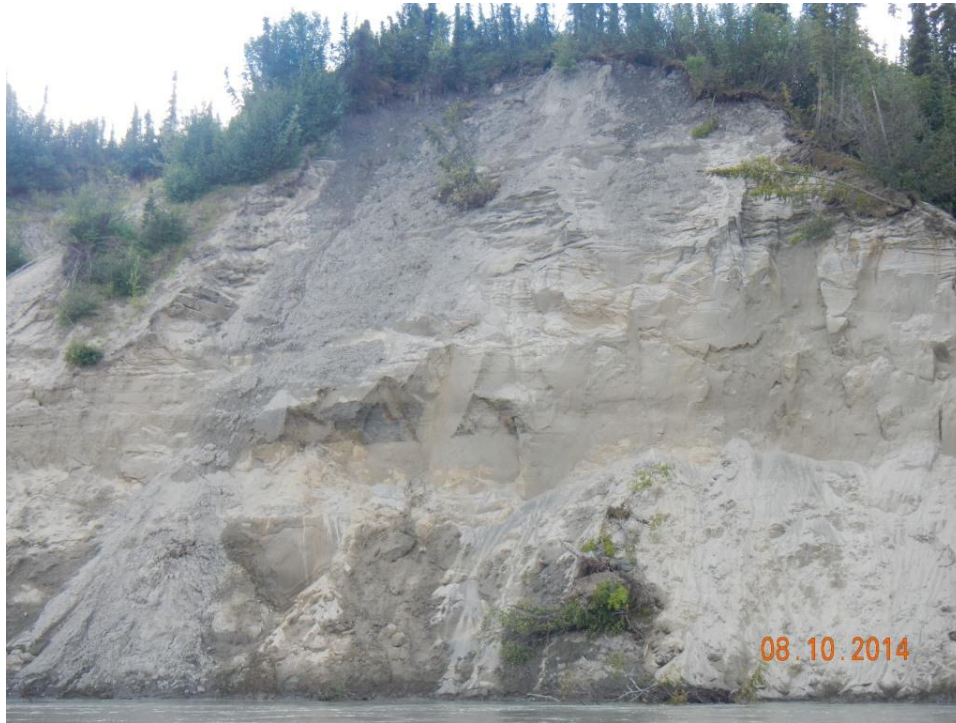
Figure A.2-3 – Eroding moraine – active landslide zone near PRM 259.5 (P219).

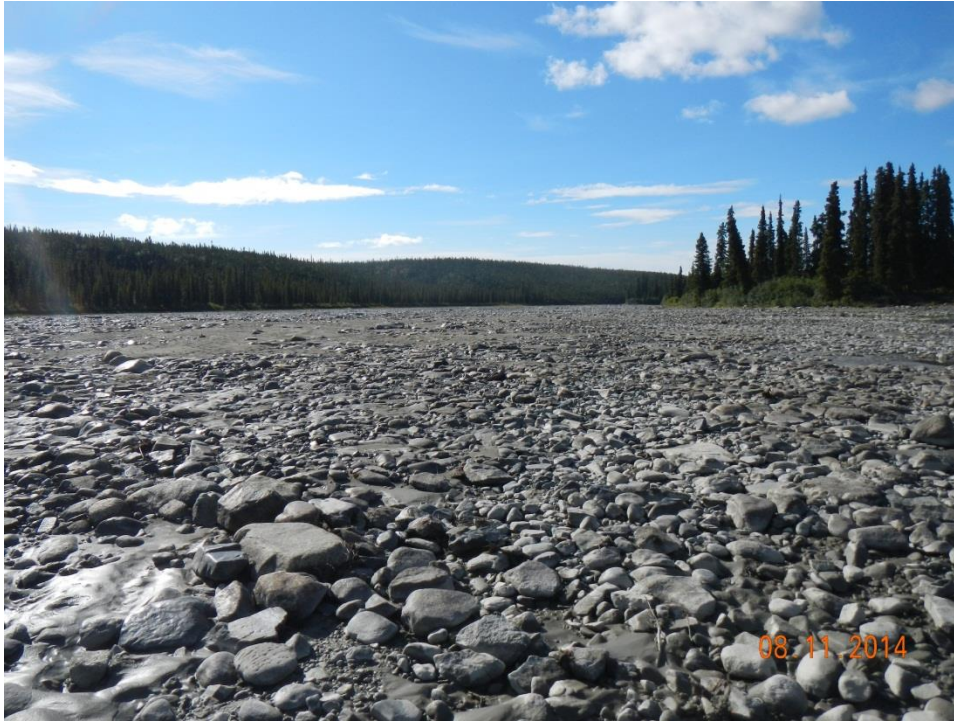
Figure A.2-11 – Armored, ice driven side channel at PRM 254.5 (P293).

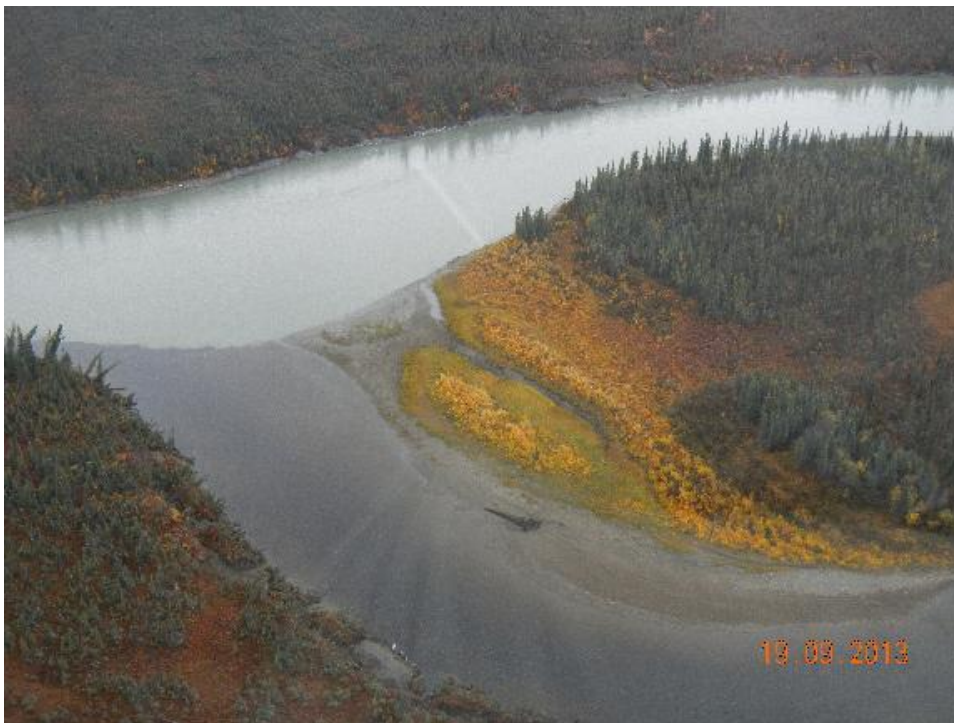
Figure A.2-22 – Tyone River confluence with Susitna at PRM 247.3 (P5530).

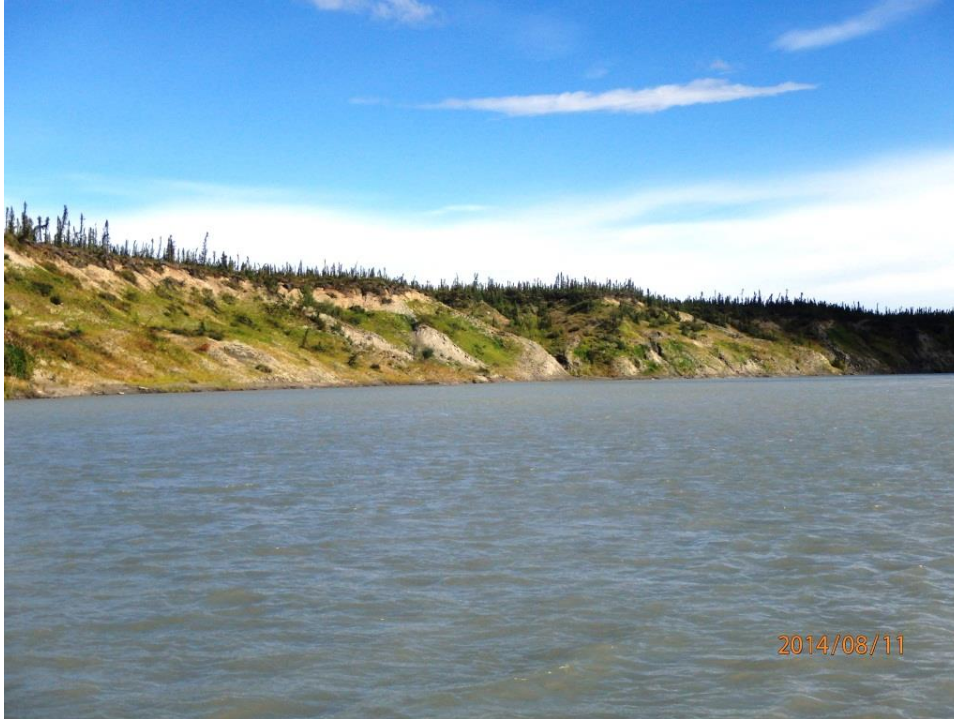
Figure A.2-23 – Eroding glacio-lacustrine deposits at PRM 248 (P898).

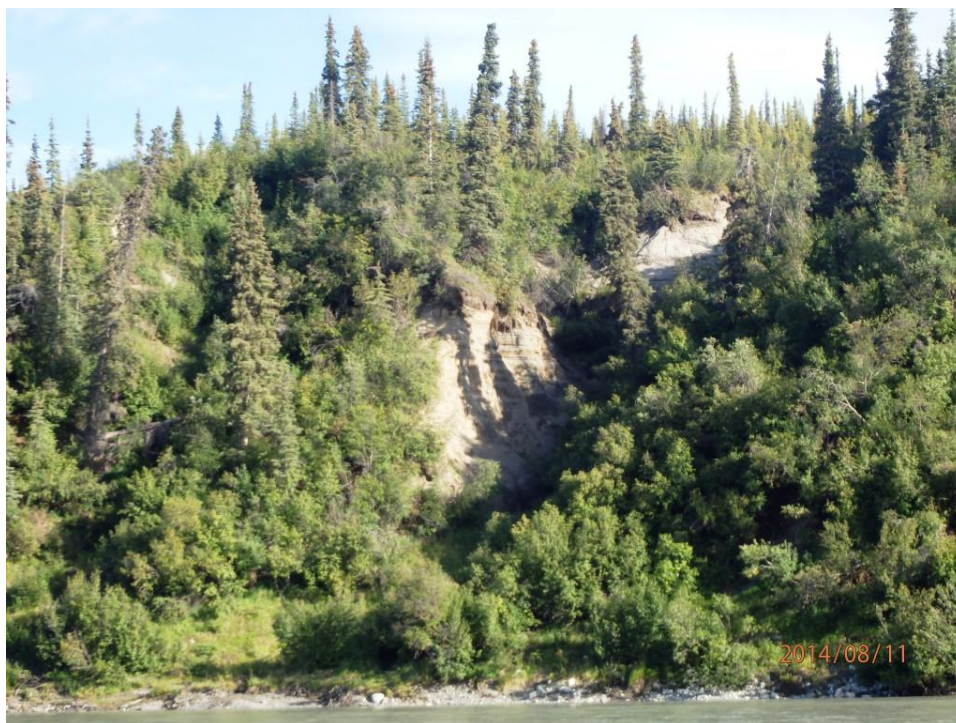
**Figure A.2-26 – Active landslide zone in till near PRM 245.5 (P973).**

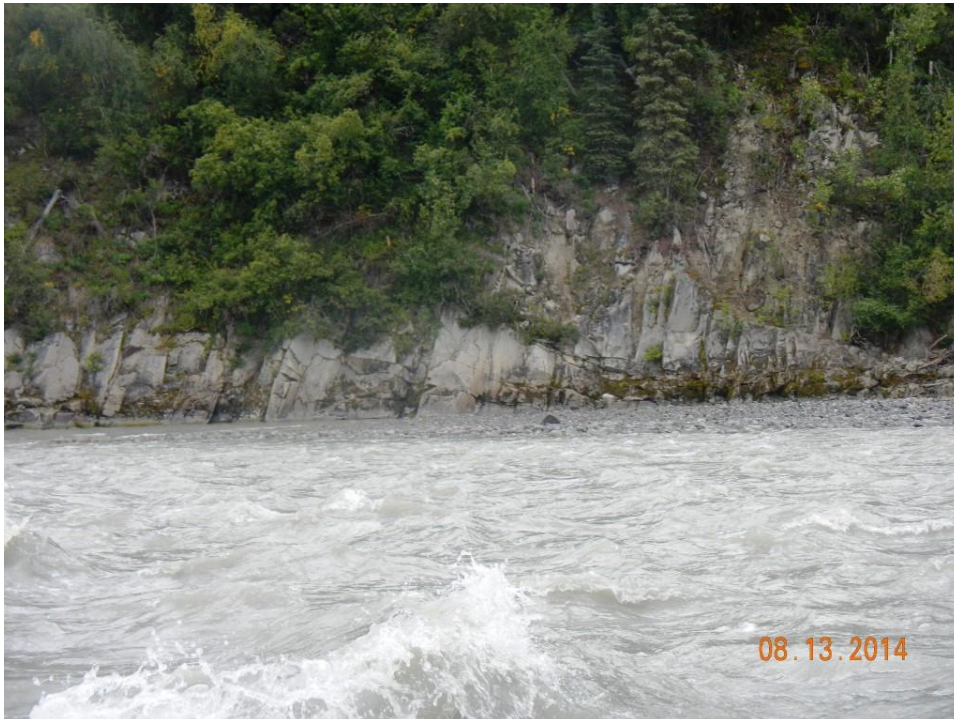
Figure A.2-44 – Bedrock right bank near PRM 232.5 (P829).

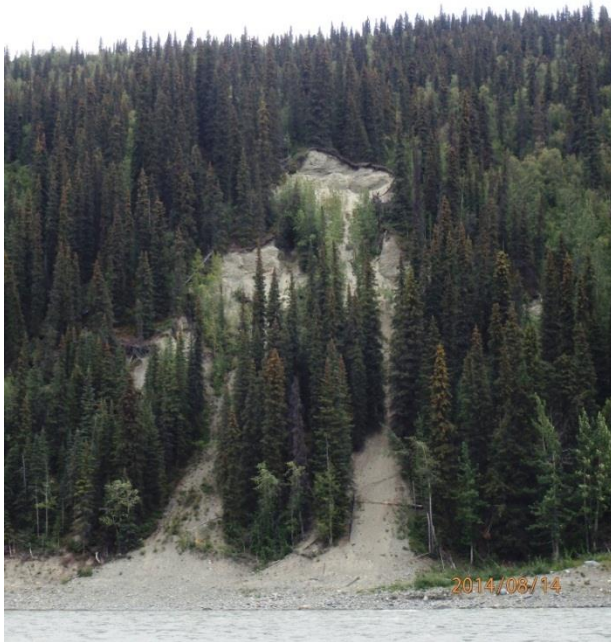
Figure A.2-52 – Active slide in till near PRM 221 (P114).

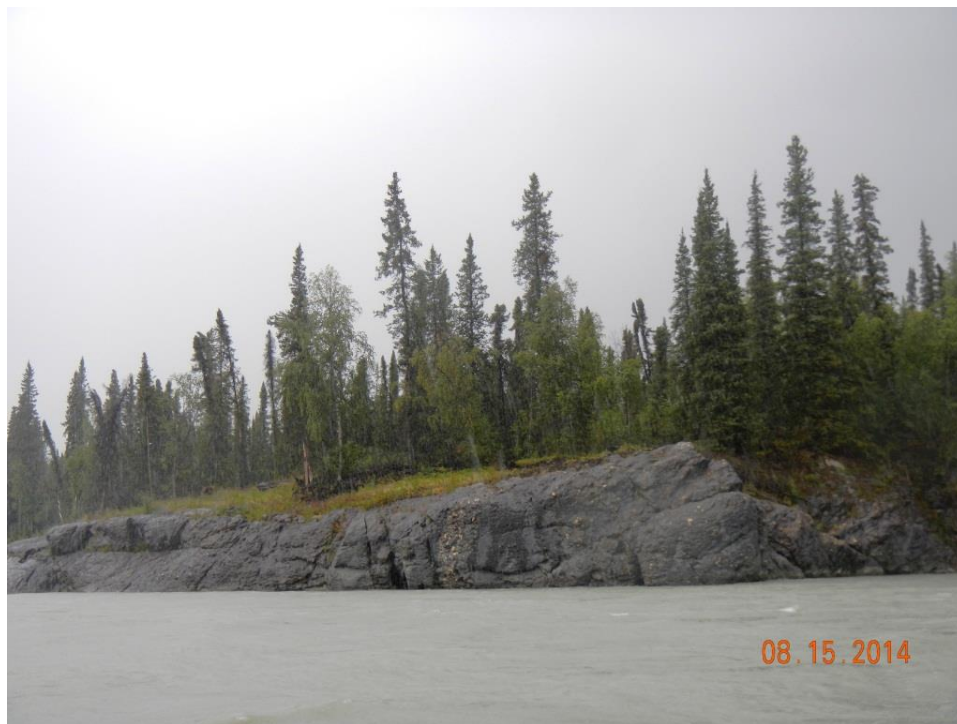
**Figure A.2-74 – Bedrock outcrop on right bank at PRM 204.1 (P210).**

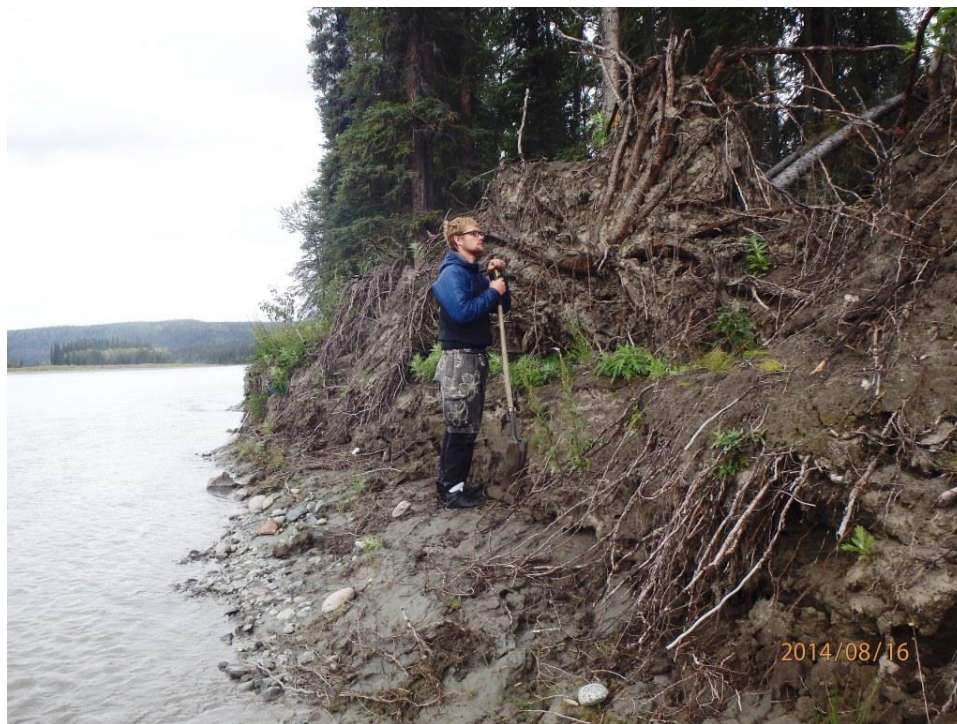
Figure A.2-86 – Ice effects on floodplain erosion near PRM 196.6 (P430).

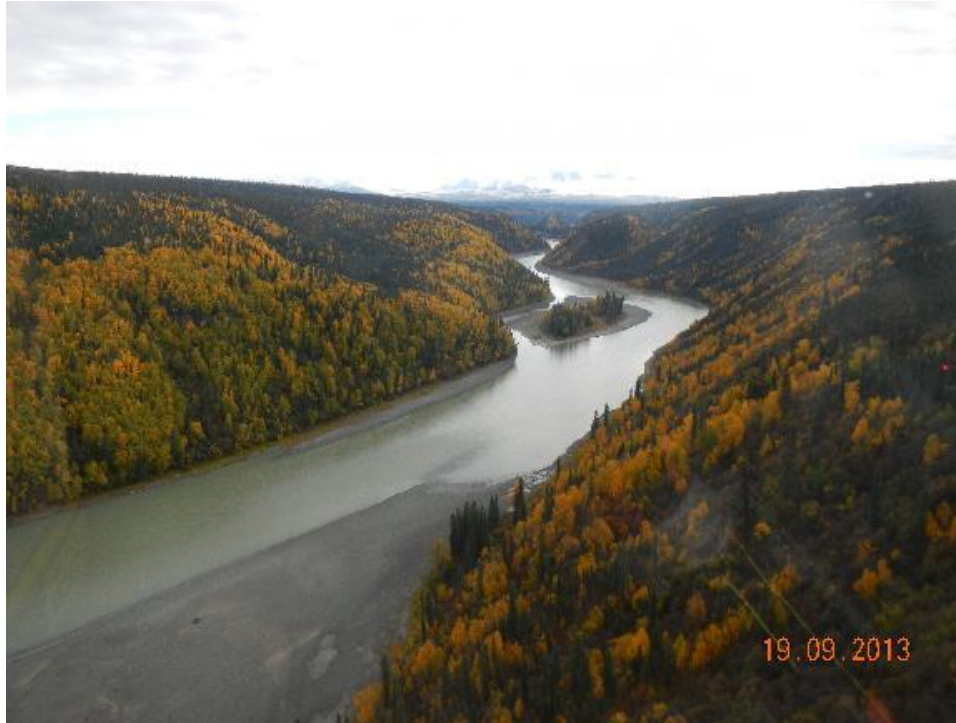
Figure A.2-90 – View upstream near PRM 191 of bedrock bounded channel (P5438).
